**42-46 King Street and 2-4 France Street,
Blackburn**

An Archaeological Building Survey

By J.M. Trippier Archaeological and Surveying Consultancy

September 2010

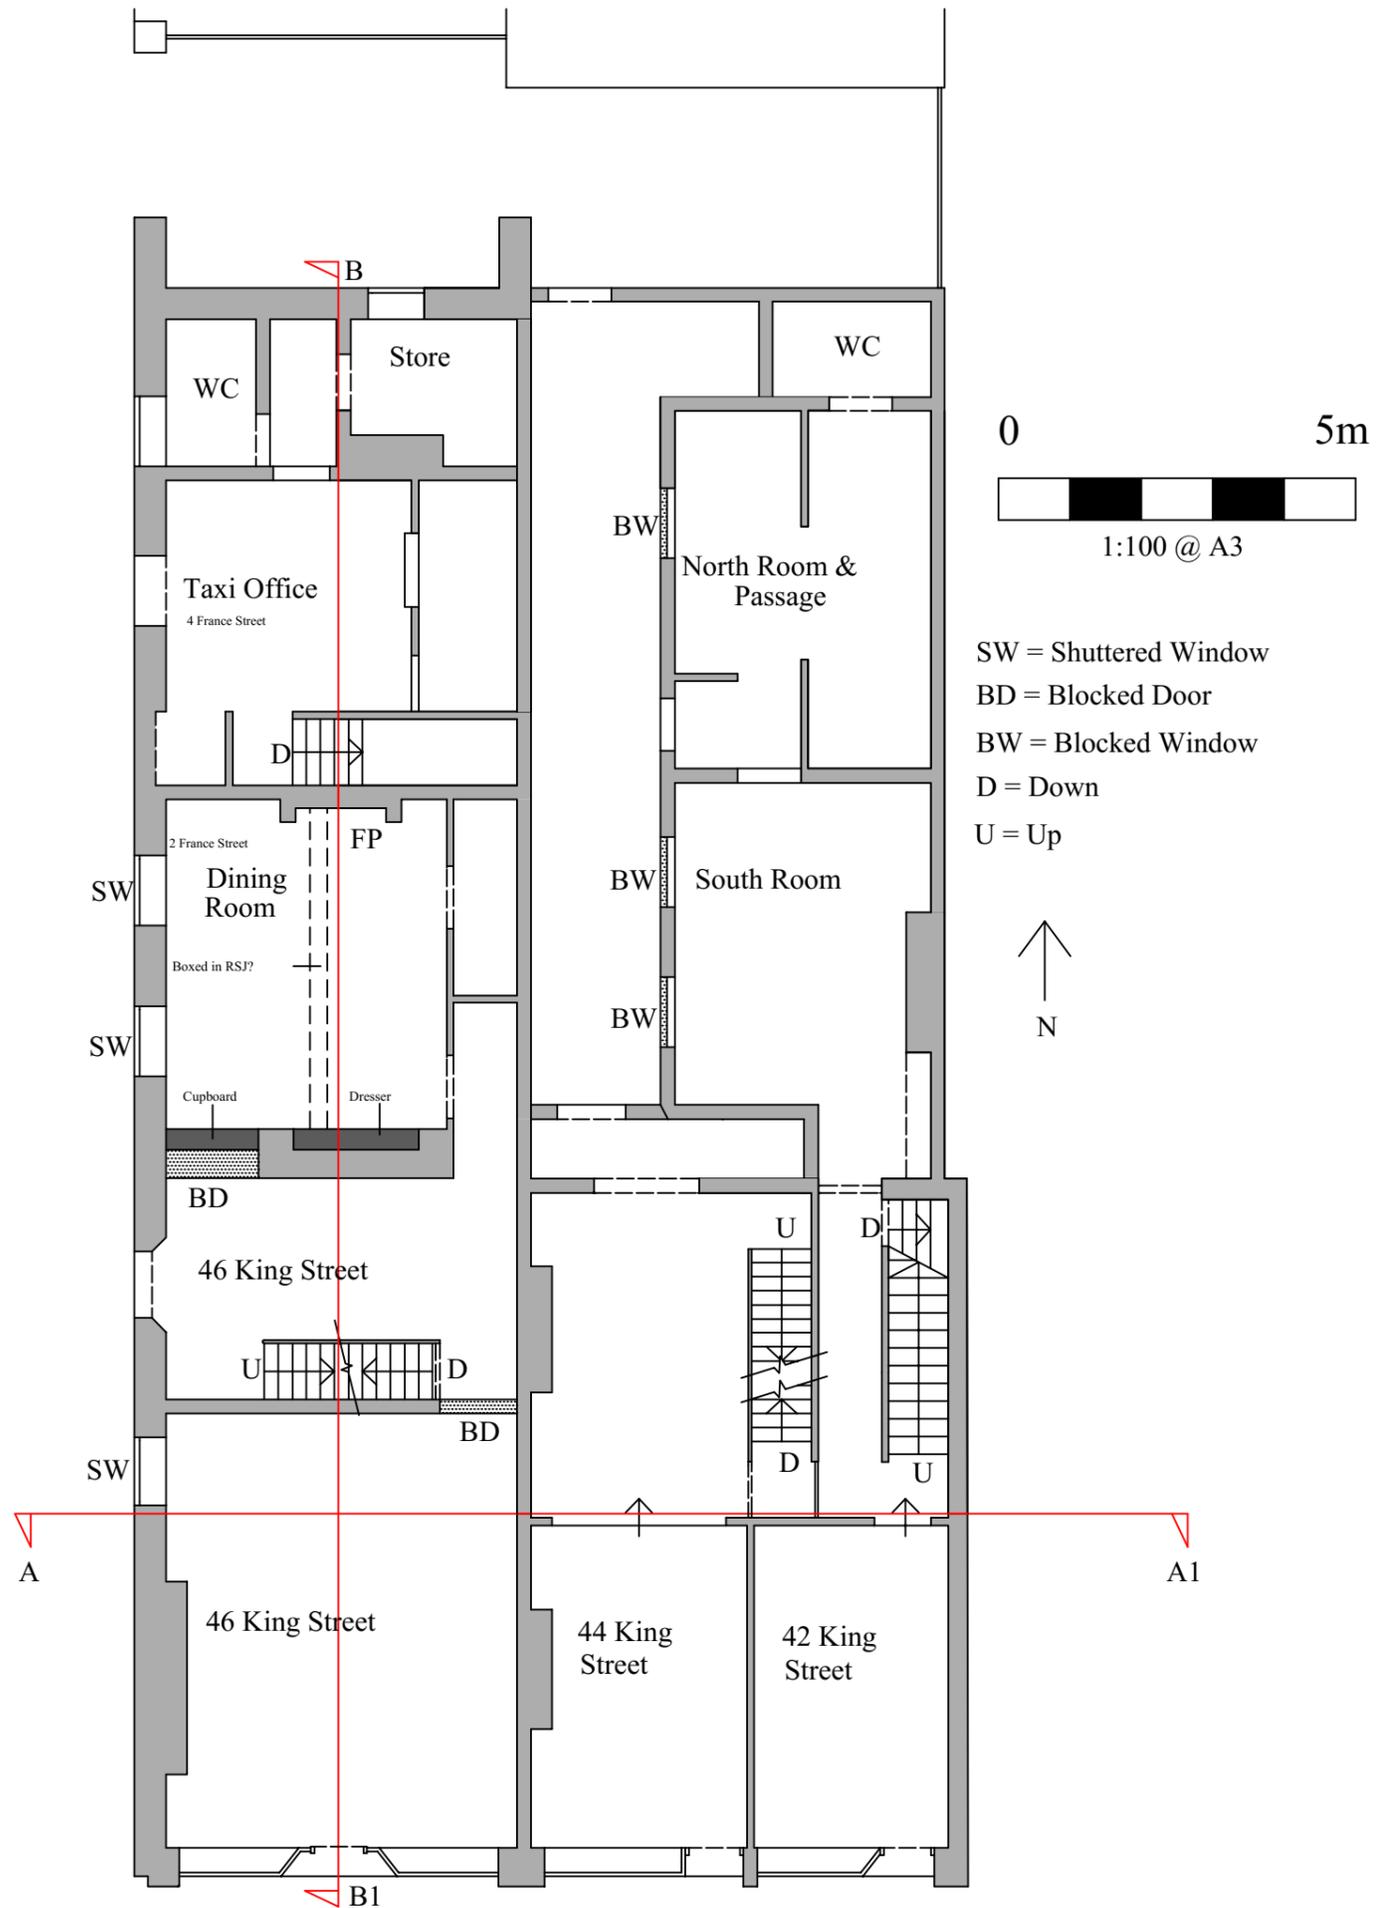
Fig. 3: Ground Floor Building Plan

- 6.3.1 General Layout (Fig. 3). This comprises a shop unit to the front of the property and workshop and storage areas to the rear at ground floor level. From this level there is both access to the cellar and the first floor. At first floor level there is a single room, with there being two rooms located at second floor level. An attic room exists within the eaves of the building.

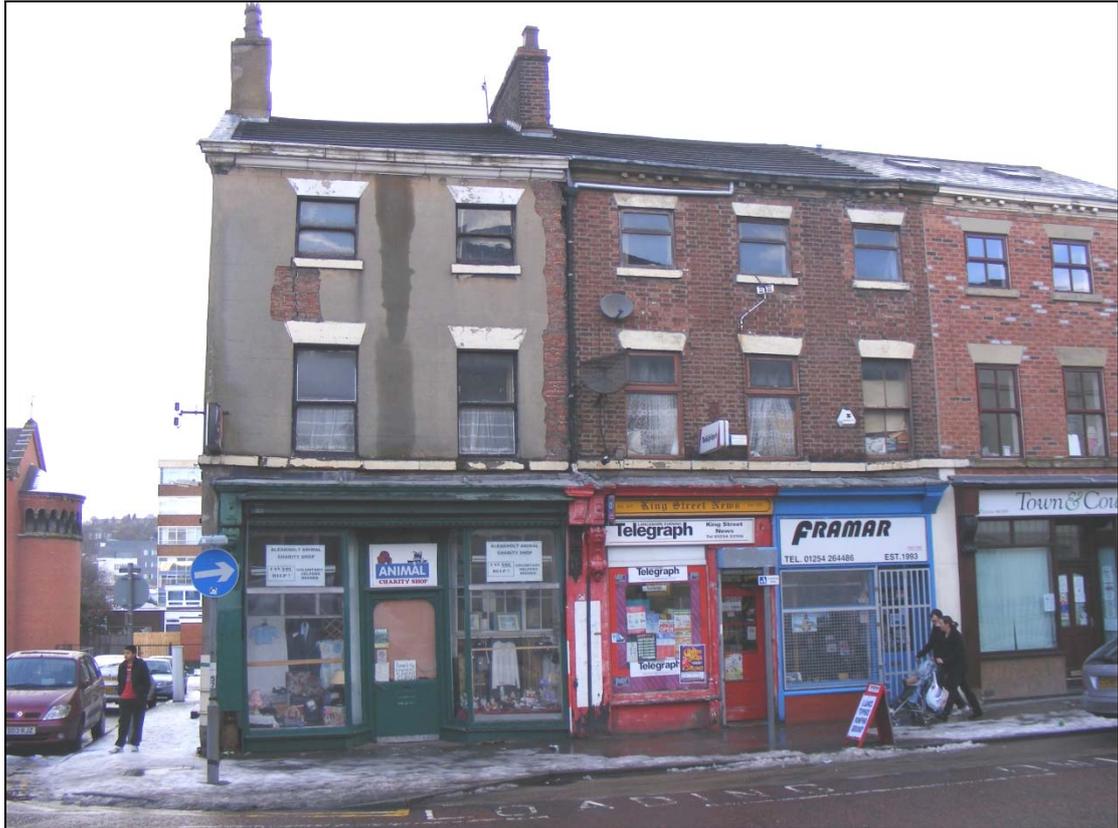
- 6.1.4 An east-west orientated double pitched gabled and slated roof covers 42 to 46 King Street (**Plate 1**). Internally it is supported by collar beam trusses with king struts and two sets of purlins (**Plate 14** and Brunskill 1985,115). A unusual feature is the basket woven and plastered lantern light within the roof space of no. 46 (**Plate 45**). There is a substantial chimney stack on the party wall between 42 to 46 King Street and another on west gable of 46 King Street is chimney stack which has 4 pots with a ‘petal effect’ design on the rim (**Plate 21**). 2-4 France Street has a north-south orientated double pitched gabled and slated roof. There are substantial chimney stacks present on north and south gables and a smaller central one (**Plates 2 & 24**). The larger ones are haunched. That on the north gable has 3 ‘petal effect’ pots similar to those on 46 King Street whilst that on the south gable has taller cowelled pots. Internally the roof is supported by common rafters and one set of purlins.

Plate 1: South elevation of 42-46 King Street

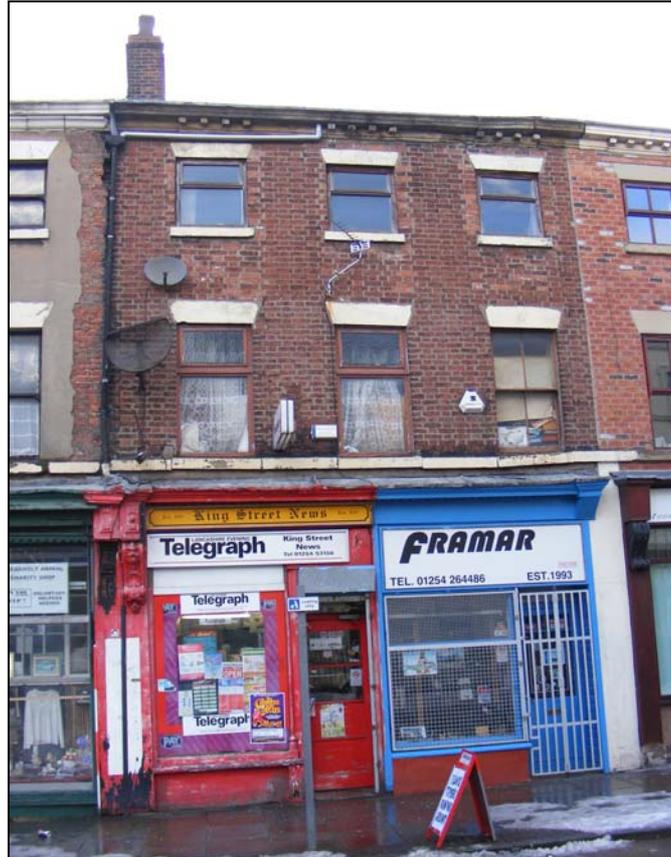
- 6.2.1 This building now comprises two ground floor shop units with two storeys over. The front (south) elevation comprises two timber framed shop fronts

(**Plate 3**). That of no.44 is the older of the two and may be a remnant of the original shop front which no doubt once extended across the whole building. It has a timber stall riser and a plain timber pilaster to the west, between this unit and no 46, which is surmounted by a console with a fielded panel supported by an exotically carved corbel (**Plate 4**). There is a plain fascia surmounted by a narrower projecting one bearing the legend 'King Street News' in antique script and the date 1878. There is a projecting moulded cornice over. The shop front to 42 King Street is more modern and plainer and has a brick stall riser. Both unit have inset doorways in open porches and timber panelled doors with the top halves glazed. At first floor level the bricks used for these two units is red-brown in colour with orange infill above and in between the upper windows. There are two modern casement windows with upper opening lights and four pane sash window at first floor level. All three windows have stone cills which form a string course continuing west to include no 46 and stone lintels. Directly above these at second floor level are three modern casement windows with upper opening lights and stone lintels and cills. There is a dentilled course of bricks supporting the guttering.

Plate 3: South Elevation of 42 & 44 King Street

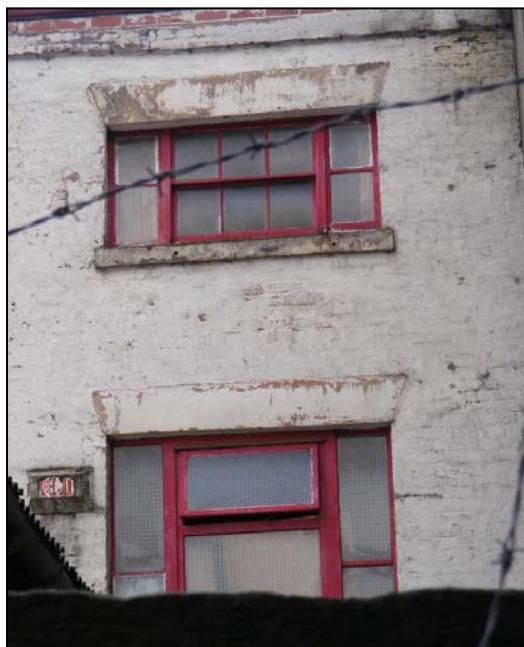
- 6.2.2 The rear of 42-44 King Street is whitewashed brick (**Plate5**). The two upper floors have unusual timber windows. At first floor level is a central casement with an upper opening light. There is a fixed light on either side each with a central transom. At second floor level is a six pane sash again with a fixed light on either side each with a central transom. At ground floor level is a modern timber lean-to with Perspex panels which leads from 44 to the rear yard. Along the east side of the yard is a rear outrigger attached to 42 King Street (**Plate 6**). The wall that comprises the outrigger of 42 King Street is of machine-cut brick and has three windows and a door, all of which appear to be modern. The roof of this comprises corrugated metal. The floor of the yard comprises of stone setts.

Plate 5: North elevation of 44 King Street

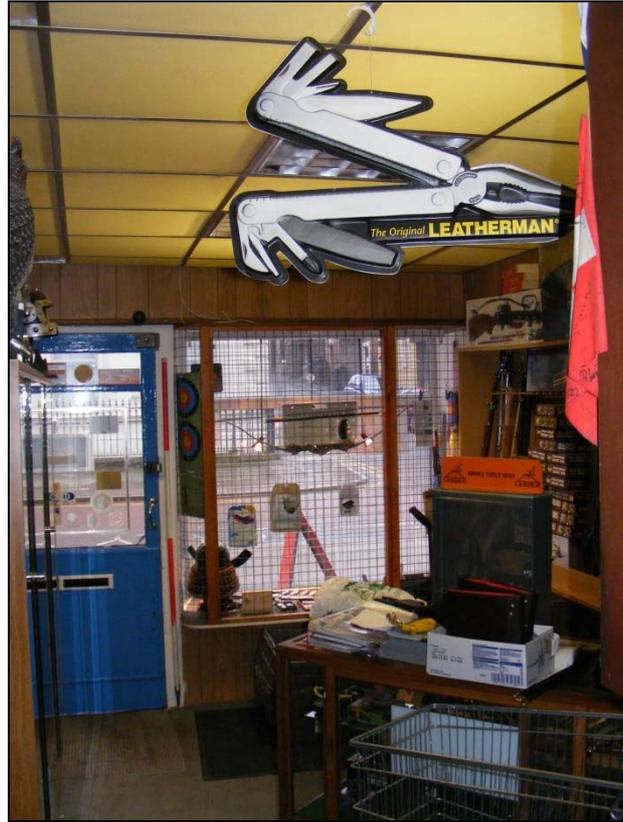
- 6.3.2 Ground Floor- Shop (Plate 7). The walls comprise fake wooden panels and typical modern shop fittings. It has a suspended Perspex ceiling complete with integrated spotlights. There is a single modern window located at the front of the property with a modern timber half-glazed glass door. Directly opposite this is a doorway that leads into the hallway area. The floor is carpeted.

Plate 7: Shop interior at 42 King Street

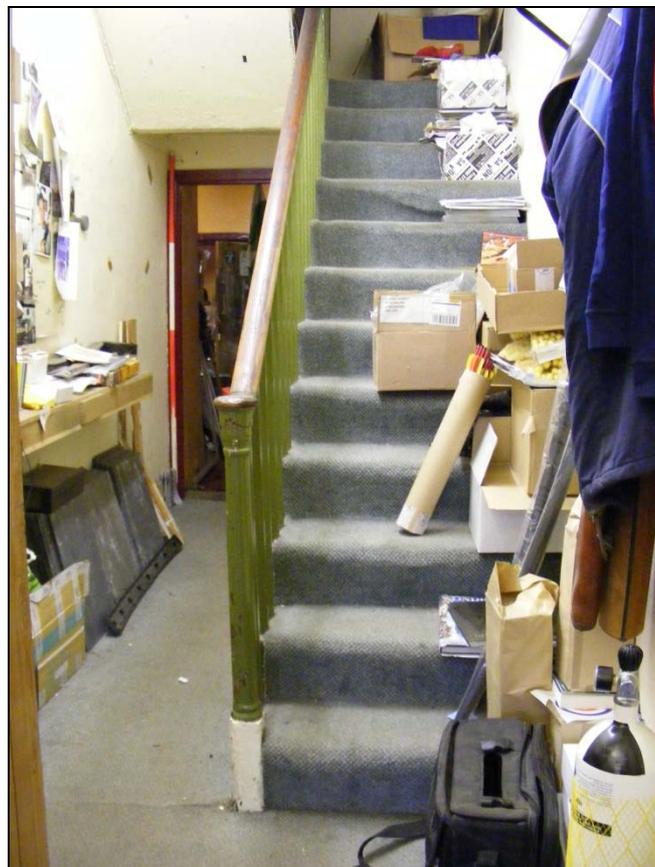
- 6.3.3 Ground Floor Hallway (Plate 8). From this point onwards the ground floor is 250mm higher than that in the shop. Located in this area is the staircase which leads to the first floor and beyond. Below the stairs is a doorway which leads

down to the cellar via a flight of stairs. The walls are plain white plastered and the floor is carpeted.

Plate 8: Stairs and rear passage at 42 King Street

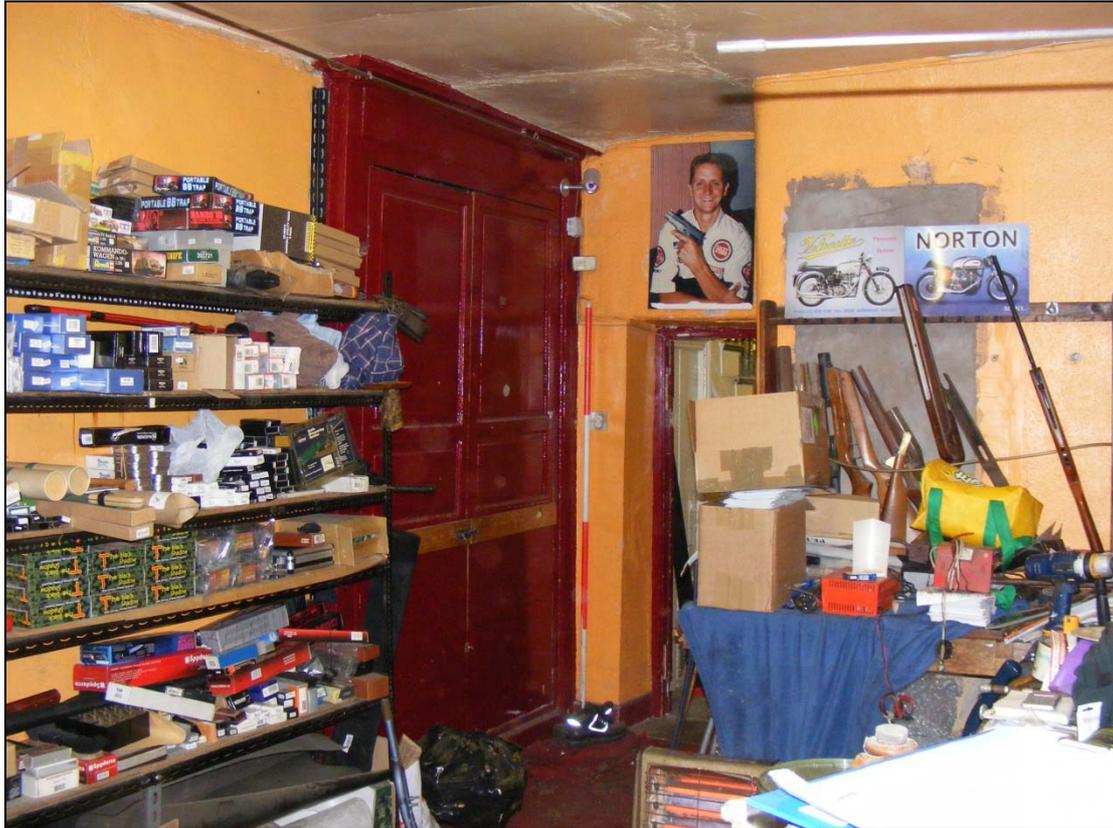
- 6.3.4 Ground Floor Workshop (Plate 9). This is located at the south end of the outrigger. The walls papered although largely covered by cupboards, shop fittings and work benches. The ceiling comprises white plaster and one strip light, with the floor being covered in stone flags. There is a blocked fireplace located in the right hand (east) wall with a double fronted cupboard being located in the alcove to the right (south) of this.

Plate 9: Interior of south room in outrigger at 42 King Street

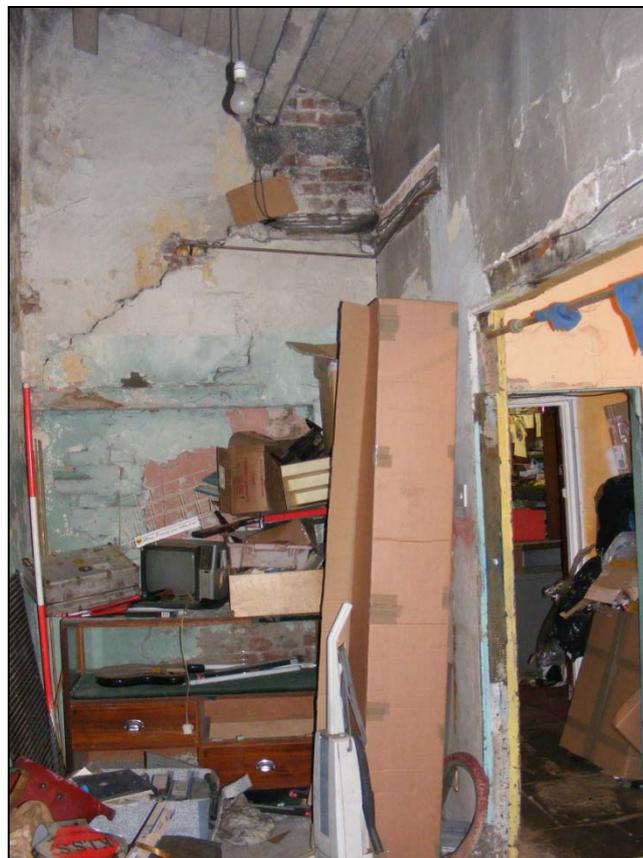
- 6.3.5 Ground Floor Storeroom and Connecting Passageway (Plate 10). This is located at the north end of the outrigger. The west half is a passageway connecting with the workshop to the south. A doorway located in the east wall leads to the storeroom. The walls and ceiling are plastered brick and the floor stone flagged. In the north-east corner of the room a small closet has been created to house a single toilet and sink. Directly above the doorway for this is a small window made out of glass bricks. In this area the corrugated metal roof is exposed along with a beam that runs approximately north-south.

Plate 10: Interior of north room in outrigger at 42 King Street

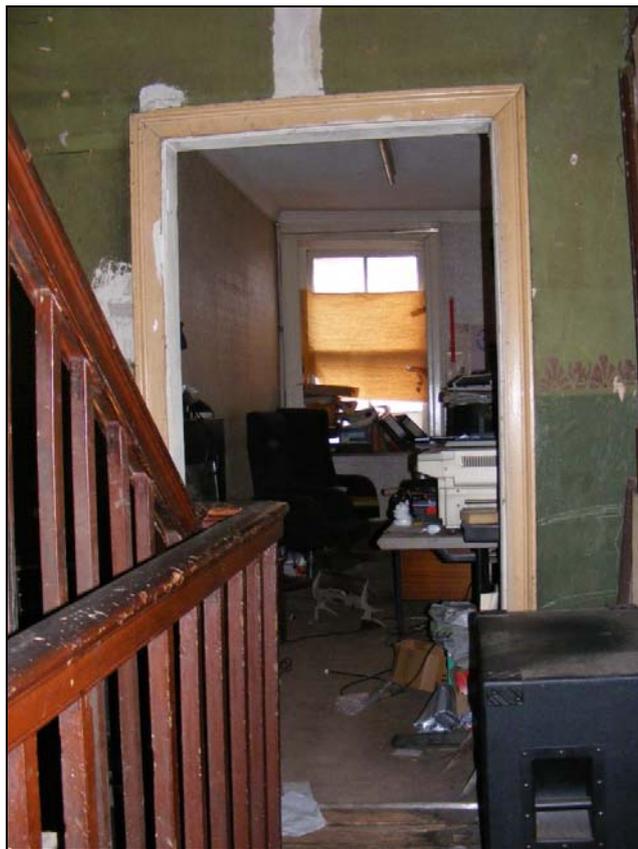
- 6.3.6 First Floor (Plate 11) This floor comprises a landing with another set of stairs providing access to the second floor and a single room at the front of the building that is currently used as an office. The walls of the landing area are plastered, but those in the office are papered. Both have plaster ceilings. The door to the office has been removed but an ornate wooden architrave remains. There is a cornice running all the way around the room. Opposite the doorway is a single four pane sash window with a wooden cill. The office floor is carpeted but the landing floorboards are bare. There is a door on the landing, which is currently obstructed by a piece of furniture, which leads to the rooms located above 44 King Street.

Plate 11: First floor landing and south room at 42 King Street

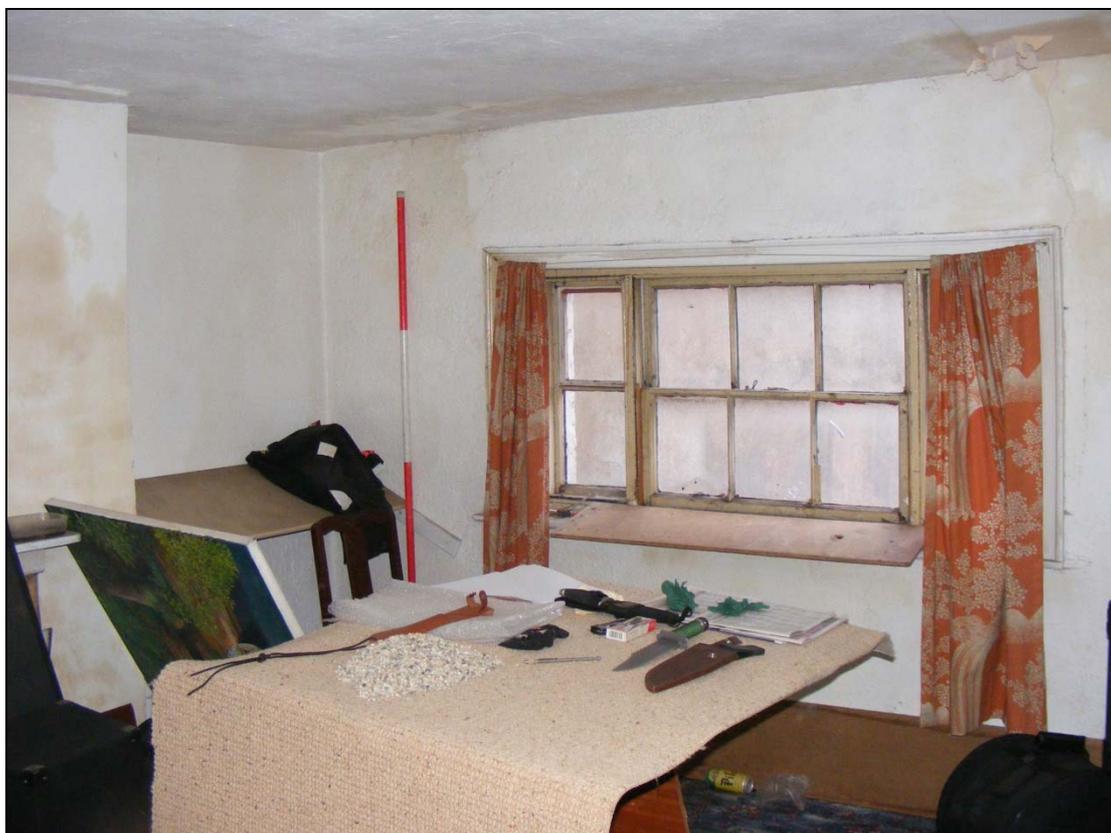
- 6.3.7 Second Floor North Room (Plate 12). This room is accessed via a timber door with four fielded panels. The walls and ceiling are plastered and the floors carpeted. Located in the rear (north) wall of the property is a ten paned sash window with a wooden cill. There is a blocked fireplace in the west wall with a cupboard being located in the left side alcove.

Plate 12: North room on second floor over 42 & 44 King Street

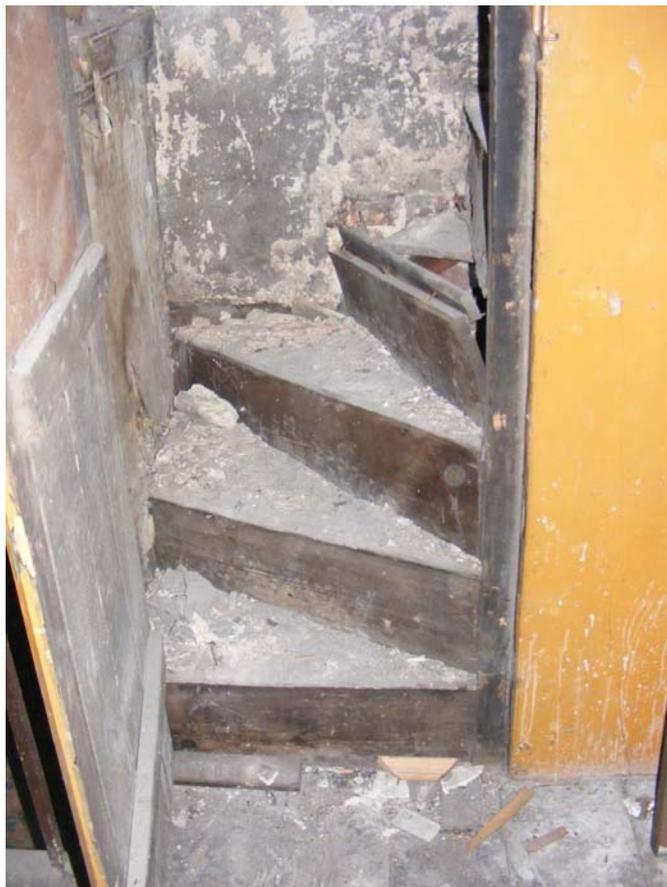
Plate 13: Stairs from second floor of 42 King Street to attic

- 6.3.9 Second Floor Landing There is a small window located in the north wall on the half landing between the first and second floors. The walls and ceiling of the landing are plastered and the floor comprises bare floorboards. Another timber doorway on the landing and another set of stairs (**Plate 13**) leads to the roof space where the western north-south brick party wall separating nos 42-44 from no 46 King St, and its smoke blackened flu is clearly visible (**Plate**

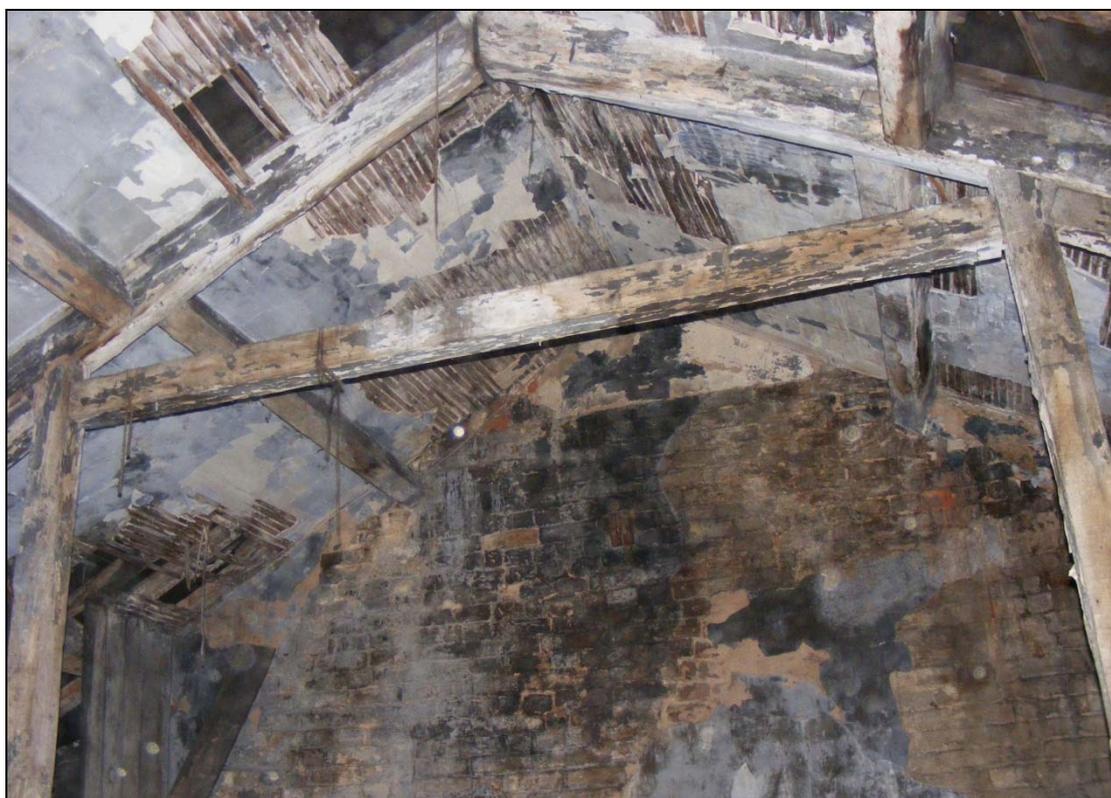
14). Also visible is the roof truss described at para. 6.1.4 above. There is a lath and plaster coating to the underside of the roof slates.

Plate 14: Roof truss and attic over 42 & 44 King Street

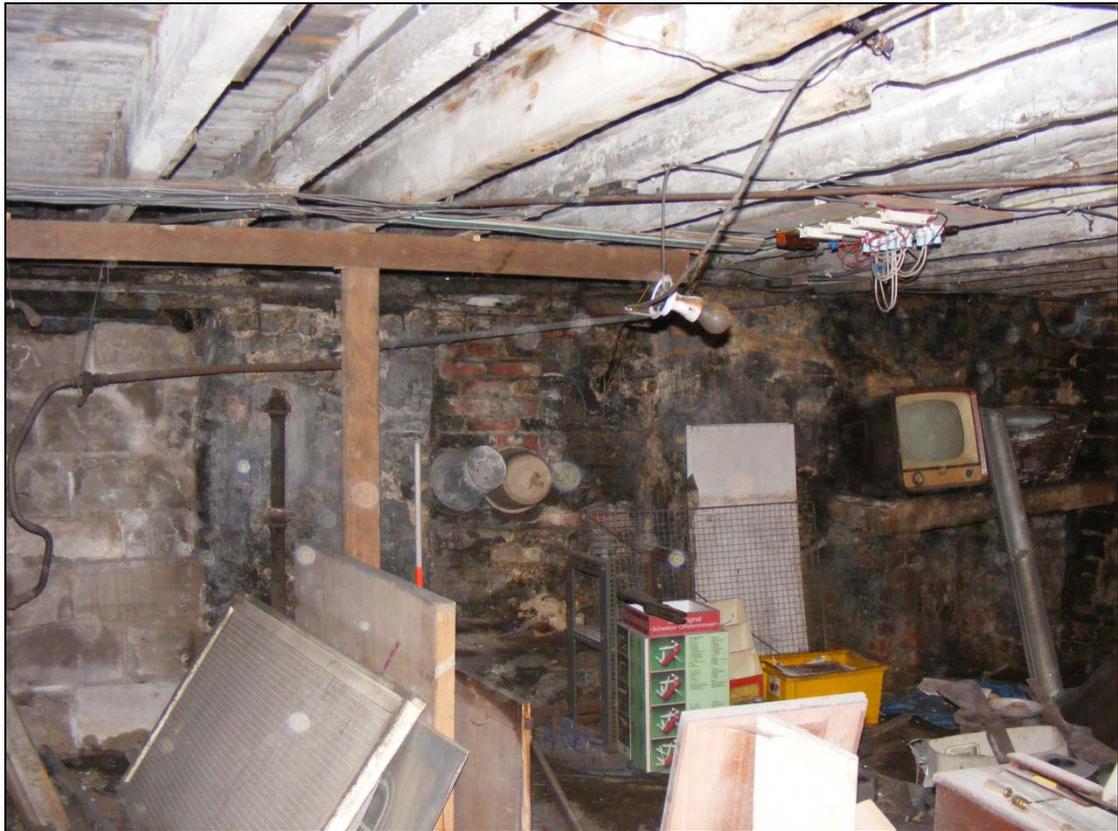
Plate 15: Cellar under front of 42-44 King Street

6.3.10 Cellar (Plate 15). This runs under the front of nos. 42 & 44. The floor is covered in stone flags and the walls comprise lime plastered brick. The ceiling is open to the underside of the floor above, with there being visible joists running on a north-south orientation. Between the joists below the floor level above is lime plaster. In the south wall there are three shallow alcoves in-between the piers that form the actual wall. Located in the southwest corner of the room is a stone sink on brick piers.

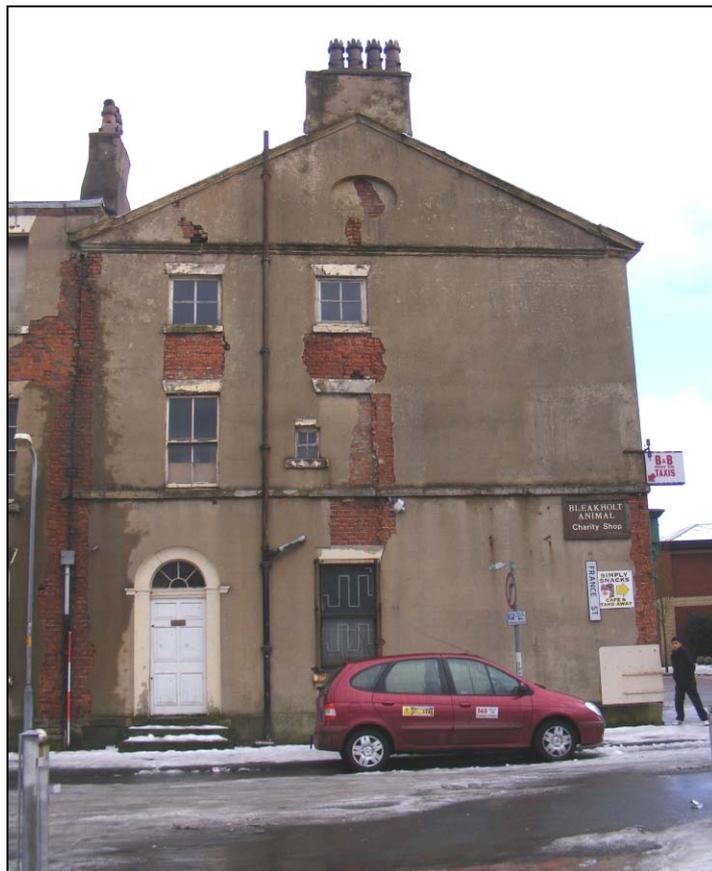
- 6.5.2 The side elevation of 46 King Street (**Plate 21**) is constructed of orange handmade bricks covered with an imitation stone block render, although this is missing in places. A plain stone string course runs below the level of the first floor windows and a moulded one runs above the windows of the second floor. The ground floor doorway is reached by three steps from street level. The door itself is a modern one but it has a period stone surround with a semi-circular arched head and a fanlight over a moulded cill (**Plate 22**). To right (south) of this a sash window with a stone lintel and cill. Above the doorway is a four pane sash window with nibs. To the south is a blocked window. The blocking has also been rendered in the same style as the main elevation. The cills for both these windows is formed by the plain string course referred to above and both have stone lintels. Partially cut into the left (north) side of the blocked window is a small four pane sash window with stone cill and lintel. At second floor level directly above those on the second floor are two ½ size four pane double hung sash windows with stone lintels and cills. At attic level is an *oculus* which is bricked up and rendered over.

Plate 21: West elevation of 46 King Street

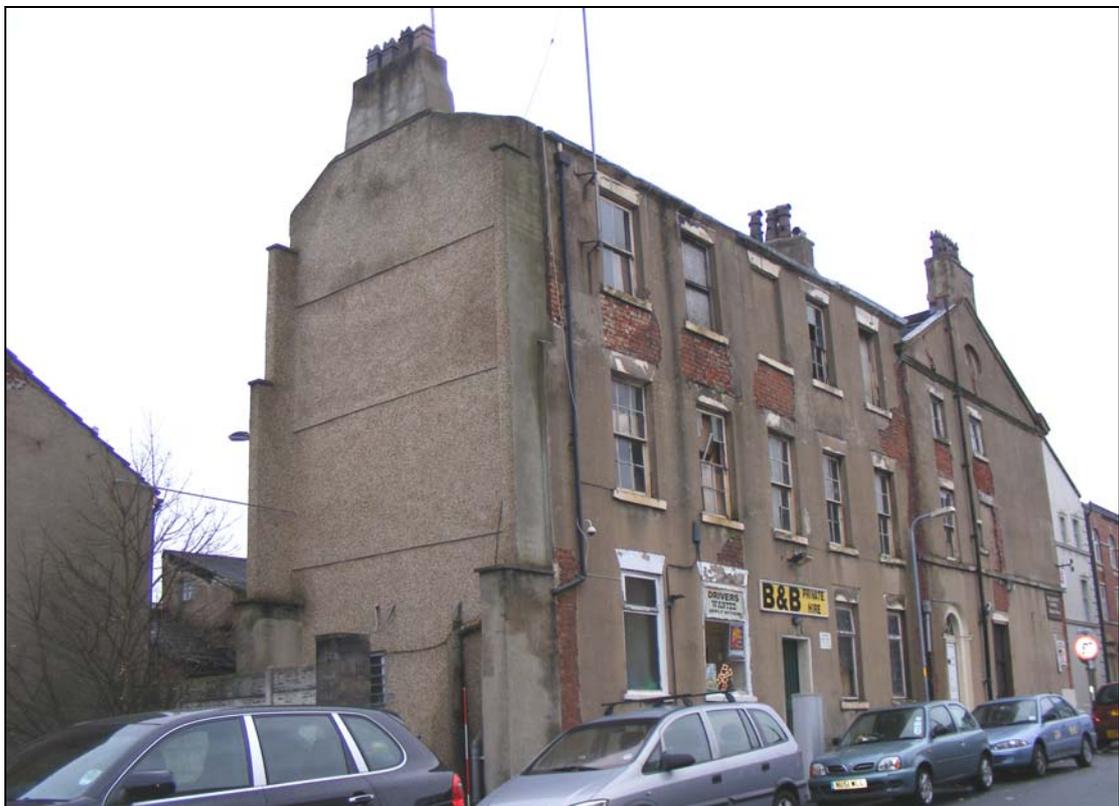
Plate 24: North gable of 2-4 France Street

- 6.5.4 The north gable end of 2-4 France Street is now pebble-dashed (**Plate 24**). There are a number of horizontal beads but the wall is otherwise blank. Two projections suggest that another building may have been attached. The east elevation is finished similarly.

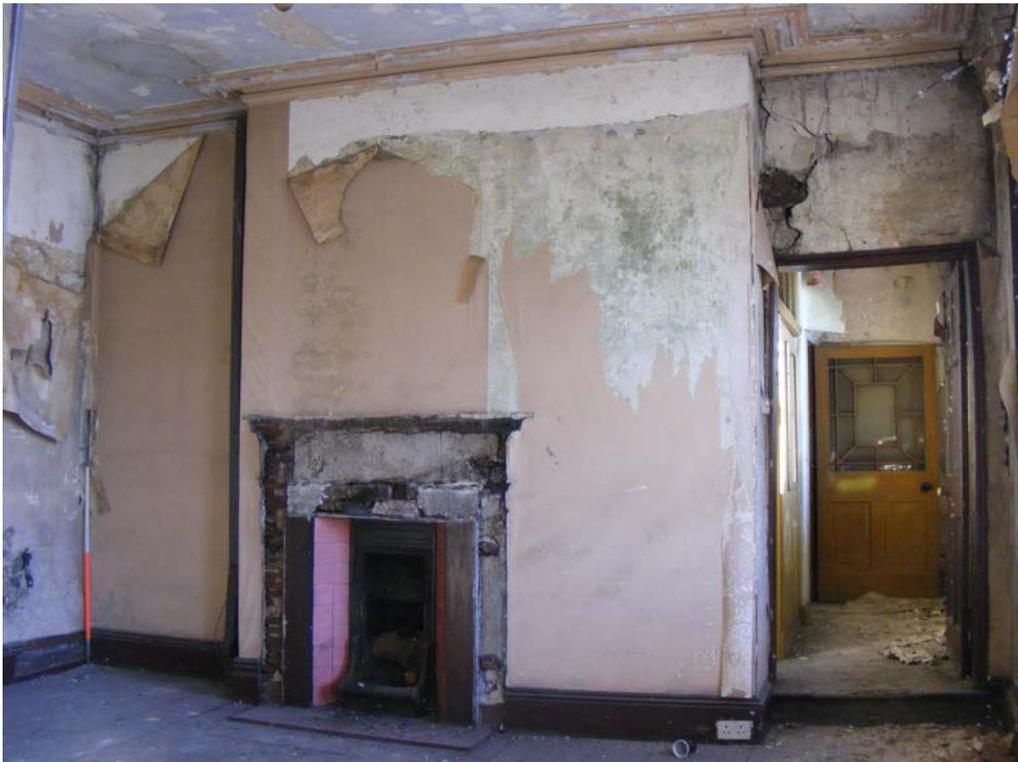
- 6.6.13 Central Room (Plate 37). This room, which lies over the dining room at 2 France Street, has papered plaster walls and a painted plastered ceiling. The floor is covered in timber boards that are up to 300mm in width but has been repaired in places by narrower boards. There is also a moulded timber skirting and a moulded plaster coving. In the south wall is a chimney breast with a cast iron grate complete with a tiled surround. There is another chimney breast in

Plate 37: Central first floor room over 2 France Street
