An archaeological building survey was required as a condition of planning permission for conversion to residential use of a barn at Wheatsheaf Hill Farm, Barn, Plantation Road, Edgworth (NGR SD 7460 1762). The work was carried out on behalf of Mr Ian Higson by J. M. Trippier Archaeological and Surveying Consultancy. The building was found to be a stone-built 'laithe barn' adjoining a dwellinghouse, both of which were built within 50 years of the enclosure of Edgworth Moor in 1797. The barn is small, comprising a hay store with a single cart door and an adjoining shippon with stallage for 8 beasts with a hay loft over. The adjoining house appears to have a loomshop window and the steading is typical of the laithe-house type which provided a profitable combination of part time farming and hand powered textile work in the Lancashire hill country around the beginning of the 19th century.

WHEATSHEAF HILL FARM, PLANTATION ROAD, EDGORTH

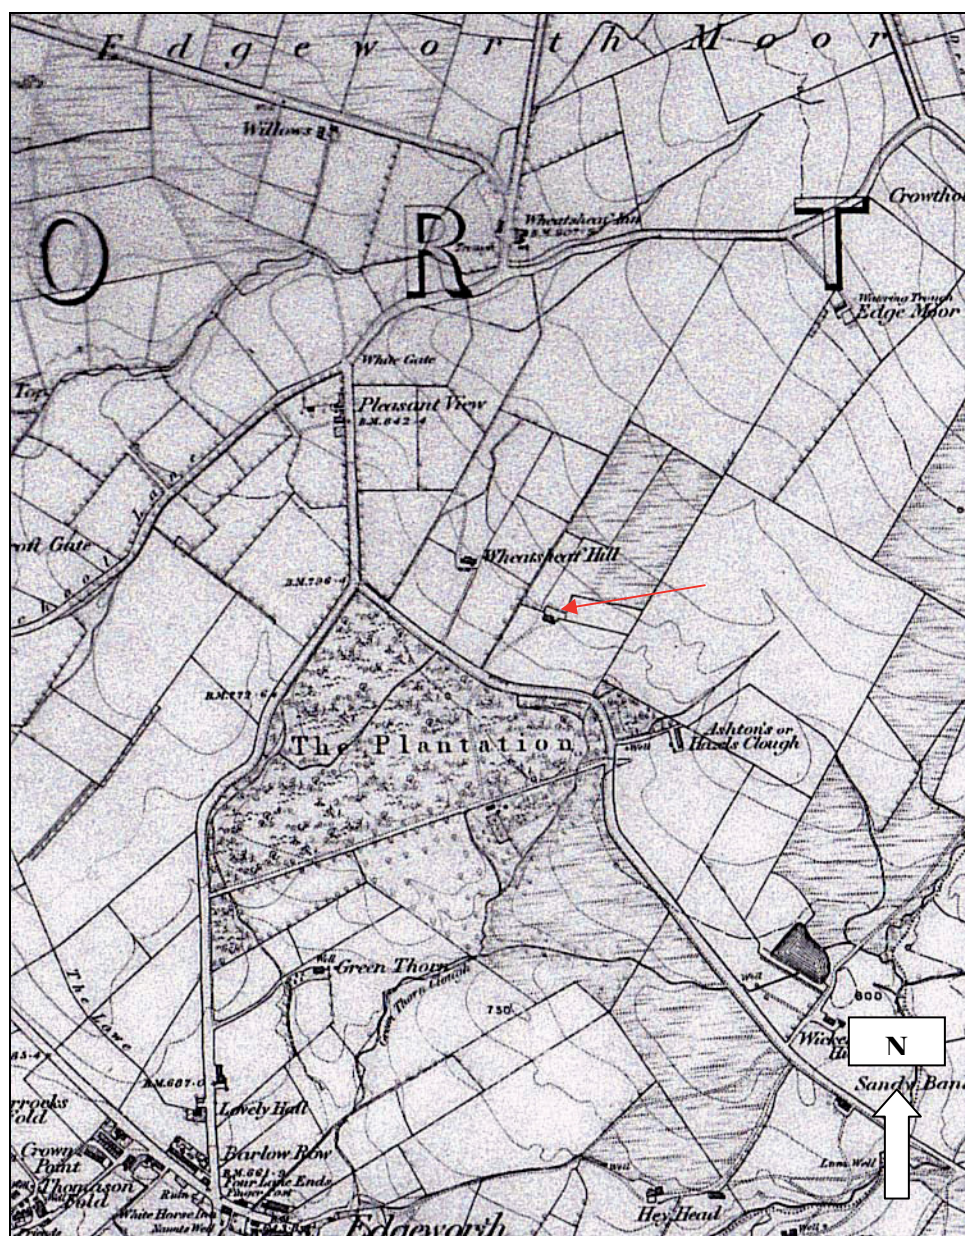
Fig. 4: OS 6" Lancashire Sheet 79, 1850 –Actual Size

- 5.5 Wheatsheaf Hill Farm Barn is shown on the 1st edition 1:10500 map of 1850 (Fig 4) as rectangular building with a small lean-to on the southern end of its eastern face. The building is not named. The census for the following year (BLSL/1851) states that it was then occupied by John Bury who lived there with his wife and daughter, as well as his illegitimate son. He is listed as a farmer of 24 acres and also a collier. He remained there until after 1861, being listed on the census of that year (BLSL/1861) by which time he had 5 children and his niece living with him, although his illegitimate son was not mentioned. Over the following decade the farm changed hands and was occupied by James Whitehead (BLSL/1871census). The neighbouring property is also listed as housing John Whitehead, James’s brother, who acted as a farm labourer, and James Entwistle, a retired farmer most likely related to the Entwistle family who had occupied the neighbouring property for many decades. By 1881 George Warburton occupied the farm with his wife Elizabeth and their 5 children, where George was listed as a farmer of 16 acres (BLSL/1881census). 1891 is the first census record to distinguish between the subject building and its neighbour, with the suffix ‘farm’ being added to the name (BLSL/1891). Once again the occupiers have changed, with William Crompton residing there with his wife and 2 children. He is, however, listed as working with looms rather than farming, although by the 1901 census the farm had changed hands once again and the occupier, William Billing, is noted as being a farmer, with his wife and eldest daughter being cotton weavers (BLSL/1901).

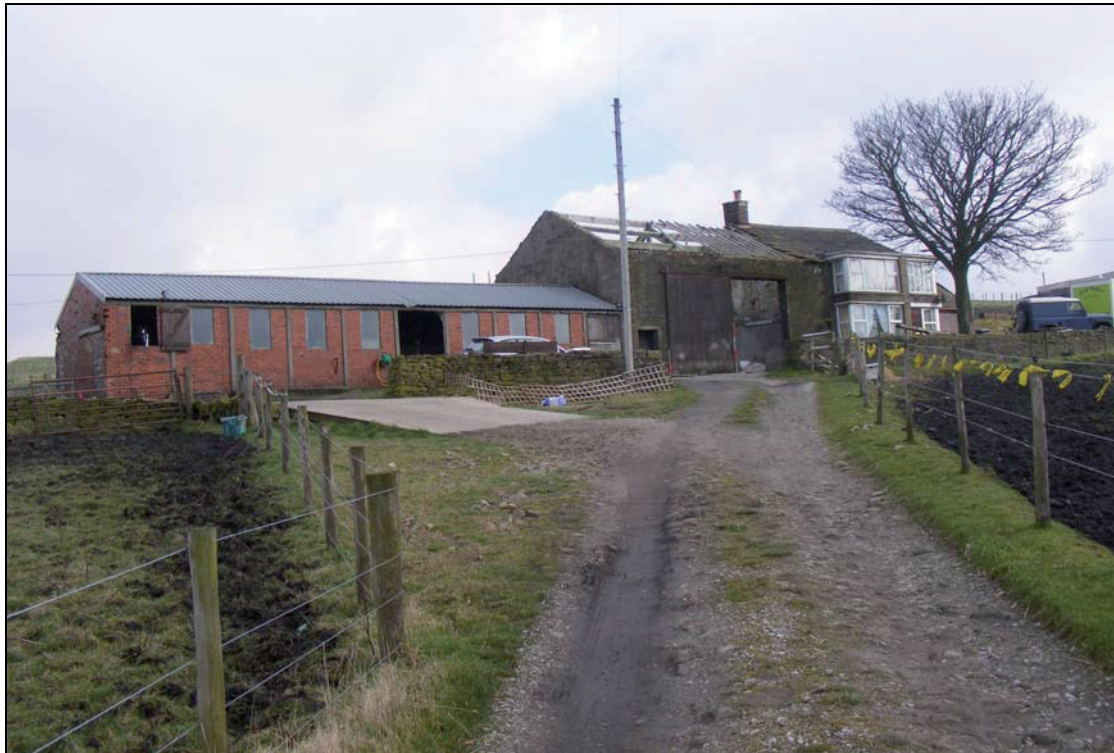
Plate 1: Farmstead from south west

6.1 General Description (Plate 1).

- 6.1.1 The subject building comprises a rectangular two storey sandstone built structure, the frontage facing south south-west. The subject, a barn, has a house constructed on its east and a modern single storey brick built stable block butting it to the west. The layout of the farmstead is elongated. The exterior fabric is in good condition although the roof has had its covering and many of its rafters removed. Stone roofing flags stored to the rear of the barn were presumably removed from it. By contrast the house roof has a Welsh slate covering. The roof is double pitched with a single king post truss in the centre. The barn is currently unused and undergoing construction work. A single sandstone chimney is visible rising from the dividing wall between the barn and the house. It has a single modern ceramic pot. Although there is evidence suggesting that the barn had a partial first floor, this is no longer present.

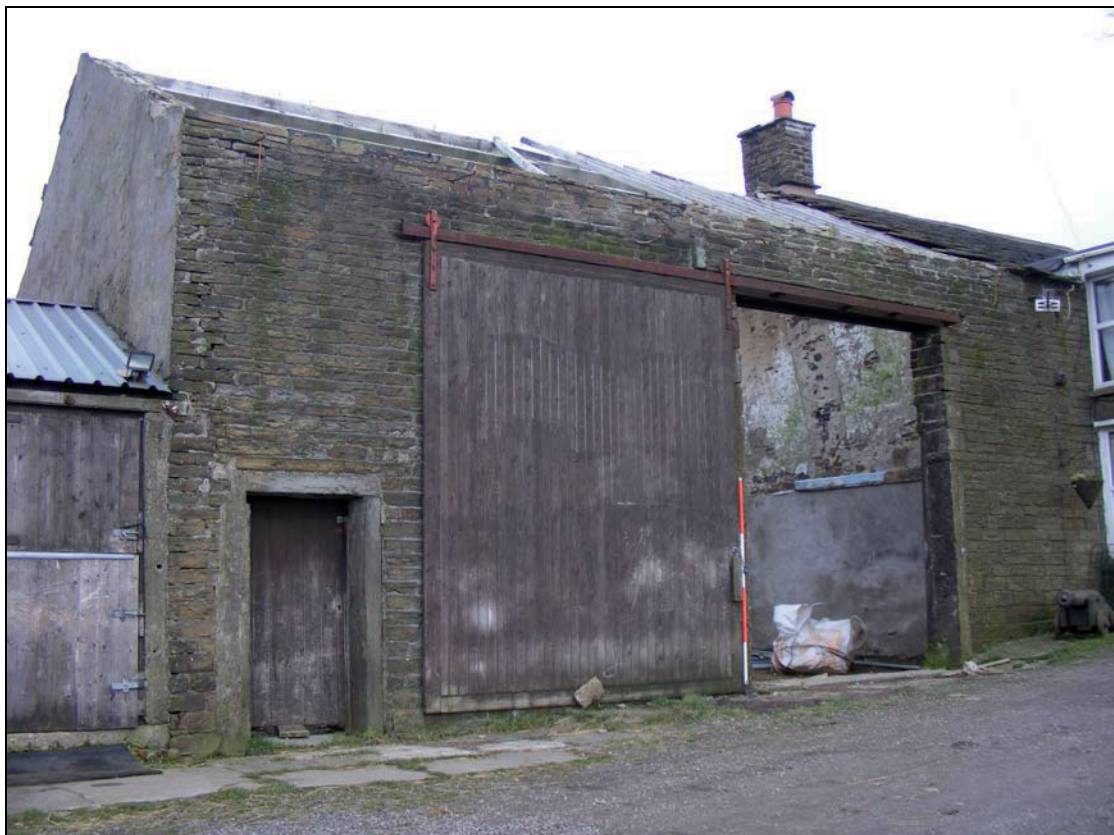
Plate 2: Barn from south west

- 6.2.1 Southern Elevation (Plate 2). This elevation comprises the front of the building and is constructed in regularly coursed and shaped sandstone rubble, with lime mortar, re-pointed with cement in places. It is characterised by two doorways; a single door located at the west end of the face and a large barn door, the western jamb of which is approximately central to the wall. The single door has a sandstone surround with cement repair work on its western jamb. It has a timber frame and door. The barn door has large sandstone jambs, reaching two thirds of the way up, capped with quoins. The lintel is formed from an RSJ which also forms the runner for a sliding timber batten door.

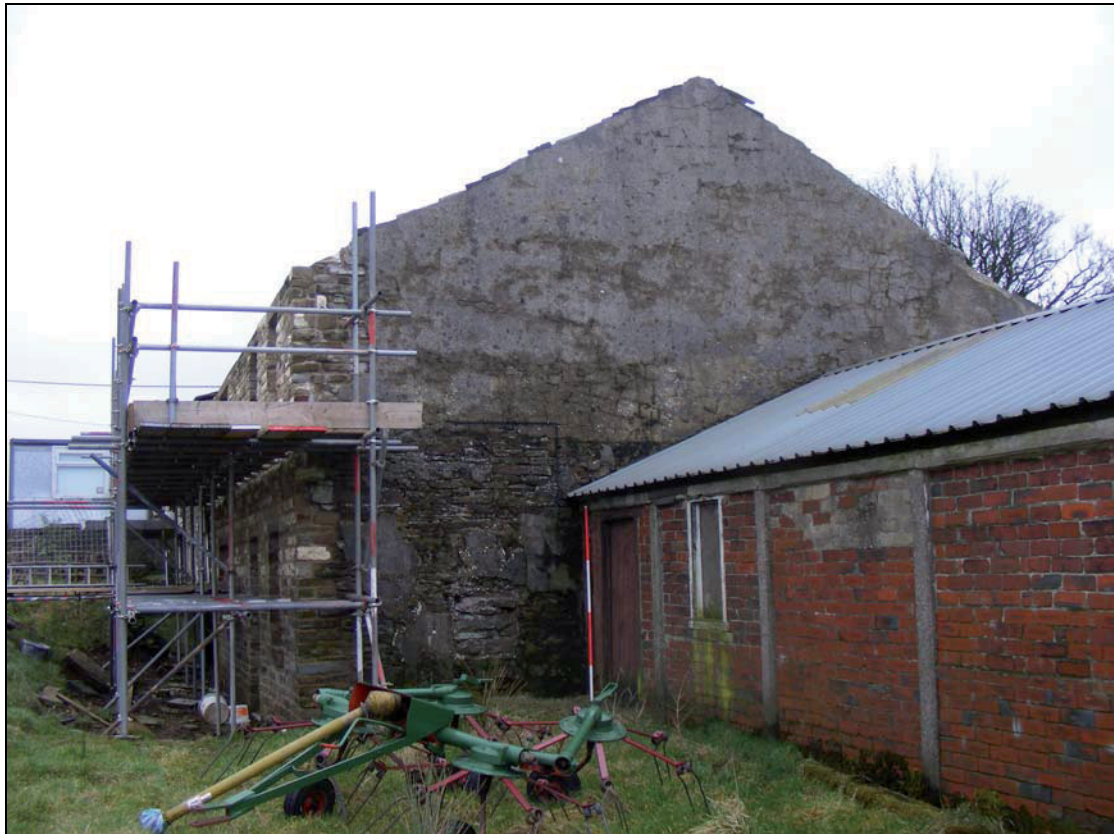
Plate 3: West elevation of barn

- 6.2.2 Western Elevation (Plate 3). This forms one of the gable ends of the building. It is partially obscured at ground floor level by the modern single storey brick built stable block although the north end of the elevation remains exposed. The elevation is built of rough sandstone blocks, occasionally brought to courses and bonded with lime mortar. It has been cement rendered and whitewashed within the modern brick stables. Outwith the stables it is

rendered at first floor level only with the north end of the elevation being exposed stonework. There is a centrally located personnel door blocked with timber within the stable block and a square window with a sandstone surround, and now blocked with sandstone, to the north. The northern edge of the building shows a clean join with the rebuilt sandstone wall of the north face, butting the original western face (see para. 6.2.3 below).

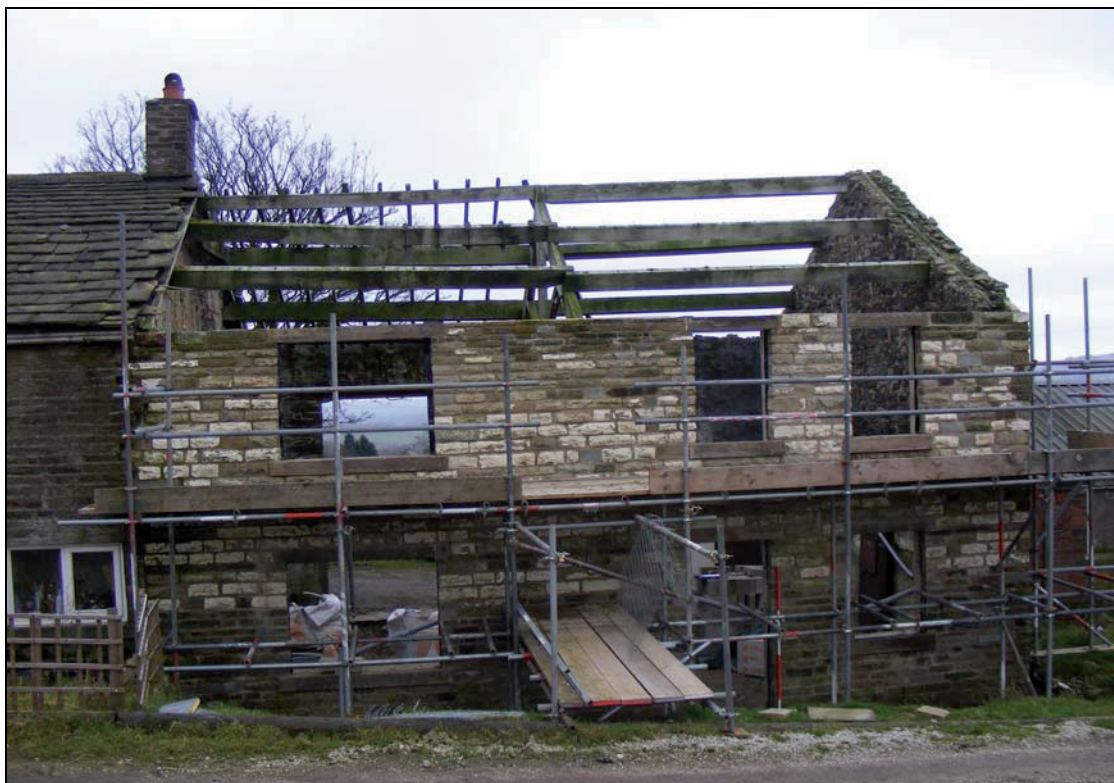
Plate 4: North elevation

- 6.2.3 Northern Elevation (Plate 4). This elevation comprises the rear of the building. The whole face is currently undergoing reconstruction in regularly coursed sandstone blocks, some of which have a rock pitched face, bonded in cement. It is characterised by five windows, three of which are at first floor level, and a single personal door. Due to the ongoing reconstruction, none of the windows or doors has frames fitted. Both windows at the eastern end of the face at ground and first floor levels are landscape, whereas the two at the western end of the face are portrait. The door is located to the west of centre with a portrait window above. Although the walls are constructed of sandstone, the cills and lintels of the doors and windows are of concrete.

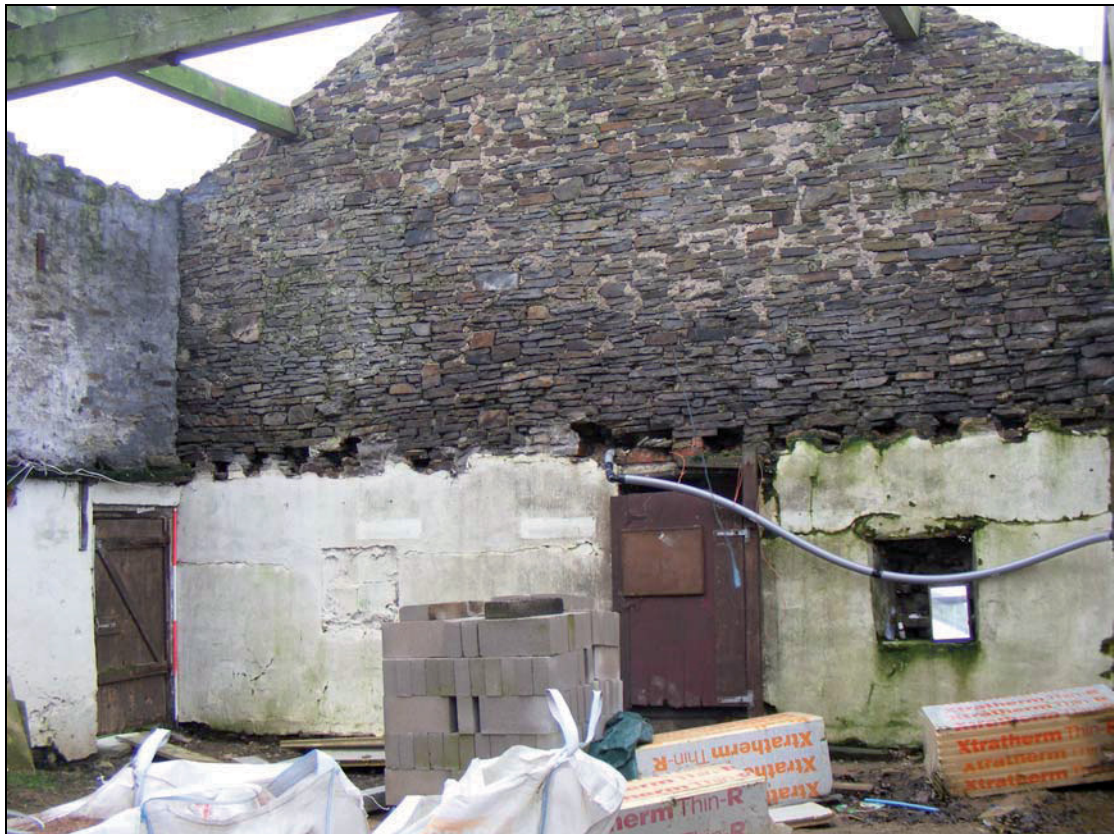
Plate 7: West wall of barn

- 6.3.2 The western wall (**Plate 7**) houses a central door with two square windows to either side, at ground floor level. Both windows have been blocked; the southern with concrete block, flush with the wall and whitewashed as with the rest of this wall at ground floor level; it is not visible externally. The northern window is blocked with sandstone, recessed and untouched by the whitewash. The door is located slightly north of centre and is fitted with a timber door, used to block the opening to the stables, rather than as a functioning door. A timber frame is still present however, as is the timber lintel. As noted the wall has been rendered and whitewashed at ground floor level, but above this can be seen the rough sandstone rubble construction. A series of timber joist holes is visible just above the whitewashed rendering indicating that a first floor has been removed.

- 7.2 The barn has had the roof covering removed and has been gutted internally. However it is apparent from the distribution of joist sockets in the west and south walls that there must have been a first floor running the depth of the building along the west wall. This would have been accessed from the door at the west end of the south wall (**Plate 9**). The presence of a tying rail just east of the doorway (**Plate 10**) indicates that the area below the first floor was used for housing beasts. The occupier of the house confirmed that there were latterly three boskins dividing the area below the first floor from west to east into four stalls. It is likely that these would have been 'doubles' allowing this shippin area to house eight beasts. The floor above would have been a haystore allowing hay to be fed down to the beasts and the open area inside the large barn door would have allowed the hay wains to gain access. It seems likely that the two blocked windows in the west wall were original although

the doorway between them is more likely to have been a later insertion associated with the single storey brick- built building to the west.

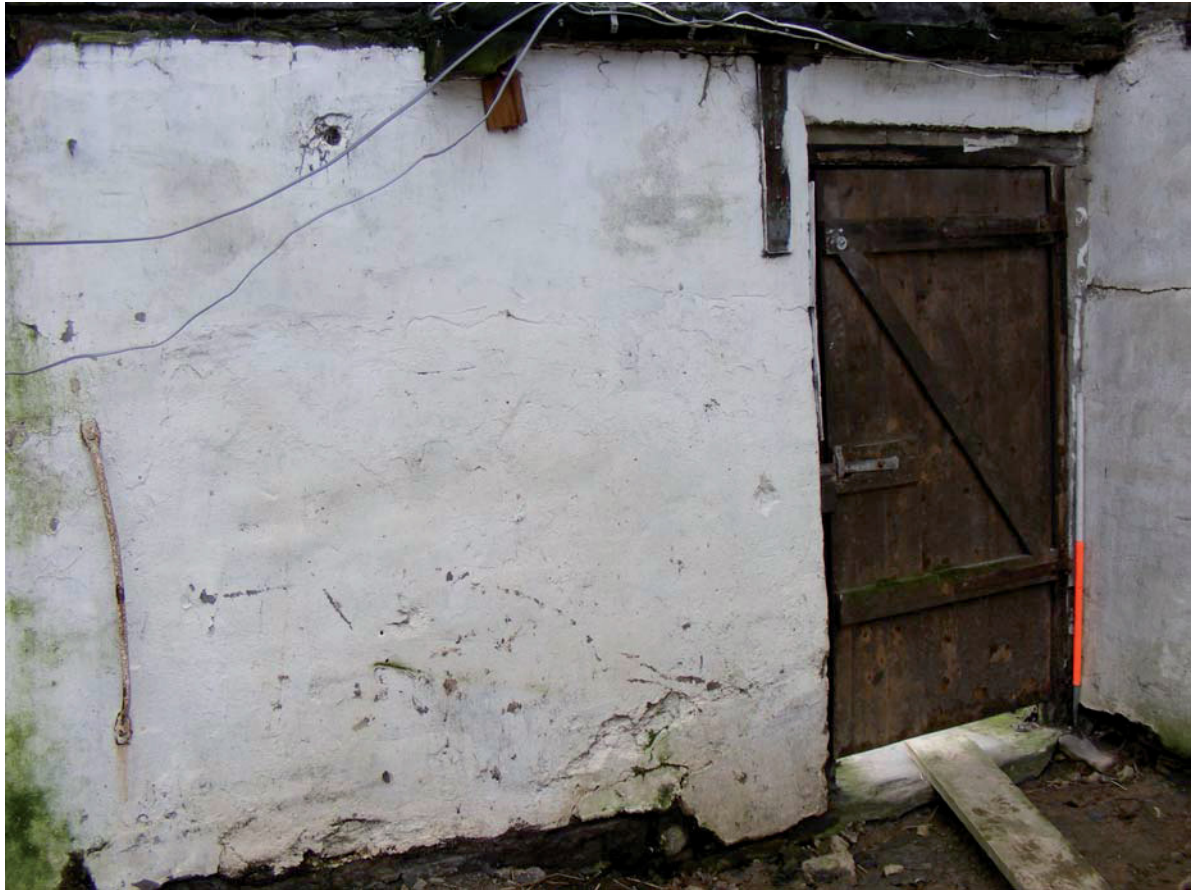
Plate 9: Shippon door in south-west corner of barn

exterior as noted at para. 6.2.1 above. The single door (**Plate 9**) is of timber batten, ledged and braced construction in a timber frame. Just east of this door is a wrought iron tie bar fixed to the wall (**Plate 10**). As noted the wall has been rendered and whitewashed at ground floor level but the rough rubble sandstone construction is once again visible at first floor level. Another joist hole is located between the single and the barn door, presumably for a cross support beam for the former first floor.

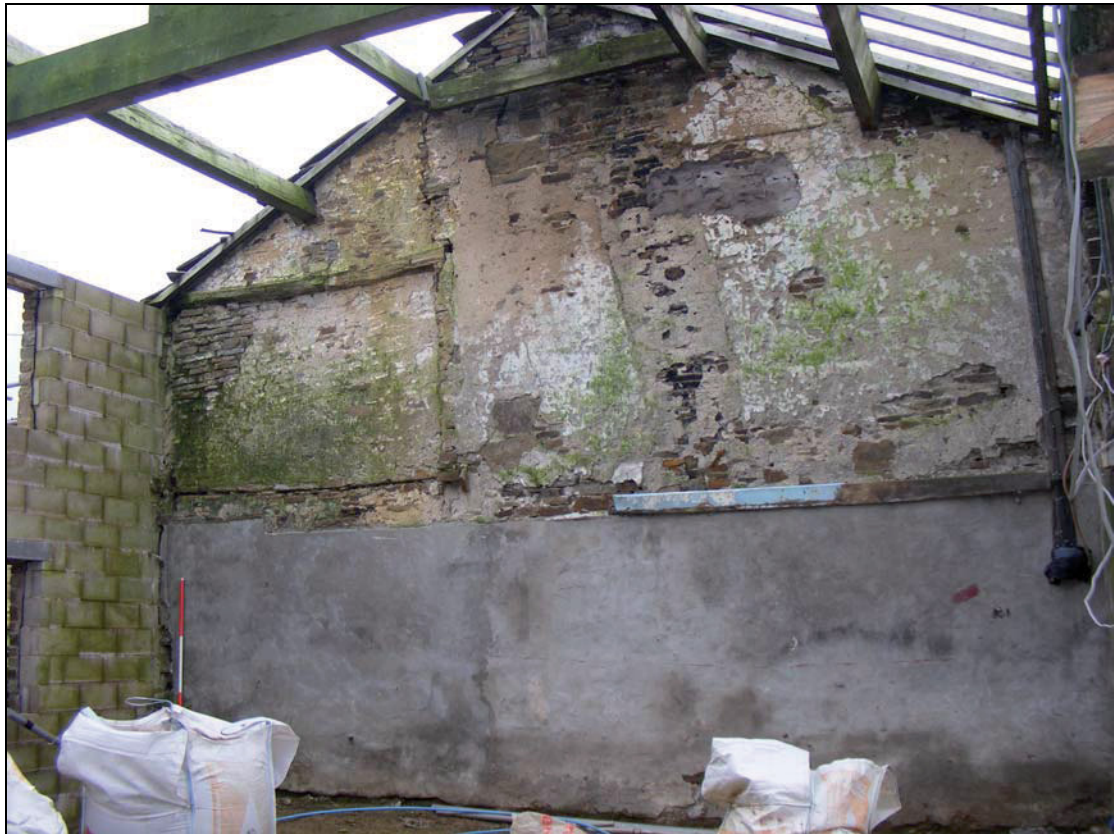
Plate 11: East wall of barn

- 6.3.4 The eastern (**Plate 11**) wall is the party wall between the barn and the house. This has evidence of lime plaster still attached and is featureless, save for a wide, apparently blocked, opening at first floor level at the north end of the wall. This is blocked with rough sandstone, in a similar manner to the wall construction, but is slightly recessed (**Plate 12**). A hand cut timber lintel is still in place. To the south of this the shadow of a flue is visible running down the wall from the chimney, turning slightly to the south as it moves down.

- 7.3 The large blocked opening in the east wall may have allowed egress to be gained from the barn to the house at first floor level. If this were the case the most likely purpose would have been as a 'taking in' door connected with the home textile industry which would have enabled bales of raw cotton or wool to have been loaded into the first floor storage area and woven cloth removed after weaving.

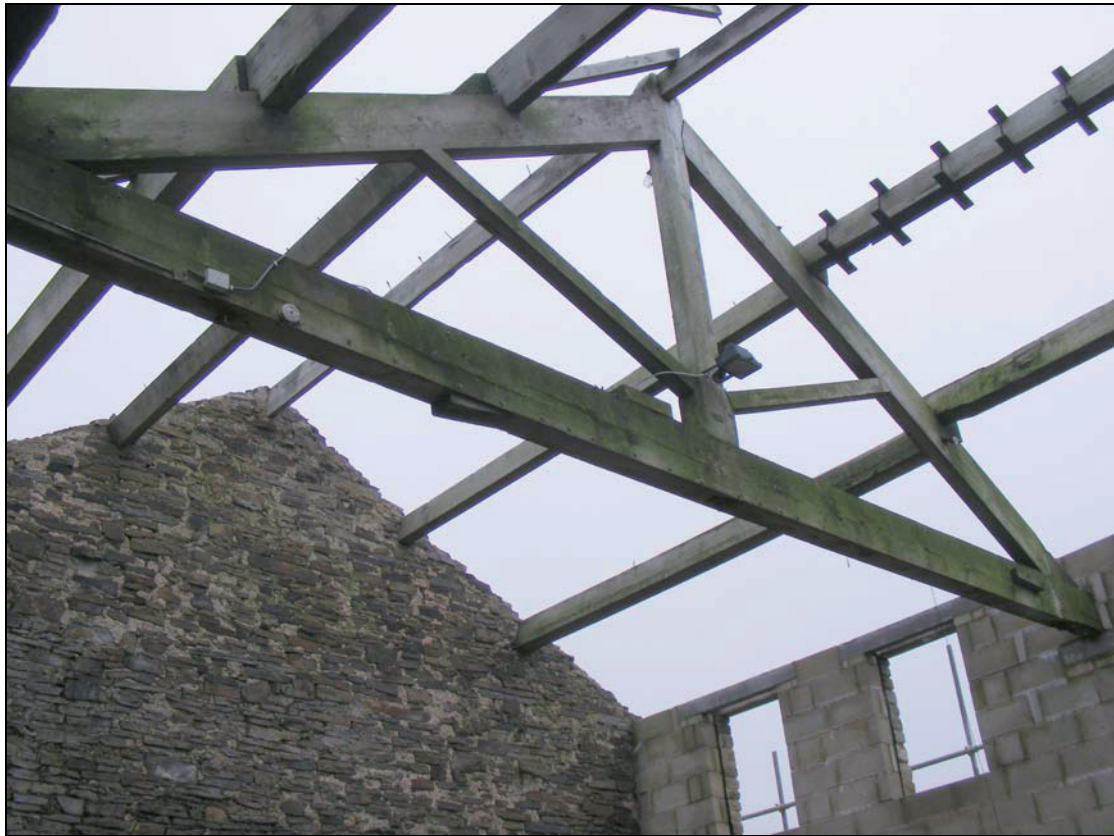
Plate 13: Roof truss from barn doorway

- 6.3.5 As noted the roof covering has been removed to reveal the roof timbers which are still in place. These comprise a single king post truss of machine cut timbers (**Plate 13**) and machine cut purlins which show no evidence of being trenched. The rafters, while having been removed over most of the roof, were partially present on the south side (**Plate 14**). The floor is earthen throughout
