# ST STEPHEN'S CHURCH, EXETER

## ARCHAEOLOGICAL FABRIC RECORDING AND EXCAVATION DURING REORDERING WORKS 2011-2012

STEWART BROWN ASSOCIATES  
MARCH 2012

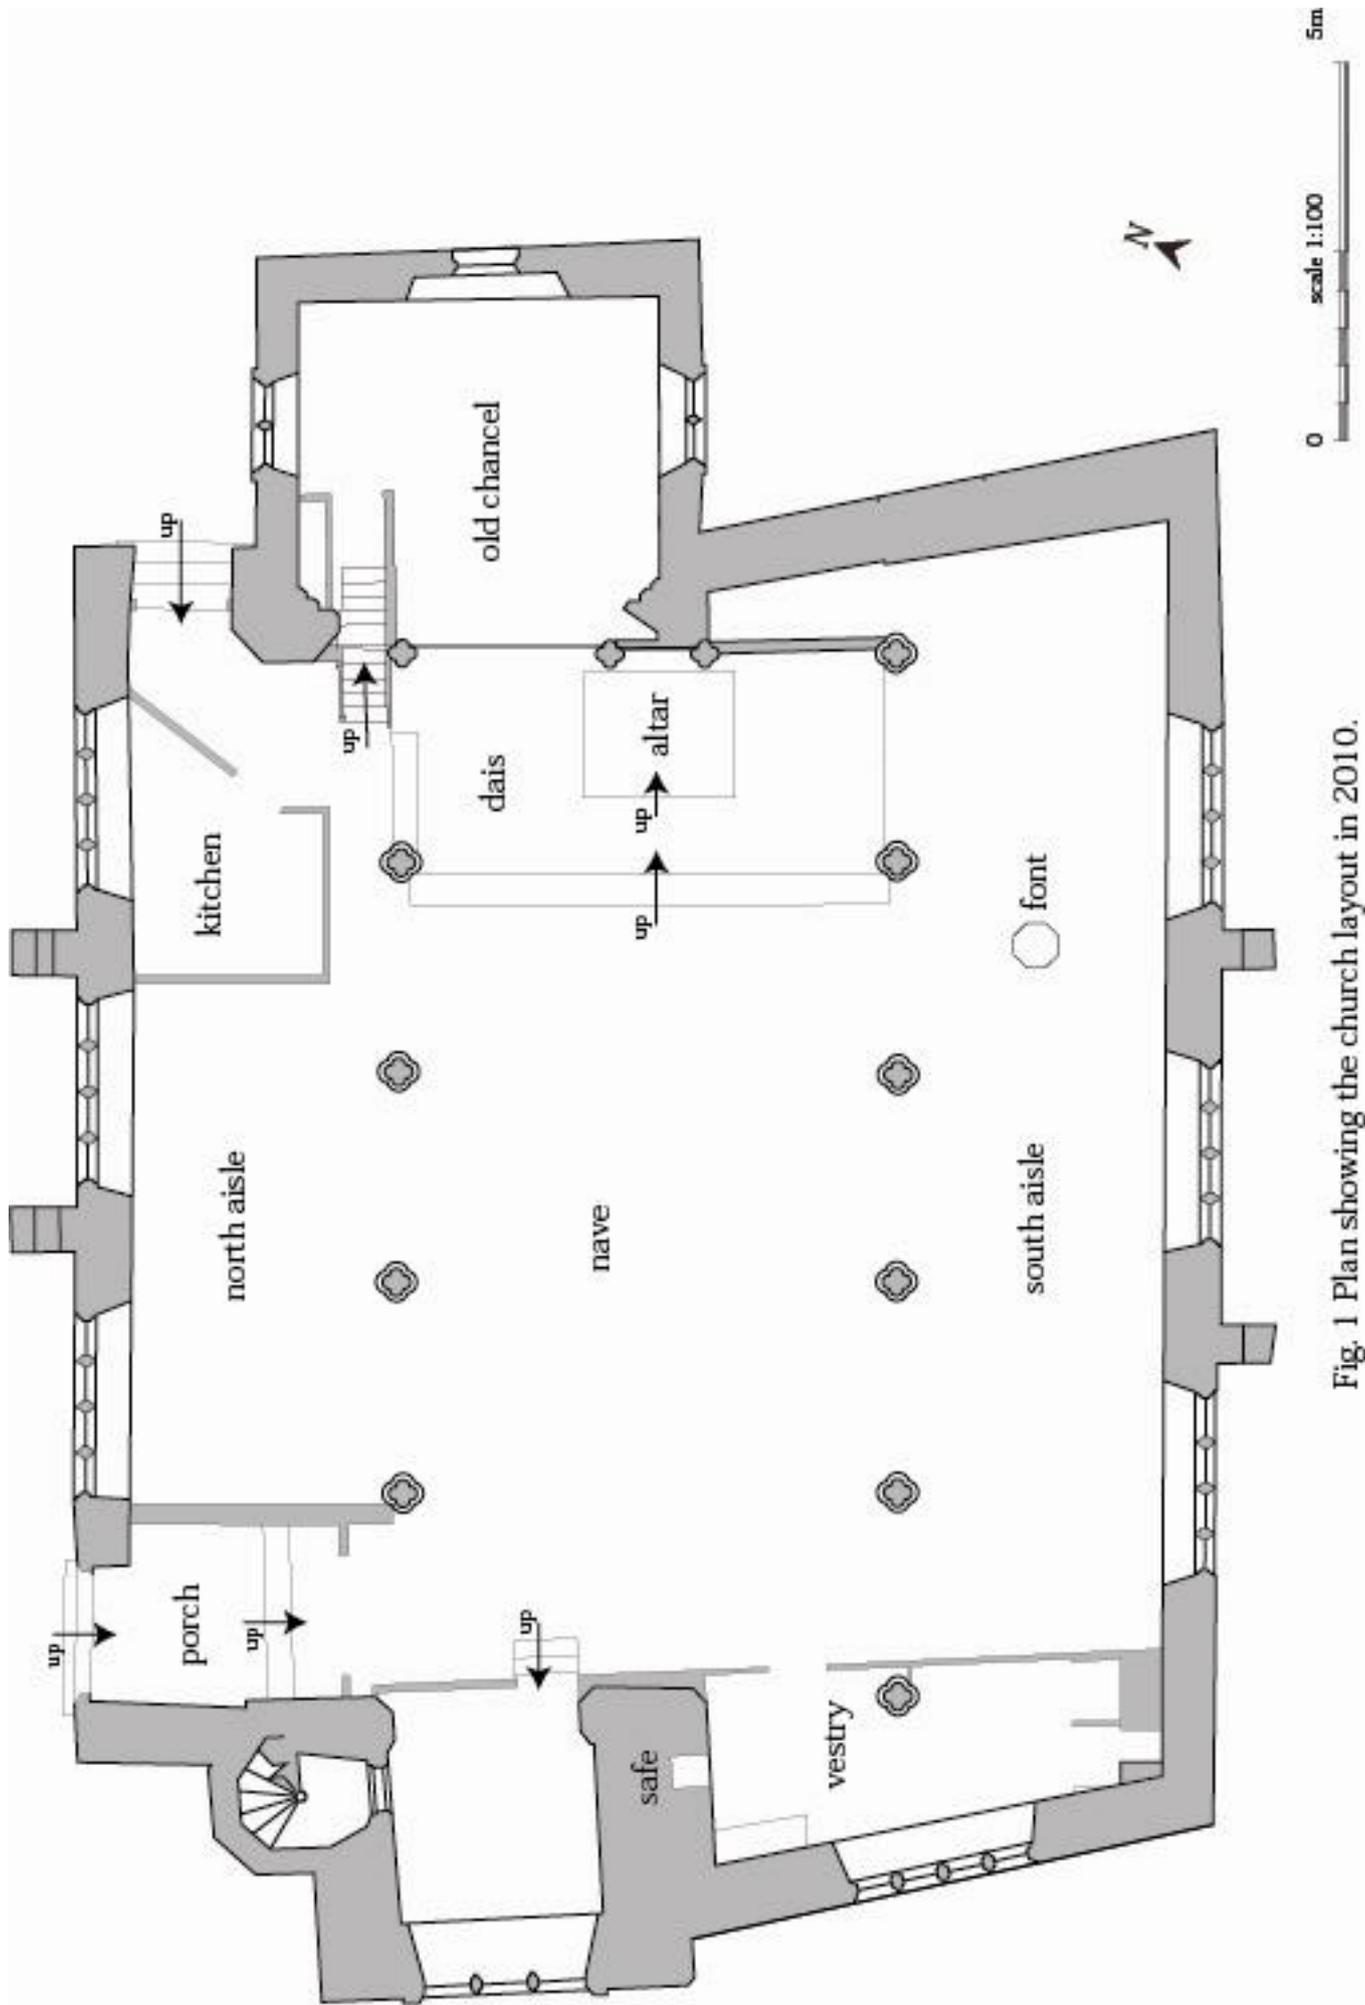
Fig. 1 Plan showing the church layout in 2010.

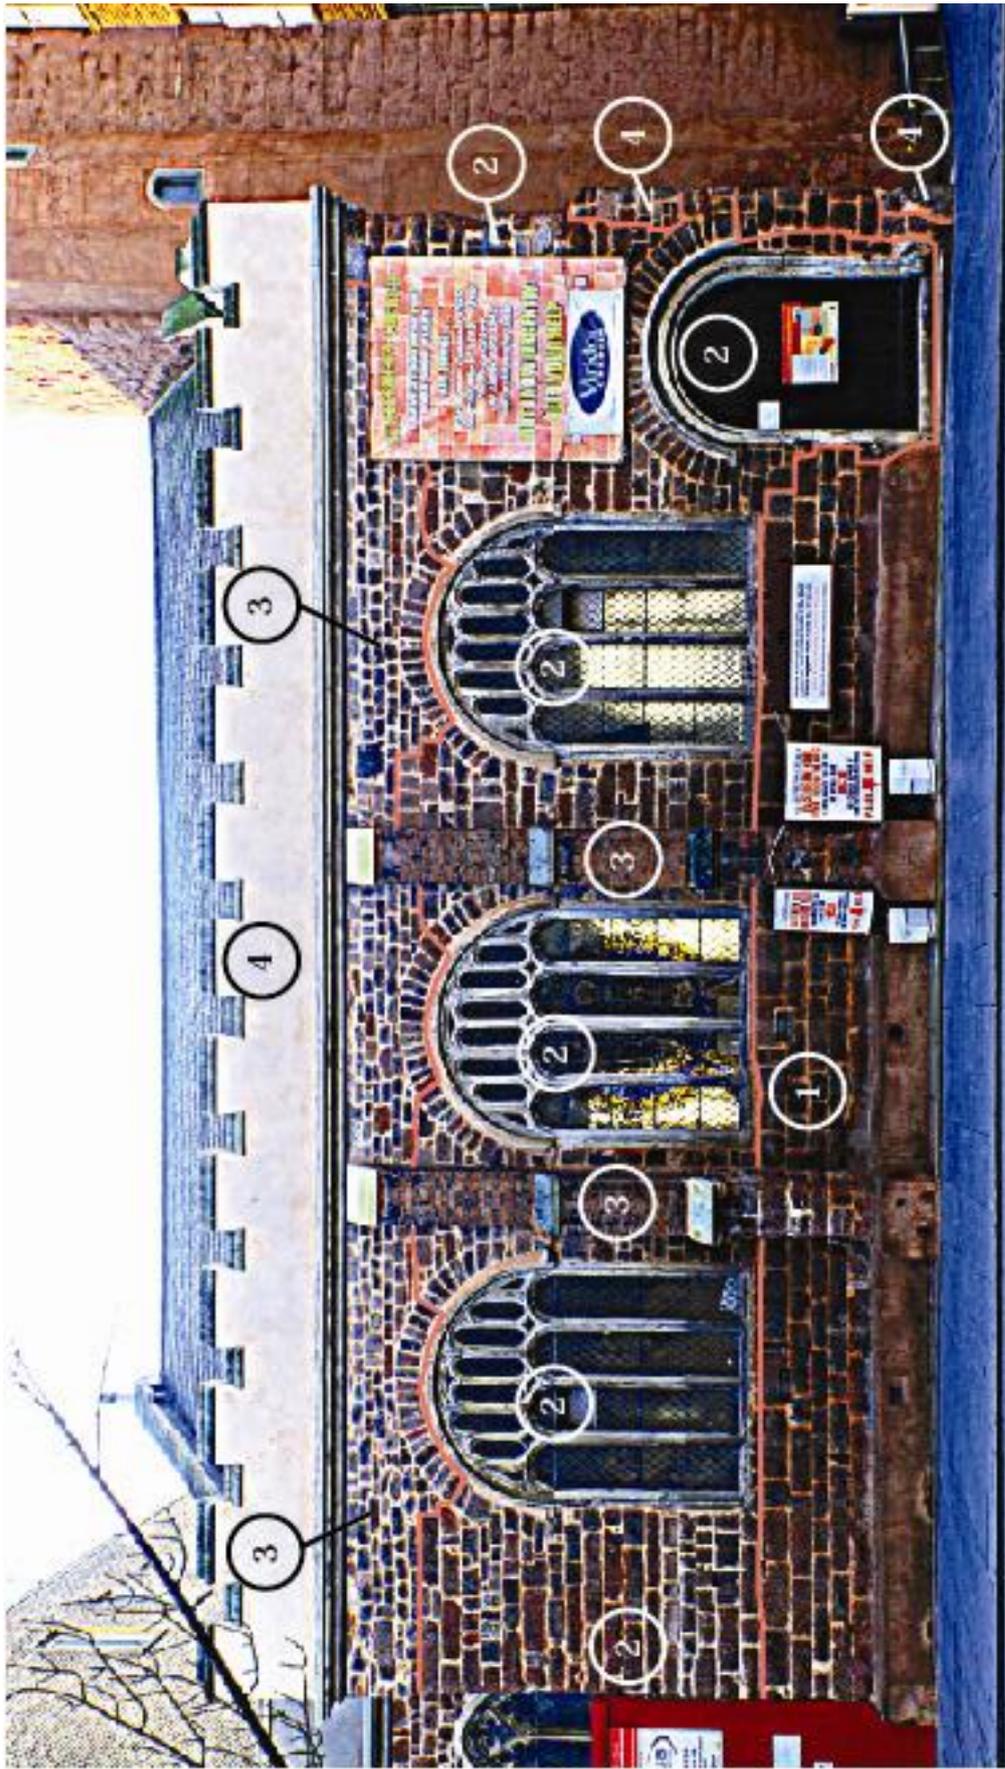
Fig. 2 Front (N) elevation of north aisle, showing phases of construction.

#### *External front (north) elevation (Fig. 2)*

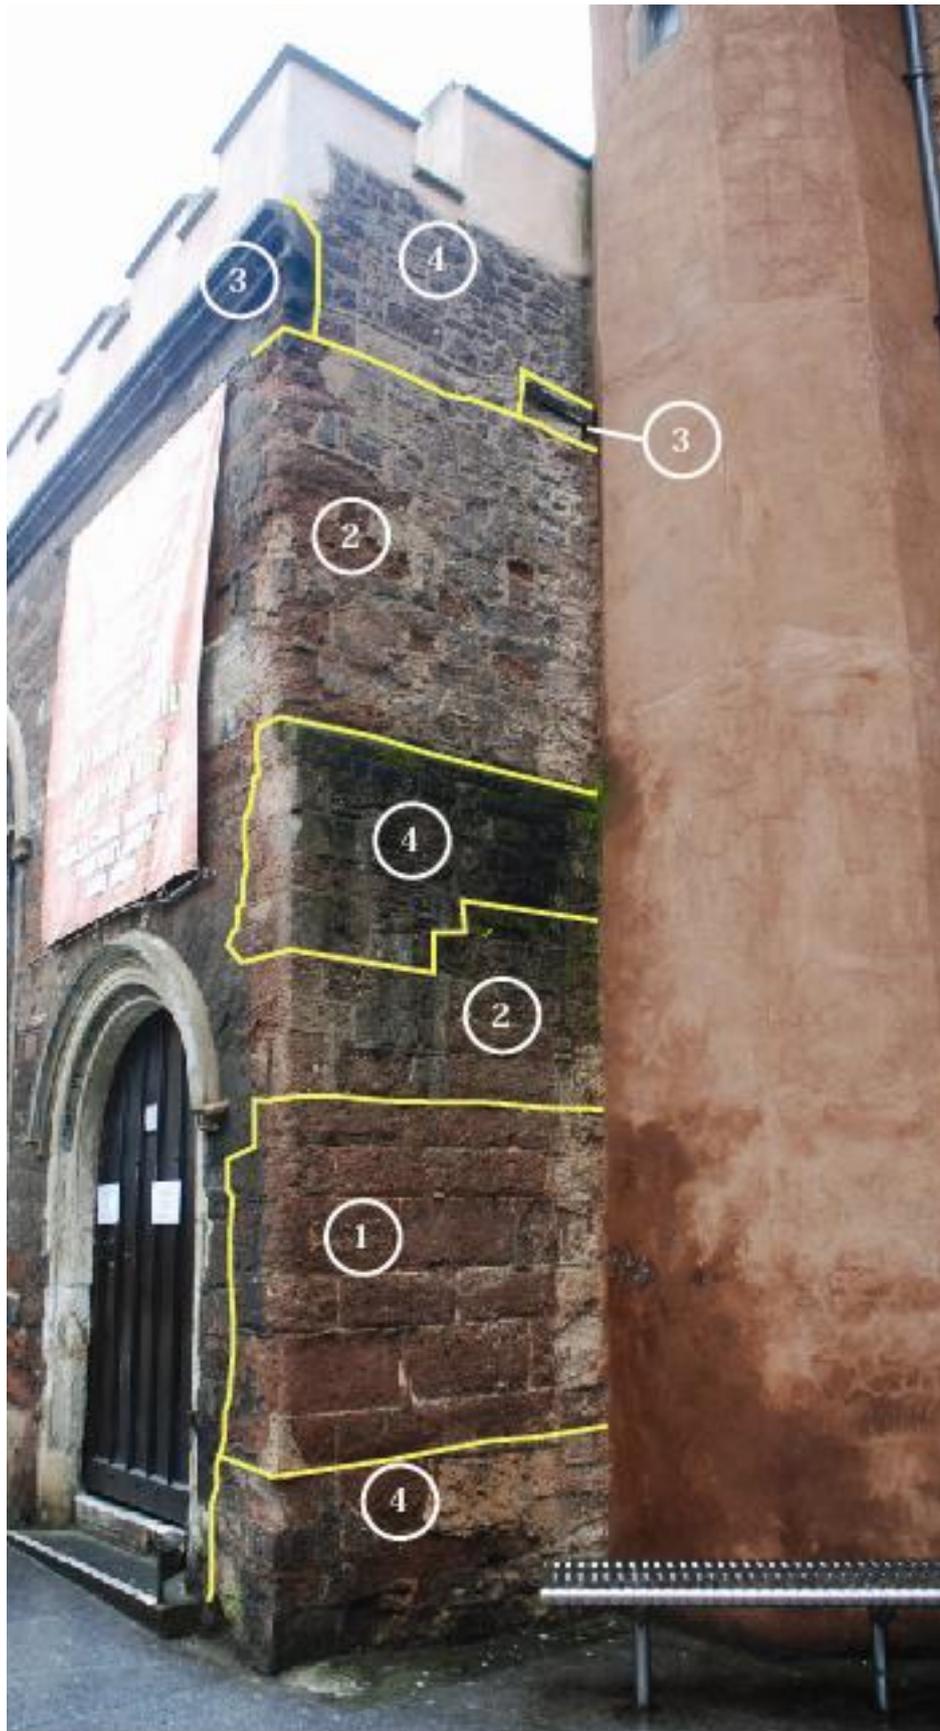
Fig. 3 West elevation of north aisle, looking southeast, showing phases of construction.

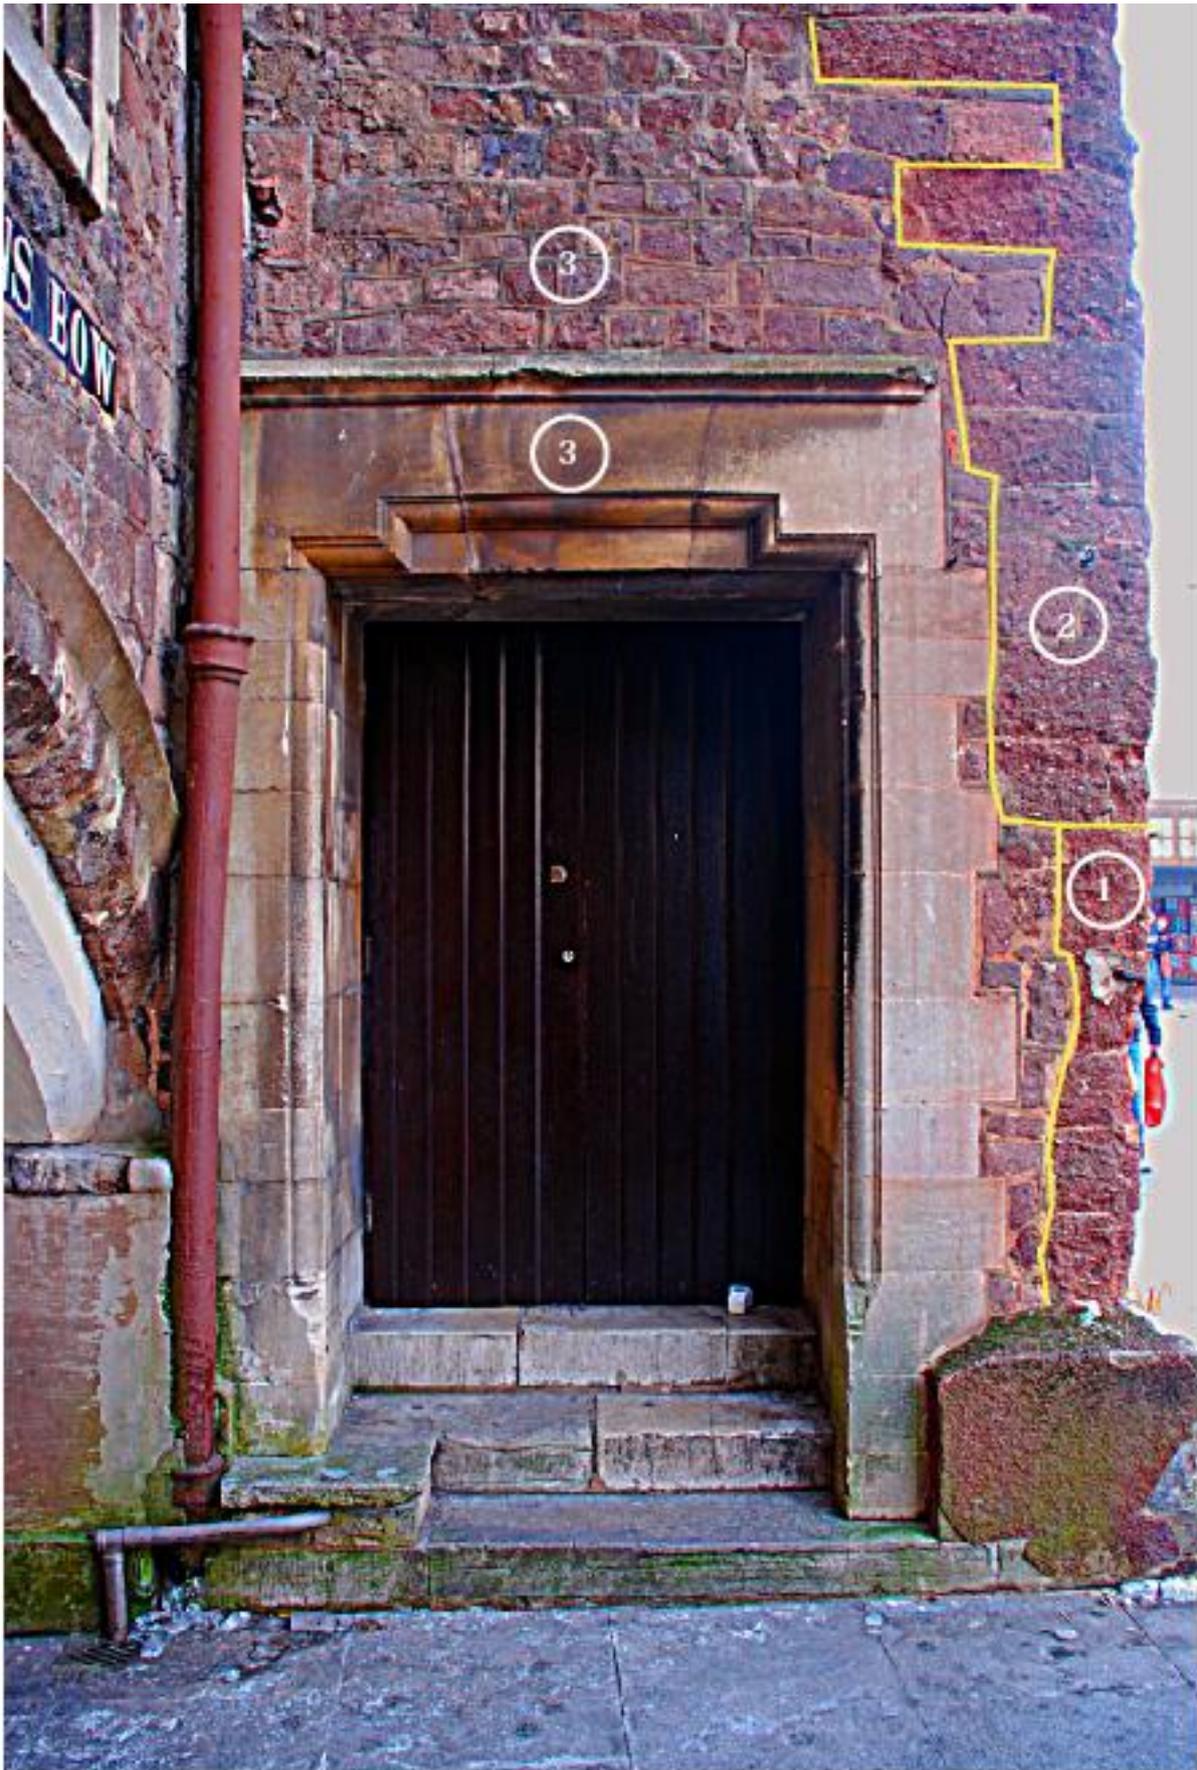
Fig. 4 East elevation of north aisle, showing phases of construction.

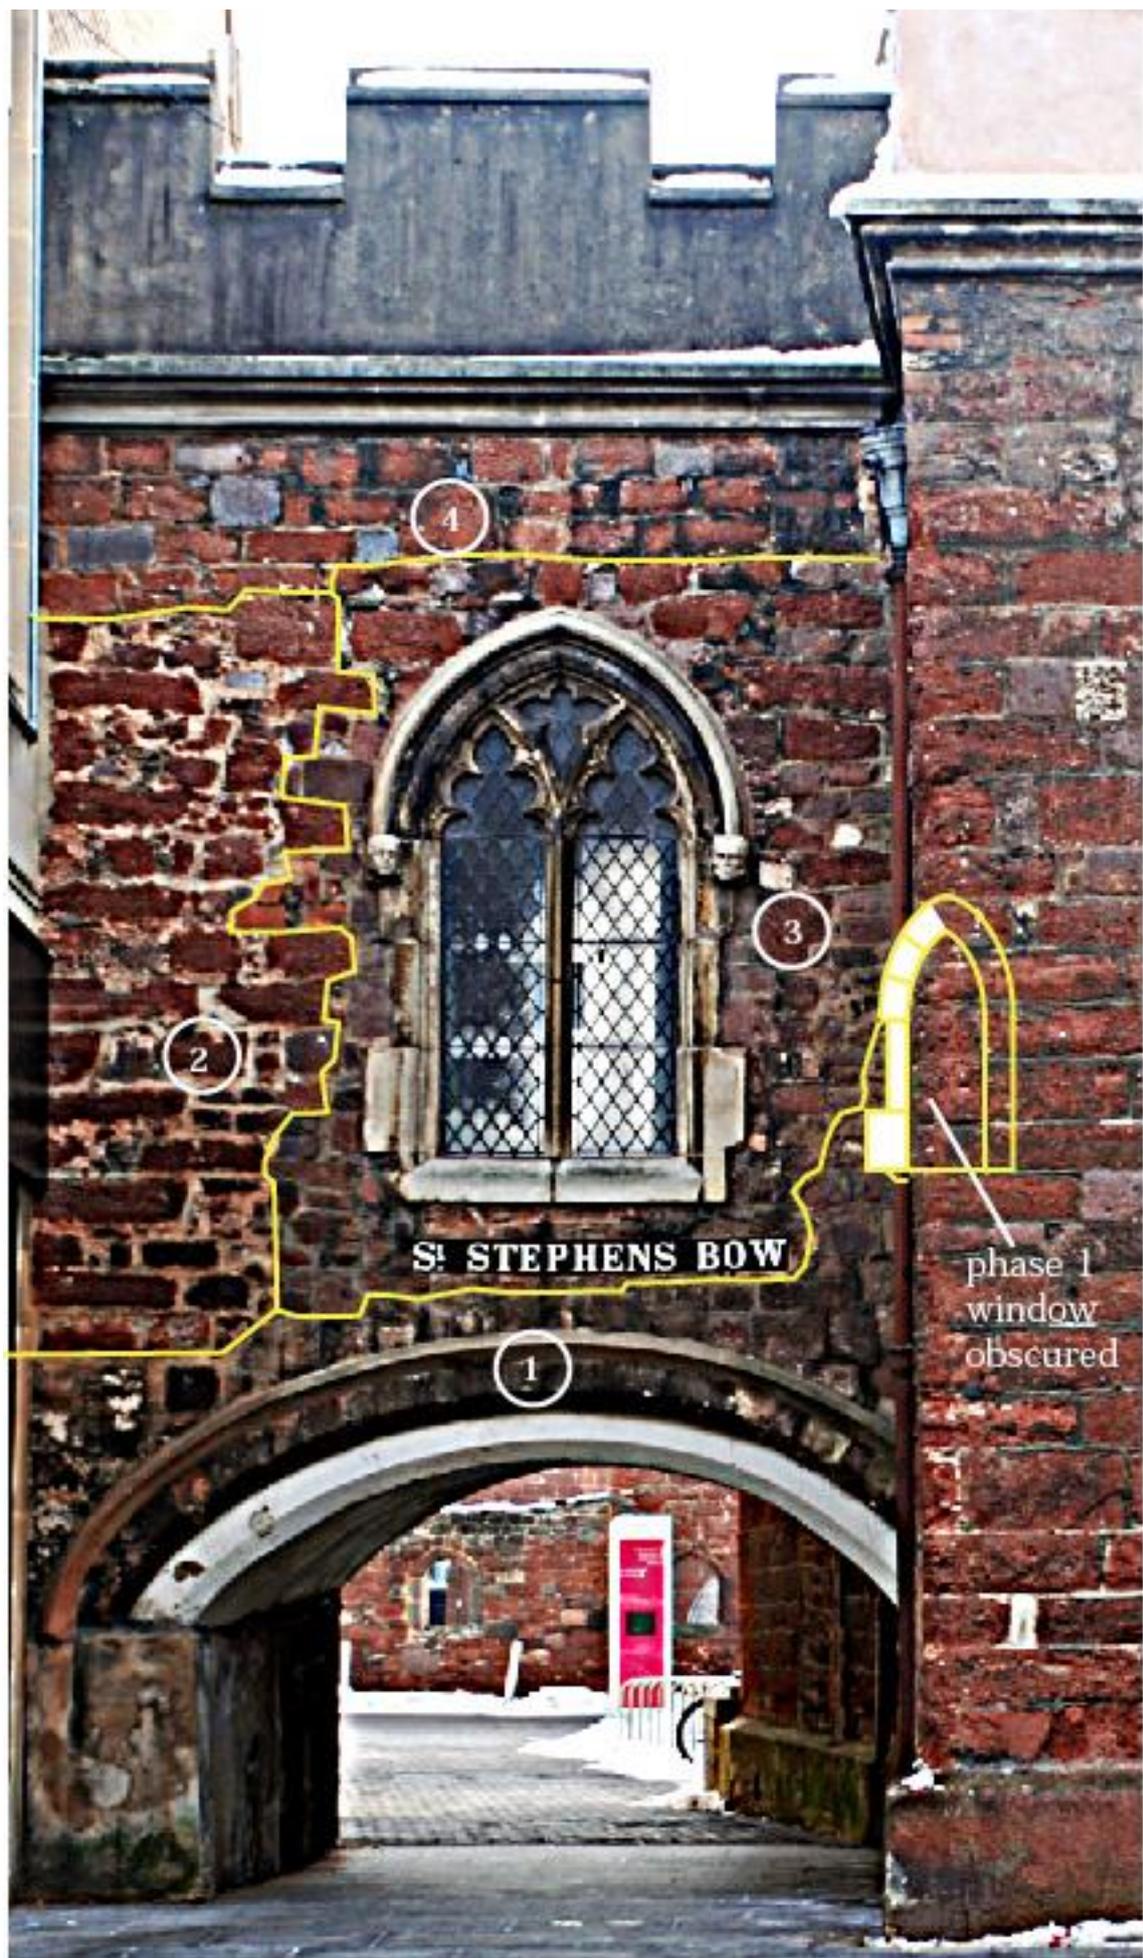
Fig. 5 Front (N) elevation of Bow archway, showing phases of construction.

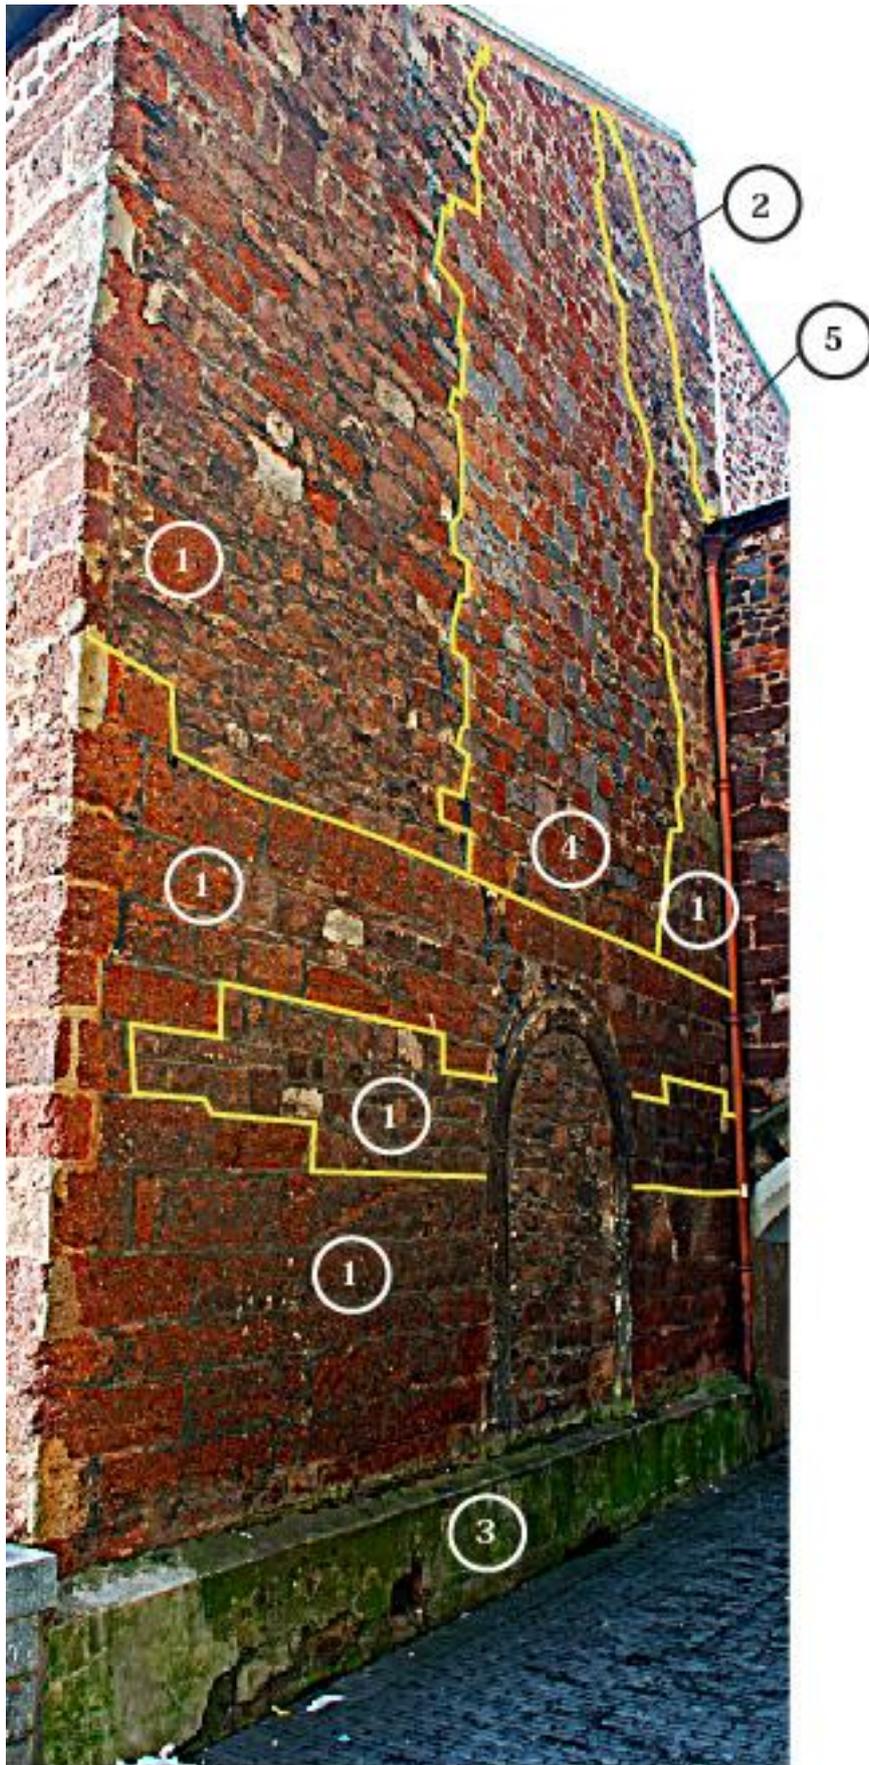
Fig. 7 East elevation of south aisle, looking NW, showing phases of construction,

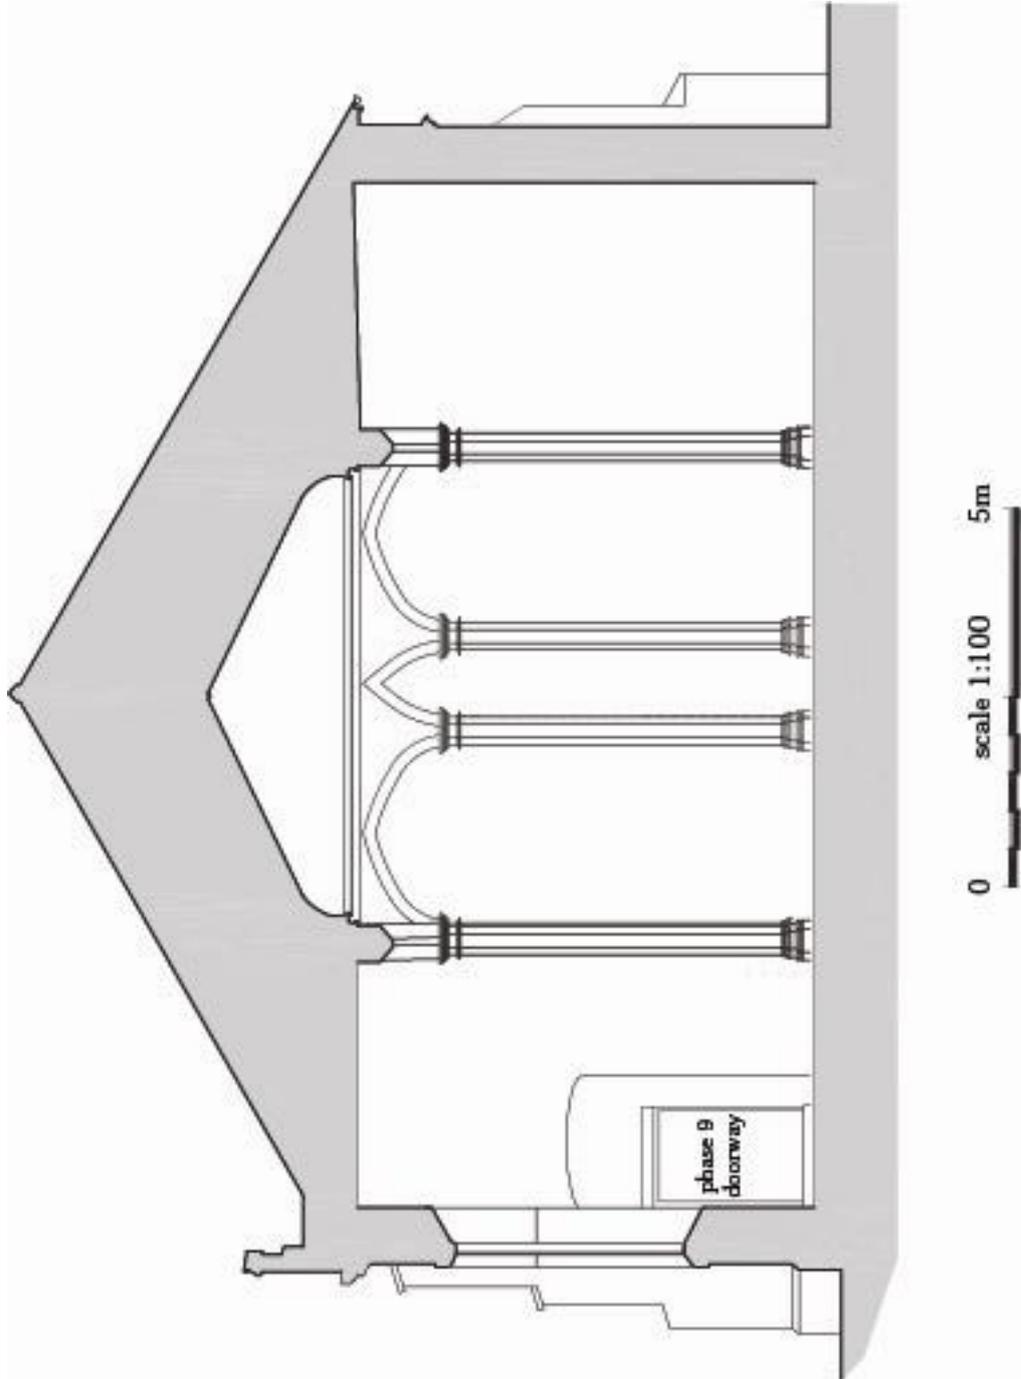
Fig. 8 Section across east end of nave, showing phase 8 (1826) arcade and phase 9 doorway. Survey drawing by Van der Steen Hall Architects.

b early 14<sup>th</sup>-century chancel arch. The arch is largely exposed on its east side (Plate 11). From the west it is obscured behind the phase 8 arcade at the west end of the nave (Fig. 8) and wall plaster. The arch is two-centred (pointed) and has plain chamfered mouldings (Fig. 12, f). It is covered with modern white paint, but in a few places where the paint has fallen away it can be observed to be built of Beer stone. Its two sides are raised up higher than the nave floor on rubble bases (Plates 12 and 13). The arch stood half-way up a flight of steps leading to the chancel. The arch clearly forms part of the phase 3 construction of the chancel above the Bow archway. Stylistically, it dates from the late 13<sup>th</sup> or early 14<sup>th</sup> century. Its rubble bases are built of volcanic and Heavitree stone, the inclusion of the latter suggesting a date in the early 14<sup>th</sup> century or later, since Heavitree stone first appears as a building stone in Exeter only at the very end of the 13<sup>th</sup> century, when it was used for prestigious structures. Here, it was used as rubble in a secondary context, so probably had been salvaged from an earlier structure. In the sequence of development phases of the church (below), the arch forms part of phase 3. Part of the arch was rebuilt in the 17<sup>th</sup> century, quite possibly owing to damage caused during the fire of 1662. Stones on the west face of the northern side of the arch were replaced with poor quality masonry comprising volcanic stones set in light brown mortar (Plates 14 and 15). This masonry is continuous with that of the north aisle above window sill level, which dates from 1664/5 (Fig. 2, phase 2, above).

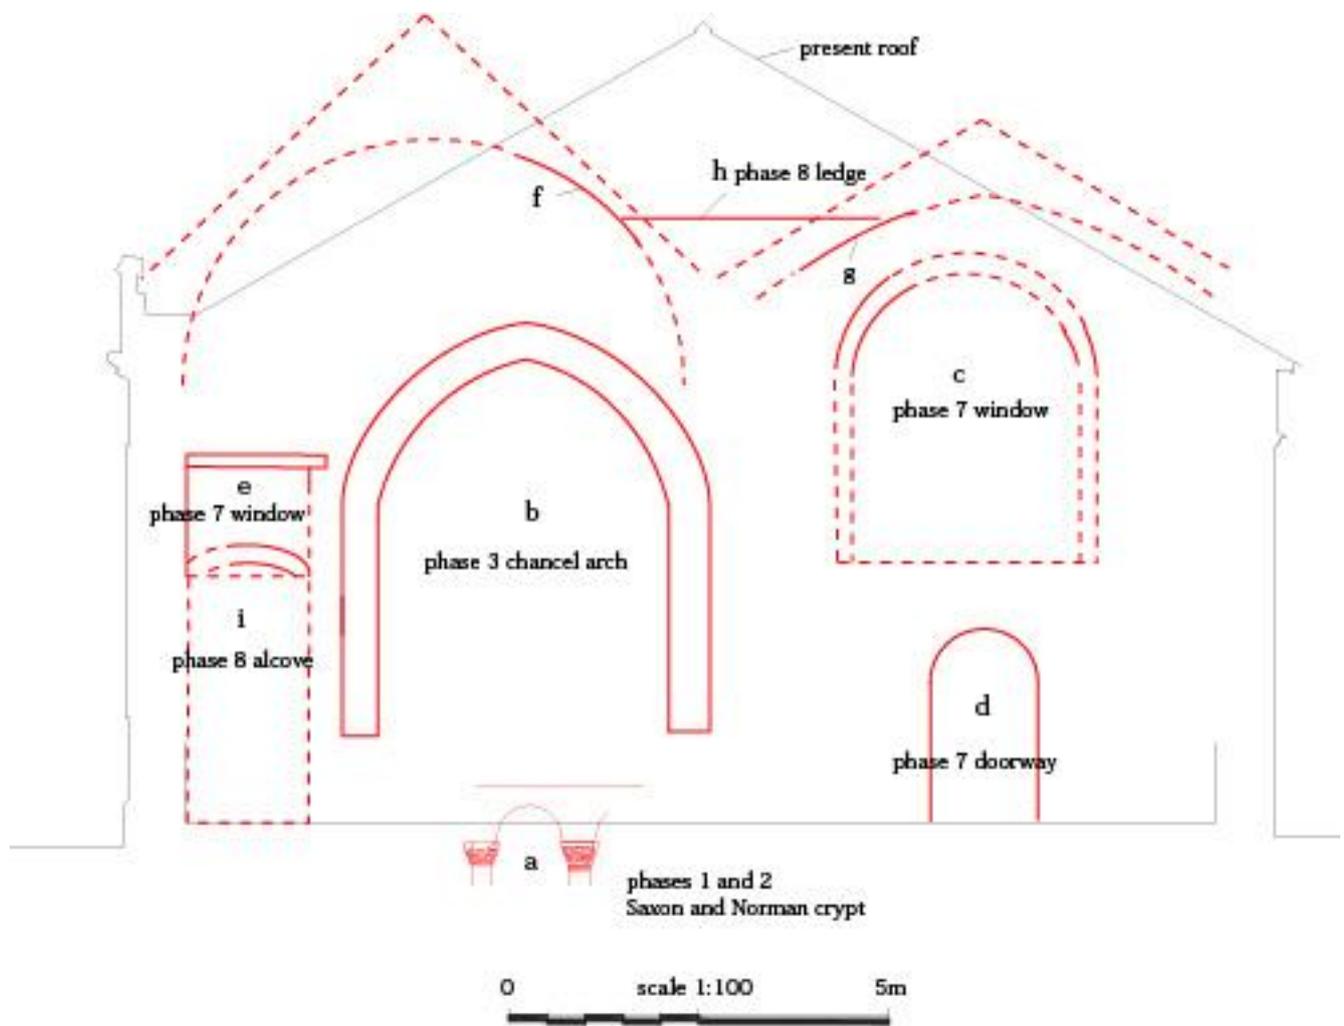
Fig. 9 Internal elevation of east end of nave, showing hidden and part-hidden features a-i, including evidence for former roofs.

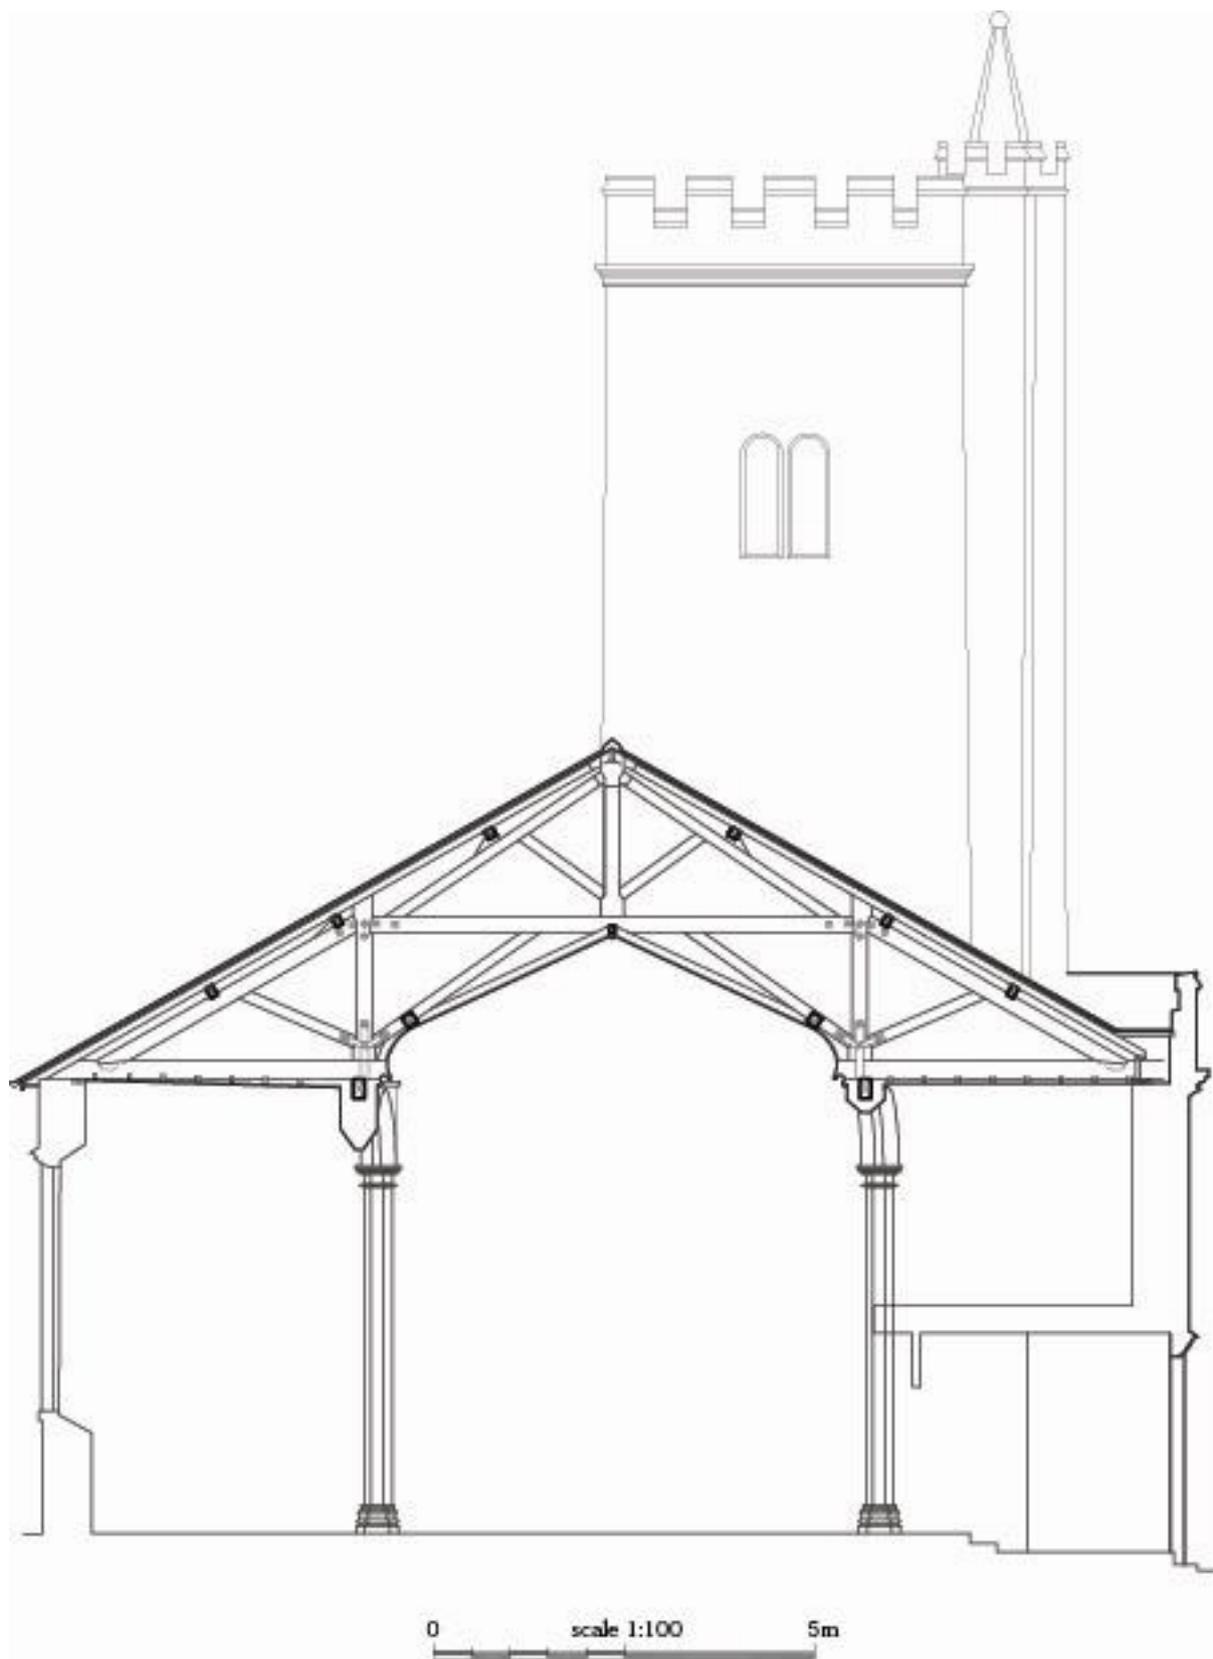
Fig. 10 Section across west end of nave, showing phase 8 roof (1826).  
Survey drawing by Van der Steen Hall Architects.

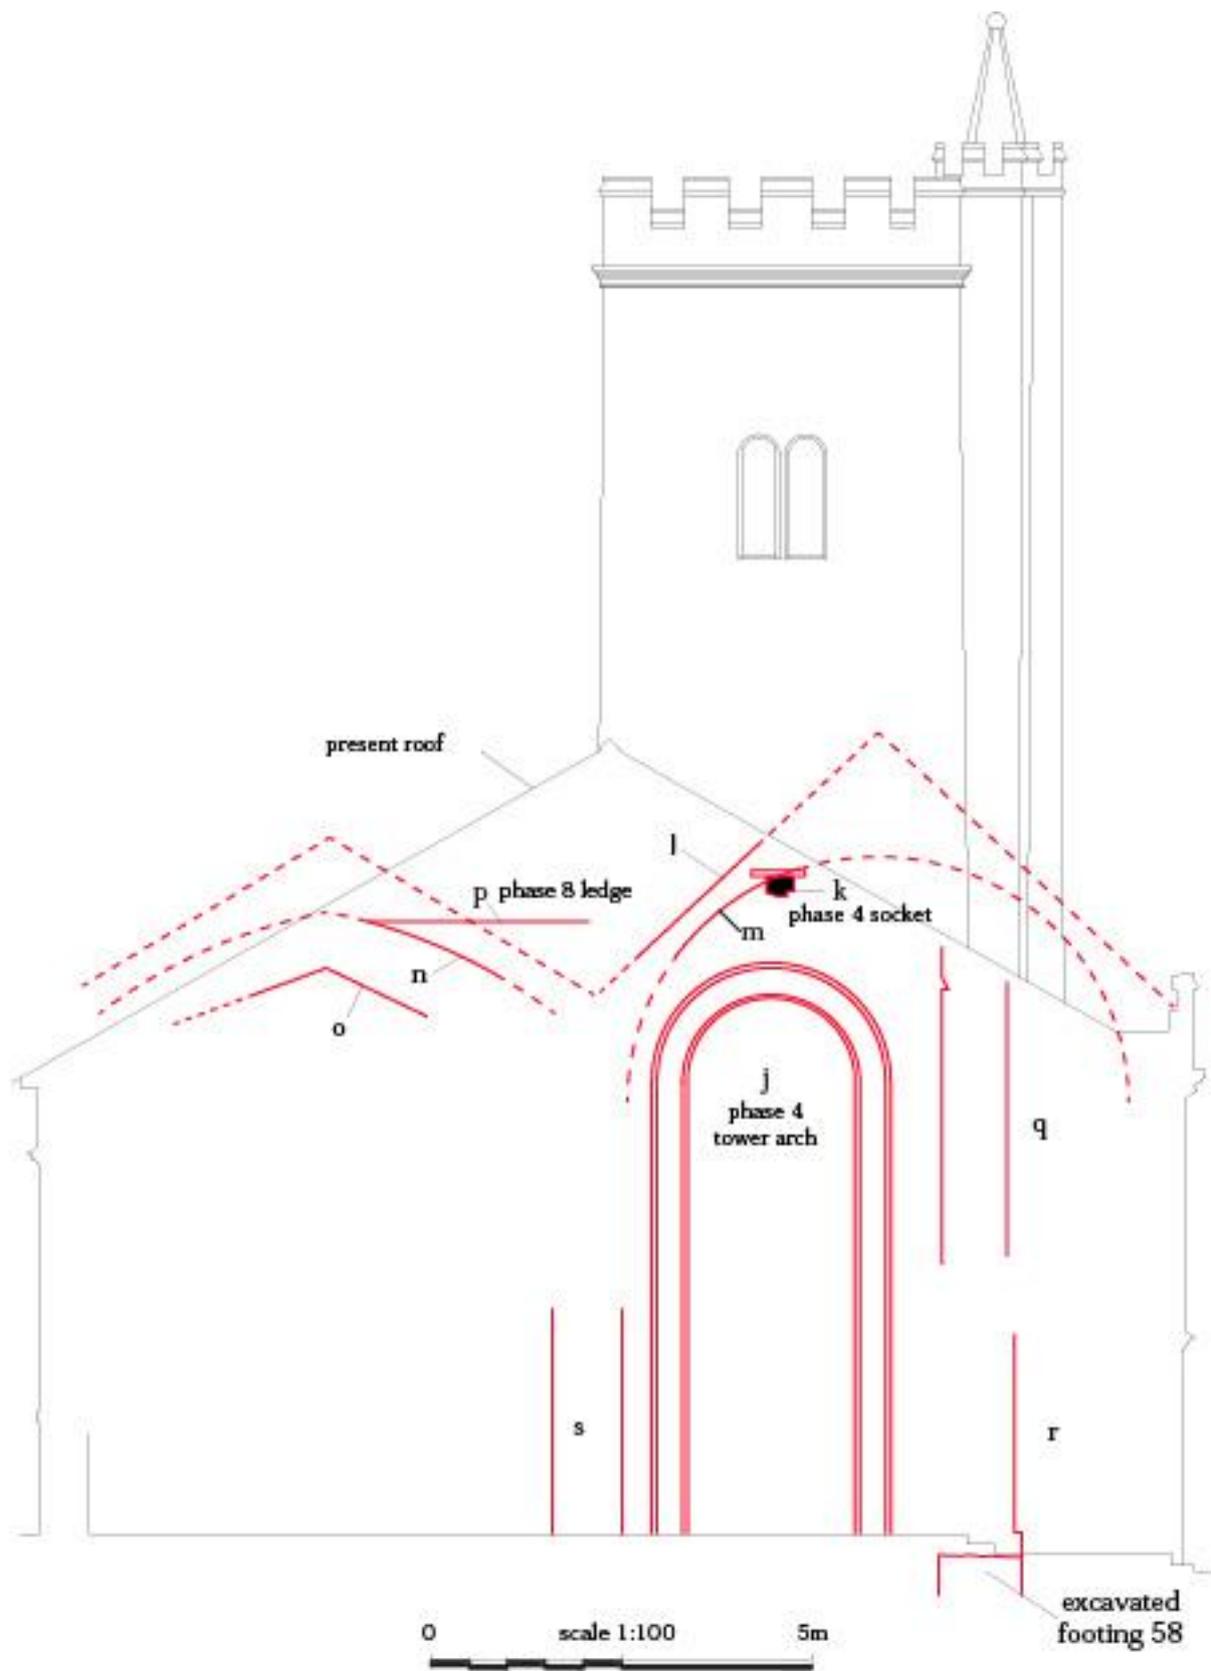
Fig. 11 Internal elevation of west end of nave, showing hidden and part-hidden features j-s, including evidence for former roofs.

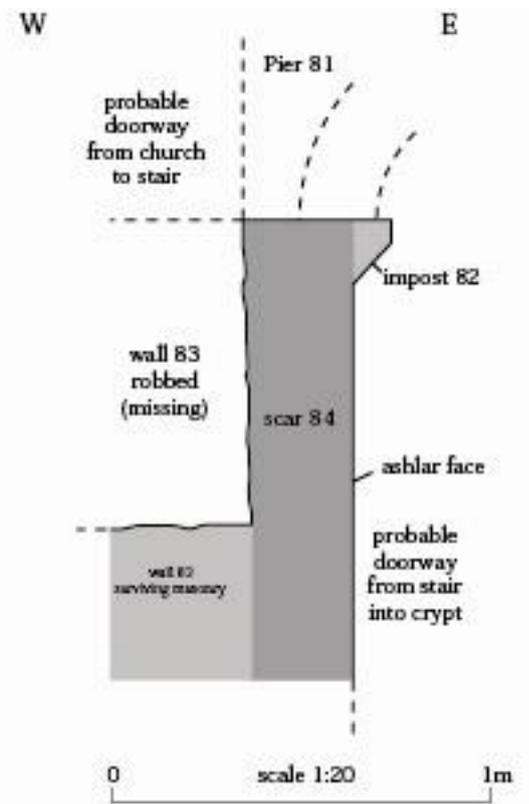
b) excavated early 14th-century pier 81, elevation looking north

Whilst removing modern concrete at the east end of the north aisle, the site contractors uncovered the top of an old masonry pier, following which a small archaeological evaluation trench was opened around the pier to a depth of 1.2m. The pier was surrounded by the same general construction and burial clearance deposits found elsewhere in the church, indicating that it had been exposed and then covered over in the 19<sup>th</sup> century. In this area, the general deposits were allocated context number 80.

The pier seems likely to have been the central support for a medieval circular stair descending below the church floor level, at the bottom of which was an arched doorway. The doorway must have led into the crypt. The stair is likely to be an inserted feature since it was not built into the thickness of a wall like many spiral stairs, but was instead constructed as an independent feature, presumably within in a gap broken through a wall for its insertion. The narrow wall leading west would have infilled the gap to the west of the pier and screened the stair from the crypt, as well as providing the stair's threshold. The feature leading south from the pier could have been a pilaster buttress. A likely date for the insertion of the stair is in the early 14<sup>th</sup> century, at about the time that the church was extended eastwards by building a new chancel over the Bow archway, since a new stair down to the crypt may have been needed following the alteration (see Development, phase 3, below).

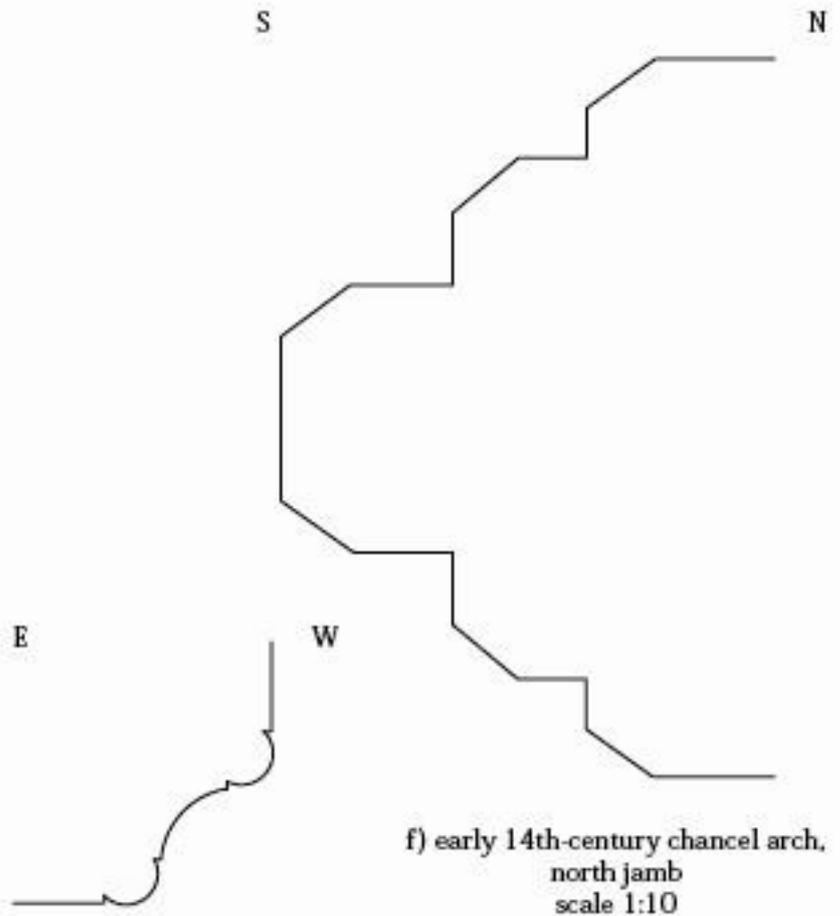
f) early 14th-century chancel arch, north jamb scale 1:10

Access to this previously closed off area beneath the chancel arch allowed further observations relating to the arch and its foundations. The Bow archway dates from the early 14<sup>th</sup> century when the church was extended eastwards by erecting a new chancel above it (see *External elevation of the front (north end) of the Bow archway, phase 1, above*). The present chancel arch also dates from this period (see *Internal elevation of the east end of the nave, b, above*). It was built on the line of the former Saxon wall to separate the older part of the church from the new chancel. Its original foundation survives on its south side, made up of white-mortared volcanic and Heavitree stone rubble (104). At the top of the foundation and immediately beneath the arch is a plinth or base of Beer stone (105). The arch is also built of Beer stone (106; Fig. 12, 00). The west face of the north side of the arch was rebuilt in the
