# ST STEPHEN'S CHURCH, EXETER

## ARCHAEOLOGICAL FABRIC RECORDING AND EXCAVATION DURING REORDERING WORKS 2011-2012

STEWART BROWN ASSOCIATES  
MARCH 2012

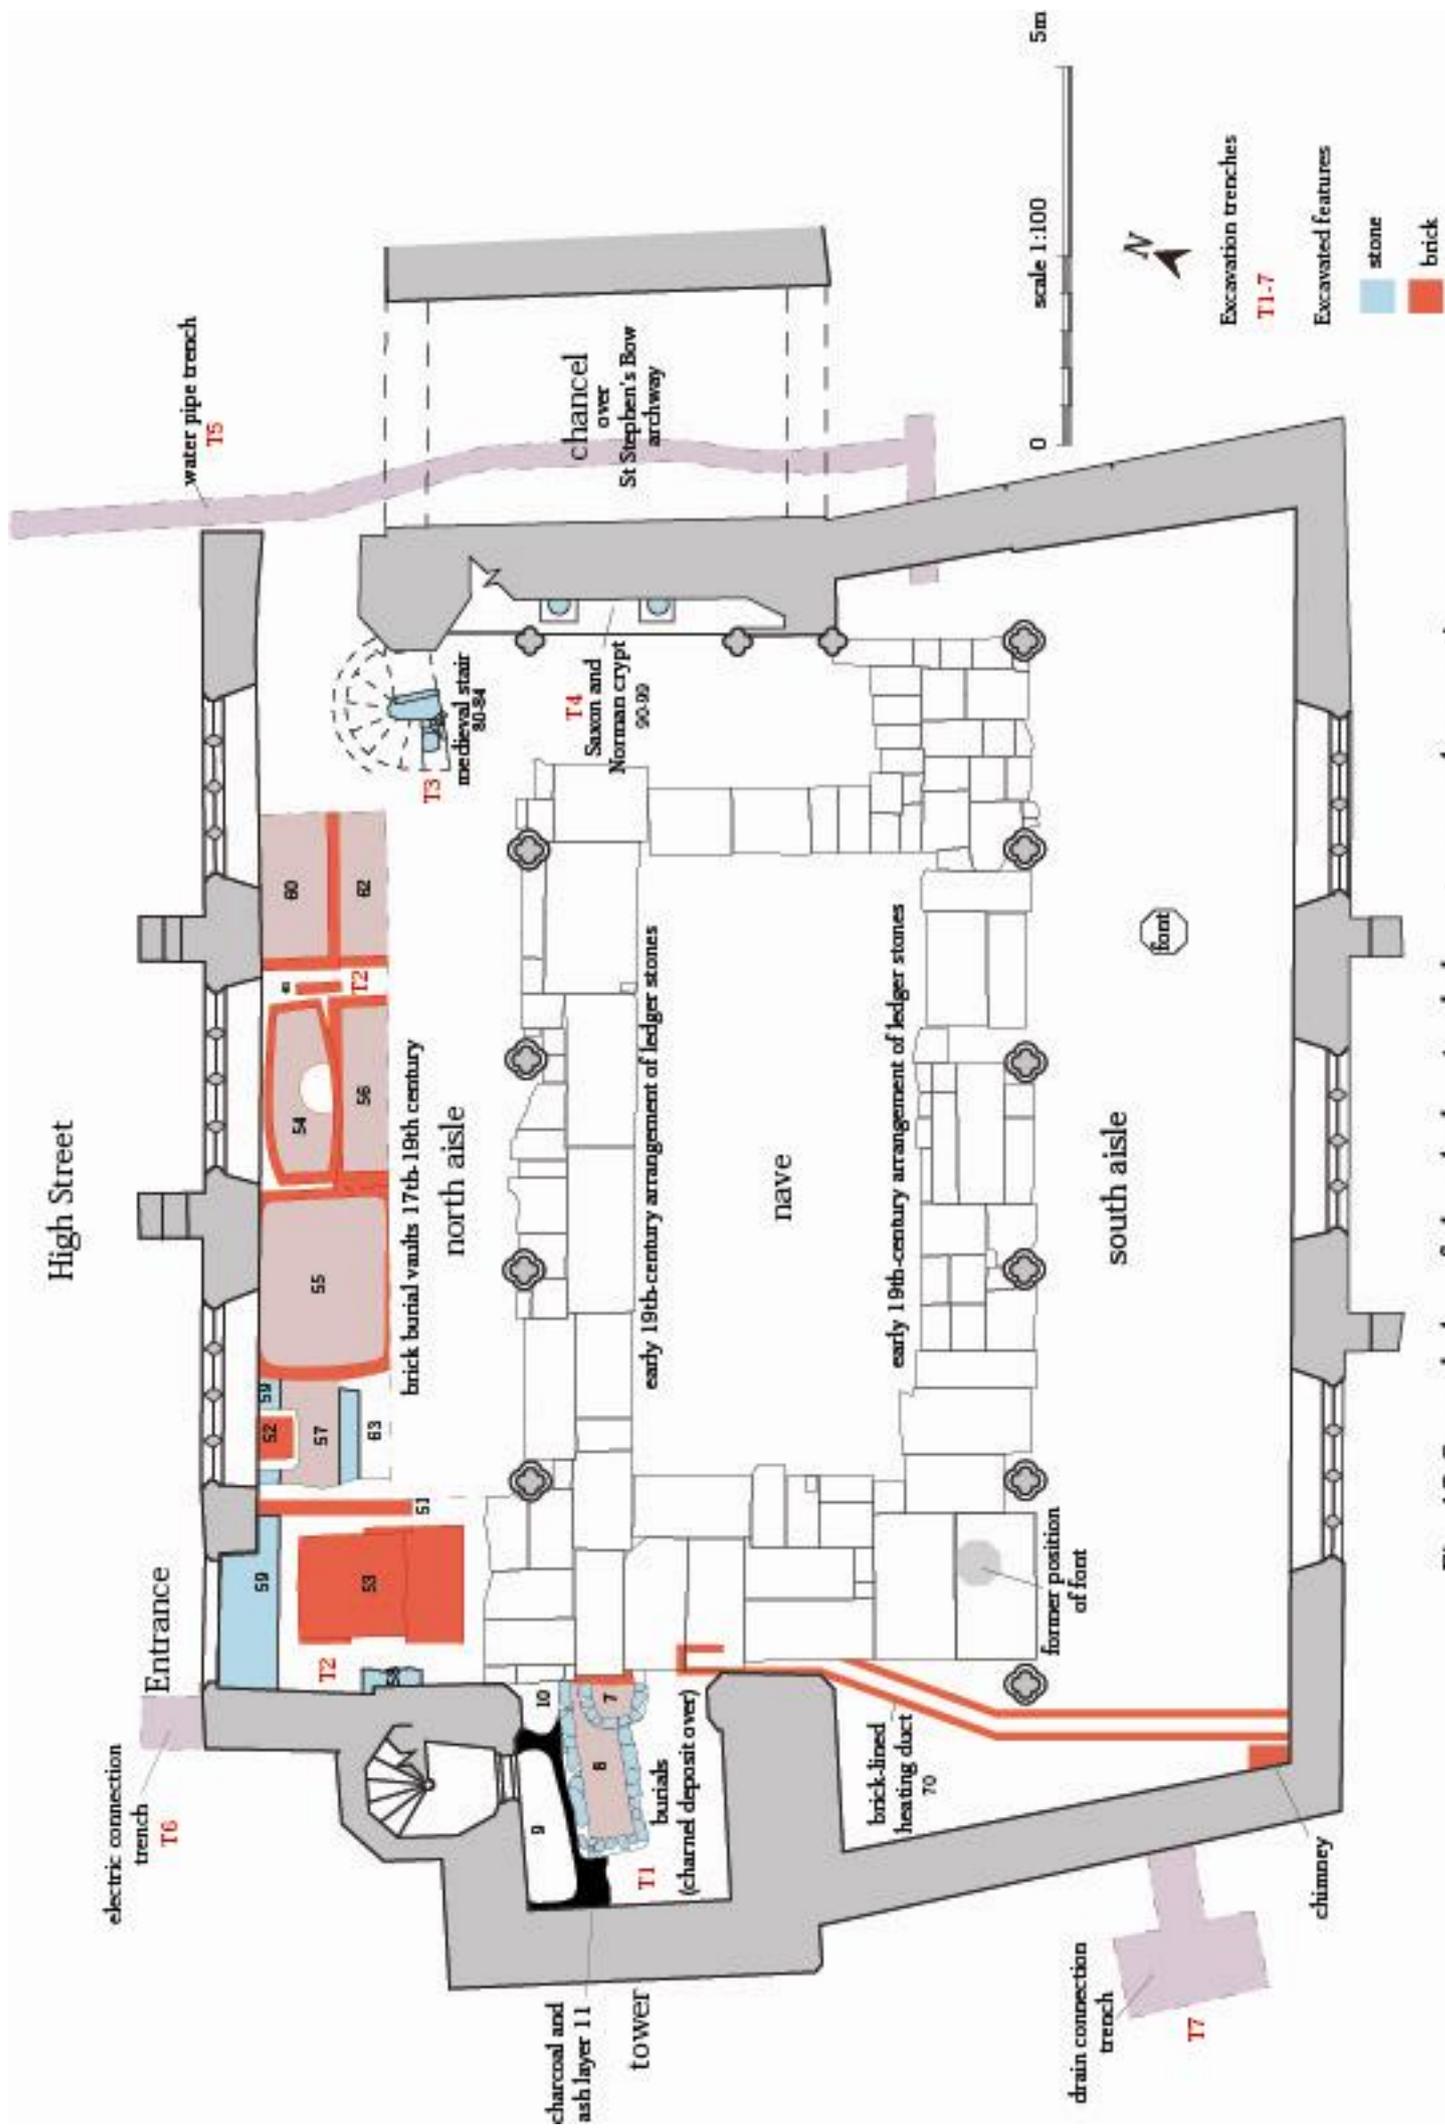
Fig. 13 Ground plan of church showing ledger stones and excavations.

Works by the contractors at floor level in the southwest corner of the church uncovered a 19<sup>th</sup>-century heating duct (Fig. 13, 70). This was cleaned and planned. The duct was lined with brick, some burnt *in situ*, and had a heavily sooted interior. It extended from close to the tower to a chimney at the southwest corner which rose up through the roof.

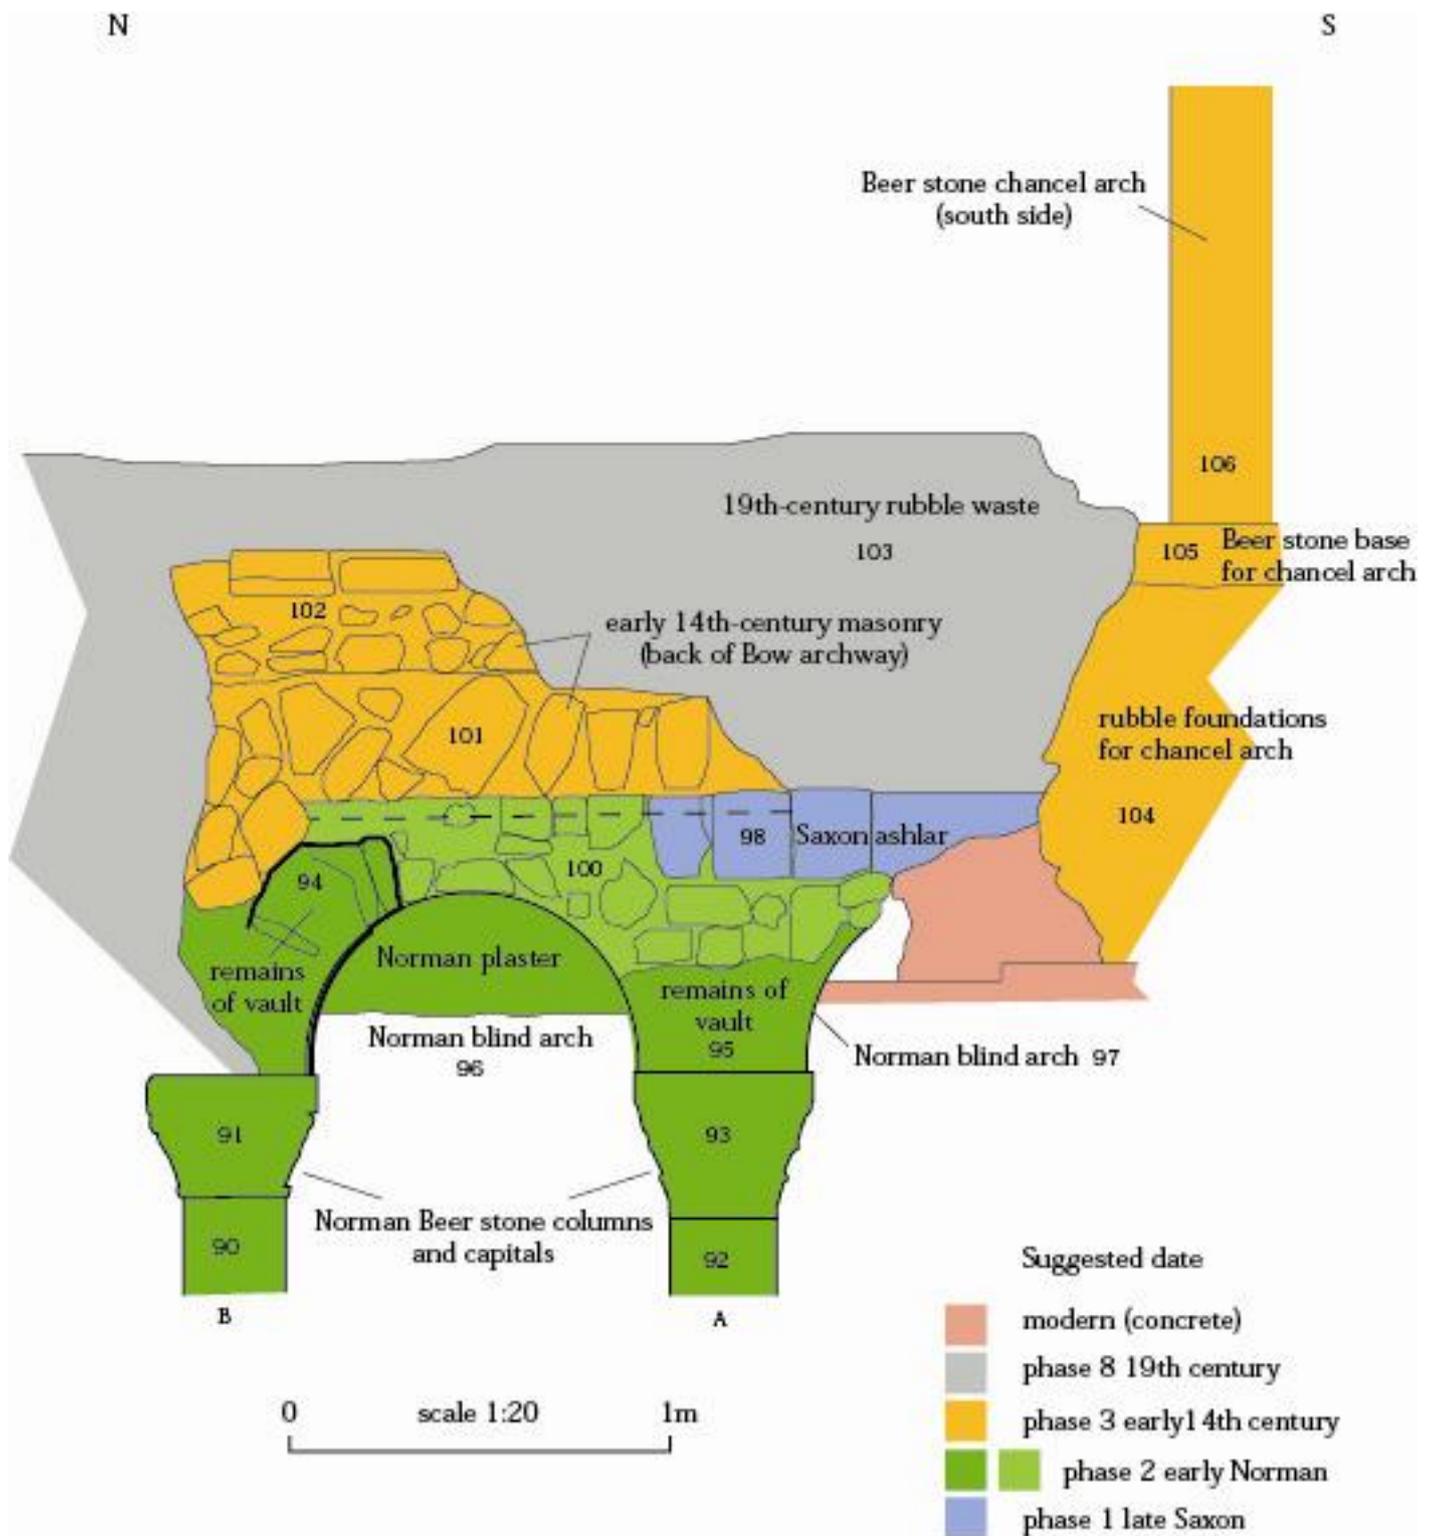
Fig. 14 Elevation of masonry excavated beneath chancel arch, looking east.

volcanic stone rubble bonded with mid brown mortar. Figs. 14 and 15 show the west elevation and E-W section respectively. Fig. 16 shows record drawings of the two capitals (A and B, see Fig. 14 for location). The vault and columns had been set against an earlier wall. Between the columns, an arched recess had been hollowed out from the earlier wall to a depth of 0.24m (96). The arch matched the vaulting precisely and continued its semicircular form into the wall. It had no voussoirs however and rather uneven rear and sides formed of stones which had been broken through. These had been covered with mid brown plaster up to 2cm thick very similar in appearance to the mortar used to build the vault. Part of another arch with a plastered rear face set back 0.24m was uncovered to the south of column 92 and capital 93 (97), showing that the Norman crypt incorporated a series of arched recesses along its east end. These would have formed a blind arcade with columns standing between the recesses. The vault of the Norman crypt continued no further eastward than the earlier wall so must originally have extended westwards from this point. The thickness of the surviving section of vaulting was 0.25m – 0.3m, so the floor level inside the Norman church above the crypt would have been about 0.25m – 0.3m above the top of the arched recess.

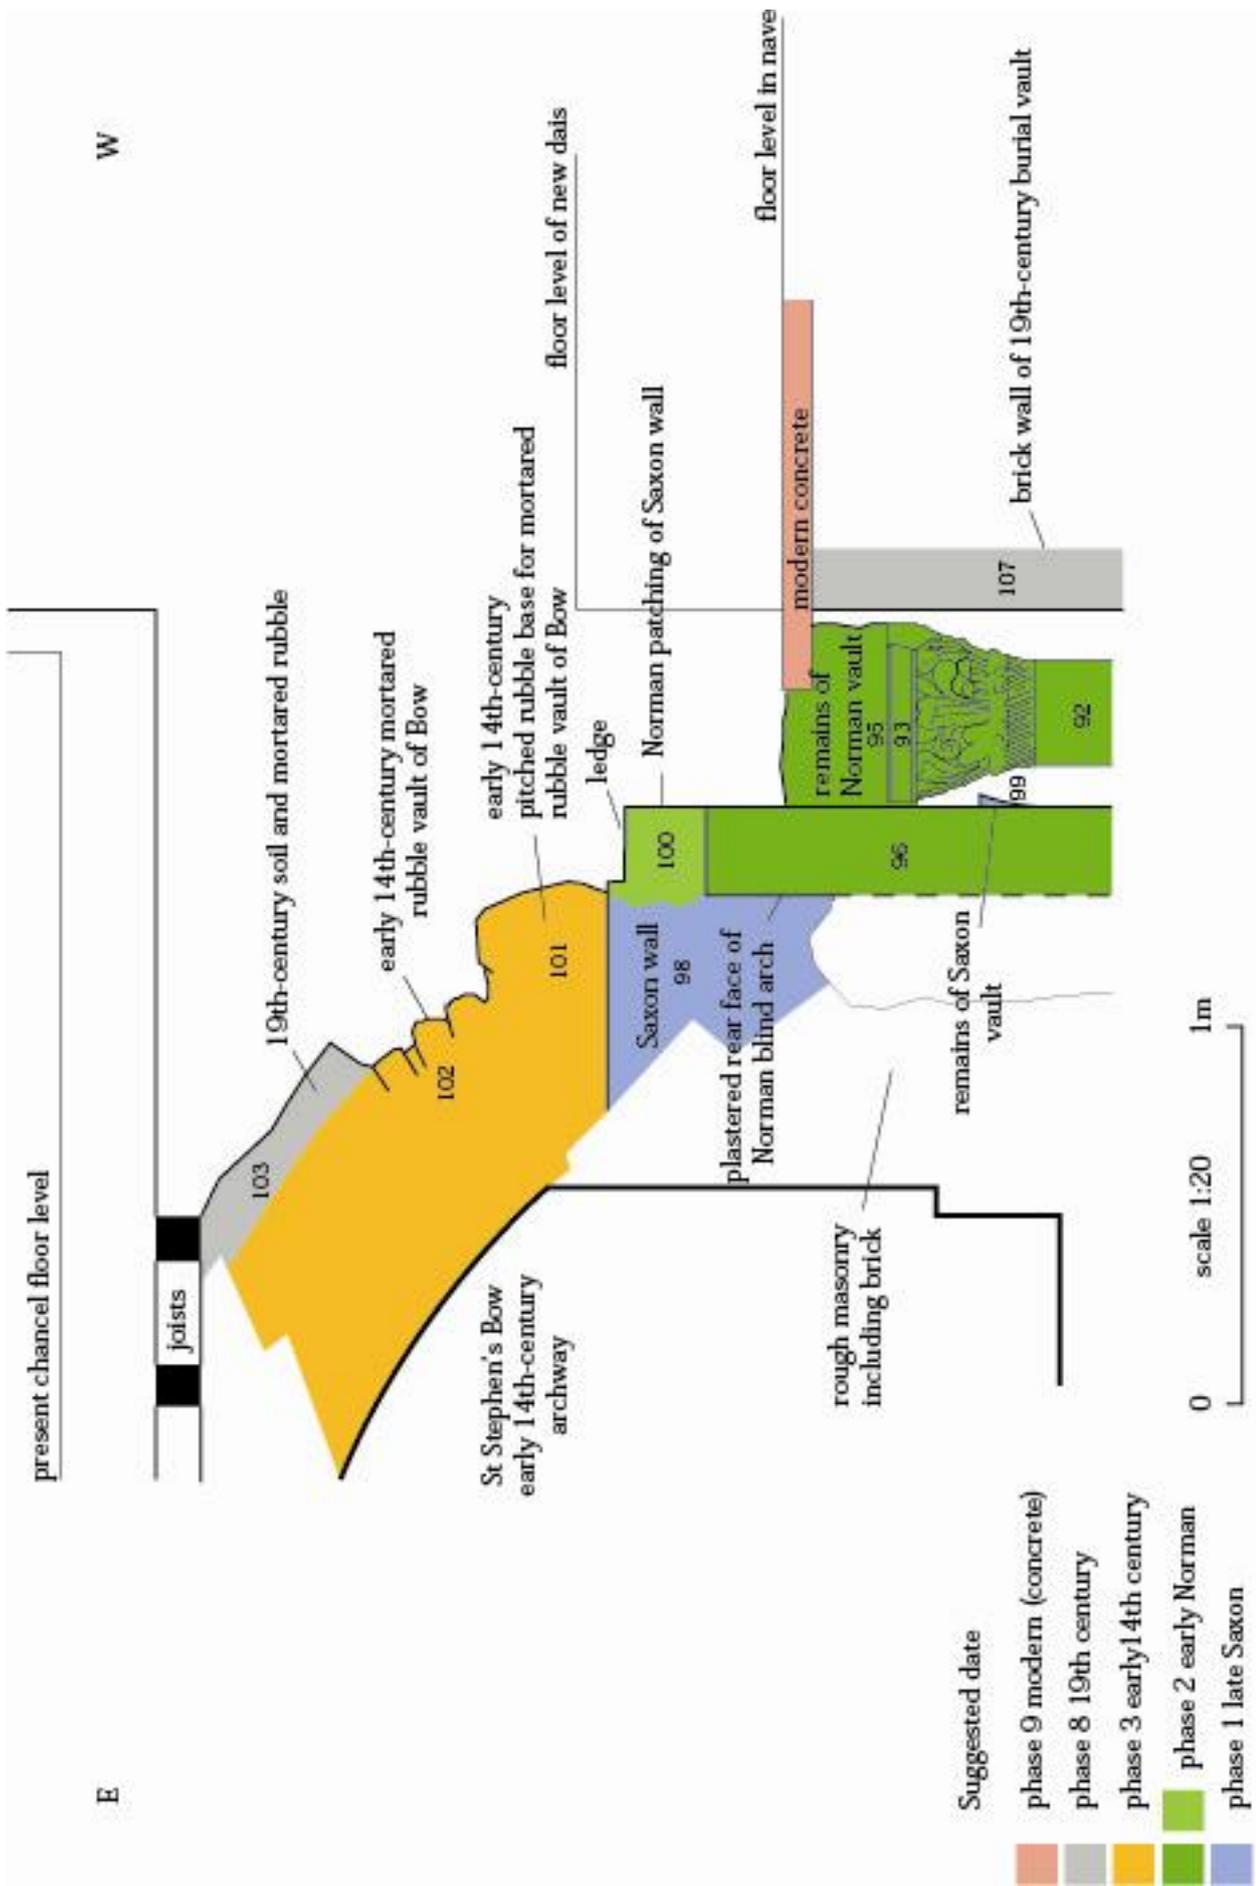
Fig. 15 Section through masonry excavated beneath chancel arch, looking south.

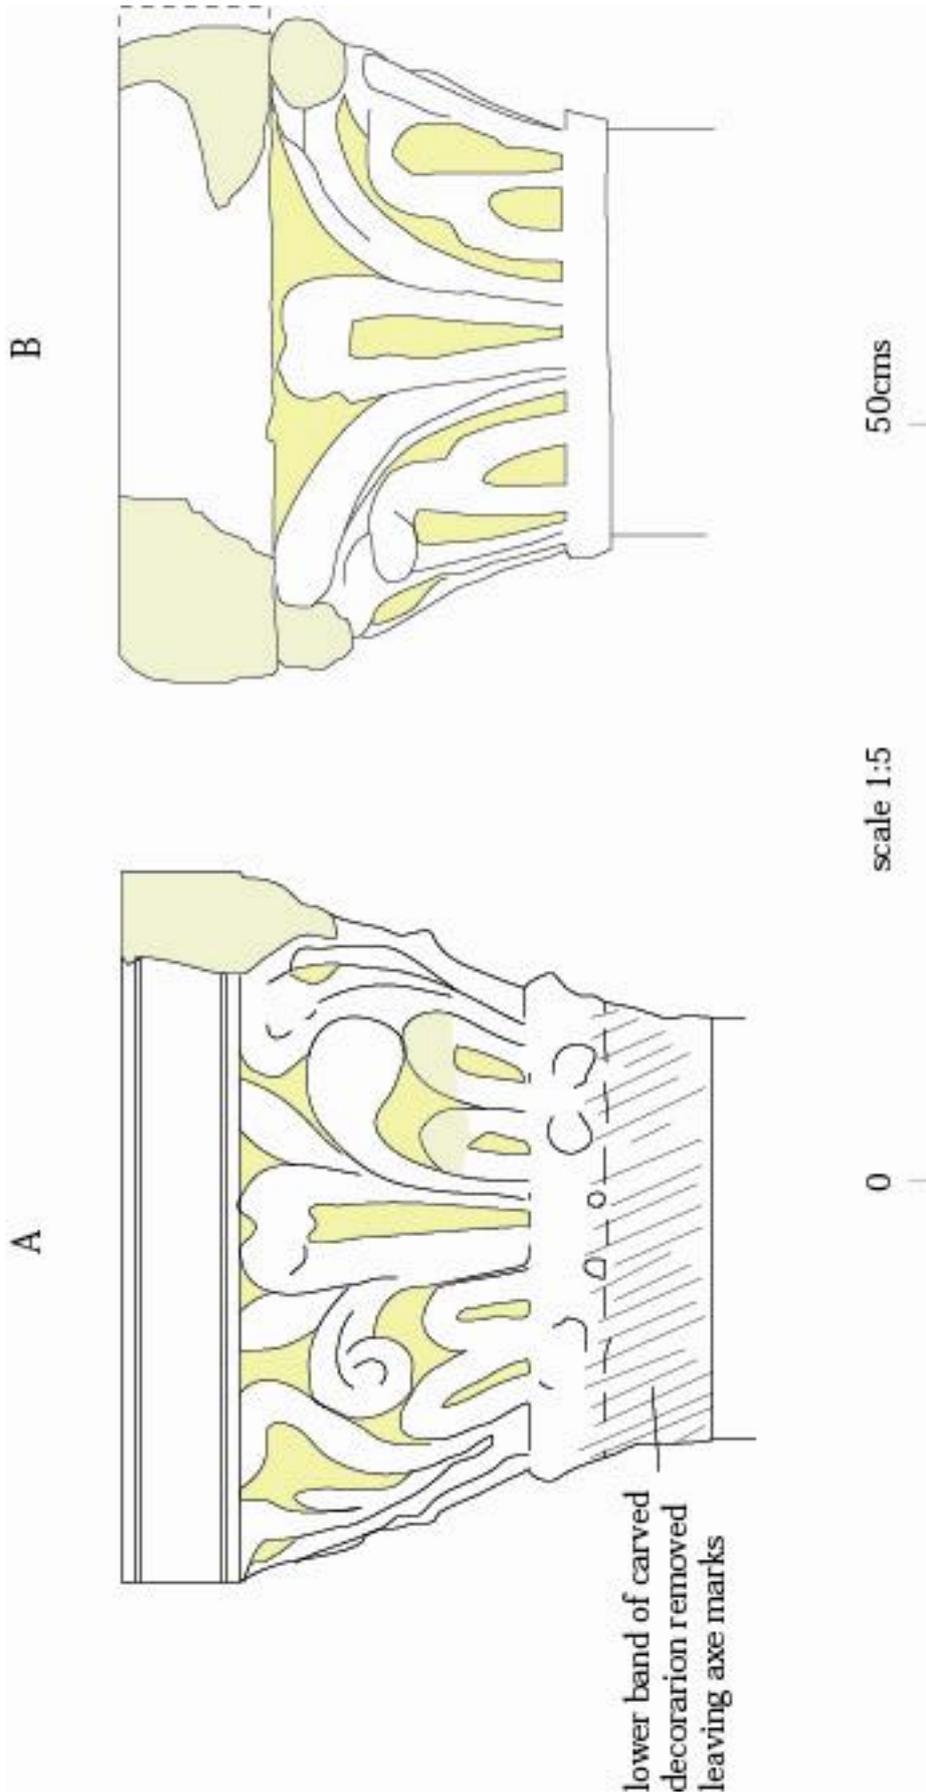
Fig16 Record drawing of the two early Norman capitals A and B.

The two Beer stone capitals are carved with different designs although both are derived from classical Corinthian capitals. The capitals have suffered damage, probably at various times when they were exposed and reburied, as well as prior to being installed in the crypt. They may represent items salvaged from elsewhere. Both had been decoratively carved in the round, even though one of their faces was hidden by being set against the east wall. Moreover, capital A shows axe marks around its lower part where a former band of decoration appears to have been removed in order to reduce the height of the capital to match that of capital B. This would suggest that the capitals came from another building, and that at least one of them had been re-modelled for use in the crypt.

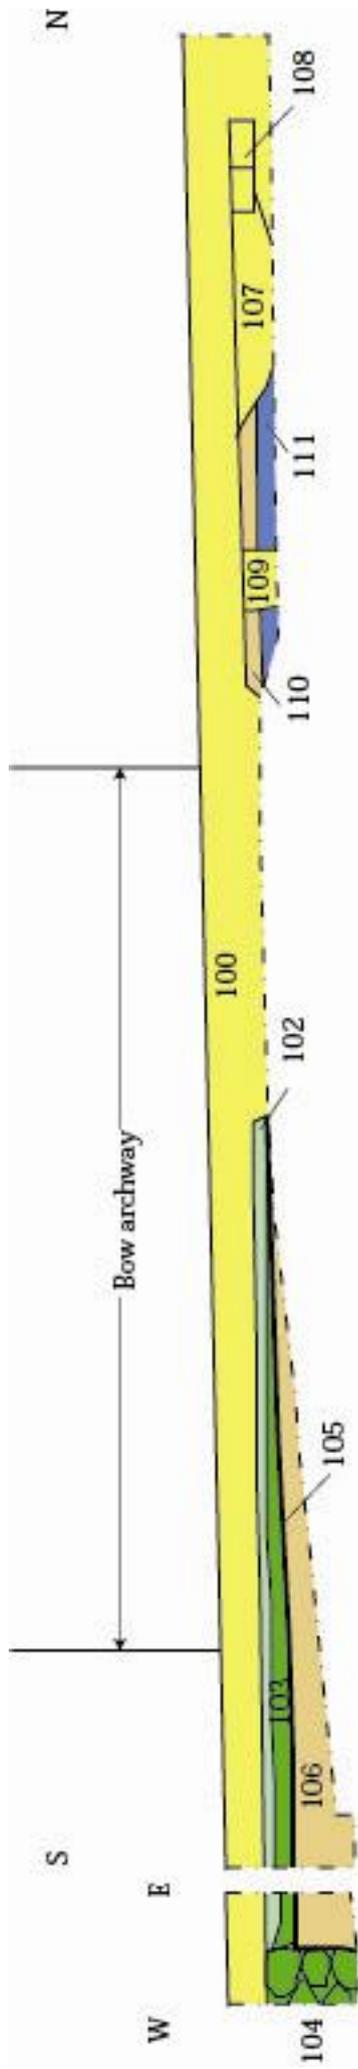
a) section of trench 5 for new water pipe through Bow archway, looking west.

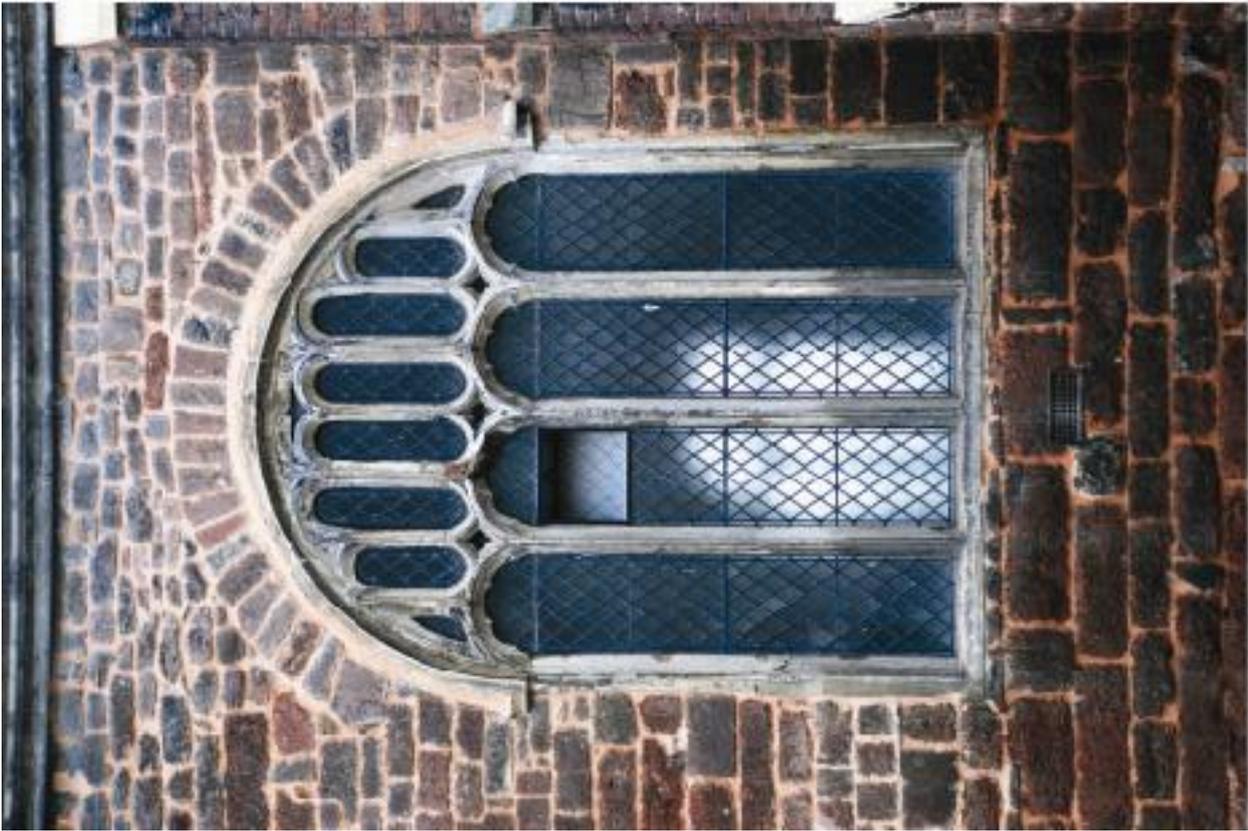
Plate 3 One of the three 17th-century windows in the front (north) wall, looking south.

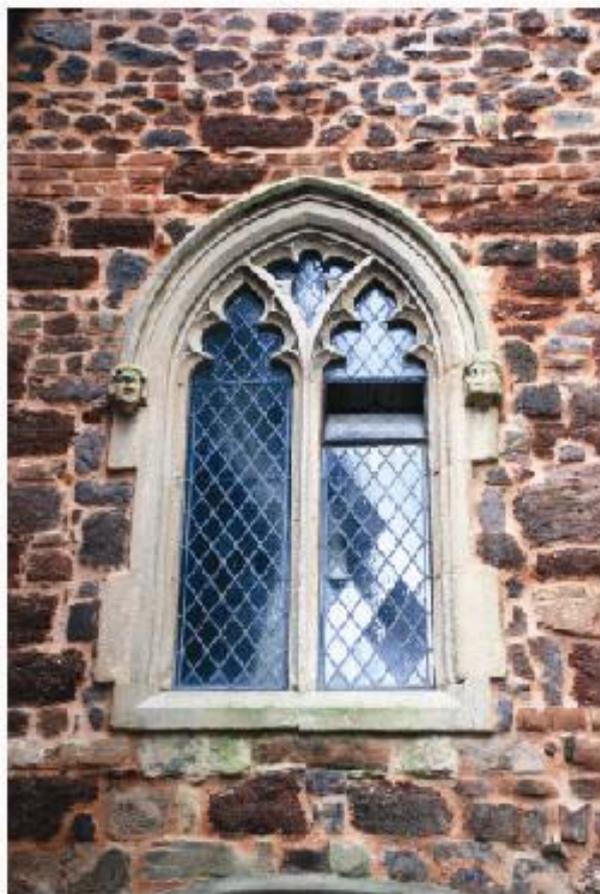
Plate 8 The 19th- or early 20th-century Bath stone window over the back (south side) of the Bow archway, looking north.

Phase 2 masonry includes and surrounds the present two-light window with pointed head (plate 8). The window, like the one in the front elevation, is built of Bath stone and has carved head stops to its drip moulding. It doubtless dates from the same period, ie 19<sup>th</sup> or 20<sup>th</sup> century, and replaced an earlier window in the same position. The phase 2 masonry was inserted through the earlier phase 1 masonry. It is made up of mixed Heavitree and volcanic rubble with some brick, set in light brown sandy mortar containing lime flecks. At its top, this masonry includes bricks.

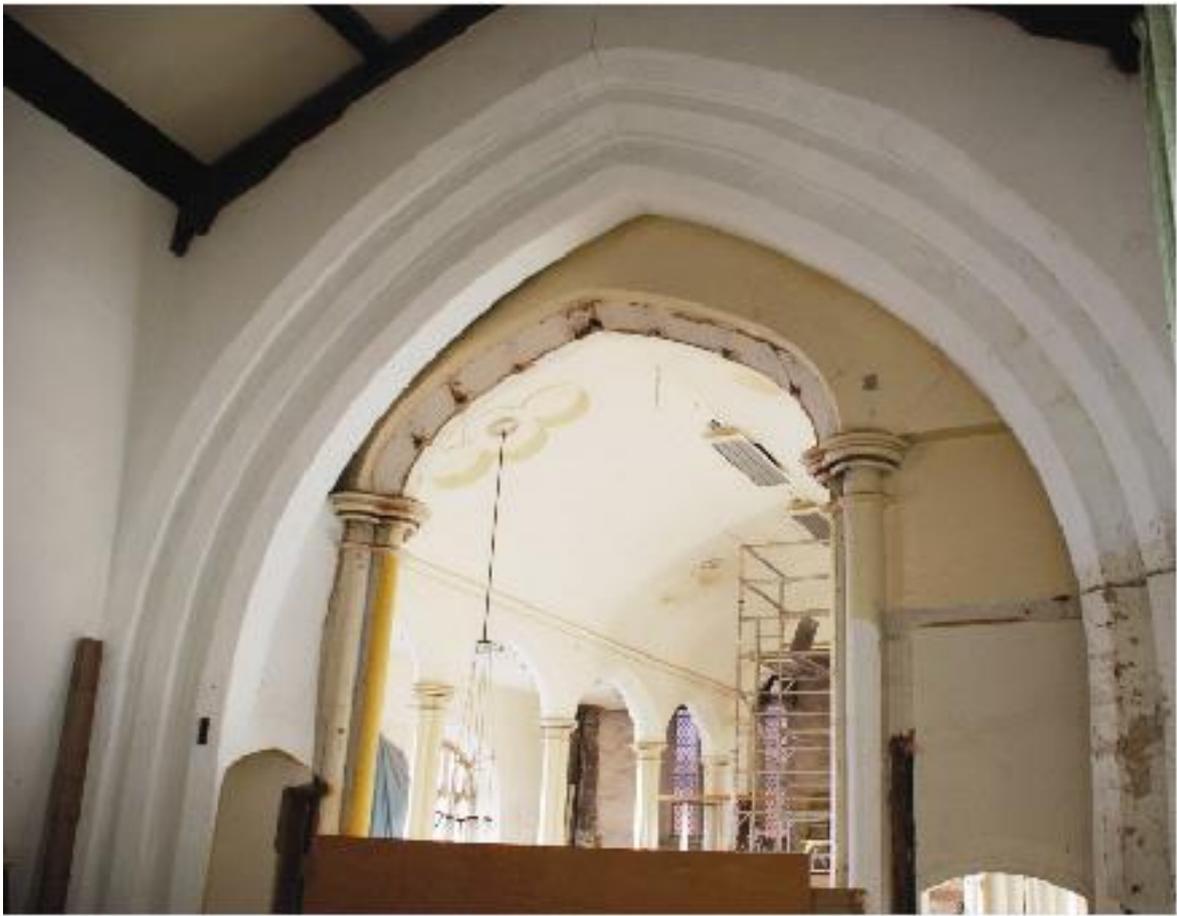
Plate 11 The early 14th-century chancel arch, looking southwest.

b early 14<sup>th</sup>-century chancel arch. The arch is largely exposed on its east side (Plate 11). From the west it is obscured behind the phase 8 arcade at the west end of the nave (Fig. 8) and wall plaster. The arch is two-centred (pointed) and has plain chamfered mouldings (Fig. 12, f). It is covered with modern white paint, but in a few places where the paint has fallen away it can be observed to be built of Beer stone. Its two sides are raised up higher than the nave floor on rubble bases (Plates 12 and 13). The arch stood half-way up a flight of steps leading to the chancel. The arch clearly forms part of the phase 3 construction of the chancel above the Bow archway. Stylistically, it dates from the late 13<sup>th</sup> or early 14<sup>th</sup> century. Its rubble bases are built of volcanic and Heavitree stone, the inclusion of the latter suggesting a date in the early 14<sup>th</sup> century or later, since Heavitree stone first appears as a building stone in Exeter only at the very end of the 13<sup>th</sup> century, when it was used for prestigious structures. Here, it was used as rubble in a secondary context, so probably had been salvaged from an earlier structure. In the sequence of development phases of the church (below), the arch forms part of phase 3. Part of the arch was rebuilt in the 17<sup>th</sup> century, quite possibly owing to damage caused during the fire of 1662. Stones on the west face of the northern side of the arch were replaced with poor quality masonry comprising volcanic stones set in light brown mortar (Plates 14 and 15). This masonry is continuous with that of the north aisle above window sill level, which dates from 1664/5 (Fig. 2, phase 2, above).

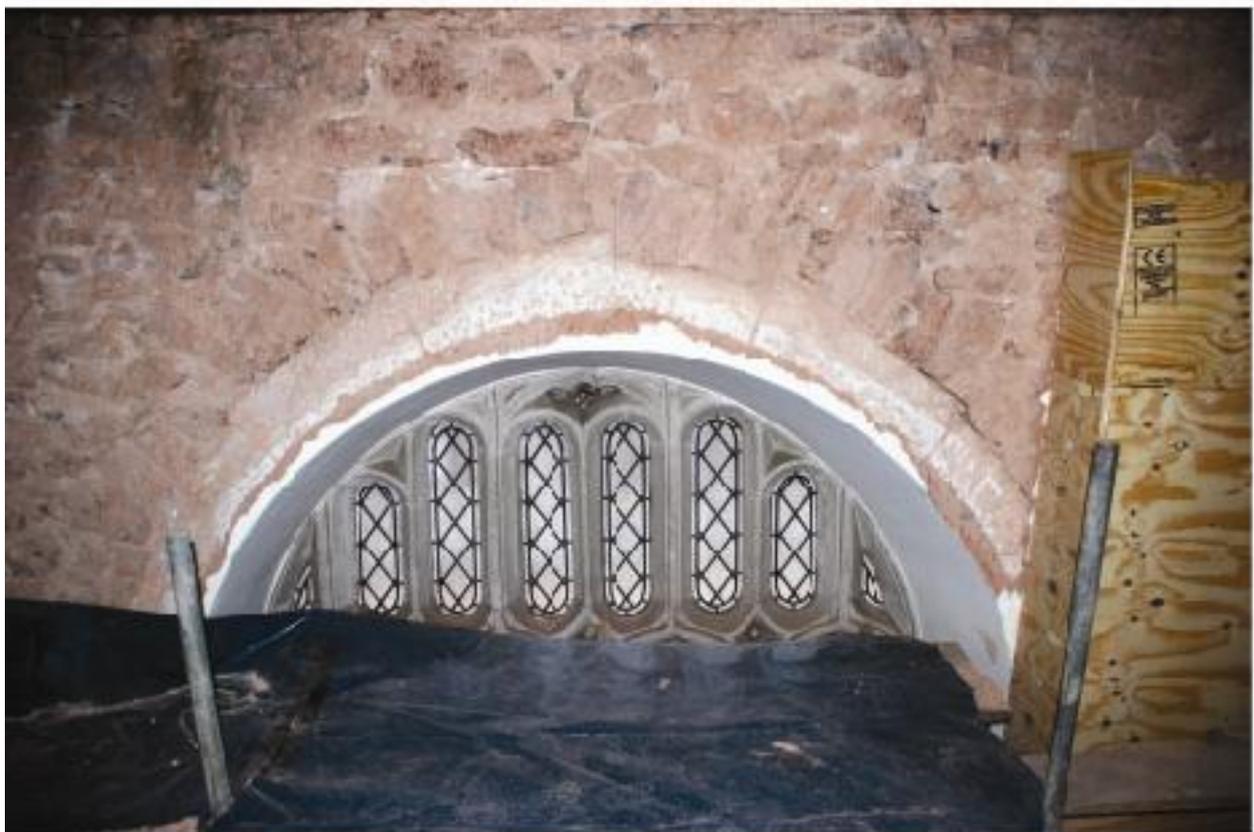
Plate 24 The re-arch of one of the windows in the front (north) wall, looking north. The re-arch is made up of re-used Beer stone fragments from an earlier window.

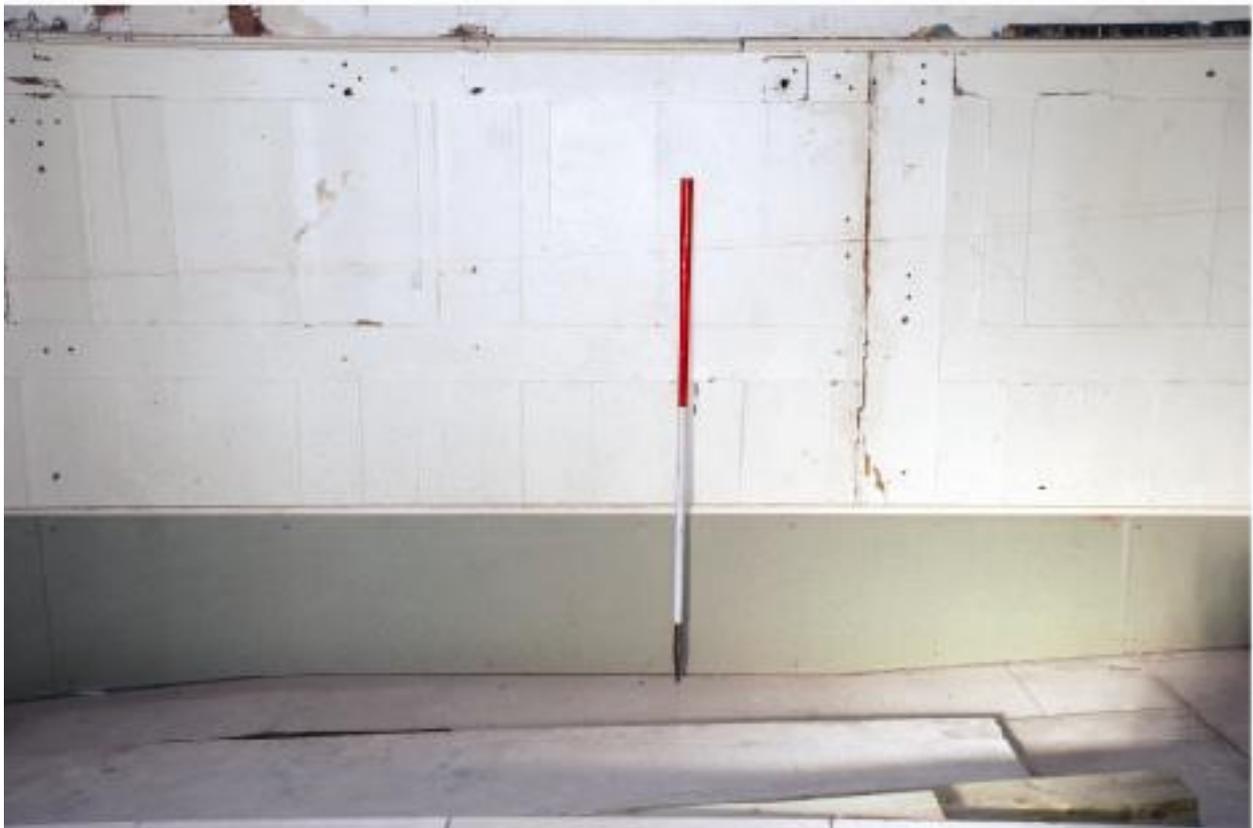
Plate 26 The present paneling in the north aisle, made up of re-used panels from 18th-century box pews, looking north.

The late 17<sup>th</sup>-century church would have had a good number of box pews. These may well have been added to or replaced in the 18<sup>th</sup> century. Remains from dismantled box pews, some with ramps, have been used as paneling in the present north and south aisles.

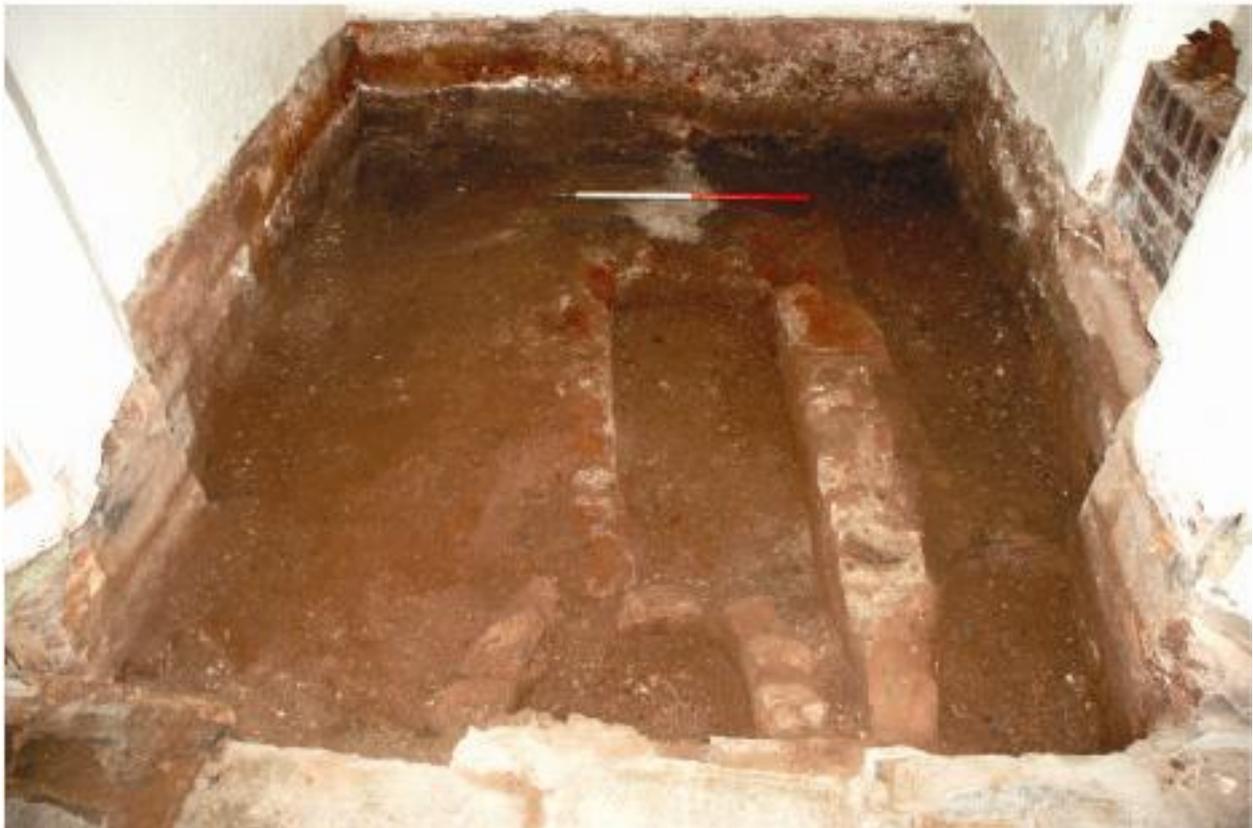
Plate 28 Excavation in the tower basement showing stone-lined graves 7 & 8, looking west.

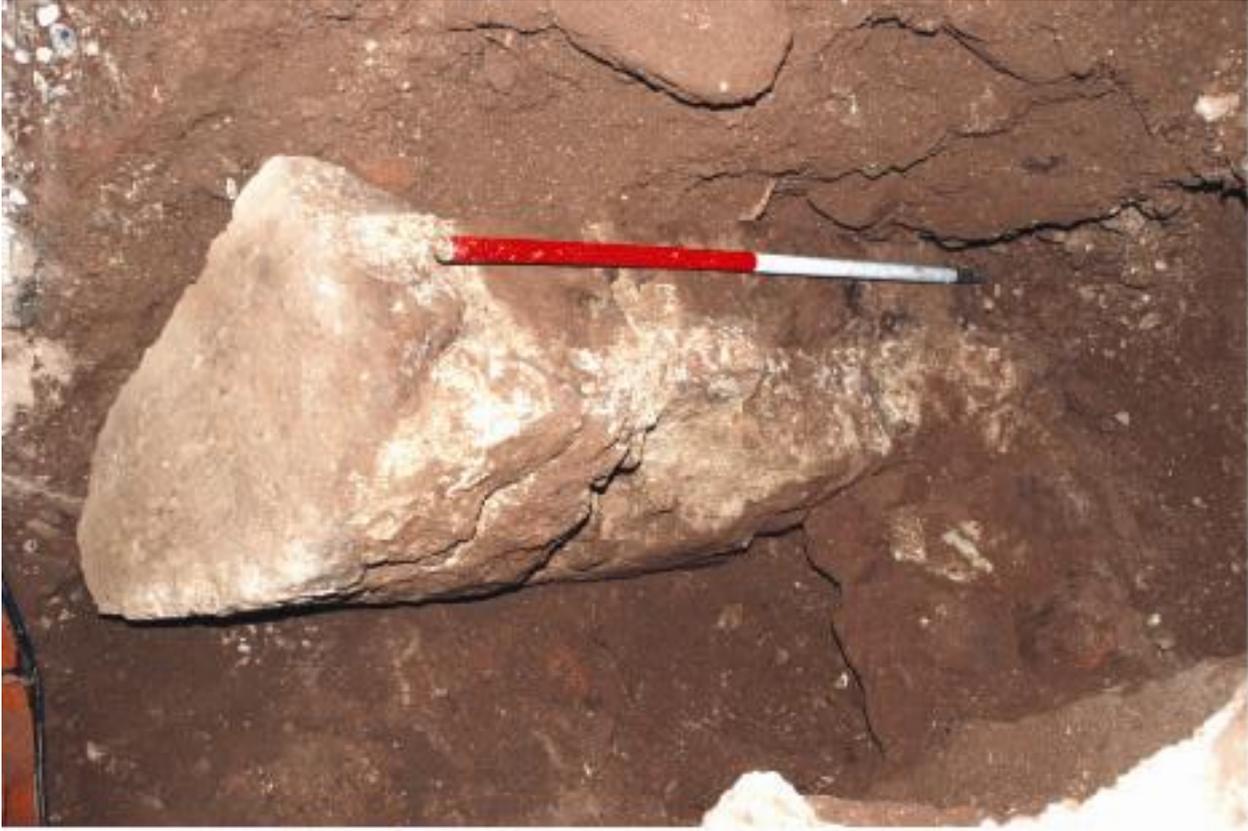
Plate 34 Excavated stone pier 81 which probably formed the central column of a medieval stair leading down to the crypt, looking northeast.

The pier seems likely to have been the central support for a medieval circular stair descending below the church floor level, at the bottom of which was an arched doorway. The doorway must have led into the crypt. The stair is likely to be an inserted feature since it was not built into the thickness of a wall like many spiral stairs, but was instead constructed as an independent feature, presumably within in a gap broken through a wall for its insertion. The narrow wall leading west would have infilled the gap to the west of the pier and screened the stair from the crypt, as well as providing the stair's threshold. The feature leading south from the pier could have been a pilaster buttress. A likely date for the insertion of the stair is in the early 14<sup>th</sup> century, at about the time that the church was extended eastwards by building a new chancel over the Bow archway, since a new stair down to the crypt may have been needed following the alteration (see Development, phase 3, below).

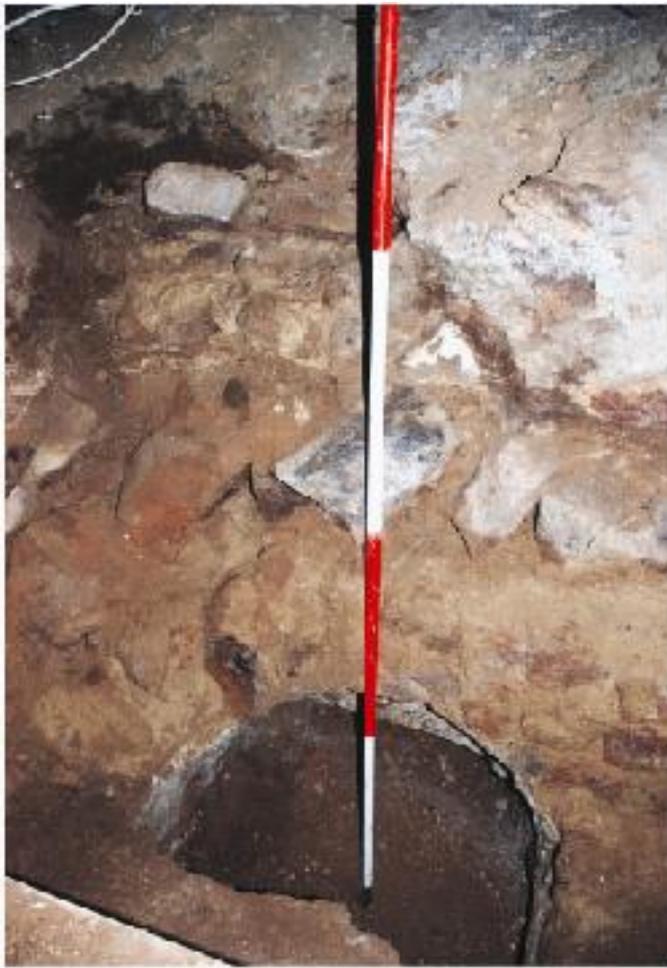
Plate 35 The crypt excavation showing early Norman arched recess 96, looking northeast.

Overlying the Saxon and Norman remains is an area of later rubble masonry which slopes backwards and rises up to the floor of the chancel over the bow archway (Plate 35). This was cleaned and investigated so far as possible in the area immediately above the excavation. The rubble was found to comprise three different layers (Figs 14 and 15, 101-103). The lowest layer was made up of large volcanic stones, some pitched on their narrow ends, set in dark brown clay (101). A few stones at the north end had tumbled forward across the wall. The rubble clearly dates from after the Saxon wall (98) had been taken down to a level just above the crypt vault. It evidently provided a base for the white-mortared rubble masonry overlying it (102), which forms part of the vault of the present Bow archway to the east. The latter mortared rubble comprises courses of volcanic stones laid at a shallow but noticeable pitch forming part of an arc.

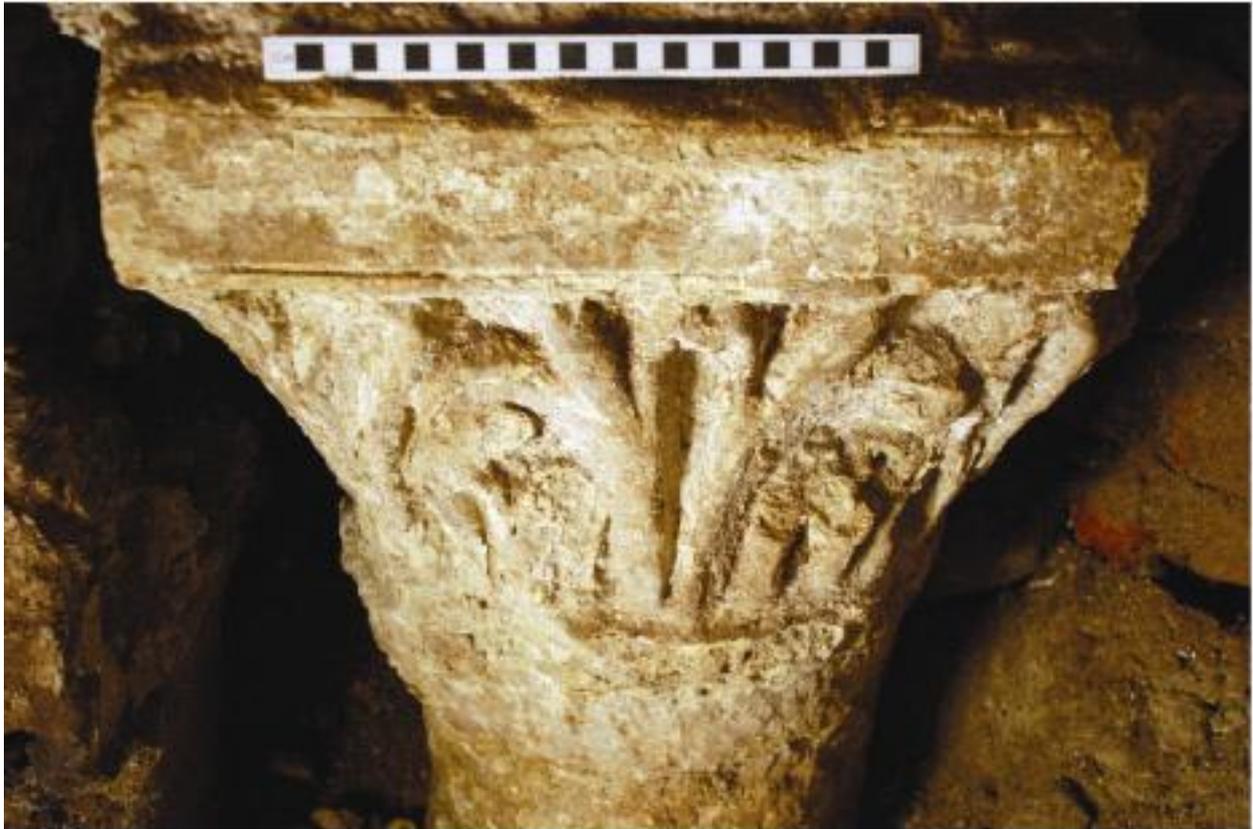
Plate 37 Early Norman capital A, showing carved detail and diagonal axe marks at the bottom, looking south.

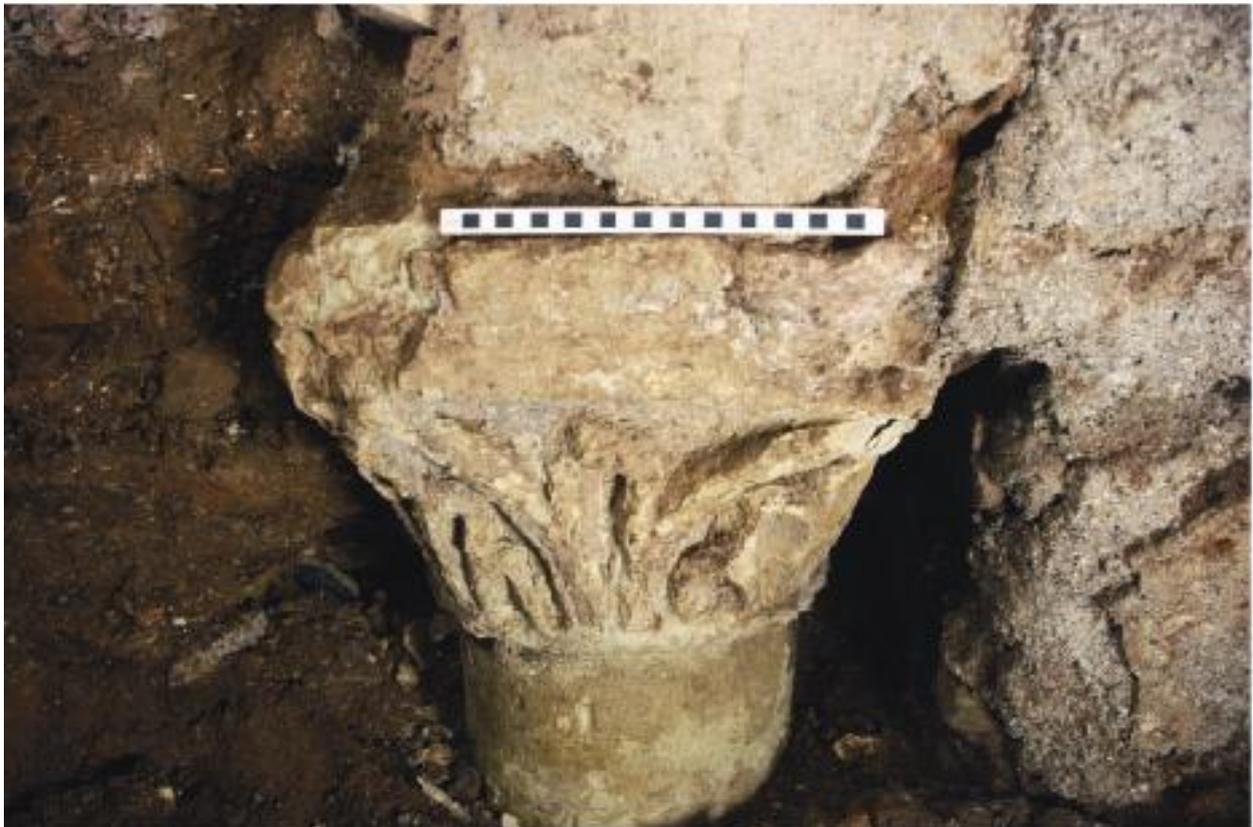
Plate 38 Early Norman capital B, showing carved detail and plastered face of the vault above, looking north.
