**Historic building recording  
at Court Farm,  
Lincomb Lane,  
Lincomb,  
Hartlebury,  
Stourport-on-Severn,  
Worcestershire,**

# **Historic building recording at Court Farm, Lincomb Lane, Lincomb, Hartlebury, Stourport-on-Severn, Worcestershire**

Historic building recording of a dwelling and associated buildings at Court Farm, Lincomb Lane, Lincomb, Hartlebury, Stourport-on-Severn, Worcestershire (SO 8237 6866; planning ref W/09/0799, Fig 1) was undertaken at the request of Julia Whelan, according to a written scheme of investigation provided by Martin Cook BA MifA and approved by Mike Glyde of Worcestershire Archive and Archaeology Service.

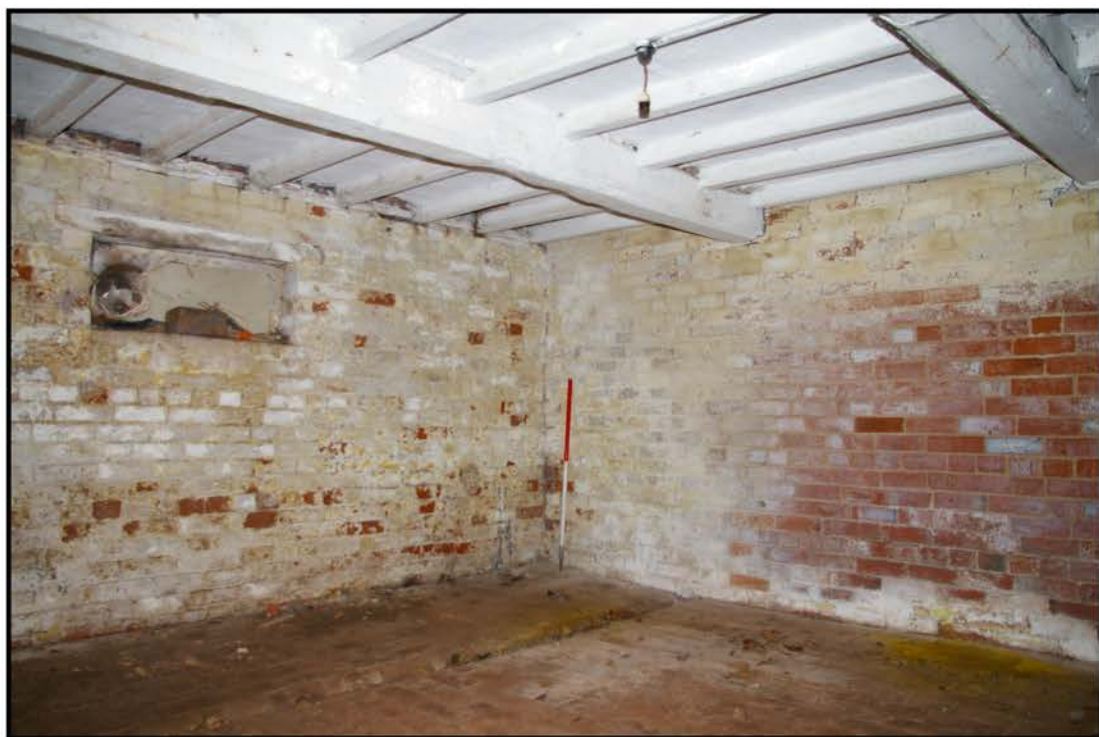
Fig 7: Farm house, cellar; phase 2

The walls are of brick (except where elements of the phase 1 structure remain; Fig 3.2), and the floor is covered with brick setts (Figs 7 and 8). The southern room was provided with a shallow channel providing drainage out through the entrance in the south-west corner.

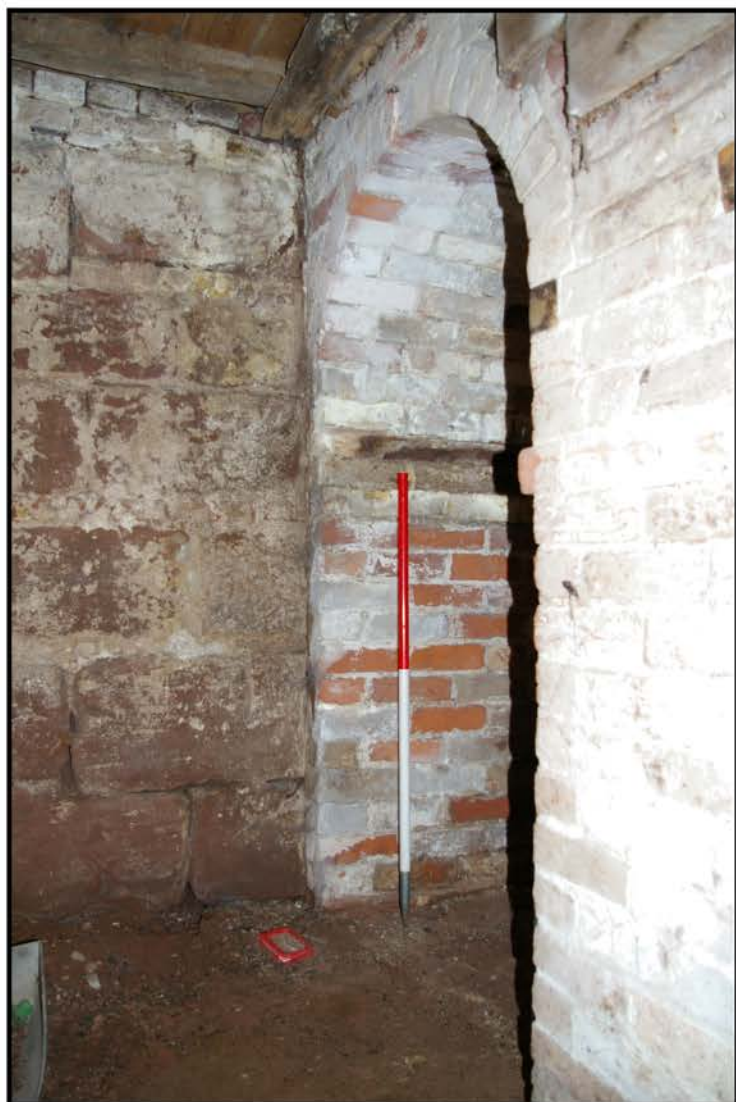
Fig 9: Farm house, cellar; phase 2 stair, showing phase 1 masonry

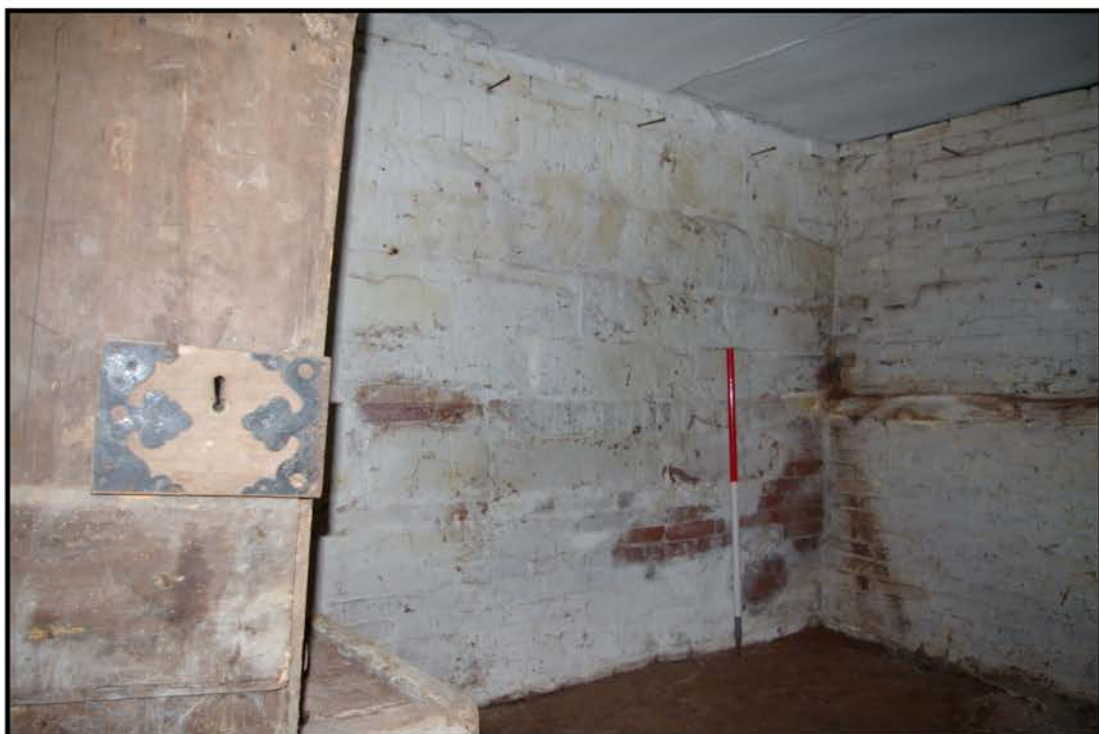
Fig 11: Farm house, cellar; phase 2, showing phase 1 masonry

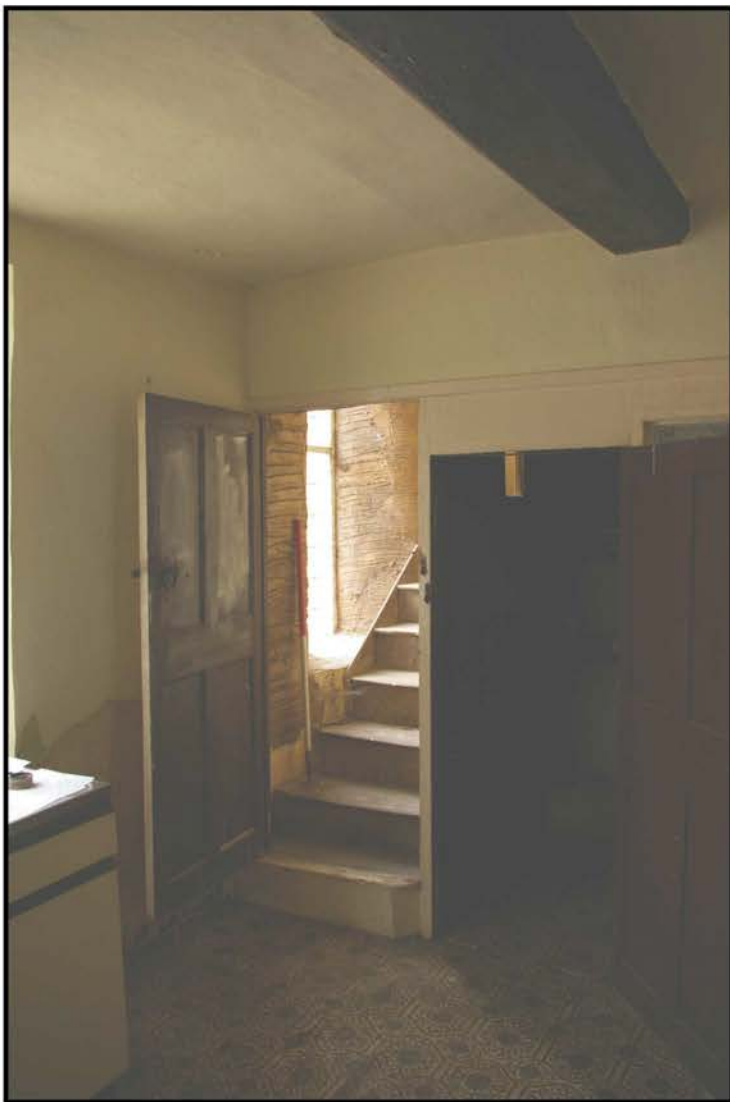
Fig 16: Farm house, ground floor; phase 1, servants' hall, detail of servants' stair

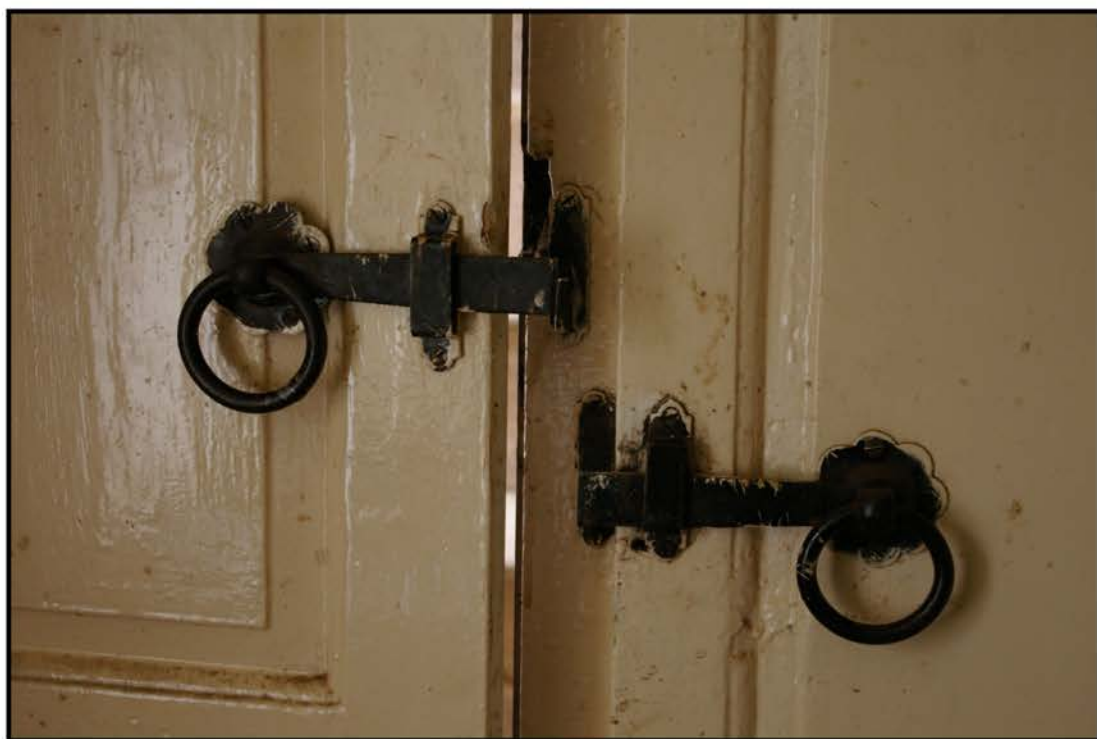
The phase 1 elements comprise three substantially built stone walls on the north, south and east, pierced by splayed openings. It is likely that the splayed opening in the east wall (Figs 3.1 and 15) was originally a window. A door dividing the winding stair from the principal room (Fig 16) and another separating it from the hall/stairwell are probably contemporary with Phase 2, as are the latches used to secure them (Fig 18).

Fig 18: Farm house, ground floor; phase 1, servants' hall'  
detail of door fittings

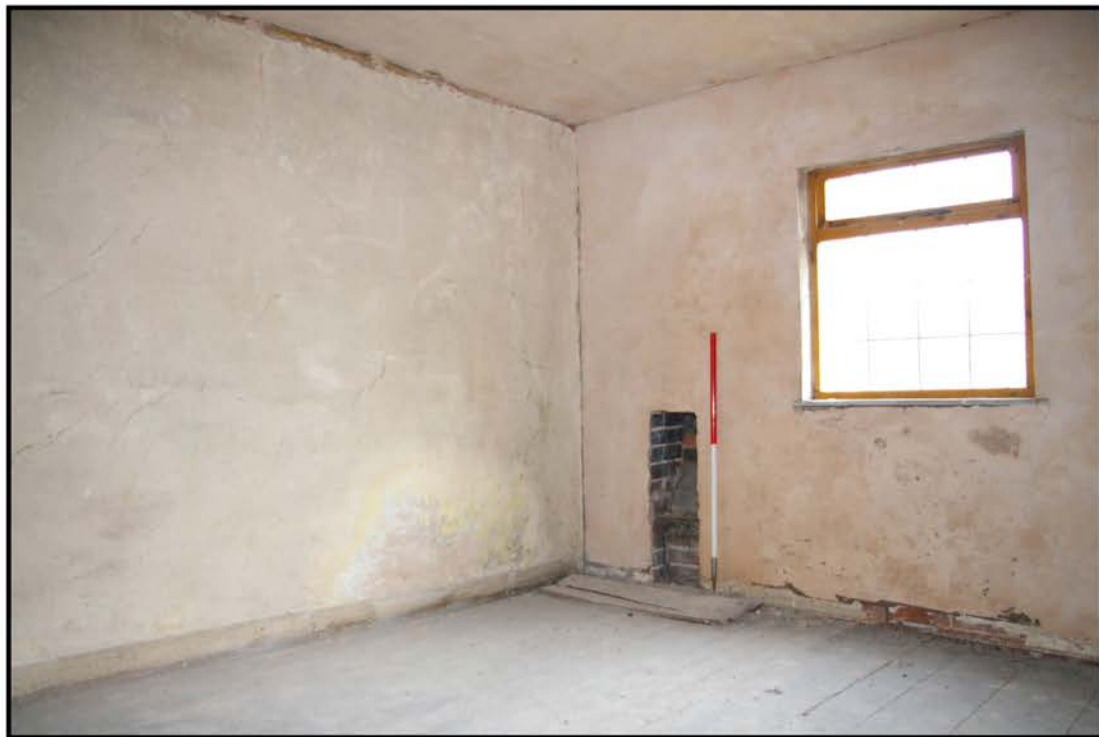
The sub-division of the phase 1 structure was accomplished with solid walling, not timber partitions, and the thickness of the two walls indicates that this was carried out in brick (Fig 3.4). The arrangement is almost exactly the reverse of the floor below with the smaller room being to the north and the larger to the south. In this case, however, the minor room is accessed from the major creating a small suite. A small, simple grate was provided in the corner of the larger room (Fig 27).

Fig 27: Farm house, second floor; phase 1, ?house keeper's bedroom

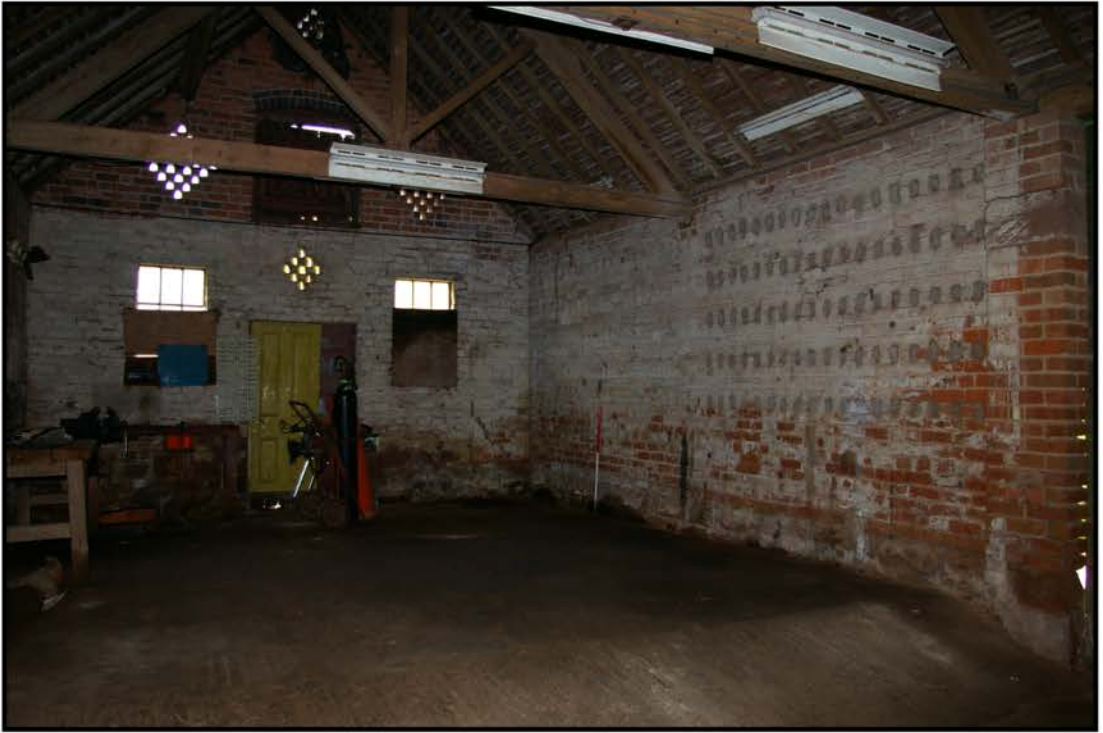
Fig 42: Combination barn and stable; barn showing king post roof truss

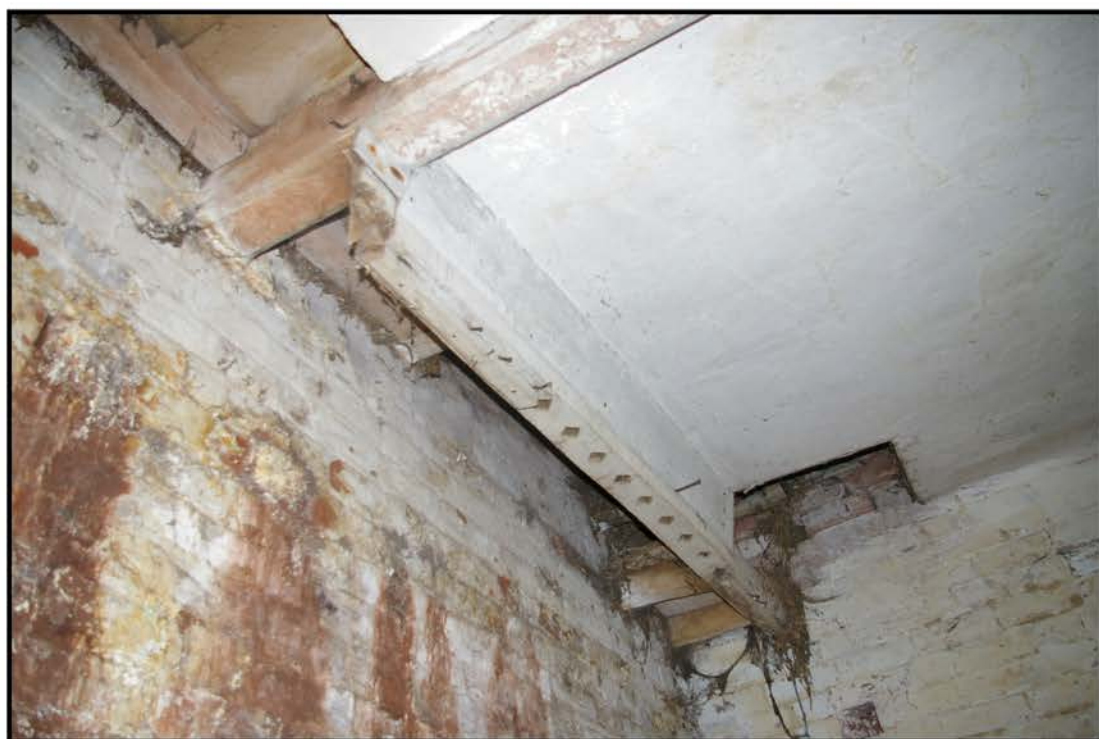
The phase 3 structure is a square extension on the northern side of the phase 2 structure (Figs 6.1, 6.2, 6.3, 6.4, 51 and 53). This was a further stable. It was built in Flemish garden wall bond and was partially subterranean, being built into the higher ground to the north. Its east elevation has a typical stable door with a small window adjacent, both with single brick arches (Figs 6.4 and 51). Its west elevation (Fig 6.4) has a blocked door and small window. The north elevation (Figs 6.3 and 53) has a small opening in the gable, spanned by a single brick arch. The interior has a floor of brick setts and the floor of the chamber above (Fig 6.2 and 49) has narrow gaps in the floor, against the northern wall.

Fig 49: Stable, showing gap in ceiling for filling hay rack and remains of hay rack

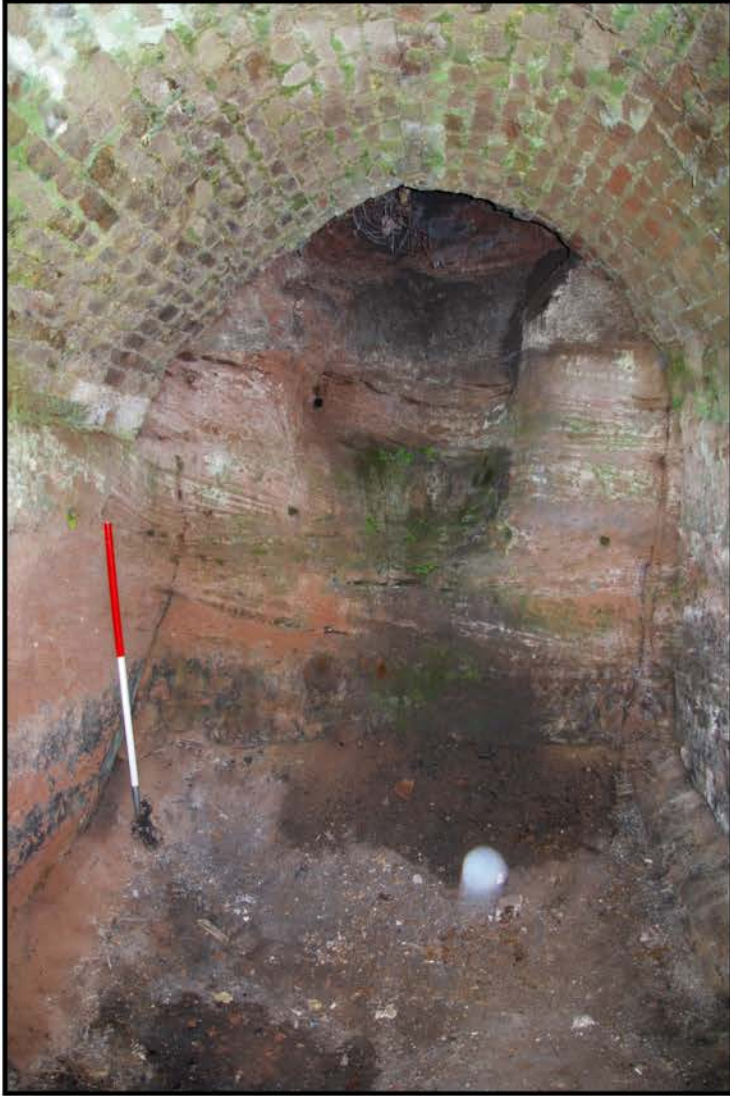
The structure known as the shed comprises two excavated chambers in the sandstone cliff to the east of the dairy and bakehouse (Figs 4.3, 54 and 55). As in the other structures described above, there is stone masonry visible in the lower parts of the wall which fronts the chambers (Figs 4.3 and 54). The majority of the facing wall, however, is in stretcher bond. The western-most chamber has a brick arch forming its roof (Fig 55); the eastern-most has a modern pitched roof (Fig 54).

Fig 55: The 'shed'; interior showing brick arch and 'chute' from bank above
