**Historic building recording  
at Folley Cottage,  
Bredons Hardwick Lane,  
Bredons Hardwick,  
Worcestershire**

2nd October 2013

WSM 49784

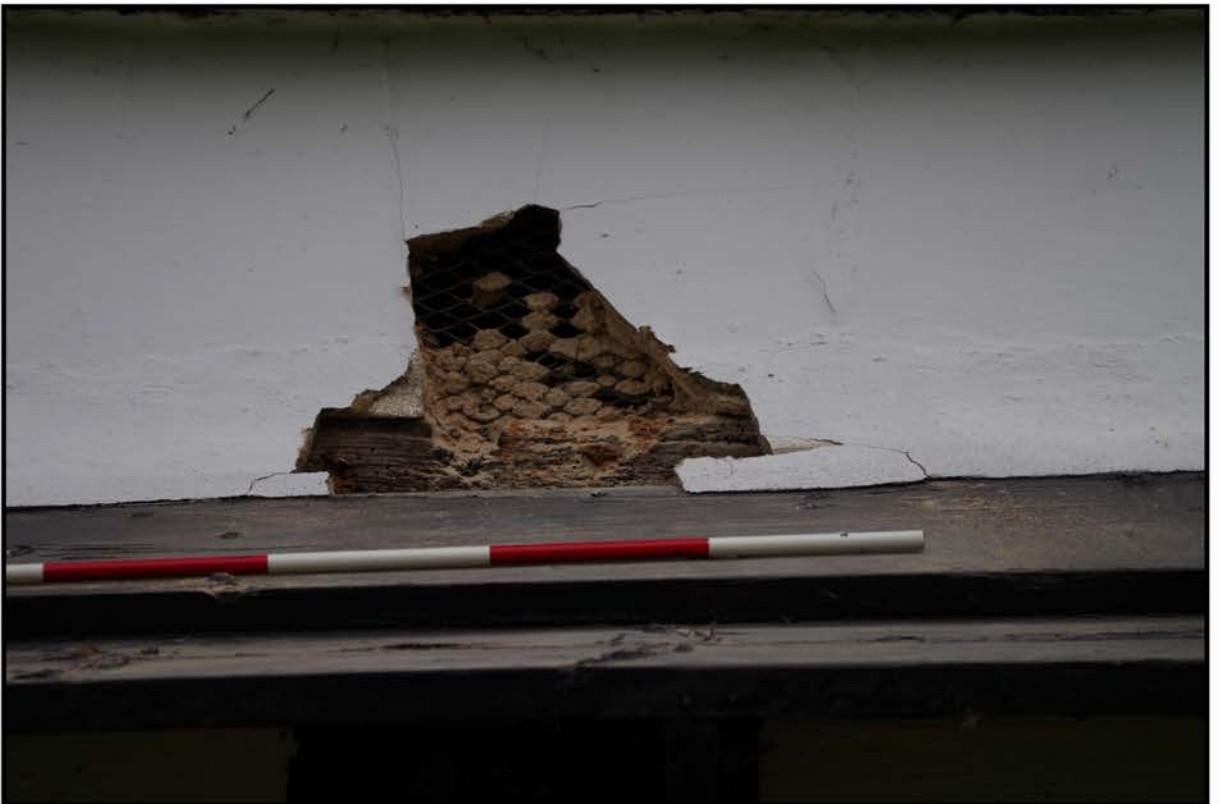
Fig 7: South-west elevation; detail of head plate or rail

- the core part of the south-east elevation (Figs 3.3, 3.4 and 3.5) of Cotswold, squared, semi-coursed stone, which forms a chimney
- a row of wooden posts and a head plate or rail (Figs 3.3 and 7) which form the remains of a timber frame building.

Intrusive investigation and analysis of the south-west elevation (Figs 3.3, 6, 7, 8 and 9) demonstrated that there were no surviving traditional timber frame infill materials such as wattle and daub. Brickwork, where it was employed, was in stretcher bond (Figs 3.3 and 4). Otherwise, the infill was cement mortar supported on a wire mesh. Under-building with brick was particularly evident on the north-west elevation (Figs 3.4 and 13) which was also executed in stretcher bond. The use of brick in the replacement of the north-west elevation may be inferred from the pier supporting one of the first floor beams (Fig 3.1) which was of a dimension consistent with this form of construction.

The timbers relating to Phase 1 were fragmentary and, in the case of the head plate, where it was observed, were worm-ridden. Given that the building is dated to the 19th century by the two historic maps that straddle its appearance (the tithe map of Bredon of 1809 and the 1st edition Ordnance Survey map of 1885) it was felt that the use of this technique was not appropriate.

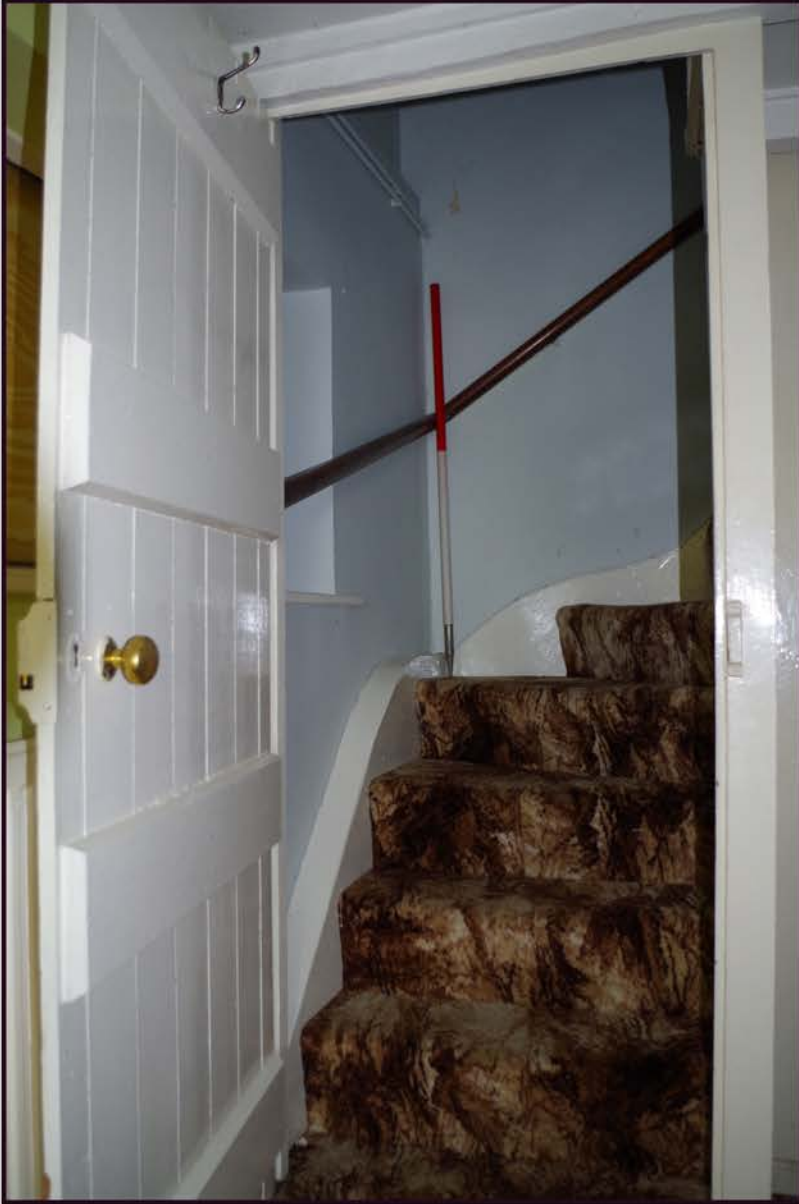
Fig 22: Ground floor; existing kitchen/diner; detail of stairwell

The staircase is of simple dog-leg form within a wooden enclosure (Figs 3.1 and 22), located in the corner of the kitchen/diner.

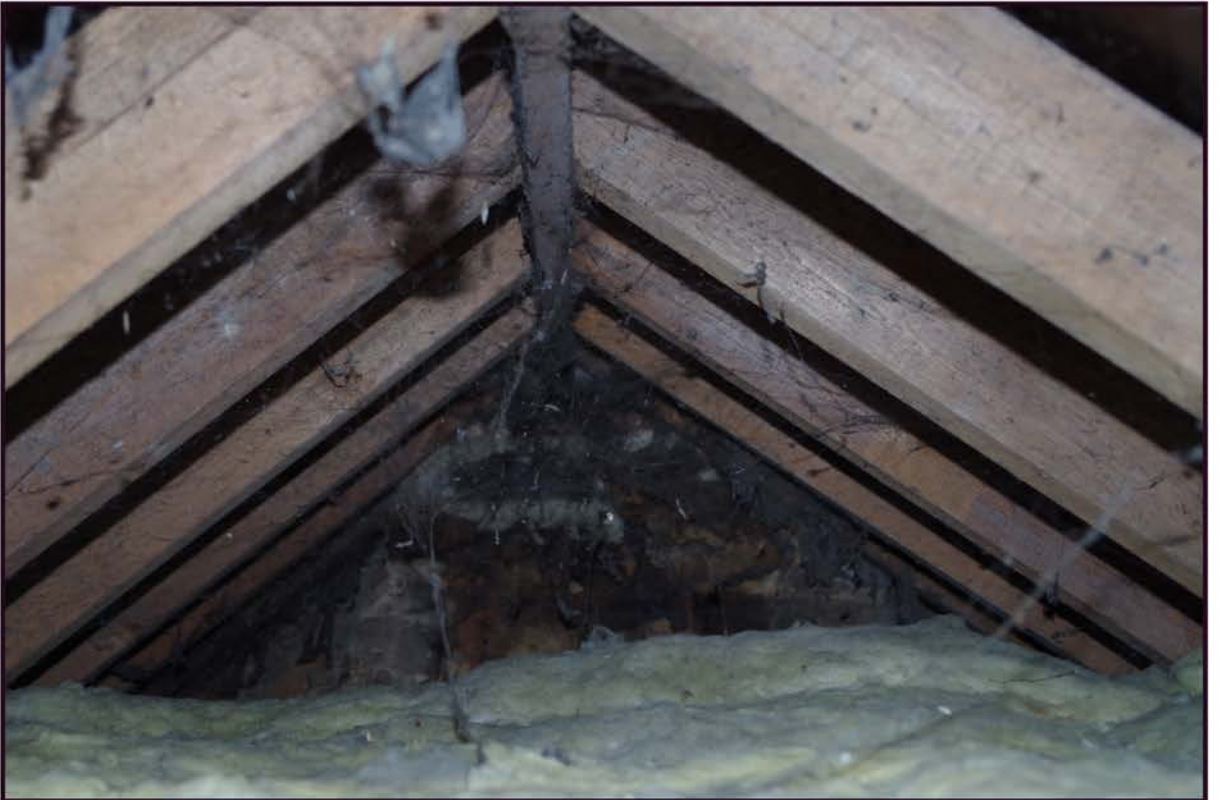
Fig 28: Roof space; detail of modern timbers

The roof structure was of a simple principal rafter design with a ridge plate at the apex (Fig 28) and is of modern date.

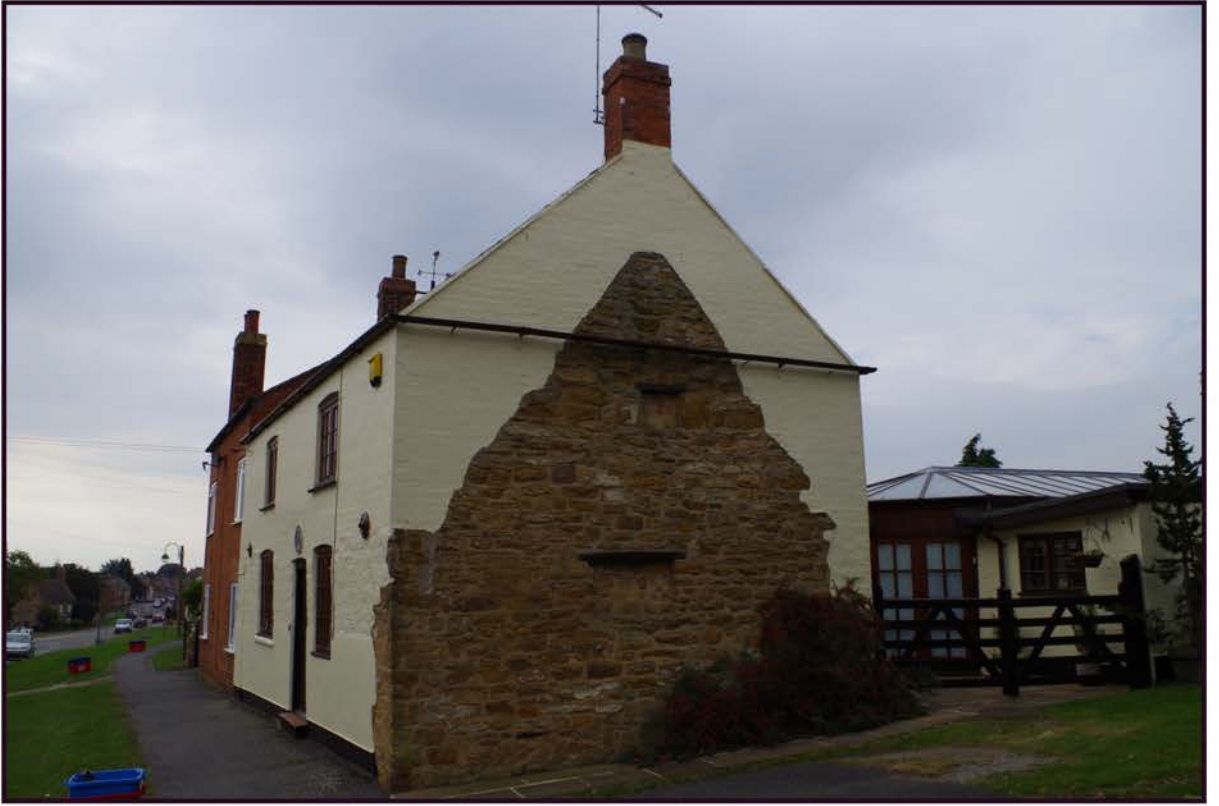
Fig 32: Comparative material: cottage, Braunston, Northamptonshire

Careful examination of the south-east elevation (Fig 3.5) revealed a number of significant features. The first of these were two stones with sloping ends, at opposite ends of the elevation, at first floor level. The presence of these indicate the former underside of an earlier roof. This would have had a much steeper pitch to the existing roof. An attempt was made to remove the pebbledash at first floor level to confirm this. This attempt failed due to the hardness of the material but a further attempt, in the corresponding position inside the building, where the material to be removed was only plaster, succeeded (Fig 25). The removal of the plaster demonstrated that the line of the stonework followed the approximate position shown by the dashed lines on Fig 3.5 (south-east elevation). It is believed that this is *prima facie* evidence for the existence of a thatched roof during Phase 1 and for the building, during this phase, to have been single storey only. Supporting evidence comprises a 'shoulder' on the south-west face of the chimney (visible on Fig 3.5; south-east elevation and Fig 10, immediately adjacent to the scale bar). This would have accommodated the thickness of the thatch. Comparative material to support this hypothesis was not difficult to acquire. A cottage in Braunston (Northamptonshire) shows clear evidence of a process such as this (Fig 32). In connection with the former thatch, the sloping boards across the front of the south-west elevation (Fig 5) may be a relict feature, intended to support the thatch over the windows. Finally, it is possible that there was a window in the south-east elevation. The pattern of stones at its southern end (Figs 3.5 and 10) is reminiscent of such a feature. Some support for this comes from the cottage in Braunston where the presence of former windows is unequivocal (Fig 32).

It was not possible to determine the material in which the first floor was added as the pebbledash, which completely covered this element of the structure was particularly tenacious and would not yield to hand tools. However, it is reasonable to infer, by comparison with the building in Braunston (Fig 32), that this was also executed in brick.
