**Historic building recording
at Langabeer Farm,
Alcester Farm,
Wythall,
Worcestershire**

Martin Cook BA MifA

10th January 2014
Revised 13th February 2014

WSM 49806

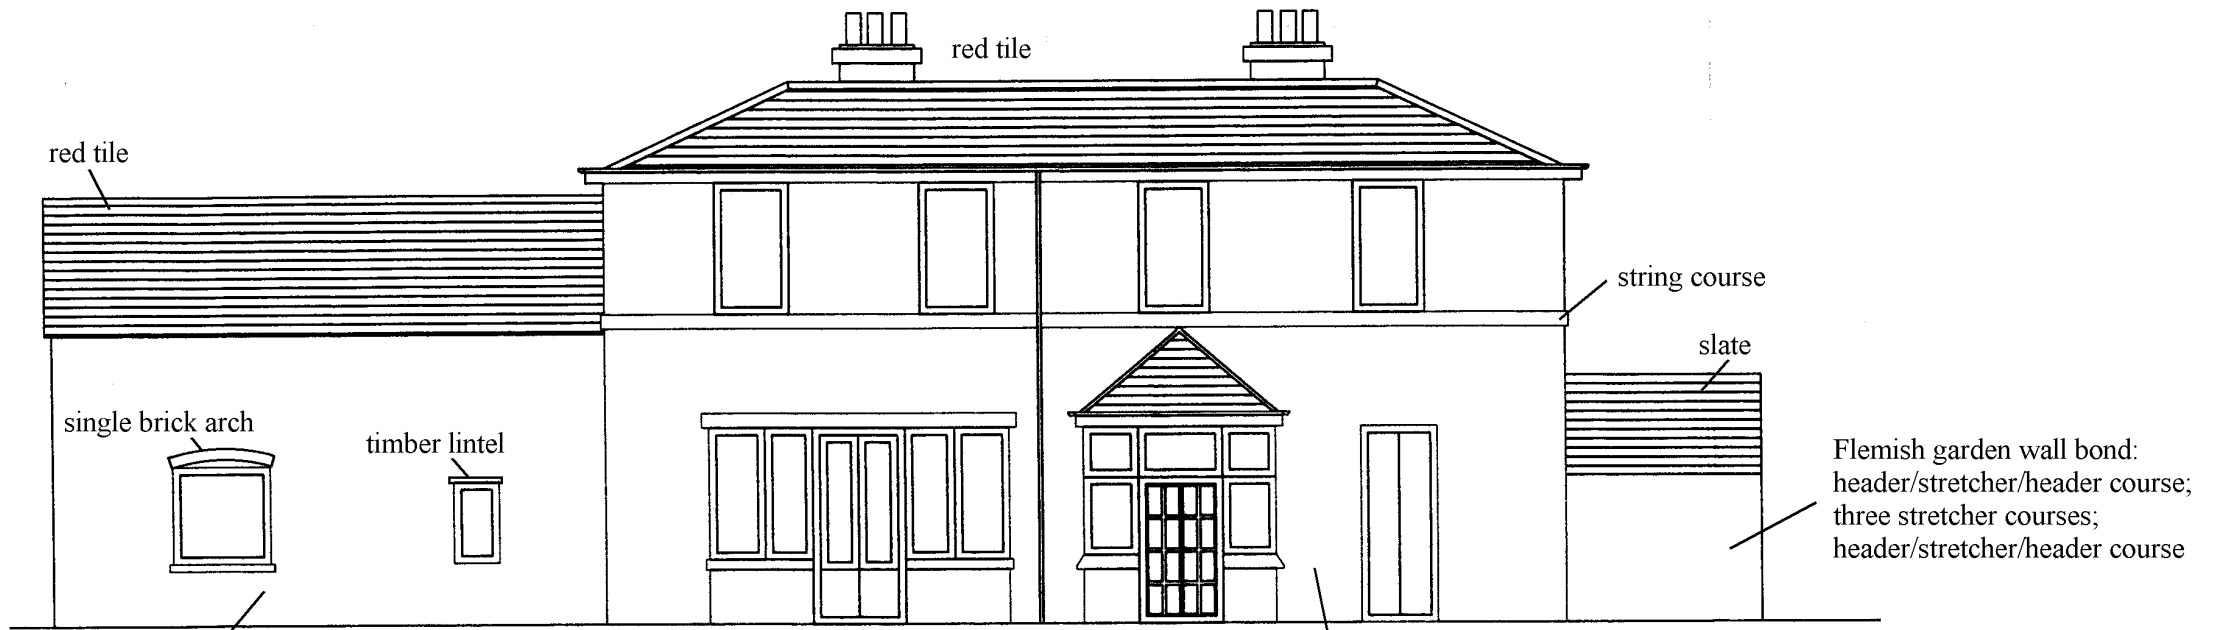
Fig 3.4: Elevations

Flemish garden wall bond:
header/stretcher/header course;
four stretcher courses;
header/stretcher/header course

cement render over brick
scored to simulate stone

Flemish garden wall bond:
header/stretcher/header course;
three stretcher courses;
header/stretcher/header course

English garden wall bond:
header course;
three stretcher courses;
header course

Flemish garden wall bond:
header/stretcher/header course;
five stretcher courses;
header/stretcher/header course

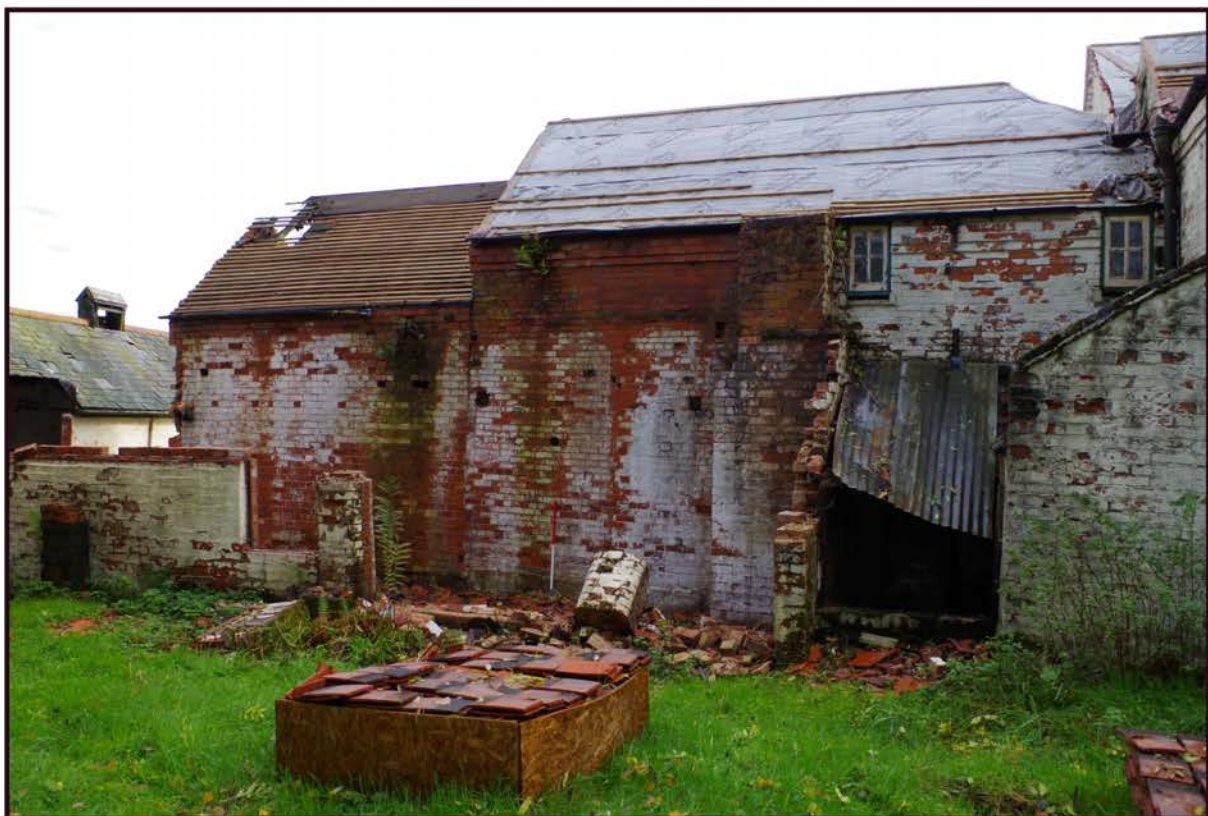
Fig 9: North-west elevation

The enclosed area on the northern side of the cottage is difficult to interpret as it was substantially collapsed at the time of the visit (Fig 9). However, since it included widely spaced brick columns with bull-nose bricks on their corners (Fig 3.1; north-west elevation), it is likely that it was originally a shelter shed or an implement store.

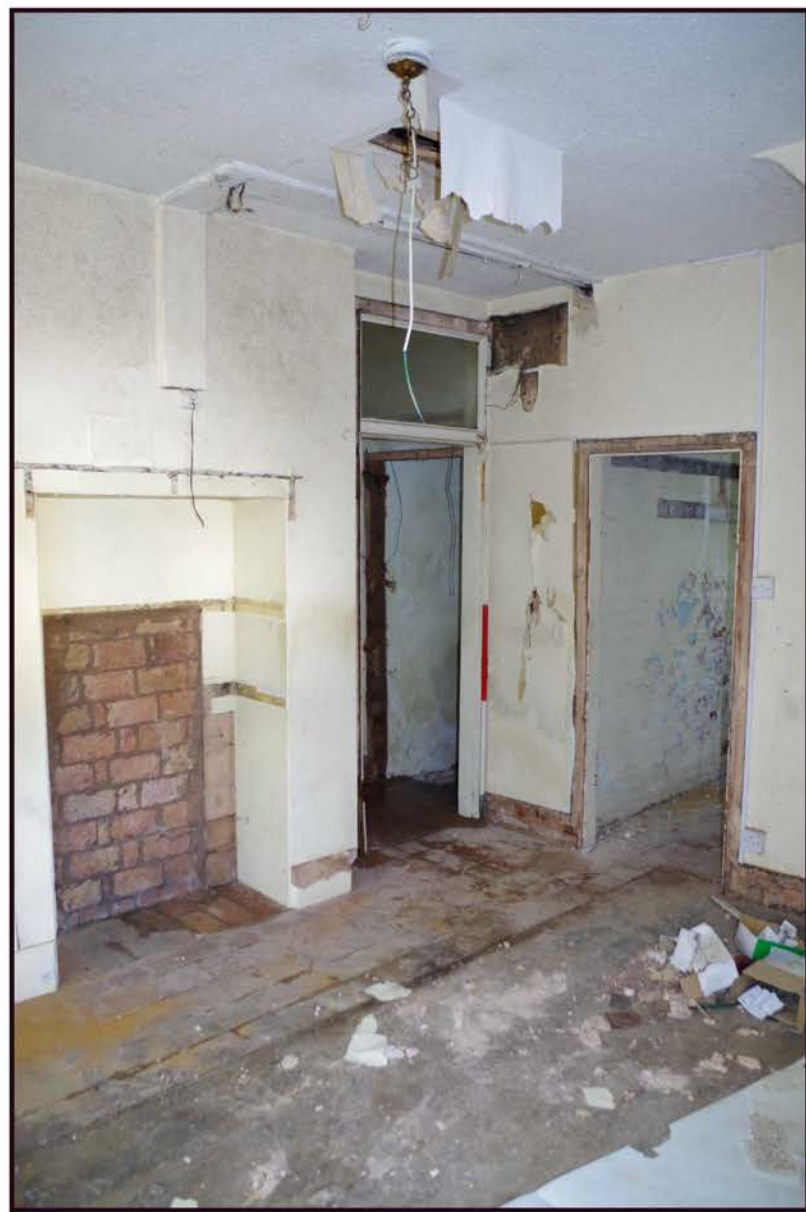
Fig 23: Phase 3; farmhouse, ground floor

The new domestic accommodation provided (at ground level) a living room with a bay window (Fig 26), a sitting room (Fig 23) and three smaller rooms at the front. The central room was clearly a dairy (Fig 24) and the other two (Figs 22 and 25) were probably of a utilitarian nature. One may have been a study or office. The two eastern-most ground floor rooms originally had windows in the contemporary eastern external wall. At first floor level (Fig 3.2) it seems likely that four additional bedrooms were provided (Figs 35, 36, 37 and 38; the sub-division of one into a bathroom and toilet being a recent change). The only access to the first floor was provided by a spur stair off of the original cottage stair.

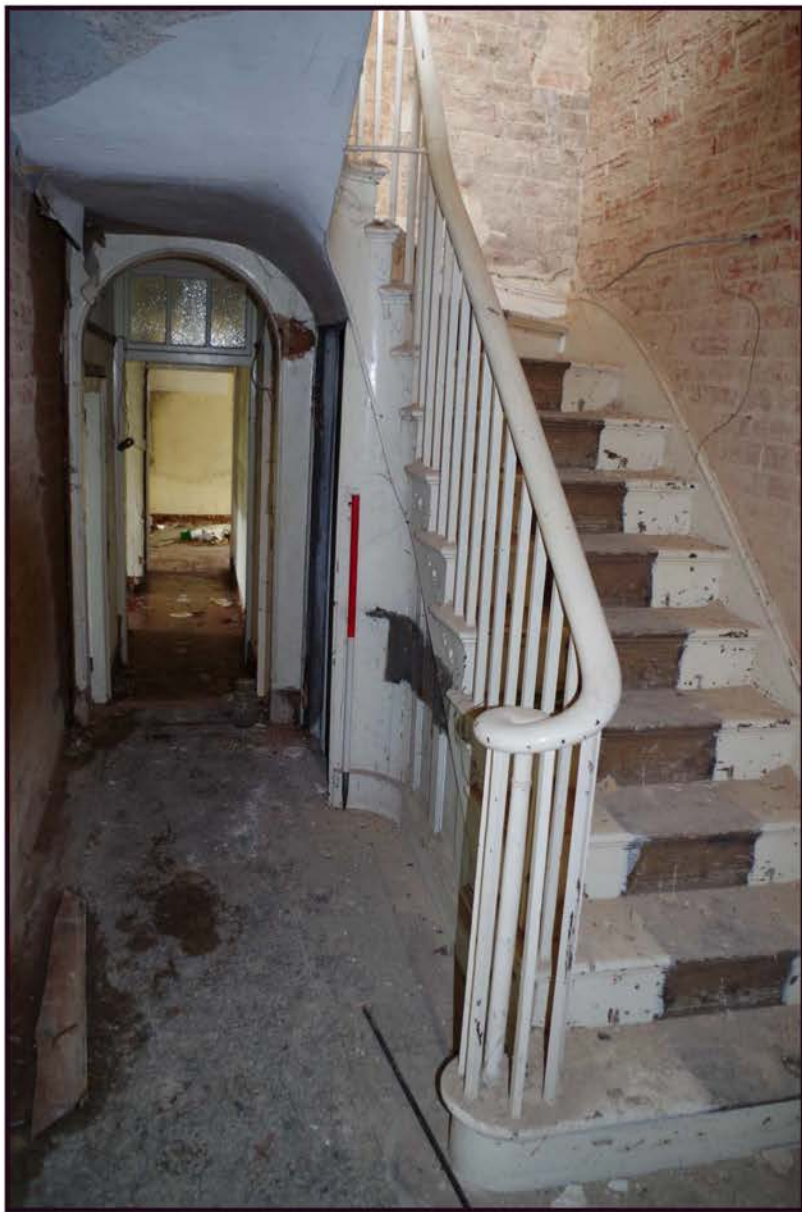
Fig 27: Phase 4; Georgian farmhouse, ground floor, entrance hall

The ground floor was of three unequal bays: an entrance hall, aligned upon the axial passage of Phase 3 and two flanking rooms (Figs 27, 28, 29 and 30). At first floor level the axial passage of Phase 3 was continued onto the Phase 4 landing (Fig 39) and the proportions of the flanking ground floor rooms are reflected at first floor level (Figs 40 and 41).

Ground floor: the drawing room was placed near the front door so that it was easily accessible (Fig 3.1; ground floor). The smaller of the two ground floor rooms is thought to have fulfilled this function. Drawing rooms were a place to greet visitors and where the women of the house could retreat after dinner. Furnishings in the drawing room were generally more feminine than those in the adjacent dining room. Double doors would lead to the dining room, which was more austere and masculine in nature. After dinner the men would remain there to enjoy conversation over port and cigars, while the women retreated to the drawing room. The closer the dining room was located to the kitchens, the warmer the food remained when it arrived at the table. At Langabeer Farm the front room next to the entrance must have been the drawing room (Fig 3.1; ground floor) with the dining room with the larger dining room accessed *via* the stairwell. This seems odd at first but it must be remembered that this stairwell was ornate for this class of house, having a curving wooden handrail and moulded decoration on the string (Fig 27).

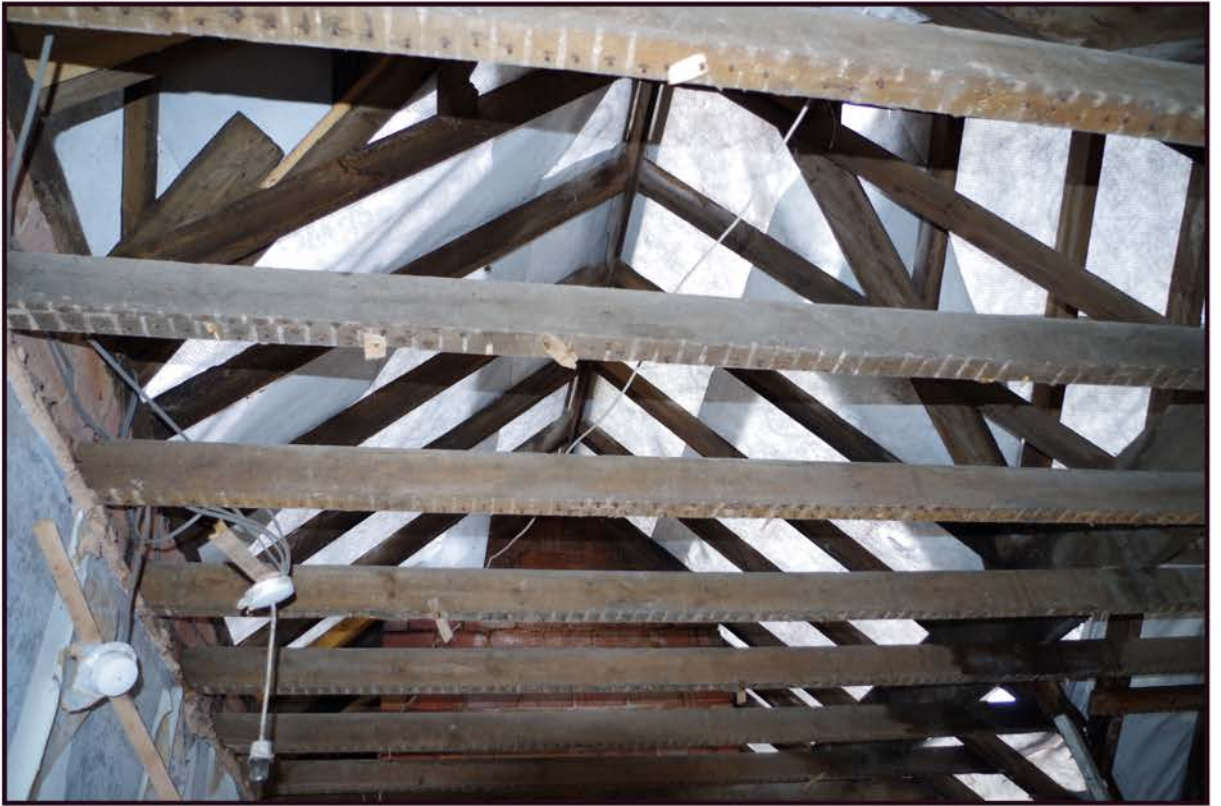
Fig 42: Phase 3 ; farmhouse, detail of roof structure

The roof is constructed entirely of sawn timber (Figs 42 and 43) which is clearly of modern date. It appears that the roof covering the entire complex was renewed in a single operation, probably around the middle of the 20th century.
