**Programme of archaeological work
at the Long Barn,
Bidford Road,
Cleeve Prior,
Evesham,
Worcestershire**

25th May 2014
17th August 2014

WSM 57115

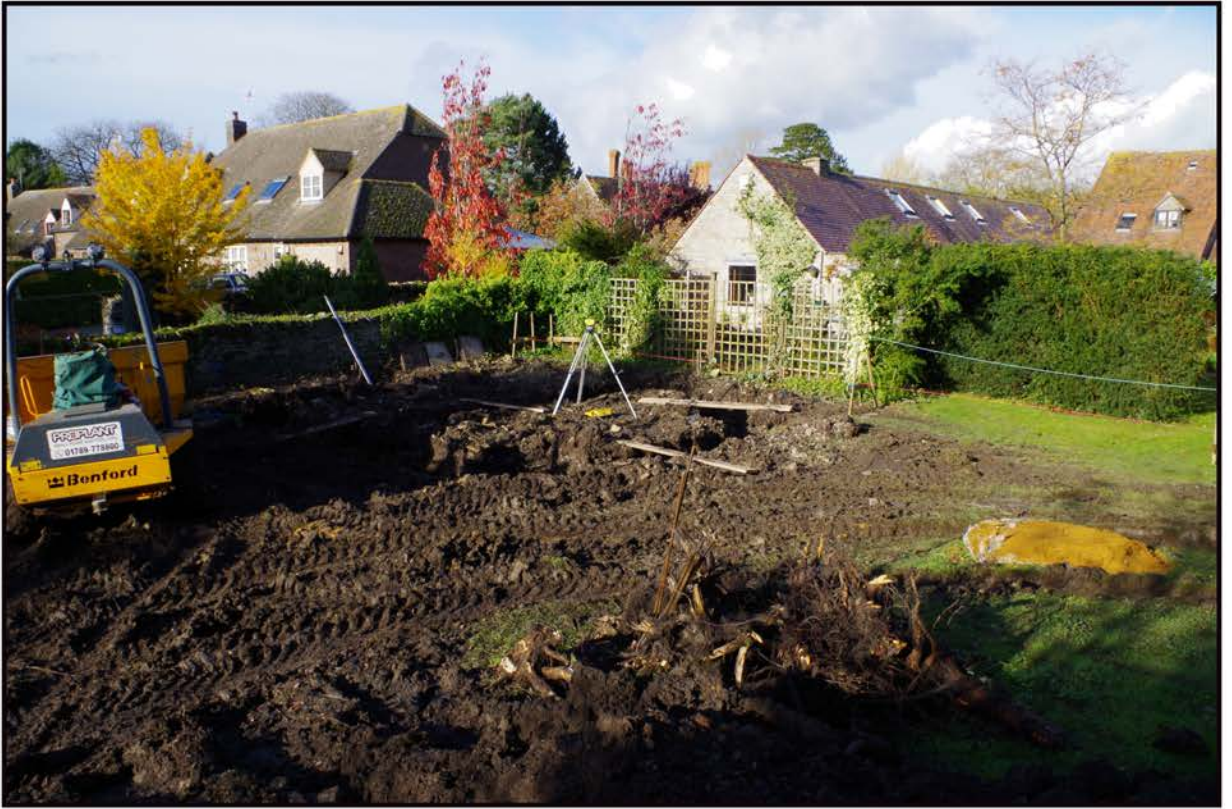
Fieldwork took place on the 11th and 12 November 2013 and on the 9th April 2014. It comprised observation of all ground breaking activity (foundation and service trenches; Figs 3.1, 4, 5 and 6) with records (drawing and photographs) made as appropriate. A full description of the contexts is given in Appendix 1; a summary being employed below.

Fig 4: View of excavations looking north-west

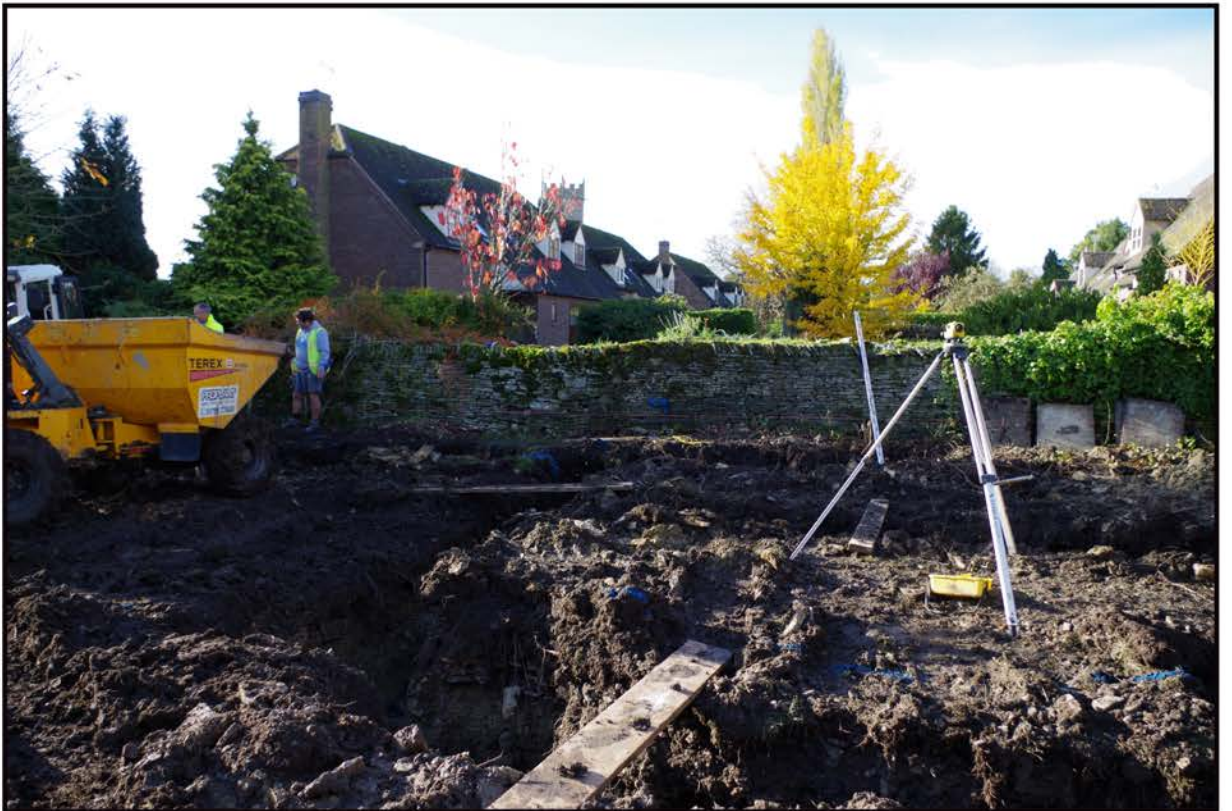
Fig 5: View of excavations looking west

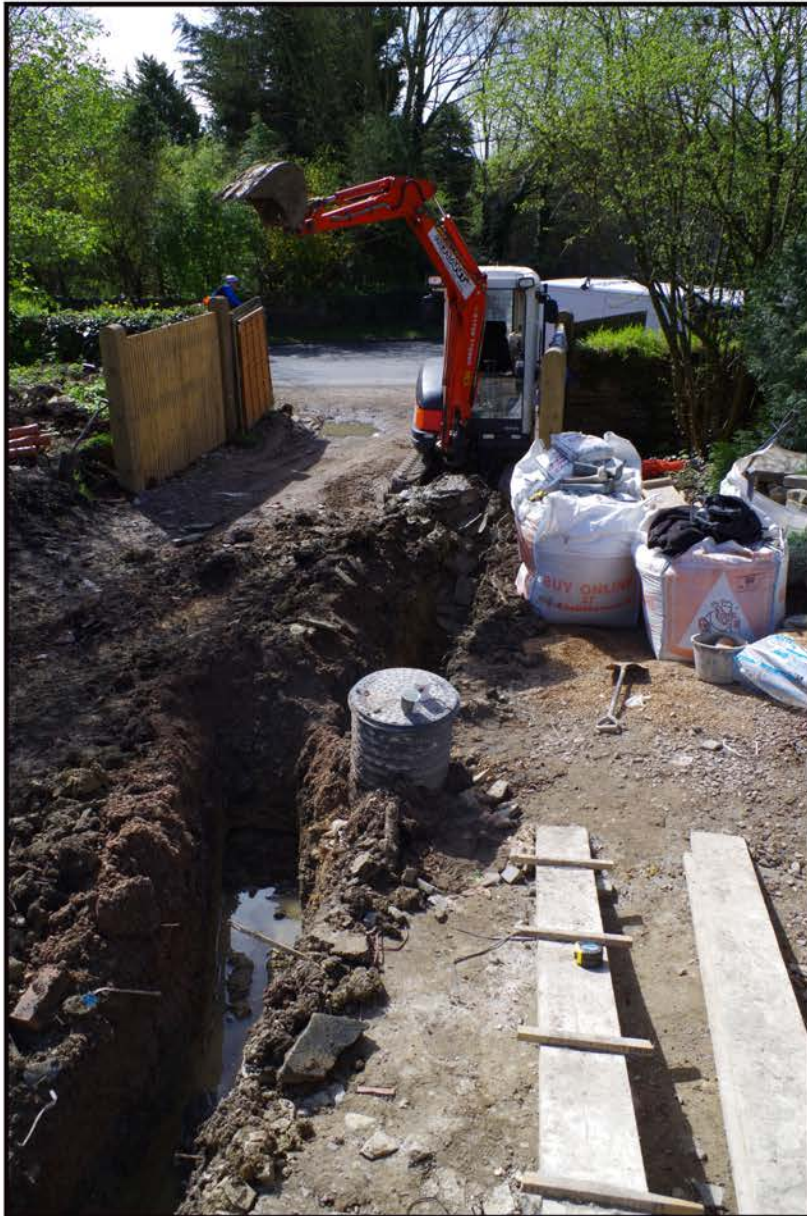
Fig 6: View of excavations looking south-west

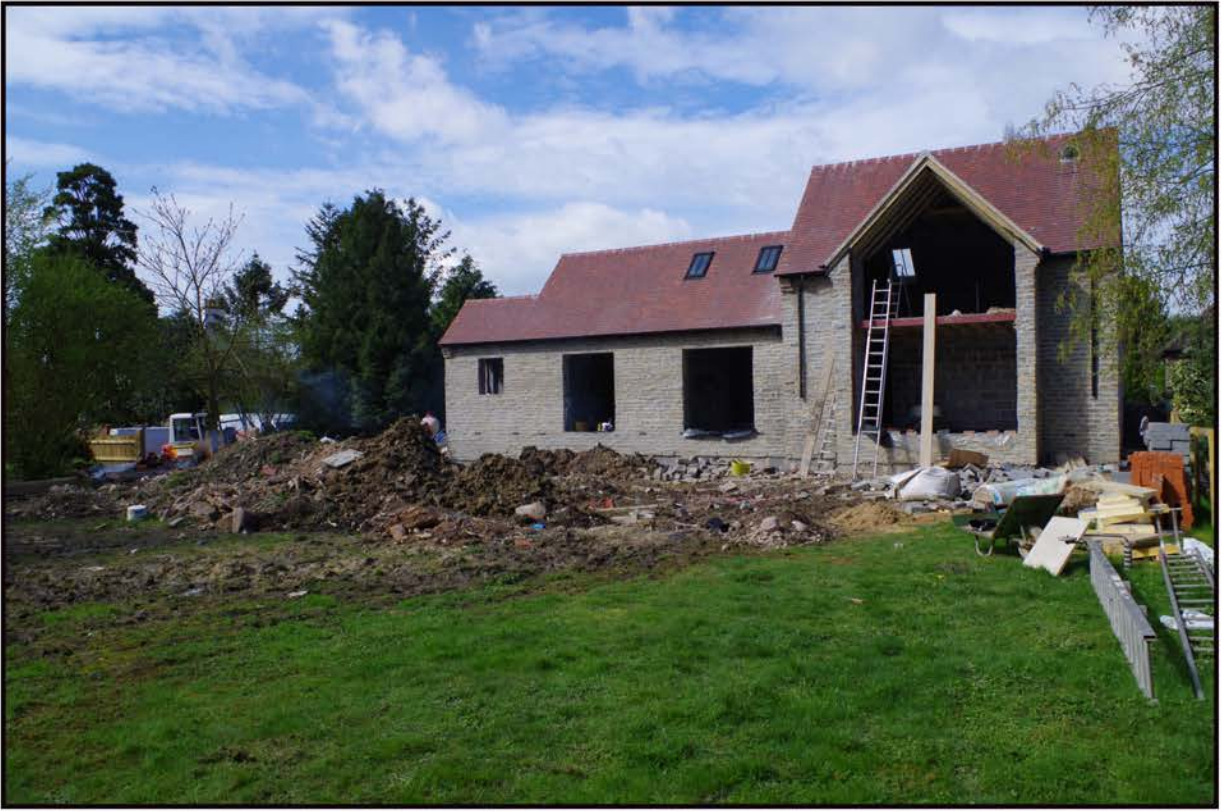
Fig 7: General view of site after erection of new building
