# **Bluestone Barn, Bluestone Lane, Mawdesley, Lancashire.**

## **An Archaeological Building Survey**

*By Archaeological Excavation Services*

**July 2008**

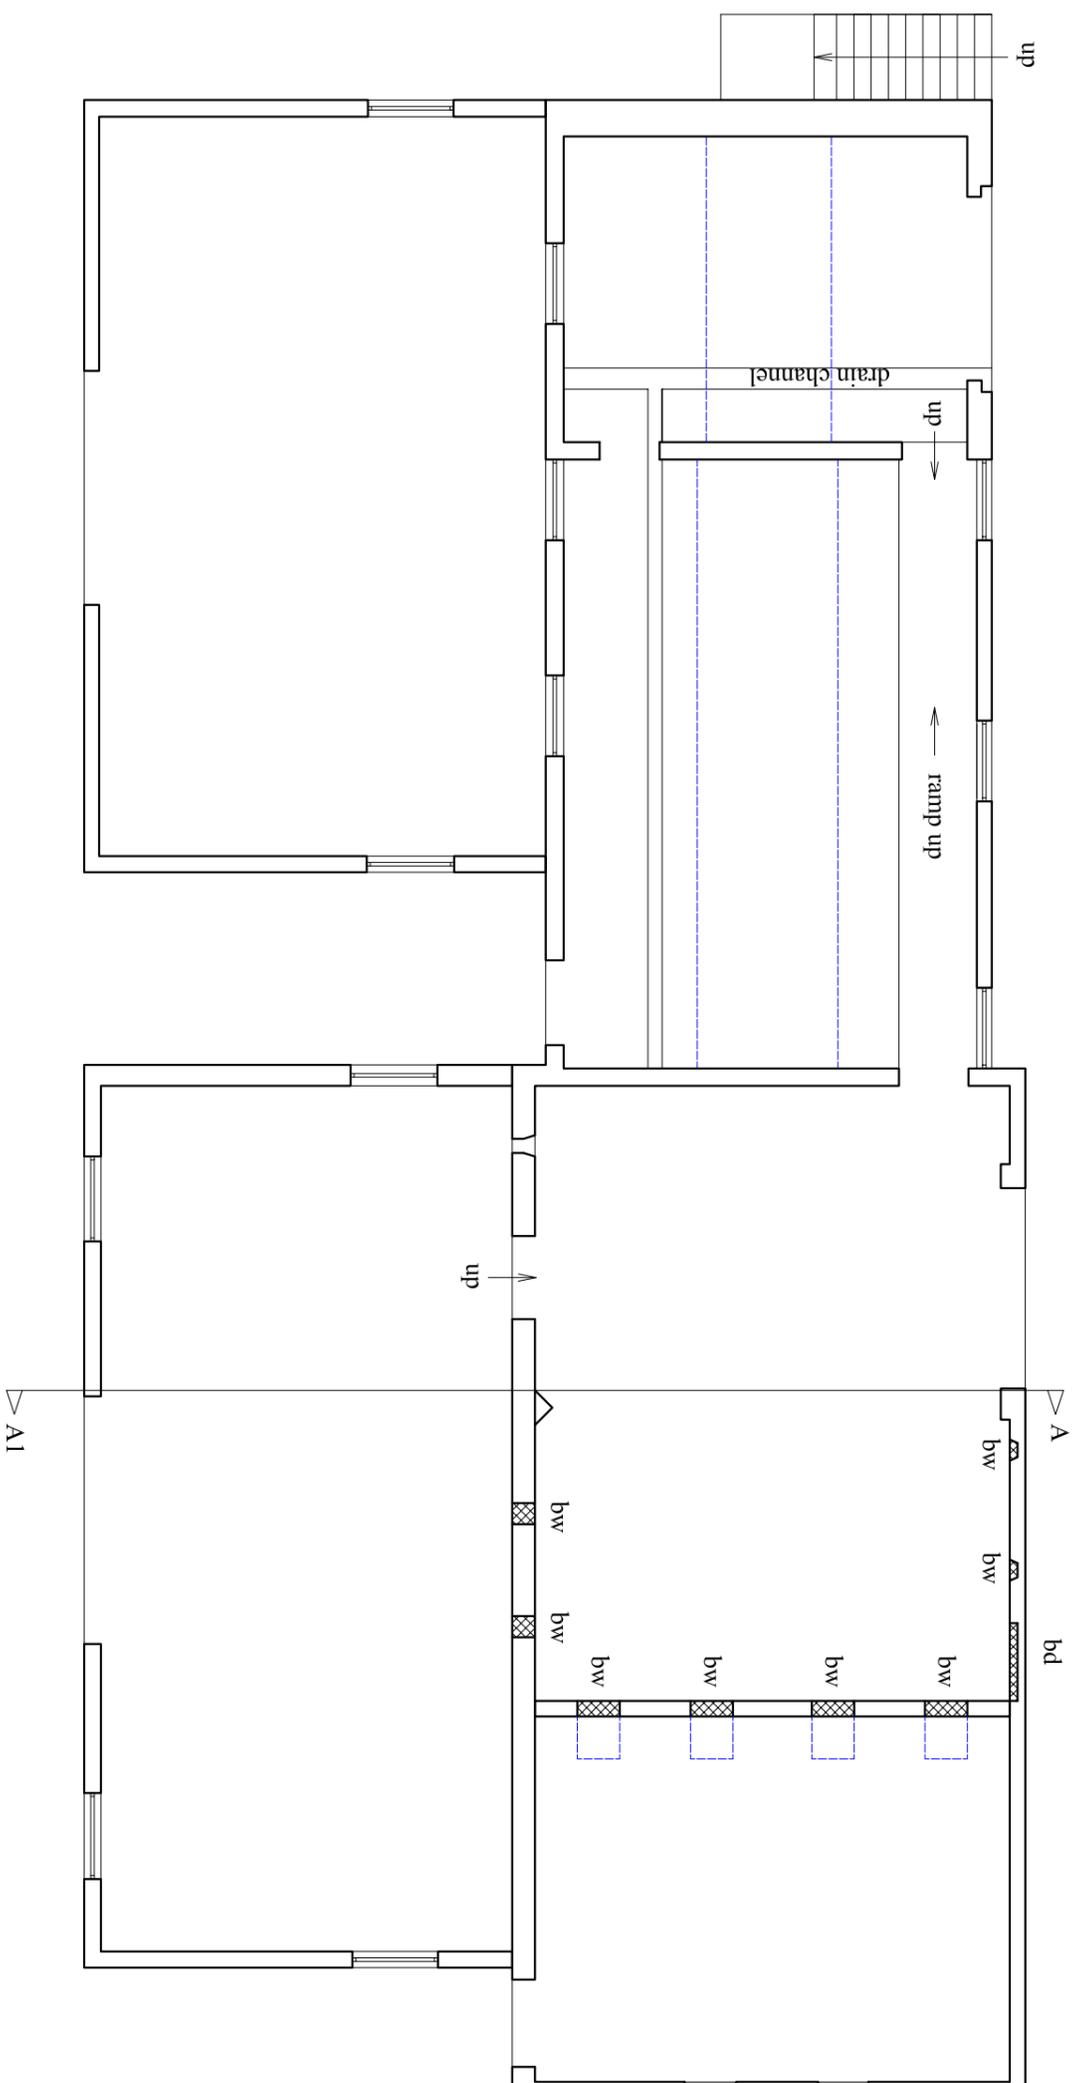
scale 1:100 @ A3

The internal space of the barn is divided into four distinct areas (bays), with upper floors at both ends of the barn and a large offset area (8.7m x 6.7m) open to the roof (threshing area), with one bay to the east and two to the west. The threshing bay flagged floor is still in situ (plate 11) and the large cart door in the north wall has a stone set in the east door pillar with a notch for a winnowing board and a hole for a harr hung door; the opposing stone is badly damaged. Two blocked vents are also visible in the north wall and to the east, a blocked doorway with a timber lintel; this doorway is not visible on the exterior of the building (plate 12). The two blocked vents are mirrored on the south wall, which is constructed of stone. Opposite the large cart door a personnel door is located in the south wall (exiting into the eastern extension) with a small window/vent to the west. Between the door and the blocked vents a triangular brick pillar rises to the roofline (plate 13) and supports a timber truss, that spans from this pillar to the eastern cart door pillar. The east wall of the threshing bay is constructed of handmade brick with four rectangular blocked feeding holes with timber lintels, at ground level and double pitching windows (smaller above larger) with timber lintels at first floor level (plate 14). The west wall of the threshing bay is constructed of handmade brick with a doorway to the north providing access to large shippon, and a large pitching window with a brick header lintel, at first floor level. To the east of the threshing bay is a four stall shippon. Constructed of older machine made brick and some stone rubble in the south wall. The shippon (5.2m x 6.7m) is accessed by the door at the rear south-east corner of the building. The floor was obscured by hard

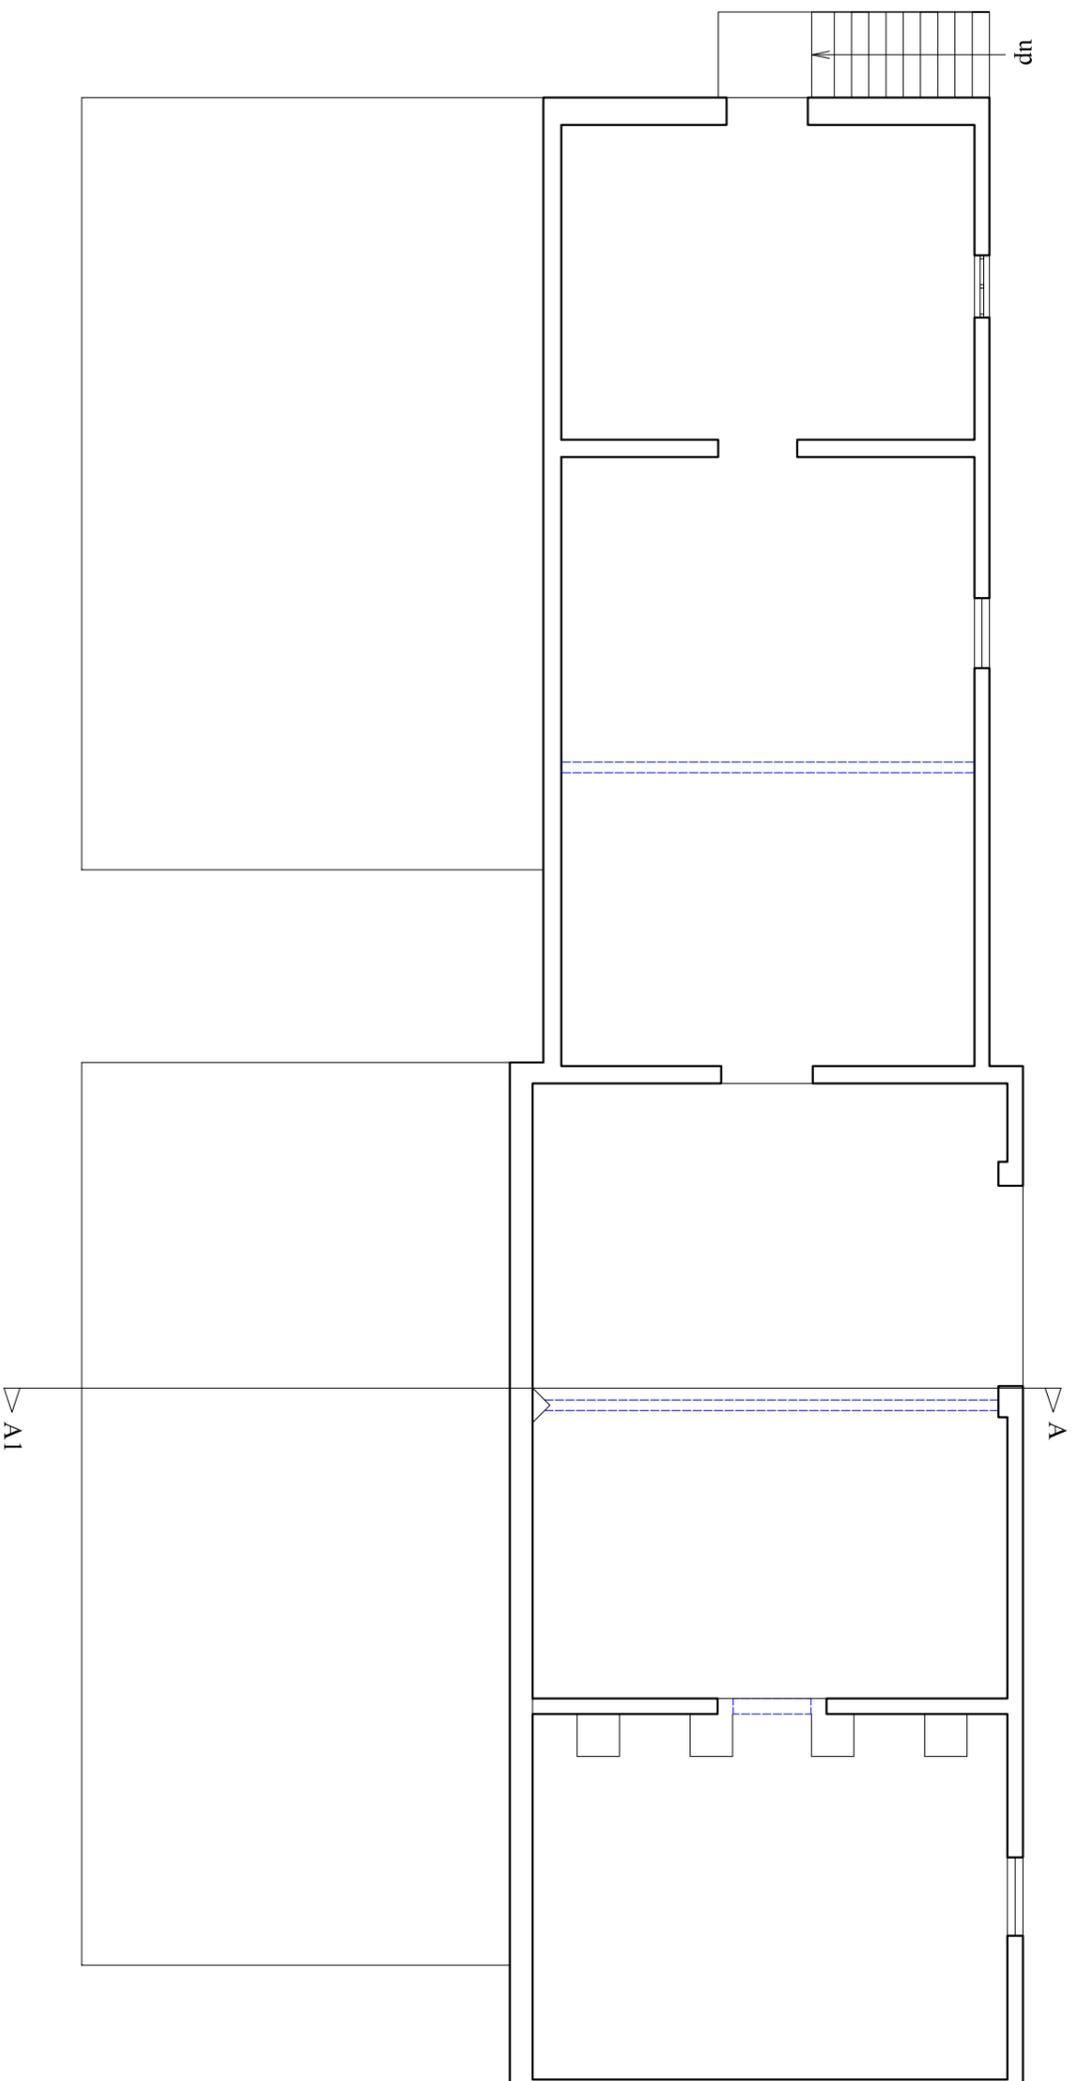
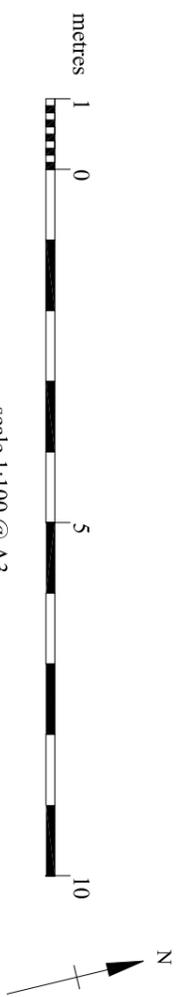
Figure No. 2  
 First Floor Plan

The first floor consists of three rooms, the first (5.2m x 6.7m) to the east of the threshing bay is accessed via the double pitching window in the threshing bay (Plate 19). The area has a timber floor into which four holes have been cut over the small shippon. A window is located in the north wall and number of slit vents are visible in the east wall. The south wall shows evidence of the raising of the original stone roofline by approximately eight courses of brickwork (plate 20). The granary (4.5m x 5.9m) at the eastern end of the building (plate 21), is accessed by the stone steps attached to the west elevation (see 6.4). A window is located in the north wall (see 6.2) and an aperture, 1.1m wide x 1.63m high provides access to the final room, a large storage area (5.9m x 8.6m) with a window located in the north wall (see 6.2) and the large pitching window which provides access to the threshing bay. A 'king post' truss spans the area and two chains attached to the cross beam, either side of the 'king post' are attached to the floor for additional support (plate 22). The heavier and older purlins in this area exhibit several Baltic timber marks (see 6.1).

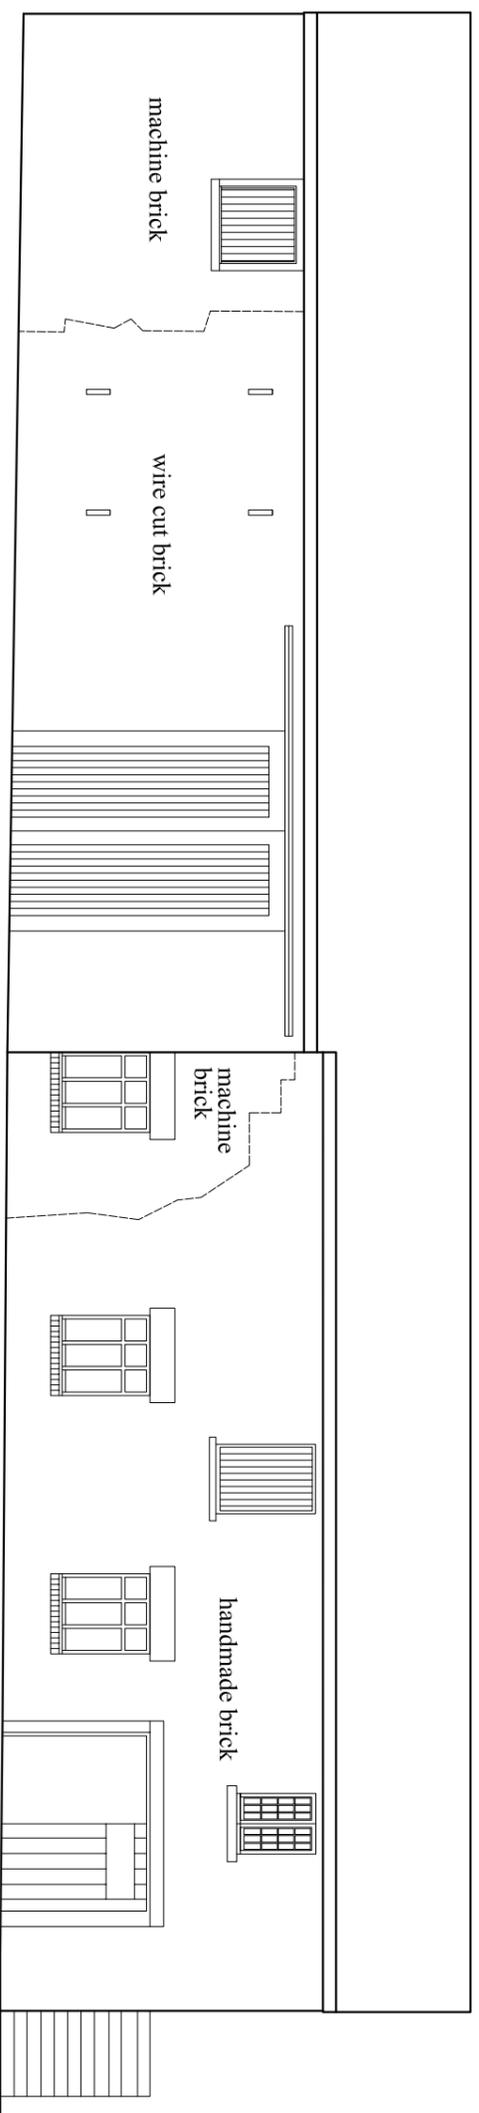
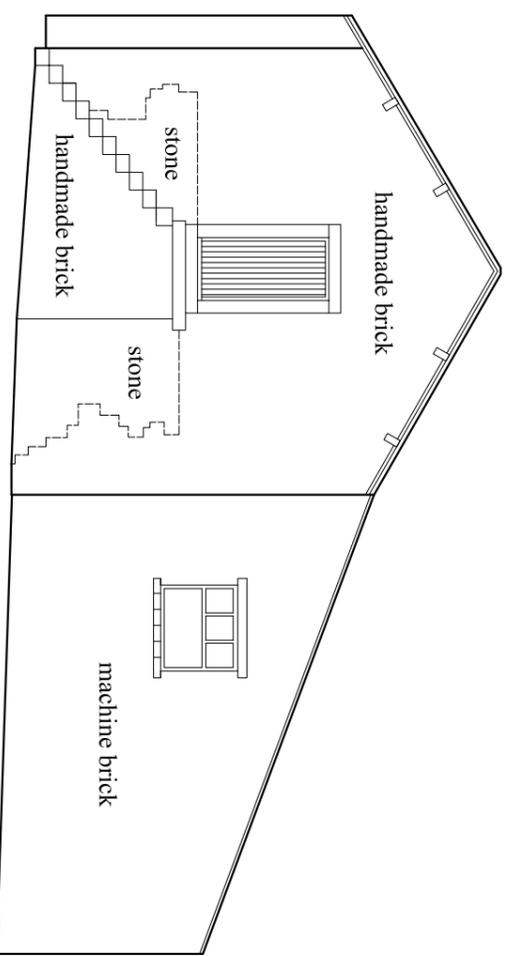
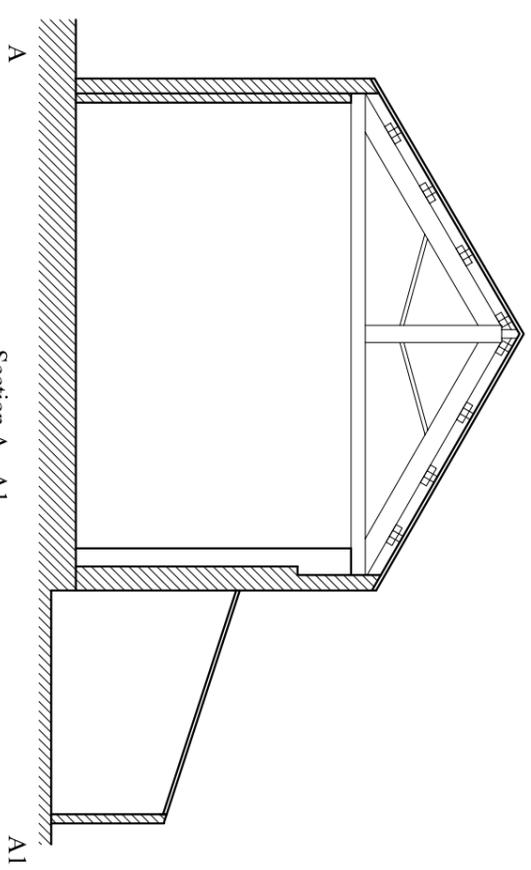
Figure No. 3  
 Elevations and Section

North Elevation

West Elevation

Section A - A1

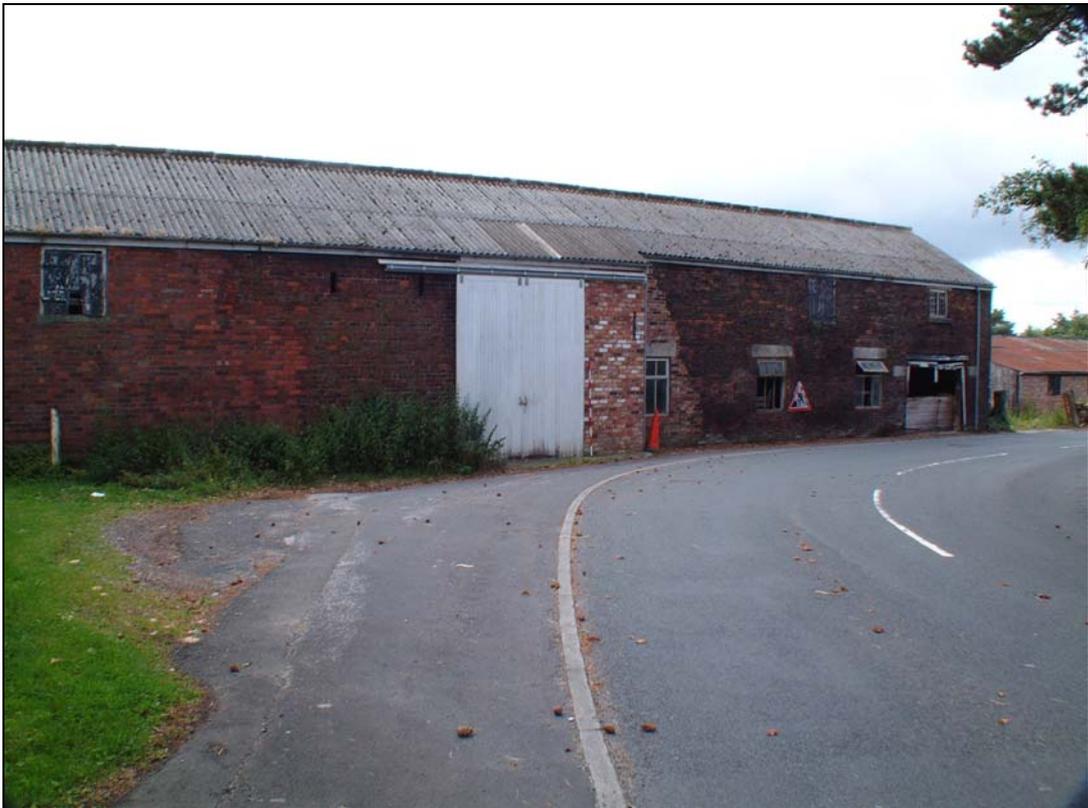
Plate 4. North elevation from the north

- 6.2 Northern Elevation.** (plate 4) This elevation is the main frontage onto Bluestone Lane and is constructed with a mix of handmade, wirecut and machine made brick, laid in an English garden wall bond with lime mortar. The eastern end of the elevation appears to be constructed in older machine made brick bonded to wirecut bricks further west to the cart door. The eastern cart door pillar and a large area east of this has been repaired with modern machine made brick. At the eastern pillar the wall is rebated approximately 0.5m, and continuing westwards the remainder of this elevation is constructed in handmade brick. The elevation is characterised by three windows on the first floor, three on the ground floor and two doorways, a large off centre full height cart door and smaller cart door at the extreme east of the elevation. Located at first floor level to the west of the large cart door is a rectangular pitching window constructed with adjoining brick jambs and a sandstone slab cill. The aperture is fitted with timber frame and a batten and braced timber hatch door. A second pitching window is located at this level on the western side of the cart door of similar construction, but slightly larger. West of this window, at ground floor level, a further window is located. This window is constructed with adjoining

brick jambs and a sandstone slab lintel and cill and is fitted with a timber multi pane frame with twenty four lights and a sliding transom. Three windows are located at first floor level on the western half of the elevation, spaced equidistantly between the two doors all windows are of the same construction and comprise adjoining brick jambs, sandstone block lintels and brick header cills. All the window apertures are fitted with timber frames and a top opening transom. The main cart doorway is constructed with brick pillar jambs and a timber lintel, the doorway is fitted with a large modern timber double sliding door. The door located at the extreme west of the elevation is a smaller cart door constructed with a brick header lintel and adjoining brick jambs with four stone quoins located and shaped to support hinges. The doorway is fitted with a timber frame set in recessed brickwork and has no door. To the east of the large cart door, four slit vents are located, two at first floor level and two, blocked, directly below at ground floor level.

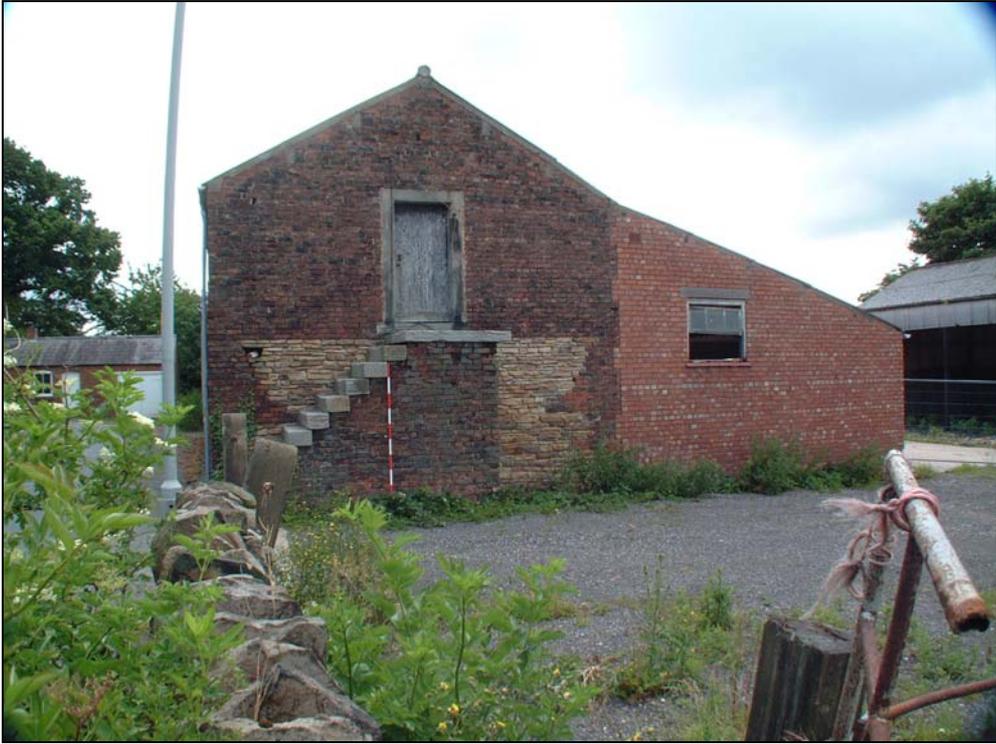
Plate 9. West elevation from the west

- 6.4 West Elevation** (plate 9). The west elevation forms one of the gable ends of the building and is characterised by a centrally located personnel doorway to a first floor granary, accessed by a sandstone slab stairway which is laid on a handmade brick plinth. The elevation is constructed with handmade brick in English garden wall bond mixed with a large area of stonework, extending either side of the stairway. The doorway is fitted with a timber frame and a solid timber door. A rear extension is keyed to the southern edge of the elevation, in which, a small window centrally located, the roof of the extension joins the original barn roofline forming an angled catslide roof.

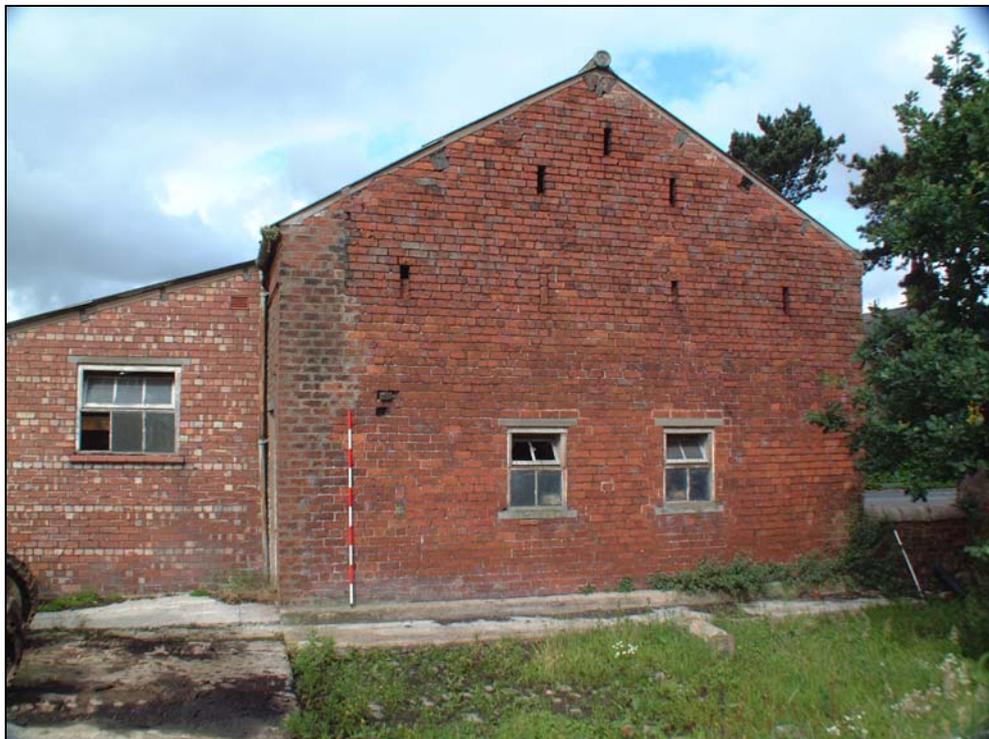
Plate 10. East elevation from the east

- 6.5 East Elevation** (plate 10). This elevation comprises the other gable end of the building and is constructed of wirecut brick. The elevation is characterised by two centrally located windows and two blocked slit vents at ground floor level. At first floor level a triangular pattern of slit vents is visible rising to the apex of the gable, one of which, in the lower row, has been blocked. The windows are constructed with adjoining brick jambs, stone slab lintels and cills. The windows are fitted with timber frames with four lights and a top opening transom. A modern extension wall is rebated approximately 1.5m, the roof of which, joins the original roof (as 6.4). A window is located in the extension (as 6.4)

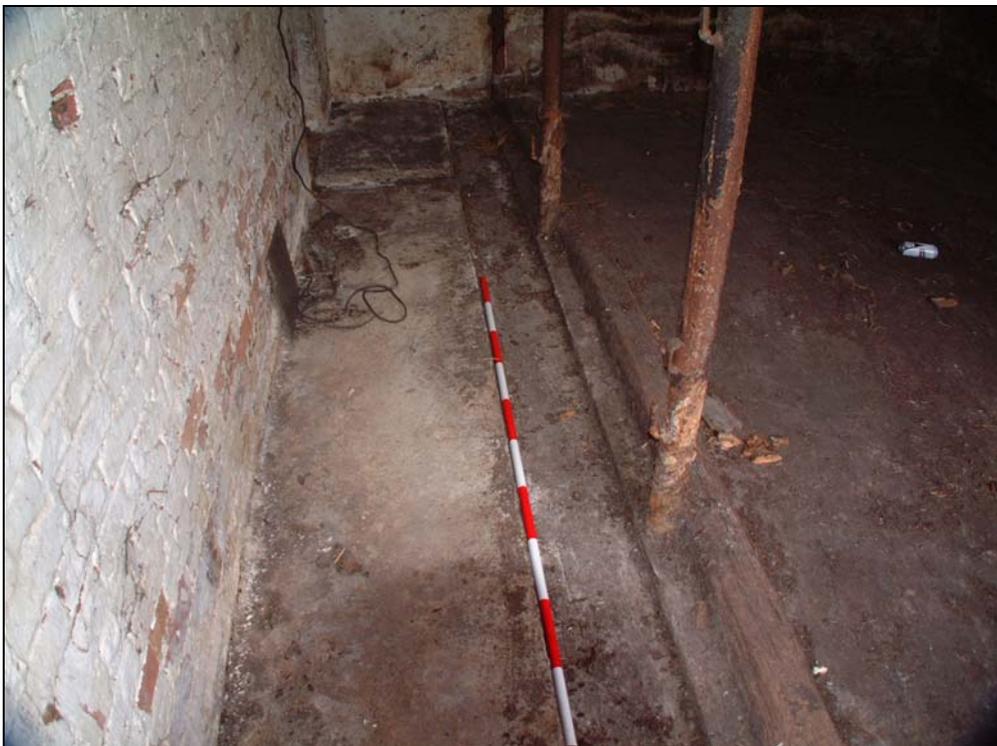
Plate 18. Drain channel in stable floor from the north

manure and straw at the time of the survey. The ceiling comprises timber planking and east-west running joists with cast iron stanchions attached that form the iron rail stalls. There are two windows and blocked vents located in the east wall (see 6.5) and four blocked feeding holes in the west wall. Four holes are cut in the timber ceiling above the blocked holes, suggesting a change in feeding practice. A large iron hay rack is attached to the west wall (plate 15). A large shippon (8.5m x 5.9m) is accessed from the doorway in the west wall of the threshing bay (plate 16), this area has been stripped of any original fittings and all that remains of the original purpose is a manuring channel running east-west in the concrete floor. The ceiling is constructed of timber planking supported by north-south running joists and two east-west timber beams. In the south wall two part blocked windows are visible (see 6.3) and a doorway that exits the building between the two extensions. Three windows are located in the north wall (see 6.2). Two doorways are located in the west wall at either side and these provide access to the room at the western end of the building (4.5m x 5.9m). The west wall of this area is constructed of random sandstone with all internal walls cement rendered to a height of 1.2m. (plate 17) and probably used as a stable. A part blocked window is located in the south wall (see 6.3) and the smaller cart door is located in the north wall. The ceiling is constructed as the previous area and the concrete floor contains north south running drain channel that links to the channel in the large shippon (plate 18).
