**Report on an Archaeological Excavation
and Monitoring at 'St Andrew's Church,
North Pickenham, Norfolk'**

NHER 4644

Reference No. CB113R
© Chris Birks March 2009

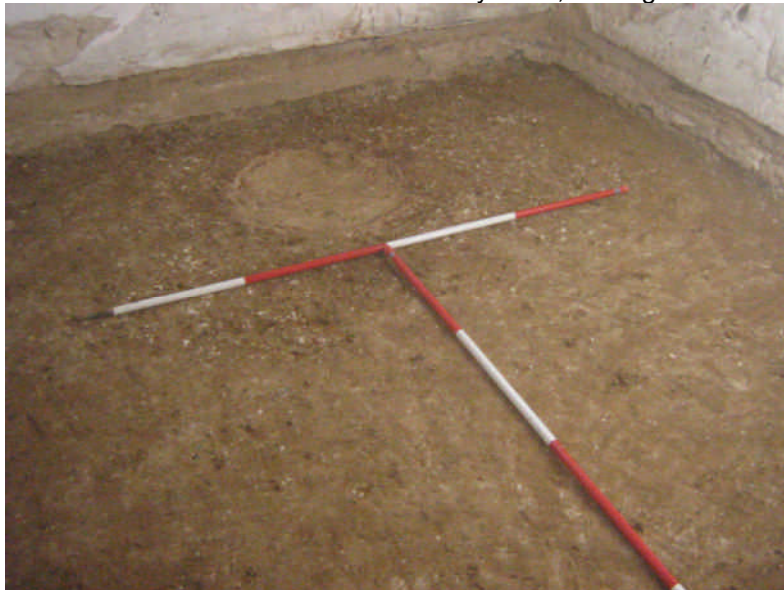
Plate 1 Interior of tower floor reduced by 0.3m, looking northwest

- 7.2 **Archaeological Excavation within the tower**
 - 7.2.1 The base of the tower was reduced internally by 0.3m depth to accommodate a concrete base for the new storeroom and disabled toilet facilities and measured c. 3.1m by c. 2.9m (*Figs. 2 and 3, Plate 1*).

- 7.2.2 Initially, 0.03m thick terracotta tiles [1] were removed that overlay 0.1m of light yellowish grey chalk and lime mortar rubble [2] with occasional small flints and 0.18m of off-white/light grey coarse chalk and lime mortar rubble [3] with small to medium sized flints and occasional limestone fragments. A carved fragment of limestone, 3 further worked fragments of limestone and a human bone were recovered from [3].

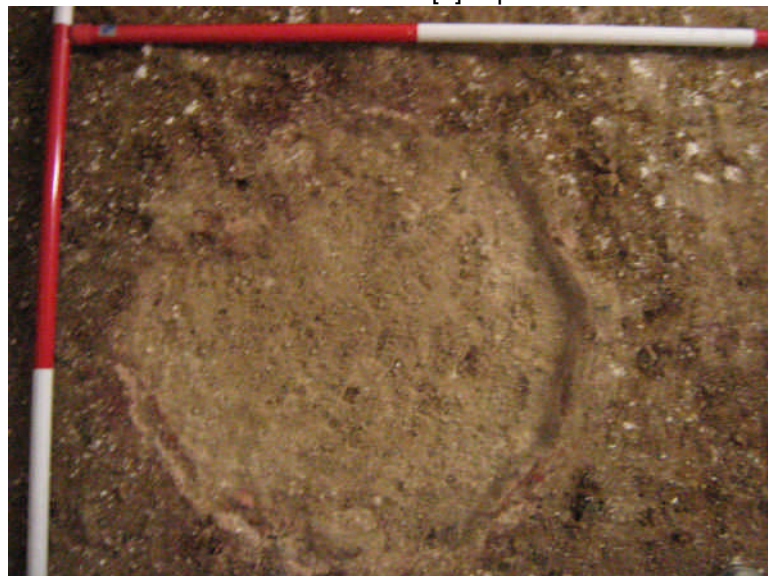
Plate 2 Feature [5] in plan

- 7.2.3 Deposit [4] was cut by a circular feature [5] within the west side of the tower (*Fig. 3, Plate 2*). It measured 0.7m in diameter and 0.27m deep. It was lined with peg roof tiles and rendered on the interior with a lime mortar. A tile was removed for analysis.

- 7.2.4 The upper fill of feature [5] comprised 0.16m of off-white/light grey chalk and lime mortar [6] (the same as [3]) that overlay a dark greyish white sandy silt [7] fill with occasional flecks of charcoal. A fragment of clay pipe tobacco bowl, a piece of lead slag and 3 worked fragments of limestone were recovered from [7].

- 9.1 The precise date or function of the feature revealed within the base of the tower is unknown. It may represent a feature used for storing molten lead from a boiling furnace during the Post-medieval period, possibly during the rebuilding of the church in the mid 19th century (*pers comm.* Edwin Rose). If this interpretation is correct, the position within the tower would perhaps be to decrease the cooling time of the lead.

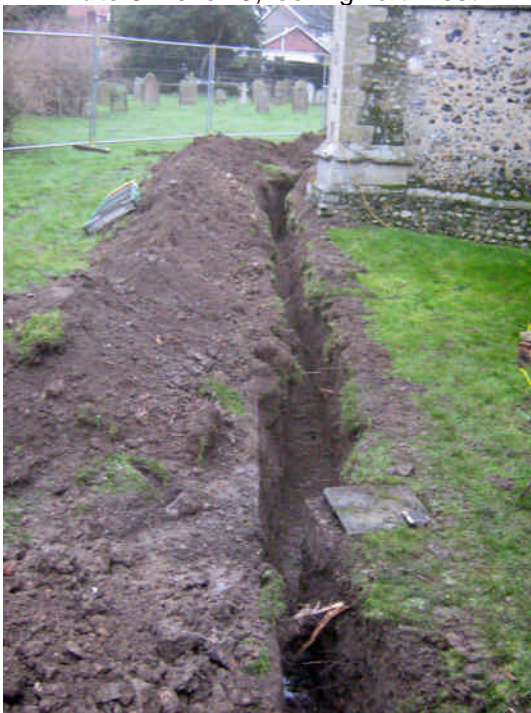
Plate 3 Trench 3, looking northwest

- 7.3 **Archaeological Monitoring**
- 7.3.1 Trench 3 (*Fig. 2, Plate 3*) measured a total length of c. 35m by 0.3m wide extending from the north side of the nave and the west side of the tower to house mains gas and water supplies. It was excavated to a maximum depth of 0.75m from present ground level removing 0.25m of dark greyish brown silty sand topsoil [10] that overlay 0.50m dark brownish yellow silty sand subsoil [11], the full extent of which extended beyond the maximum depth of excavation. Forty-six fragments of disarticulated human bone remains were recovered from subsoil deposit [11] in Trench 3. No archaeological features were encountered.

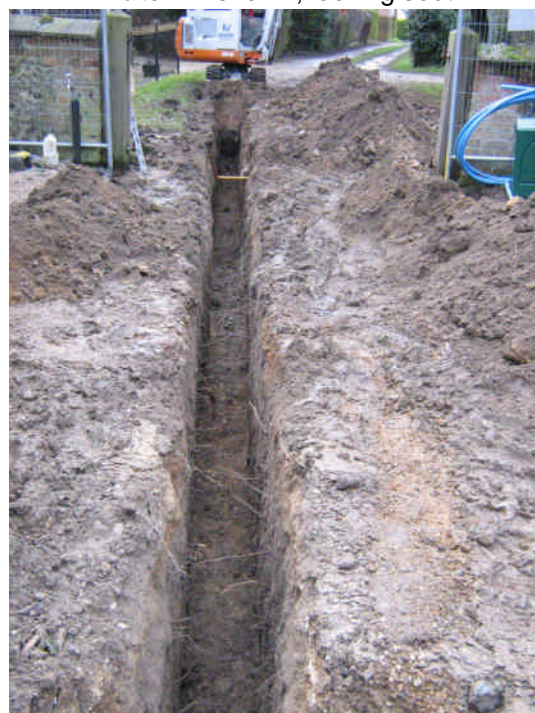
Plate 4 Trench 4, looking south

- 7.3.2 Trench 4 (*Fig. 2, Plate 4*) measured a total of c. 49m in length by 0.3m wide to house a foul water drain extending from the west side of the tower to join with the existing

sewage main to the south of the churchyard. It was excavated to a maximum depth of 0.65m removing 0.25m of dark greyish brown silty sand [10] that overlay 0.4m dark brownish yellow silty sand subsoil [11], the full extent of which extended beyond the maximum depth of excavation. Sixty-one fragments of disarticulated human bone remains were recovered from subsoil deposit [11] in Trench 4. No archaeological features were encountered.

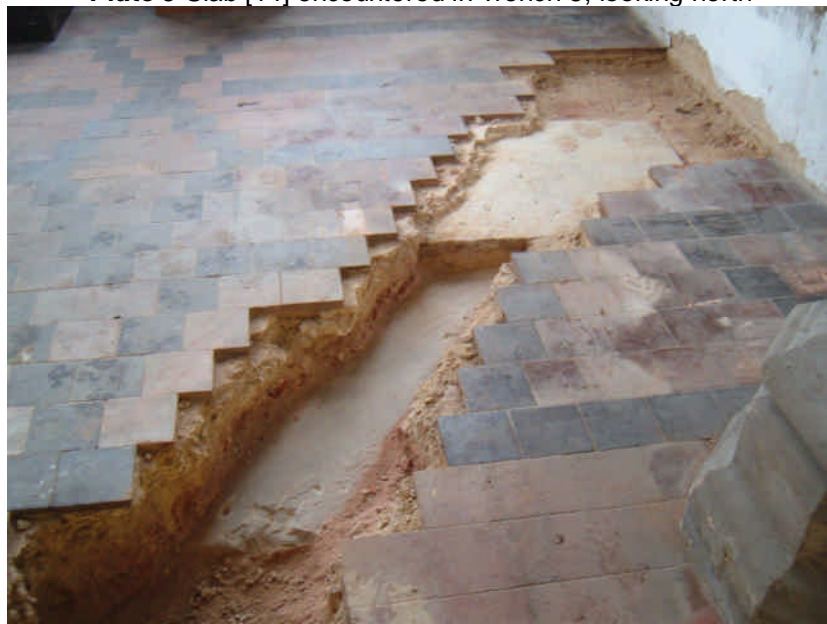
Plate 5 Slab [14] encountered in Trench 5, looking north

- 7.3.3 The timber flooring at the north side of the nave was uplifted and repaired and included an area of concrete floor that was removed and replaced by timber flooring. No disturbance of deposits occurred at these locations and the heating pipes were laid beneath the new flooring. Trench 5 (*Fig. 2*) measured c. 4m in length by 0.3m wide to house heating pipes and extended from the east end of the repaired flooring into the transept that was to become a meeting room. It was excavated to a maximum depth of c. 0.2m removing floor tiles on c. 0.05m of mortar bedding deposit [12] and light red/brown sand [13] that extended beyond the maximum depth of excavation. A stepped sandstone slab [14] was encountered and left undisturbed as it probably related to a tomb (*Plate 5*). No archaeological remains were encountered.

- 9.3 The transept may be the only original medieval part of the church other than the tower and as such date to the 14th century. The sandstone slab revealed within the transept beneath the floor tiles that extend from the transept to the nave may mark the location of a burial vault. The precise date of this feature is unknown; it may be medieval or may relate to one of the memorials in the transept that date to 1812 and the 1850s.

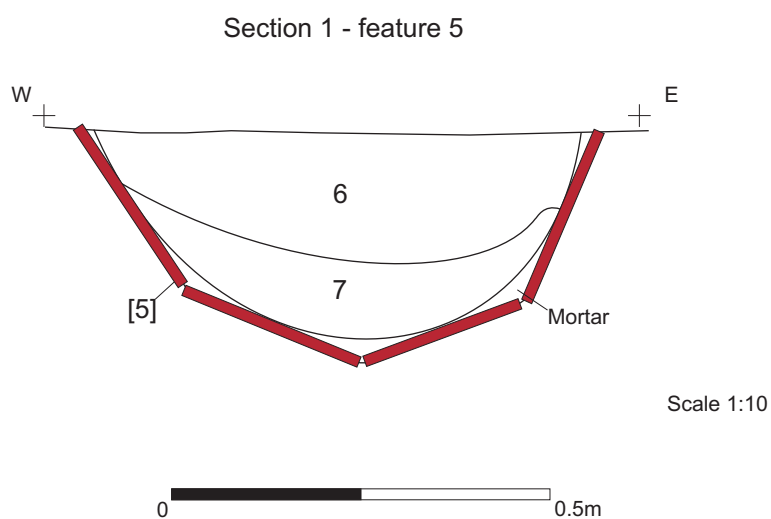
Figure 3 Plan of the tower and section drawing of feature [5]
