**Report on an Archaeological Watching  
Brief at 'The Hall, Manor Road,  
Garboldisham, Norfolk'**

**NHER 5574**

Reference No. CB160R  
© Chris Birks March 2009

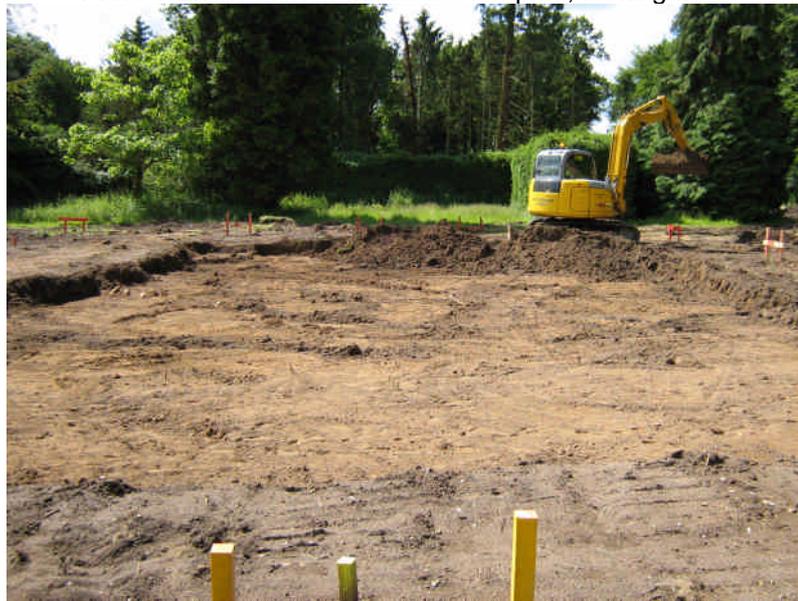
**Plate 1** Excavation of the house footprint, looking west

- 5.3 The area of the footprint of the new house (*Fig. 2, Plate 1*) was stripped with a mechanical excavator and measured c. 450m<sup>2</sup>. Initially, 0.2m of mid-greyish brown topsoil was removed that overlay 0.35m of brownish yellow sandy loam subsoil. Subsoil overlay a yellow sand undisturbed 'natural' deposit with frequent sub-angular medium sized flints. No archaeological finds, features or deposits were present.

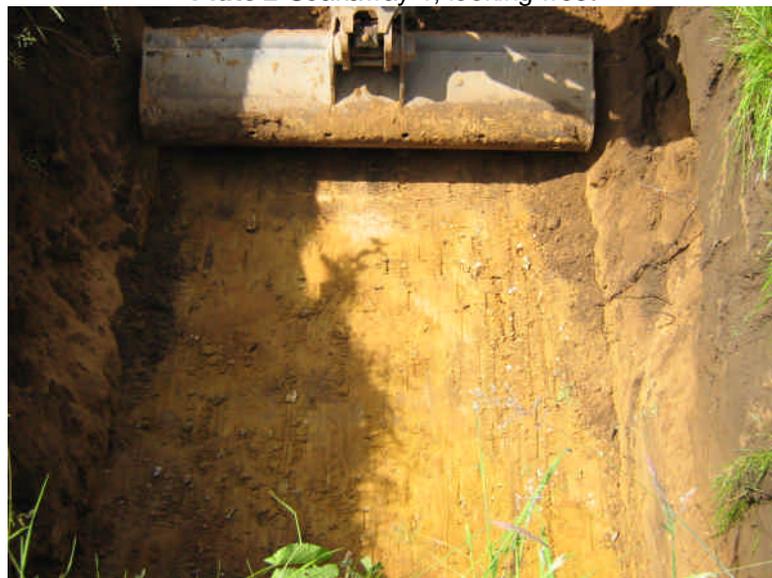
**Plate 2** Soakaway 1, looking west

- 5.4 Two rain water soakaways were excavated. Soakaway 1 measured 1.6m by 1.6m (*Plate 2*) and was excavated to a maximum depth of 1.4m from present ground level. Initially, 0.25m of mid-greyish brown topsoil was removed that overlay 0.35m of brownish yellow sandy loam subsoil. Subsoil overlay a yellow sand undisturbed 'natural' deposit with frequent sub-angular medium sized flints. No archaeological finds, features or deposits were present.

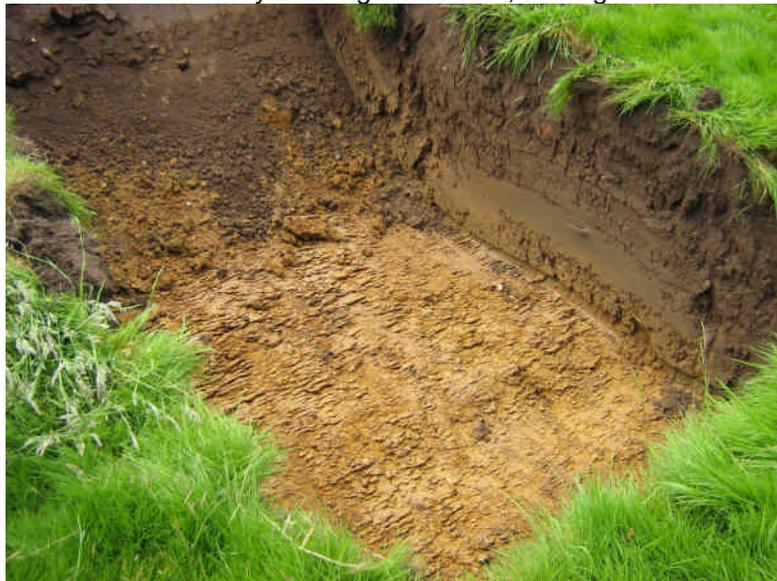
**Plate 3** Soakaway 2 during excavation, looking southwest

- 5.5 Soakaway 2 (*Plate 3*) measured 1.6m by 1.6m and was excavated to a maximum depth of 1.4m from present ground level. Initially, 0.30m of mid-greyish brown topsoil was removed that contained several small fragments of red brick. Topsoil overlay 0.45m of brownish yellow sandy loam subsoil that overlay a yellow sand undisturbed 'natural' deposit. No archaeological finds, features or deposits were present.

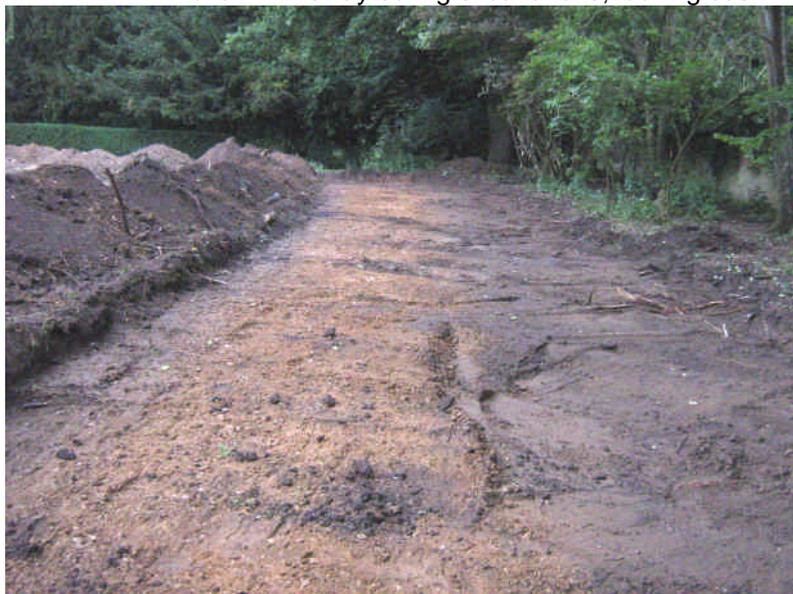
**Plate 4** Driveway during excavations, looking east

- 5.6 The driveway (*Fig.2, Plate 4*) was excavated to a maximum depth of 0.35m from present ground level removing 0.25m of mid-greyish brown topsoil that overlay brownish yellow sandy loam subsoil. No archaeological finds, features or deposits were present.

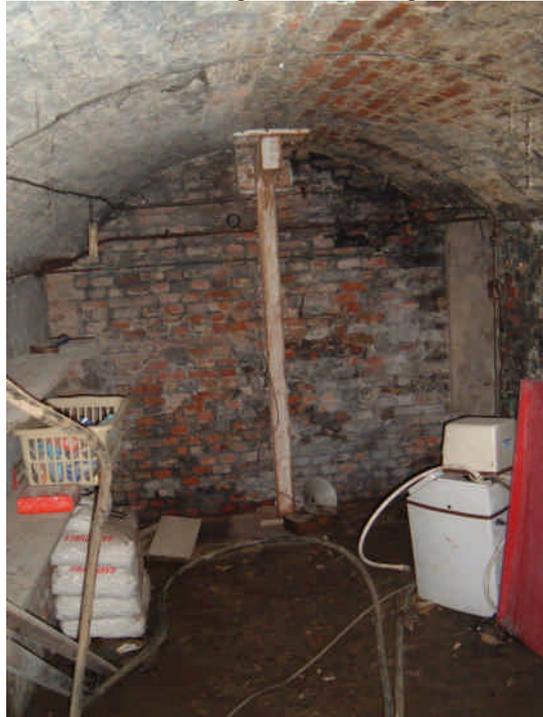
**Plate 5** Existing cellar, looking south

- 5.7 *In situ* remains of the Hall cellars survive beneath the footprint of the existing 'storage building'. This building was retained and therefore no impact upon the cellars occurred. A brief inspection was made - they have an arched brick ceiling of

red brick in a sandy light brown mortar and some whitewashing remains (*Plate 5*). The ceilings meet vertical brick walls c. 1m apart at a height of c. 1.6m forming an overall height within the cellars of c. 1.8m. The floors are also made of brick, laid perpendicular to the walls (*Plate 6*).

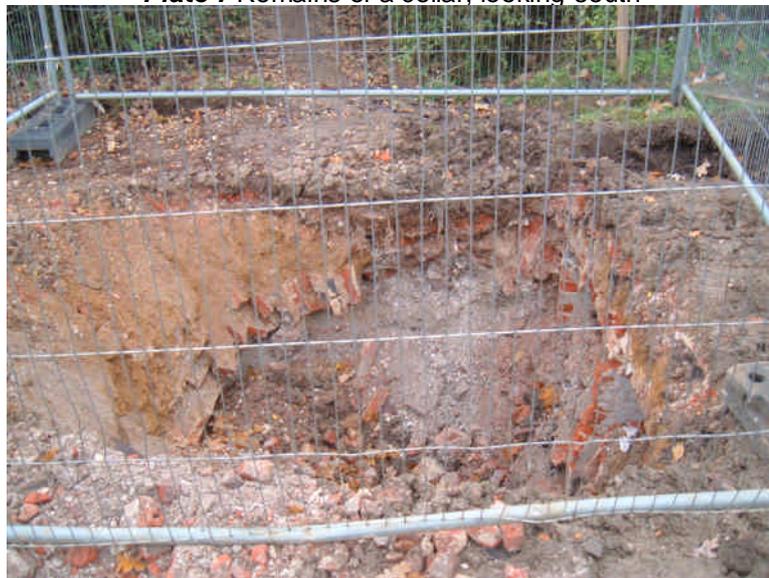
**Plate 7** Remains of a cellar, looking south

- 5.8 The present driveway to the south of the barn had been used by the contractor as an access route. A collapse in this road revealed part of a brick rubble-filled cellar (*Figs. 2 and 3, Plates 7 and 8*). In consultation with the engineer, it was decided no further material should be removed in case of further collapse and the cellar was backfilled with sand following inspection. The cellar was constructed with red bricks in a sandy

brown mortar. An arched brick ceiling was evident, though partially collapsed, extending in a north-to-south orientation beyond the south edge of the driveway. A vertical wall was present on the north side, presumably the end of the cellar. Two vertical east-to-west single-course walls with a whitewash on each face were present beneath the west side of the arched ceiling forming smaller compartments, the precise nature of which is unknown (*Plate 7*). No further information was gained. The projected dimensions and form of the cellar revealed in the driveway are comparable with the existing cellars though the location lies further towards the north. It seems likely, therefore, that the cellar relates to the central body of the Hall, in which case this lies slightly further towards the west than originally estimated during the Desk-based Assessment (*Figs. 3 and 4*)

- 6.1 The cellar is of interest as its location was not previously known. It seems likely this was associated with the central body of the Hall, the west wall of which is now estimated to have been situated further towards the west than originally thought. Although little of the cellar was revealed, the construction appears contemporary with the existing cellars that have been preserved during the development of the site and access to these has been maintained from the new garage building.
- 6.2 Despite the potential for archaeological remains to have been present, none were revealed during monitoring of the groundworks associated with the construction of the new house and garage. The precise reasons for this are unknown though the location of the new house was beyond the probable location of the former Hall, within formal gardens to the Hall.

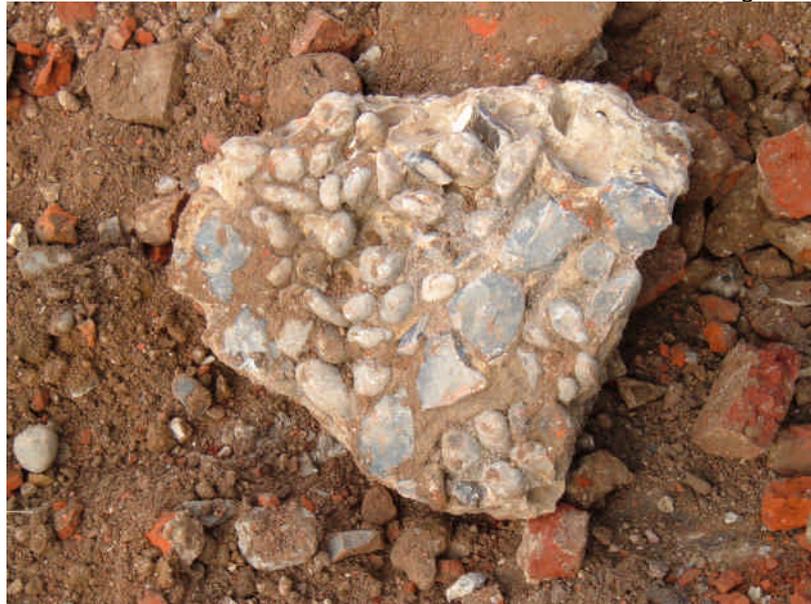
**Plate 9** Flint cobbles onto which concrete floor was laid, looking north

was carried out during works associated with the demolition of the barn. The concrete measured c. 0.3m in depth and overlay a mixed rubble bedding layer. This area was to become landscaped gardens and excavations did not exceed the bedding layer. Concrete at the north edge of the barn had clearly been laid over a flint cobbled surface, possibly an earlier floor of the barn (*Plate 9*). No evidence relating to the Hall was revealed.

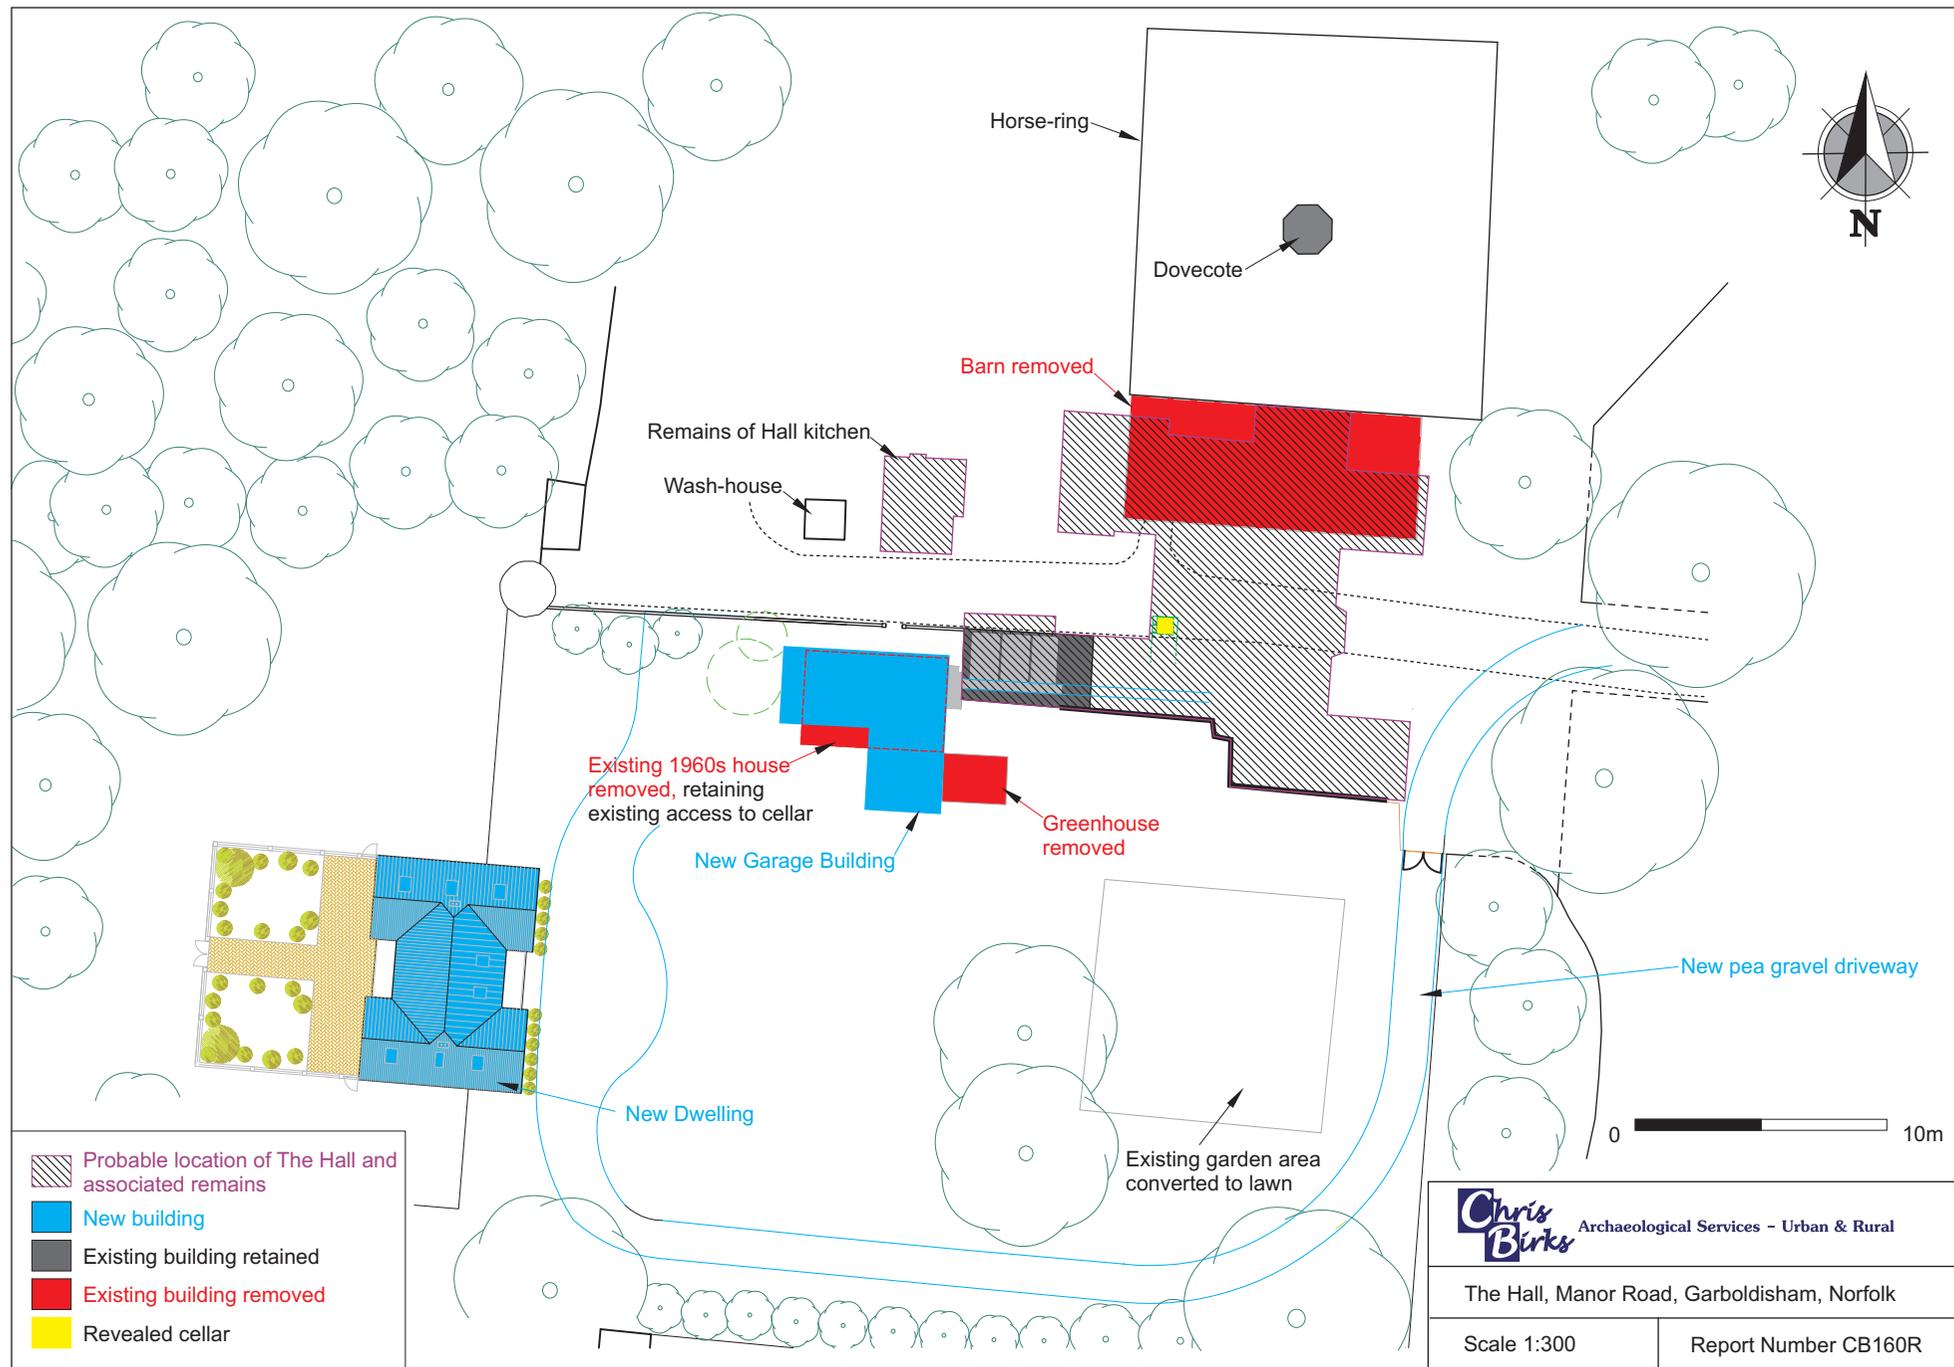
Figure 2. Site plan

- 5.9 The barn was located over a large part of the probable location of the Hall north wing (*Fig. 2*) and the barn was demolished during the present works. The west wall of the barn appeared to contain elements of the 1930s horse-ring to the north. Monitoring

- 5.10 A 1960's house was demolished as part of the current development and had access to the cellars via an existing link to the 'storage building'. A new garage building was constructed at this location and access to the cellars has been maintained. The garage foundations (*Fig. 2*) measured 0.6m wide and were excavated to a maximum depth of 1.8m from present ground level. Initially, 0.30m of mid-greyish brown topsoil was removed that overlay 0.45m of brownish yellow sandy loam subsoil. Subsoil overlay a yellow sand undisturbed 'natural' deposit with frequent sub-angular medium sized flints. Several sherds of 19<sup>th</sup> century blue & white transfer pottery were recovered from subsoil deposits. They were recorded on site but not retained. No archaeological features were present.
