# Tariff Street, Manchester

## An Archaeological Evaluation and Excavation

The University of Manchester Archaeological Unit (UMAU) were commissioned by Q2 Architects to undertake an archaeological evaluation, and subsequent excavation at land bounded by Hilton Street and Tariff Street, Manchester (NGR SJ 8472 9834).

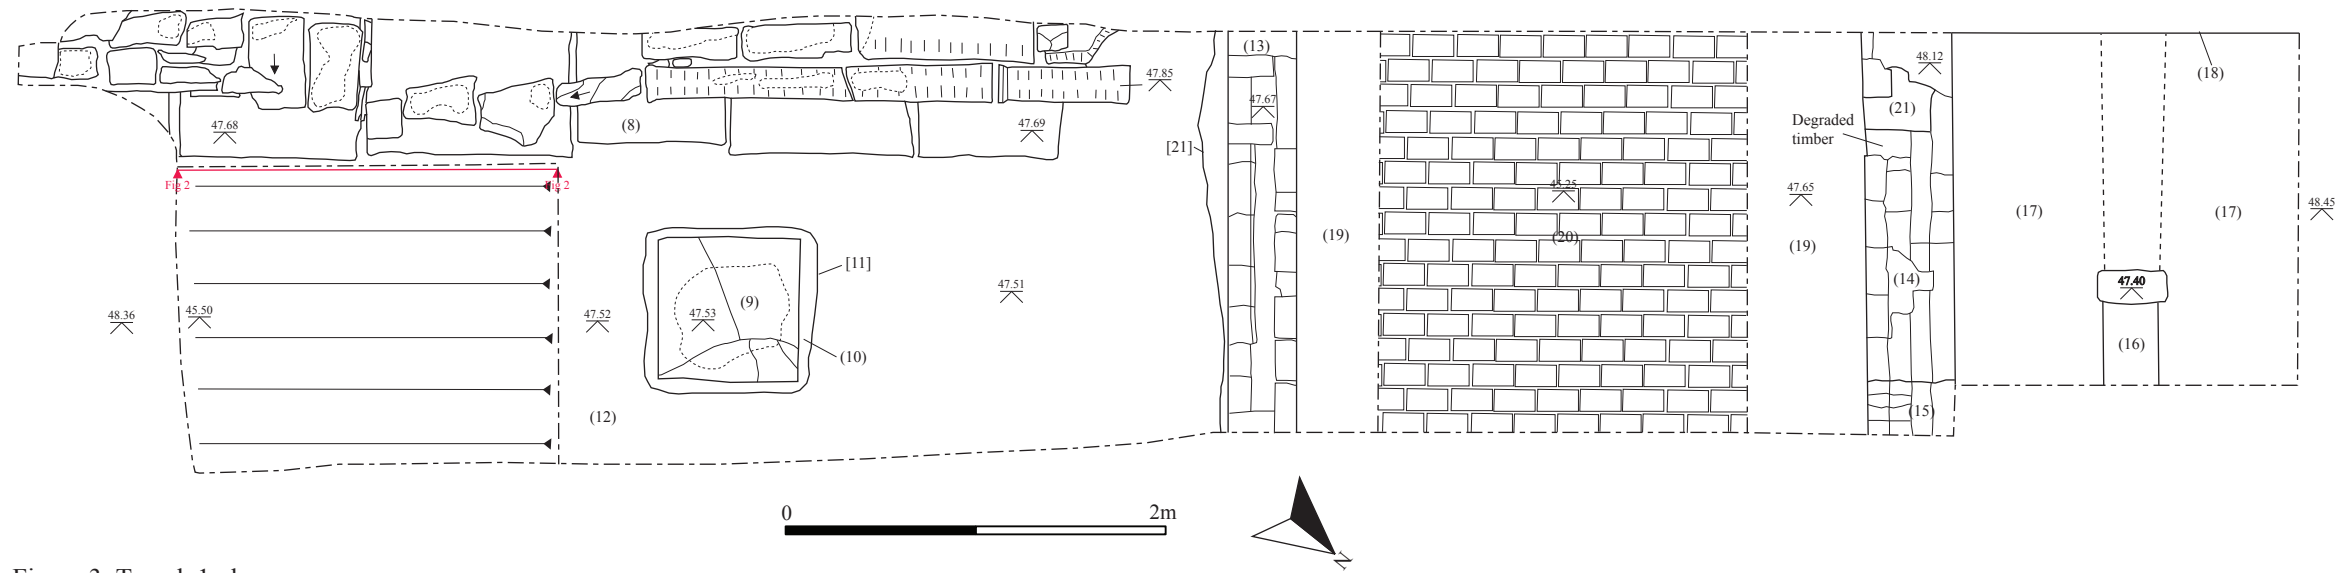
Figure 3: Trench 1 plan

Trench 1 measured 12.2m by 2.3m and was excavated to a maximum depth of 2.14m (**Fig 3, Plate 1**).

The upper layer consisted of tarmac (1) with MoT bedding (2) and compact cinder levelling material (3). This overlay a floor surface of York stone flags (4) with crushed rubble bedding (5) and mixed crushed mortar and brick levelling material (6). Below this was a layer of mixed dark cinders and rubble demolition material (7) which spread across this part of the site and sealed everything below it.

Beneath layer (7) in the south-eastern half of the trench, running north-west/south-east along the south-west edge of the trench, was a wall footing (8). This was a very roughly built structure which comprised flat stone slabs set onto the clay surface (12) below, with courses of rough stone blocks and fragments on top of it including several sections of re-used stone columns laid on their sides (**Plate 2**). Also set into clay surface (12) was a flat square stone pad (9) within a construction cut [11] filled with rusty gravel (10). The surface of the pad was covered in mortar suggesting that it had originally supported a stone or brick structure rather than a cast iron beam.

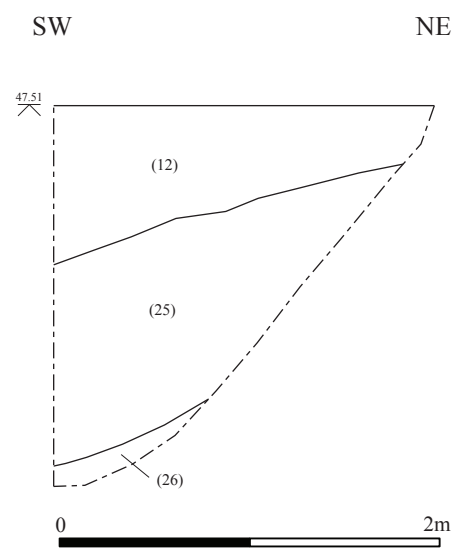
Figure 4: Trench 1 NW facing section

Clay surface (12) was of light brown well-puddled clay with very few inclusions. A section was machine excavated through this to a depth of 2m below wall (8) (**Fig 4**). The upper surface of this layer was relatively level whilst the base sloped downwards to the east following the layers below, suggesting that it was a 0.2m to 0.9m thick levelling layer. Below this was a 0.95m thick layer of mid to dark grey puddled clay with abundant brick (25) sloping downwards to the east. This overlay a 0.25m thick black silty layer overlying the natural yellowy grey clay, both of which also followed the downward slope.

The layers observed sloping downwards to the east or south-east within the sondage at the south-eastern end of the trench appeared to follow a slope or cut in the natural clay. This seemed to be heading in the direction of the canal basin and may represent part of the original construction of the canal basin during the 18<sup>th</sup> century. The layers above it contained brick fragments and sherds of 18<sup>th</sup> century pottery, fitting in with this date, and possibly representing the filling in of the construction cuts after the building of the basin was completed and the levelling of the ground in the area during late 18<sup>th</sup> and early 19<sup>th</sup> centuries.

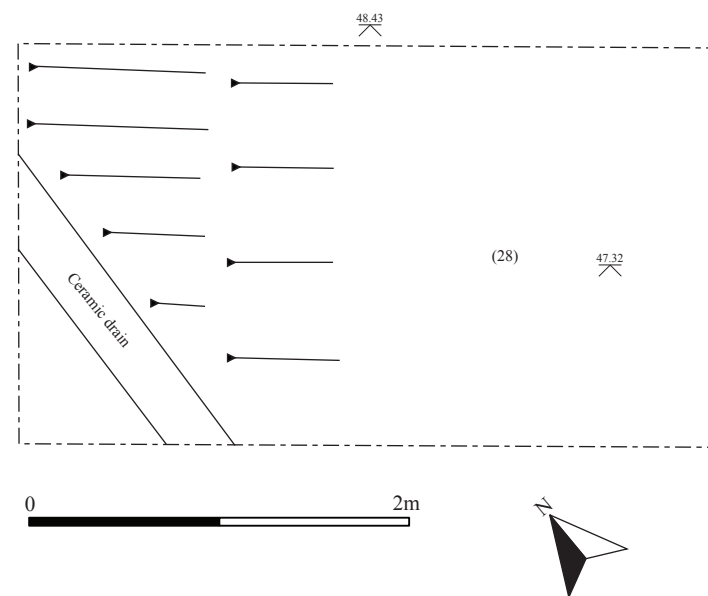
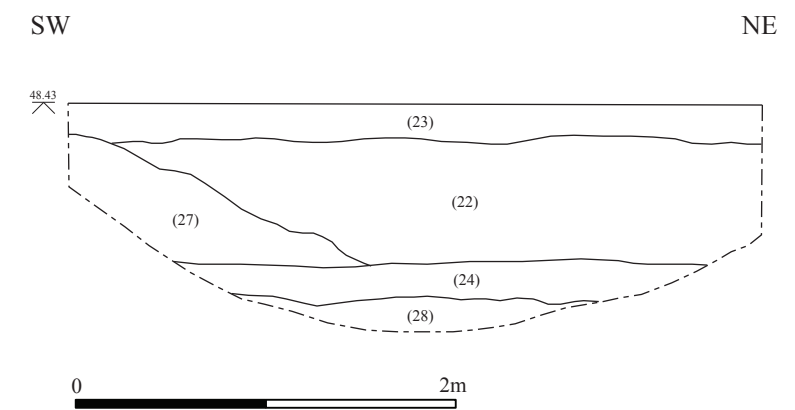
Trench 2 measured 3.8m by 2.1m and was excavated to a maximum depth of 1.2m (**Figs 5 & 6, Plate 3**).

The upper layer comprised 0.2m of demolition rubble (23) over up to 0.6m of brown sandy clay with abundant brick (22) which appeared to be levelling material. This sat above a layer of compact brown clay (27) which sloped downwards from the south-west edge of the trench and appeared to be a tip line within the levelling material. These lay above black silty clay (24), similar to (26) within trench 1. Below this was natural mottled yellowy grey natural clay (28). A ceramic drain ran across the north-west corner of the trench through layer (22).

Figure 5: Trench 2 plan

Figure 6: Trench 2 NW facing section

The layers in trench 2 appear to be a series of dumps of levelling material put down during the 19<sup>th</sup> century prior to the construction of the machine manufactory between 1831 and 1845. The exception is the sticky black silt layer (24), which is very similar to layer (26) in the trench 1 sondage and may be the remains of a deposition from the construction of the canal basin during the 18<sup>th</sup> century.

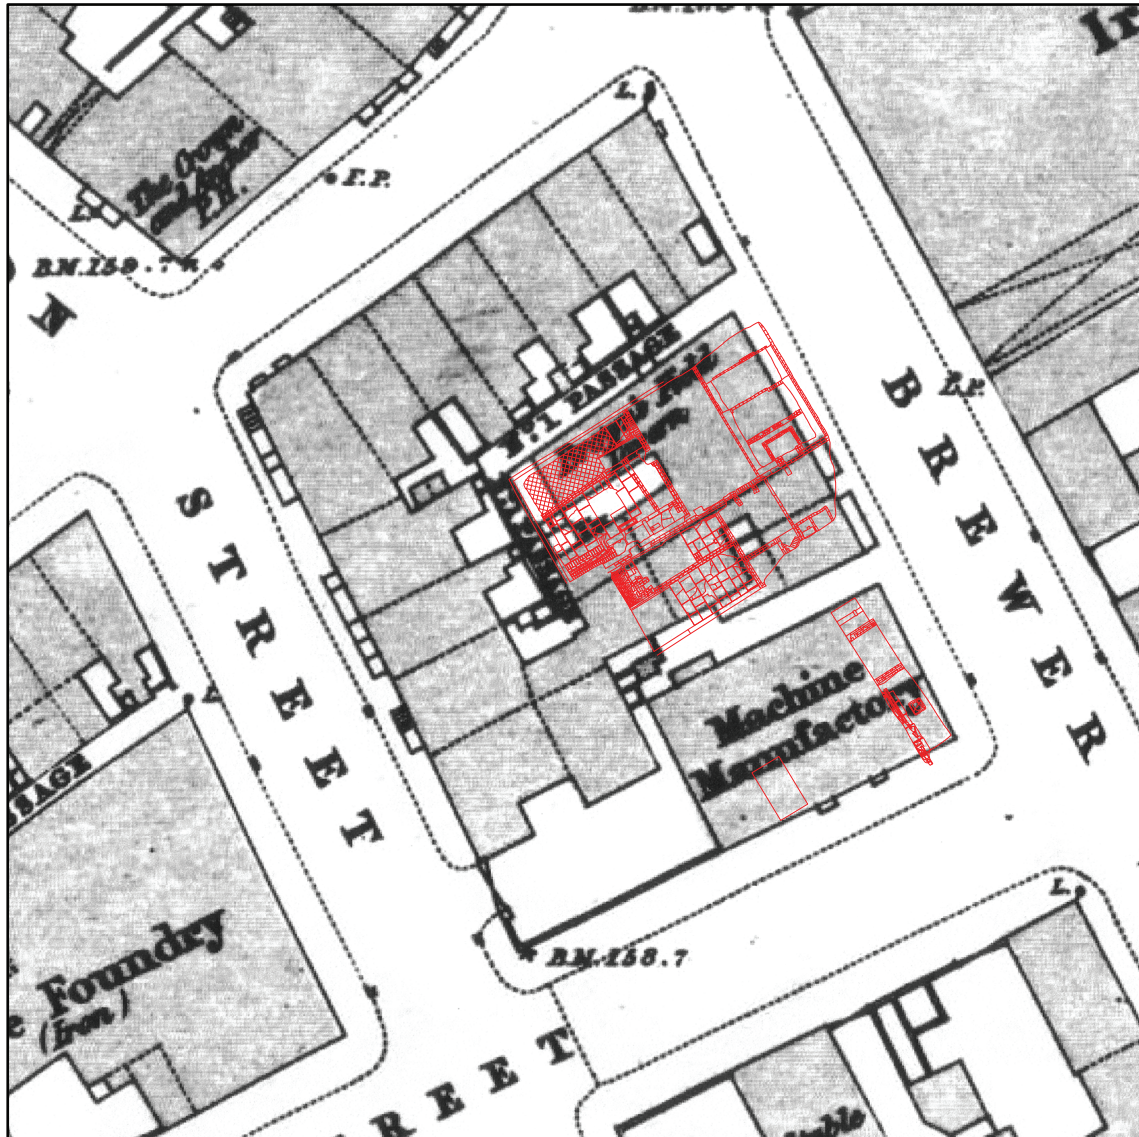
Figure 10: Trenches overlaid onto OS 5ft to 1 mile map of 1848 (NTS)

The stone pad cannot be accurately phased but it is likely to also be part of the complex of workers houses built between 1808 and 1819. This complex was replaced with a machine manufactory between 1831 and 1845 (**Fig 10**).

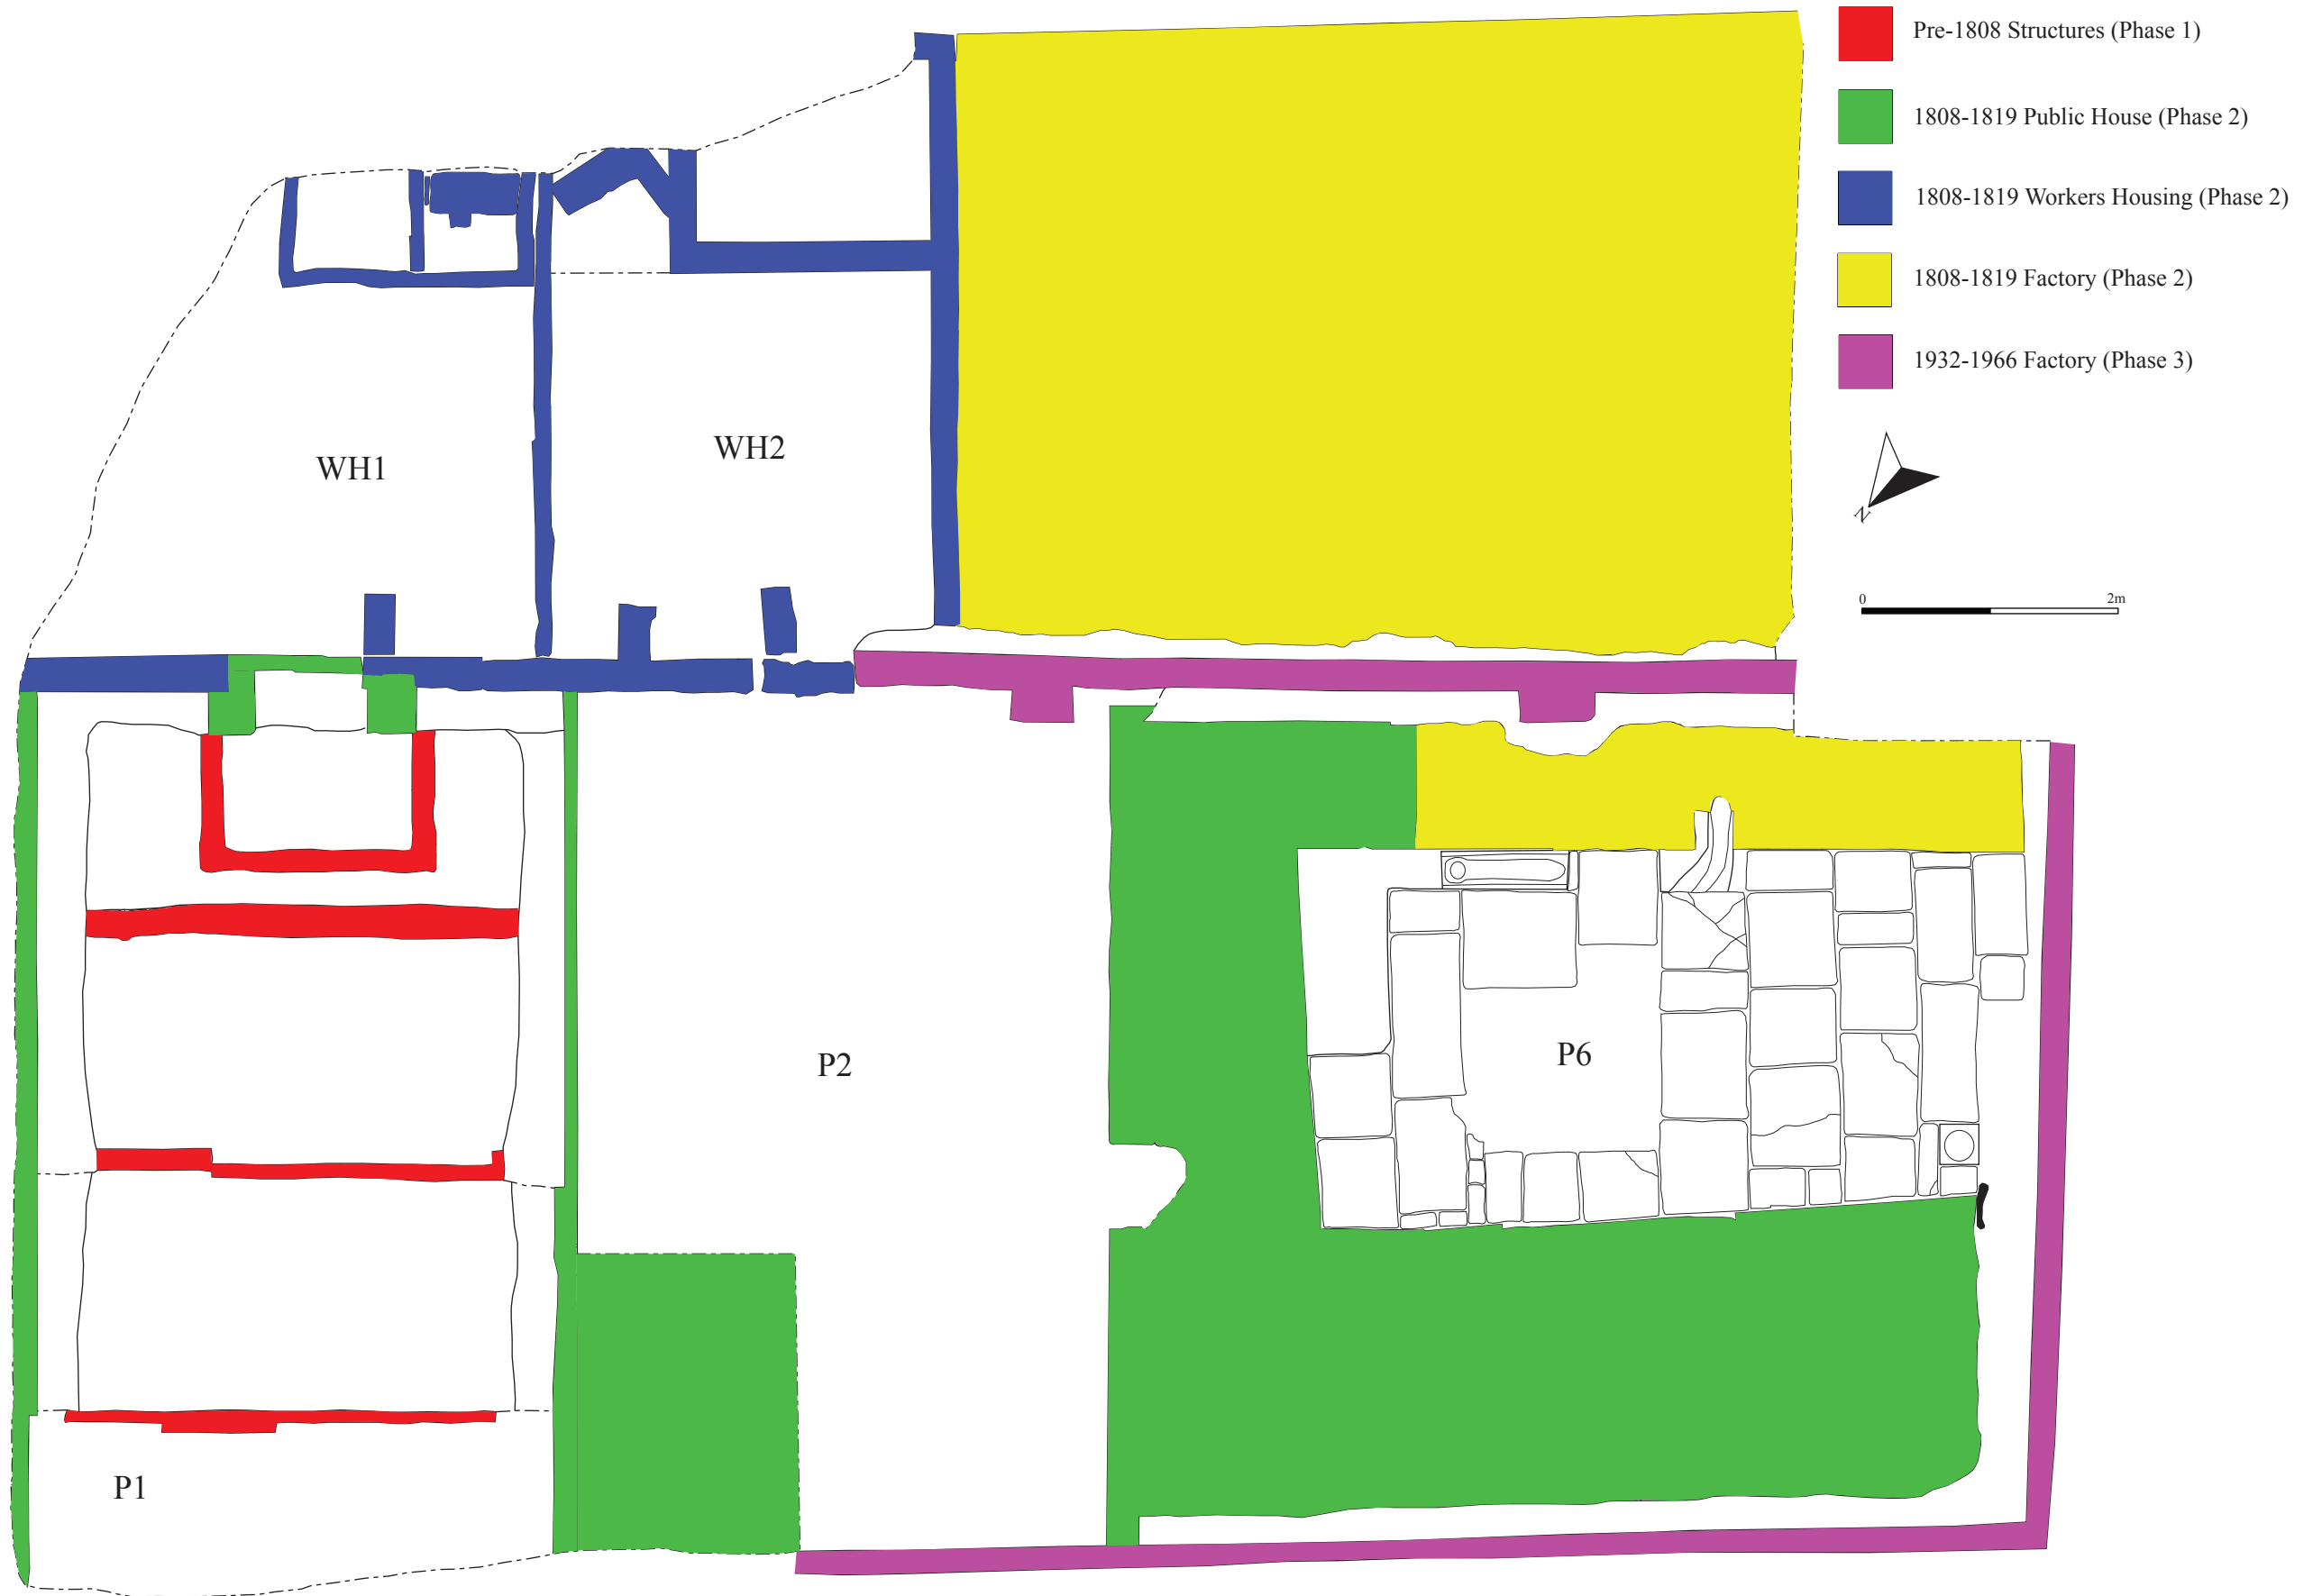
Figure 7: Open area excavation plan

From the map evidence the remains uncovered within the open area excavation trench can be split into five separate buildings covering three phases. The earliest phase consists of a series of early, pre-1808, structures. The second phase comprises three buildings, workers housing (WH1-2), a public house (PH1-6) and a factory (F1-3), all of which were built between 1808 and 1819. The final phase is the modern building which replaced the 1808-19 buildings between 1931-2 and 1965 (**Fig 11**).

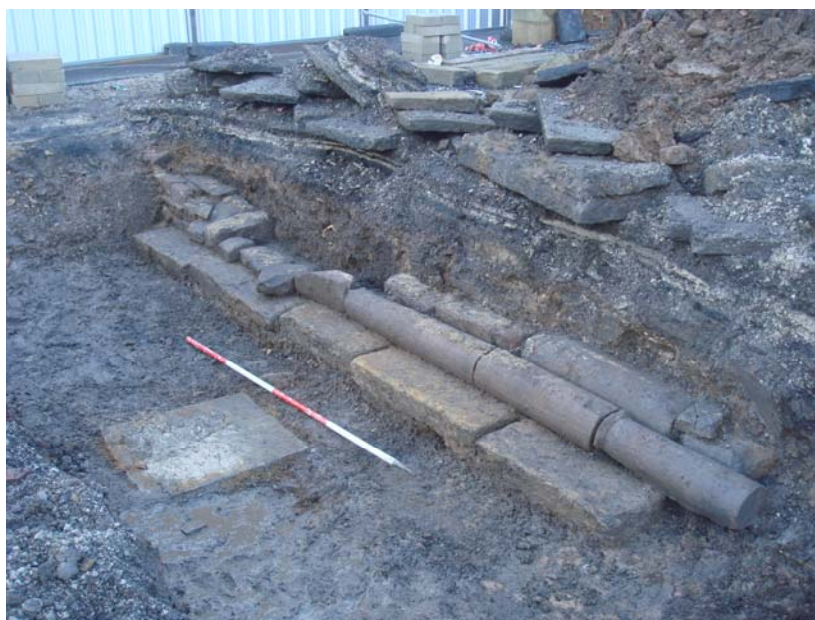
Plate 2: Columns (8) within Trench 1

Wall footings (8) were very rough and obviously built from re-used masonry. The sections of column used are indicative of those used in 18<sup>th</sup> century town house porticos and are likely to have come from 18<sup>th</sup> century buildings demolished within the immediate area and re-used in 19<sup>th</sup> century construction. The footings align well with workers housing visible on Bancks' map of 1831 (**Fig 9**). Although these are the same buildings shown on Swire's map of 1824 (**Fig 8**), with which the footings do not fit as well, this can be attributed to the quality of mapping and it is likely that these remains relate to the early 19<sup>th</sup> century workers housing built between 1808 and 1819.

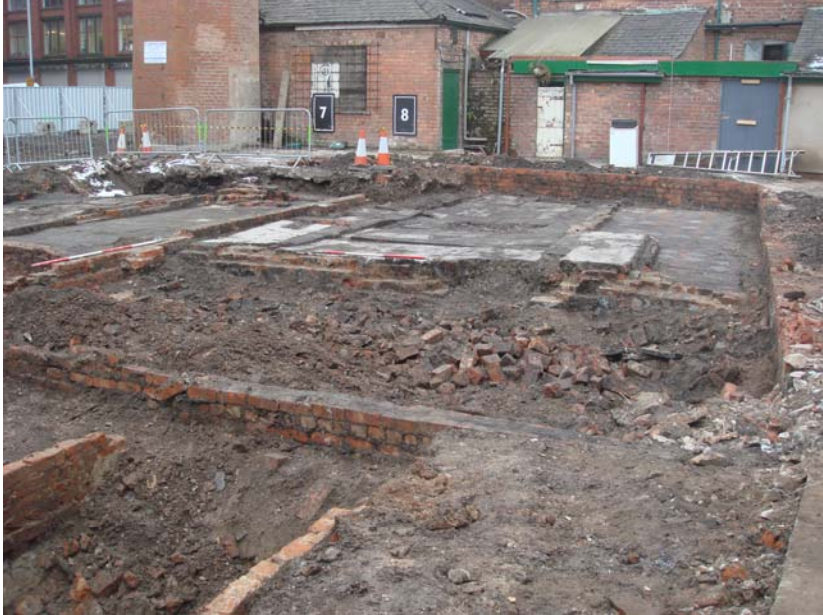
At the central northern part of the area was a rectangular, 6.8m by 4.2m and 1.9m deep, cellar filled with mixed demolition rubble (113) (**Plate 5**). This was bounded by hand made brick walls (112) to the north-east and south-west, and hand made brick wall (219) to the south-east. The north-western side was bounded by a modern machine made brick wall with the original earlier hand made brick wall below and at the base of the cellar was a stone flag floor surface (114).

Plate 5: Cellar P2

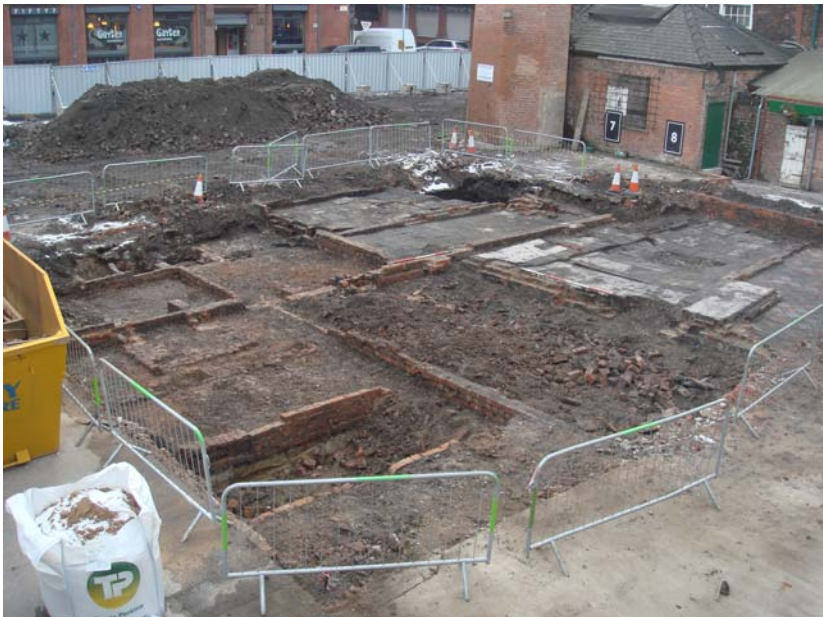
To the north-east of the cellar was an area bounded by walls (100), (112) and (219), of which (219) was butted by both (100) and (112) (**Plate 6**). Walls (100) and (219) had been cut into the original ground surface within cut [101], filled by mixed rubble and clay (102). Wall (219) had two small brick buttresses which appeared to be the remains of a hearth. Wall (112) was also contained by construction cut [103] with a mixed cinder fill (104). These walls had cut a series of earlier hand made brick walls, all aligned north-east/south-west. Wall (111) was a single course of hand made brick with a 2 brick course wide blocked entrance way. Wall (110) was 1 course wide and built from hand made brick with a single course wide repair or blocked entrance at its north-eastern end. Wall

Plate 6: Pre-1808 structures (left hand side)

The early structures (walls (108-111), footings (106-7)) do not fit with any of the other structures on site. They had been truncated by the walls of the public house which was built between 1808 and 1819 and therefore probably represent a short lived phase of buildings, by their size probably workers housing, built after 1787-94 and demolished before 1808, therefore they do not appear on any of the mapping. They appear to be a series of narrow buildings, each of a similar size to the workers houses excavated at Chapel Wharf, Salford, and at Pollard Street, Ancoats. The north-eastern and south-eastern outer walls of the later public house probably follow the same alignment as the original outer walls of these structures. The south-eastern structure appears to have had what appears to be a fireplace which has been replaced by that within wall (219).

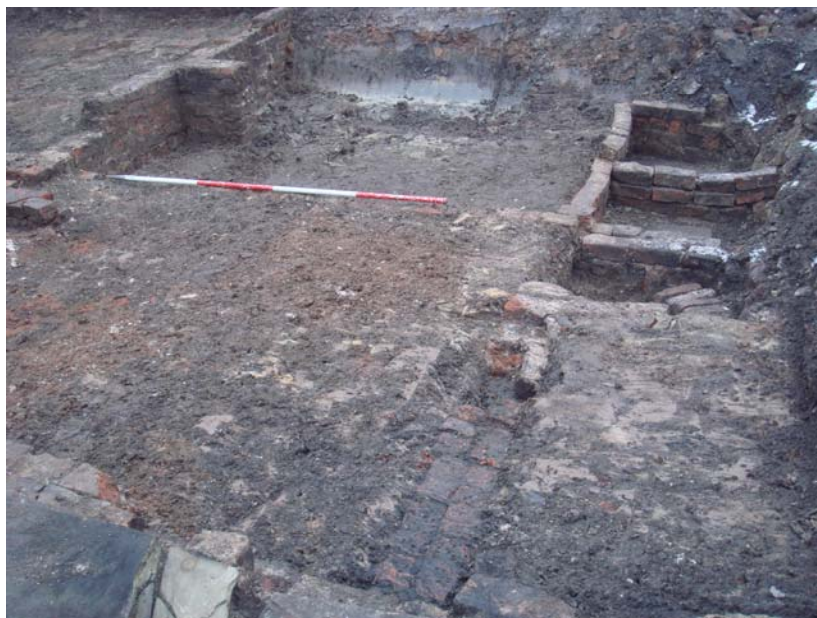
Plate 7: Workers housing WH1-2

Although little remained of the workers housing it appears to follow a pattern seen in excavations across Greater Manchester. The remains uncovered are likely to be a single house which had had a number of additions made to it. The buttresses and other internal features were much more roughly built than the original external walls and seem to be built from re-used materials as and when the occupants could find them. It is likely that buttresses (217) and (218) within room WH2 may represent a fireplace inserted when the house was split into two rooms by wall (222). The function of rectangular internal compartments in room WH1 is not known but ties in with similar structures seen at Chapel Wharf and Pollard Street. The internal walling seen within room WH2 may be an attempt to create a smaller partitioned off room within WH2. This structure represents that north-western of two workers houses built between 1808 and 1819 and are depicted as two separate double depth house on the map of 1848. These were demolished between 1931-2 and 1966 and replaced with a modern factory.

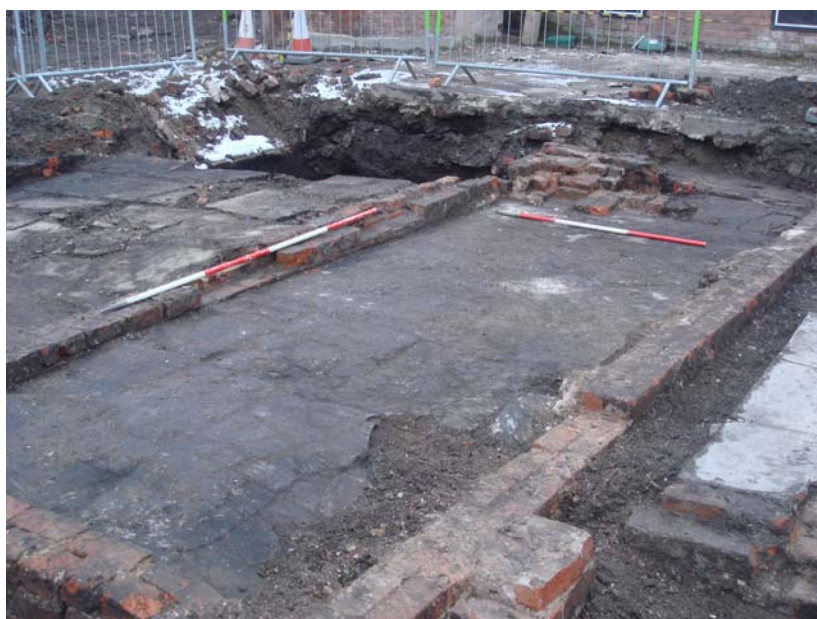
Plate 8: 1808-1819 factory F1-3

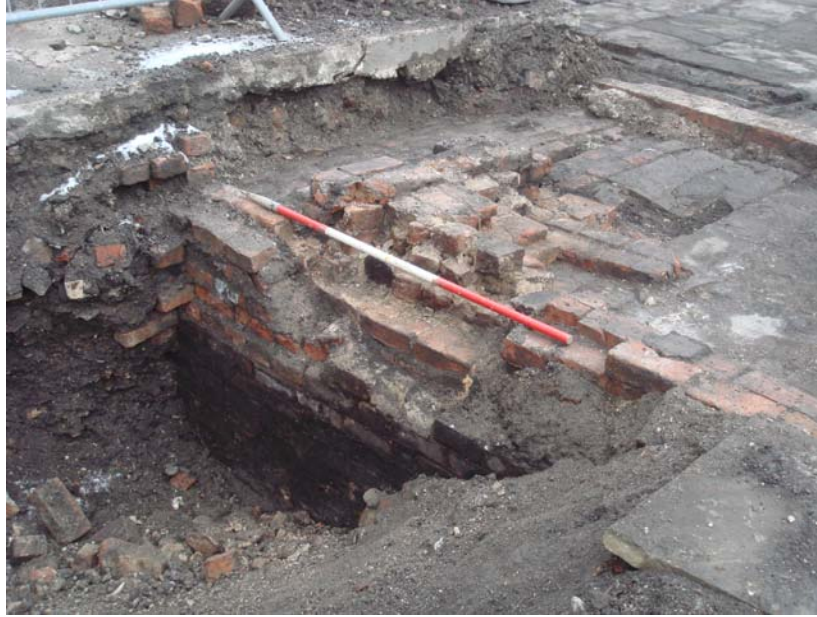
Plate 9: Boiler room and ash pit F1-2

The presence of fire bricks and the cinder filled pit within factory area F2 suggest that this may have been the boiler room. Beyond the area of the excavation trench, after demolition of number 51 Hilton Street, stone machine beds were observed in situ beneath the demolished building (**Plate 13**). These could not be cleaned and recorded at the time due to the unsafe nature of the neighbouring structure. Also observed within the north-eastern ground floor wall of this building, prior to demolition, was a very large cast iron bearing box (**Plate 14**) which, due to health and safety requirements, could only be photographed after its removal. This suggests that the boiler sat on the brick floor within factory room F3 with flues running out beyond the excavation area into the standing chimney (**Plate 15**), providing steam power for the engine room to the south-west. Goads insurance plan of 1886-1901 marks the factory as having a 30hp engine. The structures uncovered within the excavation trench were built between 1808 and 1819 but the power system must have been altered between 1831 and 1848 when 51 Hilton Street becomes linked to the factory building. The part of the factory uncovered within the excavation trench was demolished between 1931-2 and 1966 when it was replaced with a modern factory building.

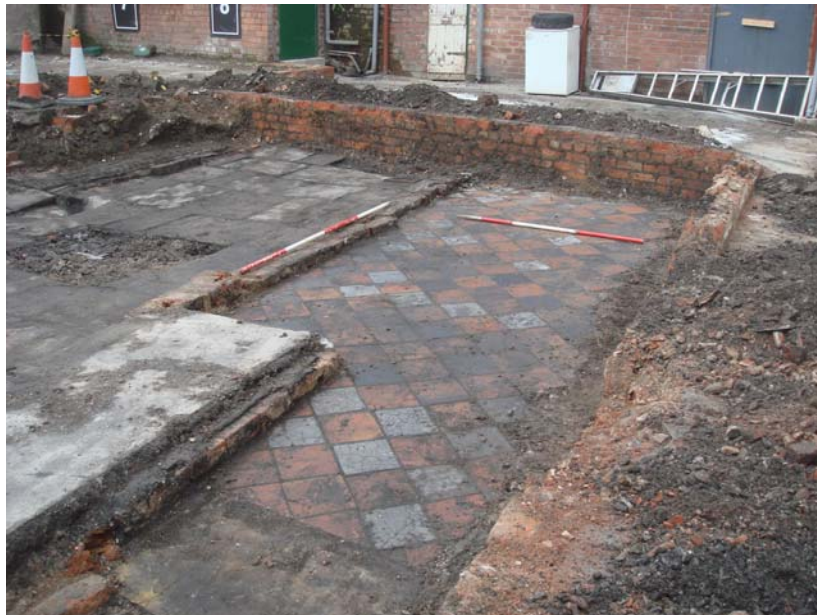
Plate 10: Tile-floored bar room P3

The public house (P1-6) was built between 1808 and 1819 and was demolished between 1931-2 and 1966. This represents over half of the area and consists of a front room (P1) at the north-eastern side with a cellar (P2) at the centre and a tile-floored bar room (P3) to the south-west of this next to a flagged open courtyard (P6). A covered corridor (P4) lay between the courtyard and cellar with access to the cellar, courtyard, tile-floored room and a small toilet (P5) to the south-east. The front room (P1) was rectangular with a fireplace at its south-eastern side. No access points were visible within this room but this may be due to the level of demolition or possibly that the entrance lay at the north-western side of the room, outside the trench area. Access was gained to and from the cellar (P2) through a doorway in corridor P4 which also allowed access between bar room P3, toilet P5 and the outside courtyard P6. It is likely that the cellar doorway also gave access to and from a room above the cellar. The had a concrete floor and a blocked entrance from the courtyard suggesting that it was a later rebuild of an earlier toilet accessed from the yard. This may have also resulted in the concrete repair (121) within the courtyard flags (122) to allow updating of the toilet drainage when it was rebuilt. Bar room P3 was accessed from the corridor P4 and the courtyard. Most of this area was tiled but had stone flags at its north-eastern side, next to the cellar, suggesting that this was the position of the bar. The addition of the concrete slab (117) may be associated with the later factory which replaced the public house. Courtyard P6 contained two ceramic drains and a sloping concrete drain allowing surface runoff (132) within the factory room F3 to drain beneath wall (133) and under the courtyard flags (122), where there was presumably a soakaway for this and the other drains. The public house was built between 1808 and 1819, the front replacing the earlier unmapped structures, and is named Brown's Field Hotel on the map of 1848. It was demolished between 1931-2 and 1966 and replaced by a modern factory.

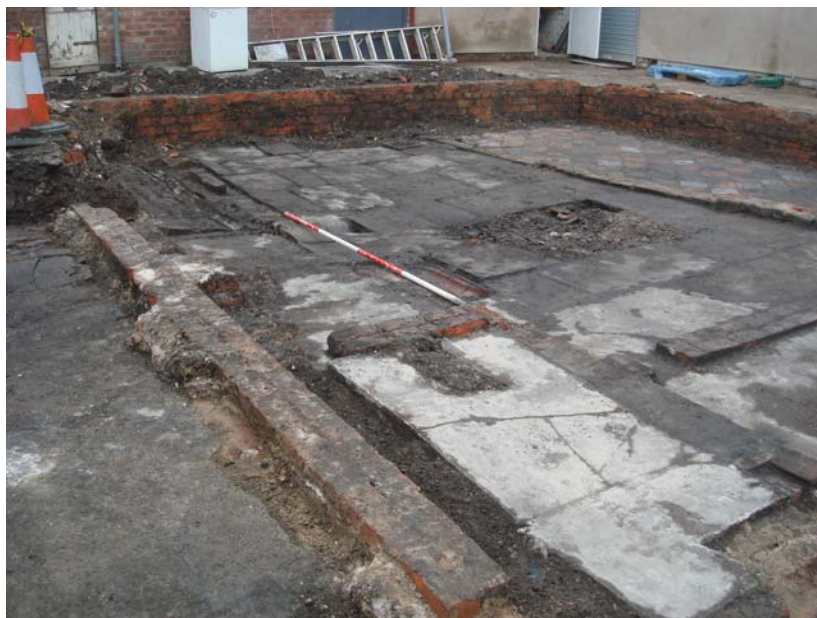
Plate 11: Public house courtyard P6 and Toilet P5

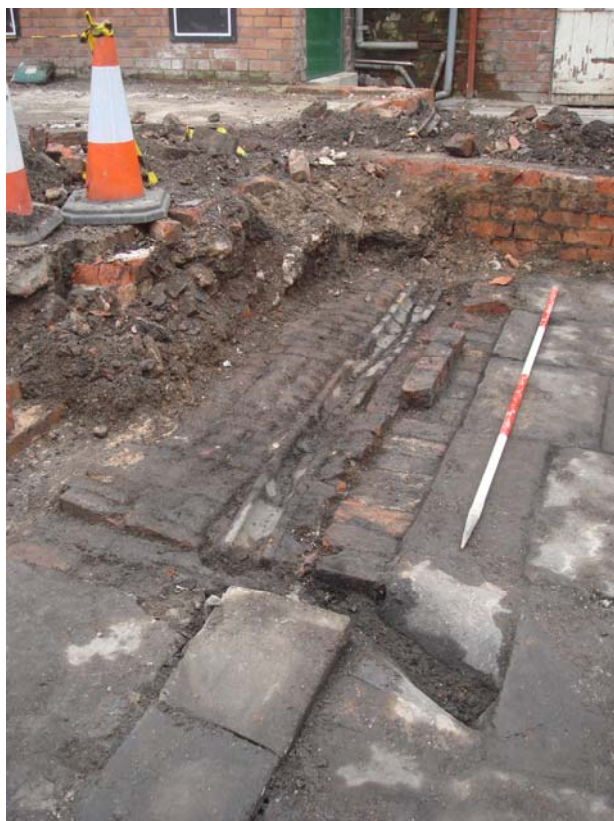
Plate 12: Factory F3 and drains

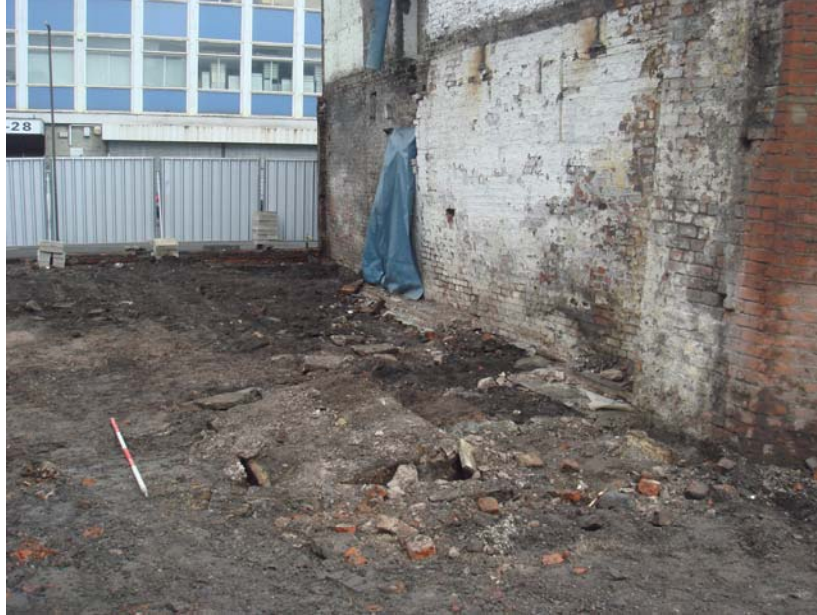
Plate 13: Engine beds below 51 Hilton Street
