An Archaeological Watching Brief at Seymour House, Landgate, Rye, East Sussex

TQ 9215 2065

December 2009

Summary

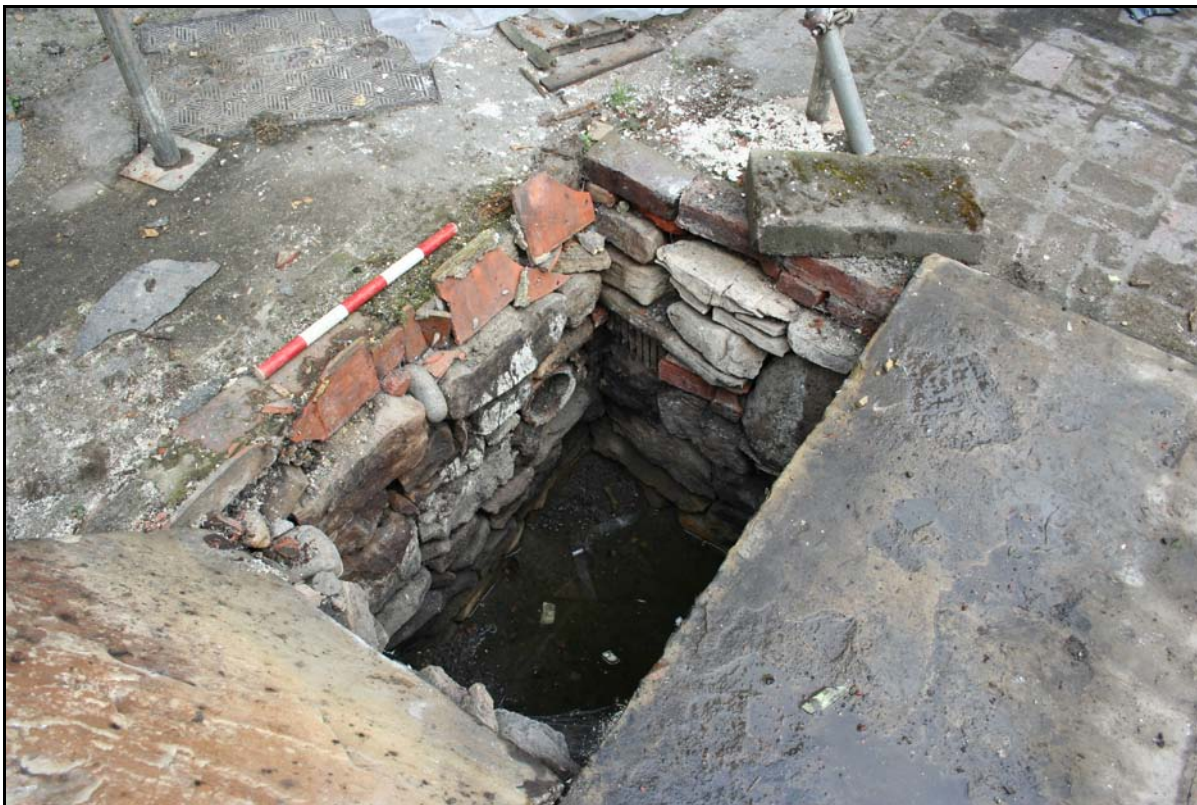
- 4.13** On the south-east side of the house below a shed which had been demolished was a rectangular stone lined soak-away and drain (Feature **15**) measuring 0.9m x 1.3m and 0.9m deep (Fig. 9). It was covered with two large rectangular stone slabs, and was lined with sandstone blocks in a roughly coursed drystone construction, and edged around the top with bricks and ceramic tile (Fig. 10). A ceramic drain pipe entered it from the west side and ran from an adjacent manhole cover.

Fig. 10: Seymour House, Rye: Photograph of Feature 15

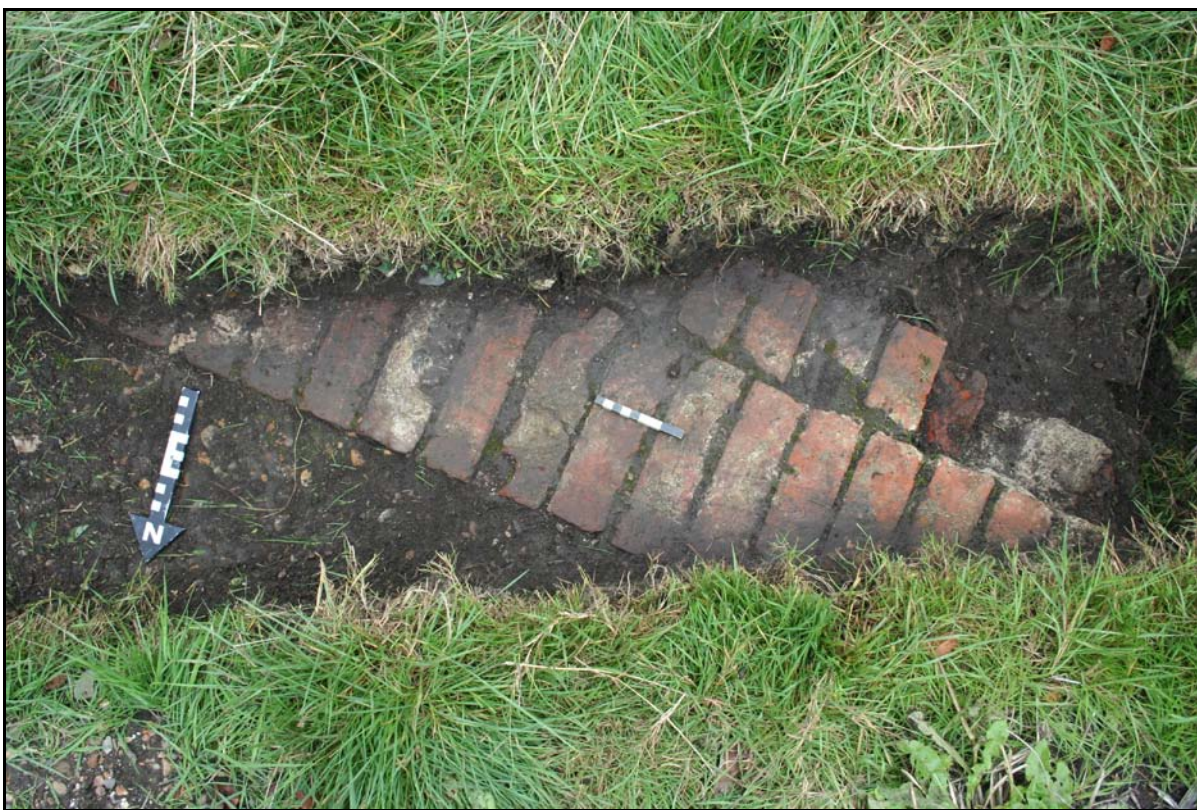
- 4.15** The brick wall (Context **10**) was orientated in an east-west direction and ran diagonally across the gas pipe trench. It comprised medium to well fired bricks with sparse/moderate fine sand and sparse/moderate iron oxide inclusions of later 18th to early 19th century date, bonded in a buff fine sandy lime mortar (Fig. 11). This wall is shown on the 1st and 2nd Edition OS maps, but had gone by the time of the 3rd Edition map (1910).

Fig. 11: Seymour House, Rye: Photograph of Wall 10

5.3.3 The only complete dimensions recorded were from a half brick taken from the wall (Context **10**) in the gas pipe trench (110mm wide by 63mm tall), and a complete brick measured in-situ in the wall which measured 230mm x 110mm x 60mm). A complete floor brick with a worn upper surface from Context **16** measured 218 x 112 x 45mm.

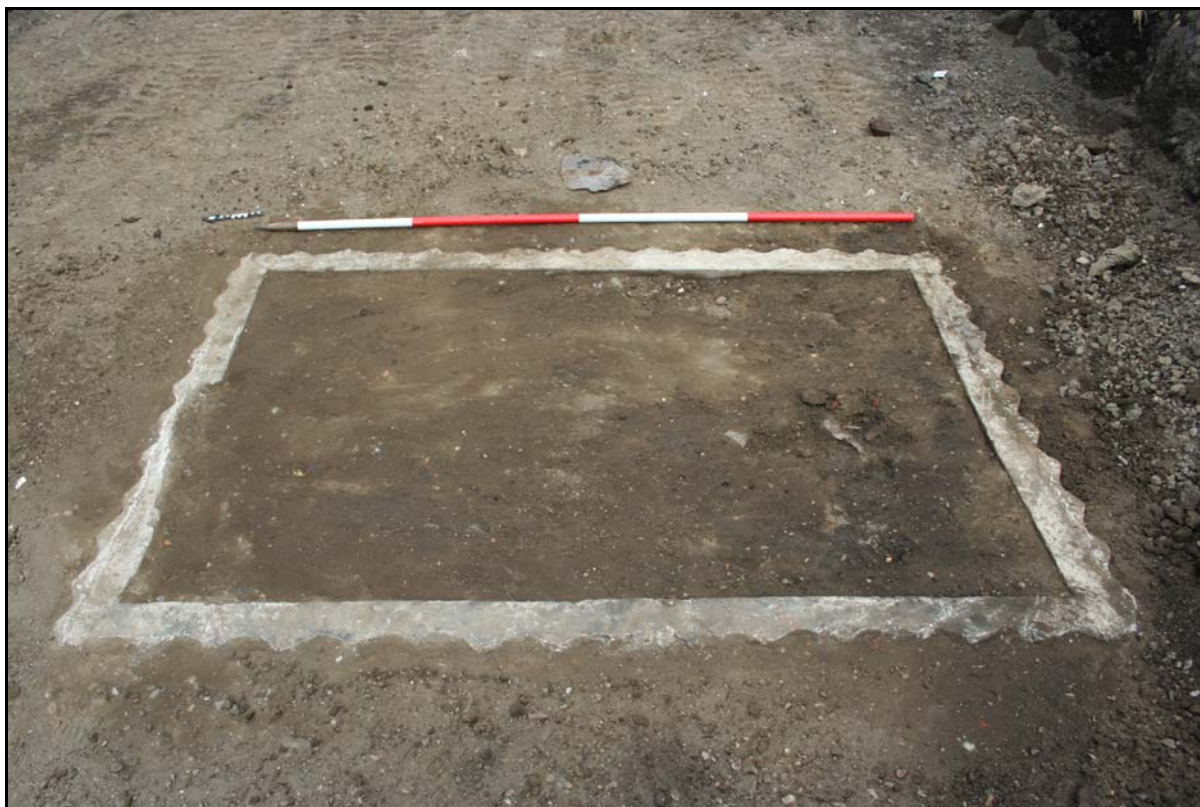
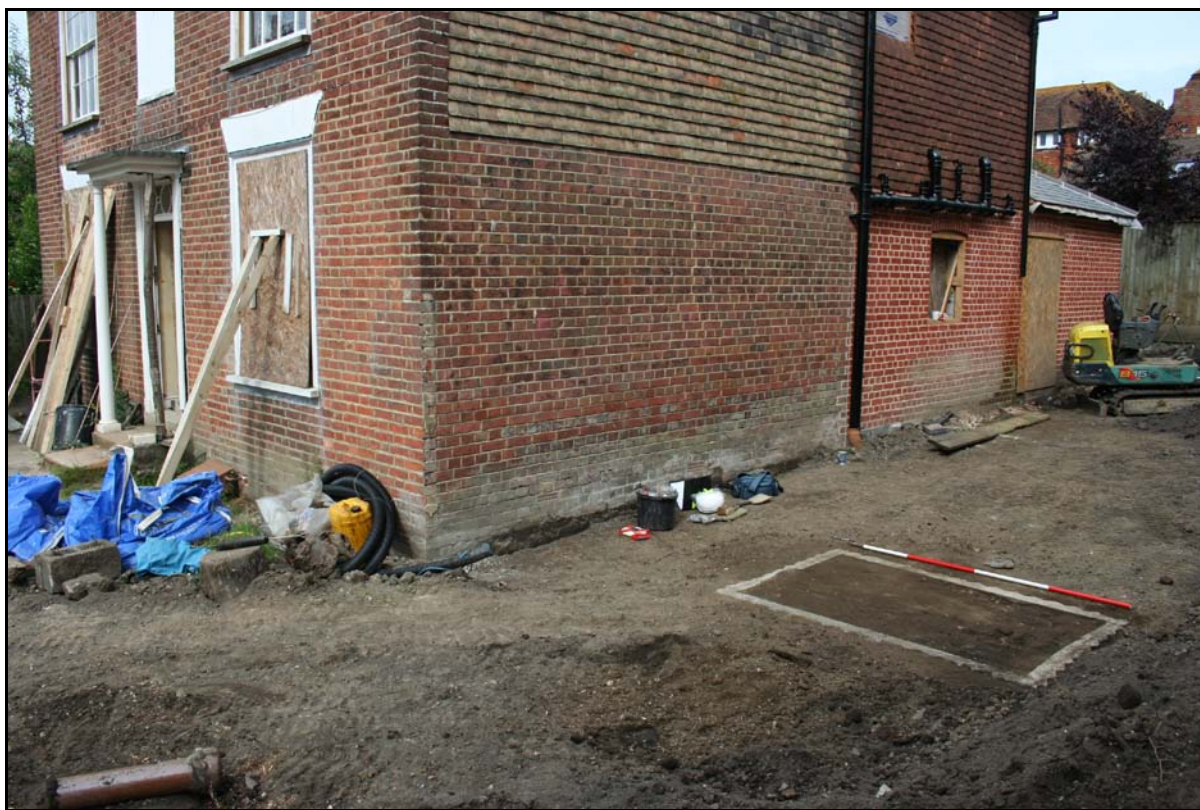
- 4.23** A concrete rectangular structure (Feature **26**) was revealed (Fig. 9) below Context **20** and cut into Context **21**. It measured 2.06m x 1.44m and was orientated north-south. The inner edge was straight whilst the outer edge was wavy (Fig. 12), the concrete varying from 88mm to 115mm thick. It was filled with a firm dark brown silty clay loam (Fill **27**) with flint pebbles to 20mm (3%), charcoal flecks and pieces (3%) and CBM (<1%), slate and 19th century pottery and CBM. This appears to have been a garden feature, perhaps holding water or plants, and was filled in during the 19th century (Fig. 13). This feature was below the depth of the excavation and will be preserved in-situ.

Fig. 12: Seymour House, Rye: Photograph of Feature 26

Fig. 13: Seymour House, Rye: Photograph showing Feature 26 and the house

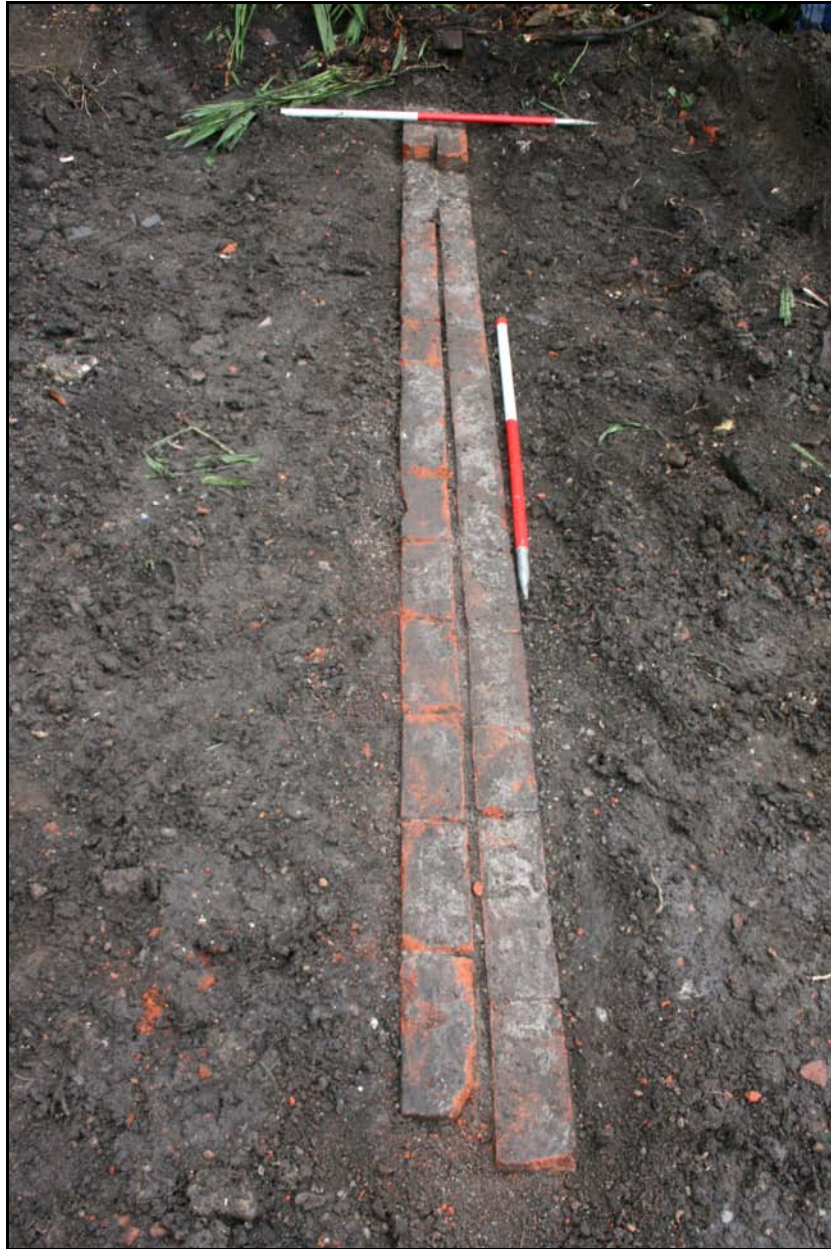
- 4.24** A brick wall (Feature **28**) running north-south was located just to the west of Feature **26** (Fig. 9). It was 240mm wide, and formed from two parallel rows of bricks held in a mid grey mortar and survived to a height of two courses and a length of 3.85m (Fig. 14). The bricks are of the same type and dimensions as Wall 10. It was set within Context **21**, and was overlain by Context **20**. This wall is shown on all of the OS maps and therefore must have been constructed in the 19th century or earlier, and survived into the mid 20th century.

Fig. 14: Seymour House, Rye: Photograph of Wall 28

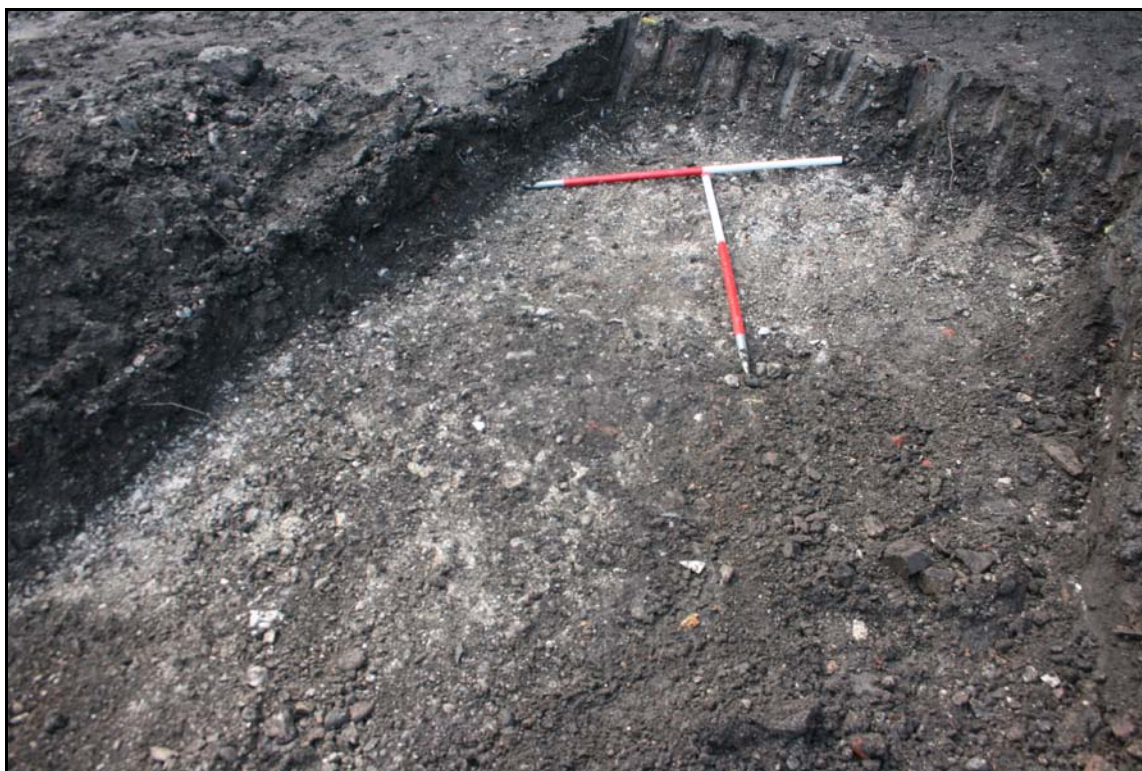
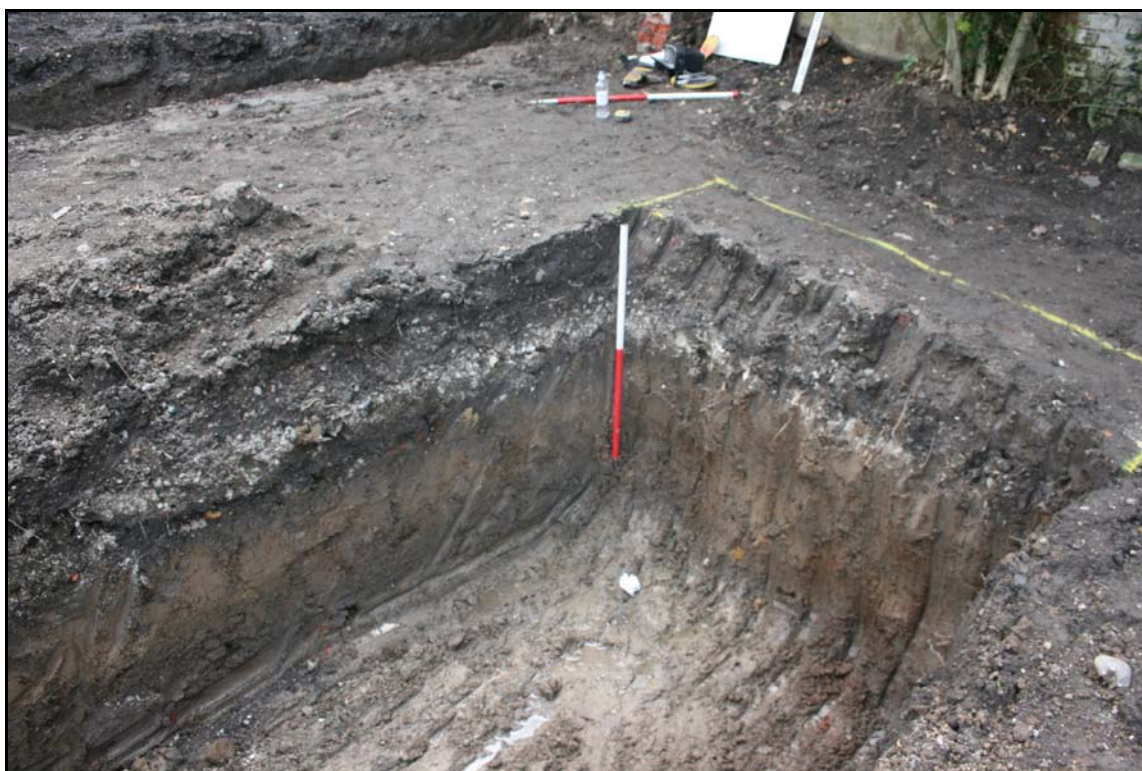
- 4.26** Within Context **29** at a depth of 150mm and extending across the south end of the hole was a layer of rammed chalk (Feature **30**) 70mm thick, containing pebbles up to 40mm (5%); this may have been the remains of a garden path (Figs. 15 & 16). Below Context **29** was a buff to mid brown firm sandy clay (Context **31**) containing sandstone pieces up to 200mm (<1%).

Fig. 15: Seymour House, Rye: Photograph of Feature 30

Fig. 16: Seymour House, Rye: Photograph of Section of Water
Storage Tank hole showing Feature 30
