Phase II: Rampart wall and turrets

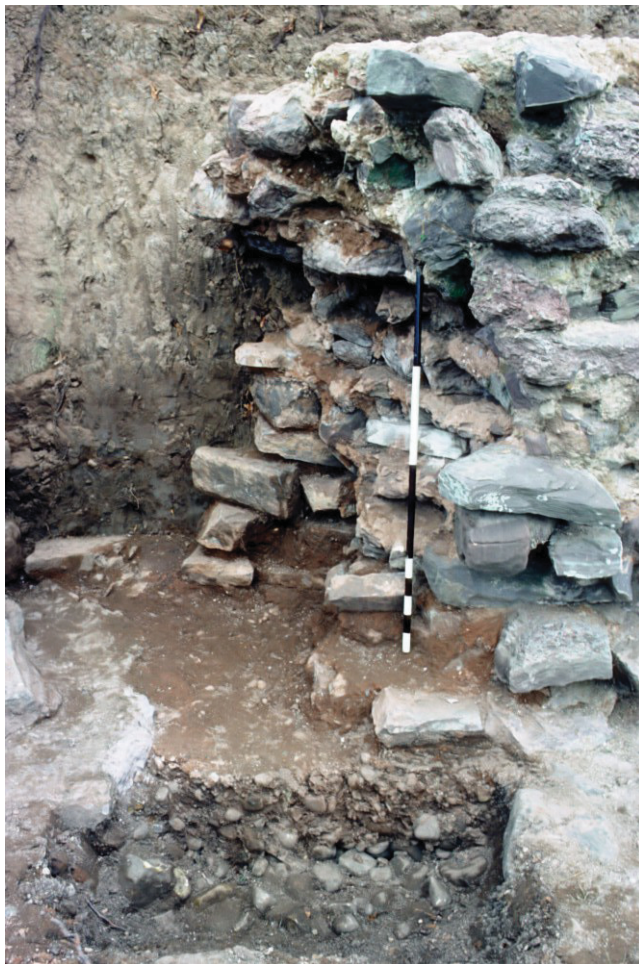
Fig. 8.
Site D curtain wall section
showing cobble foundations

The rampart wall was inserted into the front of the earthen rampart which was cut back to accommodate it. It was built upon a foundation of river worn cobbles (width c. 1.8m, depth c. 0.5-0.6m – see fig. 8). No evidence was observed to suggest that the cobbles were set in mortar, although only a limited investigation of the foundations was possible. Boon notes the use of a lime mortar in the arguably Phase II cobble foundations of the southern corner (Boon 1963, 8).

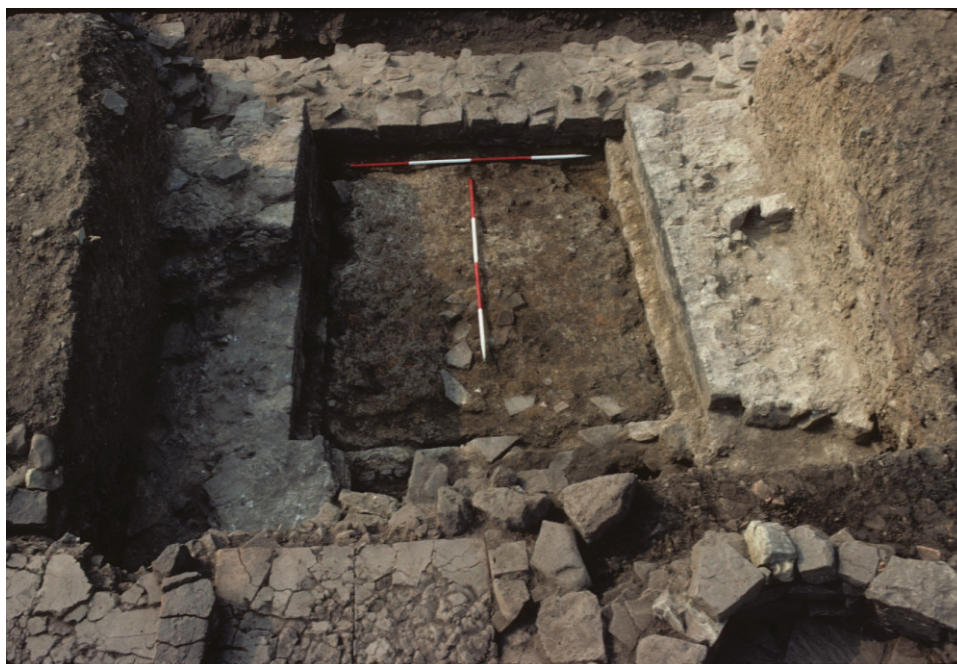
Fig. 9. Site D. The interval tower from the north east after excavations

The construction technique employed for the interval turret (Site D see fig. 9 - internal dimensions 2.60 x 3.00m; wall thickness c. 0.95m) is similar to that of the rampart wall. A section of the rampart was removed to accommodate it and a foundation trench, filled with river worn cobbles, was cut (width 1.20m; depth c. 0.50m). No evidence was recovered to suggest that the cobble foundations were set in mortar, but as with those of the rampart wall and corner turret any mortar may have been leached out. This cobble foundation trench appeared continuous with that of the rampart wall although the walls of the turret above the level of the foundations butted against the rampart wall. Following the building of the turret walls the area between the sidewalls and the cut-back rampart was backfilled with residual, displaced rampart material (these deposits were unexcavated; fig. 10). The basement floor of the interval turret was made up of several compacted layers of construction trample, consisting of mixed deposits of mortar, clay, gravelly silt and charcoal (D9, D10, D17, D18 and D19), overlain by a paved floor and associated surface (D7).

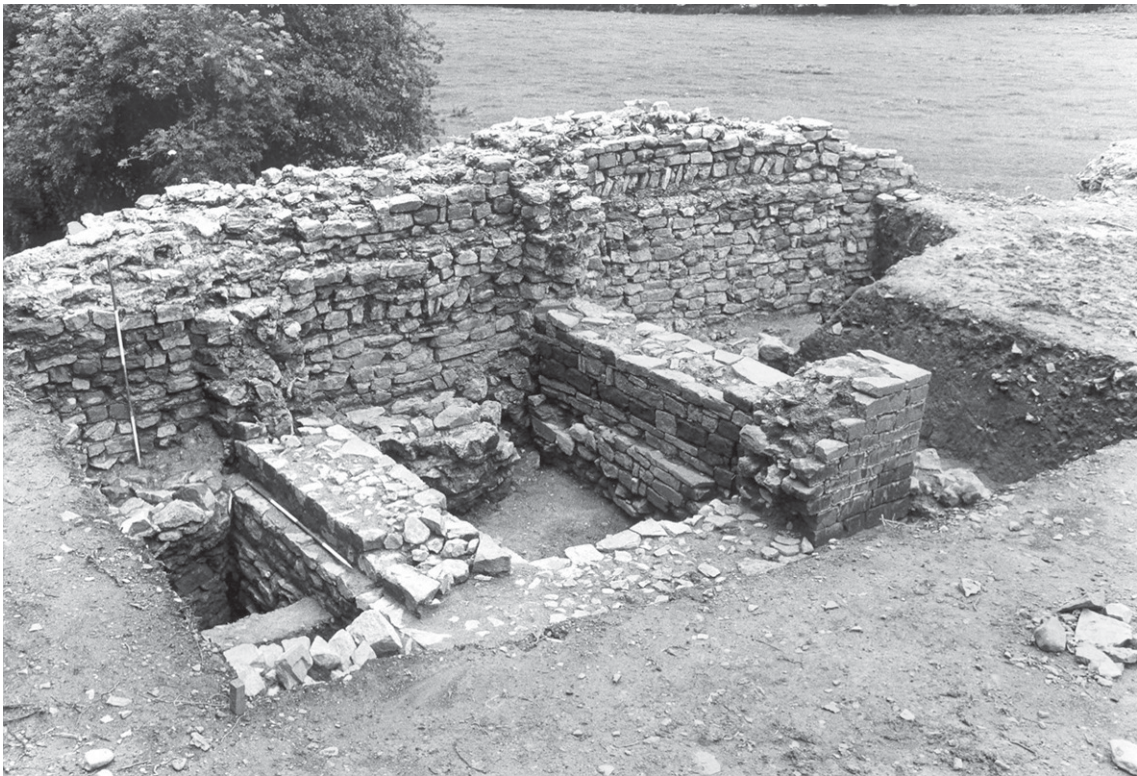
Fig. 11: Site A. The corner turret from the north

The construction technique employed on the corner turret (Site A - fig. 11 - internal dimensions 2.50 x c. 3.70m; wall thickness c. 0.95m) was similar to that used for the interval turret. The rampart was cut back and foundation trenches, subsequently filled with river worn cobbles, were cut for the walls. As with the rampart wall and interval turret, no evidence was recovered to suggest that the cobble foundations were set in mortar. The turret walls were then built and the area between them and the cut-back rampart was filled with redeposited rampart material. The opportunity was taken to excavate this backfilled material on both the western (A17 and A23) and eastern side of the turret (A10 and A4). Despite the similarities with the construction of the interval turret there were two important differences. Firstly, the 'basement' room of the corner turret was deliberately backfilled, apparently immediately after its construction, with a mass of redeposited rampart material (A22) which was itself overlaid by deliberately backfilled heavy rubble excavated in 1909 (Boon 1963, 9). This treatment would render the basement of the corner turret unusable (fig. 13). Secondly, the lower footings of the corner turret were much deeper than those of the interval turret. A slot in the outside of the western wall (A21; fig. 12) is interpreted as relating to a misaligned pile (others would have been incorporated into the core of the walling and consequently are not visible). The possible function of this is discussed on p. 41. A number of major structural cracks were visible in the north-south walls of the corner turret (figs. 14 and 15).

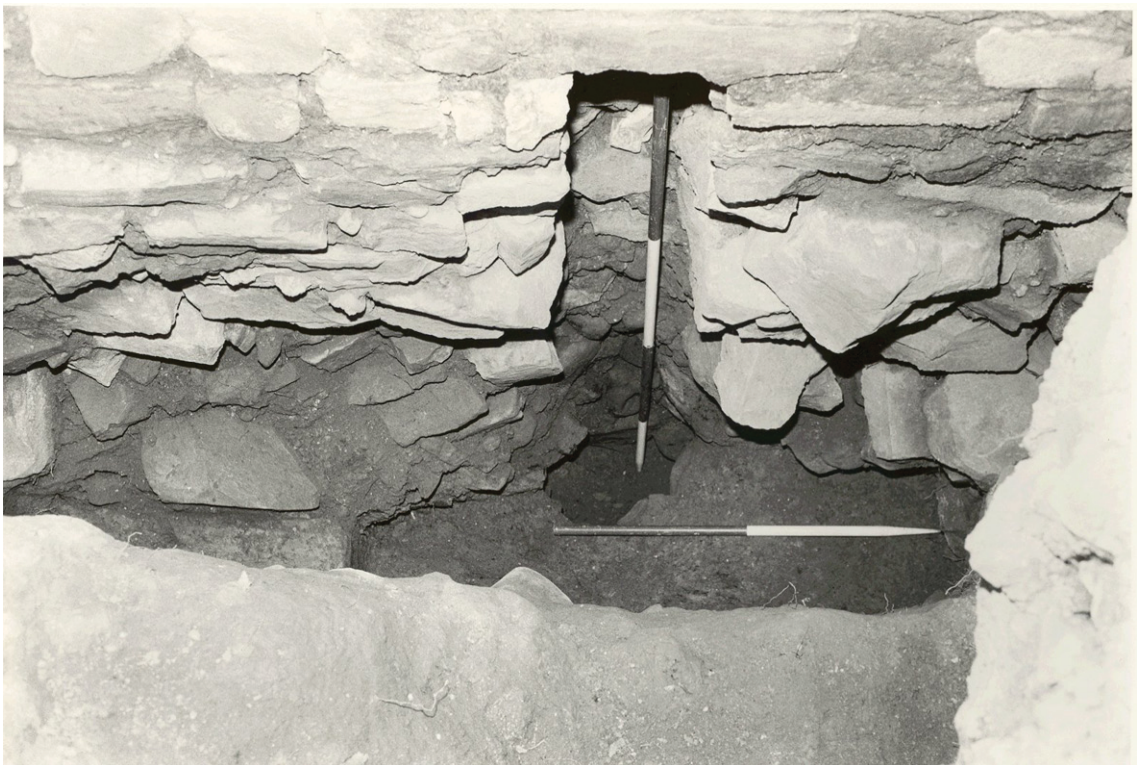
Fig. 12: Site A. The corner turret pile slot from the north-west

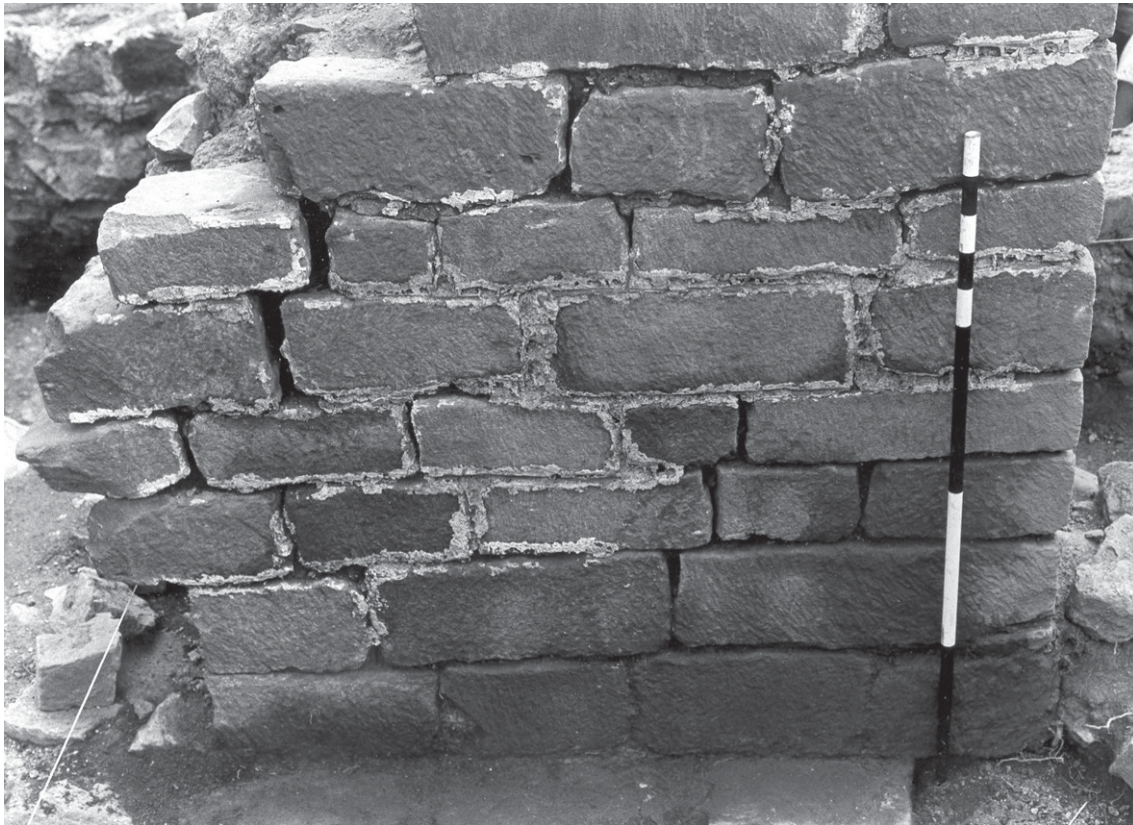
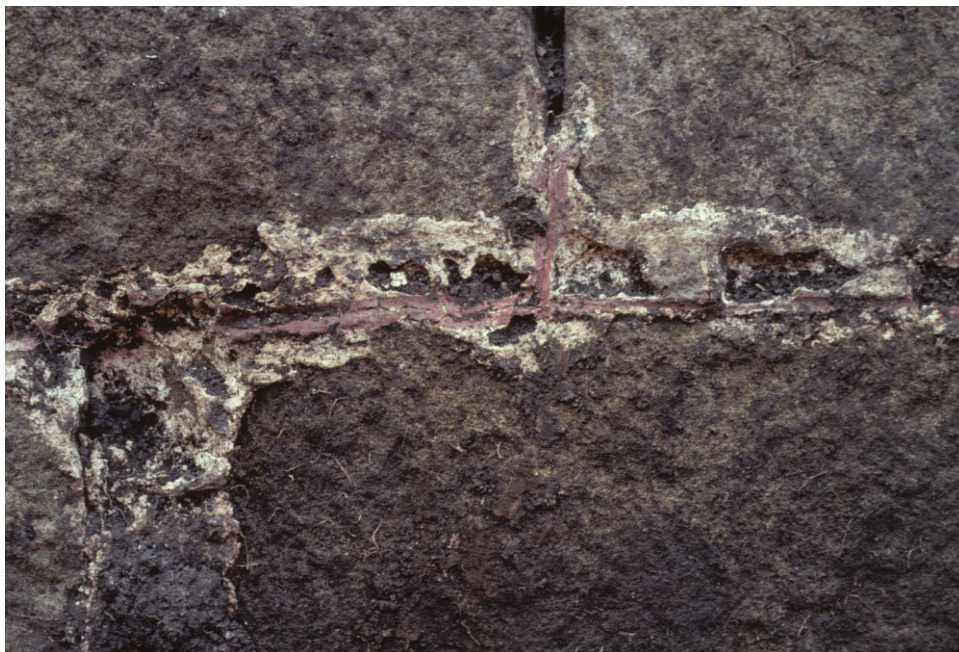
Fig. 16: Site A. the north face of the corner turret showing the 'false jointing'. The detail below shows how the grooves were picked out in red paint.

On the exterior surface of the north wall of the corner turret a patch of plaster rendering (1.3m x 0.9m), previously recorded by Bosenquet and King in 1909 (1963, 49), was observed (fig. 16). A single coat (c. 30mm thick) of plaster rendering had been applied to the external face of the turret and while it was still wet, grooves were inscribed (c. 6mm wide and up to 5mm deep) in positions that replicated the course work defined by the underlying masonry. This surface was then treated to a coat of brilliant white lime wash, perhaps while the plaster was still damp to enhance bonding, and then the grooves were picked out in red paint. The plaster was visible in the recessed joints between the blocks extending onto the margins of the blocks

themselves with ragged edges. No plaster remains on the centre of the faces, but the ragged edges are consistent with plaster that had originally been applied to the whole surface rather than just to the joint areas. If the treatment was applied to all of the visible external surfaces of the turret (and perimeter wall) this would have appeared impressive and would have provided an opportunity to regularise the coursework to form true false jointing. The surviving evidence of the dressing and coursing of the facing stones in the fortress defences indicates the masonry was laid to a high degree of quality; suggesting that it was rendered for effect rather than to conceal poor workmanship. This same phenomenon was noticed on the facing stones of the arena in the amphitheatre (Wheeler and Wheeler 1928, 118, pl. XXIV.1-2), again covering well faced stones.
