ARCHIVE REPORT

ARCHAEOLOGICAL MONITORING AND RECORDING

**12a CHURCHILLS RISE
HEMYOCK
DEVON
EX15 3AU**

SEPTEMBER 2012

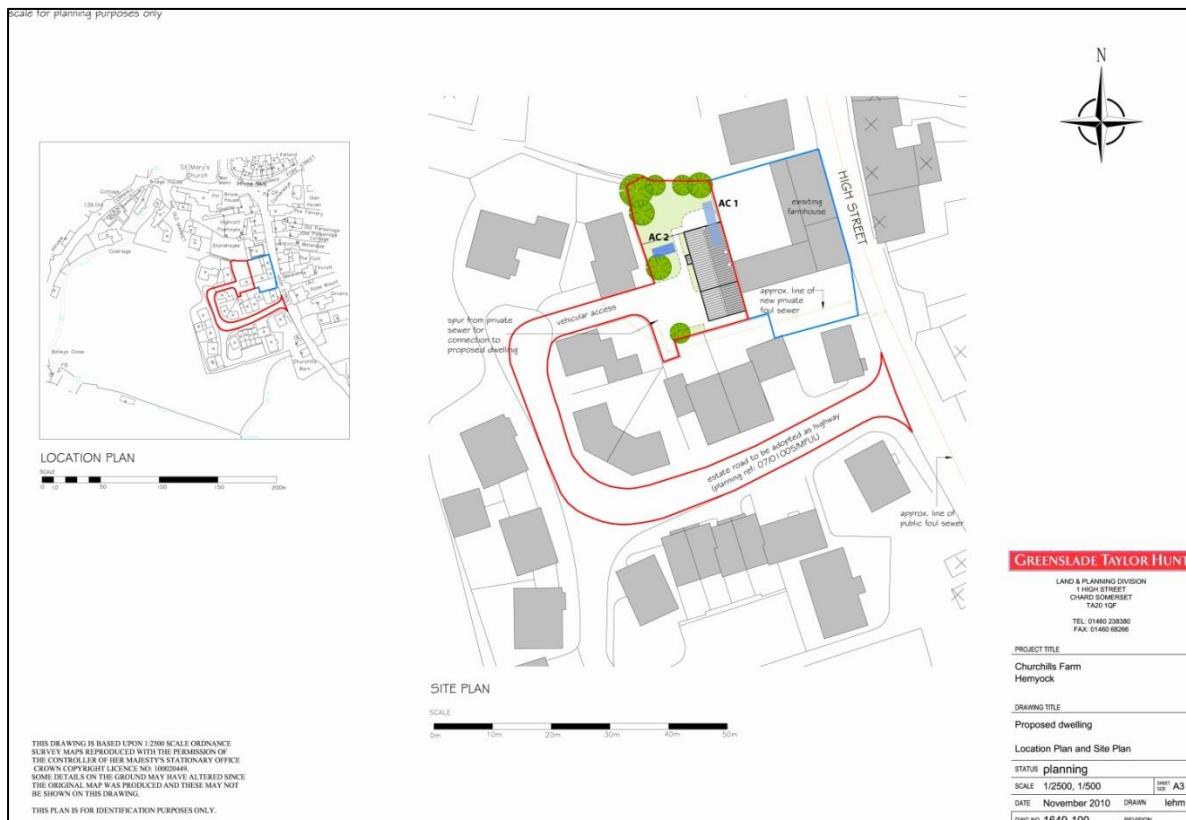
Fig. 1 Position of proposed development area. The published positions of AC Archaeology's 2009 trenches 1 and 2 are shown (AC1 / AC2); the floor plan (from the WSI) is of the building originally proposed, not that constructed as a result of the revised application.

The plot had previously been sampled by AC Archaeology in September 2009 (Hughes, S., 2009) by means of two evaluation trenches (positions shown on Figs 1-2). The eastern foundation trench for the house was cut along the published position of the southern part of AC Trench 1 (*ibid.* Fig. 2).

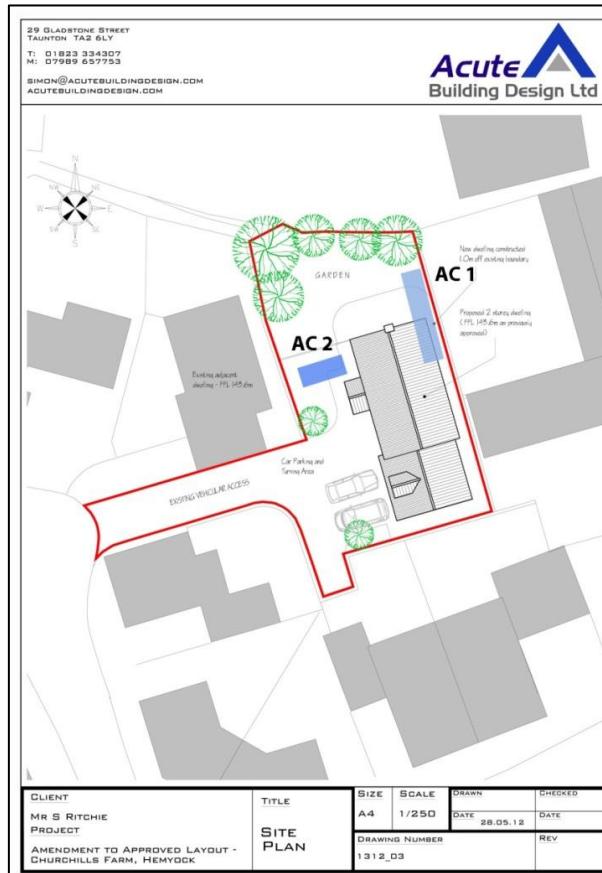
Fig. 2. Block plan showing published positions of AC Archaeology's Trenches 1 and 2.

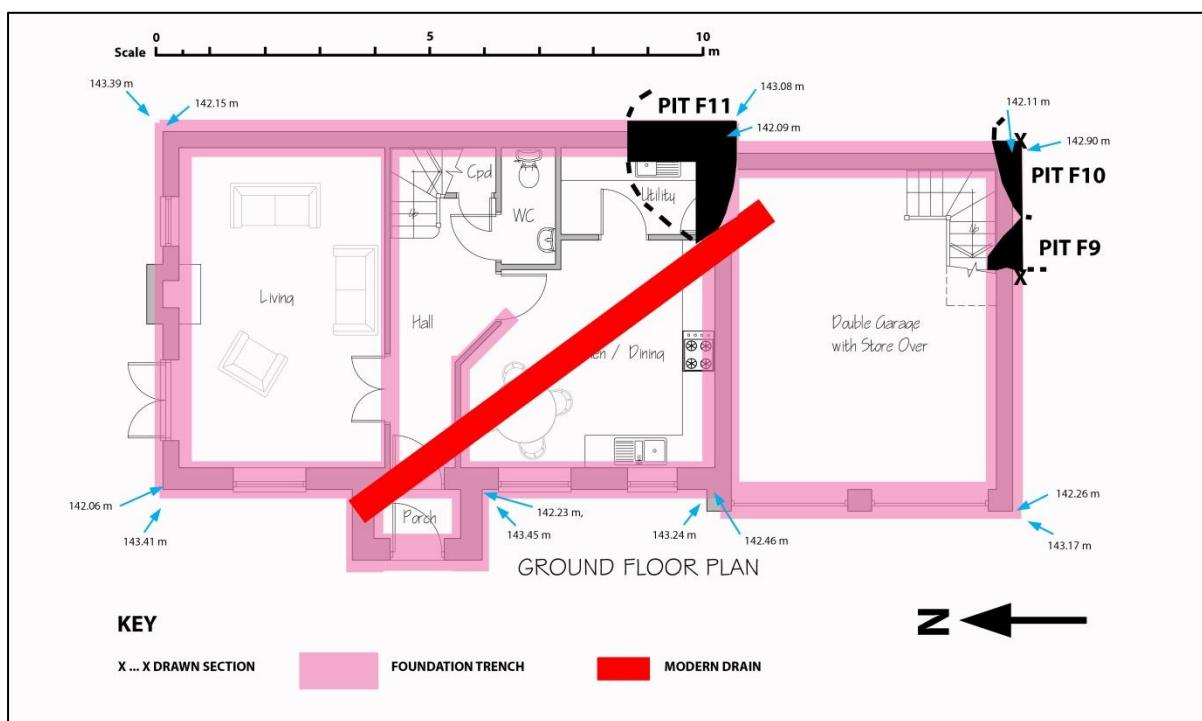
Fig. 3. Ground floor plan showing positions of walls, foundation trenches, modern disturbance and archaeological features. The position of the section shown in Fig. 4 is indicated by X-X. The plan above is based on an electronic copy of the Architect's plan submitted with the planning application, at a scale of 1:50. The black areas showing the pits show their plan as exposed below the reinforced concrete in the case of Pits 9 and 10, and below turf in the case of Pit 11; the dashed lines show the likely projections of the pit edges. The positions of spot heights are shown by blue arrows, the digits are metres above OSD Newlyn; the TBM is taken from Hughes 2009, Fig. 2.

The positions and plans of archaeological features, drawn section and levels were plotted onto a 1:50 scale plan (a copy of the Architect's plan submitted with the planning application), provided by SIR Construction.

Archaeological features were sparse, comprising three pits only. Two of these (Fs 9 and 10) lay at the eastern end of the southernmost foundation trench (Plan Fig. 3, Section Fig. 4), where they were visible below immediately under the hardcore for the concrete surface of the farmyard area; they were cut into the surface of natural subsoil. Machining of the foundation trenches commenced at the eastern end of the southern foundation trench, where Pits F 9 and 10 occur; although the pits were suspected during machining, their plan as shown in Fig. 3 is mainly reconstructed from section.

The third pit, F11, was cut close to the original break of slope along the southern end of the garage, and was visible in section in both sides of the eastern foundation trench, and northern face of the trench between the house and garage (Plan Fig. 3, Plate 3); the feature was destroyed in the east-west trench by a ceramic land drain with brick surround and capping (Plate 3). F 11 occurred at the starts of the foundation trench between the house and garage, and the eastern foundation trench. It was recognised during the closely observed machining, and sampled by trowelling during the machining process; after cleaning the bottom of the eastern foundation trench it was further sampled to a depth of 200 mm in an attempt to recover finds and look for any

The ceramic drain referred to in the preceding paragraph and shown in Fig. 3 would have destroyed the possible gully F202 recorded by AC Archaeology in their Trench 2.

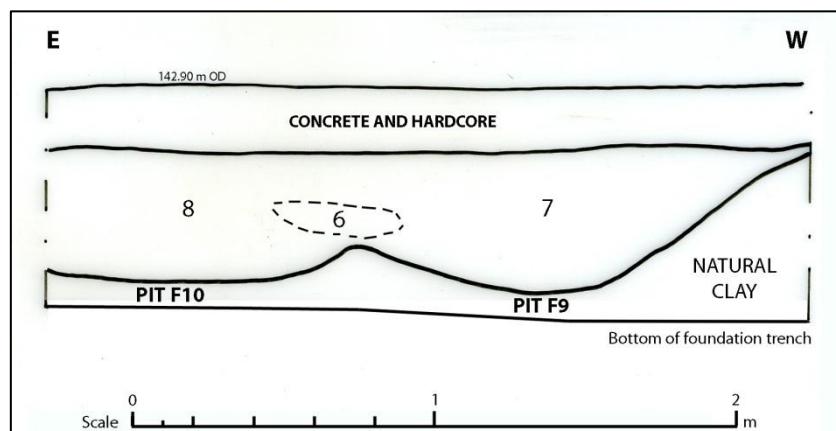
Fig. 4. Section of east end of southern foundation trench.

Features 9 and 10 appear to have been backfilled in a single episode, a patchy layer of redeposited natural clay in section running across the intersection of the two pits (context 6); it may in fact have been the case that Fs 9 and 10 were parts of a single irregular feature.

F 9 was filled by fill context 7. In the southern section of the trench it was 1.55 m wide, narrowing to 200 mm wide in the northern side of the trench; it bottomed out in section (Fig. 4), and appears to have been an irregular feature 460 mm deep. It had an homogenous fill, context 7, which was clearly defined against the natural clay. Context 7 was a dark grey slightly sandy clay silt loam with occasional charcoal flecks and patches of redeposited natural clay, and rare small pebbles, rare small pieces of burnt flint and rare bunt clay flecks.

The adjacent pit F10 was visible in the southern section of this foundation trench, and the eastern side of the main north-south foundation trench. It was of maximum depth 420 mm, at least 1 m wide and of unknown length. Its fill, context 8, was the same as context 7.

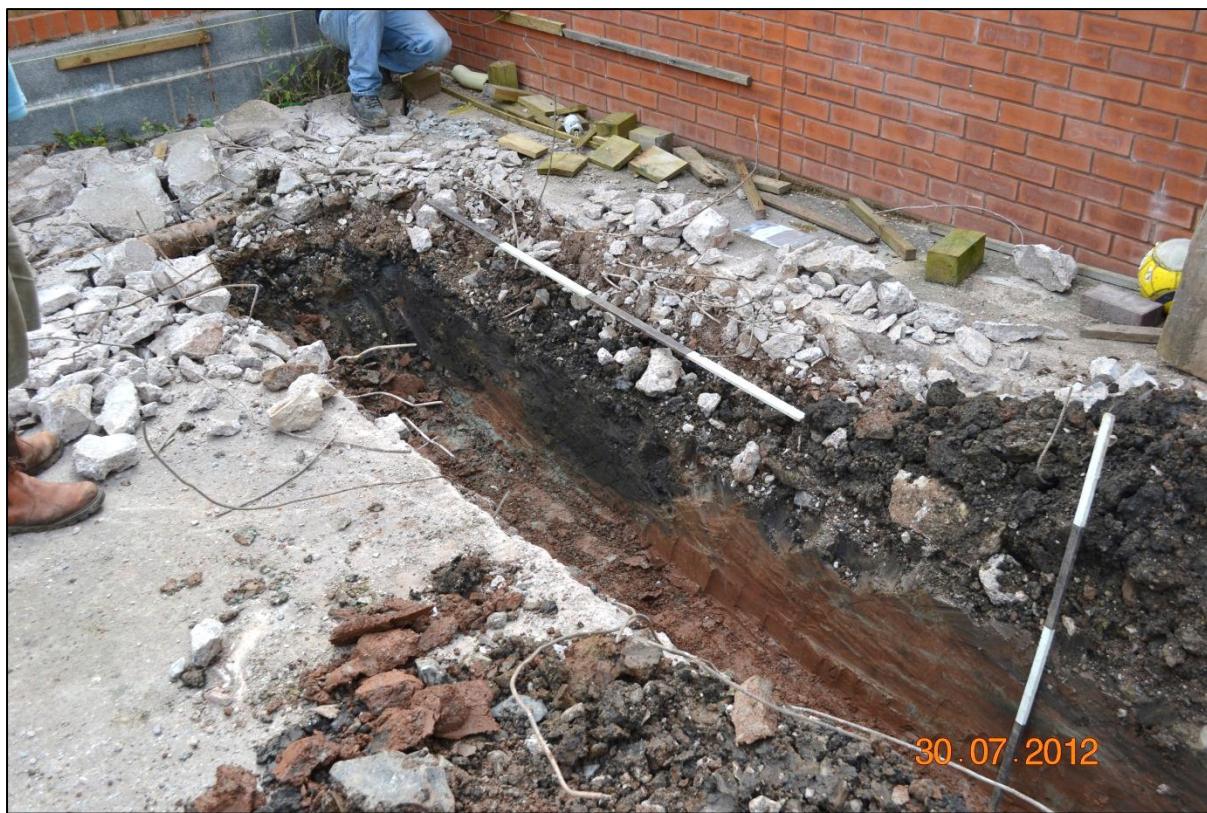
Plate 1: Pits 9 and 10, facing SE. Scales 2 m and 1 m.

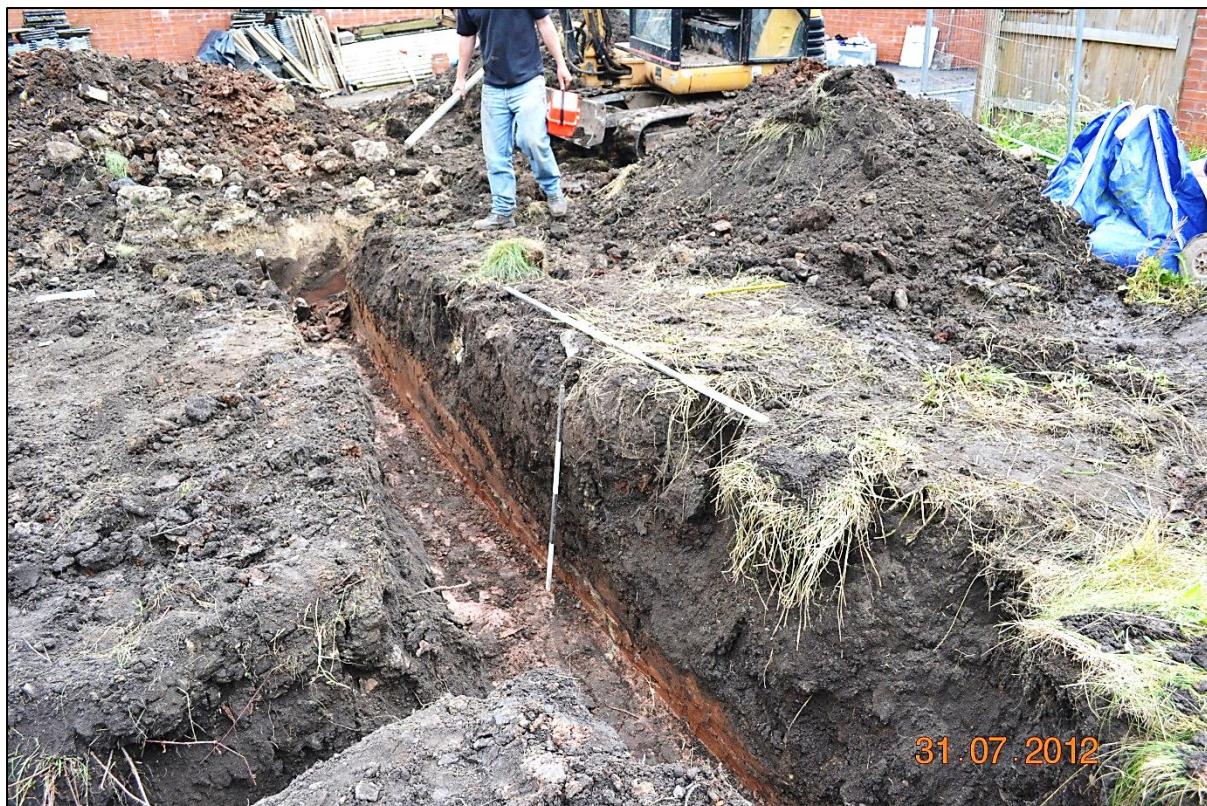
Plate 2: Part of western foundation trench, facing SSW, showing fall in original ground surface from south to north, natural overlain by undifferentiated topsoil context 2/3. The disturbance in the bottom right of the photo is the edge of the land drain. Scales 2 m and 1 m.

It was clear from the profile of the subsoil surface in the two north-south foundation trenches (Plate 2) that the ancient topography had comprised a slope down through the north end of the development area (plot). There was a drop of 50-60 cm from the northern end of the plot to the levelled ground surface in the garden of the house to the north, and extension of the line of the surface of the subsoil in the sampled plot would have approximately met the ground level in the garden to the north. In the western foundation trench of the house, the subsoil surface below the surface of turf fell from 60 cm in the northern end of the garage area, to one metre in the porch area, to 1.3 m in the northern foundation trench.

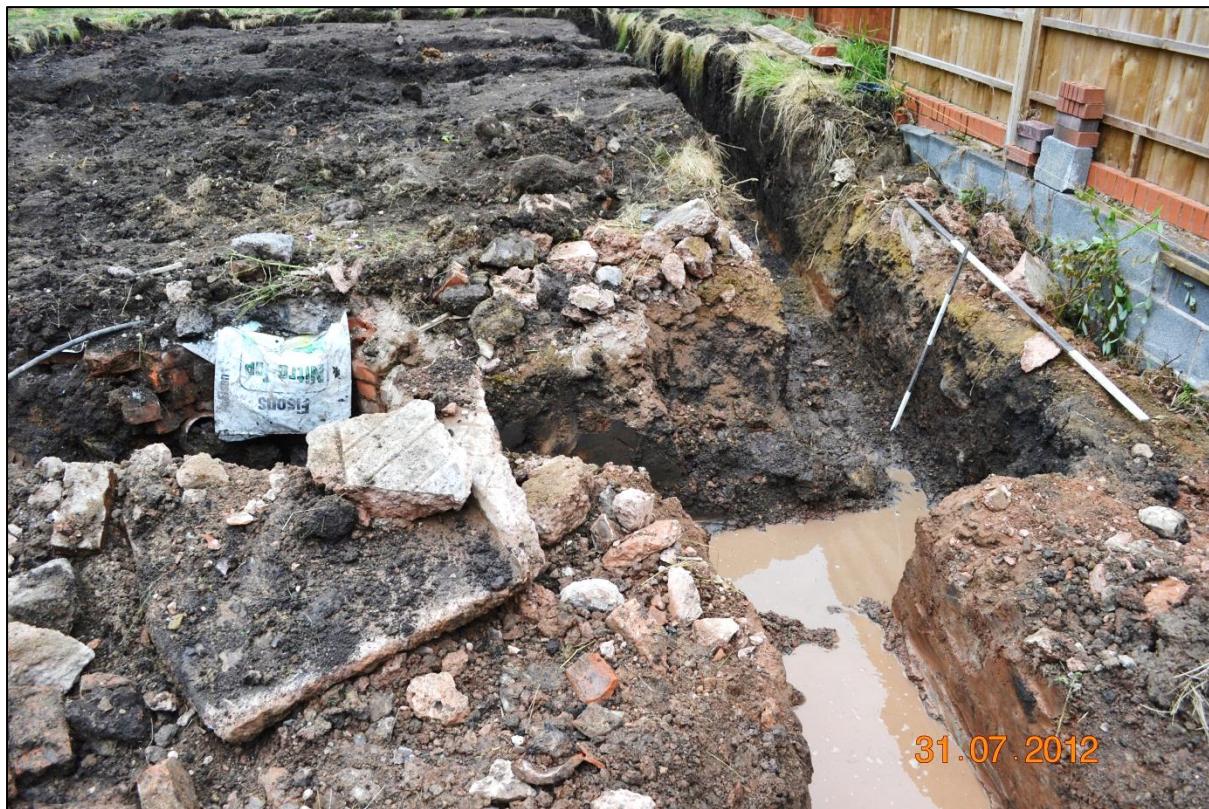
Plate 3: Dogleg in eastern foundation trench, facing NNE. Pit F11 is below 2m scale (vertical scale is 1m); modern drain disturbance visible on left centre. Photograph taken before cleaning and sampling of fill exposed in bottom of trench.

change in the fill. F11 was a large pit, 2.1 m long in the eastern side of the N-S trench, and more than 1.5 m E-W. It was cut into natural clay to a depth below modern ground surface of at least 1100 mm, and was steep sided at its southern and northern ends. Its western side was destroyed by a ceramic land drain whose upper part was encased in modern brick (Plate 3). It was filled by context 12, an homogenous mid grey sandy silty loam with abundant inclusions of burnt clay flecks. There was no sign whatever of burning *in situ*. There was an absence of silt lenses in the fill which might have indicated that the feature had naturally infilled over a period of time, and in view of the homogeneity of the fill it seems most likely that the pit was deliberately infilled in a single episode with material originating from an area of burning.

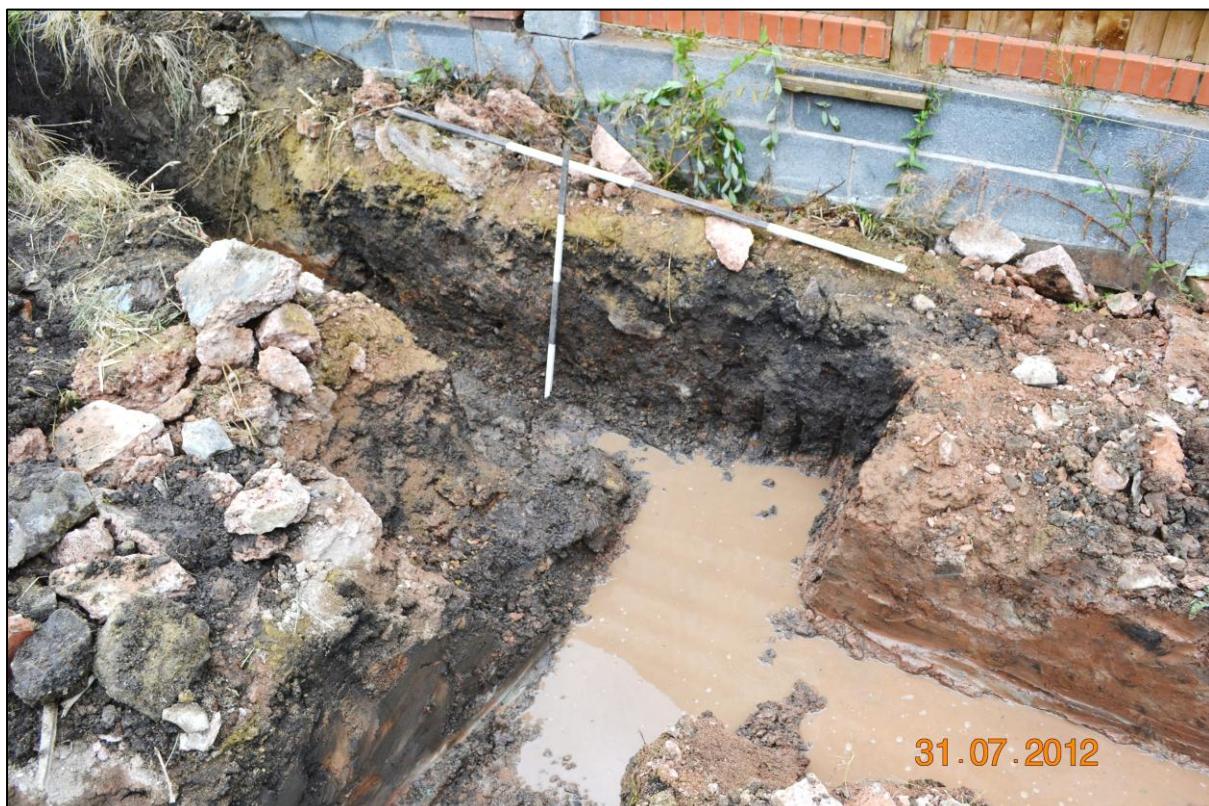
Plate 4: Dogleg in eastern foundation trench, facing ENE. Pit F11 is below 2m scale (vertical scale is 1m); photograph taken before cleaning and sampling of fill exposed in bottom of trench.
