REPORT ON
ARCHAEOLOGICAL
EVALUATION
ON LAND
SOUTH OF ORCHARD COTTAGE
DUNKESWELL ABBEY
DEVON
EX14 4RP

East Devon District Council planning application 09/1906/FUL

MARCH 2010

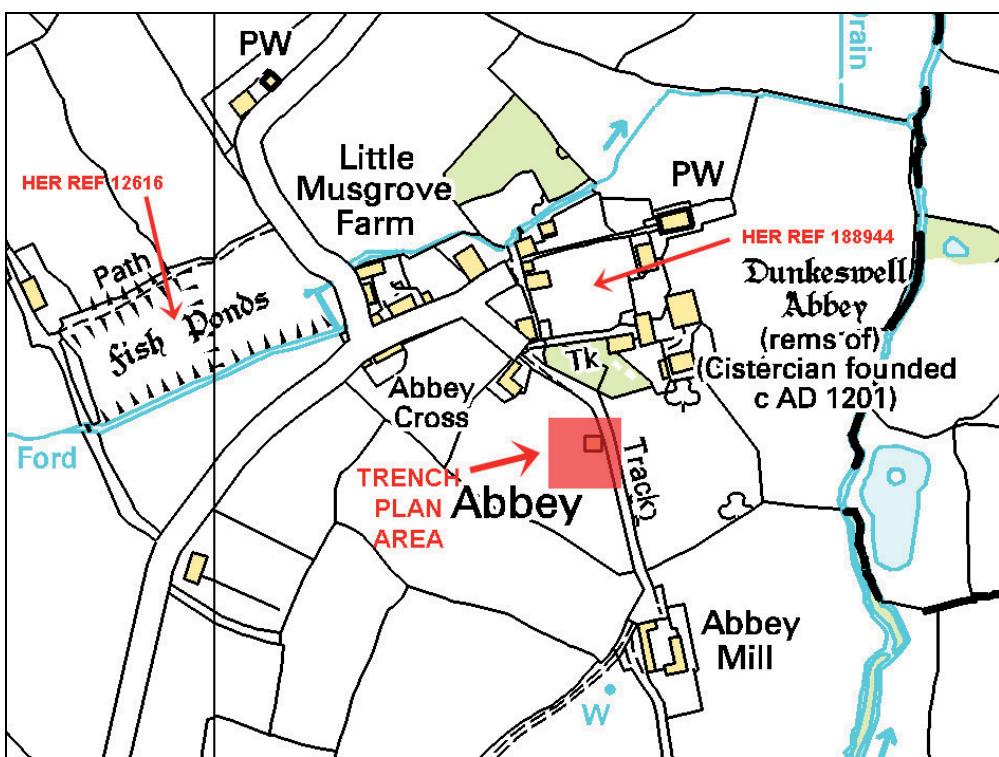
Fig. 1 Location plan showing relevant HER references and position of trench plan area (Fig. 5). Reproduced from Ordnance Survey digital map data © Crown copyright 2010. All rights reserved. Licence number 0100031673

(monument No. 188944, Fig. 1), a Cistercian Abbey founded by monks from Forde Abbey in 1201; it was dissolved in 1539. The abbey remains are some 100 m to the north of the area of proposed development, and there are currently no indications that buildings associated with the abbey lie in the area of the APD. Fishponds (monument ref. 12616, Fig. 1) to the west of the Abbey complex are shown on the OS maps; channels and hollows are present to the south and south-west of the village (centred on ST 1422 1058, off area of map), which may be contemporary with Abbey use, and further hollows and channels are present to the south of the Abbey Mill south of the APD (HER record for monument no. 188944). Two possible iron working sites are nearby, their relationship to the abbey undetermined (HER refs 1468460 and 1507682, off area of map).

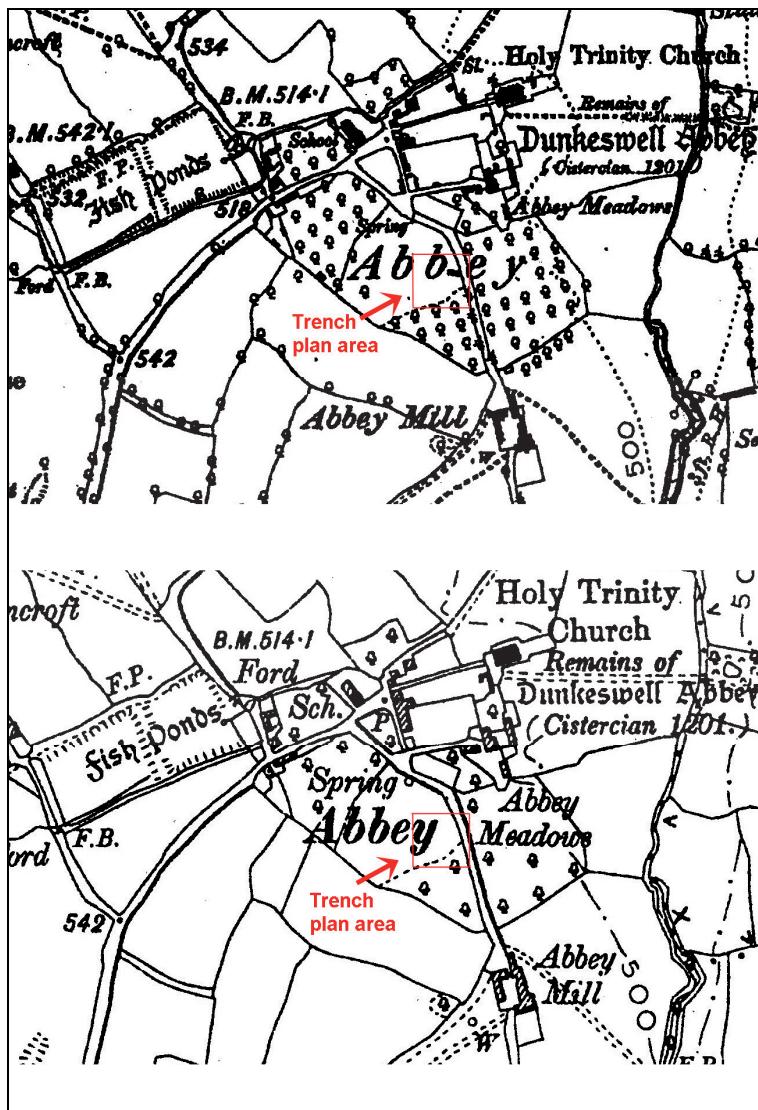
Fig. 2: OS 1st edition 6" map (1891, surveyed 1887) (above) and 2nd edition 6" map (1905)

The earliest available mapping was therefore the first and second edition OS 6 inch maps, reproduced in Fig. 2 above.

It appears from the above the area of the proposed development lies surrounded by orchard, however itself was not orchard. A use is not indicated on the maps, however in view of the water-logging at the time of the site visit this may not have been suitable for arable uses, and grazing is more likely. The barn is shown on the 1st edition map however is not shown on the 2nd edition map; this would seem unlikely to be an error, and suggests that the barn was omitted from the map because it had become disused between 1887 and 1905. A boundary, presumably a ditch, is shown on both maps, bounding the southern area of orchard; no trace of this was observed during the site visit, and it has presumably been infilled. Its line runs to the immediate south of the barn, however is not directly affected by any planned works.

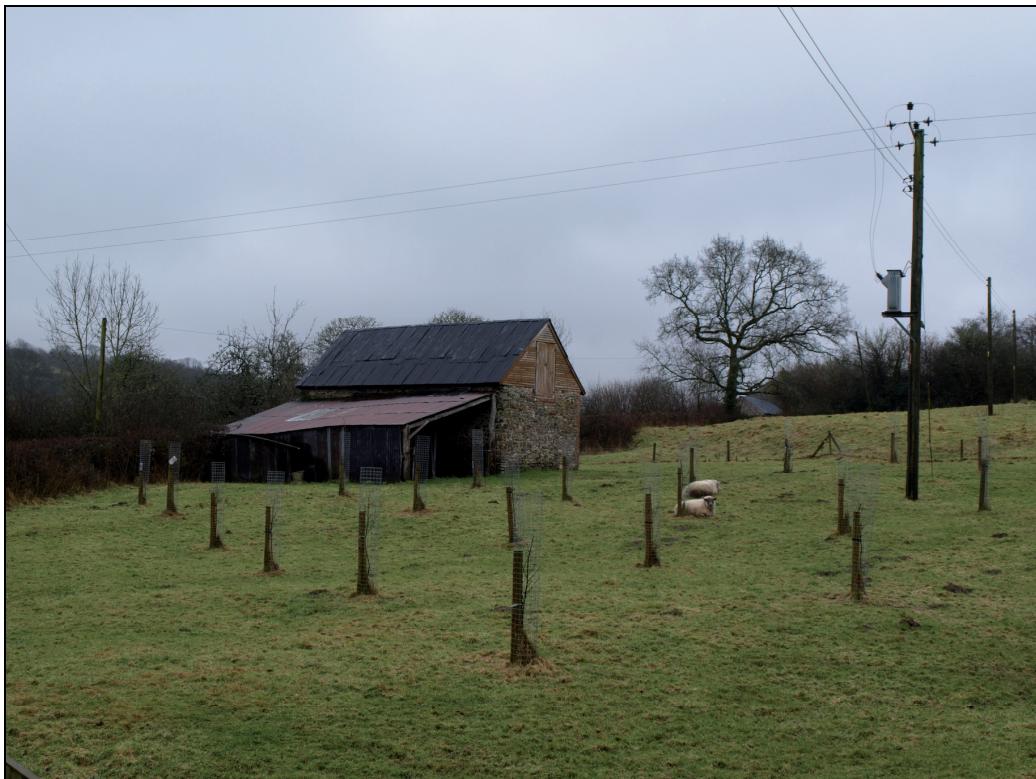
Fig. 3 The barn, from the NNW. The scarp in the ground surface (Fig. 4) lies on the right hand side of the image, behind the barn. Photo CPC, 22 January 2010 (Ref. AA 120 pre EX 05).

The local topography features a shallow scarp running southeast to northwest (Fig. 3), most pronounced to the southeast of Trench 1. The southern side of the field is bounded by low bank, which lies on the southern side of a leat carrying water to Abby Mill. North of the bank, the higher ground is characterised by shallow linear depressions, spaced at 6-7 m, with low, wide ridges between them (Fig. 4). The land was used for an apple orchard , within living memory (pers. comm. G. Bowey); the furrow system probably represents recent drainage channels, with the apple trees placed on the slightly raised ridges. Minor variations in the land form within this system are likely to represent tree throws. This perpetuates the tradition of orchard for the land.

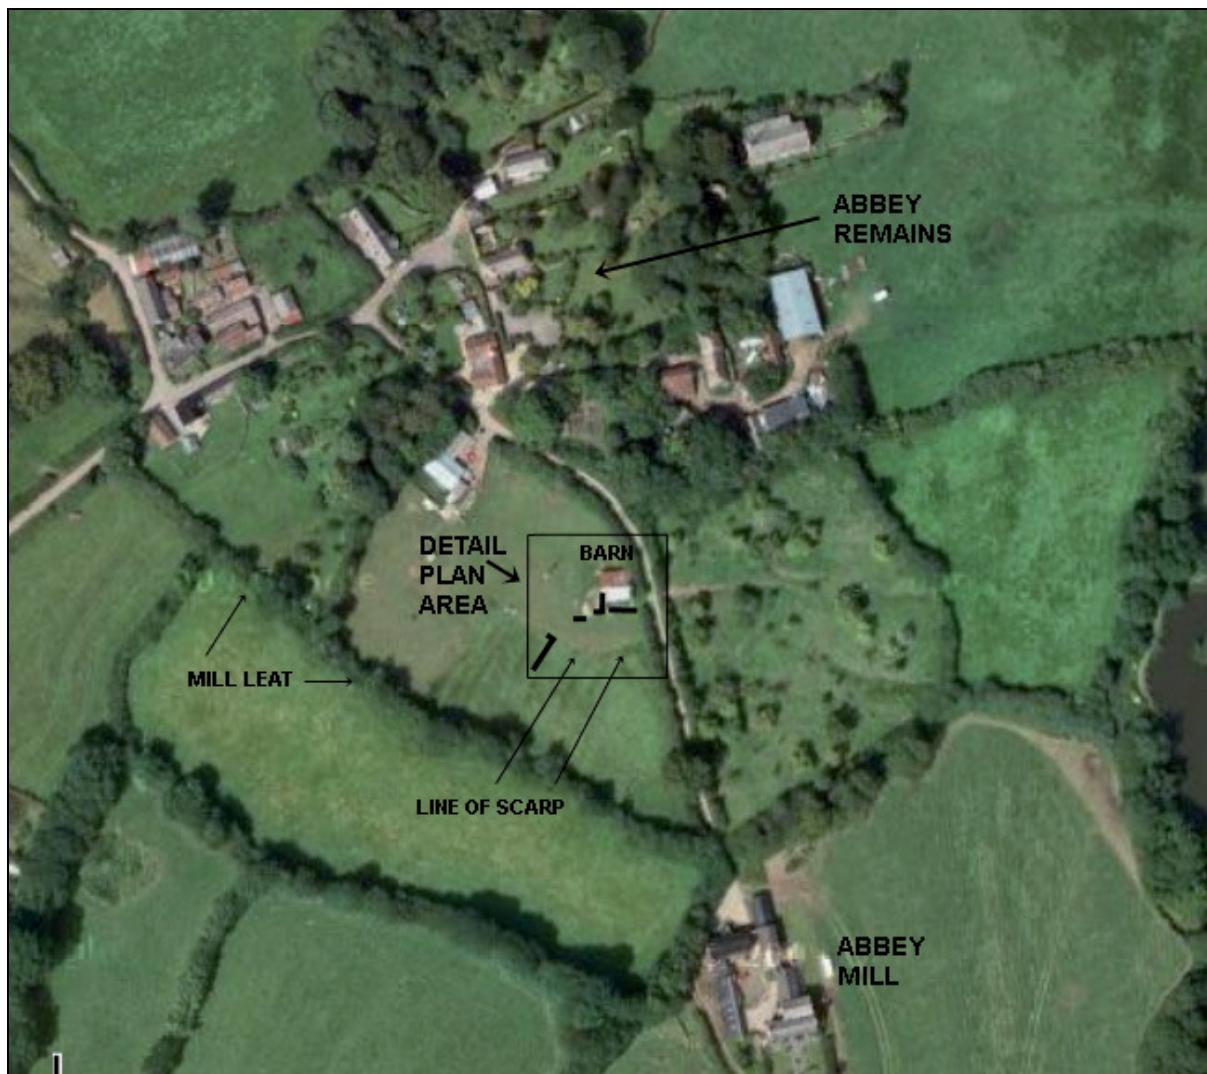
Fig. 4 Position of the evaluation area and trenches detailed in Fig. 5 and other details, superimposed on aerial photograph from Google Earth. The scarp is shown in photograph Fig. 3. Note the linear earthworks in the south of the field. North at top of photograph.

Four trenches were excavated (Figs 4-5). Two of these were of amended position and size from those proposed in the WSI (Clarke, 2010, Fig. 3) because of the local topography, to allow evaluation of the area to which the treatment works might be repositioned to reduce the height to which waste matter might need to be pumped to the treatment plant. The first trench therefore, Trench 1, was extended to include the original site down to lower ground, north of a drop in ground level, and the second trench, Trench 2, was positioned midway between the barn and the possible final position of the treatment works.

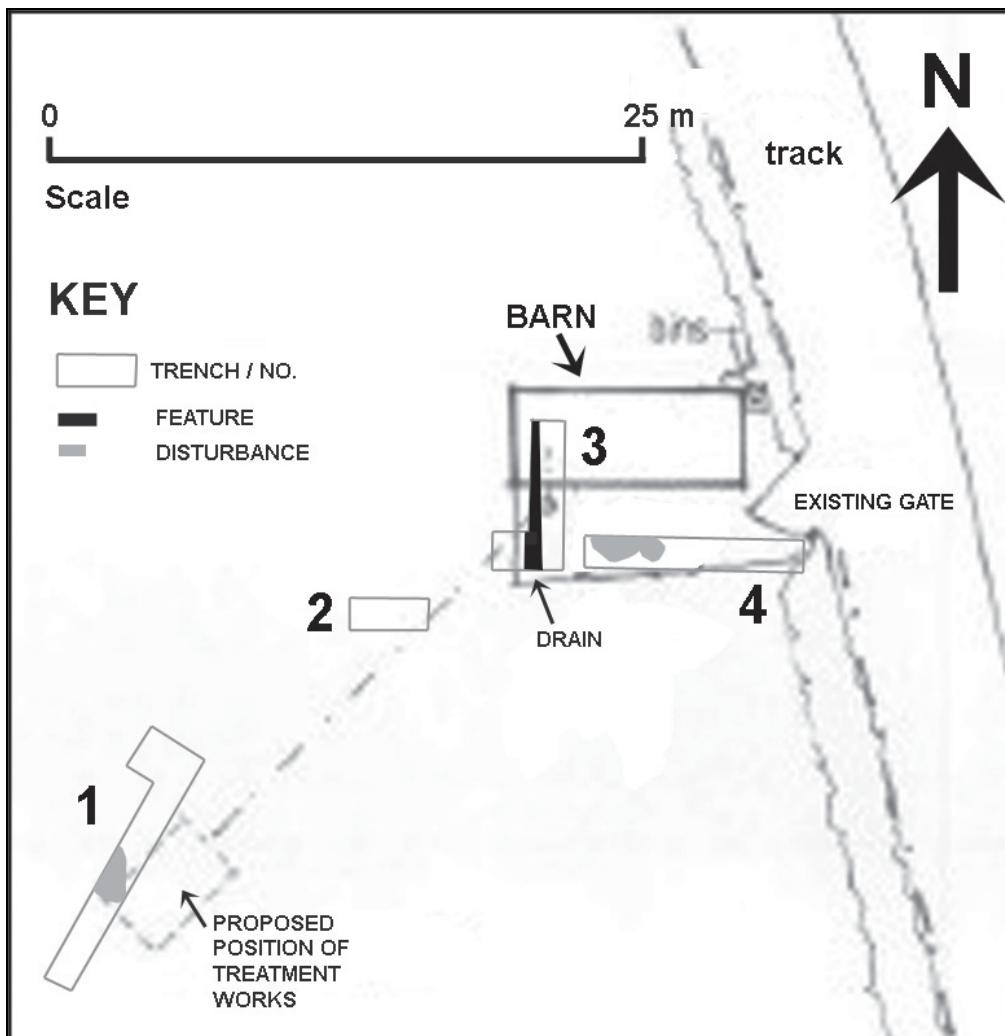
Fig. 5 Detail plan of trench positions and features. Photo Fig. 6.

Trench positions are shown in Figs 4-5. Trench dimensions and depths are as below. All trenches were machined by mini-excavator using a 1.25 m ditching bucket, under the supervision of the writer.

Trench	Length (m)	Max width (m)	Depth (cm)	Topsoil thickness (cm)
1	10.6	2.5	20-50	20-45
2	3.7	1.25	25-70	15-20
3	6.1	3.0	20-30	20
4	8.9	1.25	10-40	20

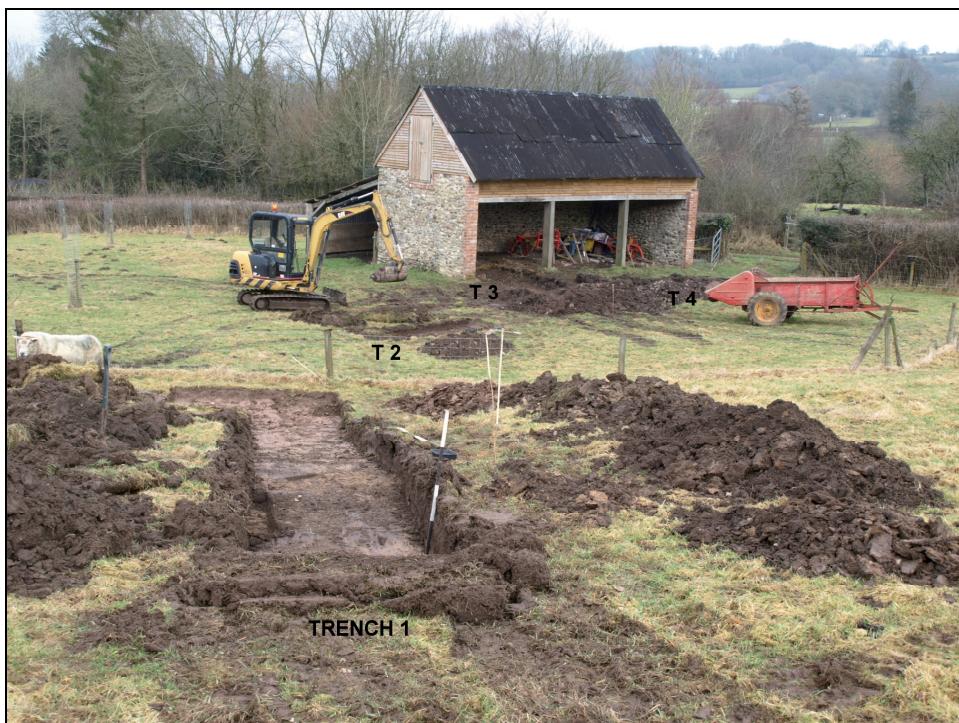
Fig. 6 Photograph from SSW, Trench 1 in foreground. Photo CPC, 17 February 2010 (based on Ref. AA 120 EX 04)

The length of Trench 1 was extended from the proposed 5 m to 10.6 m to enable evaluation of a larger area to facilitate moving the position of the treatment works. The width of the trench was increased to 2.5 m at its northern end, in the likely revised position of the treatment plant.

Topsoil was deeper in the southern half of the trench, south of the line of the scarp; this may have been due to positioning of the trench within the orchard ridges, although this was not visible in the pre-machining surface.

The trench was machined to subsoil, and the bottom hand-cleaned in its eastern side. Natural subsoil was a sandy clay, of buff to predominantly reddish-brown colour, becoming redder towards the lower (northern) end of the trench, with patches of bluish grey clay in places. The sandy clay subsoil was of consistent texture.

The bottom of the trench was marked in places by very irregular patches of mid grey, sometimes slightly charcoally, sandy clay loam. These were always very shallow (maximum depth 5cm), and always contained bands of fill in the otherwise natural cleaned bottoms, and these were clearly the result of burrowing activity, probably by moles; in one case, the band of fill collapsed into a void. Where sampled, these variations in clean natural contained rare fragments of slate and brick.
