# Standing Building Survey

## Craighead Farm, by Stanley

14<sup>th</sup> October 2009

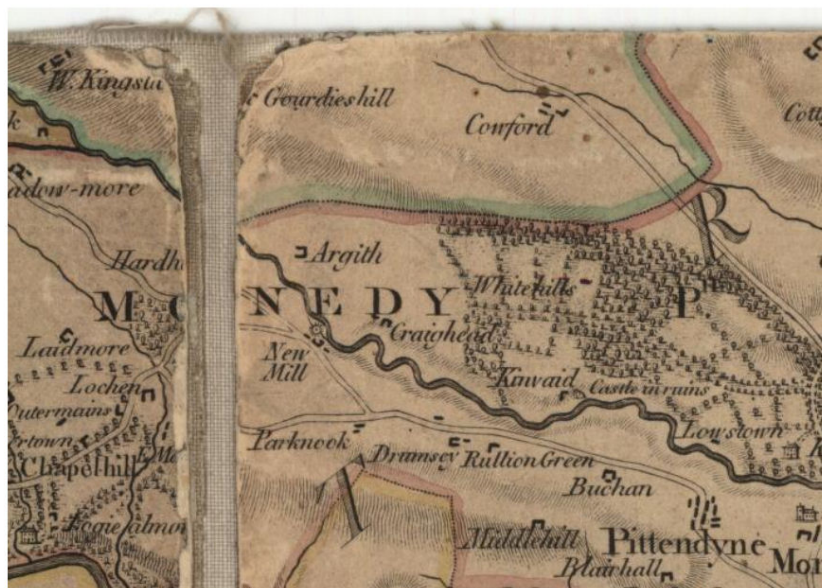
Illus 1 James Stobie's map of 1783 showing Craighead

The earliest cartographic record of a building or buildings at Craighead is on Stobie's map of 1783 (Illus 1), Craighead is then shown in greater detail on the First Edition Ordnance Survey map of 1862 (Illus 2). At this date the former farm buildings to the north of the farmhouse included a horse mill. From limited research in the Perth and Kinross Council Archives it has been possible to identify the tenant of Craighead Farm in 1858-9 as Mr John Law and the farm is listed as being under the proprietorship of his grace the Duke of Atholl (Perth and Kinross Valuation Roll 1858-9).

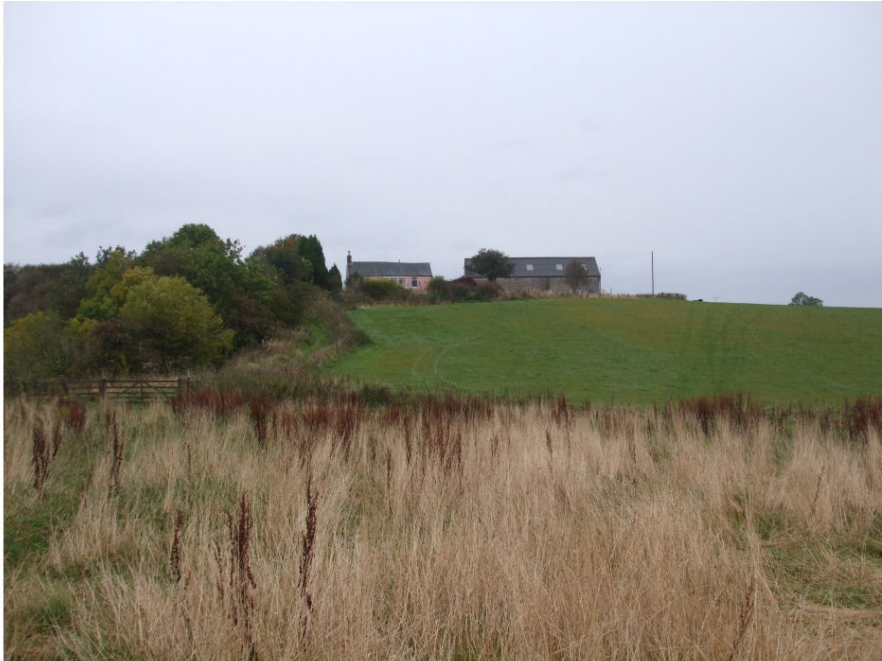
Craighead Farm stands at the head of a knoll which overlooks the Shochie Burn to the E and has excellent views to the SE of both the Braes of the Carse and the Sidlaw Hills. It is a single storey building with an L-shaped ground plan made of two wings running E-W and N-S respectively. It is externally harled in a pink wash, the same colour as the neighbouring farm of Blackhills. It has a slated roof which is made up of small slates and three chimneys.

Illus 3 Craighead Farm from the south

**Illus 3 Craighead Farm from the south**

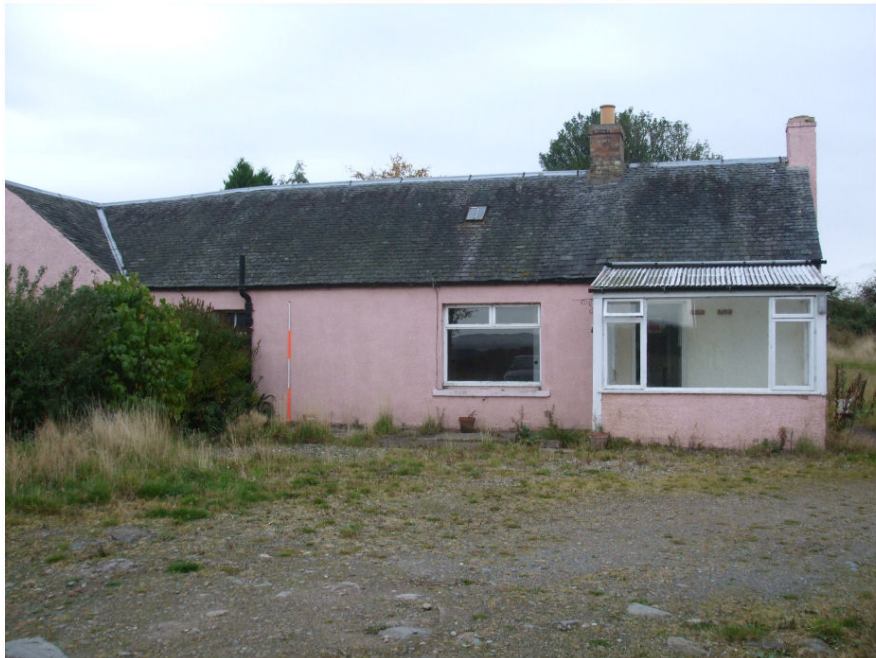
The building has a glass fronted porch attached to the N end of this elevation and has one large window and two smaller windows, the E end of the Southern arm of the L is blank with no window.

Illus 4 East facing elevation of Craighead Farmhouse

**Illus 4 East facing elevation of Craighead Farmhouse**

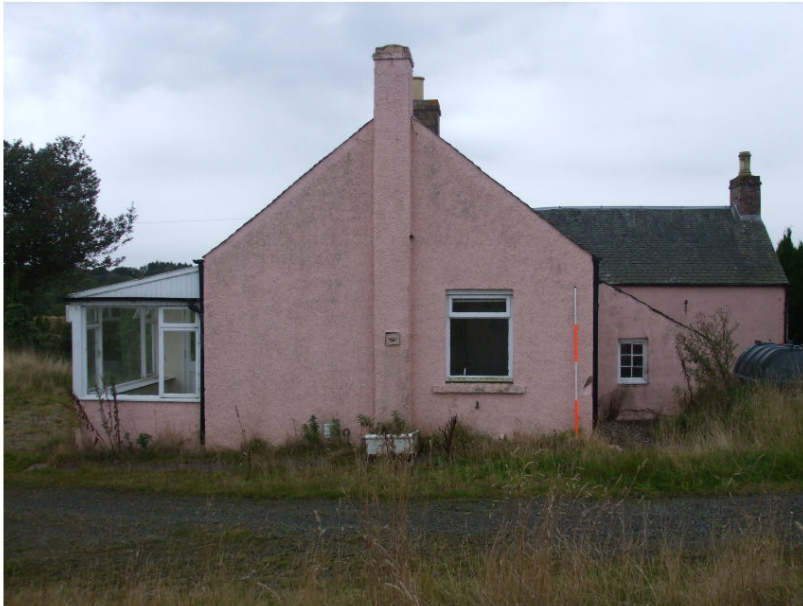
This elevation has a chimney stack rising to the top of the gable and one small window to the W of this.

Illus 5 North facing elevation

**Illus 5 North facing elevation**

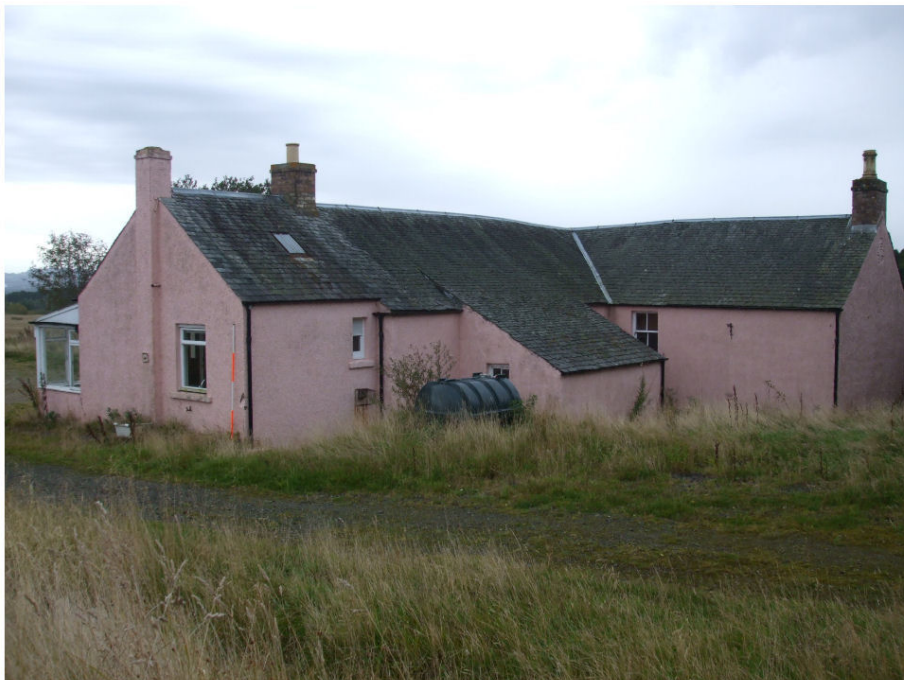
Careful study of this elevation indicates that the Northern end of the structure has had a brick built extension attached to it (containing the kitchen area). Midway along the elevation a smaller room extends to the W with windows in its Northern and Southern gable ends. At the S end of this elevation the return of the L shape extends to the W and has a brick built chimney at its apex.

Illus 6 Craighead looking South East

**Illus 6 Craighead looking South East**

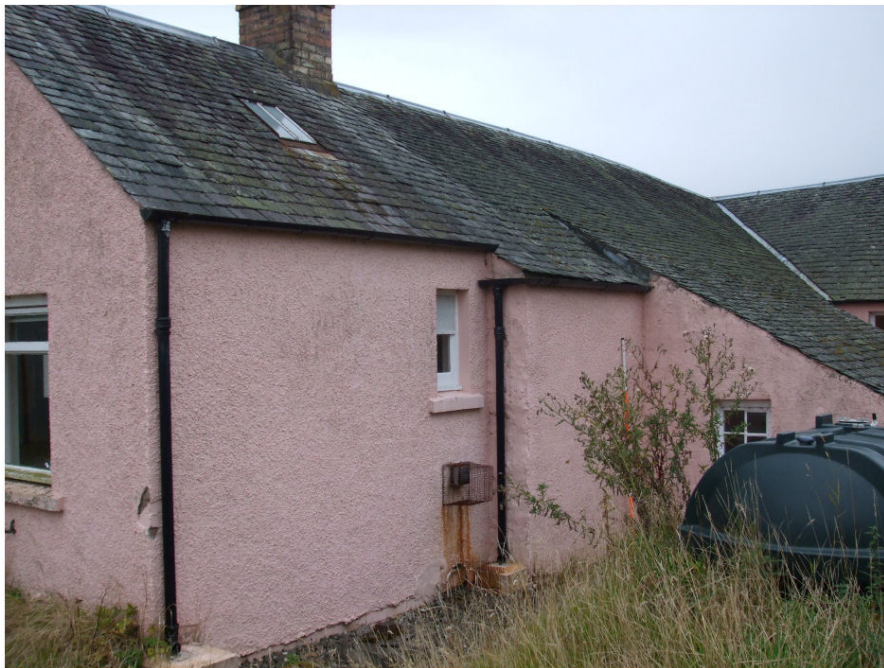
There are stepped foundation courses visible on the Northern and Western walls of the southern arm of the L – shape, these protrude from the standing building line by c 0.20m and may indicate an earlier structure. The part of the farmhouse currently occupied by the kitchen area is a brick built extension that has been added to the original stone built house, the inner of the two chimneys at the north end of the building indicates the original northern limit of the farmhouse prior to the addition of the extension.

Illus 7 Detail of brick built extension showing junction with main farmhouse

**Illus 7 Detail of brick built extension showing junction with main farmhouse**

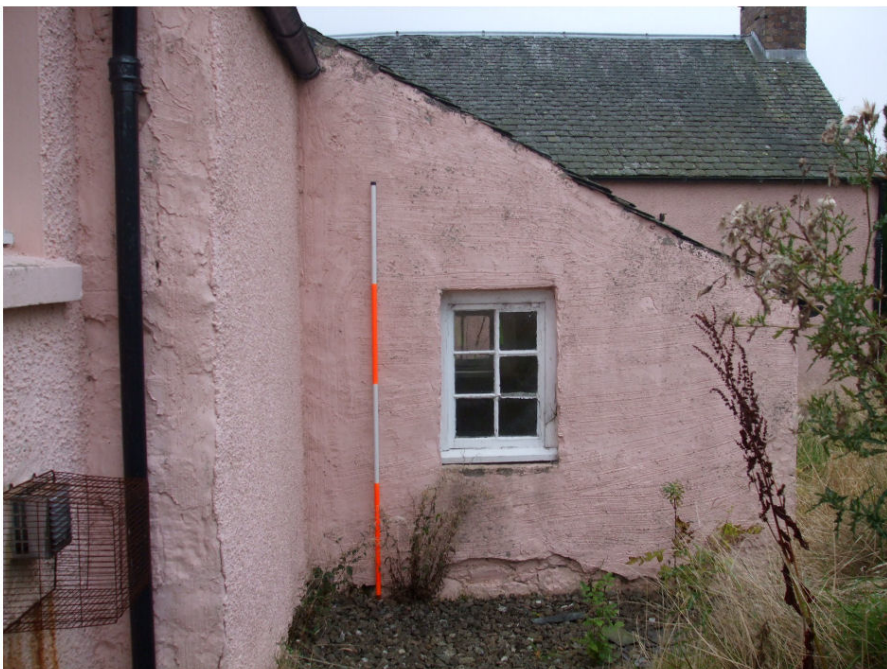
Where there are gaps in the harling it is possible to see that the vast percentage of the building is stone built, the northern extension is brick built as are the chimneys on the W gable and close to the N gable.

Illus 8 North facing gable of western extension (stonework visible in cracked harling)

**Illus 8 North facing gable of Western extension (stonework visible in cracked harling)**

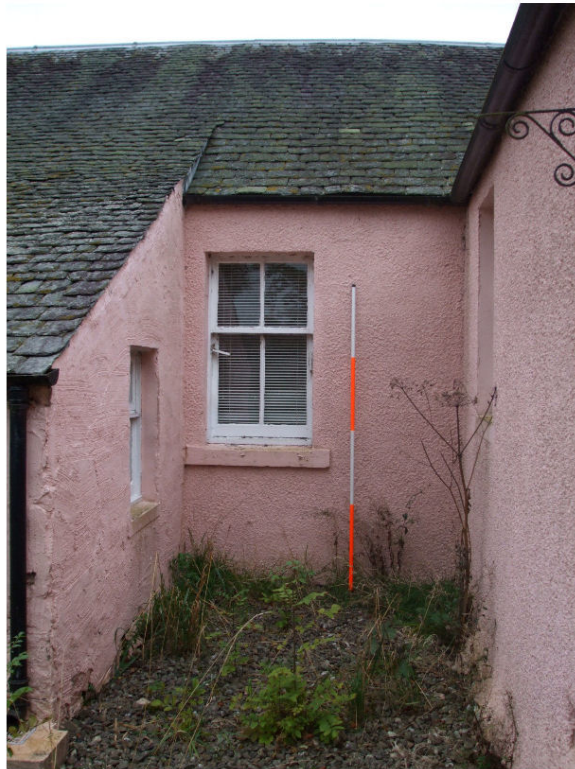
Illus 9 South facing gable of western extension and window in western elevation of farmhouse

**Illus 9 S facing gable of western extension and window in western elevation of farmhouse**

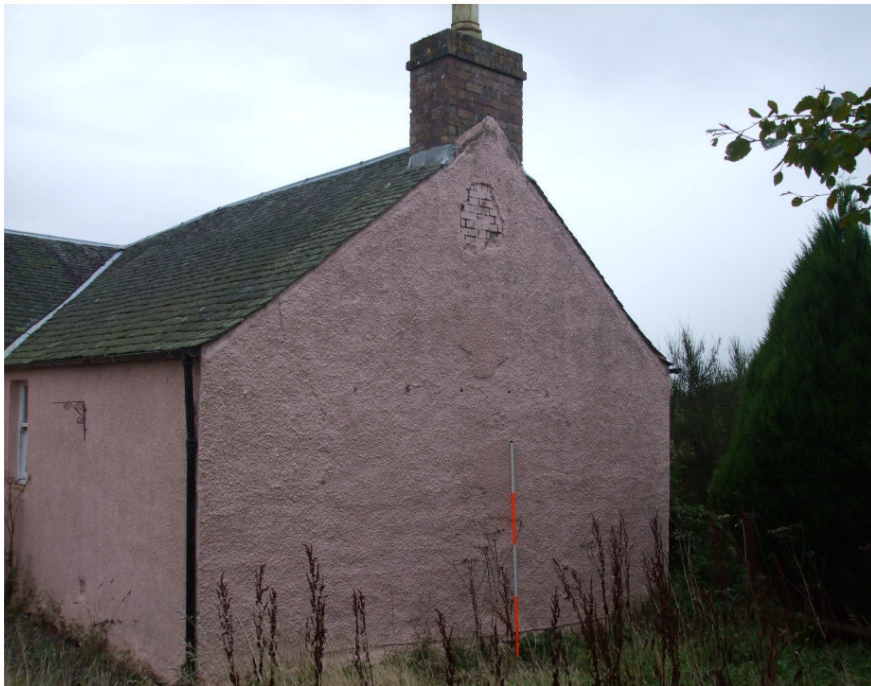
Illus 10 Western gable of southern wing of farmhouse

**Illus 10 Western gable of Southern wing of farmhouse**

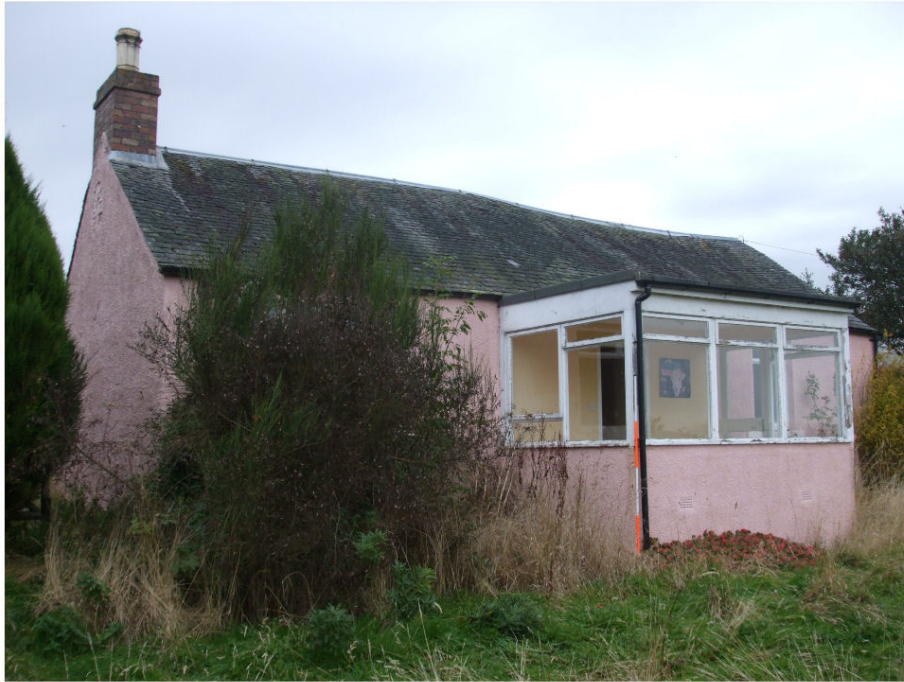
A glass fronted porch is attached midway on this elevation with an entrance on its Eastern side with a small flight of steps. This elevation has windows at its W and E ends.

Illus 11 South facing elevation of southern wing of farmhouse

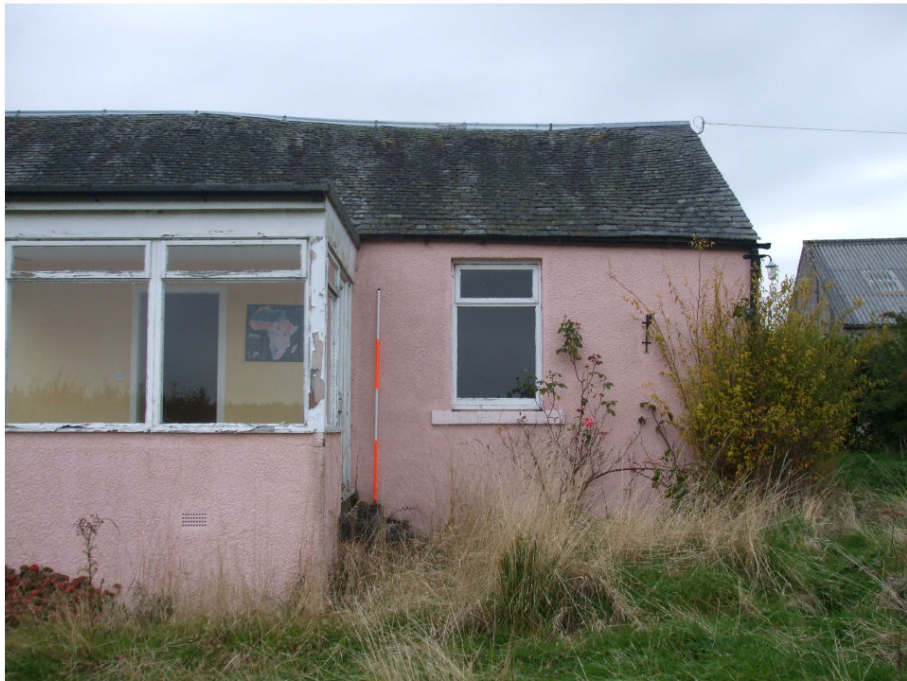
Illus 12 Window at eastern end of southern elevation of southern wing and porch (note sag in roof line)

Illus 12 window at eastern end of south facing elevation of southern wing and porch  
(note sag in roof line)

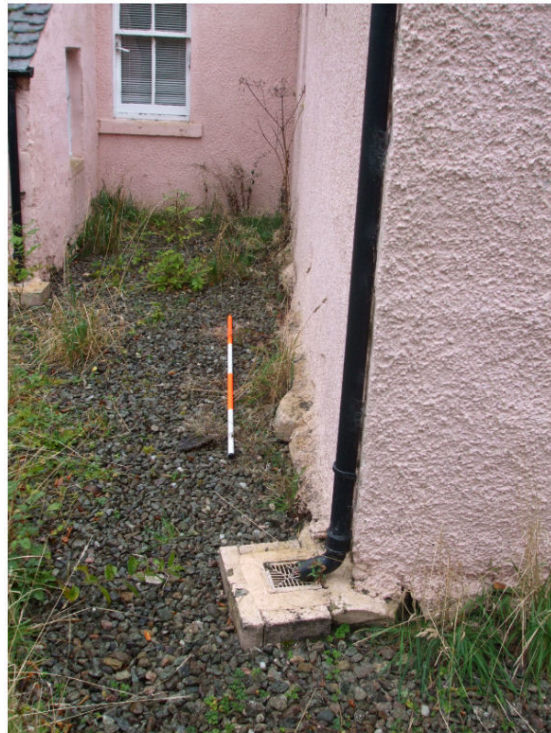
Illus 13 Stepped foundation course under northern wall of southern wing

**Illus 13 stepped foundation course under northern wall of southern wing**

The author feels that the photographic survey and written notes on the building are an adequate record of the farmhouse prior to its demolition, the presence of possible earlier foundation courses under its Southern wing may suggest that a watching brief on the demolition of the structure may be worthwhile to record the presence of any other earlier structural remains that may survive on the site. However the final decision on the need for any further work rests with Perth and Kinross Heritage Trust.

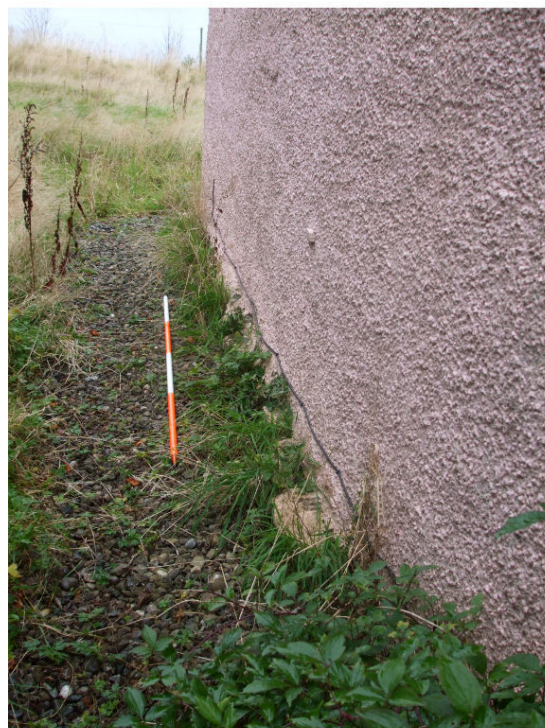
Illus 14 Stepped foundation course under western wall of southern wing

**Illus 14 stepped foundation course under western wall of southern wing of farmhouse**

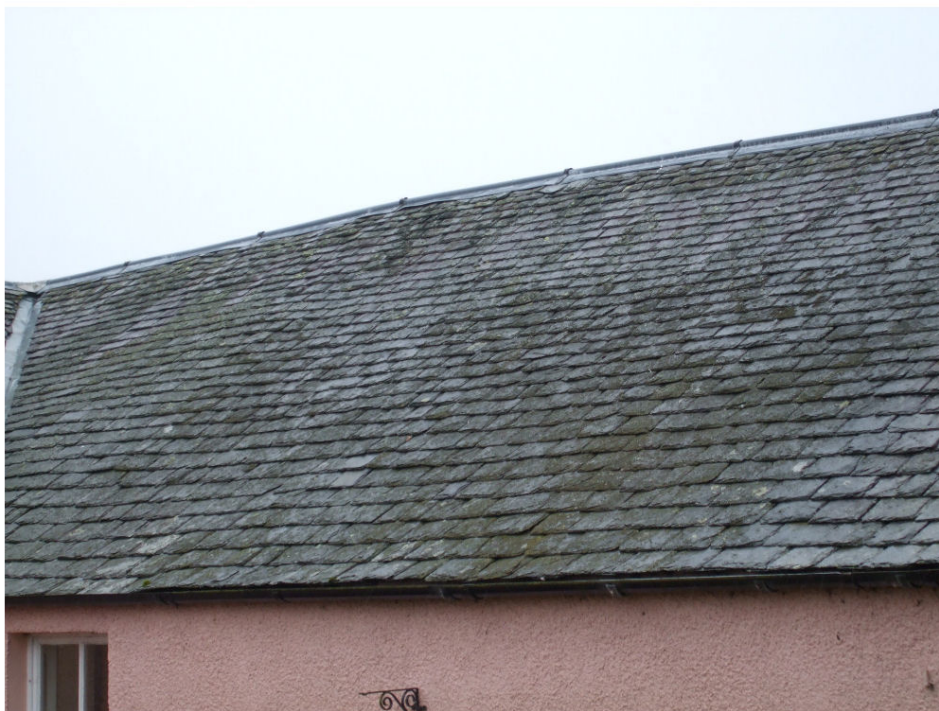
Illus 15 Slate roof on southern wing of farmhouse

**Illus 15 Slate roof on southern wing of farmhouse**

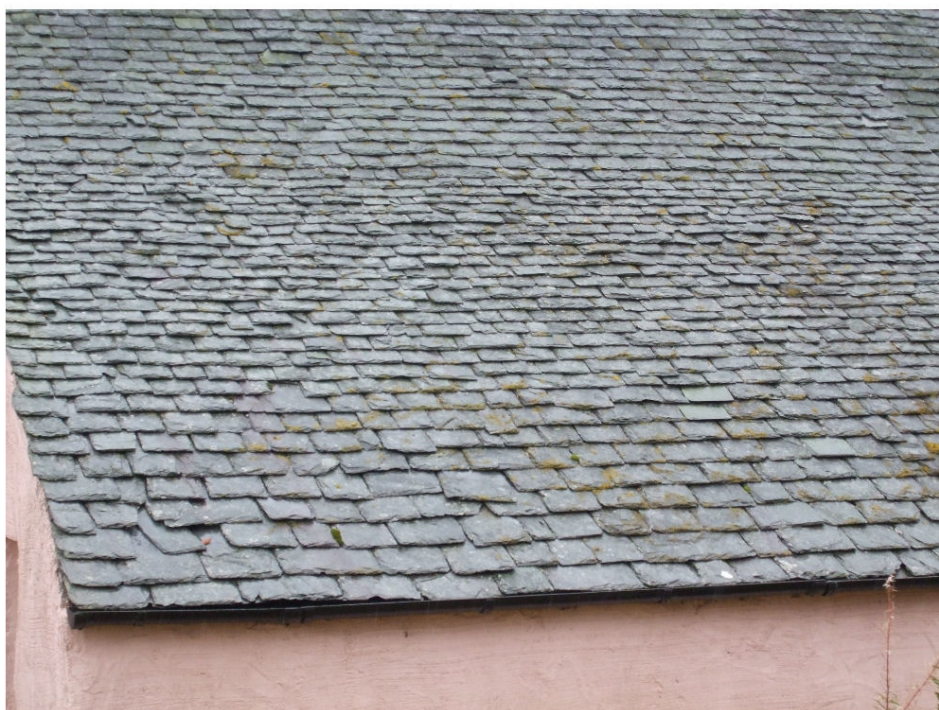
Illus 16 Slate roof on western extension

**Illus 16 Slate roof on western extension**

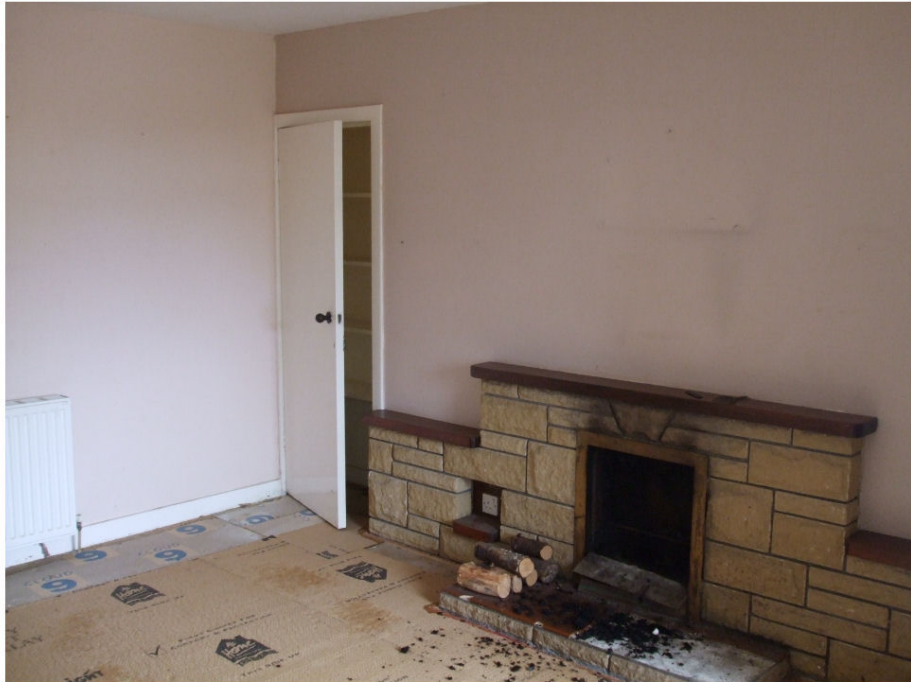
The interior of the building has been fitted out as a modern holiday home and shows no trace of any original fittings. The small extension on the western elevation has a flagstone floor which lies c 0.40m lower than the other internal floors of the structure.

Illus 17 Interior view of living room adjacent to kitchen extension

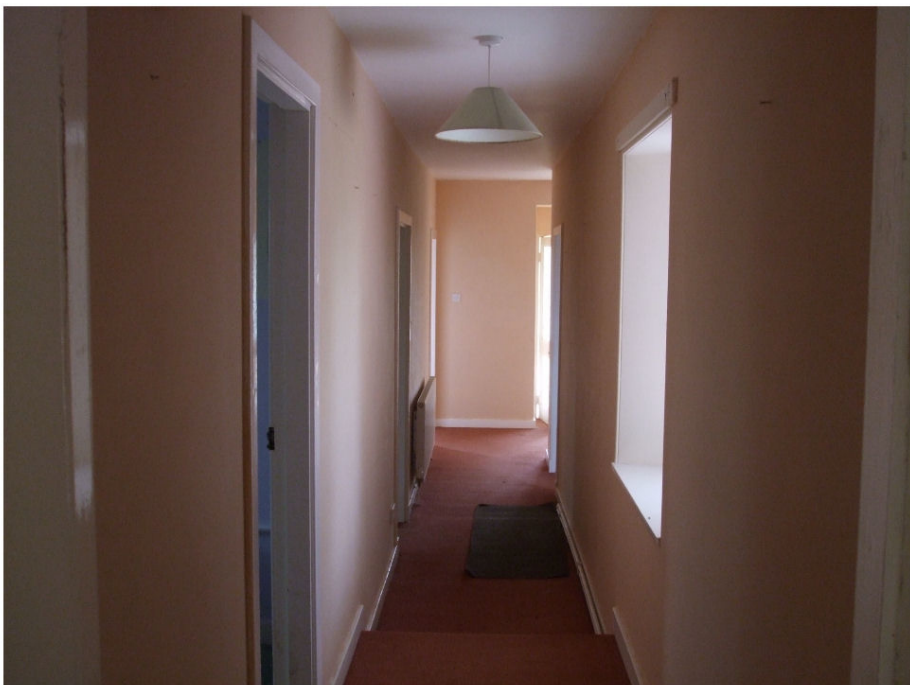
Illus 18 Corridor running length of farmhouse (North to South)

Illus 18 Corridor running length of farmhouse

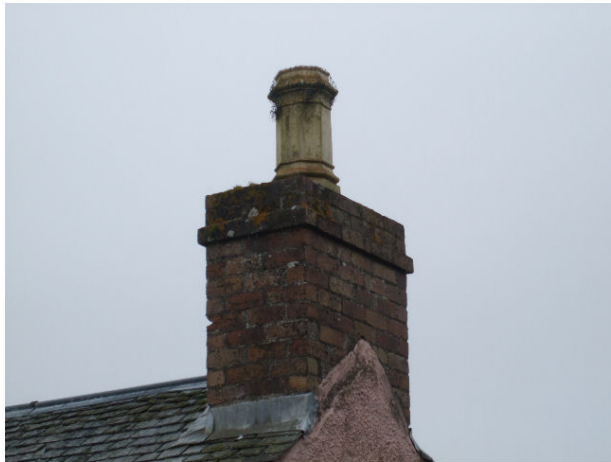
Illus 19 Chimney at W gable of southern wing

Illus 19 Chimney at W gable end of southern wing

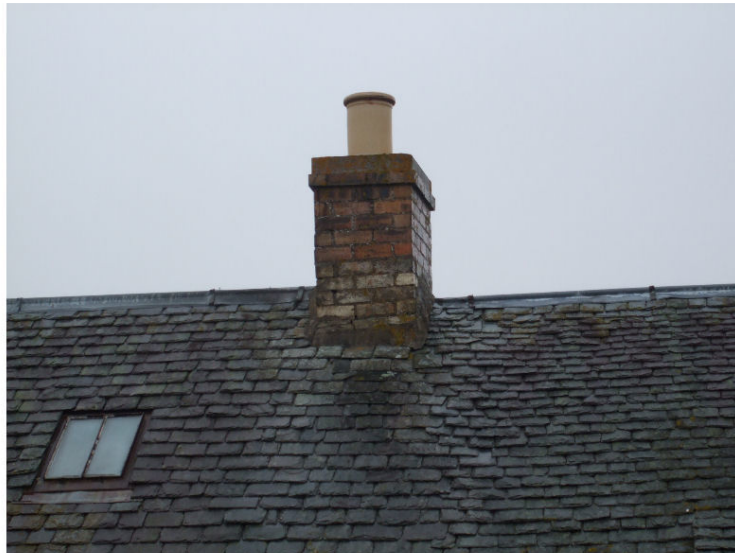
Illus 20 Chimney at junction of kitchen extension and farmhouse

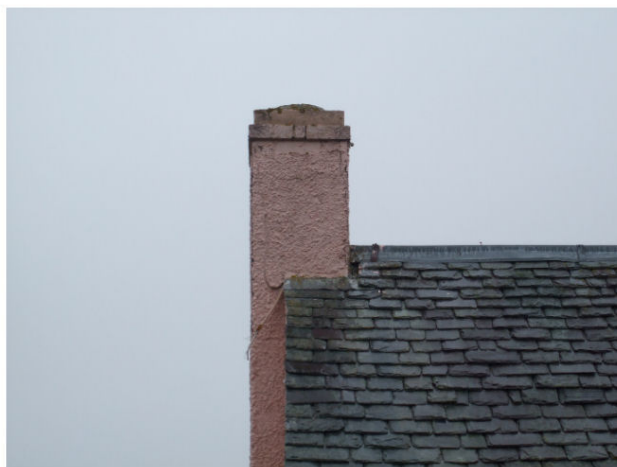
Illus 21 Chimney at N gable of kitchen extension

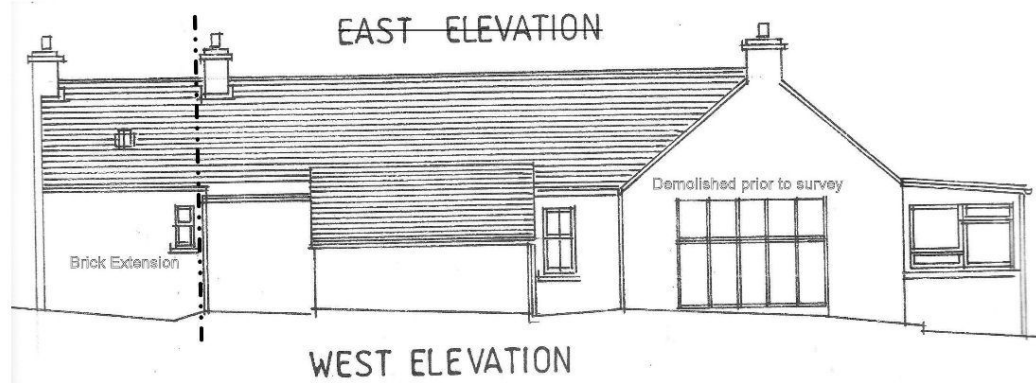
Illus 22 Architects drawing of Western elevation marked up to show position of brick built extension and former structure on N gable demolished prior to survey

**Illus 22 Architects drawing of West elevation marked up to show position of brick built extension and former structure on N gable demolished prior to survey Scale 1:100**
