Standing Building Survey
Old Church Cottage, Lawers

29th January 2010

LOCAL AUTHORITY:	Perth and Kinross
PROJECT TITLE/SITE NAME:	Old Church Cottage, Lawers
PROJECT CODE:	LAW01
PARISH:	Killin
NAME OF CONTRIBUTOR(S):	Derek Hall
NAME OF ORGANISATION:	Derek Hall, archaeologist and ceramic specialist
TYPE(S) OF PROJECT:	Standing Building Survey
NMRS NO(S):	None
SITE/MONUMENT TYPE(S):	Cottage
SIGNIFICANT FINDS:	None
NGR (2 letters, 6 figures)	NN 677 393
START DATE	22 nd January 2010
END DATE	22 nd January 2010
PREVIOUS WORK (incl. <i>DES</i> ref.)	None
MAIN (NARRATIVE) DESCRIPTION: (May include information from other fields)	A rapid photographic standing building survey was undertaken in advance of the demolition of this cottage for redevelopment. Evidence was recorded for an earlier blocked doorway and wide entrance in the buildings North elevation. No structural evidence was located to suggest that the building originated as part of the 18 th century settlement of Tomb.
PROPOSED FUTURE WORK:	Watching Brief

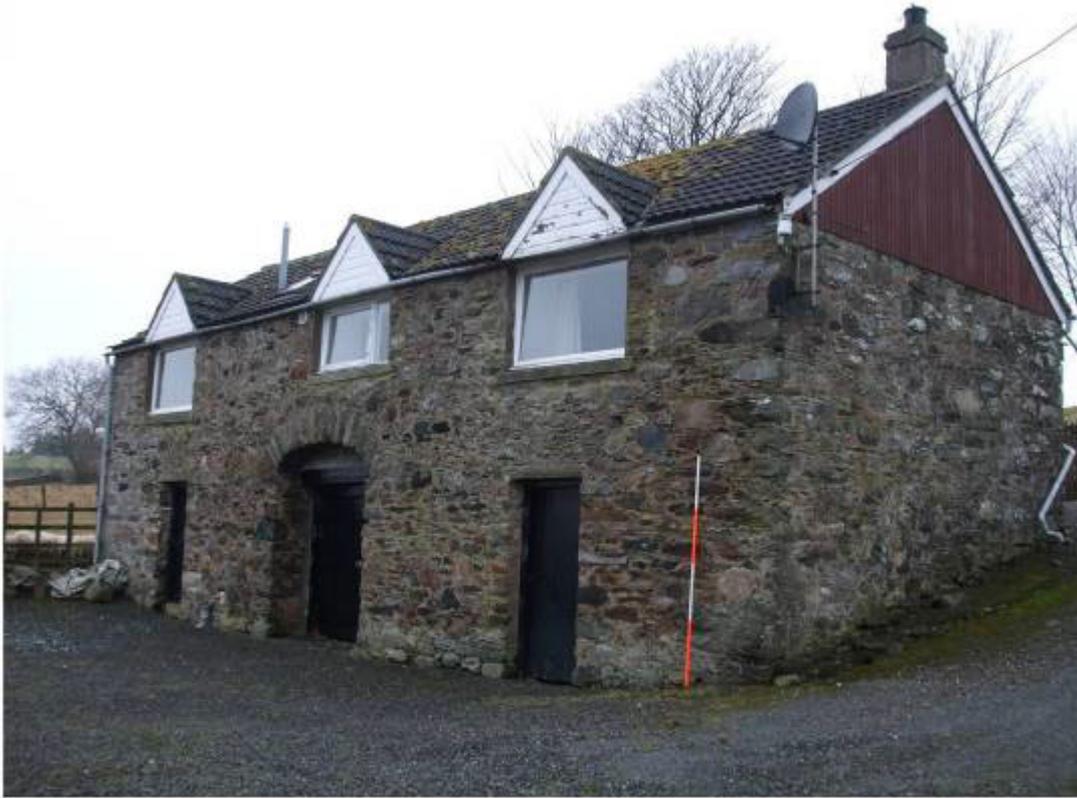
Illustration 7 South Facing elevation looking North West

This elevation has two storeys, on the lower storey there are doors at either end of the building and a central arched doorway in the middle. On the upper storey there are three windows the tops of which have partial gables in the roof line.

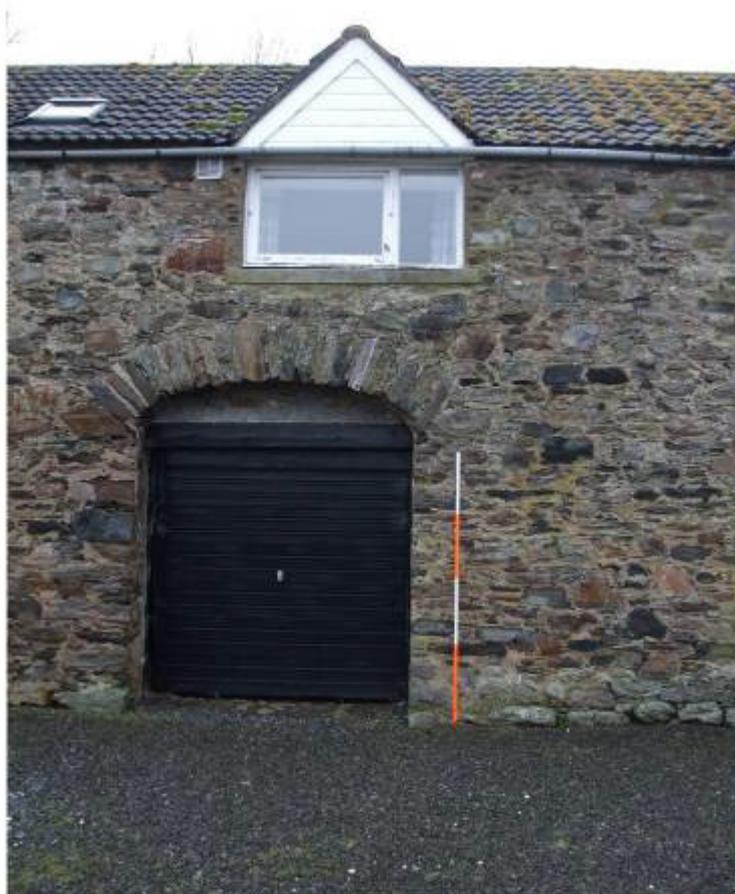
Illustration 10 Middle of Southern Elevation

The central arched doorway in the southern elevation opens into a storage area which runs right through to the north wall of the cottage. All internal walls are blank with no further doorways or windows. The door at the western end of this elevation was locked shut and therefore in accessible. The door at the eastern end opens out into a narrow 'porch' like area before encountering a further doorway inserted into a temporary wall running across the building. This door was also locked but examination over the wall head indicated that the room beyond was also used for storage. The eastern jamb of the outer eastern doorway seems to retain evidence for an earlier method of blocking the door using timbers (Illus 11).

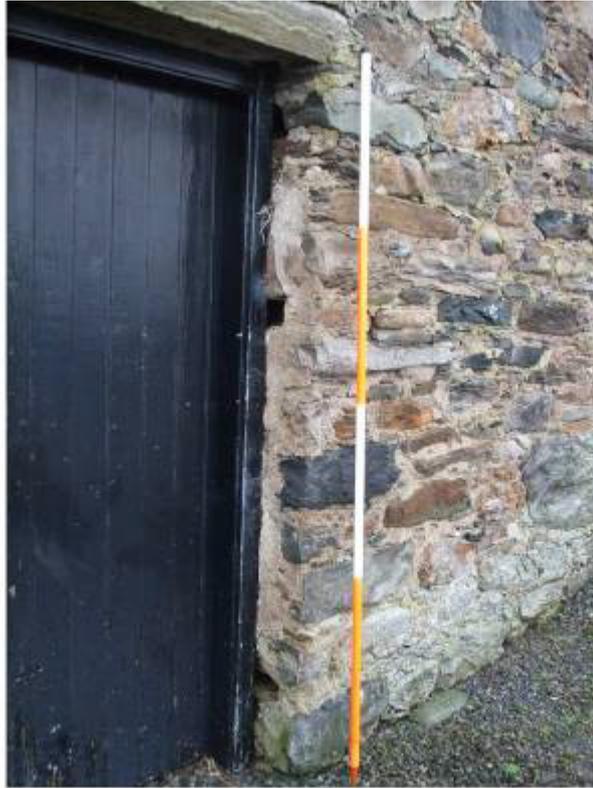
Illustration 11 Evidence for former timber sockets in doorway at Eastern end of Southern Elevation

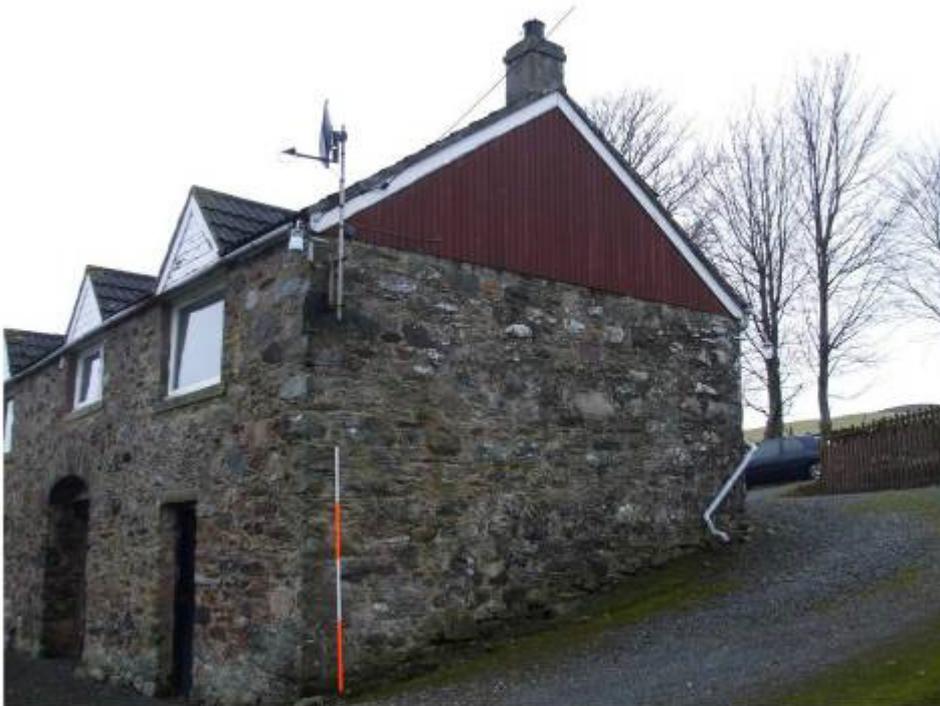
Illustration 12 Eastern gable end of cottage

The wall face on this elevation is blank and there is a stove chimney at its southern end. The roof has been added to the top of the wall head as a single unit there is wooden cladding to a maximum depth of 2.25m from the apex.

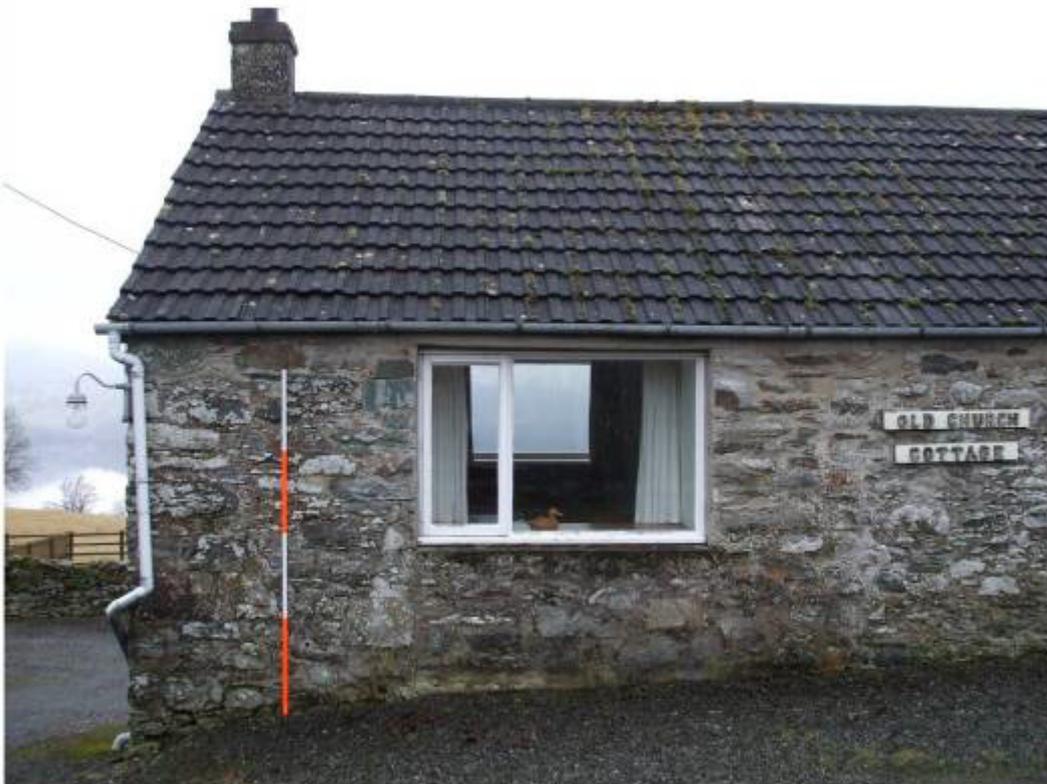
This single storey elevation has a window at both end and a central main doorway into the cottage. Careful examination of this elevation revealed that there are blocked former doorways at both its W and E ends. The blocked entrance at the W end lies 1.77m from the W gable end is 0.94m wide and 1.88m high with a former threshold 0.08m high. The blocked entrance at the E end lies 1.76m from the E gable is 2.54m wide and 1.84m high with a former threshold 0.20m high.

This elevation shows evidence for a blocked doorway and a blocked entrance at its Western and Eastern ends respectively. The central doorway and windows have been added at the time of the buildings conversion into a holiday house.

Illustration 14 Western end of North elevation (window sits in blocked entrance)

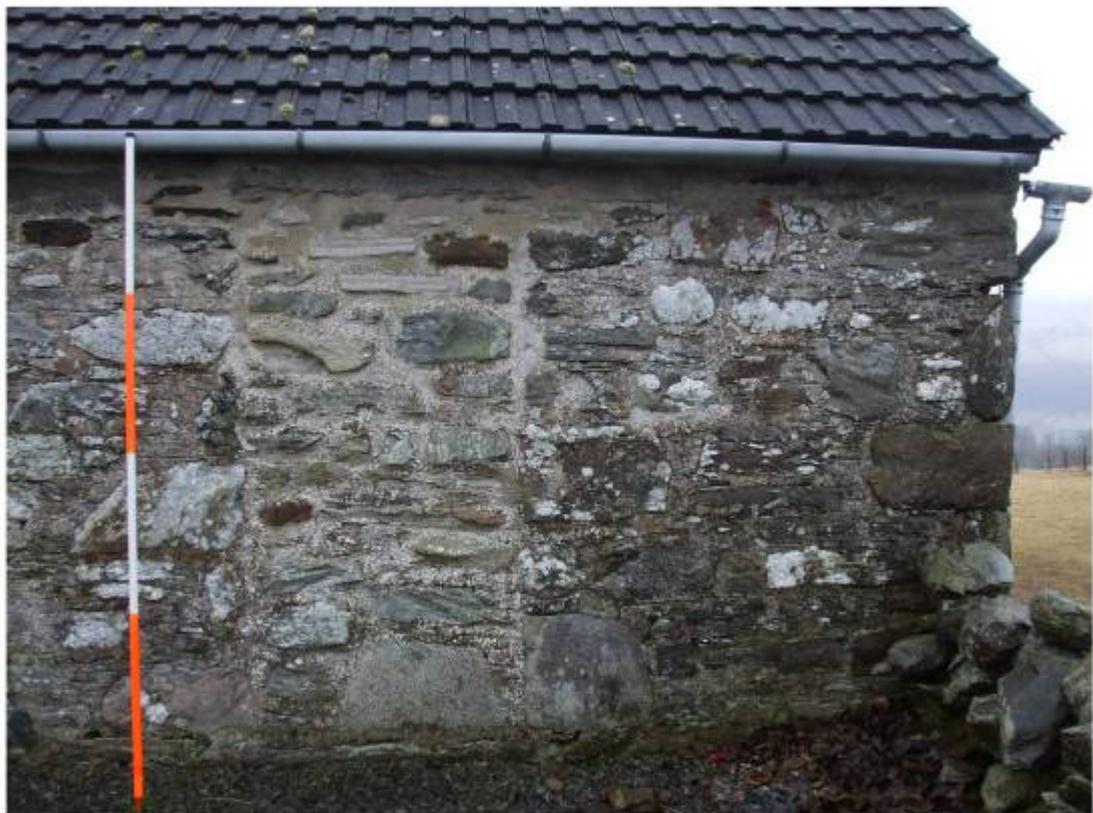
Illustration 16 Eastern end of Northern Elevation (blocked doorway to right of scale)

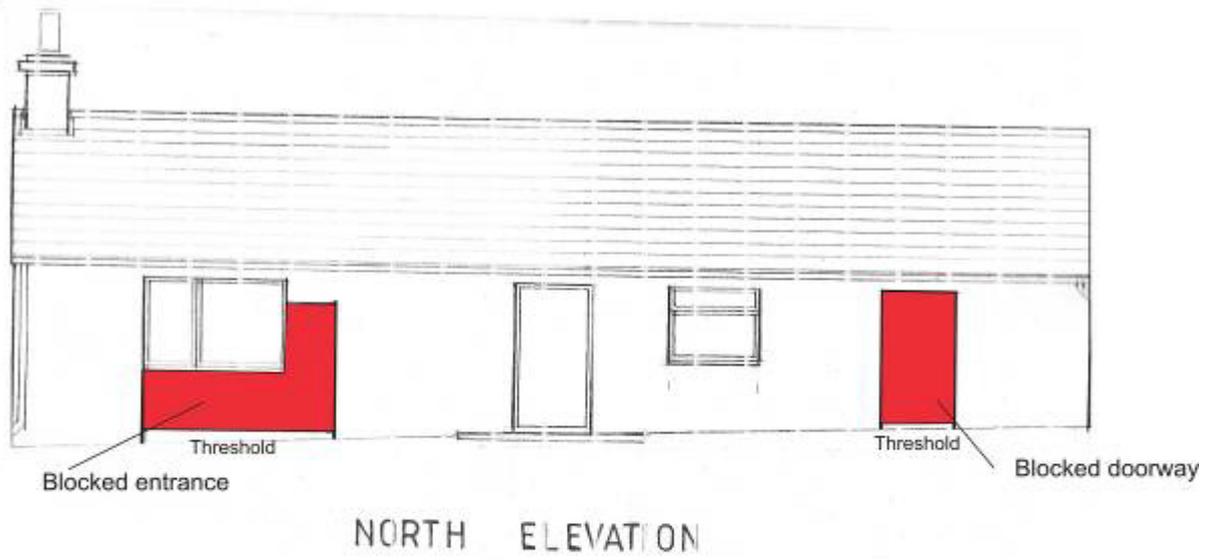
The blocked doorway and entrance in the North facing elevation and the central arched entrance in the South facing elevation would seem to suggest a former agricultural function for the cottage prior to its conversion to a holiday house in the 1960's. This suggestion may be backed up by the buildings absence from the Valuation Rolls (see Historical Background).

Illustration 17 North facing elevation showing blocked entrance and doorway (Scale 1:50 after H Paterson)

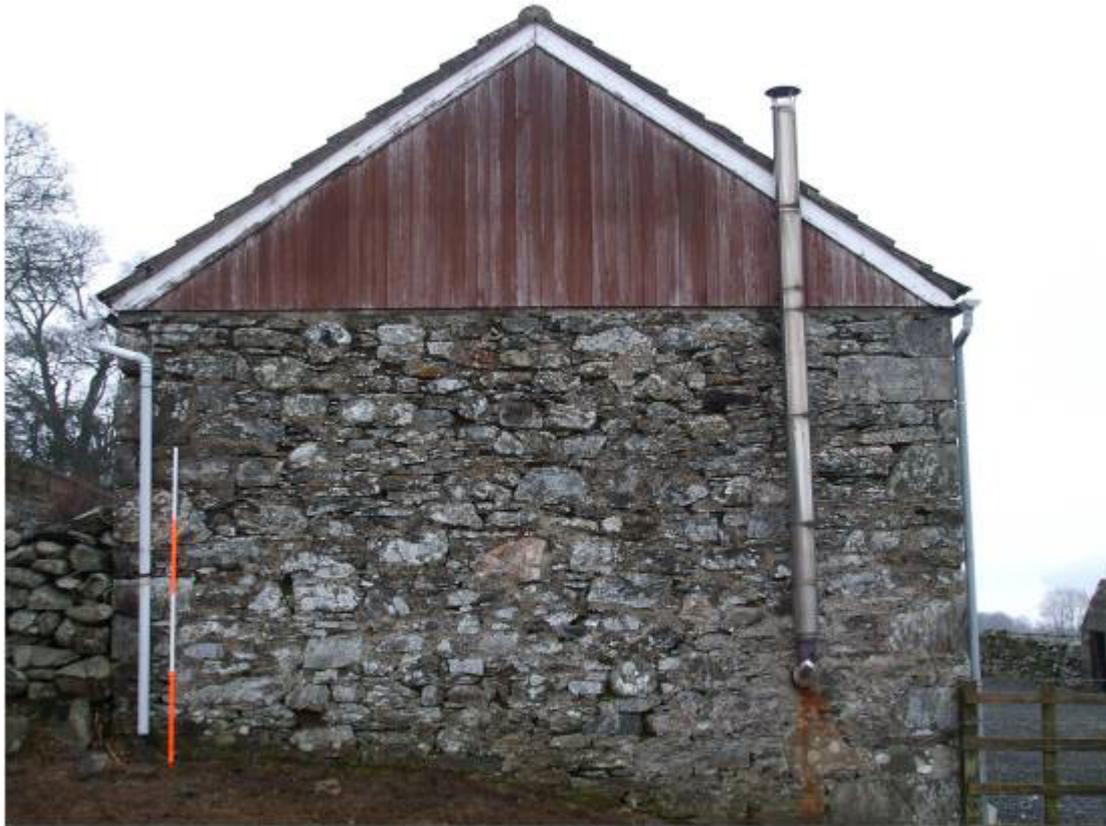
Illustration 18 Western Gable of cottage

The wall face on this elevation is blank and there is a chimney at the apex of the gable. The roof has been added to the top of the wall head as a single unit there is wooden cladding to a maximum depth of 2.25m from the apex.

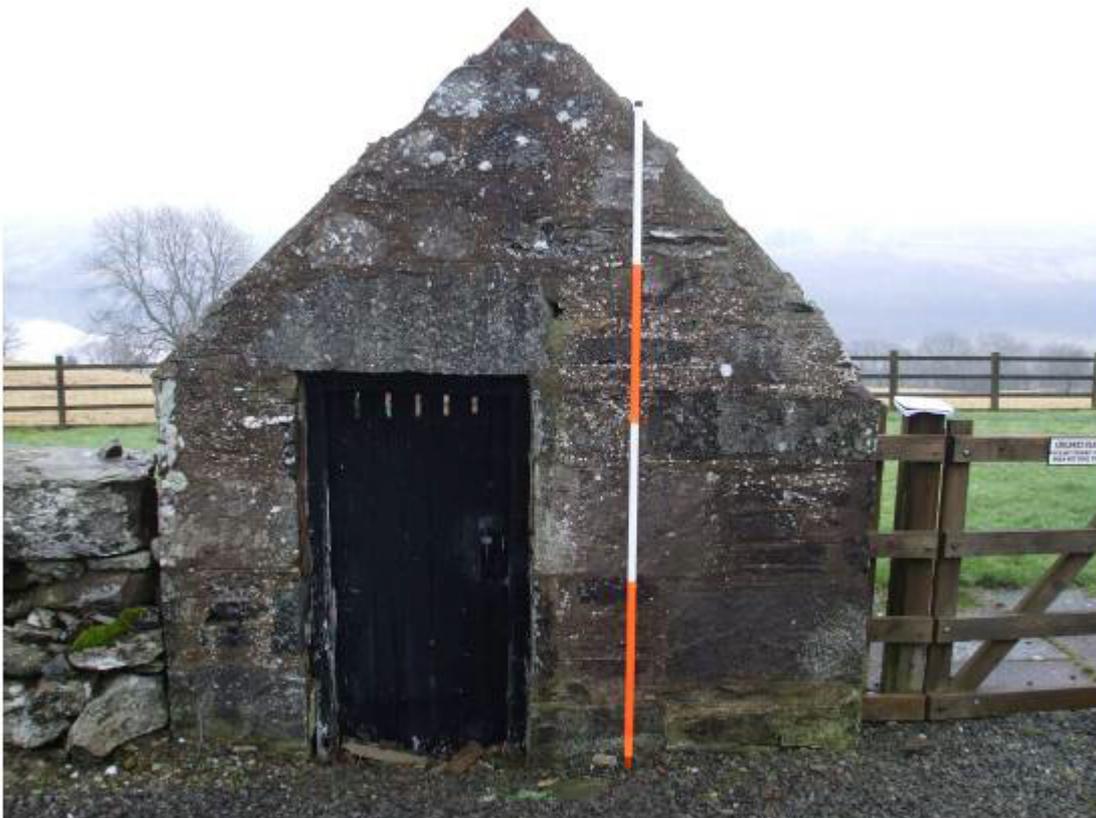
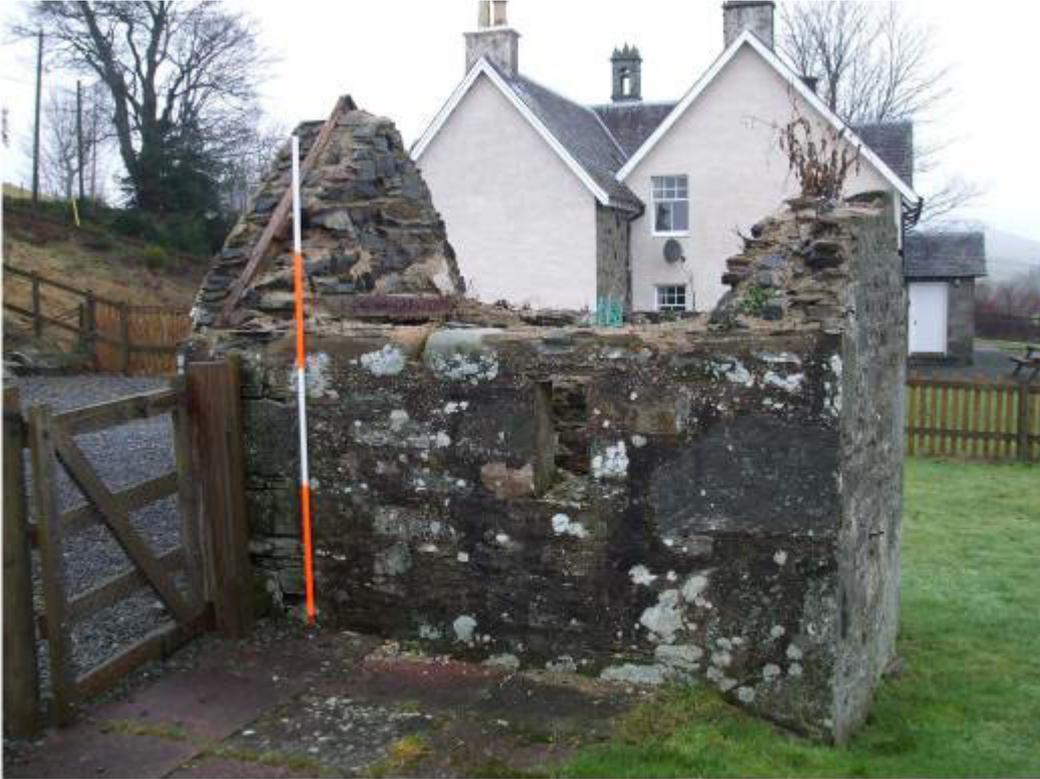
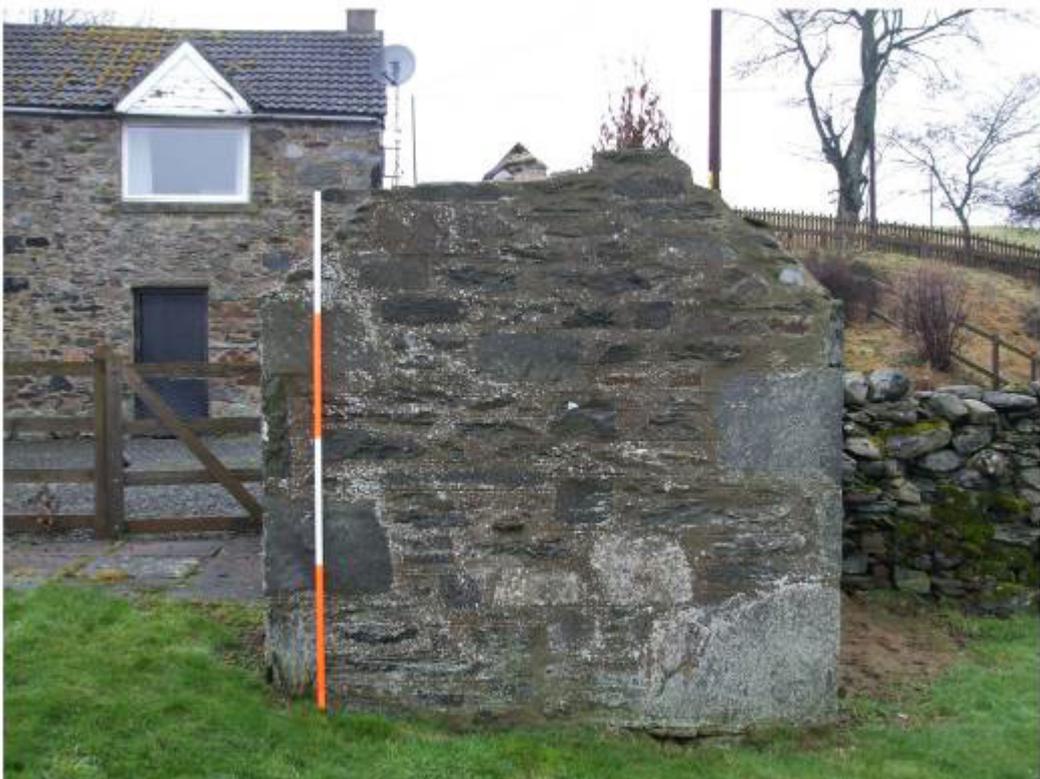
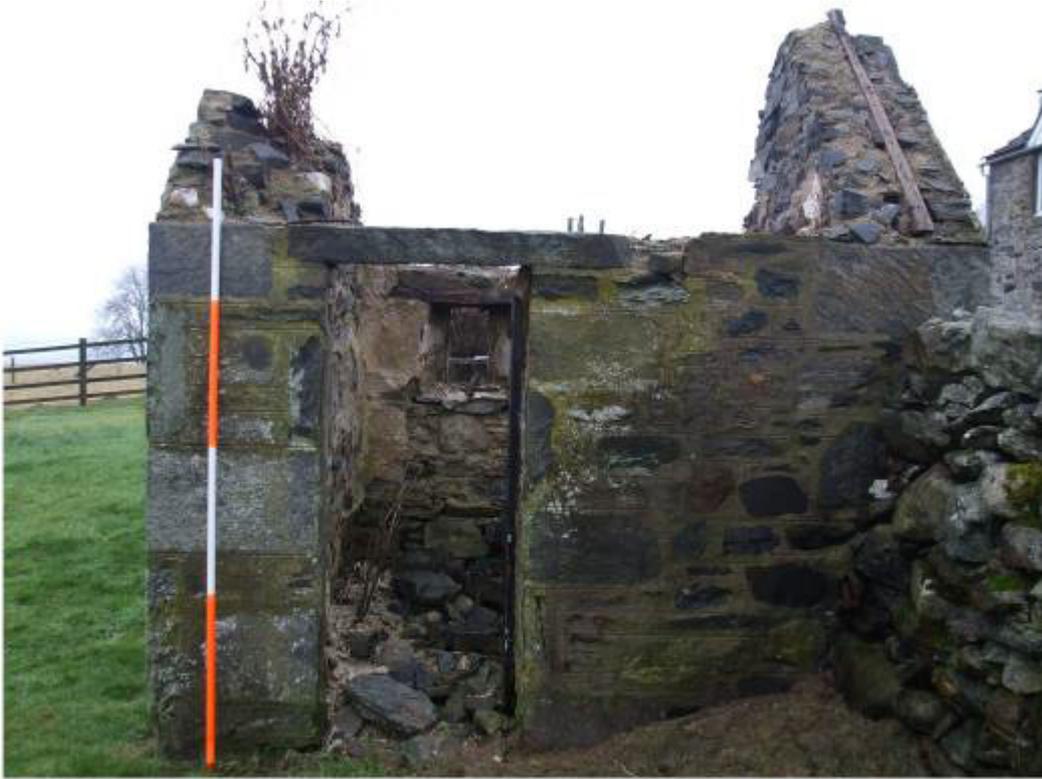
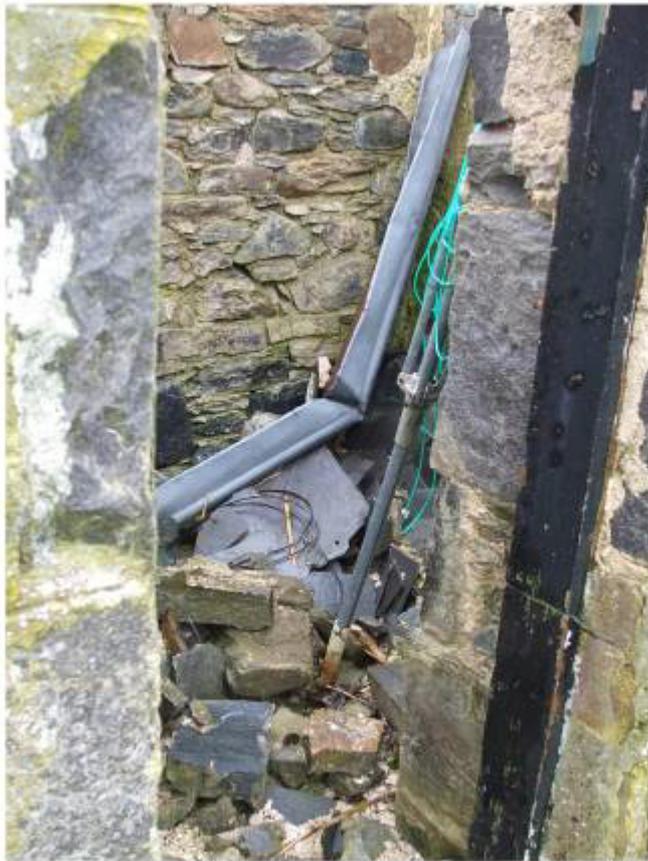
9m to the South of the cottage lay the derelict remains of a small outhouse with doorways in its Northern and Eastern walls. This building formerly had a gabled roof running North to South it is not marked on the 1st Edition Ordnance Survey map.

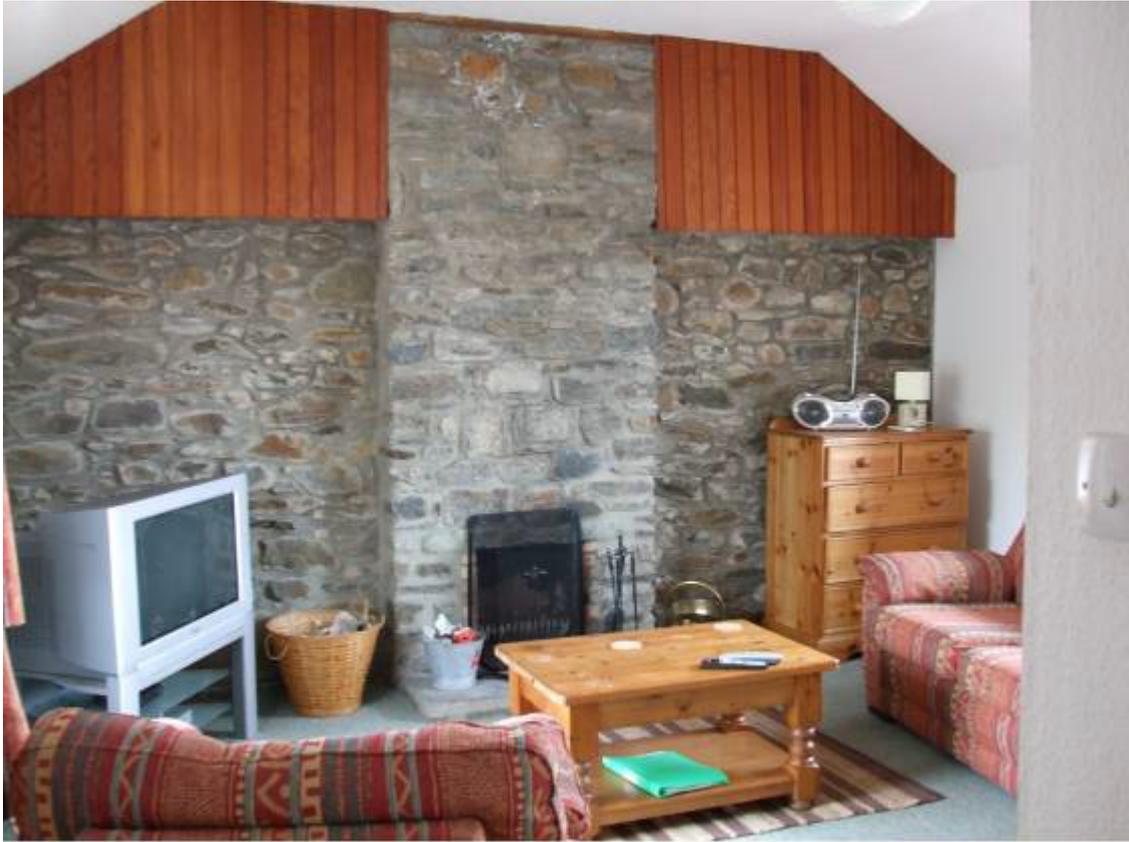
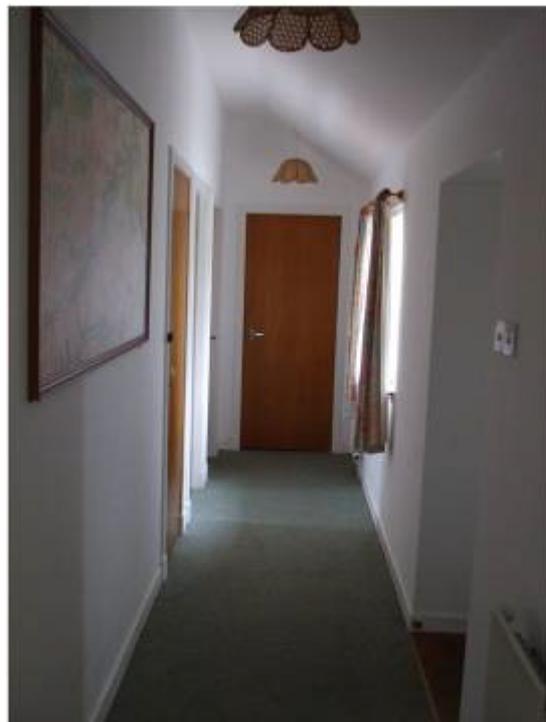
The central doorway opens into an internal corridor running East to West which leads to a living room and kitchen, a bathroom and bedroom. There is no access from upper to lower storey. The interior of the building has been fitted out as a modern holiday home and shows no trace of any original fittings.
