Archaeological Watching Brief

Victoria House, 84 West North Street, Aberdeen

30th June 2010

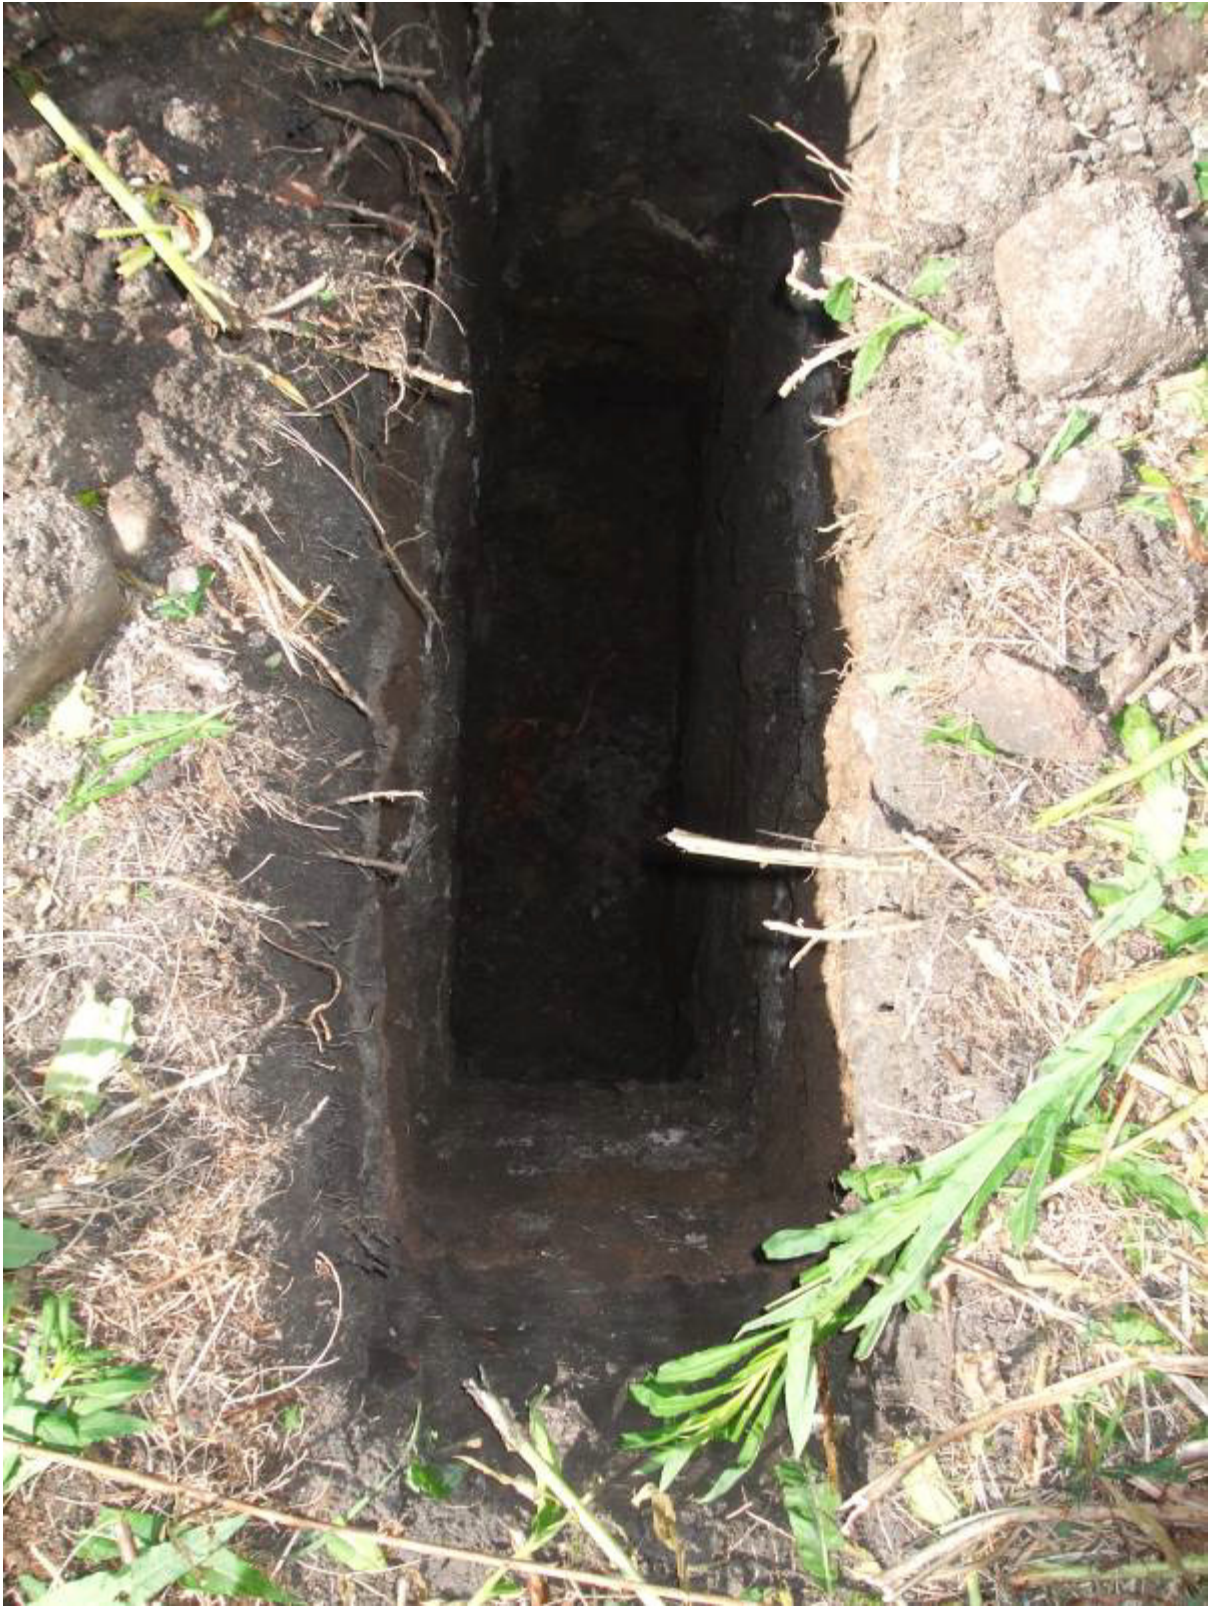
of the silty clays (context 3 in Trench 1, context 7 in Trench 2) but the bottle glass and clay pipe fragment from trench 1 suggest a Post Medieval date for those horizons (late 18th / early 19th century). The mortar bonded stonework encountered at 1.7m below modern ground level in Trench 2 is difficult to interpret but could potentially be of a medieval or post medieval date.

Illustration 7 Mortar bonded stonework visible at base of Test Pit

There is a considerable depth of deposit to the rear of Victoria House which seals structural remains which could potentially be of a medieval or post medieval date.

Depending on the development proposals and the foundation design of the proposed new build on this site there may be a need for further archaeological work prior to any proposed redevelopment, the final decision however rests with the Aberdeen City Council archaeologist.

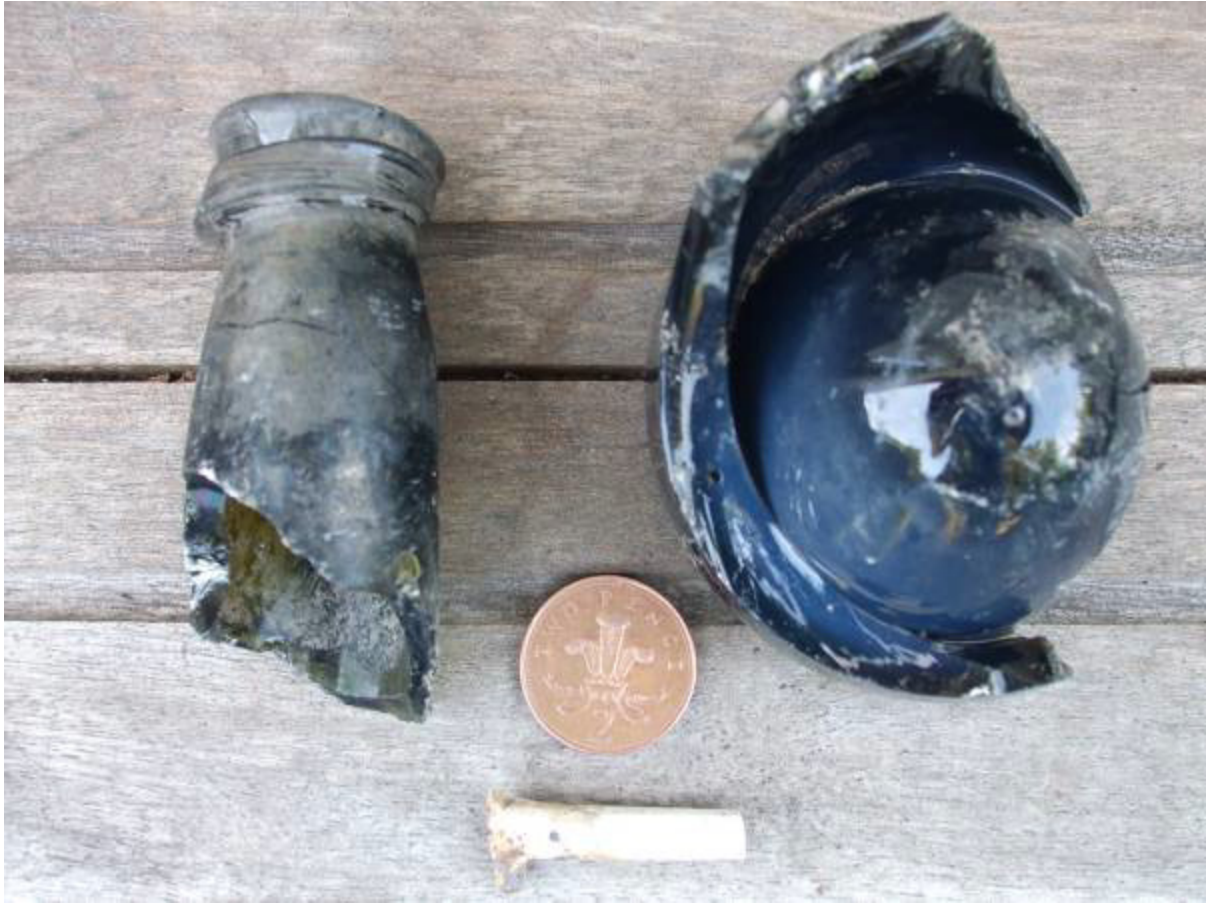
Context 3 in Test Pit 1 produced a neck and dimpled base from a glass bottle and a clay pipe stem with a narrow bore. Both the glass and clay pipe are of a late 18th or early 19th century date.

Illustration 8 Neck and base from glass bottle and clay pipe stem from context 3 in Test Pit 1
