Standing Building Survey
Former mill building, Middle Cardney
Butterstone, Perth and Kinross

Former mill building looking East

21st July 2010

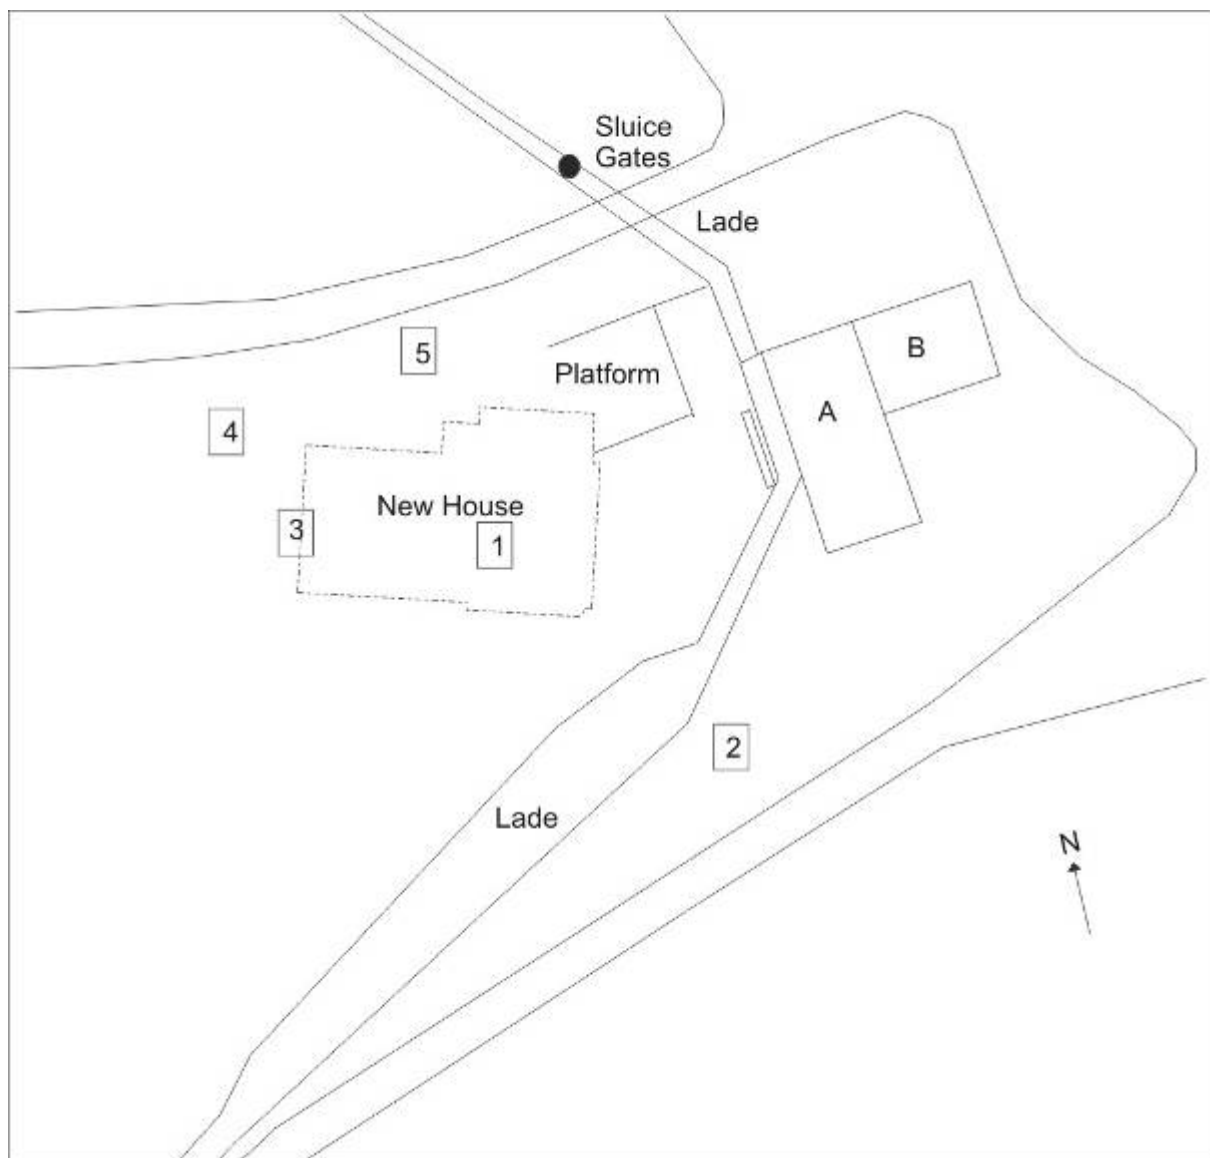
Illustration 2 Mill buildings at Middle Cardney as numbered for survey, new house plot marked by dashed outline and engineers test pits by numbered boxes Scale 1:500

The five test pits that had been dug in the footprint of the new house were also recorded as part of this survey exercise.

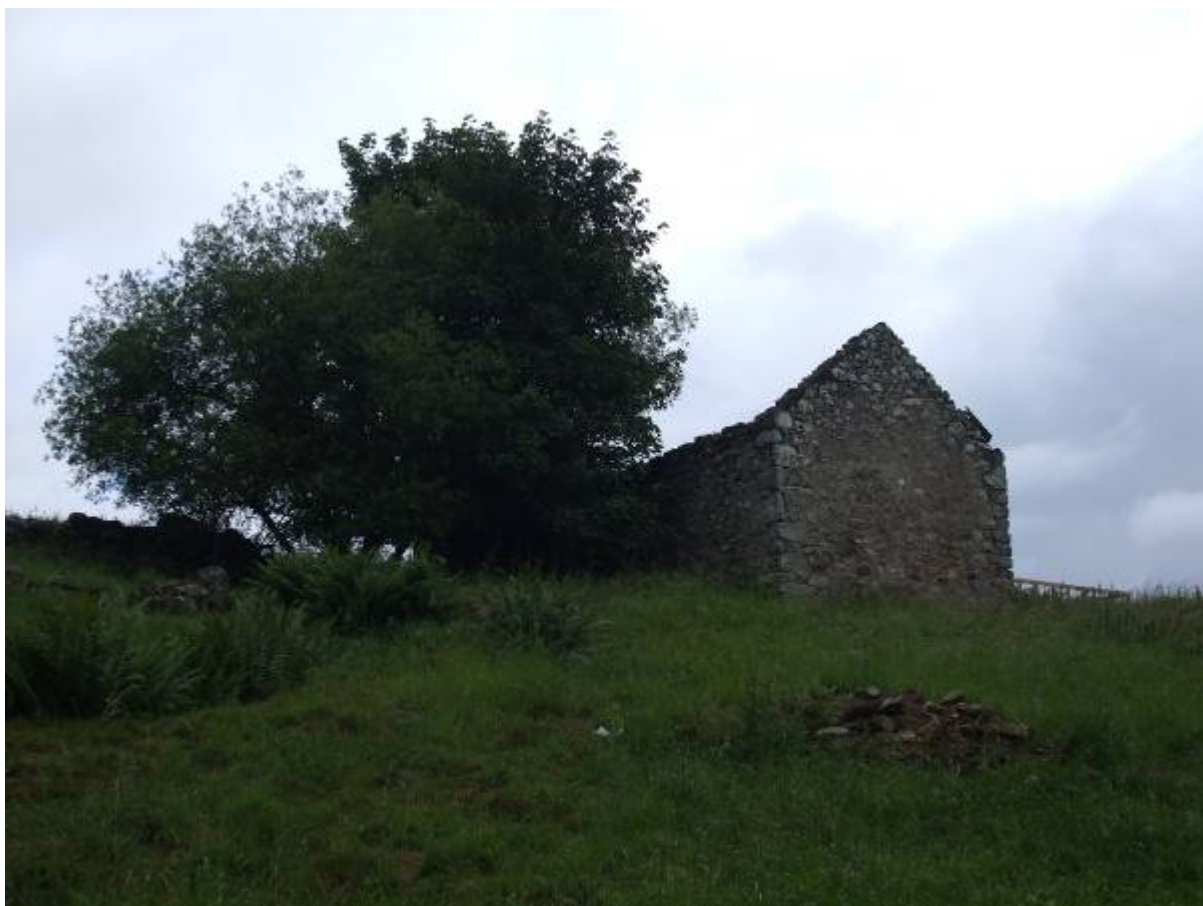
This gable elevation is blank and is constructed of rough stone rubble bonded with a thin lime mortar mixed with soil and small stones. The gable end walls are constructed of alternate shaped stone blocks. There is a large vertical crack in this elevation at its East end.

Illustration 7 Southern elevation of Building A looking North East

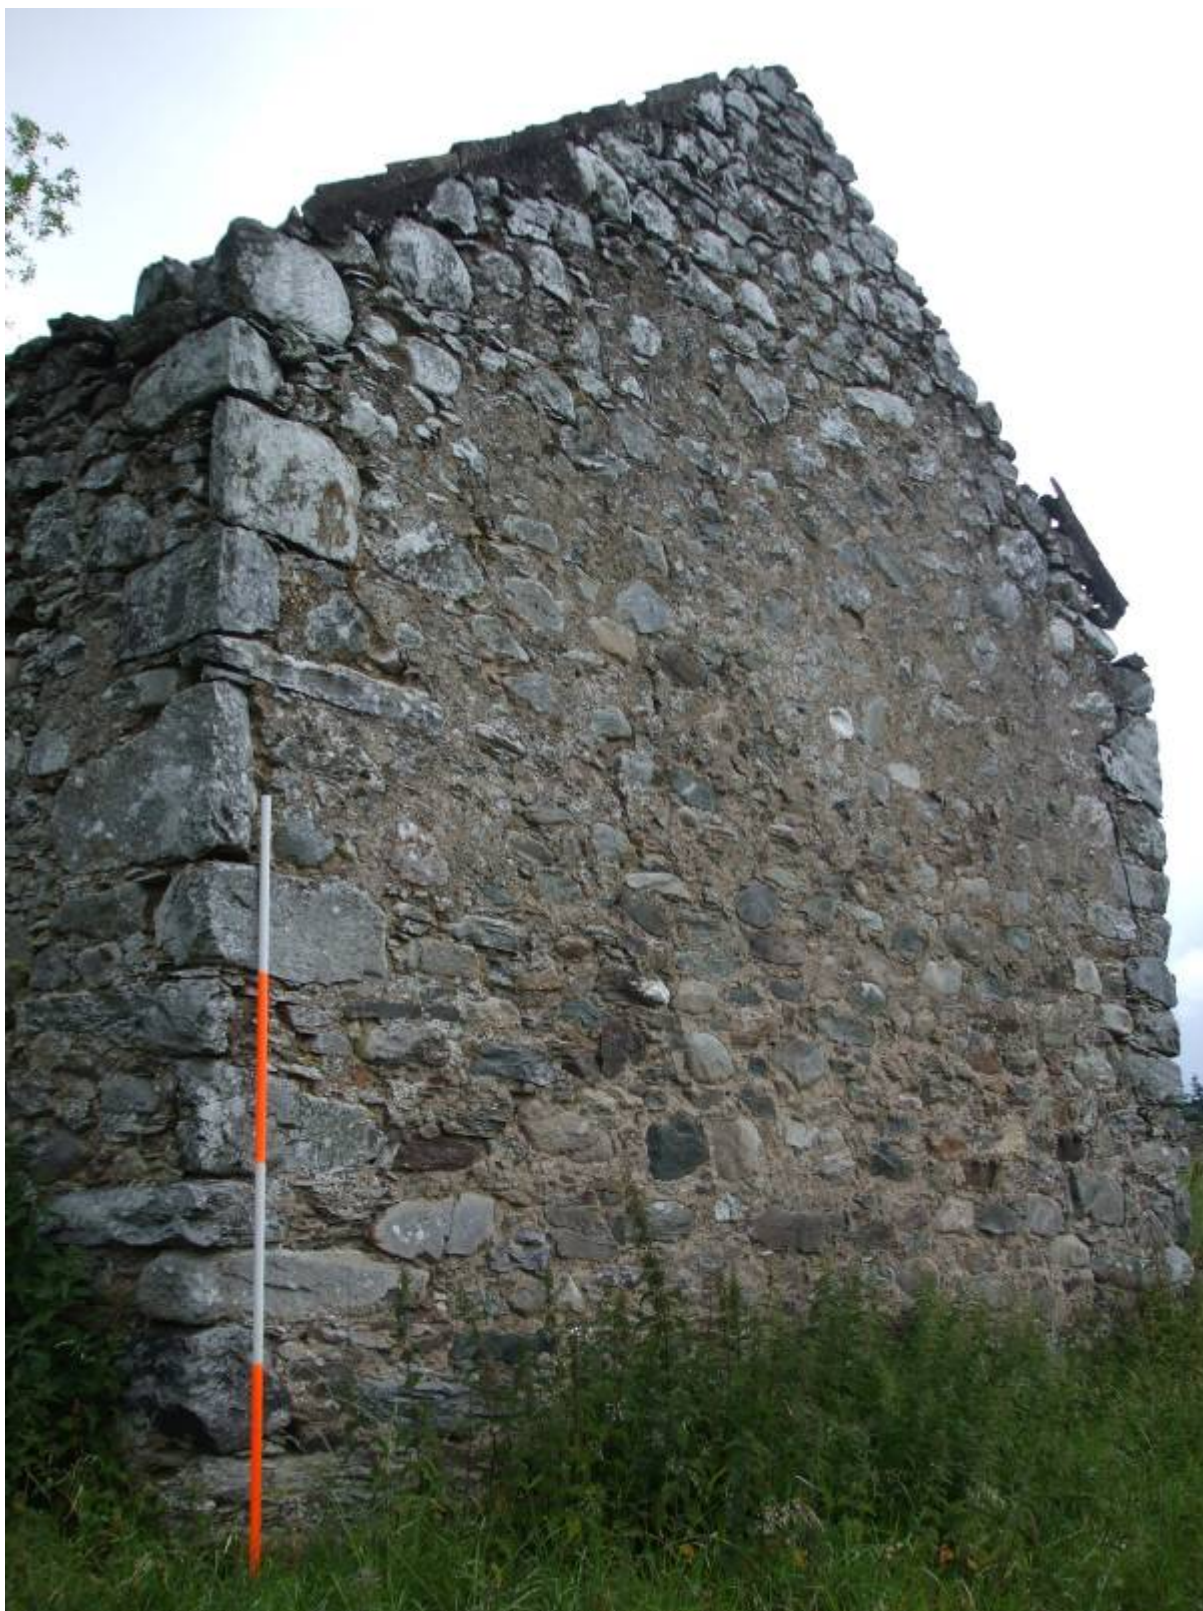
Illustration 8 Detail view of Southern gable elevation of Building A

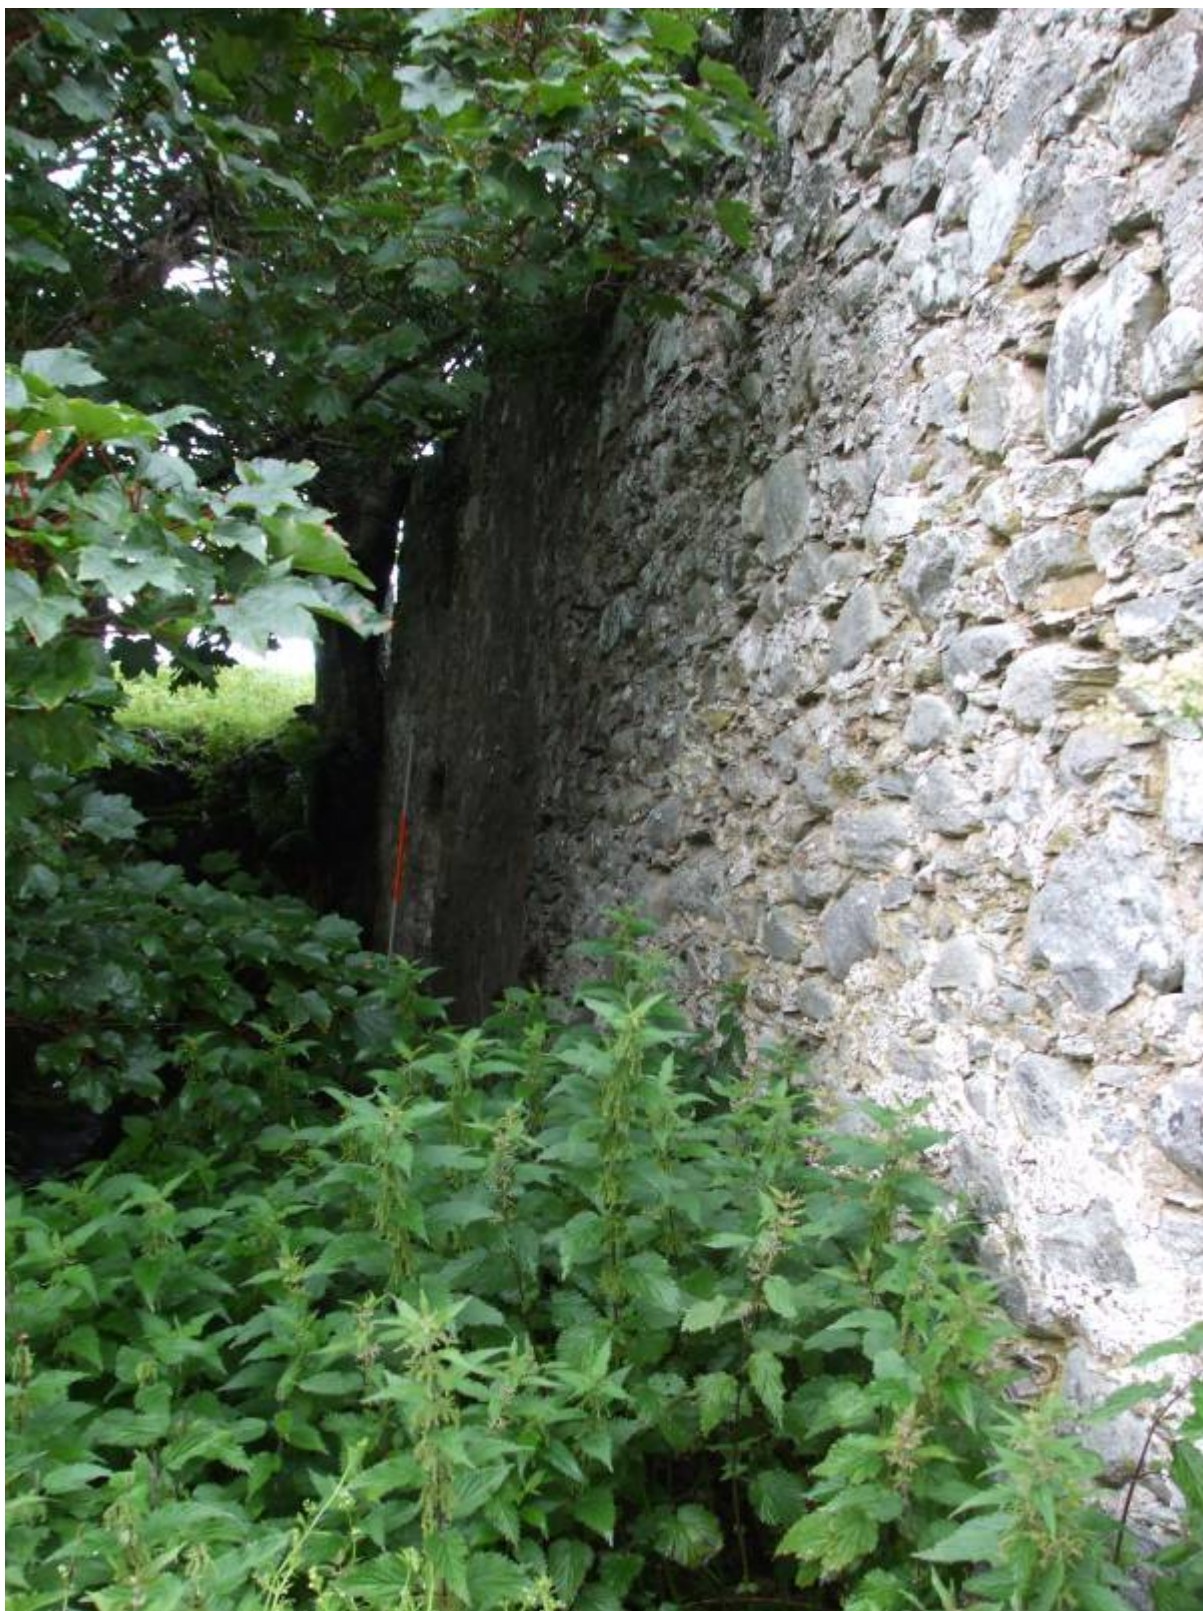
This side elevation is built against the exposed rock face and has a doorway (1.28m high by 0.76m wide) and a small window (0.75m high by 0.40m wide) at its Northern end, the mill wheel pit is built against it. It is constructed of rough stone rubble and is bonded in a similar manner to the Southern elevation, this wall face is plastered for a distance of 5.75m from its north end. The socket for holding the shaft of the mill wheel lies half way along this elevation (0.46m high by 0.38m wide).

Illustration 9 Western elevation of Building A

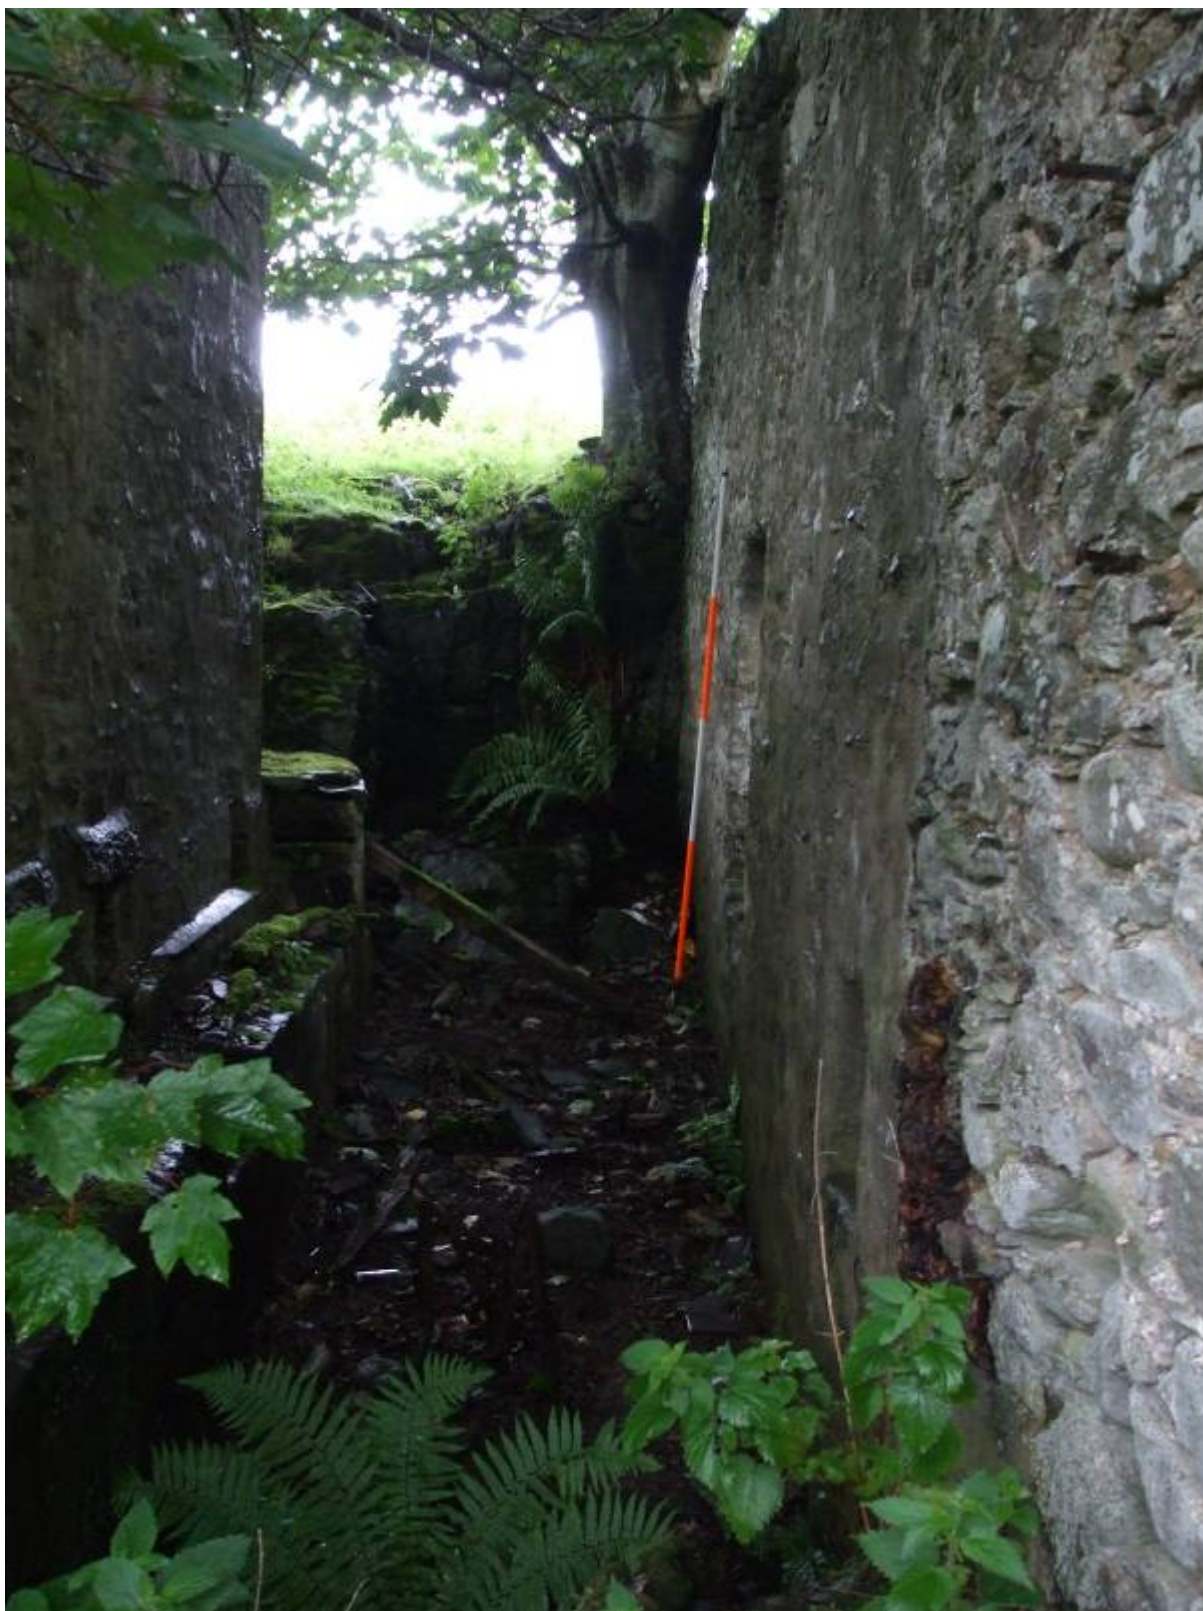
The wheel pit is 1.75m wide and currently at a depth of 0.80m although it is full of rubble, wood and plastic cans and is probably much deeper. The pit was fed from a lade to the north and the water then ran out into another lade which heads off South West from the mill. A mortar bonded rough stone rubble wall (0.45m thick) stands on the Western side of the wheel pit and contains the socket for the other side of the mill wheel shaft. This wall stands on a much wider wall (0.78m) which forms the Western side of the wheel pit.

Illustration 10 View across wheel pit looking North

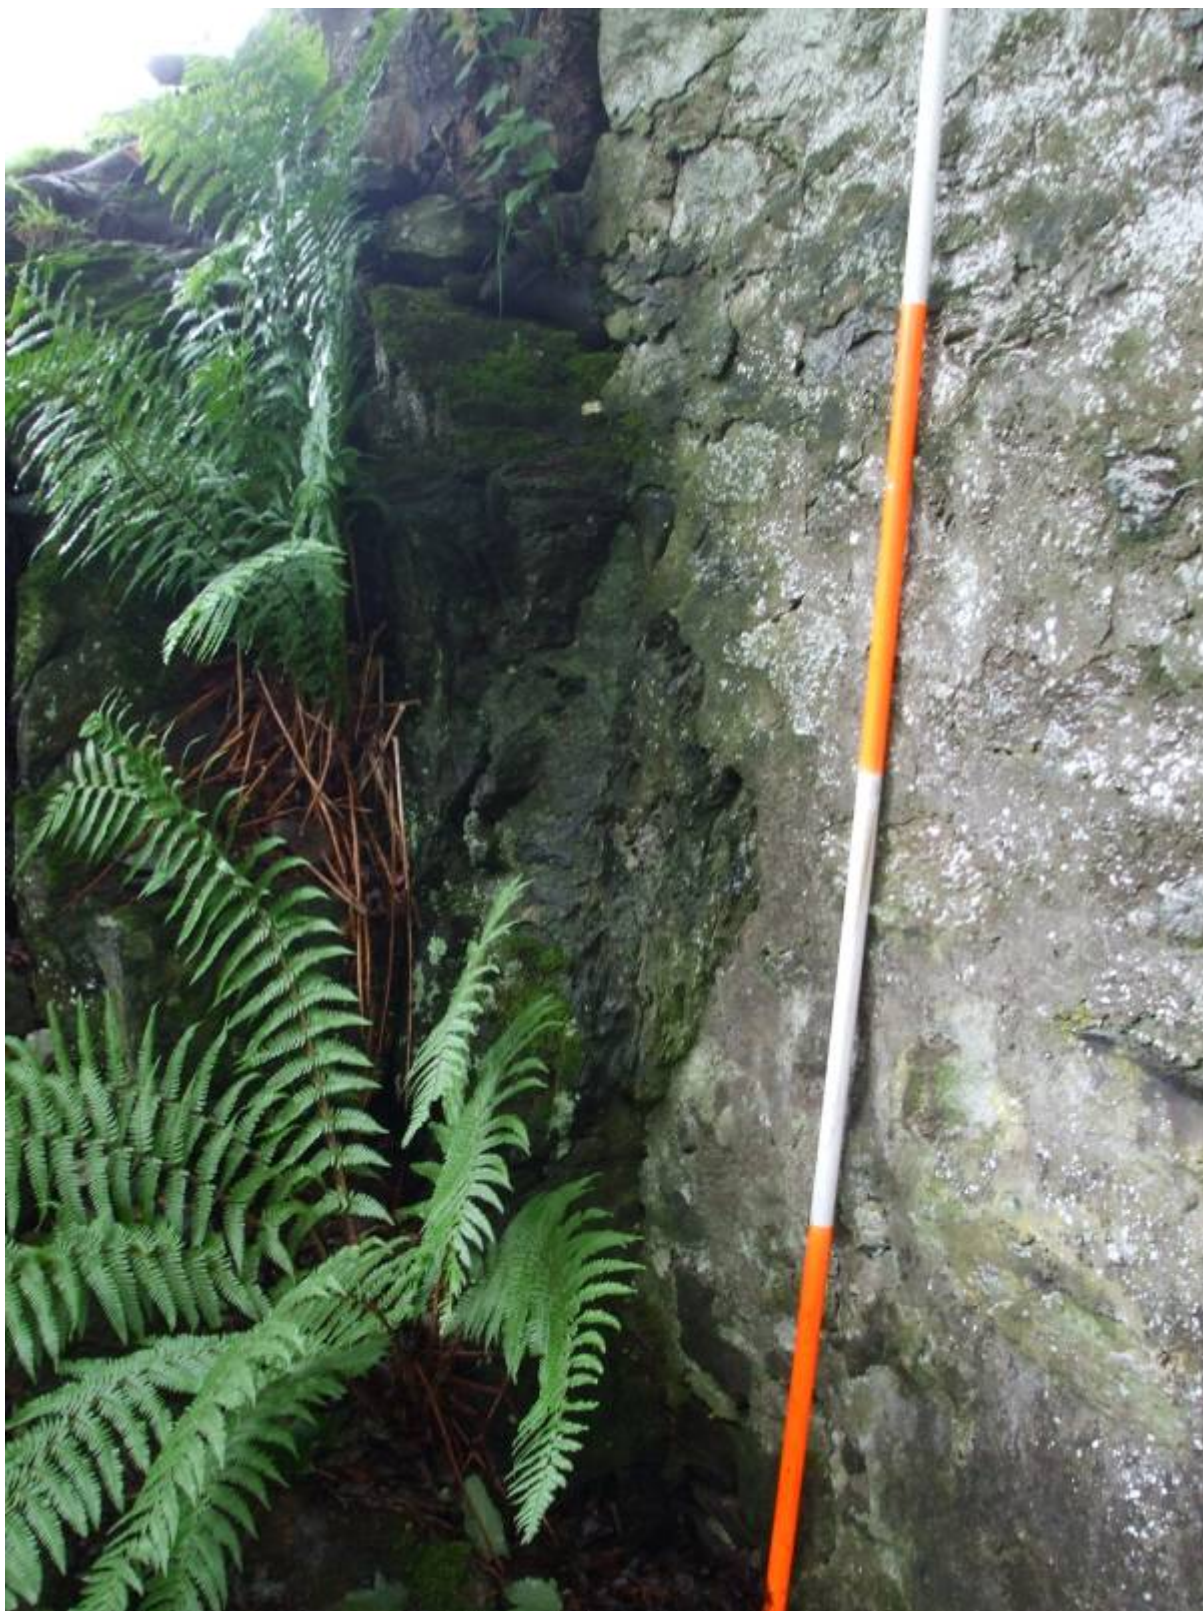
Illustration 11 Western elevation of Building A built against rock face looking North

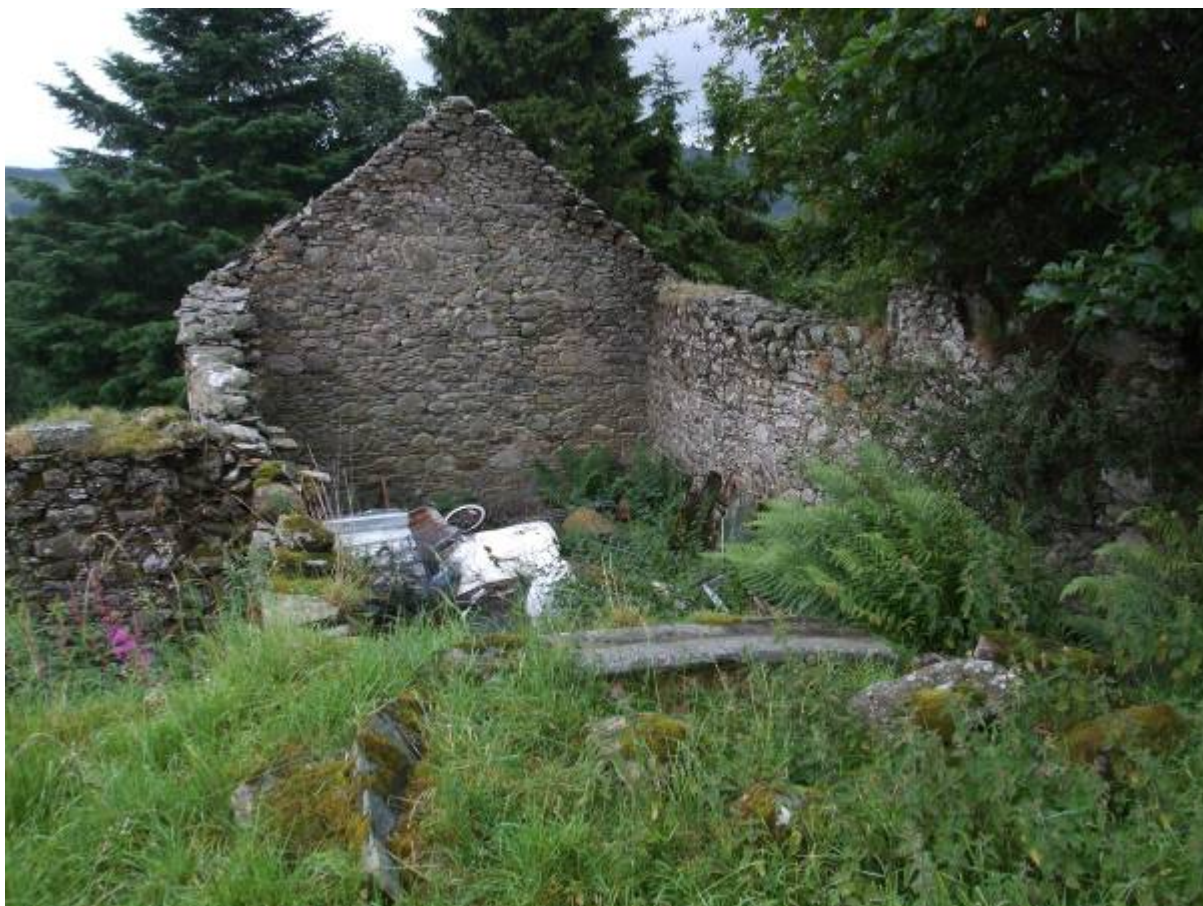
This wall is constructed of rough stone rubble bonded with a thin lime mortar mixed with soil and small stones and is built directly against the exposed rock face. A threshold stone (1.53m long by 0.35m wide) is visible at its eastern end which presumably afforded access to an upper storey at the northern end of the building.

Illustration 12 Threshold in northern elevation of Building A looking South

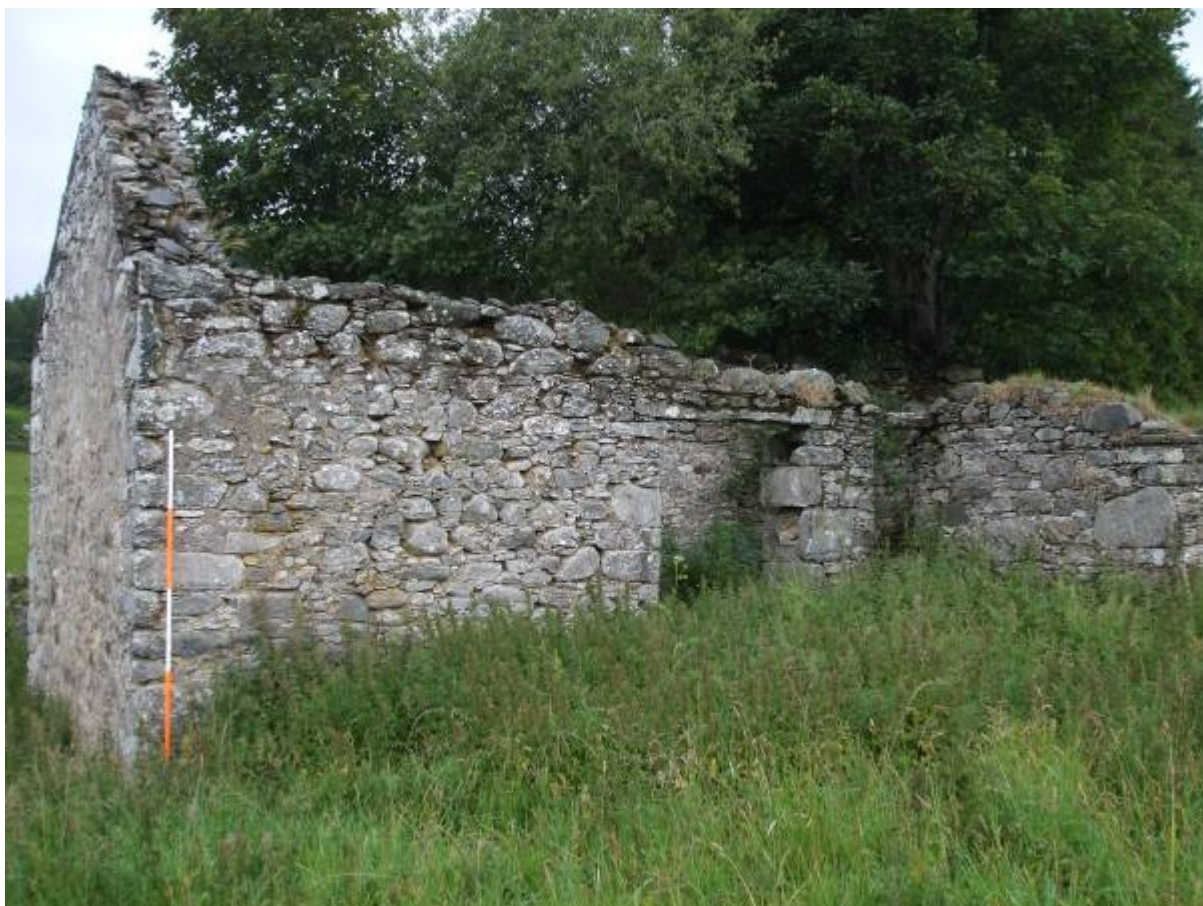
This wall is constructed of rough stone rubble bonded with a thin lime mortar mixed with soil and small stones. It contains a single doorway (1.48m wide by at least 2.07m high) and a window (0.77m wide by 1.20m high). The second building in this complex (B) is butted against this elevation.

Illustration 13 Eastern elevation of Building A at southern end

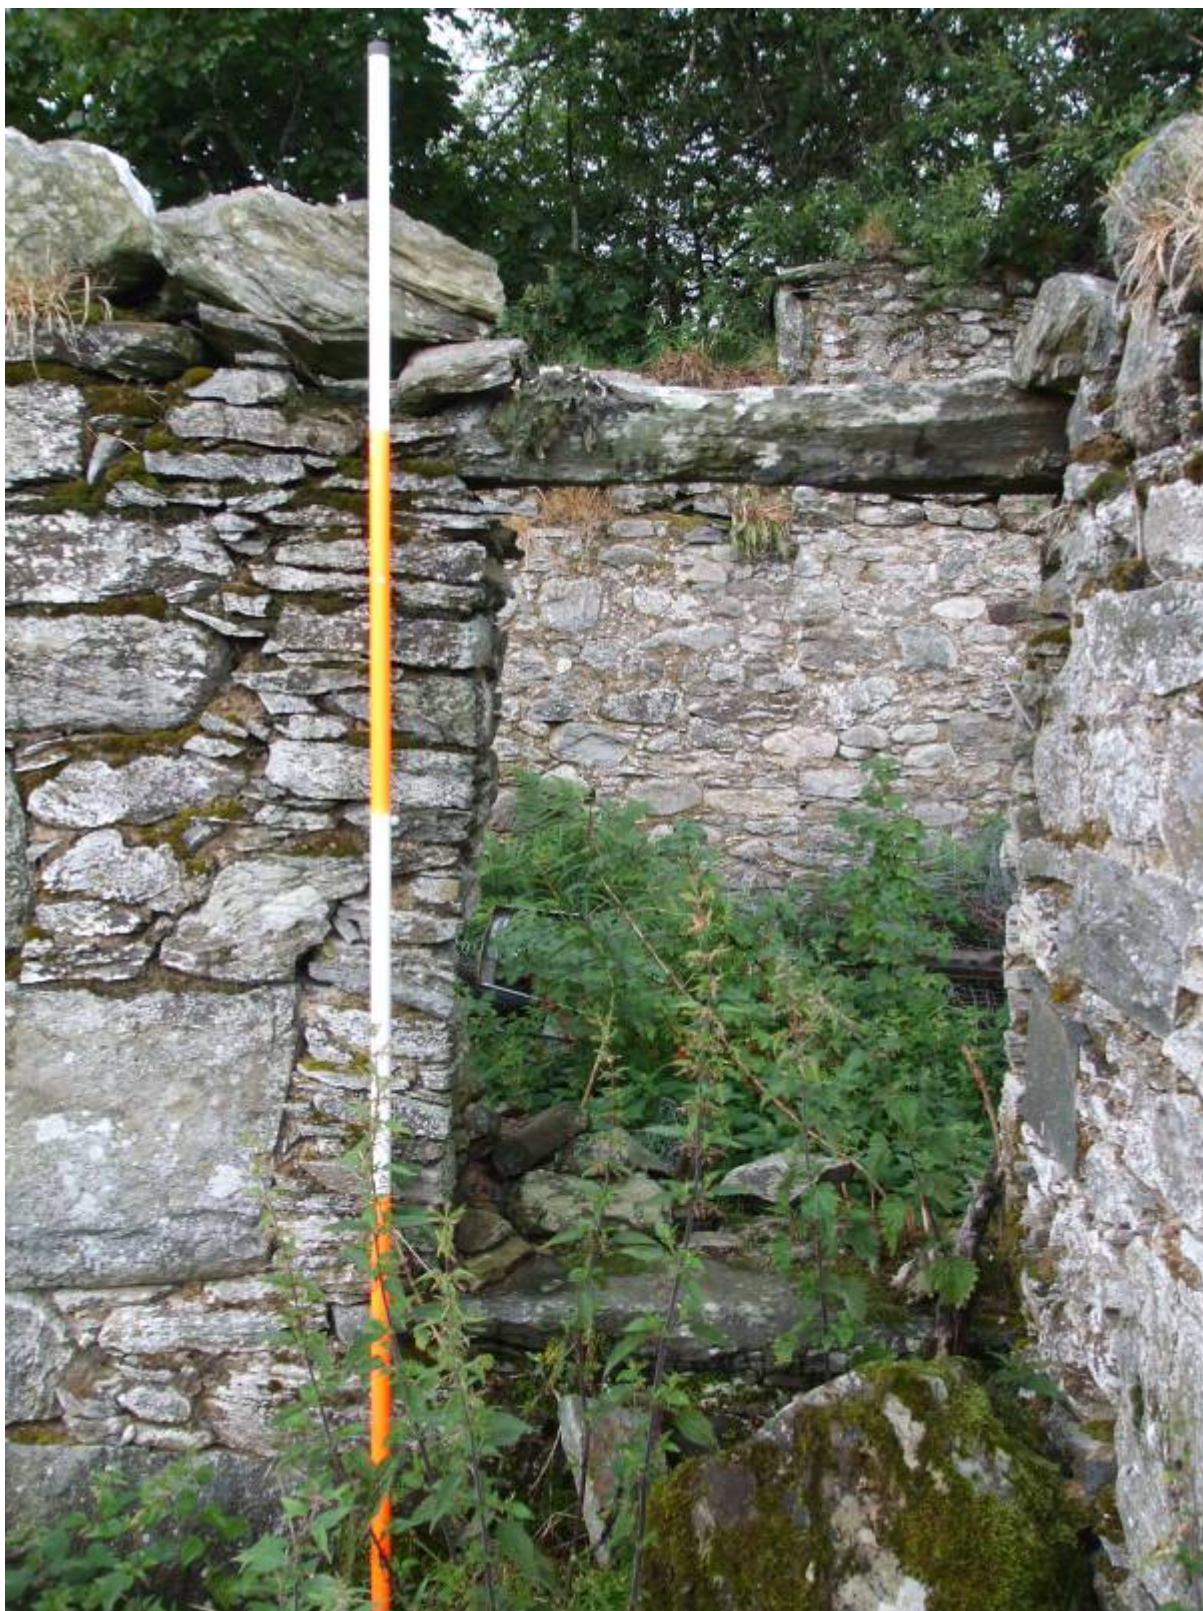
Illustration 14 Window in eastern elevation of building A

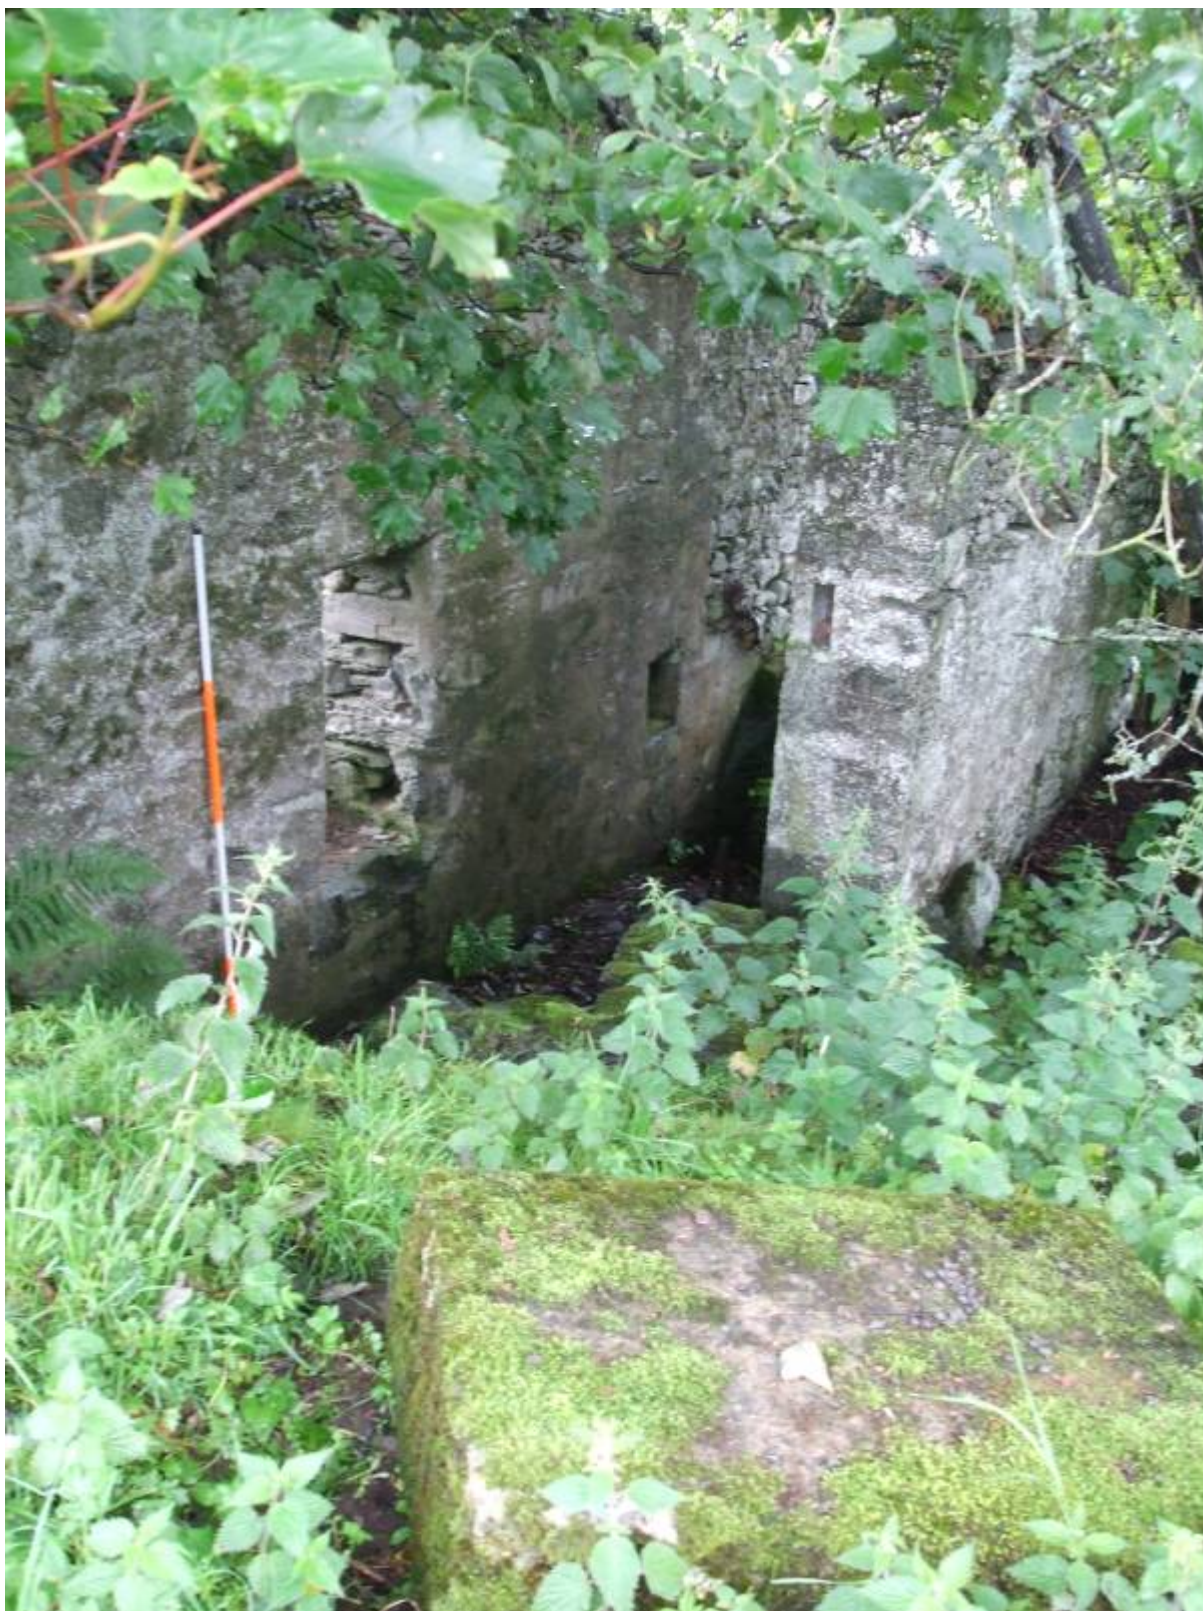
Illustration 15 Wheel pit against Western elevation of building A looking South East

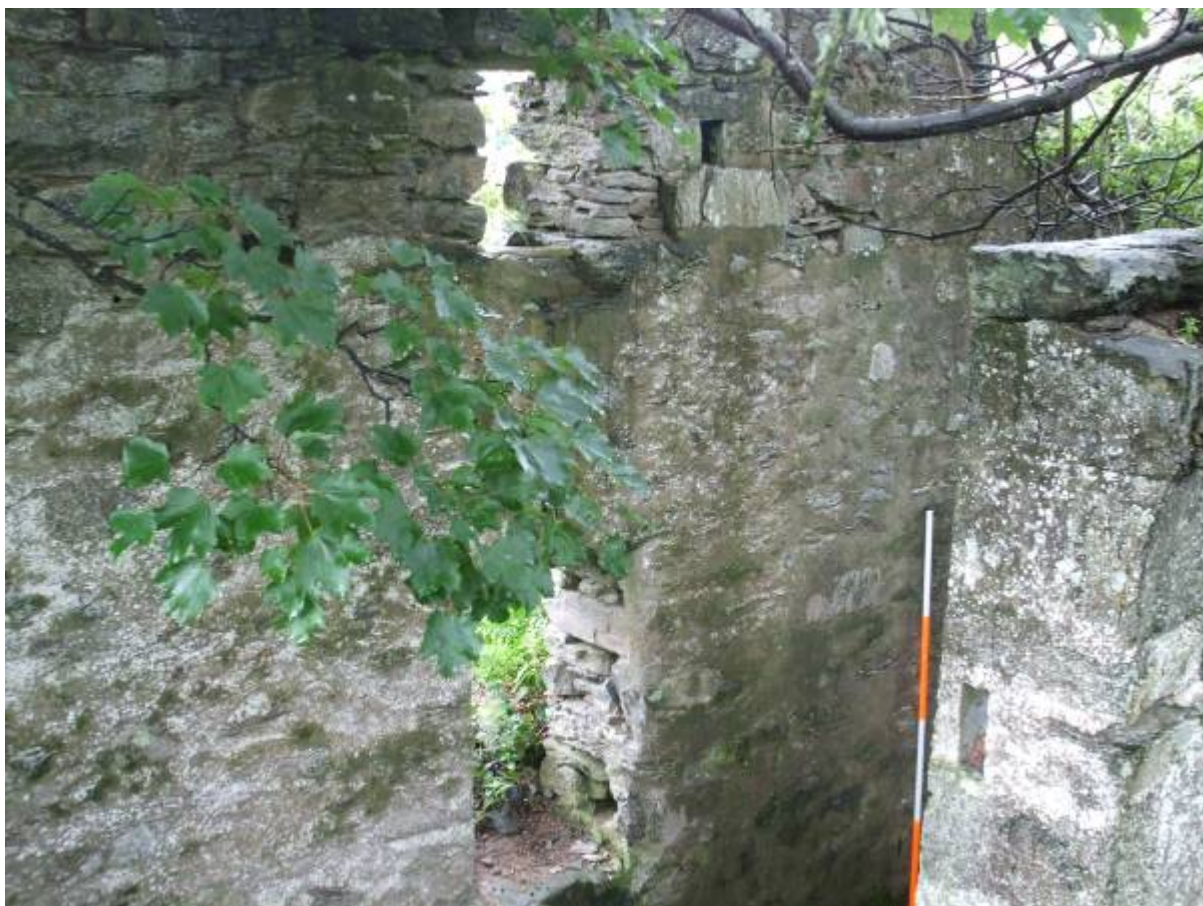
Illustration 16 Doorway and window in Western elevation of Building A

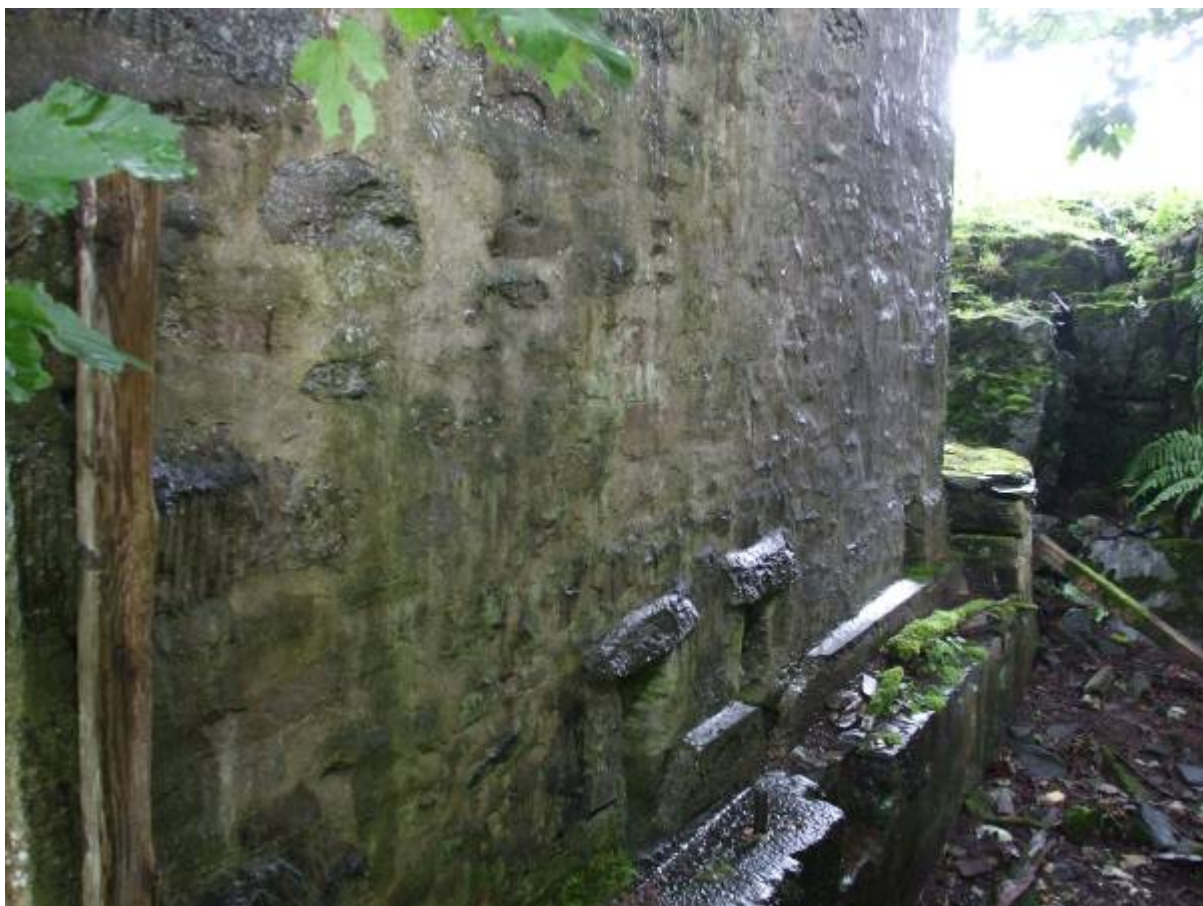
Illustration 17 Wall on Western side of wheel pit looking North West showing socket for mill wheel

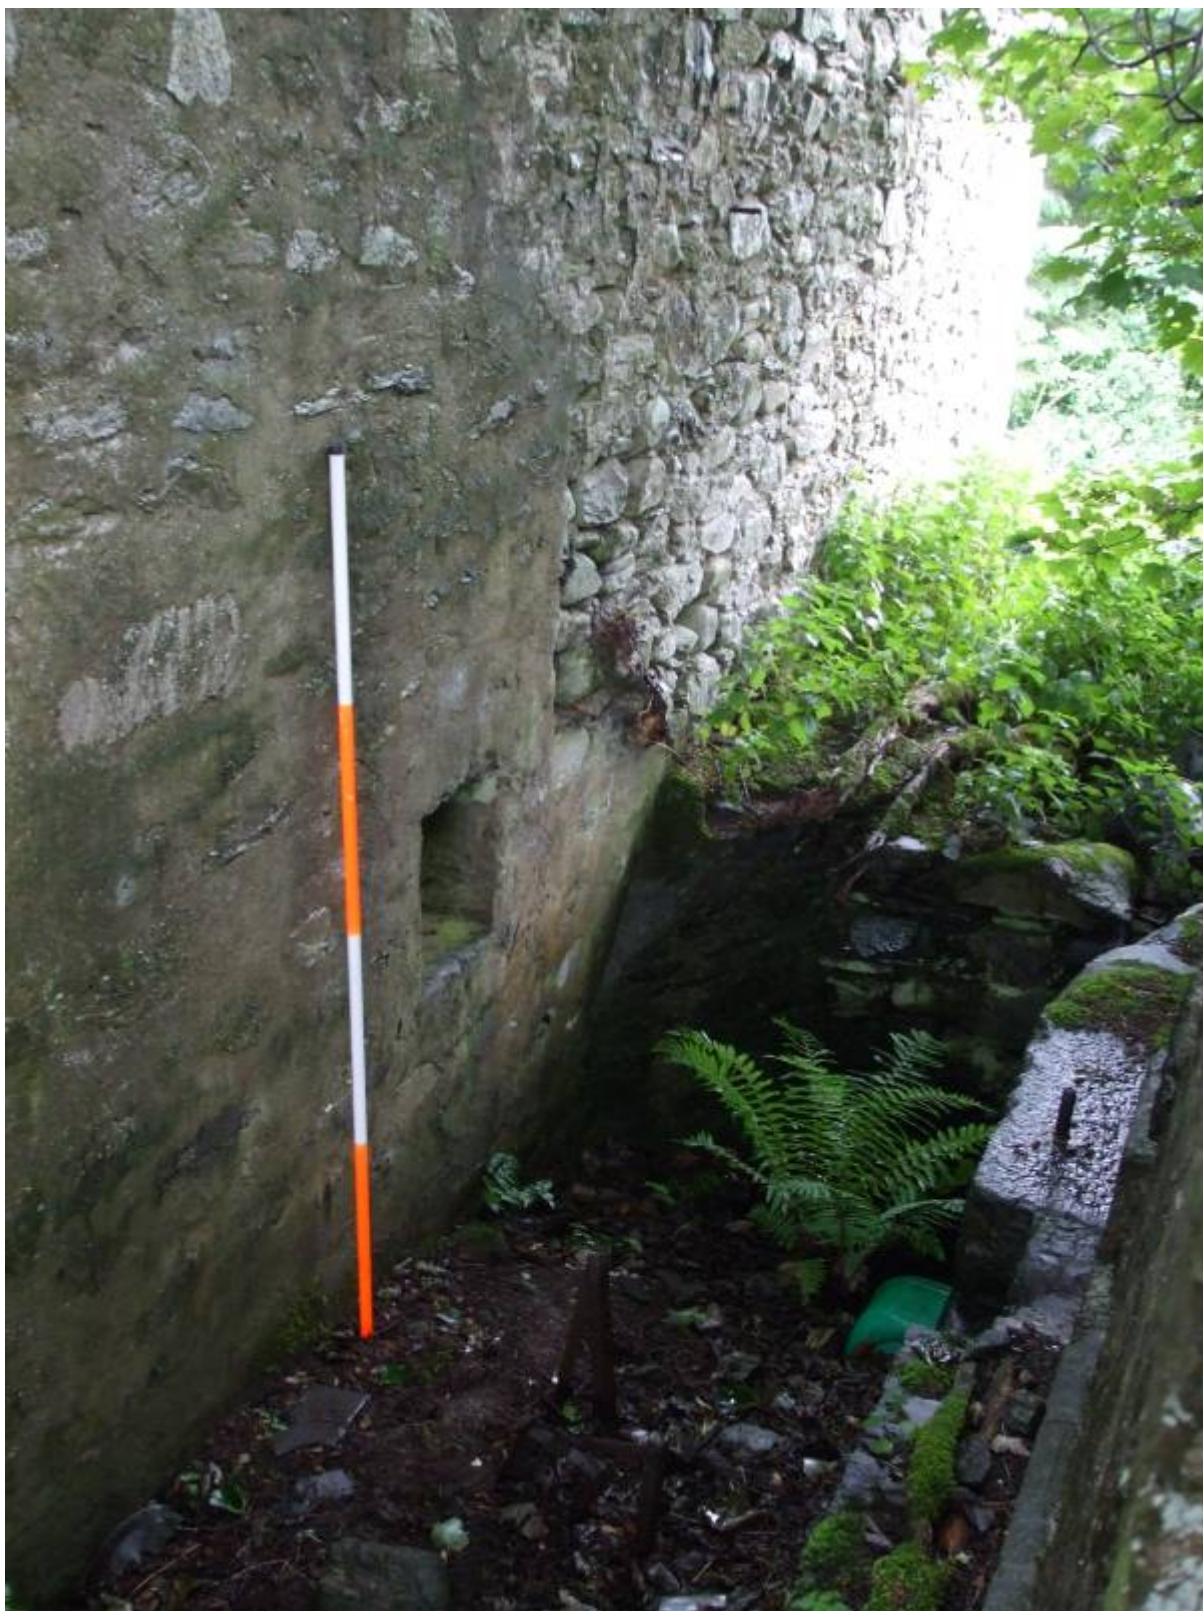
Illustration 18 Socket for mill wheel in Western elevation of Building A

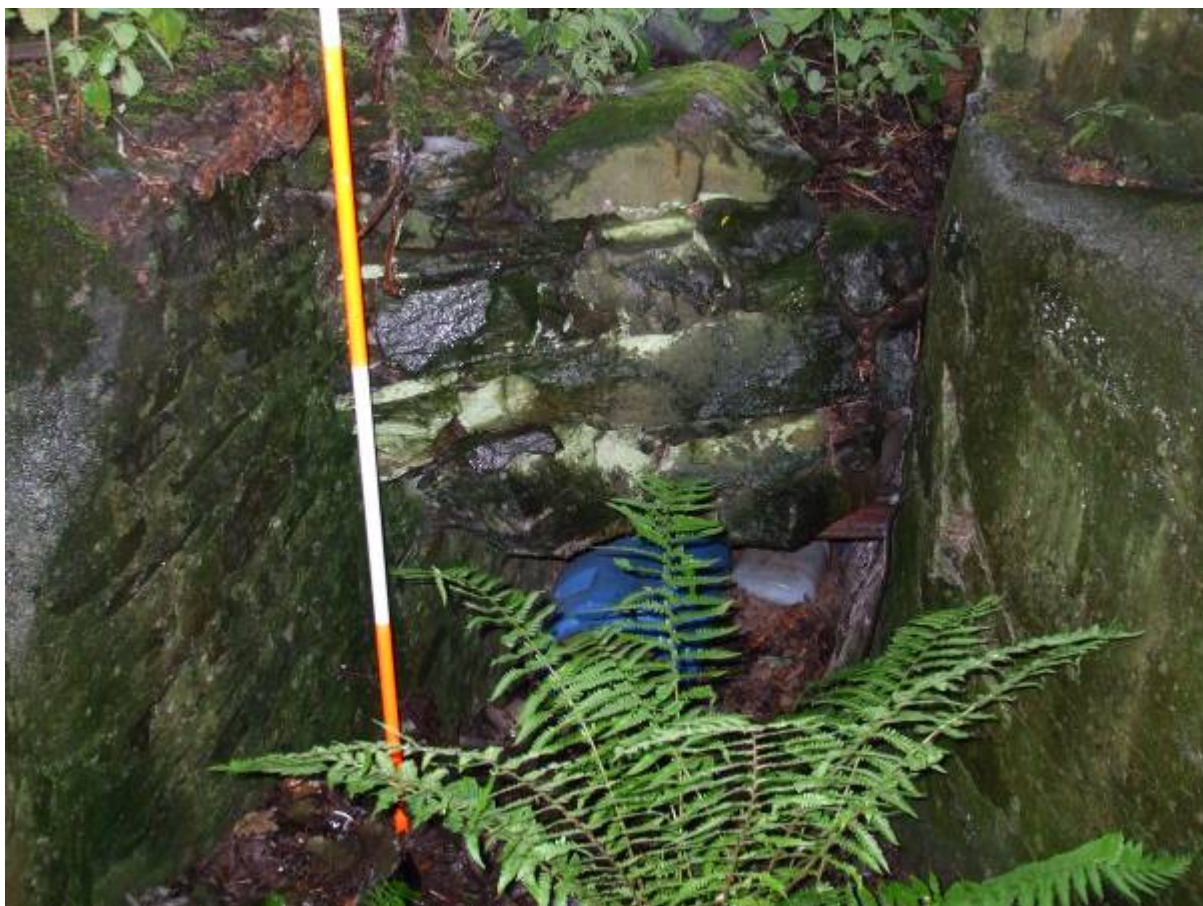
Building A's mill wheel was fed by a capped stone lined lade 0.70m wide which approaches the site from the North. The remains of two sluice gates are visible. Once the water had run through the wheel pit it then ran off into another lade which runs off south west to join the Cardney Burn. This lade is capped for a distance of 12m before it then becomes an open watercourse running down the hill.

Illustration 19 Entrance from wheel pit into southern mill lade
