Standing Building Survey
Former mill building, Middle Cardney
Butterstone, Perth and Kinross

Former mill building looking East

21st July 2010

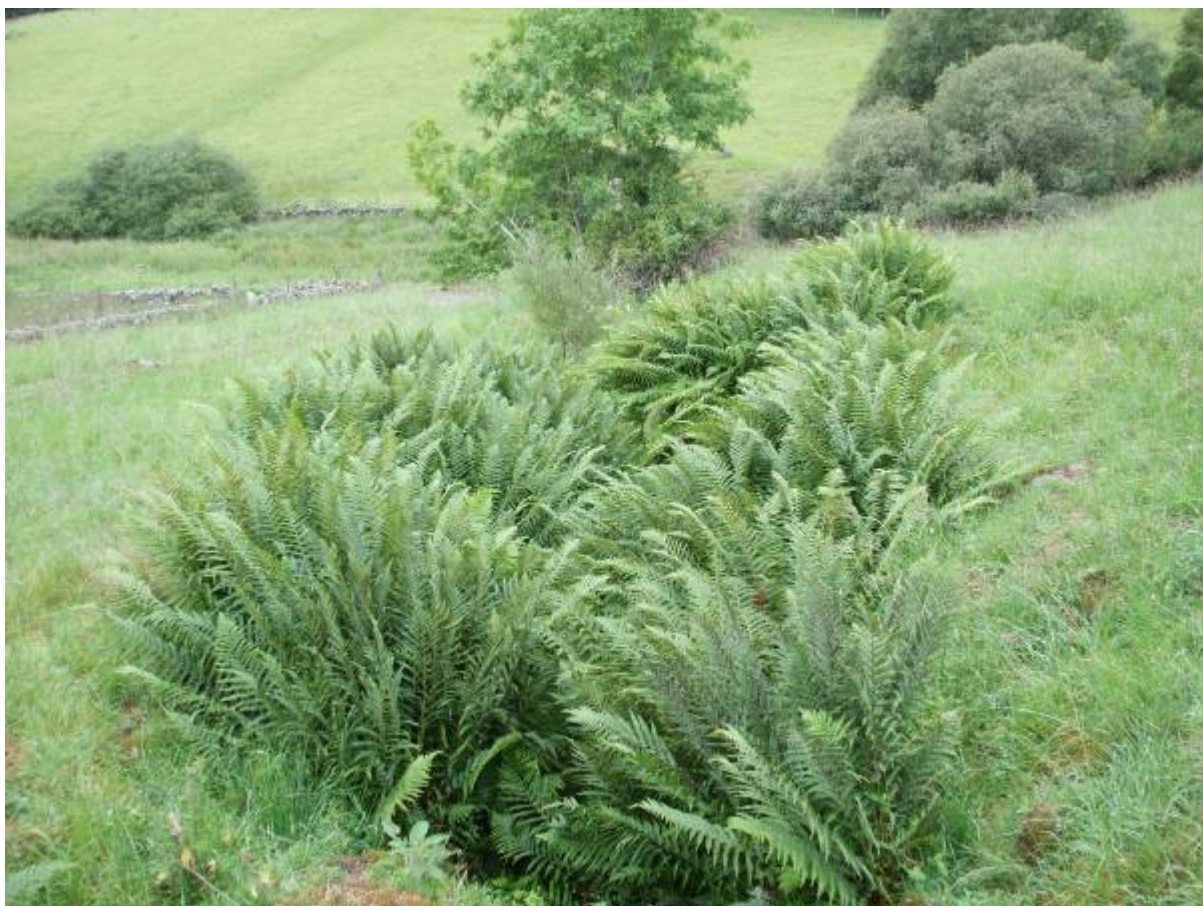
Building A's mill wheel was fed by a capped stone lined lade 0.70m wide which approaches the site from the North. The remains of two sluice gates are visible. Once the water had run through the wheel pit it then ran off into another lade which runs off south west to join the Cardney Burn. This lade is capped for a distance of 12m before it then becomes an open watercourse running down the hill.

Illustration 20 Southern mill lade running down hill to South West from mill

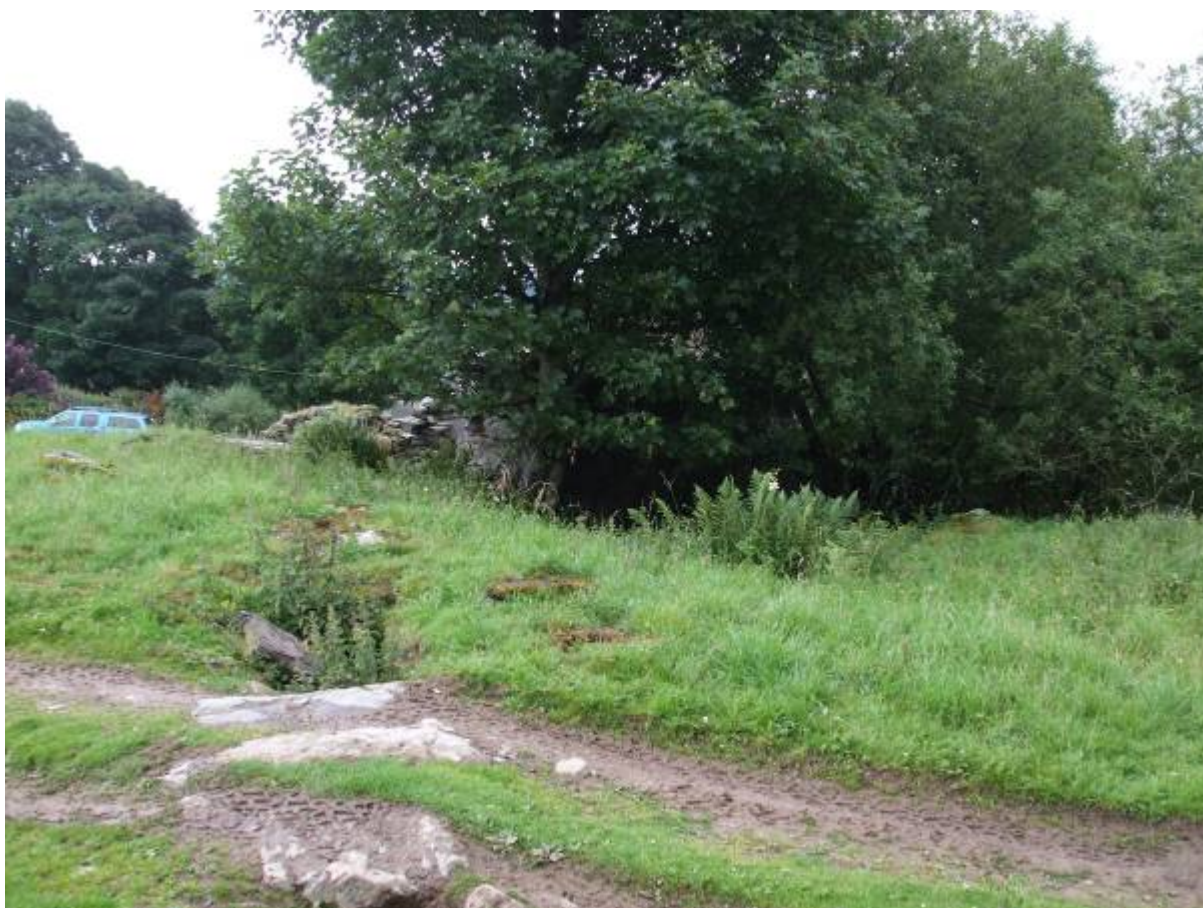
Illustration 21 Northern mill lade heading towards wheel pit

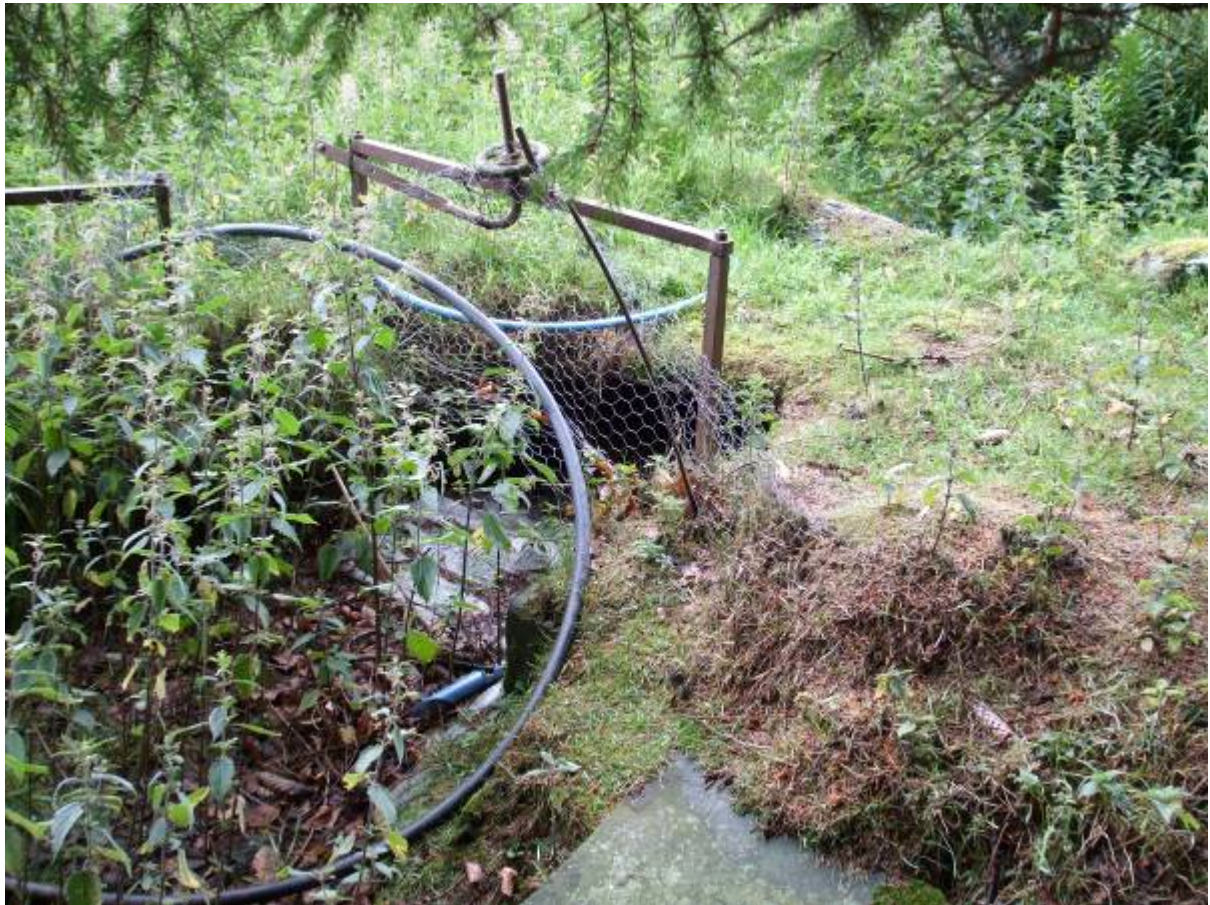
Illustration 22 Remains of sluice gates in northern mill lade looking South

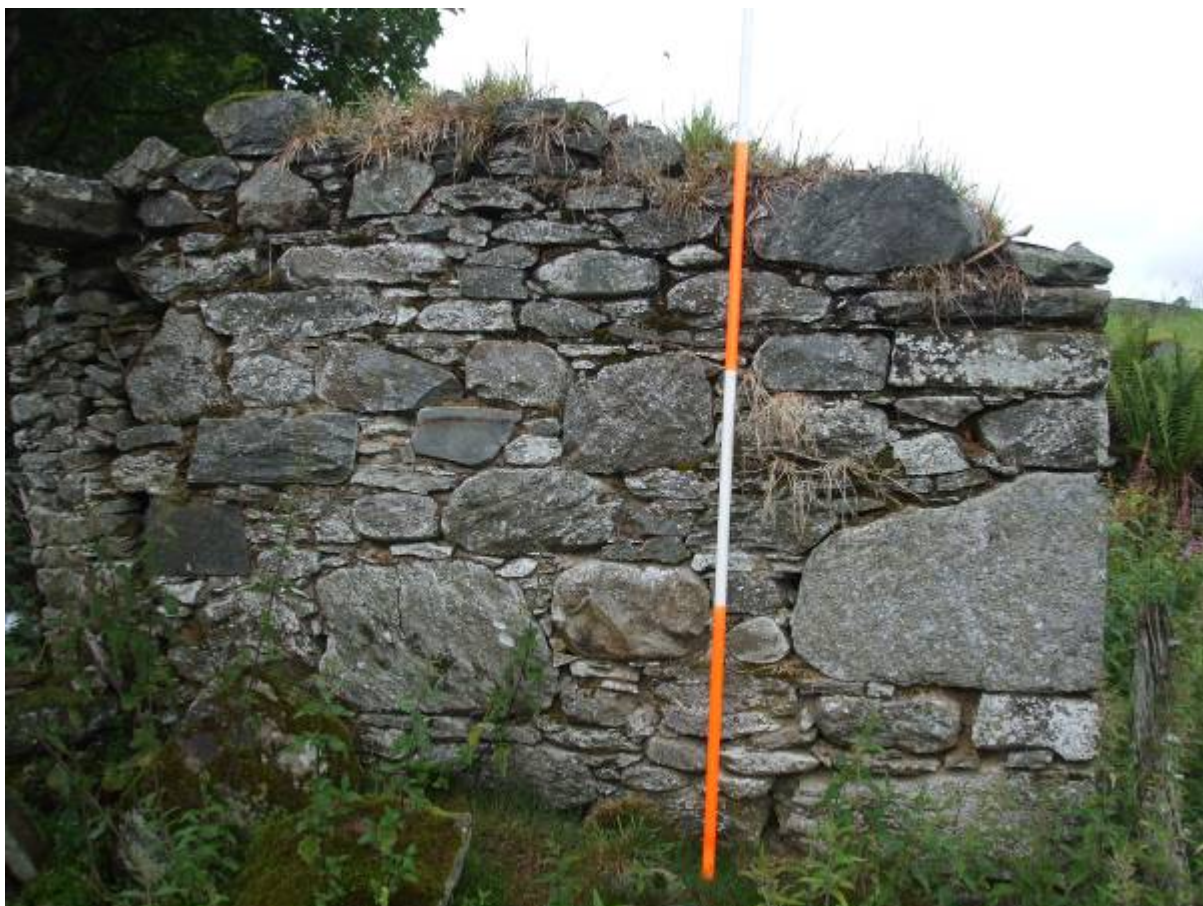
This is constructed of larger more regular stone rubble than Building A and is bonded with lime mortar. This elevation runs for 2.25m East of Building A before stopping at one side of a former entrance. The remainder of this elevation has gone.

Illustration 23 Only standing element of Southern elevation of building B

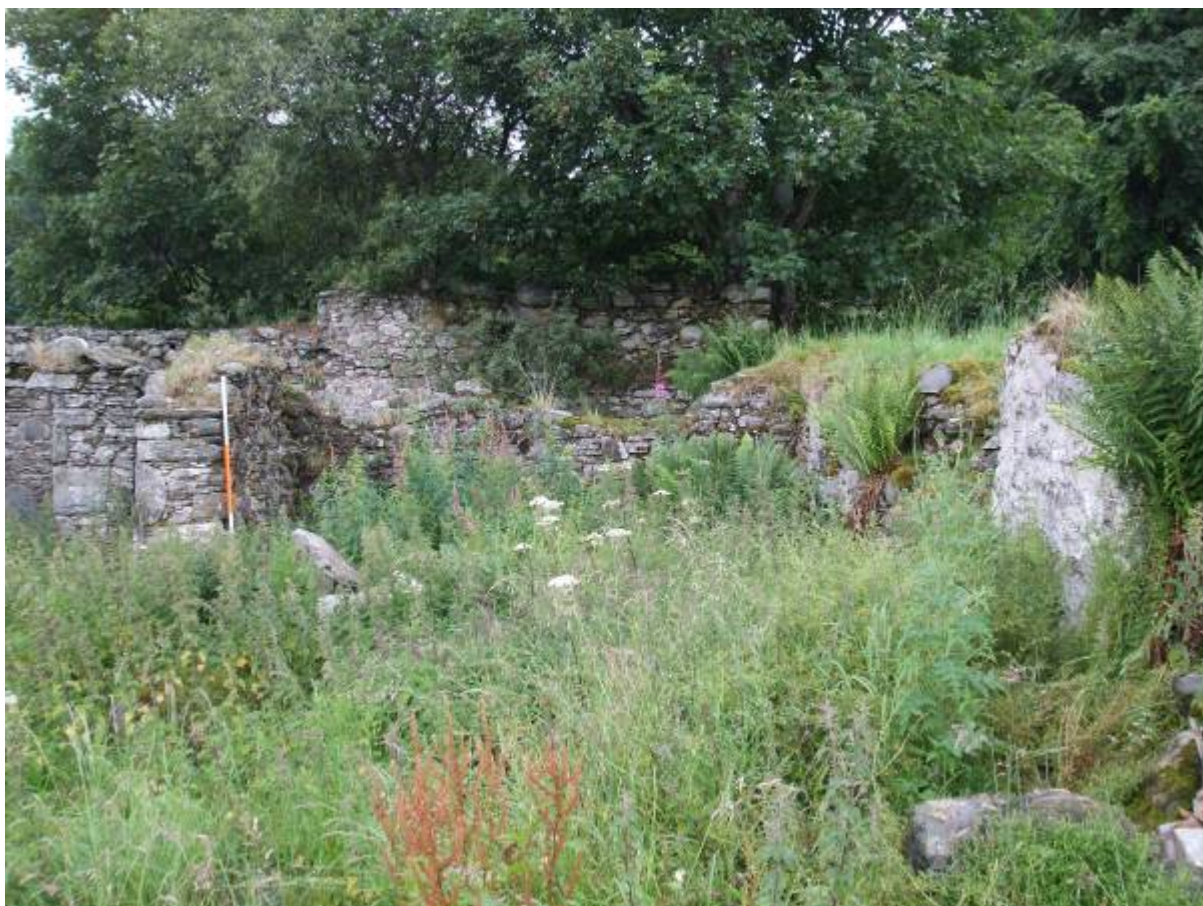
This is constructed of large mortar bonded rough stone rubble and is built against the exposed rock face. A small part of the interior face of this wall is plastered at its eastern end.

Illustration 24 General view across site of building B (Scale stands against Southern elevation), slightly plastered northern elevation visible on right of picture

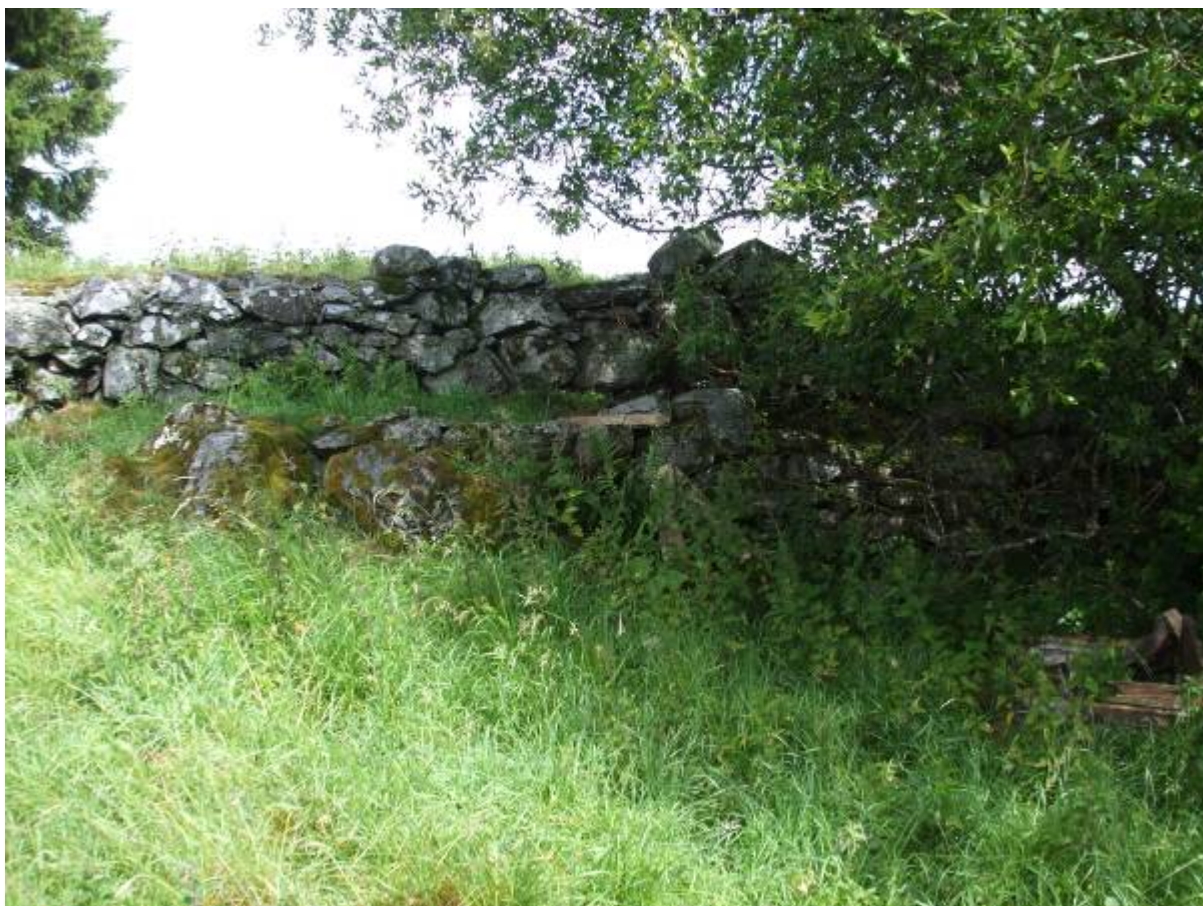
To the north west of building A is a stone built platform with revetted stone wall faces on its Southern side. This appears to have been designed as a loading area associated with the mill building.

Illustration 26 Revetted rubble platform to West of Building A

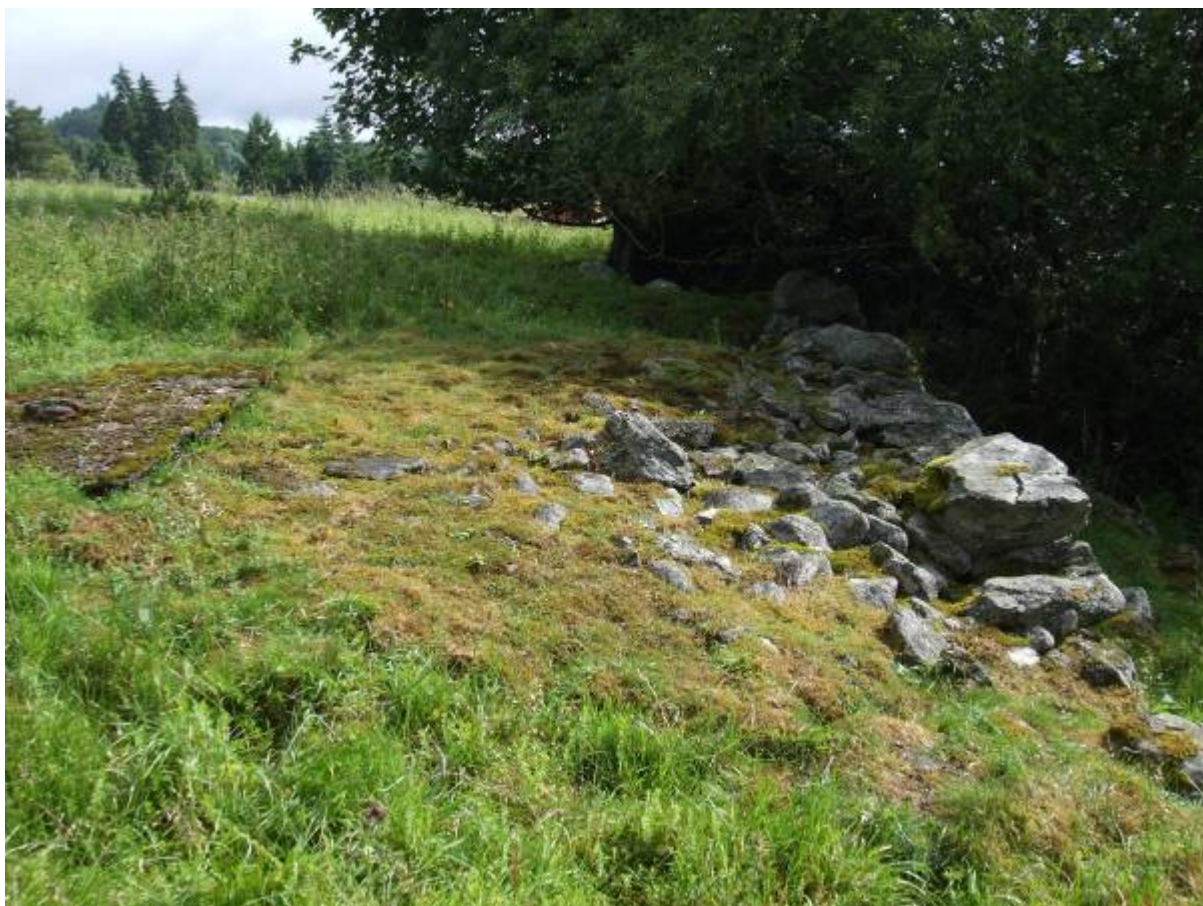
Illustration 27 Surface of revetted rubble platform to West of building A

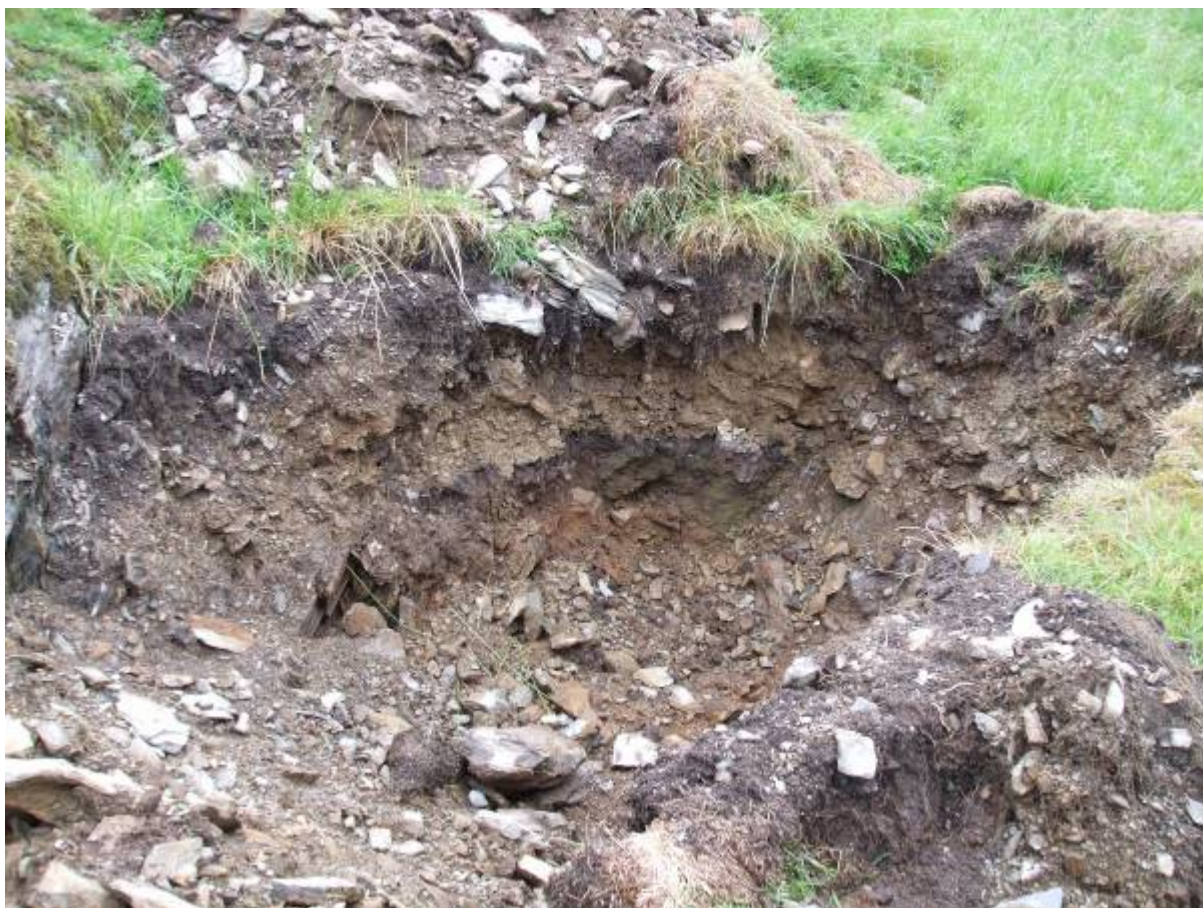
This pit measures 2.5m by 1.5m and has been dug to a depth of 1m below current ground level. From the top the deposit sequence is as follows: 0.20m of turf and topsoil overlies 0.30m of rubble and mortar which overlies an orange brown silty clay 0.20m thick. This last deposit lies directly above natural rock and glacial till. There were no finds present in this pit.

Illustration 28 Engineers test pit 1 in footprint of new house
