Standing Building Survey
West Ardler farmhouse
Ardler, Perth and Kinross

23rd November 2010

Introduction (Illustrations 1 and 2)

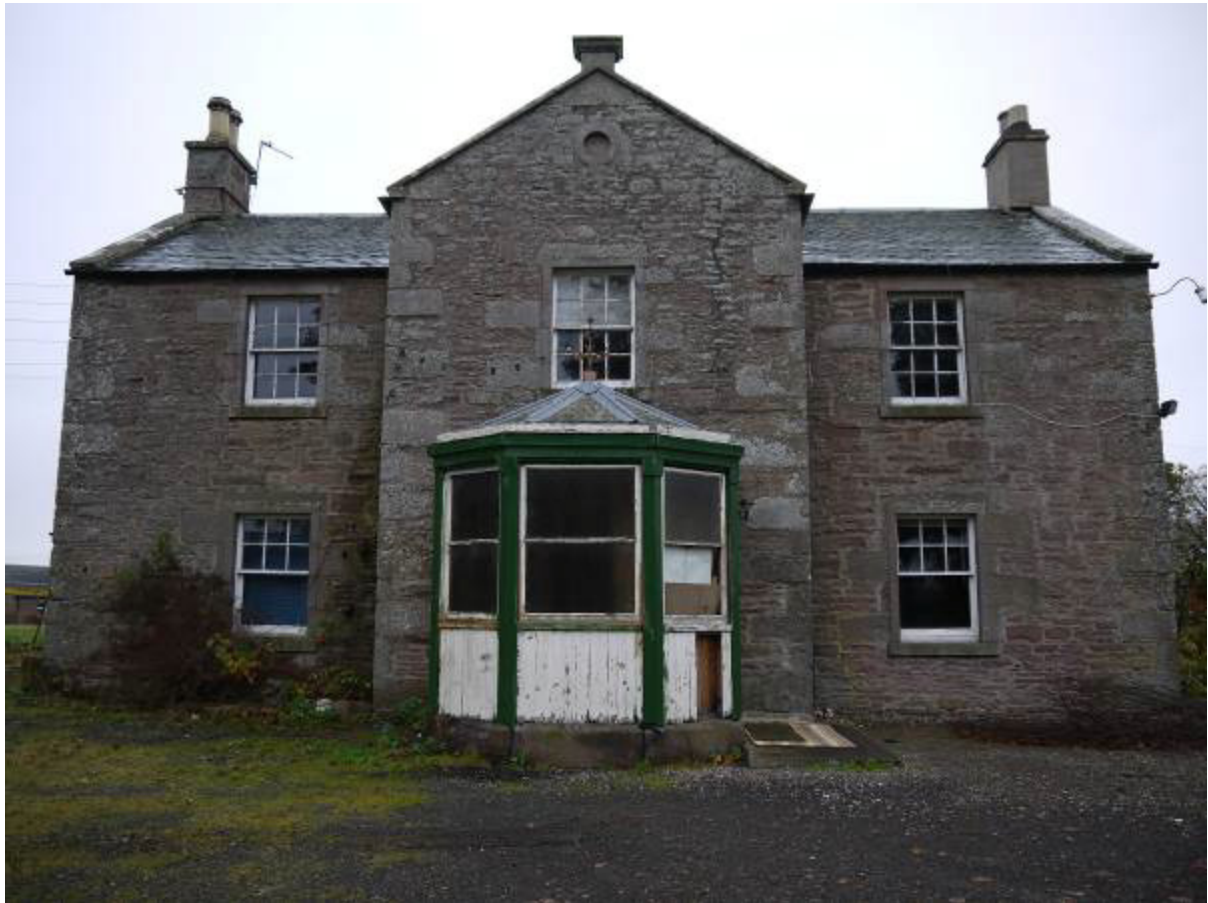
Illustration 5 Western elevation of farmhouse (Building A) looking North East

This elevation has a central pediment with a small roundel at its top and is capped with a finial. A small glazed wooden porch has been built against the front of the pediment. The Northern and Southern wings of this elevation each have two wooden windows built into the wall one above the other.

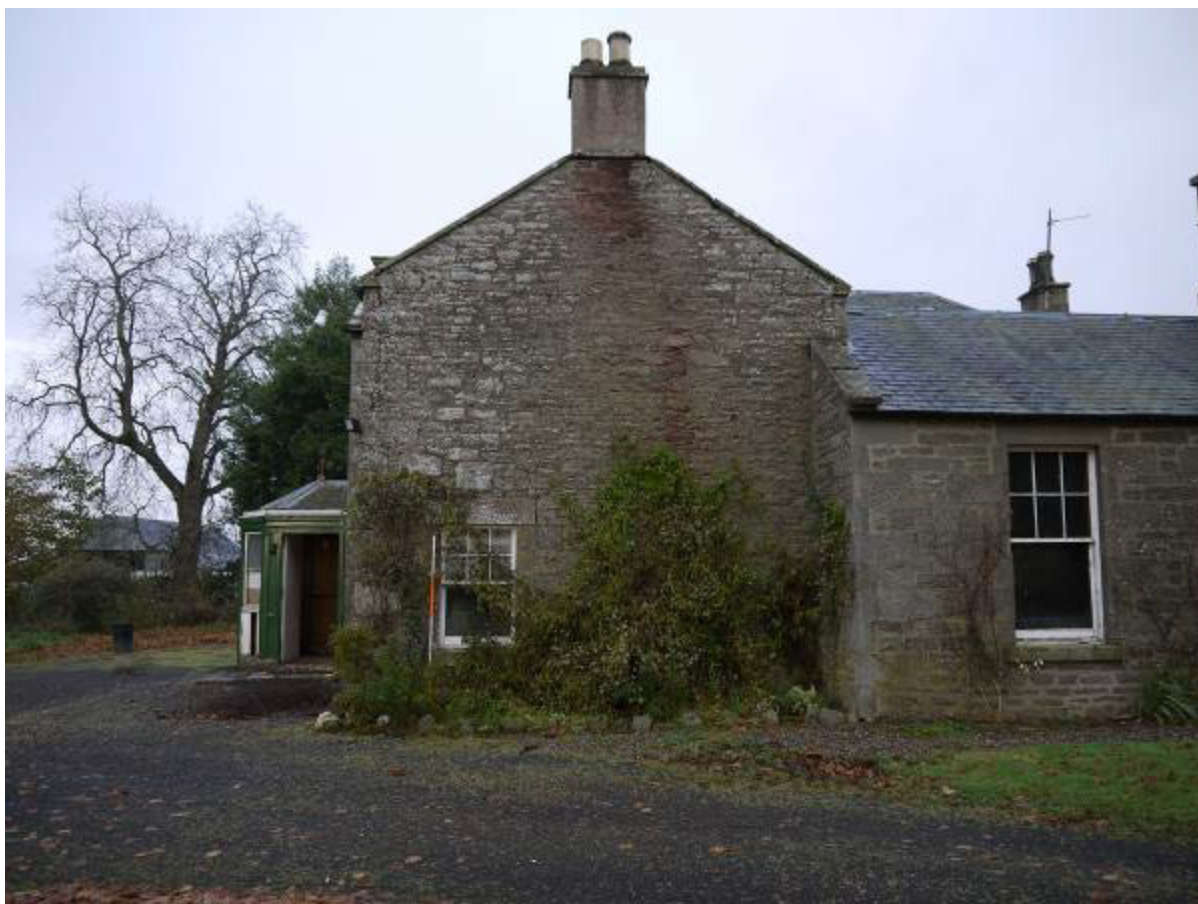
Illustration 8 South Eastern elevation looking North West

This elevation has a single wooden window at ground level and has had a large single storey building (B) attached to its eastern side.

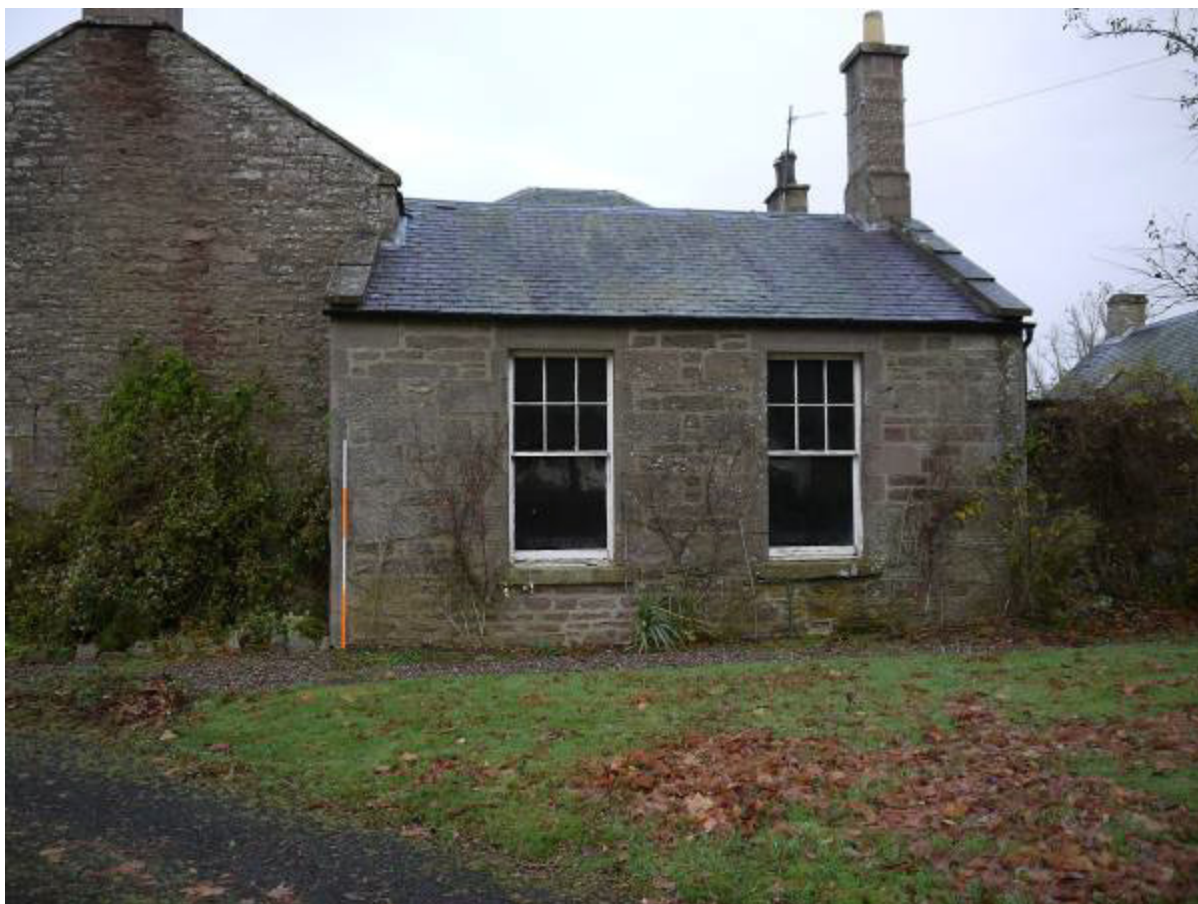
Illustration 9 South Eastern elevation of Building B built against North Eastern side of farmhouse

This elevation contains two tall wooden windows.

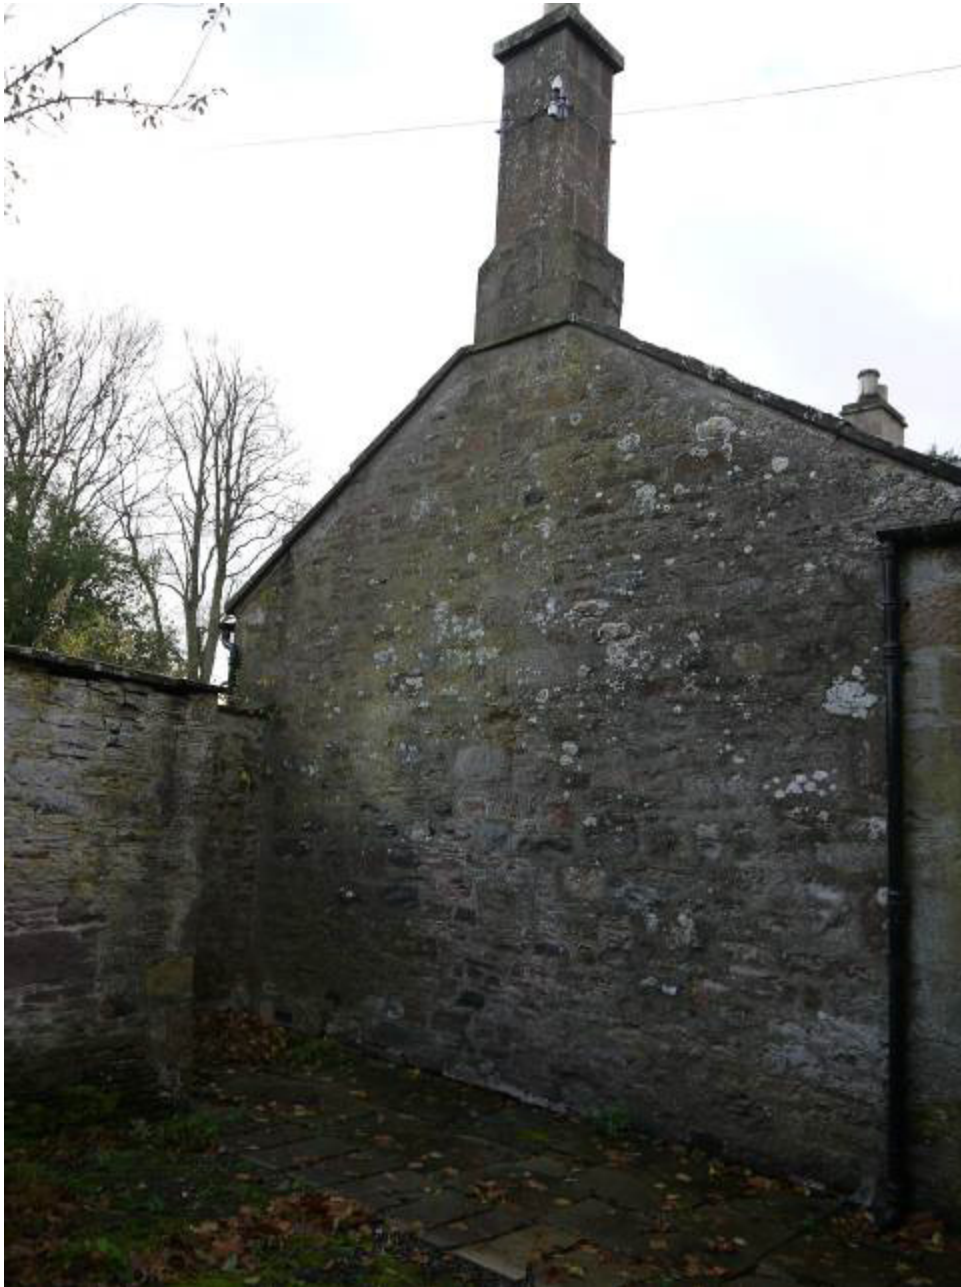
Illustration 10 North East facing elevation of Building B looking South West

This elevation has a blank wall face and a tall chimney at its gable.

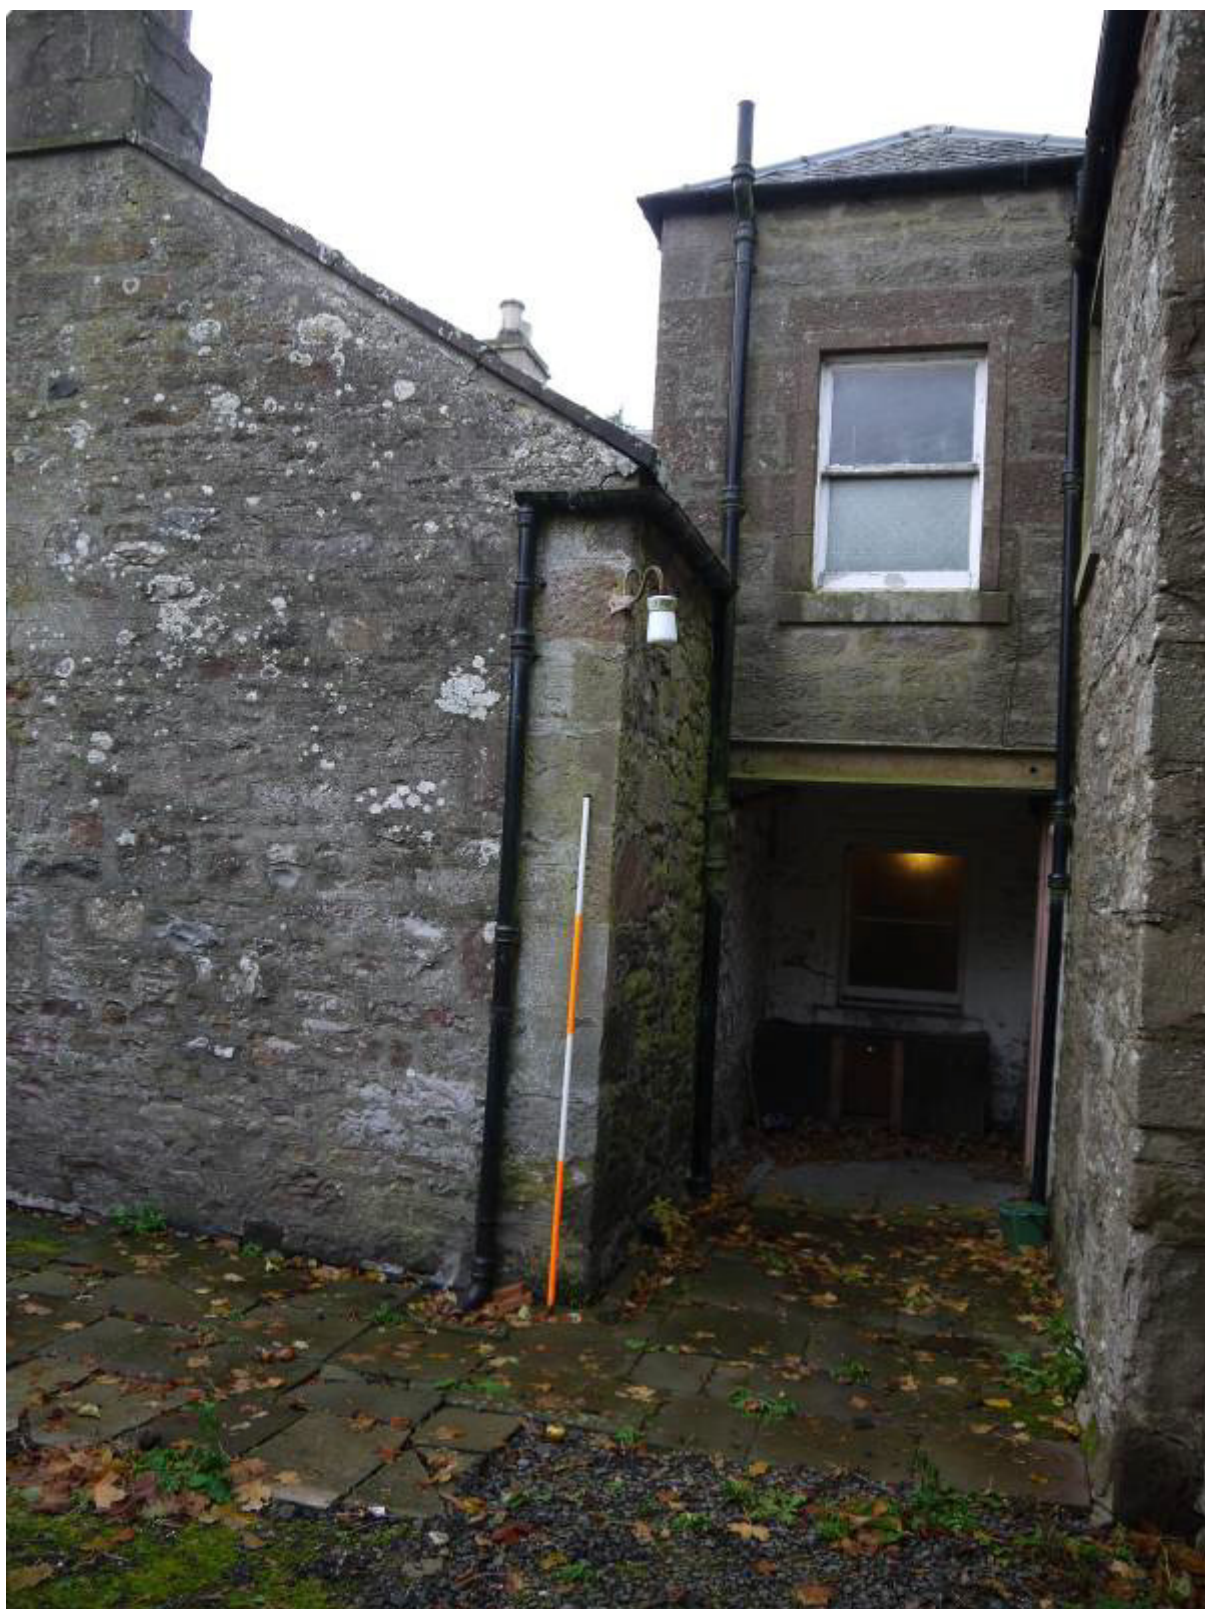
Illustration 11 South Western elevation of Building B and visible remnant of elevation of Building A

The face of this elevation has been obscured by the construction of Building B against its face and the addition of a small bathroom extension at first floor level that is supported by a RSJ. The small section visible includes a wooden window at ground floor level.

This elevation has a blank wall face.

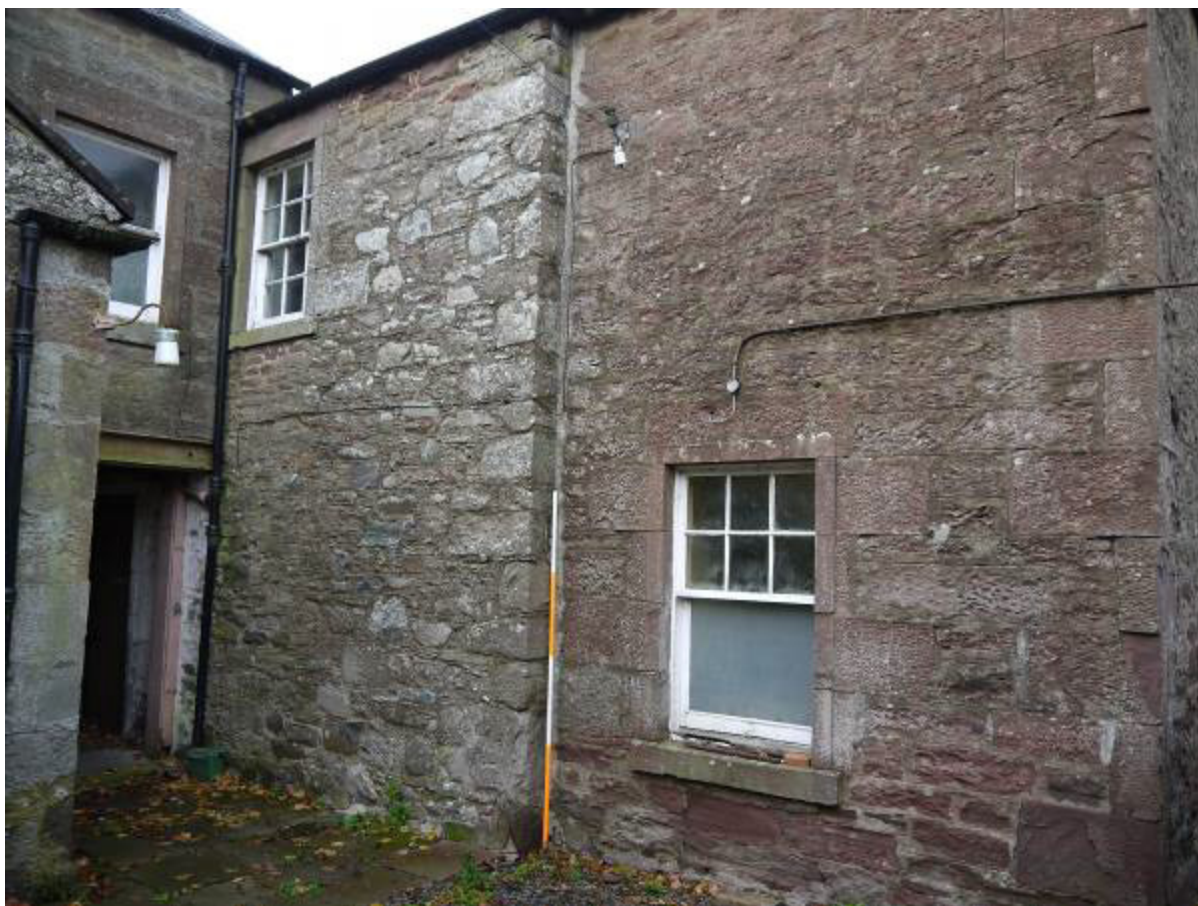
Illustration 12 North Western elevation of Building A showing extension

This elevation has a blank wall face at its Western end. 10m North East along this elevation are two adjacent wooden windows at ground level and a further two windows at first floor level. A small single storey structure has been built against the wall face which partially obscures the corner of one of these windows. The North Eastern end of this elevation has been extended 3m beyond the original gable line which is topped by a chimney.

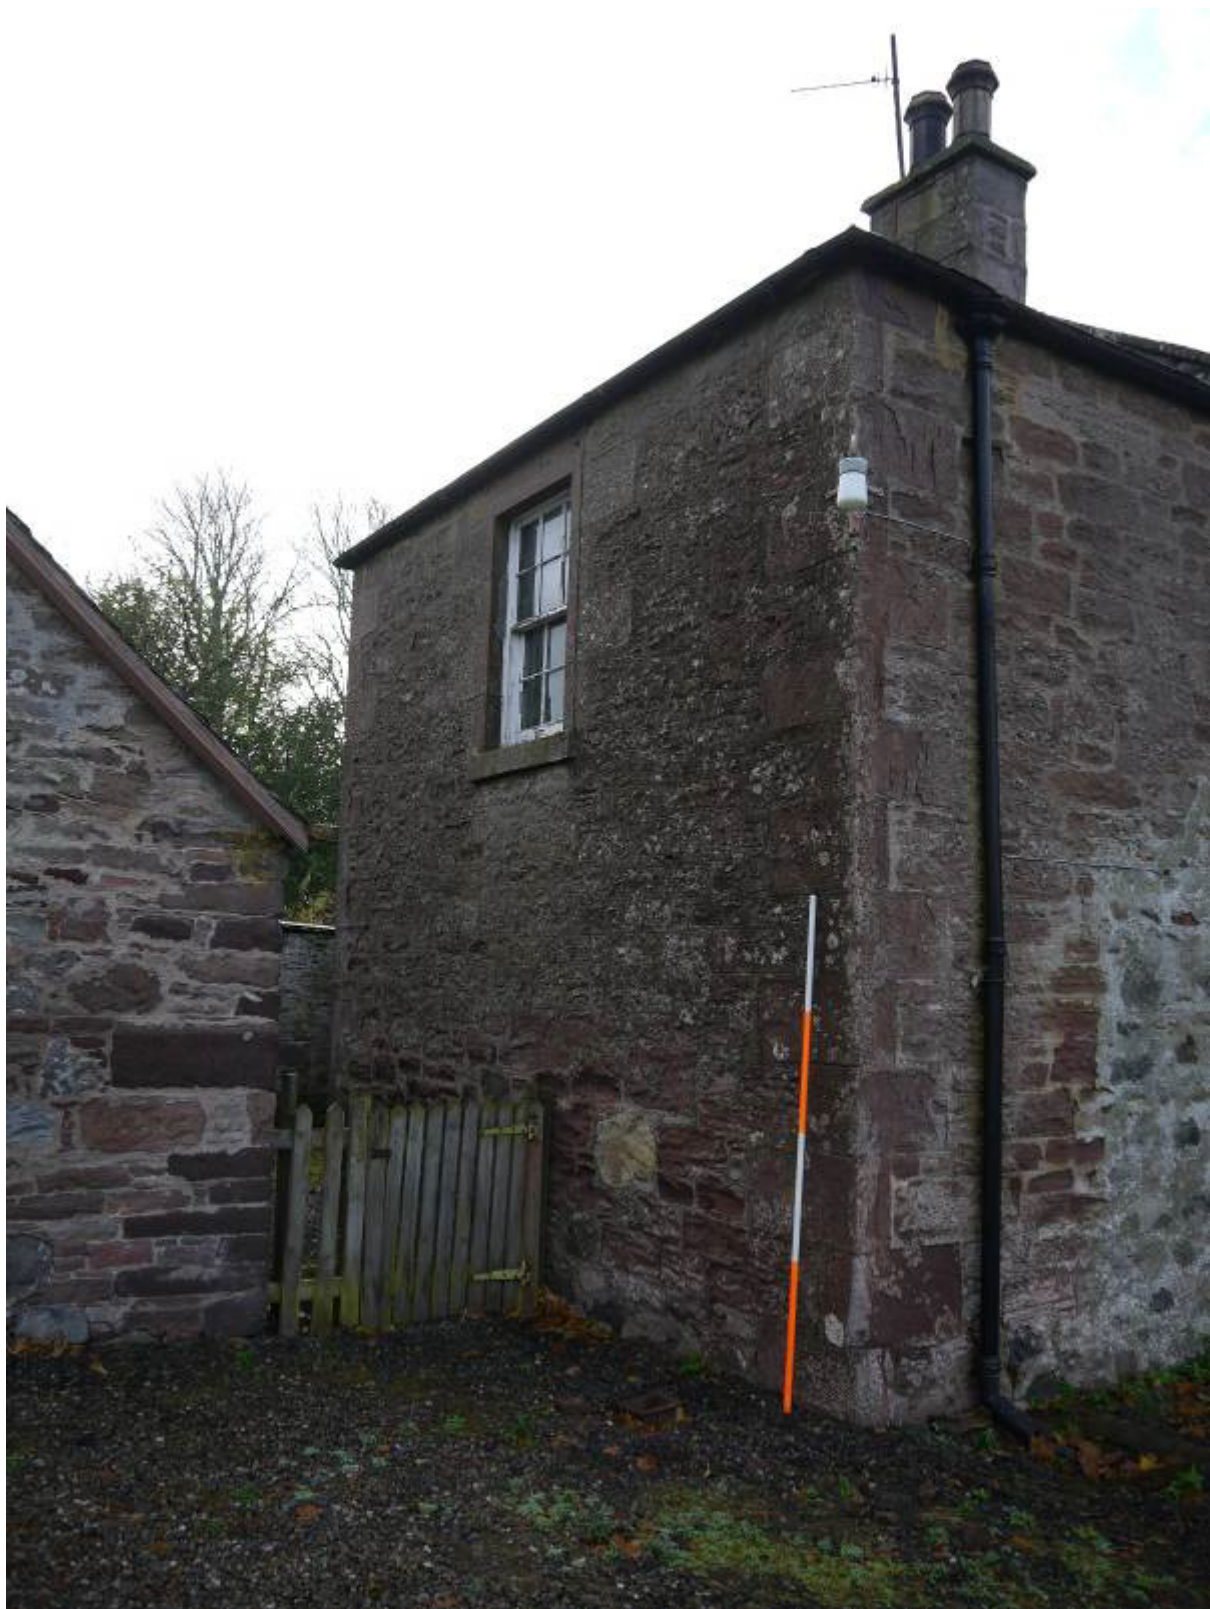
Illustration 13 South Western elevation of extension to Building A

This elevation has a doorway at ground floor level in the angle of the junction with the Southern arm of the building and a wooden window at first floor level. The North Eastern extension to this arm has a single wooden window at ground floor level.

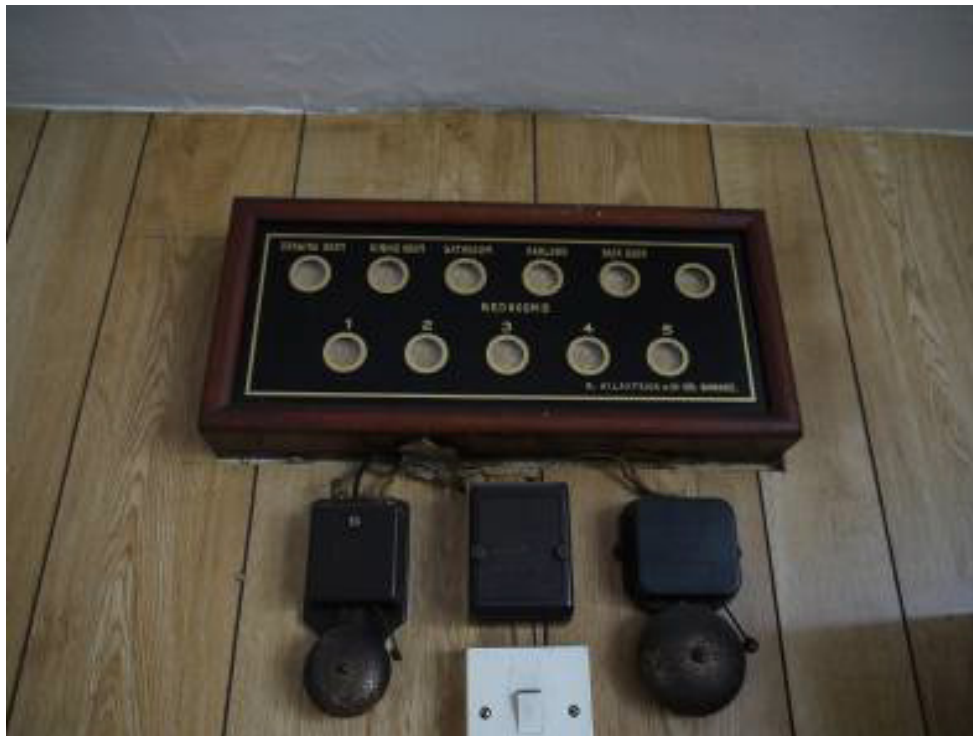
Illustration 22 Call system in kitchen

extension that has been added to the North Eastern arm of the farmhouse. The call system visible in the kitchen was presumably added at the same time (Illustration 22).

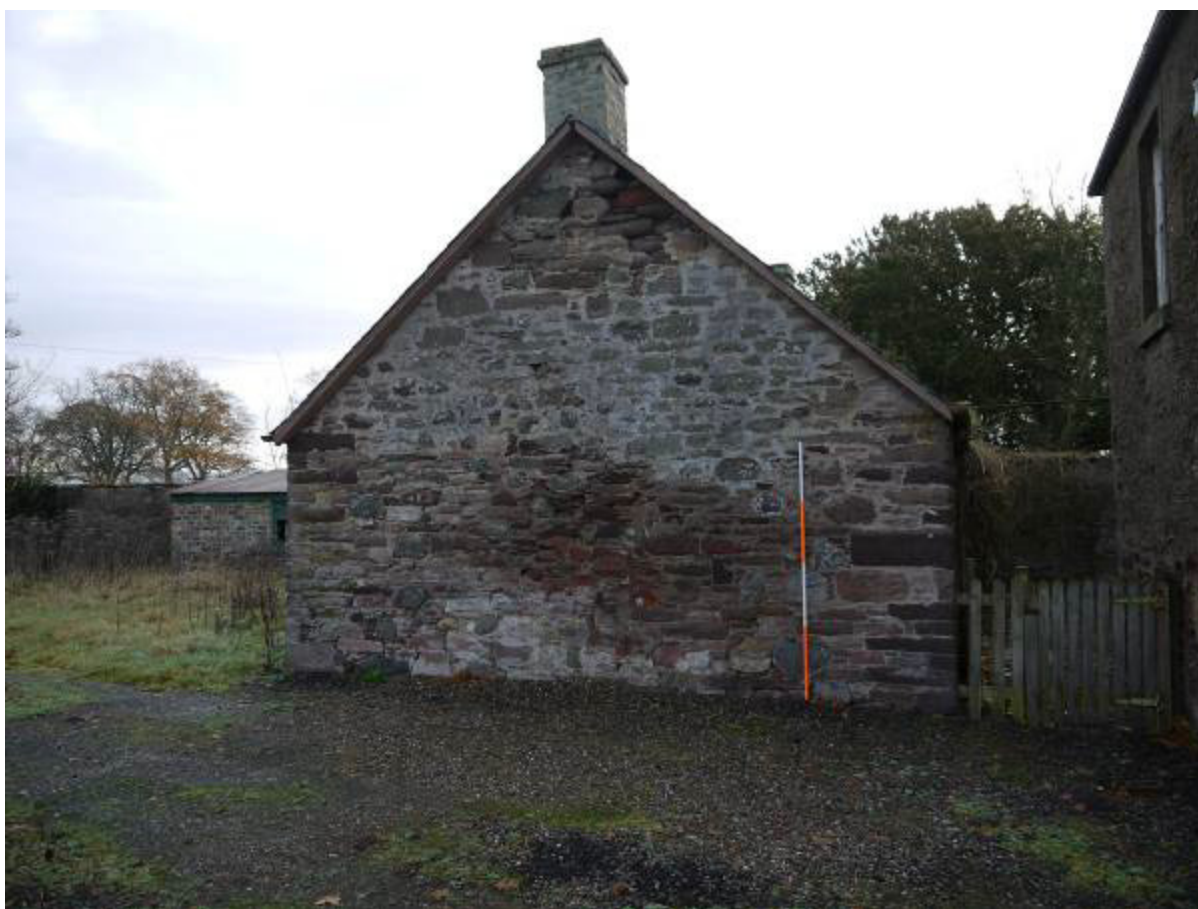
Illustration 24 North Western elevation of Building C looking South East

This elevation has a blank wall face although there are traces of a blocked narrow window; some of the blocking is made up of handmade red bricks.

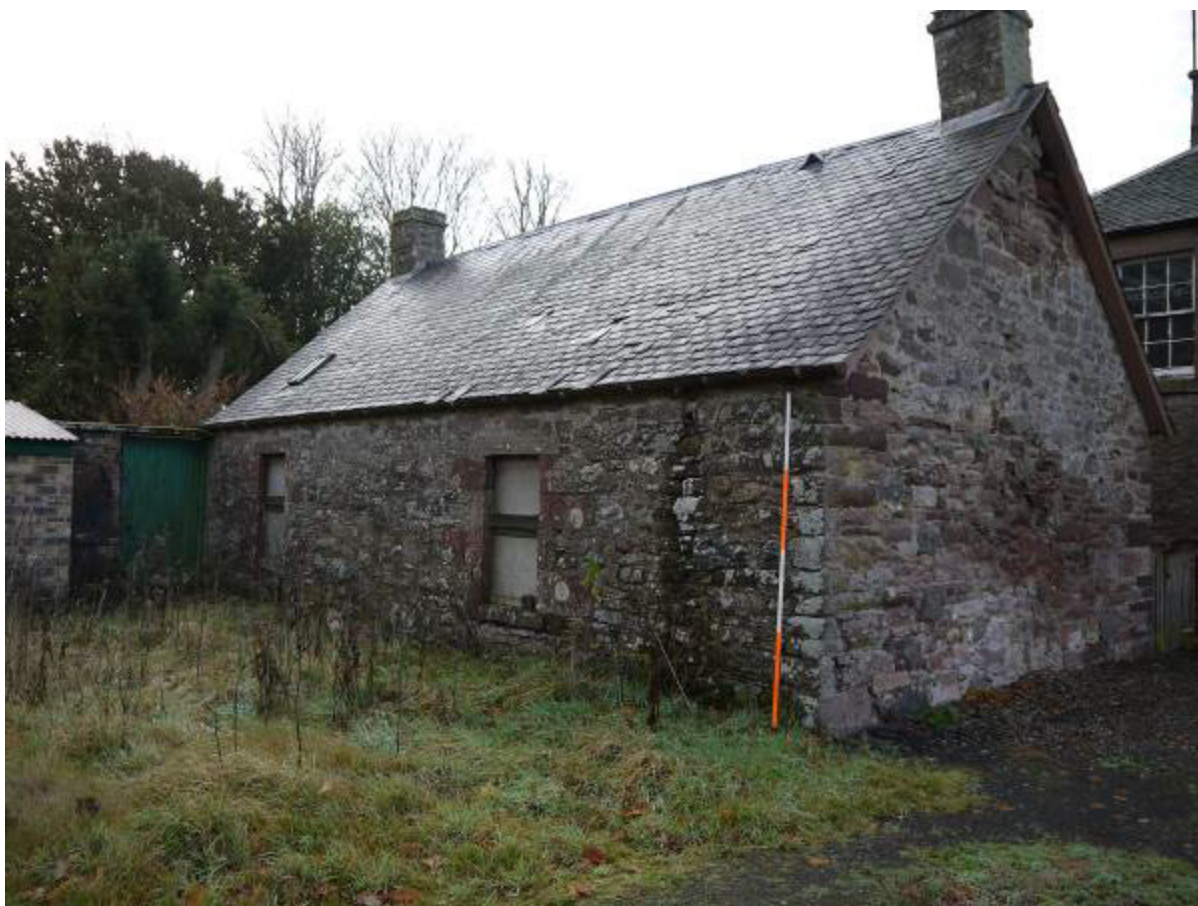
Illustration 25 North Eastern elevation of Building C looking South West

This elevation has a wooden window at either end.

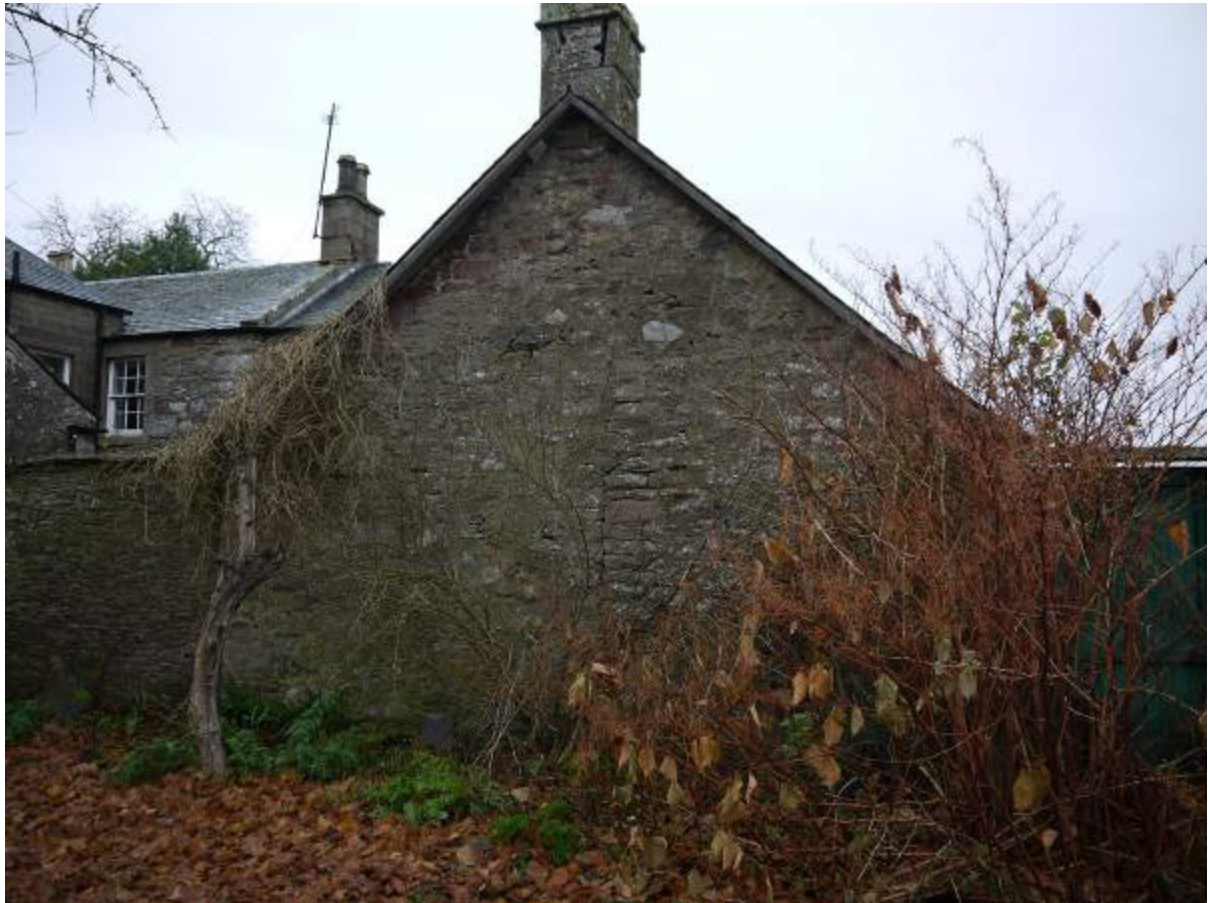
Illustration 26 South Eastern elevation of Building C

This elevation has a central doorway with a wooden door and a wooden window on its northern side.

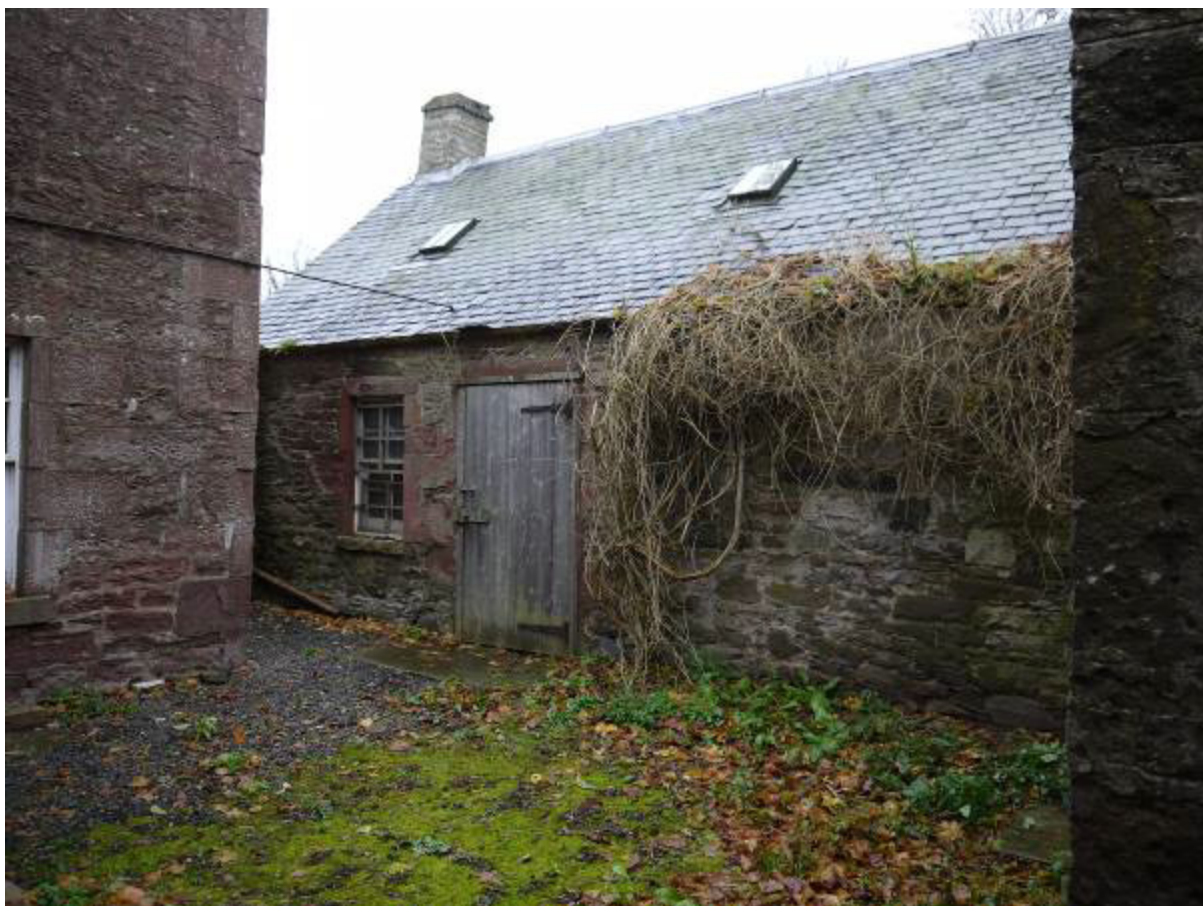
Illustration 27 South Western elevation of Building C

This elevation contains traces of a blocked doorway at its Eastern end.

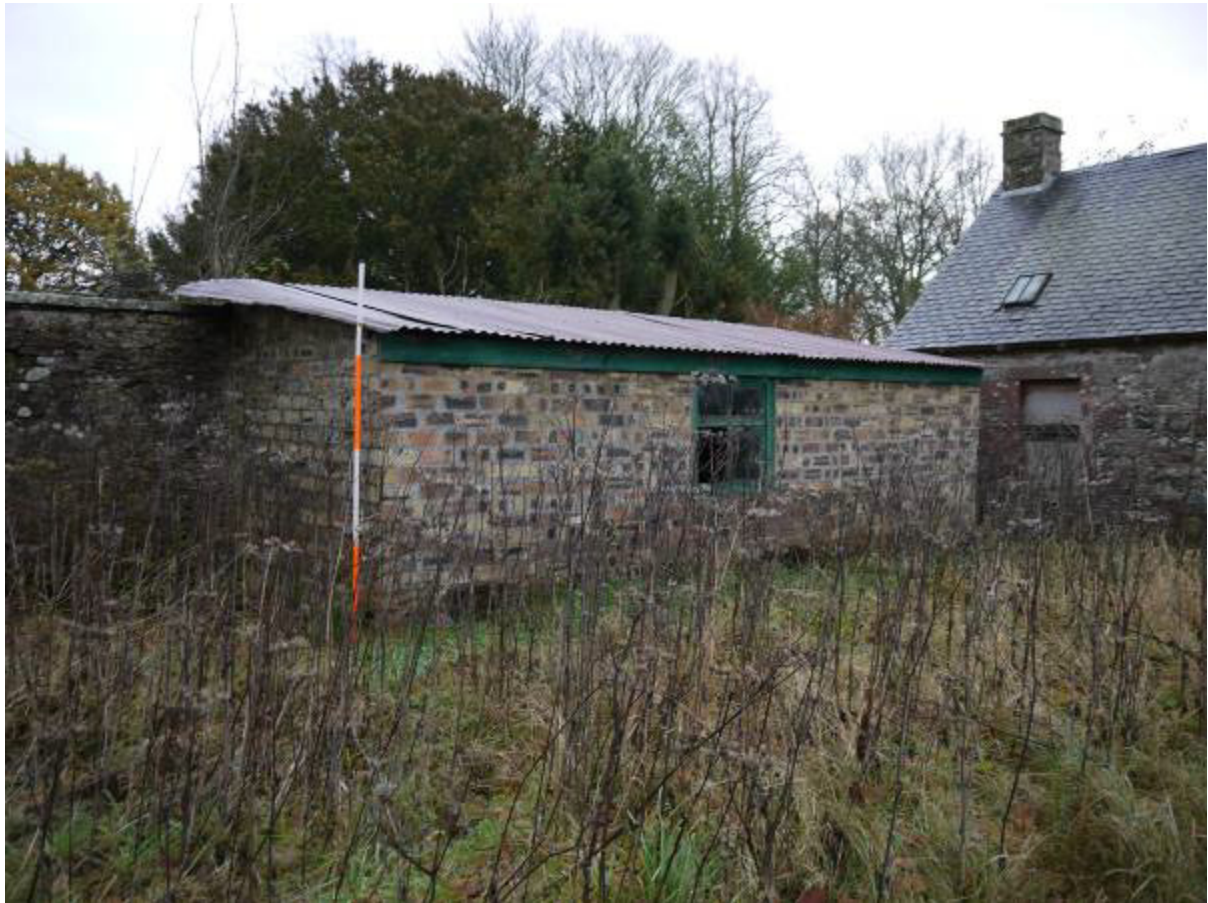
Illustration 28 Building D looking South West

Built against the Northern face of the stone wall is a small brick built shed with a single wooden window in its Northern wall, a doorway in its eastern end and a corrugated iron roof.

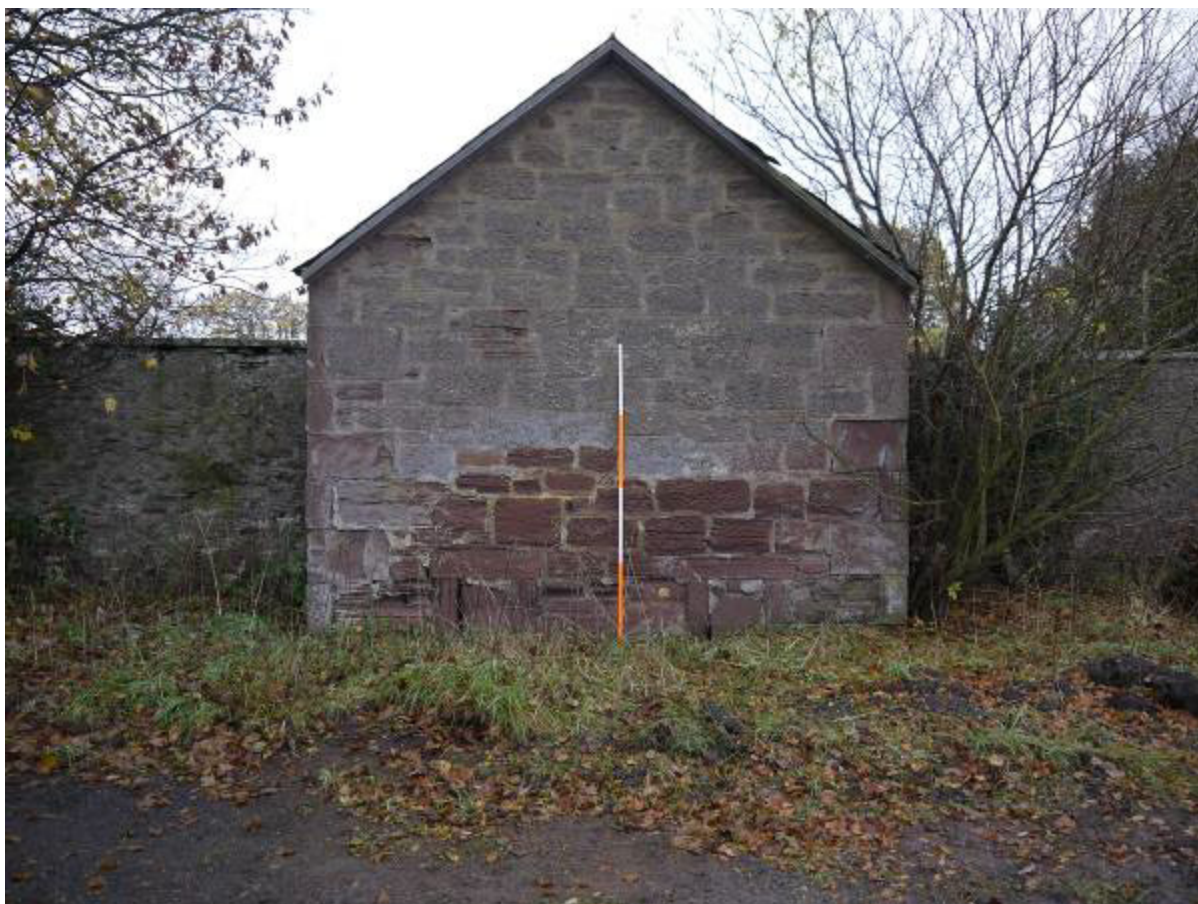
Illustration 29 North Western elevation of Building E looking South East

This elevation is gable ended with a blank wall face but two built stone structures are visible in the wall at ground level. The Easternmost of these is 0.66m high and 0.70m wide and is built of three large stones with a fourth stone filling the gap; there is a very slight gap along one of the edges of this stone. The Westernmost is built in a similar manner but is 0.64m high.

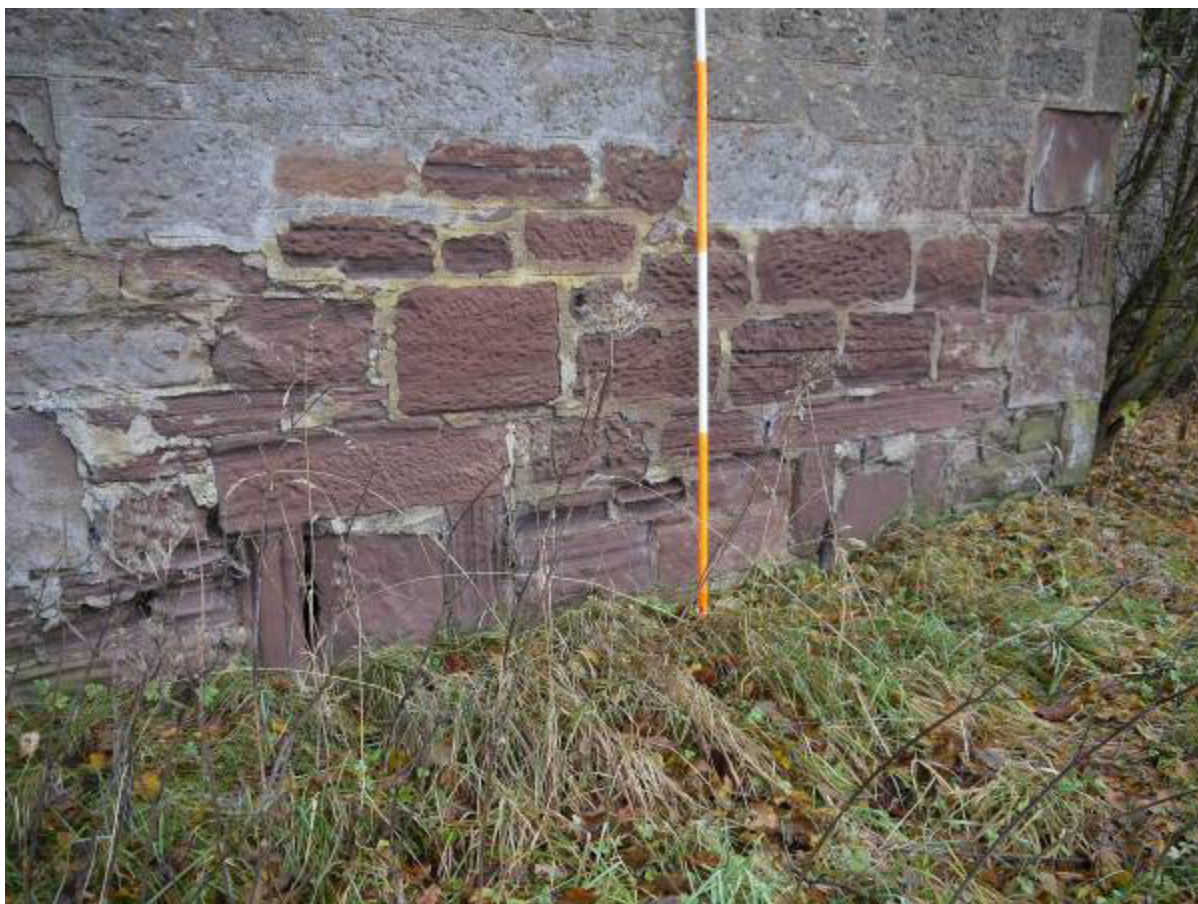
Illustration 30 North Western elevation of Building E showing built structures at foot of wall looking South East

West Ardler farmhouse is a fine example of a late 18th / early 19th century building. It appears to have gone through a period of several alterations which include an extension for servant's accommodation to the North East, provision of an upstairs bathroom and the addition of a large well light room on its South Eastern side. To its North East there is a garden area bounded by a well built stone wall on its North Western side. Built into this wall and presumably contemporary with its construction is a small gable ended building split into two rooms which contain wooden benches associated with what maybe some sort of ventilation in the structures North wall. The function and purpose of these features is a mystery and despite some research and discussions with colleagues in the archaeological profession the author has not been able to find any parallels for them.

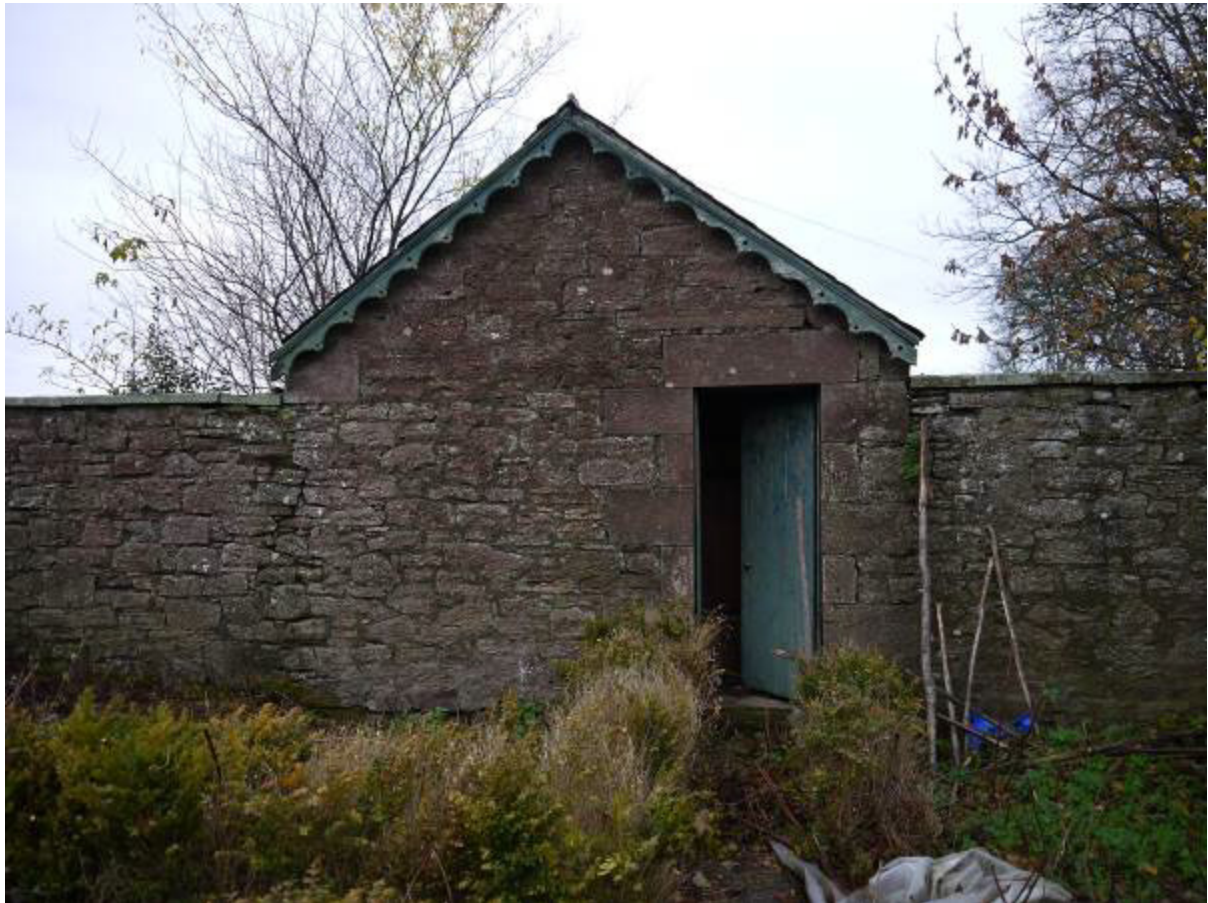
Illustration 31 South Eastern elevation of Building E looking North West

There is a single narrow window with wooden frame in this elevation.

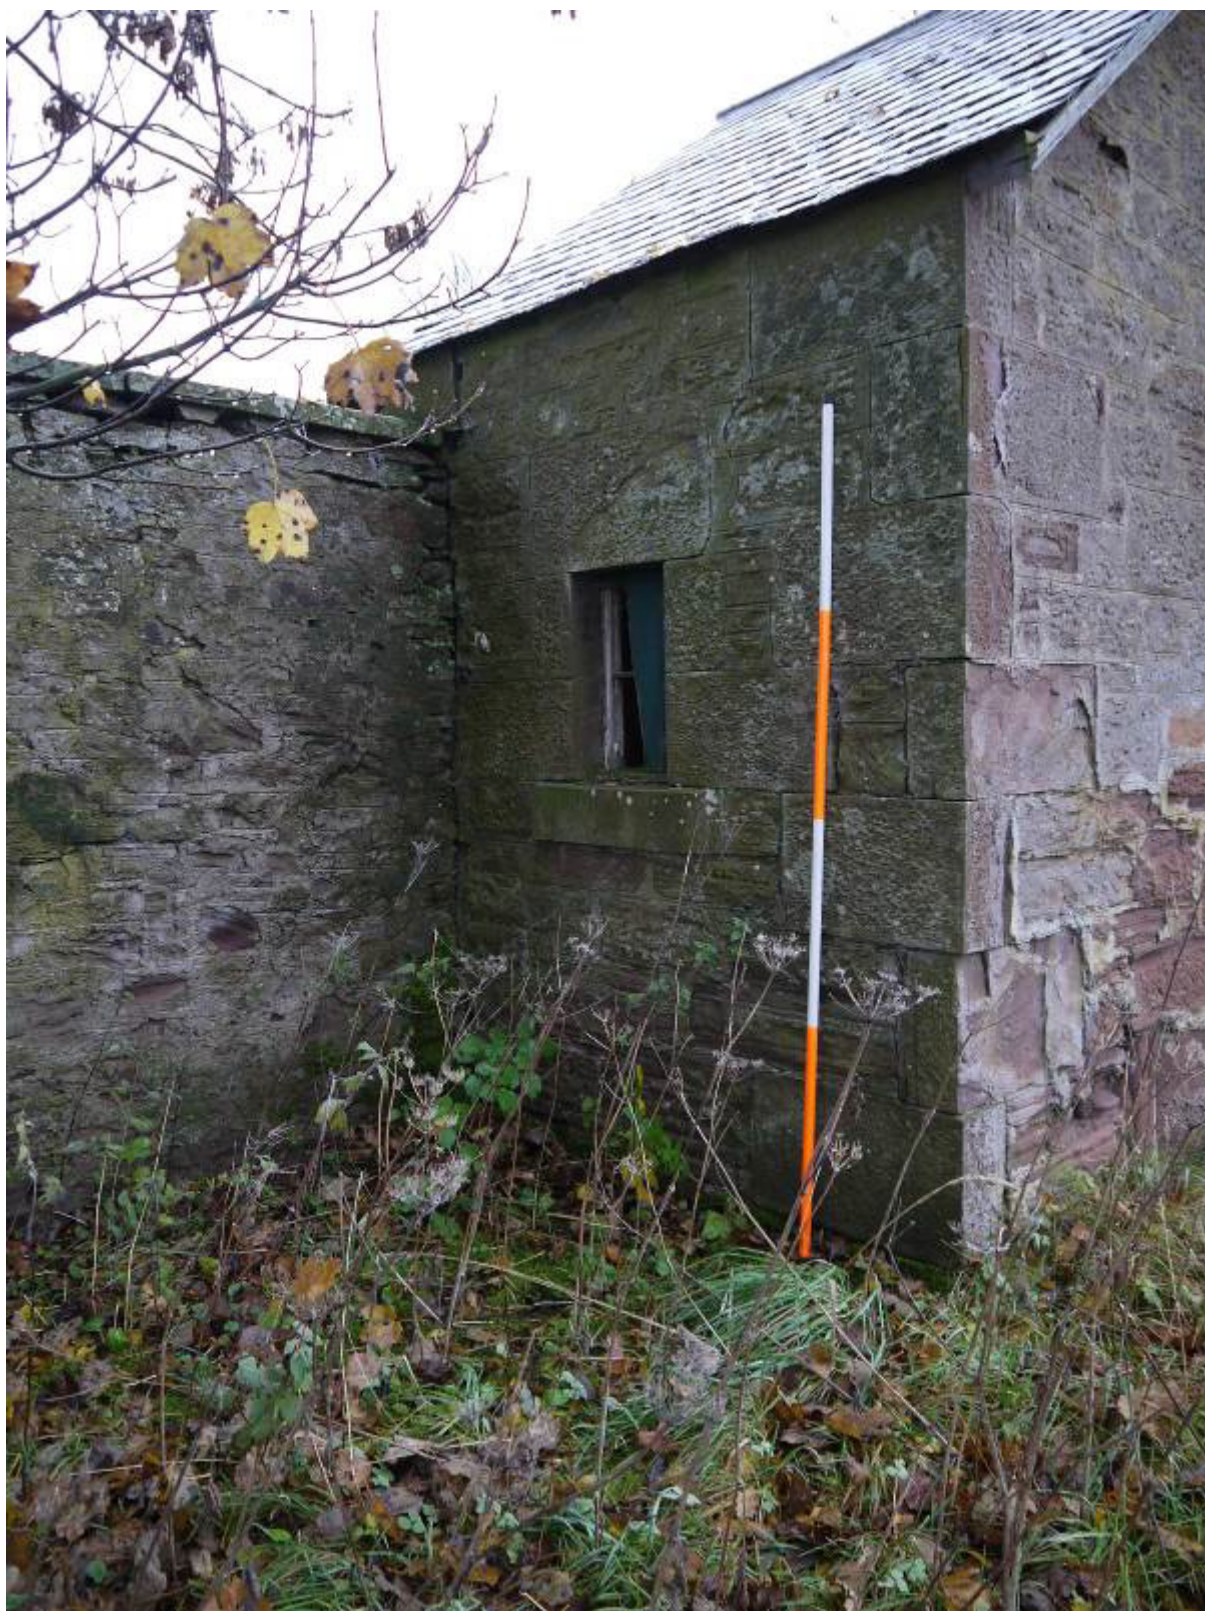
Illustration 32 North Eastern elevation of Building E looking South West

This gable ended elevation is flush with the line of the garden wall and has a doorway into a small room on this side of the building. The roof lines of the gable are decorated with scalloped wooden decoration.
