Standing Building Survey
West Ardler farmhouse
Ardler, Perth and Kinross

23rd November 2010

Introduction (Illustrations 1 and 2)

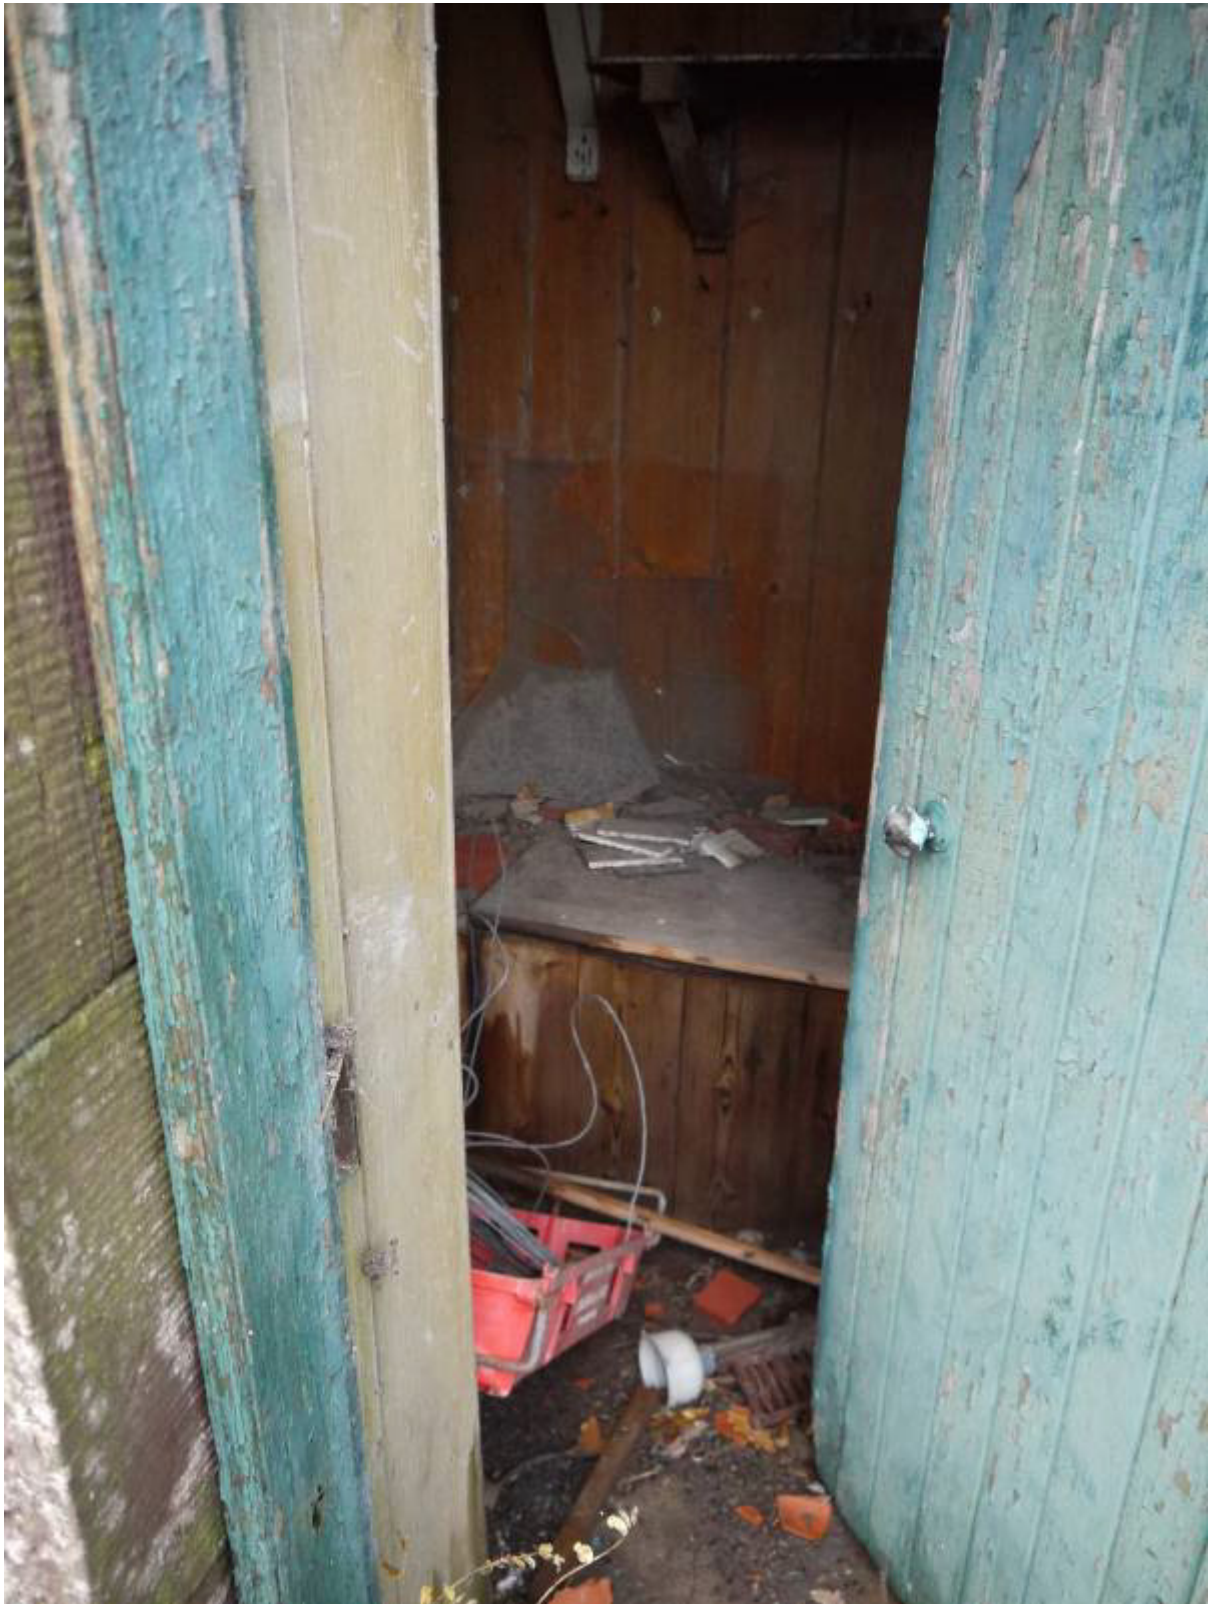
Illustration 33 Wooden 'bench' inside room in Building E looking North West

The two small rooms in the interior of this structure both have wooden bench like structures against the inside face of their North Western walls. Both these benches are 0.45m high above the stone floor and could originally be opened; they appear to have an as yet not known function in relation to the built stone structures in the North Western elevation.

West Ardler farmhouse is a fine example of a late 18th / early 19th century building. It appears to have gone through a period of several alterations which include an extension for servant's accommodation to the North East, provision of an upstairs bathroom and the addition of a large well light room on its South Eastern side. To its North East there is a garden area bounded by a well built stone wall on its North Western side. Built into this wall and presumably contemporary with its construction is a small gable ended building split into two rooms which contain wooden benches associated with what maybe some sort of ventilation in the structures North wall. The function and purpose of these features is a mystery and despite some research and discussions with colleagues in the archaeological profession the author has not been able to find any parallels for them.

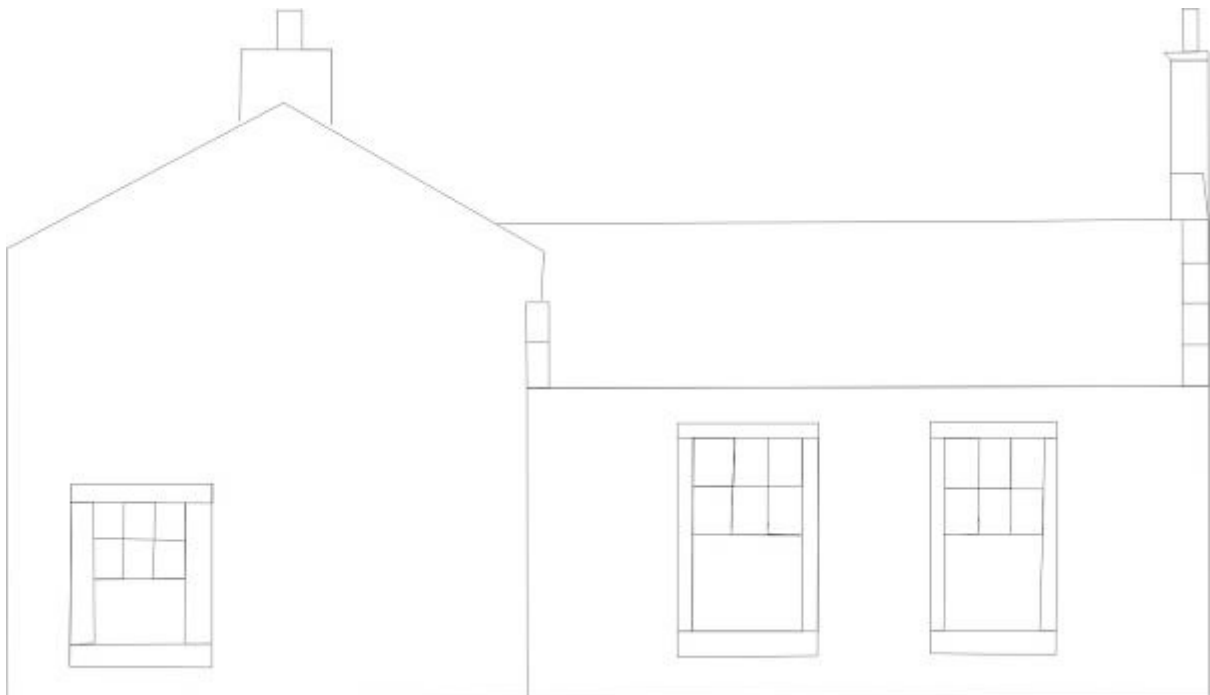
Illustration 36 South Eastern elevation of Building A (farmhouse) and Building B (Large room) Scale 1:100

This elevation has a single wooden window at ground level and has had a large single storey building (B) attached to its eastern side.
