Standing Building Survey
45, 47 and 49G High Street,
Brechtin, Angus

Introduction (Illustration 1)

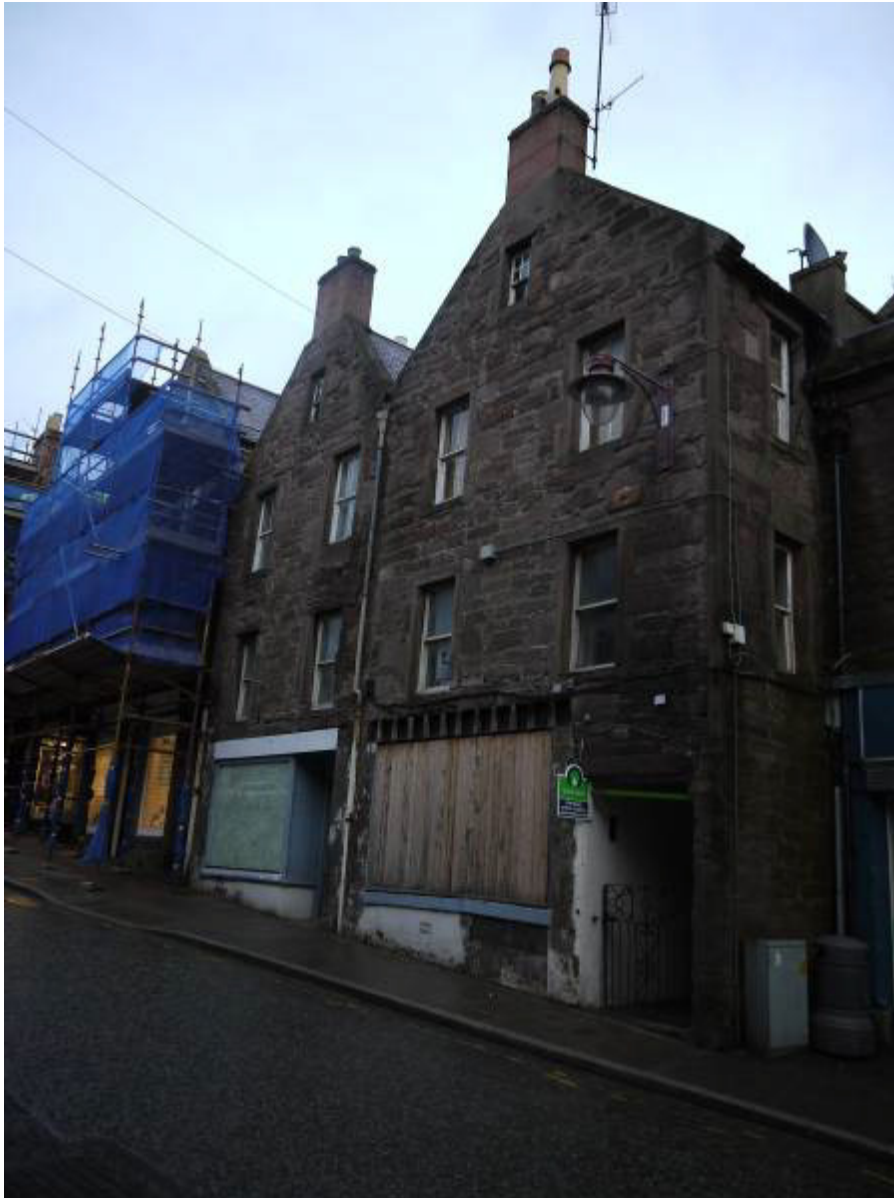
High Street frontage of 45 and 47 (49G at First floor level) looking North East

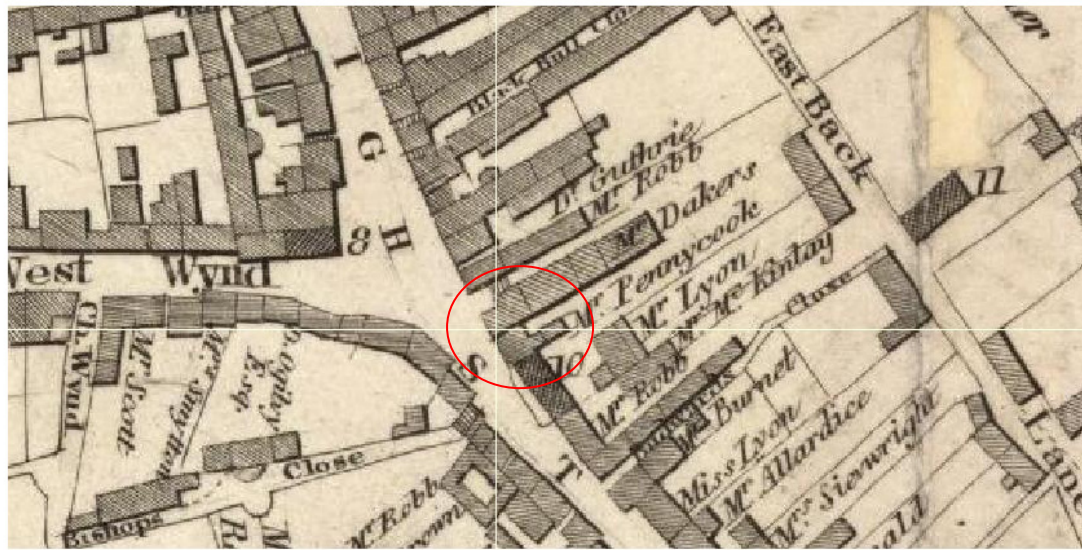
Illustration 2 John Wood's map of 1823 showing no's 45 and 47 occupied (or owned) by Mr Dakers and Mr Pennycook respectively (© Trustees of National Library of Scotland)

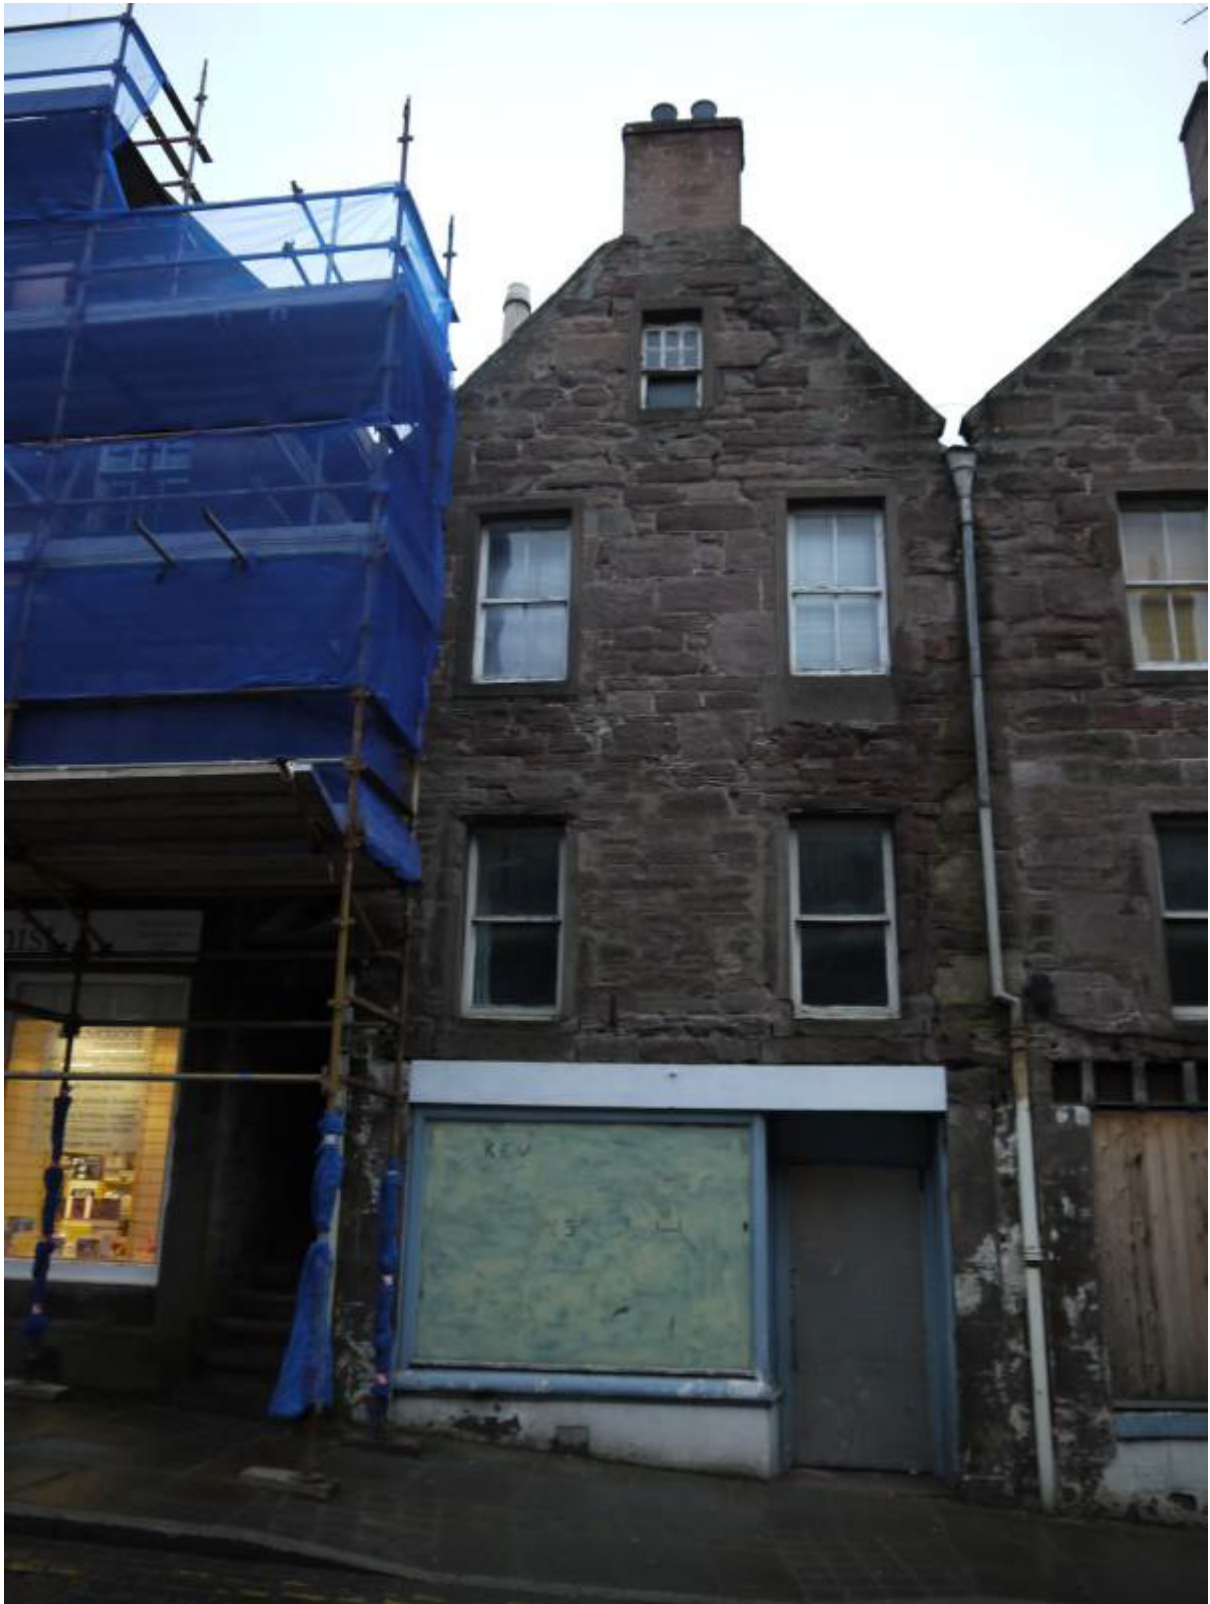
Built of mortar bonded sandstone this elevation is two and a half storeys high with its gable end to the High Street. The ground floor is taken up by a large shop front window with a doorway on its southern side. The First and Second floors have pairs of windows, the upper half storey below the apex of the gable has a small window. The gable end is topped by a chimney. The northern side of this elevation has a covered pend with stairs leading to first floor level.

Illustration 5 Western (High Street) Elevation of 45 High Street (pend with stairs on left)

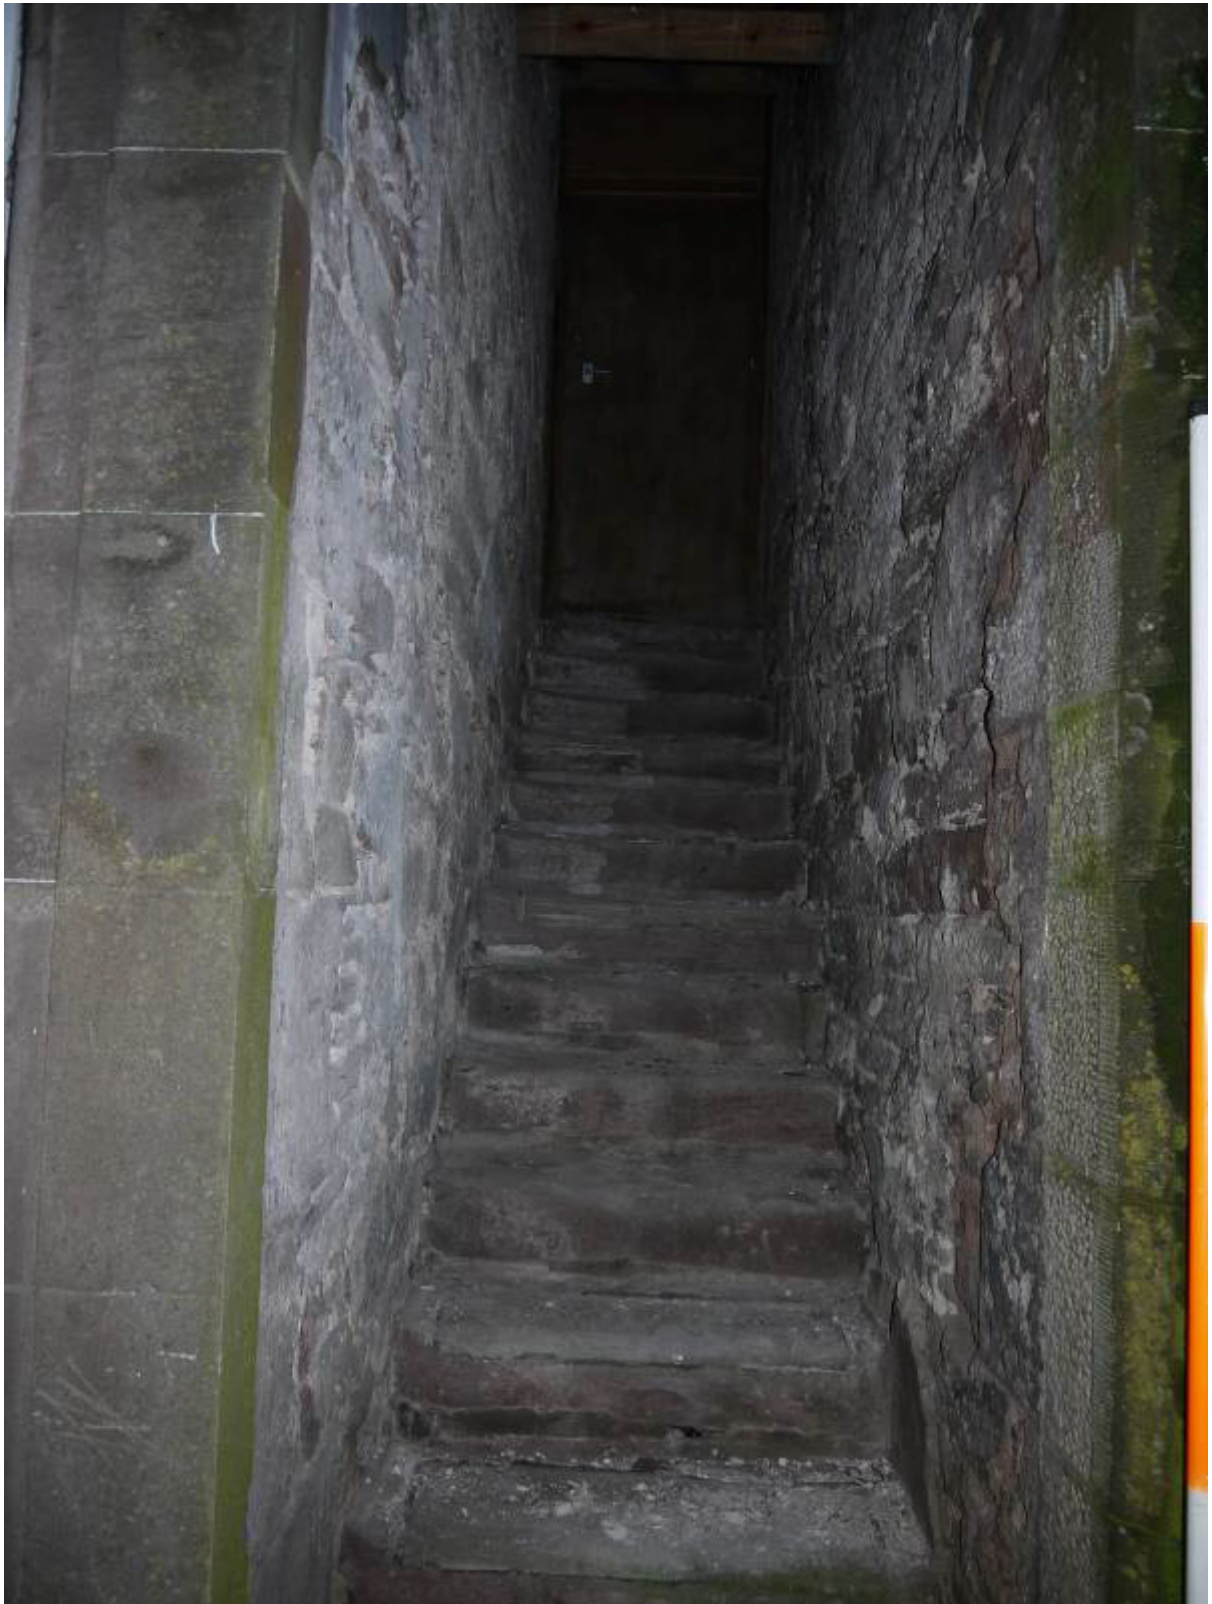
Illustration 6 Pend with stairs on North side of no 45 High Street

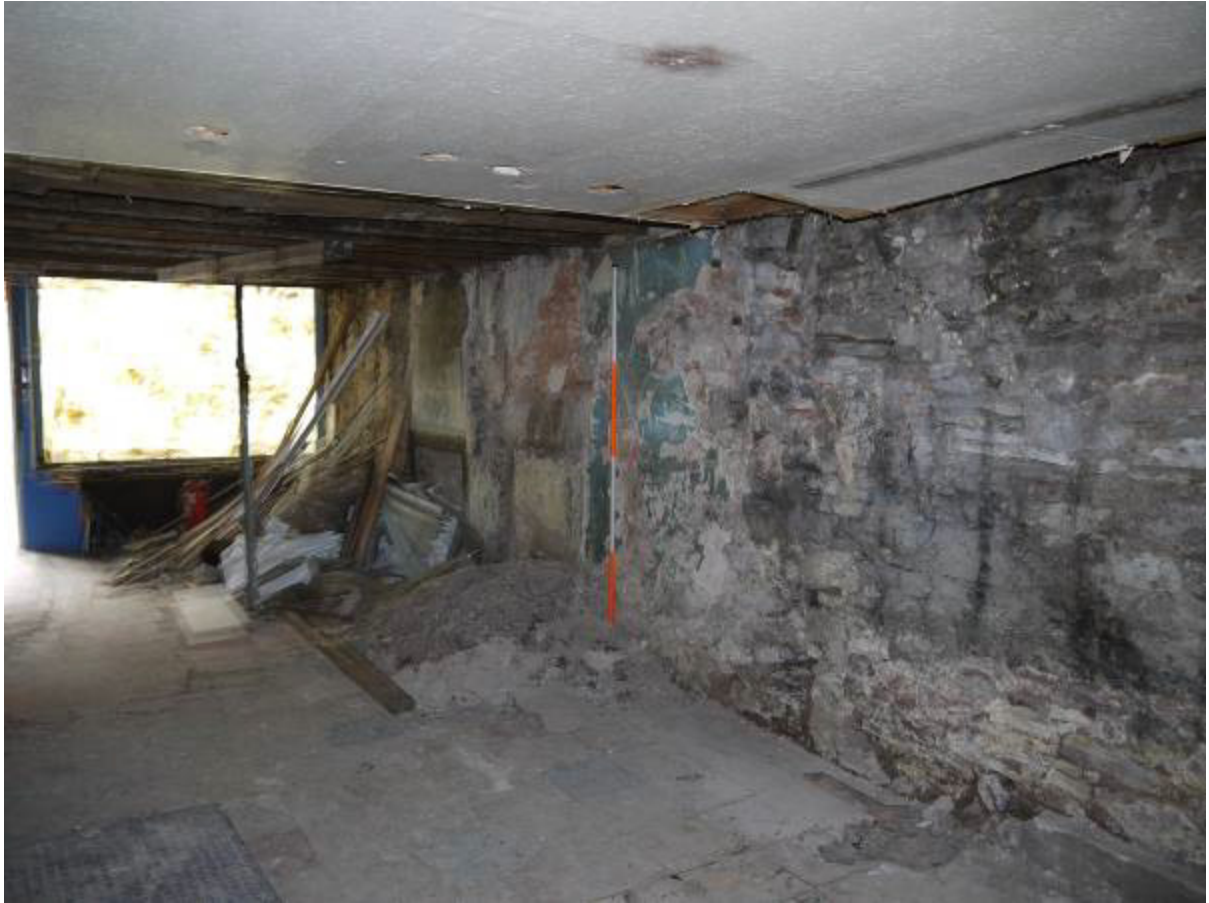
This wall is built of mortar bonded small rough sandstones and has traces of green plaster in places. It has two fireplaces at its Western end and the bottom of a stone threshold at first floor level is visible 6.5m East of the High Street frontage at a height of 2.07m from the floor level. This threshold lies just below the surviving timber floor/ceiling at first floor level.

Illustration 8 Internal Southern elevation looking North West

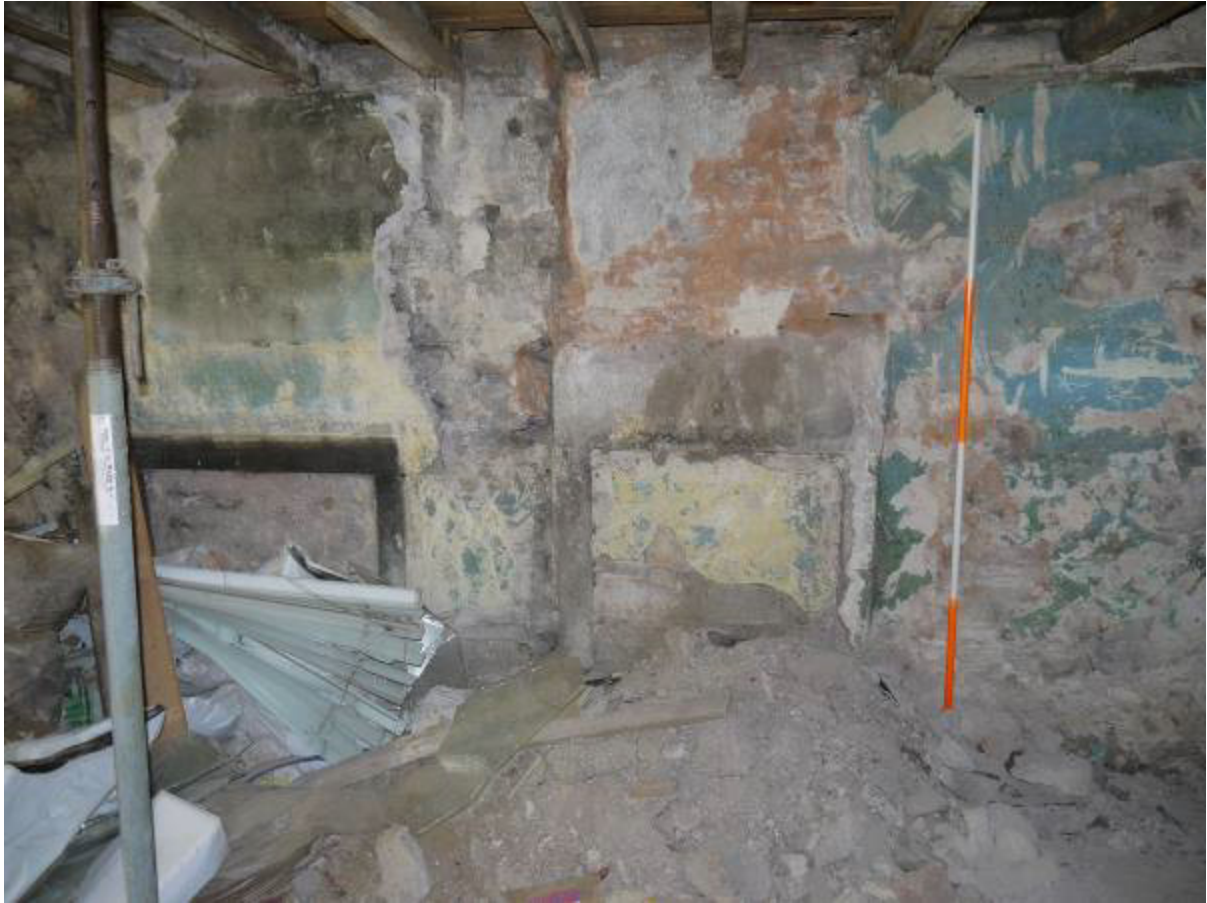
Illustration 9 Double fireplace in internal Southern elevation looking North

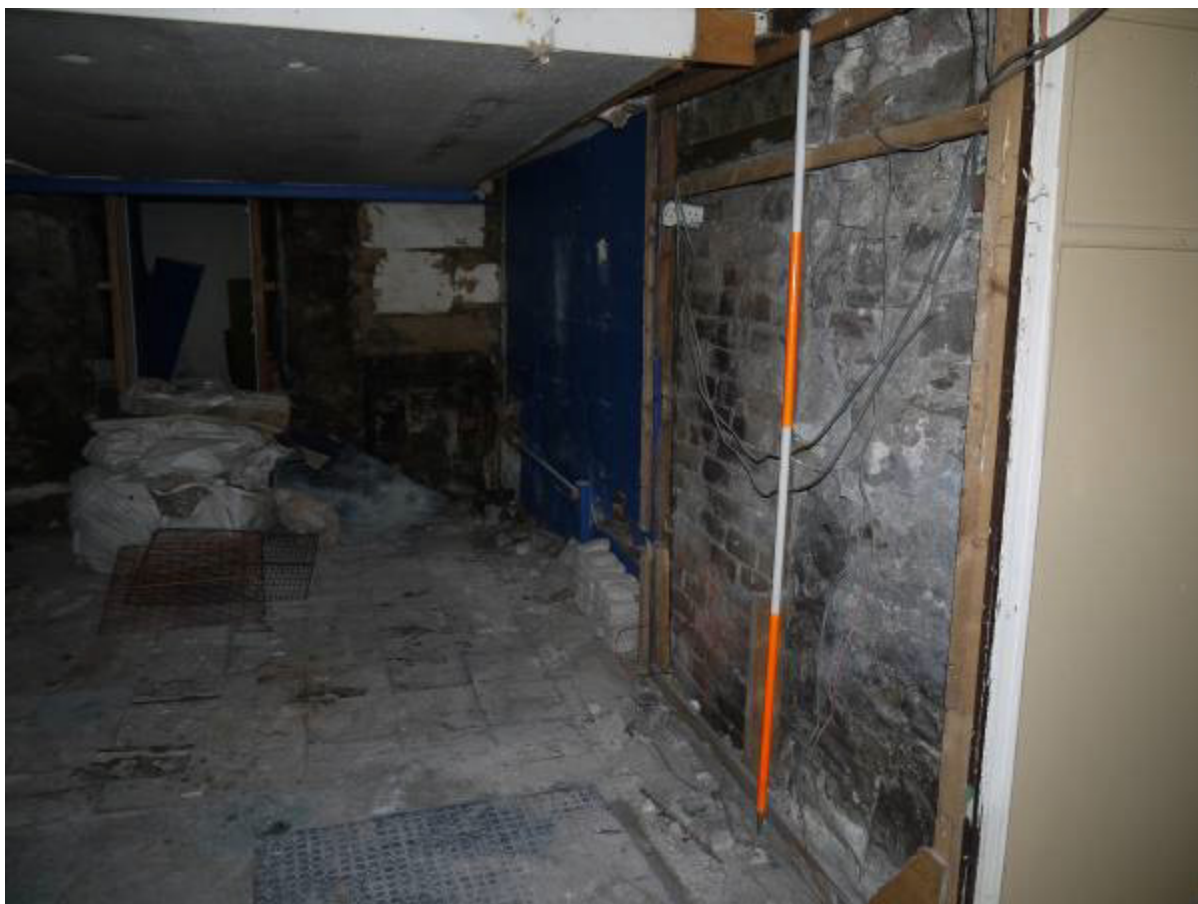
This wall is built of mortar bonded small rough sandstones and has a central doorway with two steps leading up into a rear extension. There is another fireplace in this wall on the South side of the doorway.

There is no sign of an original wall between no's 47 and 45 and there is a gap for a length of 3.6m which enables both ground floors to operate as one shop unit. From the High Street entrance a 2m length of mortar bonded sandstone wall survives up to the start of the gap. On the Eastern side of the gap the wall starts again for a length of 5.25m up to its junction with the East wall of the building. A visible 2.25m length of the wall is brick built, mortar bonded and unpainted the remaining 2.25m length is painted blue over brick.

Illustration 10 Northern elevation and Western elevation showing doorway into extension and fireplace in corner

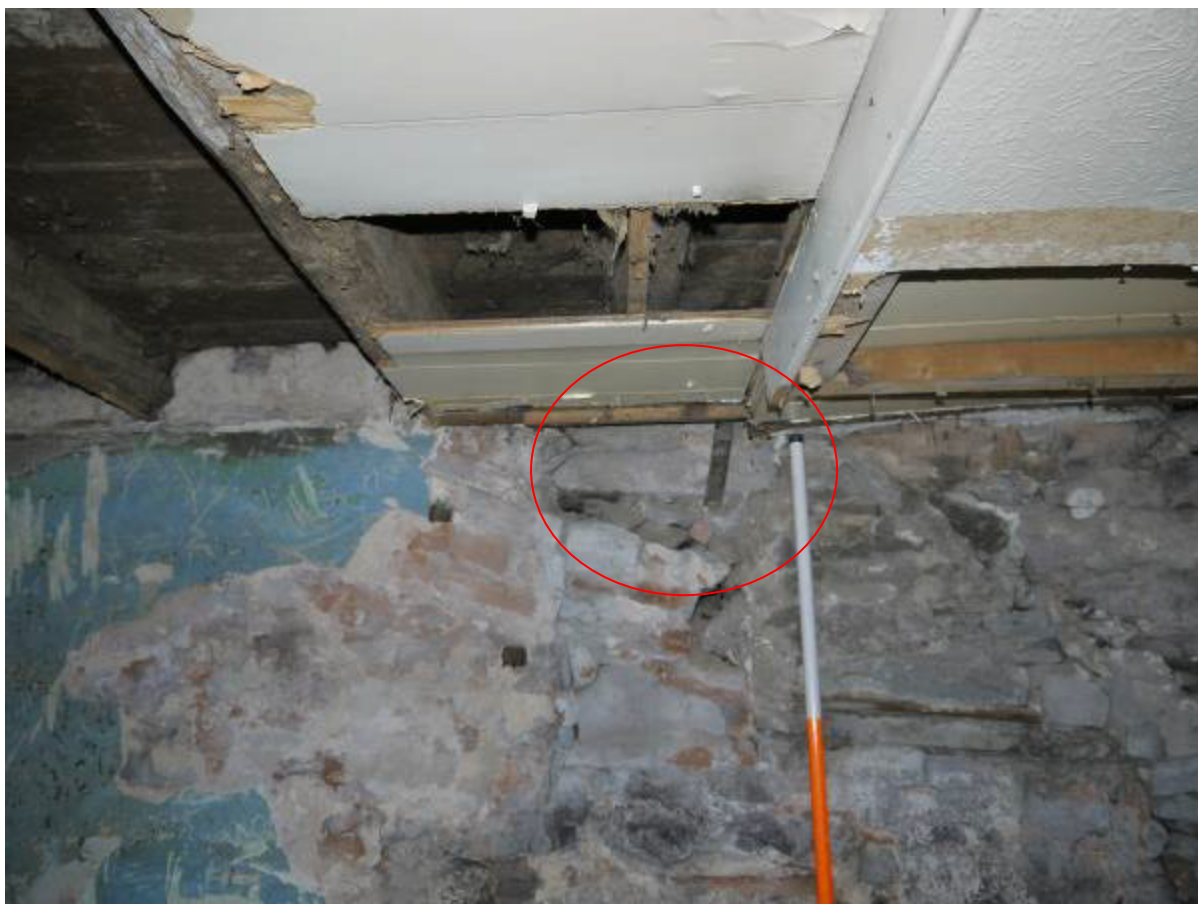
Illustration 11 Bottom of threshold at first floor level in internal Southern elevation of no 45 High Street

Numbers 45, 47 and 49G High Street are interesting survivals of probably late 18th century urban architecture. Careful examination of visible wall elevations suggests that they have quite a complicated history. For example the fragment of threshold visible in the Southern elevation of no 45 just below ceiling level suggests that the former ceiling / floor level in that building was at least 0.10m lower than it is now. In a similar manner to the blocked doorway that is visible in the Southern internal elevation of room 4 in 49G this threshold may relate to a doorway leading out onto the pend with the stairway that lies on the North side of the building. The two fireplaces side by side in the North elevation of no 45 may relate to its recorded use as a bakers shop in the 19th century Brechin Valuation Rolls (see historical background). The blocked doorway and window in the hidden rear Western elevation of no 45 may represent the original access to no's 45 and 47 prior to the construction of the ground level extension to the rear. At first floor level in Room 3 of 49G it is clear that the construction of the neighbouring Episcopal Church in the early 1800's had a considerable effect on the structure of no 47, examination of the 1st Edition Ordnance Survey map of 1862 indicates a considerable rebuild of this side of the building (see Historical Background and Illus 3).

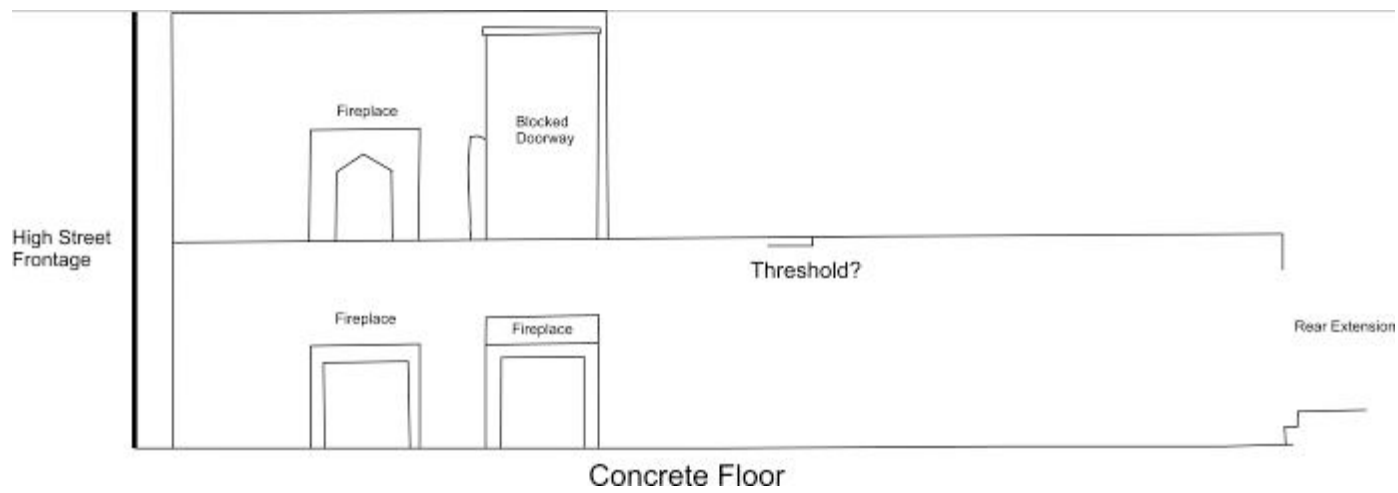
The panelling has been removed from this wall to expose the stone wall face which is built of shaped sandstone blocks. It contains a fireplace and a blocked doorway with a wooden lintel at its Eastern end. The stone blocking of this doorway is bonded with red clay. This doorway presumably led out onto the pend with stairs on this side of the building.

Illustration 12 Internal Southern elevation of no 45 High Street showing double fireplace and first floor threshold at ground floor level and fireplace and blocked doorway in Room 4 at first floor level
Scale 1:50

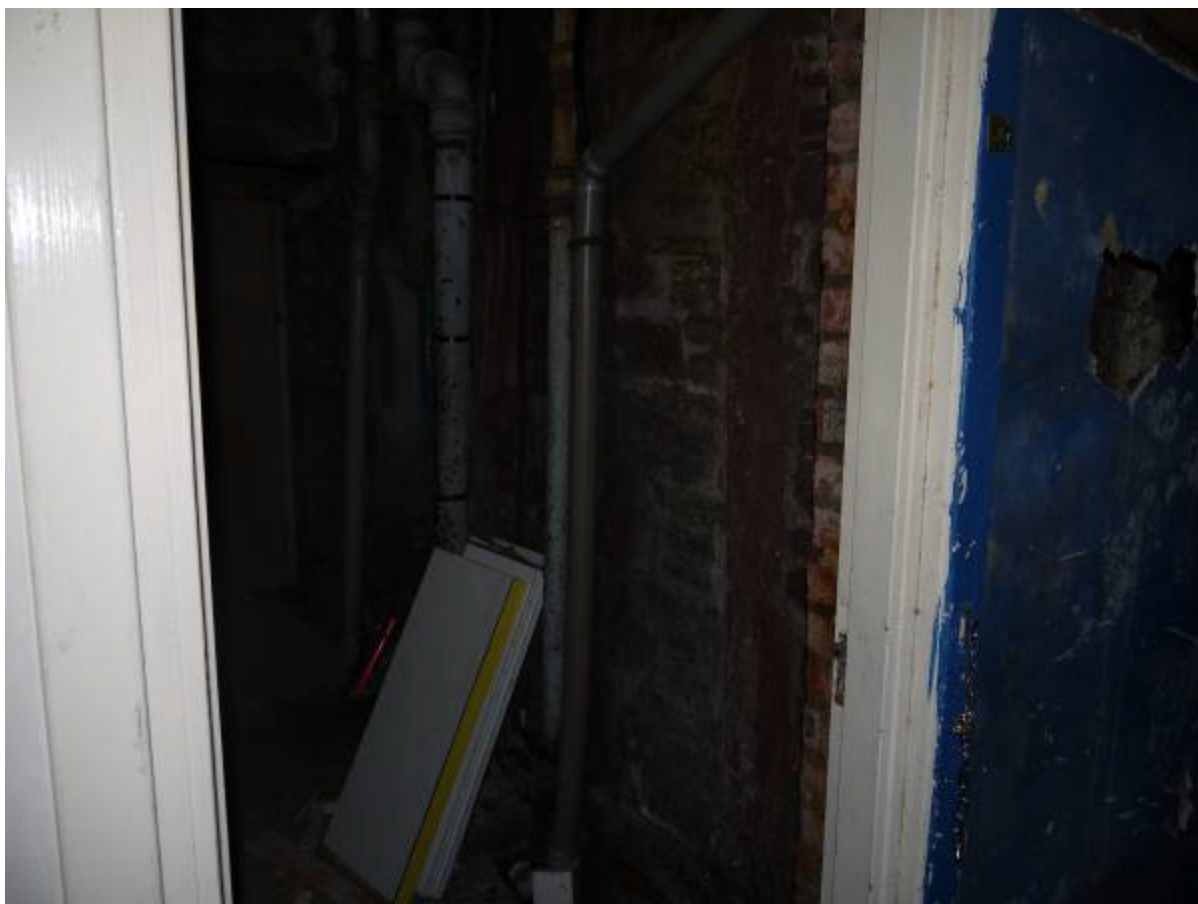
This room is accessed by two steps up from the ground floor of 45 High Street and has plasterboard on both walls and ceilings. A doorway from this room leads South into a narrow pend which leads to a locked door that leads out onto the covered pend that leads to the stair access for 49g High Street. The Eastern side of this pend is formed by the mortar bonded original outer sandstone wall of 45 High Street and includes a blocked doorway and window that formerly provided access into 45 High Street from the rear.

Illustration 13 Blocked doorway and window in pend leading from extension to rear of 45 High Street

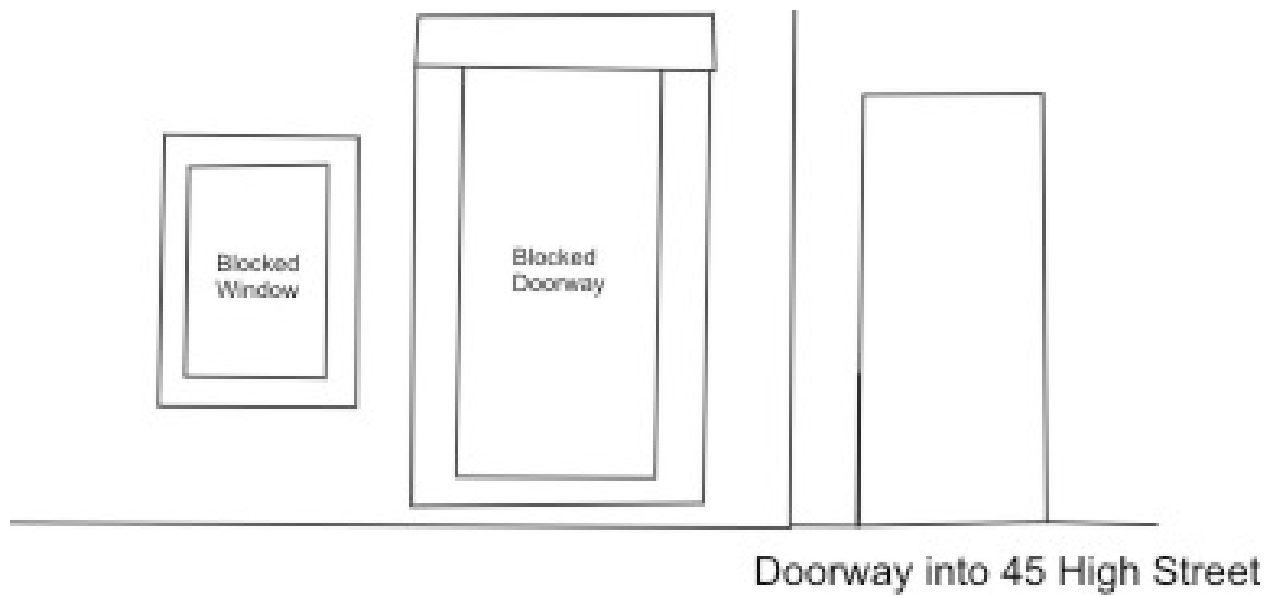
Illustration 14 Blocked doorway and window in rear Eastern elevation of No 45 High Street and doorway from extension into 45 High Street (see Illus 7 for location) Scale 1:50

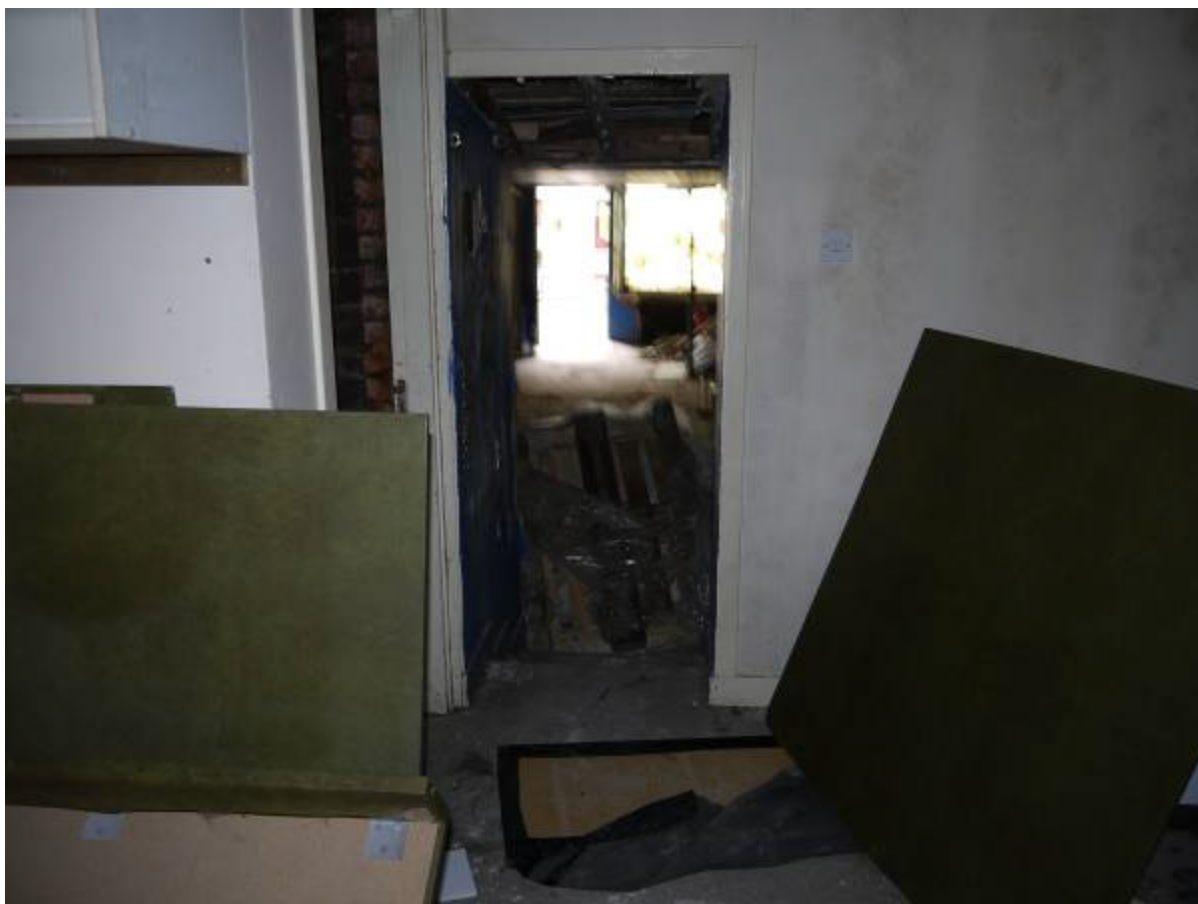
Illustration 15 View from back extension into 45 High Street (blocked doorway and window through doorway on left)

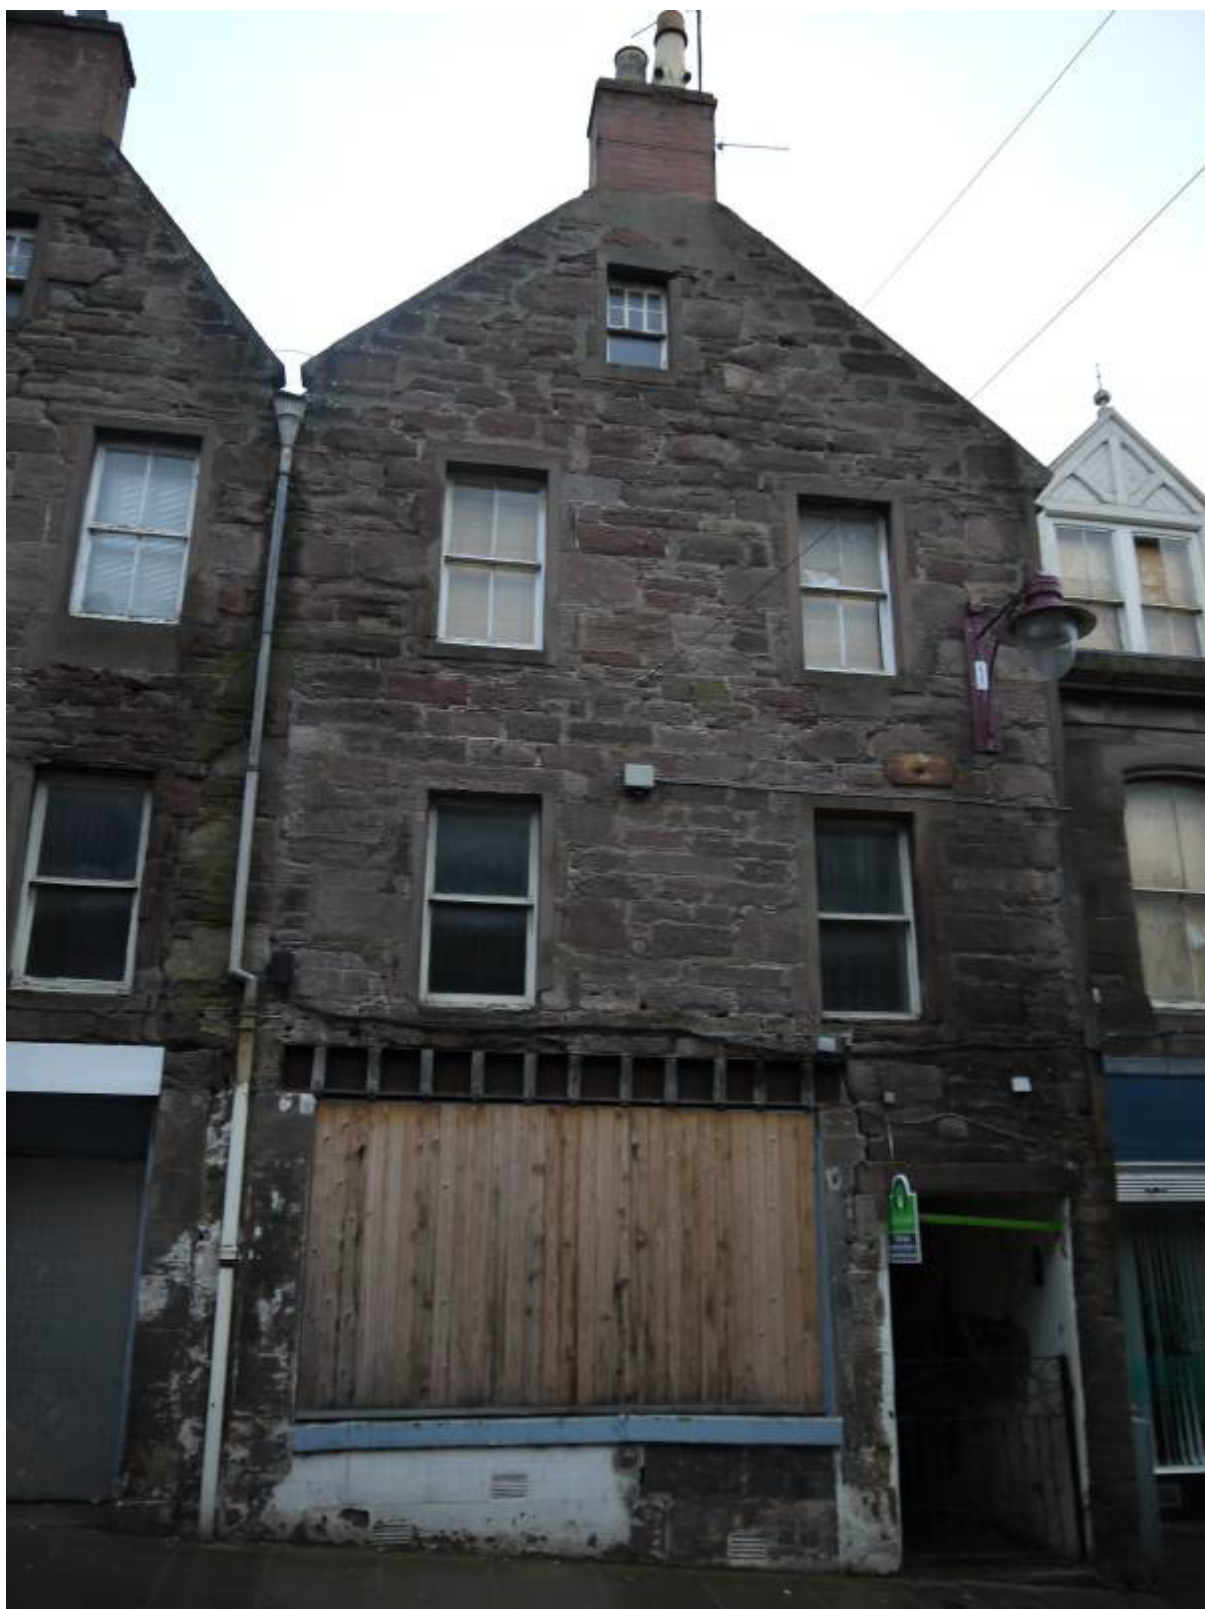
Built of mortar bonded sandstone this elevation is two and a half storeys high with its gable end to the High Street. The ground floor is taken up by a large shop front window with a gated pend on its Southern side that leads to the stair access for 49G. The First and Second floors have pairs of windows the upper half storey below the apex of the gable has a small window. The gable end is topped by a chimney. The northern side of this elevation has a covered pend with stairs leading to first floor level.

Illustration 16 Western (High Street) elevation of 47 High Street

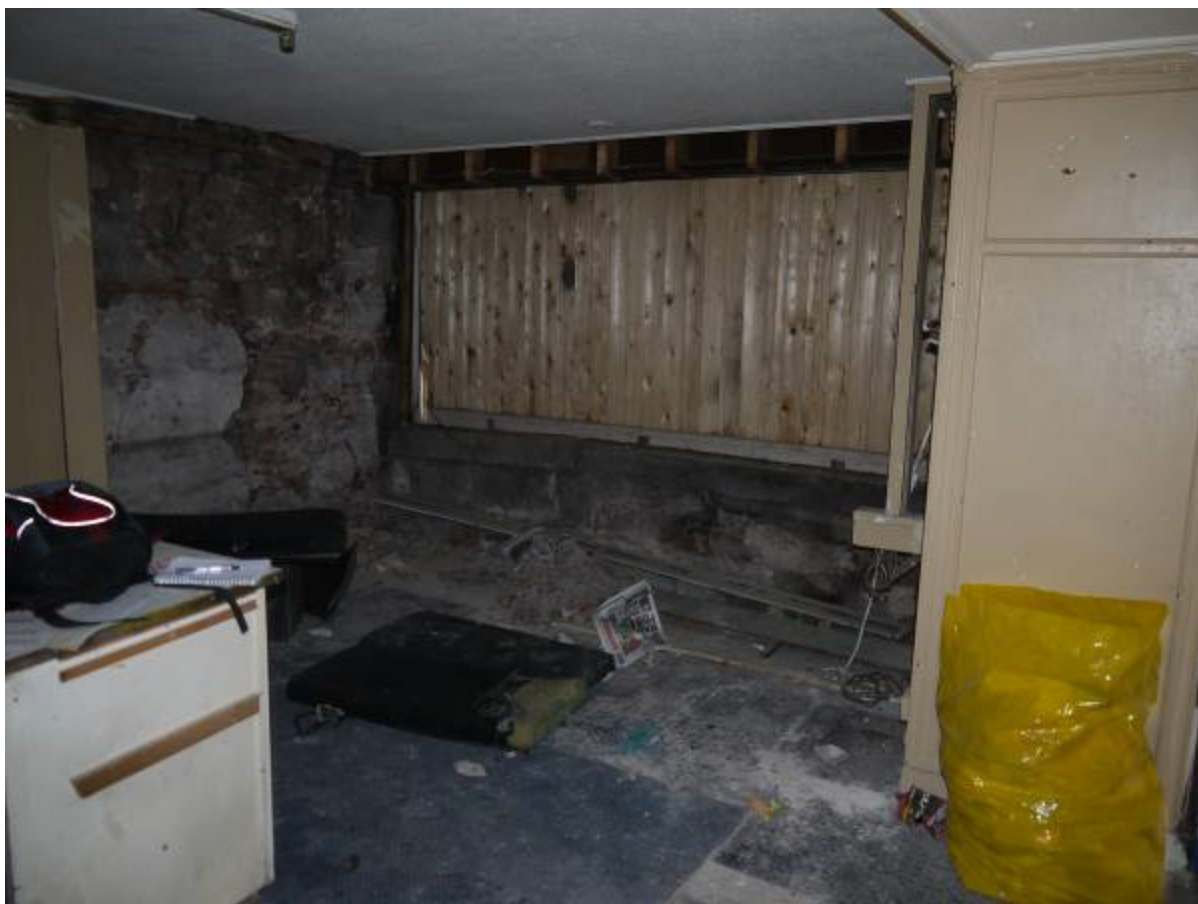
This wall face is timber panelled and painted a cream colour and has a doorway leading into a kitchen area.

Illustration 17 Internal Eastern elevation of no 47 High Street

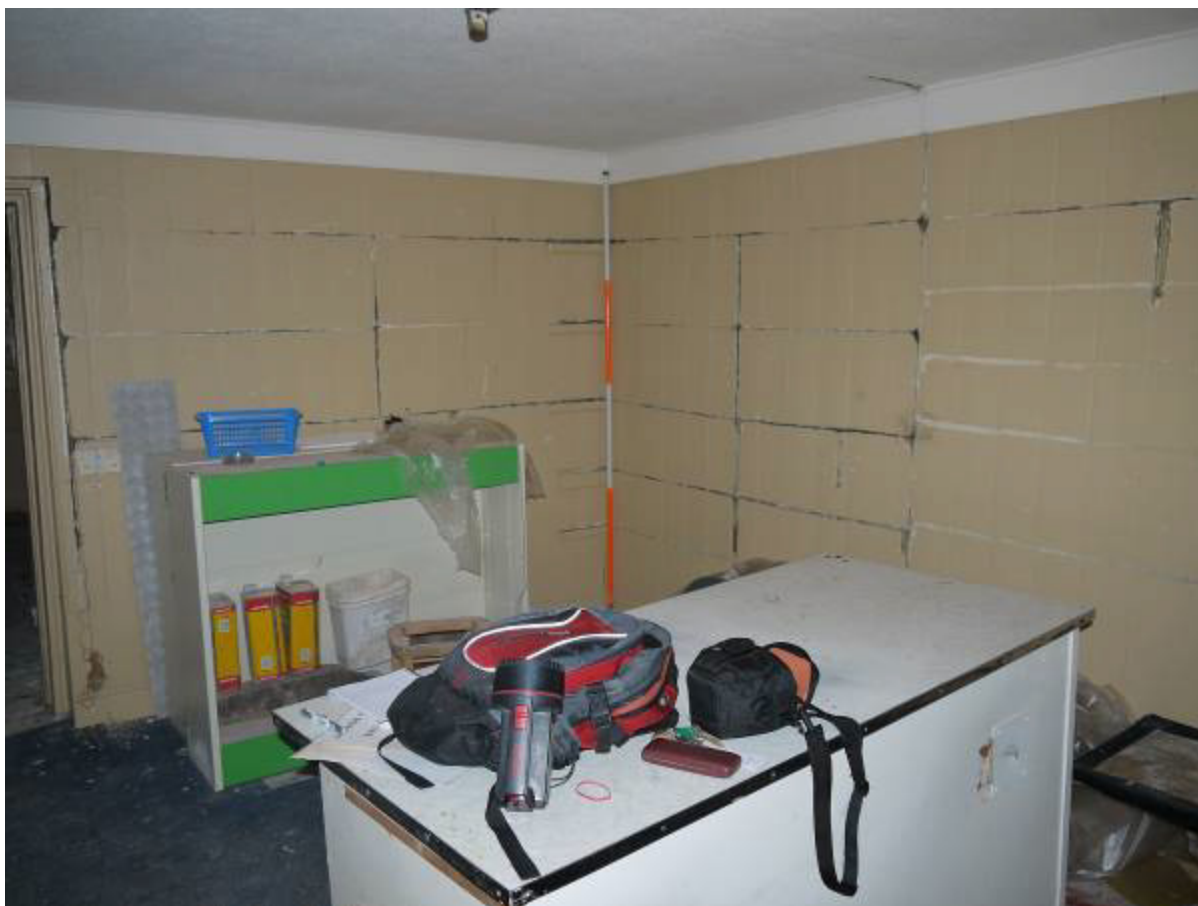
This wall is built of mortar bonded sandstone blocks and has a blank face. The first 2m length of this wall is exposed mortar bonded stone the remainder is timber panelled and painted a cream colour for a length of 4m.

Illustration 18 Internal Northern and Western elevation of no 47 High Street

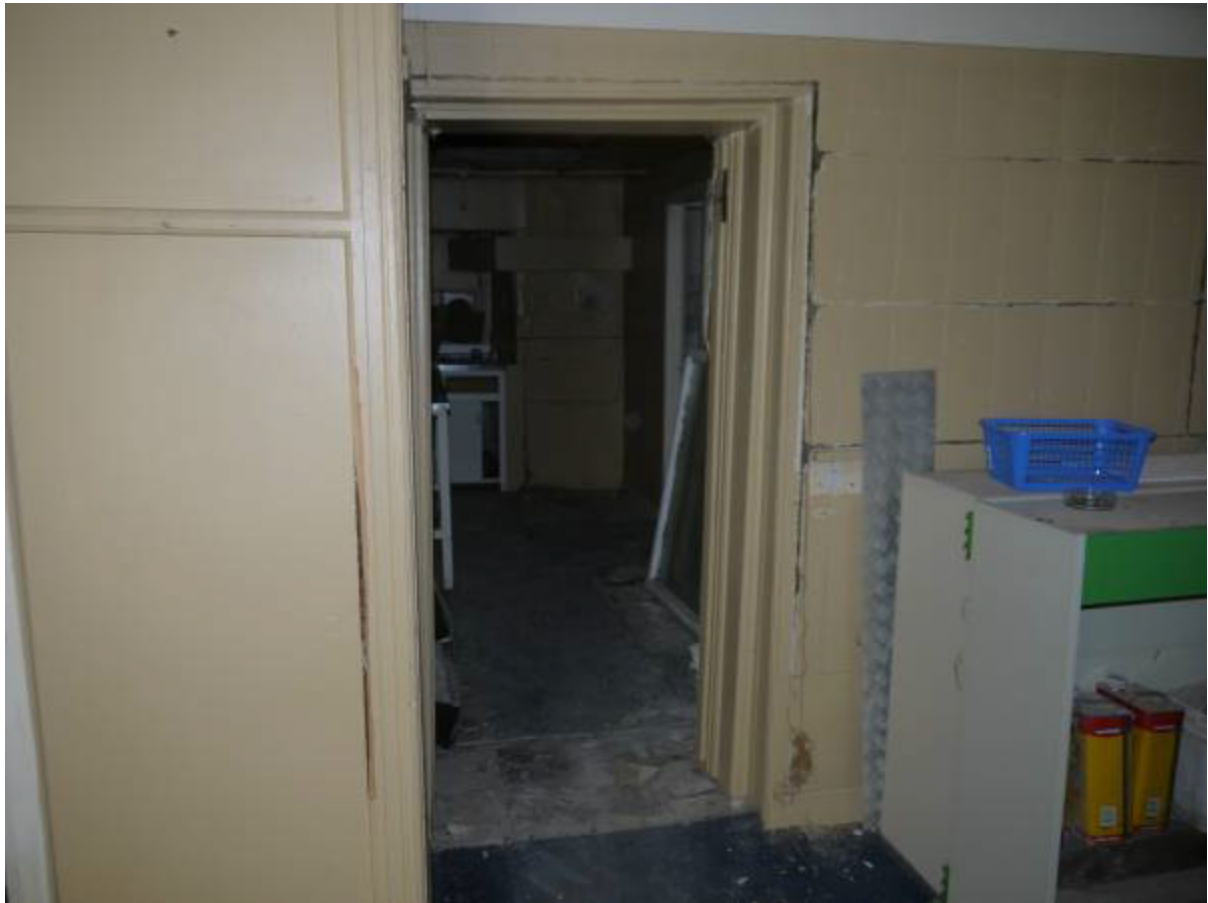
This area has poured concrete floors with linoleum squares and is fitted out as a kitchen, store and toilet area. The walls are panelled and painted a cream colour.

Illustration 19 Internal Western elevation of No 47 showing door into kitchen, store and toilet area

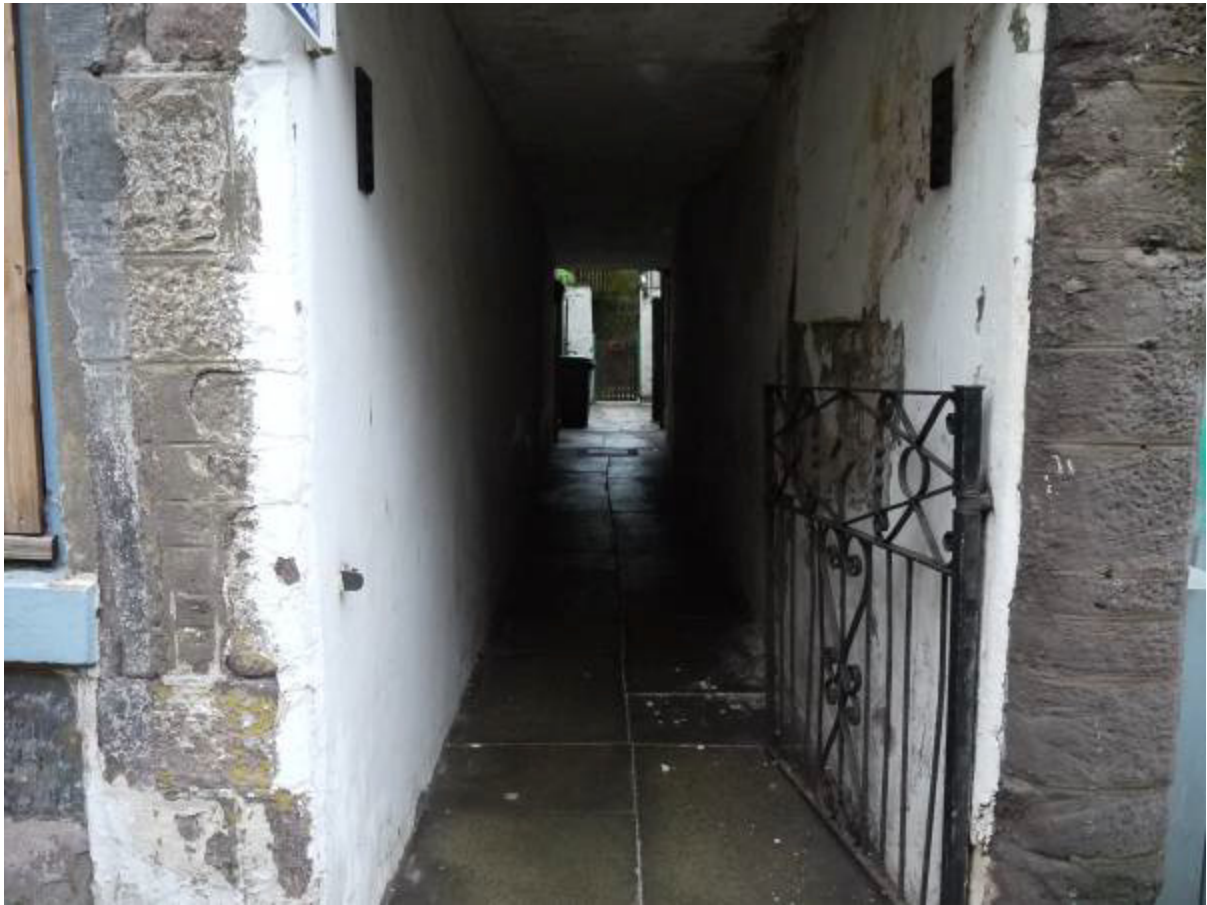
A gated covered pend leads from the High Street and provides access to the stair tower that leads to the upstairs flat (49G).

Illustration 20 Covered pend providing access to stair tower accessing 49G High Street looking East
