Standing Building Survey
45, 47 and 49G High Street,
Brechtin, Angus

Introduction (Illustration 1)

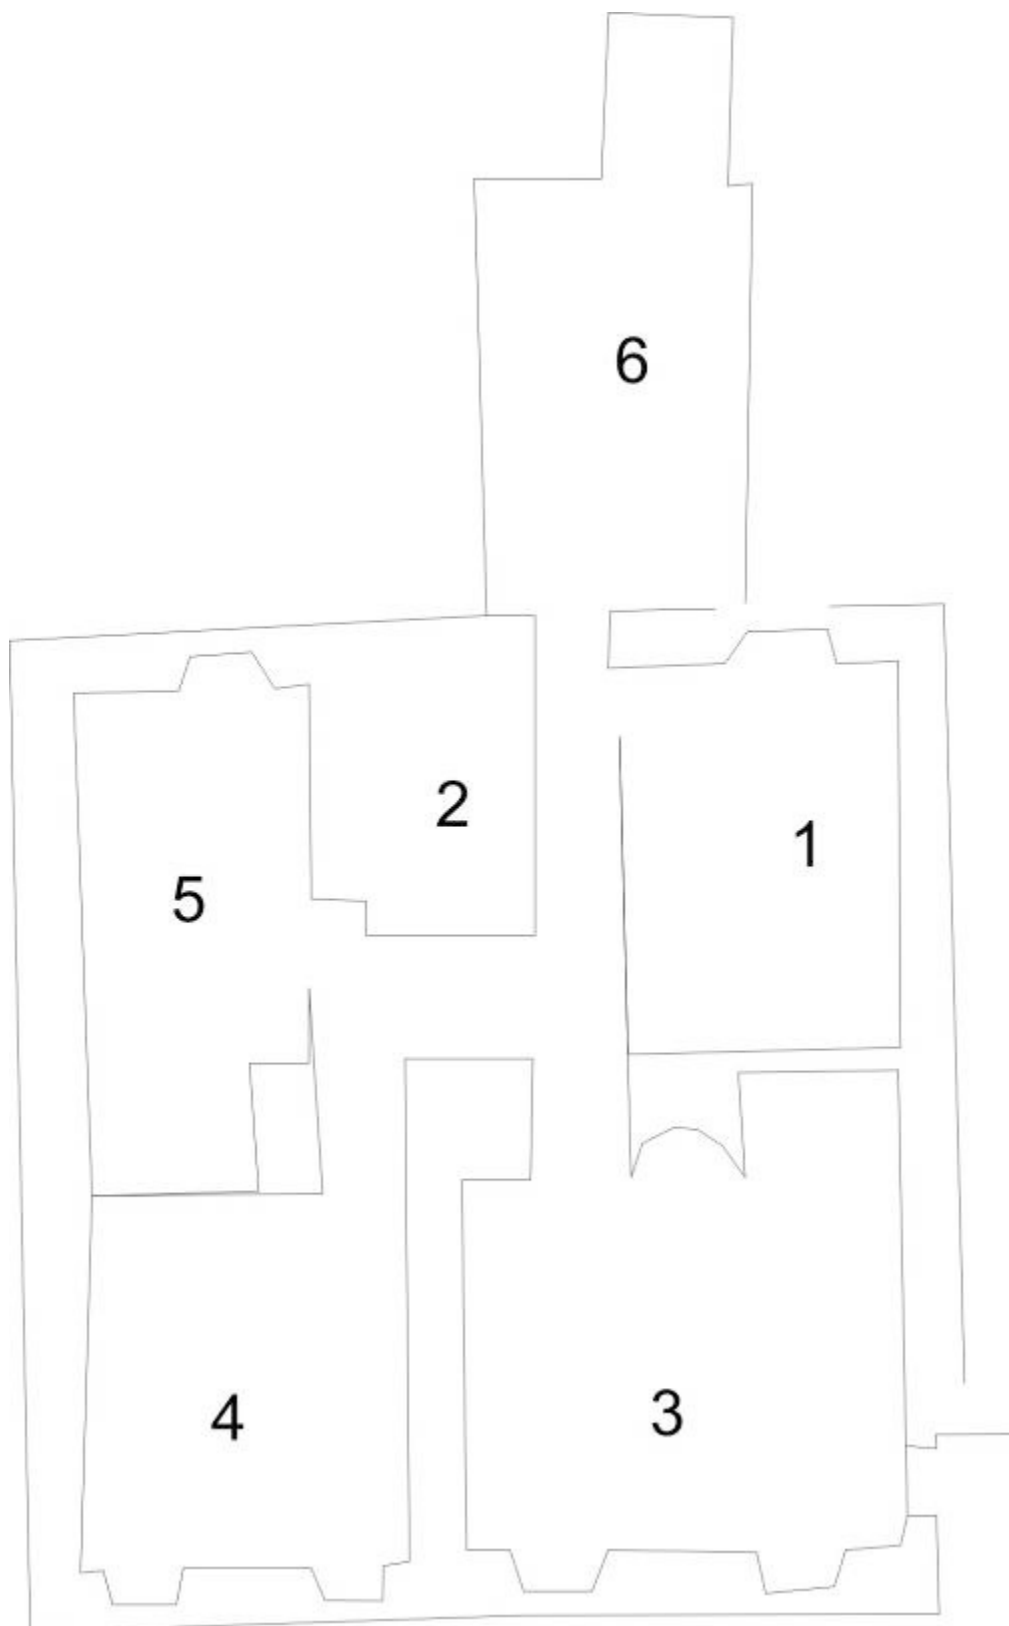
Illustration 21 Rooms in Flat 49G as numbered for survey Scale 1:50

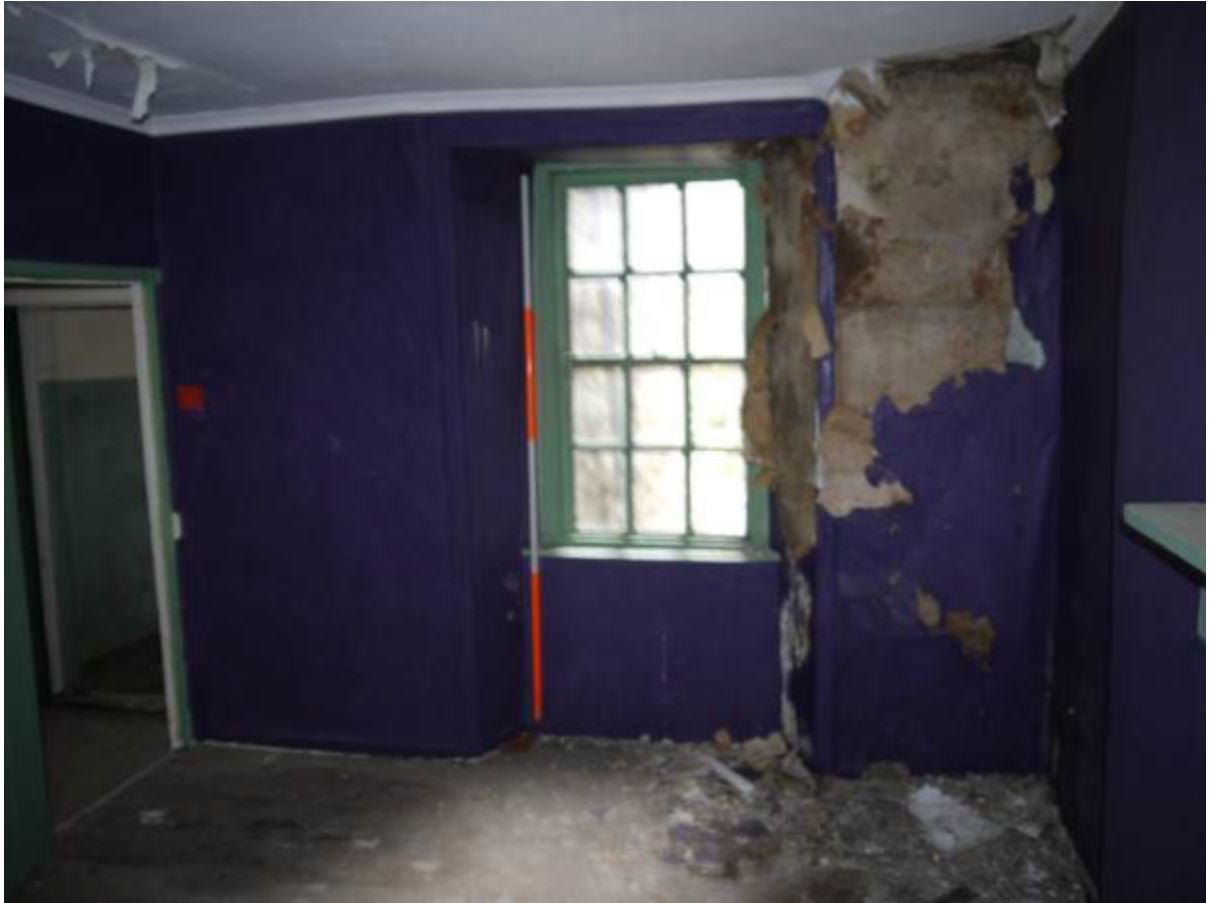
This wall has a window overlooking the pend, it is painted purple.

Illustration 22 Western elevation Room 1

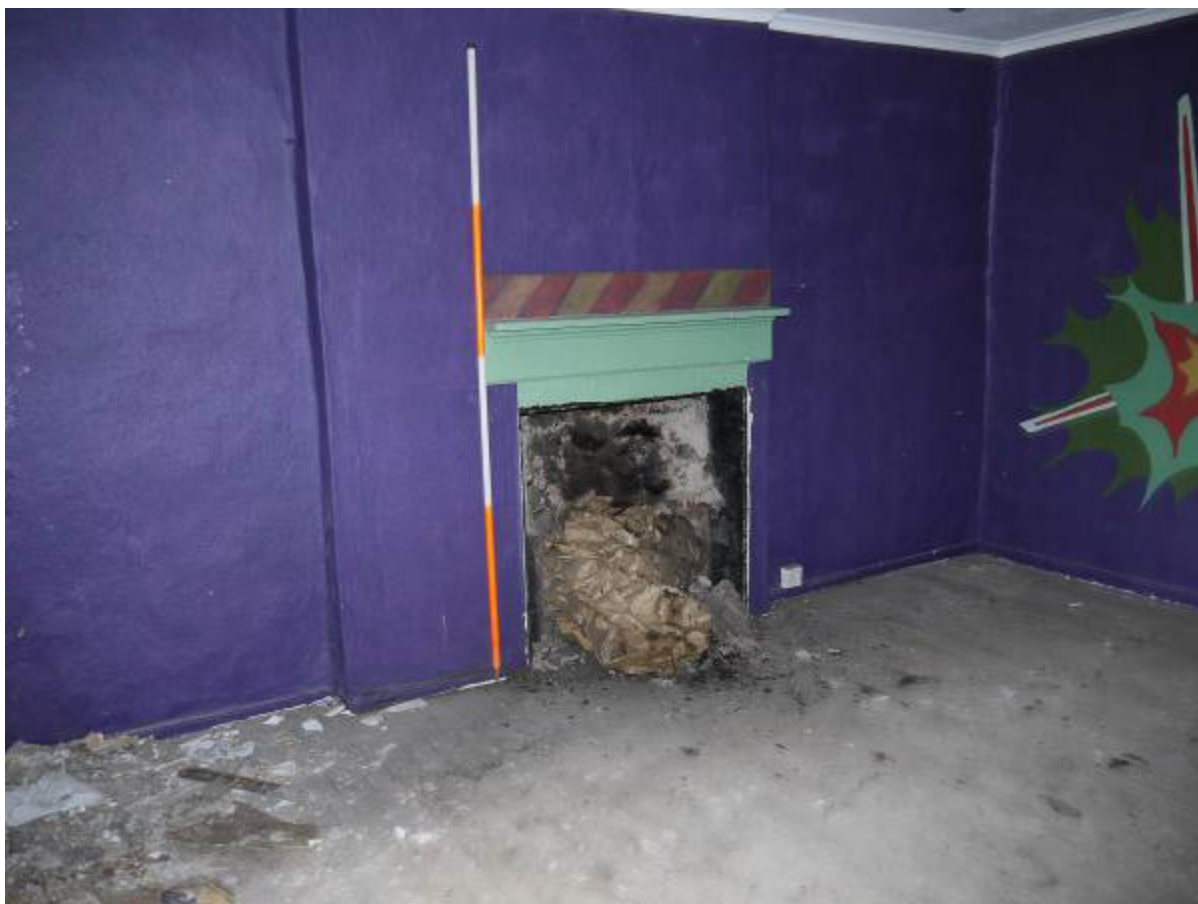
This wall has a central fireplace and is painted purple.

Illustration 23 Northern elevation Room 1

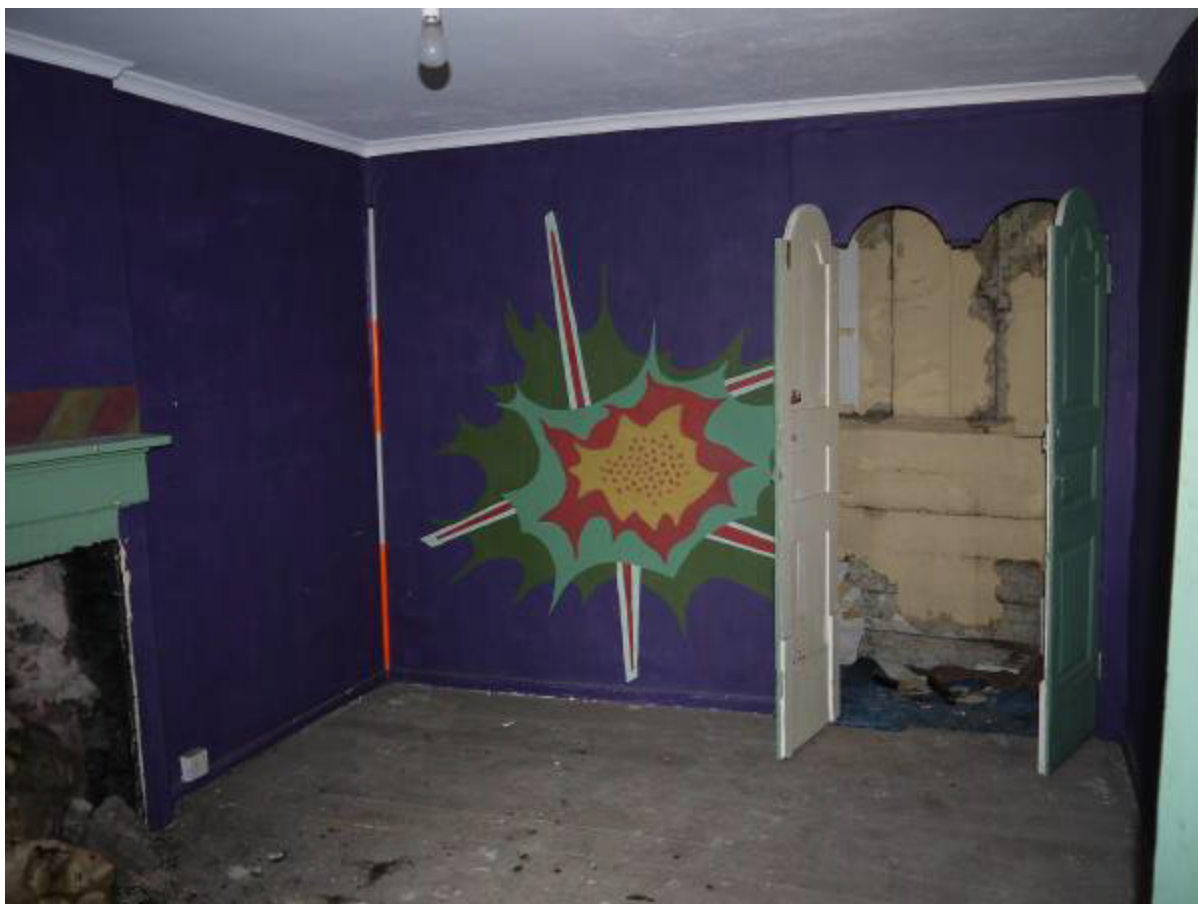
This wall has a cupboard at its northern end with a very ornate double door, it is painted purple with an abstract 'explosive' design in red and yellow.

Illustration 24 Eastern elevation Room 1

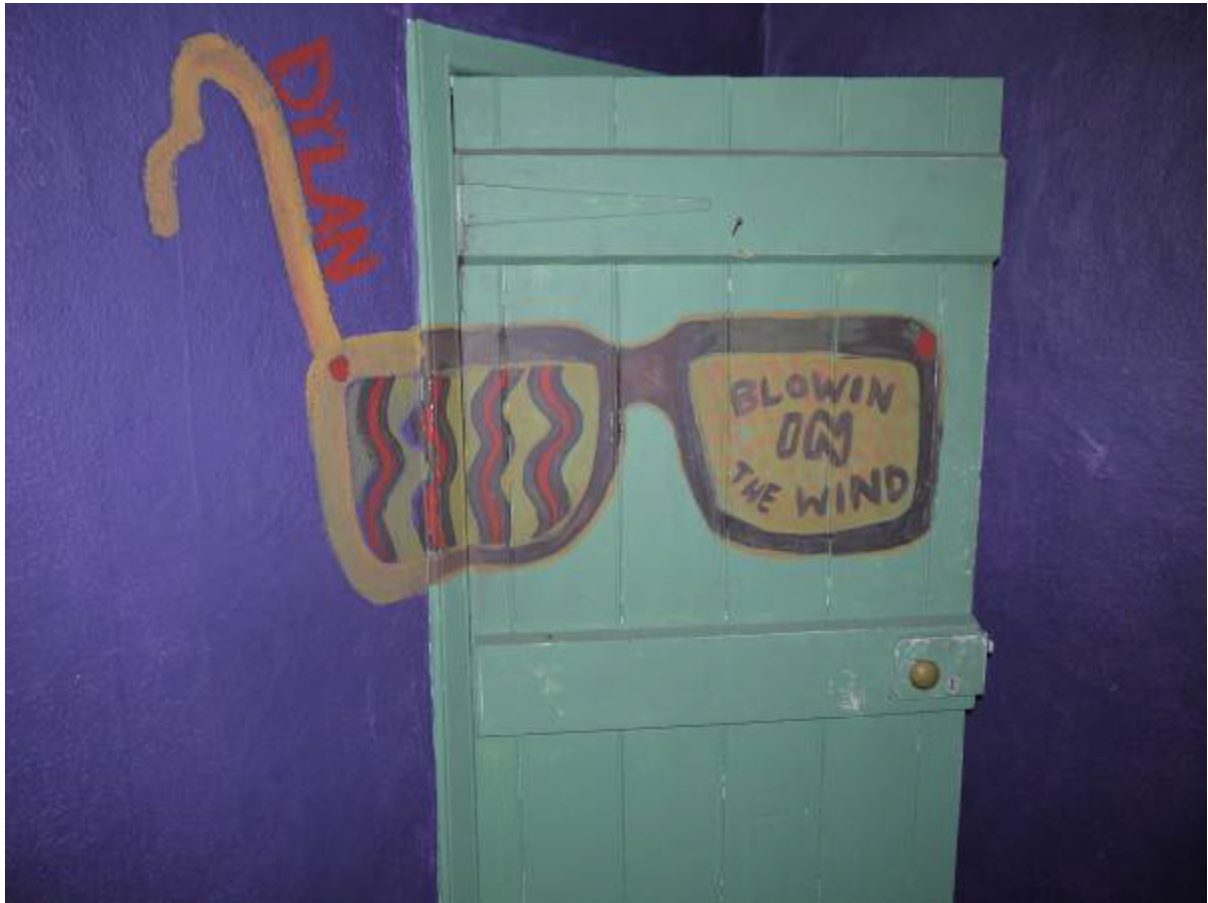
This wall has a doorway at its Eastern end and is painted purple with a pair of spectacles surmounted with 'Dylan BLOWIN in the WIND' painted in purple, yellow and red.

Illustration 25 Graffiti on Southern elevation Room 1

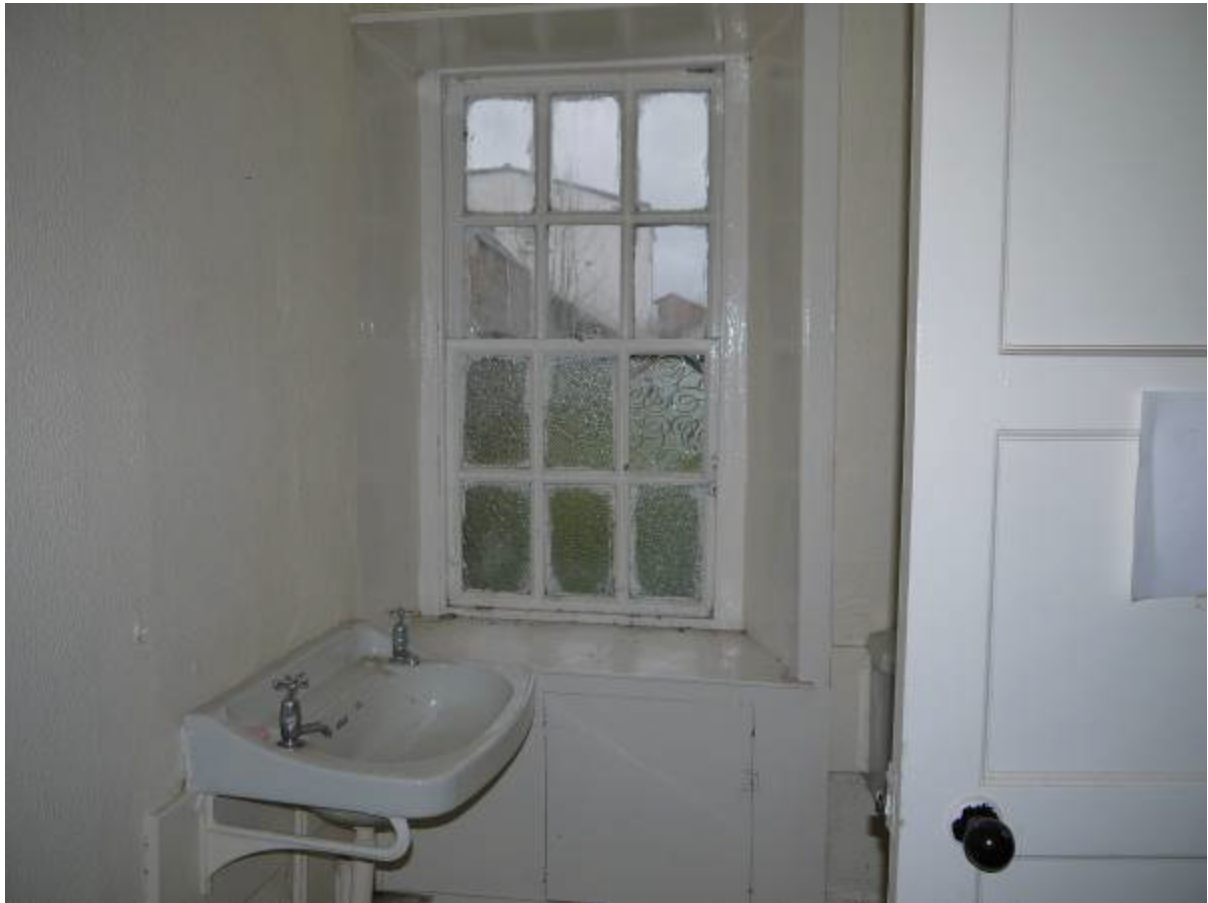
This is a bathroom with a window overlooking the back garden area and has a wooden floor. It is painted a cream colour.

Illustration 26 Western elevation Room 2

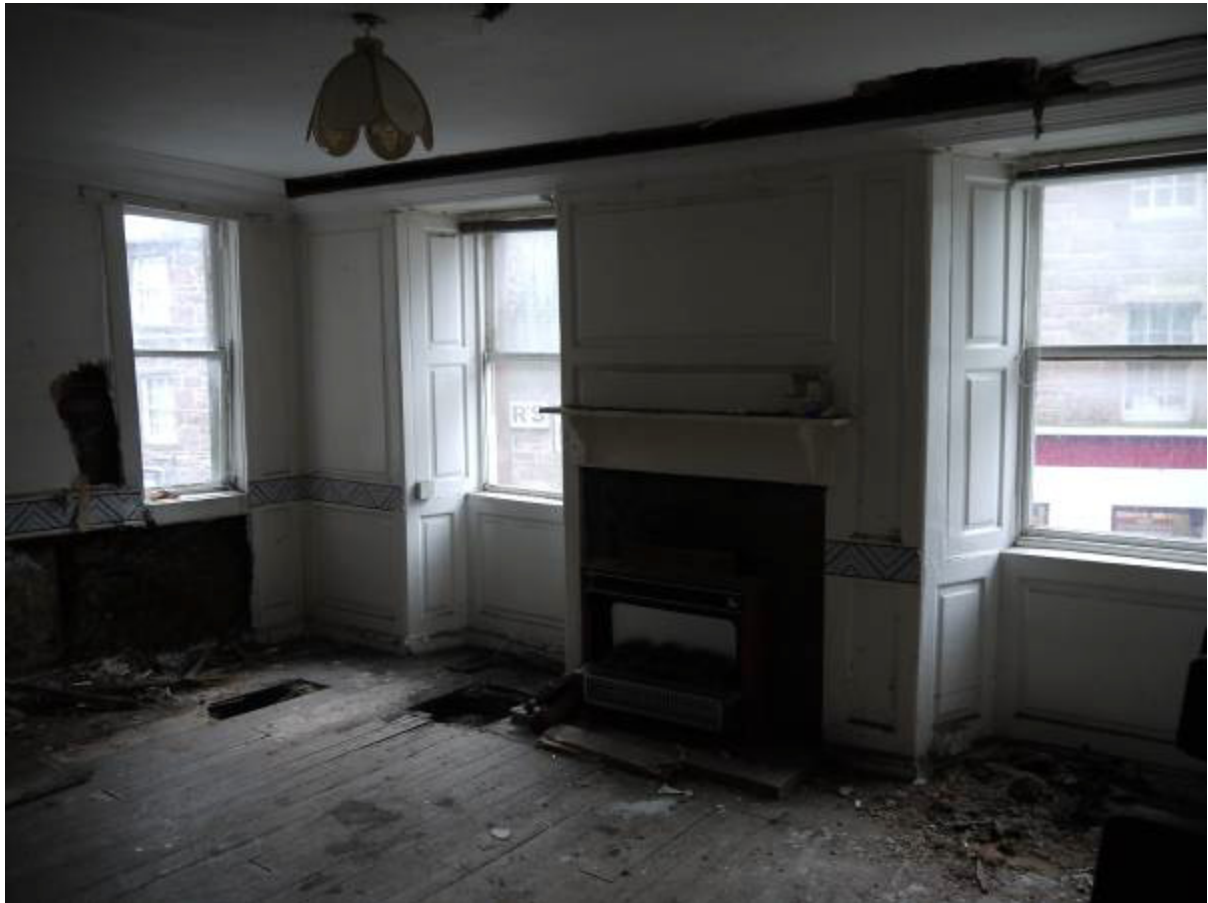
This wall is 0.70m thick and contains two large well light windows overlooking the High Street. There is a central fireplace in this wall.

Illustration 27 Eastern (High Street) elevation Room 3

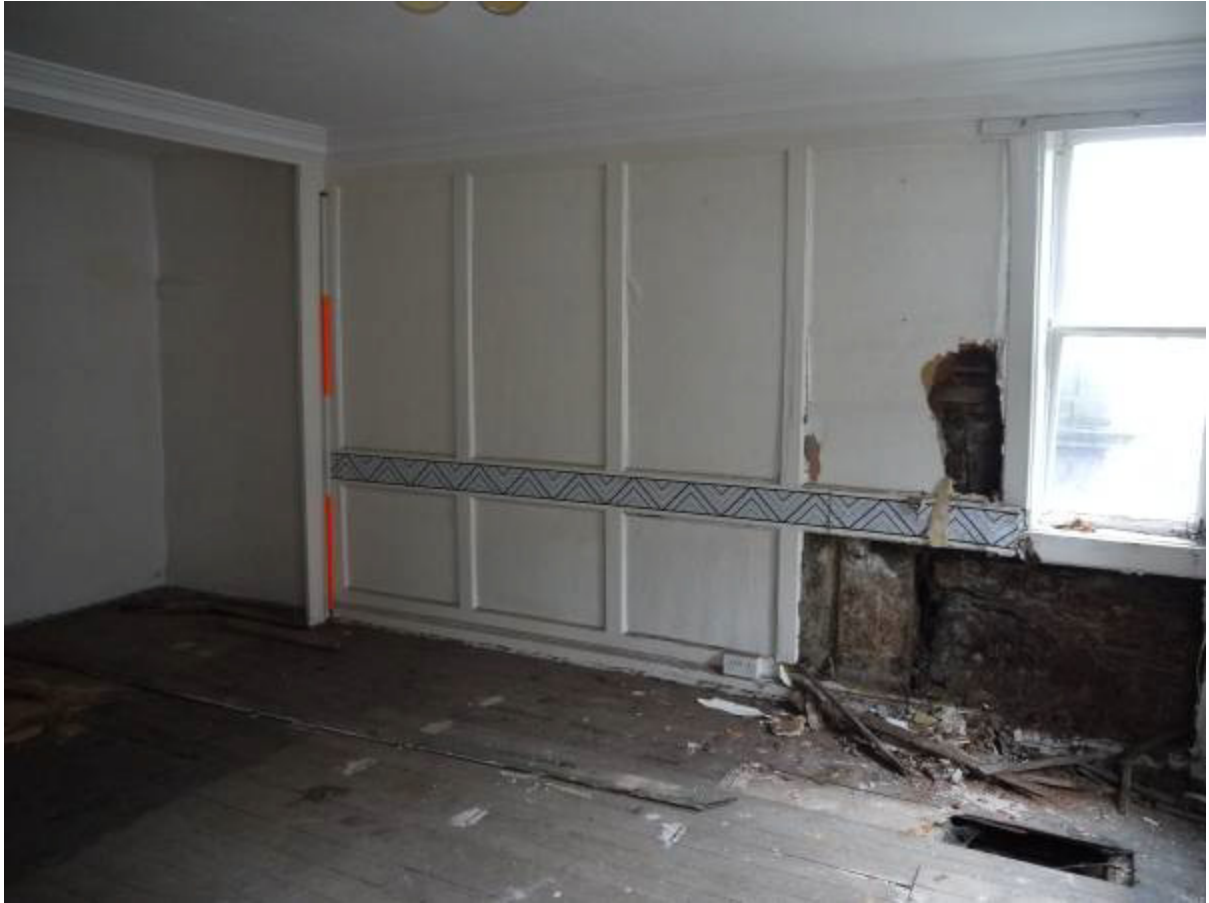
The panelling on this wall has been removed at its Western end to expose the stone wall face. At this point the frontage wall of the neighbouring building (former Episcopal Church) is visible with the projecting Eastern elevation of 47 High Street apparently built against it. There is a single window in this elevation that looks down the High Street to the South.

Illustration 28 Northern elevation Room 3

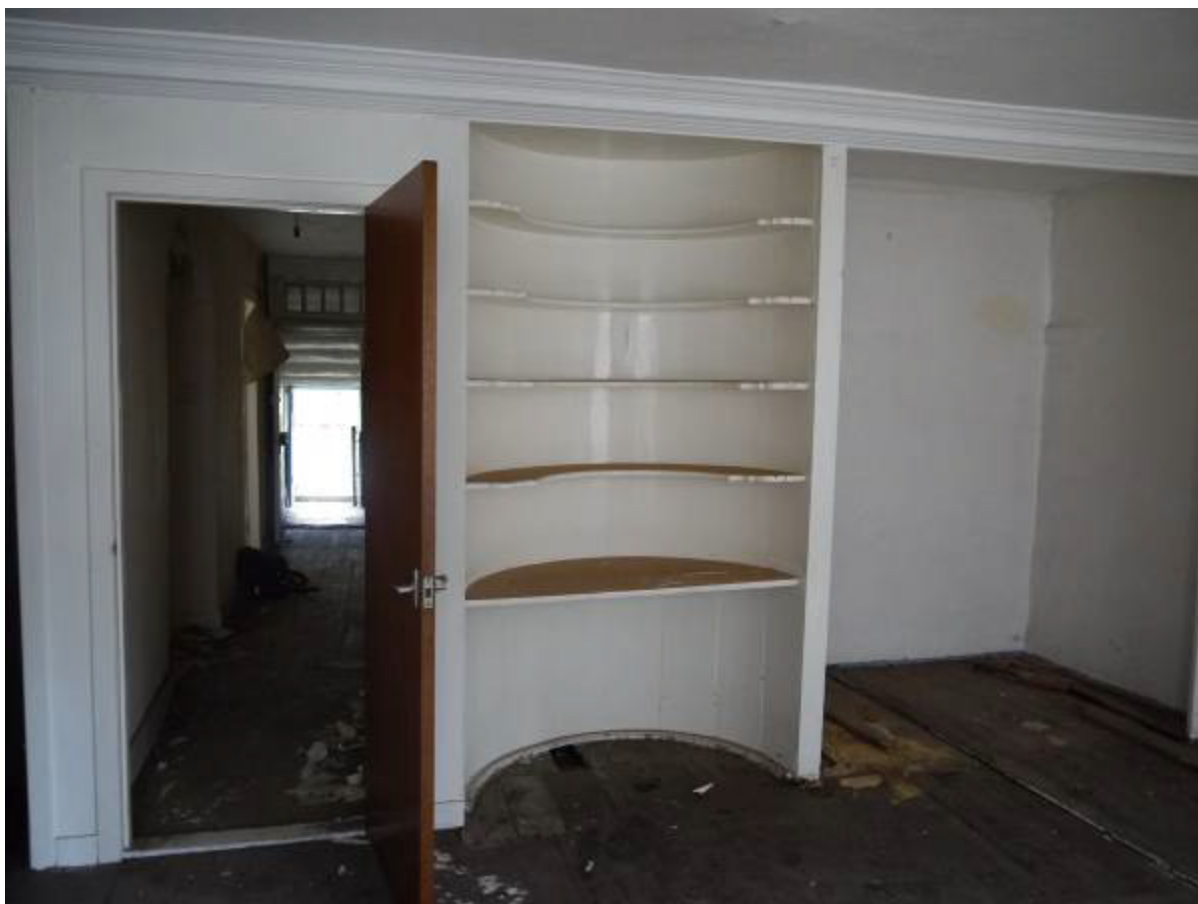
This panelled wall includes a cupboard with a door at its Northern end, a doorway, an ornate shelved cupboard or display area with 5 shelves and a recess at its Southern end.

Illustration 30 Western elevation of Room 3 with ornate shelved cupboard and alcove

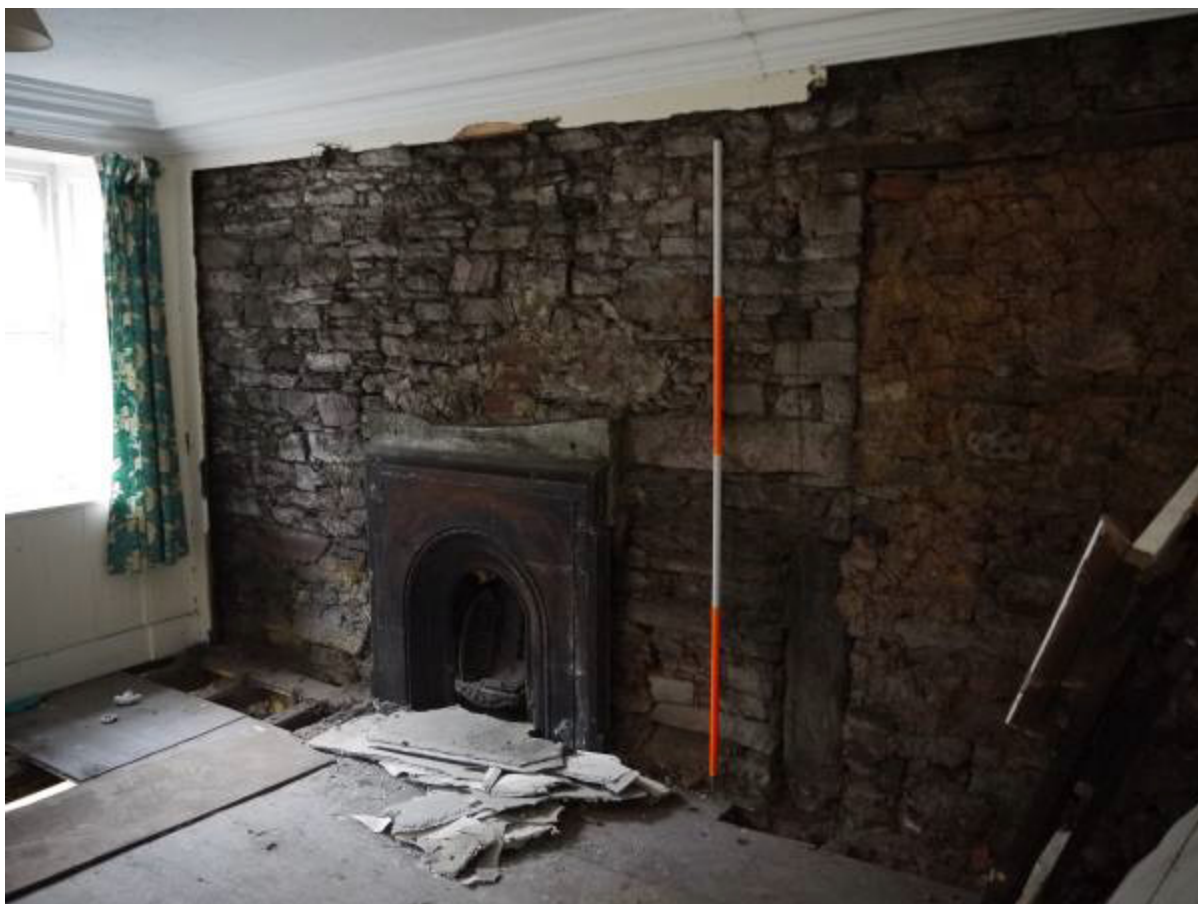
The panelling has been removed from this wall to expose the stone wall face which is built of shaped sandstone blocks. It contains a fireplace and a blocked doorway with a wooden lintel at its Eastern end. The stone blocking of this doorway is bonded with red clay. This doorway presumably led out onto the pend with stairs on this side of the building.

Illustration 33 Southern elevation of Room 4 showing blocked doorway to right

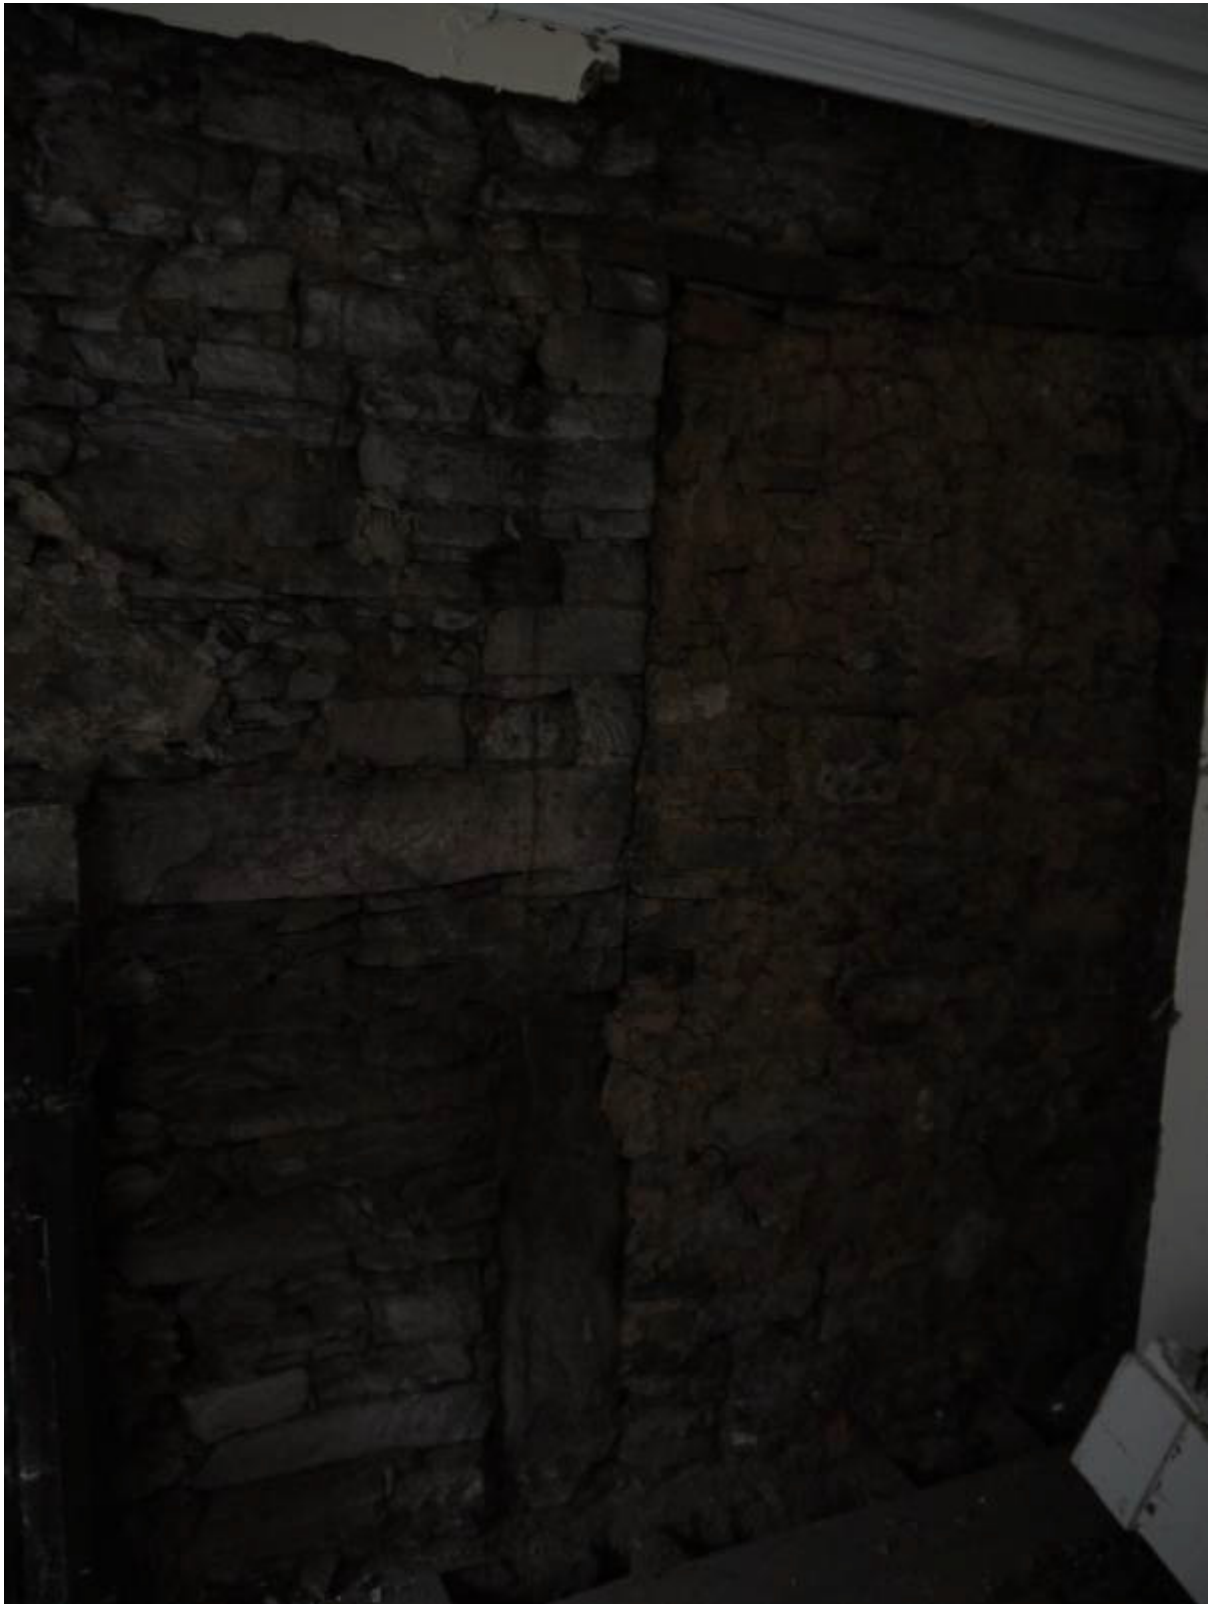
Illustration 34 Detail of blocked doorway in Room 4

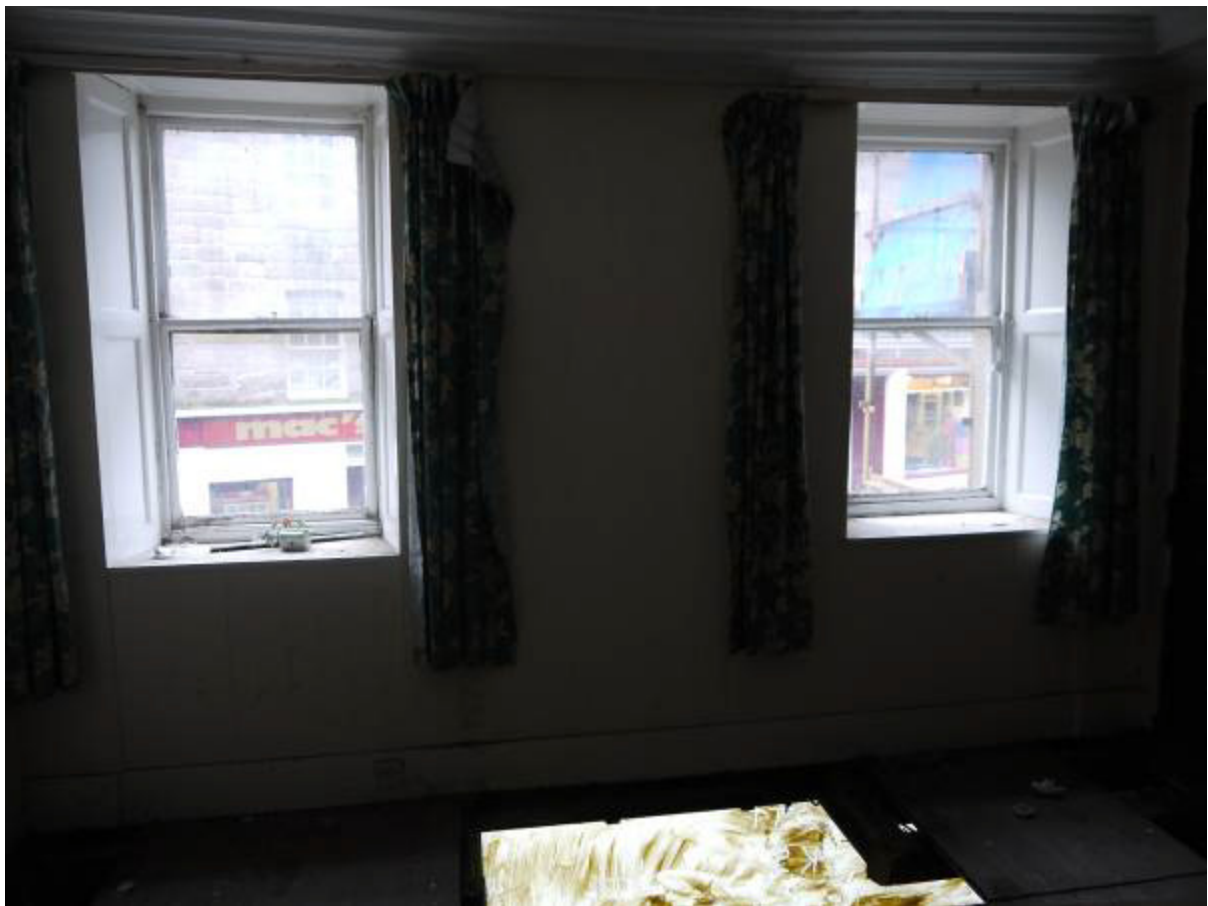
This wall has two windows overlooking the High Street.

Illustration 35 Eastern (High Street) elevation of Room 4

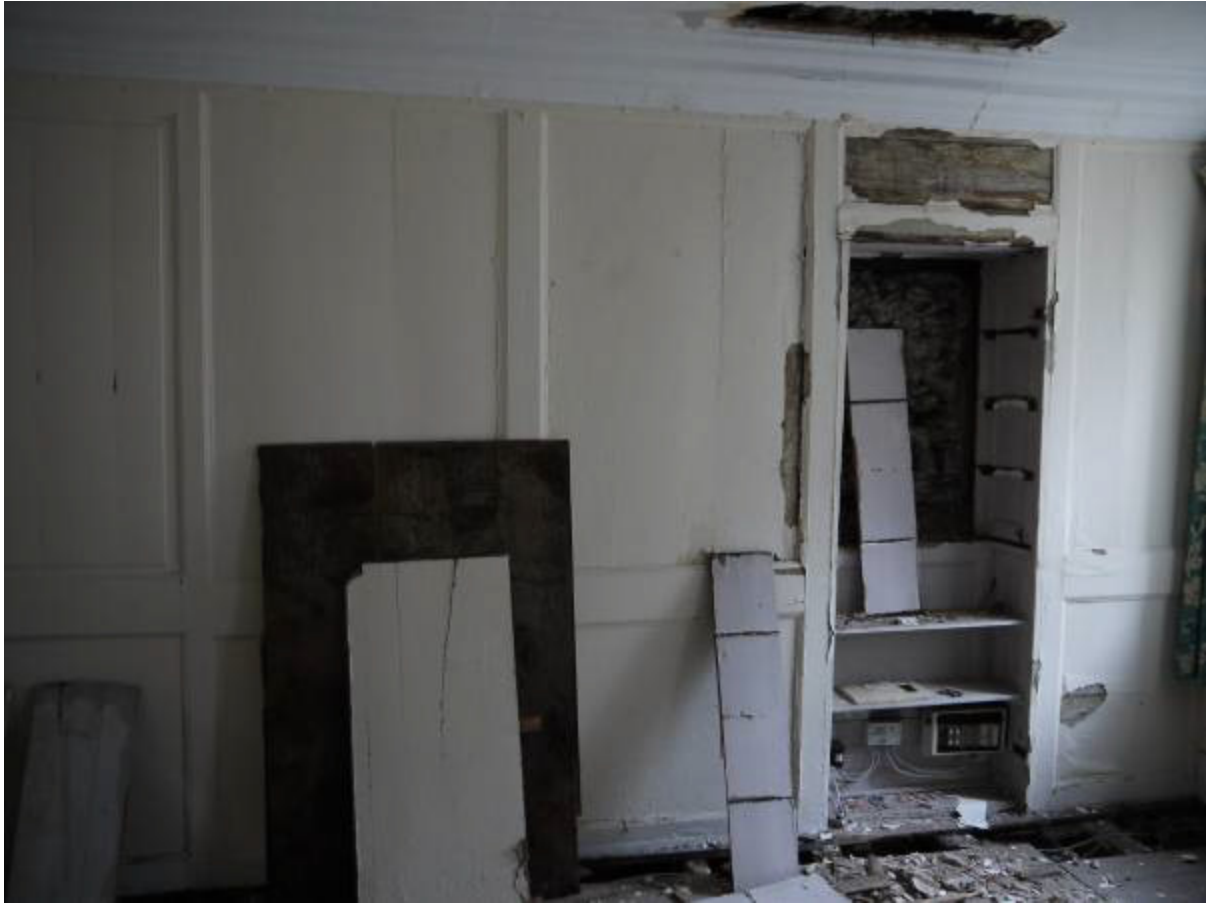
This wall contains a cupboard at its Eastern end which may contain a blocked window above the fuse box.

Illustration 36 Northern elevation of Room 4

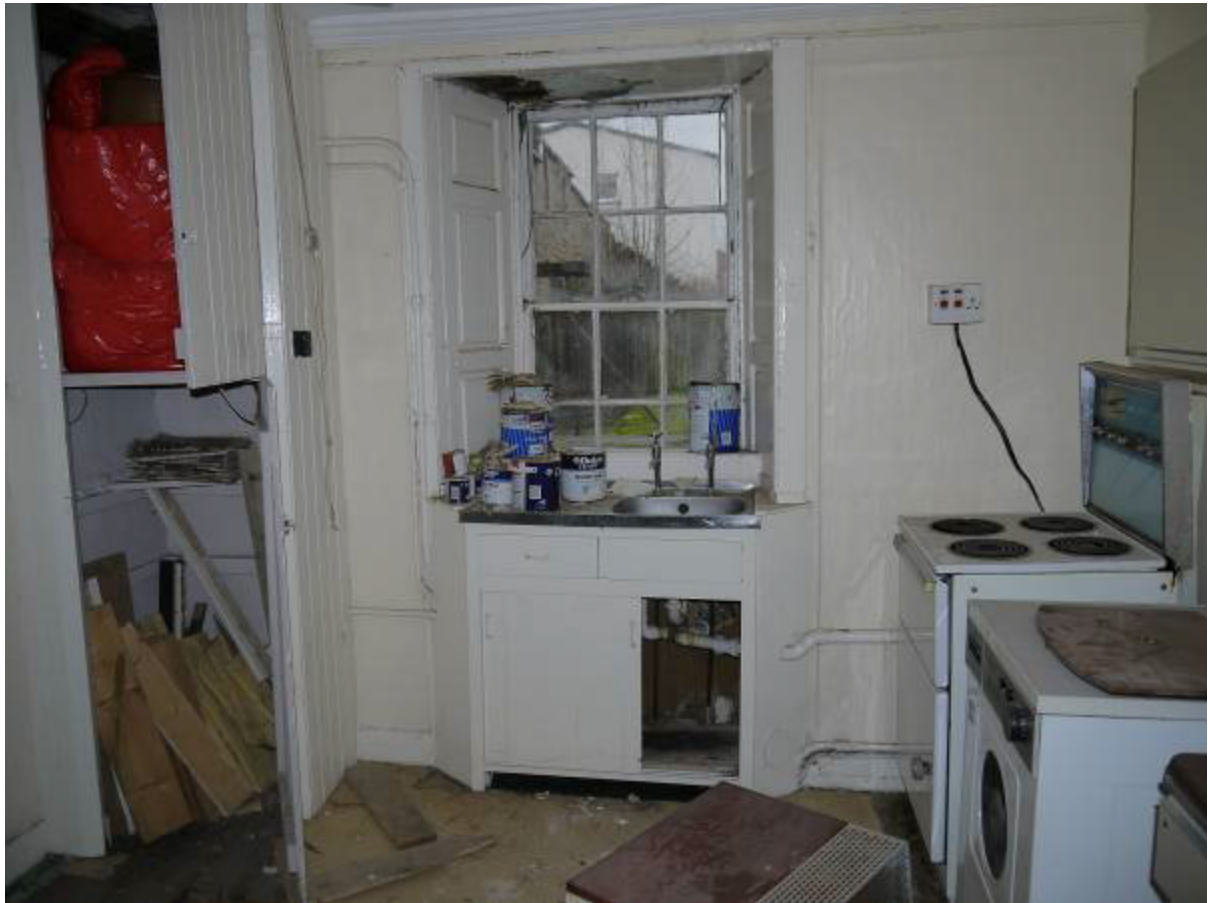
This wall contains a cupboard at its South end and an alcove at its North end. Part of the wallpaper on the East wall of the alcove has been removed to reveal that that section of the wall is timber built.

Illustration 31 Western elevation of Room 5

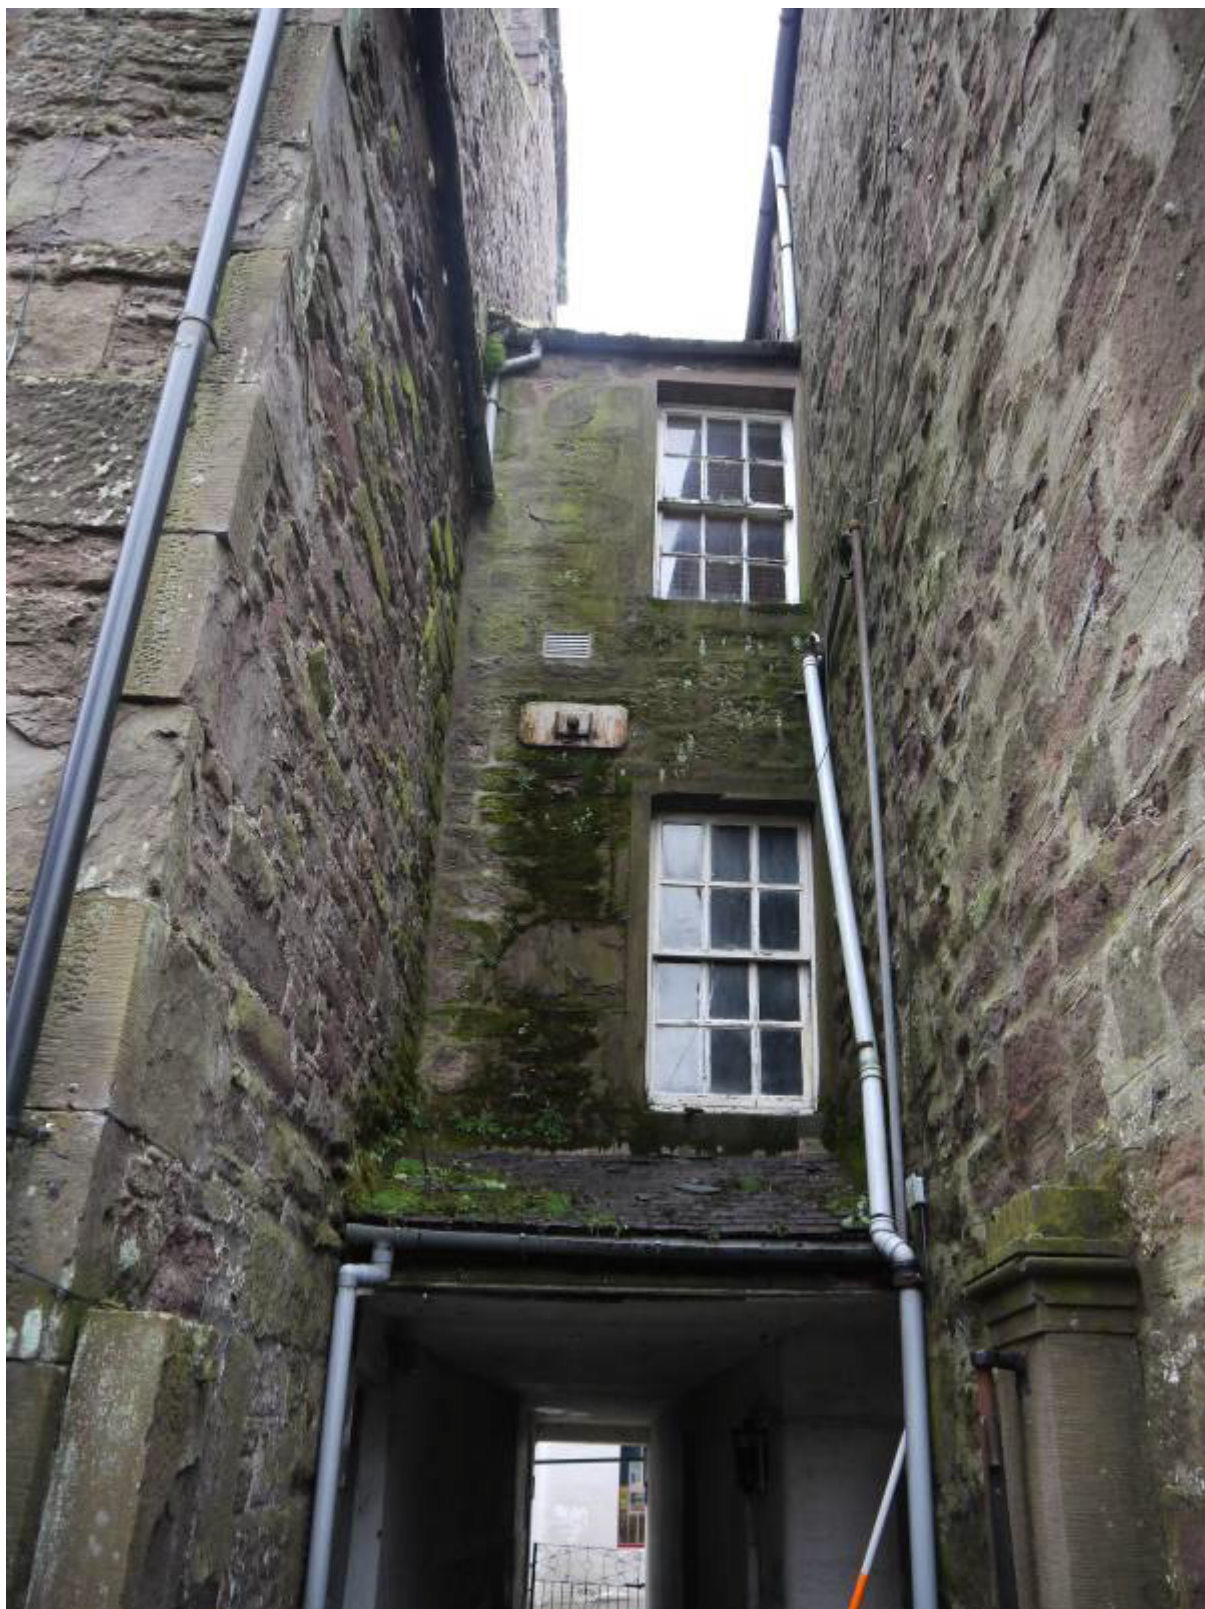
Above the covered pend to the south of the stair tower there are single windows at first and second floor levels. The roof of the extension to the rear of 45 High Street is visible from the back garden level standing 1.5m above garden level. Above this the first and second floors have two sets of two windows one above the other. The roof is covered with small grey slates

Illustration 38 Eastern elevation above pend and to South of stair tower

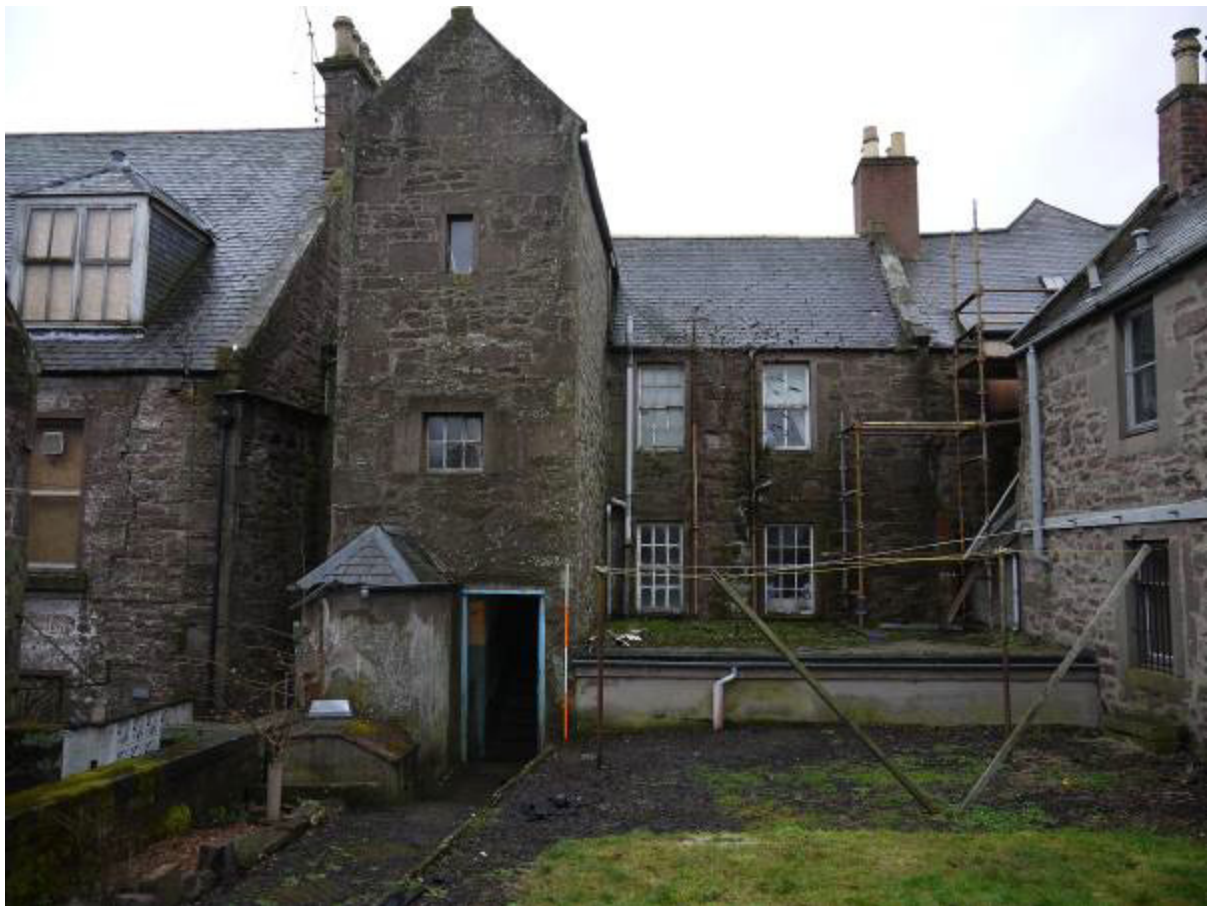
Illustration 39 Rear (Eastern) elevation of No's 45, 47 and 49 High Street, Brechin

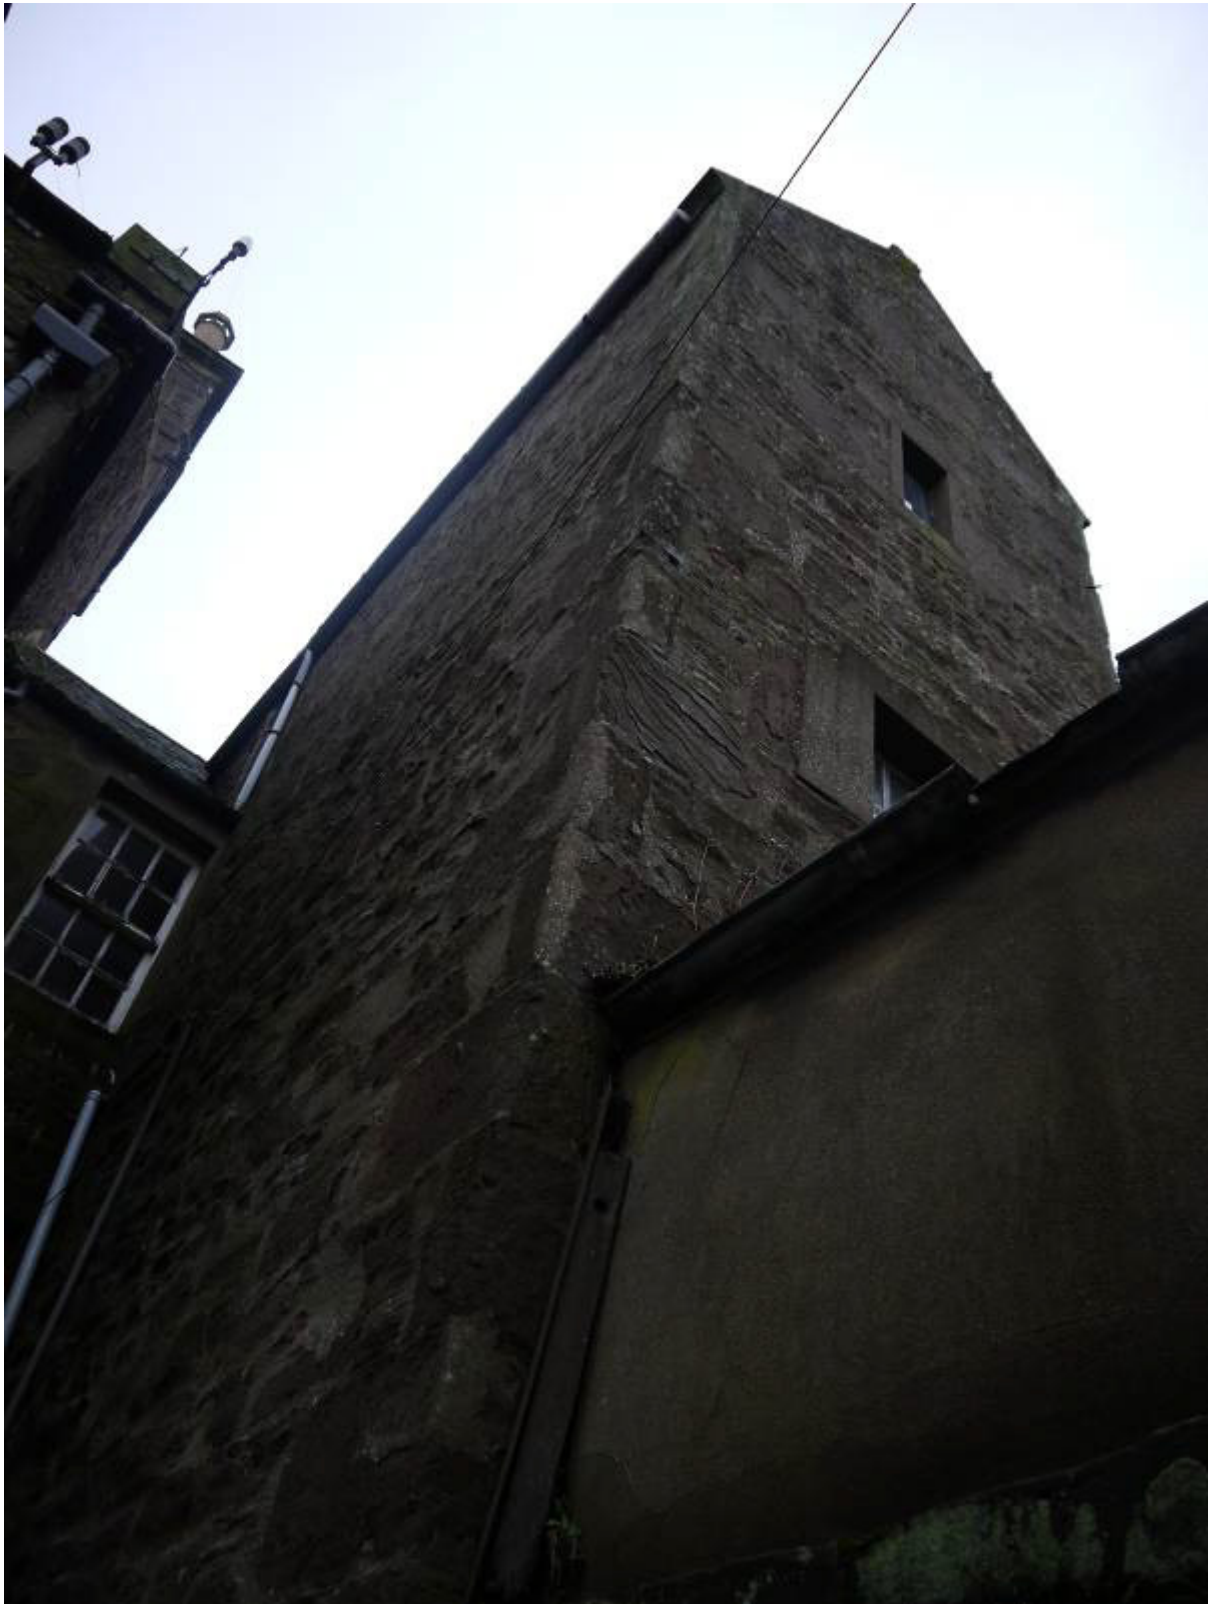
There is a narrow stair tower that provides access from ground floor level to both first and second floor levels of the building. The Eastern elevation of the stair tower contains a doorway at garden level and windows at first and second floor levels.

Illustration 40 Stair tower from Pend looking North West
