**AXMINSTER BYPASS 1990
EXCAVATIONS ON THE
YARTY FLOODPLAIN**

S. Reed

Between May and August 1990 the Exeter Museums Archaeological Field Unit (EMAFU) undertook an archaeological investigation on the Yarty floodplain prior to the construction of the Axminster Bypass. The site was selected in order to locate the Exeter-Dorchester Roman road at a point where it diverged from the present day A35 road (Fig. 1). The site was directed by C.G. Henderson and supervised by R. Mortimer. Post-excavation work was undertaken by S. Reed.

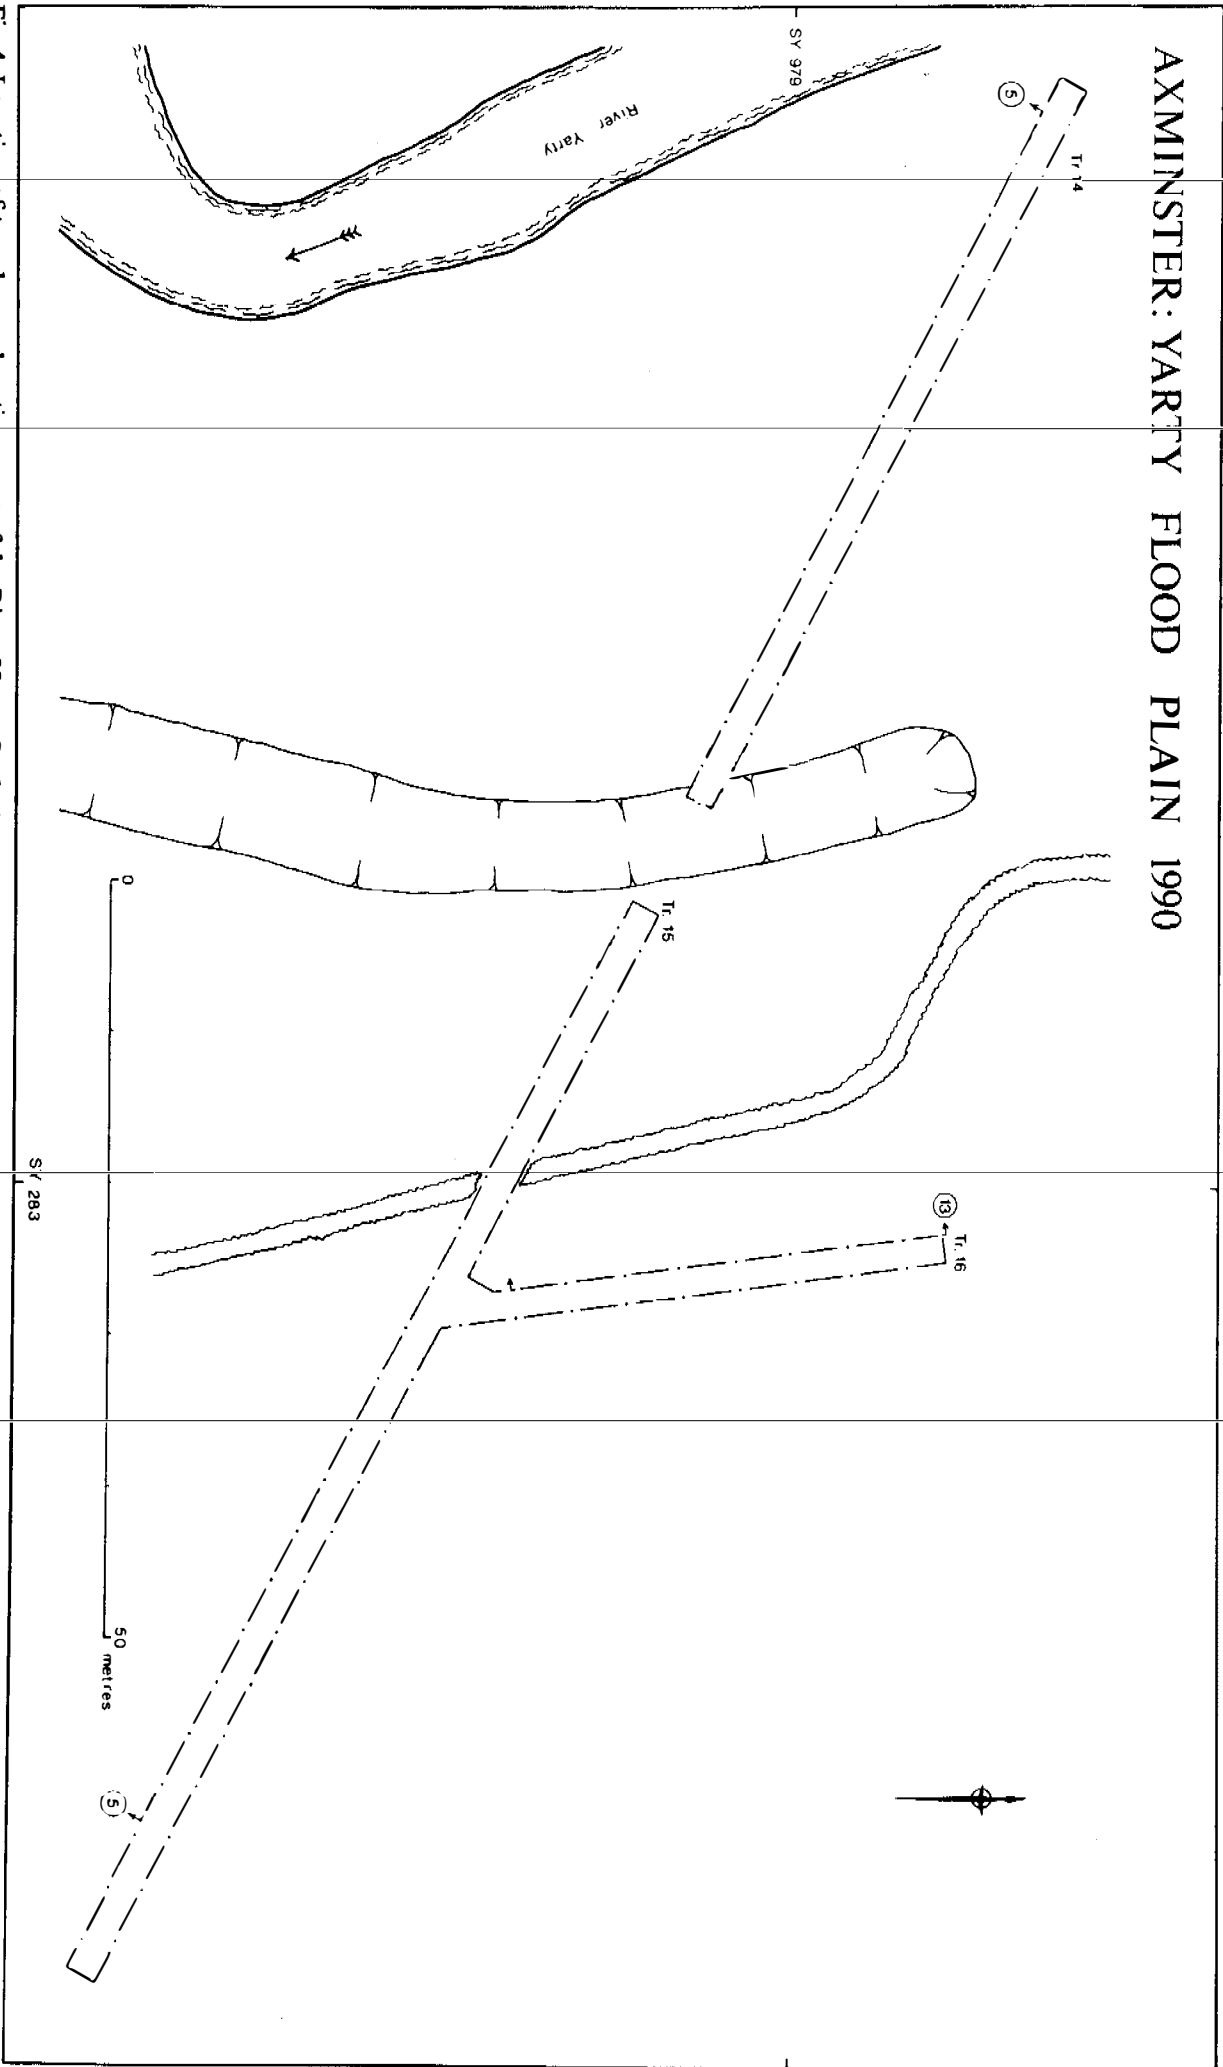
Fig 4 Location of trenches and sections east of the River Yarty. Scale 1:500.

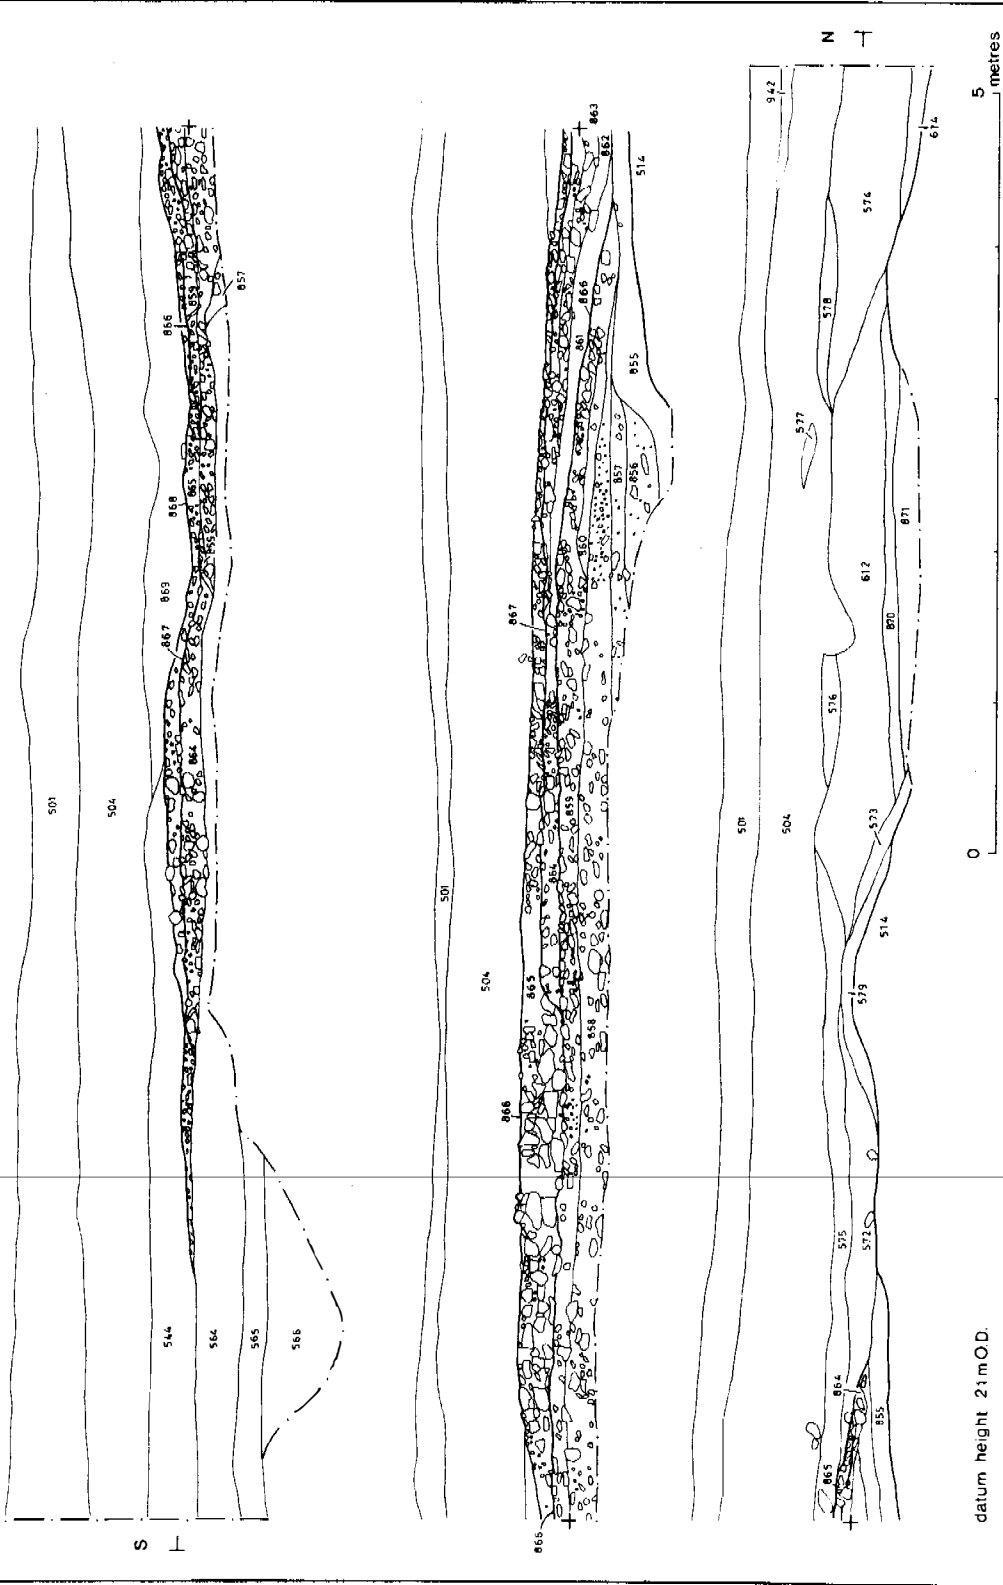
Section 19

Fig 6 Section 19. Scale 1:50.

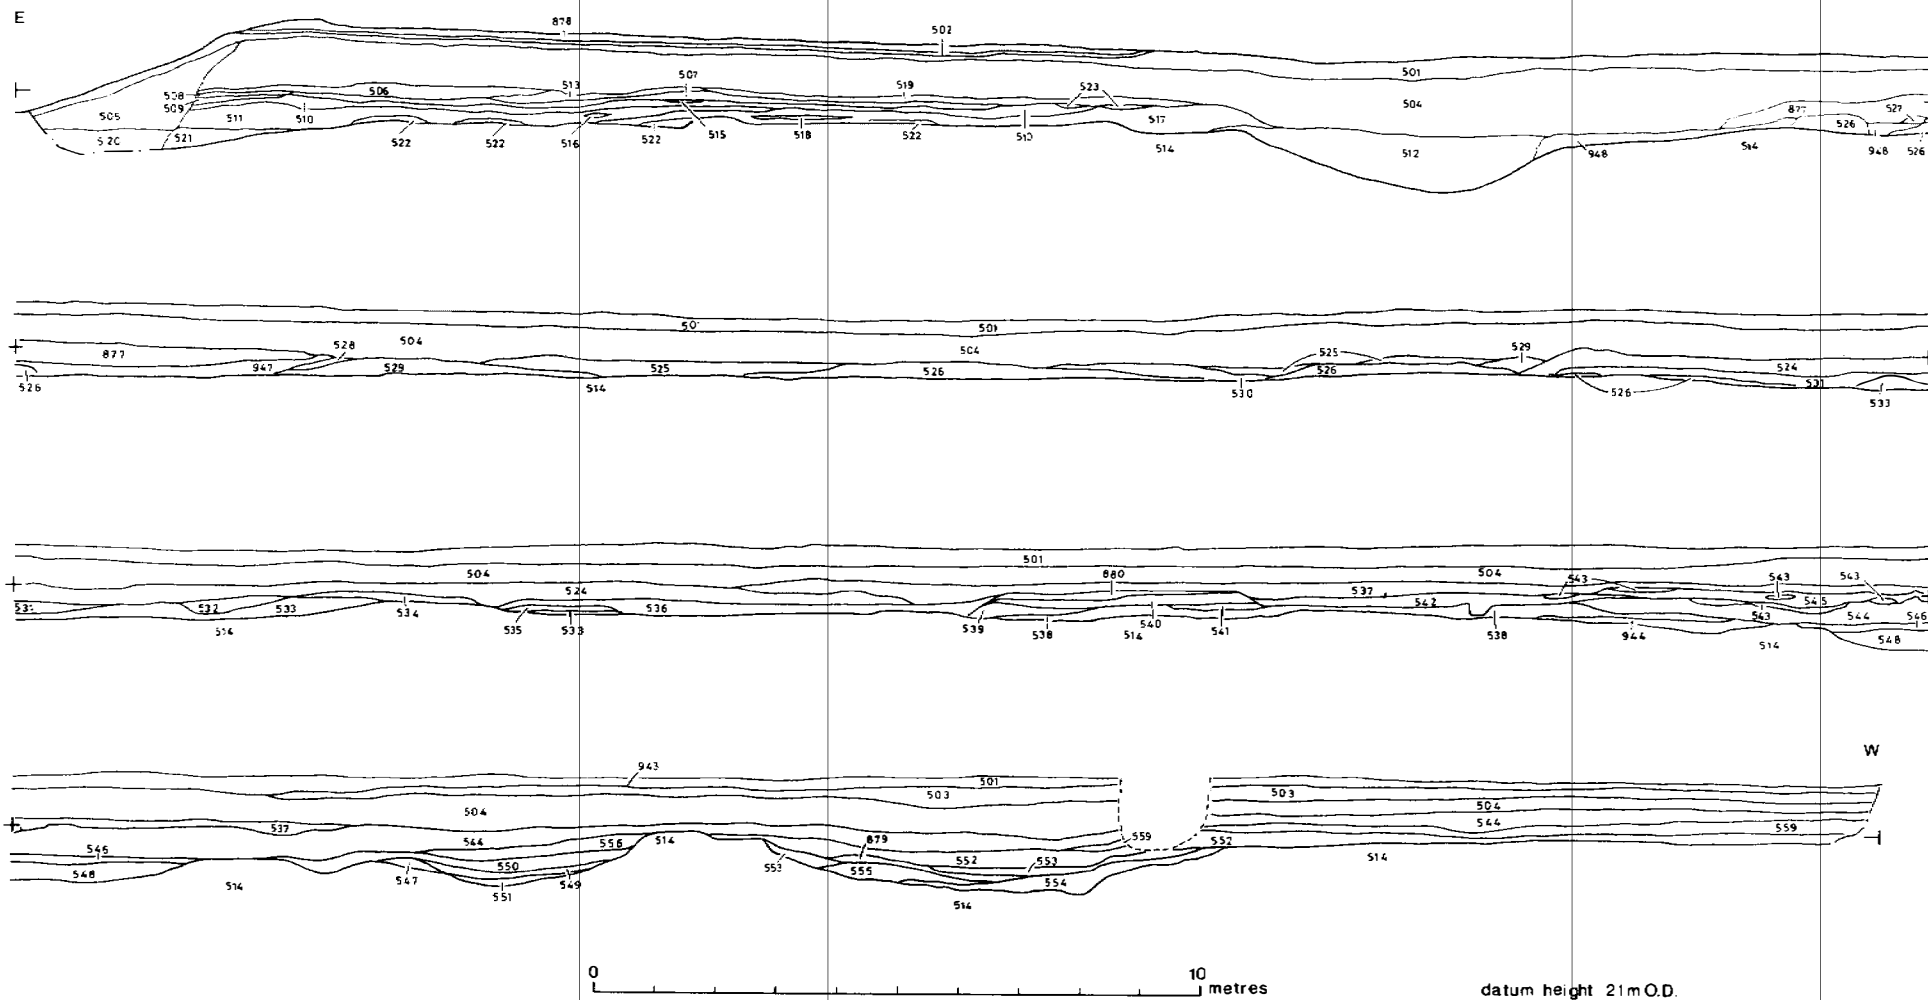
Section 1

Fig 7 Section 1. Scale 1:100.

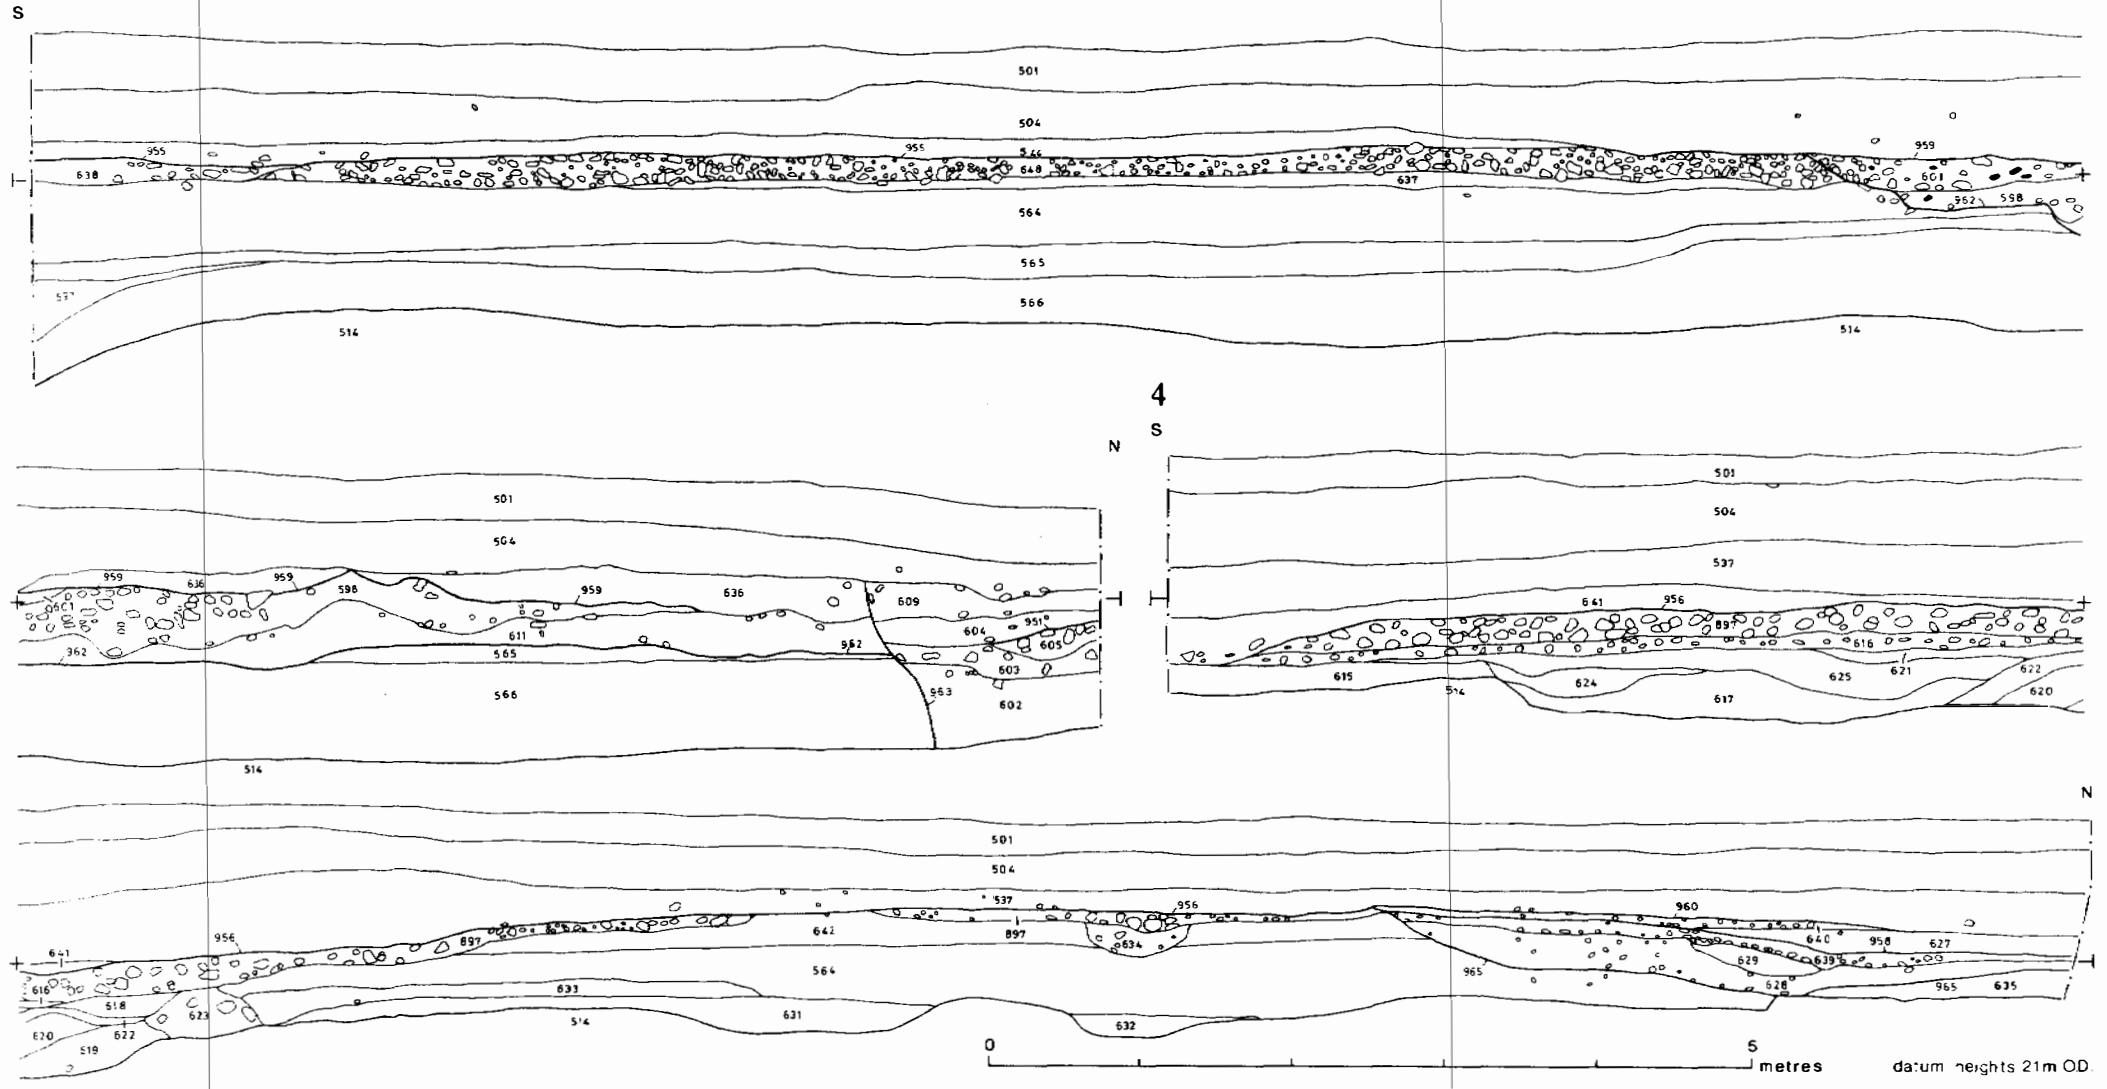
Fig 8 Sections 7 and 4. Scale 1:50.

- 638 Make-up for Roman road surface 955. Comprises small-sized gravel and medium to large waterworn stones in a sandy matrix. Le = 14.5m; D = 0.2m.
- 639 Repair build of the northern side of the Roman road exposed in Section 4. This context is make-up for surface 958. The repair is probably due to the northern edge of road make-up 945 being washed away by river action. Le = 4.5m; D = 0.1m.

- 640 The last repair of the Roman road in Section 4 on the northern camber before the road was covered by alluvial deposits. Grey sandy clay, friable, common small, medium and large waterworn and angular stones. Le = 3.3m; D = 0.05m.

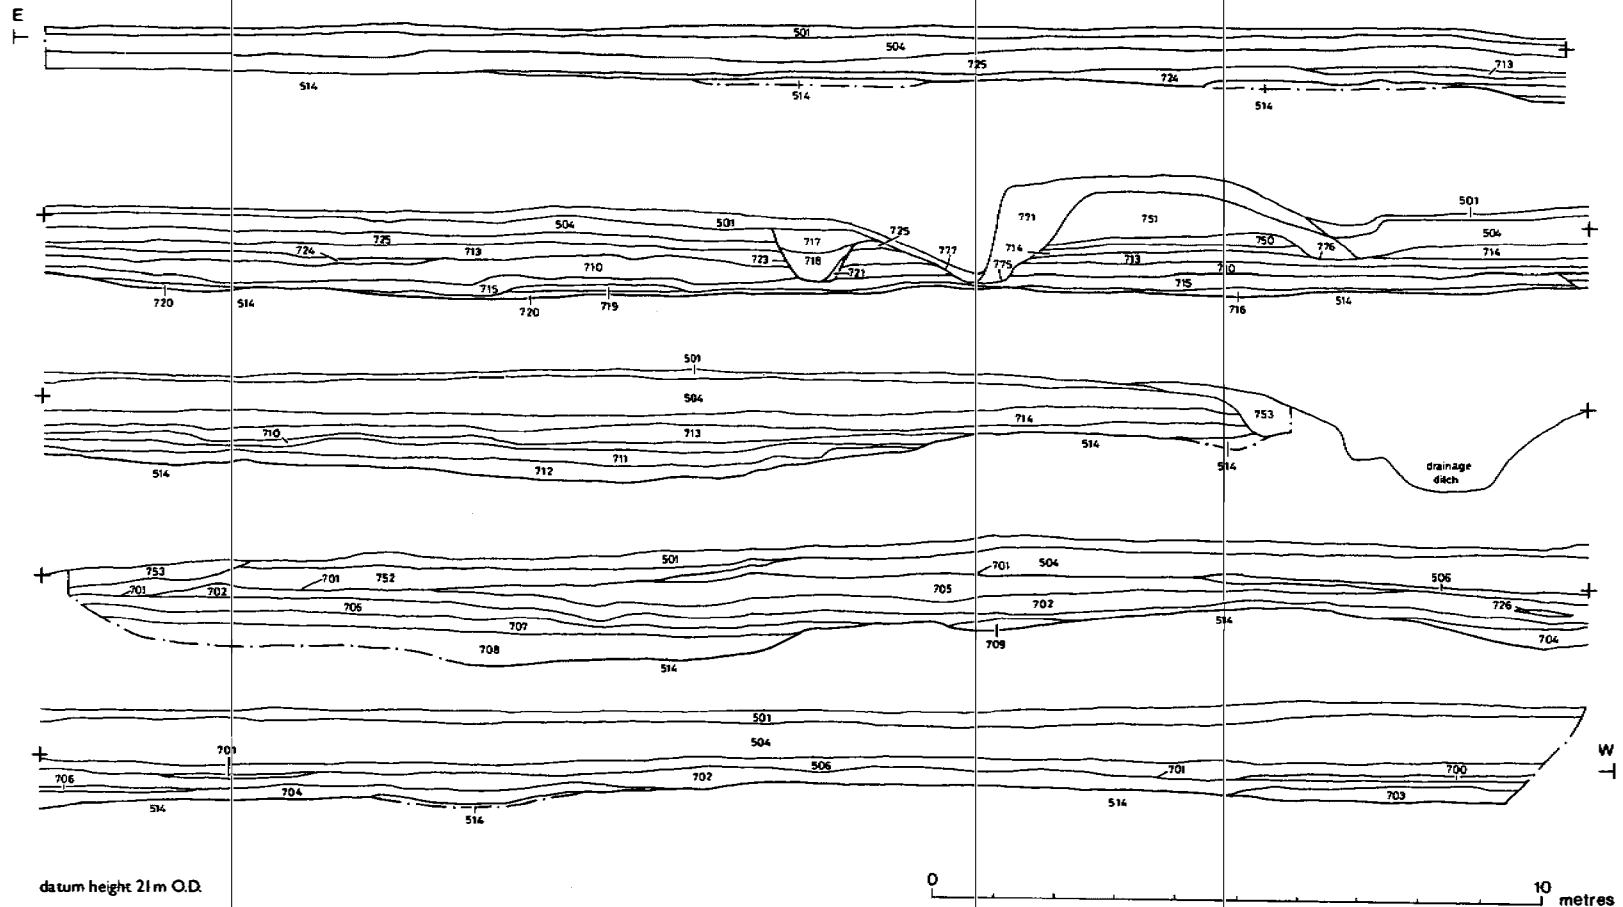
Section 5

Fig 13 Section 5. Scale 1:125.

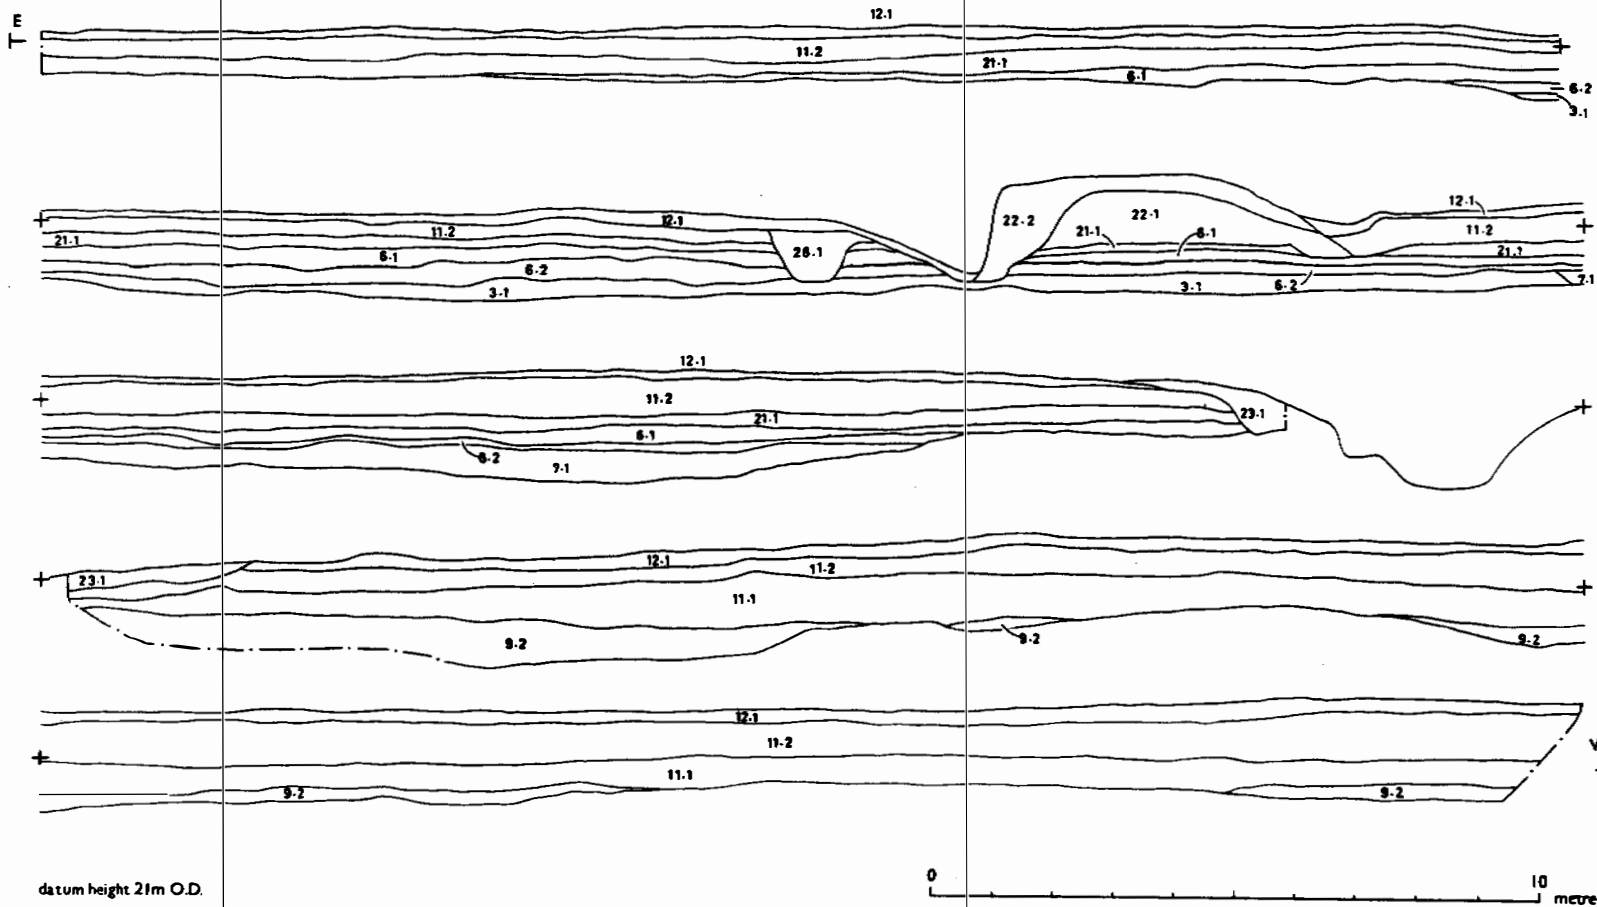
Fig 14 Simplified group section 5. Scale 1:125.

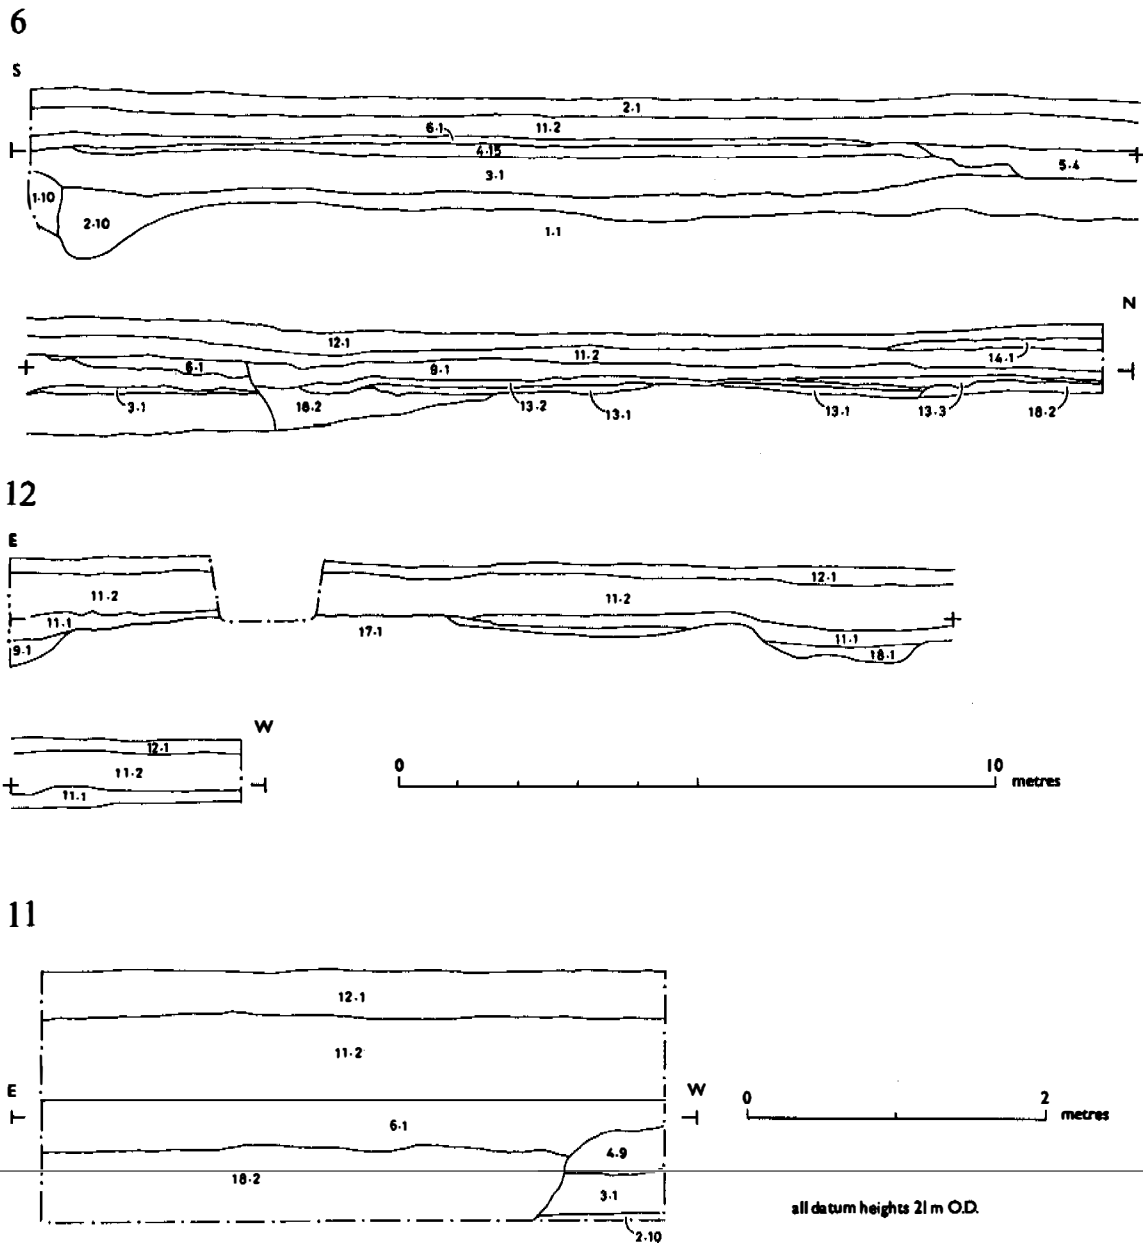
Fig 15 Simplified group sections 6,12 and 11. Scale 1:50.

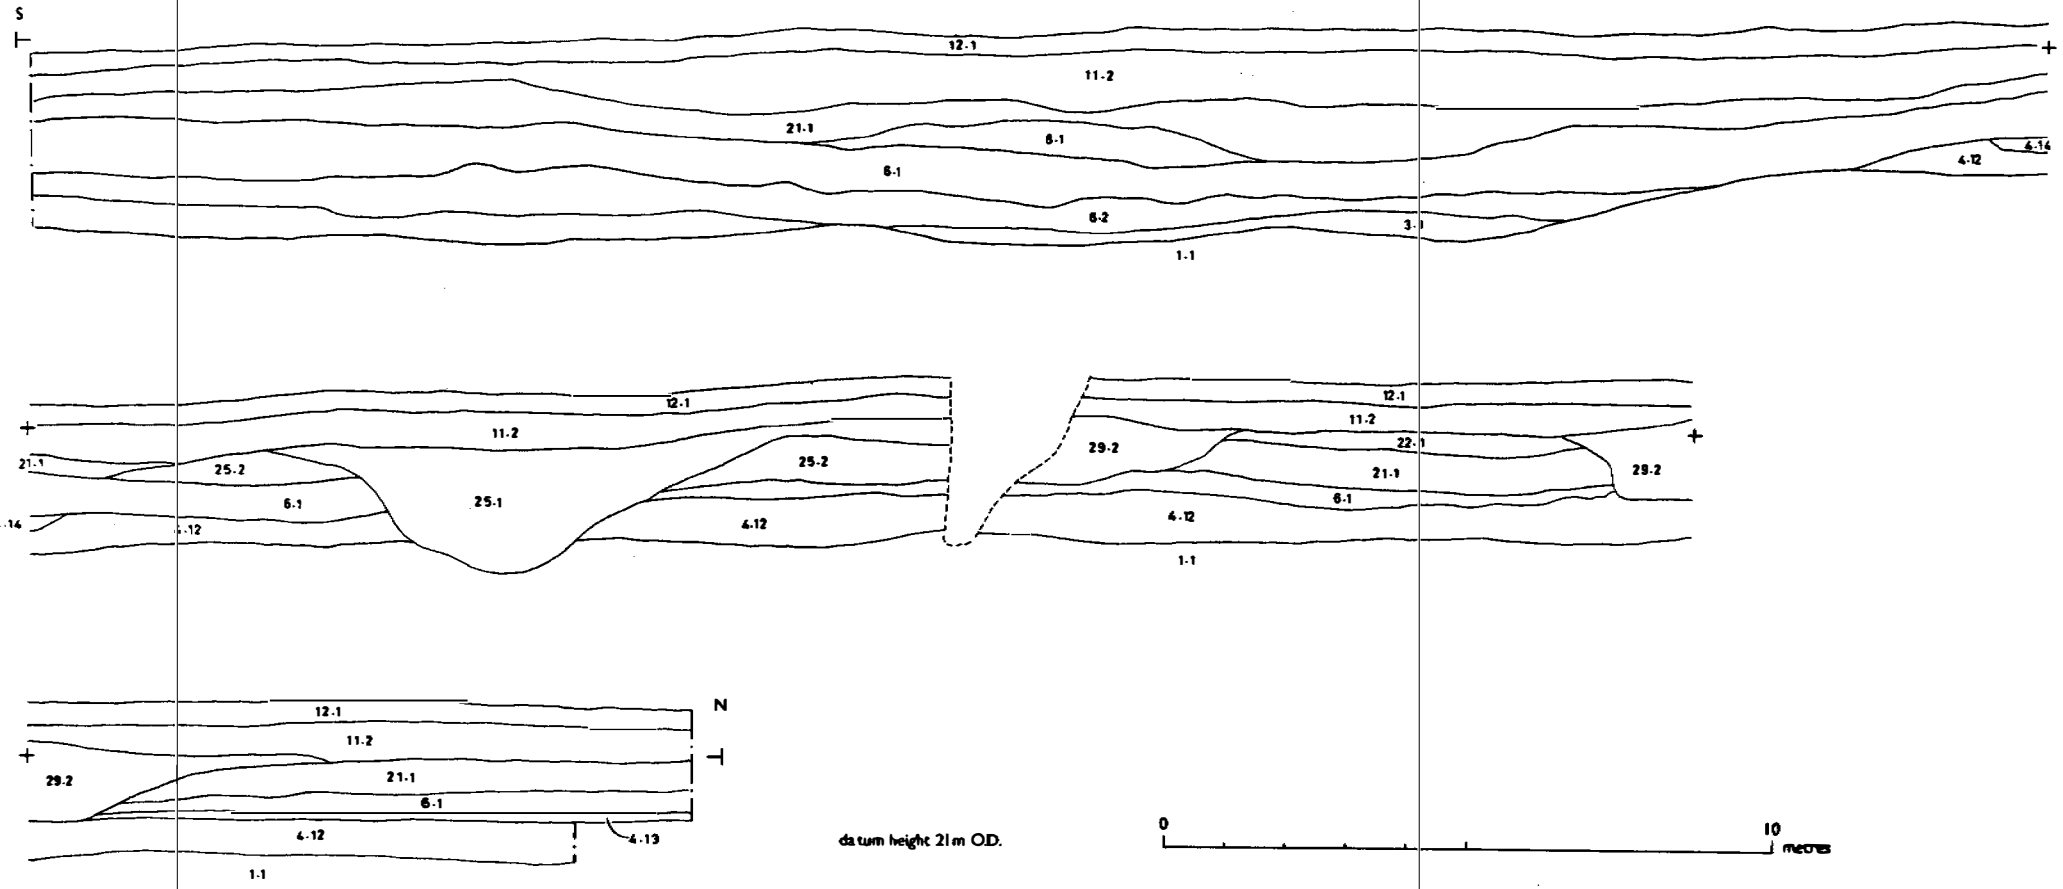
Fig 16 Simplified group section 13. Scale 1:50.

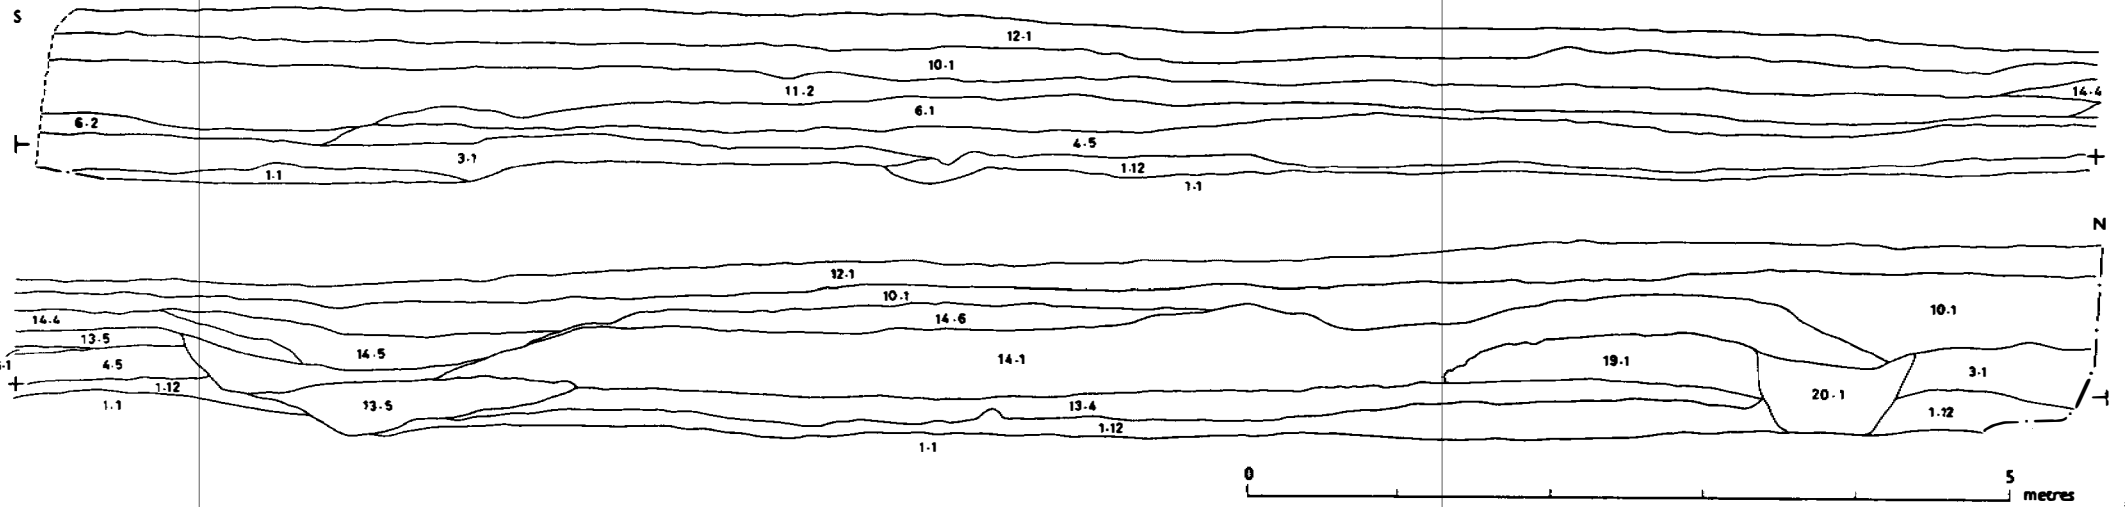
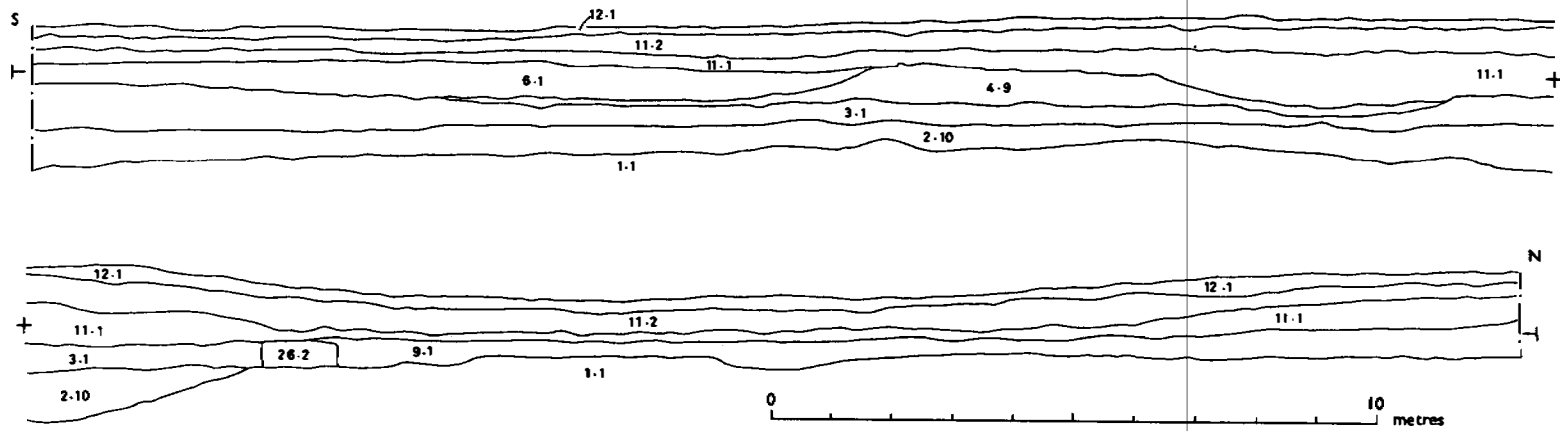
Fig 17 Simplified group sections 14 and 16. Scale 1:50.

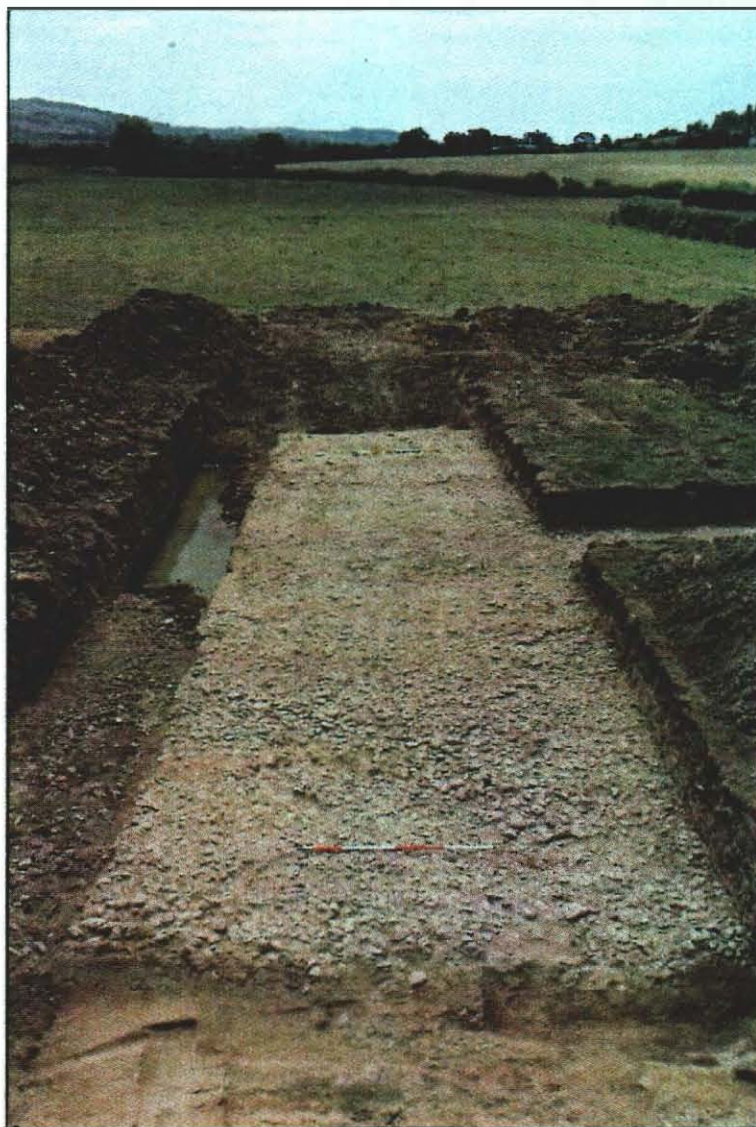
Pl. 1 Roman road exposed in plan, trench 6. Scale 2m. Looking south.

- 4.6 Primary make-up and surface of Roman road. The make-up consists of pea-sized gravel with small to large waterworn stones in a sandy clay matrix. The make-up and surface have been eroded away and repaired along its northern camber. Contains contexts: 648, 638, 955.

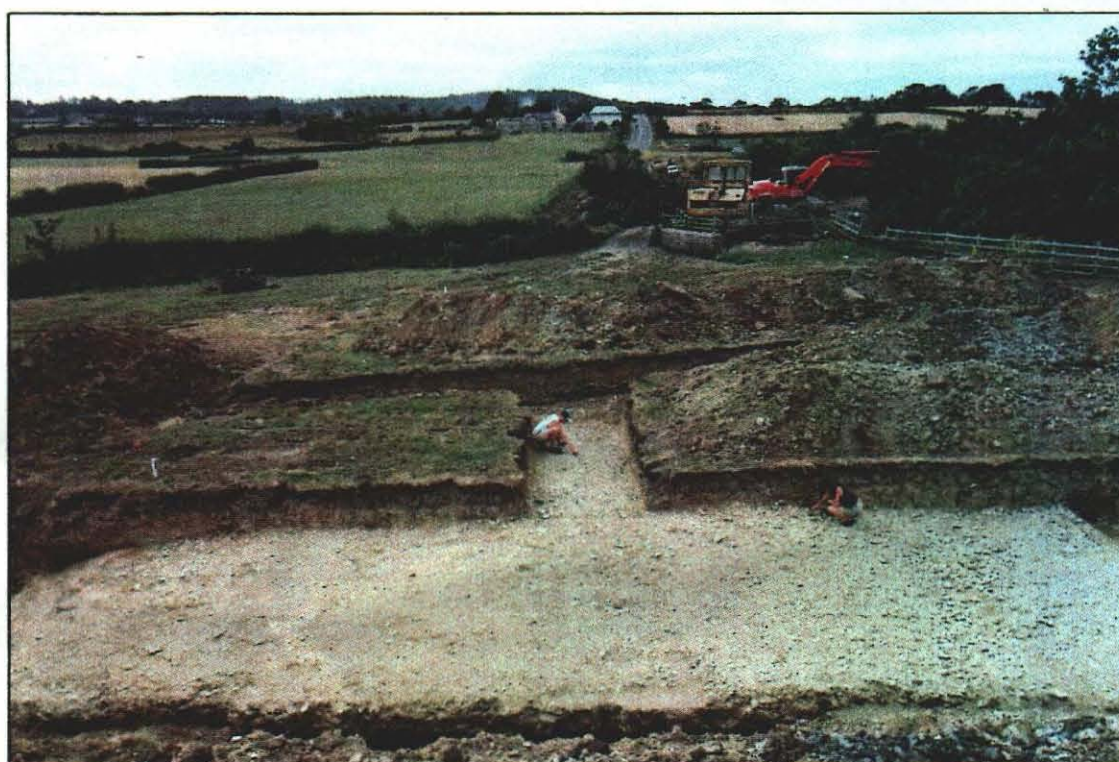
Pl. 2 Roman road exposed in plan, trench 6. Looking west.

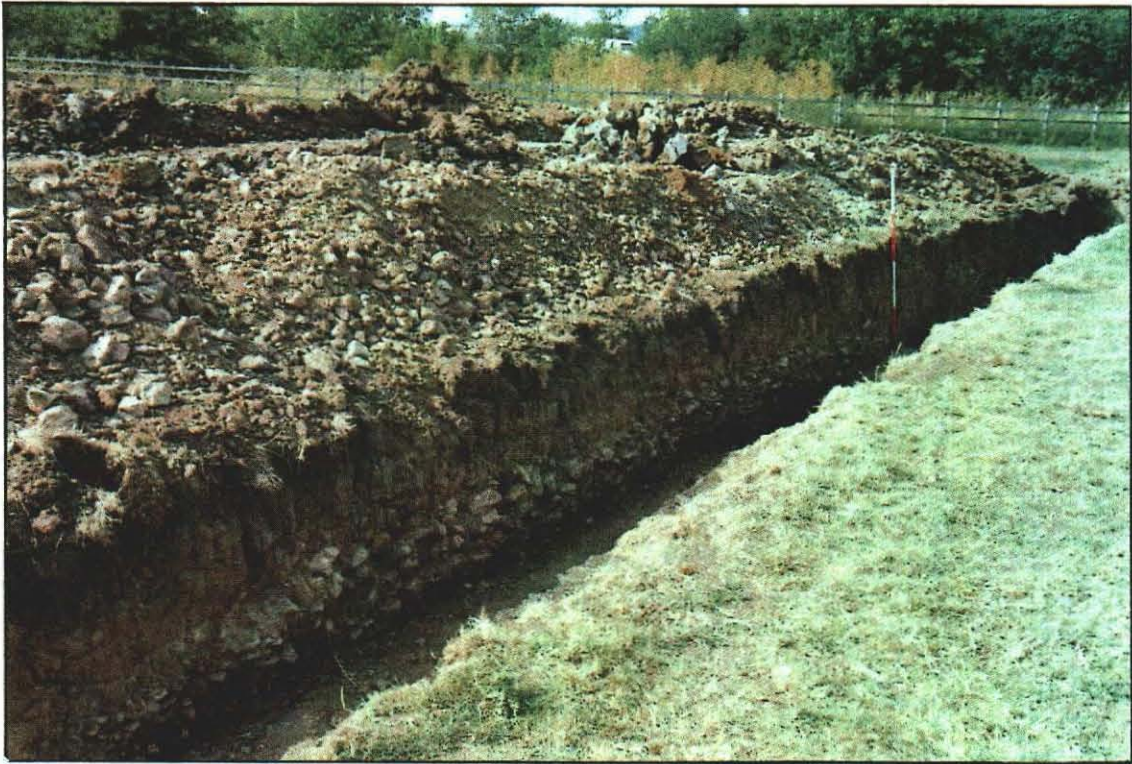
Pl. 3 Roman road exposed in section, trench 16. Scale 2m. Looking north-west.
