CITY HALL, BEAUMONT FEE
ARCHAEOLOGICAL WATCHING BRIEF

CLAU ARCHAEOLOGICAL REPORT NO: 212

CITY HALL BEAUMONT FEE, LINCOLN

ARCHAEOLOGICAL WATCHING BRIEF

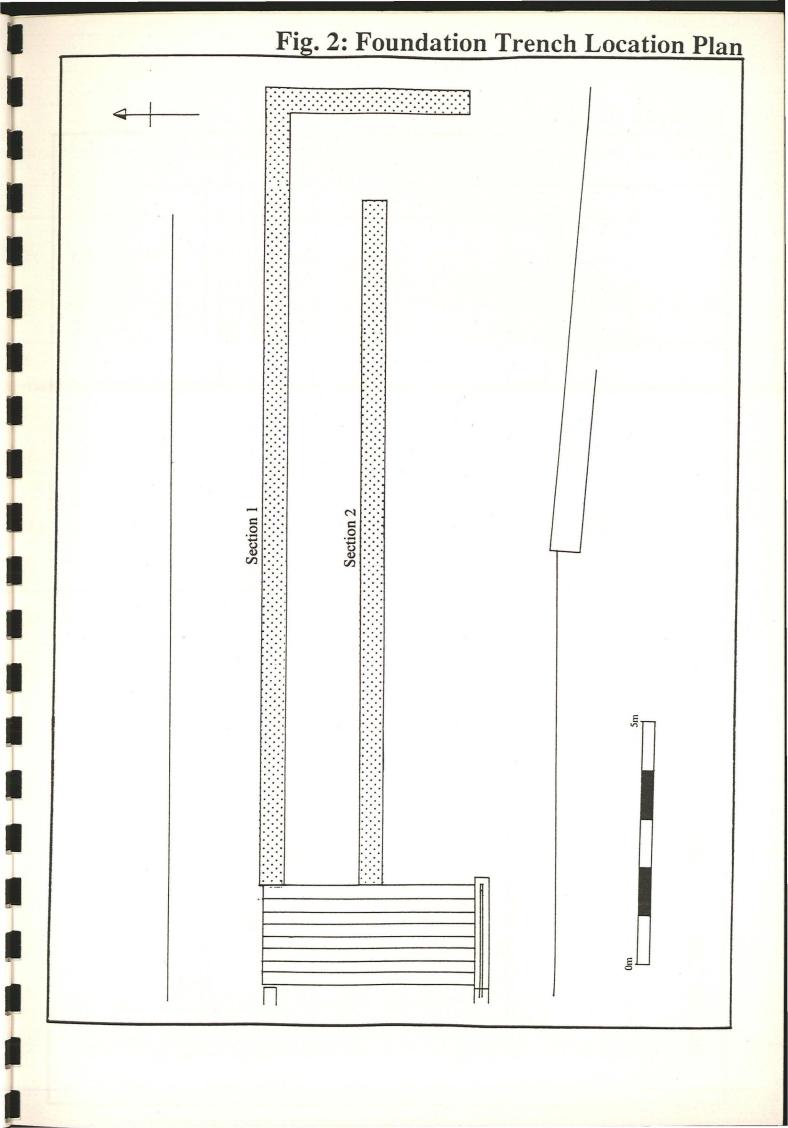
3. Aims and Methodology (Fig. 2)

The aims of the archaeological watching brief were to record any archaeological deposits which might have been disturbed during the excavation of foundation trenches associated with the construction of the access ramp. These trenches were nominally 900mm deep and 450mm wide and extended east from the base of the steps leading up to the reception area for c.16m.

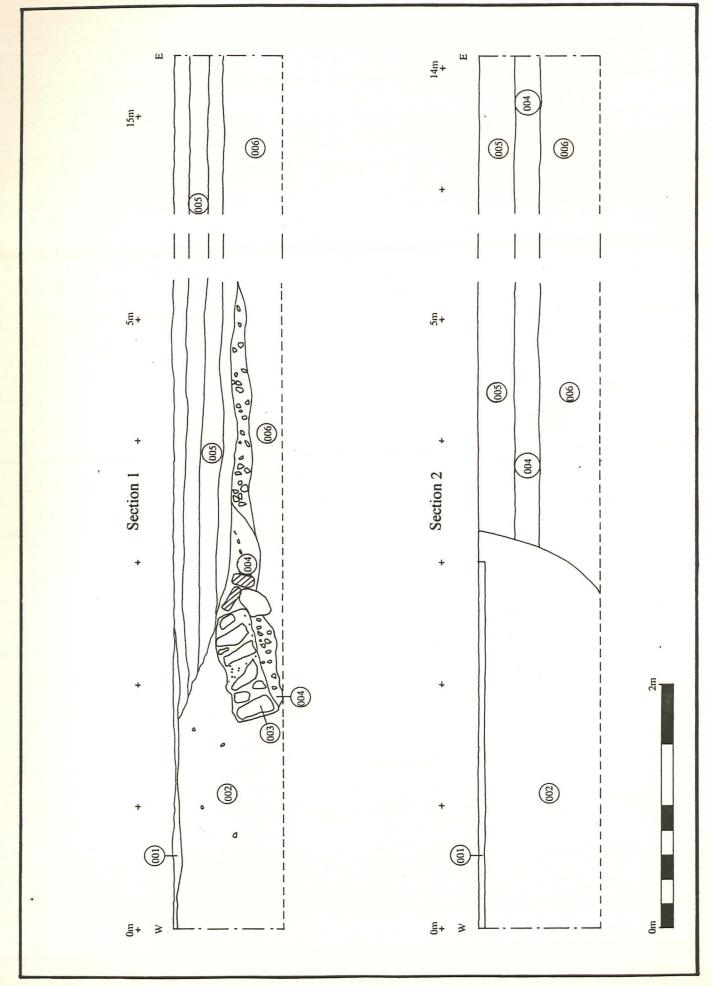
Fig. 3: Sections

The earliest deposits recorded in the two foundation trenches were a series of shallow, horizontal, levelling deposits [004, 005, 006]. These deposits varied in their composition from a dark brown clay soil containing frequent inclusions of limestone, concrete and steel rod [006], to [004] a band of clean limestone hardcore.

A large cut [007] was observed at the far west end of the foundation trenches. Only the eastern half of the cuts profile was recorded within the confines of the foundation trench. This cut lay at the base of and extended beneath steps rising up to the first floor reception area.

A large fragment of bonded masonry was recorded lying on the east side of cut [007], in the north section of foundation trench two. Cleaning of this masonry fragment revealed it to have been bonded by an apparently modern concrete mortar. A deposit of limestone hardcore [002], sealed this masonry fragment and infilled cut [007].

Sealing this hardcore and in part deposit [005] was a narrow skim of concrete, which had been used as a base for paving slabs, forming a paved standing area at the base of the steps into the Council offices. The paving was removed by hand prior to the excavation of the foundation trenches.

From the observations made during the watching brief it can be assumed that deposits relating to pre-modern land use are not evident above the level of the foundation disturbance. Those deposits recorded were all recent in date and likely to be contemporary with the construction of the Council building (c.1972).
