**ARCHAEOLOGICAL EVALUATION
AT BARDNEY ABBEY,
BARDNEY,
LINCOLNSHIRE
BASM 09**

Work Undertaken for
The Jews' Court Trust

December 2009

APS Report No: 122/09

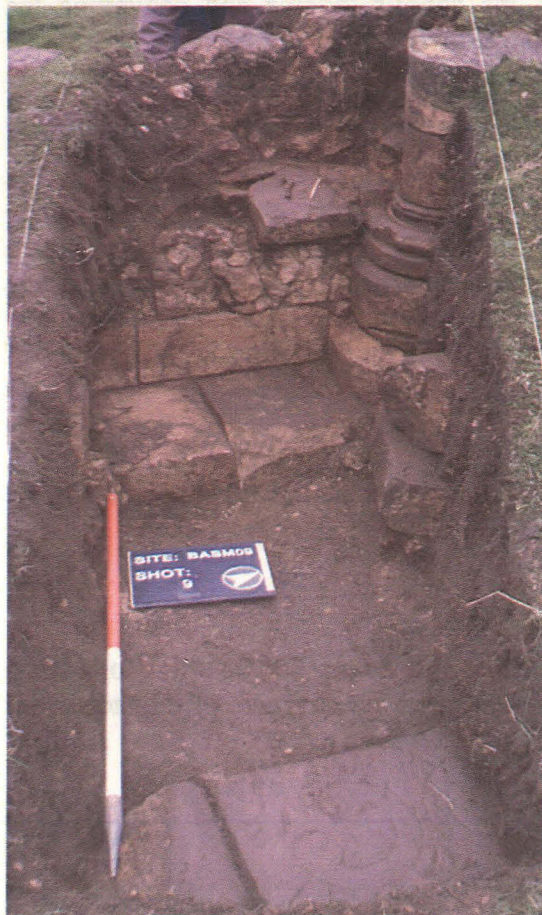
This trench was excavated across the west wall of the church to the south of the north arcade pier respond. It measured 5m long and 1m wide. The western part of the trench contained *in situ* wall core, including that for a buttress, with no exterior worked stone present. Within the church, the western respond base was partially exposed resting on the foundation course. Two courses of stonework of the west wall were exposed, the

upper quite badly damaged. Upon this, a flat piece of ashlar perhaps indicates a bench, a feature not recorded during the initial excavation.

Plate 1 – Trench 1 after cleaning, looking northwest. North arcade pier respond can be seen resting on the foundation course, with elements of the wall and bench in the background. In the foreground are two grave slabs.

At the eastern end of the trench were two fragments of grave slabs. Both are shown on Brakspear's plan with a brief description in Appendix 1 of the report. The more northerly slab has an inscribed clustered trefoil cross which Brakspear does not mention.

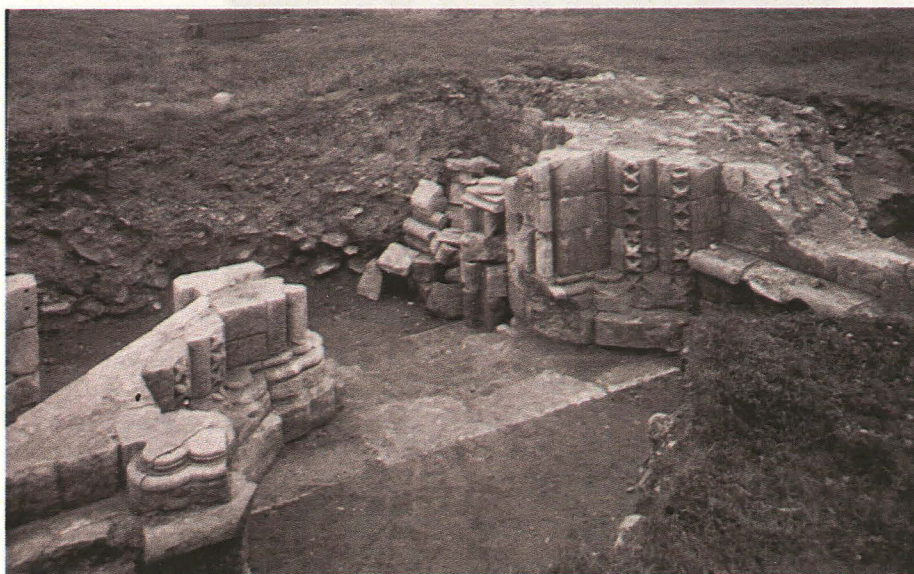
during the excavations show the doorway to survive to two courses above its plinth course with the interior surviving to a greater height. A column base for a blind arcade on the west front was the only stone to remain *in situ*.

Plate 2 – The south doorway of the church following excavation by Laing between 1909-14. Trench 2 was located to the left of this view

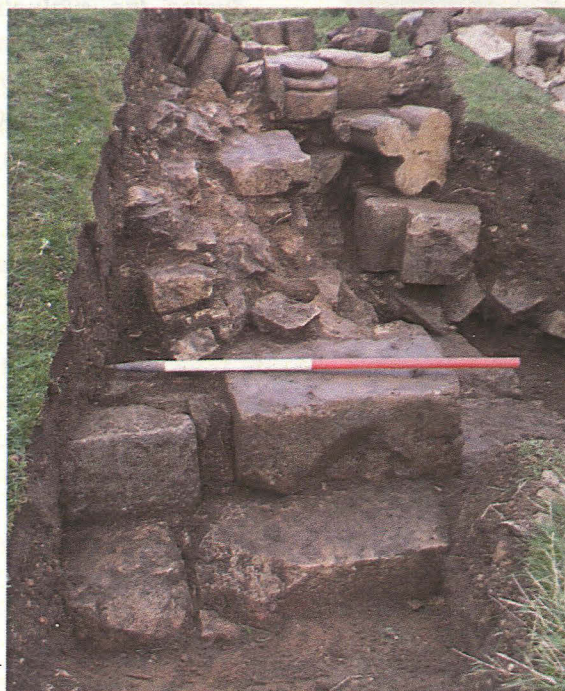
Plate 3 – The west front as revealed in Trench 2 showing the foundation plinth, the intact wall core and worked stone. The column base (centre top) is *in situ*

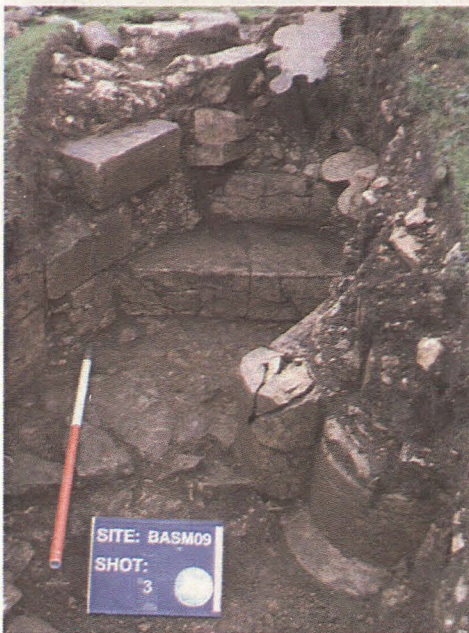
Plate 5 – The stairway as revealed during the evaluation. Up to three courses of stonework have been removed and some damage has occurred to the masonry

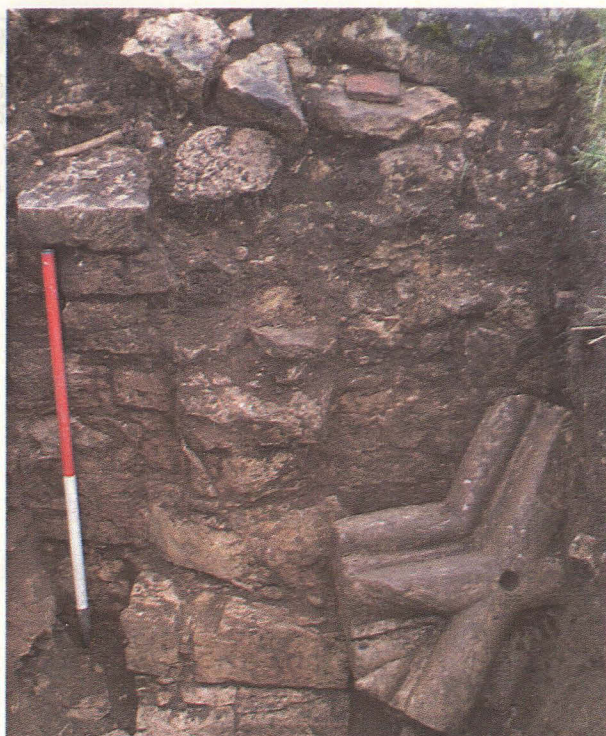
A small exploratory trench, measuring 1.6m by 1.5m, adjacent to the south wall of the church was opened (instead of a second trench over the refectory) and situated over the base of a respond for a vault shaft. The wall survived to a height of c. 1.3m within the trench and was partly covered by a lime render. A keystone for the vault lay against the wall (ribs for the vault were revealed in Trench 2).

Plate 6 – Trench 3 after excavation showing the base of the vault shaft and keystone of the vault, looking south

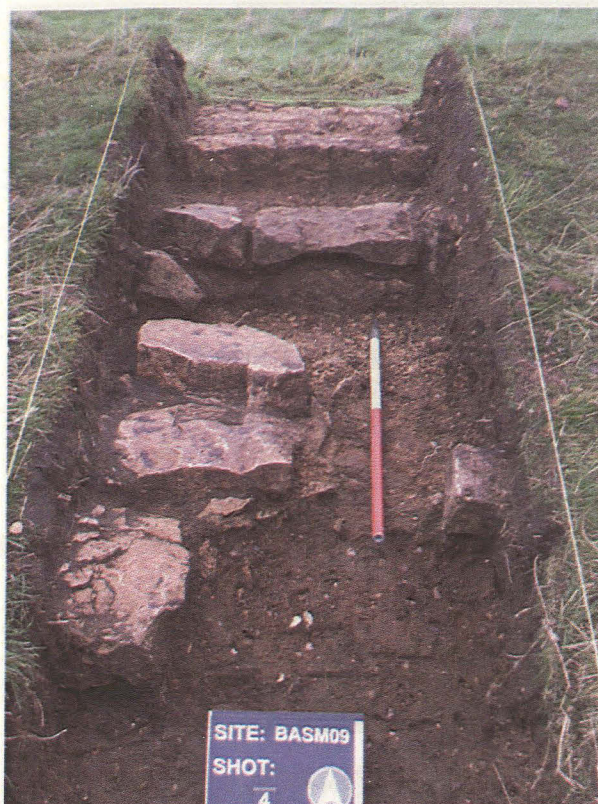
A trench was excavated over the north wall of the refectory measuring 5.35m by 1m wide. The north wall of the refectory was exposed, along with the base of the bench and a socketed stone that supported the trestle table. There was a further step down to the floor well, though no surfaces were identified during the work. Within the cloister alley, the edge of the original excavation trench was found approximately 0.45m to the north of the refectory wall, suggesting Laing was excavating along the lines of walls within the cloister area.

Plate 7 – Trench 4 looking north. The north wall of the refectory is visible at the back with the bench to the front. The stone support for the trestle table lies left of the scale
