WEOLEY CASTLE -
an appraisal of the surviving
Archaeological Archive

by
Stephen J. Linnane

2011

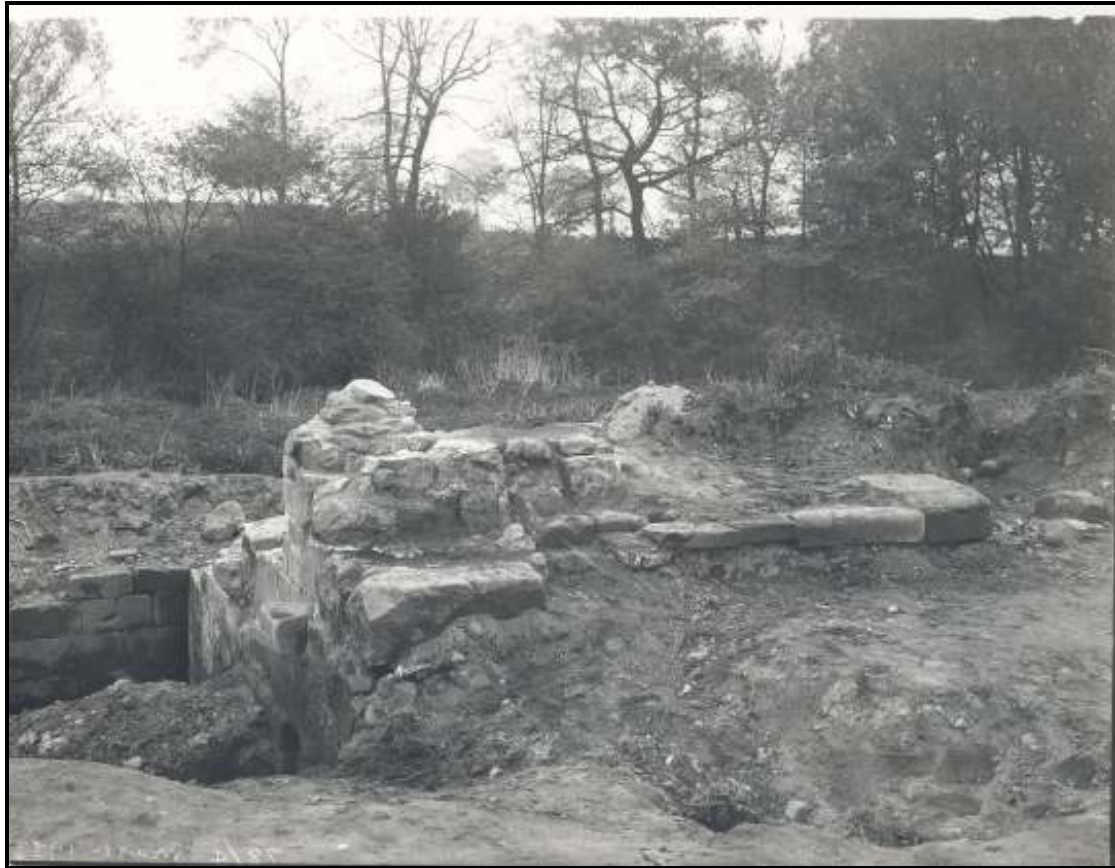
(Scan 190)

Fig. 2.2: Initial clearance, uncertain location, Gate Tower, looking west?

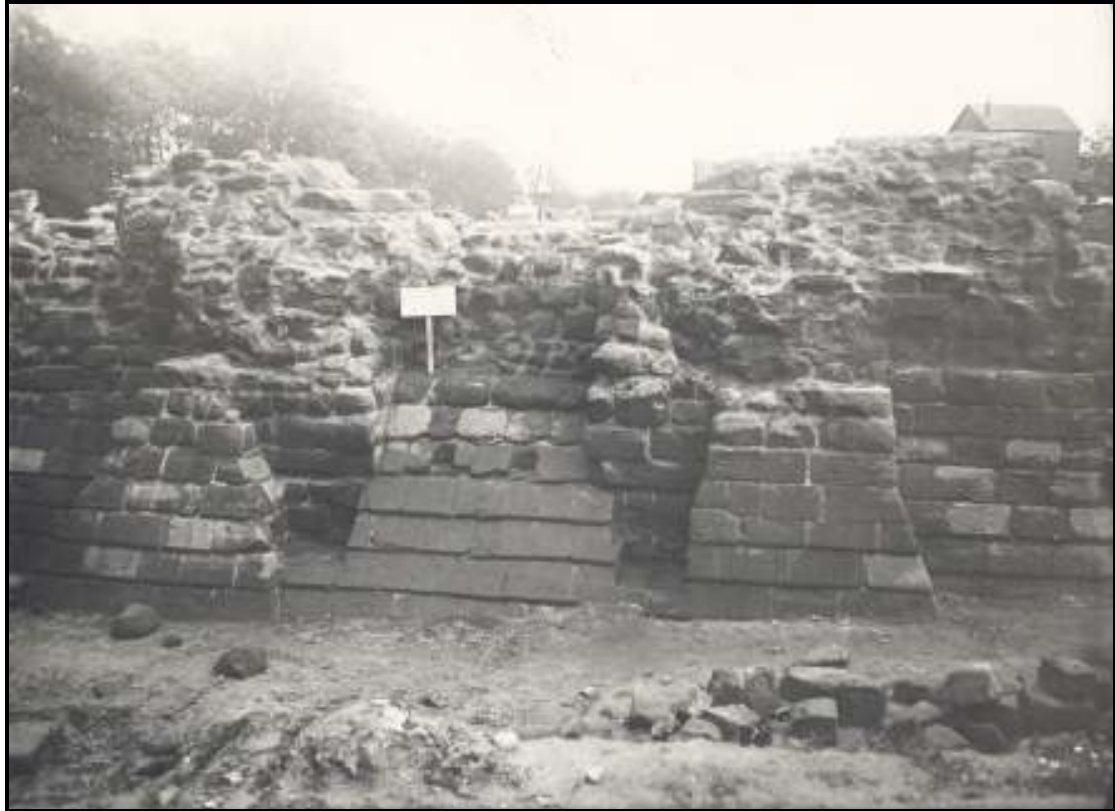
Fig. 2.6: The Gatehouse façade, looking east (Scan 931)

The Gatehouse Tower measures 5.75m wide by 6.30m and projects only slightly from the curtain wall façade. The centre-line of its passageway is 8.67m from the inner face of the northern curtain. The north and south walls are 1.92m thick whilst the west wall is 1.40m thick, just as the majority of the curtain wall, and the east wall 0.80m thick. The internal passage measures 3.00m wide by 4.10m and the gateway was 2.50m wide. Very little survives above ground level but what does survive is the complex bridge abutment below, which projects slightly into the moat and was used in conjunction with the timber drawbridge described within the post-war excavations. The external face of the Gatehouse Tower was 8.90m wide, projected from the wall line by 1.70m and had the usual chamfered plinth below. Central to the facade is a broad, shallow recess, measuring 5.30m wide by 0.50m deep, effectively leaving a buttress 1.80m wide at either side of the facade. Central to the recess was a 2.40m wide battered recess set back a further 1.00m from the facade. On either side of this

recess and some 1.00m below the start of its batter were level platforms measuring 0.70m square. These would have supported massive timbers which stood either horizontally or vertically and were associated with the bridging structure discussed elsewhere. Two sockets cut into the central batter could have taken diagonal struts to brace the bridge arrangement above. There are no obvious details to point to a pivot point for a drawbridge and if such existed it must have been within masonry now destroyed or possibly within the timbers once positioned in the sockets described above. The central feature equates in width to the gate as it appears on the various pre-war surveys. An arrow loop was located equi-distant between the northwest, internal, corner of the castle and the Gatehouse.

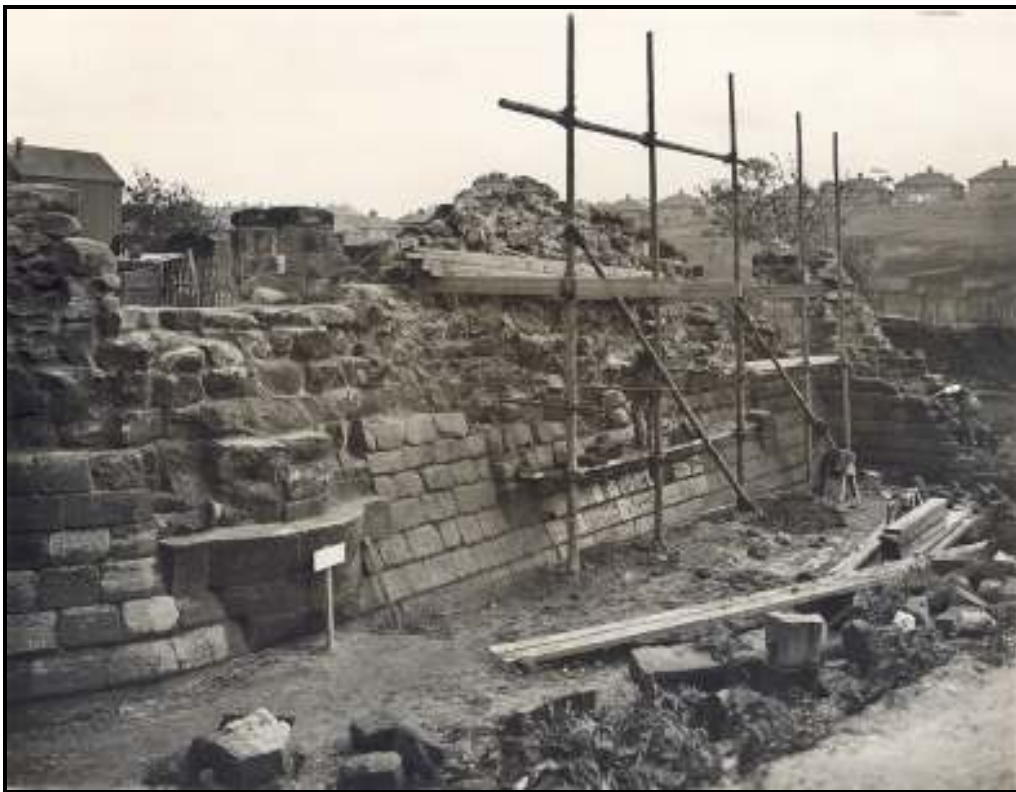
Fig. 2.7: The Round Turret, looking southeast (Scan 007)

At a distance of 15.00m from the inner face of the northern curtain, the west wall changes direction slightly to create an internal angle of 152 degrees and then runs to the southeast. Immediately after this angle a round turret was inserted into the wall. The turret was 3.80m in diameter with a 0.40m thick wall providing a 3.00m internal diameter. The turret was mostly encased within the curtain wall but projected slightly beyond the wall line where it was supported by a platform corbelled out from the battered plinth of the original wall line. A doorway led into the turret at ground level and it is assumed that the turret functioned as a stair tower providing access to the

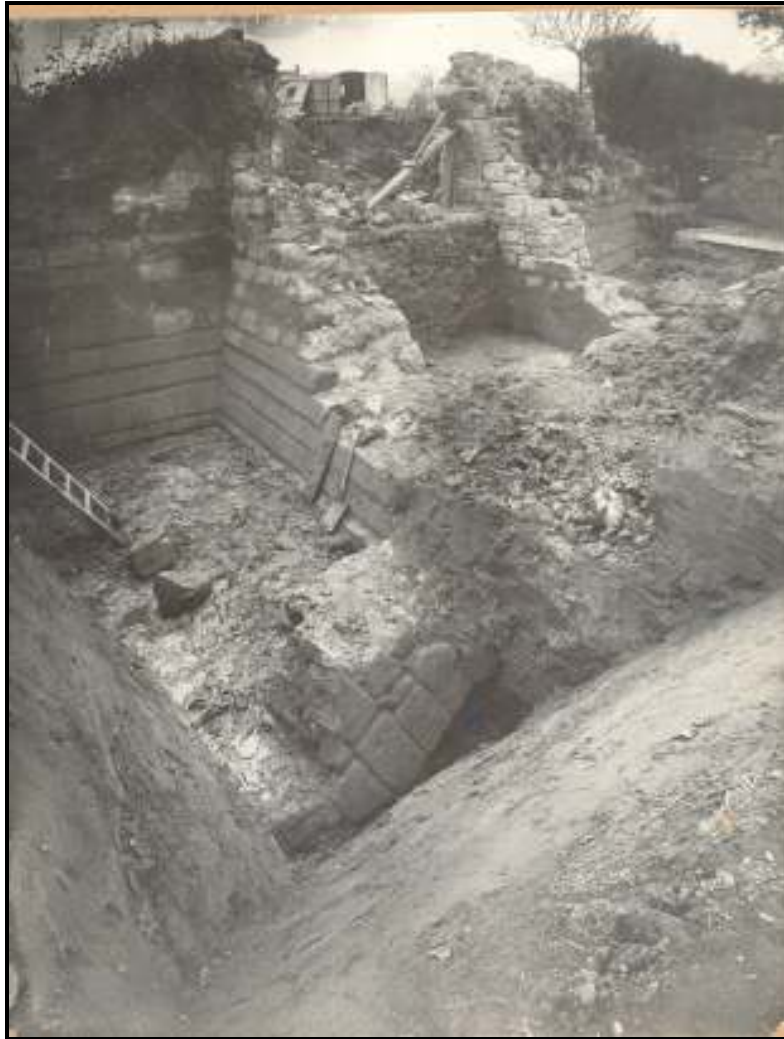
Fig. 2.8: The West Tower, looking southeast (Scan 912)

The West tower is 5.00m wide and projects into the moat 3.60m, disregarding the battered plinth. The walls are 1.00m thick, enclosing an internal space of 2.90m by 5.00m. Arrow loops survived in the north and south walls, and probably existed in the west wall also. An important feature of this tower is the survival of the springers of a two-centred arch spanning the rear wall. Excavation proved that there was no walling at foundation level joining the curtain walls to either side of the tower - being further

proof that the towers were of the same build as the curtain walls. At the southeast corner of the West Tower the curtain turns again with an internal angle of 161 degrees and then extends for 30.00m, interrupted by the causeway retained to provide visitor access into the castle's interior. Internal to the wall were the Granary and the Bakery buildings excavated by Oswald. Features visible within this stretch of wall is an arrow loops at 7.50m from the West Tower, the remains of a buttress and a feature described as a "sink" - as in the south curtain wall. The feature is 1.80m wide and projects from the plinth in the same manner as the buttresses. The features are described in more detail within the accounts of the post-war excavations.

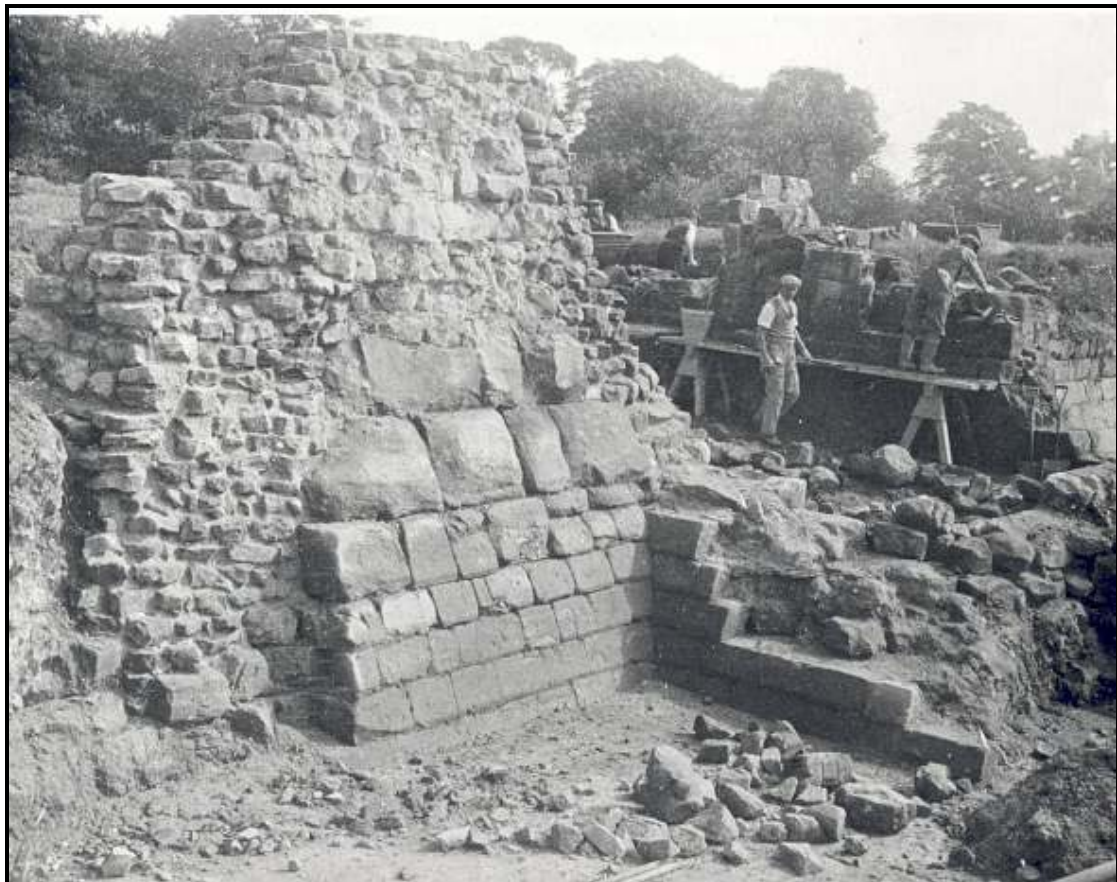
Fig. 2.9: The South Tower, looking northeast (Scan 885)

The South Tower is located 13.40m from the southwest corner. Disregarding its battered plinth, the tower projects from the line of the curtain by 2.70m and was

4.90m wide. The walls were 1.00m thick and an arrow loop is noted to the east on the 1940 survey, probably balanced by one to the west. The internal space within the tower was approximately 2.90m square. The substantial masonry to the west of the tower survives to a height of 5.00m above the moat base but no excavation has indicated what structures may have lain internal to the wall in this area. To the east of the South Tower the wall is characterised by four buttresses. The buttresses are 0.60m wide with distances of 5.80m from the West Tower to the first buttress, 5.40m from first to second, an estimated 5.90m from second to third and third to fourth. The third buttress has been removed by the insertion of a wide rectangular feature commonly referred to as “the sink”. There are three small openings through the wall all towards the east and associated with kitchen drainage.

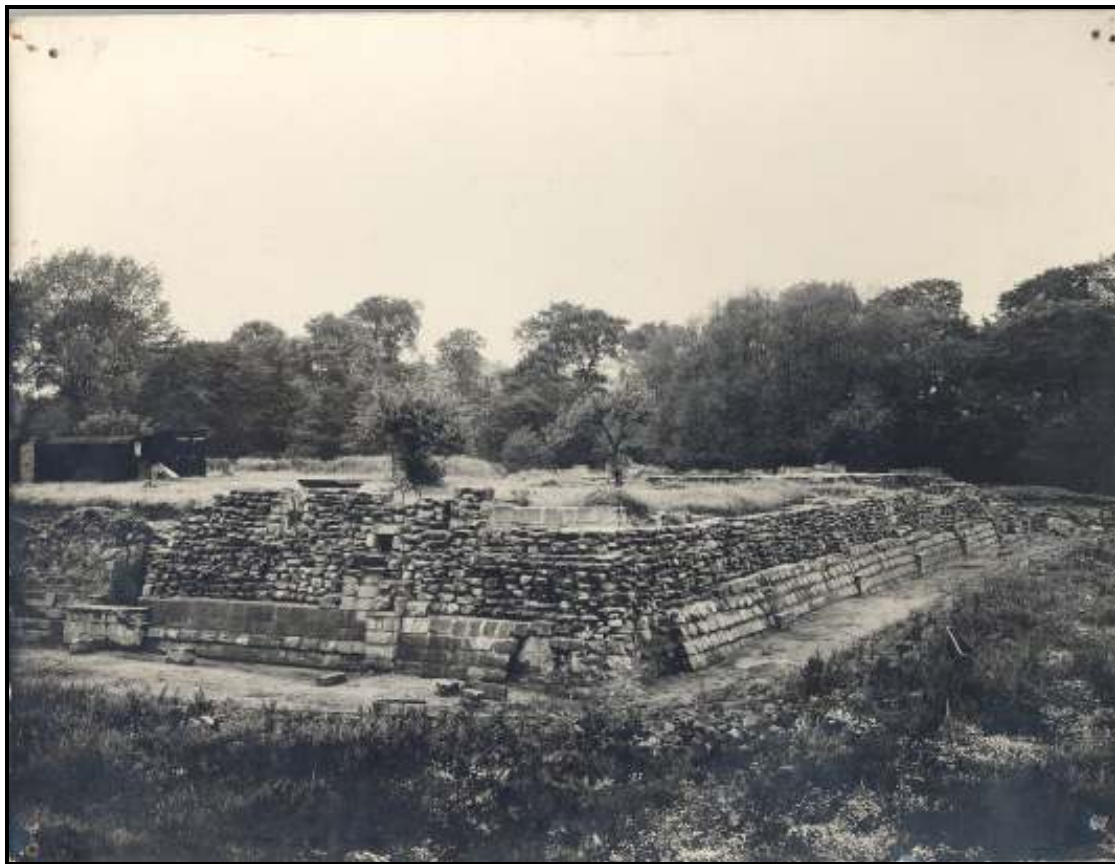
Fig. 2.10: The southeast corner, looking northwest (Scan 132)

The southeast corner is notable for a diagonal buttress inserted into the corner contemporary with the Octagonal Turret. Oswald dated the buttress and turret to Period VII, 1400-1450, based on the stratigraphical interpretation of a coin find. The slightly irregular Octagonal Turret measures 4.50m from flat to flat externally and has walls of 0.65m width which leaves an internal space measuring 3.0m from flat to flat.

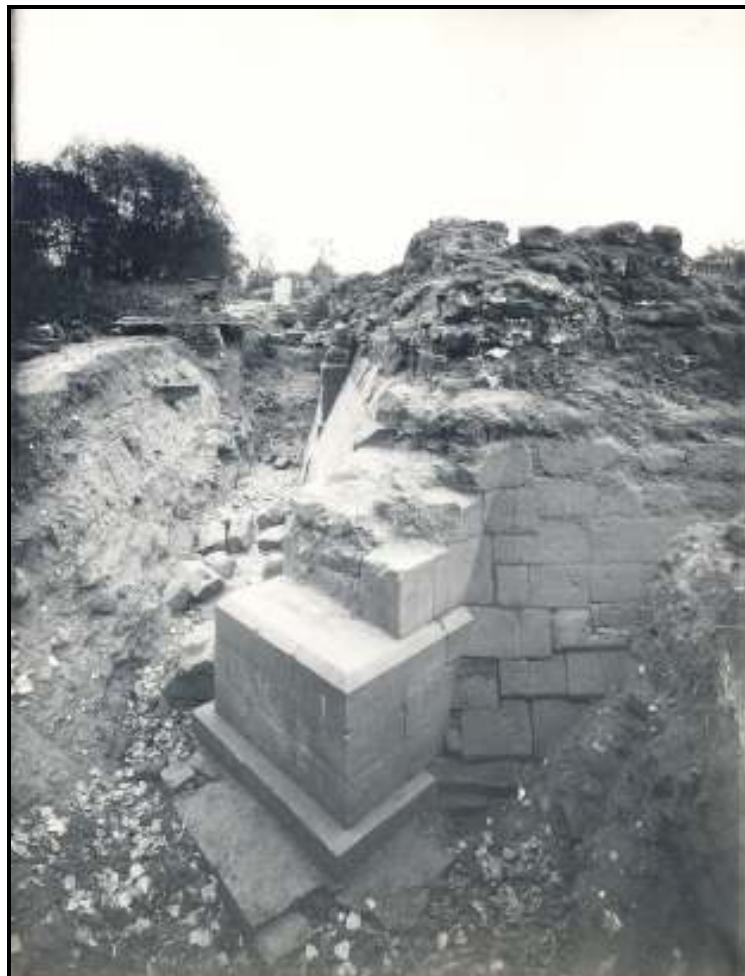
Fig. 2.13: The northwest corner, looking east (Scan 195)

The northwest corner is a further 7.30m to the west and is notable for the insertion of a diagonal buttress approximately 1.00m square to reinforce the corner masonry possibly inserted at the same time as those on the North Tower. The buttress consists of a flat plinth a first course with chamfer and a further three courses the top one of which is also chamfered and a last, partially robbed, course.

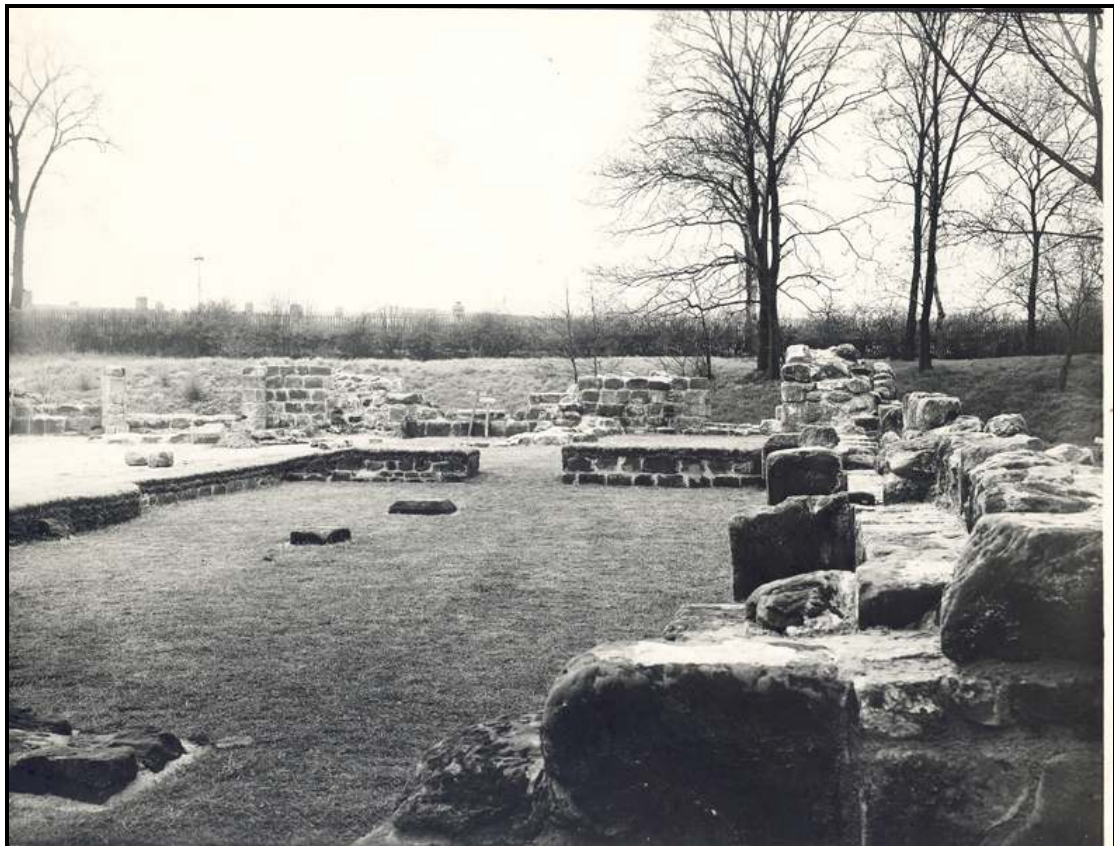
Fig. 2.14: The Lodgings, looking west (Scan 006)

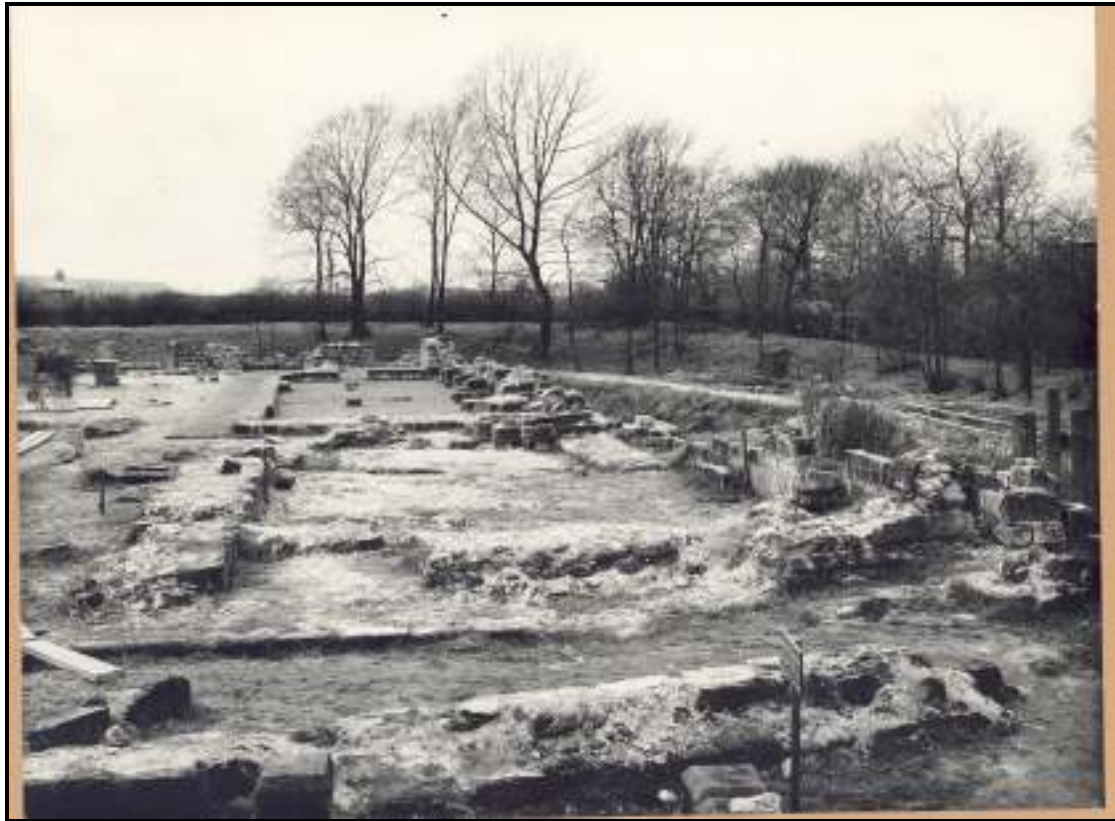
Fig. 2.15: The Chapel, looking west (Scan 944)

A building, without doubt correctly identified as the chapel, was located 1.90m to the east of the Lodging Block. This building measured 16.00m from west to east by 7.67m, narrowing to 7.00m at the western end. The wall foundations were 1.60m wide whilst the masonry above would have been 1.40m wide. Within the western gable the northern door jamb is shown and if the door was central to the wall it would have been 1.50m wide. Two further doors are shown; one in the eastern gable end to the north of the altar block giving access to an open area *c.*4.00m wide and facing a door giving access to the northwest chamber of the solar block, the second between the northwest corner of the vestry and the nave immediately west of the steps dividing nave and chancel. A single arrow loop within the curtain wall was partially blocked

by a dividing wall which created a divide between the altar area, at 1.90m wide, and the nave. Two sandstone steps, leading to the altar, emphasised the divide. The rubble base of the altar block survived against the east wall measuring 3.00m by 1.40m. Two areas of tiled flooring and window glass were recorded as having been found within the chapel, helping to confirm its usage. The flimsy footings of a building constructed against the southeast corner of the chapel have been identified as a vestry with internal dimensions of 5.20m west to east by 3.00m. The stone footings probably served as a support for a timber superstructure.

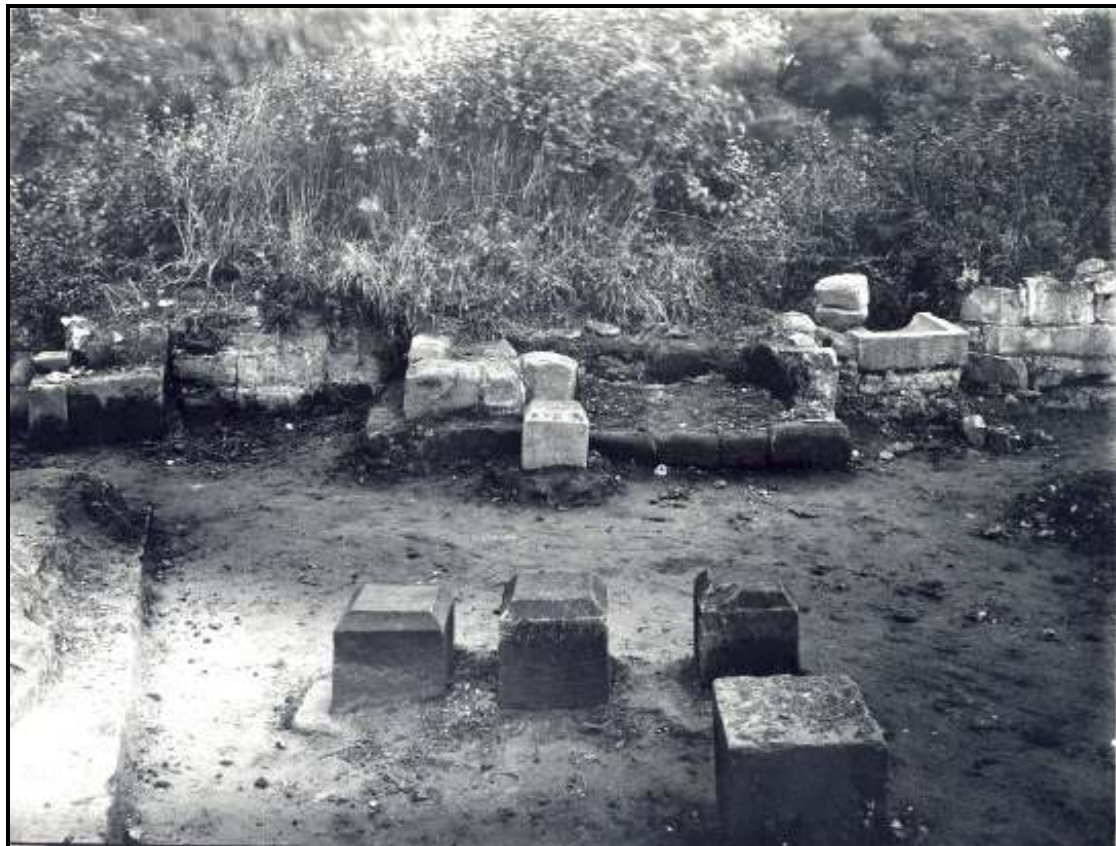
Fig. 2.16: The Northwest Chamber, looking north (Scan 900)

An intriguing aspect of this chamber was the number of square stone pier bases found within the interior. Presumably they were placed there late in the life of the building or even maybe after it had gone out of use. The carefully worked stones were chamfered on each side, at the top. In some instances they were carefully positioned on stone pads and were certainly not placed at random in other instances they were upside down or had no pad. Presumably they had been collected from elsewhere in the castle and positioned to possibly to support a floor for a structure such as a granary when the buildings were being used as little more than farm out-houses.

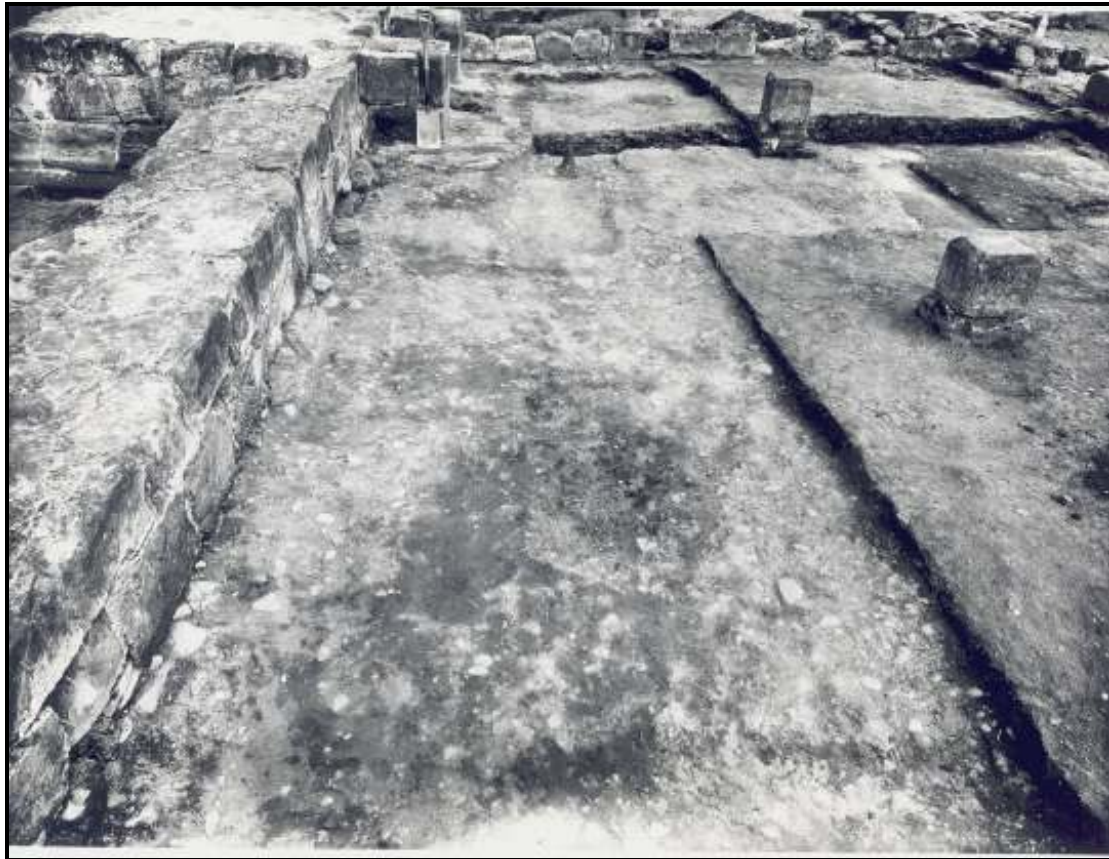
Fig. 2.17: The South Chamber, looking east (Scan 079)

Internally there are three square, chamfered pier bases, a fourth was replaced by a later internal partition wall. The pier bases are positioned along the centre line of the chamber and divide the room into five bays each 3.05m wide. At a later date a wall was constructed, dividing the chamber into two along the line of the third bay. Access into the East cellar must have been from this chamber but neither Bark nor Oswald

noted any such arrangement. It seems probable that this ground floor chamber would have served for storage below the Solar proper and no fireplace was noted within it.

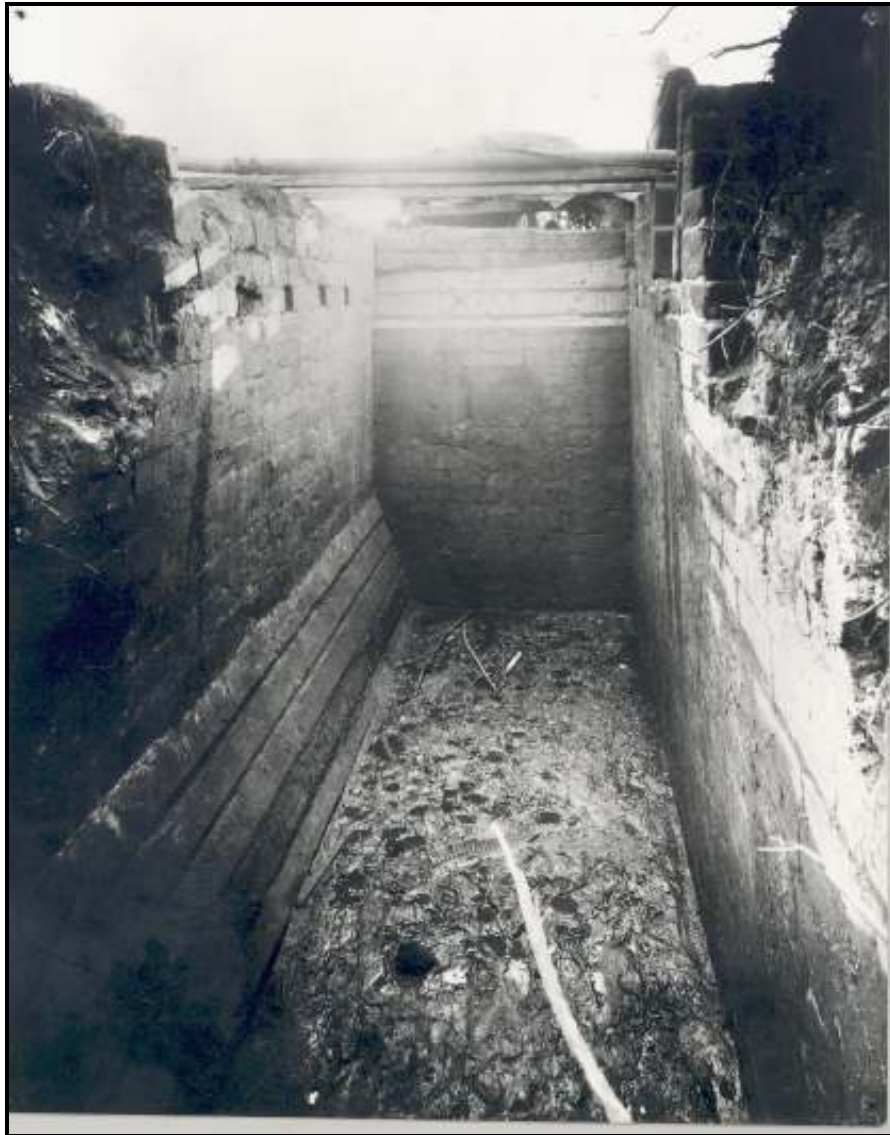
Fig. 2.18: The West Cellar, looking south (Scan 127)

This chamber was 8.50m, north to south by 2.75m and *c.*3.00m deep below the door thresholds to the west. There were no doorways leading to it and joist holes within its walls indicate that the timber floor of the chamber above formed its roof. The north and west walls were vertical whilst those to the east and south were battered with the batter of the southern wall overlaying that of the east suggesting that the south wall was later. The northern part of the chamber projected into the moat to form the Northwest Tower. At ground floor level the walls were 1.20m wide to west and east and the south wall was 2.60m wide being a part of the Central Masonry Block.

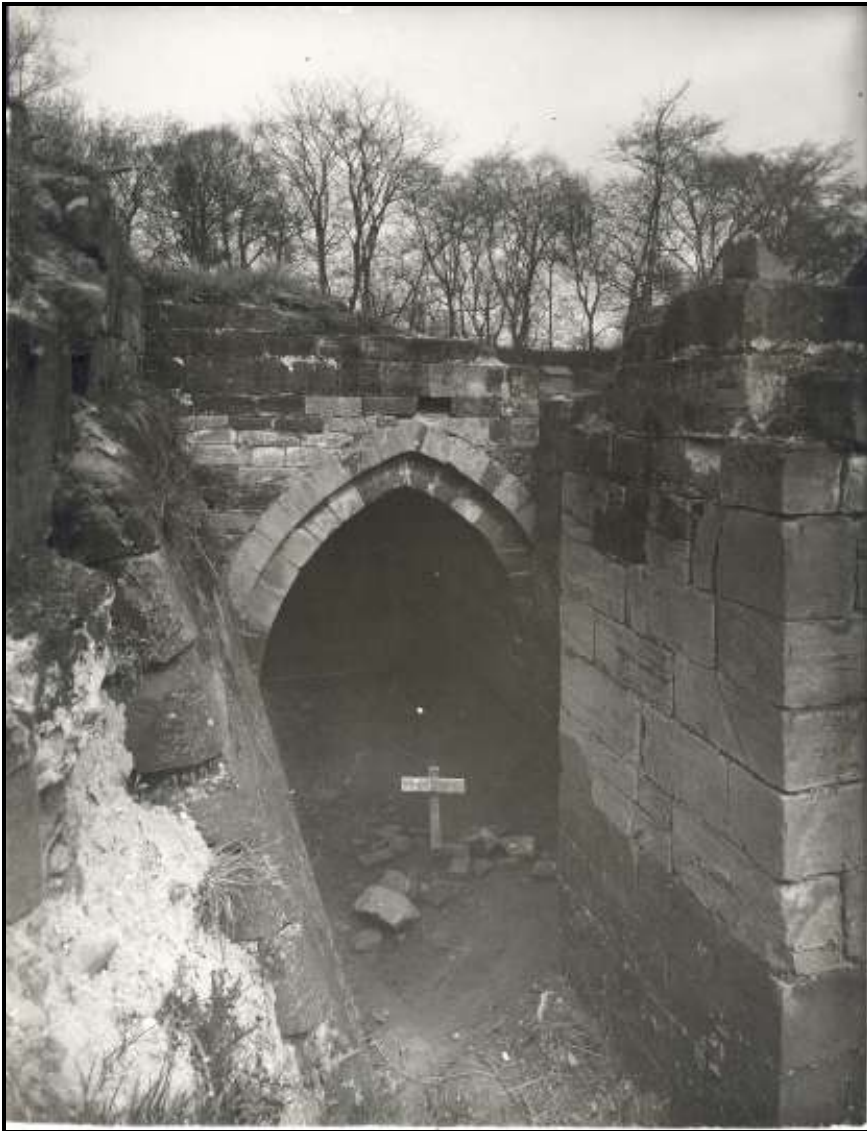
Fig. 2.19: The East Cellar, looking north (Scan 940)

This chamber measured 5.60m north-south by 3.80m and was *c.*3.00m deep. The chamber was entered via an opening in the south wall some 2.20m wide although no record survives as to how this entrance was arrived at – it is notable that the masonry of the east of the doorway is of good quality and is unlikely to have been within a foundation trench whilst that to the east is very poor quality and may even have been partially slighted and then poorly re-faced. The chamber was divided into two parts by

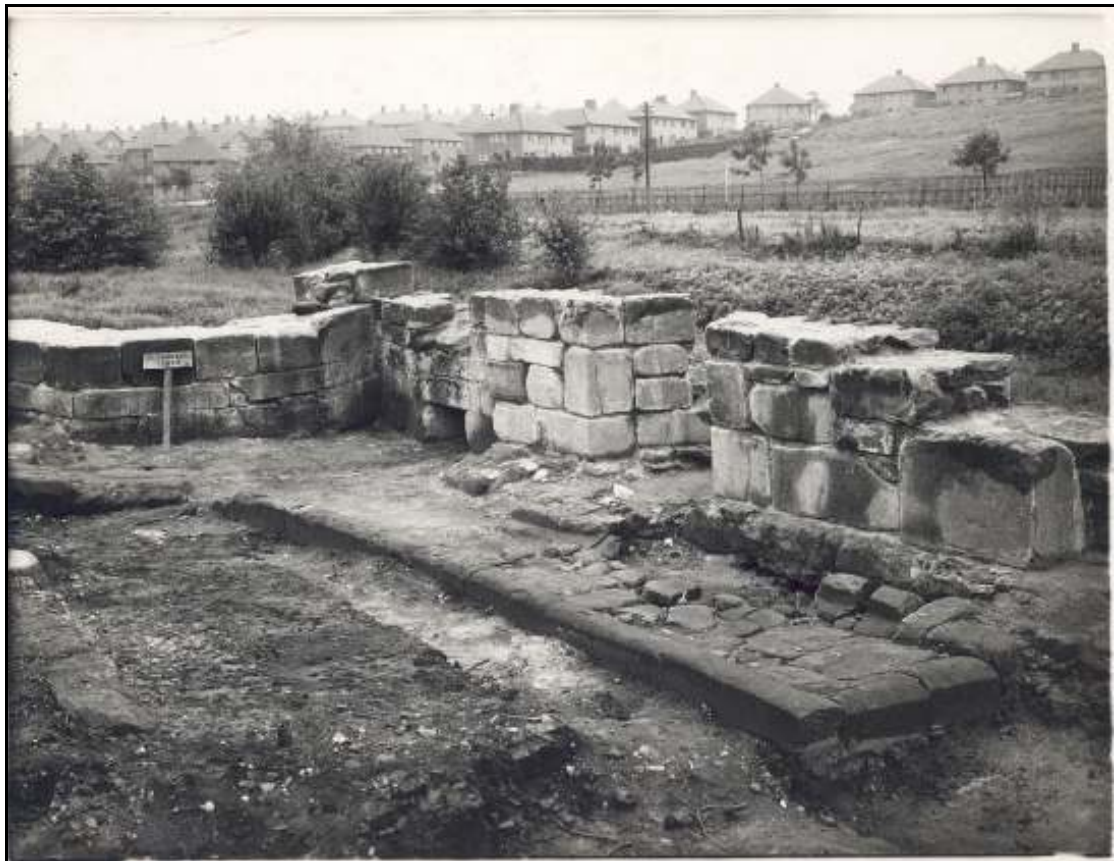
***Fig. 2.20: The Kitchen, also showing the octagonal turret, looking southeast
(Scan 156)***

Scan 156 was taken from the Octagonal Turret, looking west across the stone-slabbed wet area and the area of the Laundry. A cutting measuring approximately 0.50m deep by 3.00m wide has been excavated through the overlying rough turf and rubble to reveal wall foundations along the full length of the south side of the castle, presumably at a very early stage of works within the interior.

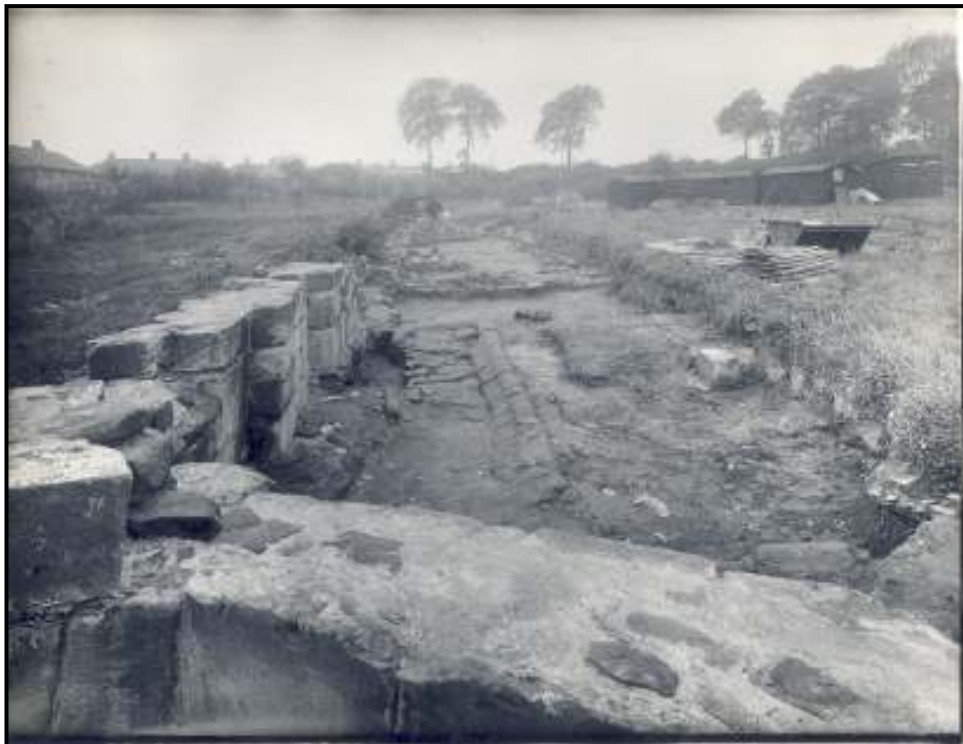
Fig. 2.21: The Laundry beyond the Kitchen, looking west (Scan 402)

Scan 402 was the only photograph of the Laundry identified and was taken looking west from the Kitchen showing the interior at an early stage of excavation. The pier bases mentioned below are not obvious in this photograph but appear on the pencil survey of the southeast corner of the castle (Scans 069-072). Abutting the south curtain and immediately to the east of the South Tower a rectangular building was uncovered. The building had internal dimensions of 12.65m west-east by 4.95m with walls 0.55m thick. Internally, in the east end were four pier bases. The two southern were placed 0.55m from the Outer Wall and were 2.75m apart, the eastern one was 1.54 from the eastern wall. The two northern were placed 2.20m to the north. This layout if continued westward might suggest a building of four and a half bays of 2.75m width, the same width as identified in the Lodgings Block. Possibly, those pier bases found in the West Chamber of the North-east Complex came from the west end of this building. A fireplace had been constructed against the curtain wall, measuring 2.75m west-east by 1.32m. The flimsy nature of the surviving stone wall footings, some of which were chamfered externally, along with the layout of the pier bases might suggest a timber superstructure.

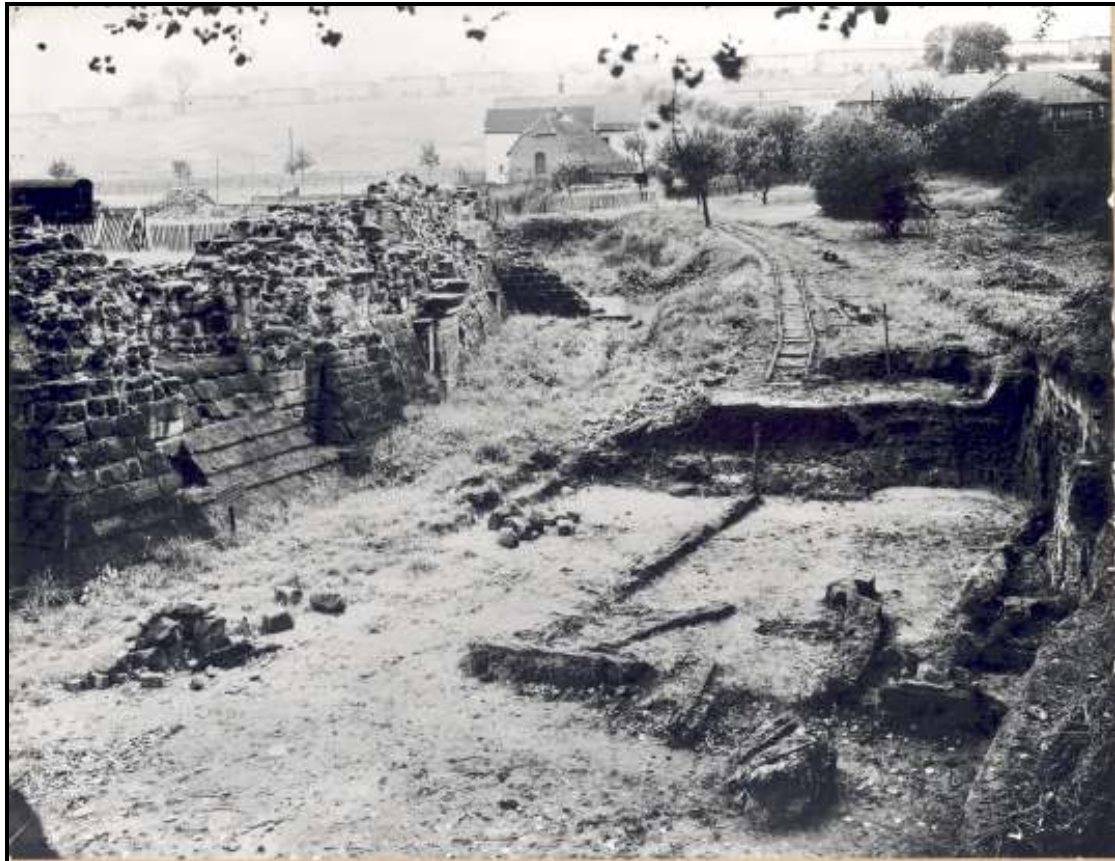
Fig. 3.02: The timber bridge at the Gatehouse Tower, looking south (Scan 953)

There are no detailed records of the excavations which Bark undertook within the moat. However the photographic archive reveals glimpses of his activities e.g. the carved stone details recovered from the northwest corner etc. Generally the excavation can be seen to have been a wall chasing exercise intended to expose the curtain wall to the base of the moat and only then to expand the excavation to open out the moat to a width of approximately 8.00m. Thus it is that the eastern end of the northwest bridge was exposed but the western end was left for Oswald to excavate after the war. Photographs of the pre-war moat excavations are to be viewed in the folder Pre-war Excavations/Standing Masonry/External). It would appear that Bark excavated to the base of the moat in some areas whilst in others; notably to the south, he left approximately 1.00m of moat deposits to be excavated by Oswald in the post-

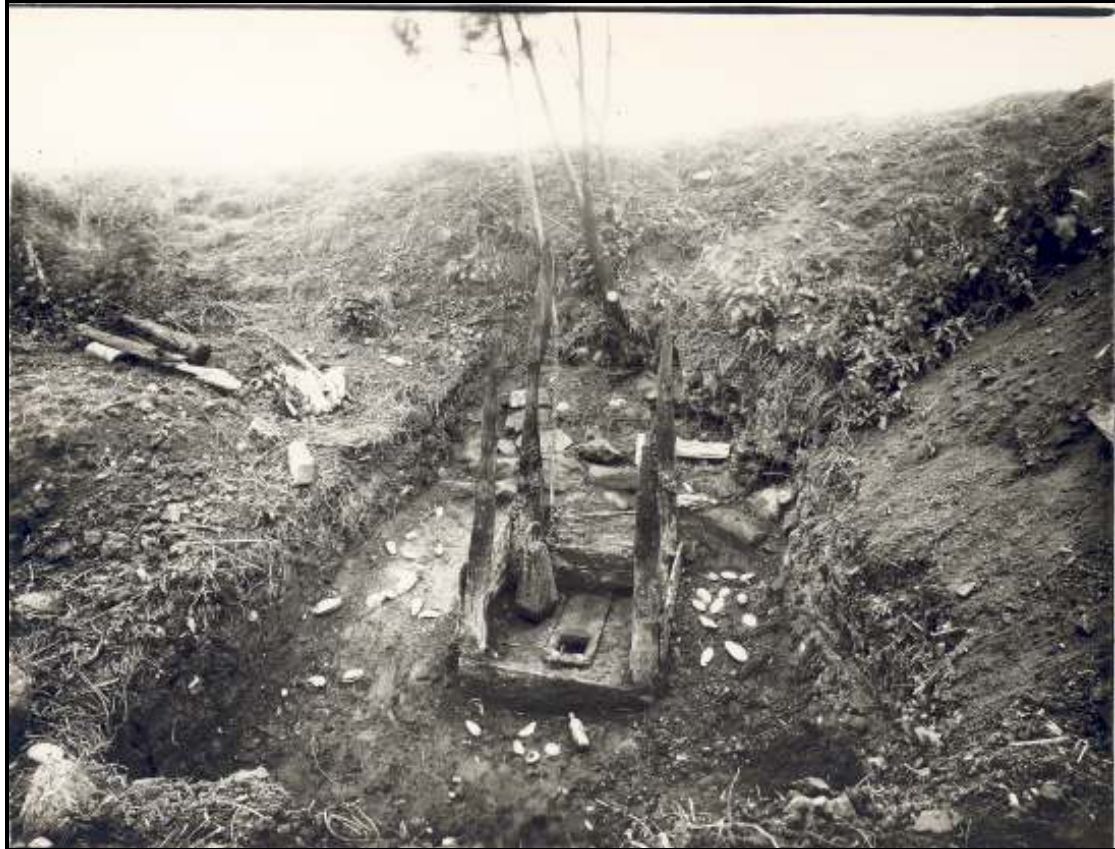
Fig. 3.03: The sluice, looking ? (Scan 957)

Three photographs show an unusual feature which appears to be a drain and which was not located on any plan. The photographs do not have a scale and are thought to be pre-war although this may be mistaken. The feature consisted of four substantial, squared timber uprights forming a 1.00m square box with the remains of planking surviving to a height of *c.*0.30m and surrounding a squared timber beam of *c.*0.30m width with a square socket cut into it. The socket would appear to have functioned as a plug-hole and the plug is pictured, having also been recovered. The plug was made of lead? and is square with a sharply tapering base and gradually tapering shank containing an iron ring attached to a chain? The vertical, surrounding planking is perforated and was probably intended to allow water to drain through to the plug-hole whilst filtering any potential blockages. The feature was cut into a substantial bank and the excavation cutting shows stonework which may have been a dry-stone

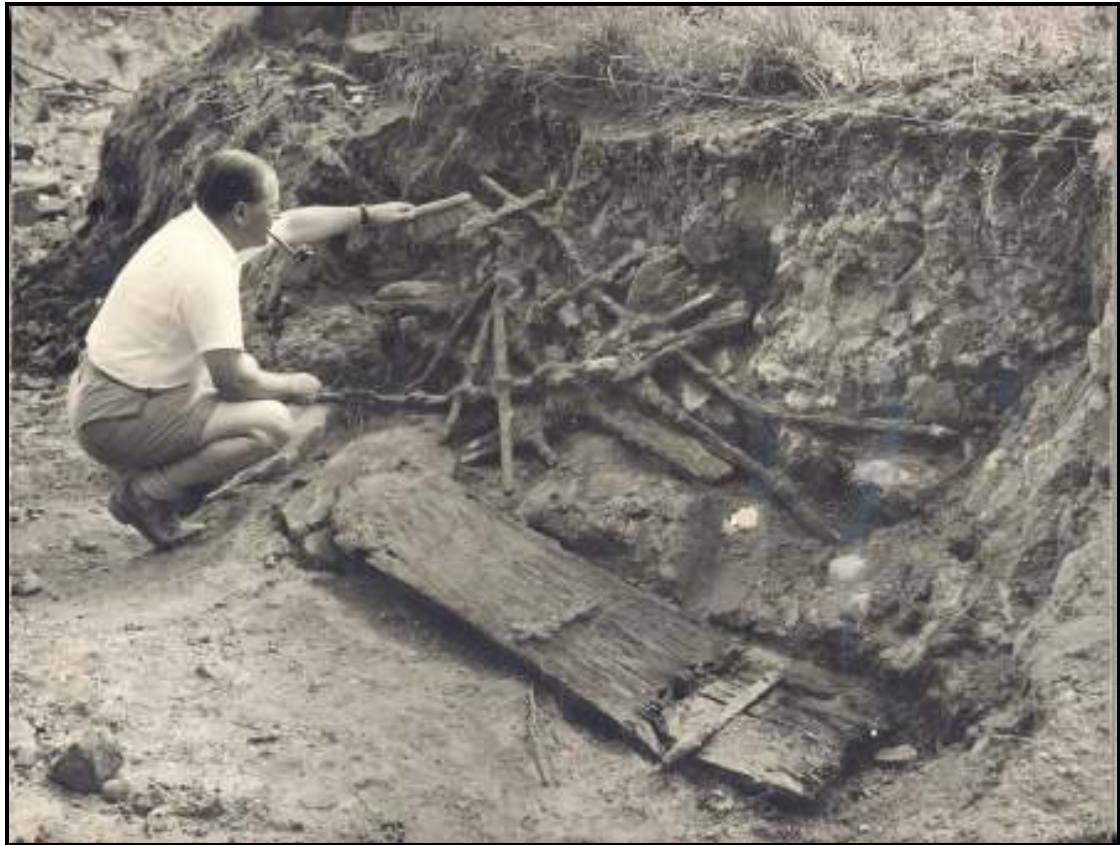
Fig 3.08: The Grill and associated elements, looking northwest? (Scan 595)

It seems probable that the grill, wooden door and jamb stones were all part of the same structure – a window with external protective grill, inward opening wooden shutters and dressed stone jambs, it is possible that the stone to the left, partially underlying the wooden shutter is a jamb stone with a glazing groove. The stratigraphy Oswald describes can not be discerned from any of the photographs and, as Scan 595 shows the feature is very close to the turf-line. The idea of a disastrous demolition – nobody would have wasted such a significant quantity of expensive iron – followed by a major re-build is attractive but further proof is lacking for this and a historical context has not yet been identified.

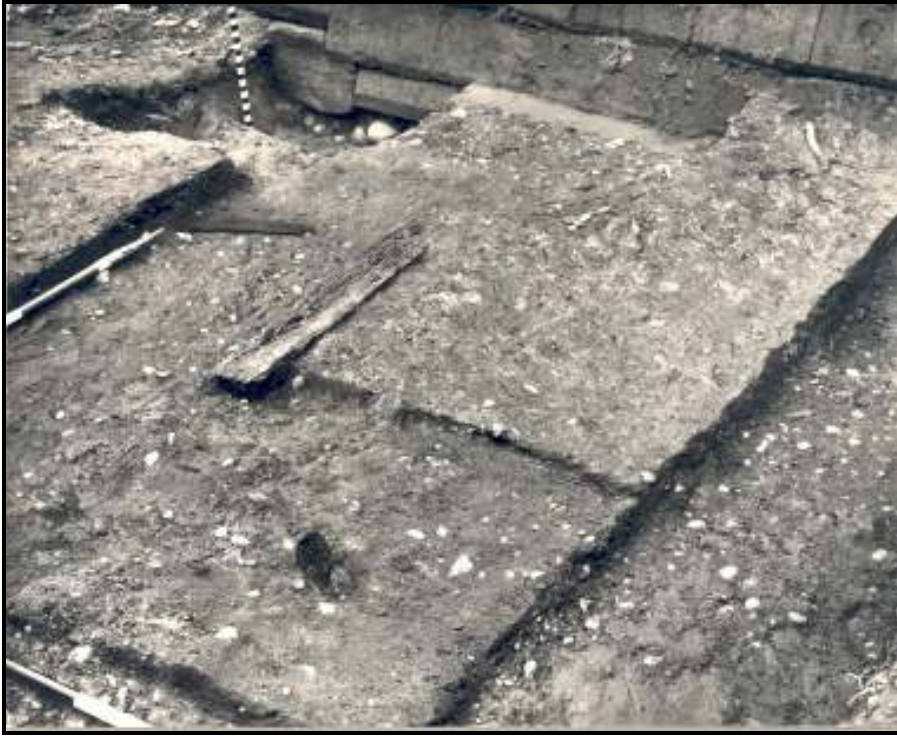
Fig. 3.09: The Northeast Bridge, looking south? (Scan 198)

Note: Interestingly Scan 198 shows a pit excavated against the footings of the ashlar apron and reveals the wall to be founded on a bed of cobbles. This is not seen or noted elsewhere within the Archive.

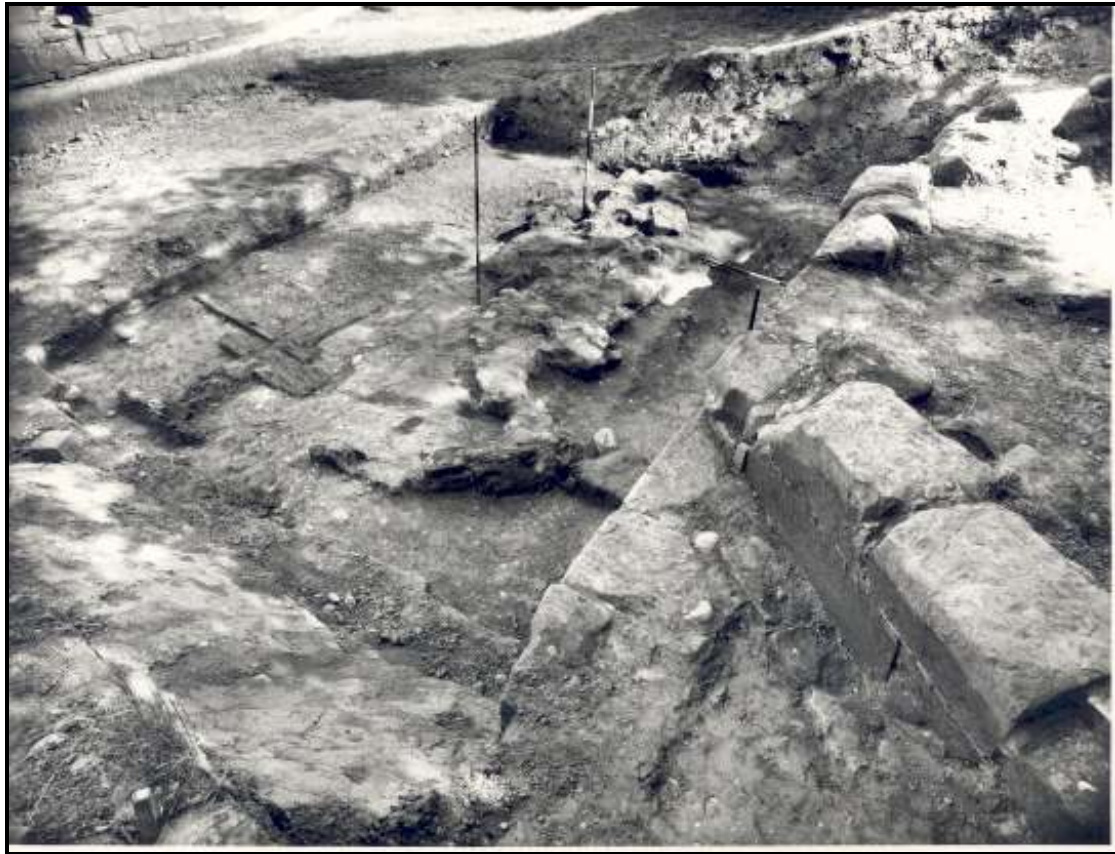
Fig. 3.12: The Northwest Bridge and West Abutment, looking southeast (Scan 126)

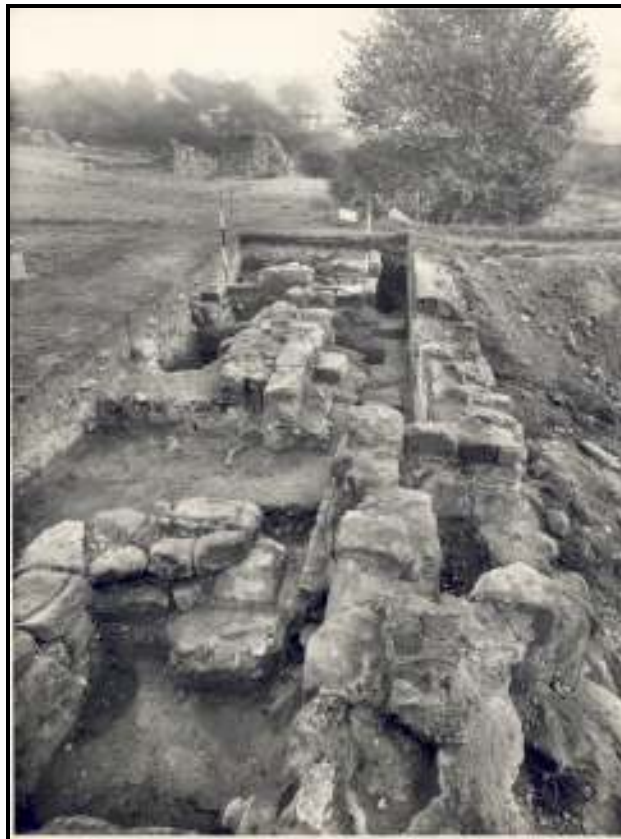
Fig. 3.13: Area D, mid-excavation, looking southeast (Scan 210)
