WEOLEY CASTLE -
an appraisal of the surviving
Archaeological Archive

by
Stephen J. Linnane

2011

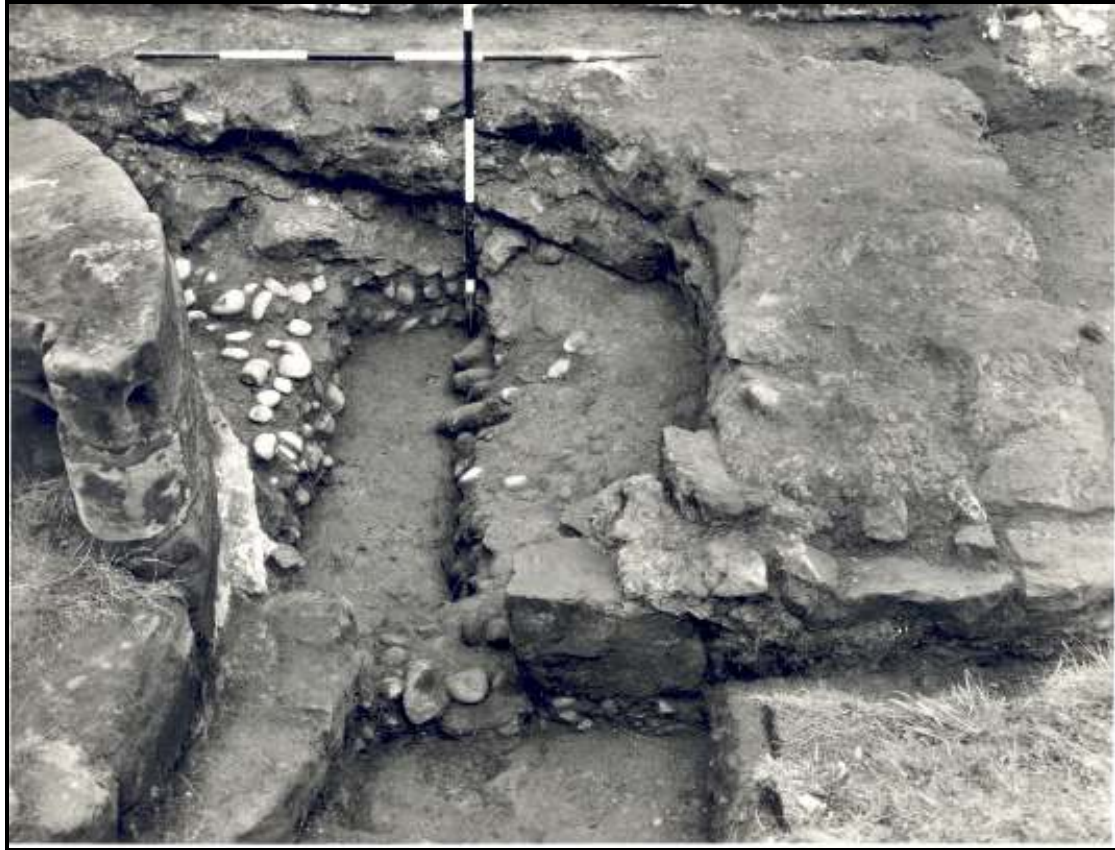
Fig. 3.16: The Round Turret, adjacent excavations, looking north (Scan 223)

This excavation occurred between 1955 and 1957 and appears to have been an extension of Area D. Although Oswald refers to further excavations by the Gatehouse Tower no records survive.

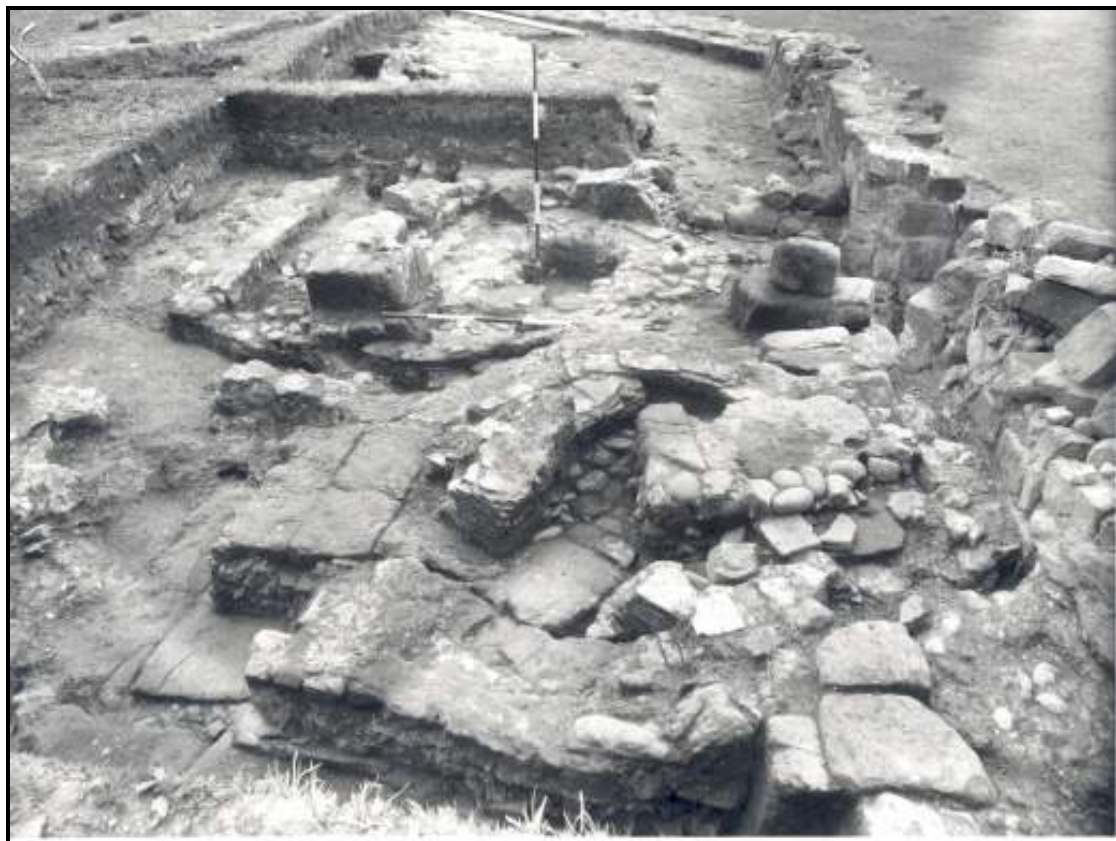
Fig. 3.18: Area F, the Bakehouse, looking south (Scan 117)

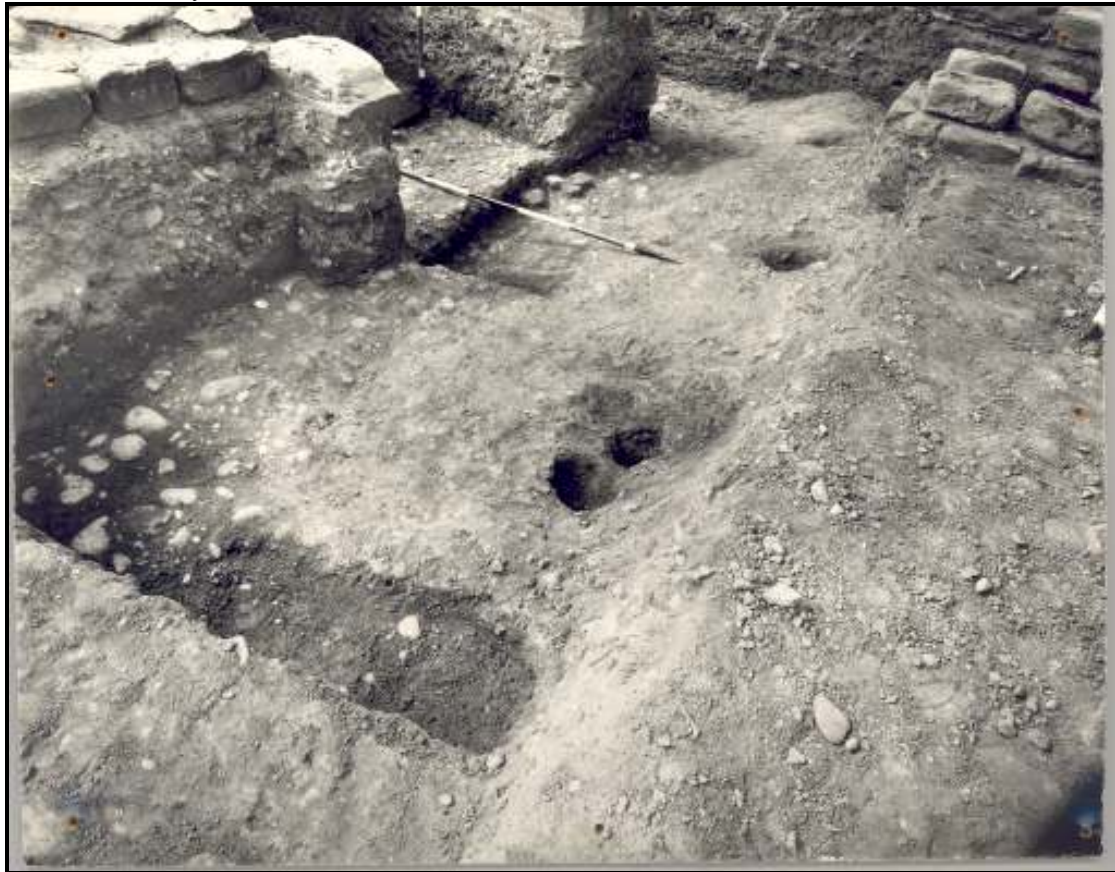
Fig. 3.20: Post-holes of the palisade in Area # (Scan 101)

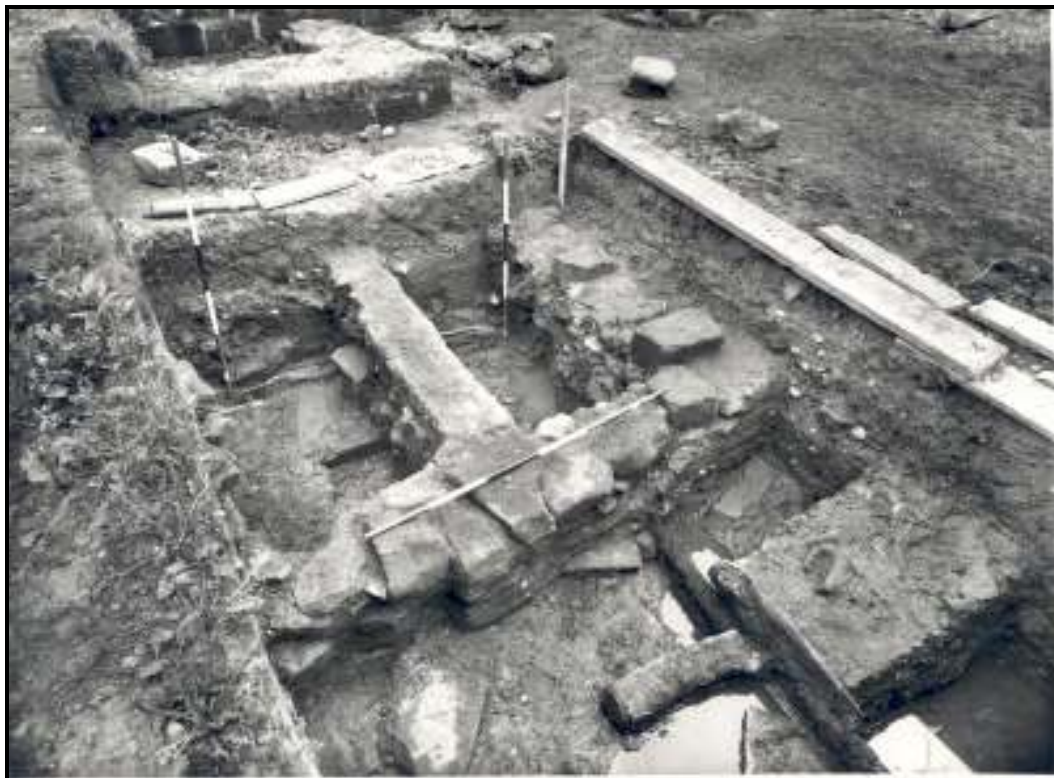
Fig. 3.25: Area E, looking southwest (Scan 119)

Located approximately 1.00m to the west of the southeast corner of the Granary excavation (Area D) a new trench was opened, measuring 4.90m southwest-northeast by 2.30m. The plan shows the corner of a timber building, the northwest side consisted of a timber beam of which 4.14m was exposed. The timber was 0.25m wide and of unrecorded depth and its upper surface retained two rectangular mortise holes the larger measuring 0.40m by 0.10m. The second mortise was somewhat smaller and centred 0.94m to the northeast. A third mortise probably existed below the retained baulk below a later wall. A slot had been cut into the beam between the mortise holes to take weather-boarding – probably horizontal. At its western end the sill beam had rebates cut into both sides, possibly suggesting that it had been re-used. Forming a right angle to this at the western end was another sill beam 1.87m long, 0.29m wide with a slot cut into its centre line and with rebate at its southern end but tapering to a point at its northern, again suggesting re-use. On the plan a pit is indicated at the junction of the two posts and another at the southern end of the latter timber. These would have taken vertical timbers which were removed when the building was dismantled. Traces of cobbling lay directly to the south of the second beam and pit and the plan suggests that this is a doorway. Assuming that the doorway was central to the gable end and was 1.00m wide the building could have been approximately 5.30m wide.

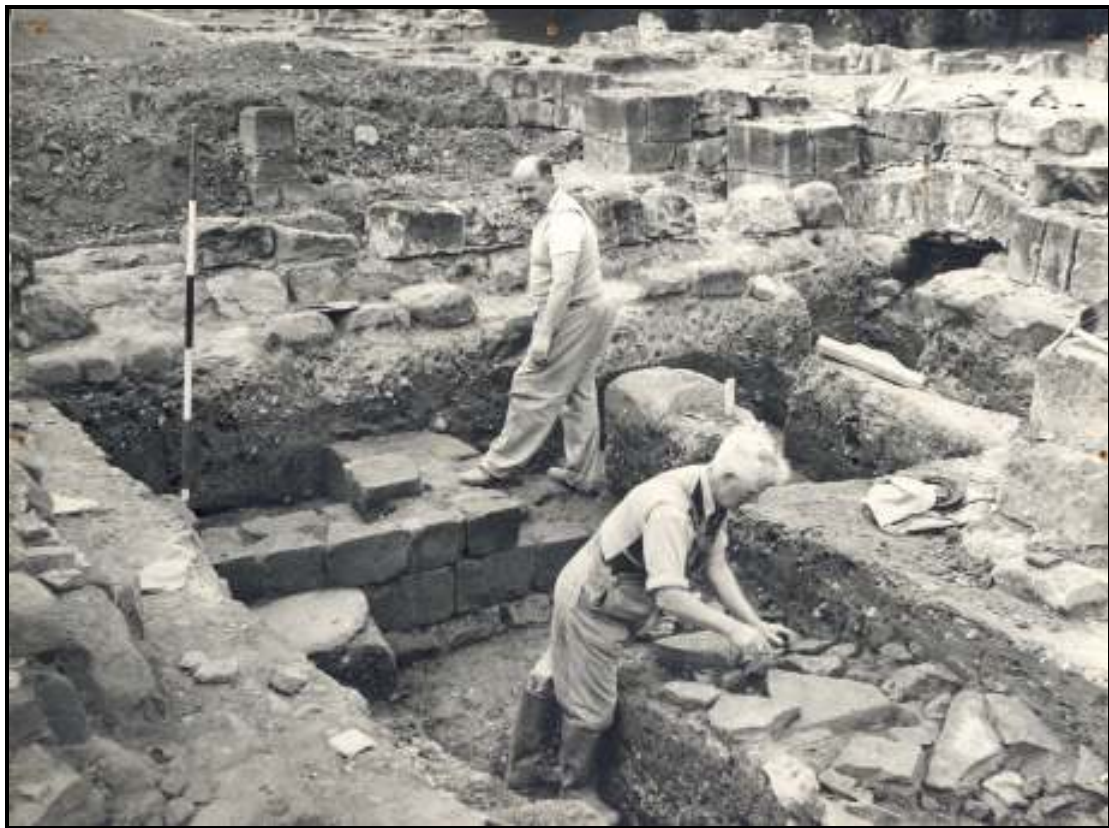
Fig. 3.26: The Hall, mid-excavation, showing Oswald standing on the remains of the east wall, looking northwest (Scan 1343)

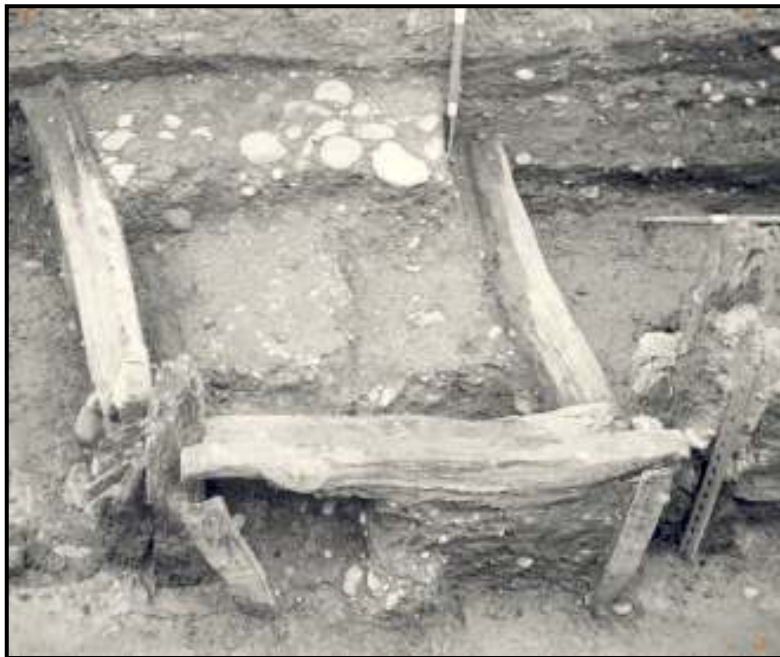
The sill beam was again replaced by a less substantial beam whilst externally the passageway became wider, possibly 2.34m wide. The new western beam survived but no evidence for an eastern beam was found only two stake-holes and the robber trench of a timber drain, 0.26m wide, running eastwards 0.40m outside the building.

Fig. 3.33: The doorway, looking north, showing the Phase V sill and cobbled causeway, looking north (Scan 341)
