LAND ADJOINING HUCCLECOTE RESOURCE  
CENTRE, CHURCHDOWN LANE,  
GLOUCESTER

ARCHAEOLOGICAL EVALUATION

GLOUCESTER ARCHAEOLOGY UNIT 1996

**LAND ADJOINING HUCCLECOTE RESOURCE CENTRE,  
CHURCHDOWN LANE, HUCCLECOTE, GLOUCESTER.  
(SITE 12/96)**

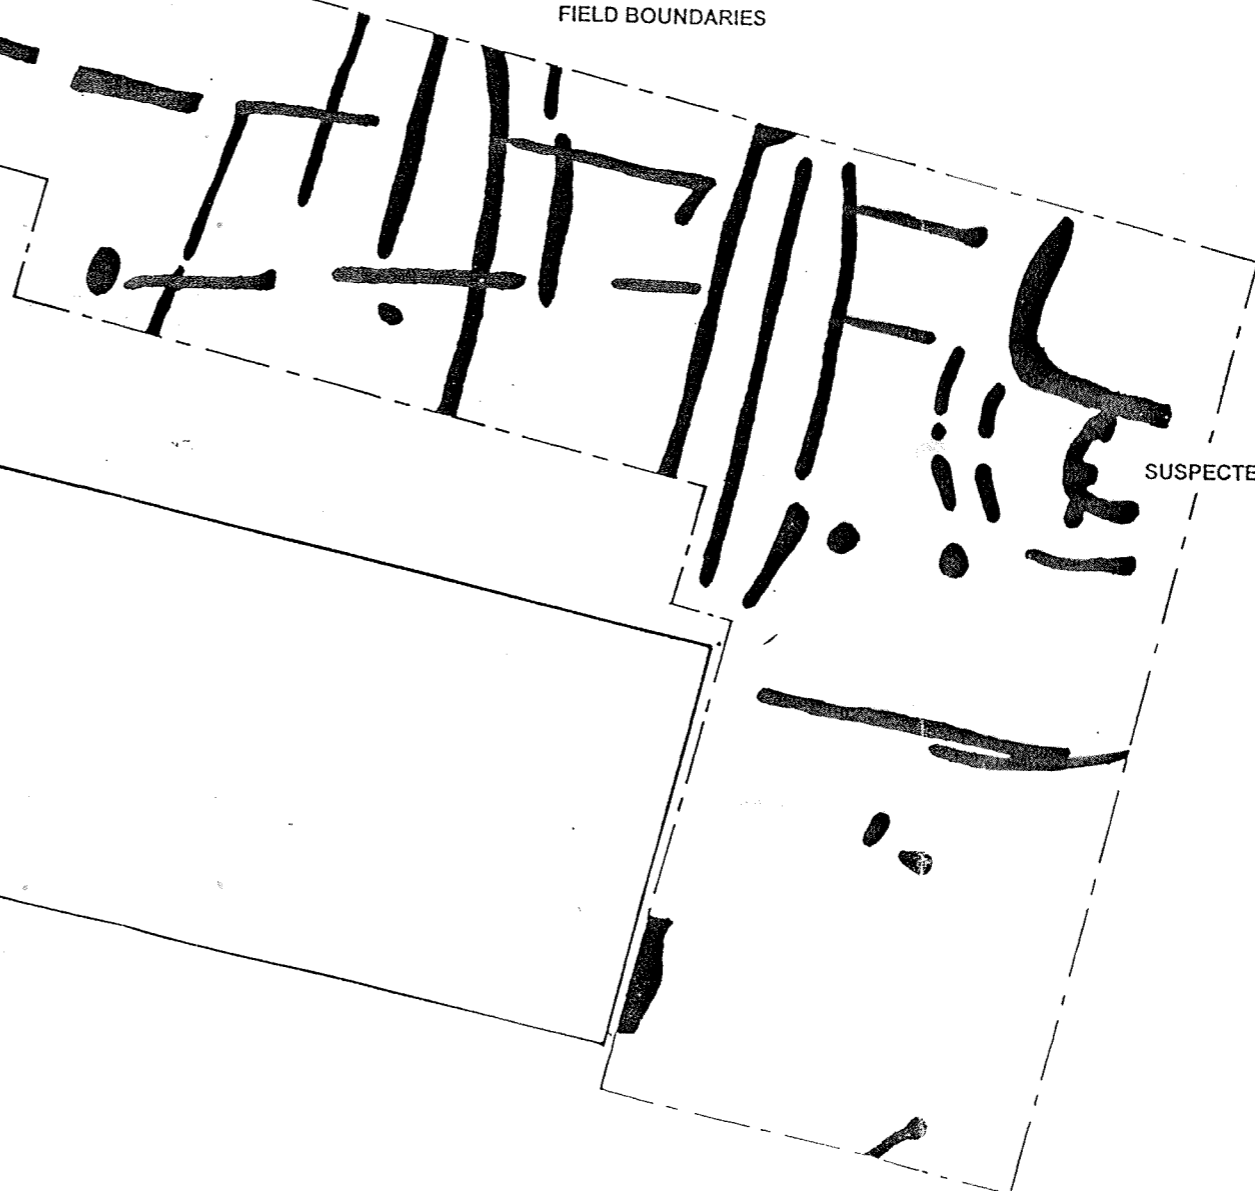
12/96 HUCCLECOTE - GEOPHYSICAL SURVEY RESULTS

The plan derived from the geophysical data is generally self explanatory in terms of the type of features that may be present within the development area.

The villa plan is clearly outlined to the west with the intercutting series of ditched field boundaries, following broadly the same alignment, to the east and south.

As can be seen from the geophysical survey results there are an abundance of archaeological features in this area and in particular a circular structure on the eastern boundary.

SUSPECTED IRON AGE ROUNDHOUSE

The initial theory that the circular feature may represent an Iron age roundhouse has proved not to be the case. Rather, this feature now appears to be the corner of a field system that extends eastwards away from the survey area.
