BATTLE ABBEY

The Eastern Range
and the Excavations
of 1978-80

J N HARE

Historic Buildings & Monuments Commission for England
Archaeological Report no 2

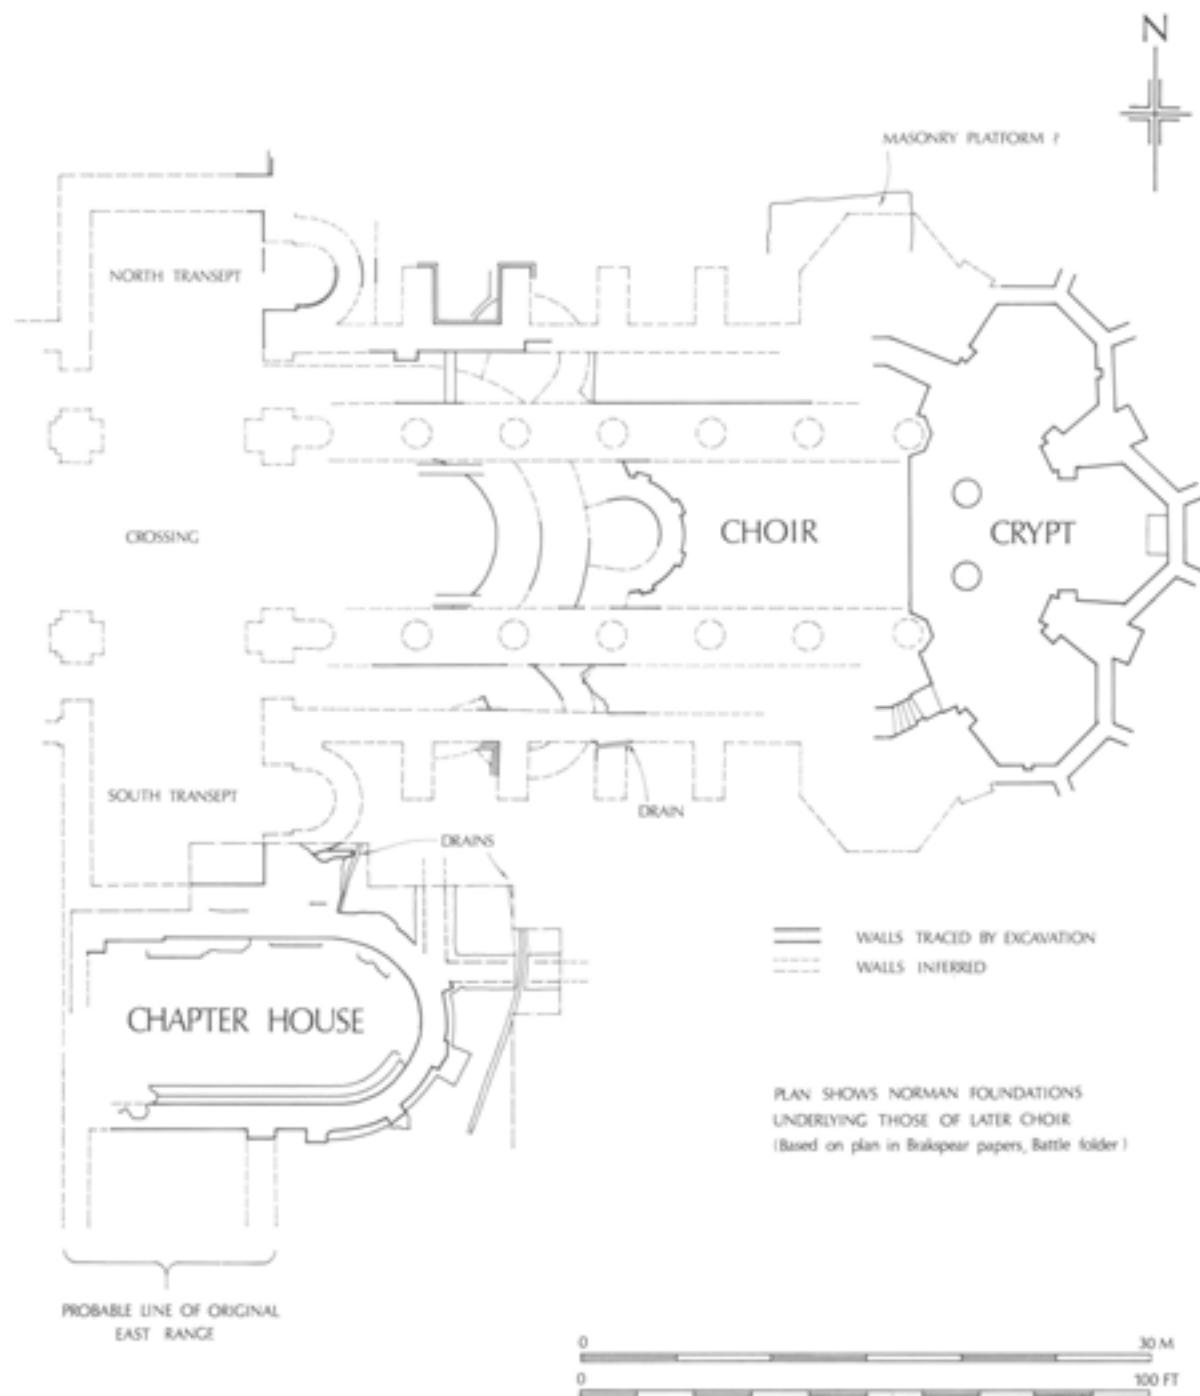
BATTLE ABBEY · EASTERN ARM OF CHURCH

The recent excavations have produced additional information on the footings for the church as well as providing confirmation for Brakspear's plan. The lowest course of the wall of the south transept apse was found very close (0.2m) to the present surface and consisted of blocks of ashlar with coarse diagonal tooling of early Norman character and wide joints, such as survive in the remains of the south aisle wall of the nave (plate 5). The three ashlar blocks provided a length of 1.10m and clearly confirmed the curve of the apse. The wall itself was seated on broad stone footings up to 3.6m in width. The foundations were not, however, uniform. The lowest level was revealed in the north-west corner of the chapter house where post-Dissolution activity had destroyed the wall of the chapter house and so exposed the base of the footings. It consisted of large boulders now set in sand and apparently without mortar. Above this were the main footings with much smaller stones set in a pale mortar. The footings were not entirely regular and they were much wider at the south-west and south-east corners of the transept, where they extended beyond the line of the chapter house wall and were revealed in the excavations within the latter building (figure 6). It is not clear whether these extensions should be inter-

preted as a base for substantial corner buttresses or as indicating the presence of turrets or towers over the transepts. Footings found by Brakspear at the north-east corner of the north transept may indicate a similar situation there.

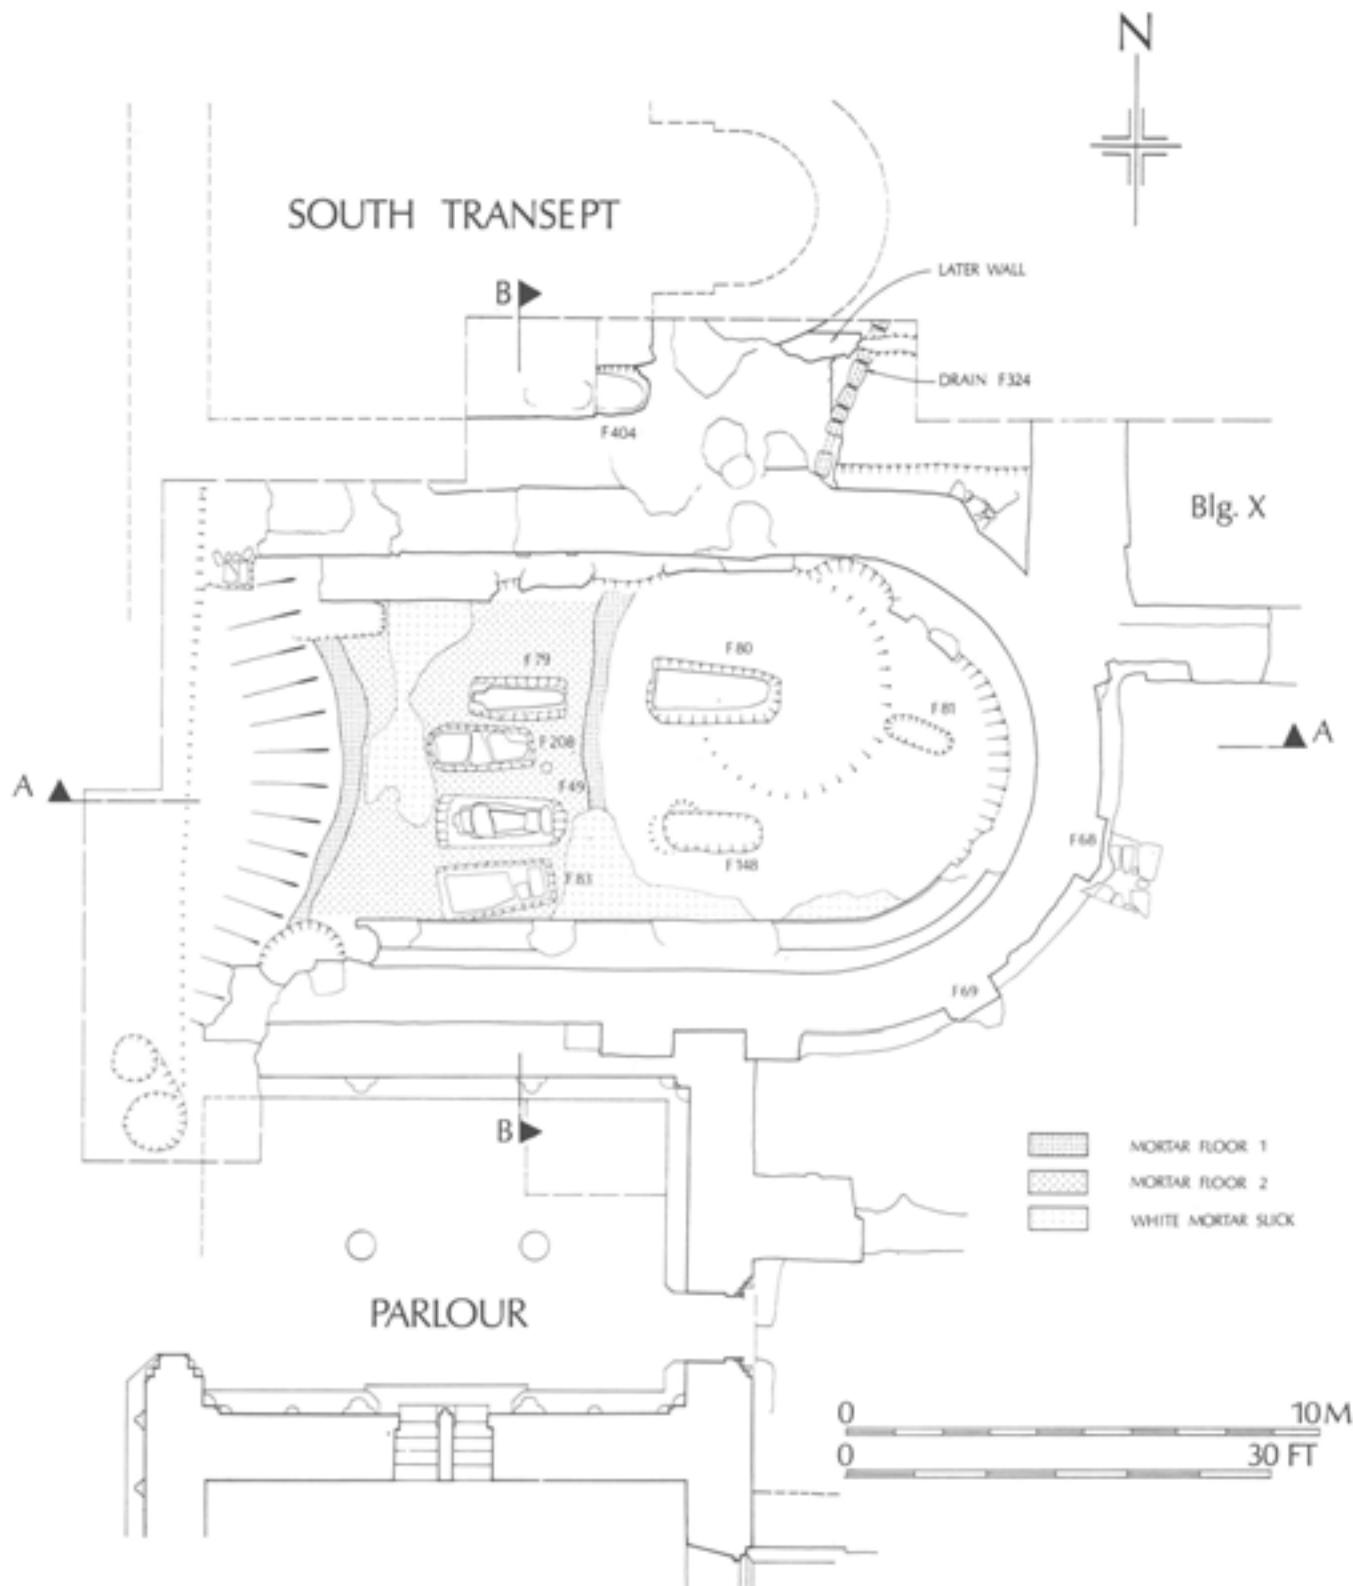
BATTLE ABBEY · CHAPTER HOUSE

No consistent floor level survived within the building. The latest one was of a white mortar and survived fragmentarily across the chapter house. It overlay a thin yellow slick and the natural clay, except in the south-west corner where the ground dipped away and the floor level had subsequently been raised. Thus sealed below the later mortar layer and up to 0.1 m of make-up was an earlier, yellow-mortar layer which in one area had been reddened by burning. This hard, flat surface was evidently a floor and one which pre-dated the addition of the stone benching as this sat on the make-up above the early floor.

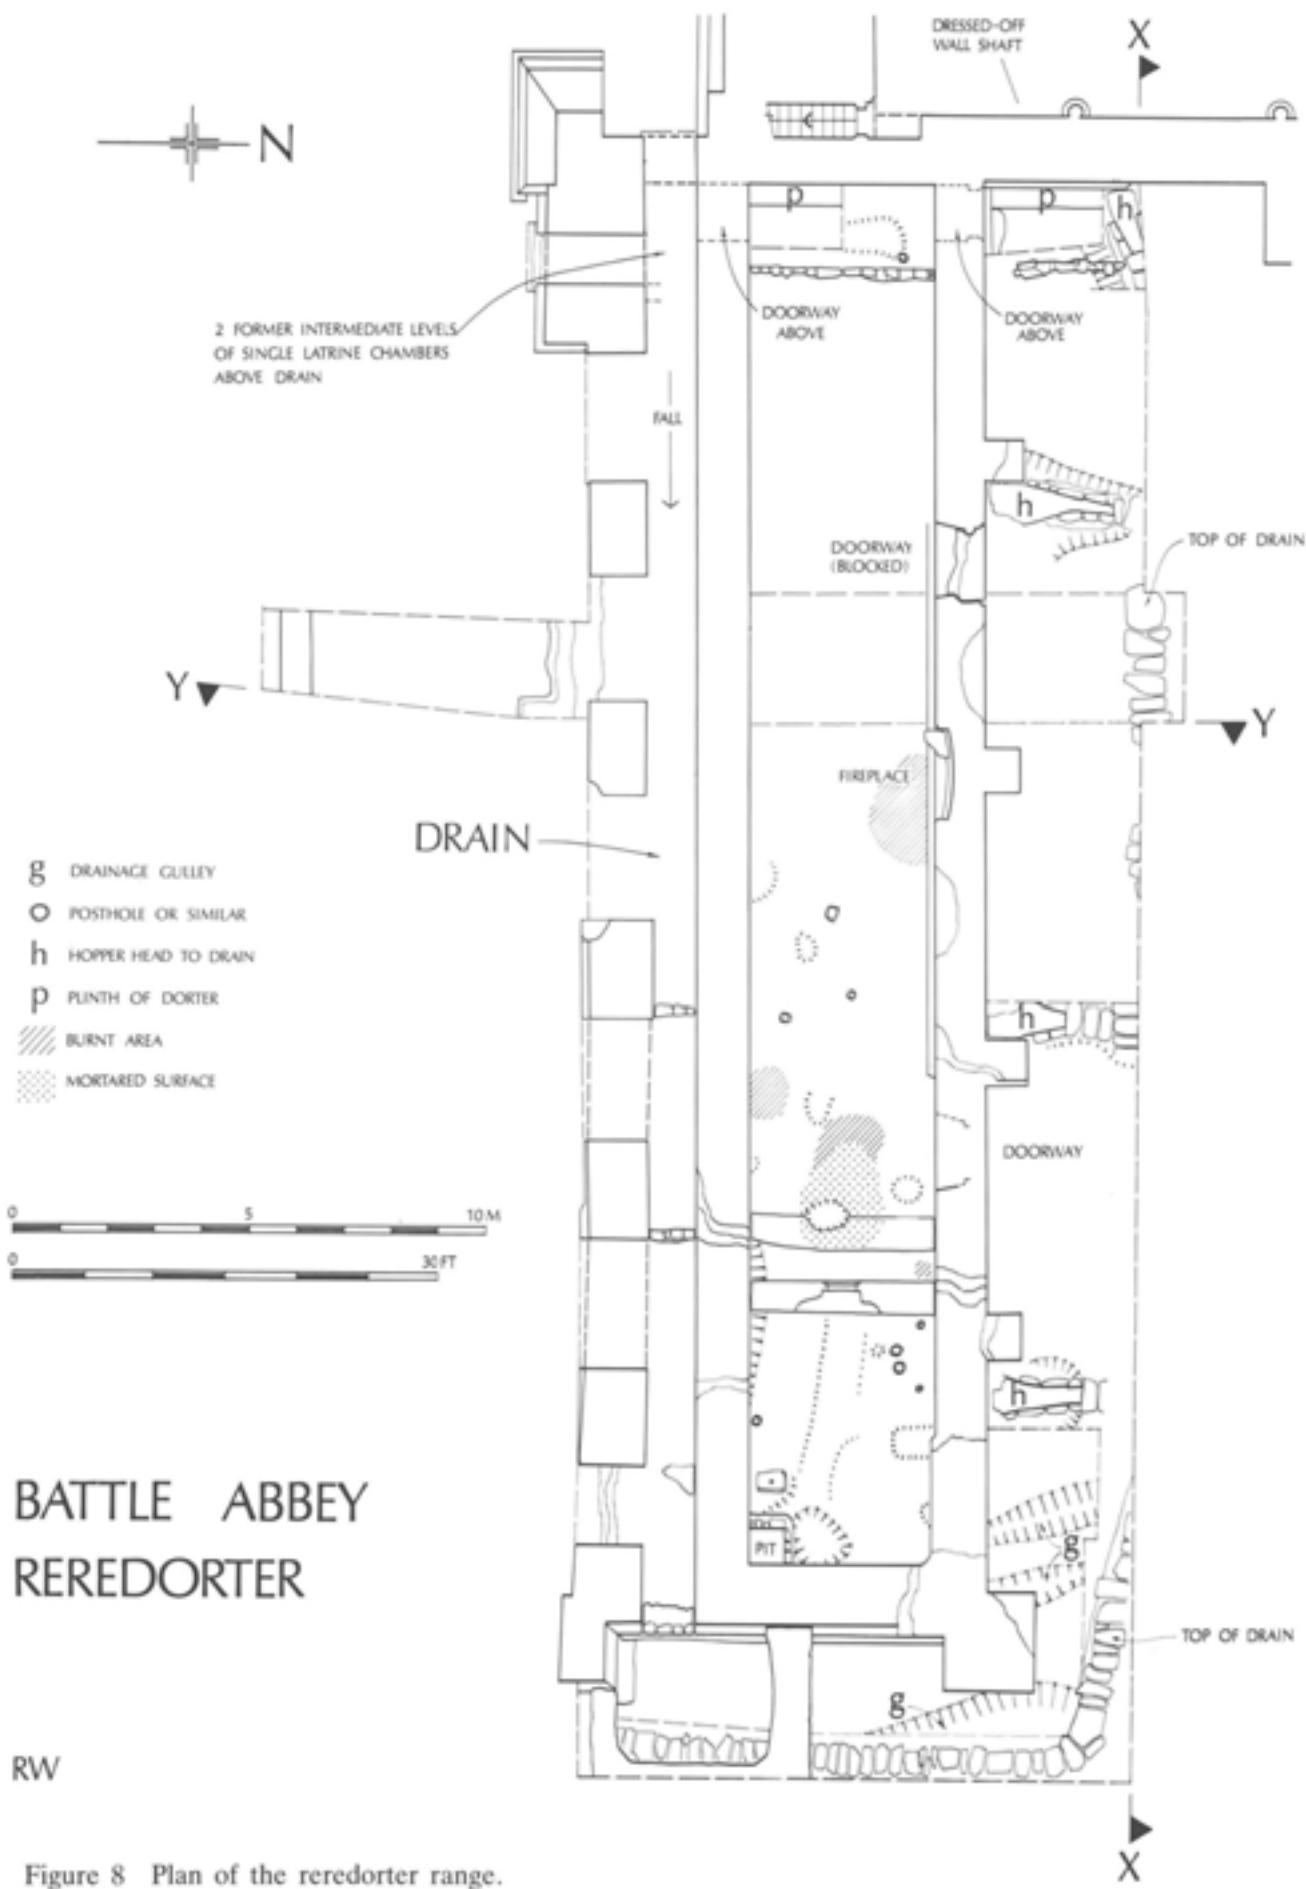
Figure 8 Plan of the reredorter range.

The main drain of the reredorter was of very unusual design. Although on one side it was enclosed by a solid wall, on its outer or southern side it was open, the outer wall being carried on an arcade of five high (4.5 m) open arches and two smaller ones (2.15 m high). For three of the arches, only the rectangular piers survive, but the arches survived complete until the eighteenth century (Plate 23). Excavations were carried out at two places outside

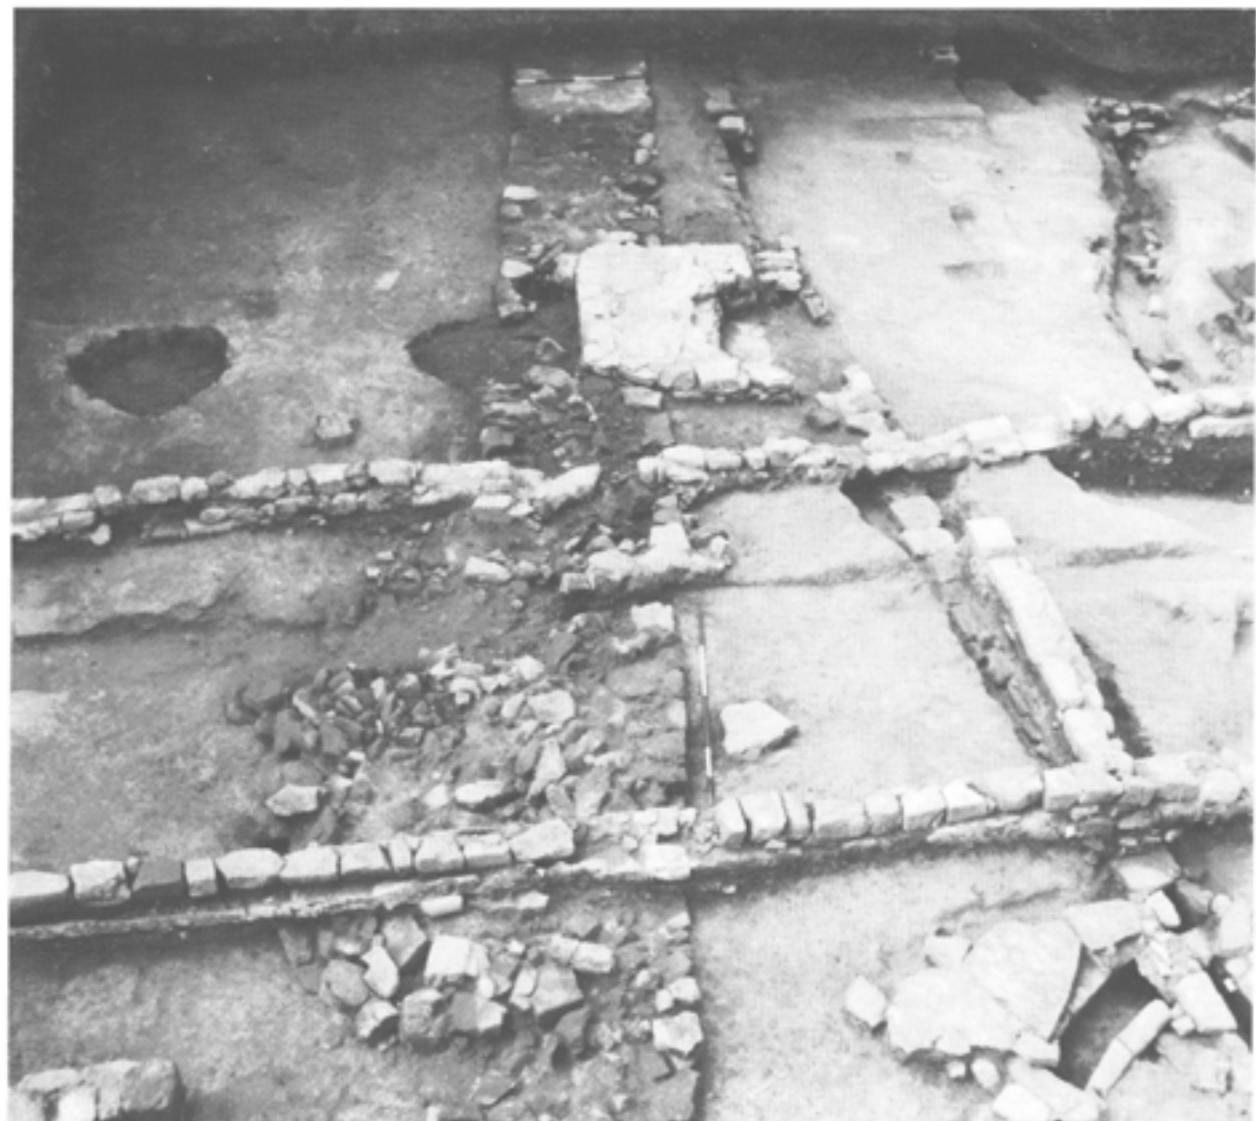
Plate 7 The wall of the infirmary (building Z) looking south, also showing post-medieval structures and the late medieval drains.

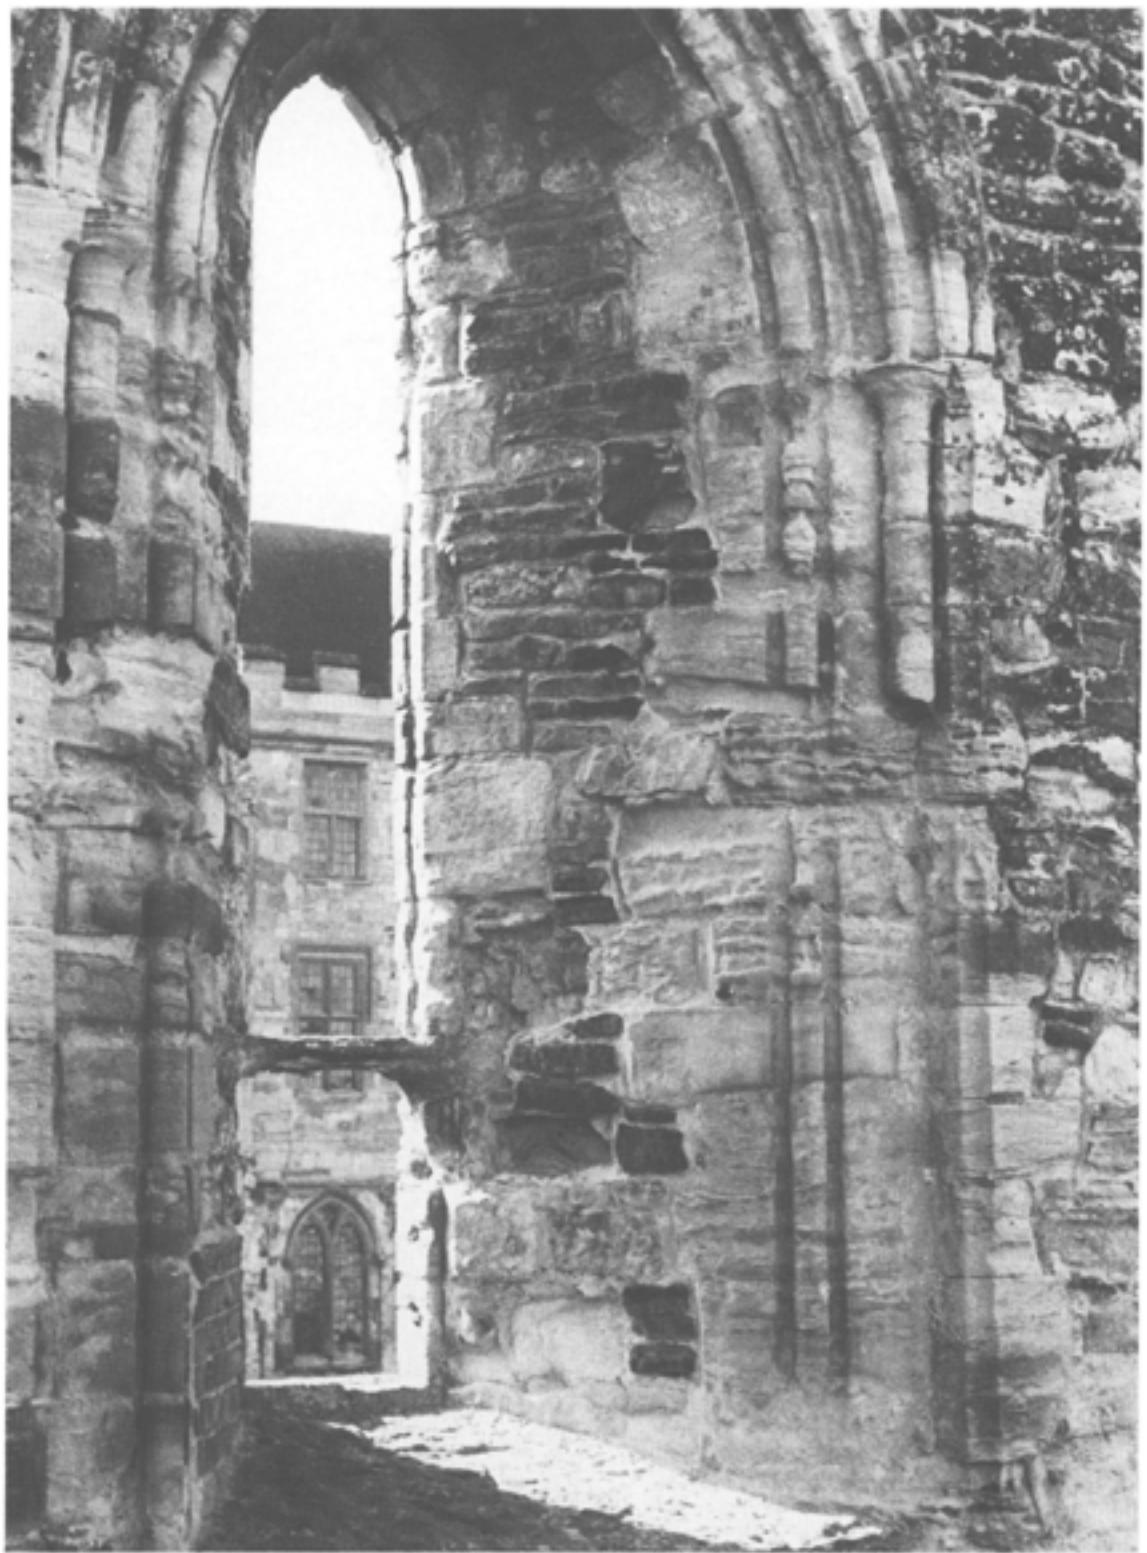
Plate 10 The dormitory: window moulding, and evidence for glazing and shuttering.

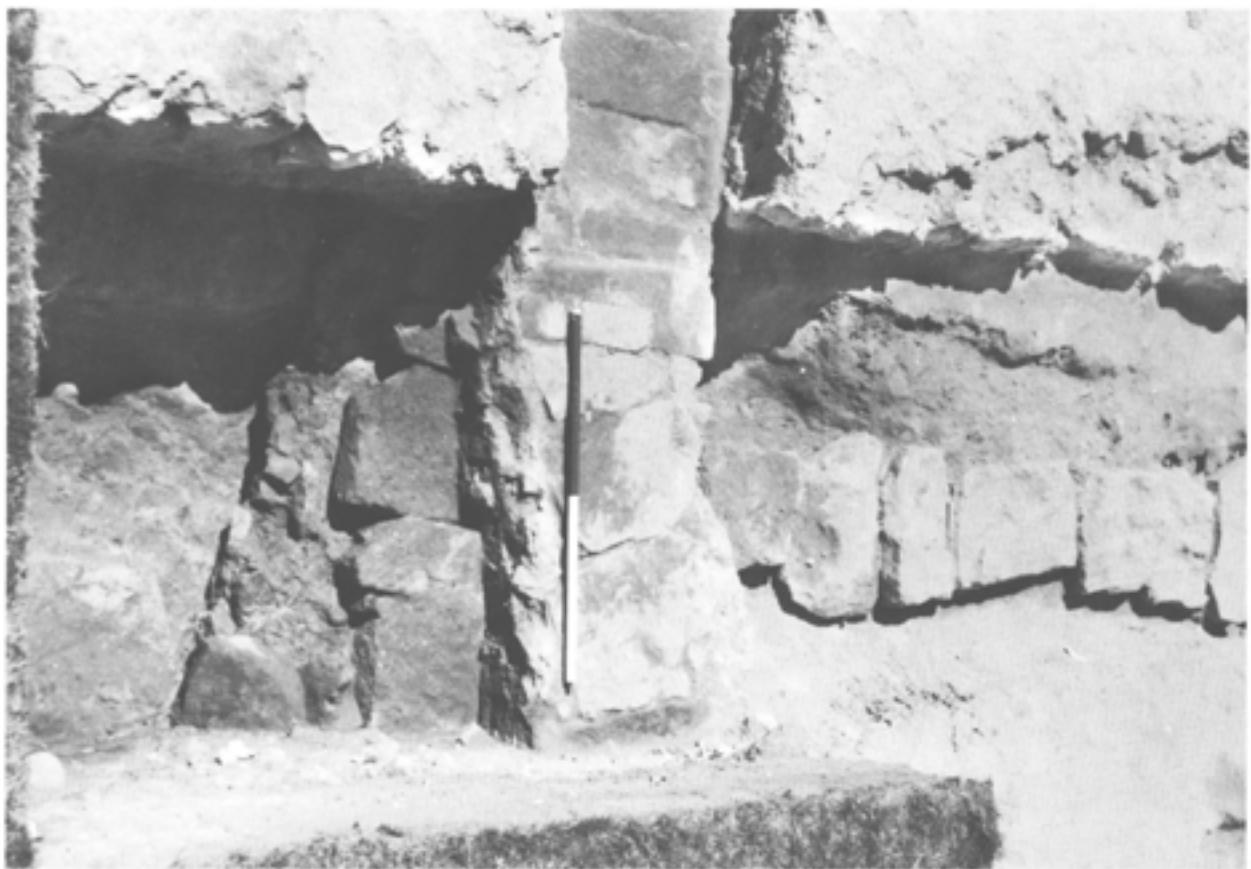
Plate 18 Trenches M and F from the east: the two sets of overlying drains.

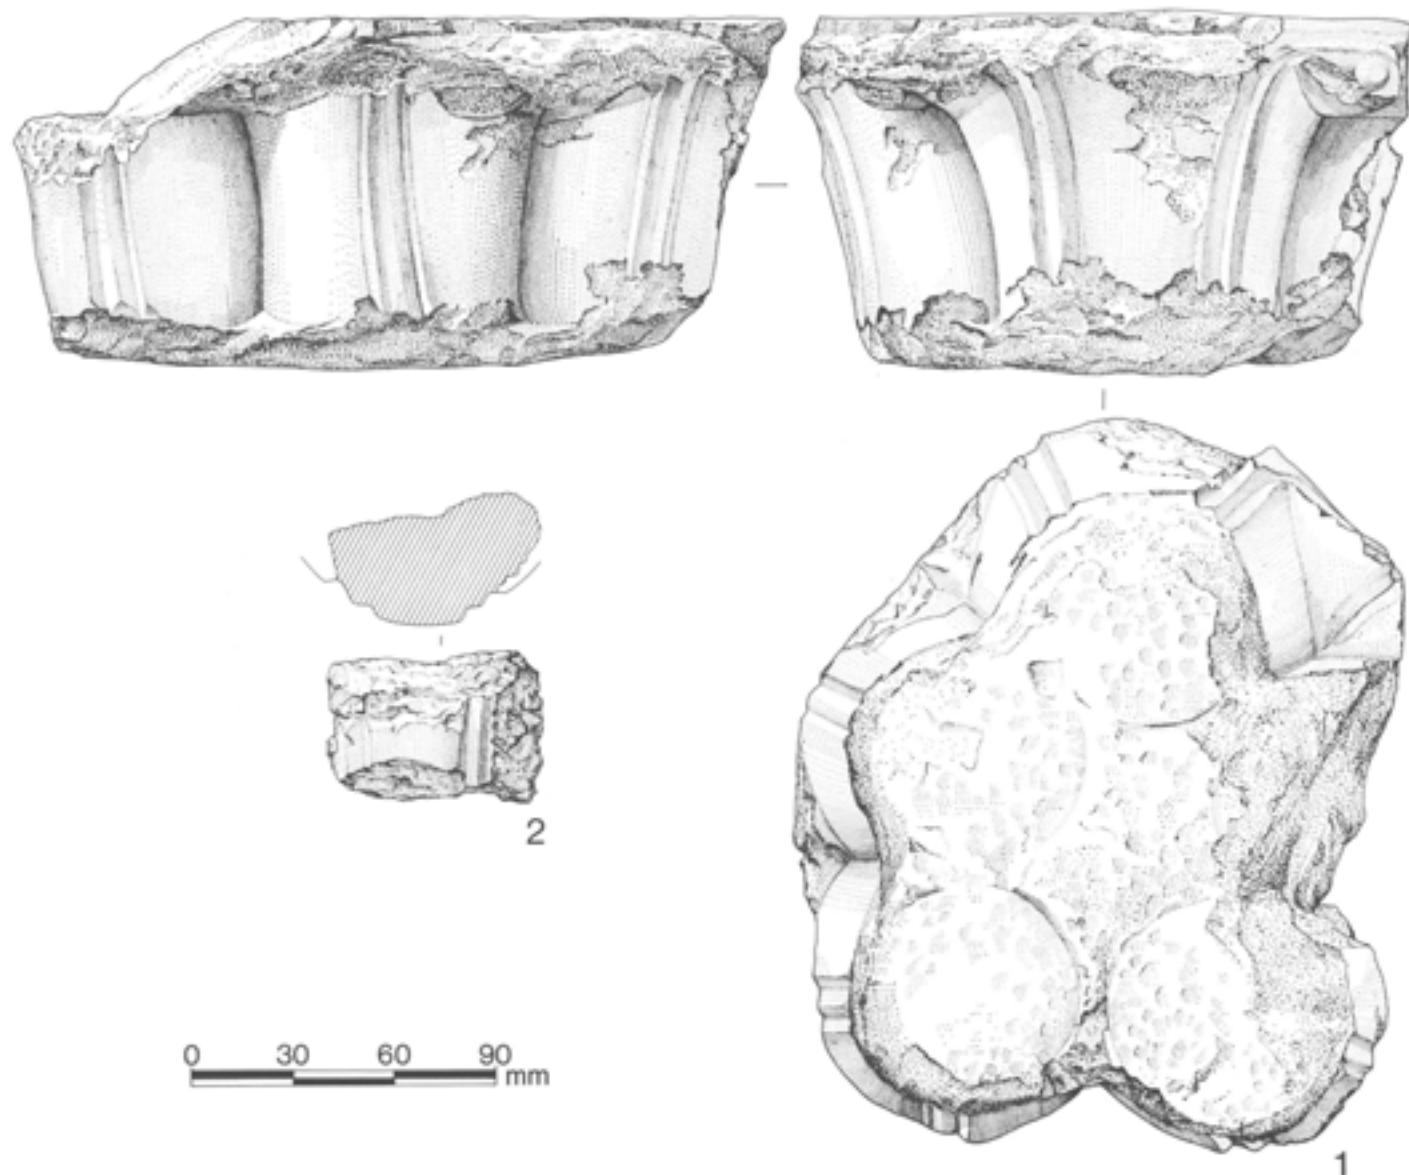
Figure 12 Battle Abbey. Architectural fragments nos 1-2.

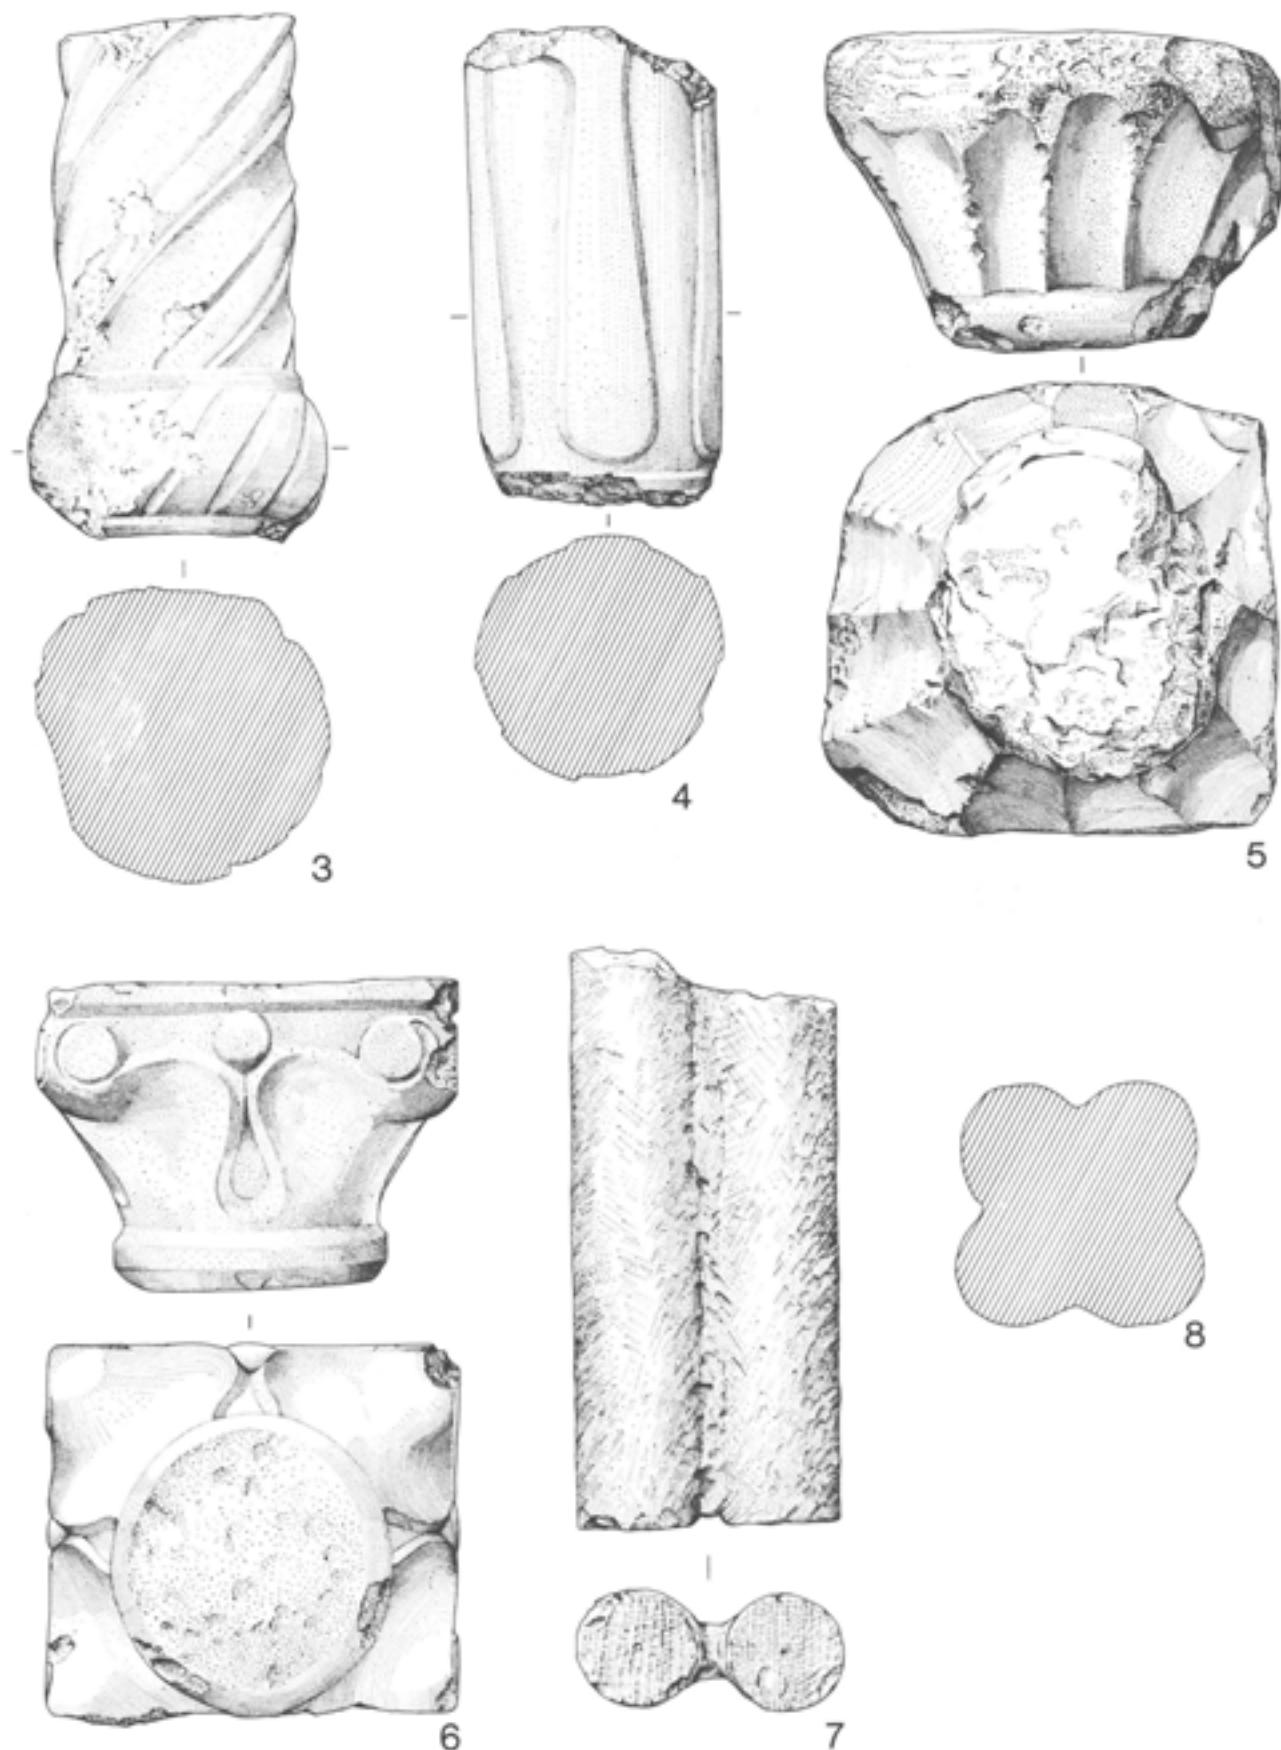
Figure 13 Battle Abbey. Architectural fragments nos 3-8 (§)

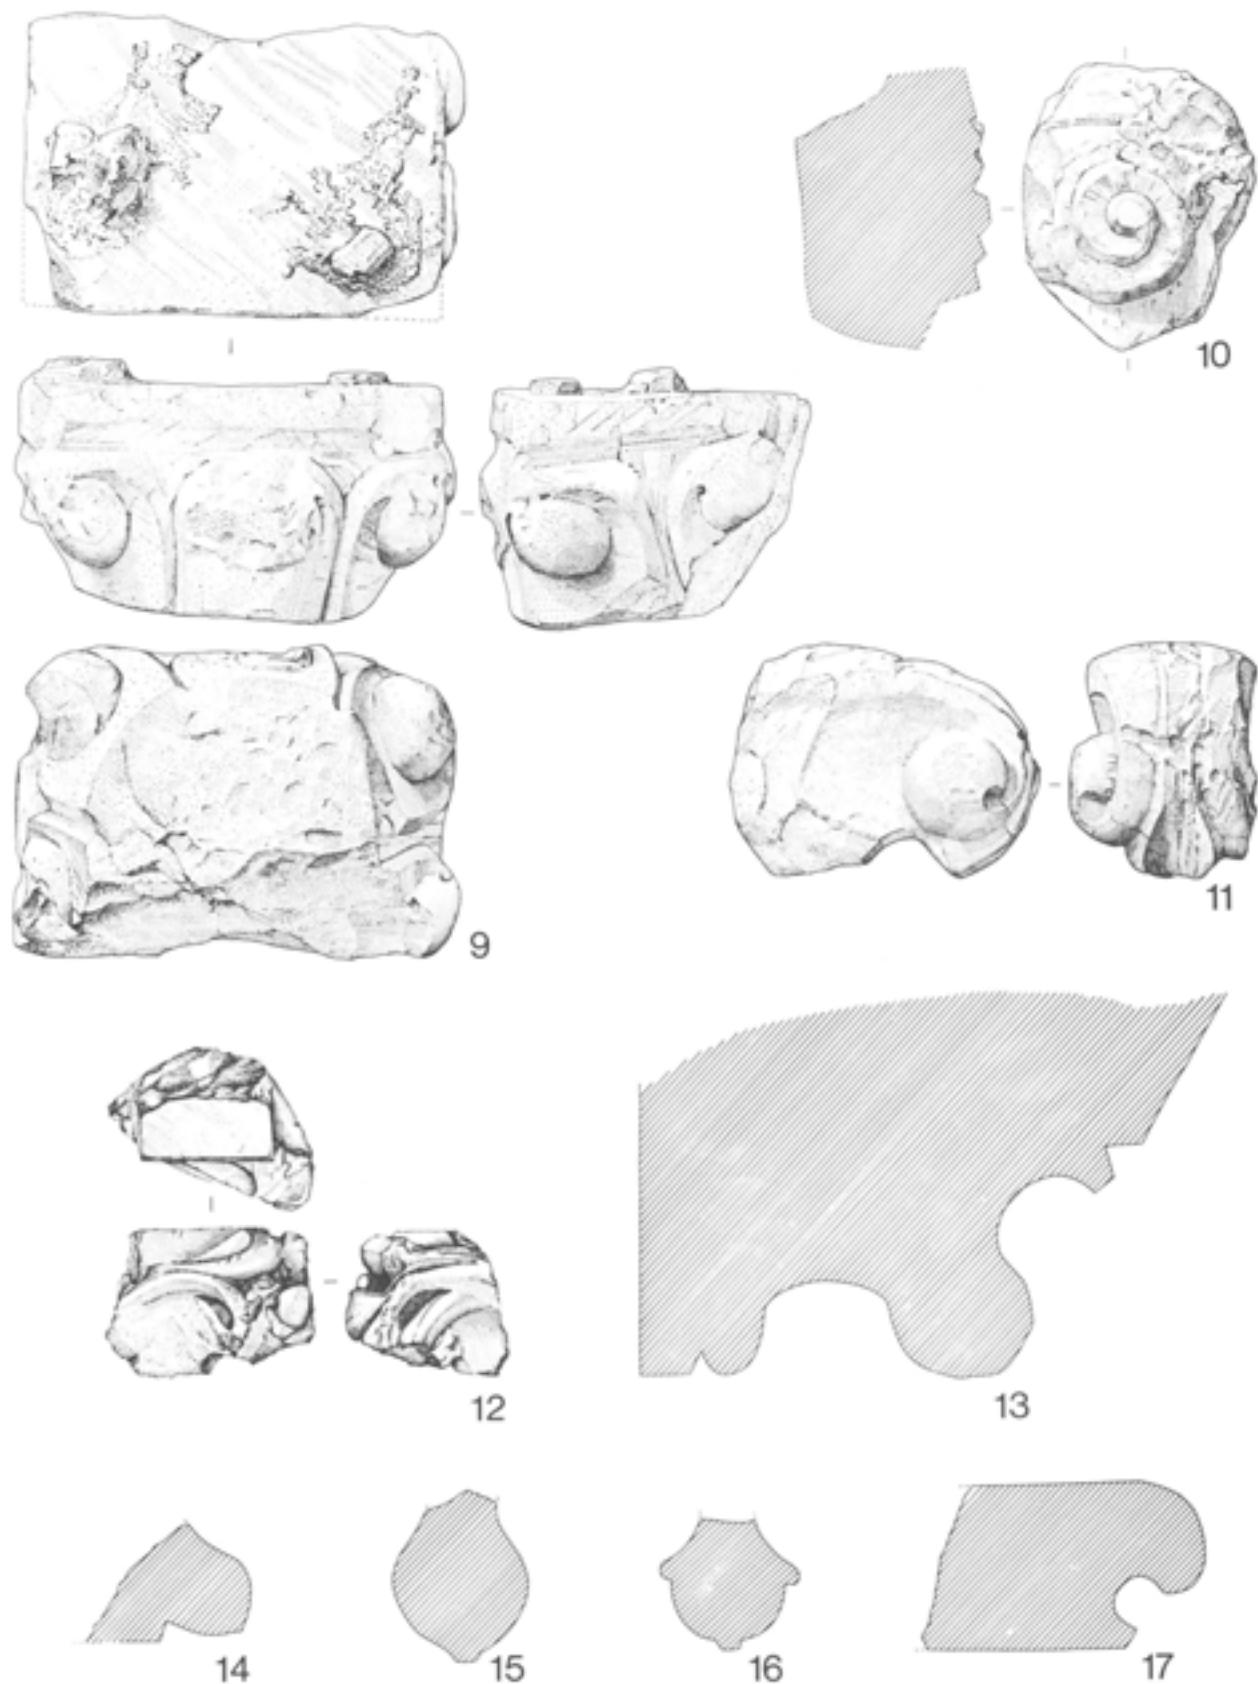
Figure 14 Battle Abbey. Architectural fragments nos 9-17 (1)

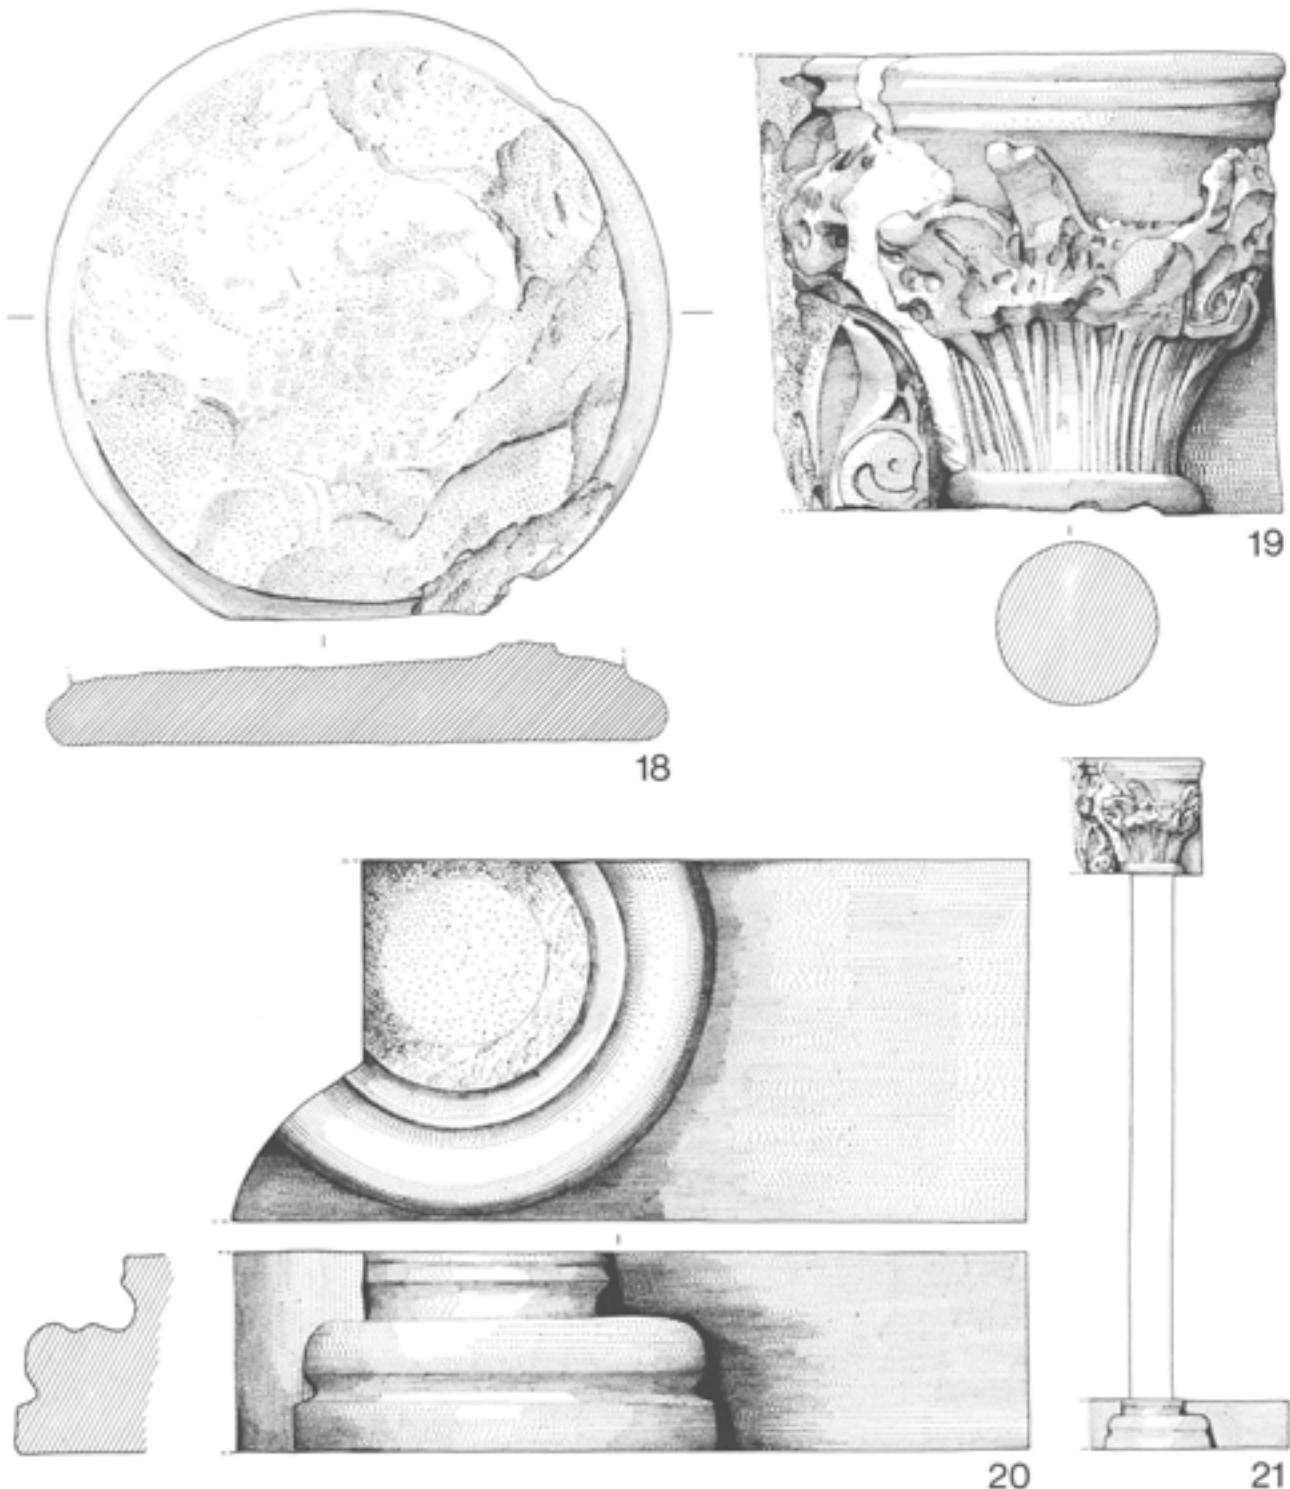
Figure 15 Battle Abbey. Architectural fragment (no. 18), and details of the main entrance to the dormitory (nos. 19-21) (§)

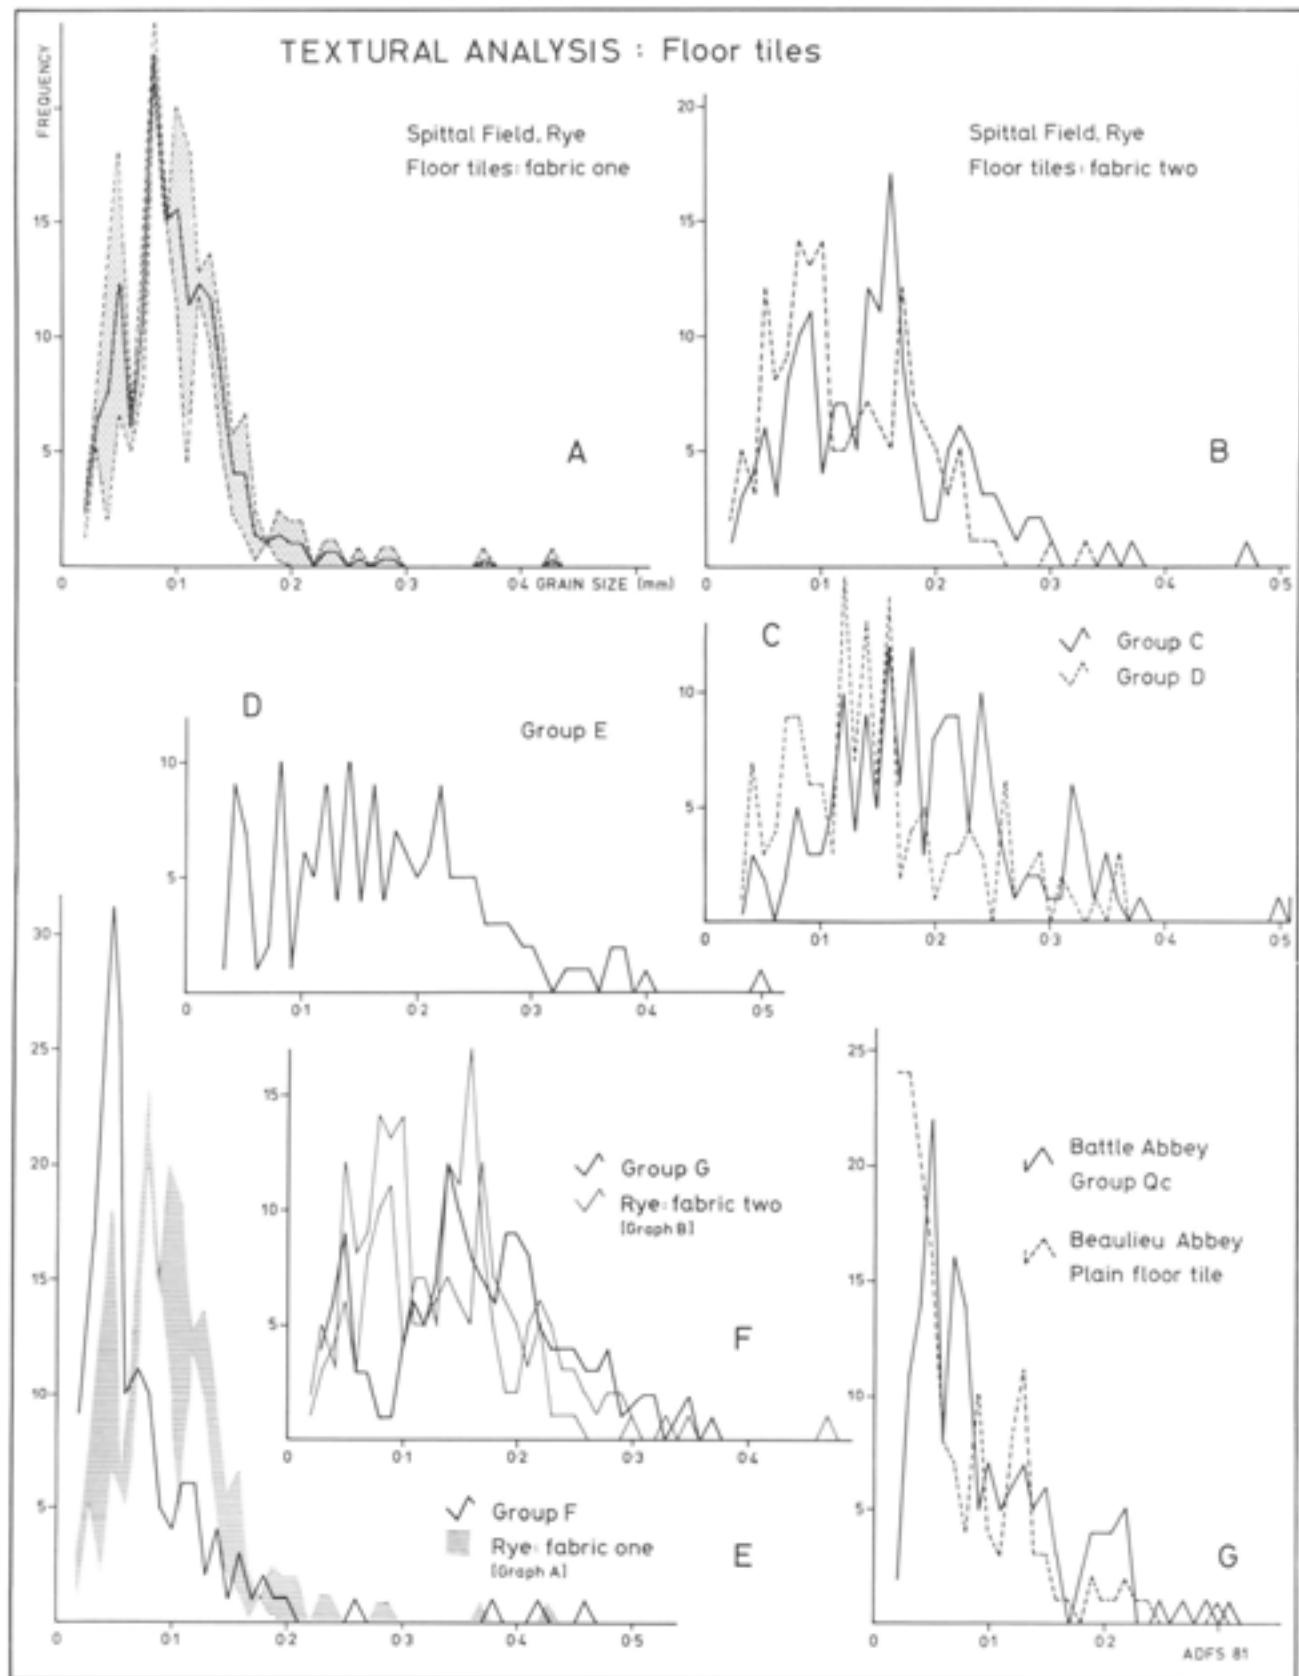
Figure 18 Textural analysis of medieval floor tiles.

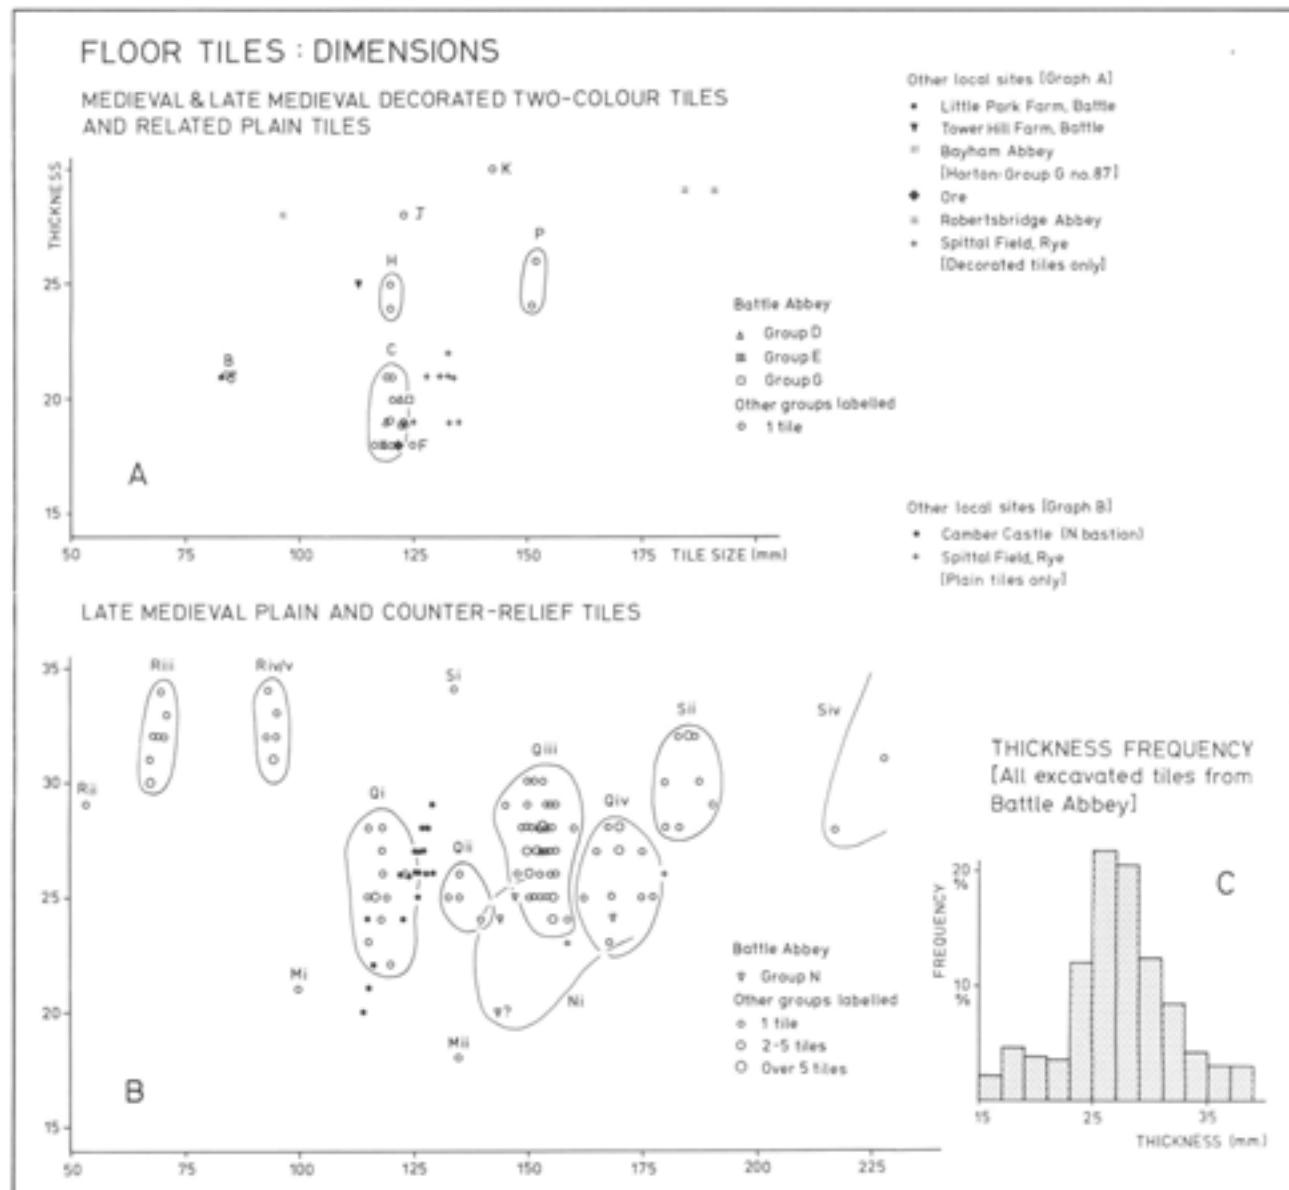
Figure 21 Battle Abbey. Graphs illustrating the classification of medieval floor tiles according to their size and thickness.
