BATTLE ABBEY

The Eastern Range
and the Excavations
of 1978-80

J N HARE

Historic Buildings & Monuments Commission for England
Archaeological Report no 2

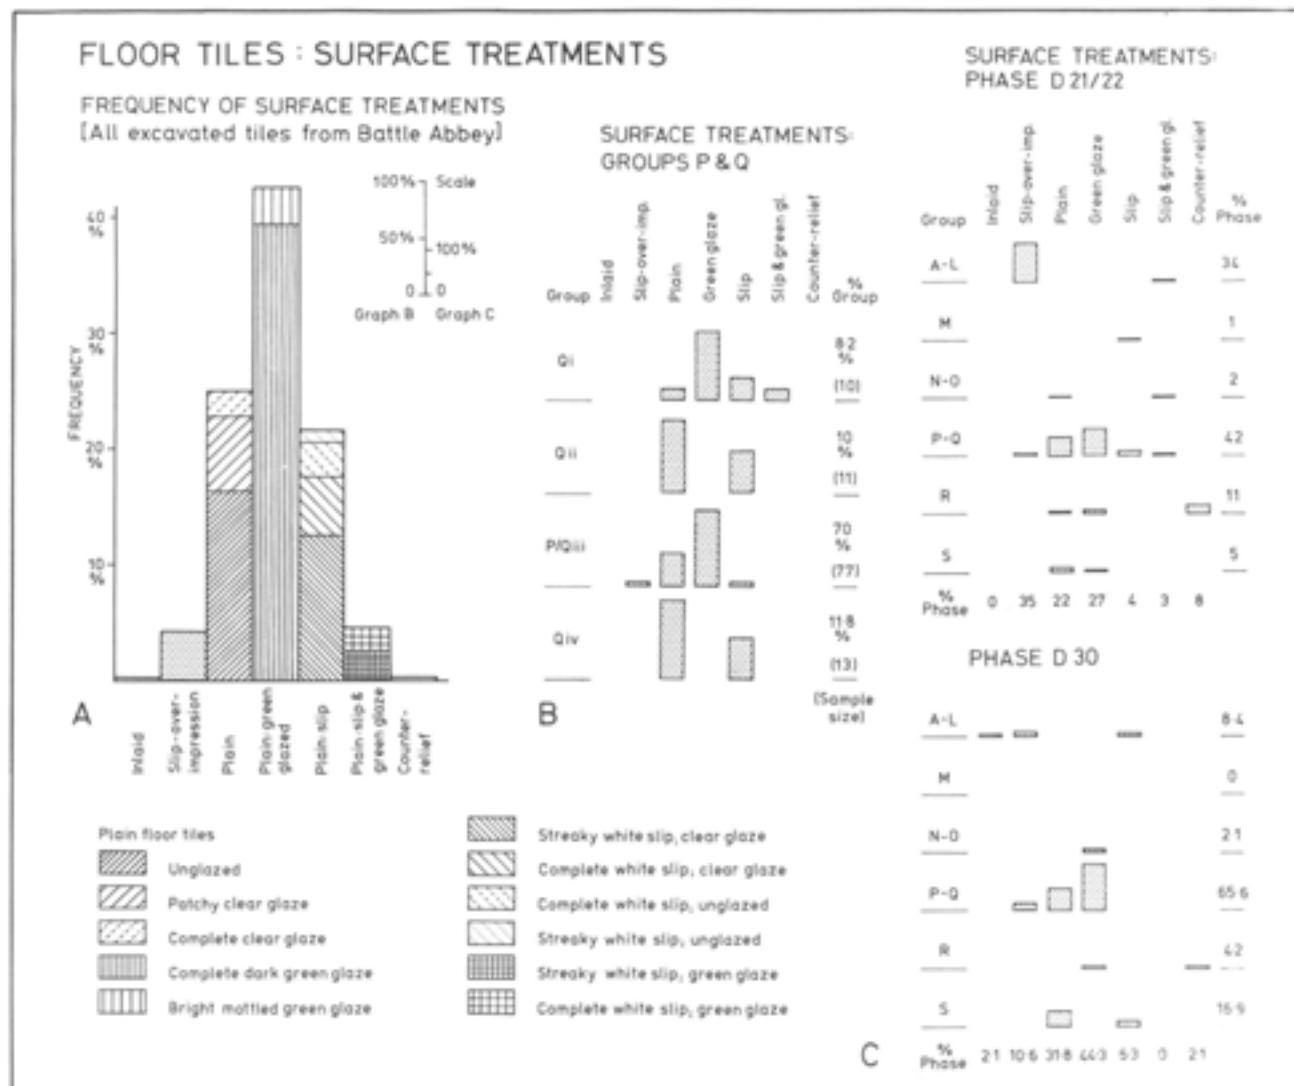
Figure 22 Battle Abbey. Histograms showing the occurrence of surface treatments on medieval floor tiles from all phases [A]; in Groups P and Q [B]; and among Dissolution debris in the reredorter area [C].

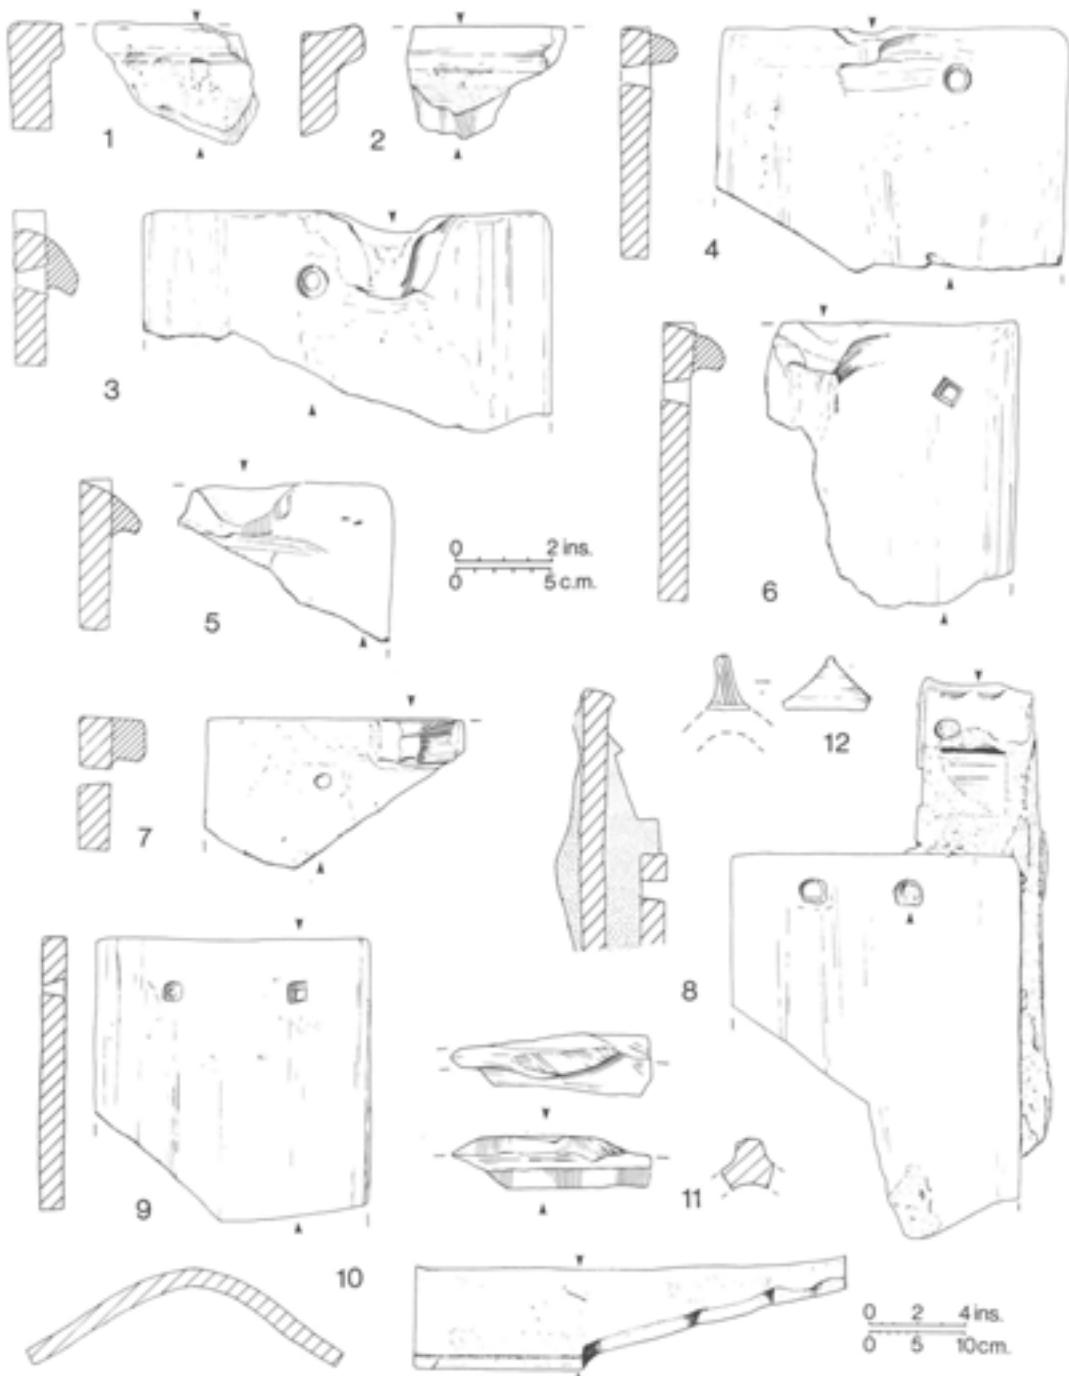
Figure 23 Battle Abbey. Medieval roof tiles. 1-9 and 11-12 (1); 10 (2).

Most of the nib tiles used on the monastic buildings had both a nib and a hole, but there are a few examples with a

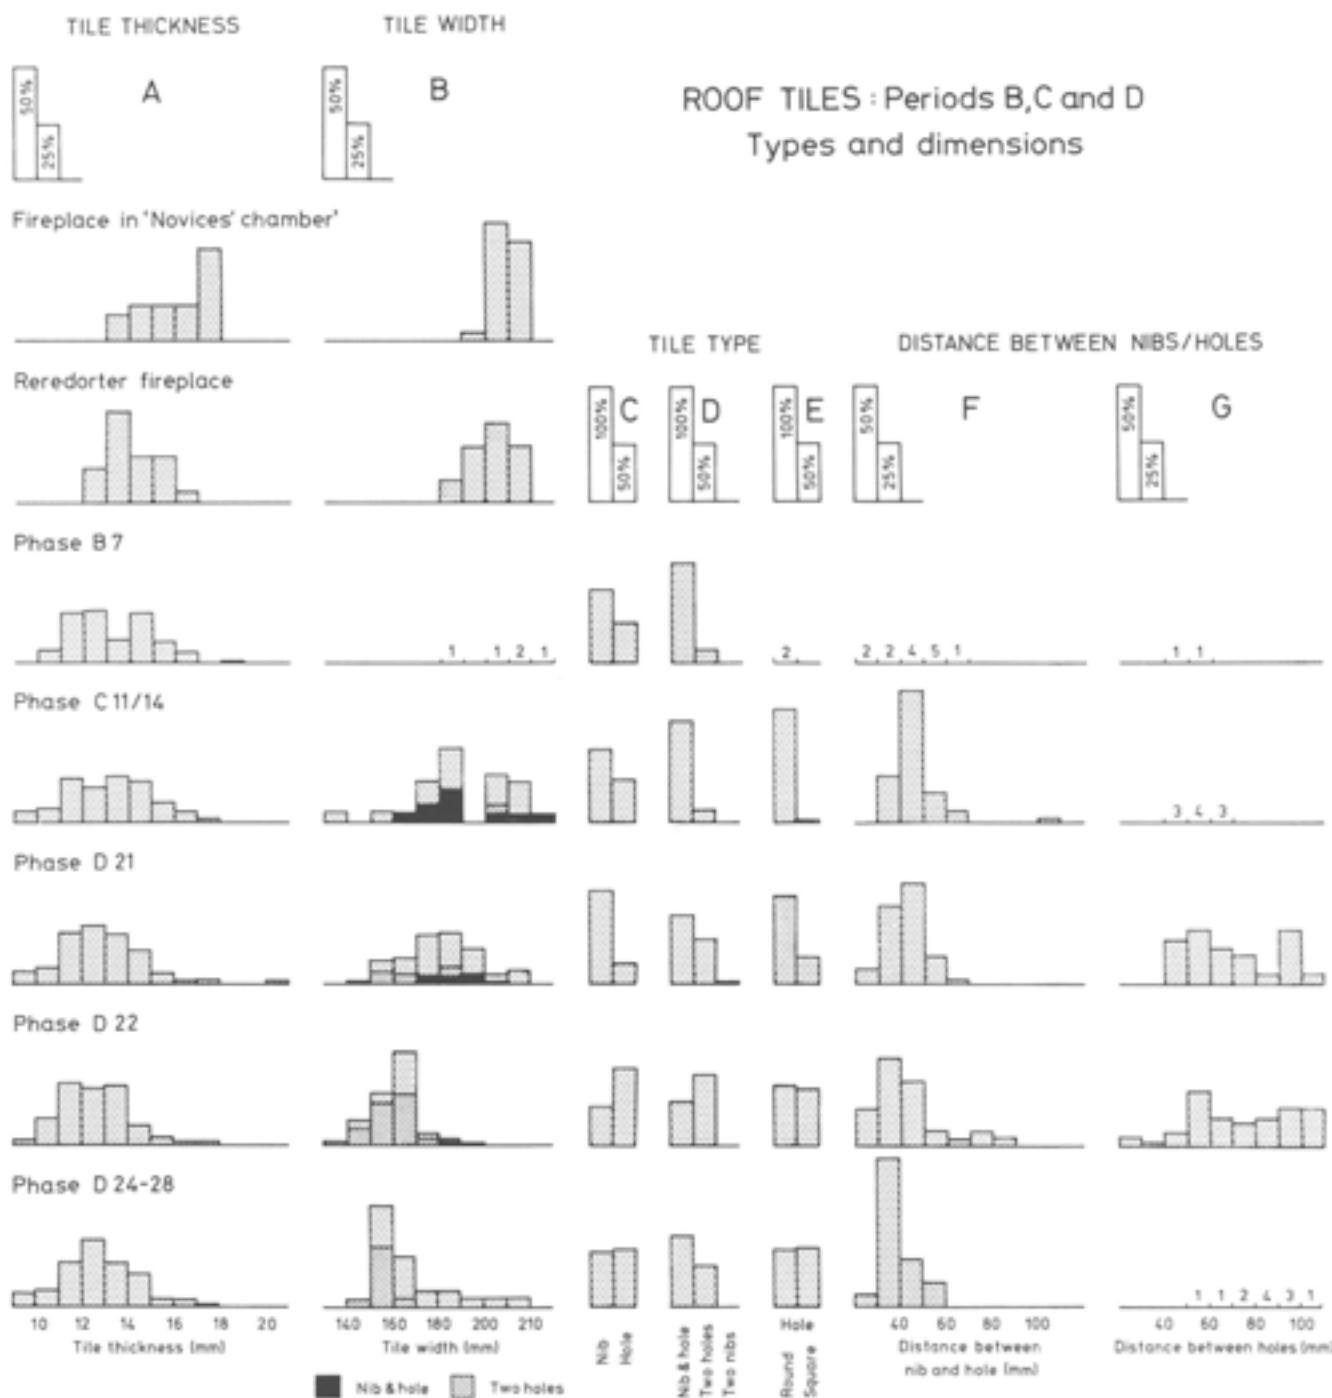
Figure 25 Battle Abbey. Histograms showing the dimensions and other characteristics of medieval and later roof tiles in selected phases.
