# Henry VIII's Coastal Artillery Fort at Camber Castle, Rye, East Sussex

*An archaeological, structural and historical investigation*

Published by the  
Oxford Archaeological Unit  
for English Heritage  
2001

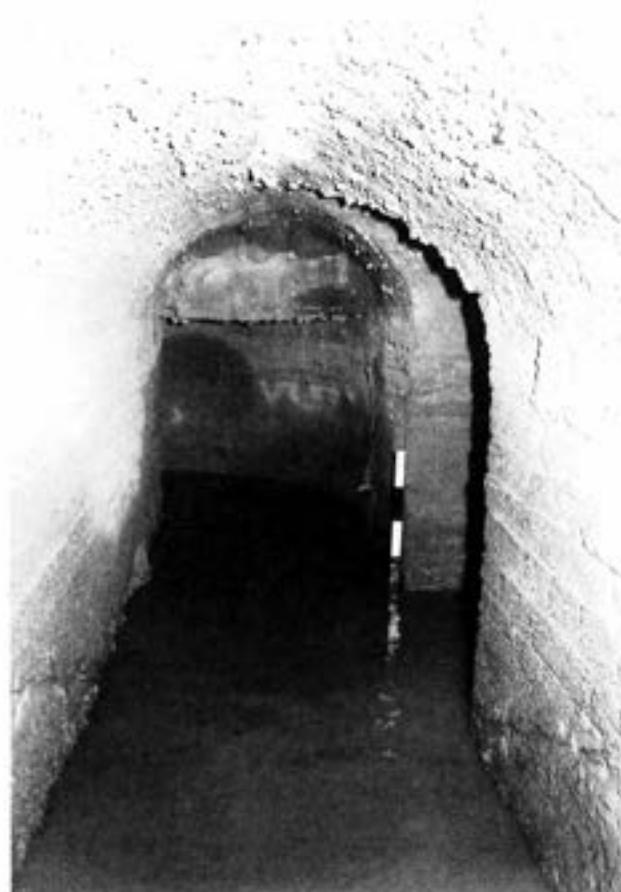
Plate 3.3: Gatehouse subterranean passages; viewed from beneath the front wall, looking west. The photograph shows the high water table that caused problems at the time of construction, 1983 (English Heritage)

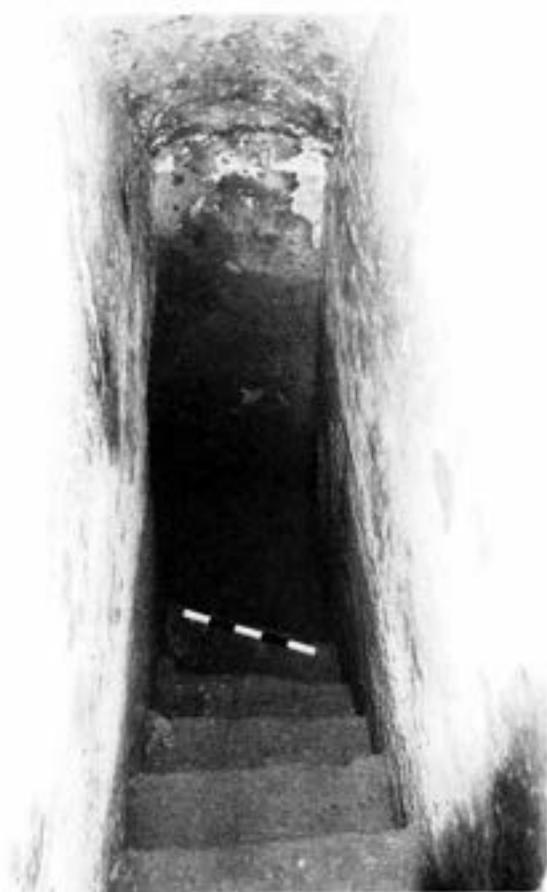
Plate 3.4 Gatehouse subterranean passages: flight of steps leading down from the gallery basement landing into the west subterranean passage underneath the Gatehouse, looking north-east, 1983 (English Heritage)

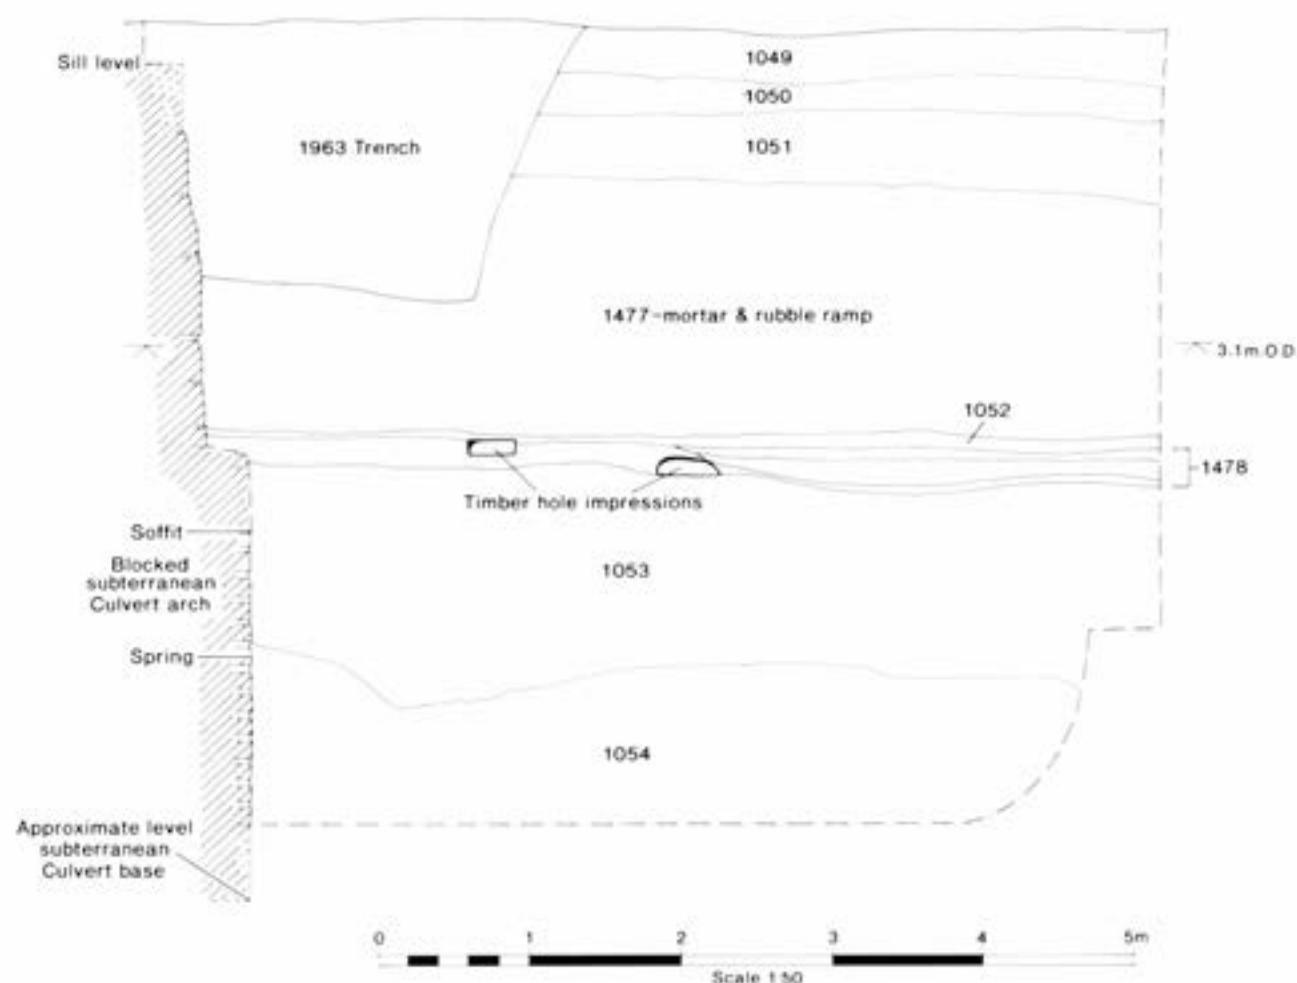
Figure 3.12: Section of 1965 trench outside N wall of Entrance Bastion

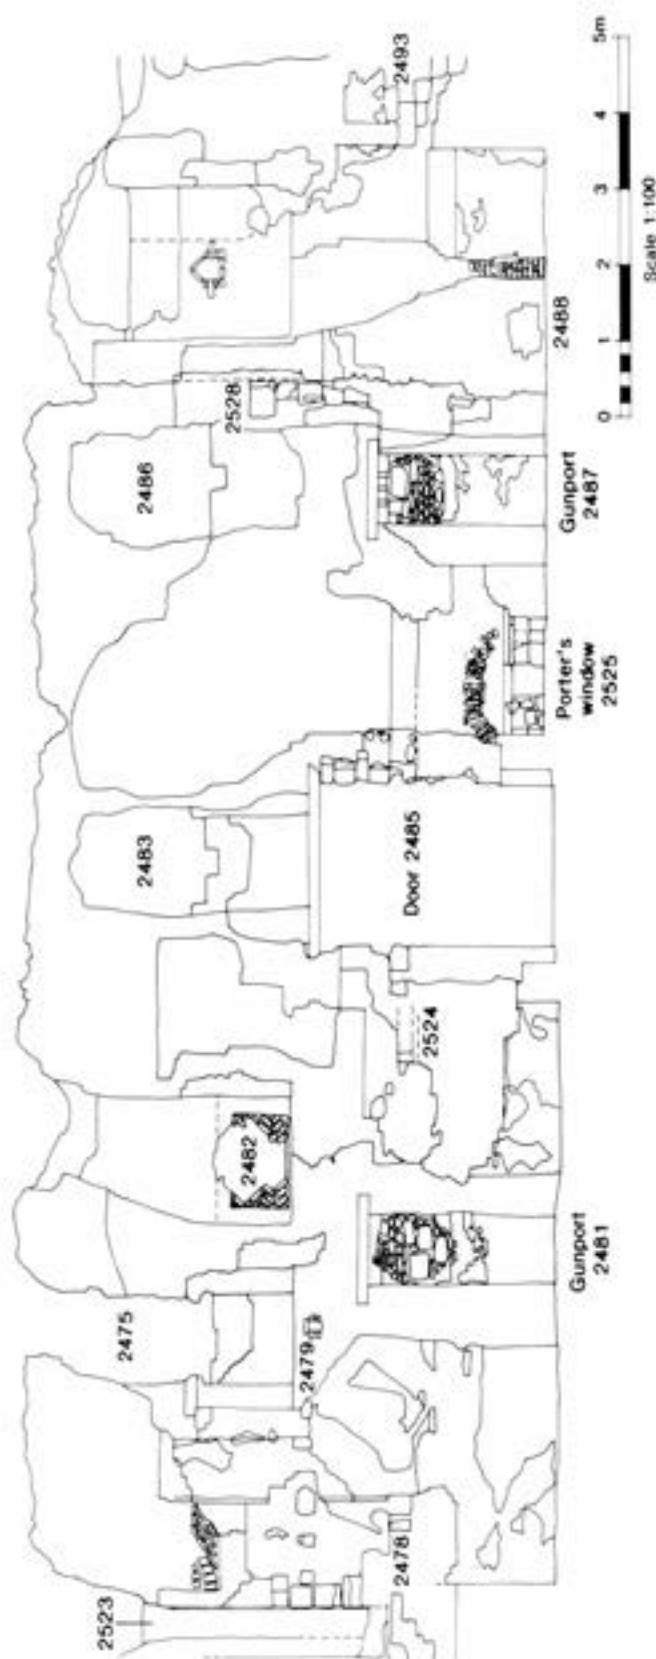
Figure 3.13: Entrance Bastion; internal elevation

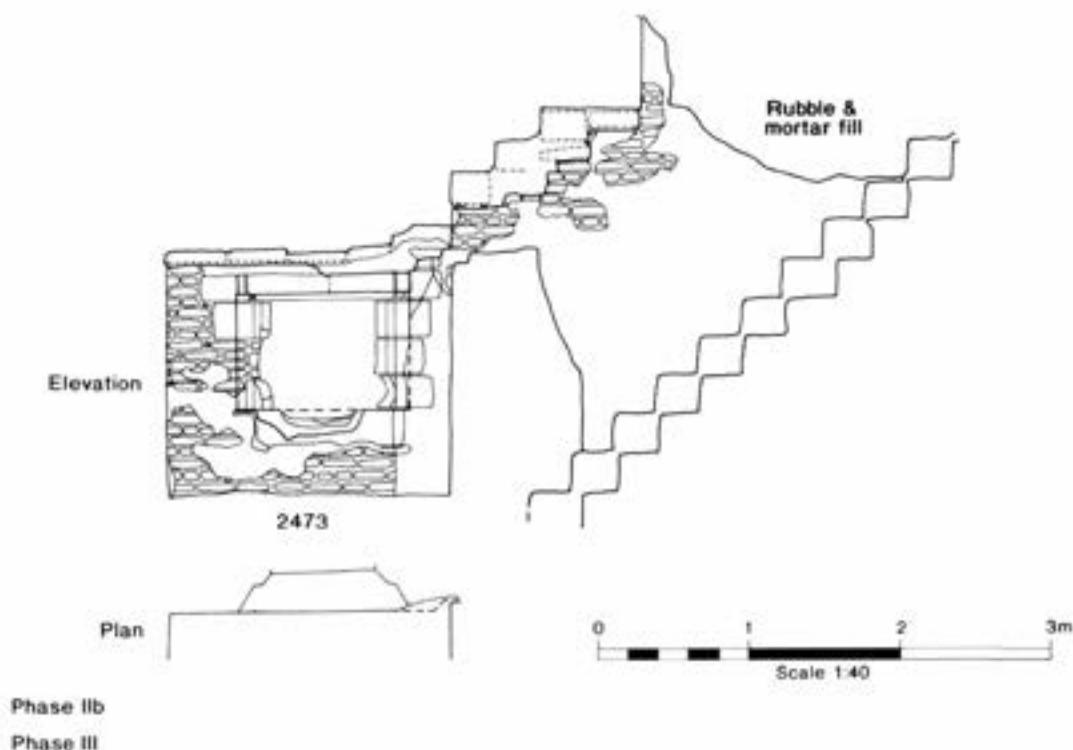
Figure 3.14: Entrance Bastion internal elevation: detail of stair

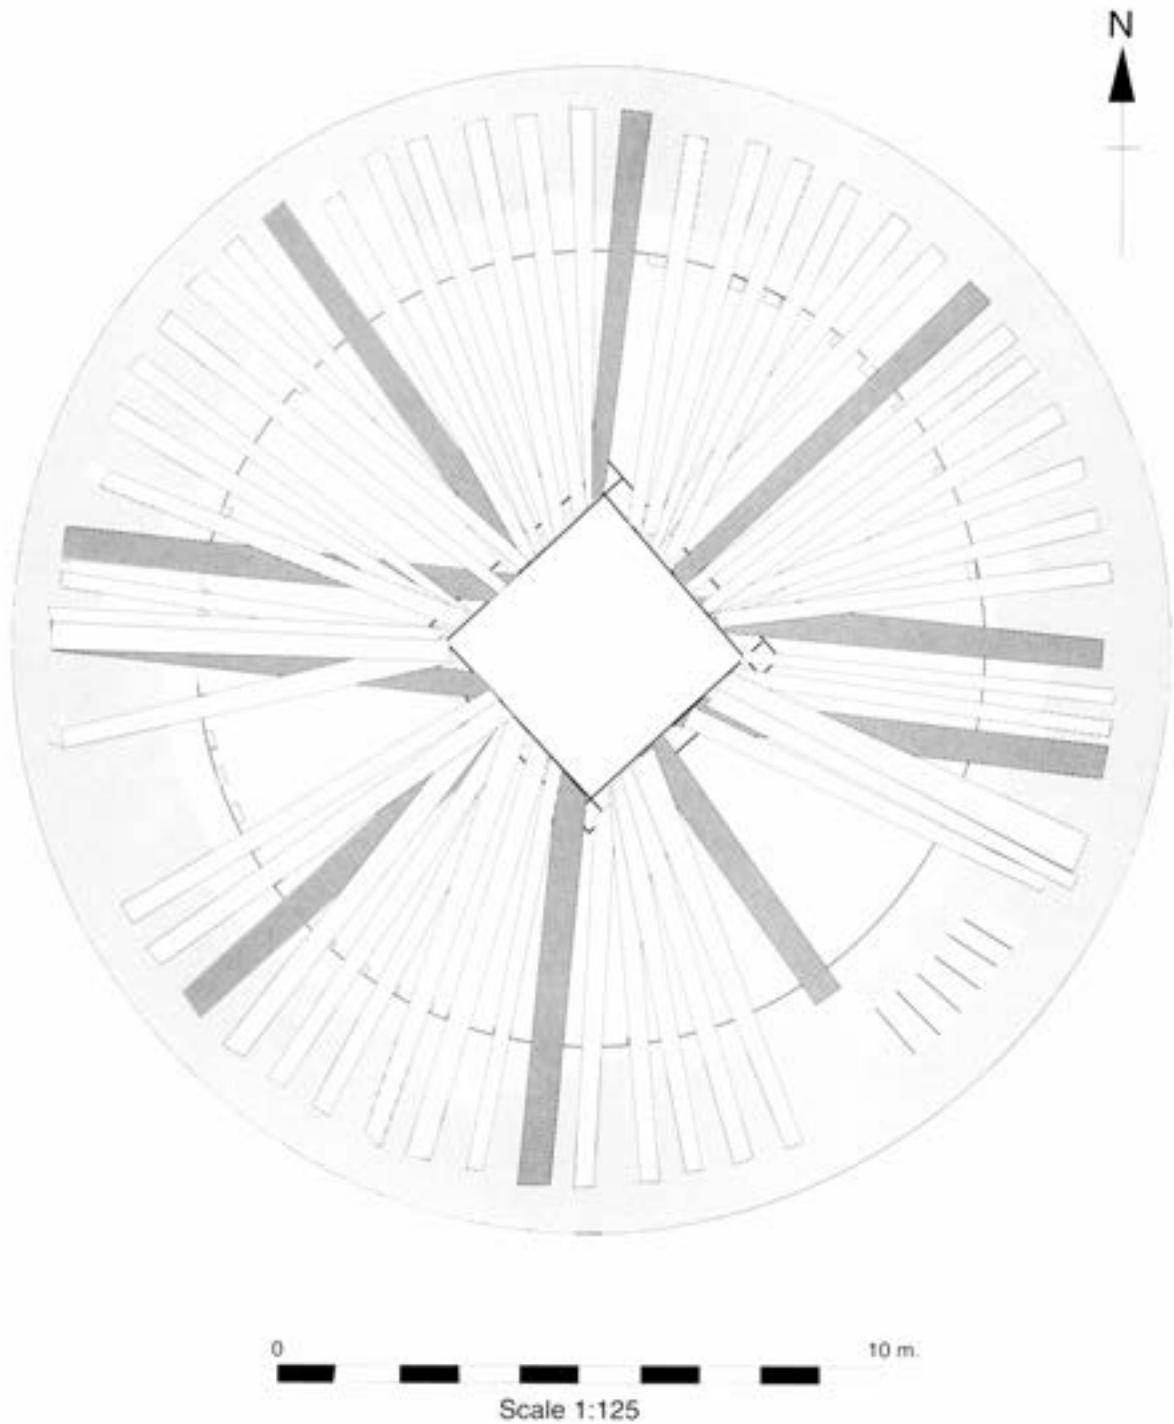
Figure 3.16: *The Keep*: reconstruction of cannon deck timbers

Four large pier bases of chamfered stone were found at the level of the later phase III Keep floor (see below), and it is possible that they were inserted to replace rotted timber. It seems probable that this frame would have incorporated a hatch at cannon deck level, so that it could be used for hoisting cannon onto the roof; no direct evidence of this hatch survives. The square frame is likely to be the specially made timber structure 'for the greatt towre' referred to in the documentary sources (Chapter 2, above).

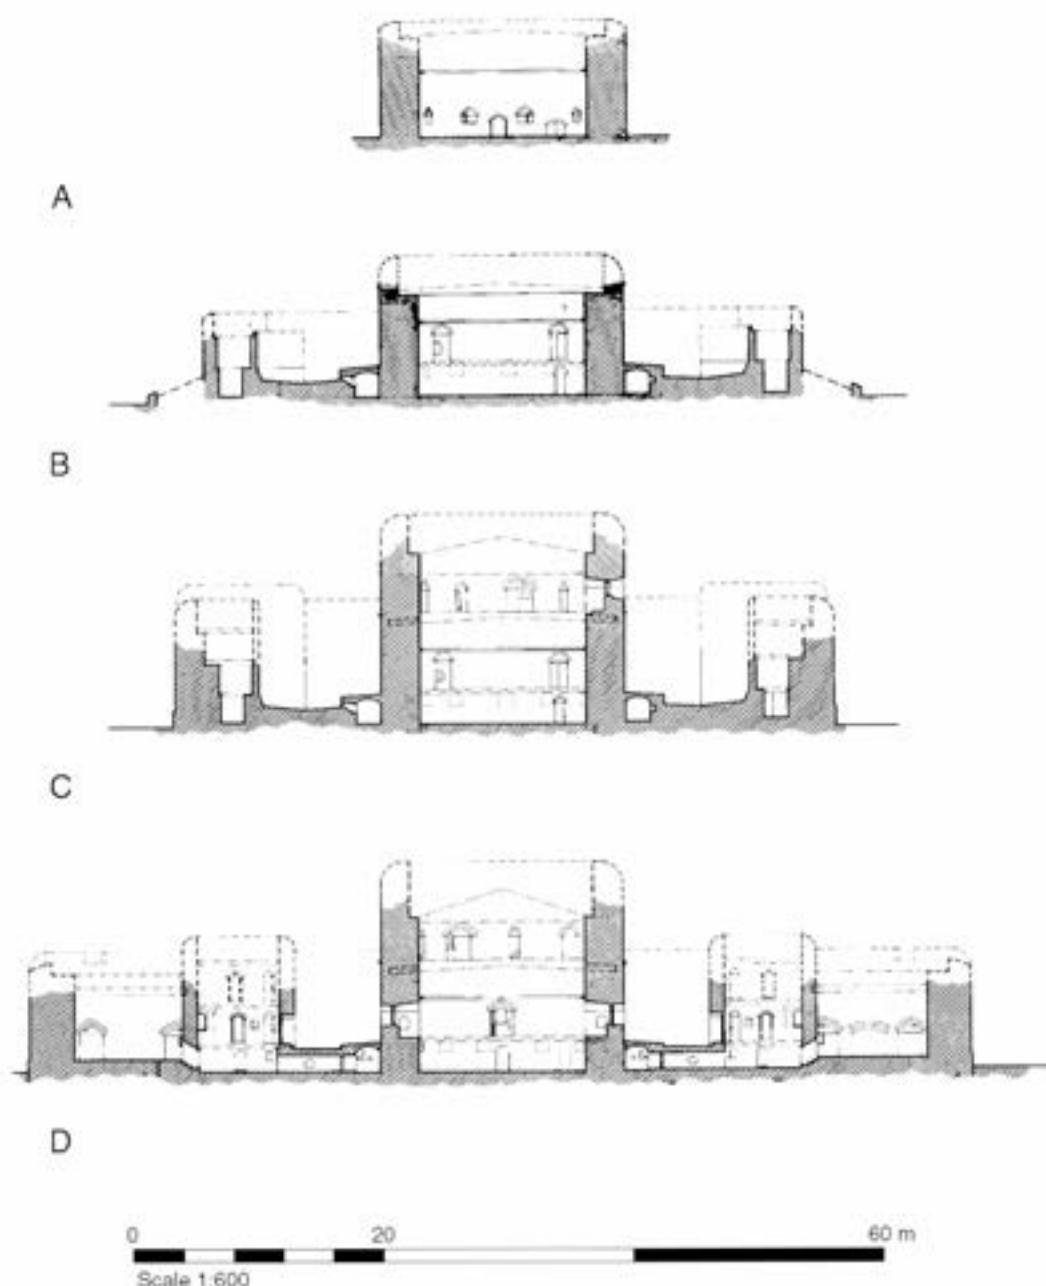
Figure 3.17: *The Keep: reconstructed cross-section views showing changing floor levels; A Phase I; B Phase IIb; C and D Phase III (see Fig. 3.2) (from History of the King's Works, Volume IV 1485-1660 (Part II) Fig 31: © Crown copyright material 1982. Reproduced with the permission of the Controller of Her Majesty's Stationery Office)*

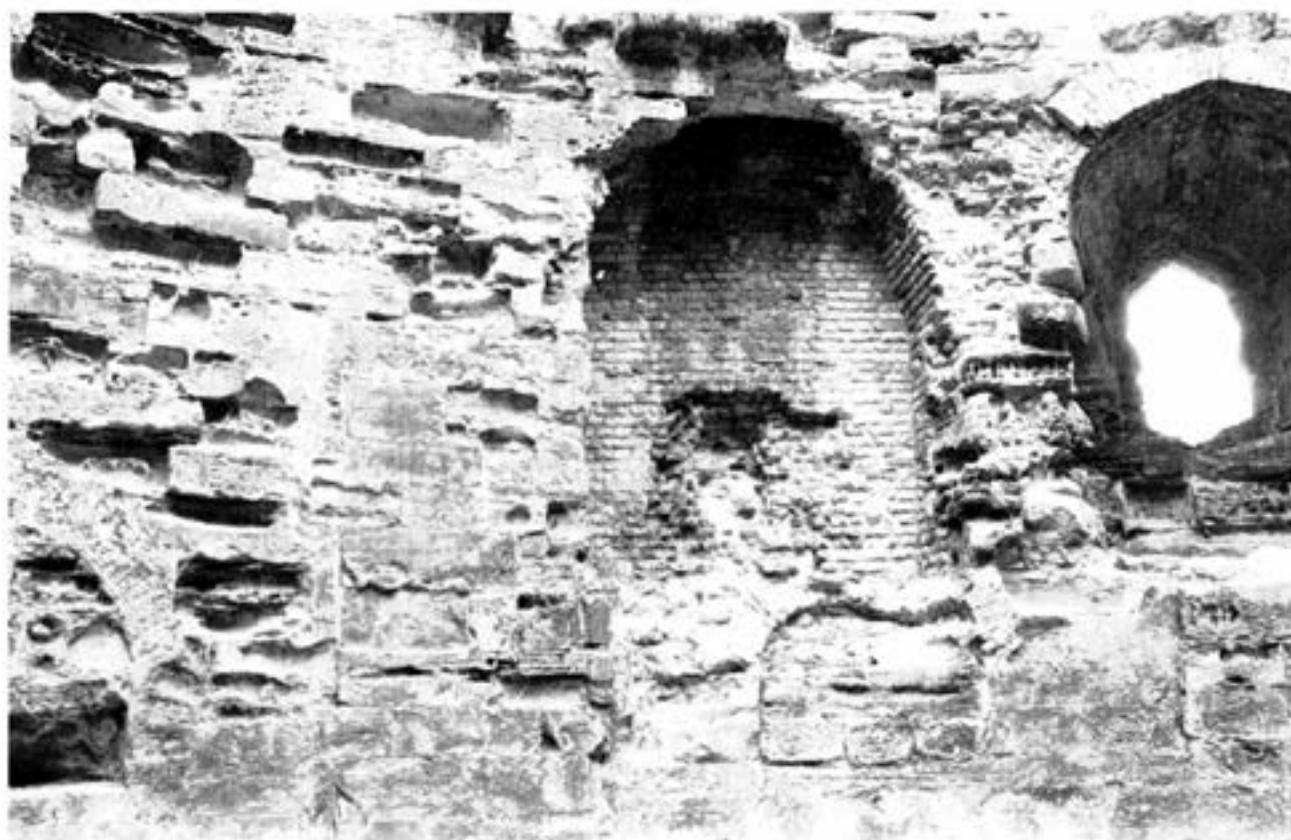
*Plate 3.13: The Keep; detail of south-west wall elevation. The replacement fireplace of phase IIb (2115) is visible in the centre of the shot, with the phase IIb west window (2116) immediately adjacent. Below fireplace 2115 is a blocked phase I gunport (2123), and the blocked phase I fireplace (2186) can be seen immediately below the window. The blocked phase Ib door (2185) can be seen on the left of the shot. 1998 (OAU)*

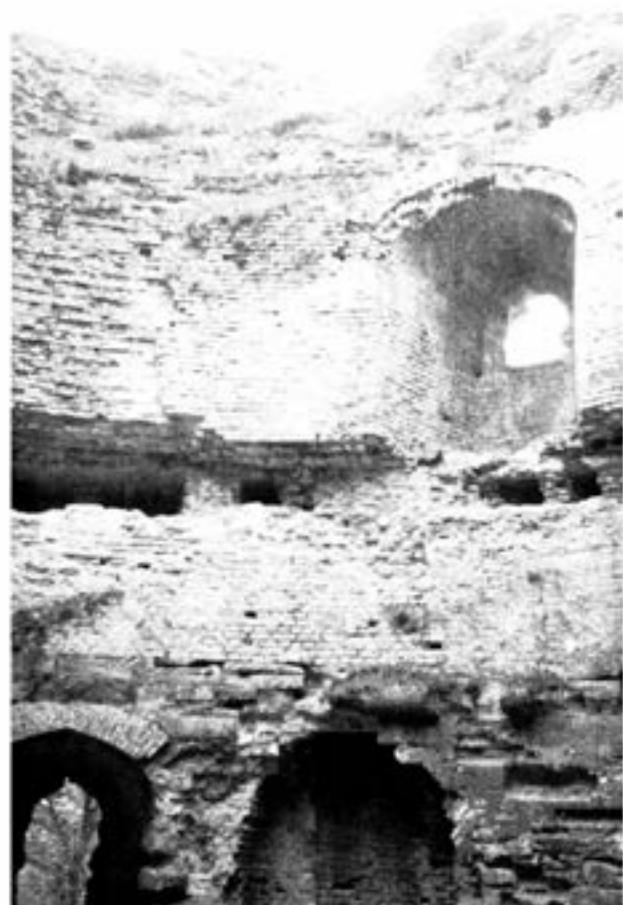
Plate 3.14: *The Keep; housing for the phase IIb cannon deck joists. 1963 (English Heritage/Biddle)*

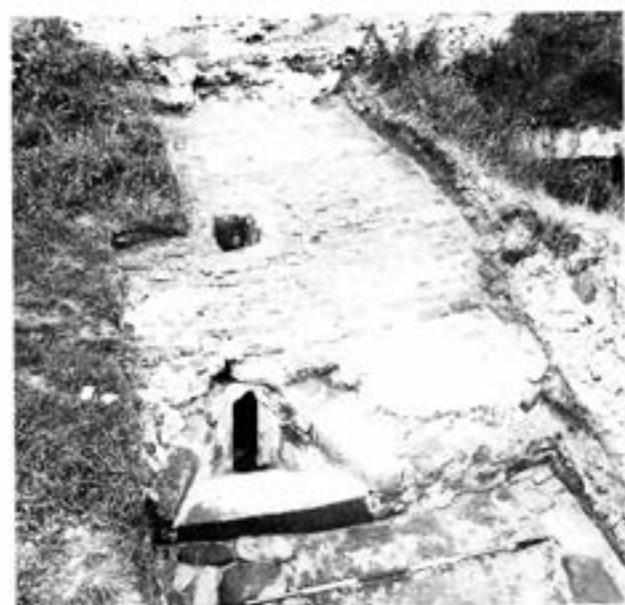
*Plate 3.16: The Vaulted Ring Passage; north-west section showing surviving vault from outside, with a gun loop and a smoke vent. 1963 (English Heritage)*

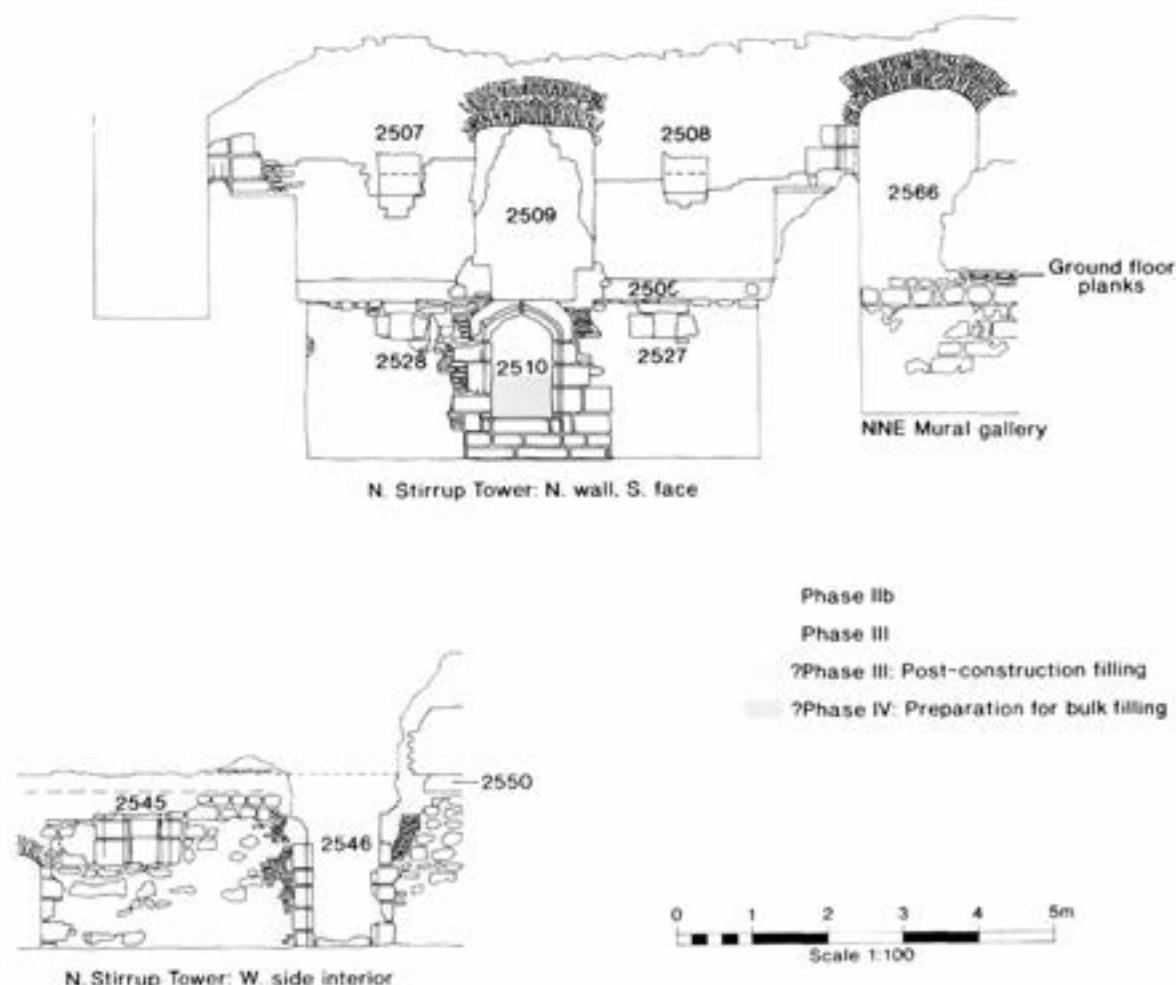
Figure 3.19: N Stirrup Tower elevations: chord wall south face; west side interior

Details of the internal and external elevations of the chord wall of the N Stirrup Tower are illustrated in Figures 3.19 and 3.20, but here, too, original openings have been masked by later insertions. Plate 3.17 shows the typical arrangement represented by the N Stirrup Tower. Here, the roof of the N Radial Passage can be seen at the bottom right of the picture, leading to the N Stirrup Tower. The curved rear wall of the Stirrup Tower can be seen immediately beyond the Radial Passage vault. In the foreground is a gunloop within the Stirrup Tower wall.

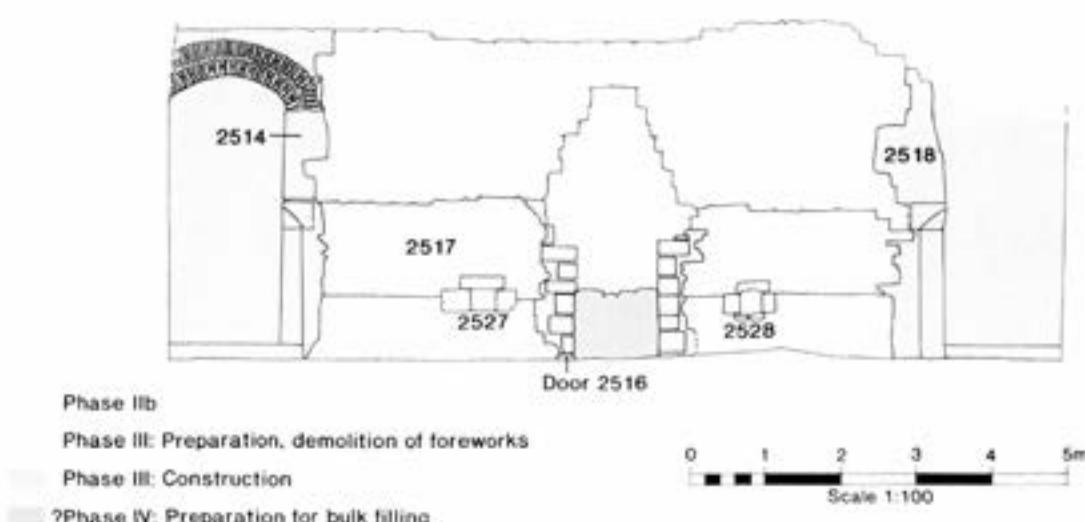
Figure 3.20: N Stirrup Tower chord wall north face

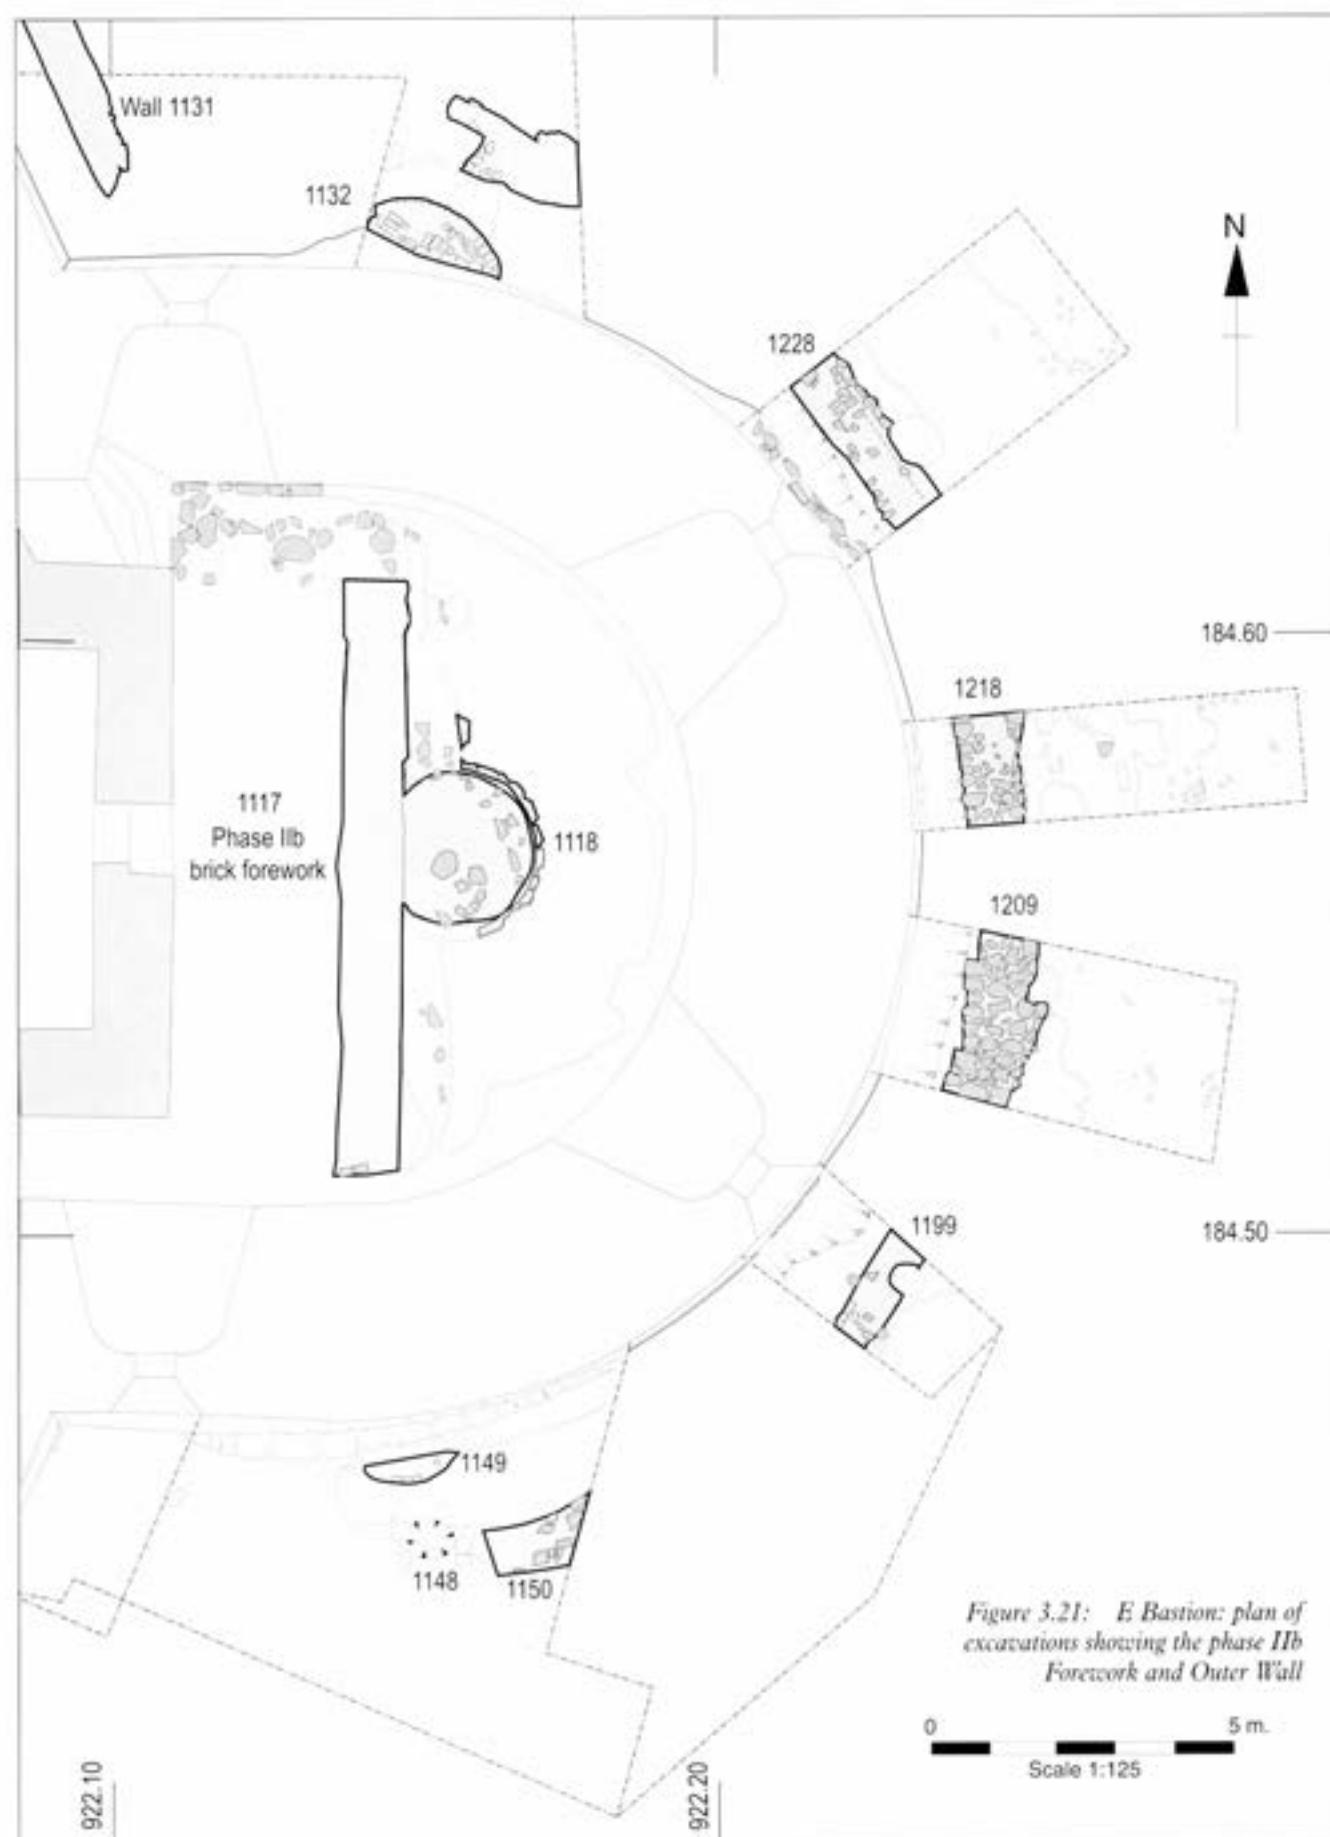
*Figure 3.21: E Bastion: plan of excavations showing the phase IIb Forework and Outer Wall*

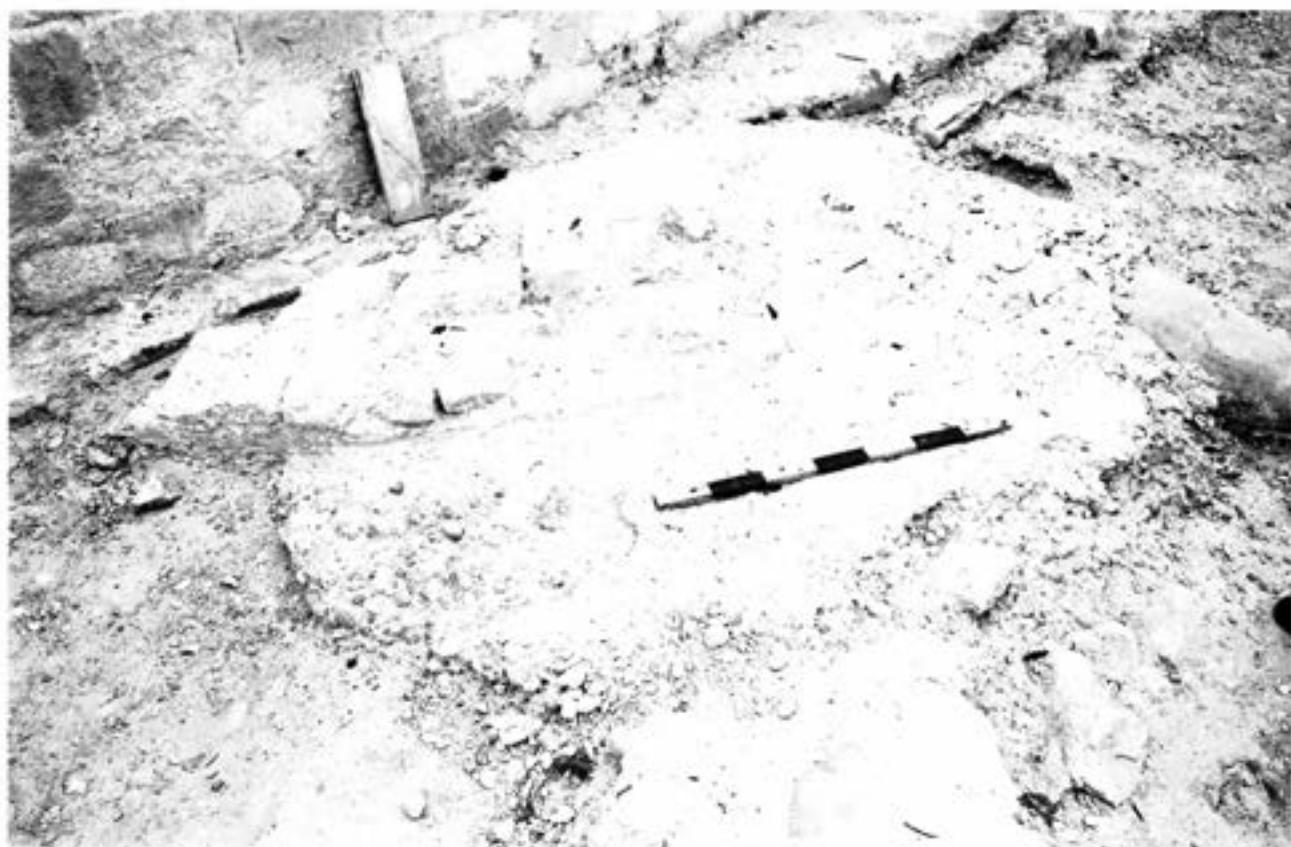
Plate 3.21: The E Bastion; detail of the phase IIb north-east Forework turret (1132). 1975 (English Heritage/Ames)

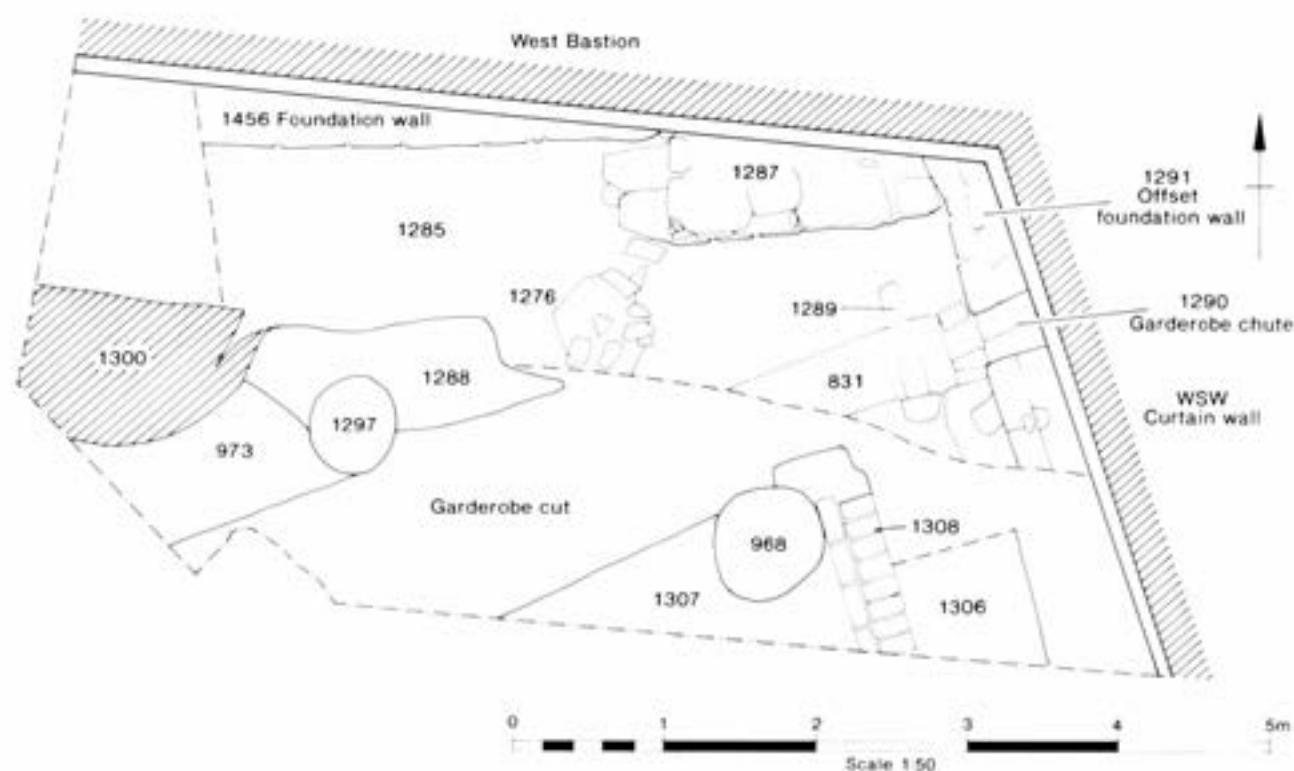
Figure 3.23: W Bastion external trench WBY: plan showing phase IIb Forework and Outer Wall

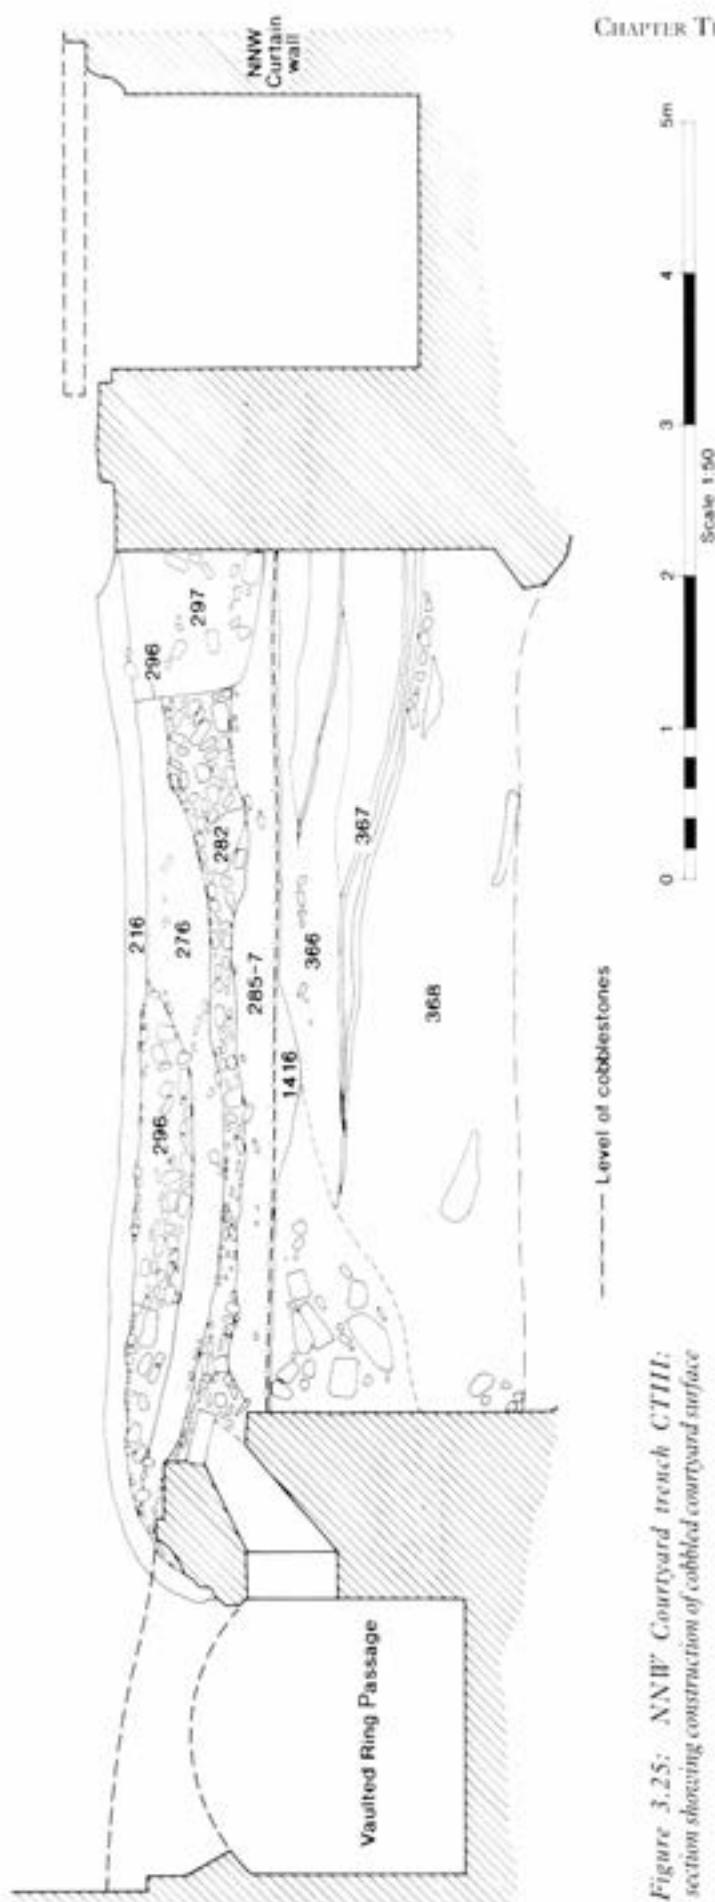
Figure 3.25: NNW Courtyard trench CTIII; section showing construction of cobbled courtyard surface

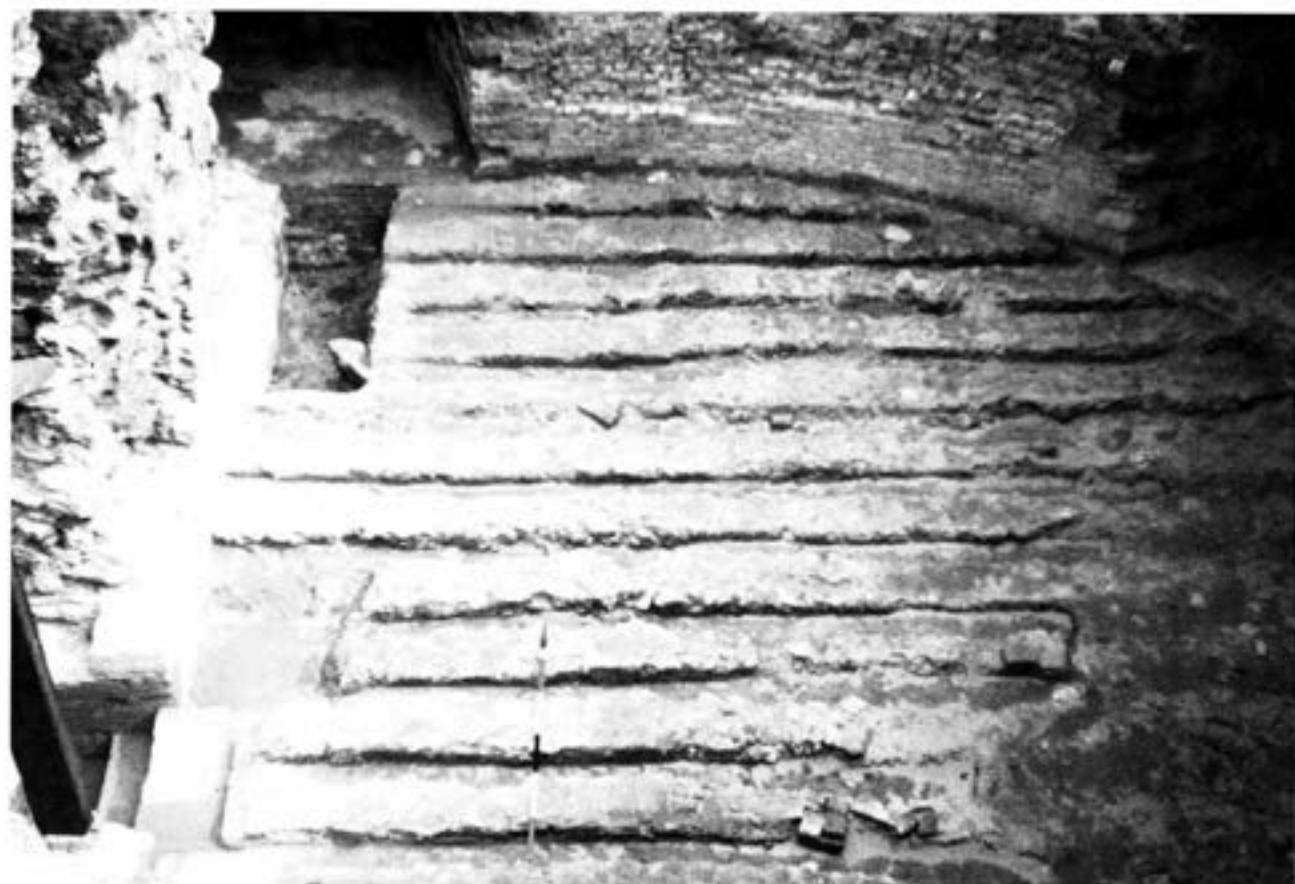
Plate 3.26: E Bastion interior, under excavation in 1973; the impressions of floor beams (602–3) are clear, in the background are the north and north-east casemates, with the area of blocking between, possibly the site of a temporary works access. (English Heritage/Ames)

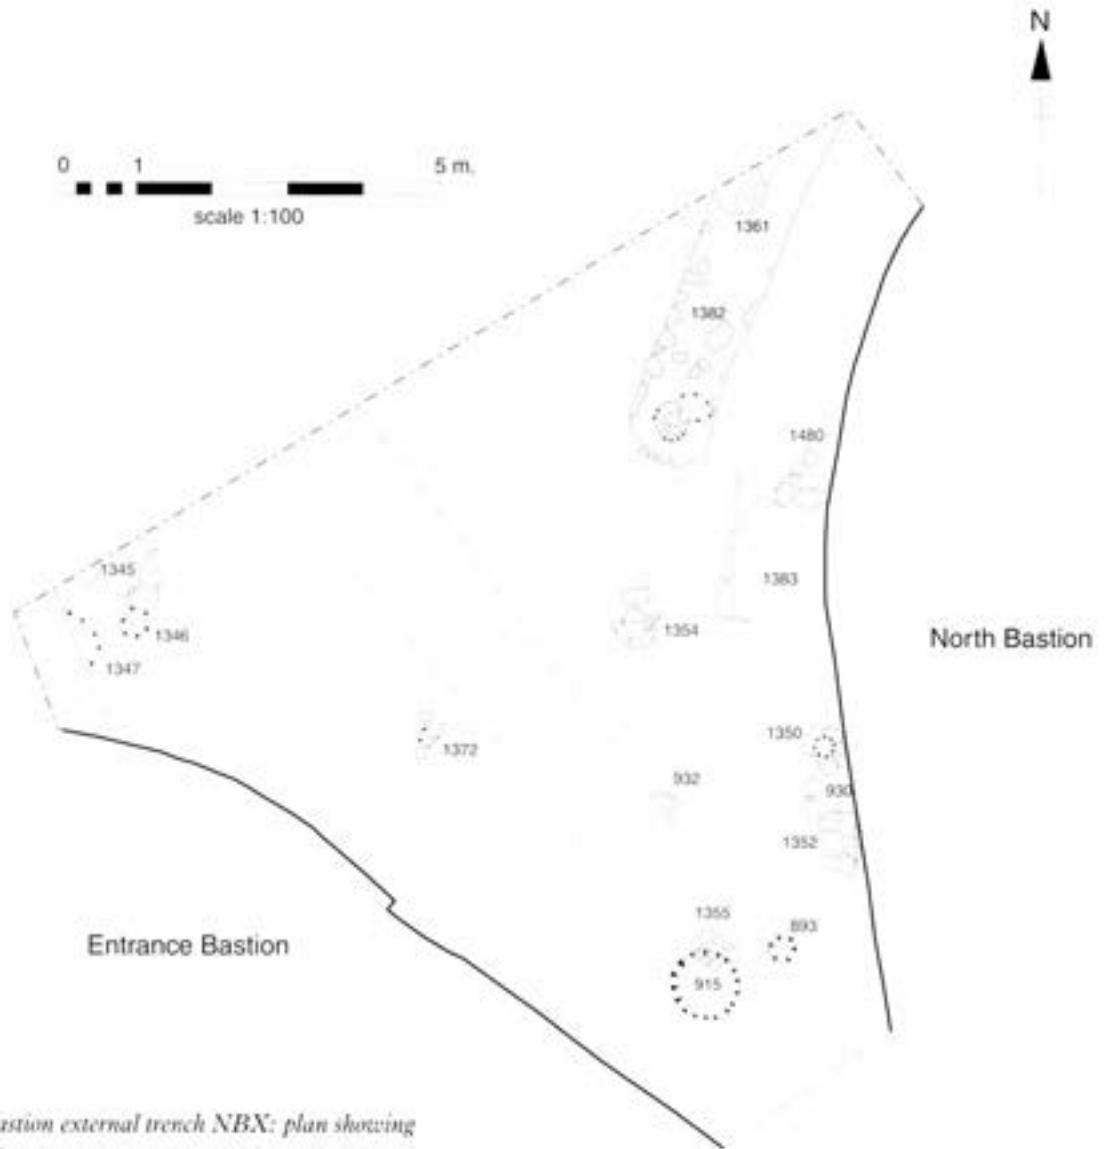
Figure 3.28: N Bastion external trench NBX: plan showing construction features

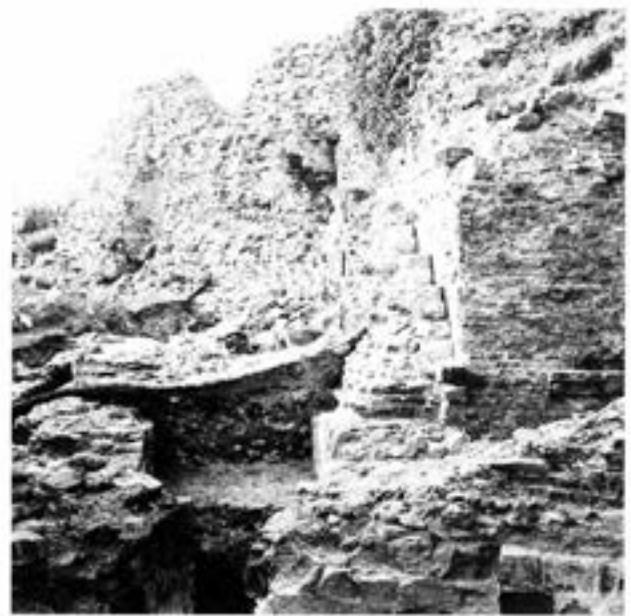
Plate 3.27: E Curtain Wall Gallery looking north; to the right of the picture can be seen the straight joint between the phase IIb and phase III Curtain Walls.

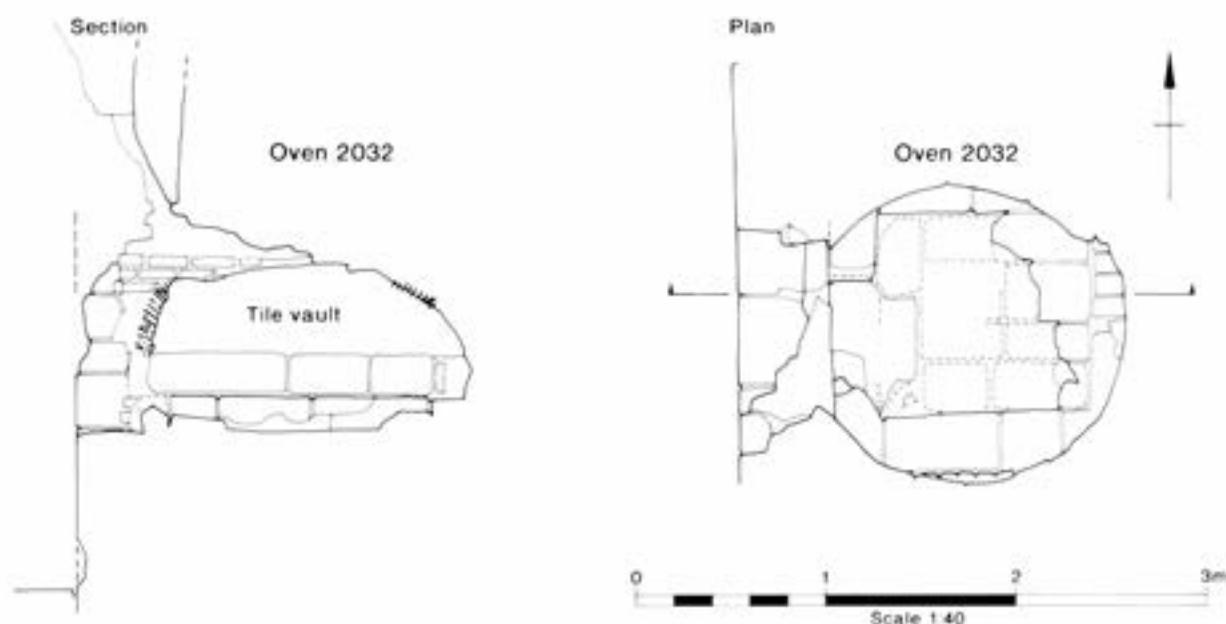
Figure 3.35: W Bastion: detail plan and elevation of oven 2302

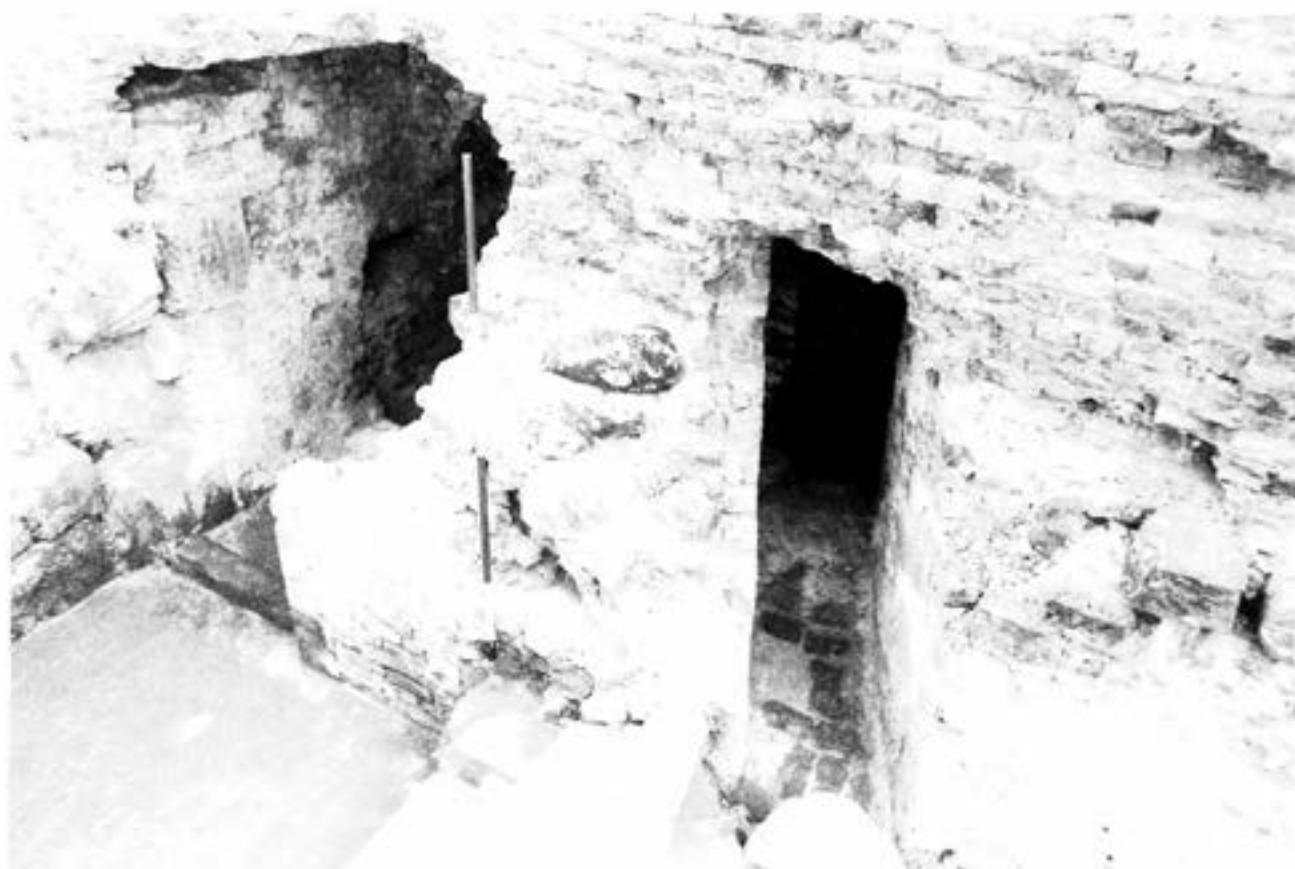
Plate 3.29: SW Curtain Wall Gallery GVI; entrances to multiple wardrobe (on the left of the photograph) and single wardrobes. 1982 (*English Heritage/Streeten*)
