# Henry VIII's Coastal Artillery Fort at Camber Castle, Rye, East Sussex

*An archaeological, structural and historical investigation*

Published by the  
Oxford Archaeological Unit  
for English Heritage  
2001

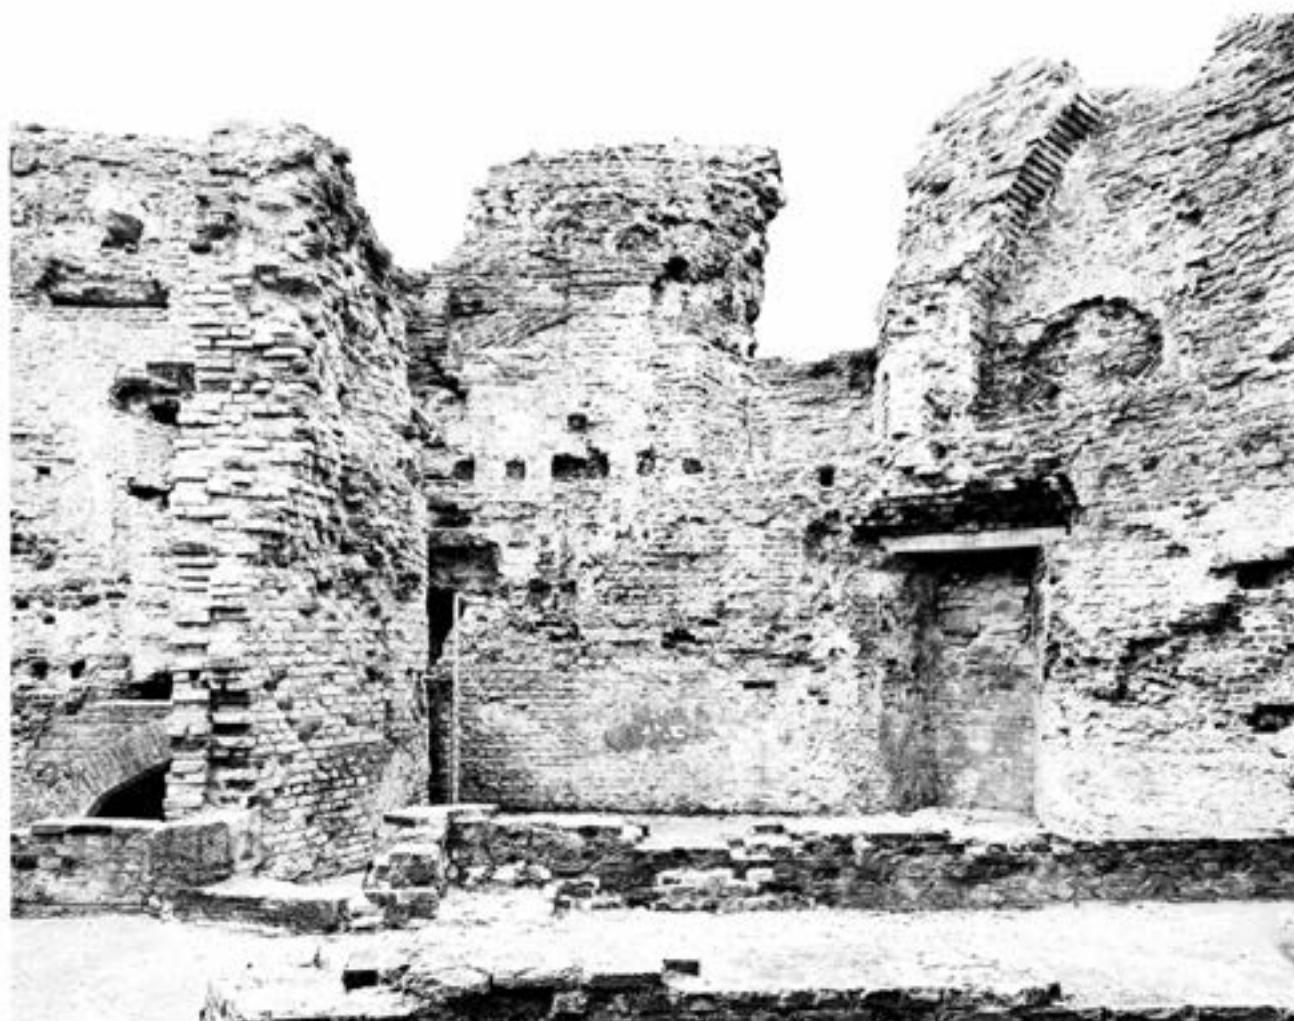
*Plate 3.33: Entrance Bastion north-west interior elevation; towards the right of the photograph, at ground floor level, is gunport 2481. Above the gunport are the remains of the brick-arched fireplace 2482, with window 2475 immediately adjacent. The cross-wall dividing the D-shaped bastion from the Gatehouse can be seen towards the left of the photograph; immediately to the right of this wall on the photograph are the remains of joistholes for the floor timbers. 1998 (English Heritage)*

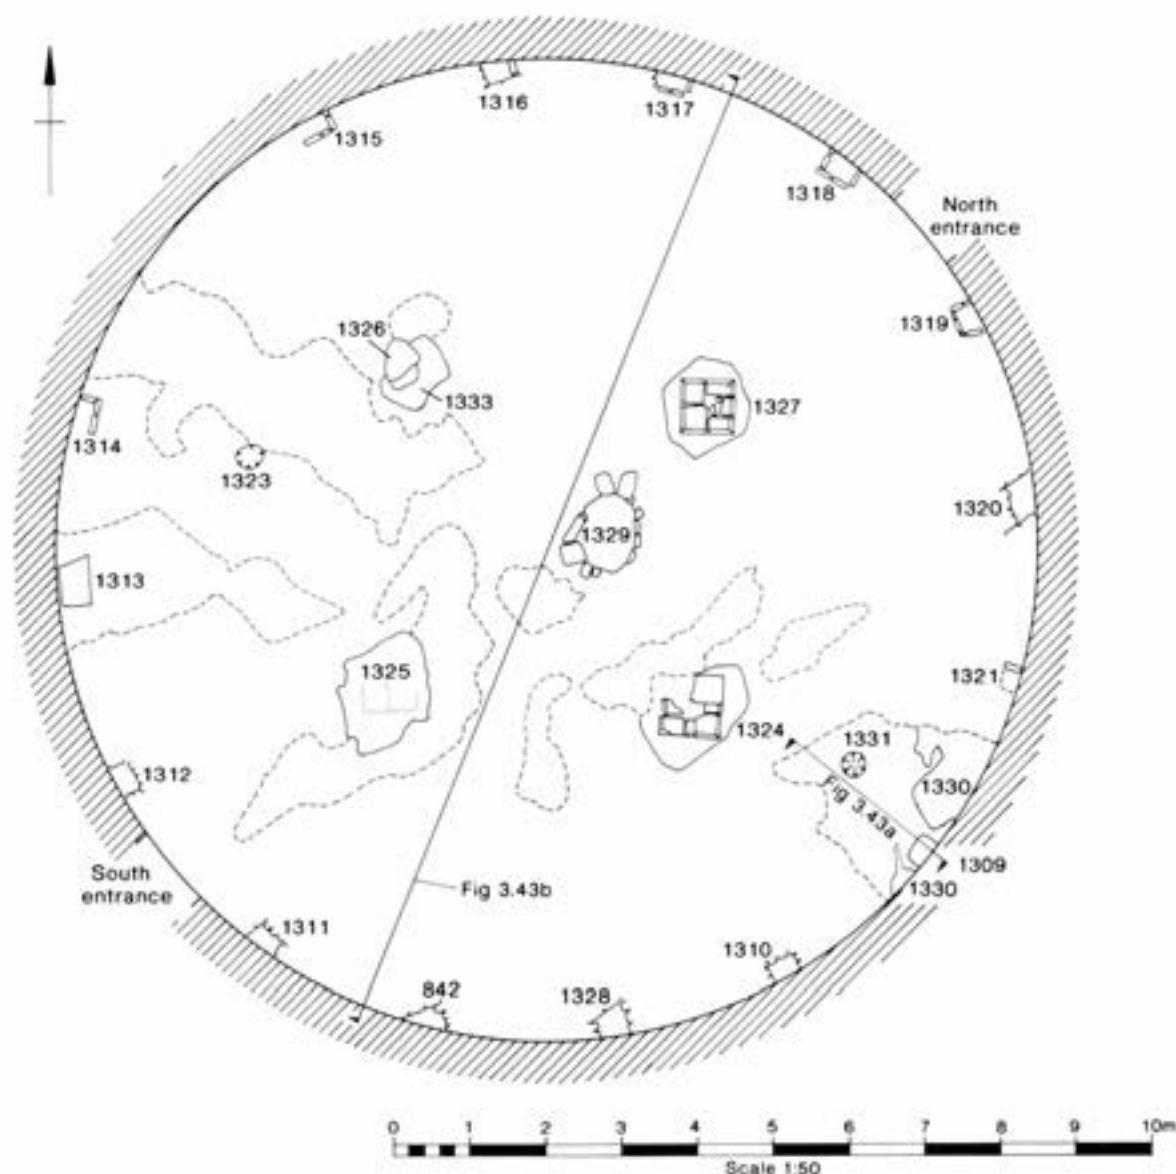
Figure 3.42: *The Keep: phase III basement floor showing timber positions, four-post structure and well*

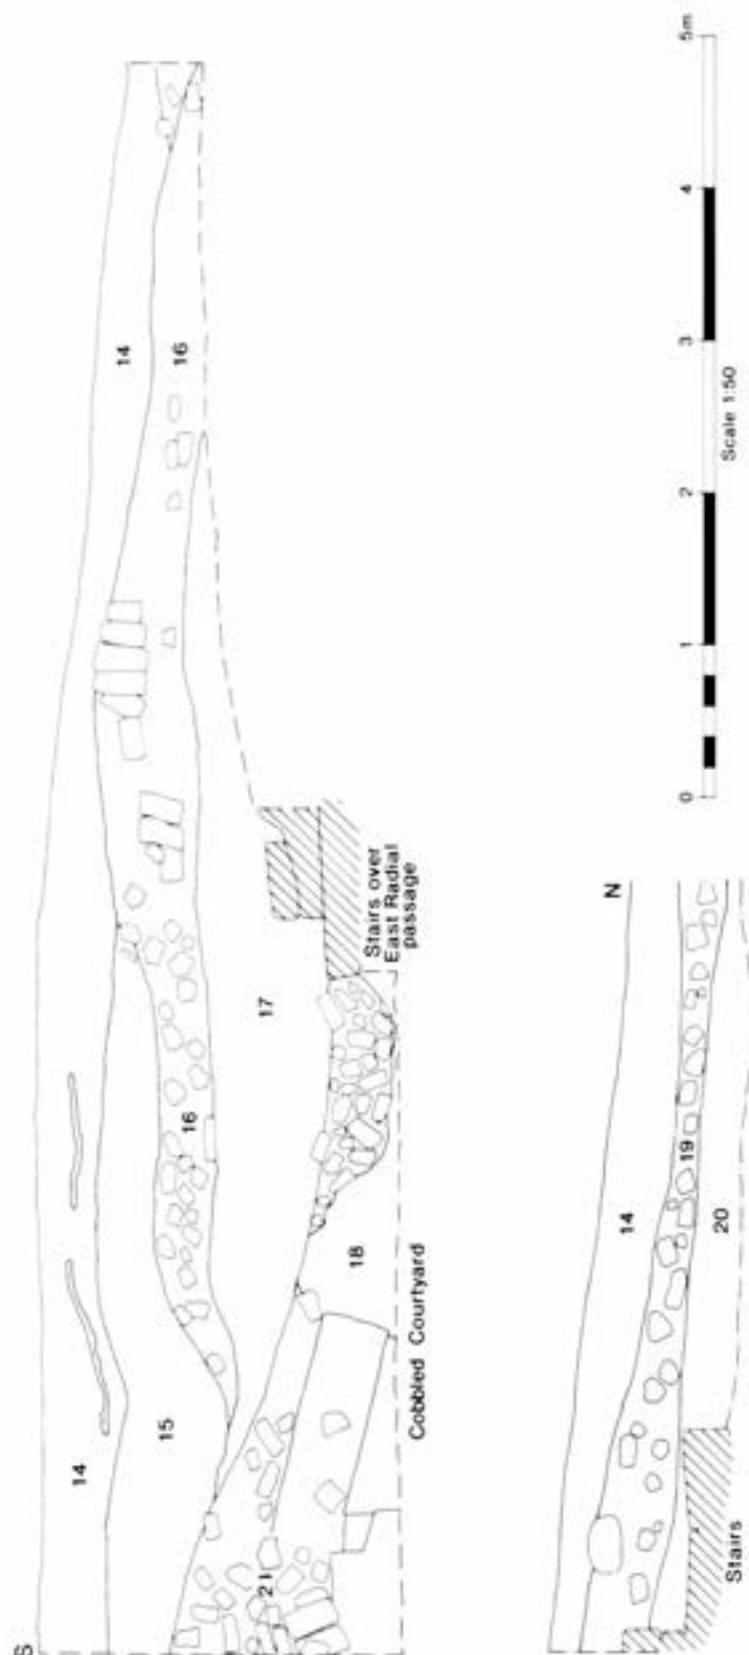
Figure 3.47: SE Courtyard trench CT1: section

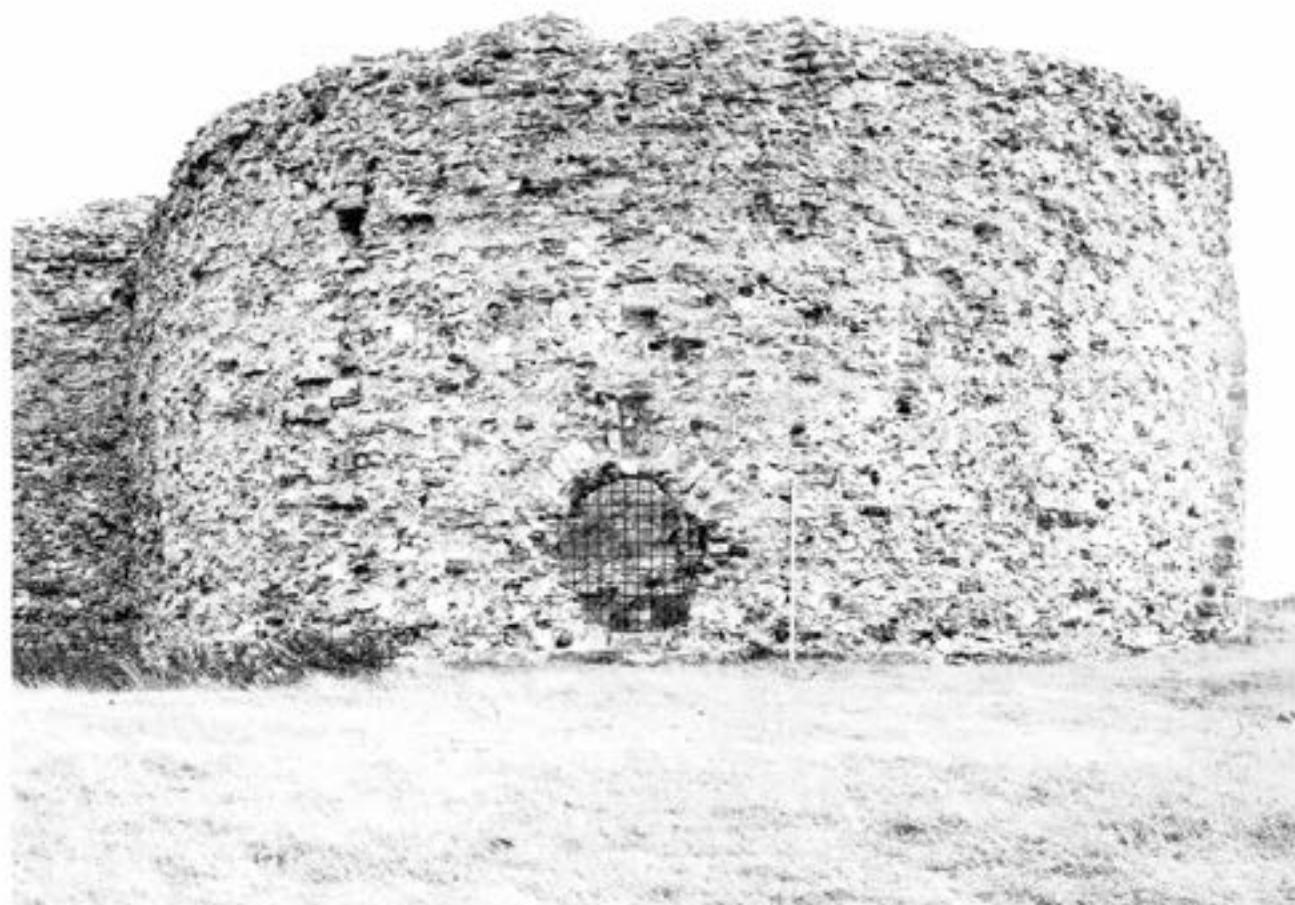
*Plate 3.40: W Bastion exterior, looking south-east; showing the enlargement of the NW-facing gunport, perhaps used as a doorway for the removal of salvage material. 1998 (English Heritage)*

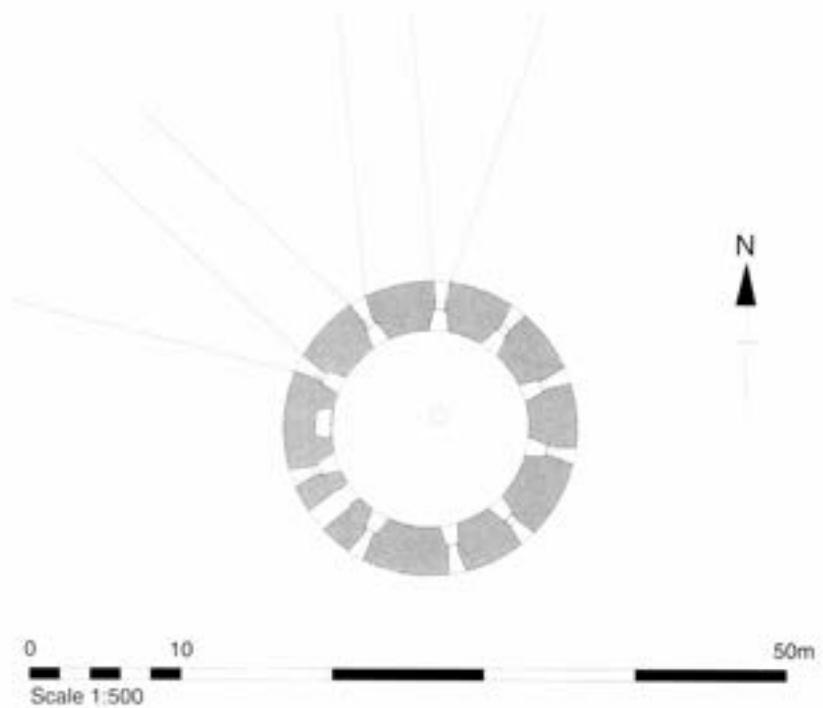
Figure 9.2: The Phase I Tower, fields of fire

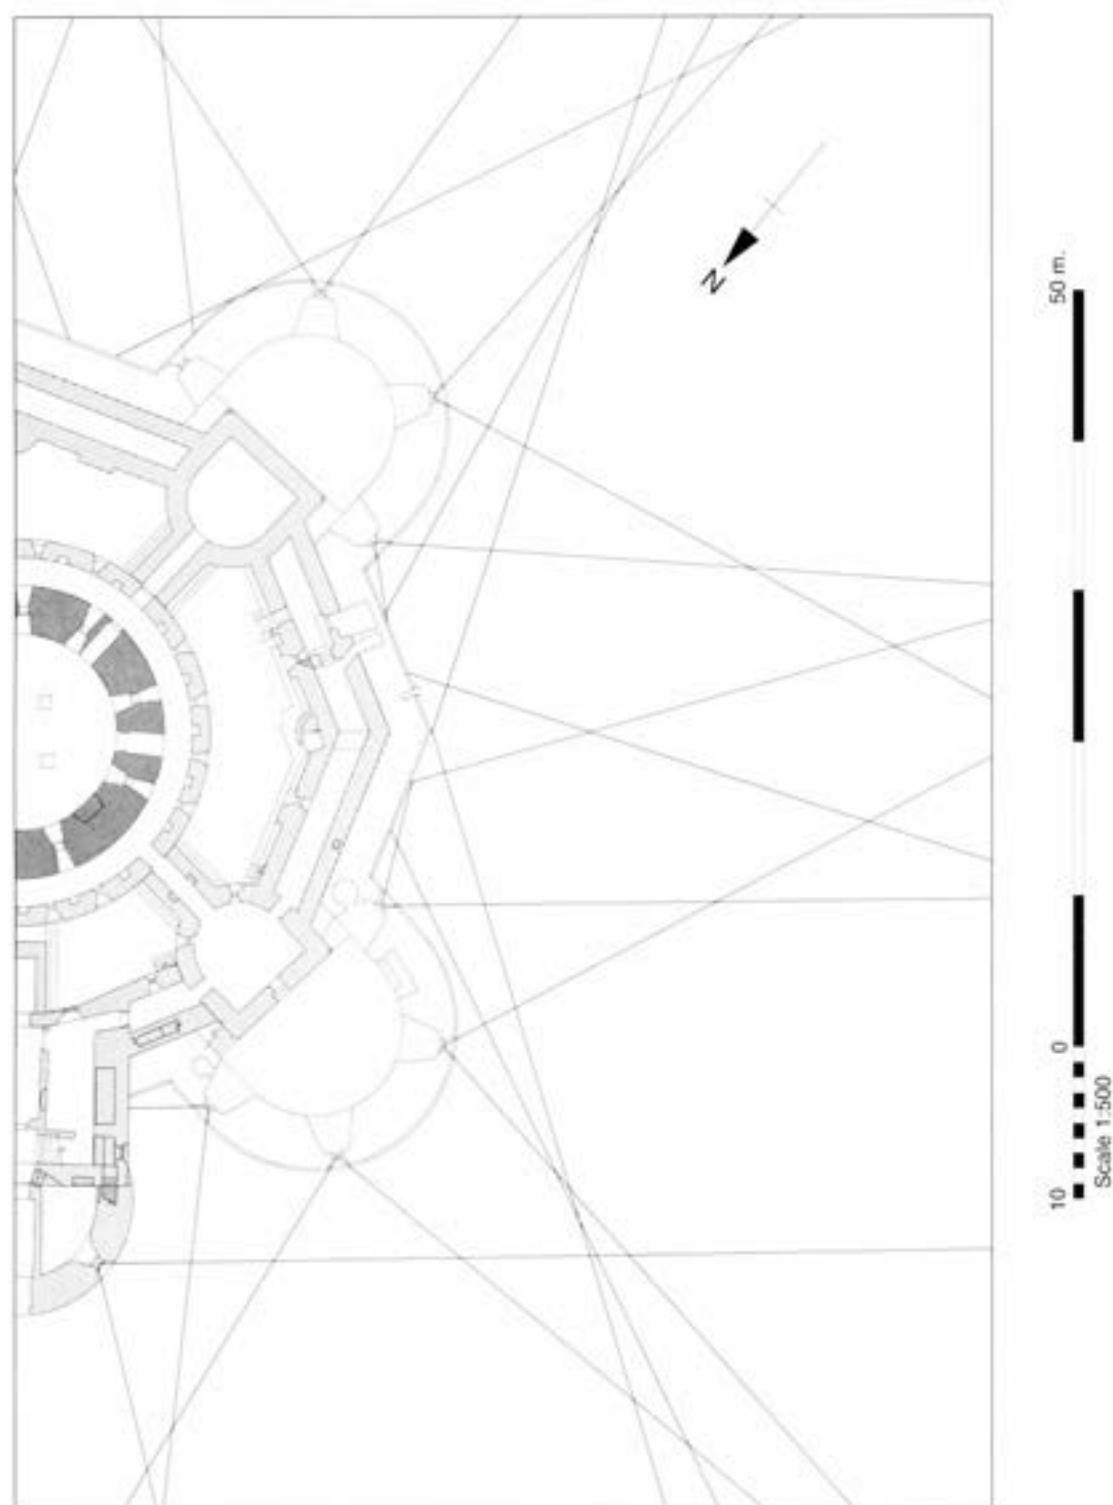
Figure 9.4: The Phase III castle, fields of flanking fire
