ST HELEN'S CHURCH SKIPWITH NORTH YORKSHIRE

Report on an
Archaeological
Excavation

by R.A. Hall, T. Kendall & C. Briden

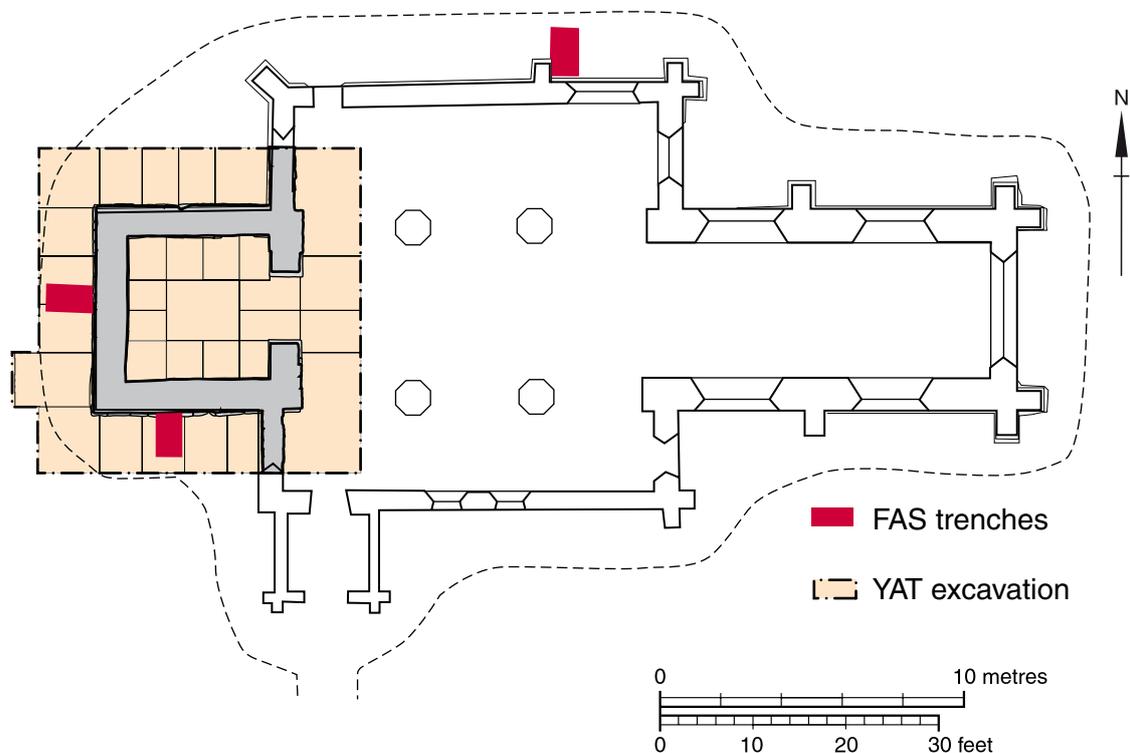
Fig. 3: Plan of the church showing excavation trenches

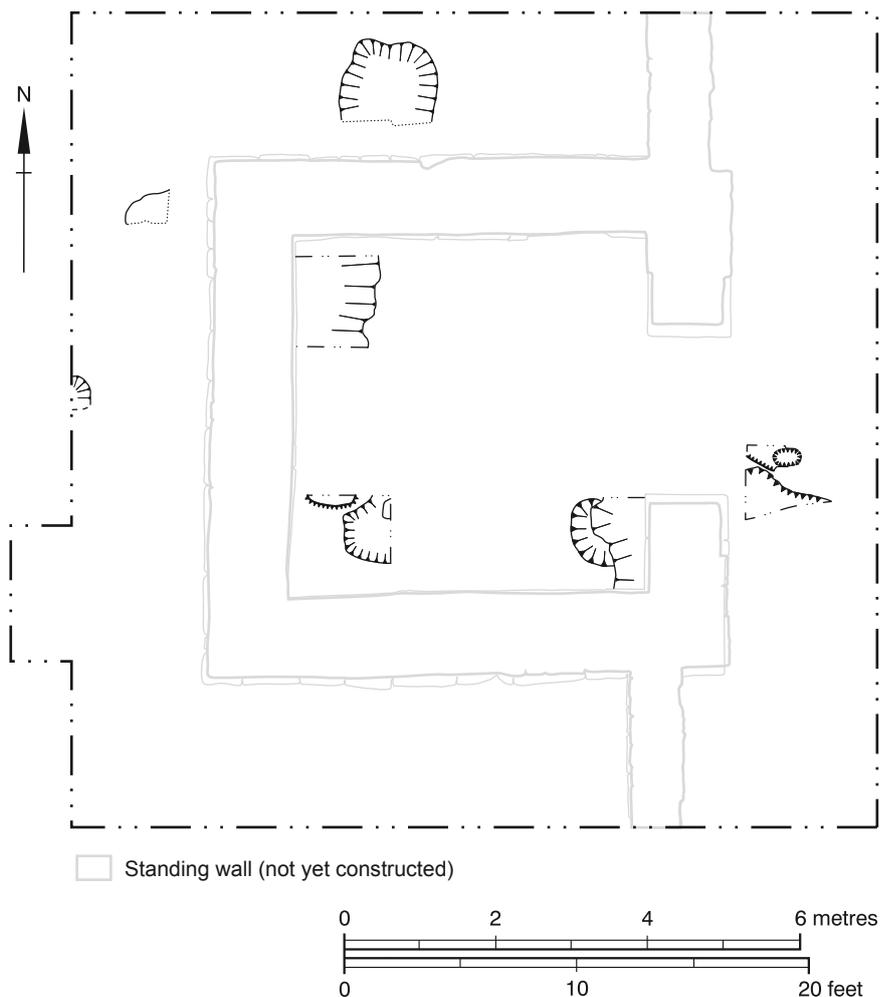
Fig. 4: Earliest features

The earliest archaeological features to be recognised either pre-date the earliest structural traces on the site, or were linked with their construction. Outside the present church such features were faint and impossible to define with much confidence, but internally they were more clearly discernible. There, however, restrictions on the depth and extent of excavation precluded an examination of all contemporary levels, and the picture is correspondingly incomplete (Fig. 4).

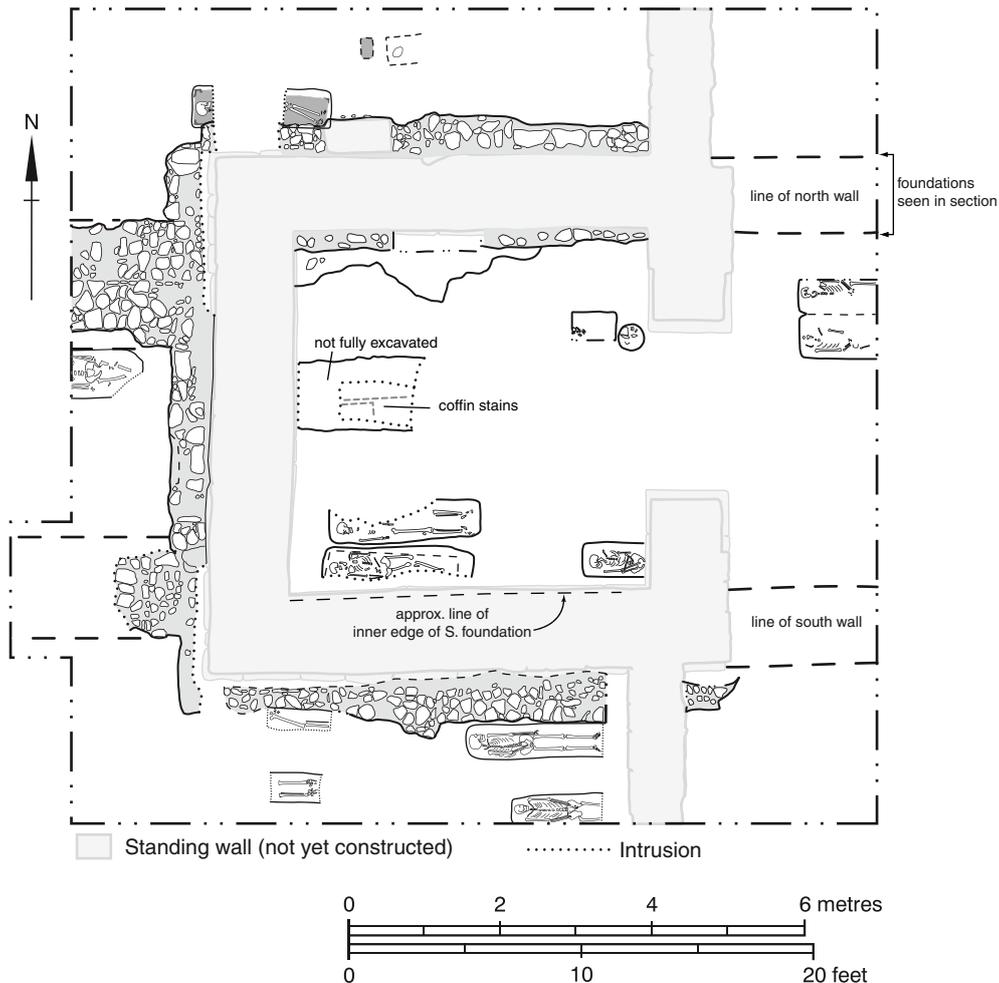
Fig. 5: Foundations of pre-tower church and associated burials

The foundations (Fig. 5) protrude externally below parts of the north, south and west foundation for the standing tower. The inner face of the north foundation projects slightly from the inner face of the tower's north wall, whereas the inner face of the south foundation is set some 0.10m

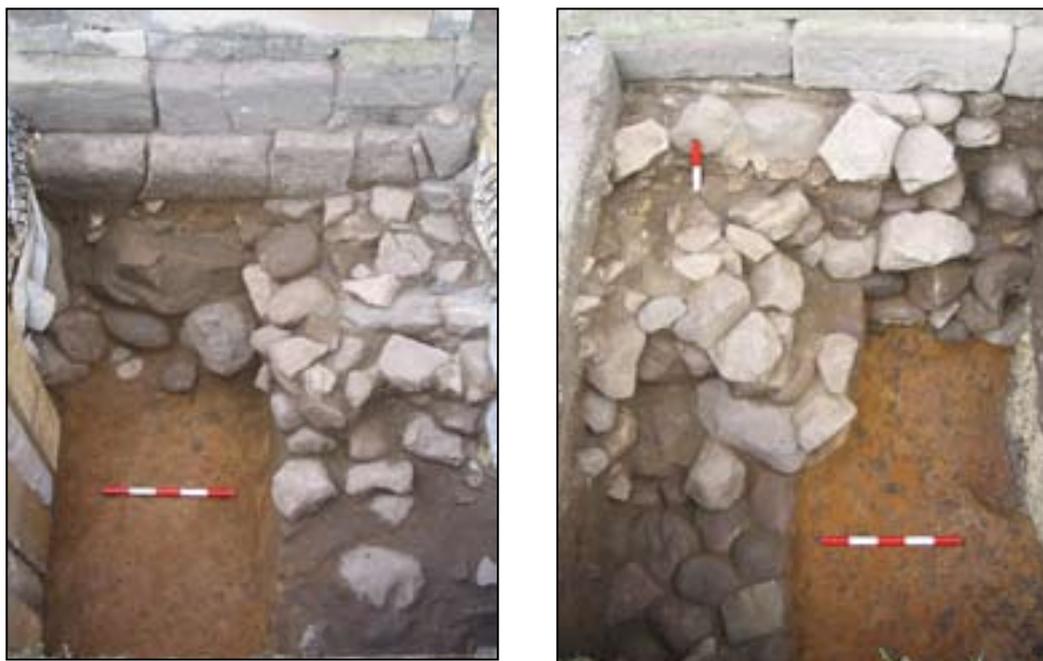
Fig. 6a, 6b: Northernmost of the two foundations projecting westwards below the tower's west wall, seen in two adjacent trenches, looking east. Scale unit 100mm

Running west from the early west wall foundation were two parallel foundations of similar form and character to those for the north, south and west walls, and apparently of integral construction with them (Figs 5, 6a and 6b). Their western ends, and the return that presumably linked them, lay beyond the limits of the excavation; a length of only 1.3m survived within the excavated area. They represent a further cell of the structure, measuring c.5.6m externally from extreme north to south; if the superimposed walls had stood upon the inner edges of these foundations, the area

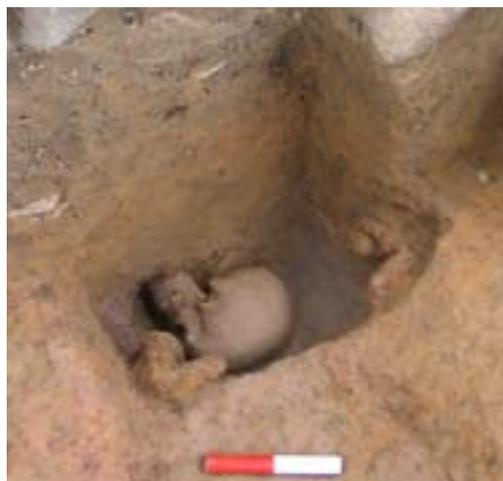
Fig. 7: Earlier burial to the north of the tower, with metal coffin fittings of Anglian date. Scale unit: 100 mm

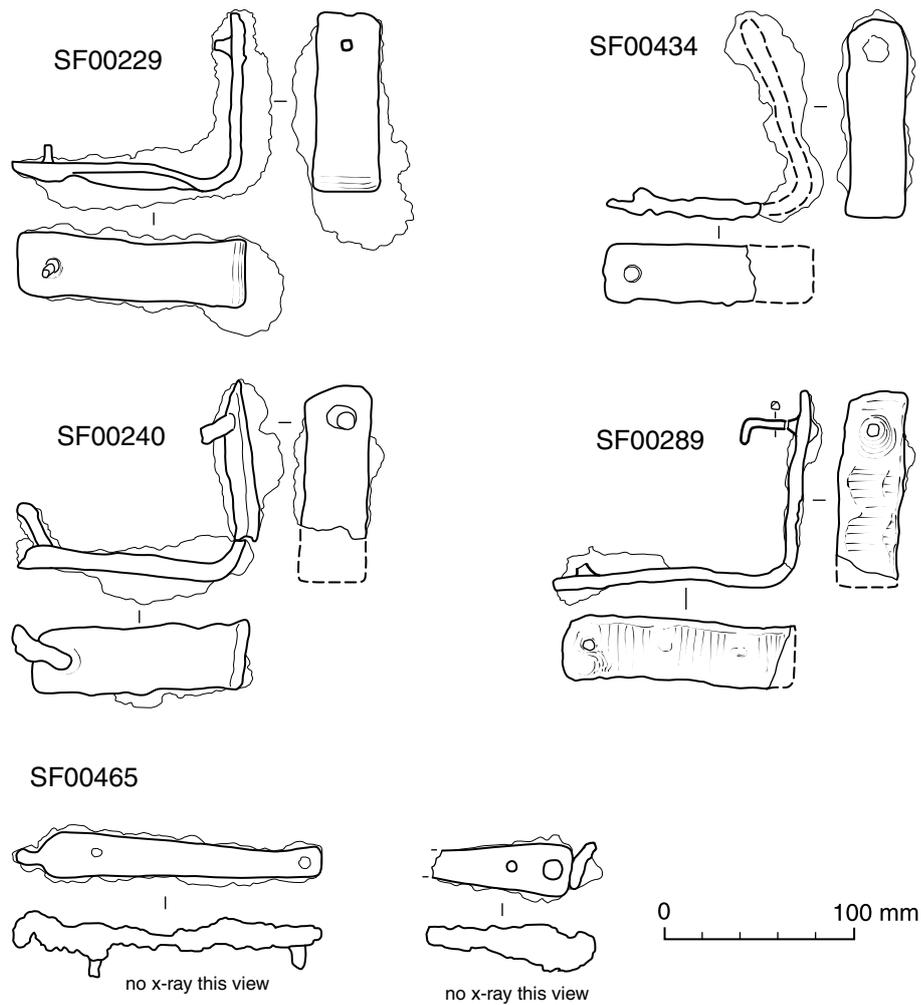
Fig. 8: Iron corner brackets and hinge straps (drawn from x-rays).

Also possibly from chests are four corner brackets, all associated with the burial at the tower's north-west corner which was truncated by the foundation for the medieval north aisle (Fig. 8). In addition, a looped staple fragment was found externally where the north wall of the tower abuts the aisle; this deposit may have been as early as the 10th century but had been disturbed by the medieval aisle and by a modern flue. One function of looped staples was to attach hasps to chest lids, so it is possible that it had originated in another disturbed chest burial.

Dr P.J. Ottaway writes: The type of chest from which these fittings would probably have come was an oblong box with a flat lid, the corners strengthened by brackets, and the lid attached to the box by two pairs of hinge straps. The chest would probably have been jointed together with wooden dowels or pegs (Watson in Ottaway 1996, 113). The earliest examples of chests used for burials are probably Romano-British (Ottaway 1996, 112), but the 8th – 10th century appears to be the period of the greatest popularity for this particular custom (Ottaway forthcoming a). Within this period, the majority of chest burials appear to come from the northern half of England; sites which have produced them include several in North Yorkshire including Ailcy Hill, Ripon (Ottaway 1996), Ainderby Steeple near Northallerton, and Spofforth (Ottaway pers.comm.). Other sites are Thwing, East Riding of Yorkshire (Ottaway forthcoming a), Dacre, Cumbria (Ottaway forthcoming b), and Norton, Teesside. The chest burials from all these sites were dated 8th – mid-9th centuries. Later examples are also known, however, for example from York Minster (9th – 10th century; Kyølbye-Biddle 1995). Chest burials were never common in mid-late Anglo-Saxon cemeteries, and in many they are unknown. It has been noted that where the custom does occur, it often appears to be concentrated in certain locations within the cemetery (Ottaway forthcoming a), and it may have been reserved for people of distinct status, probably of high social rank (Ottaway 1996, 113). It seems probable that both these Skipwith chest burials date from the same period as the other chest burials from North Yorkshire, that is c. AD 700 – 850, and thus they are probably contemporary with the earliest dated burial at Skipwith, with its radiocarbon determination of AD 680-880.

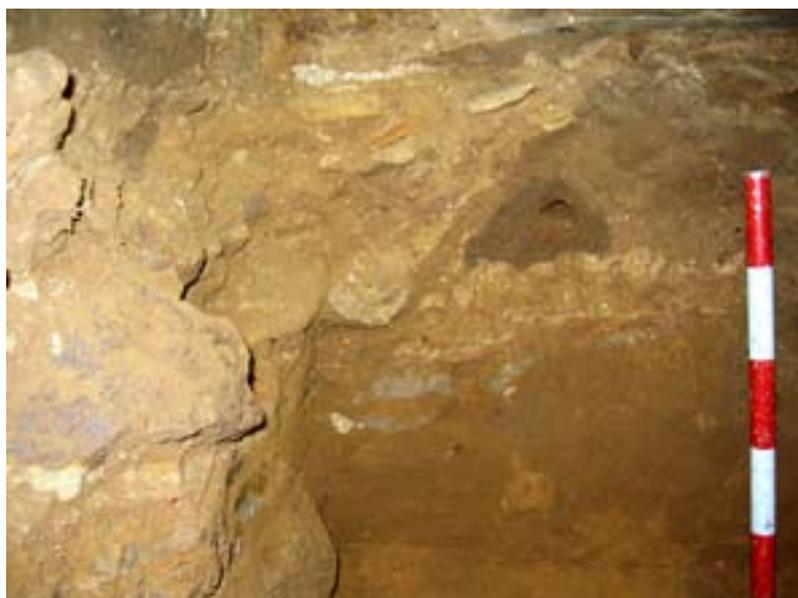
Fig. 9: Section through foundations of standing building, clearly showing the construction trench for the standing tower cut diagonally through the build-up after the earlier building and mortar surface.

Cut into the thick mixed deposit described above were the foundation trenches for the north, south and east walls of the standing tower (Fig. 9); no traces of a foundation trench (as opposed to the foundations themselves) survived along either side of the west wall (see below), or on the outside of the north and south walls. On the north, west and south sides the bases of these foundations impinged upon the foundations of the pre-tower church.

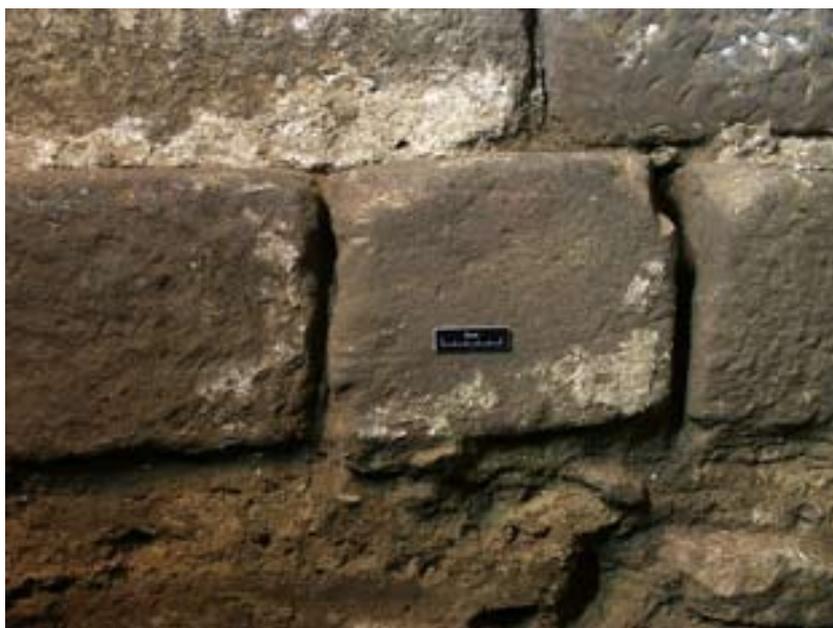
Fig. 10: Plaster/ render on internal face of re-used gritstone blocks in the foundation for the tower's west wall.

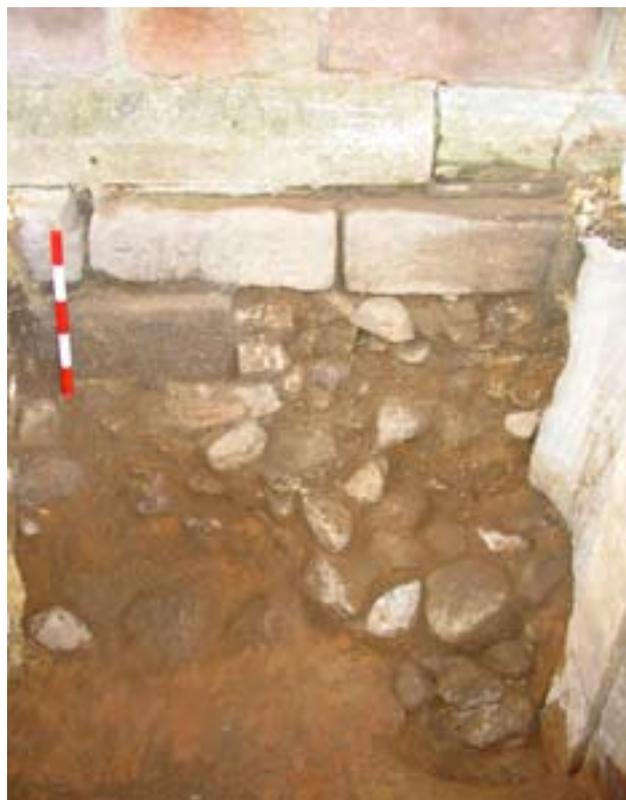
Fig. 11: The junction between gritstone block and rubble foundations for the standing tower, over the earlier cobble foundations, below the south wall of the tower. Scale unit 100 mm.

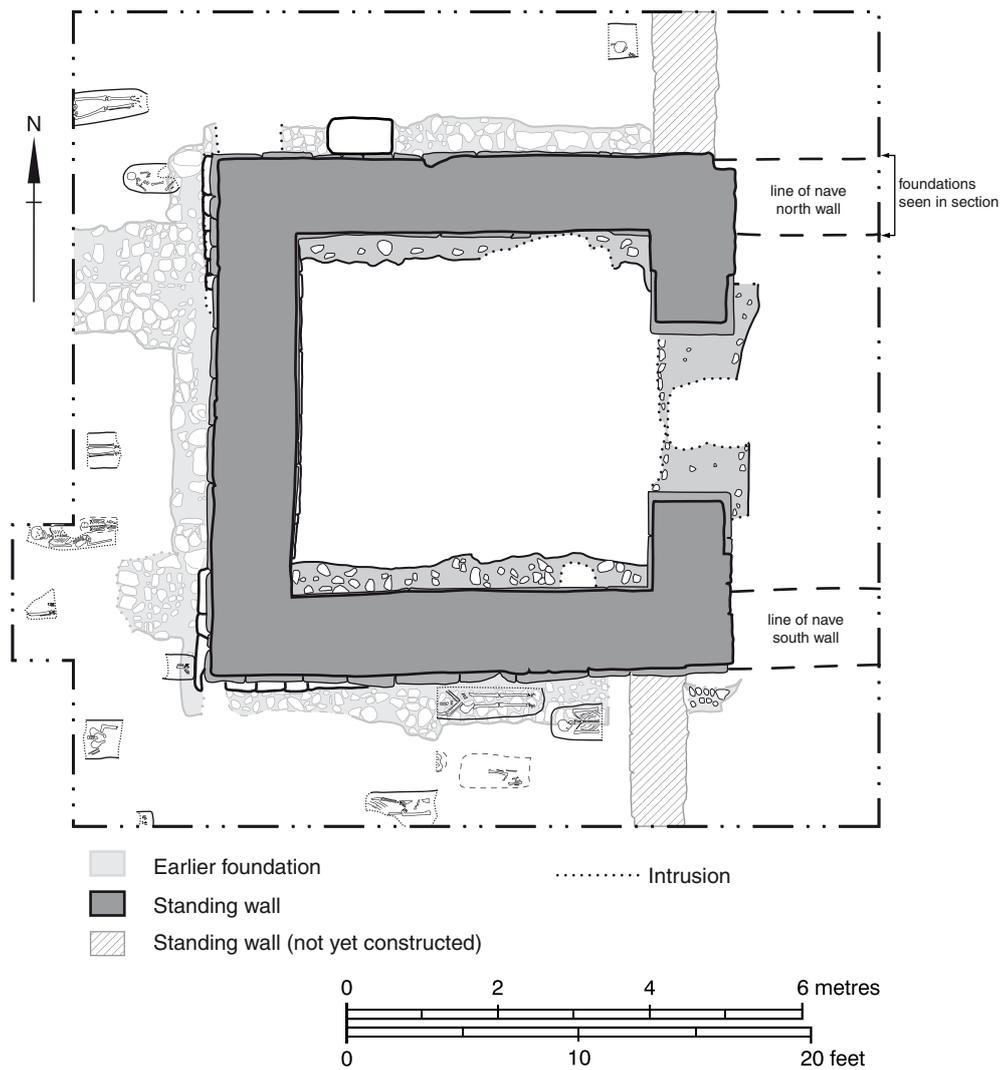
Fig. 12: Construction of the standing tower and associated features

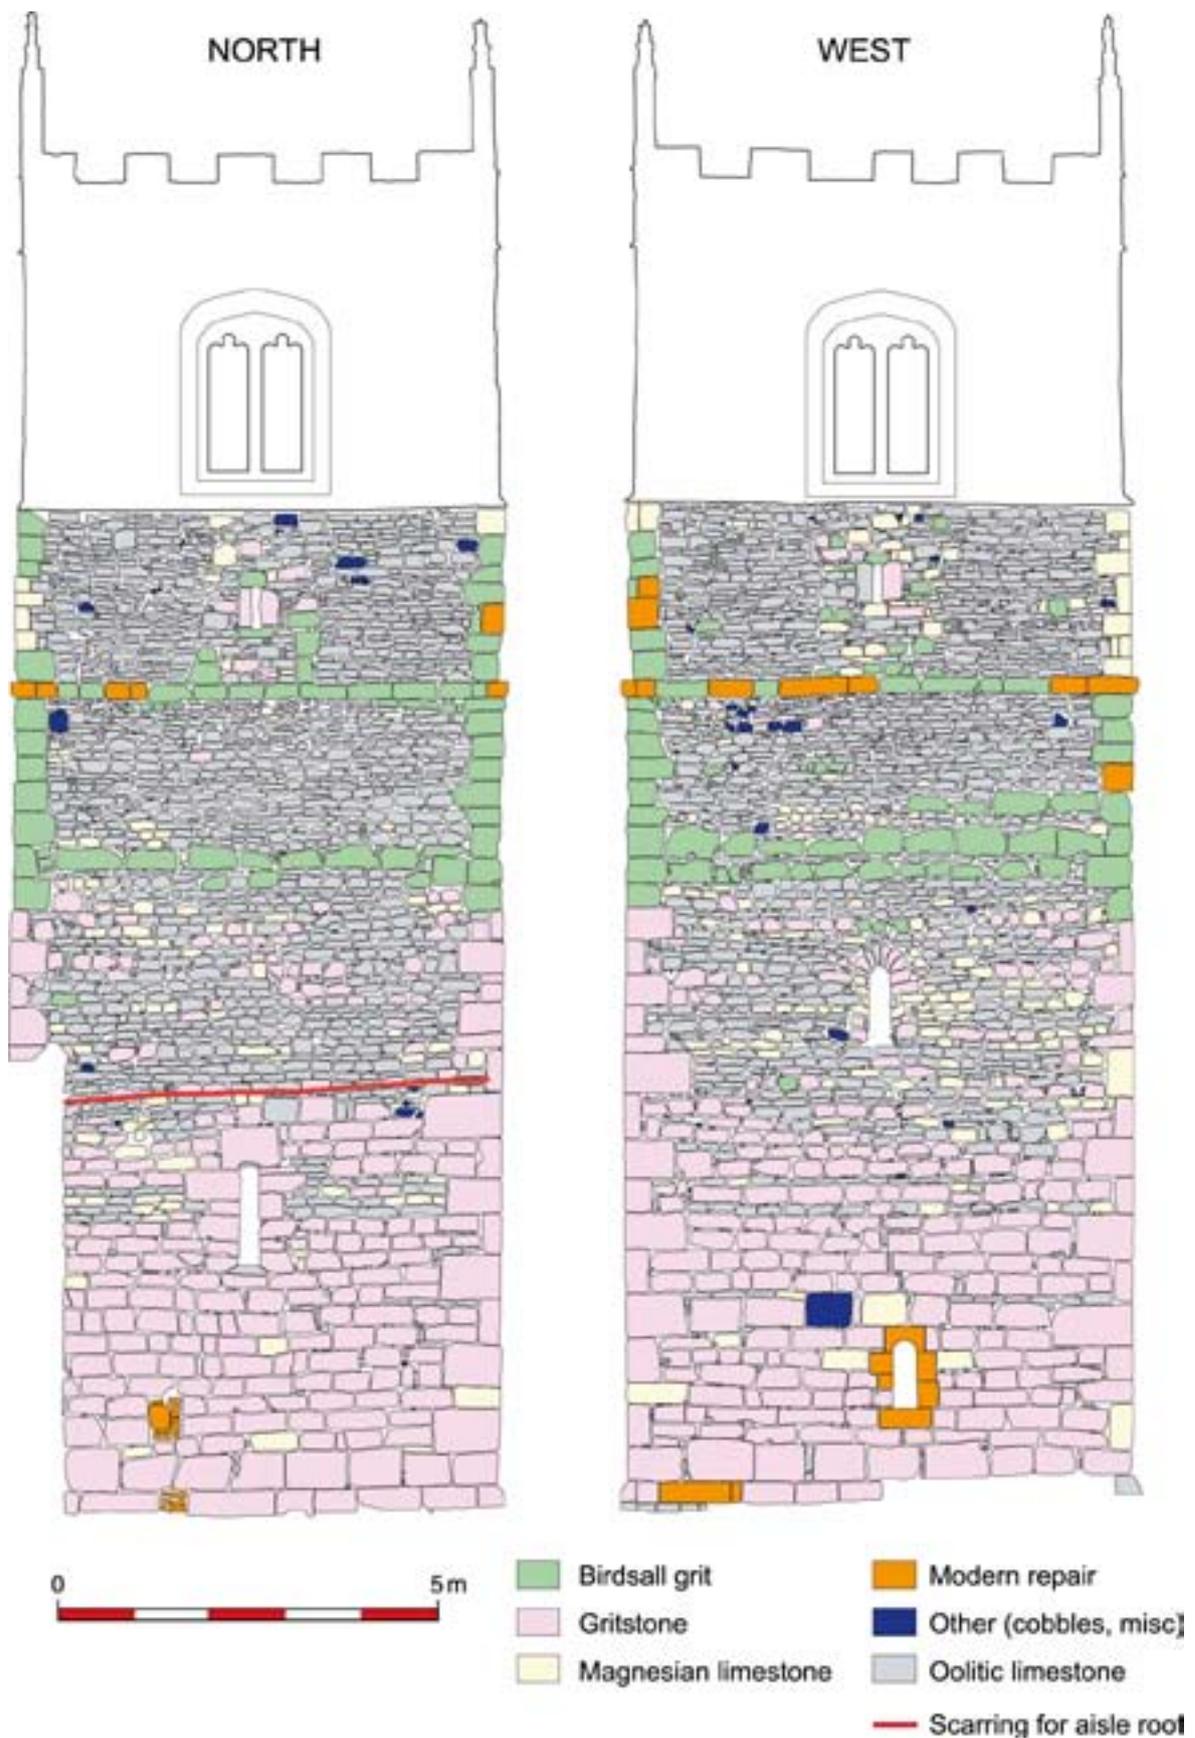
Fig. 13a: North and West elevations showing stone types

In the late medieval period a belfry was added to the tower above a chamfered string course (Fig 13a,b). It has been heavily restored at various subsequent periods but was originally constructed of good quality magnesian limestone ashlar. If the pre-existing tower had east and west gables they were lowered, and the original belfry openings were infilled. Narrow slit windows were left to illuminate the belfry chamber and possibly the second floor chamber too, if the original belfry's floor was removed at the same time. Some of the original quoins may also have been replaced in this period. Major repairs were carried out to the east face of the tower immediately above the north pitch of the nave roof, where there is now a large area of disturbed fabric with blocks of magnesian limestone and inclusions of clay tile. Nothing is known of the medieval roof: the present roof is entirely 19th-century.

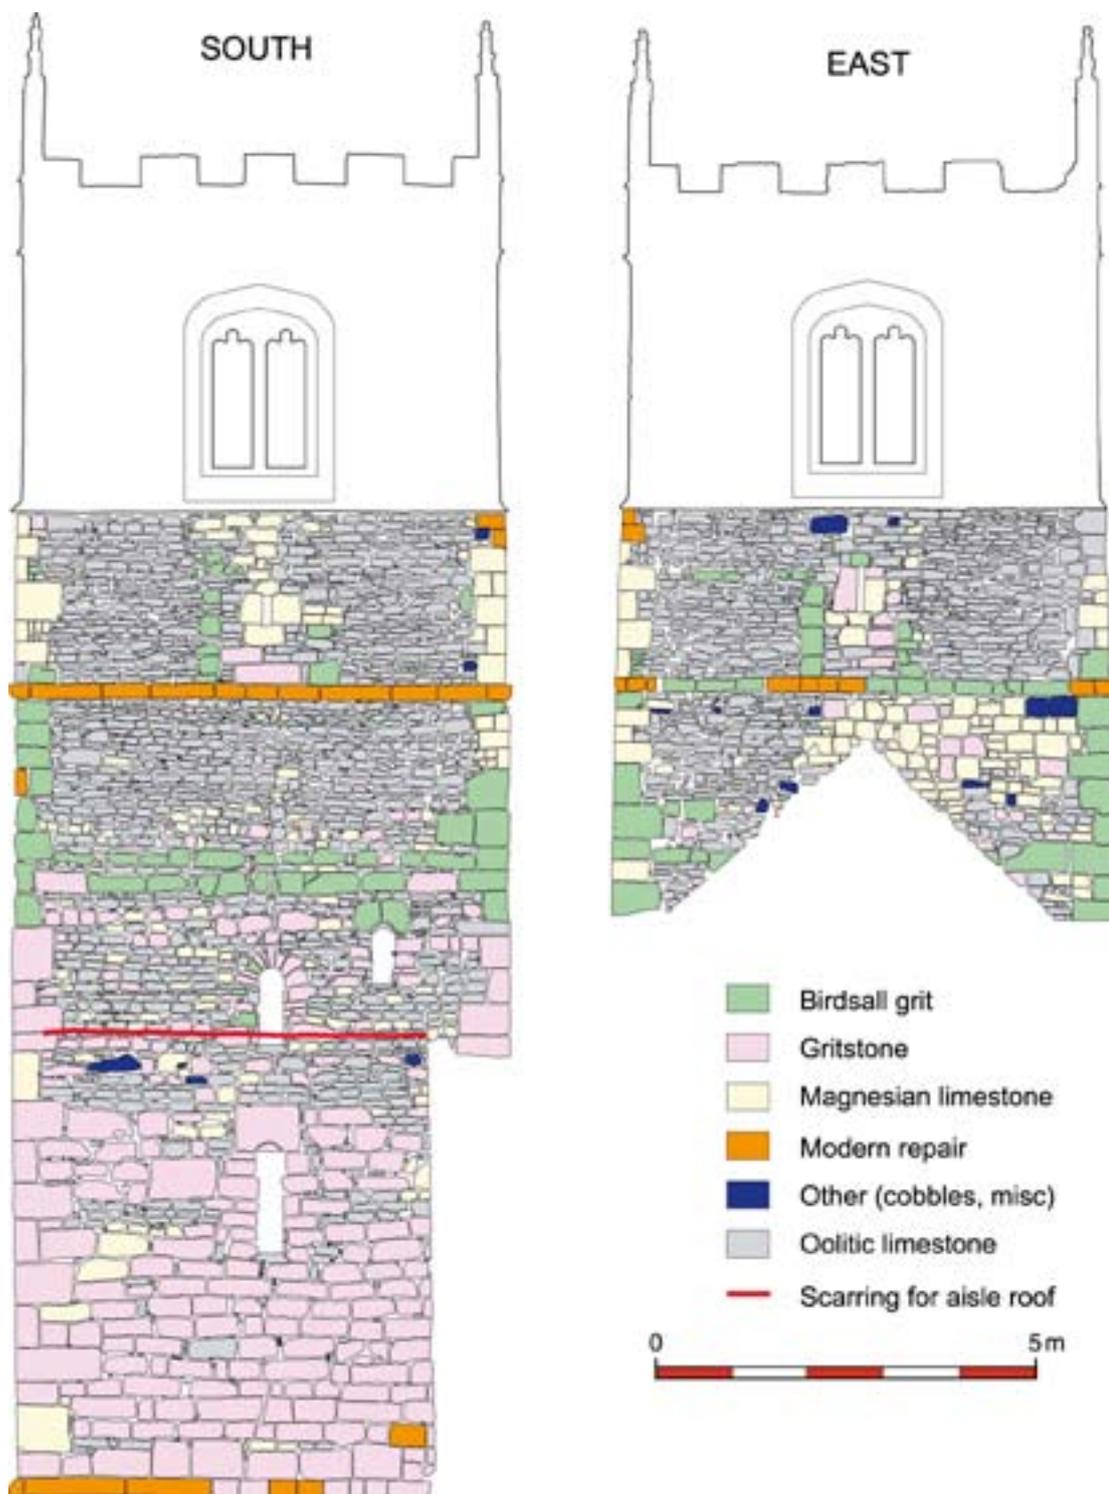
Fig. 13b: South and East elevations showing stone types

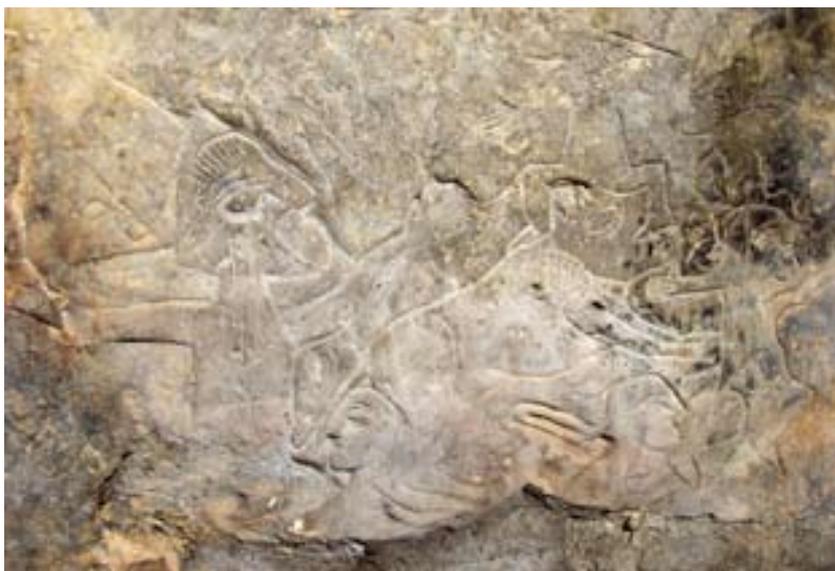
Fig. 14: Graffito interpreted as representing Ragnarök, on the tower's north wall.

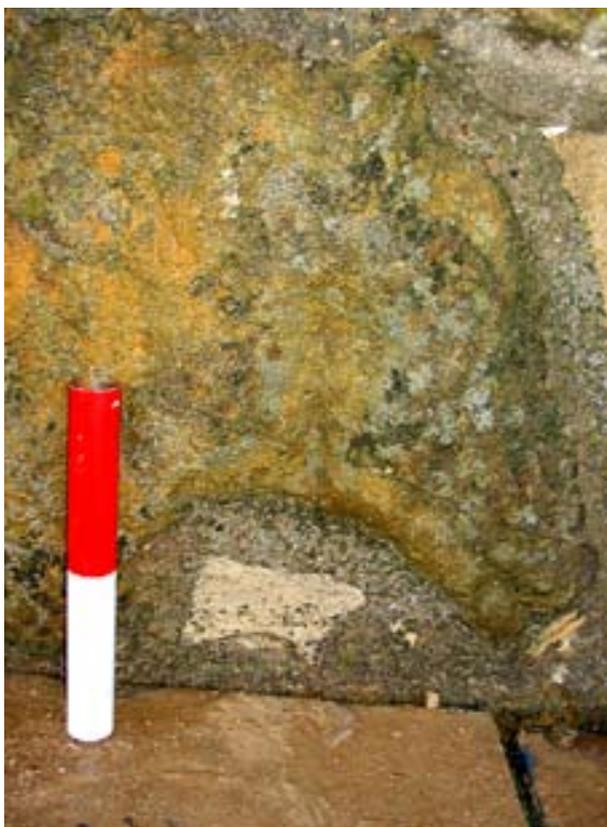
*Fig. 15: Detail of the 'Bear Stone'.
Scale unit 100 mm.*

On the south external elevation, adjacent to the western quoin which is at the same level as the head of the south window, is a gritstone block modelled in low relief with a zoomorphic shape that is known locally as the Bear Stone. This, however, seems to be a misnomer, for the animal has bovine characteristics at its mouth and ear (Fig. 15).

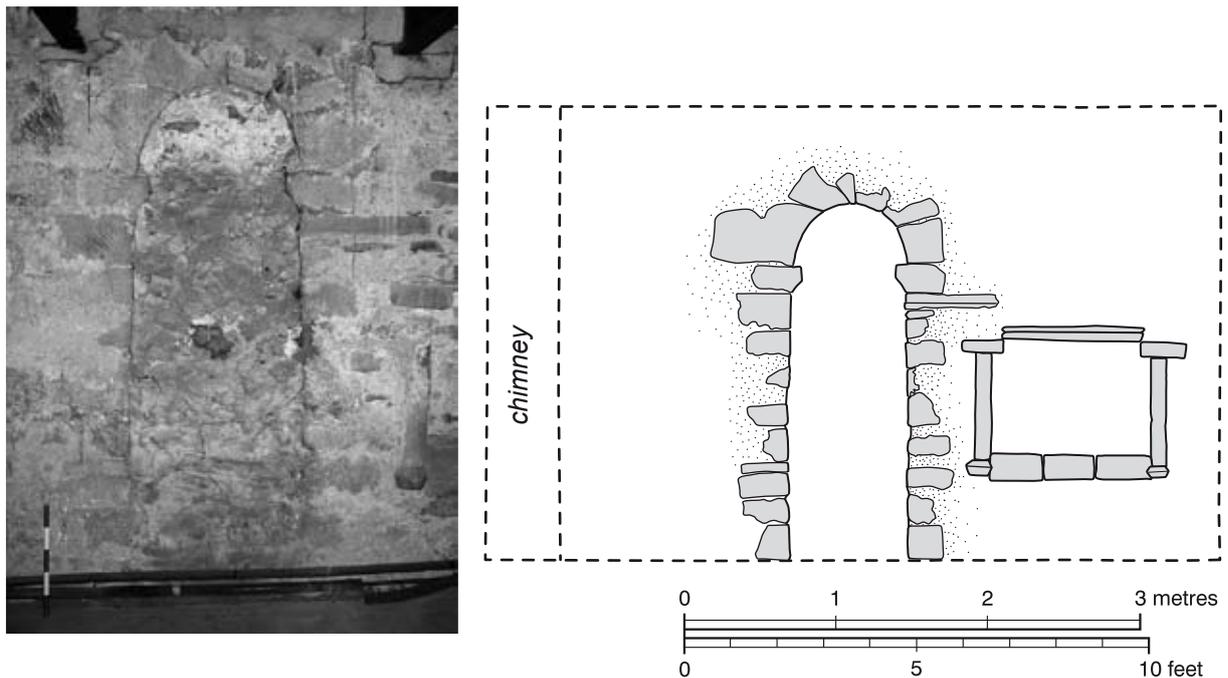
Fig. 16: Photograph and drawn elevation of blocked doorway in east wall of tower, and adjacent recess, showing inter alia the extent of mortar/plaster rendering

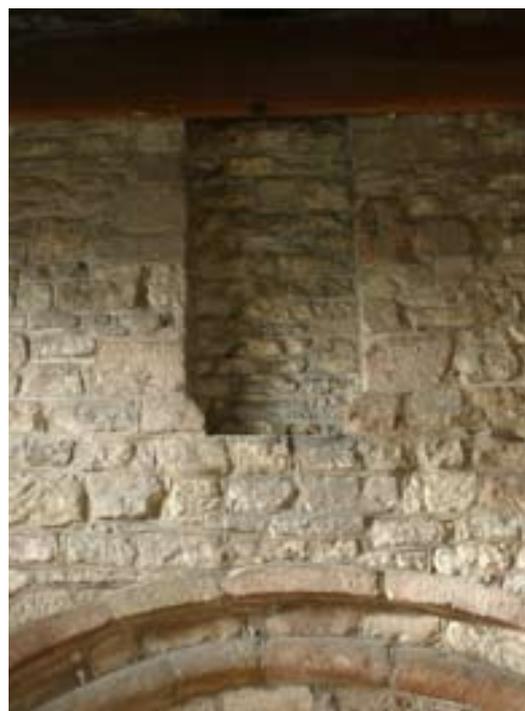
Fig. 17: Blocked doorway at first floor level in tower, seen from the nave

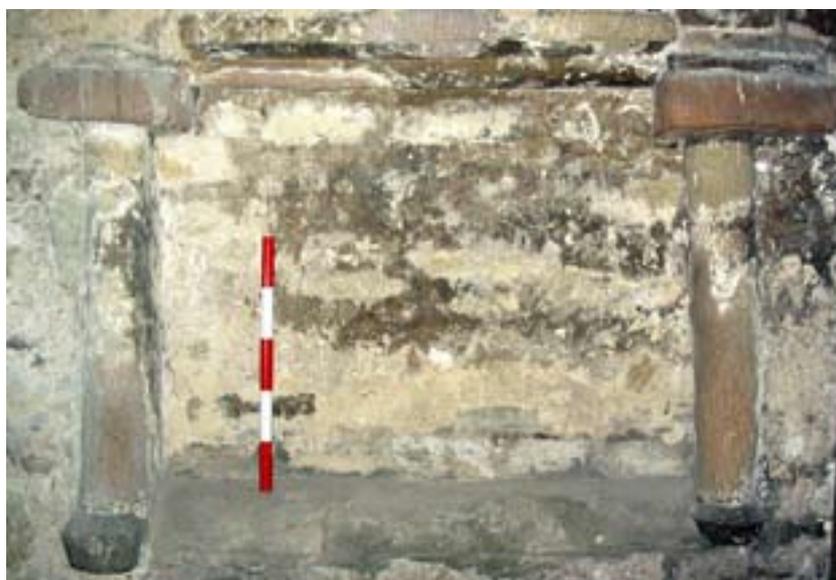
Fig. 18: Recess in inner face of the east wall of the tower, at first floor level. Scale unit: 100 mm.

A shallow oblong recess in the east wall of this chamber, south of the doorway into the nave, has been interpreted as an altar position (Fig. 18). The feature is flanked by colonnettes which rise from unmatched biconical corbels to carry impost blocks; the top of the recess, apparently made from two stones of very unequal length, is set flush with the face of the wall between, but not upon, the imposts. Its chamfered and rolled profile is correctly illustrated in Brown 1925, 333, fig 149, with detail; *contra* Taylor and Taylor 1965, 553, fig 269. The moulding which defines the bottom of the recess is made of three stones of unequal length. The recess is slightly deeper at its base than at its top; its back is partly covered by a skim of white plaster. Indeed, there is sufficient lime mortar adhering to the walls of this chamber to suggest that it was rendered and plastered throughout, although all traces of fine finishing plaster have fallen; all that is left is the lowermost layer. This detail and the presence of the altar both suggest that this room was at one time in regular use.

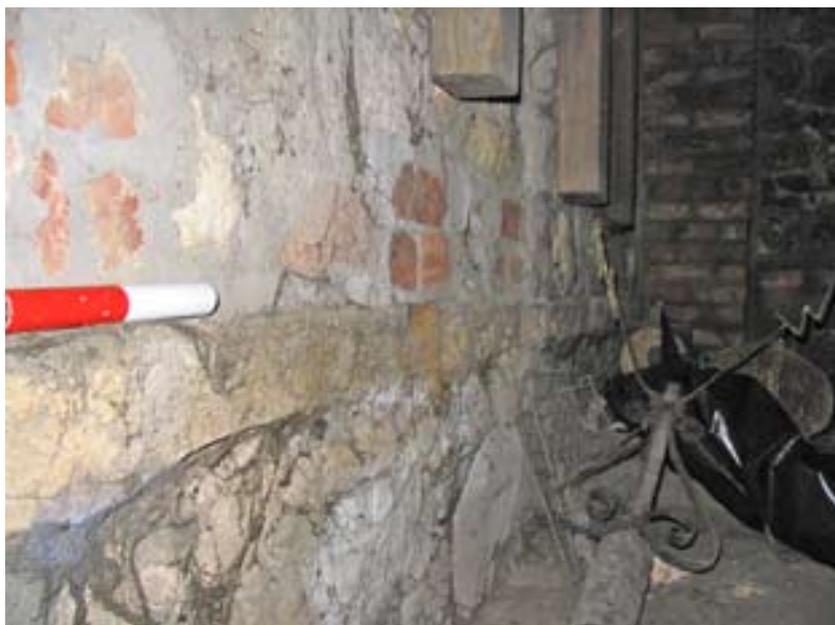
Fig. 19: Possible wall plate, with the scale resting on its upper edge, in the internal north elevation of the tower. View looking east. Scale unit 100 mm.

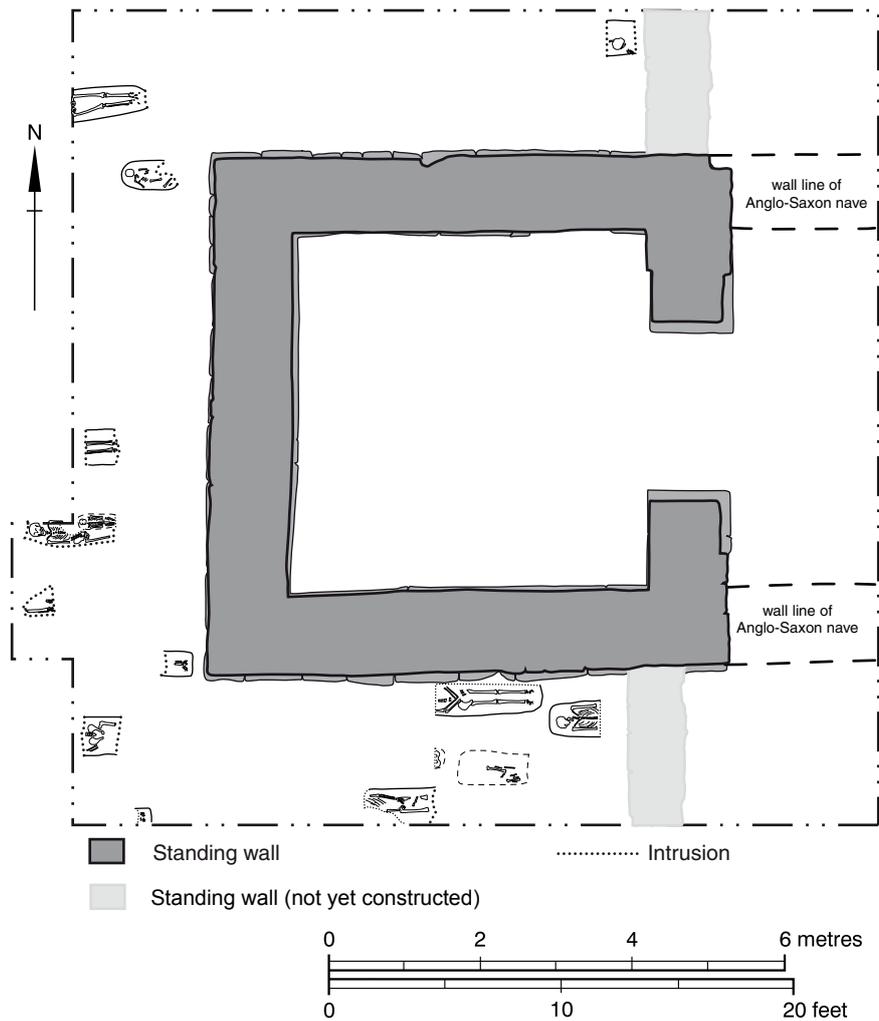
Fig. 20: 11th-12th century activity

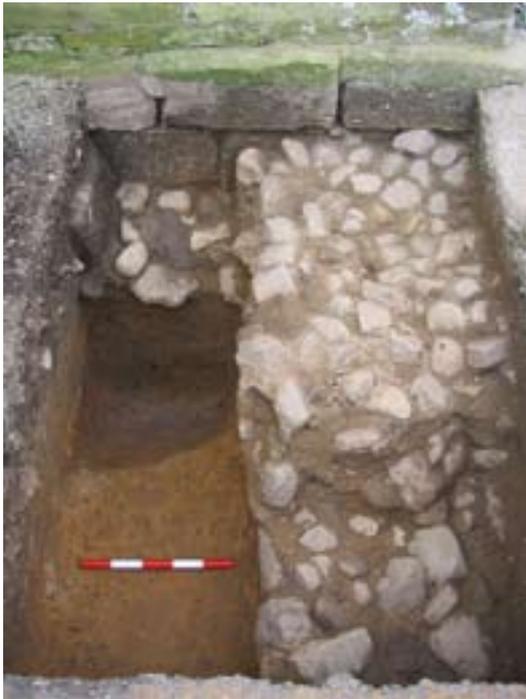
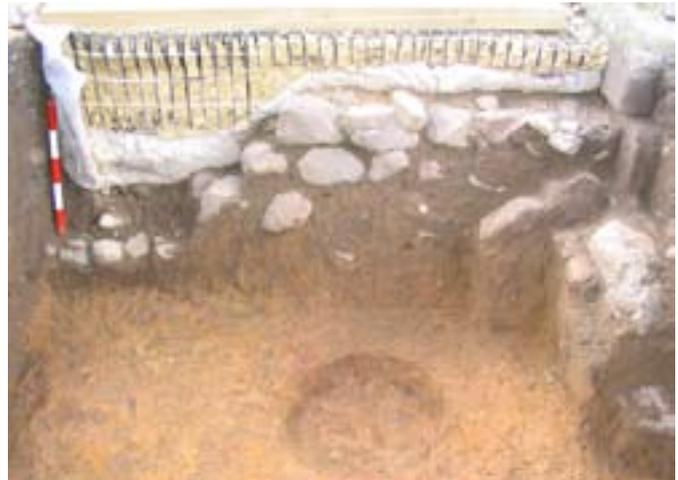
Fig. 21a,b: showing the northern aisle foundation in plan, looking southwards and section, looking eastwards. Scale unit 100 mm.

That to the north was made up of field stones, possibly derived from the boulder clay, in a matrix of silty sand, and clearly abutted the foundations of the standing tower (Fig. 21). A single piece of ceramic building material dated to the 13th-16th centuries was found on the surviving top of this foundation, not assuredly deposited during construction. That to the south consisted of a basal layer of oolitic limestone fragments, covered by cobbles with both oolitic and magnesian limestone fragments (Fig. 22, 23). On top of the foundation were two small oolitic limestone blocks that may have been part of the aisle wall. There was no independent dating evidence for this foundation. The fact that elements of it were incorporated into the fabric of the tower (Fig 23b) indicates that there had already been some subsidence here which had created the gaps into which the new work was inserted. Unfortunately the more recent insertion of a repair to the base of the wall masked any further evidence.

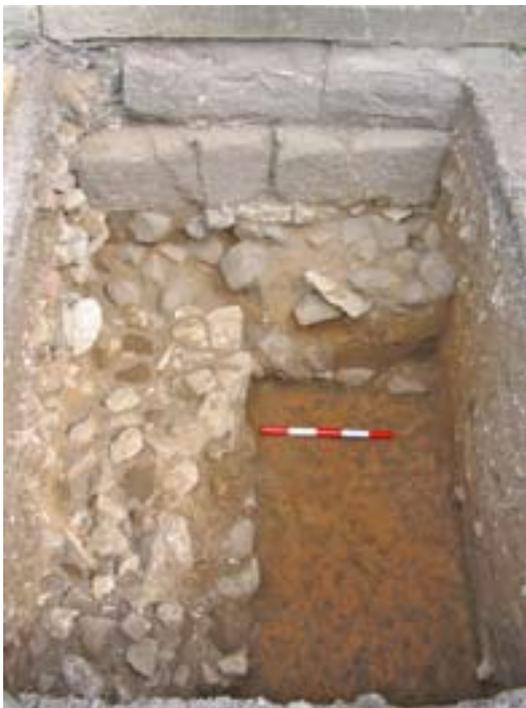
Fig. 22: Part of southern aisle foundation, looking north. Scale unit: 100 mm.

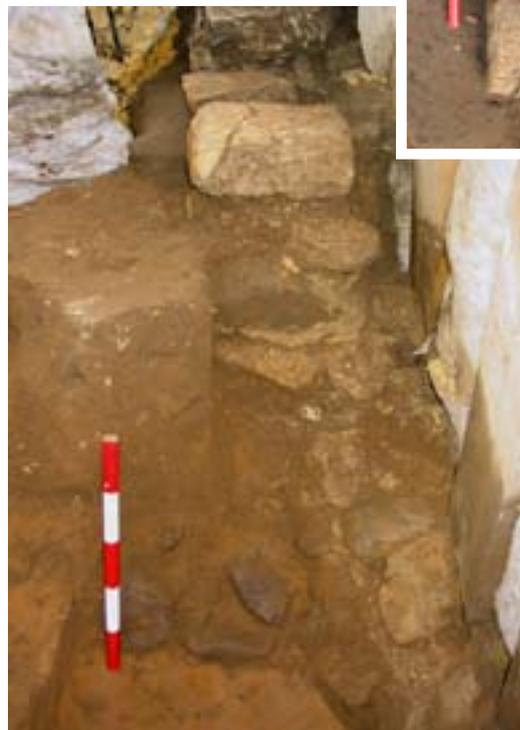
Fig. 23a (below): Southern aisle wall structure and foundation seen in section; Fig. 23b (inset) two oolitic limestone blocks, one interposed below an overhanging stone in the tower wall, viewed from above. Scale unit: 100 mm.

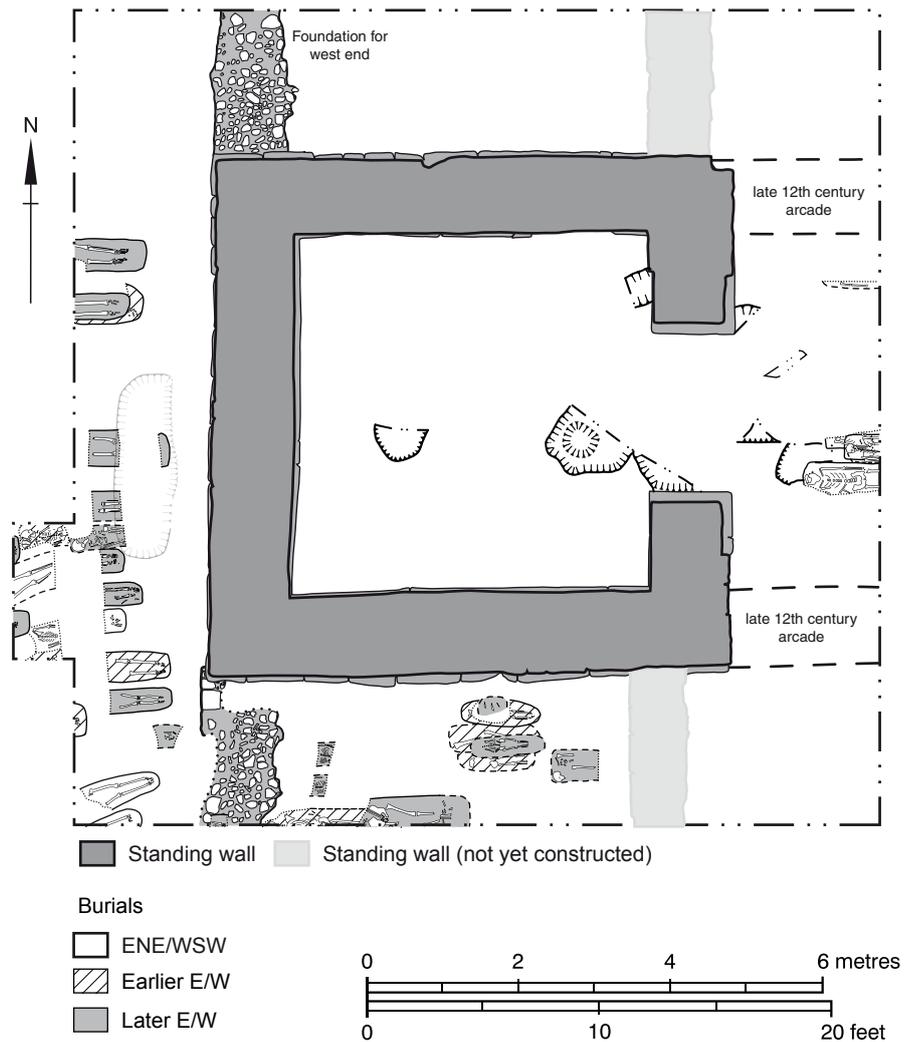
Fig. 24: Medieval burials and other activity

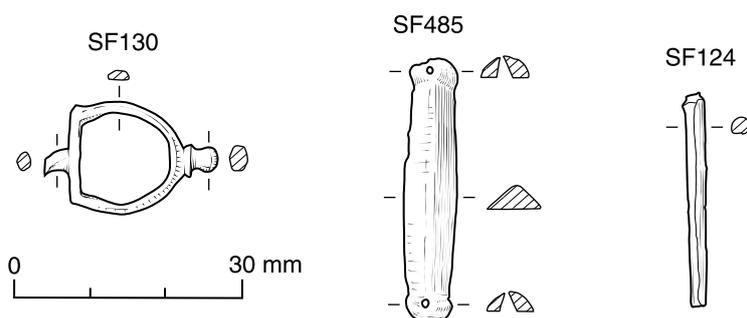
Fig. 25: Copper alloy strap guide, bar mount and lace tag. Scale 1:1

N S H Rogers writes: A small number of artefacts was recovered from these deposits (Fig. 25). They include a strap-guide and a bar mount, both used on belts, and both from the same context; and a medieval lace tag, all made of copper alloy. The strap-guide is a D-shaped loop with a decorative collared knob to one side and an external rivet on the other: these fittings were used to secure the part of a strap or belt which extended beyond the buckle, the rivet being used for attachment to the strap. A similar strap-guide was found at the College of the Vicars Choral, Bedern, York in

a mid-14th to early 15th-century deposit (Ottaway and Rogers 2002, 2903, fig.1477, 14387). The bar mount would have decorated a belt or, perhaps, a horse-harness strap (Egan and Pritchard 1991, 209), and closely resembles an example from London from a late 13th to mid 14th-century deposit (*ibid*, 213, fig.134, 1150). The lace tag would have been used to prevent the end of a lace fraying, and could be contemporary with the strap guide and bar mount. Similar examples from York appear to be mainly 15th – 16th century in date, but they have been recovered from 14th-century deposits (Ottaway and Rogers 2002, 2920-1).

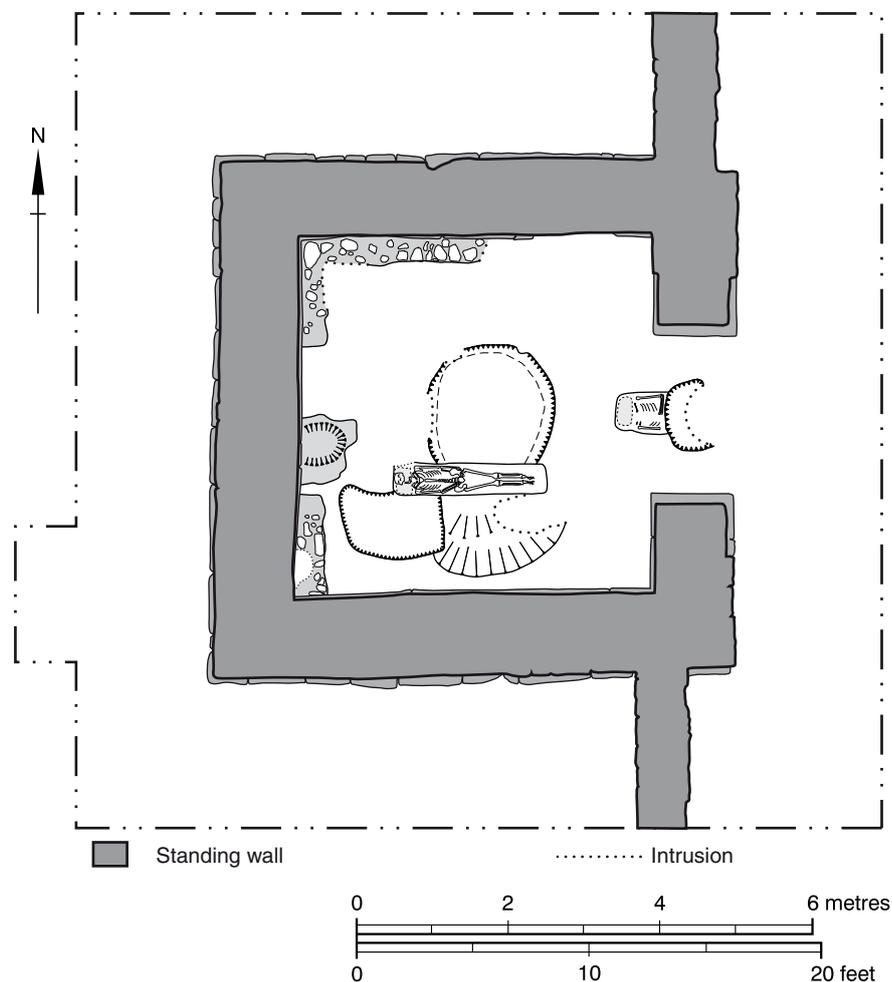
Fig. 26: Late medieval and post-medieval activity

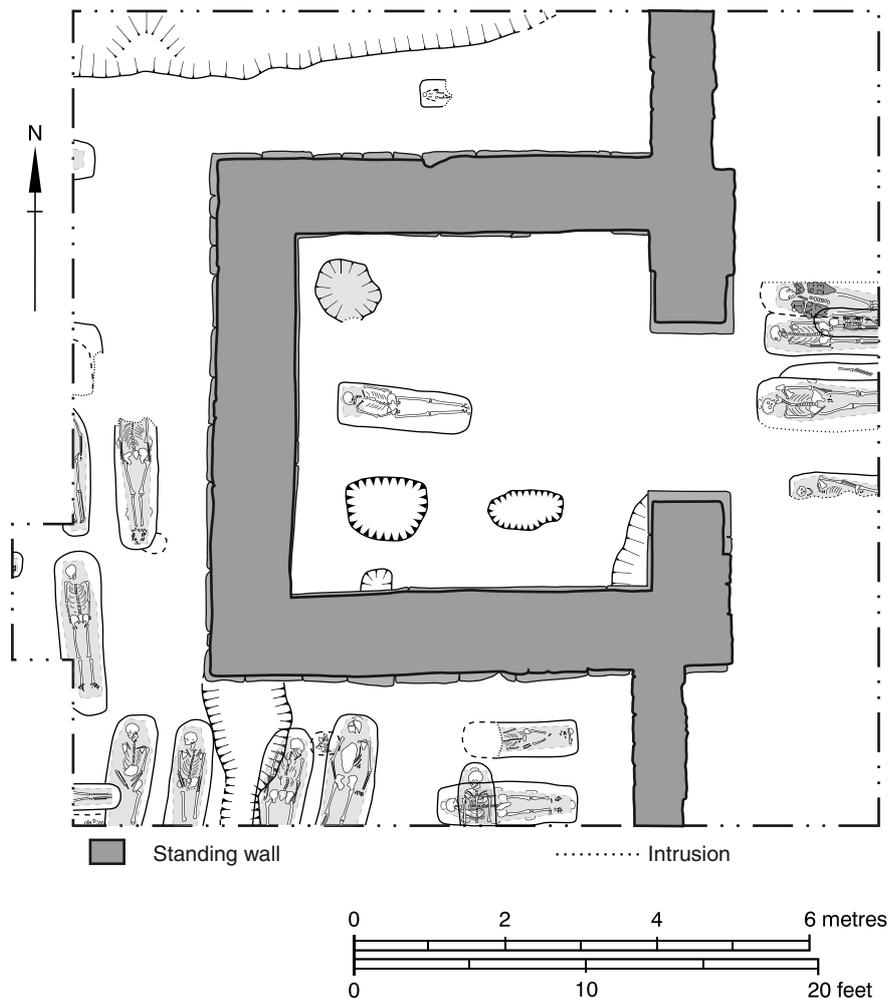
Fig. 27: Early modern activity
