ST HELEN'S CHURCH SKIPWITH NORTH YORKSHIRE

Report on an
Archaeological
Excavation

by R.A. Hall, T. Kendall & C. Briden

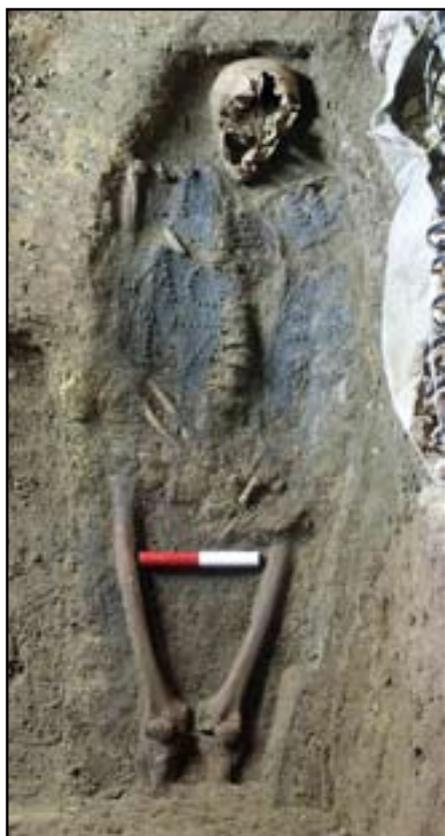
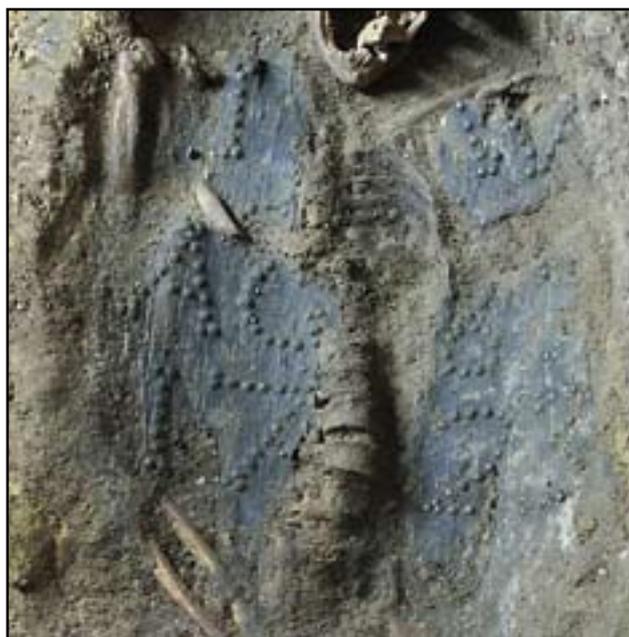
Fig. 28a,b: Burial, and detail of partially preserved coffin lid with copper alloy decorative studs, 'JW AG 61 1723'.

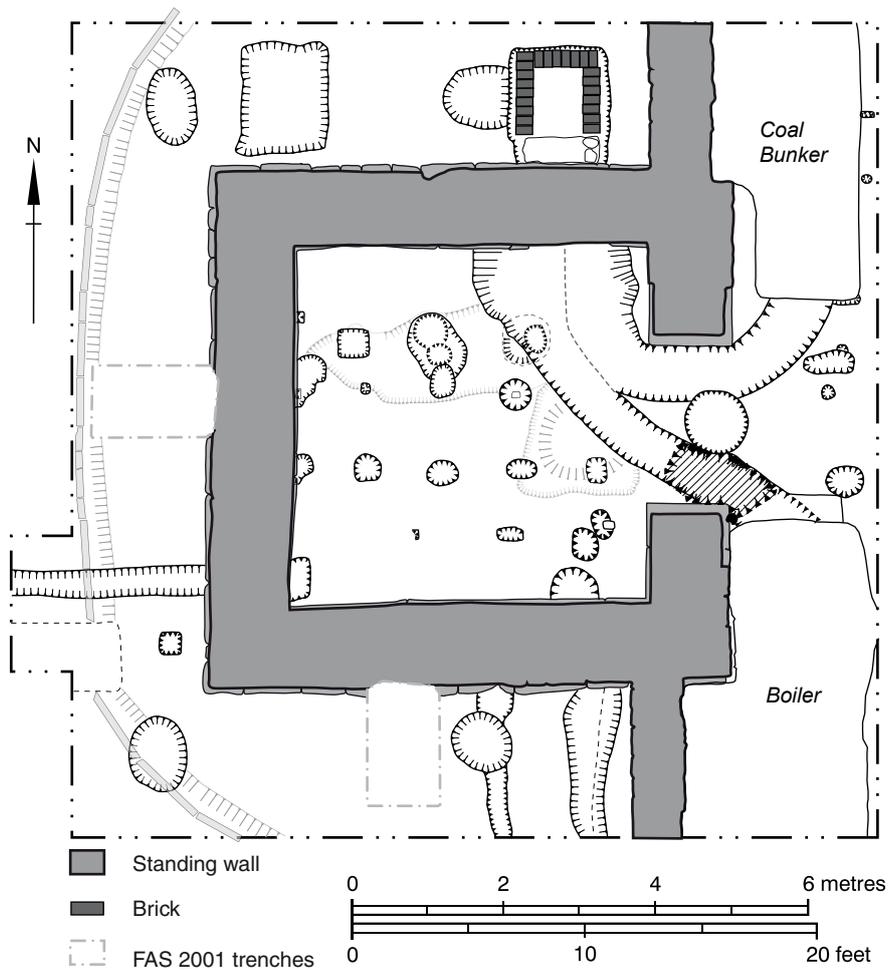
Fig. 29: Victorian and later activity

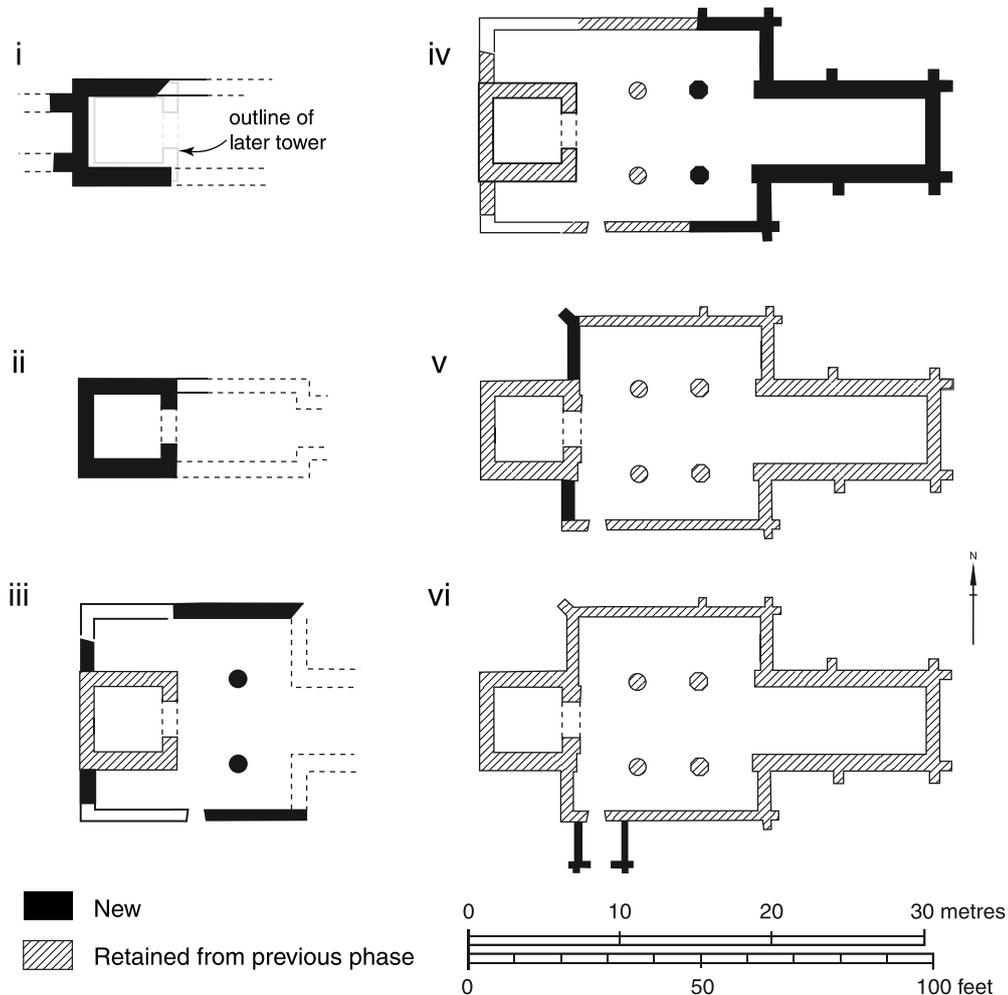
Fig. 30: Possible sequence for the development of the church's plan
