# GATEBECK LOW GUNPOWDER WORKS AND THE WORKERS' SETTLEMENTS OF ENDMOOR AND GATEBECK, CUMBRIA AN ARCHAEOLOGICAL AND ARCHITECTURAL SURVEY

## SURVEY REPORT

NGR: SD 544 853

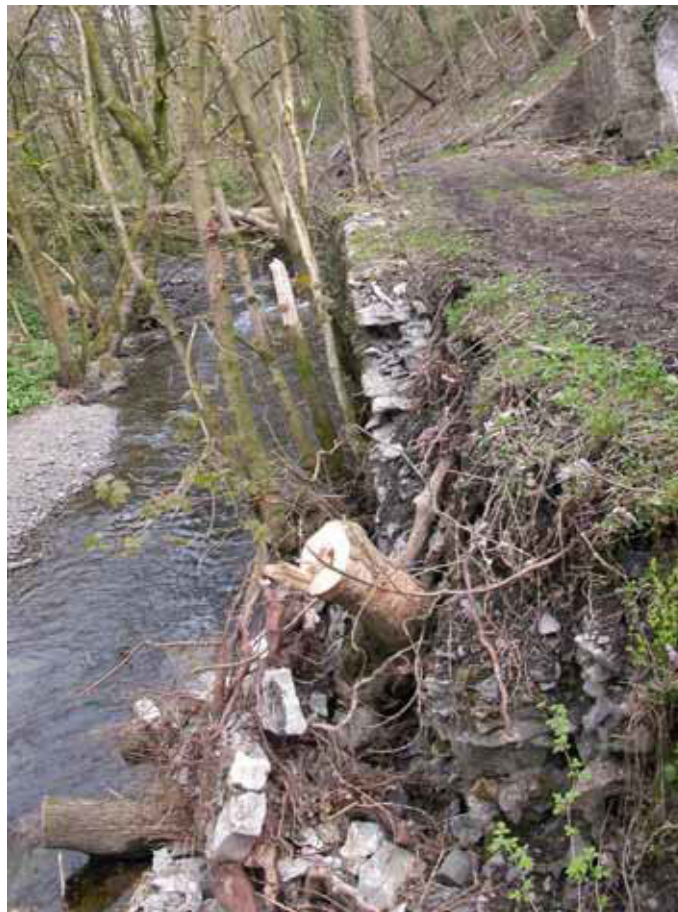
*Figure 3: Collapsed stream revetment opposite the northern charge house (building 6)  
(Photograph: Christopher Dunn 2006, © English Heritage)*

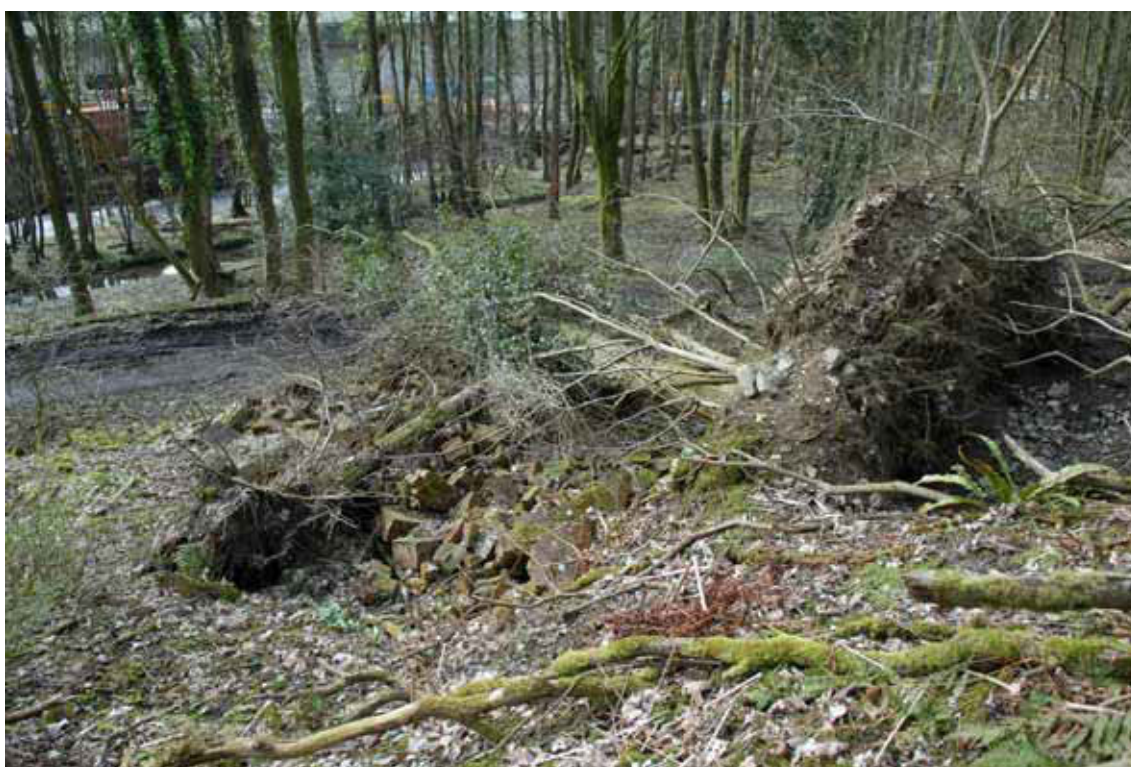
*Figure 4: The 'power house' (building 13a) north of the large corning house, destroyed by a wind-blown tree  
(Photograph: Christopher Dunn 2006, © English Heritage)*

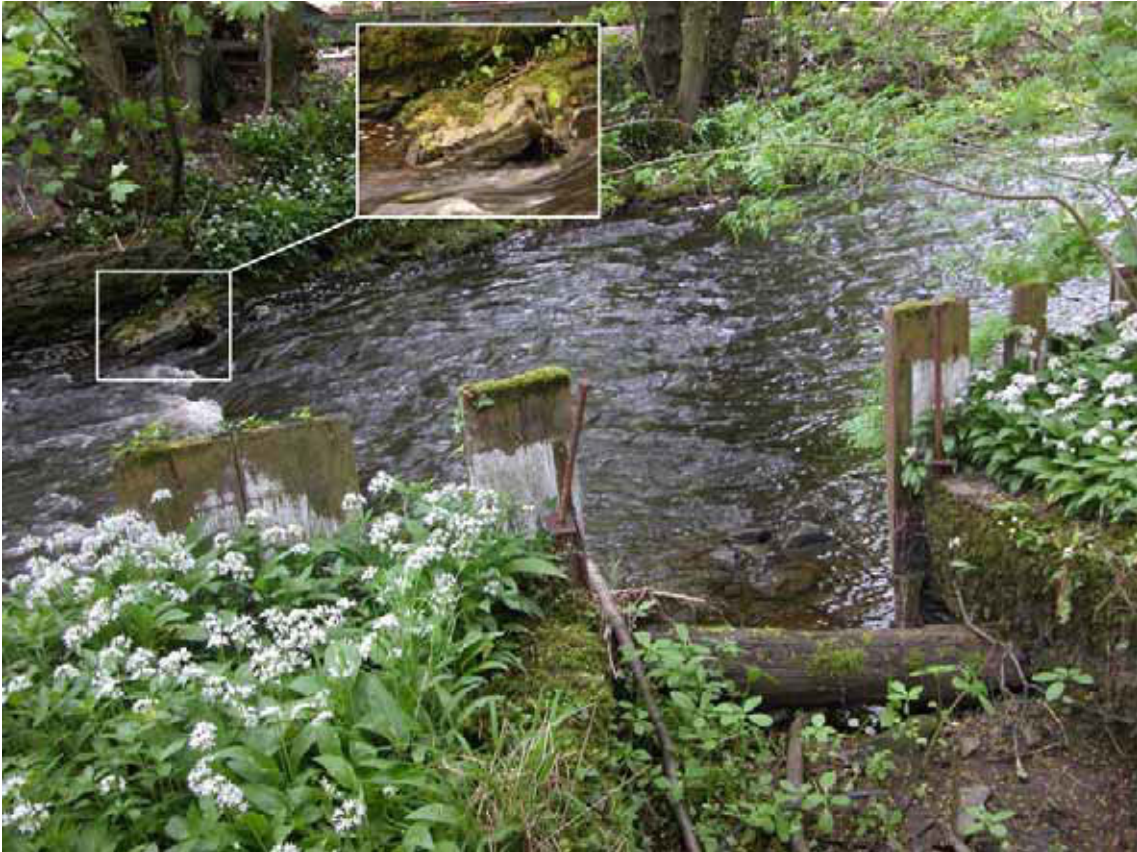
Figure 6: The pre-gunpowder weir (far side shown in detail at inset) and start of the headrace  
(Photograph: Christopher Dunn 2006, © English Heritage)

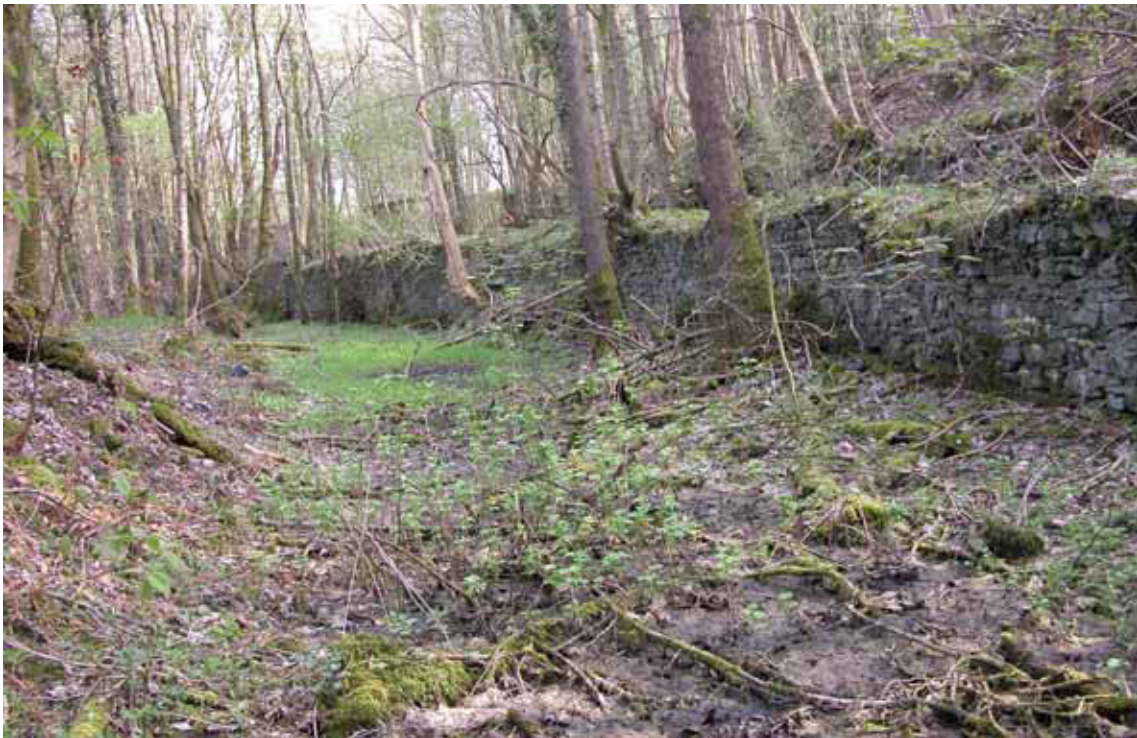
Figure 7: The pre-gunpowder millpond looking north  
(Photograph: Christopher Dunn 2006, © English Heritage)

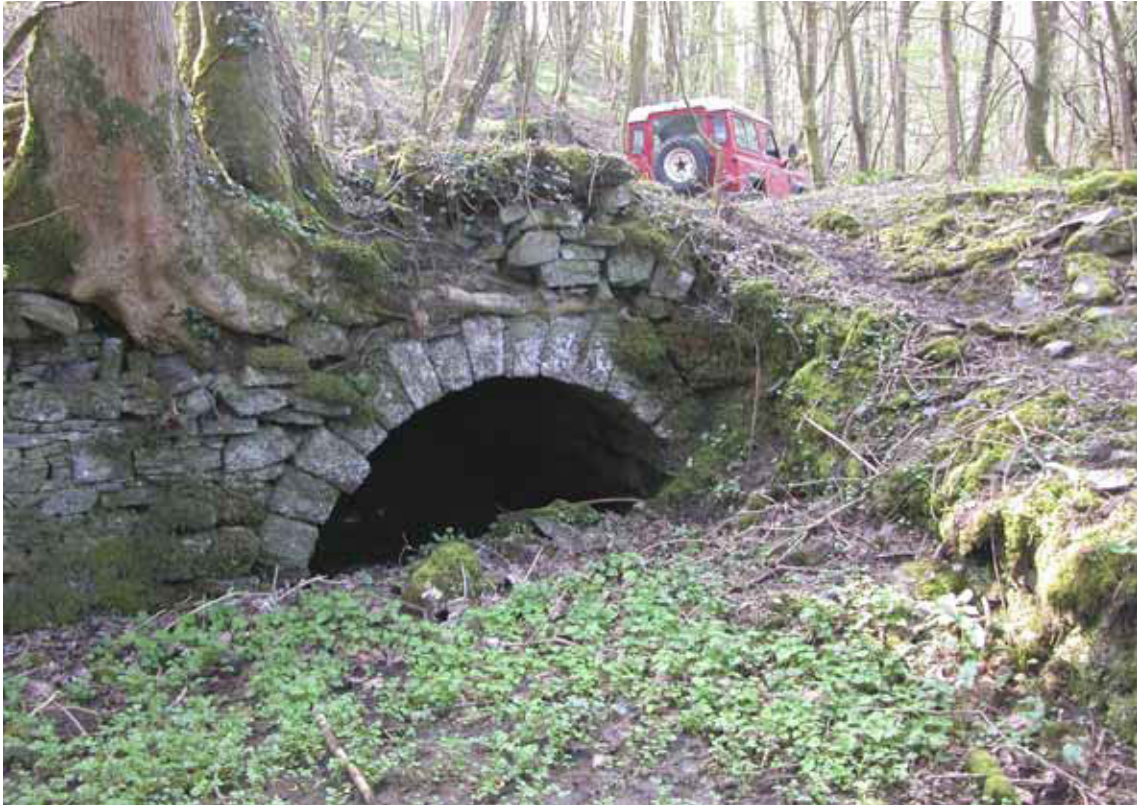
Figure 8: Entrance portal to the high-level culverted leat at the south end of the pre-gunpowder millpond (Photograph: Christopher Dunn 2006, © English Heritage)

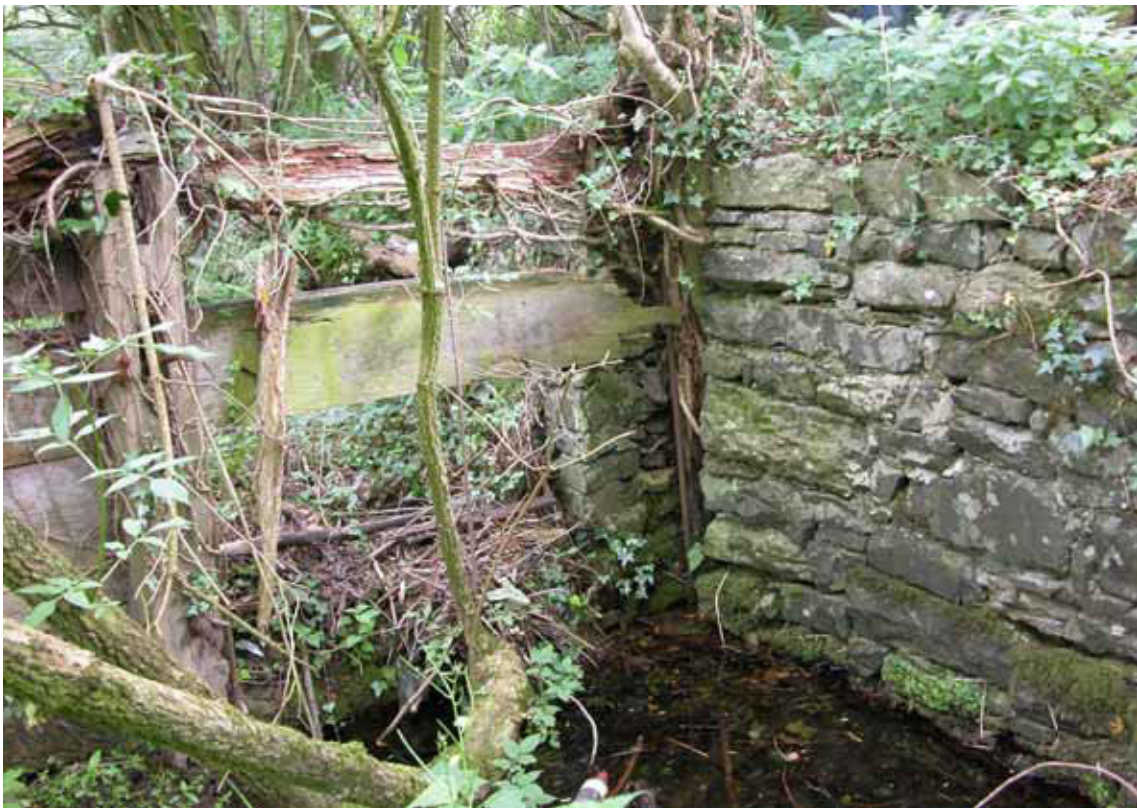
The stone-built gunpowder weir survives in reasonable condition, although the wooden sluice gate controlling the flow of water into the mill leat is now ruinous (Fig 9). As the

Figure 9: The sluiceway at the head of the gunpowder mill leat (Photograph: Christopher Dunn 2006, © English Heritage)

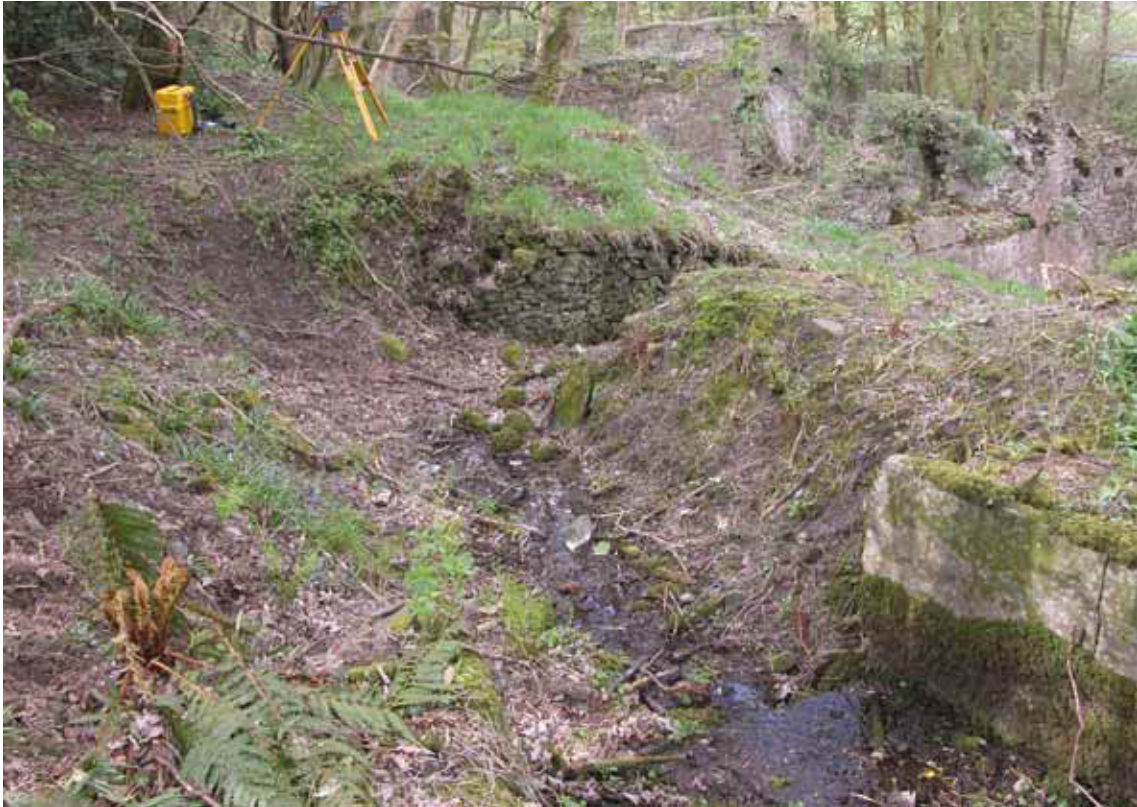
*Figure 10: The south end of the mill leat and start of the sloping culvert  
(Photograph: Christopher Dunn 2006, © English Heritage)*

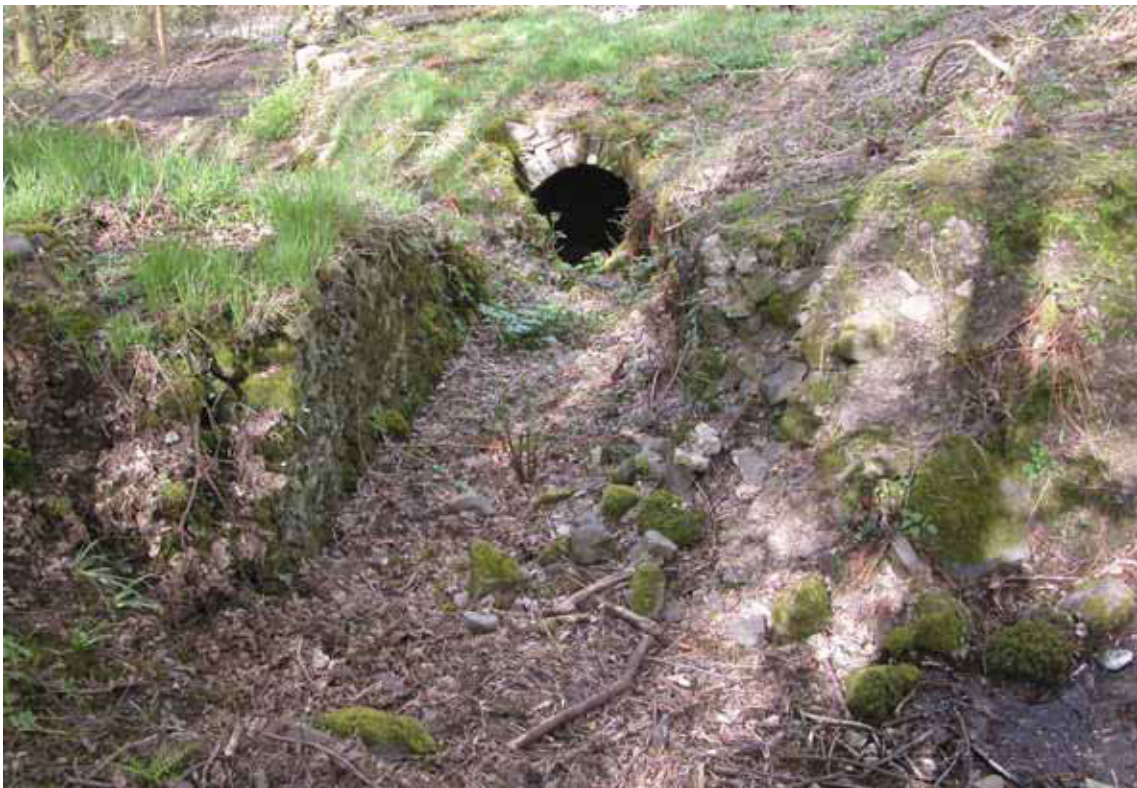
*Figure 11: The sloping culvert looking west (downhill)  
(Photograph: Christopher Dunn 2006, © English Heritage)*

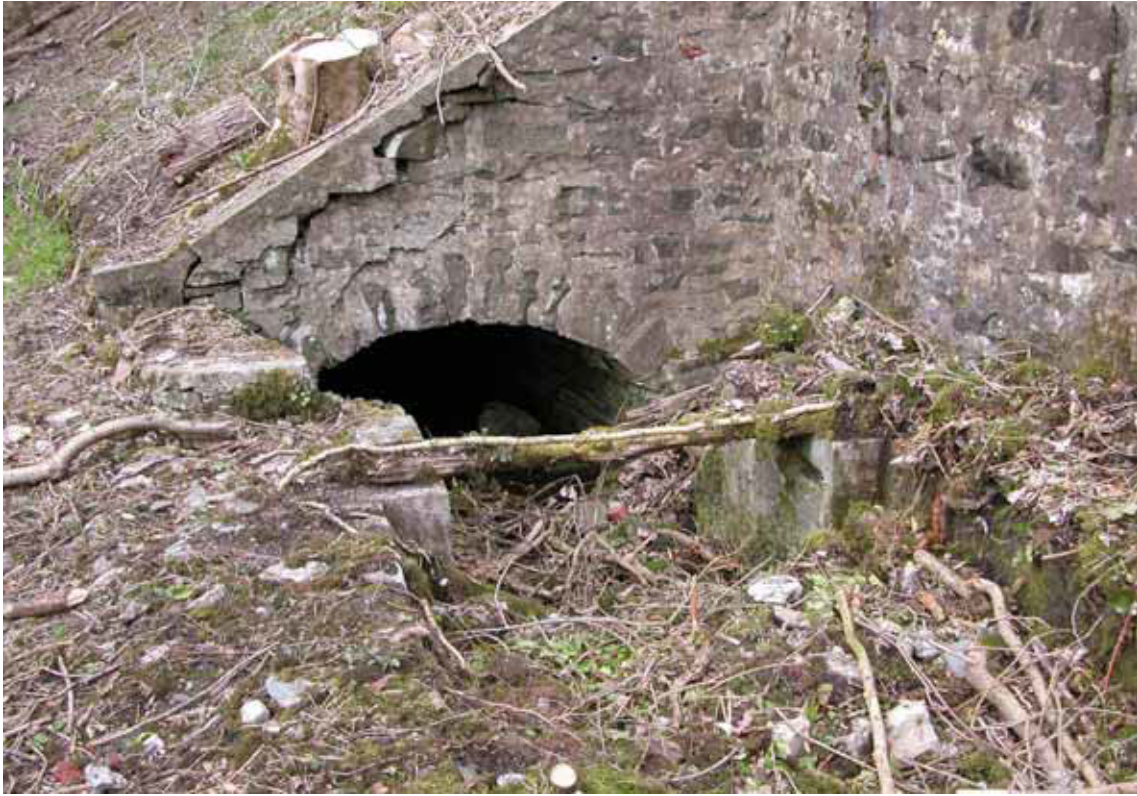
Figure 12: The short open-air section of the high-level culverted leat north of incorporating mill 7  
(Photograph: Christopher Dunn 2006, © English Heritage)

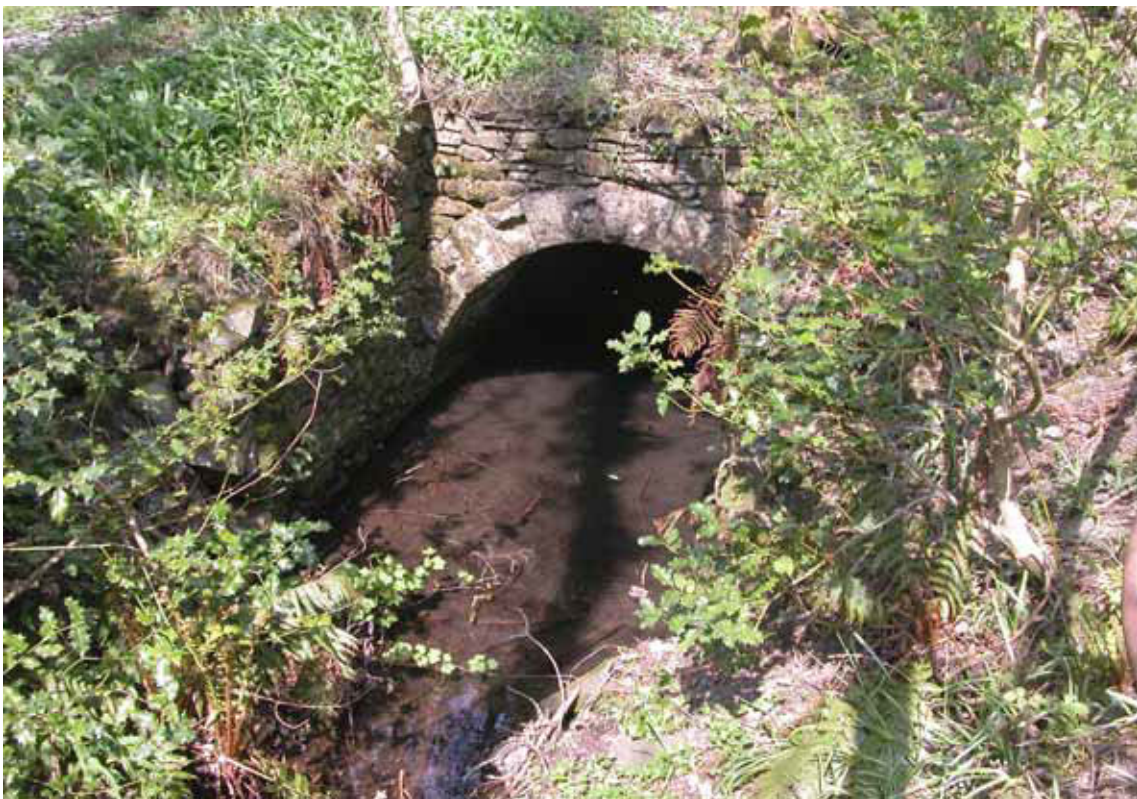
Figure 13: The exit portal of the low-level culverted leat north of Challon Hall  
(Photograph: Christopher Dunn 2006, © English Heritage)

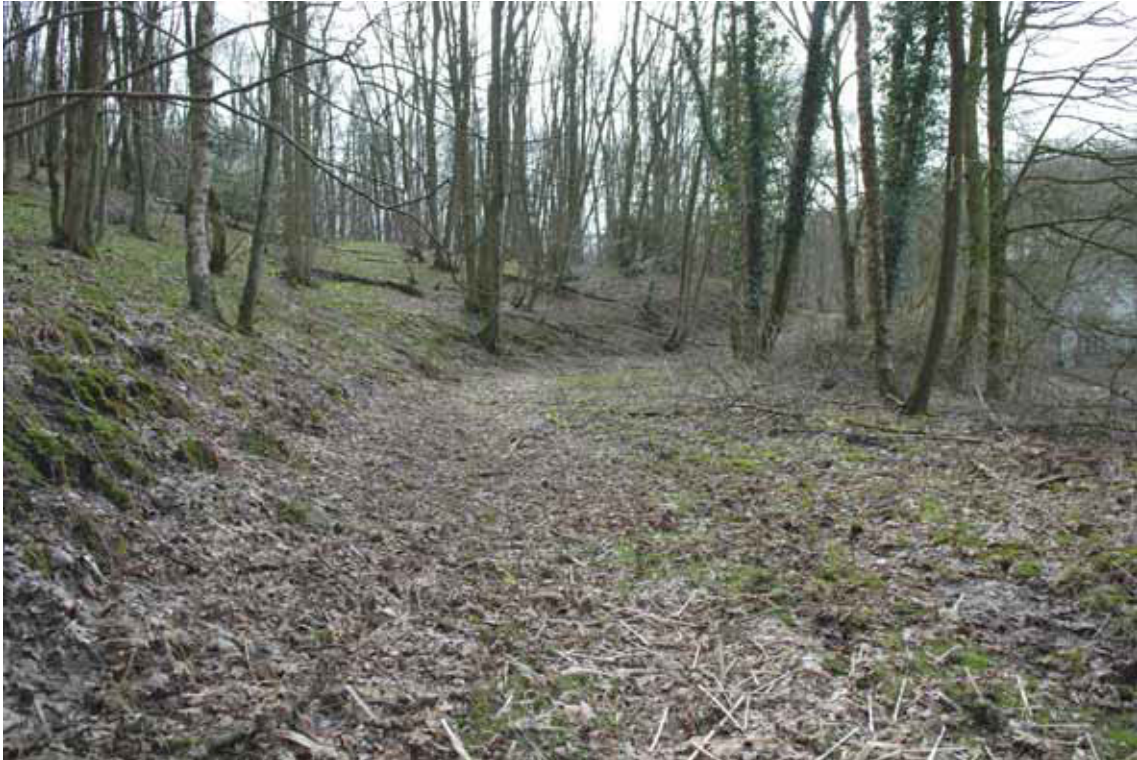
The leat survives in reasonable condition. The central section between the smithy (building 30) and mechanics' shop (building 22) is infilled (Fig 14) and part of the western side bulldozed to create ramped access up to it. Very little of the lining is visible in this section, perhaps destroyed during the infilling (which presumably dates from the time when the site was used for Civil Defence Training or immediately after), but from the large corning house southwards where the channel narrows (Fig 15), the original stone-lining is much better preserved albeit collapsing in places. South of the corning house much of the west side of the leat is rendered or rebuilt in concrete, suggesting a period of probably 20th-century repair.

*Figure 14: The infilled mill leat looking south from the near the joiners' shop (building 29)  
(Photograph: Christopher Dunn 2006, © English Heritage)*

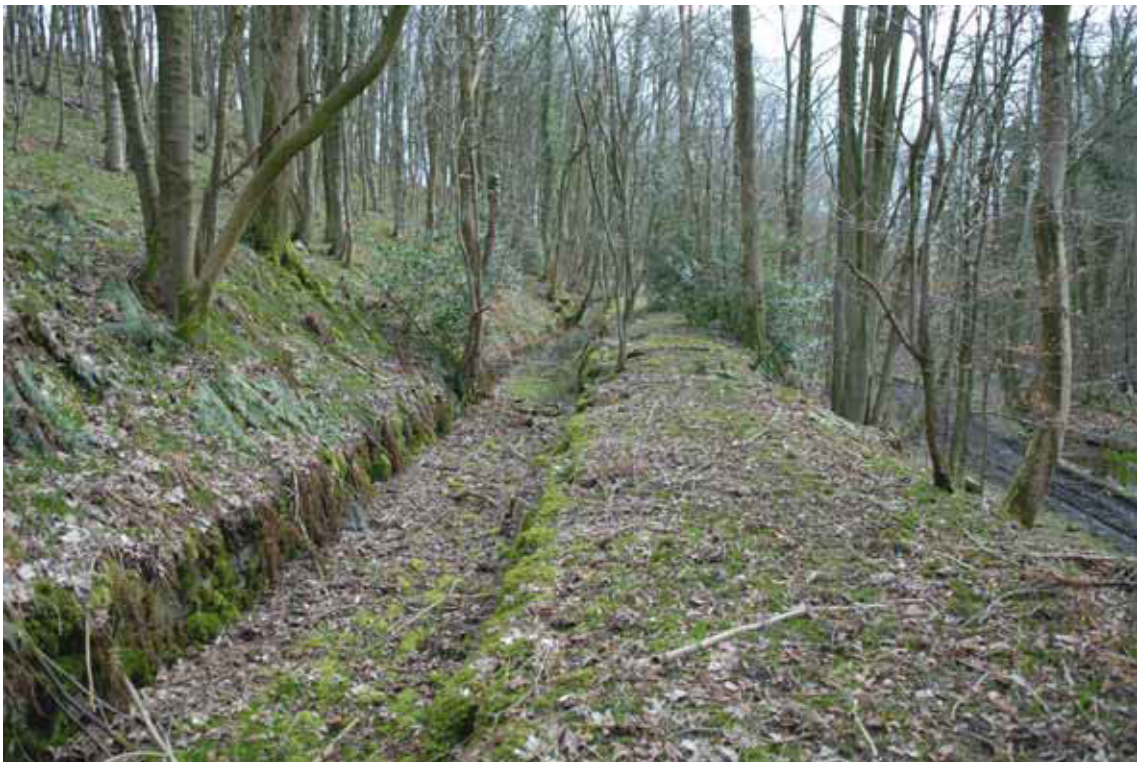
*Figure 15: The narrow mill leat looking south from near the glazing house (building 9)  
(Photograph: Christopher Dunn 2006, © English Heritage)*

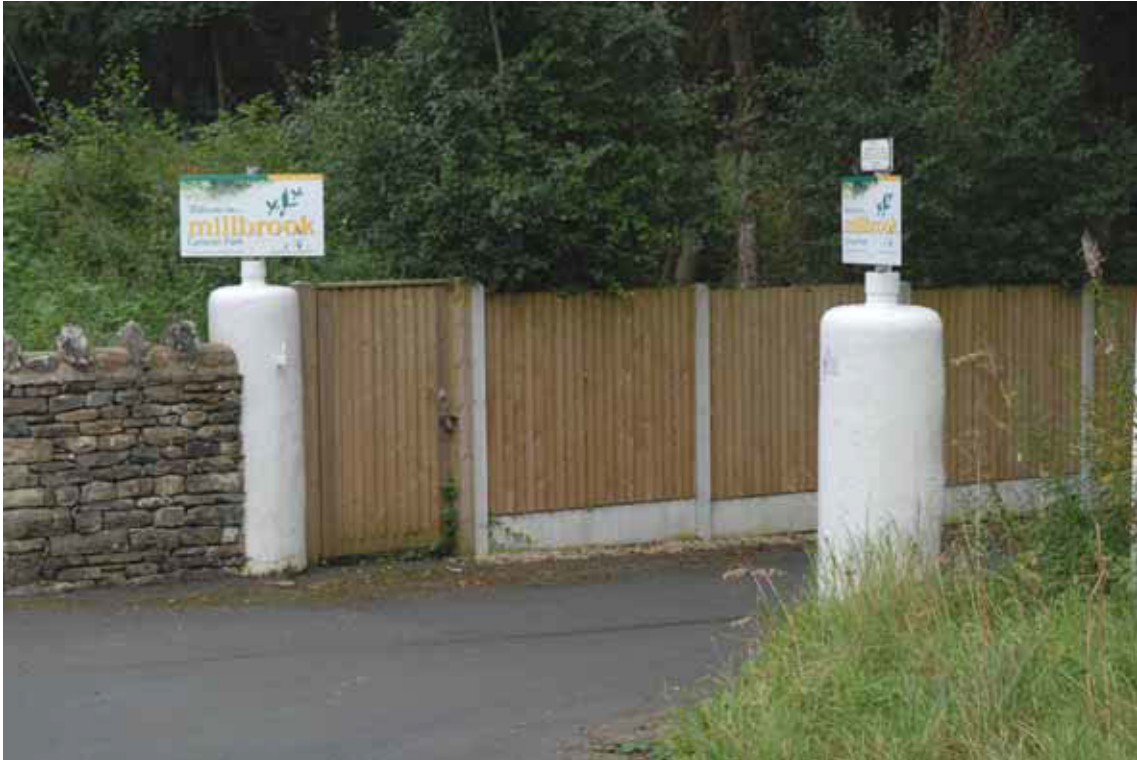
Figure 16: Charcoal retorts reused as gateposts at the junction of the access road with Gatebeck Road (Photograph: Christopher Dunn 2008, © English Heritage)

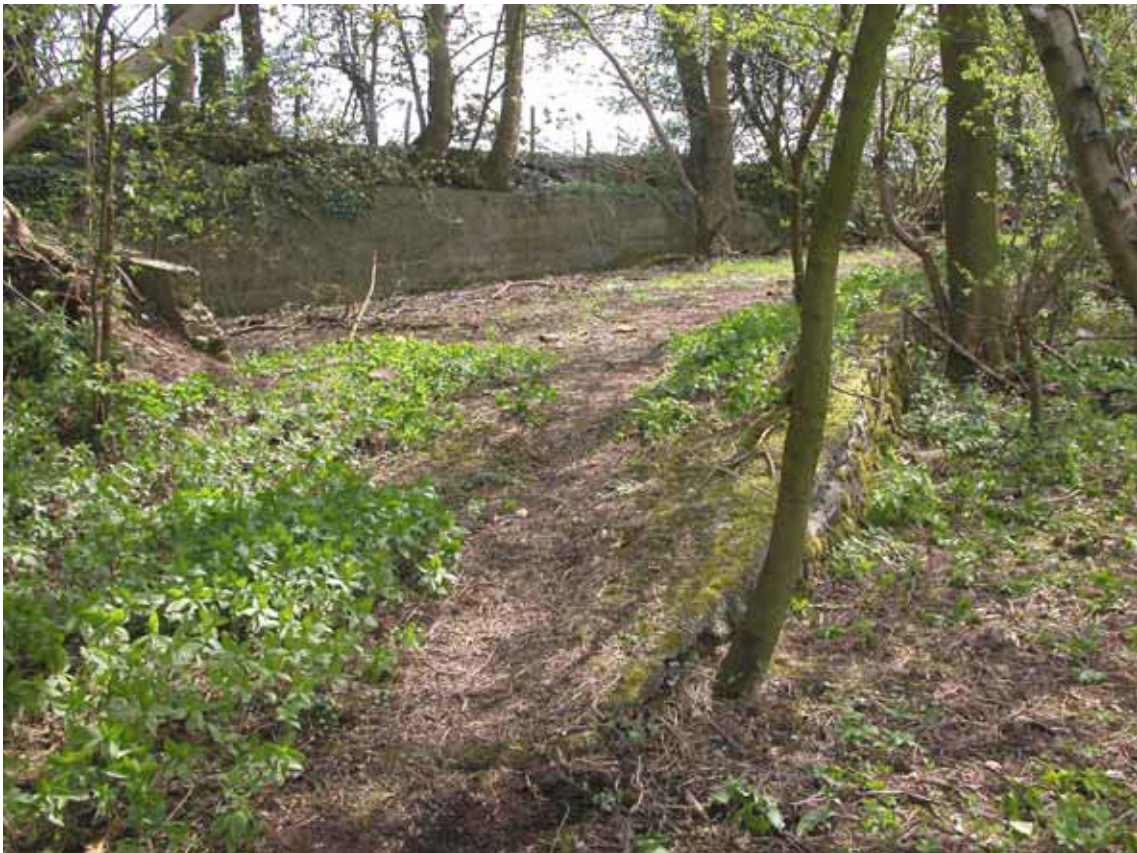
Figure 17: The platform for the charcoal store (building 53) from the north-west (Photograph: Christopher Dunn 2006, © English Heritage)

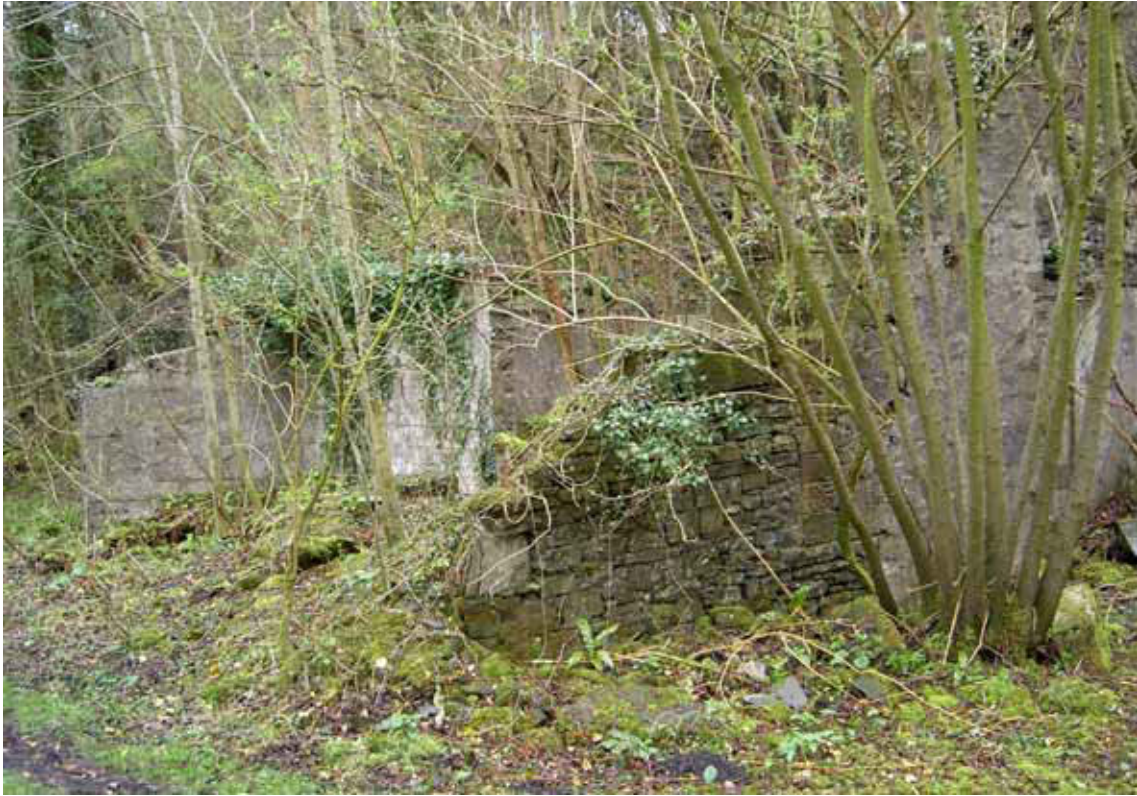
*Figure 18: Incorporating mill I before tree clearance  
(Photograph: Christopher Dunn 2005, © English Heritage)*

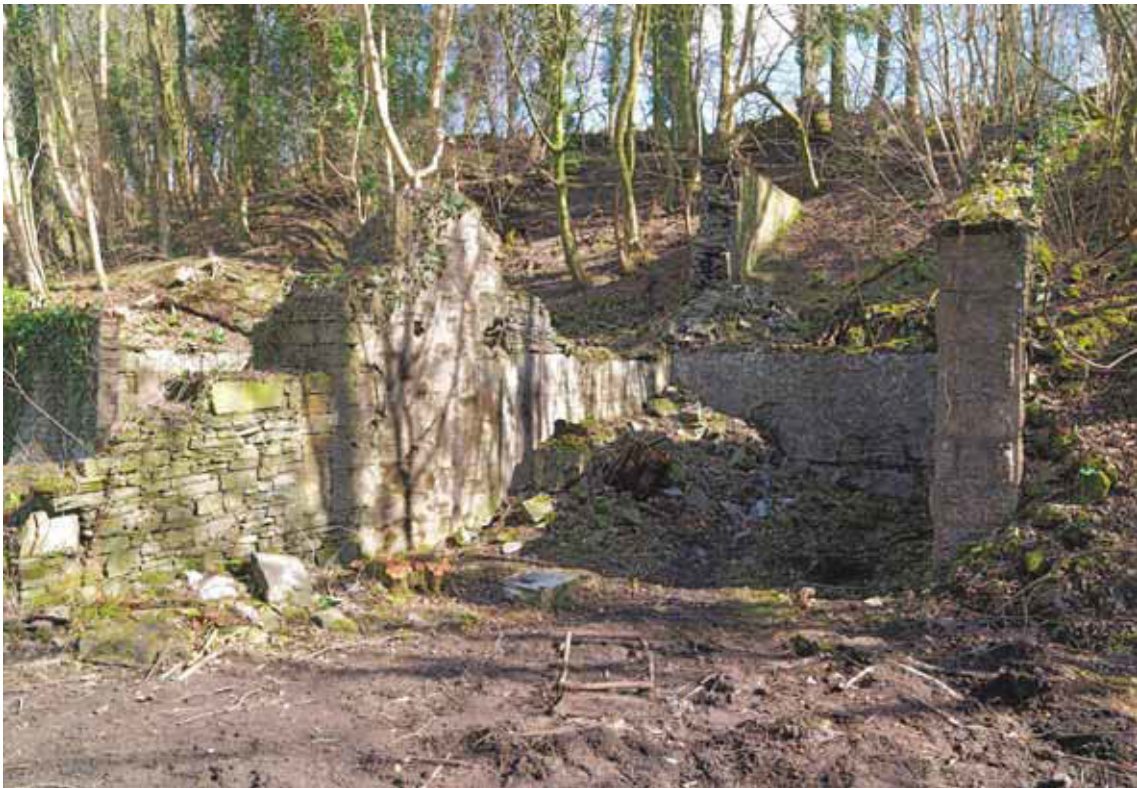
*Figure 19: The south chamber of incorporating mill I following tree clearance  
(Photograph: Bob Skingle 2006, DP028056 © English Heritage.NMR)*

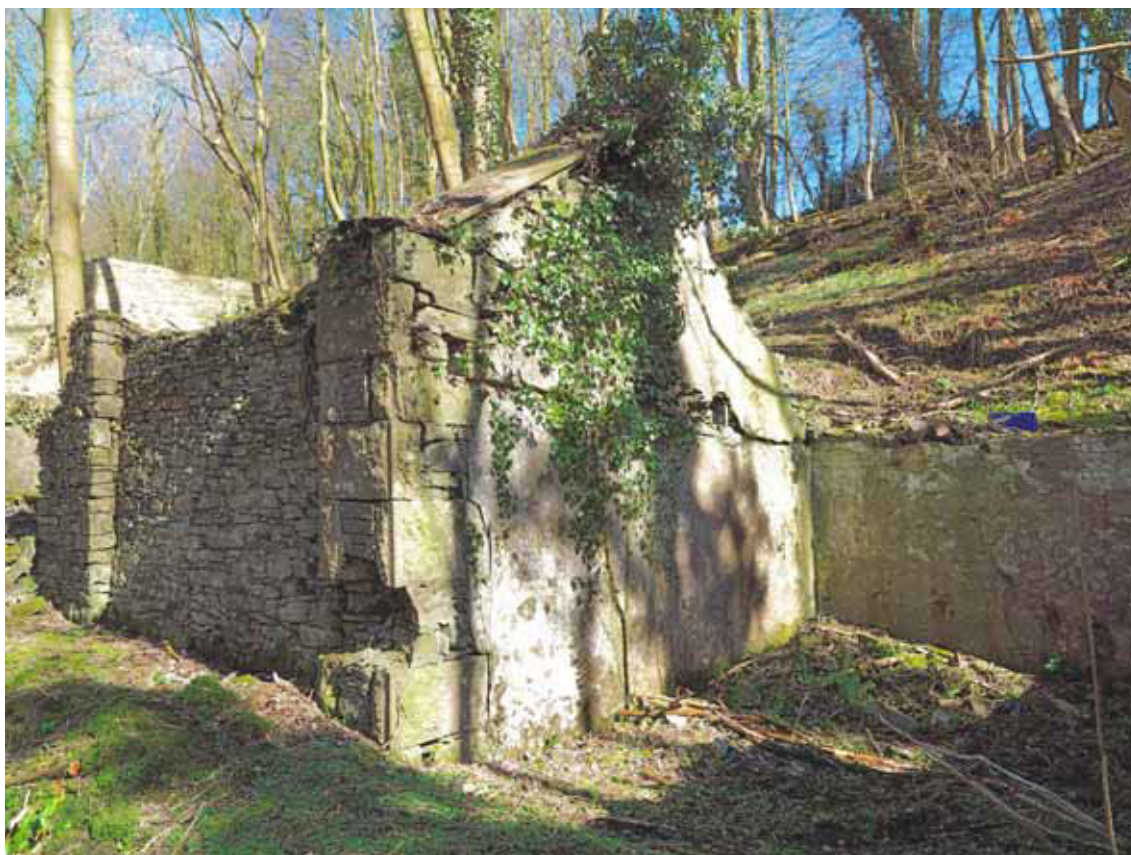
*Figure 24: The north chamber of incorporating mill 3 and retaining wall to the north  
Photograph: Bob Skingle 2006, DP028069 © English Heritage.NMR)*

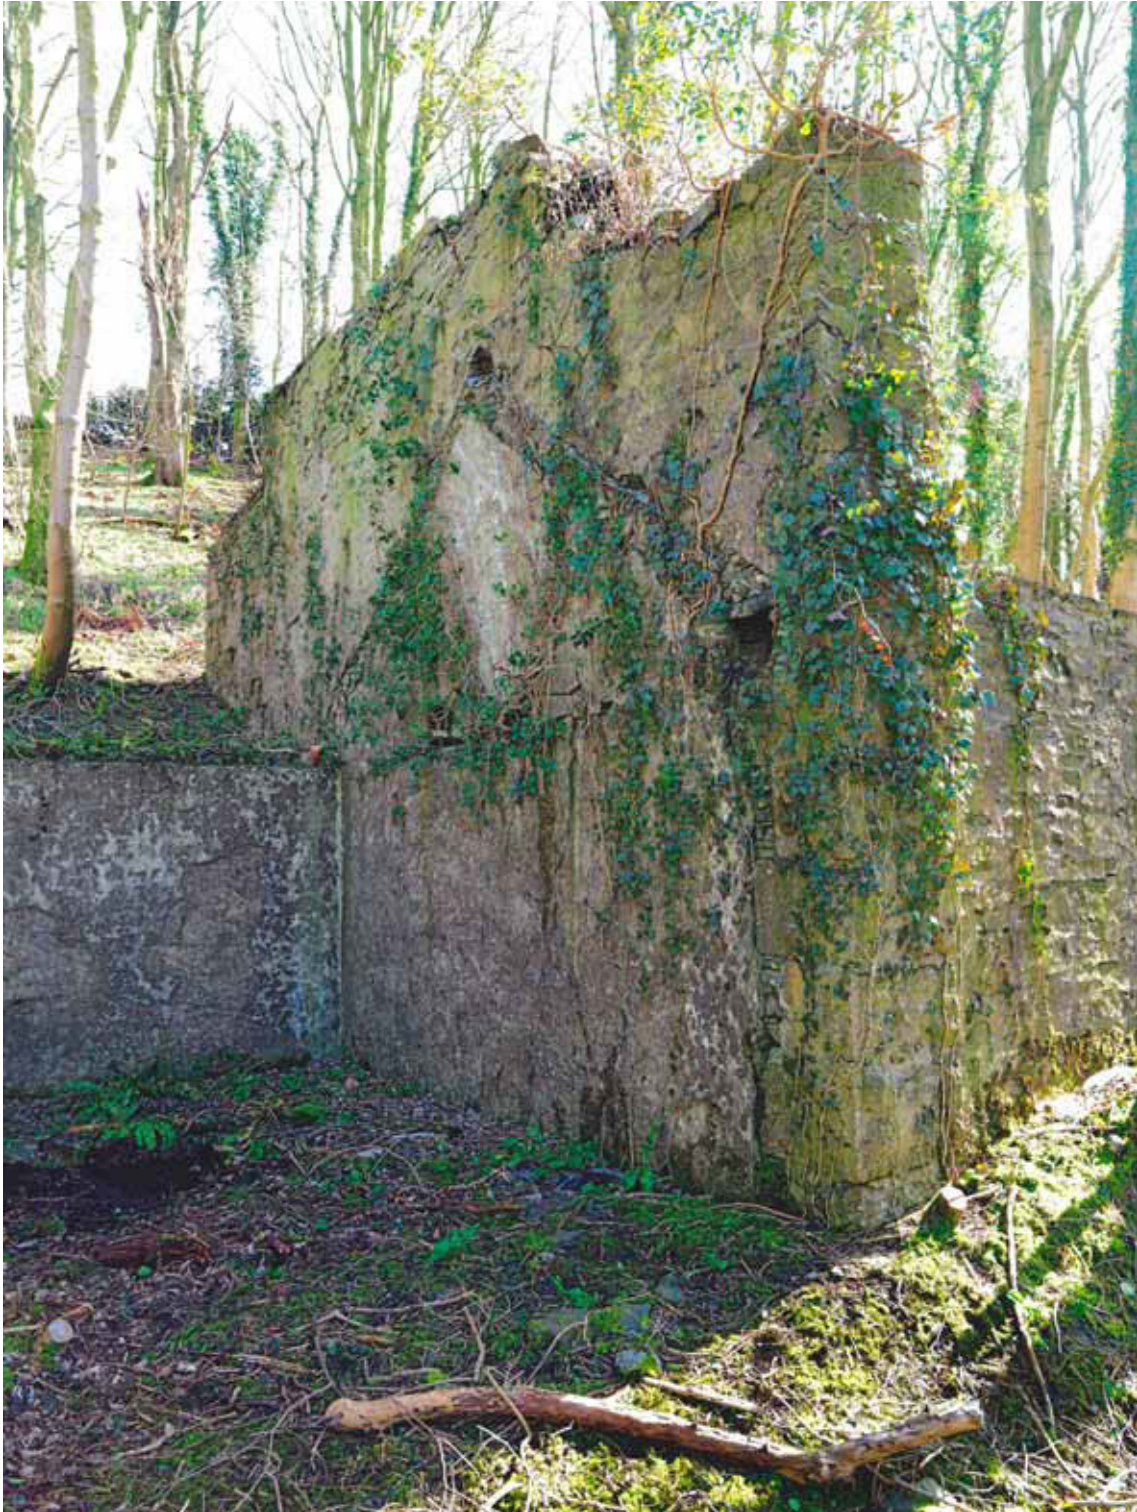
*Figure 25: The south wall of the south chamber of incorporating mill 5  
(Photograph: Bob Skingle 2006, DP028072 © English Heritage.NMR)*

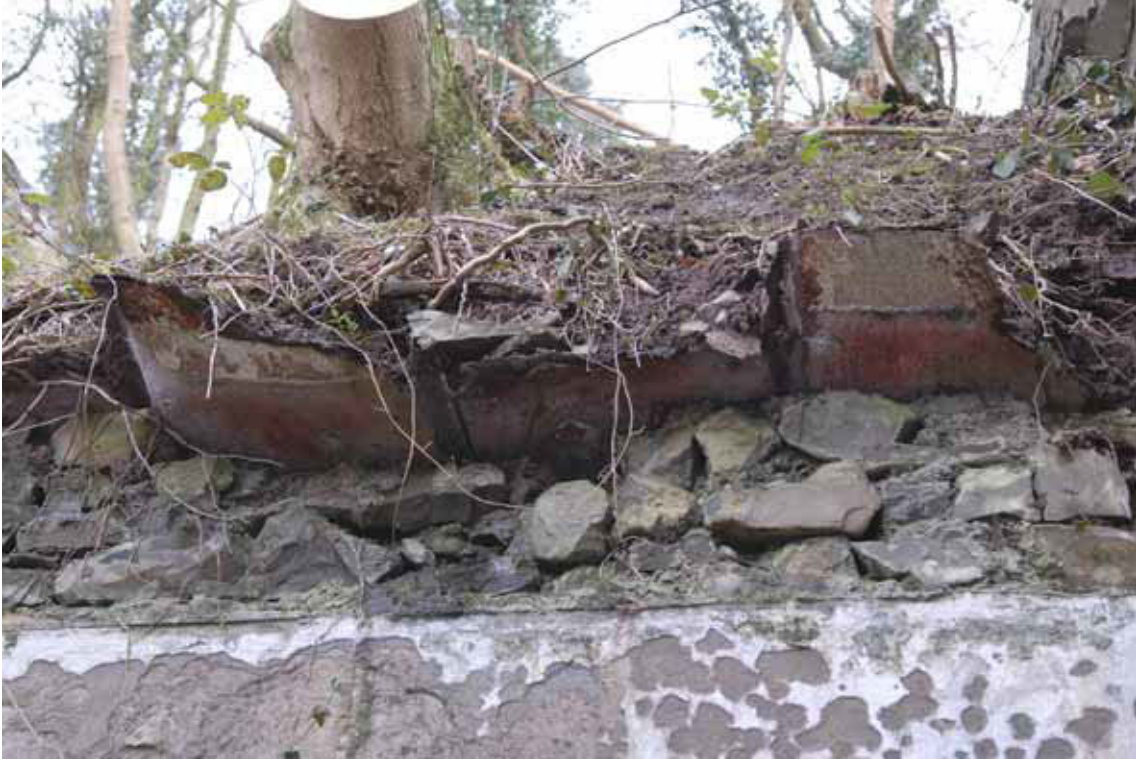
*Figure 26: Detail of metal roof panels surviving in the rear wall of the south chamber of incorporating mill 3  
(Photograph: Christopher Dunn 2006, © English Heritage)*

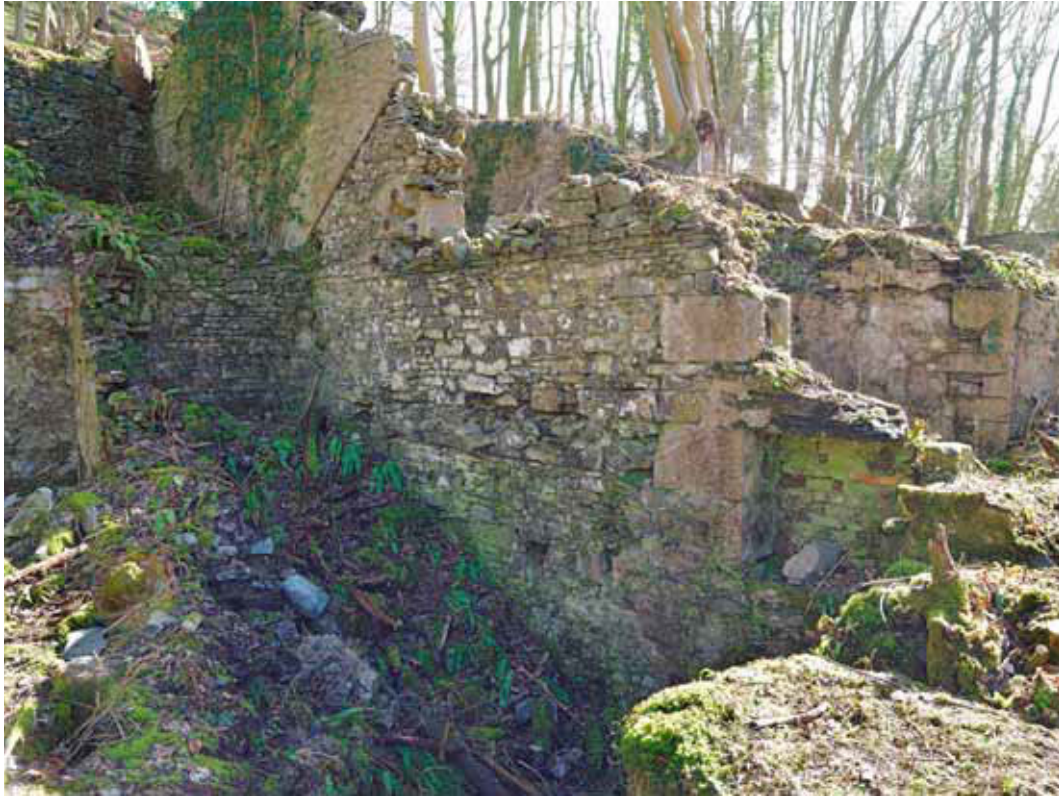
Figure 28: The waterwheel house and drive-shaft aperture at incorporating mill 7  
(Photograph: Bob Skingle 2006, DP028080 © English Heritage.NMR)

The only definite such feature is to be found in the south wall of the wheel house at incorporating mill 7 (Figs 28 and 29), but is probably a late example since it is comparable to drive-shaft apertures in the final phase adaptation of incorporating mills 25/26 and the mark IV large corning house at Lowwood (Jecock *et al* 2005, 84-9 and 109-12), both of which date to after ICI's acquisition of that site. Evidence for earlier

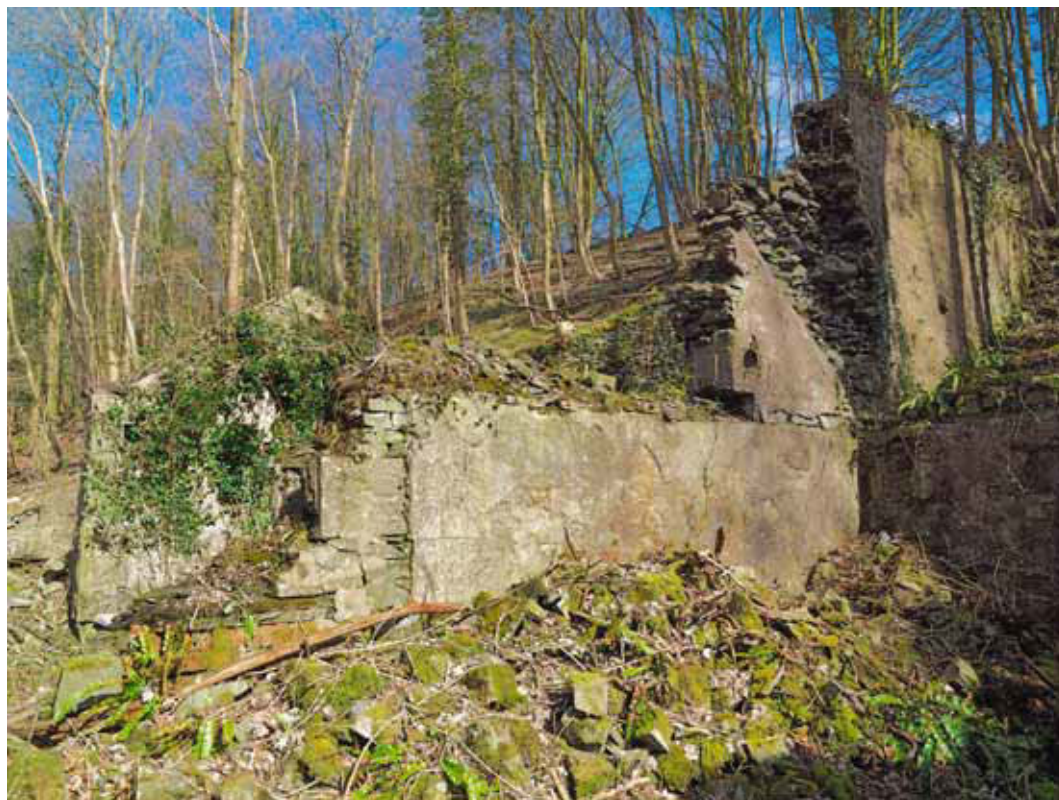
Figure 29: The drive-shaft aperture in the south chamber of incorporating mill 7 from the south  
(Photograph: Bob Skingle 2006, DP028078 © English Heritage.NMR)

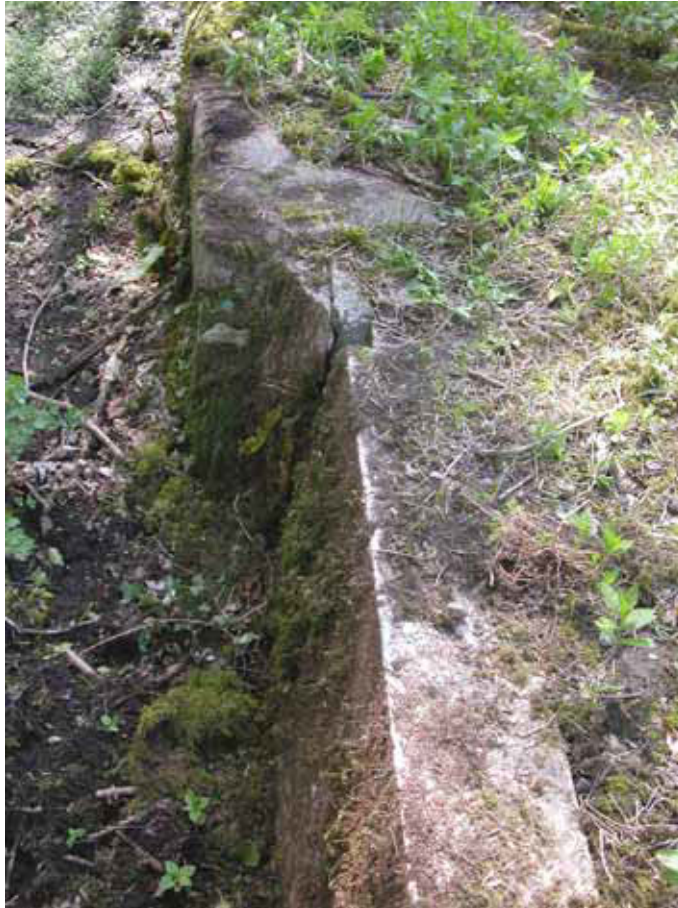
Figure 31: Unconformity in the side of the mill leat above incorporating mill 7  
(Photograph: Christopher Dunn 2006, © English Heritage)

The explanation might be that only the northernmost pair of incorporating mills was originally powered from above by water from the main leat, the disturbance in the leat side marking the position of the take-off point for a short headrace removed before 1896. This putative headrace may have powered a conventional waterwheel but, since there is no evidence (Fig 20) for the position of axle bearings, etc, in the extant southern side of the waterwheel house (the northern side has largely collapsed down to the floor level of the adjoining chamber (Fig 28)) more likely led to a turbine positioned low down towards the centre or rear of the wheel-pit, the supports for which are now obscured by rubble. Since the waterwheel house corresponds to a drop in the level of the culverted leat, the tailrace by which waste water exited the pit into the southern, lower, level of the culverted leat is also now obscured by debris (compare Figs 21 and 33). A blind, stone arch (Fig 32) in the pit's front (west) wall may mark the blocked entrance to an original tailrace at high level, but is more likely to be simply the support for a platform (largely destroyed) on which the turning-handle controlling the gate for starting and stopping the turbine, was situated; bolts for some kind of fitting survive at the centre of a timber beam that spans the width of the arch. The original platform was presumably, like the arch beneath, built in stone, but the

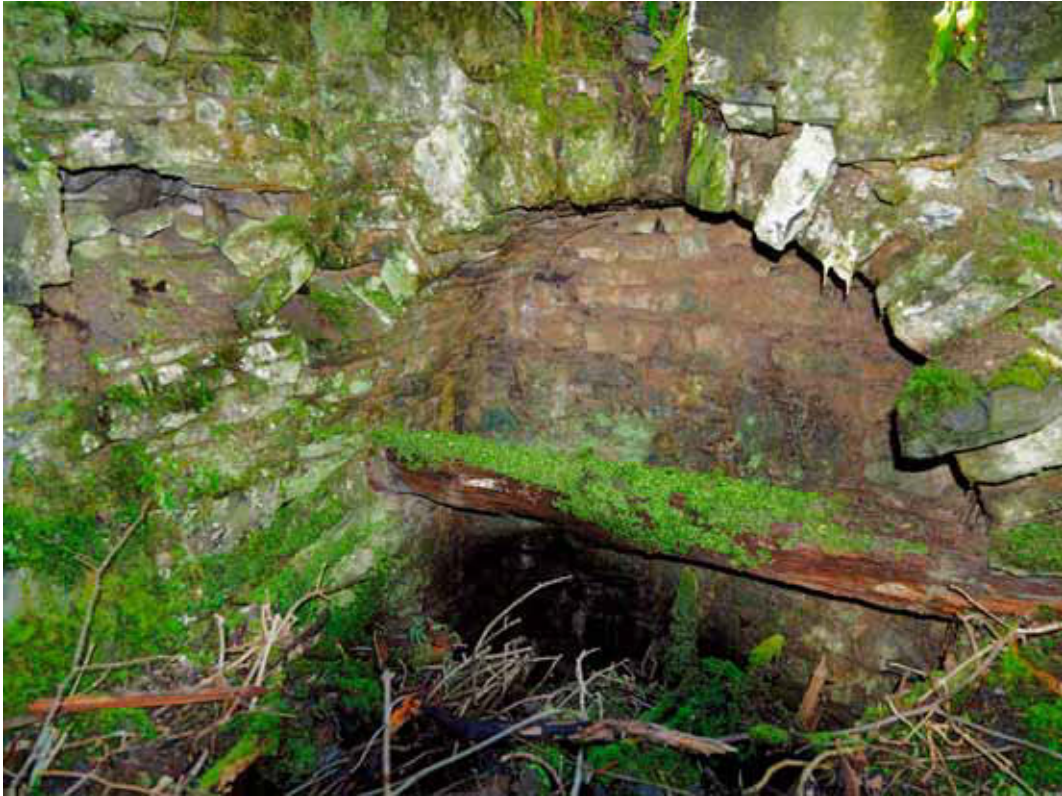
Figure 32: Blind arch in waterwheel house in incorporating mill 7  
(Photograph: Bob Skingle 2006, DP028081 © English Heritage.NMR)
