# GATEBECK LOW GUNPOWDER WORKS AND THE WORKERS' SETTLEMENTS OF ENDMOOR AND GATEBECK, CUMBRIA AN ARCHAEOLOGICAL AND ARCHITECTURAL SURVEY

## SURVEY REPORT

NGR: SD 544 853

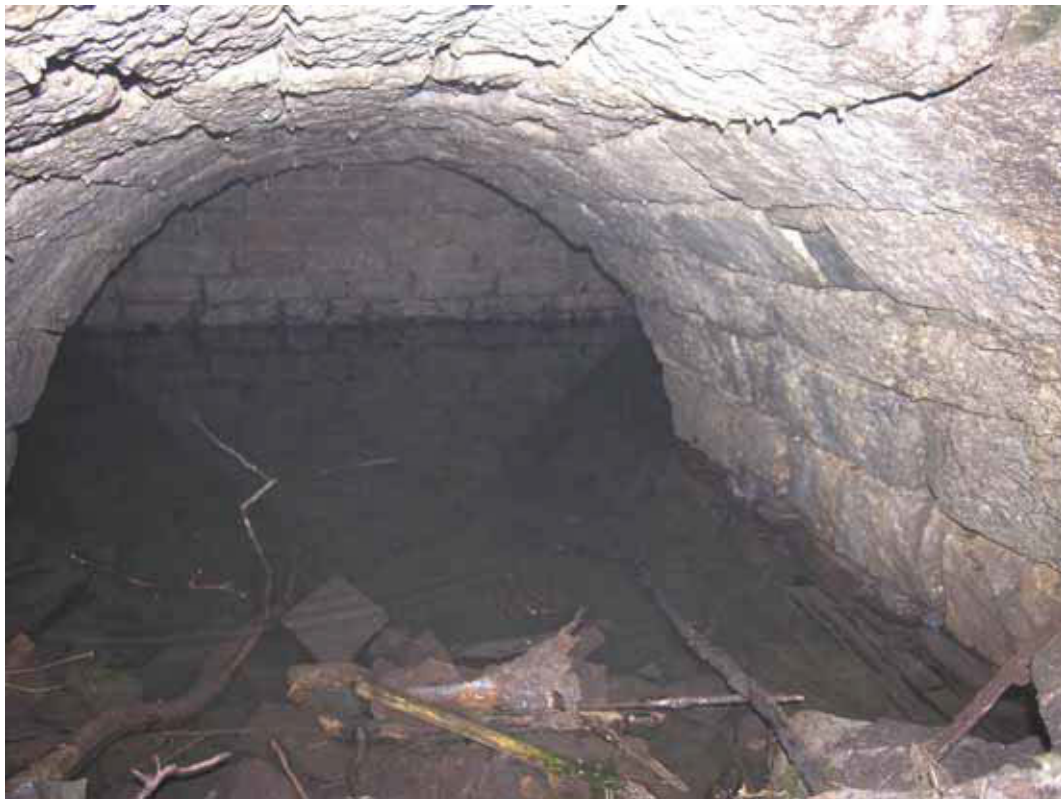
Figure 33: The tailrace from incorporating mill 3, showing its junction with the low-level culverted leat (Photograph: Marcus Jecock 2008, © English Heritage)

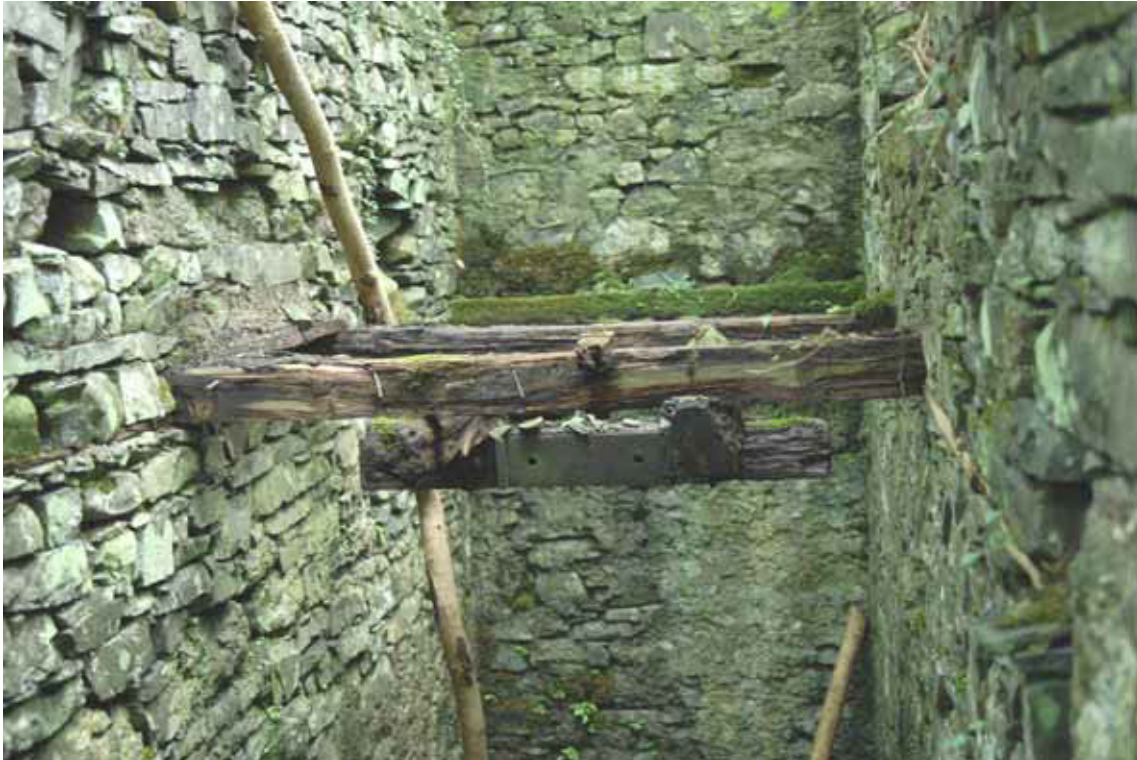
Figure 34. Timber framework supporting the drive shaft from the turbine in incorporating mill 3 (Photograph: Christopher Dunn 2008, © English Heritage)

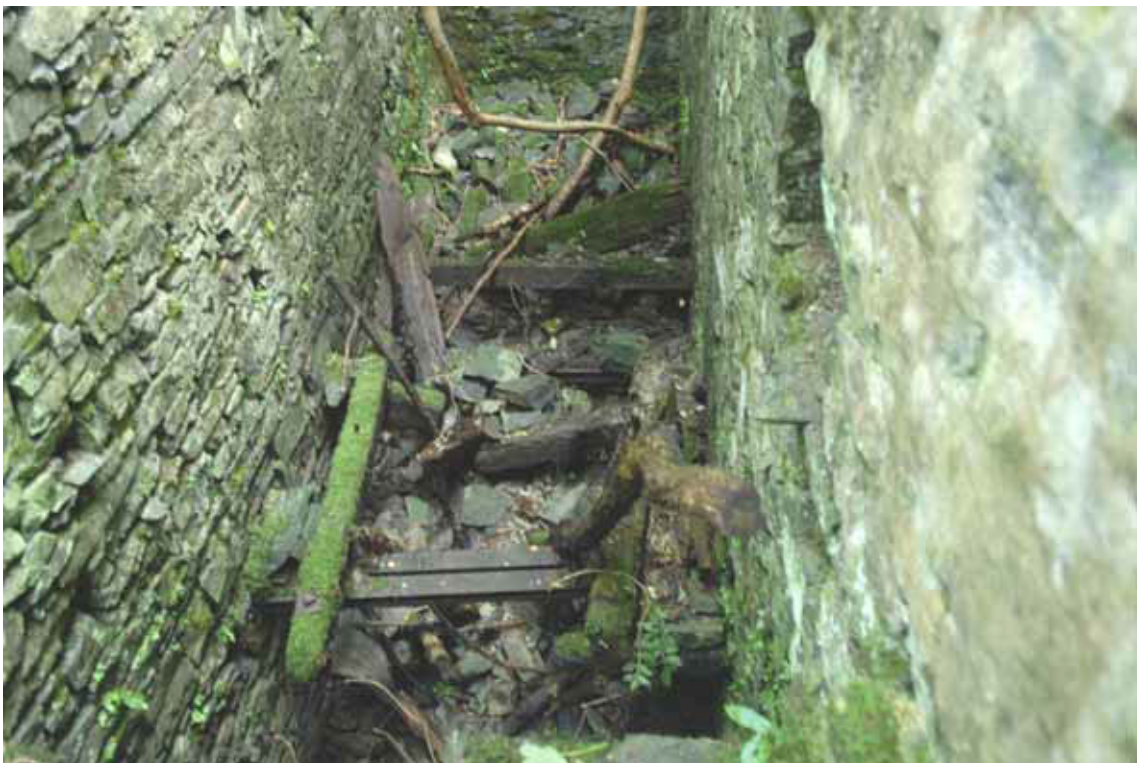
Figure 35: Timber and iron framework to support the base of a flume and turbine in incorporating mill 3 (Photograph: Christopher Dunn 2008, © English Heritage)

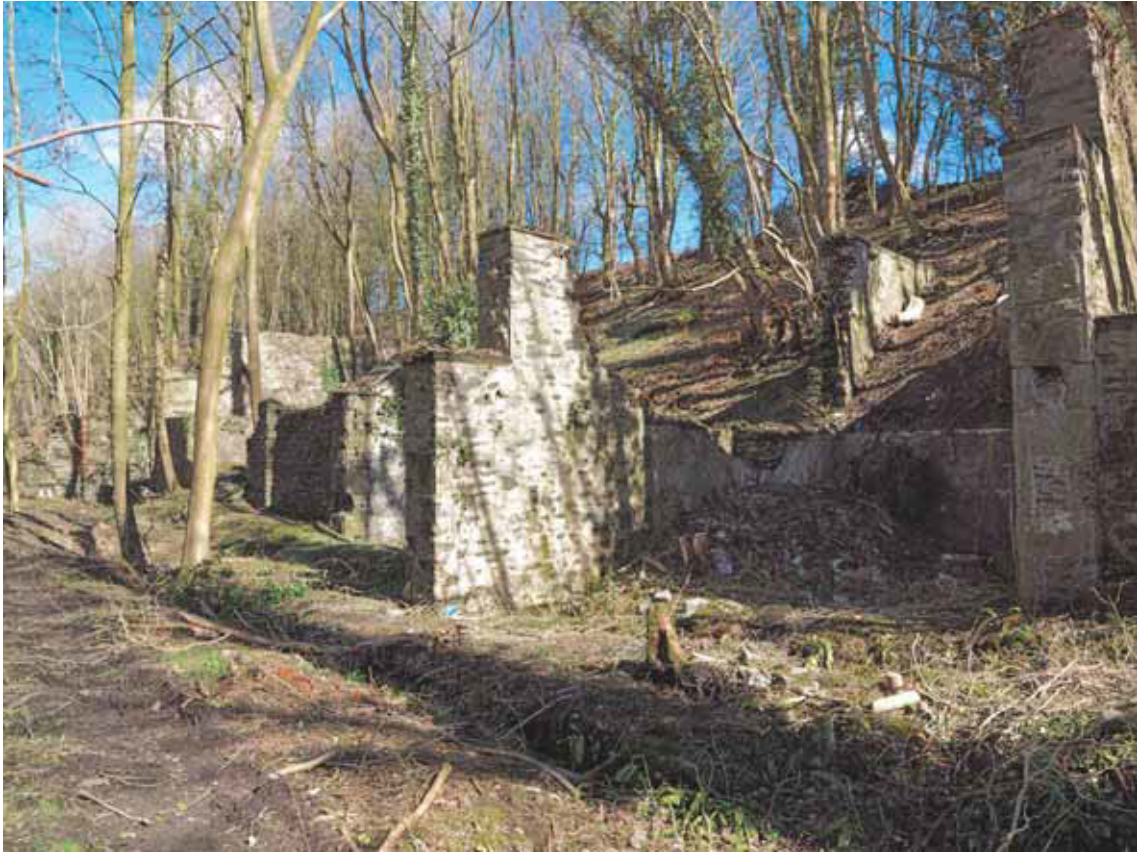
Figure 36: The southern chamber and extended blast wall of incorporating mill 3  
(Photograph: Bob Skingle 2006, DP028065 © English Heritage.NMR)

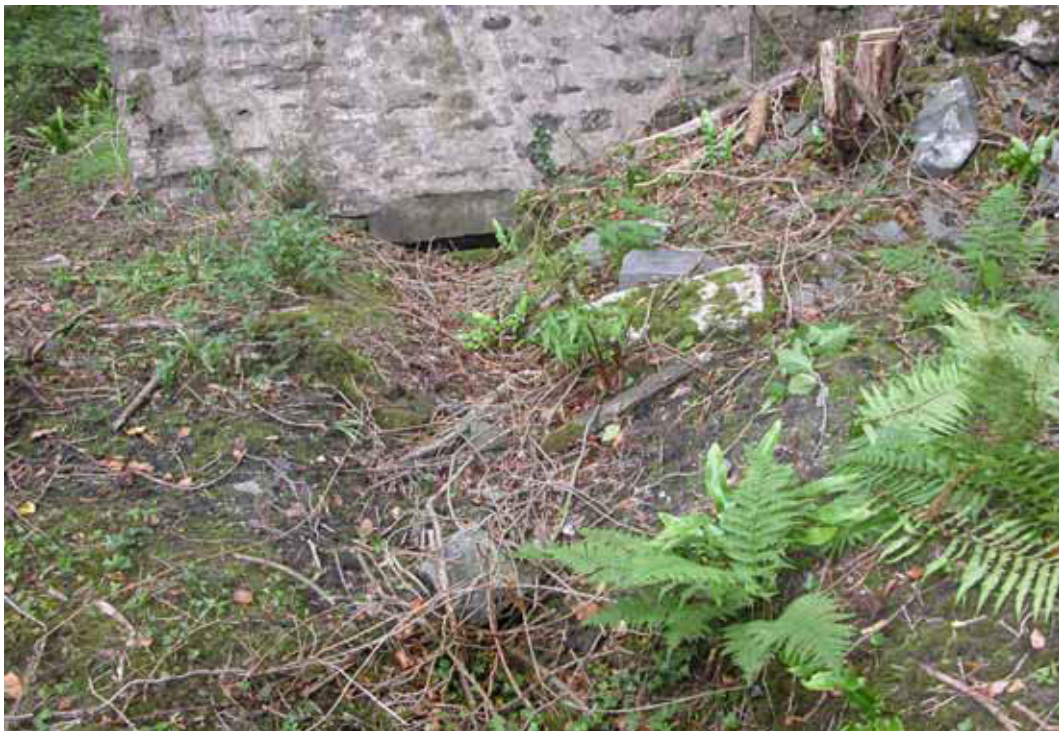
Figure 37: Detail of the wall of incorporating mill 3 extended over the turbine race  
(Photograph: Christopher Dunn 2006, © English Heritage)

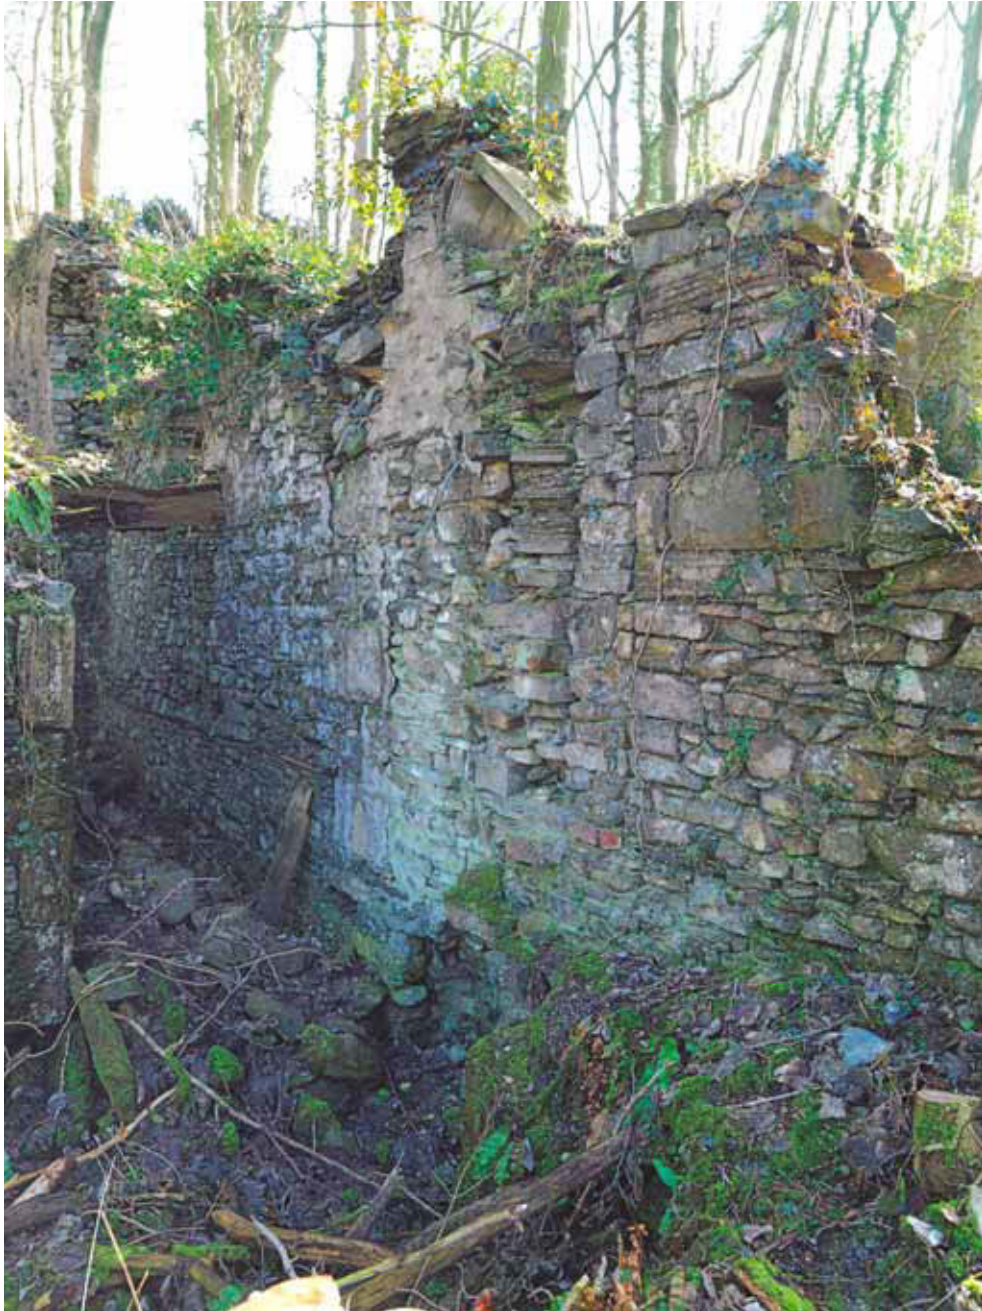
*Figure 38: The extended wall of incorporating mill 5  
(Photograph: Bob Skingle 2006, DP028075 © English Heritage.NMR)*

appears on the 1911 OS map as well (Figs 138 and 139); it is here numbered building 5a. The factory plan's failure to differentiate and name it in the same manner as building 52 suggests that it was erected without the need for an Amending Licence - that is before the requirements of the 1875 Explosives Act came into force. All the mill pairs appear to have been extended westwards (Fig 36) to accommodate line shafting transmitting power from the new engine houses (which is an argument against the primacy of steam power at mills 1 and 3). Large stone lintels carry these extensions over the posited turbine race (Fig 37) in front of incorporating mill pairs 3 and 5: in each case the north side wall of the south chamber was extended forward, the later builds clearly butting against the quoins which marked the original wall ends (Figs 34 and 38).

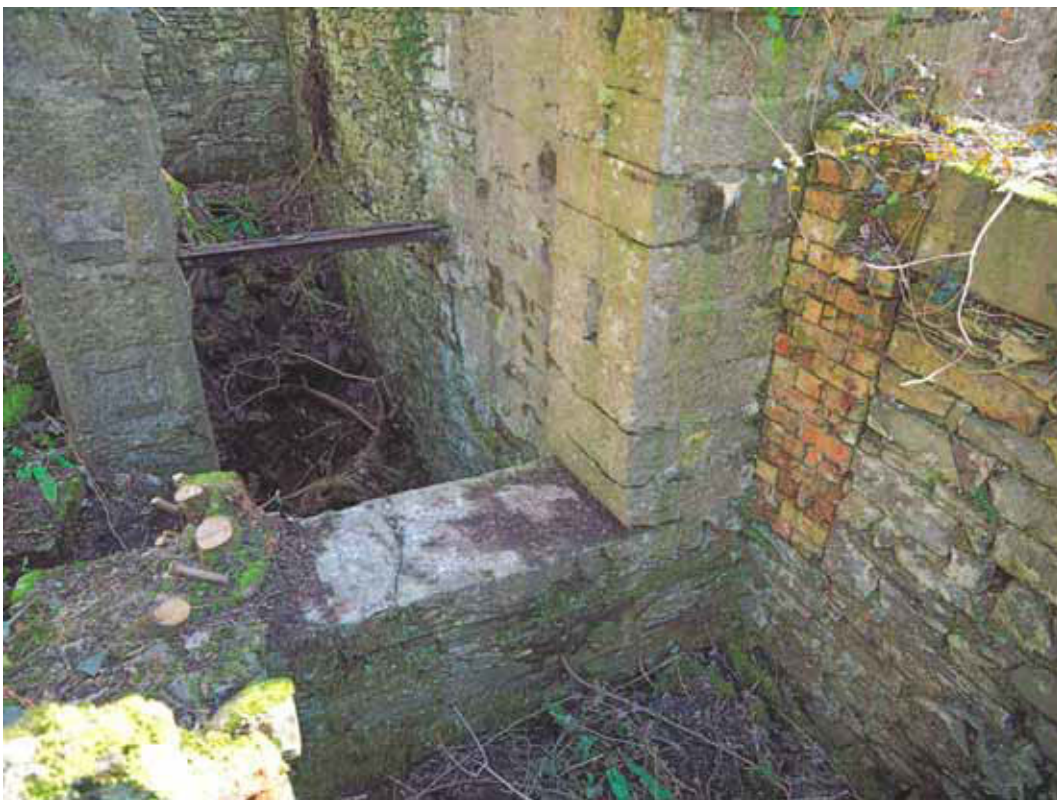
Engine house 52 in front of incorporating mill pair 1 has lost its machinery and roof and most of its walls have been reduced to stubs (Figs 20 and 39). It was built against the extended north wall of the south mill chamber, in which there is a deep slot for rope or belt drive, latterly infilled with brick (presumably when the engines were retired), and a north-facing socket, just above head height, with a mount for line-shaft bearing boxes. It retains a central engine mounting and had an entrance on the east side. A similar arrangement appears to have been in place in building 5a (Fig 22). Although this (presumed) engine house has been almost completely destroyed, the extended north wall of the south mill chamber exhibits a similar deep slot for rope or belt drive, latterly infilled with rubble and red brick, and a north-facing socket above head height with a mount for line-shaft bearing boxes (Figs 38 and 40). The arrangement suggests that the engine in front of mill pair 1 was capable of driving that pair and pair 3 while the engine in front of mill pair 5 was capable of driving that pair and pair 7. A shallow, stone-lined channel in the ground, which extends from engine house 52 as far as mill pair 5, might have accommodated steam pipes from the boiler house or further line shafting related to this.

*Figure 39: Engine house 52 in front of incorporating mill 1  
(Photograph: Bob Skingle 2006, DP028058 © English Heritage.NMR)*

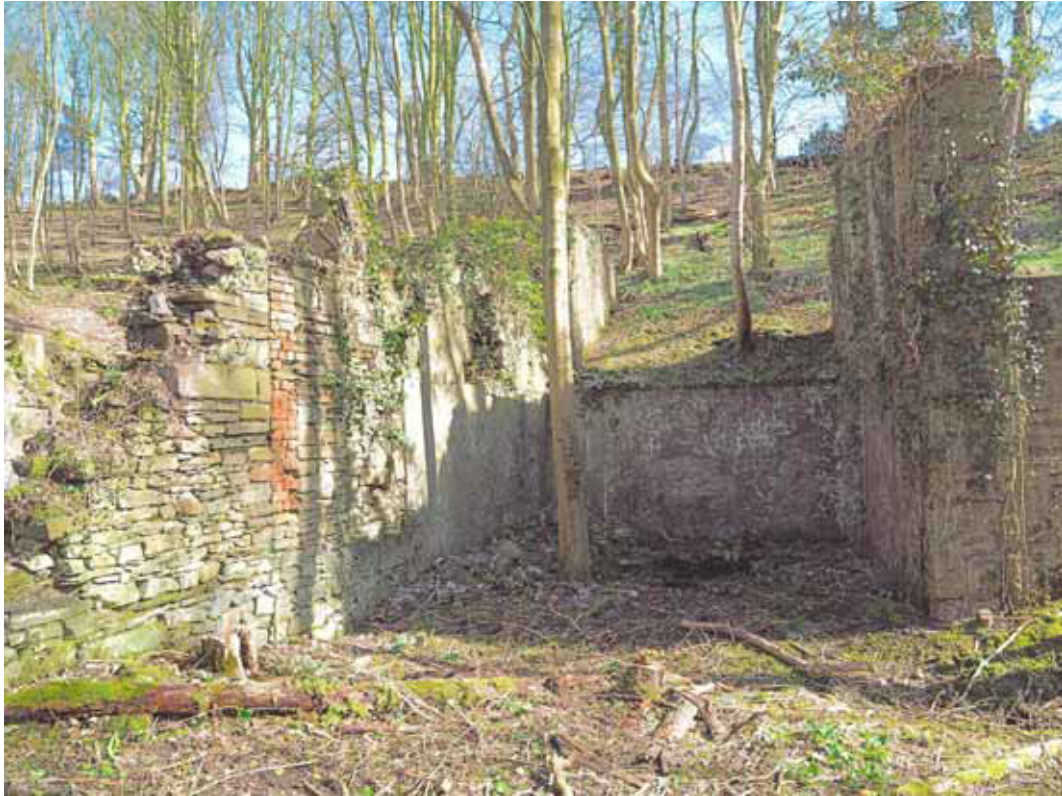
Figure 40: The south chamber of incorporating mill 5, showing later extension westward  
(Photograph: Bob Skingle 2006, DP028071 © English Heritage.NMR)

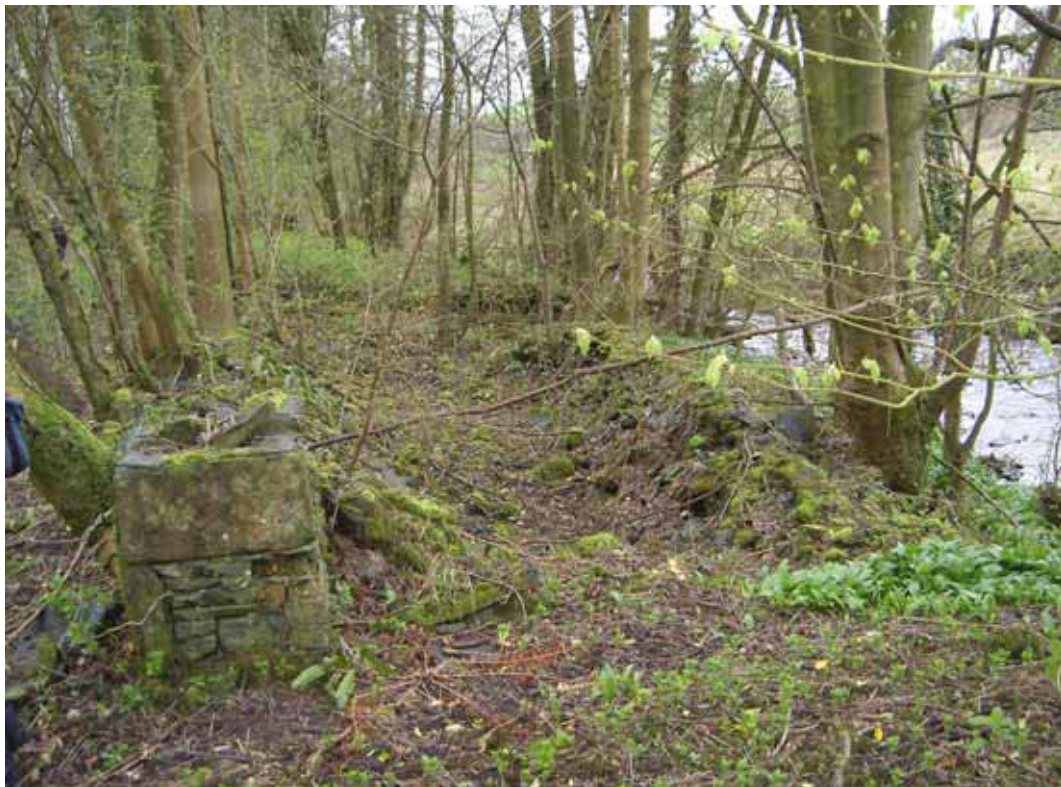
The walls of the boiler house (building 8) have been reduced to low stubs and few structural details are now discernible (Figs 21 and 41). However, the visible plan of the building matches the depiction that appears on the 1896 and 1911 OS maps (Figs 138 and 139), that is a long, narrow structure, roughly rectangular but with a slightly wider south end. The walls are of stone rubble with some ashlar quoins surviving. The remains of a buried, stone-lined flue pass from the wider, southern end of the building, under the tramway, up the hillside immediately south of incorporating mill pair 3 and lead to

Figure 41: The steam-boiler house (building 8) from the north  
(Photograph: Christopher Dunn 2006, © English Heritage)

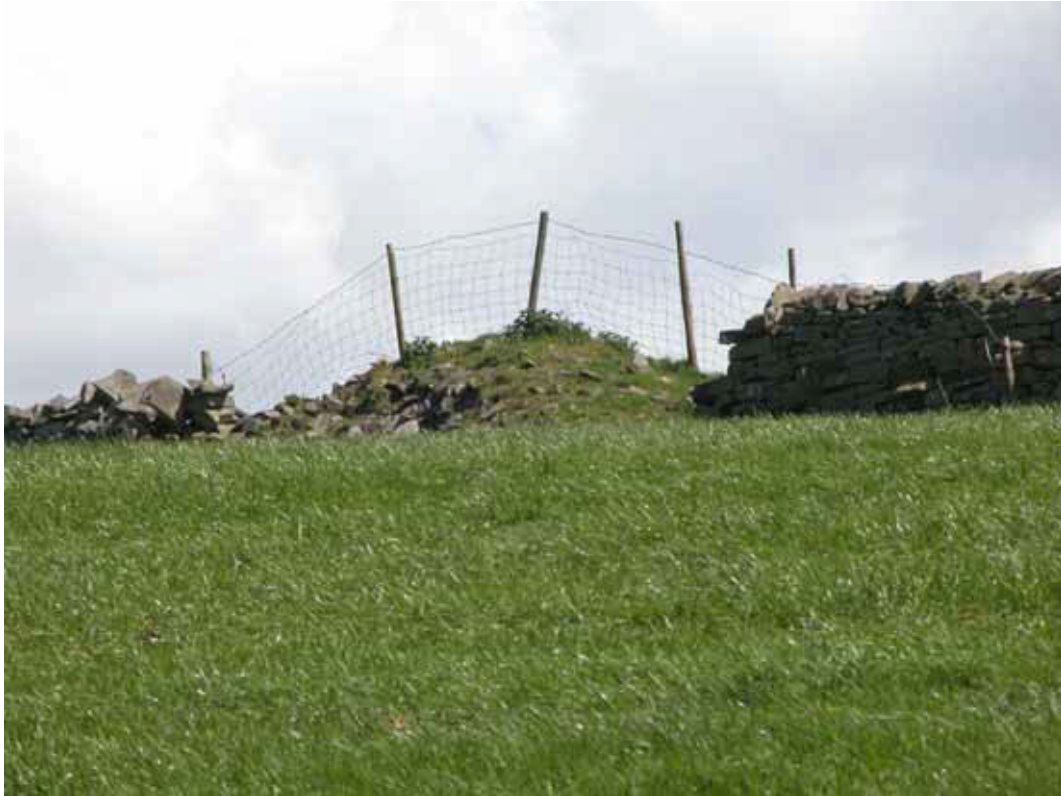
*Figure 42: Boiler-house chimney (building 8b) from the west  
(Photograph: Christopher Dunn 2006, © English Heritage)*

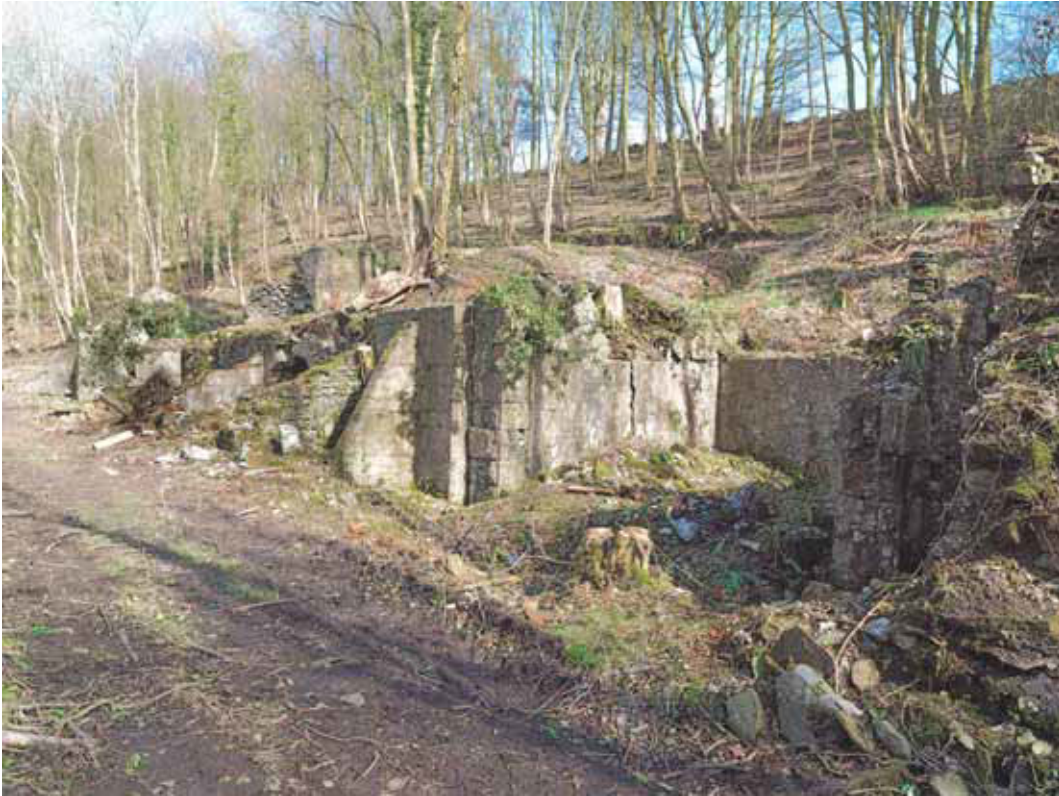
Figure 43: Concrete buttress north of incorporating mill 5  
(Photograph: Bob Skingle 2006, DP028074 © English Heritage.NMR)

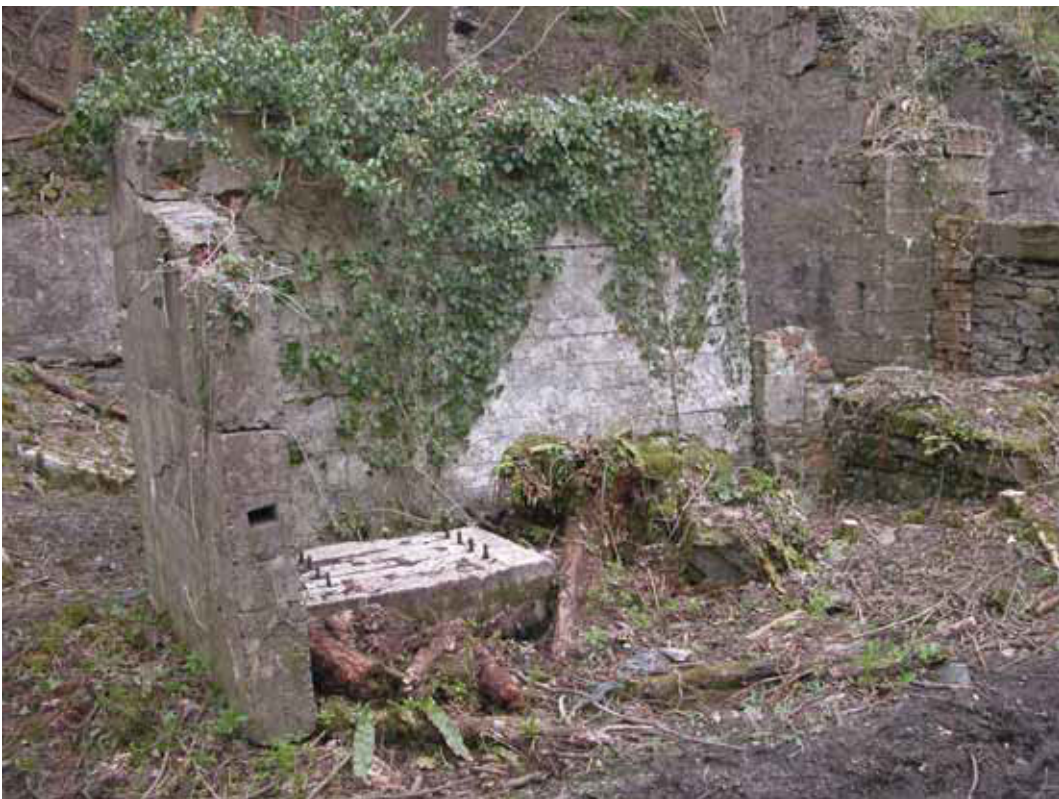
Figure 44: The electric-motor house (building 52a) from the west  
(Photograph: Christopher Dunn 2006, © English Heritage)

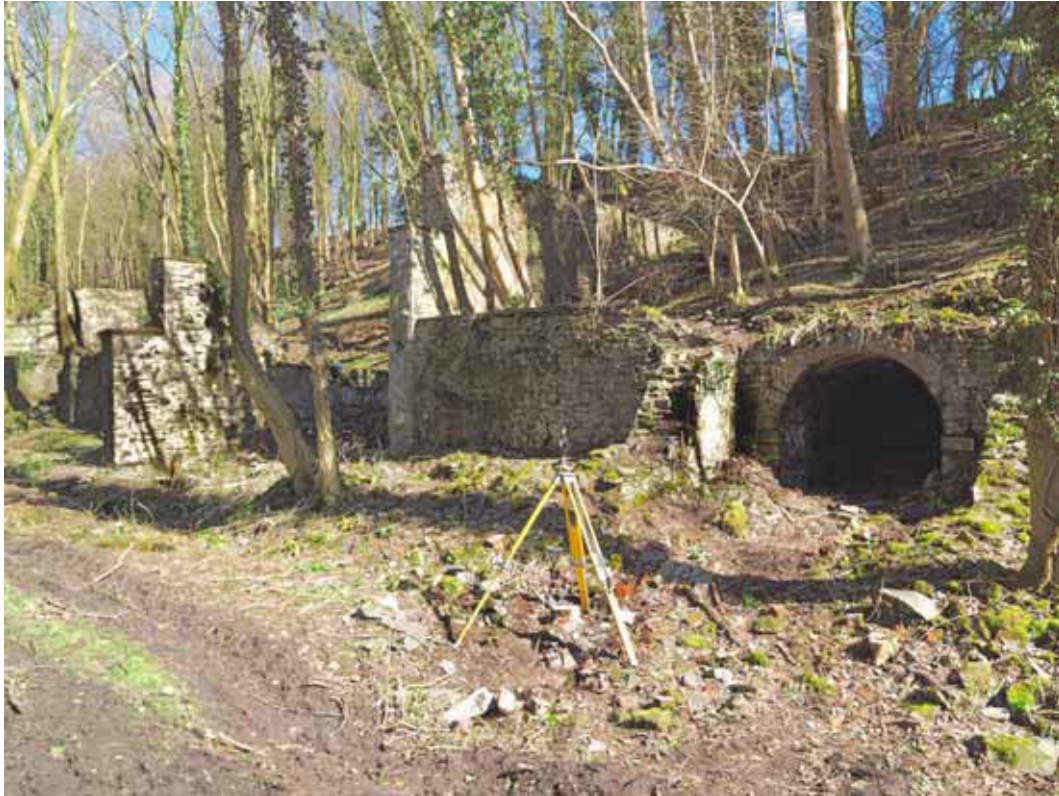
Figure 47: The southern charge house (building 2) from the west  
(Photograph: Bob Skingle 2006, DP028064 © English Heritage.NMR)

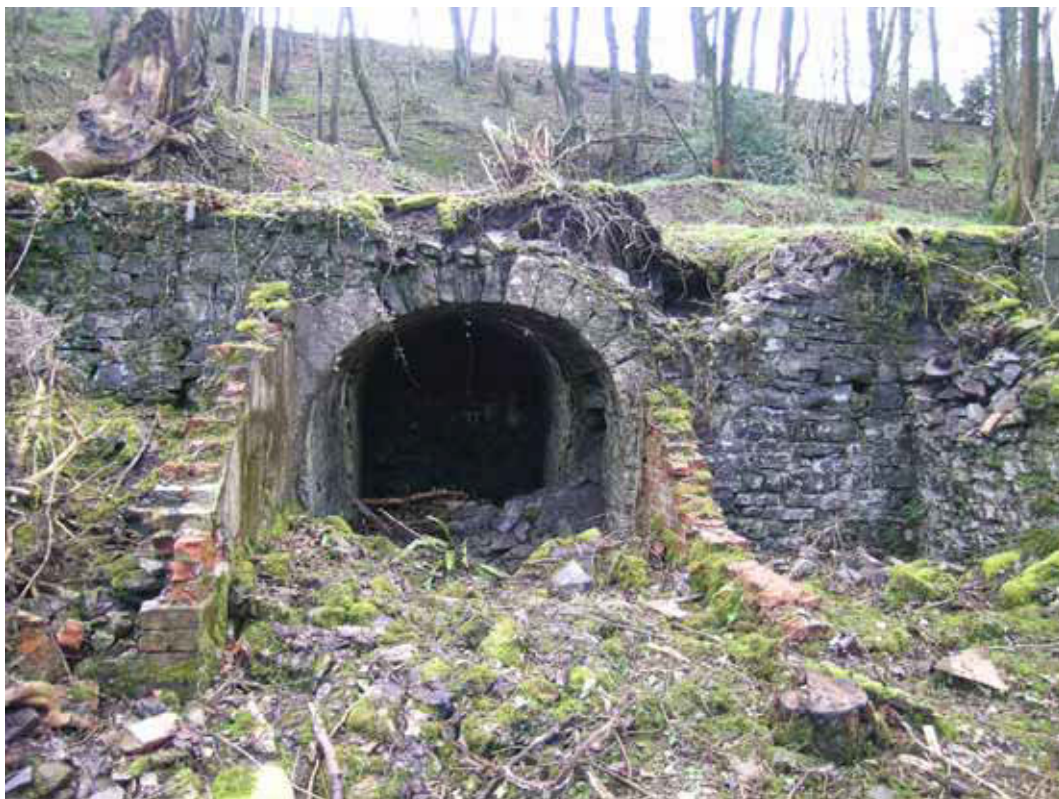
Figure 48: The northern charge house (building 6) from the west  
(Photograph: Tony Berry 2006, © English Heritage)

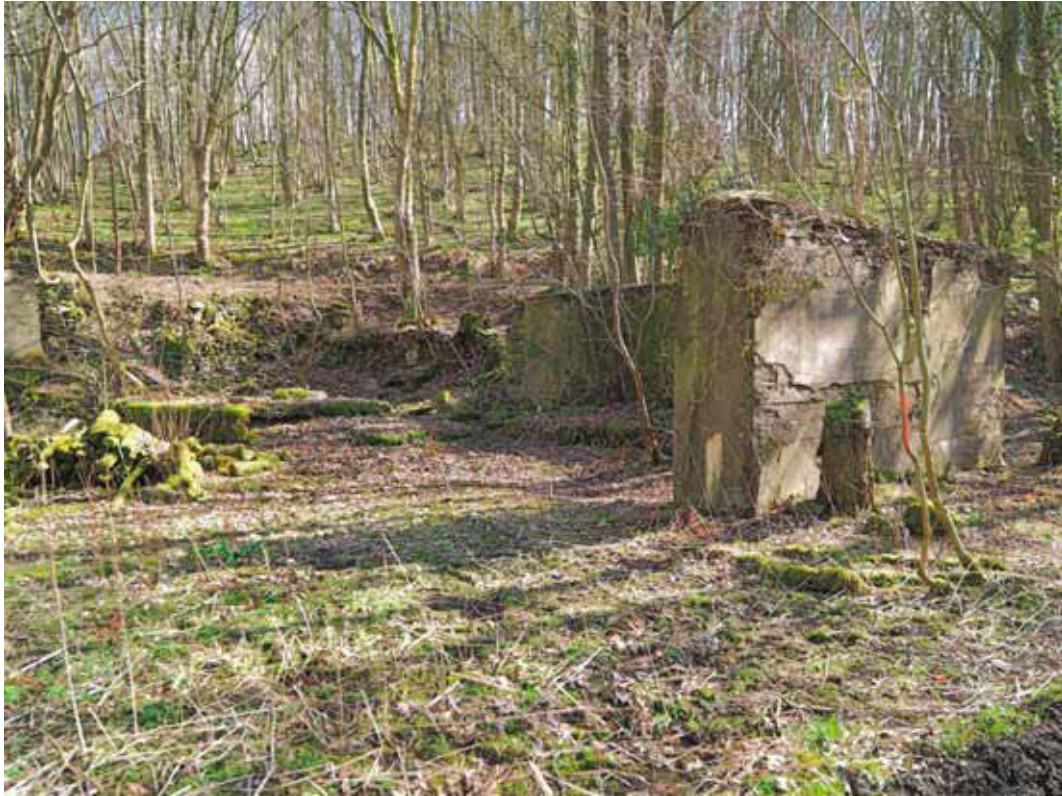
Figure 49: The southern end of the platform for the large corning house (building 12) shielded by blast walls BW2 and BW3  
(Photograph: Bob Skingle 2006, DP028050 © English Heritage.NMR)

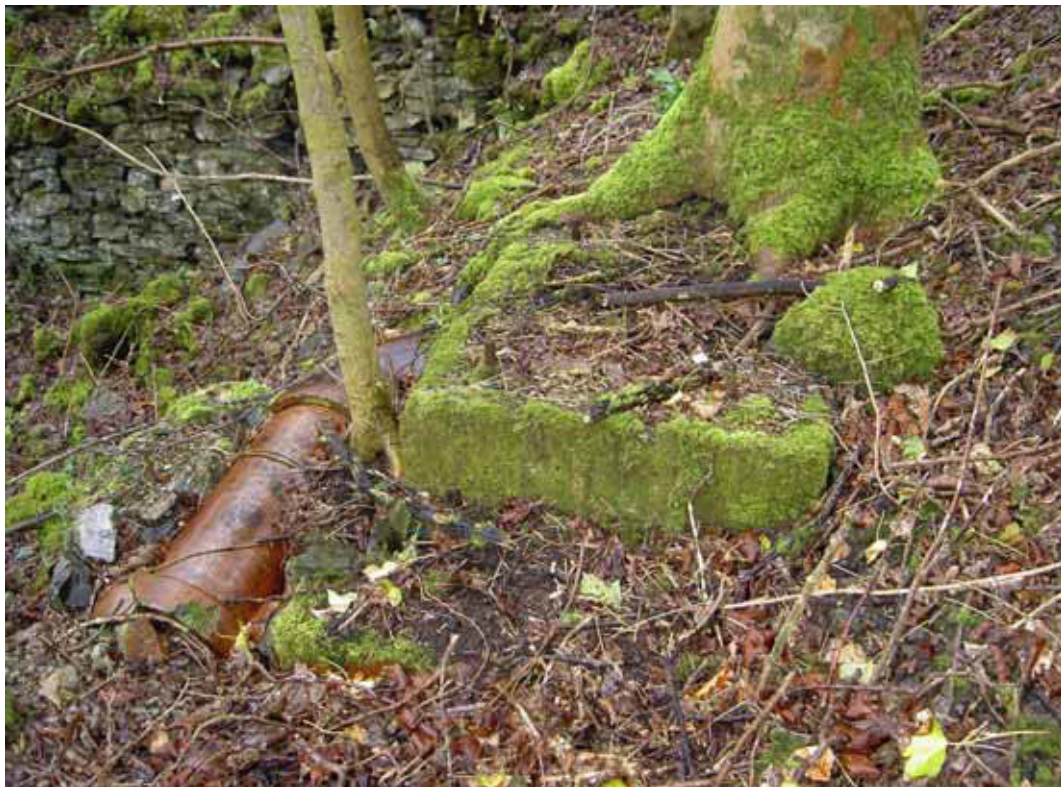
Figure 50: Concrete base with securing bolts, possibly part of the mark I engine-house flue  
(Photograph: Christopher Dunn 2006, © English Heritage)

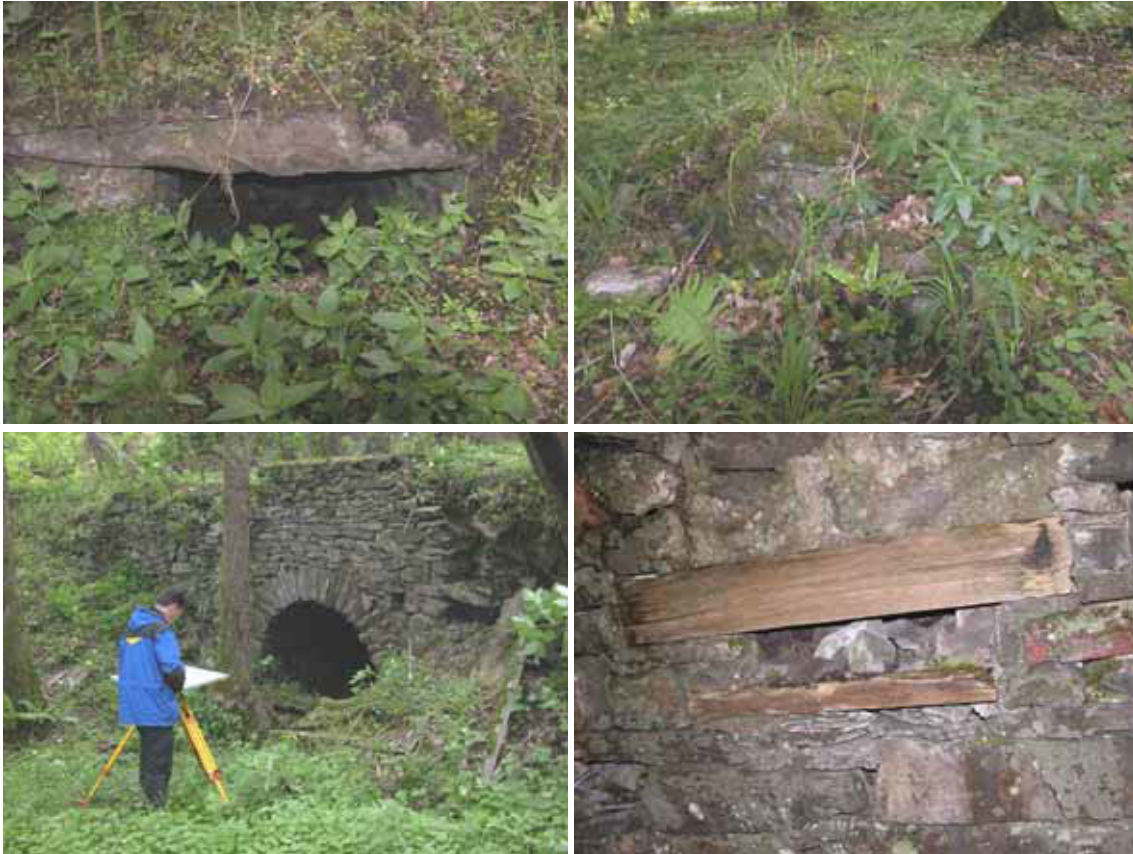
(Clockwise from top left)

A stone arch in the wall revetting the side of the pre-gunpowder mill leat (sections 6.1.2 and 6.2.1 above) is the exit portal of the tailrace from the waterwheel-pit of the mark I corning house (Fig 54), culverted under the line of the tramway. The portal is in line with a silted channel on the far side of the pre-gunpowder mill leat, presumably to allow water exiting the culvert to flow straight into the beck and not erode the edge of the leat, although the channel is not shown on any of the three OS map editions; its head was subsequently blocked off with concrete (presumably in 1923 when the tailrace became redundant). A shallow rectangular depression next to the mill leat behind building 12, cut through by the later retaining/blast wall BW4 of the mark II house, corresponds to line detail on the 1858 OS map (Fig 137), but is of unknown function. Whatever its purpose, the feature is not indicated on the 1896 OS map (Fig 138) and would therefore seem to have been disused before the end of the century.

- Figure 51: The stone-lined box in the wall revetting the pre-gunpowder mill leat  
 Figure 52: Stone support for the pressurised-water pipe to the southern press house  
 Figure 53: The wood-lined box in the wall revetting the pre-gunpowder mill leat  
 Figure 54: The exit portal of the tailrace from the mark I large corning house  
 (All Photographs: Christopher Dunn 2006, © English Heritage)

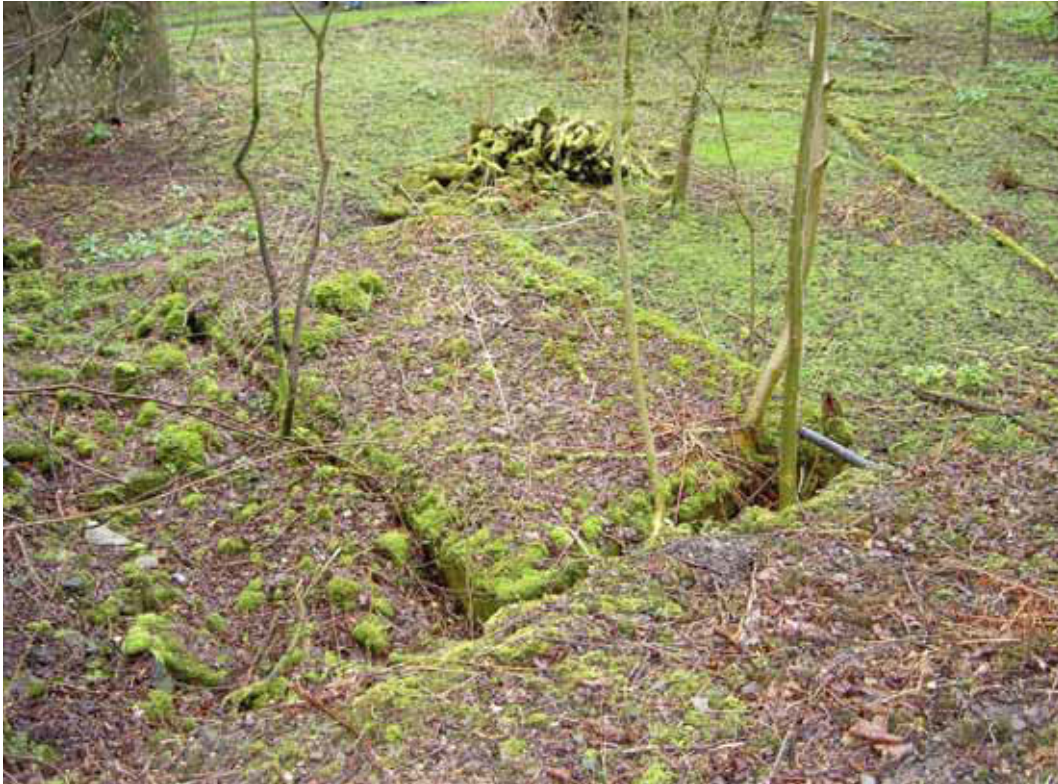
Figure 55: The raised, southern compartment of the mark II large corning house, looking west  
(Photograph: Christopher Dunn 2006, © English Heritage)

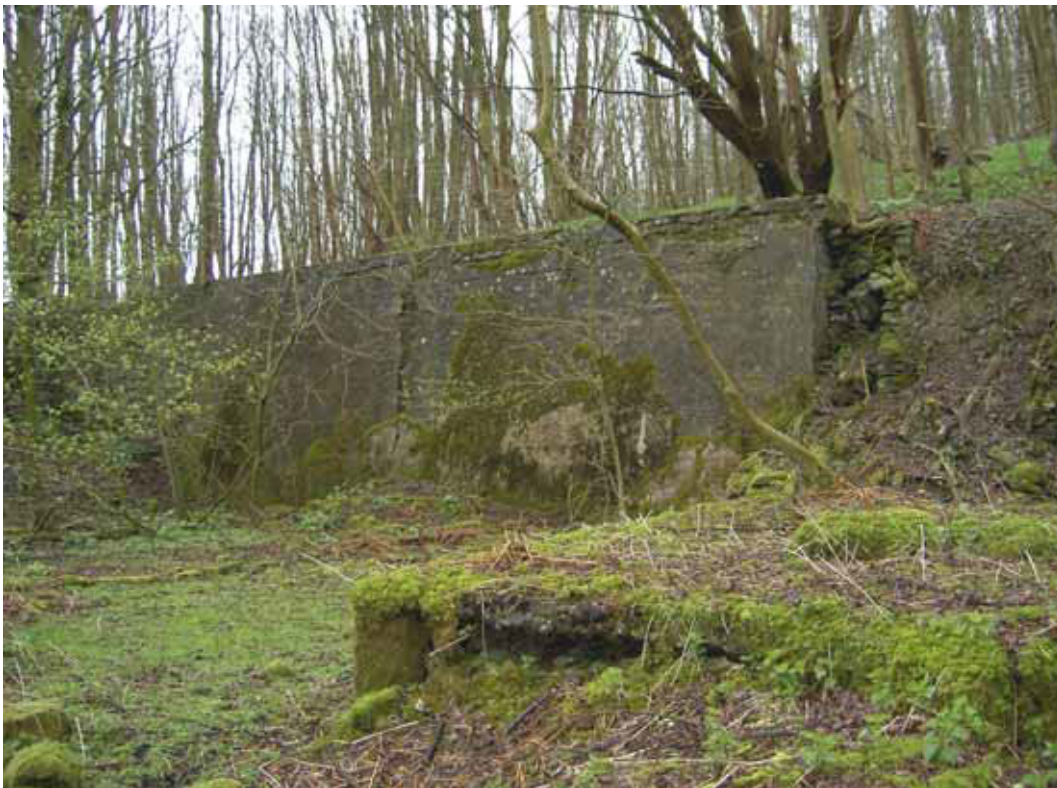
and solidity of a new length of battered retaining wall (Fig 56) constructed immediately behind the corning compartment of the mark II building, connecting earlier masonry, indicates that it was more than simply a retaining wall, and was designed to withstand the blast of the corning house exploding (BW4). All four are essentially intact, although beginning to lose some of their concrete render; where this is the case, it reveals that the walls are constructed in stone and brick beneath at least two coats of render (Fig 49). Together with blast bank BBI (described above) to the north shielding power house 13a, the mark II house thus had blast protection on all four sides. Blast protection may also have been provided to users of the tramline running out to the expense magazine and press houses on the other side of the beck, for a line of three regularly spaced post-supports along the southern edge of the tram bridge's eastern embankment (Fig 57) indicate that some form of timber screening stood here, too. The supports are built of brick covered in concrete render; they held uprights 0.15m square. (See also Blast Banks and Walls, section 6.2.10 below).

Figure 56: Blast wall BW4 behind the mark II large corning house, looking north-east  
(Photograph: Christopher Dunn 2006, © English Heritage)

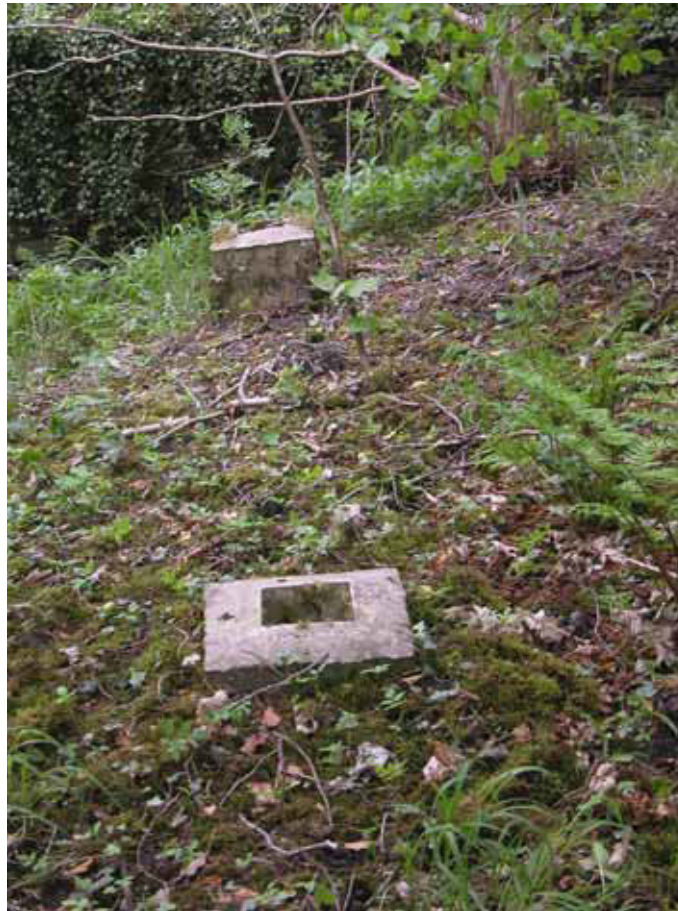
Figure 57: Post-supports for blast screen along tram embankment  
(Photograph: Christopher Dunn 2006, © English Heritage)

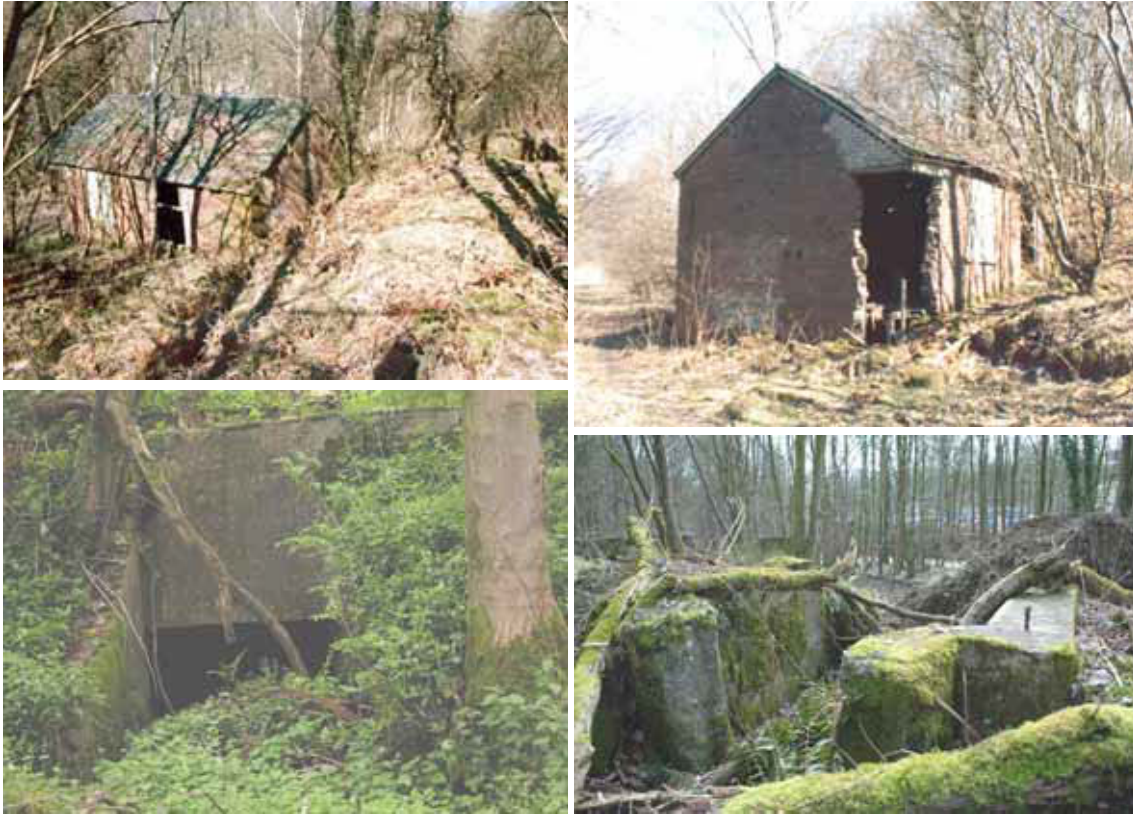
(Clockwise from top left)

Figure 58: Power house building 13a from the south-east in 1978/9

Figure 59 The west gable end of building 13a in 1978/9

The large corning house mark II was undoubtedly powered by the 12 bhp (8.9kW) Vortex unit (manufacturer's no. 3049) which the company bought from the local Kendal firm of Gilkes in 1923 (section 4.2 above). This was housed in a new brick-built 'Power House' (building 13 on the 1923 factory plan, re-labelled 13a for the purposes of the present report) sited north of the corning house. The building survived relatively intact until recently, as shown by photographs taken by Ted Patterson in 1979 (Figs 58 and 59) and Ian Tyler (2002, 58) *circa* 2000, but unfortunately was almost completely demolished sometime prior to survey in 2006 by a falling tree. The trunk and branches of the tree remained *in situ* across the ruins at the time English Heritage carried out fieldwork and prevented close inspection or recording, particularly of the interior (Fig 4). A concrete header tank (Fig 60) built into the top of the embankment to the mill leat above the power house, and the culverted tailrace (Fig 61) leading from the building, both survive in reasonably good condition, however.

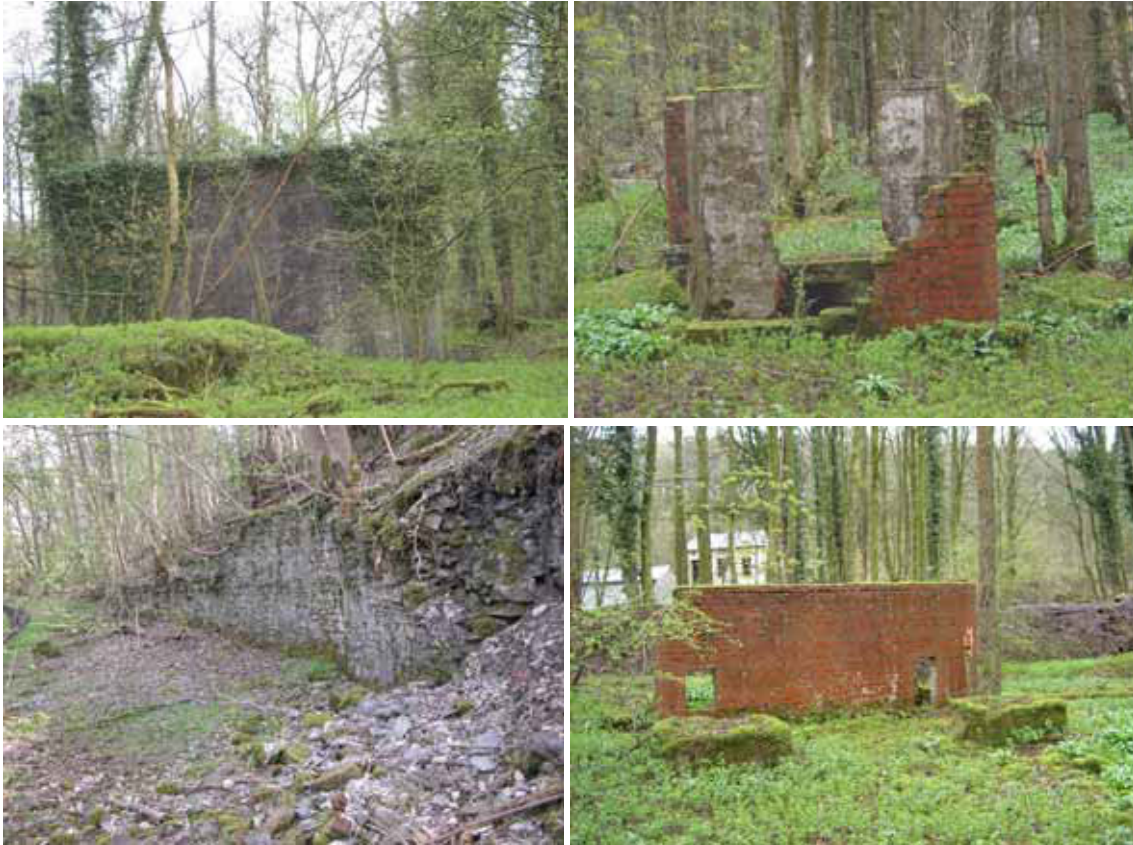
(Clockwise from top left)

Figure 63: Blast wall BW5 north of the small corning house, from the south

The concrete floor slabs of both chambers survive, as do the ends of the intervening, stone, blast wall up to a height of *circa* 1m, all much obscured by demolition debris and a build-up of leaf mould and earth. A second, free-standing blast wall (BW5) still stands to its full height of over 3m immediately north of the corning house (Fig 63). As at the large corning house, a separate, raised compartment exists at one end of the corning chamber. Also like the large corning house, a brick plinth (with occasional upstanding metal bolts which would have secured the base plates of lightweight timber or metal wall panels to the plinth) runs around much of the perimeter of both chambers, although in this case the positions of doorways in to the chambers are masked by the amount of overlying rubble and humus. An incomplete opening, *circa* 0.24m square, low down in the surviving southern end of the blast wall marks the position of one of the housings through which the line shafts powering the corning machine would have passed. The actual housing has been lost, but it was probably similar if not identical to those that survive at the mark IV lower corning house at Lowwood (Jecock *et al* 2005, 110-12). No doubt the Lowwood corning house also provides the pattern for the position of other housings in the demolished blast wall at Gatebeck.
