# GATEBECK LOW GUNPOWDER WORKS AND THE WORKERS' SETTLEMENTS OF ENDMOOR AND GATEBECK, CUMBRIA AN ARCHAEOLOGICAL AND ARCHITECTURAL SURVEY

## SURVEY REPORT

NGR: SD 544 853

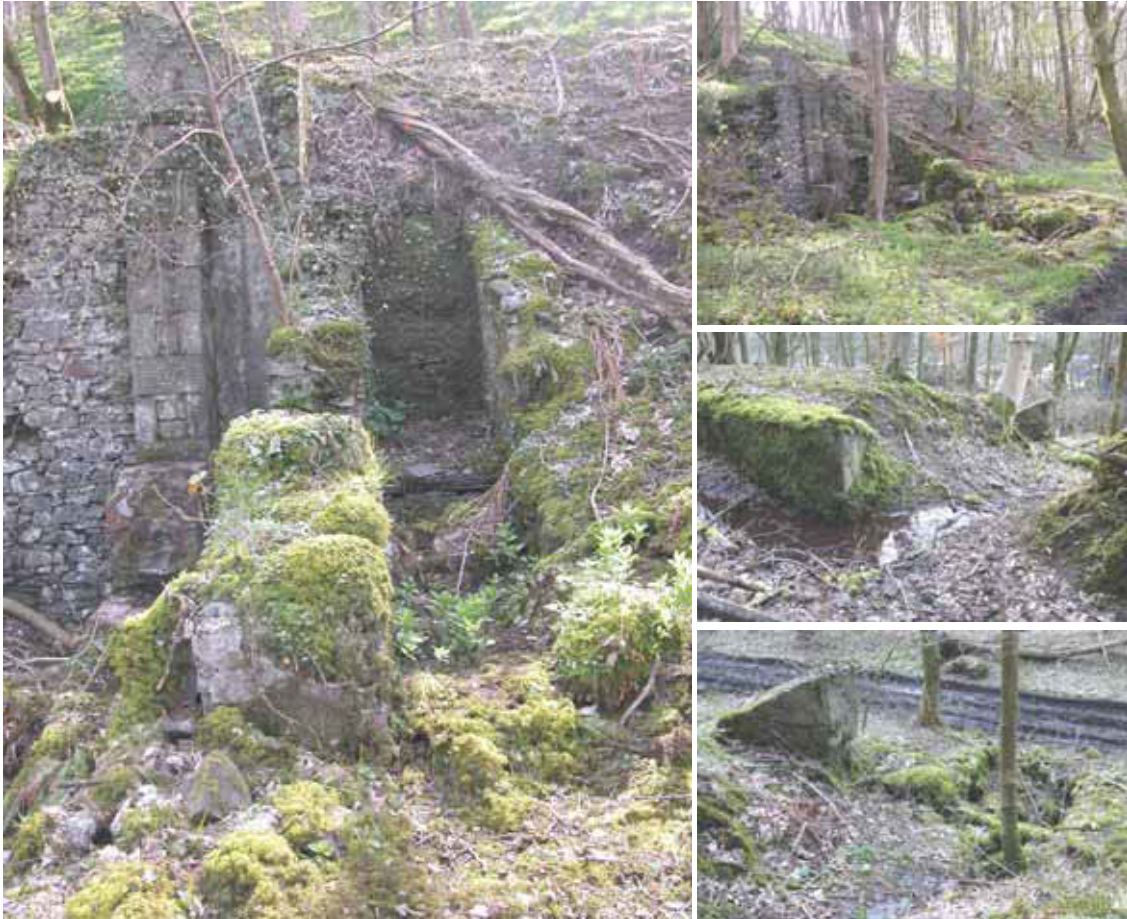
(Clockwise from top right)

Figure 67: Compartment 1 in the glazing house (building 9) from the north-west

Compartment 1 at the southern end of the building (Fig 67) is now ruinous, but seems to have been built initially as a waterwheel house later adapted to accommodate a water-turbine. Only the rear (eastern) wall of the compartment stands to anything like its original height, but the surviving angle of the eaves indicates that it had a south-facing single-pitched roof. A short headrace evidently brought water from the main mill leat that flowed at high level behind the glazing house, into the north-east corner of the compartment. The position of the headrace is marked on the ground today by a simple cut channel (Figs 68 and 69); the absence of any kind of visible lining to the channel sides suggests that the headrace itself consisted of a metal or wooden launder and pentrough - either salvaged for scrap when the works closed or since rotted away. Inside the compartment, the waterwheel/turbine-pit occupied the northern half of the

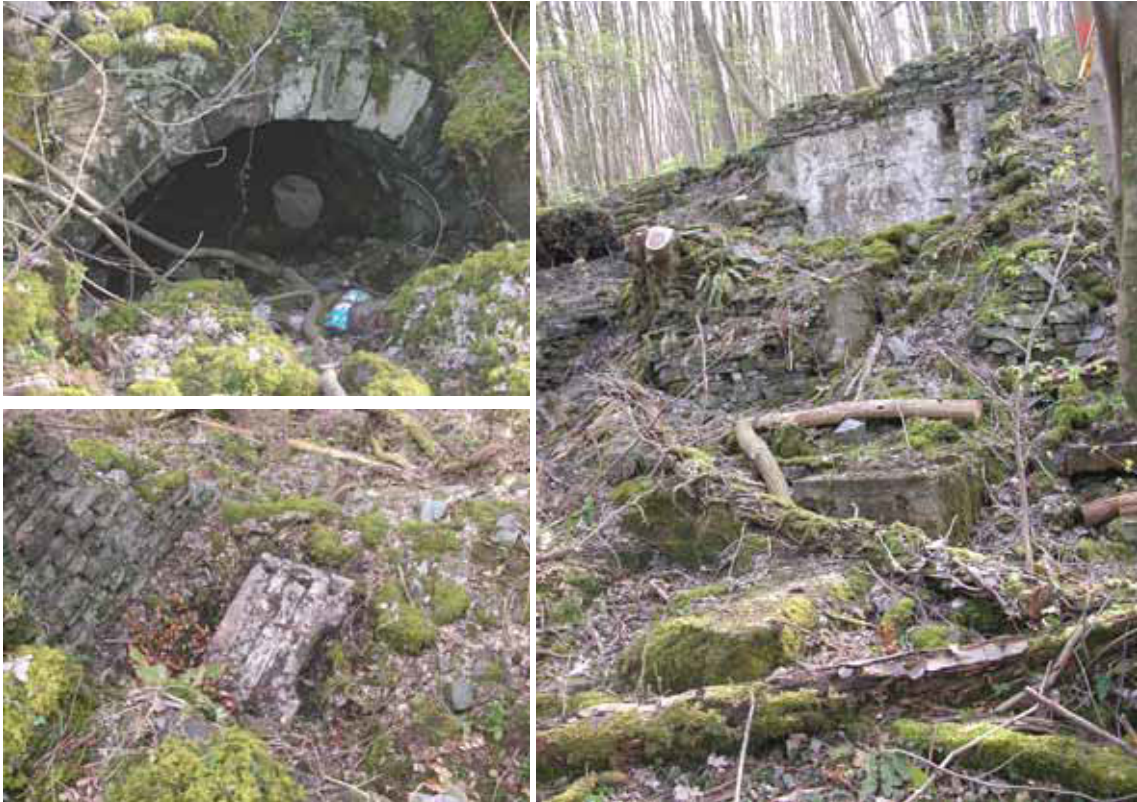
(Clockwise from top left)

Figure 71: Intersection of the culverted leat with the waterwheel/turbine-pit in compartment 1

building, but is heavily infilled by fallen masonry and other debris and there are few visible clues to indicate the position of the wheel or turbine within it; the axle mounts of the former may well have been destroyed or removed when the latter was fitted anyway. Nevertheless, it is tempting to suggest that a flue-like recess in the rear (east) wall (Fig 70) is either a flywheel-pit or a late feature built to accommodate a turbine feedpipe, and that two openings in a low internal wall that divides the southern half of the compartment accommodated wall boxes supporting line shafts turned by cog-wheels or belt drives. The western end of the pit is more open, and evidently connected directly into the culverted leat that ran past the building and acted as the tailrace for it, for its northern and southern edges (Fig 71) are pierced by well-formed segmental arches; the pit must originally have been guarded or capped by some form of railing or grille to prevent people falling in.

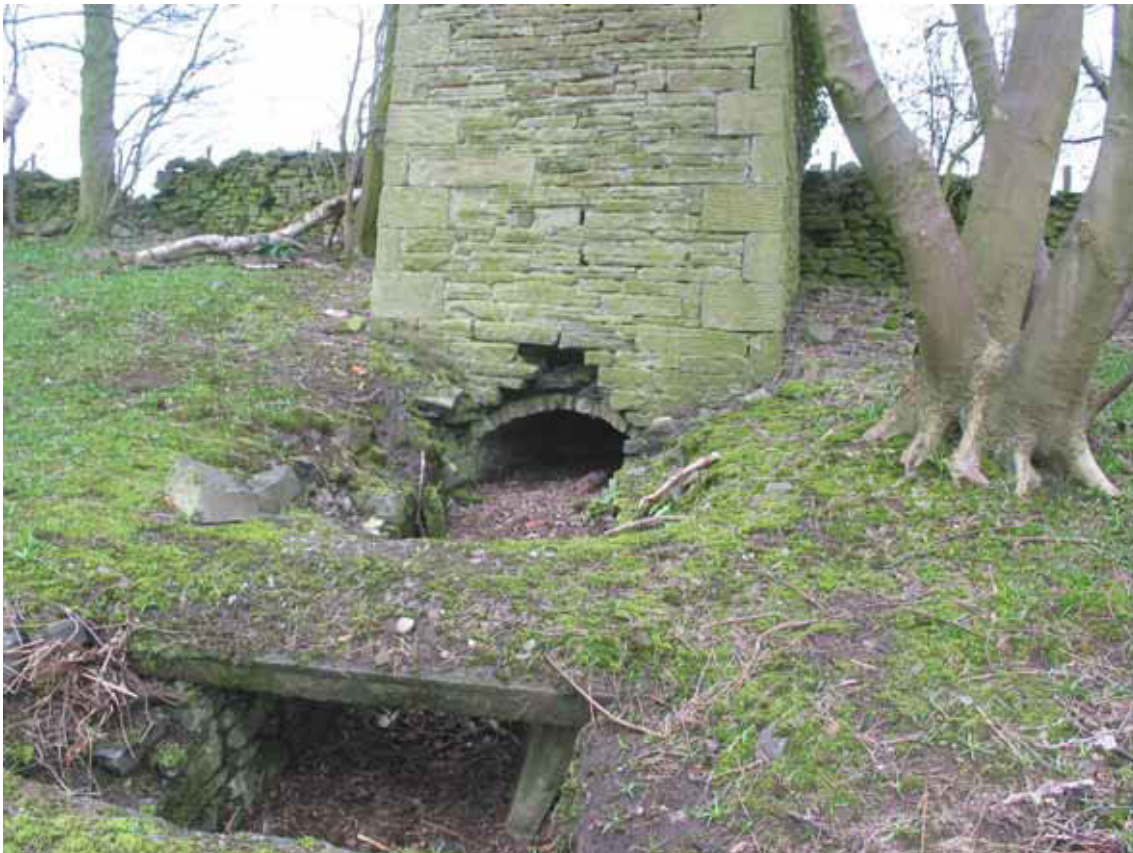
Figure 74: The flue from the glazing house and the base of chimney 9a.  
(Photograph: Simon Taylor 2006, © English Heritage)

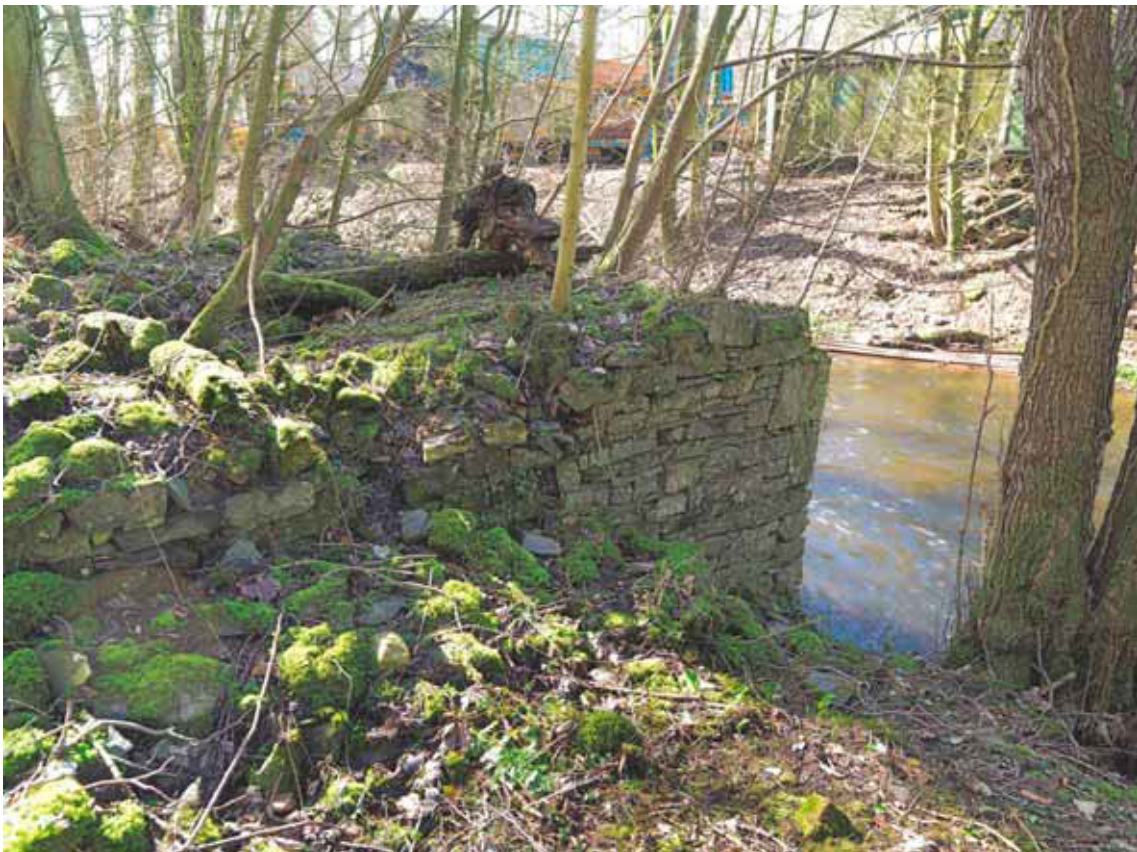
*Figure 75: The small stove (building 10), looking south-west  
(Photograph: Bob Skingle 2006, DP028054 © English Heritage.NMR)*

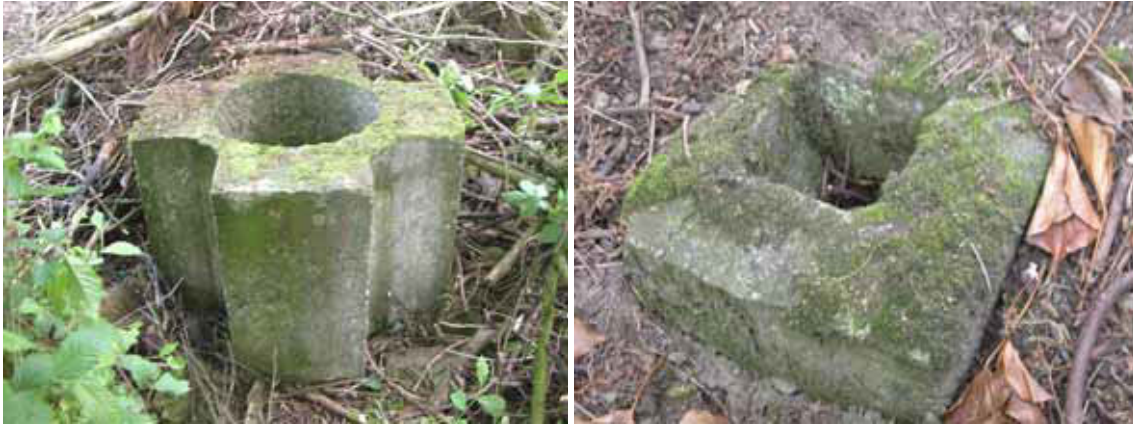
Figure 76 (above left): Concrete block at site of cartridge-pressing house 49  
 Figure 77 (above right): Concrete post-support behind cartridge-pressing house 50  
 (Photographs: Christopher Dunn 2006, © English Heritage)

Nothing structural is now visible of any of the buildings, although their sites are identifiable on the ground as rubble-strewn, overgrown, walled platforms cut into the side of the embankment retaining the main mill leat. No measured survey was undertaken, but a concrete block of cruciform plan measuring 1.05m square and with a central perforation of 0.57m diameter lies on the platform of building 49 (Fig 76); it is of unknown origin or purpose. A number of post-supports also survive set into the ground behind and above both platforms – one above building 49, and four in line *circa* 2.9m apart above building 50 (Fig 77). As with others that survive along the tram spur

out to expense magazine 15 (Large Corning House, section 6.2.3 above), the supports are probably the bases for timber uprights supporting some form of blast screen – presumably in this case to shield Gatebeck Farm and/or workers using a footpath that formerly ran along the side of the mill leat (Figs 137-8) to reach the sluiceway at the leat head (see also Blast Banks and Walls, section 6.2.10 below).

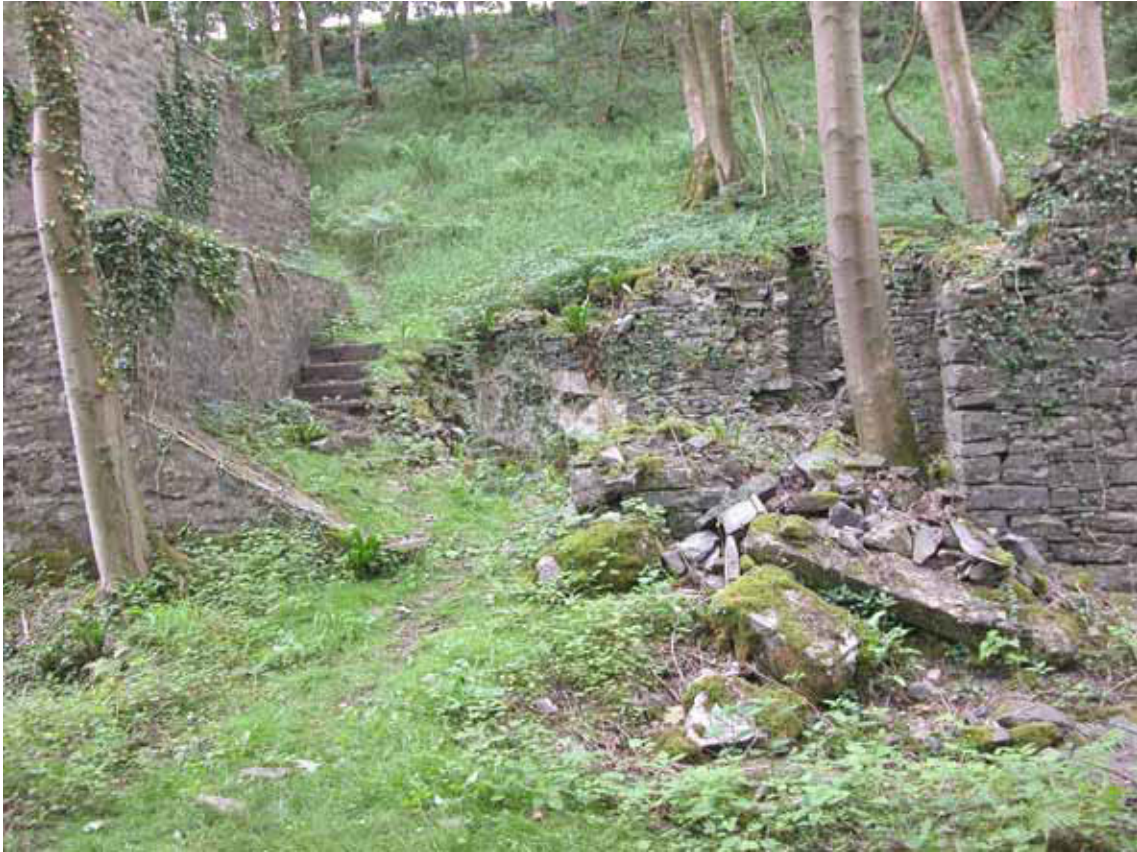
*Figure 79: The watch house from the west, showing wall flue and steps to leat  
(Photograph: Christopher Dunn 2006, © English Heritage)*

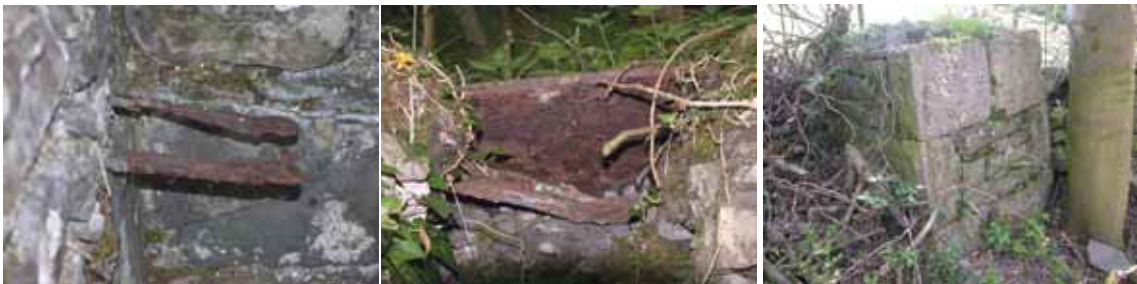
*Figure 80 (above left): Iron pins in the rear wall of the watch house  
Figure 81: (above middle): inspection cover at top of wall flue  
Figure 82 (above right): The watch-house chimney (building 4a)  
(All photographs: Christopher Dunn 2006, © English Heritage)*

(Fig 81). A flight of stone steps rises to the immediate left of the watchman's house and provided access to the main mill leat behind the adjacent incorporating mills, presumably for inspection and maintenance purposes and/or control of the flow of water into the culverted leat below the mills. The detached chimney (unlabelled on the factory plans, but for the purpose of the present report numbered building 4a) is also now ruinous, and survives to a height of no more than 1m; it is rubble-built with ashlar quoins (Fig 82).

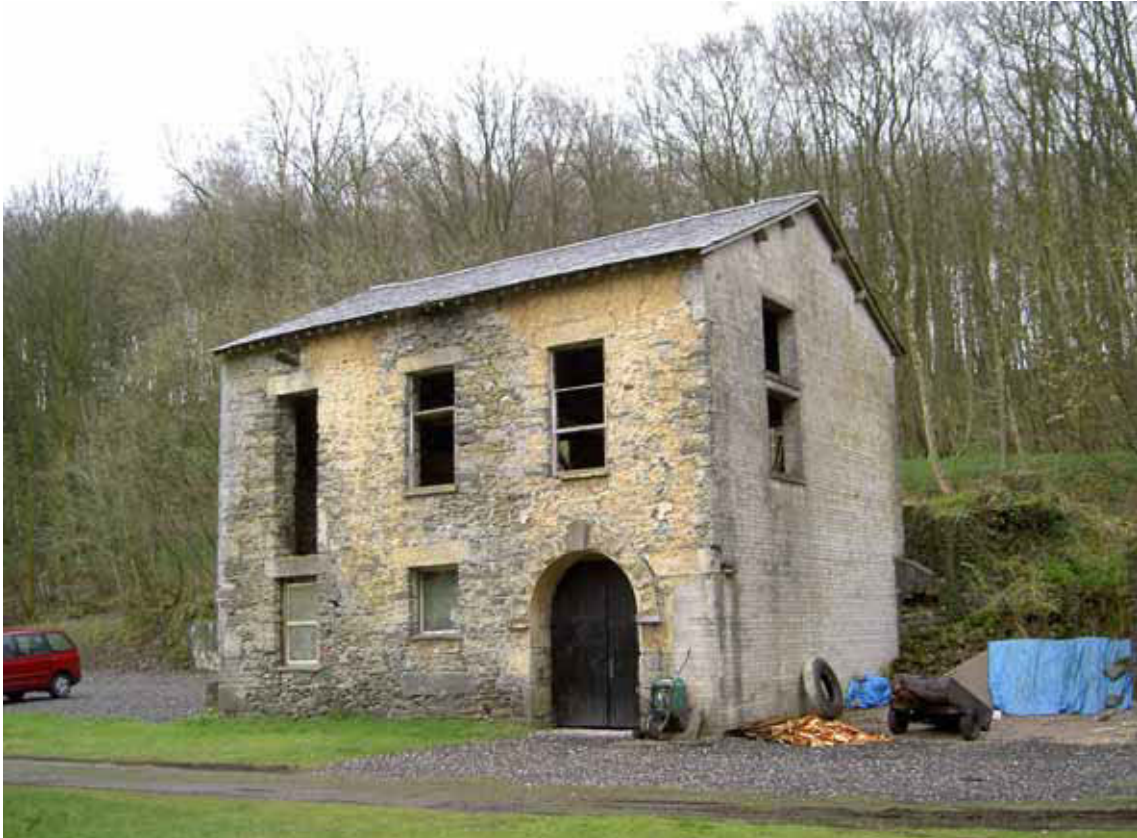
*Figure 84: The sawmill/mechanics' shop from the west  
(Photograph: Christopher Dunn 2005, © English Heritage)*

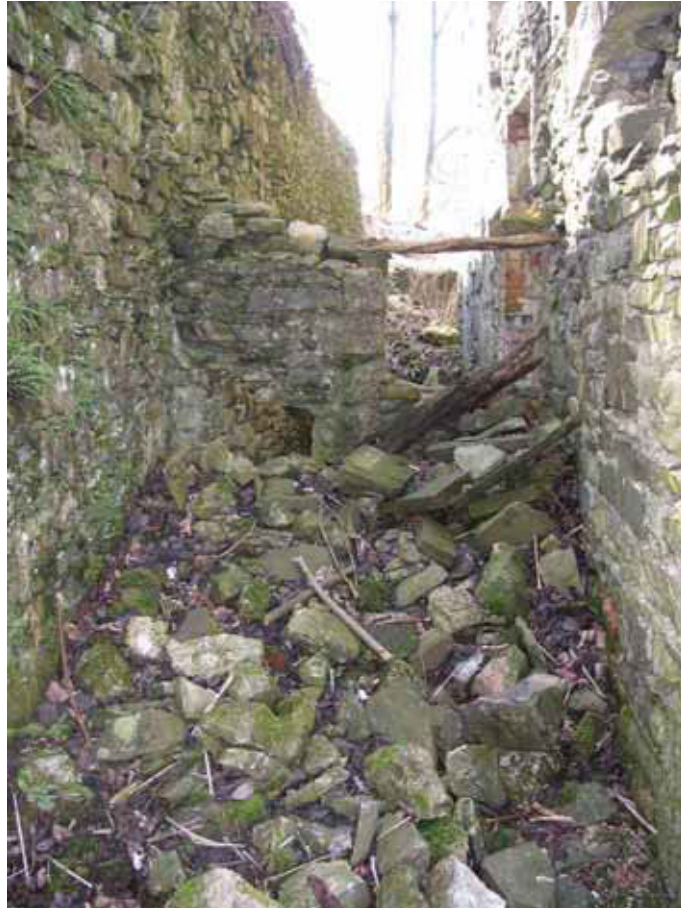
*Figure 85: Roofed lean-to behind sawmill/mechanics' shop, used as a line-shaft alley  
(Photograph: Simon Taylor 2006, © English Heritage)*

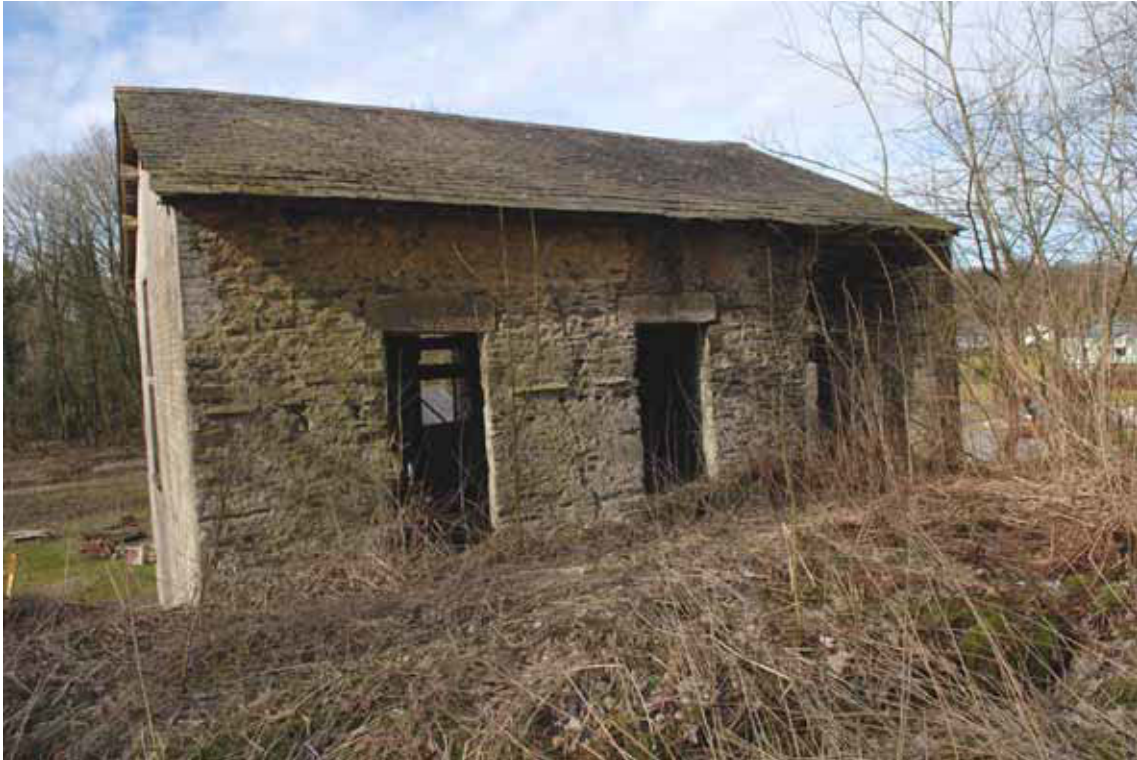
*Figure 86: The rear (south) elevation of the sawmill/mechanics' shop  
(Photograph: Christopher Dunn 2006, © English Heritage)*

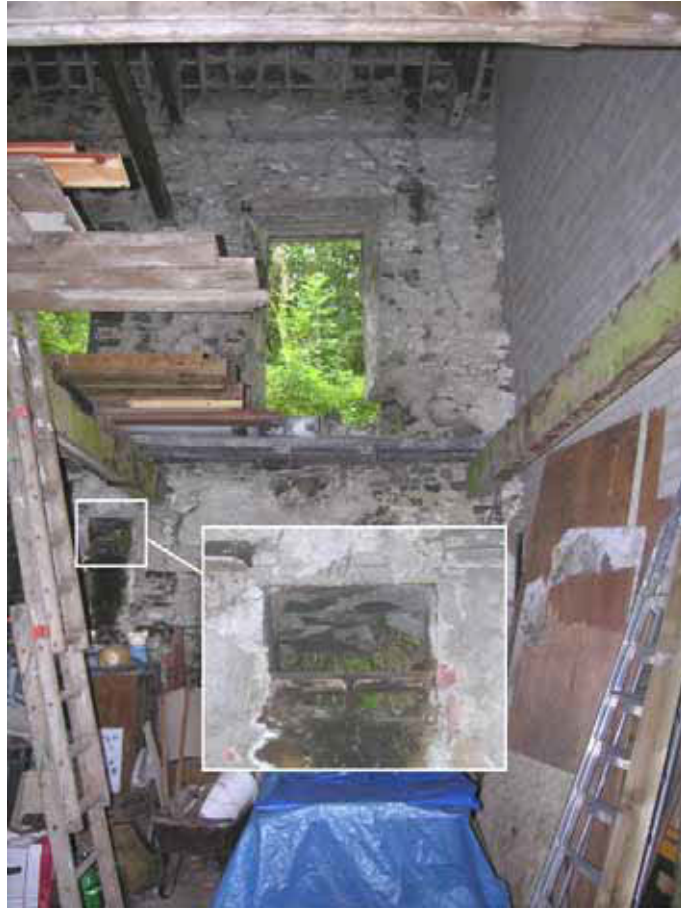
Figure 87: Interior view of the rear wall of the sawmill/mechanics' shop, with bearing box shown in detail at inset  
(Photograph: Simon Taylor 2006, © English Heritage)

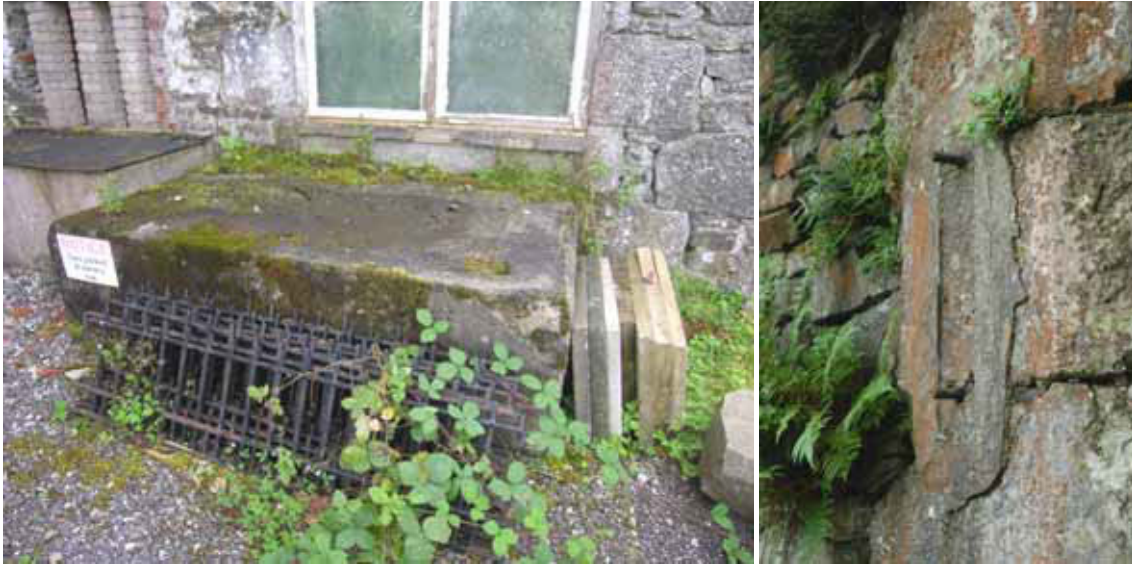
Figure 88 (above left): The engine-bed outside the east gable wall  
 (Photograph: Simon Taylor 2006, © English Heritage)

Figure 89 (above right): Detail of the line-shaft bearer east of the mechanics' shop  
 (Photograph: Christopher Dunn 2008, © English Heritage)

north adjacent to the saltpetre refinery and store. Three surviving features relate to the infill building. To the north it was either open-fronted or incorporated a wide entrance, since the end of a timber lintel remains embedded in the gable wall. Against the gable wall there is a large bed for an engine (Fig 88) or other fixture blocking the earlier wide doorway linking the two buildings. This raises the possibility that latterly the mechanics' shop was powered by an external engine rather than by water, but if so the existing power transmission system seems to have been retained. The same wall also contains a large area of 20th-century brick patching, partly obscuring the first-floor taking-in doorway, and incorporating ventilation slots on the ground floor. The vertical extent of the patching suggests making good after the removal of a flue, but the outline is irregular and there is no sign of an associated chimney. If the waterwheel was retained, power may have been carried beyond the original shaft alley into the rear of the infill building: there is what appears to be a line-shaft bearer (Fig 89) attached to the revetment immediately east of the mechanics' shop, and in line with an opening in the original east wall of the lean-to (Fig 85).

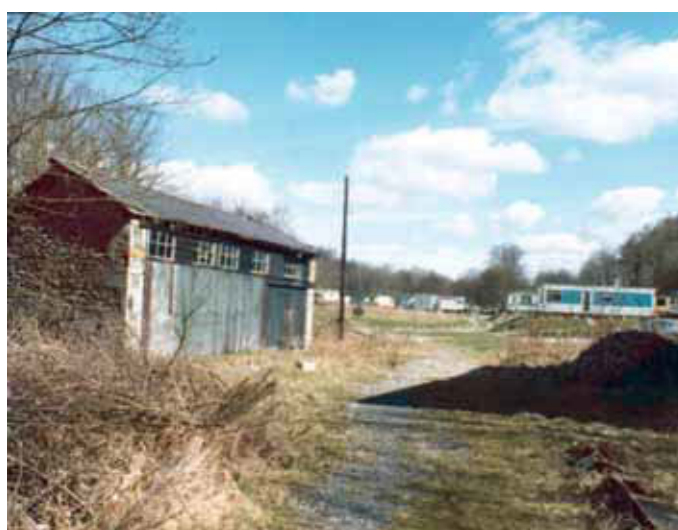
*Figure 90: Engineering store (building 24) from the south in 1978/9  
(Photograph: Patterson Collection OP04684, © English Heritage.NMR)*

Photographs taken by Ted Patterson in 1979 (one reproduced here as Fig 90) reveal that the main block consisted of stone end walls beneath a slate roof, with the south-east side wall composed of vertical timber panels (some possibly opening as doors) with a series of six-light small-pane windows above; the form of the opposing wall is unknown.

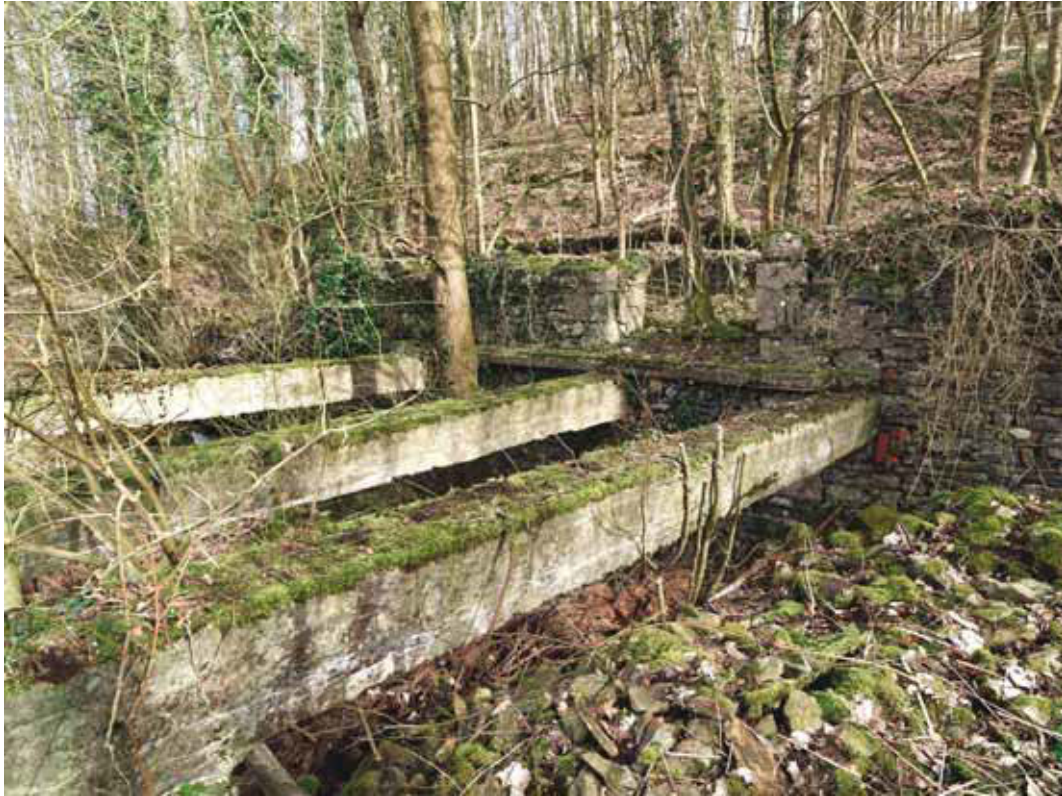
*Figure 92: Joists spanning the mill leat at the joiners' shop  
(Photograph: Bob Skingle 2006, DP028090 © English Heritage.NMR)*

brick walls at the foot of the leat embankment and adjacent to the leat itself, three large iron joists encased in concrete laid across the leat (Fig 92) and the floor slab of the infill building (Fig 93). Of

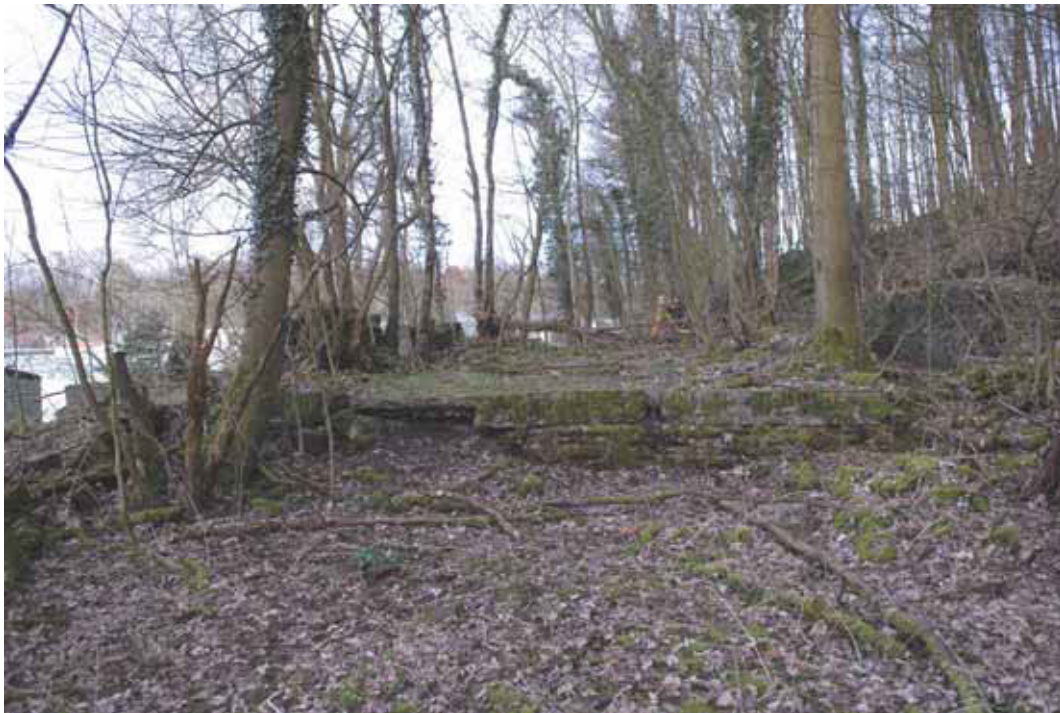
*Fig 93: The infill building between the joiners' shop and smithy, from the south-west  
(Photograph: Christopher Dunn 2006, © English Heritage)*

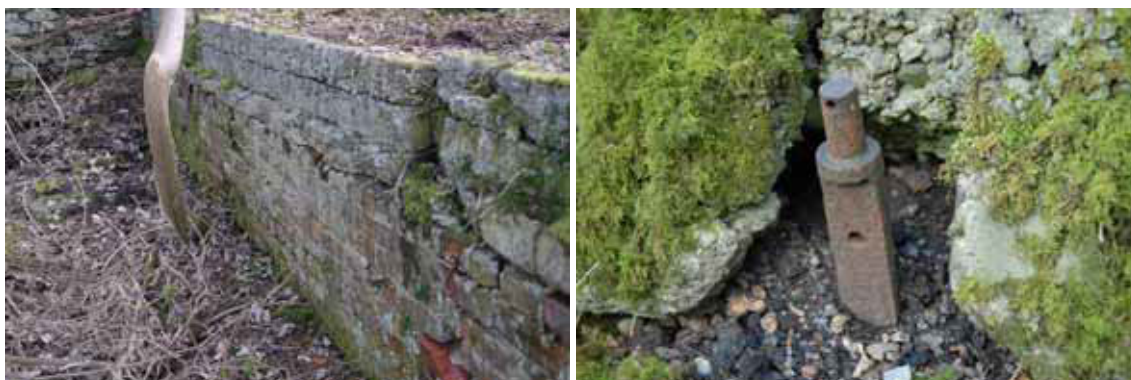
*Fig 94 (above left): Detail of the north-east end of the floor slab of the infill building*

*Fig 95 (above right): Detail of wall fastening in floor slab of infill building*

these, only the last is described further. The floor slab consists of a brick plinth *circa* 0.6m high on top of which is 0.3m of concrete, laid in three spits (presumably due to the thickness of flooring required, but all representing a single constructional episode) (Fig 94). The side walls of the building were provided by the existing structures to east and west (buildings 29 and 30), but the two end walls appear to have been formed by metal panels (the edge of the concrete is corrugated) bolted to metal bars set into recesses in the concrete floor (Fig 95). The lack of evidence for external steps against either end wall suggests that the building was only accessible from the smithy and adjacent parts of the joiners' shop. Due to the layer of humus and wall tumble that now obscures the floor and weed trees rooting on and around the walls, it was not possible to identify machine bases or other evidence of internal fittings that might shed light on the nature of the tasks carried on inside the building.

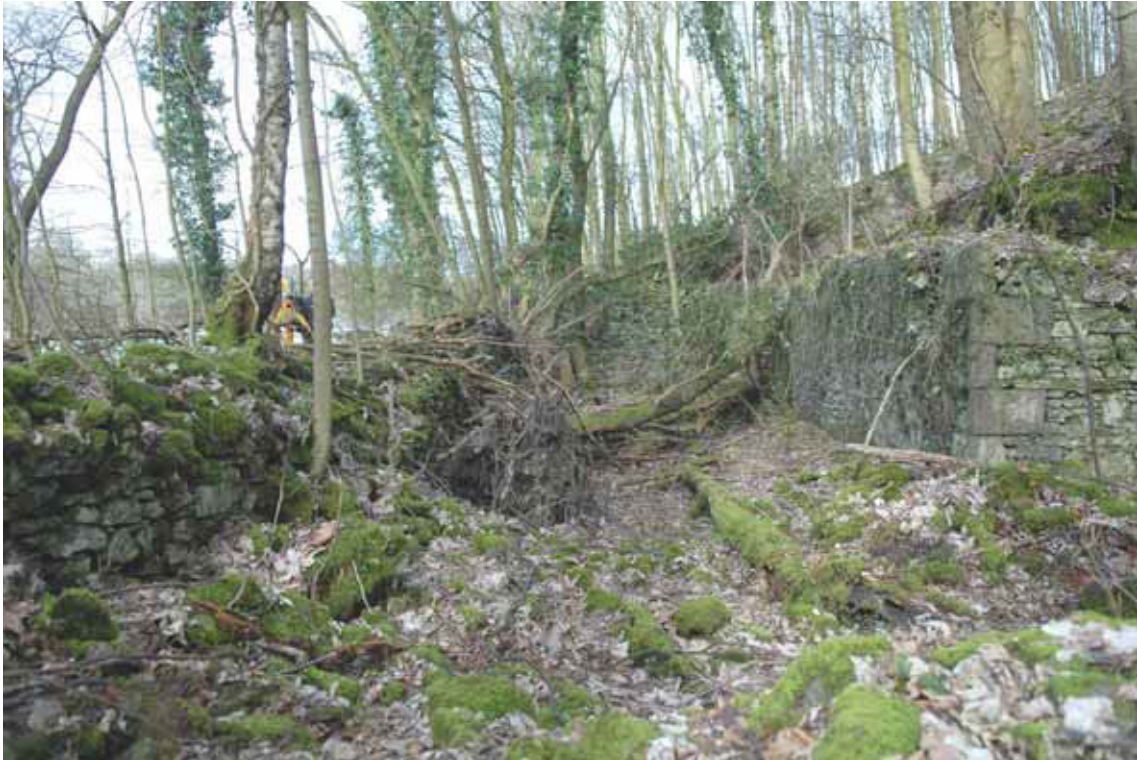
Figure 96: The smithy, looking north-east  
(Photograph: Christopher Dunn 2006, © English Heritage)

Much of the smithy is now ruinous with the interior overgrown by weed trees and obscured by collapsed masonry (Fig 96); only the south-eastern (rear) and north-western (end) wall of the central and south blocks, the former built back to earth, survive to anything approaching their original height. The central block evidently comprised two compartments (Fig 91), both most likely entered by doorways facing the leat. Each compartment appears to have been independent of its neighbour, however, for there is no evidence of access between them; nor is there evidence of access between the central block and that to the south which must also have been entered from the east. A brick smithing hearth with stone lintel and small brick flue stands against the rear wall of the northern compartment (Fig 97), opposite the doorway. Much of the floor of

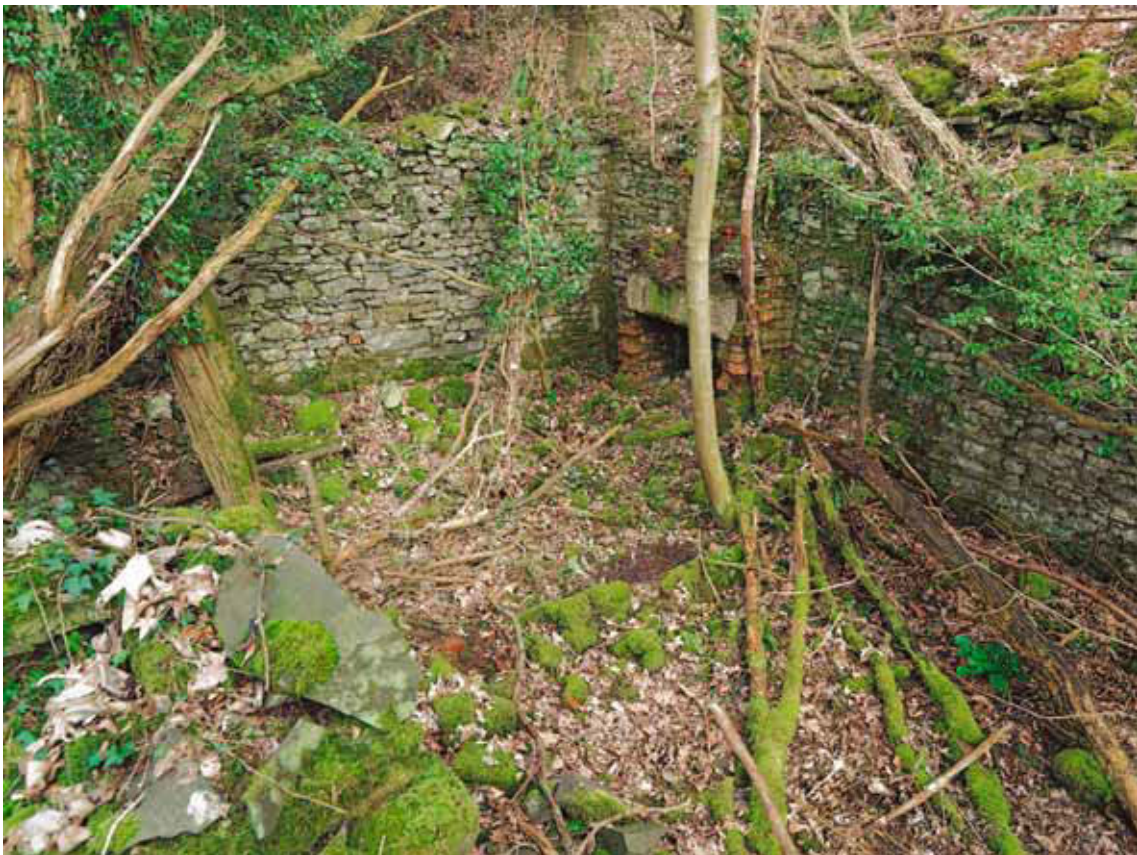
Figure 97: Smithing hearth within building 30  
(Photograph: Bob Skingle 2006, DP028089 © English Heritage.NMR)

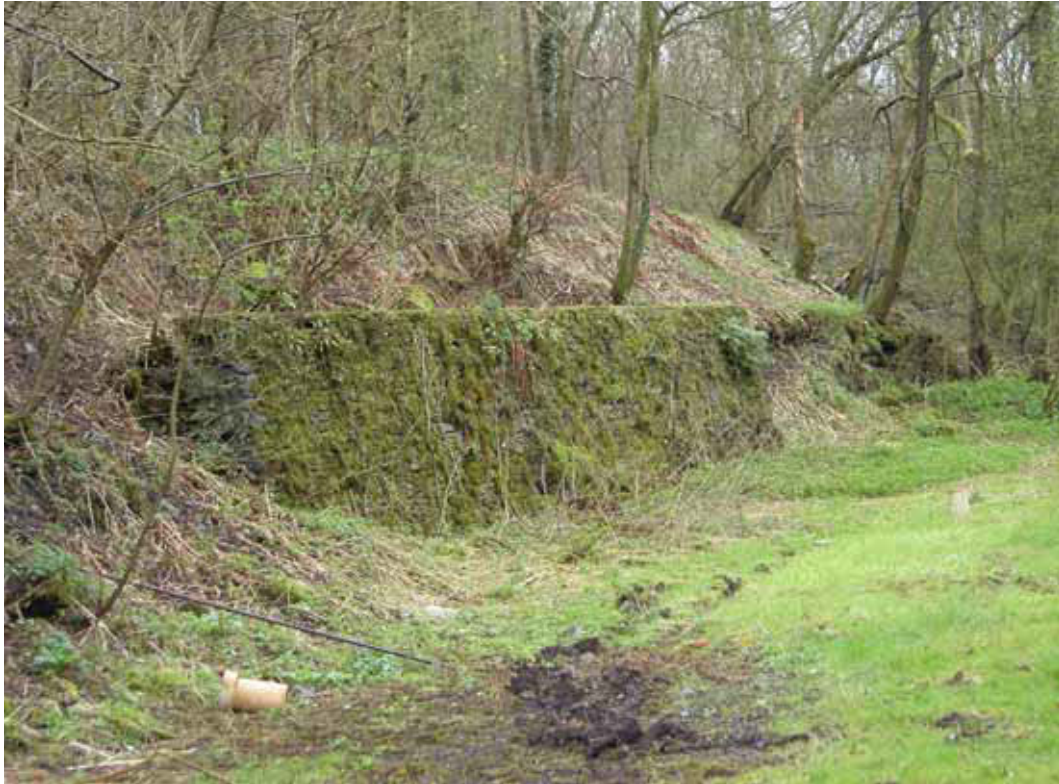
*Figure 98: Rear wall of pattern store (building 18), from the north  
(Photograph: Christopher Dunn 2005, © English Heritage)*

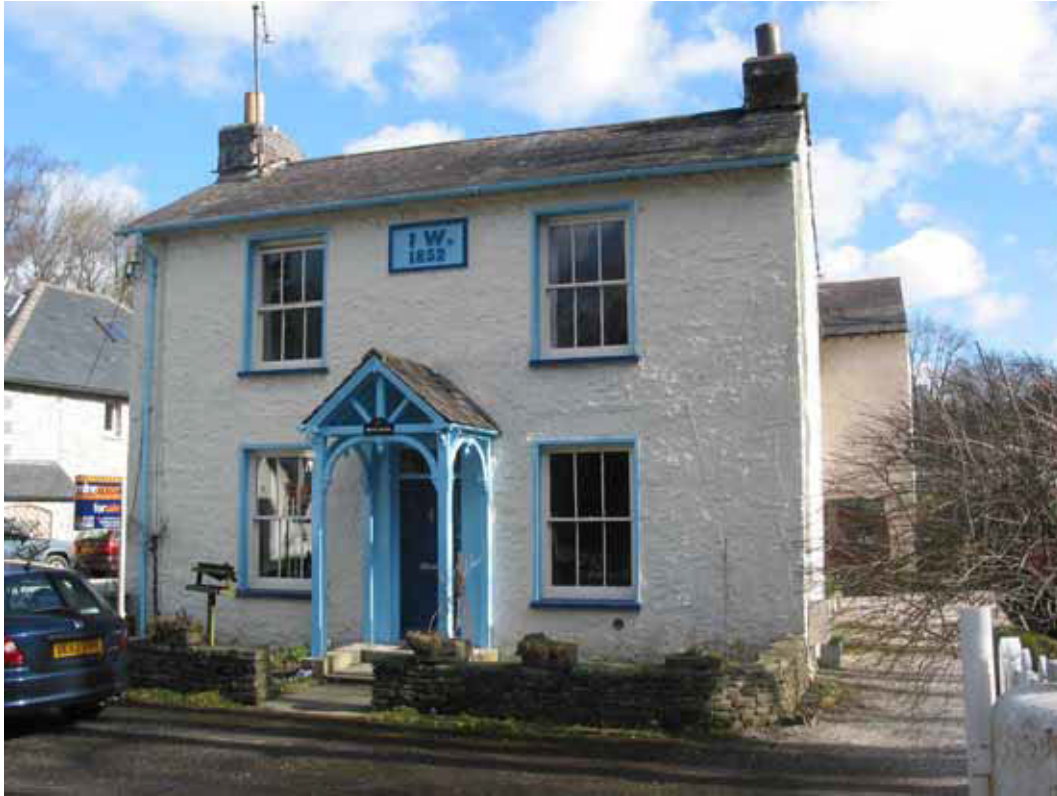
*Figure 99: The south-west elevation of Brook House  
(formerly building 34: foreman's house and office)  
(Photograph: Simon Taylor 2006, © English Heritage)*

Brook House is T-shaped in plan, two storeys high and built of thinly-rendered stone rubble with limestone quoins, lintels and window sills (Fig 99). The gabled roof is slated and has plain grey ridge tiles. The house is double fronted with a three-bay front elevation with a central entrance which has a small open-sided timber porch with king-post gable. The bay above is blind but is occupied by a tablet, which bears the inscription 'IW. 1852', positioned close to the eaves; the two initials must refer to either John Wakefield III (the I denoting a J) or Isaac Wakefield, his uncle. At ground- and first-floor levels the entrance and tablet respectively are flanked by window openings containing sash boxes and hornless, vertically sliding, three-paned sashes. Two-flued chimney stacks rise above each gable end indicating four heated rooms in the body of the house.

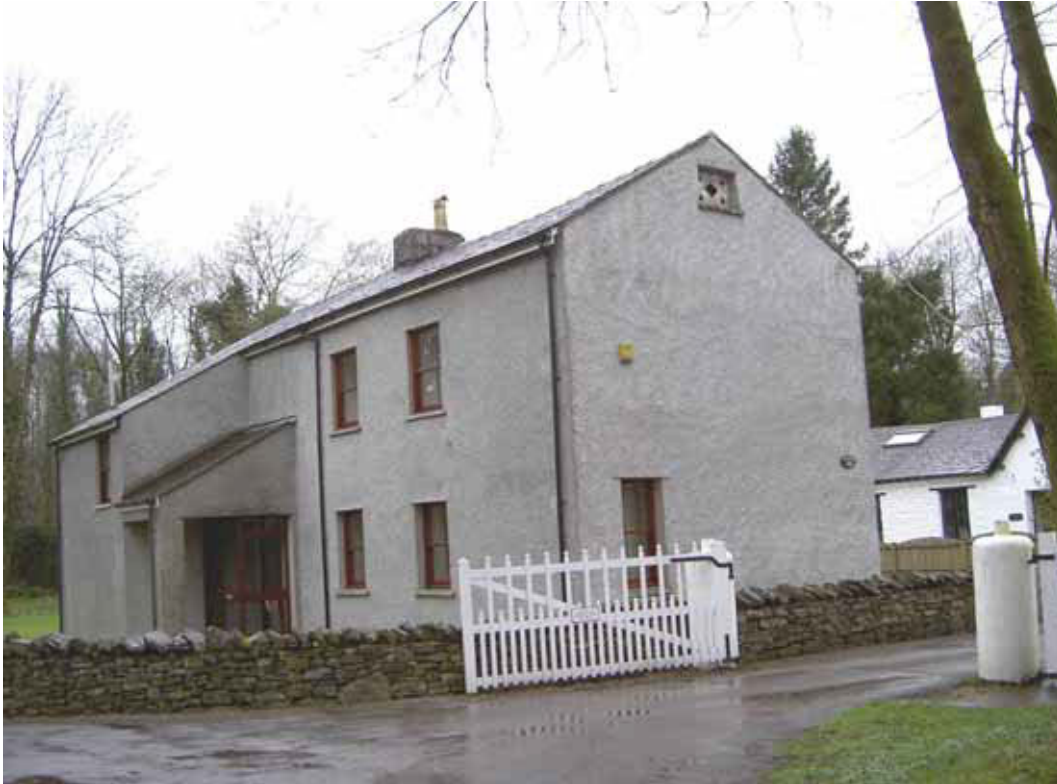
*Figure 100: Millbrook House (formerly building 35: laboratory, store and tailor's shop or office), from the north-east  
(Photograph: Christopher Dunn 2005, © English Heritage)*

Although the building (Fig 100) has been extensively remodelled and extended, its appearance prior to conversion is known from photographs (belonging to the residents at the time of survey) taken during the early stages of the work. It was two-storeys

high and of roughly coursed stone rubble with a simple gabled roof of king-post roof construction, with iron-strapped collar beams rather than tie beams, covered with slates with a single stone-built two-flued ridge stack at the south-west end. It was three bays long and the south-east elevation had a doorway, with a timber surround and hood on shaped brackets and a four-panelled door with low overhead, on the right side. There were paired ground- and first-floor window openings, with wooden sills containing three-pane, vertically sliding sashes at ground-floor level, and six-pane casements with single, central, upper-hinged sashes at first-floor level. The south-west elevation (now obscured by the modern extension) had narrow rectangular window openings on the right-hand side at ground- and first-floor level with wooden sills and frames with two-pane vertically sliding sashes. The north-east elevation was the same as the south-west elevation with window openings on the left-hand side and an additional rectangular aperture with a wooden sill high in the gable containing a recessed panel perforated with a central diamond opening and four circular openings, bearing traces of plaster. The purpose of this panel is unclear but it might have been a ventilator - perhaps related to the building's early use as a laboratory - or formerly borne a sign board. A small wooden lean-to (since demolished) with a south-east-facing door stood at ground level against the right-hand side of the gable wall, but the date of this structure is unknown. The appearance of the north-west elevation prior to conversion is also unknown.

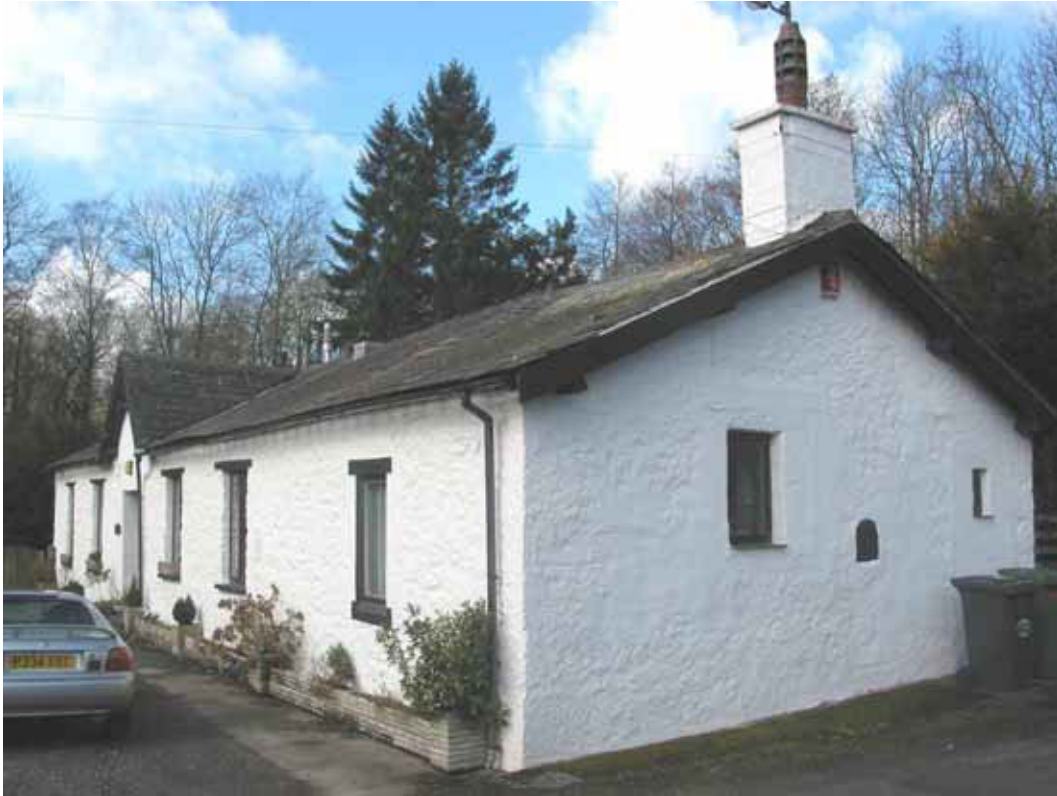
The present structure is long, single-storeyed and one room deep, is built of stone rubble and has a pitched slate roof. The south-east elevation is six bays long with a gabled entrance in the third bay from the left. Local residents report that this was formerly a garage entrance, inserted in 1966, but since reduced in size, with brick infill, for pedestrian use. The window opening in the sixth bay from the left is smaller than the rest and has quoined jambs, now almost completely concealed beneath render. The rest of the window openings in this elevation are either replacements or insertions and have slate sills. The window in the fifth bay from the left has a blocking beneath it suggesting conversion from a door. The north-east end elevation has a single window, with quoined jambs, on the left side. It has been partially blocked and a smaller light inserted. There is a further blocking on the right side, possibly a former door; and between the two blockings is a round-arched niche with a hinged, iron cover-plate, perhaps a soot box for the single-flued ridge chimney which rises through the roof at this end of the building. The north-west elevation is six bays long with a doorway in the third bay from the left and window openings with slate sills in the others. The fifth bay from the left contains a smaller window which might have been reduced in size or even be a conversion from a door. A single-flued square stone stack rises through the pitch of the roof behind it. There is a soot box in the wall between the first and second bays from the left and although there is no chimney in this position now, it is close to a rise in the ridge line of the roof which indicates the presence of a substantial internal wall which might be the original end wall of the building. Any chimney formerly in this position might have been removed when the building was extended. There is another niche, with an iron-framed entrance, lacking its cover, between the third and fourth bays from the left. It is round-backed, brick-lined and has

*Figure 101: Millbrook Cottage (formerly building 36: office) from the north-east  
(Photograph: Simon Taylor 2006, © English Heritage)*

a ceramic pipe rising through the wall from its top. The purpose of this niche is unclear. The south-west elevation has a tall central blocking beneath a lintel, presumably a former window, which was dropped before blocking, with a doorway to its left.

Building 36 was converted into domestic accommodation during the late 20th century, and is now known as Millbrook Cottage (Fig 101). Heavy render obscures much of the evidence for the earlier pattern of doors and windows, but the building's appearance prior to conversion is partly known from photographs taken during the course of the conversion work.

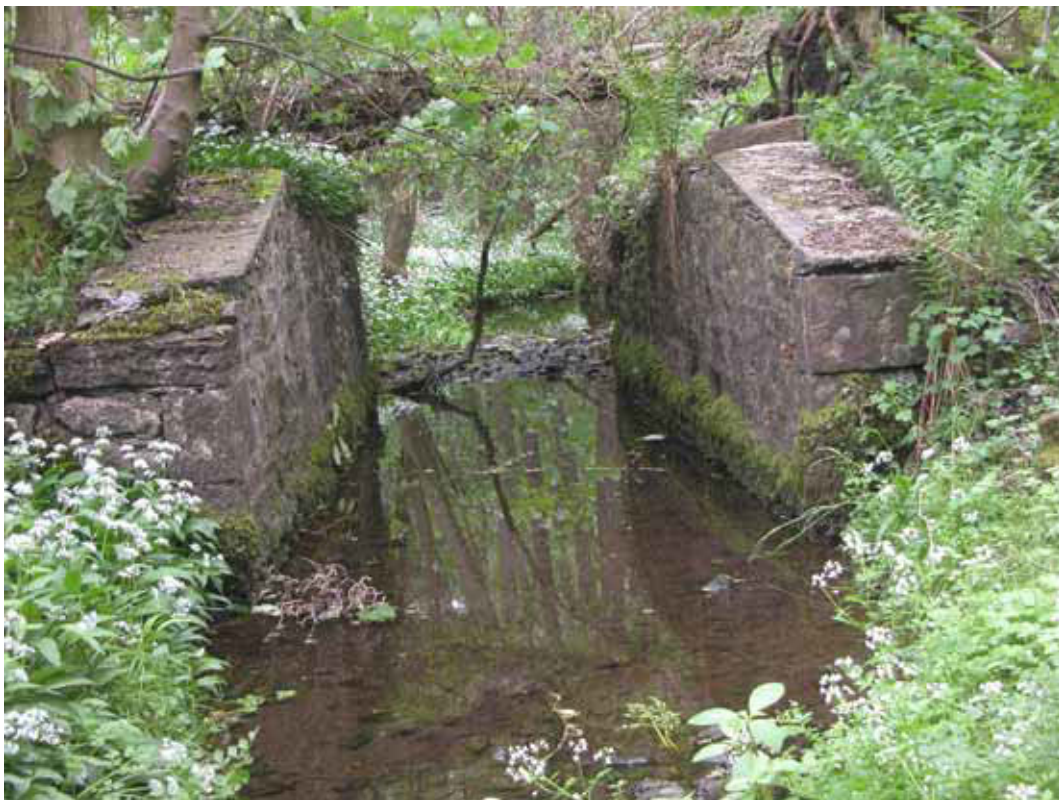
*Figure 103: Bridge abutments on the tram spur to the press houses  
(Photograph: Christopher Dunn 2006, © English Heritage)*
