# GATEBECK LOW GUNPOWDER WORKS AND THE WORKERS' SETTLEMENTS OF ENDMOOR AND GATEBECK, CUMBRIA AN ARCHAEOLOGICAL AND ARCHITECTURAL SURVEY

## SURVEY REPORT

NGR: SD 544 853

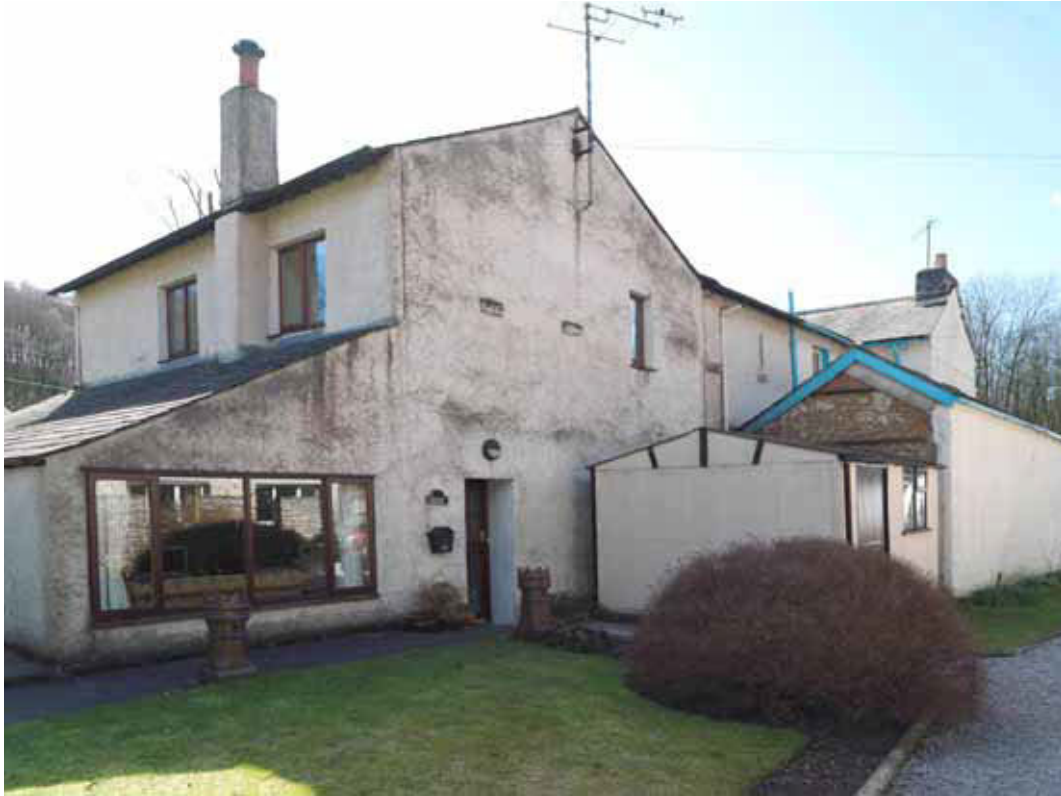
The rear wing of the Foreman's House (now Brook House, section 6.2.6 above) continues as an L-shaped former stable block (building 33). The stables were apparently still in use in 1898 but are reported as disused by 1923 (Figs 5 and 140). They were converted to domestic use in the second half of the 20th century, and the building (Fig 104), now known as September Cottage, has been heavily altered. Like Brook House, it is two storeys high and built of stone rubble with a gabled, slate-covered roof. Little evidence of the building's original use as stables remains but there is a row of ventilation slits at first-floor level in the north-east elevation, indicating former use for hay storage above, and circular ventilation holes at the tops of the side gables. All that now survives of the other stables (building 21) is the rear (stone) wall built back to earth (Fig 105) and slight traces of the returns of three walls coming off it, presumably the stables' two end walls plus one internal subdivision: of these, the west end wall is built in brick and may be a late rebuild.

Figure 104: September Cottage (formerly building 33: stables), from the north  
(Photograph: Bob Skingle 2006, DP028045 © English Heritage.NMR)

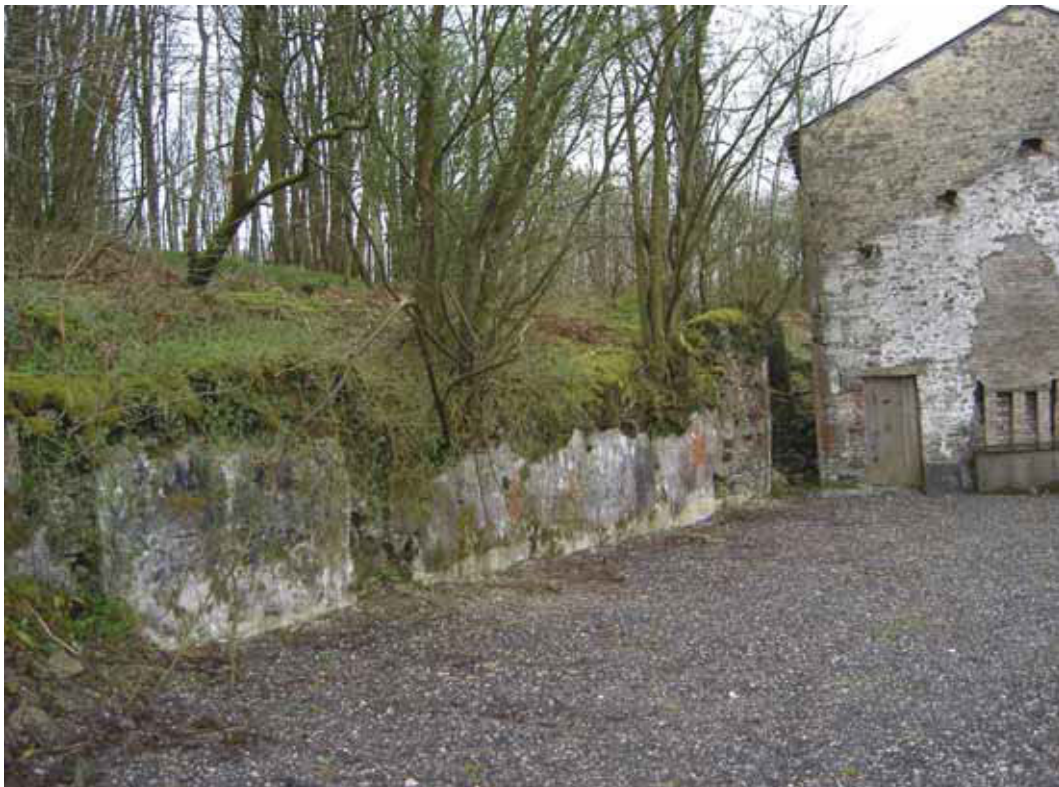
Figure 105: Rear wall of stables (building 22) and north gable of mechanics' shop  
showing the scar of the infill building  
(Photograph: Christopher Dunn 2005, © English Heritage)

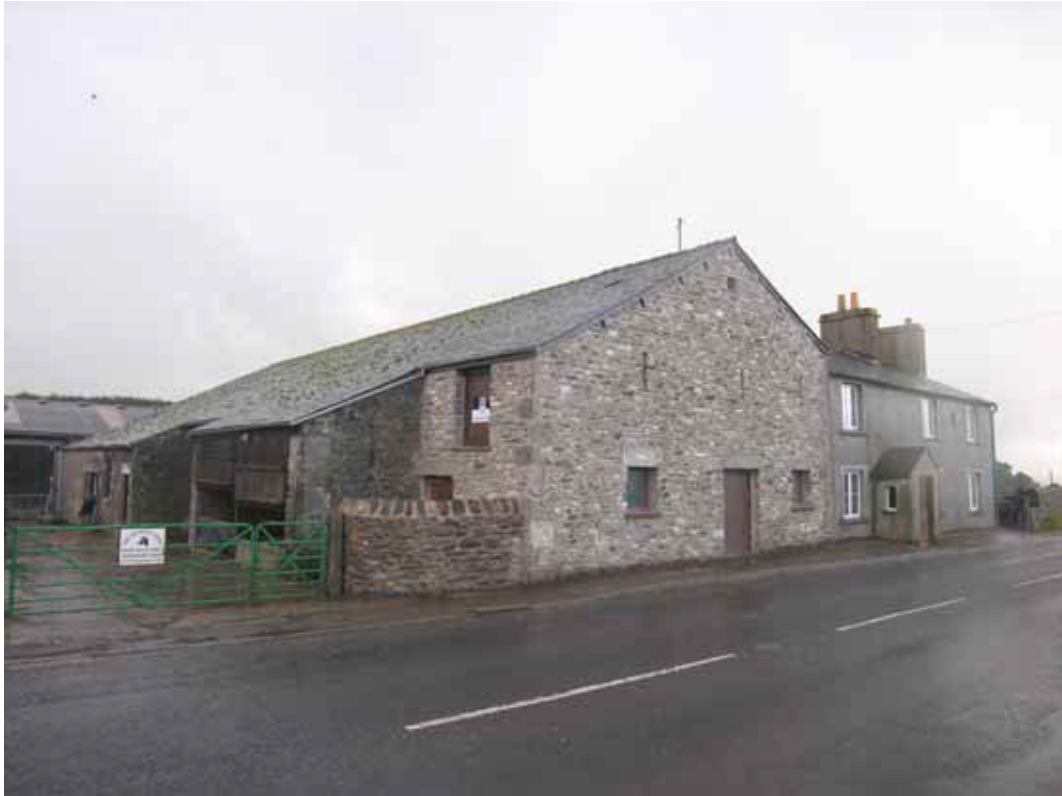
The 1858 OS map (Fig 137) shows Endmoor much as it was before the coming of the gunpowder works. Endmoor Farm (Fig 106), now a cattle farm, was probably built during the late 18th or early 19th century. It consists of a two-storeyed, three-cell linear-plan farmhouse, built of random stone rubble, with rough-dressed stone quoins to the corners and to the three chimney stacks, each of which contains two flues, with a slated gabled roof. It stands hard up against the main road, aligned north-east to south-west, and has an entrance in its north-west side with a small gabled porch. Adjoining the farmhouse on its north-east side is a two-storeyed mixed agricultural range, a form of 'bank barn', also built of random stone rubble with heavy stone quoins to the corners and with a gabled and slated roof. Accommodation for cattle, and possibly stabling, was provided on the ground floor with hay and probably grain storage above. This block is set at right angles to the main road, and its north-west end which projects slightly forward of the farmhouse, has a central ground-floor entrance flanked by windows, which probably provides access to a central feeding and manure passage. There are slit vents in the wall at first-floor level and two porch-like lean-to shelters on the north-east side which also has a further ground-floor doorway at the north-west end and a first-floor taking-in door. The farm was substantially enlarged during the 20th century with the addition of extensive new cattle accommodation on the south-east side of the farmyard.

Figure 106: Endmoor Farm  
(Photograph: Simon Taylor 2006, © English Heritage)

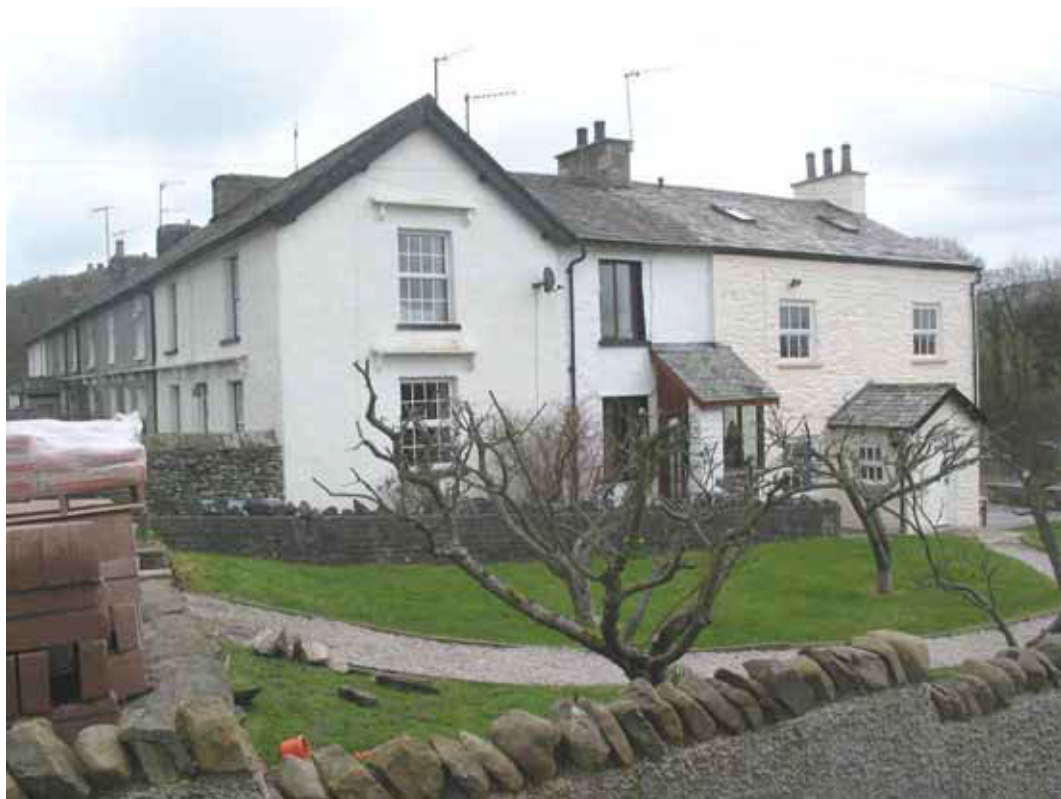
Figure 107: Front elevations of Bela View and Nos. 21-25 Low Cottages, Endmoor  
(Photograph: Simon Taylor 2006, © English Heritage)

Bela View (Fig 107), named after the River Bela (also called Peasey Beck), is a two-storeyed, double-fronted, central-entry house facing south-west and along the river valley. It is built of random stone rubble and has roughly dressed stone quoins to the

Nos. 21-25 Low Cottages (Fig 107) is a row of five, two-storeyed, double-fronted houses, one-room deep with central entrances and staircases, built of rendered stone with slated, pitched roofs. Each house has a small front garden, originally separated from the road by a low wall of massive stones, most of which have been lost. No. 25 retains its original 16-pane, hornless hung sash windows and a Gothic-style front door set in a beaded frame with three-light rectangular overlight. Window sills are deep, with a tooled margin and a groove beneath the tooling, although the sills of Nos. 24 and 25 differ slightly from those of Nos. 21-23. A projecting inclined slate band on shaped stone brackets runs along the front and around the south gable of the terrace at first-floor level, with a break between No. 23 and No. 24. No. 25 has south-facing, centrally-positioned windows with bracketed hoods in its gable end at ground and first-floor levels; these are lacking in the opposing gable end of No. 21. Originally, the houses appear to have been blind-backed and lacked back doors and, apart from No. 25, rear wings, but later doors and windows have been inserted into the rear elevations, opening on to a rear courtyard. Cartographic evidence and the discontinuities between Nos. 21-23 and 24-25 indicate that, although built to a single design, this terrace was built in at least two phases with Nos. 24-25, at the south end of the terrace, being the earliest. These two, along with Bela View and a block linking it with No. 25 are shown on the 1858 OS map (Fig 137); the remainder of the terrace appears complete on the 1896 OS map (Fig 138).

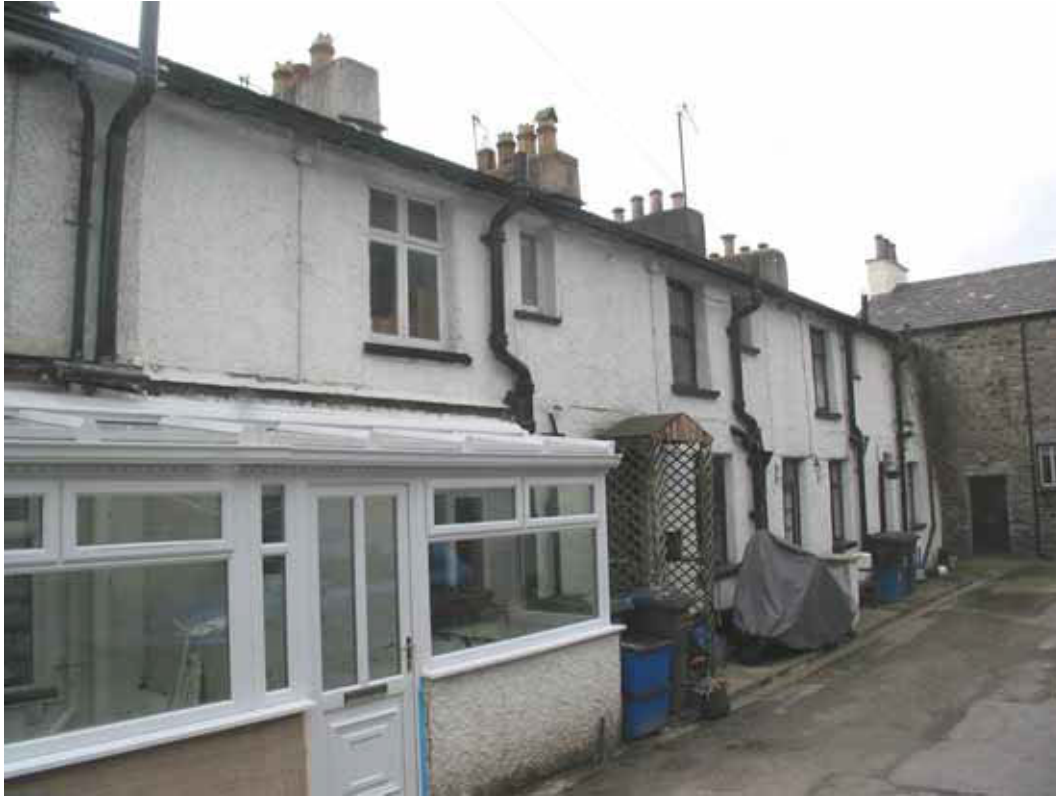
Nos. 13-20 Low Cottages is a terrace of eight, single-fronted houses built of random stone rubble, unrendered, with large, roughly shaped stone lintels and sills to windows and doors and slated, pitched roofs. Each house is two rooms deep and has four heated rooms in total, the four flues being contained in a single ridge stack, one per house. The terrace lies to the south and east of Nos. 1-12 and parallel to Nos. 21-25, and faces south-east at the top of a slope overlooking Peasey Beck and the incorporating mills of the Low Works. Each house has a small front garden running down the slope to the east, with stone steps leading up to the front door. The rear elevation of the terrace indicates a difference in plan form between Nos. 13-16 and Nos. 17-20: the former have a symmetrical one-up-one-down window pattern and no back door, while the latter (Fig 108) have an original back door with two full-size and one small window opening on to the rear courtyard. Cartographic evidence, supported by the differences in the rear

Figure 108: Rear elevations of Nos. 17-20 Low Cottages, Endmoor  
(Photograph: Simon Taylor 2006, © English Heritage)

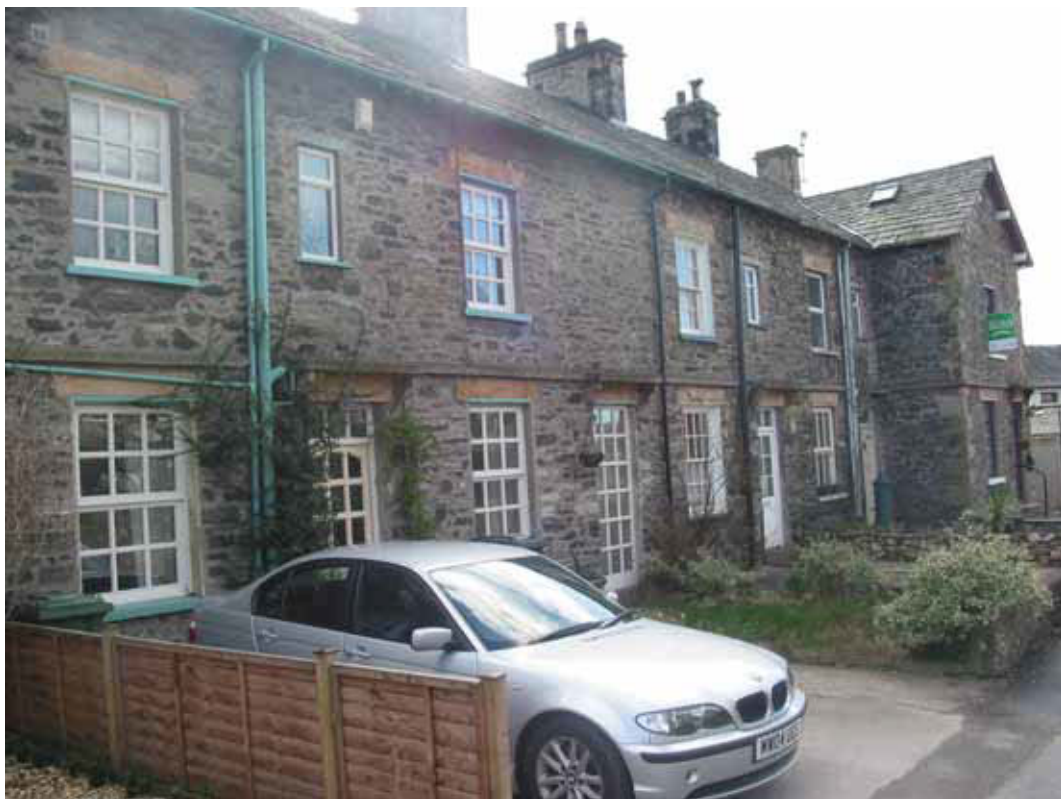
Nos. 1-12 Low Cottages (Fig 109) is a terrace of originally ten, two-storeyed, single-fronted houses without rear wings, built of roughly-coursed stone rubble with slated, pitched roofs. There are rock-faced lintels with marginal dressing to the windows and the two end houses each project forward of the rest of the terrace as gable-fronted pavilions with rock-faced, marginally dressed limestone quoins and attic windows in their gable ends. A projecting stone band runs along the front and sides of the front of the terrace at first-floor level, supported on shaped stone brackets positioned either side of each front door where the band projects forward as a hood. The end houses are larger than the mid-terrace houses (which are two rooms deep and each have four heated rooms in total, the four flues being contained in single ridge stacks, one per house) and might have been built for workers holding more senior positions at the Low Works. The roof line and eaves step down between Nos. 6 and 7 and the arrangement of front doors and chimney stacks is reversed in the southern half of the terrace, but there is no evidence to suggest phased construction. The rear elevations mirror the frontages with back doors opposing the front doors. The houses were separated from the lane by front gardens, originally with walls of large limestone blocks, most of which have been removed. The walls are, however, shown in an early 20th-century photograph (Sturt *et al* 1990, 31) which also shows the original hornless, 16-pane hung sash windows now only retained at No. 9.

Figure 109: Front elevations of Nos. 1-12 Low Cottages, Endmoor  
(Photograph: Simon Taylor 2006, © English Heritage)

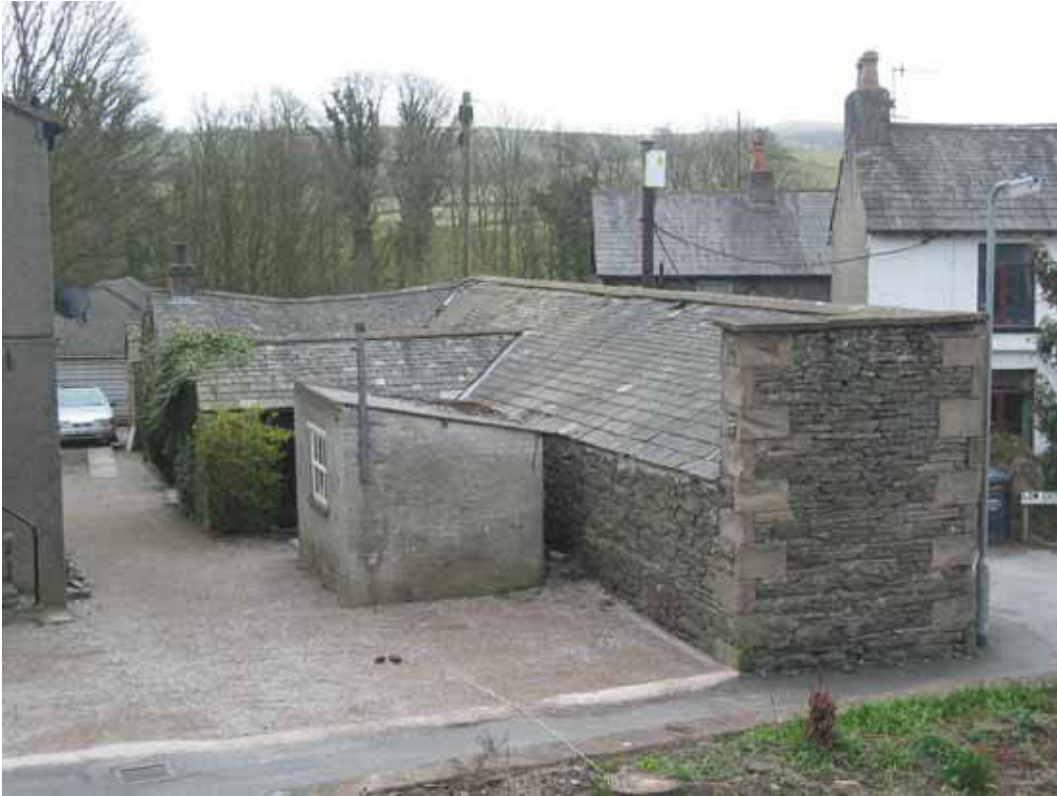
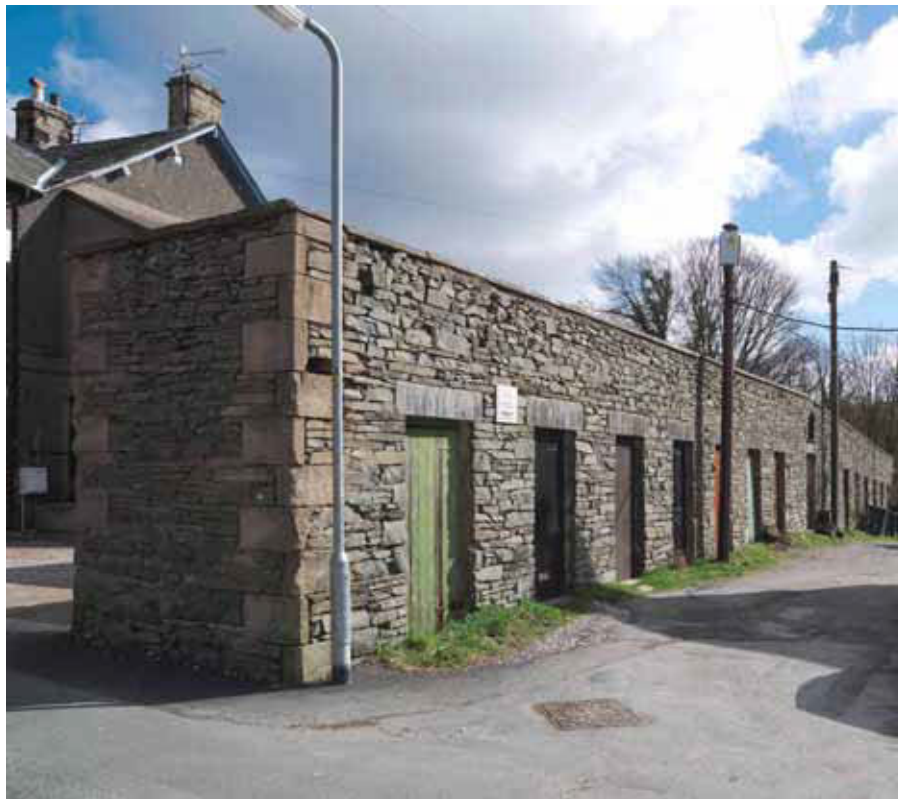
A continuous, single-storeyed, south-facing linear block containing what are probably fourteen peat or coal houses, four further units in two rear wings and a central, communal washhouse (for domestic laundry) stands between Nos. 1-12 Low Cottages to the north and Nos. 13-20 and 21-25 Low Cottages to the south (Fig 110). The block is built of random stone rubble, with roughly dressed sandstone quoins to the corners and large irregular stone lintels to the doors. The roof is single-pitched, except over the wings and wash house, and is hidden behind cheek walls which rise as flat-topped parapets at either end. The peat or coal houses are small and rectangular with simple plank doors and no windows (Fig 111). The washhouse is gabled to the rear and extends northwards from the rear of the main block, but is entered from the south. Its doorway, the eighth from the left, is wider than those of the peat or coal houses and has a louvred vent above it: the rear elevation of the washhouse also has a blocked aperture in the gable, which probably once contained a similar louvred vent. It is lit by windows in each side of the projecting section. There is a single ridge chimney towards the rear of the building,

presumably for a copper, and at the time of survey a local resident remembered a boiler and sinks formerly surviving in the washhouse. The washhouse is flanked by two similar but smaller gabled wings, each containing two further peat houses, or possibly privies serving 1-12 Low Cottages with, originally, doors in pairs facing east and west in each wing respectively.

Figure 110: Rear elevations of peat houses and washhouse at Low Cottages, Endmoor  
(Photograph: Simon Taylor 2006, © English Heritage)

Figure 111: Front elevations of peat houses and washhouse at Low Cottages, Endmoor  
(Photograph: Bob Skingle 2006, DP028030 © English Heritage.NMR)

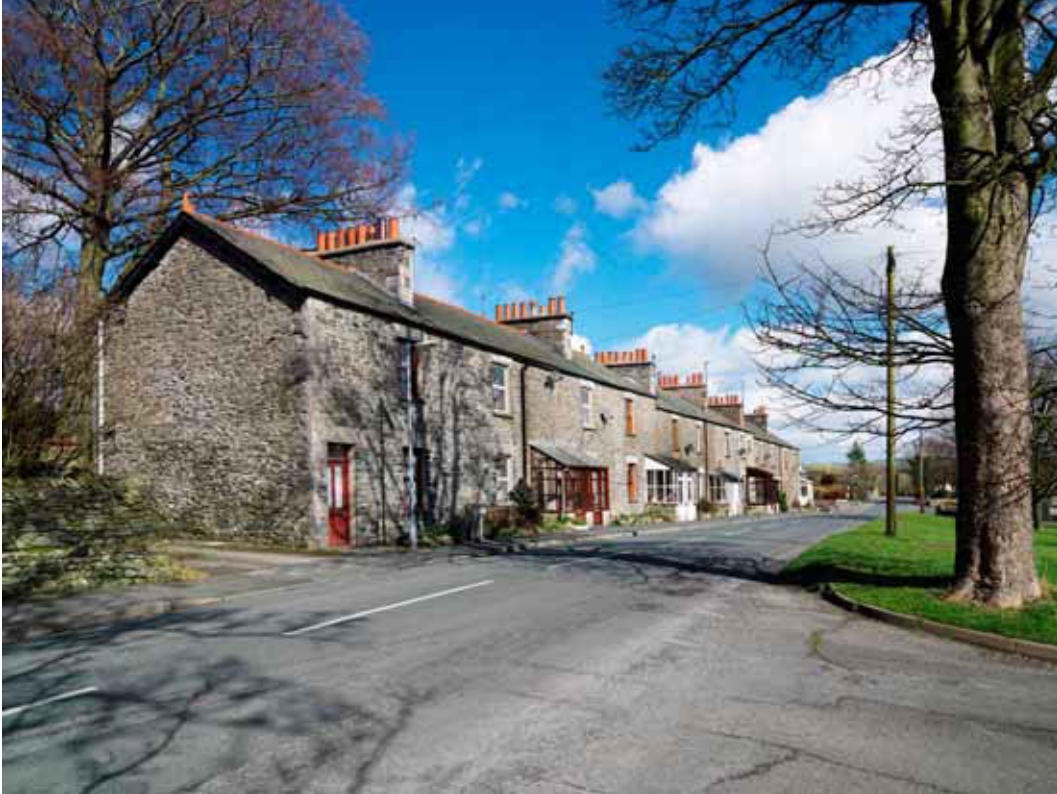
Woodside Terrace (Fig 113) is so named on the 1911 OS map (Fig 139) and is a terrace of twelve, single-fronted houses without rear wings, numbered from south to north. It is built of random stone rubble with marginally dressed, rock-faced limestone quoins to the corners and lintels to the doors and windows. The pitched roof is slated and has ceramic roof tiles and gable finials, and the ridge and eaves step down between Nos. 4 and 5 and again between Nos. 8 and 9 as the land falls to the north. Each house is two rooms deep and its plan form is a mirror of its immediate neighbour. With the exceptions of Nos. 1 and 12, which have isolated front doors in their left- and right-most bays respectively, front doors are situated beside each other in pairs. The rear elevations each have a roughly central back door flanked at ground-floor level by a rear kitchen window on one side and by a smaller window, possibly for a water closet or pantry under the stairs, on the other, in alternating sequence between houses. Each house had four heated rooms, two up and two down; single ridge chimney stacks, containing eight flues in line, are shared by each pair of houses.

*Figure 113: Front elevations of Woodside Terrace, Endmoor  
(Photograph: Bob Skingle 2006, DP028033 © English Heritage.NMR)*

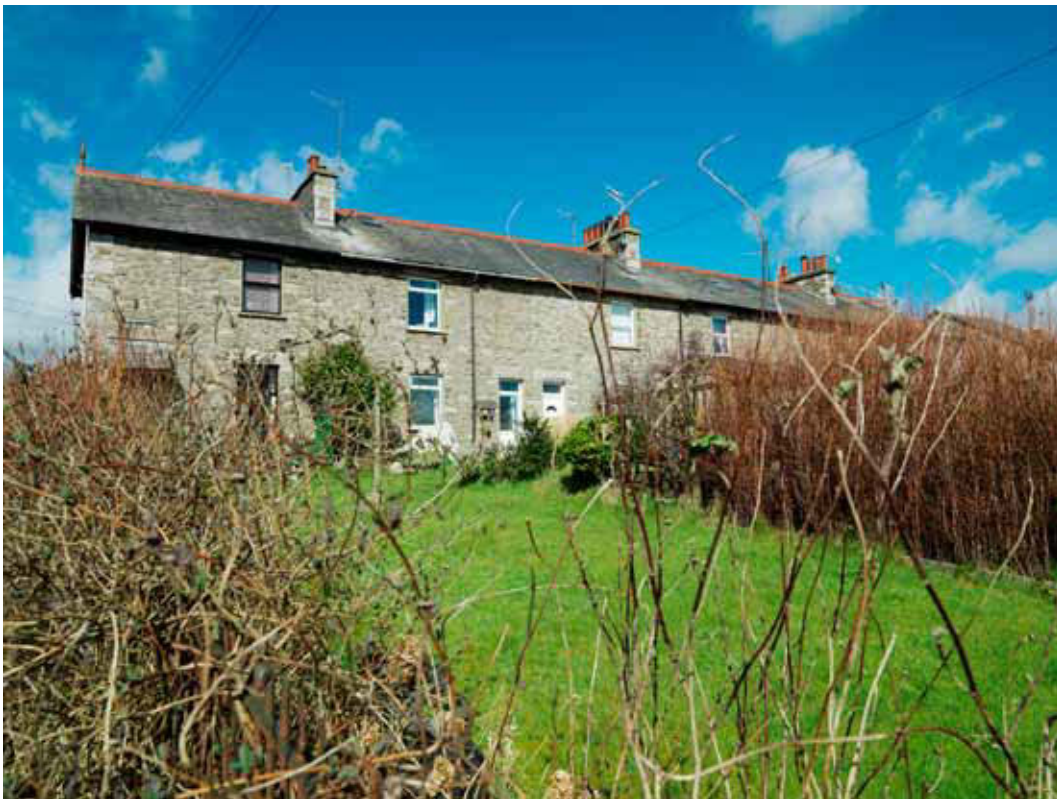
Nos. 1-6 Woodside (Fig 114) is a terrace of six houses built of random rubble with rock-faced limestone dressings similar to those at Woodside Terrace which it resembles in most other respects. It is, however, set further back from Woodside Road and the houses have long front gardens, front doors originally being reached by a communal footpath immediately in front of the terrace. Decorative bands of limestone are built into the rubble stone of the northern three houses and it is possible that this reflects different phases of building. A back lane separates the terrace from a single, centrally-placed, east-facing block of three former peat or coal houses or possibly privies, with a single-pitched roof and rendered walls (Fig 115).

*Figure 114: Front elevations of Nos. 1-6 Woodside, Endmoor  
(Photograph: Bob Skingle 2006, DP028034 © English Heritage.NMR)*

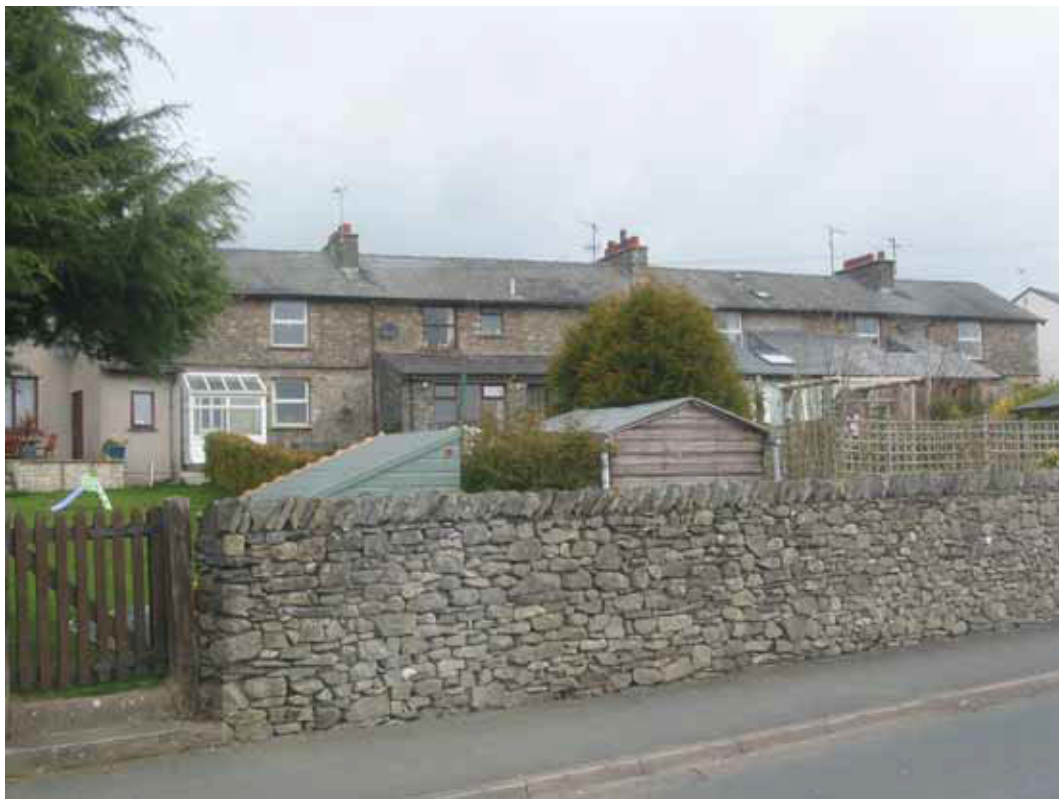
Nos. 7-12 Woodside (Fig 116) does not appear on the 1896 and 1911 OS maps or the 1923 factory plan, but whilst erroneous omission is unlikely, at least by the Ordnance

Figure 116: Front elevations of Nos. 7-12 Woodside, Endmoor  
(Photograph: Simon Taylor 2006, © English Heritage)

Survey, the nature of the building and the accommodation provided - both of which are largely identical to those at Woodside Terrace and Nos. 1-6 Woodside - would suggest a pre-First World War building date. It is a terrace of six houses and stands a little to the north of Nos. 1-6 Woodside although it has a slightly different orientation and has smooth sandstone rather than rock-faced limestone dressings. The pitched roof is of slate and has plain grey ridge tiles but no gable finials. A back lane separates the terrace from a large, long, single-storeyed, rectangular gabled block containing a washhouse at either end and fourteen former peat or coal houses arranged in two back-to-back rows of seven (Fig 117). The roof of the block is slated and the outer walls are of random stone rubble, with large but smooth sandstone quoins at the corners. The internal partitions are of red brick. Each peat or coal house has only a simple plank door while each washhouse has an entrance on its south-east side and a window in its north-west wall. The washhouse at the north-east end retains a circular copper, with a wooden lid, over a firebox within a square, red-brick housing set in the north-west corner (Fig 118). Given its size, it is likely that the facilities in this block were originally also used by the residents of Nos. 1-6 Woodside, suggesting that it is also close to its date.

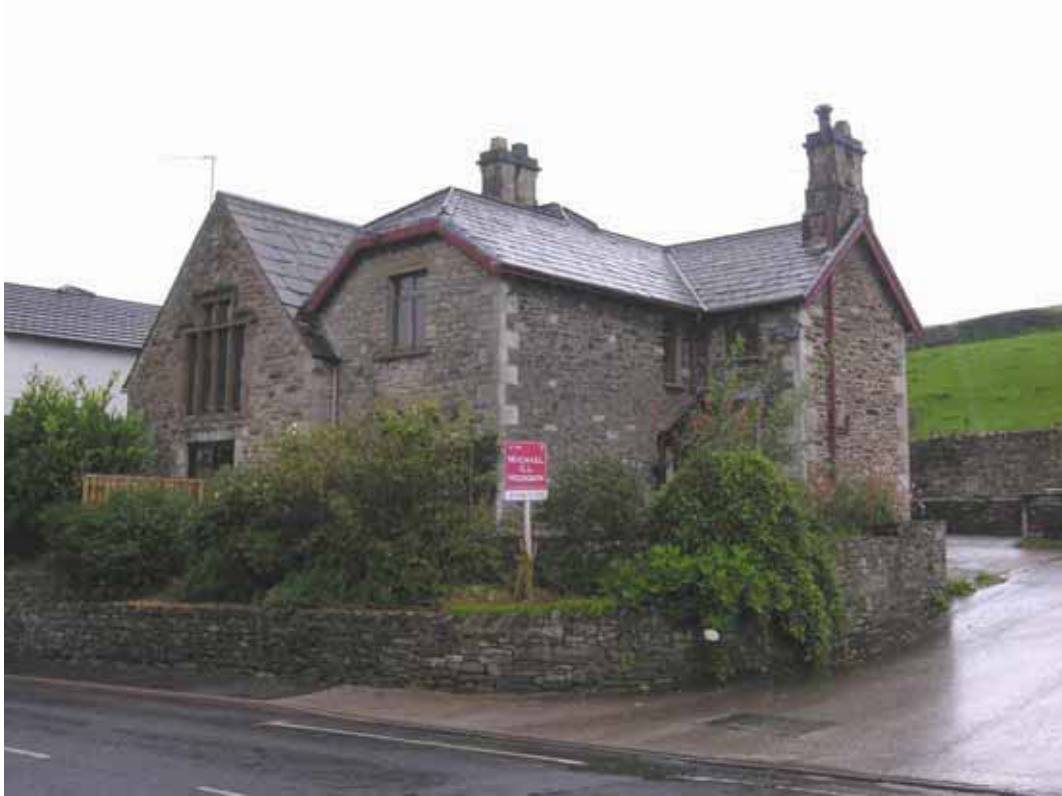
The school at Endmoor (Fig 120) was built in 1862: the date appears in a panel in the gable over the hall block. The building is one and two storeys high and is of random stone rubble, with dressed stone quoins to the corners, in a rough Tudor style. It is an irregular L-shape in plan and has a gabled hall aligned south-east to north-west, with a six-light mullion and transom window, above which is the datestone, at the street end. Two-storeyed, gabled and hipped former classroom wings are attached to the north-east side and there were formerly single-storeyed hipped and gabled classroom wings attached to the south-west side. The school was enlarged in 1970 by the addition of a single-storeyed system-built wing (*ibid*, 26), since demolished, and it finally closed in 1990. Endmoor School has since been converted into two separate dwellings, a process which evidently involved the removal of the original south-west classroom wings from the former hall; it is now known as School House.

*Figure 120: Endmoor School  
(Photograph: Simon Taylor 2006, © English Heritage)*

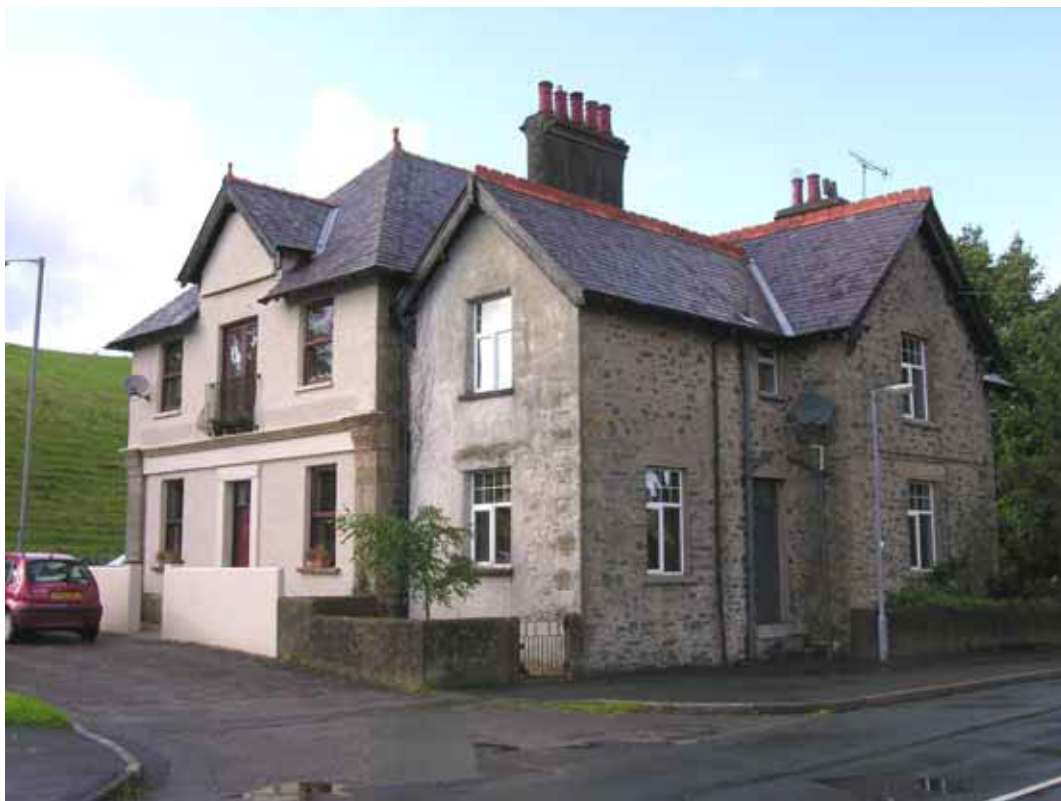
The Co-operative store (Fig 121), a branch of the Kendal Co-operative Society Limited, was built in 1902 in the angle formed by the fork of the main Kendal to Lancaster road and Woodside Road. It is a two-storeyed building of random stone rubble with roughly dressed stone quoins to the corners. The main block has a hipped, slate roof and faces south. The ground floor was formerly occupied by a large shop front, originally with large shop windows flanking a central entrance with a classical entablature - lacking an architrave but with a double-ovolo moulded cornice above a frieze – over all. The first floor was probably used for warehousing and the central bay terminated vertically with a faux timber-framed gablet, now rendered. To the rear is a gabled cross wing with a ground-floor taking-in door in the west end, below another faux timber-framed gable, and living accommodation, also provided in attached and gabled rear and side wings, in the east end. The stores closed in the late 1970s and the building is now used only as domestic accommodation.

*Figure 121: Co-operative store, Endmoor  
(Photograph: Simon Taylor 2006, © English Heritage)*

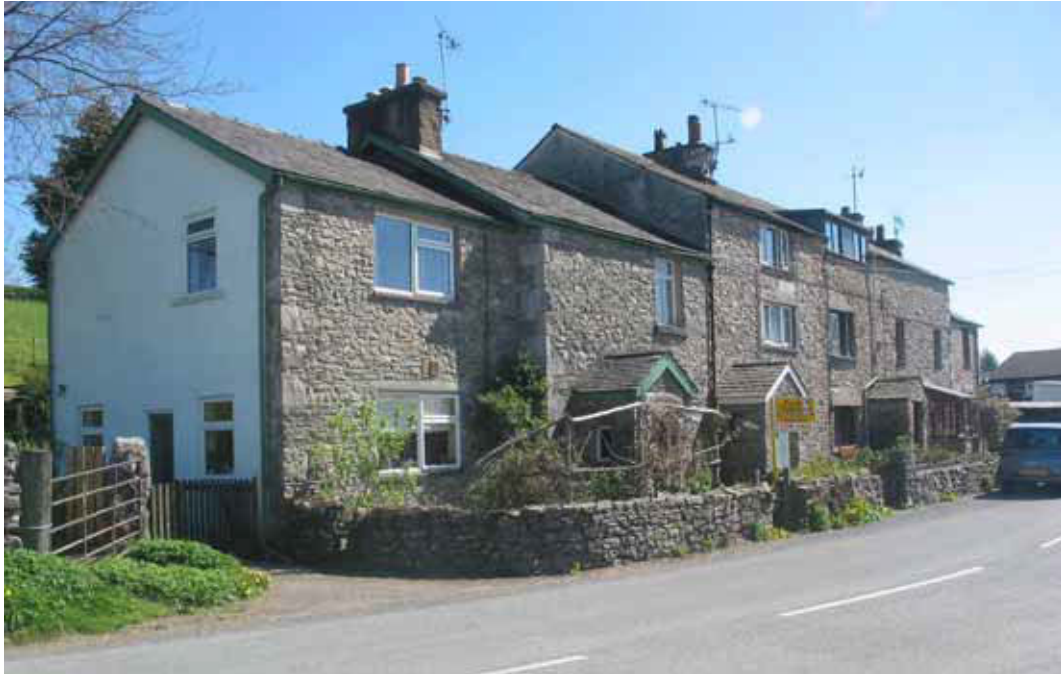
Nos. 1 – 4a Gatebeck (Fig 122) is now a range of five dwellings of two and three storeys built of random stone rubble with pitched slate roofs. At the core of the range is a block of what are now three, three-storeyed dwellings and one, two-storeyed dwelling (Nos. 2 – 4 Gatebeck and No. 4a Gatebeck respectively), apparently one room deep and, in the case of Nos. 2 – 4, originally blind to the front at second-floor level. Nos. 3 and 4 are single fronted and originally had large, roughly dressed stone lintels to single ground- and first-floor windows. The lintels remain *in situ* but both houses have been re-fenestrated. No. 2 is now a double-fronted, central-entry house and has cambered arches with roughly dressed stone voussoirs rather than stone lintels to the first-floor window openings, but might originally have been two, single-fronted houses (like Nos. 3 and 4). The ground-floor windows also have stone voussoirs but have been widened. Nos. 3 and 4 have small gabled stone porches and there is a later timber porch to the front door of No. 2. There is no clear joint between Nos. 3 – 4 Gatebeck and No. 4a which is built of

*Figure 122: Front elevations of Nos. 1-4a Gatebeck  
(Photograph: Simon Taylor 2006, © English Heritage)*

the same type of random stone rubble as Nos. 2 – 4 and has a similar stone lintel to its ground-floor window as Nos. 3 - 4. It has good quoins to its north-west corner, similar to those at the south-west corner of No. 2, and it is likely that it is part of the same build unit as Nos. 2 – 4, which might therefore have originally comprised a terrace of four or five three-storeyed houses. No. 4a is now only two storeys high but the projecting gable end of No. 4 is uneven and rendered, suggesting a patch which might indicate that No. 4a has lost a storey and that the houses originally had a shared loft or garret. A later, lower, two-storeyed, single-bay gabled block butts against the north end of No. 4a. It has good quoins to its north-west corner but they are lacking from the south-west corner; the windows in the front elevation are insertions and entry is via the north end. It now forms one dwelling with No. 4a. At the south end of the range is a further addition, No. 1 Gatebeck, which butts against No. 2. It is a two-storeyed, single-fronted house with large, roughly dressed stone lintels to the windows and door which is on the left side of the frontage, its left jamb formed by the former side of No. 2 where quoins have been removed. The lintel above is also set partly within the wall of No. 2 and above it the corner of No. 2 is quoined. There is a single, two-flued ridge stack at the south end.

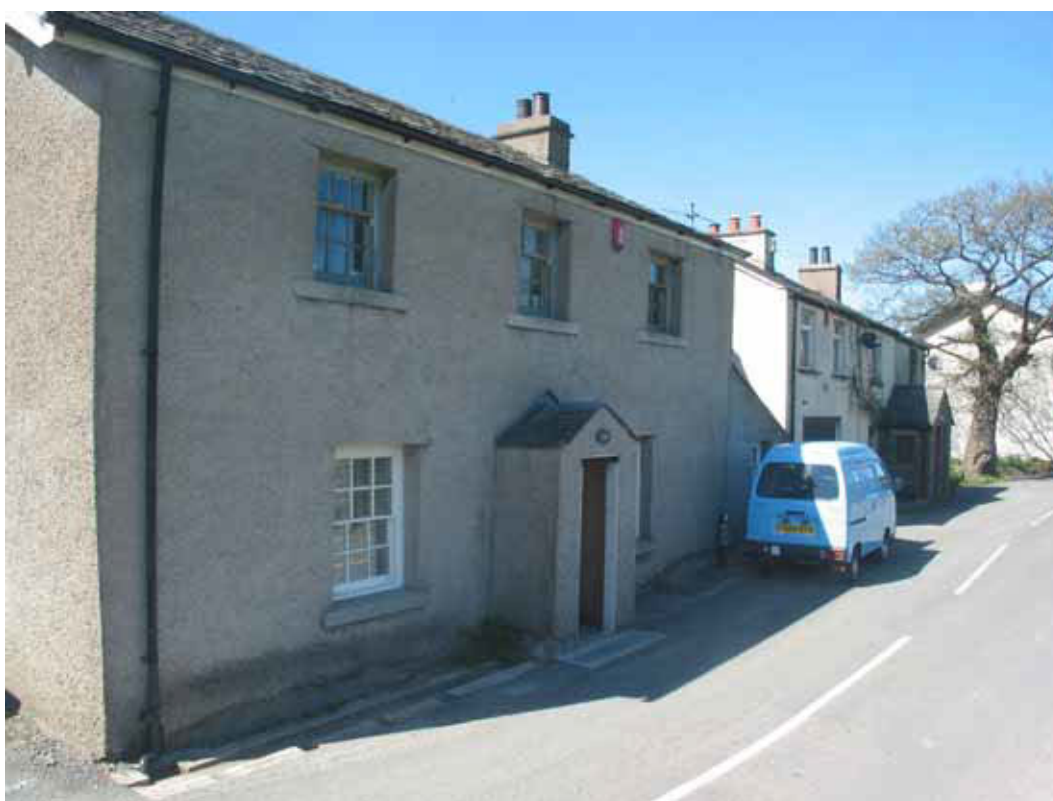
At the south end of the range is a three-bay, two-storeyed house with a central entrance with a small gabled porch (Fig 123). It has a slated, pitched roof with two-flued ridge stacks at each end. It is now thickly covered with even render and the front windows have replacement cement sills. There is a single ground-floor window on the left side of the south gable and a simple lean-to

*Figure 123: Front elevations of Nos. 5-6 Gatebeck  
(Photograph: Simon Taylor 2006, © English Heritage)*

extension with a corrugated iron roof against the north gable. It is now numbered 5 – 6 but No. 6 was probably originally the number of a house which formerly butted to the immediate north but which has been demolished leaving a gap between the present Nos. 5 – 6 and 7 – 8 Gatebeck. The lean-to extension on the north side of Nos. 5 – 6 now partly occupies this gap.

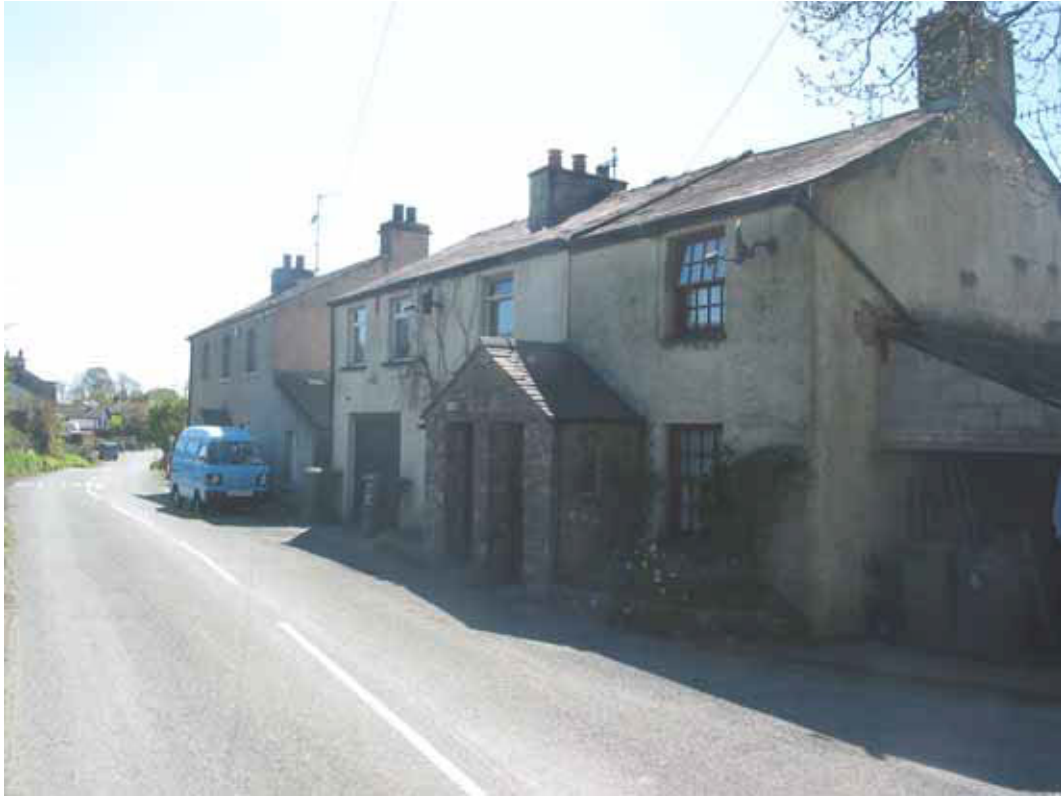
Nos. 7 – 8 Gatebeck (Fig 124) are now a pair of two-storeyed, single-fronted houses with a pitched slate roof with paired front doors, now with a single, gabled, stone porch. There are paired, single-storeyed, rear wings, that of No. 8 extended to full width. The

*Figure 124: Front elevations of Nos. 7-8 Gatebeck  
(Photograph: Simon Taylor 2006, © English Heritage)*

OS map of 1858 (Fig 137) shows these as a single building labelled as 'School' and it is possible that the two cottages were originally a single three-bay house. They had, however, been subdivided by 1896 (Fig 138).

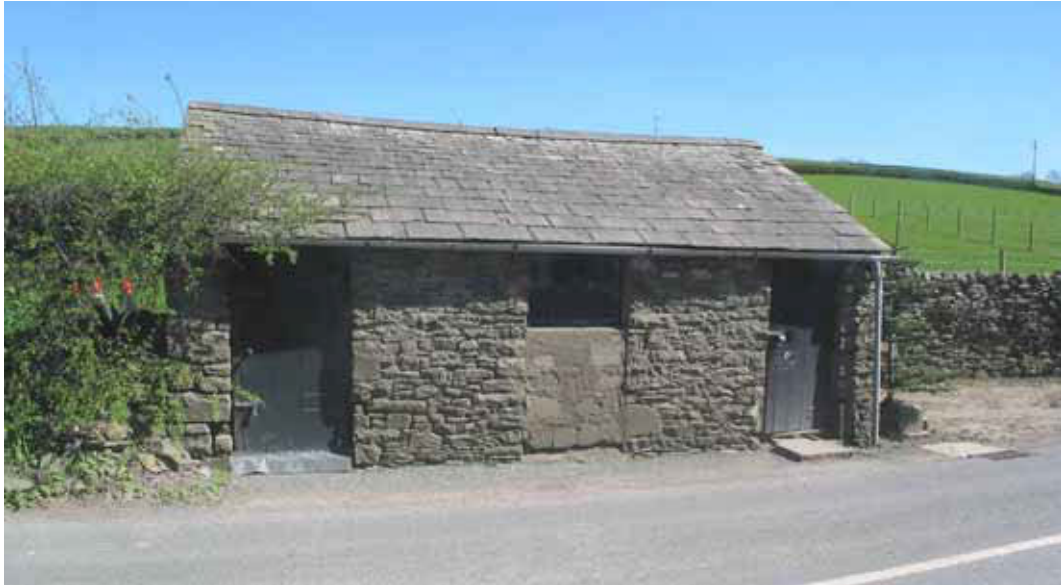
On the opposite side of the road from Nos. 5-8 Gatebeck stands a rectangular, single-storeyed building (Fig 125) of roughly-coursed stone rubble, lacking quoins to the corners but with a pitched slate roof of diminishing courses, and also in existence by 1858 (Fig 137). Its west front has three regularly spaced, full-height openings, the outer two with simple plank doors, the central one part blocked to convert it into a window. The original function of the structure is unclear but it might have been built as a peat house or animal shelter. A large vehicle entrance has subsequently been inserted into its south end and so its last use was probably as a vehicle house, any internal partitioning having been removed to facilitate this.

*Figure 125: Ancillary building opposite Nos. 5-8 Gatebeck  
(Photograph: Simon Taylor 2006, © English Heritage)*

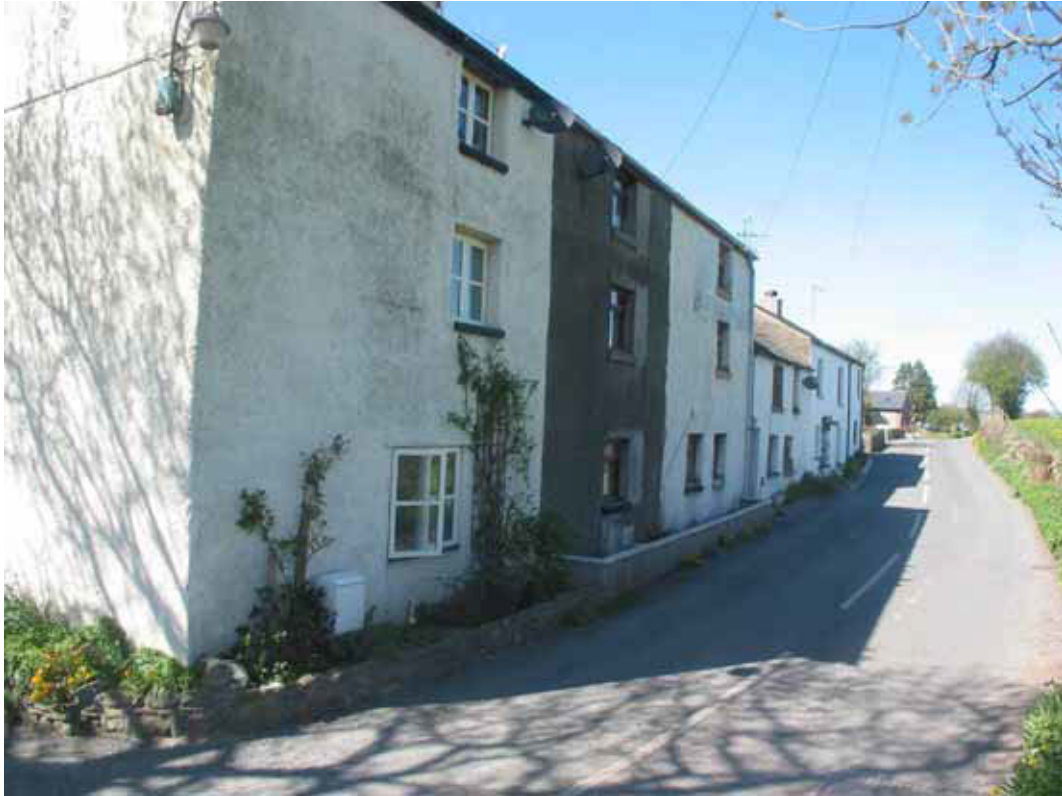
Figure 126: Front elevations of Nos. 9-11 Gatebeck  
(Photograph: Simon Taylor 2006, © English Heritage)

Nos. 9 – 11 are now three, three-storeyed houses (Fig 126) and are shown as three units on the OS map of 1858 (Fig 137). Although heavily rendered they are almost certainly built of stone rubble and have pitched slate roofs. The east elevations each have a single tier of rectangular windows on all floors with stone sills; Nos. 9 and 11 have an additional ground-floor window to the left of each tier. The west elevations (Fig 127) also have single full-height window tiers to each house and ground-floor entrances, now behind secondary porches with single-pitched roofs. Nos. 10 – 11 have latterly been converted into a single dwelling.

No. 15 is a low, two-storeyed house with a three-bay façade to the road (Fig 126): the left-most bay is occupied by an inserted doorway and the next two bays by ground- and first-floor windows. The ground-floor window in the right-most bay is wider than the others and might be a conversion from an earlier doorway as there is what might be a former stone threshold beneath it and the OS map of 1896 (Fig 138) appears to show a porch in this position. Thick render, however, obscures any conclusive evidence. The rear of No. 15 extends westwards as a short wing (Fig 127) and the range continues as Nos. 13 and 12, all now simple, single-fronted, two-storeyed houses with continuous eaves. Nos. 12 and 14, which are contiguous at the west end of the range in spite of non-consecutive numbering, were probably built as a pair at the end of the rear wing of No. 15 and have a slightly higher ridge line and a single central ridge stack. That said, the non-consecutive numbering might indicate that No. 14 was originally part of a larger No. 12 and was renumbered when it was partitioned into a separate dwelling. No. 13 appears originally to have been part of the rear wing of No. 15 or an extension of it, but is now combined with No. 12 to form a single dwelling. Local residents report that Nos. 13 – 14 were formerly in use as a public house.

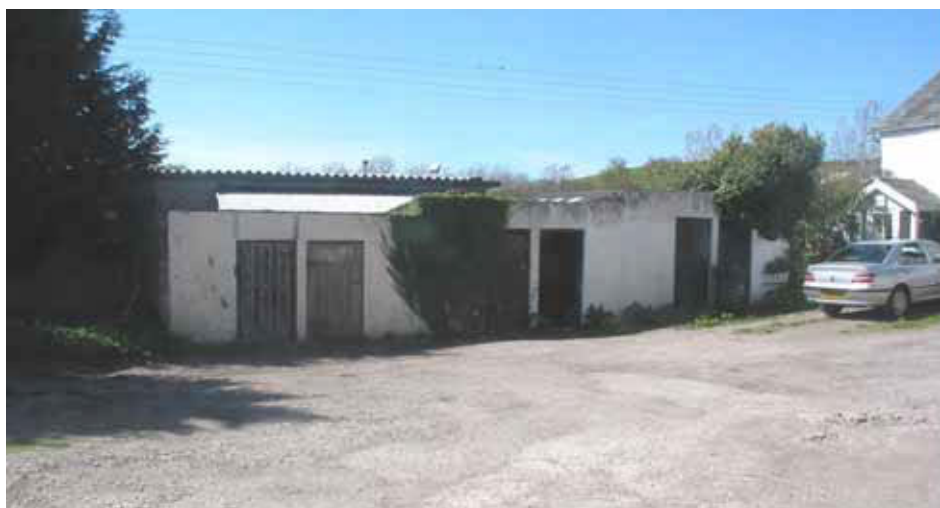
*Figure 128: Ancillary block at Nos. 9-16 Gatebeck  
(Photograph: Simon Taylor 2006, © English Heritage)*

The yard into which all the houses, except No. 16, face has a linear rendered block of six peat houses or privies built between 1858 and 1896 (compare Figs 137 and 138) along its western side. The block (Fig 128) is single-storeyed and has a single-pitched roof now covered with corrugated iron. Six doorways with simple plank doors arranged in pairs face eastwards onto the yard. A further ancillary building, shown on both the 1896 and 1911 OS maps (Figs 138-9), formerly butted against the south end of the block but has been demolished leaving the scar of its roof line in the south end wall.

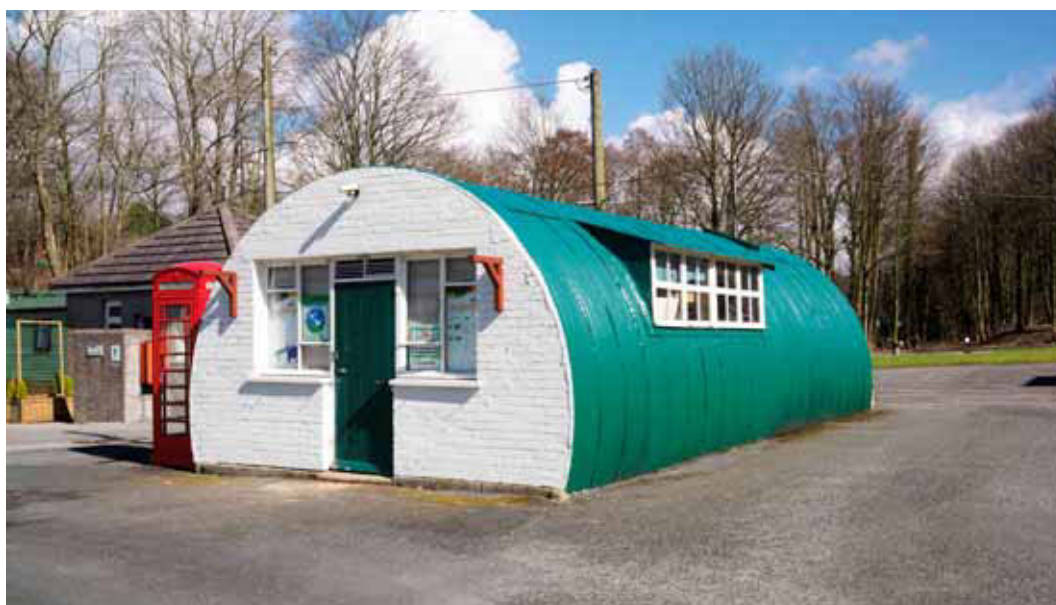
*Figure 129: Nissen hut from the west  
(Photograph: Bob Skingle 2006, DP028047 © English Heritage.NMR)*

A six-bay, 16-foot span Nissen hut with original dormer window (Fig 129) stands between the toilet blocks. Although most likely erected by the County Council at the same time as the toilet facilities, it is possible that it dates instead from the military use of the site in World War II. The building now serves as the caravan park shop.
