# GATEBECK LOW GUNPOWDER WORKS AND THE WORKERS' SETTLEMENTS OF ENDMOOR AND GATEBECK, CUMBRIA AN ARCHAEOLOGICAL AND ARCHITECTURAL SURVEY

## SURVEY REPORT

NGR: SD 544 853

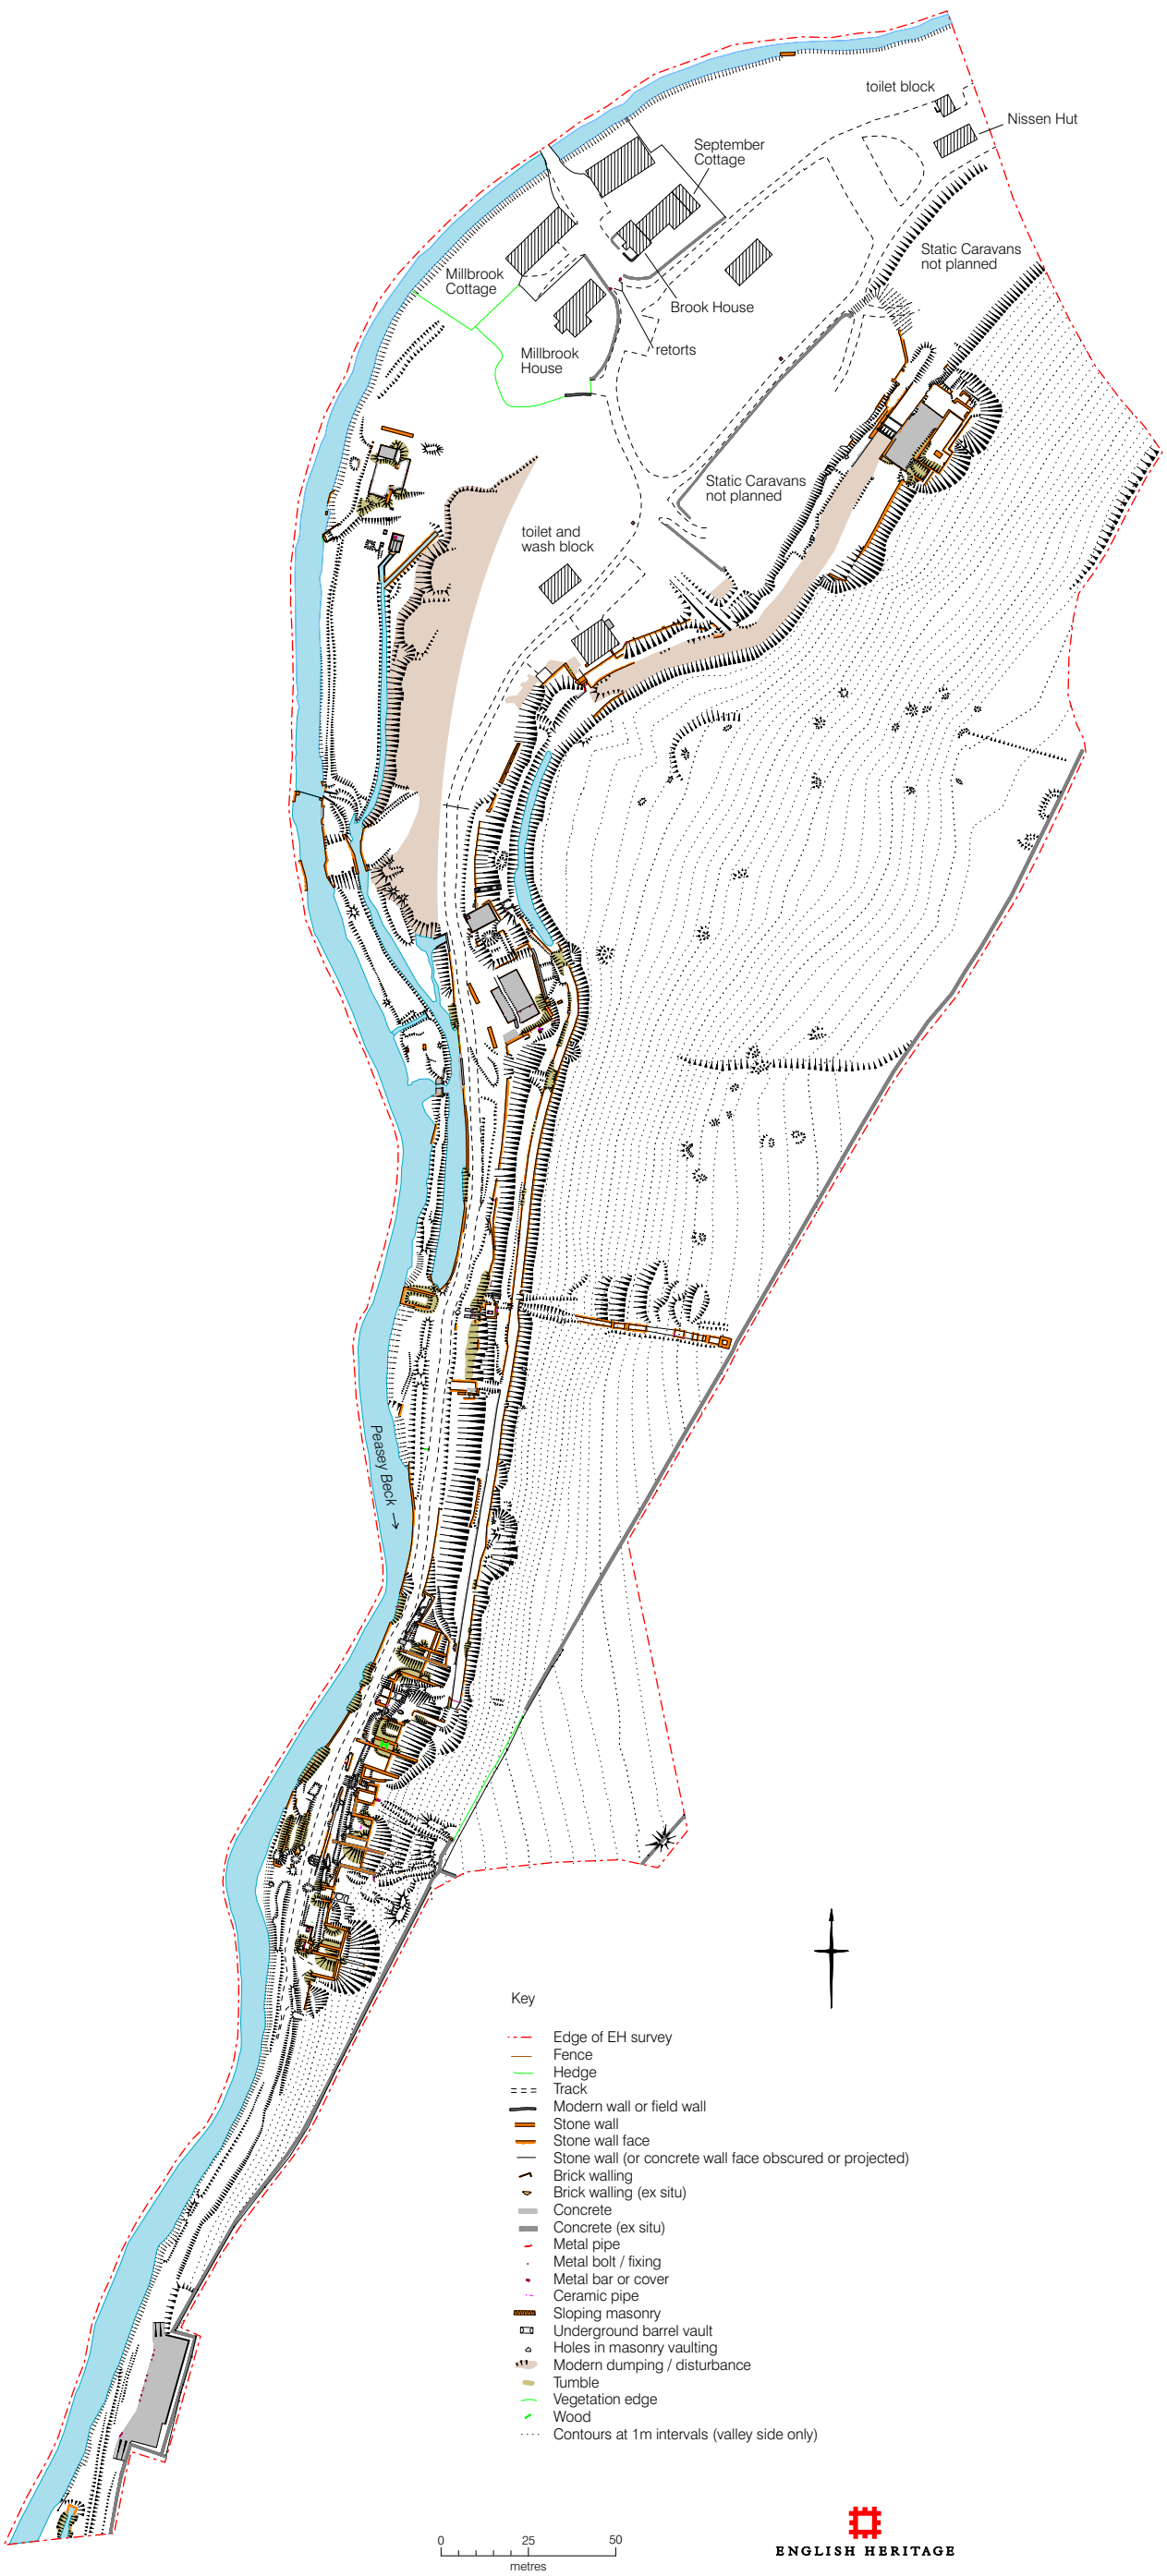
Figure 143.  
English Heritage earthwork plan of  
Gatebeck Low Works, reproduced  
at 1:2000 scale  
(© English Heritage)
