PROCEEDINGS
OF THE
CAMBRIDGE ANTIQUARIAN
SOCIETY

EXCAVATIONS AT CROMWELL HOUSE, HUNTINGDON, 1984

DAVID HAIGH

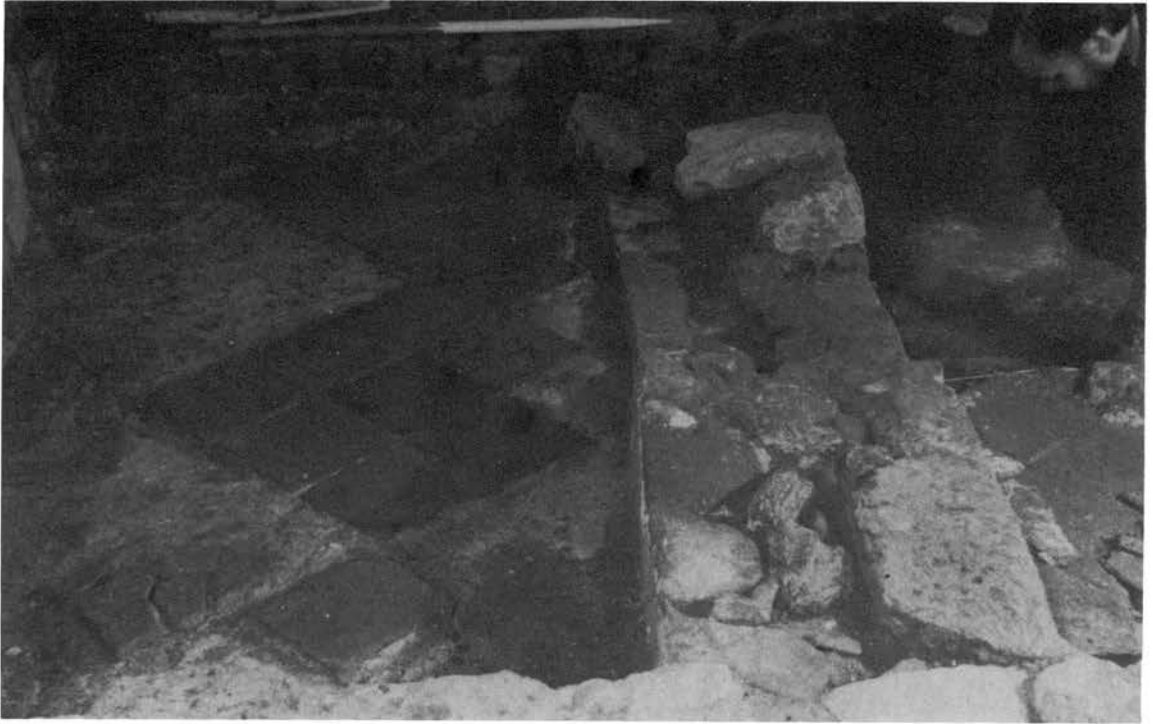
Plate 1*a*. Trench (1), wall (5) and tiled floor (4) looking east.

(4) Tiled floor on mortar foundation, underlies wall (10) and butts against wall (11). Predates the construction of wall (5), which cuts it. First phase of priory building associated with the construction of wall (11). Of c. thirteenth-century date.

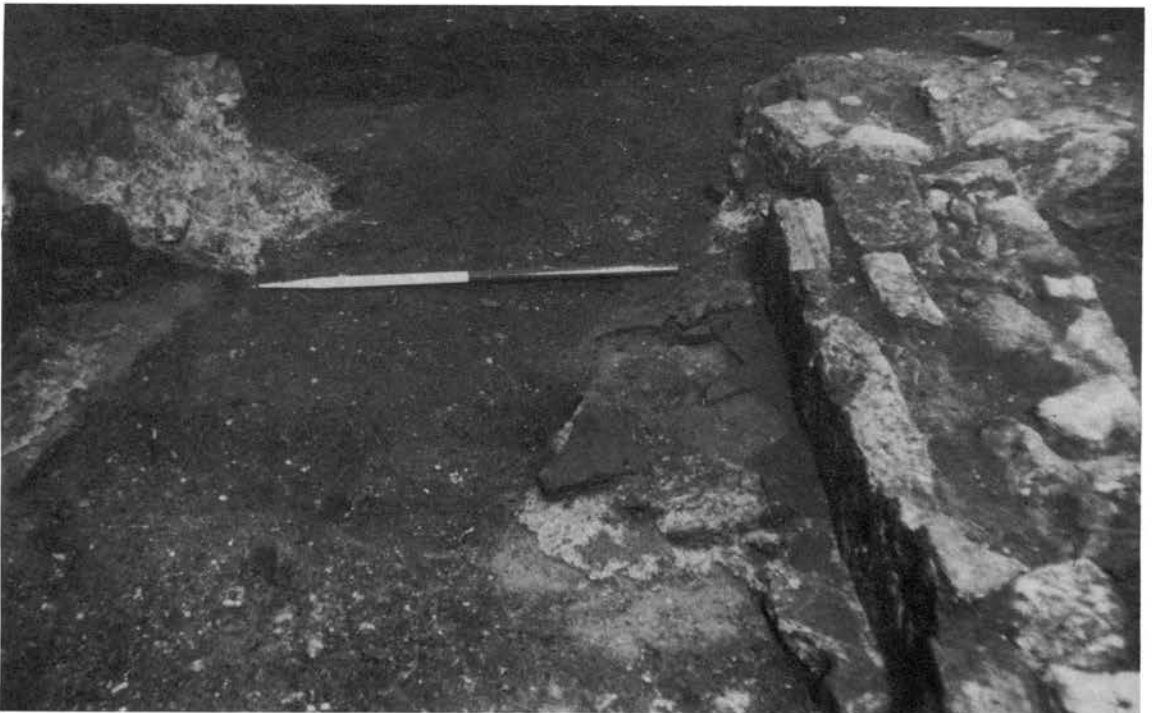
Plate 1*b*. Trench (1); wall (11) cut by a later drain, and wall (5).

(11) Substantial wall of dressed Barnack stone with a mortared rubble core. The wall was plastered at least twice on both faces, and was strengthened with an additional row of stones added to the south side after the first and before the second coat of plaster was added. This wall was exposed in both excavated areas and incorporated two stone doorways, one at least of which is of thirteenth-century date. The wall is associated with the earliest phase of the friary buildings and the earliest phases of the tiled floors.

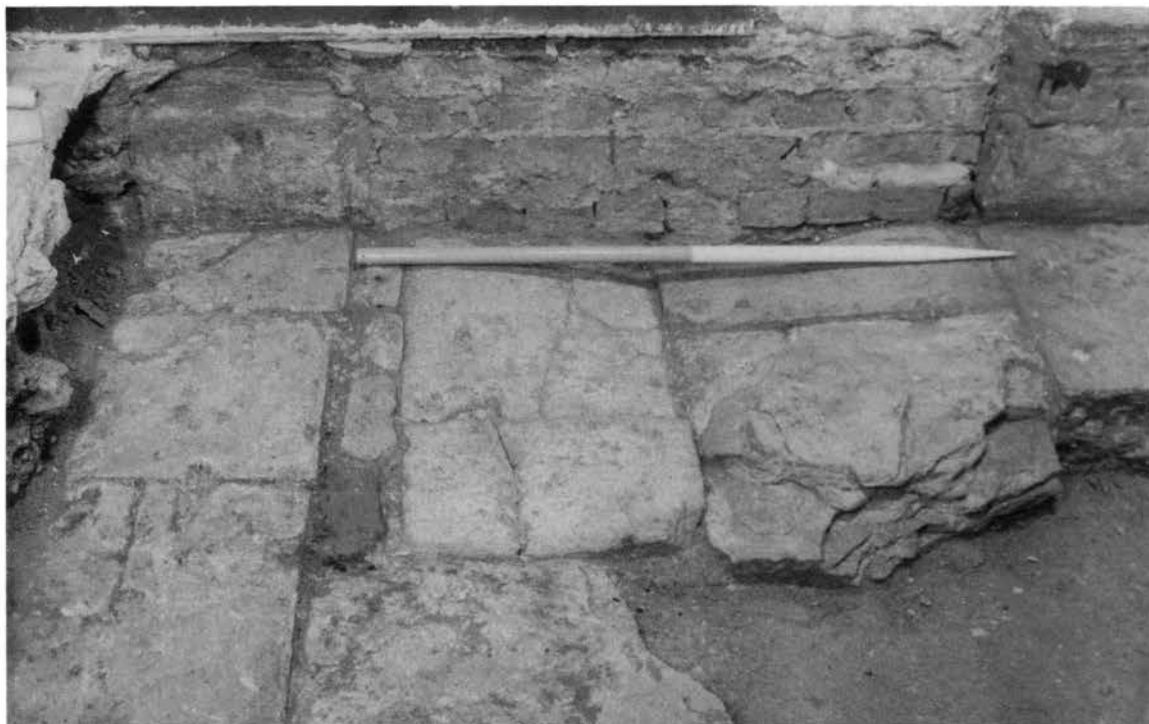
Plate 2*a*. Trench (2); blocked thirteenth-century door and worn paving.

Inskip Ladds had seen two stone doorways apparently along the line of the main north-south wall somewhere to the south of this trench. He recorded that the doorways could still be seen below the floor of the passage leading from the hall of the present house. In the light of this information a small area was exposed at the possible site of the northern doorway in order to confirm their positions. We were permitted to open an area 2 × 1 m in the former scullery, 4.5 m south of the point where this wall was exposed within the hall. The door and adjacent worn stone paving was revealed just as described by Inskip Ladds (Plate 2 *a*).

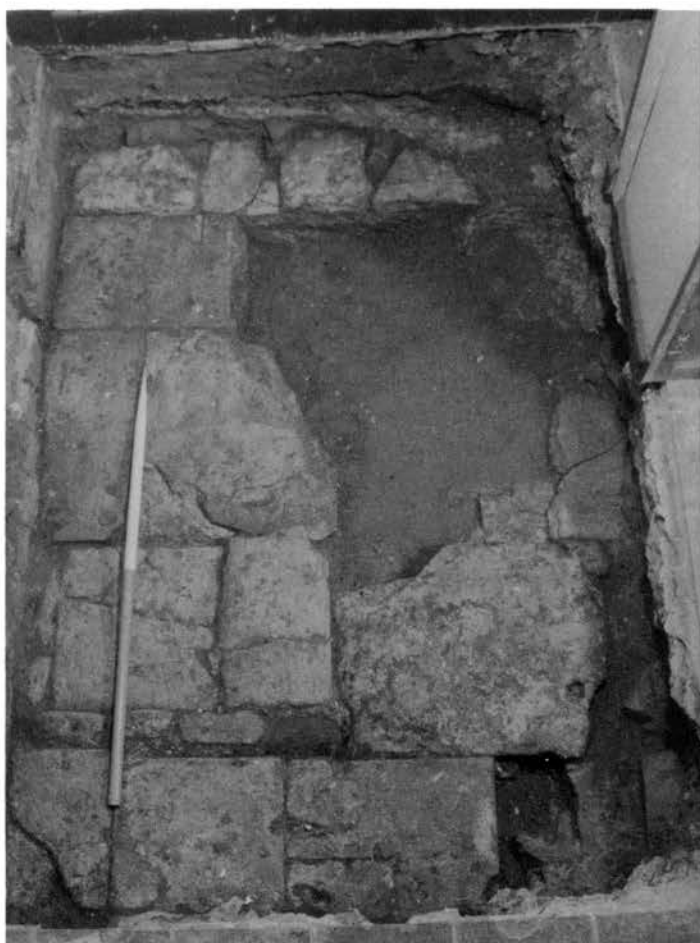
Plate 2*b*. Trench (2); worn paving with wall (15) at the top.

(15) Wall parallel to (5) plastered on both faces with the plastering carrying round on to the already plastered face of (11). This wall butts (11) and is technically later than it. The flagged surface was laid after the wall was built, but as this appears to be contemporary with the doorway in wall (11), the cross wall is clearly contemporary and we are just seeing the sequence of construction.
