Colley Hill Farm
Colmworth, Bedfordshire
(TL 106 582)

Archaeological Evaluation

(Planning Application Ref. 11/01704/FUL)

Archaeological Evaluation Report

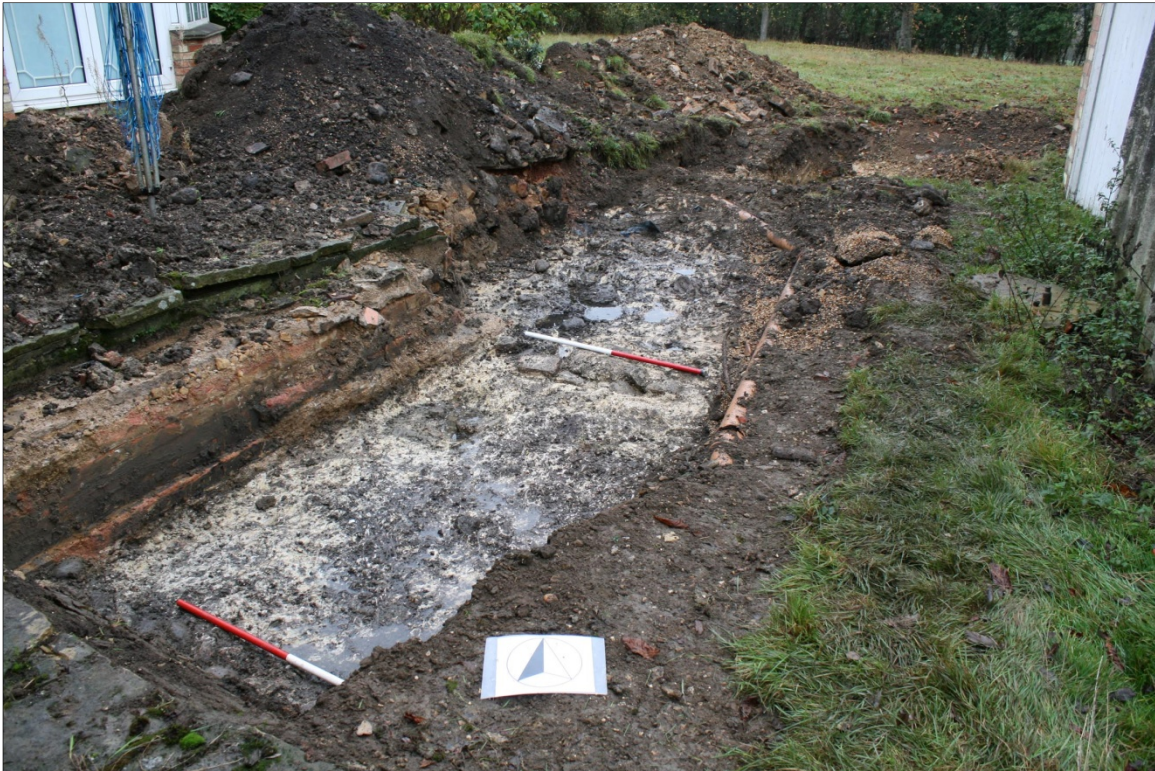
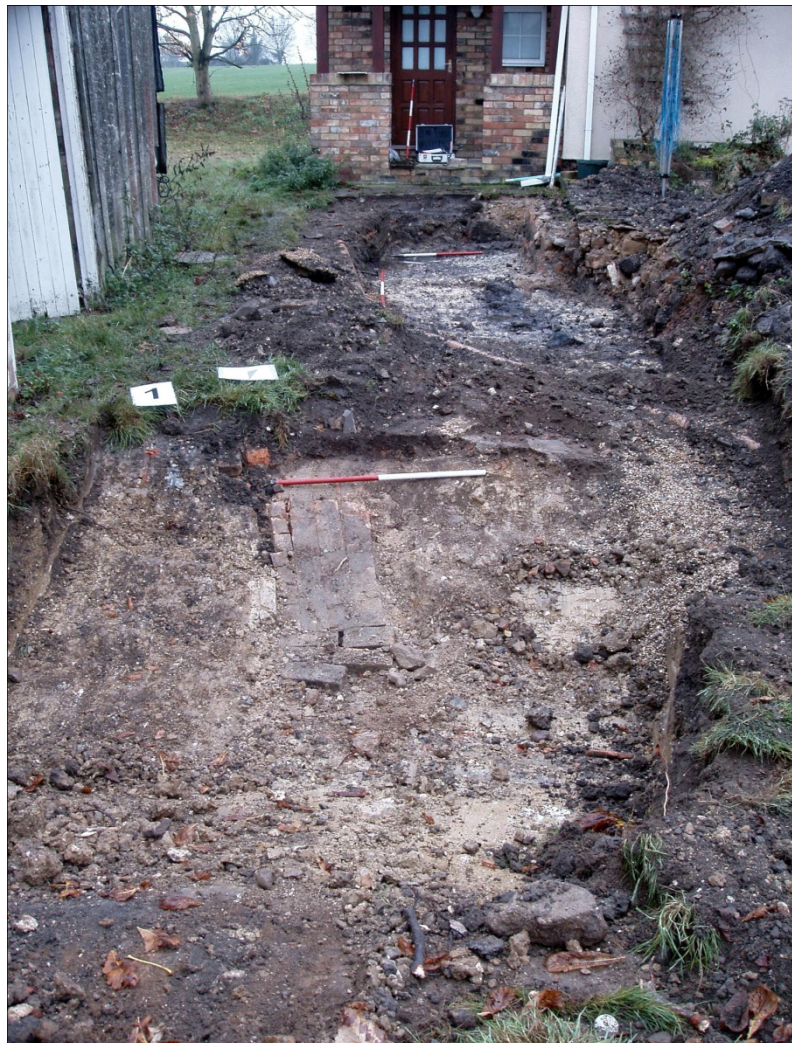
Figure 4.
Overviews of Trench 1
Top: facing N.
Bottom: facing SW

- 8.2 The trench was situated in Area A (Figures 2 and 3), in the patio and garden area immediately north east of the existing house, and within the development footprint of the proposed new dwelling. It was 10.87m in length and aligned north-northeast / south-southwest. Its width was irregular, between 1.57 and 2.32m, due to physical constraints and buried services. The overall area investigated was approximately 24.3sq.m.

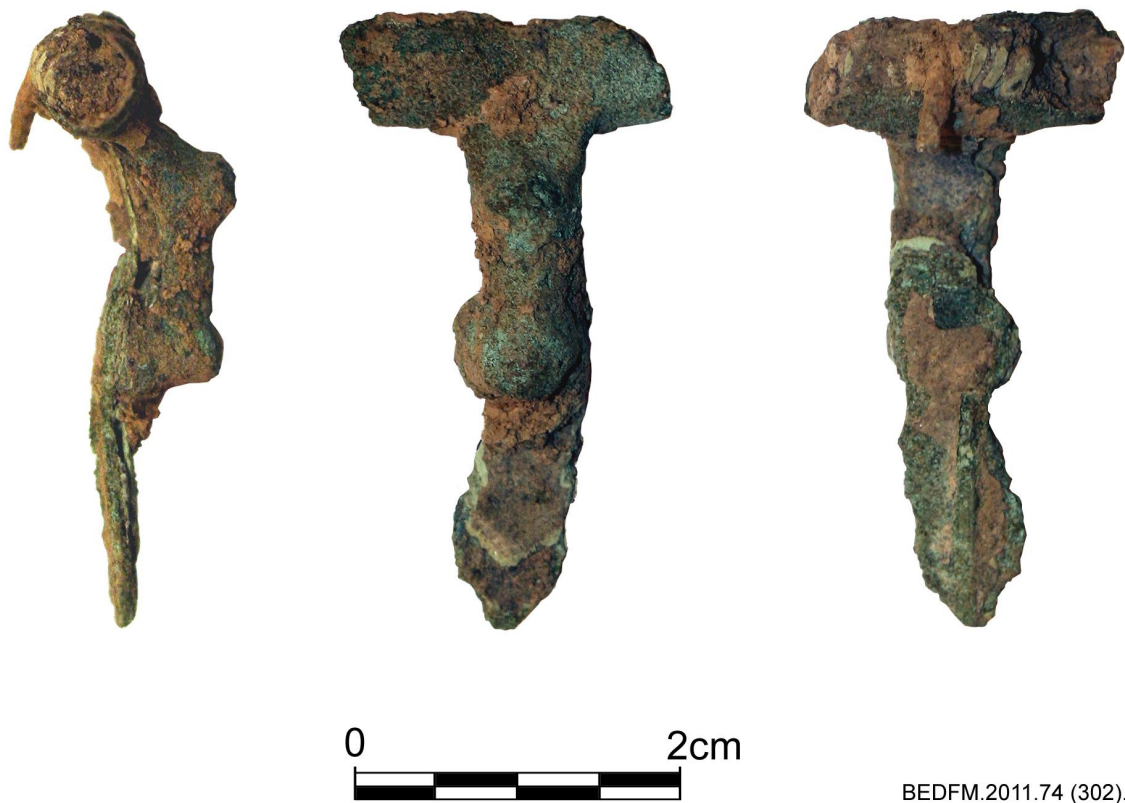
Figure 13. Copper alloy brooch from Iron Age ditch in Trench 3 (302)

- 8.22 A broken copper-alloy (Cu) brooch (SF1) was recovered from the intermediate fill (302) of a large ditch revealed in Trenches 3 and 4 [301]/[408]. While the brooch is in-keeping in style with Roman forms, the presence of mid-to late Iron Age pottery and notable absence of 'Romanised' ceramic forms in any of the contexts, seems to suggest that the brooch is a pre-conquest item.

9.6 The pottery is predominantly from the late Iron Age (c.100BC to 43AD) with a few abraded pieces from the Middle Iron Age (c.400-c.100BC), thus indicating the longevity of settlement at Colley Hill. A small Roman-style bow brooch was found in the intermediate fill (an erosion by-product) of the ditch in Trench 3 and is considered to be a pre-conquest item, since there are no 'Romanised' pottery sherds present in the assemblage.
