ARCHAEOLOGICAL MONITORING

SEWER RENEWAL WILLOW GROVE, EARSWICK

NAA 18/71
August 2018

SEWER RENEWAL, WILLOW GROVE, EARSWICK, YORK

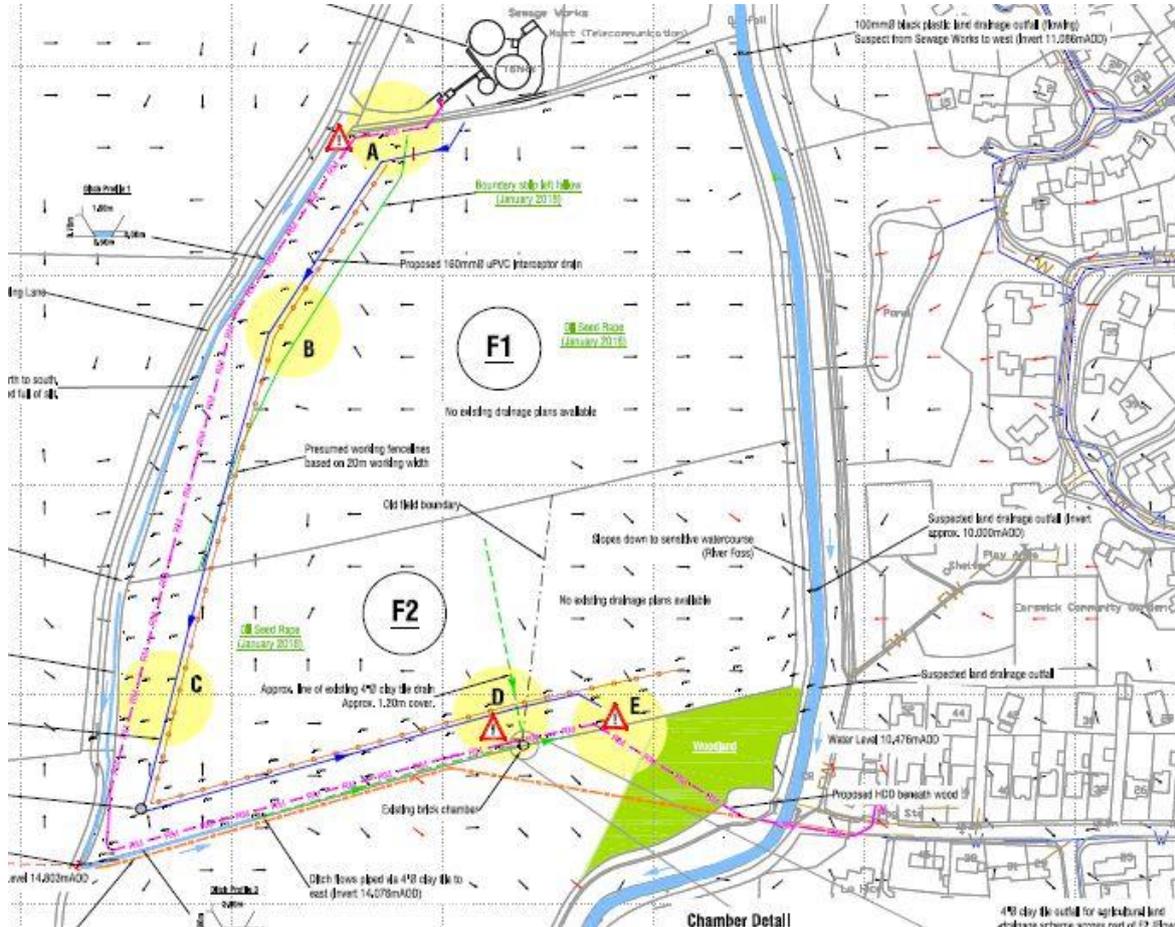
Figure 2. Archaeological monitoring area (between pink and black line), based on excerpt from client drawing

The groundwork was located on the west side of the river Foss, some 2km to the north of York city centre. Work was undertaken within 614m of easement for the construction of the pipeline (Figure 2).

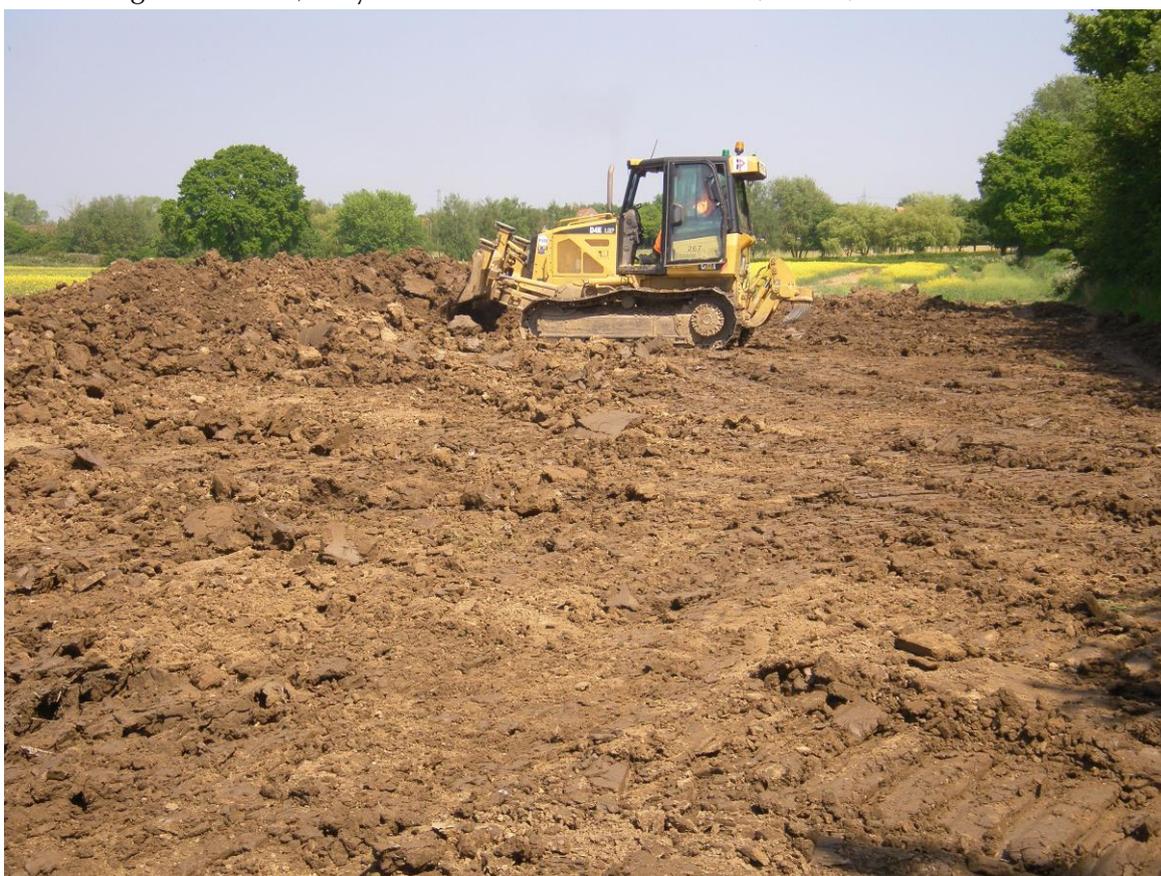
Plate 1. Bulldozer stripping topsoil

The second area of excavation was located close to the hedge-line adjacent to Landing Lane, extending for 394m south-westwards then turning eastwards for 253m towards the river Foss. The topsoil was initially stripped to a width of 9m using a bulldozer (Plate 1); the pipe trench was excavated by 360° excavator with a 1.5m-wide ditching bucket, with a variable depth of up to 1.8m. Excavation for the pipe trench (614m) revealed no archaeological features, only undisturbed natural substrate (Plate 2).

The topsoil for the pipeline easement was stripped using a bulldozer, with an archaeologist present, but against the advice of NAA. As this did not provide the opportunity to observe the natural substrate, and therefore to identify any features of potential archaeological interest, the mechanical excavation of the pipe trench was also monitored by the archaeologist.

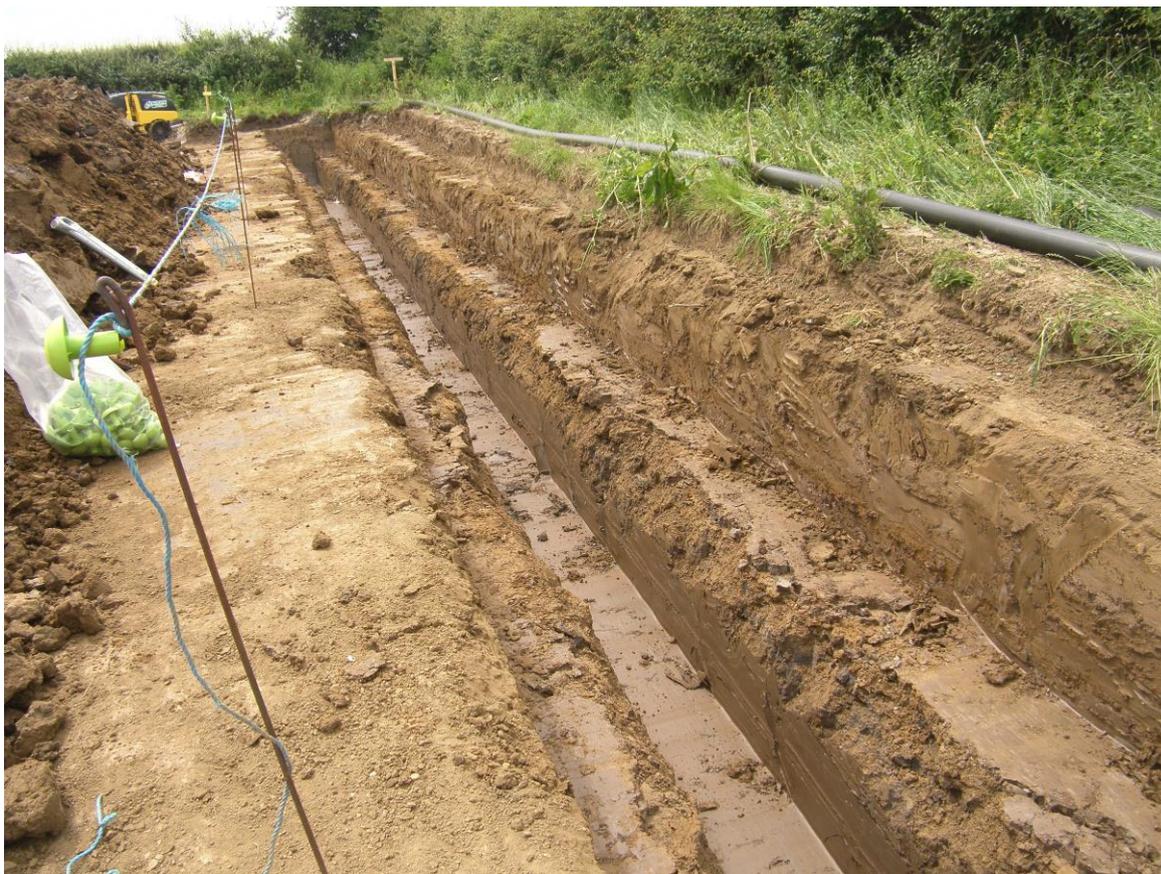
Plate 2. Sample section of pipe trench showing boulder clay

Topsoil comprised reddish brown silty sand up to 0.40m deep. The natural substrate was mainly boulder clay with localised areas of sand (see Plates 1 and 2)

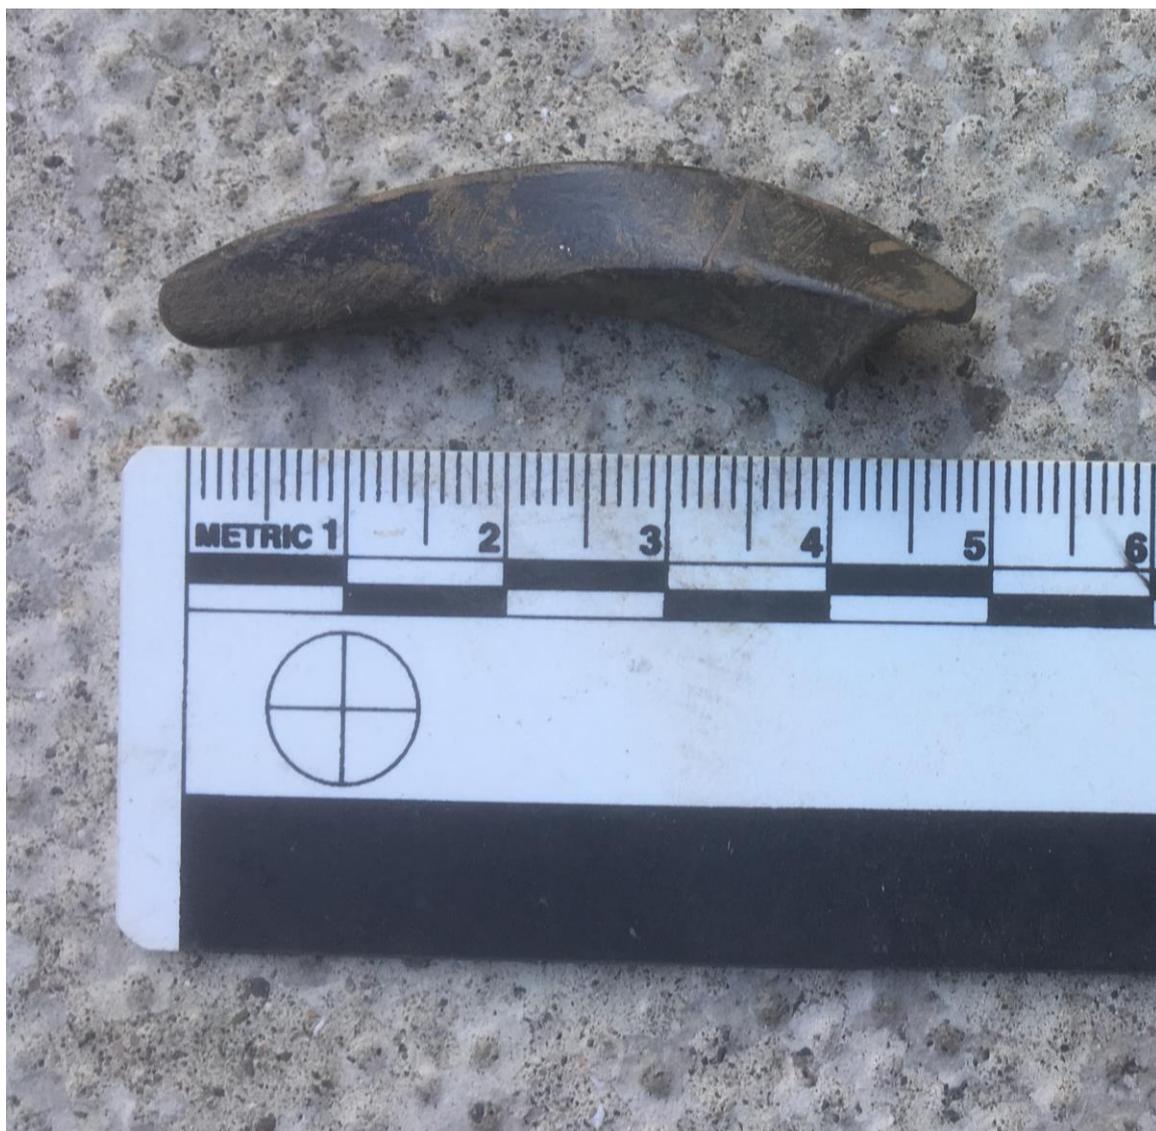
Plate 3. Jet object

There was a single fragment of worked jet/shale or similar material. It was a long rod that tapered to a dull point. It had a twisted square cross-section and a slight curve, which suggested that it may have come from a bangle style of bracelet. Jet bangles were worn in the Roman period, although known examples were annular (with no ends), whereas the tapered point of this fragment suggested that it would have been from a penannular shaped bangle. It is not clear what type of object this fragment is from.

Jet or 'jet-like' twisted square-sectioned rod. One end tapered to a dull point, while the other end had broken away. Length: 49.4mm, Width (max) 8.4mm x 8.0mm. Weight: 2.9 grams. WGE18, Context 100.

All finds derived from the topsoil (Appendix A). These included a small assemblage of Roman pottery (Appendix B) centred on SE 61581 57294, one piece of worked jet (Appendix C; Plate 3) at SE 61454 57562, and a mixed assemblage of animal bone, clay pipe stem, medieval, post-medieval, 18th to 20th-century pottery, and broken glass bottle and bowl fragments. The later material appeared to have been dumped in the topsoil, possibly during early 20th-century use of night soil for manuring.
