The Barrow Steam Corn Mill, 1870-1972

DANIEL W. ELSWORTH AND SAM WHITEHEAD

Prior to redevelopment of a large area adjoining Hindpool Road and Cornmill Crossing in Barrow-in-Furness, Greenlane Archaeology was commissioned to carry out a series of archaeological investigations. The largest element of this was the excavation of the entire remains of the former Barrow Steam Corn Mill, which was established in 1870 during a time of rapid growth for the town. Documentary study and the results of the excavation showed that the mill went through several stages of expansion and improvement, all of which reflected the changing nature of grain milling at the time, and many of which utilised the most advanced techniques and technology available. The expansion of the mill reflects the industrial growth of Barrow-in-Furness during the late nineteenth century, realised by the newly created dockyard, itself the product of the wealth and vision of a syndicate of local businessmen. At its peak the mill was part of an international trade in grain and flour and was at the forefront of both the local use of electricity and the national use of sprinkler systems. It remained in operation for almost 100

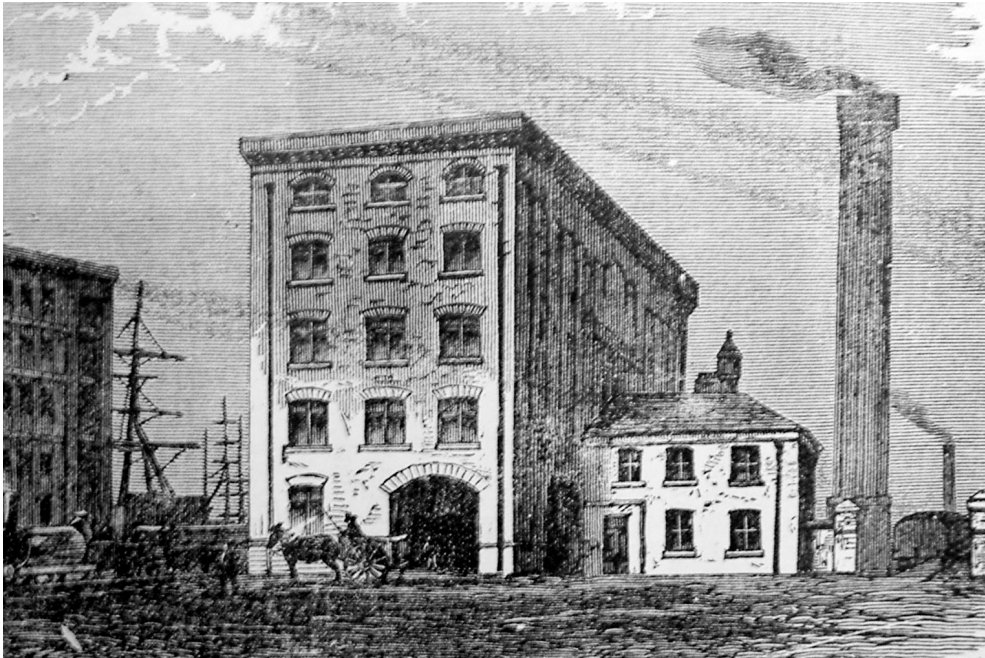
FIG. 2. The corn mill in 1872 (Phase 1), viewed from the east (Leach, 1872).

Walls within the area subsequently forming Building 13 (see top right Fig. 5) were clearly constructed as part of the original mill design, Leach's engraving from 1872 (Fig. 2) shows a two storey structure of domestic appearance, which has consequently been interpreted as the original mill offices. The Ordnance Survey map of *c.*1873 (Fig. 8) suggests that there were two separate buildings in this area separated by a narrow gap, the east part being the offices, while the west seems to be linked to the original engine room. Excavation of this area bore this out, with a smaller room in the west part of this area and a separate building occupying the east part. Kiln tiles found within the west room suggest that it may have been the location of a drying kiln; and substantial quantities of charred oats were recovered from residues found within the kiln tile apertures. A tall chimney is visible on Leach's engraving which further supports this idea, the base of which is probably evident in the excavated remains (Figs. 4 and 6).

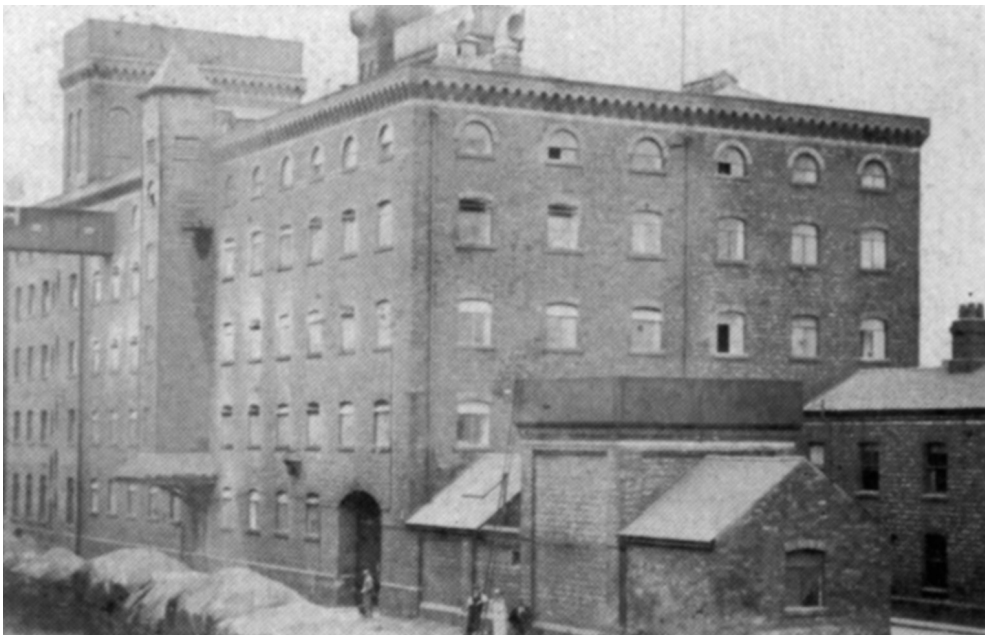
FIG. 3. The corn mill in 1907 (Phase 3) from the south (Garbutt and Marsh, 2002).

The rail lines to the south were not exposed during the excavation, however the branch line that led into, and out of the south-east corner of the mill building was located (entrance evident in Fig. 3). This probably represents the point at which the flour entered the mill from the opposing warehouse (Fig. 2) and left the mill to be shipped. After the turn of the century the mill was fed directly from four dockside silos via bridged conveyers (Fig. 3).

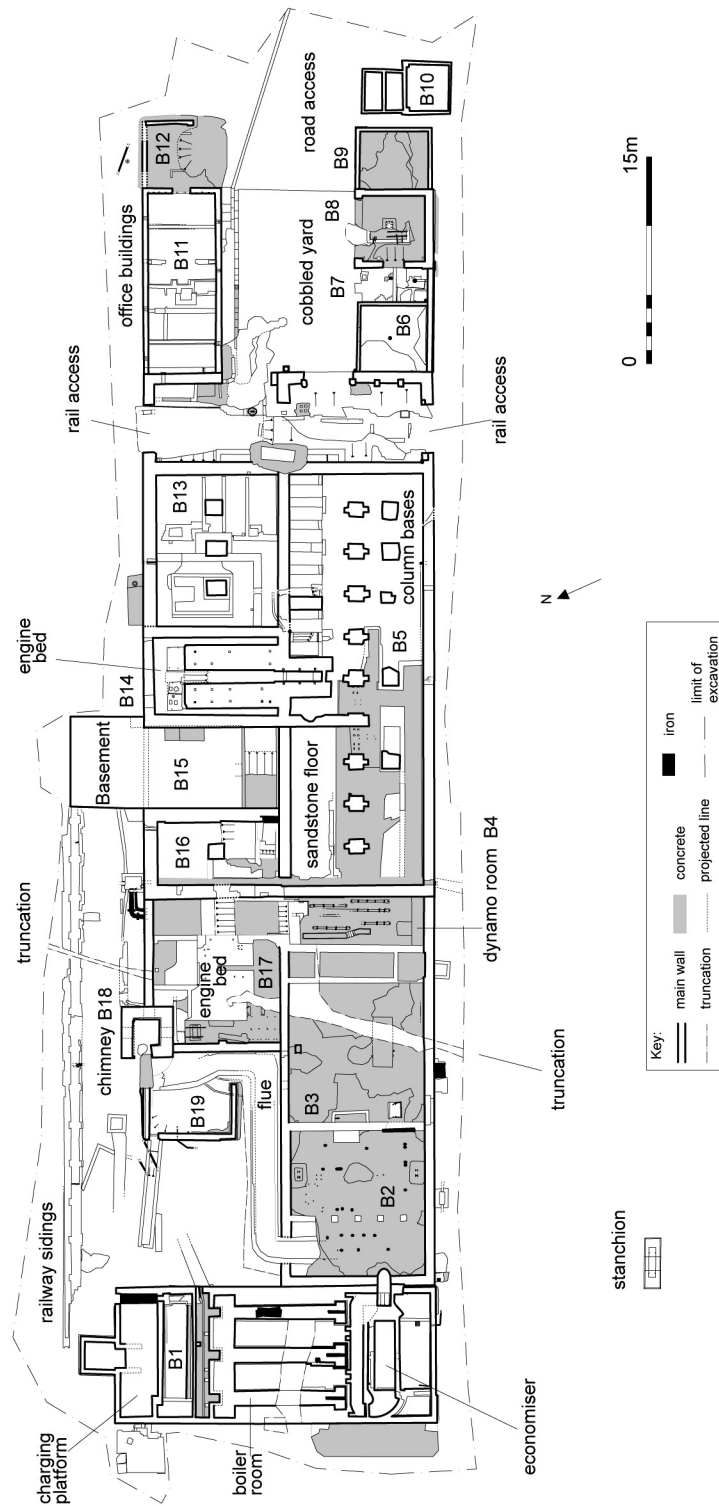
FIG. 4. Building elements (B1-B19) and other features revealed during excavations.

The physical remains of the buildings were represented by red brick flooring and walls which had later been truncated by the re-organisation of the rail tracks to the north of the mill. This building was easy to identify as it had a slightly different orientation from the main mill buildings (see Figs. 4, 5 and 6).

Building 4 was evidently a dynamo room and had a concrete floor with various scars and channels in it (see Fig. 4). The scars presumably represent the position of equipment fixed to the floor with iron plates, while the channel, which still had *in situ* timber boards covering it, seems likely to have formed a conduit for cabling. The area represented by Building 17 was largely occupied by an engine bed that was constructed from huge ashlar blocks of fine-grained greenish-yellow and bluish-green stone, which were 0.50m thick. This engine formed part of the electricity generation equipment that ran the lighting at the mill; the blocks and the associated concrete flooring to the west and south housed bolts for associated machinery and conduit channels (see Fig. 2). The boilers that provided the steam power for this process were not located although they could well have been quite small. Documentary sources (Anon, 1901) state that Walmsley and Smith were responsible for installing plant to provide electric lighting at the mill in 1885, and it is likely that some or all of these structures relate to this. The high pressure steam pipes that exited the north wall of Building 17 and feed into the drain to the north of Building 16 are something of a mystery as their origin was never ascertained. It seems likely that these relate to the main condensing engine, or could be re-used pipework that fulfilled a different function entirely.

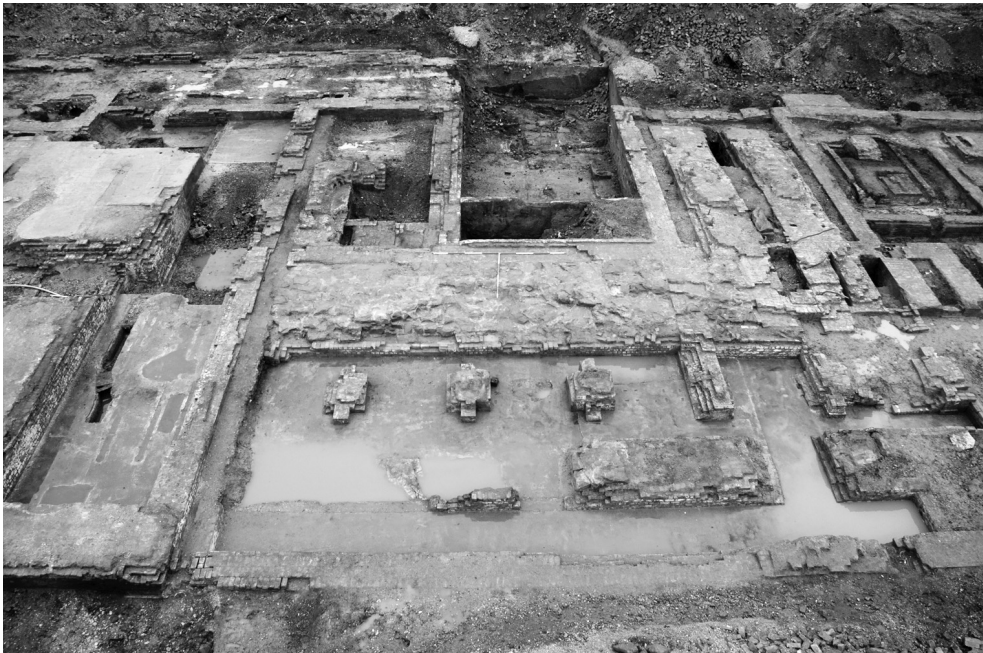
FIG. 5. The Phase 1 engine bed (14) to the right of the large cellar, western stanchions of Building 5 in the foreground. The dynamo room (4) and Phase 3 engine bed (17) can be seen at the left of the shot.

The stanchions within this first phase of the main mill building (5) formed two rows, although it was not clear whether these were contemporary or not. The northerly row of stanchions were cruciform in shape and constructed from red brick; the central location of these within the building would suggest that they were original. It seems likely that these were the bases for iron columns that would have supported the beams of the upper floors. The row to the south were approximately square and formed from mortared sandstone blocks, these may have formed the support for vertical driveshafts. It is likely that these were original too given the difficulties that would have been faced adding them at a later date; the use of the local red sandstone was also exclusive to Phase 1. In the north-east part of Building 5 there was a row of eight brick built bases that formed tanks or shaft bases, which at the time was filled with clinker. These structures are evident to the east of the red sandstone floor which also forms part of Building 5 (see ranging rods, Fig. 5). The purpose of these structures

The rail sidings that ran to the north of the mill were evident in the form of a pair of long walls with a flat paved area between that was 0.65m wide (see Fig. 5, top left). Areas of black clinker were observed to the north of these walls. While there was a rail line in the original phase of the mill's construction these sidings were clearly later, relating to the expansion of the rail network to the north of the mill. This was shown by the fact that these sidings truncated the small building to the north and west of the original mill, which is evident on the Ordnance Survey Plan of *c.* 1873. This building is also evident on Fig. 5 towards the top left side, its two truncated walls having a different alignment from the other mill buildings.

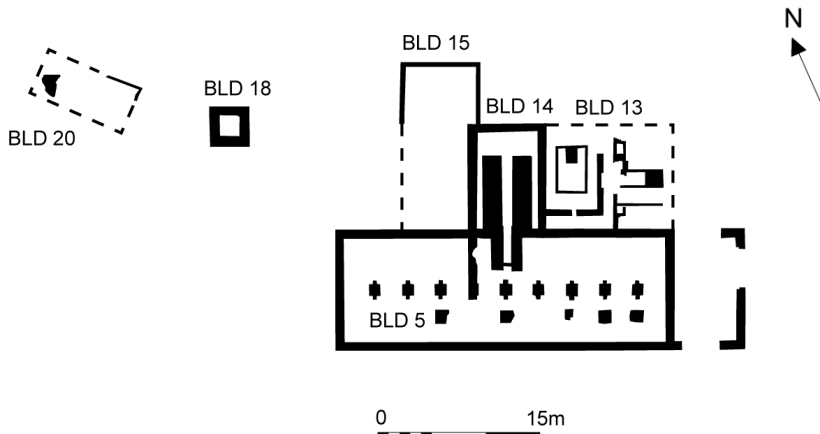
FIG. 6. Plan of Phase 1 elements (1870-1871).

The first phase of building represents the plan of the original steam corn mill, as built in 1870-1871 (Marshall, 1958). Structural elements recorded from this phase include the engine room (14), column bases or stanchions within the main body of the mill (5), the remains of the chimney (18), the original offices and possible drying kiln (13), and the truncated remains of small buildings to the north-west (Fig. 4). The nature of the subsequent phases of development seems to indicate that the intention from the outset was to expand the mill as soon as it was economically viable; this is also suggested by the location of the chimney, which was constructed some distance to the west of the main building.

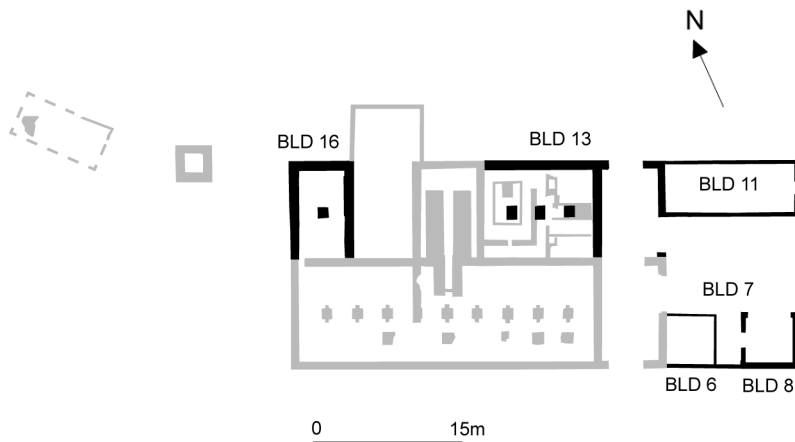
FIG. 7. Plan of Phase 2 additions (1874).

Documentary sources reveal that the mill grew substantially between 1873 and 1874, the main developments at this stage including the re-development of Building 13, the addition of Building 16 as well as offices and out-buildings (Buildings 6, 8, and 11) to the east of the main mill structure, and the growth of the rail links to the north of the mill.

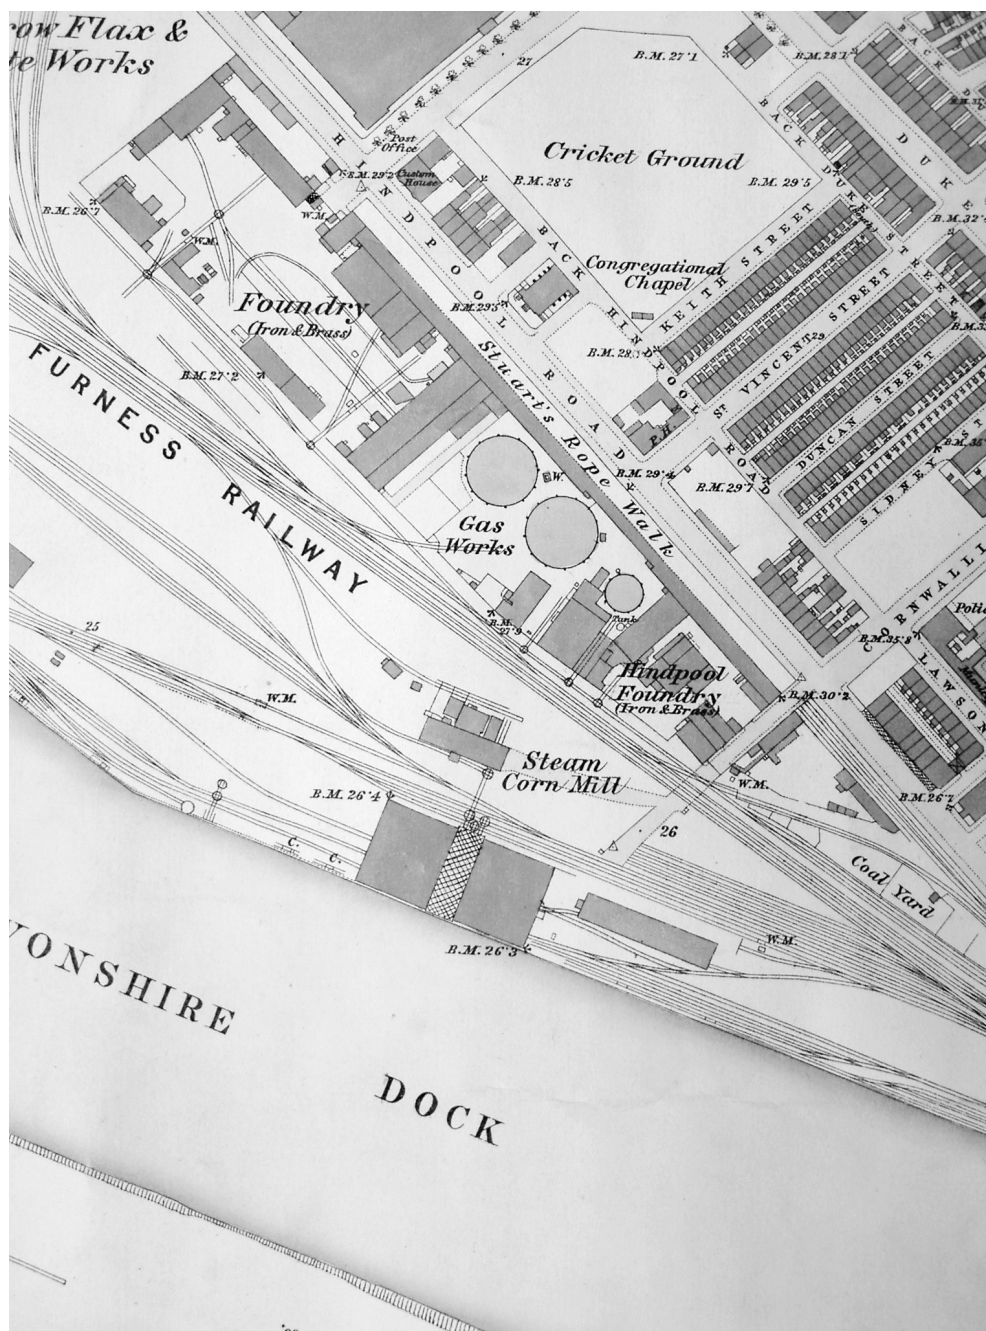
FIG. 8. Ordnance Survey Map, c. 1873 showing the corn mill and its surroundings.

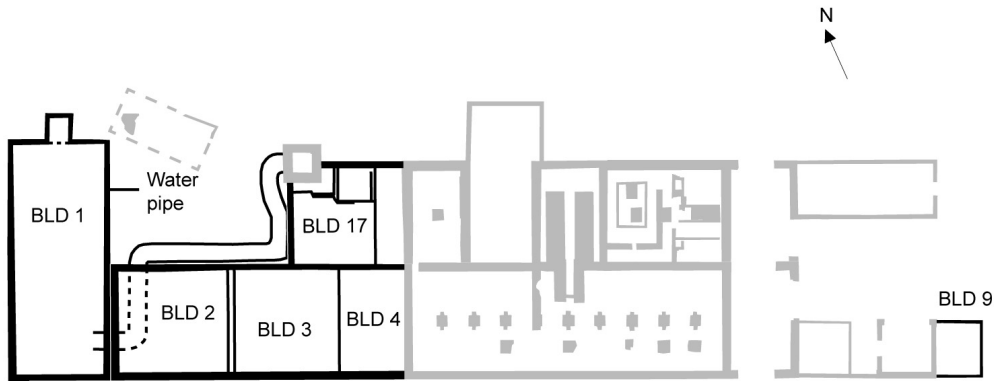
FIG. 9. Plan of Phase 3 additions (1881-1911).

at the mill that includes the introduction of electrical lighting (Buildings 4 and 17), a new boiler room (Building 1), general expansion of the mill's size and capacity (Buildings 2 and 3), and the evidence for the growth and development of the rail links to the north side of the mill. It is during this time that the mill was first fed directly from new silos at the dockside, and sprinkler systems were added.

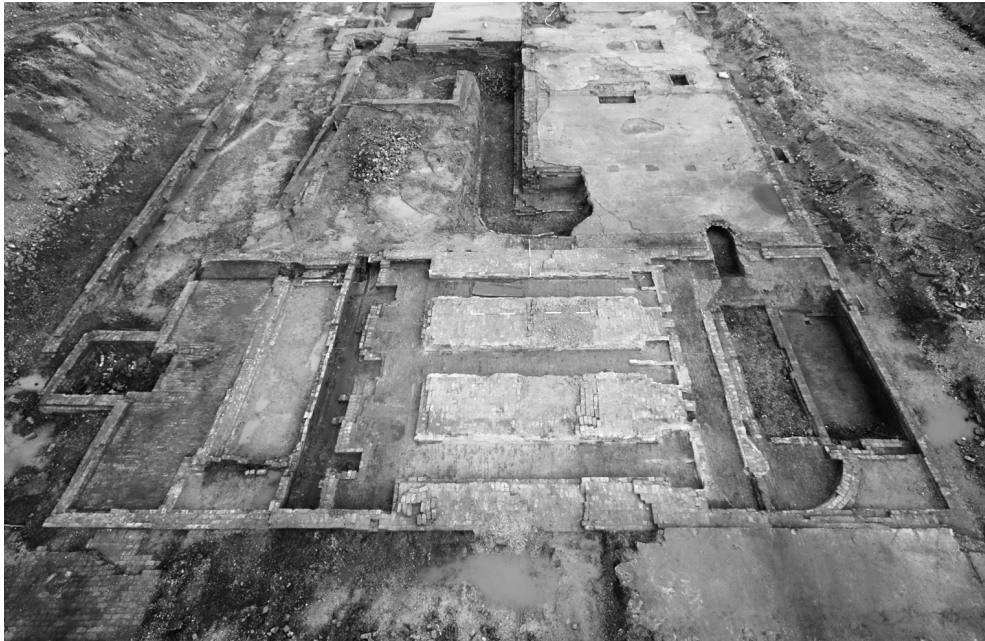
FIG. 10. The boiler room (Building 1) from the west. The photograph shows the location of the three boilers in the centre with the flue running under the floor of Building 2 from the area of the economiser, and out to the chimney. To the north of the boilers the charging platform and rail fed coal tank are evident. (Photograph by Aerial-Cam. www.aerial-cam.co.uk)

Excavation of the boiler room (Building 1) revealed it to be in very good condition (Fig. 10). The relative lack of truncation by later activity in this area allowed the following processes to be easily re-constructed: the coal was unloaded into a sump by train from the rail lines to the north and could then be shovelled into the three Lancashire boilers from the charging platform; the heating process was made more efficient by the presence of an economiser, which was warmed by smoke exiting the

boiler room through the large flue to the east. The boilers had been removed but their concave supports constructed from fire bricks were evident, and a couple of substantial curved and riveted iron plates, presumably from a boiler, survived along with some of the purple, silty boiler residues. The flue itself was a substantial inverted 'U'-shaped brick-built arch that was over 35m in length and during its excavation it was evident that it had truncated an earlier flue system. Unfortunately the origin of this earlier flue could not be found during the demolition phase, and the location of the earlier boilers remains a mystery. It is assumed that the new boiler room still fed steam to the main engine in Building 14 although the associated pipework was never discovered.

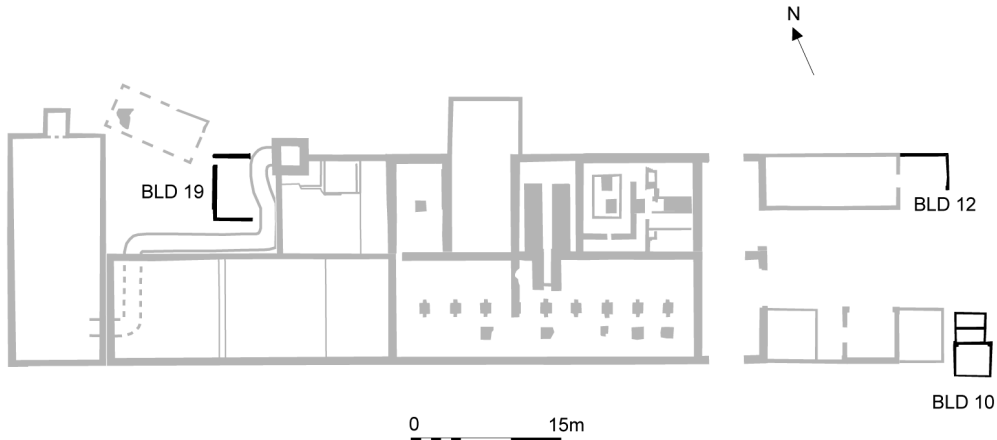
FIG. 11. Plan of Phase 4 additions (1911-1967).

This phase spans the period between the last recorded major improvements in 1910/11 and the closure of the site in 1967, and comprises relatively minor alterations, some of which probably relate to activities taking place on site after the mill had gone out of use. (See Fig. 11)

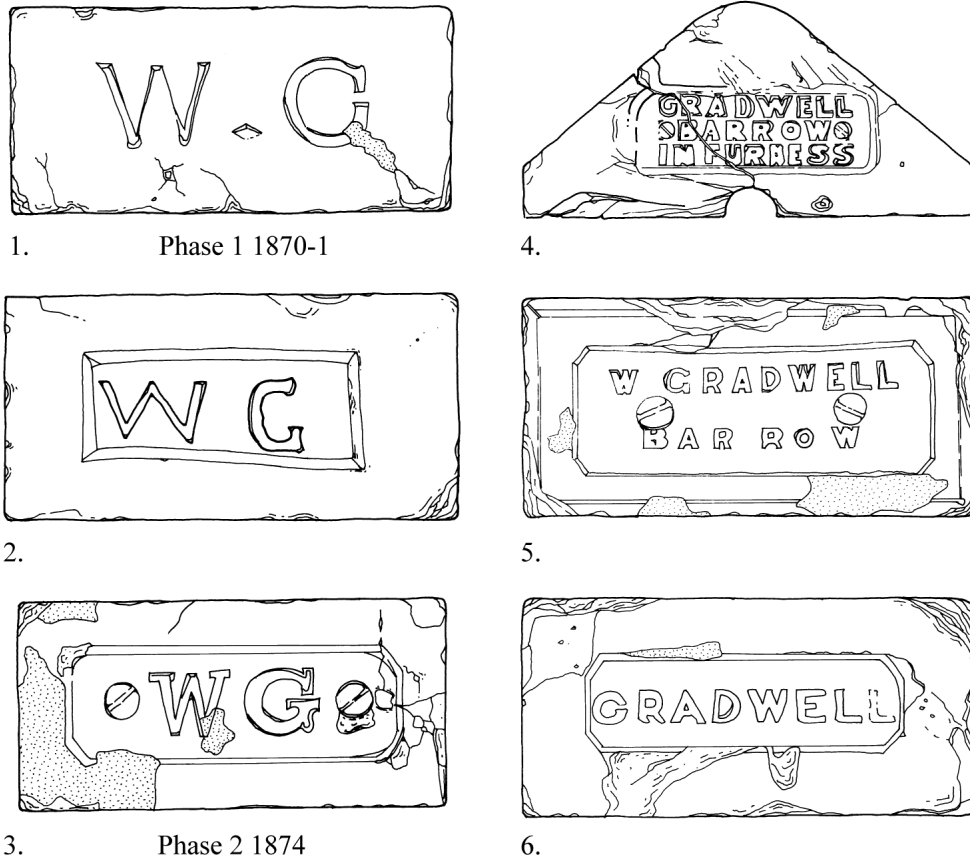
FIG. 12. Selection of Gradwell bricks at a scale of 1:4. The only Gradwell bricks illustrated to be found *in situ* were 1 (Building 5, phase 1) and 3 (Building 6, phase 2). (Illustrations by John Godbert.)

these bricks can hopefully occur if they are subsequently recorded *in situ* within other buildings of known date. The brick types illustrated in Fig. 12 are arranged in what is thought to be chronological order. Only brick types 1 and 3 were recovered *in situ* and therefore can be closely dated. A Gradwell brick with a stamp mark identical to brick type 3 has also been recorded at 104 Abbey Road, Barrow, which was probably built in 1874-5 (Greenlane Archaeology, 2008, 29), and suggests the date range of this brick type is relatively limited.
