Graven Hill, MOD Bicester, Oxfordshire

Archaeological Building Recording

Client Name: Graven Hill Village Development Company

Document Reference: WIB13983-106_R_1_1_3_TM

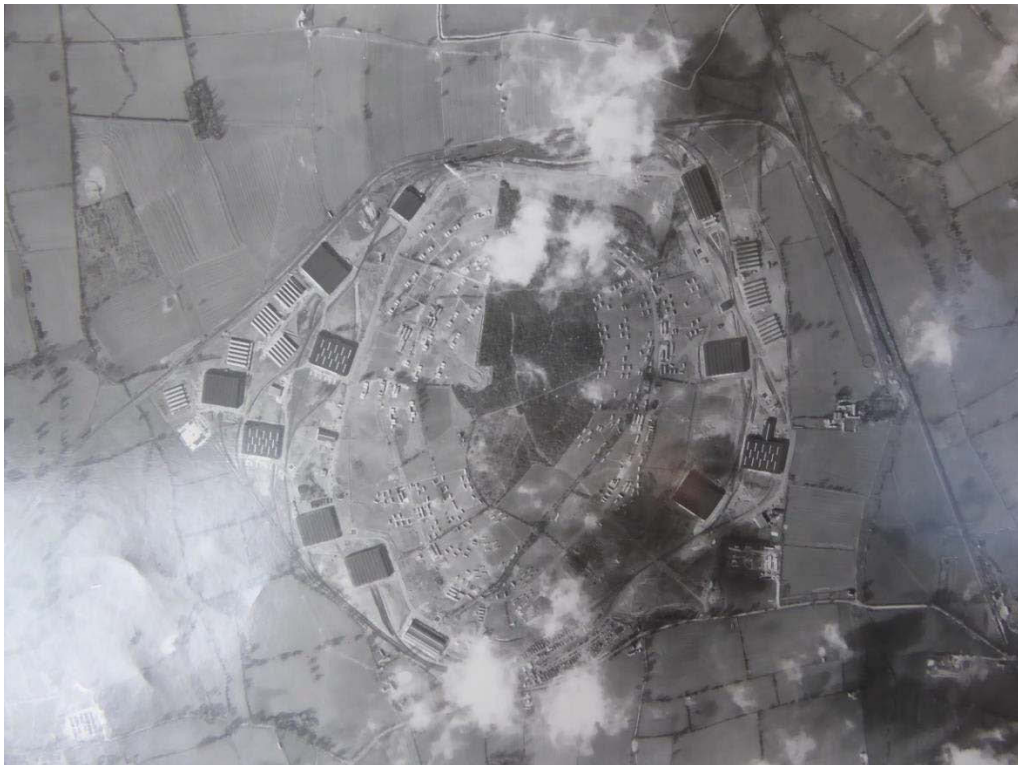
Figure 6: Aerial photograph of Graven Hill, c.1945.

Note accommodation huts located around the base of the hill

- 4.24. By 1944, over half of the country's total output of small arms were stored at Graven Hill; this included thousands of 9-mm Sten machine carbines (sub-machine guns) and the total output of 6-pounder anti-tank guns⁹. By 1944, some 20,000 troops and members of the Auxiliary Territorial Service (ATS) were employed at the depot and supporting garrison. Living accommodation for troops and personnel was provided in temporary hut structures; this was the situation until 1958 when two modern barrack blocks (St David's Barracks) were constructed. Historic aerial photography (Figure 6) shows the extensive layout of huts around the base of Graven Hill.

- 4.50. The container depot, known as the Bicester International Freight Terminal, is located to the north of D9 and south east of the OSU. This is believed to be the original location of the Graven Hill Gun Park (Figure 6) which would have been used to store artillery on the large area of hardstanding. The depot, which is accessed via Pioneer Road, today comprises a large area of hard standing, a Romney hut, prefabricated hut and later office accommodation. Aerial photography suggests that the Romney hut and prefabricated office are the only buildings surviving, in this area, from the World War Two construction.

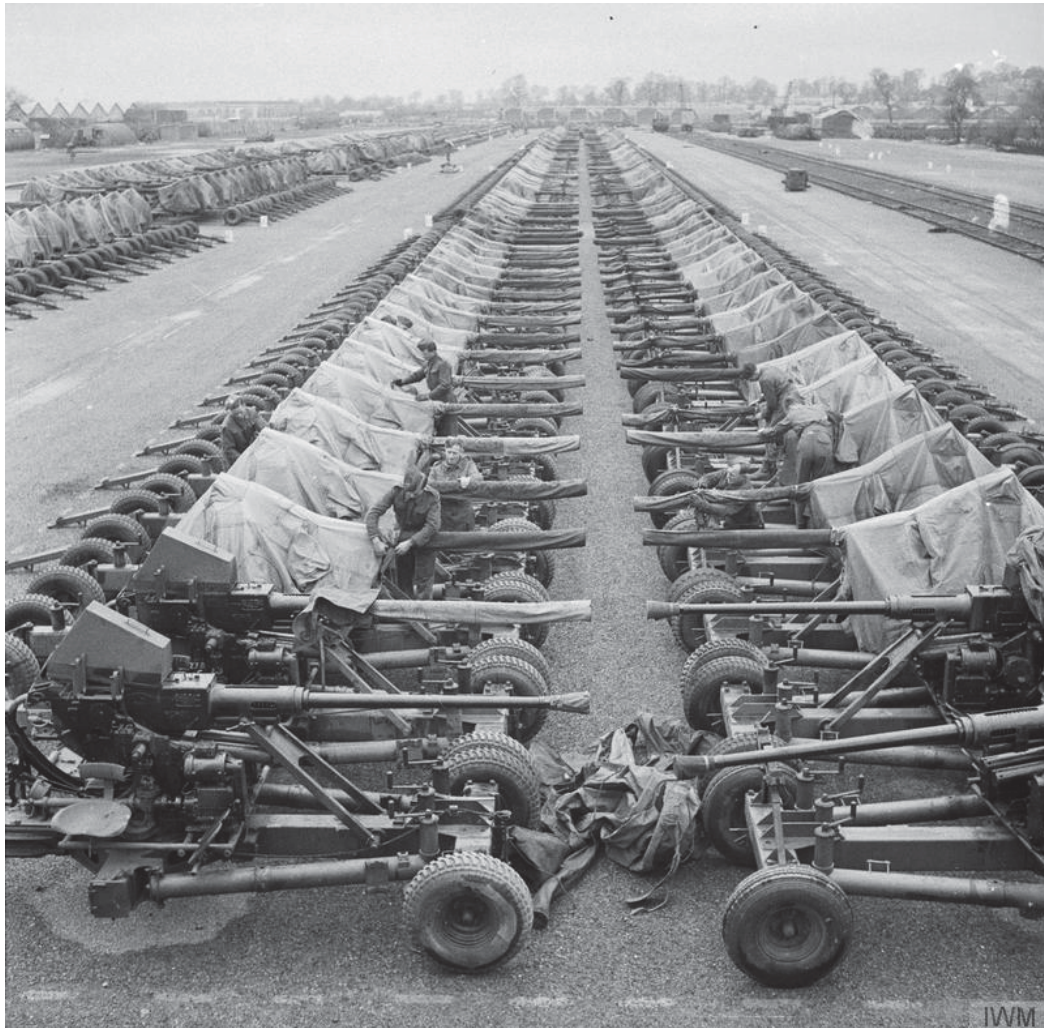
Figure 7: 40mm Bofors Light AA guns on Mk II mountings lined up in a gun park at COD Bicester in preparation for D-Day.

This may be, or a scene similar, to the gun park at Graven Hill (now the container depot of Bicester International Freight Terminal)

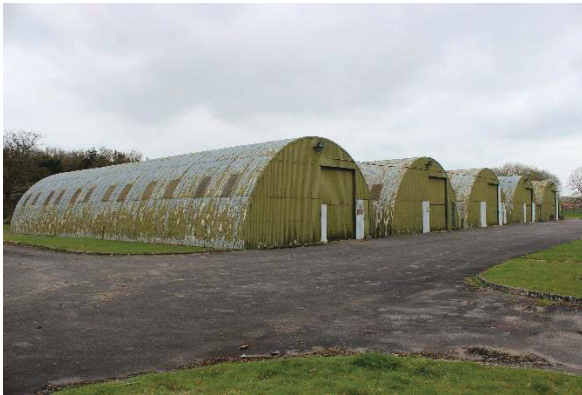
Figure 15: Romney huts in the OSU

- 4.52. Romney huts, which derive from World War Two, are located throughout the Site. Romney huts were developed during World War Two to supplement the Nissen hut, which had been developed in World War One, and supersede the Iris hut in 1941 as these were not found to be structurally robust.

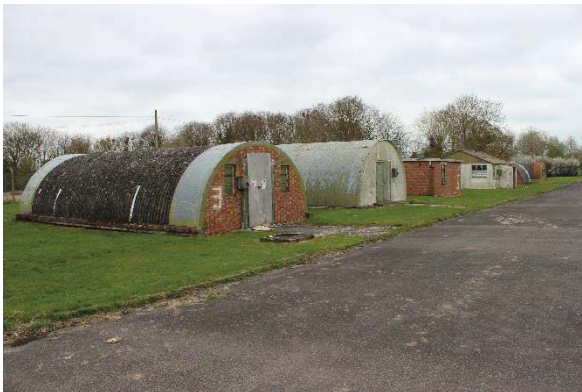
Figure 17: Nissen hut in OSU

- 4.58. A total of five Nissen huts are located around the Site. Four are located in the OSU and a single Nissen hut adjacent to building D14. None of the huts retain any fixtures and fittings, making their original specific use almost indiscernible. The huts located in the OSU are in close proximity to an ablutions block suggesting they may have either been barracks or used for storage.

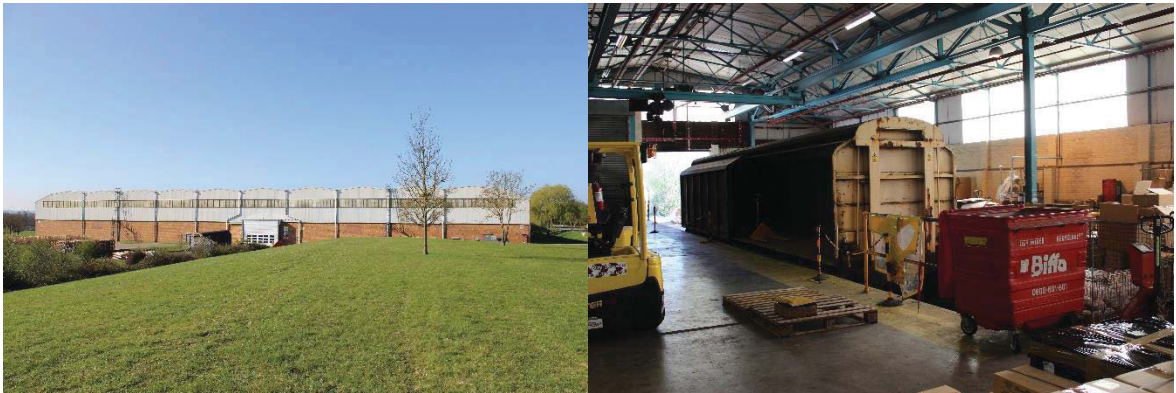
Figure 19: View of storage hangar (Building D7) Figure 20: Interior of storage hangar

- 4.61. Large storage hangars are located throughout D and E Sites. Storage hangars include Buildings E1, E2, E3, E15, D1, D2, D4, D6, D7, D8 and D9. The buildings are original to the World War Two construction, although have been subject to significant alteration.

- 4.62. The hangars are constructed of brick, laid in English bond. The roofs are not original and replacements were installed in the second half of the twentieth century in the form of plastic coated corrugated metal sheeting. The exact original form of the roof structures is unknown. They may have either been the same in form except clad with corrugated asbestos cement sheeting or significantly different as vaulted concrete roofs, the former is more likely. The existing roofs are supported by an internal steel frame. The roofs of the larger storage hangars are generally 10 bays wide with depressed gables and lean-to cat-slide roof at the outer bays. The only hangar with a significantly different roof is Building D9 which is of three bays.

- 4.63. The hangars are internally open in plan (with exception of modern metal partitions installed in recent years), which is enclosed by the brick curtain. The construction would appear to have been designed so that should there have been an impact (such as bomb/blast damage) the adverse effect on structural integrity would have been localised within the hangar, this is achieved through the construction of an almost freestanding brick curtain within minimal attachment to the internal steel frame.

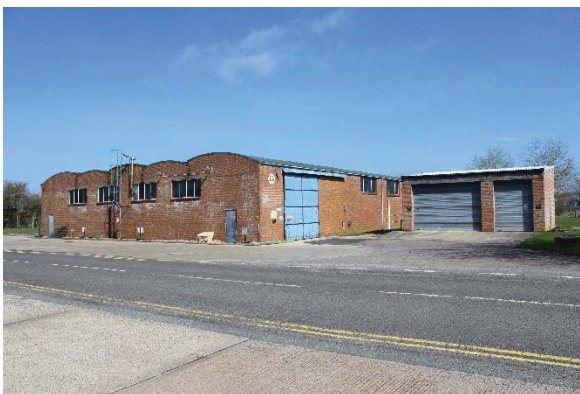
Figure 21: Building E5

- 4.67. Three vaulted roof hangars were identified in D and E Site; Buildings E4, E5, and D10.
- 4.68. The vaulted hangars are smaller, in plan, than those discussed above, and the roofs may represent a type that was originally installed to the larger hangars.

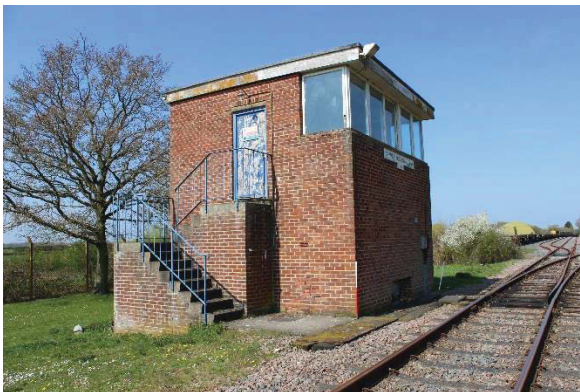
Figure 23: D Site Signal Box

- 4.71. Few railway structures deriving from the Site's war time use have survived and many have been demolished.
- 4.72. A signal box is located in D Site to the west of building D8 (Figure 23). The building, known as 'Graven Hill Signal Box: A Cabin', was constructed post-war. The building is constructed of red brick,

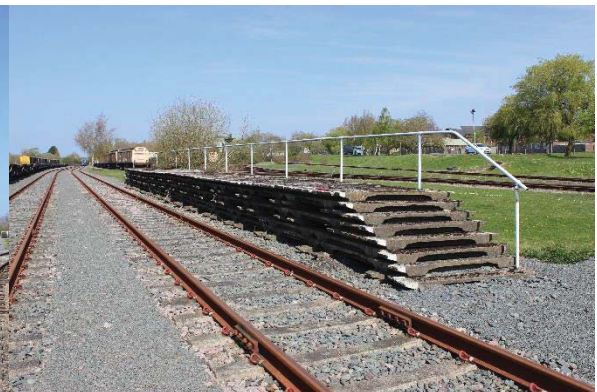
Figure 24: Platform made of sleepers (D Site)

- 4.75. Only one platform (Figure 24) was found to survive within the Graven Hill site. This is located within the sorting sidings, located to the south west of building D99. The platform is constructed of concrete sleepers which have been stacked. The 'Queens Platform' (formerly called Graven Hill Station prior to Queen Elizabeth's visit on 16th May 1978) was located to the south-east of building D4 (see Drawing 7 Appendix G), this has been removed and no evidence was found to survive.

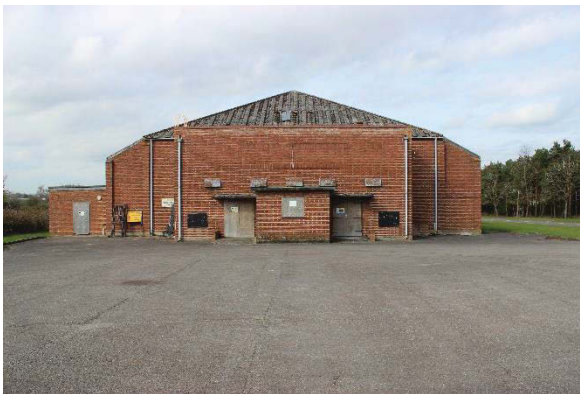
Figure 25: Front (south) elevation

- 4.81. The building is constructed of red brick, laid in English bond. The pitched roof (hipped at south gable) is of concrete tile. The public entrance is located at the south of the structure (Figure 25) with stage access at the north. The building, from exterior inspection, appears to have been subject to minimal alteration.
- 4.82. The interior spaces, which were inspected, revealed few original fixtures and fittings. The stage is located at the north end. The floor steps up to towards the south to facilitate chairs (not fixed). Two bars, or recent derivation, have been fitted to the south wall of the auditorium. No original fixtures were noted, from limited inspection, with exception of doors in the foyer.

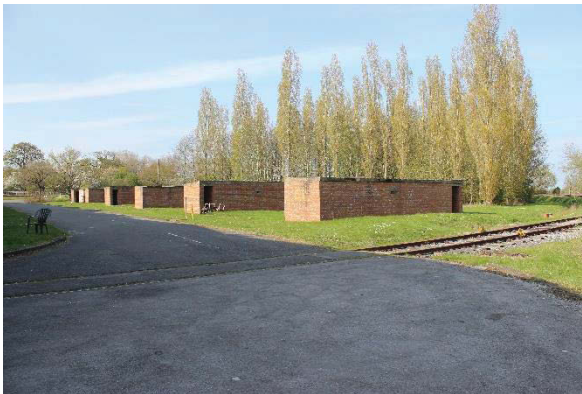
Figure 27 : Air raid shelters adjacent to Building D2

- 4.84. The structures are built of 350 mm thick brick walls, laid in English bond, set upon a concrete floor plate. The roof is constructed of reinforced concrete which, in most cases, had been cast on a corrugated material providing a rough ceiling finish. Entrances are typically located (in the detached examples) in opposing corners. The shelters are not believed to ever have included doors as no evidence of hinges were found. Unusual splayed loop-holed windows are located in each of the long elevations of the rectangular plan. The absence of a door suggests the loop holes were not designed to be defensive, rather the splayed opening was installed to limit entry to the shelter of material from ordnance. A 350 mm thick blast wall protects one end of the interior of the shelter. The opposing end also has a blast wall which forms a party wall with two small rooms; these may have been used as lavatories (afforded a chemical latrine or a bucket). No fixtures and fittings were found in any of the shelters accessed; fixtures would have most likely been removable and minimal such as wooden benches.

- 4.86. A complete set of six free standing air raid shelters is located adjacent to the east side of hangar building D2 (Figure 27) some of which retain their original painted 'Air Raid Shelter' sign on the exterior. Three of the original six shelters (concrete base for all six survives) are found adjacent to hangar building D1. Two shelters are located on either side of building D3. No other buildings within the Site are known to have had been afforded freestanding air raid shelters with exception of building E1, now demolished, shown on historic aerial photography.

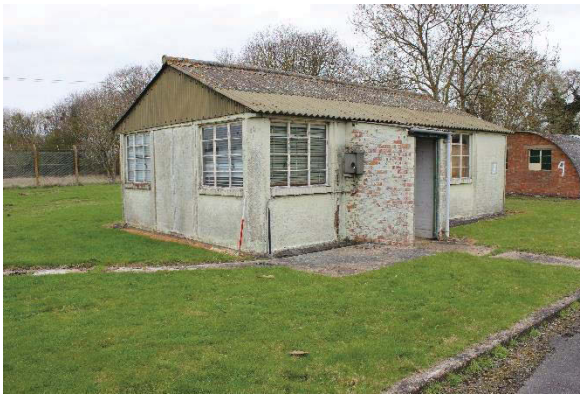
Figure 29 : Hut in OSU

- 4.89. Single-storey prefabricated huts, constructed in World War Two, were noted throughout the Site. The hut walls are constructed of either brick or pre-cast concrete sections. The roof is constructed of corrugated sheet, possibly asbestos sheet.
- 4.90. The huts were likely used as office accommodation. Two huts are located in the OSU complex (Figure 29). A hut located on the east side of Building E31 (Figure 30) retains its original blast walls which protected the doors of the building. The largest collection of the huts is located in the Rodney House complex.

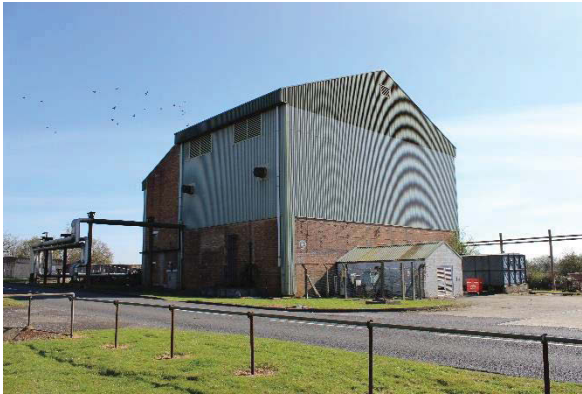
Figure 33 : View of boiler house from north

- 4.93. Building E14 was constructed during the original phase and is the tallest building at Graven Hill. The building provided heating to the storage hangars via a system of insulated pipes supported on concrete posts; the network of concrete posts are still visible around the Site.
- 4.94. The building is constructed of brick with later plastic coated metal sheeting on the upper part of the elevation. Associated structures are located around the building (Figure 34) which likely derive from a 1980s upgrade when a British Rail automated coal unloading system was installed.
- 4.95. The interior was not accessed for health and safety reasons.

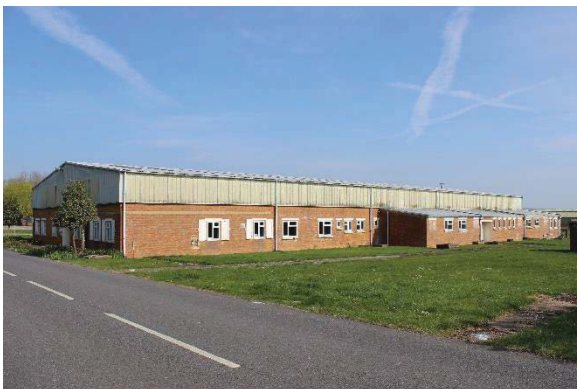
Figure 35 : View of Building D3 from north west

- 4.96. The training block is constructed in the same form of the hangars, although smaller in plan. The gable-end building is constructed of brick with a replacement roof structure. Plastic coated metal corrugated cladding replaced an earlier asbestos cement cladding.

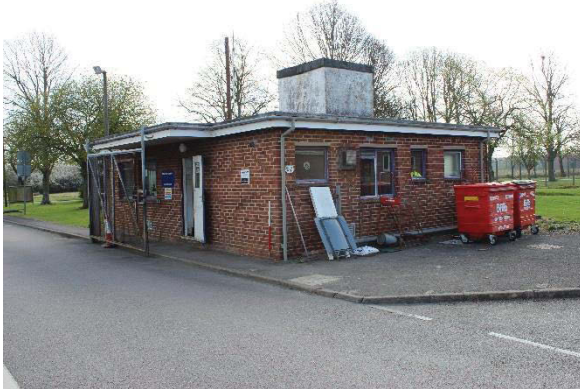
Figure 37: Guard post at E Site entrance

4.100. Guard posts are located at the entrances to D Site, E Site, St David's Barracks and Building E72 where the BMR meets the main rail line. The structures are not contemporary to each other but all of a similar brick and flat roof construction. The guard posts at entrances to D Site and E Site were the only buildings still in use at the time of survey. Additional guard houses (Figure 38) are also located adjacent to the guard blocks at entrances to D and E Site, these are believed to have been formerly occupied by the police.
