DISCOVERY AND SURVEY OF WORLD WAR I PRACTICE TRENCHES, BURBAGE, DERBYSHIRE

By JOHN BARNATT

SUMMARY

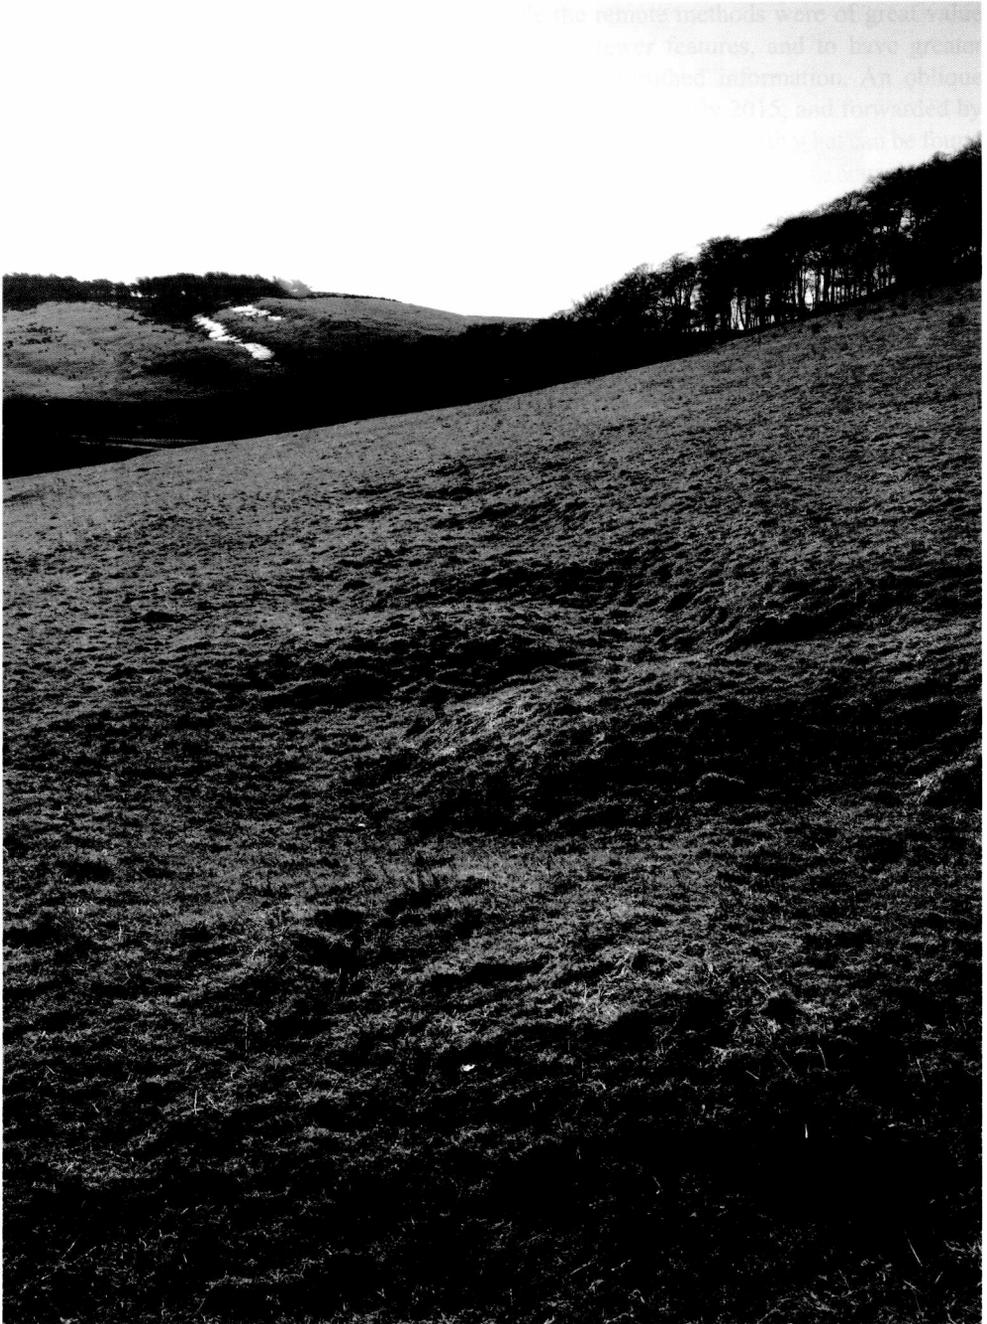
Plate 1: The area 23 '*fire trench*' in the pasture below Burbage Edge, illustrating that even when the vegetation is low all that can normally be seen at the Burbage Edge trenches are shallow earthworks.

In contrast to most features at Burbage Edge which are incomplete, there is one trench in the eastern field, at Area 23, which appears exceptionally well preserved. Despite the clear plan it is only shallow and may have been designed in this way as it is unclear how any substantive infilling would have been done whilst retaining the clear form. Perhaps slighting was confined to the dismantling of an upslope parapet as there is no visible bank here today. However, if

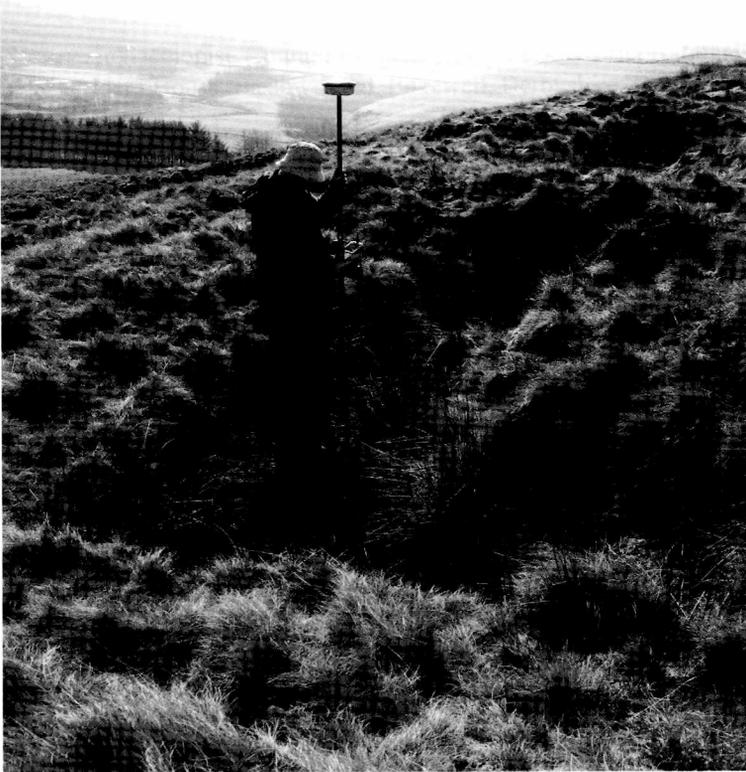
Plate 2: Surveying at the intact 'fire trench' on Watford Moor which was never backfilled.

it never had a parapet bank, perhaps it was not a functioning trench, but dug only to explore in plan the design trenches should follow, rather than to be used for practice manoeuvres; whether any other features at Burbage Edge can be similarly interpreted is unclear. As a further and starker contrast, the trench on Watford Moor was never backfilled and this is deep enough to have been a functional practice trench.

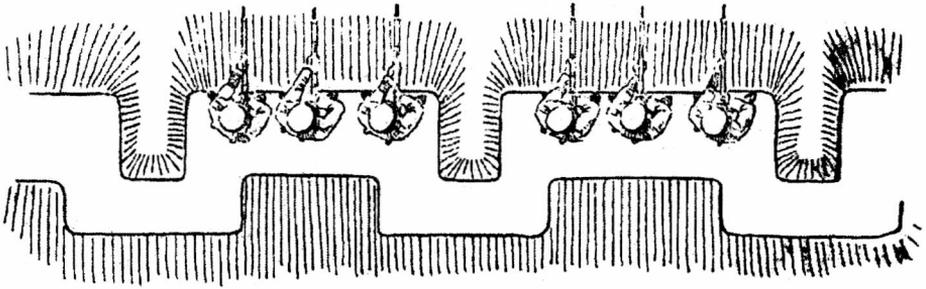
Fig. 1: A design for a small 1914-15 'fire trench', showing men in 'bays' with 'traverses' in between (Bull 2008).

The most distinctive features at the three locations above Burbage are crenellated '*fire trenches*' dug in straight lines following the contour as front-line earthworks, each with a series of shooting '*bays*' separated by '*traverses*' (Figs 1, 2). The latter were designed as barriers to stop enemy fire when the trench was stormed reaching all troops along the trench. In at least two cases above Burbage there are also straight banks and lynchets of uncertain interpretation immediately behind and parallel to the '*fire trenches*'. They are too close for what are usually termed '*supervision trenches*' as shown in the training manuals; these also recommended such trenches were again either crenellated or sinuous in plan. At Burbage Edge there are also several '*communication trenches*', approaching the '*fire trenches*' from a variety of angles, which were designed to allow the latter to be entered whilst staying under cover (Figs 3, 4); these have a variety of zig-zag, dogleg and straight forms. On the Western Front such trenches led back to '*supervision trenches*' and '*support trenches*', but these are not certainly present at Burbage; while some '*fire trenches*' lie behind others, they are not directly linked by '*communication trenches*' and it may be that the '*fire trenches*' were dug at different times rather than being designed to work together. Features that can be interpreted as '*machine gun emplacements*', '*officer posts*' and '*observation trenches*' are present. There are also two examples of oval '*redoubts*' with crenellated trenches, which were designed as strong points within trench networks for front line command, field kitchens, supply posts, etc. (Fig. 5).

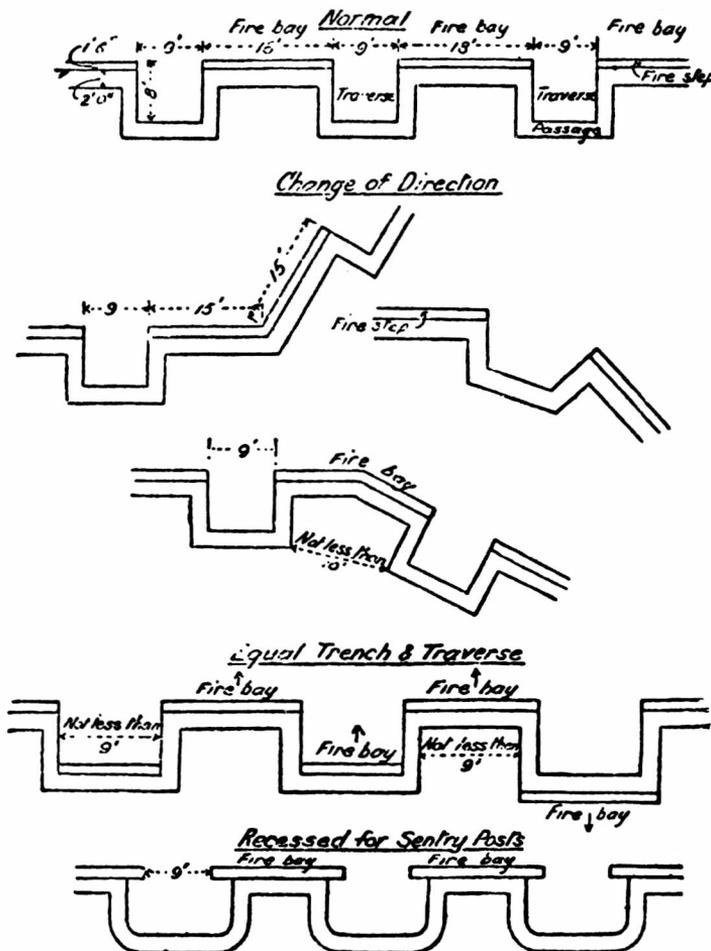
Fig. 2: Designs for 'fire trenches' from a 1917-18 reference manual (General Staff, War Office 1917-18).

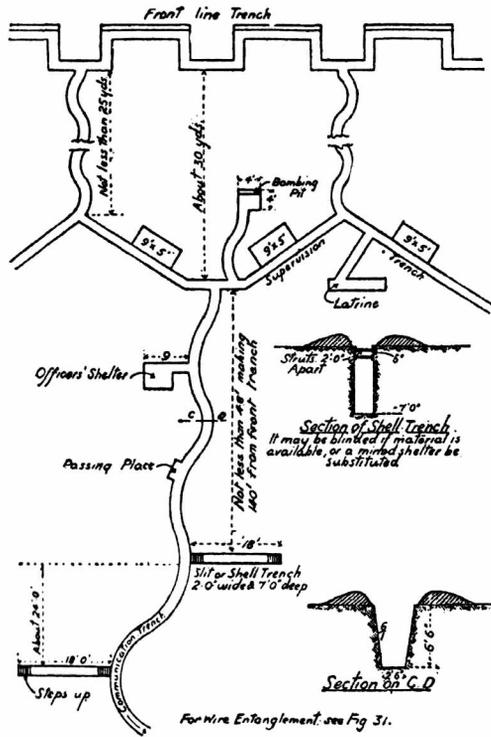
Fig. 3: Design for 'fire', 'supervision' and 'communication trenches' from a 1917-18 reference manual; no 'shelters' for men and officers are now obvious at Burbage (General Staff, War Office 1917-18).

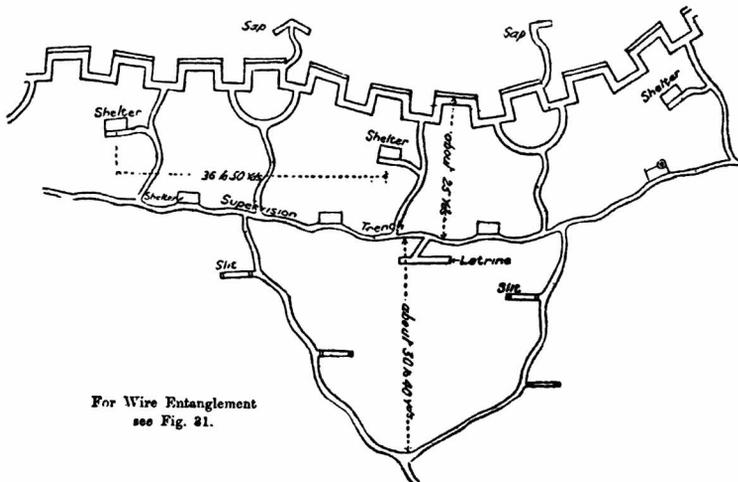
Fig. 4: Design for 'fire', 'supervision' and 'communication trenches' from a 1917-18 reference manual, including forward trenches, here shown to be used for sappers to pass the barbed wire entanglements; similarly placed forward positions were used for machine guns and lookout posts (General Staff, War Office 1917-18).

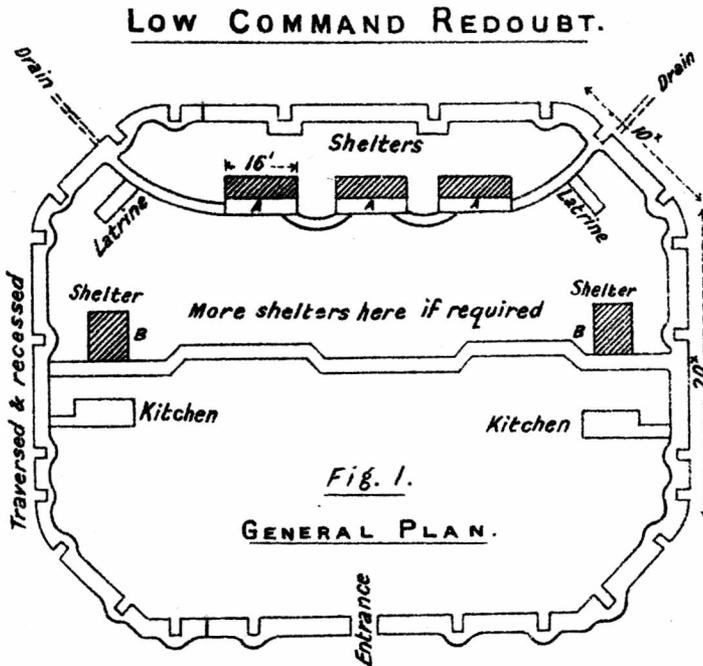
Fig. 5: Design for a 1914-15 'redoubt' (Bull 2008).

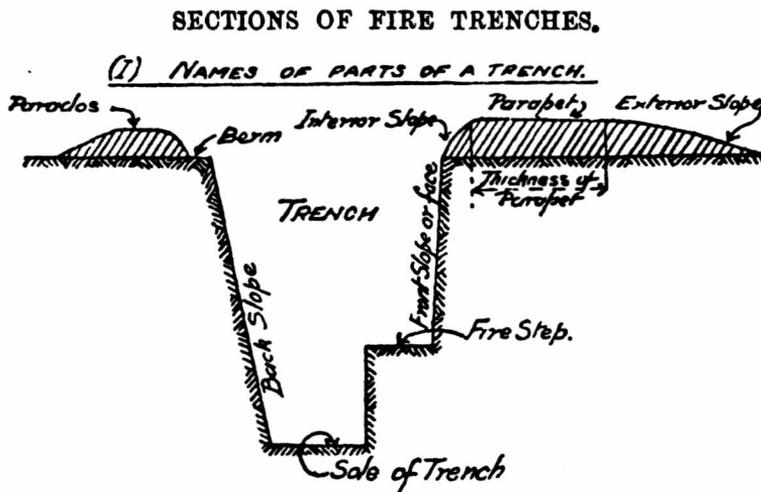
Fig. 6: Typical design for a 'fire trench' from a 1917-18 reference manual (General Staff, War Office 1917-18).

Many visible features at Burbage Edge are defined today by shallow ditches, often only partially visible, along the lines of presumably largely-backfilled trenches; training manuals suggest these originally should have been c. 1.3-1.7m deep with low banks to either side, usually 0.3-0.5m high (Fig. 6). Exceptions with regard to trench depth were made when the ground was wet (Fig. 7) and presumably also when there was intractable bedrock. The bank at the front was termed a '*parapet*' and gave additional protection from enemy fire; that at the back was termed a '*parados*' and protected men from shrapnel during shelling.

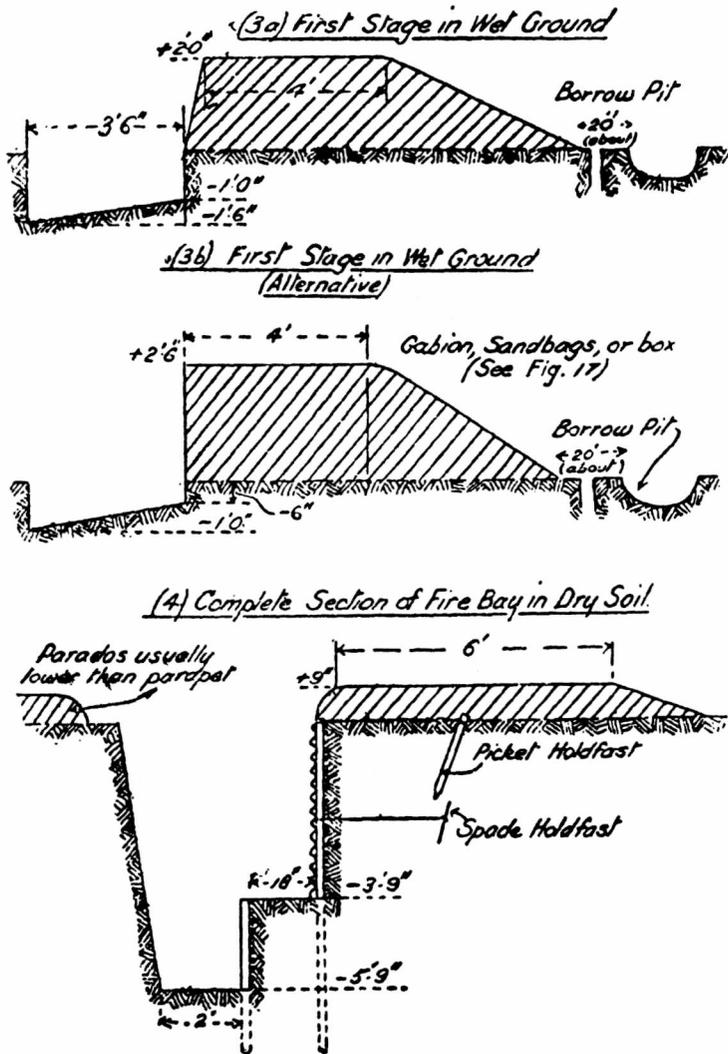
Fig. 7: Design details for 'fire trenches' in wet and dry soils, from a 1917-18 reference manual (General Staff, War Office 1917-18)

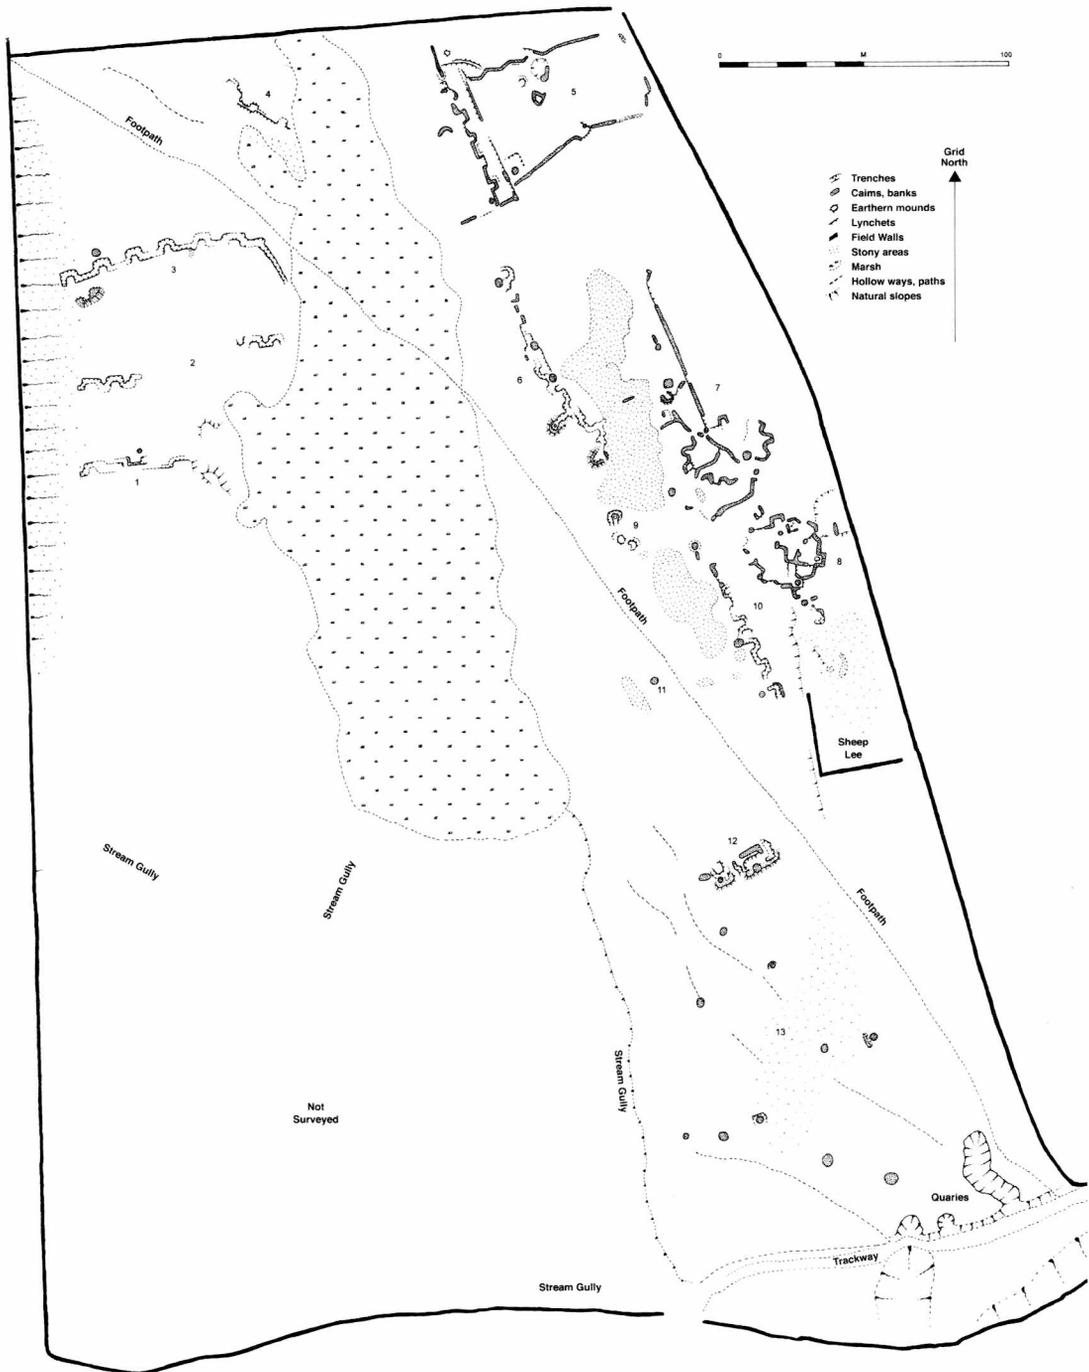
Burbage Edge - Western Moor (Fig. 8)

This enclosed area above the scarp has partially reverted to moorland. World War 1 features are in the northern half, to the west on rough grassland (Areas 1-4) and, beyond a marsh to the east, on grassland which is more closely grazed (Areas 5-11). Topographic detail to the south-west was not surveyed as no relevant archaeological features were found here. The wartime features to the west include broad silted trenches in soft ground, whereas to the east most features comprise low banks/cairns and bedrock is close to surface.

There are seven to nine 'fire trenches' (at Areas 1, 2 [x2], 3, 5, 6, 10, and possibly 4, 12). At Area 5 is a long linear terrace of uncertain interpretation running behind and defined to the east side by a straight bank/lynchet; at Area 7 there is a similar linear feature but set much further back. Some fire trenches point in opposite directions to each other, as at the two short examples in Area 2 which face upslope, in contrast to those adjacent in Areas 1 and 3 which face downslope. Three to the east on the scarp top all face downslope towards the marsh to the west.

Trenches at Areas 3 and/or 4 could possibly be 'supervision trenches' or 'support trenches' for that at Area 1, while vestiges of similar features may be present to the east end of Area 5 next to the field wall. Associated with the 'fire trenches' there are also one to three sets of 'communication trenches' (at 5 and possibly 3, 7). Half of one of two long trench banks in

Area 5 has classic zig-zag form. There are also between three and six recognisable 'forward observation trenches' or 'machine-gun emplacements' (at 3, 6 [x2] and possibly 5 [x2], 9), while another feature is possibly a small 'officer post' and/or a complex 'machine-gun emplacement' (at 12).

Two distinctive crenellated ovals are 'redoubts' (at 7, 8); whether internal divisions belong with this phase or to different phases of activity is unclear. In Area 7 some banks appear to cross-cut the oval earthwork. In Area 8 internal banks and lynchets define small internal sub-rectangular areas, while outside the main 'redoubt' line there are traces of further small sub-rectangular features extending short distances to north and south.

Fig. 8: The western area of the Burbage Edge practice trenches.

presumed 19th century date (at 11, 13). However, at the few cairns where the turf is absent, they have many small stones that could be argued to be atypically small in size for field clearance. In addition, two cairns have possible surrounding trenches which could indicate they have a now-obscure military explanation. Another has a short bank adjacent, which may be alternatively explained as a hollow-way related feature. Similar small cairns are commonly found associated with the trenches (at 1, 3, 5, 7, 8, 10, 12); some at least, and probably most or all, may well have been created as part of the wartime activity. There are no clear indicators that Areas 11 and 13 once had World War 1 trenches now fully levelled and this seems unlikely as further visible vestiges would be anticipated.

In Area 5, between the two '*communication trenches*' on the highest point, there is what appears to be a small and part-backfilled stone-getting pit and upcast heap, while a penannular bank nearby to the south may be a robbed waste heap or a small, embanked, '*machine-gun post*'. A third feature, comprising a curved 'ditch', may be fortuitous.

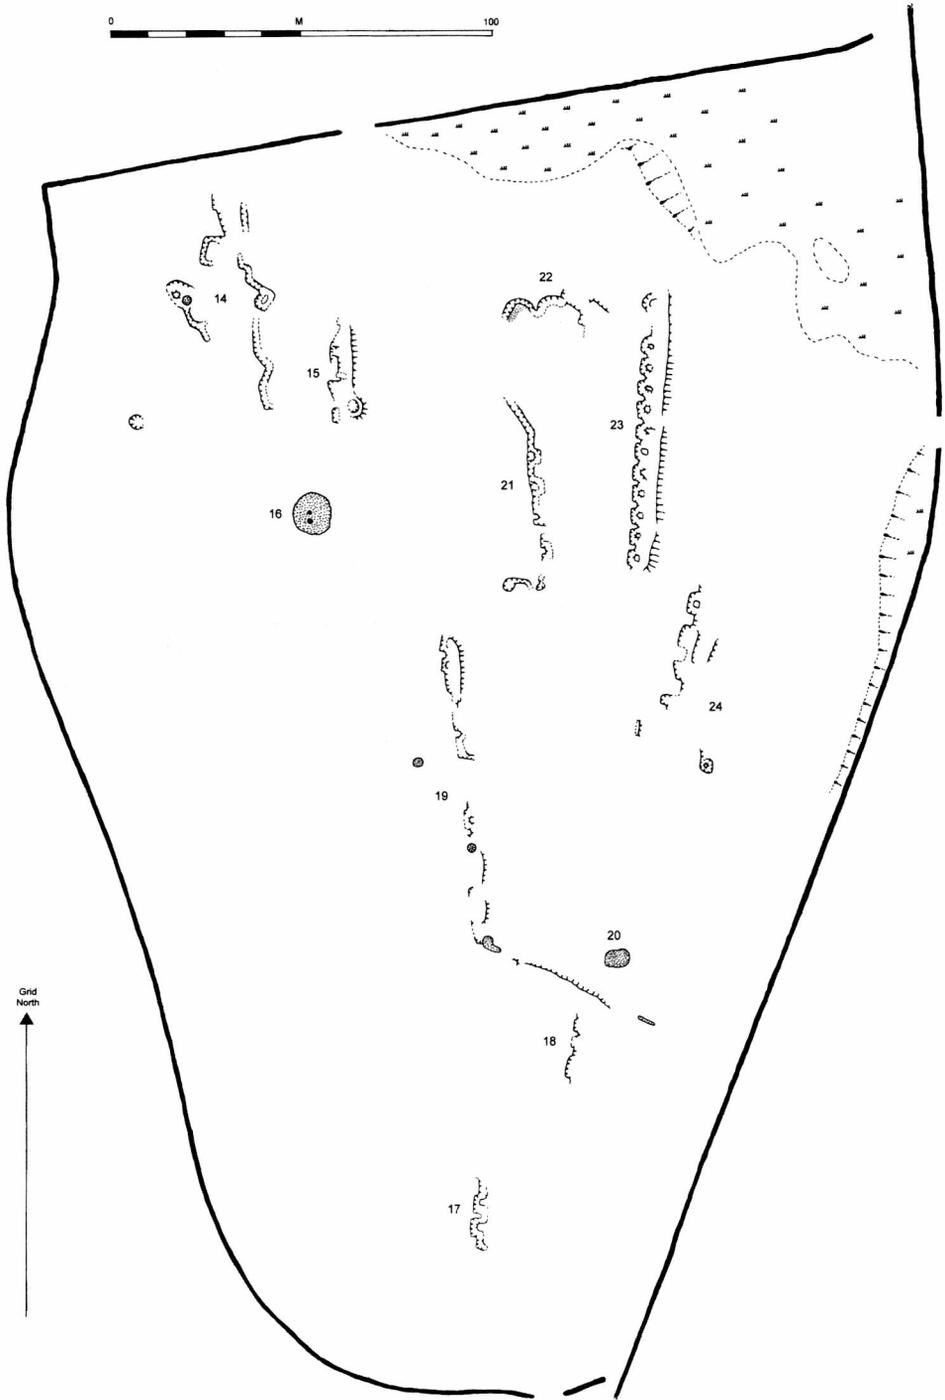
Burbage Edge - Eastern Field (Fig. 9)

Fig. 9: The eastern area of the Burbage Edge practice trenches.

This large field on the lower scarp has a wide scattering of visible World War 1 remains and other features (Areas 14-24). All trenches are now slight and with one exception appear to be only partially visible. Somewhat smoothed profiles suggest the field has been harrowed for reseeded. There are six to eight '*fire trenches*', all facing upslope (at 17, 18, 19, 21, 23, 24 and possibly 14, 15). That at Area 23 is well preserved, with 11-12 small bays, although it is also slight; behind is a long linear terrace with downslope a lynchet of uncertain interpretation running parallel to the main trench; further possible examples of these back lynchets are seen elsewhere (at 15, 19, 24). Associated with the '*fire trenches*' there are also two to four '*communication trenches*' (at 14, 22 and possibly 19, 21), and a possible forward '*observation trench*' or '*machine-gun emplacement*' (at 21).

There is a large clearance cairn of presumed 19th century date (at 16), with a smaller example (at 20), and small cairns associated with the trenches (at 14, 19). To the north-west is what may well be a small isolated stone-getting pit, with features at trenches nearby of obscure interpretation (at 14, 15), while a small penannular feature further downslope is also un-interpreted (at 24).

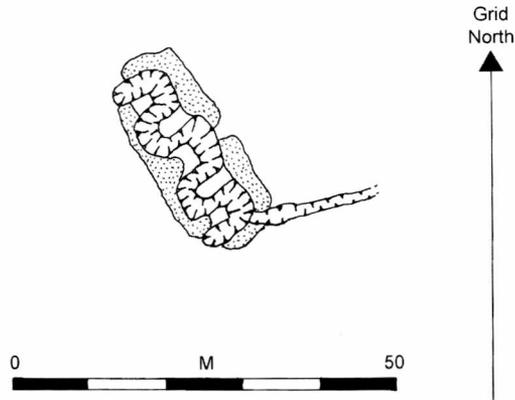
Watford Moor (Fig. 10)

The only feature here is a well-preserved crenellated '*fire trench*', on a flat area at the top of a north-east facing slope to the valley below. It lies next to and parallel with a public footpath which follows an old hollow-way braid running across the moor. The wartime trench faces north-east and has three '*bays*' and two '*traverses*', with a substantive but low '*parapet bank*' on the downslope side, and a slighter '*parados bank*' behind (Plates 3, 4). A short break at the centre of the '*parapet bank*' may indicate a machine gun position. Today the trench is about 1m deep including the upcast banks to either side; the original depth before silting is unknown. The trench is on peaty ground and the base may have filled with water as it was dug, which would explain why further features were not created nearby. A now-shallow drainage trench runs downslope from the south-east corner into another hollow-way braid. To the south-east, beyond a drystone wall, are the butts of a shooting range, built in the 1880s-90s, but perhaps also used in World War 1.

Fig. 10: The Watford Moor practice trench.

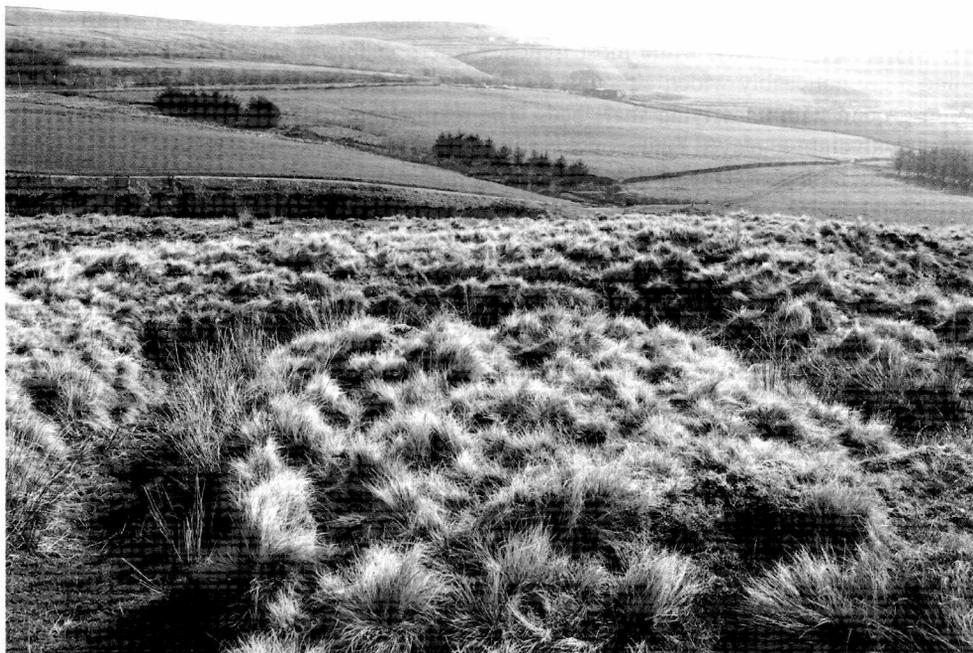
Plate 3: Detail of the Watford Moor practice trench, showing a single firing 'bay'.

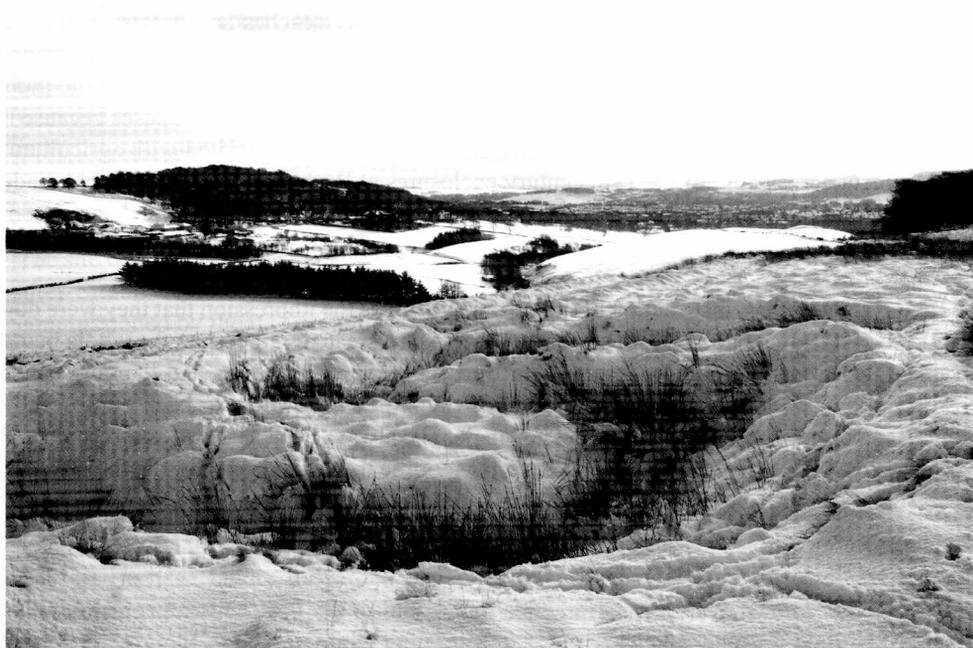
Plate 4: Detail of the Watford Moor practice trench, showing a 'traverse' and the south-eastern firing 'bay'.
