The Barland's Farm Romano-Celtic Boat

Nigel Nayling and Seán McGrail

Published in 2004 by the Council for British Archaeology
Bowes Morrell House, 111 Walmgate, York, YO1 9WA

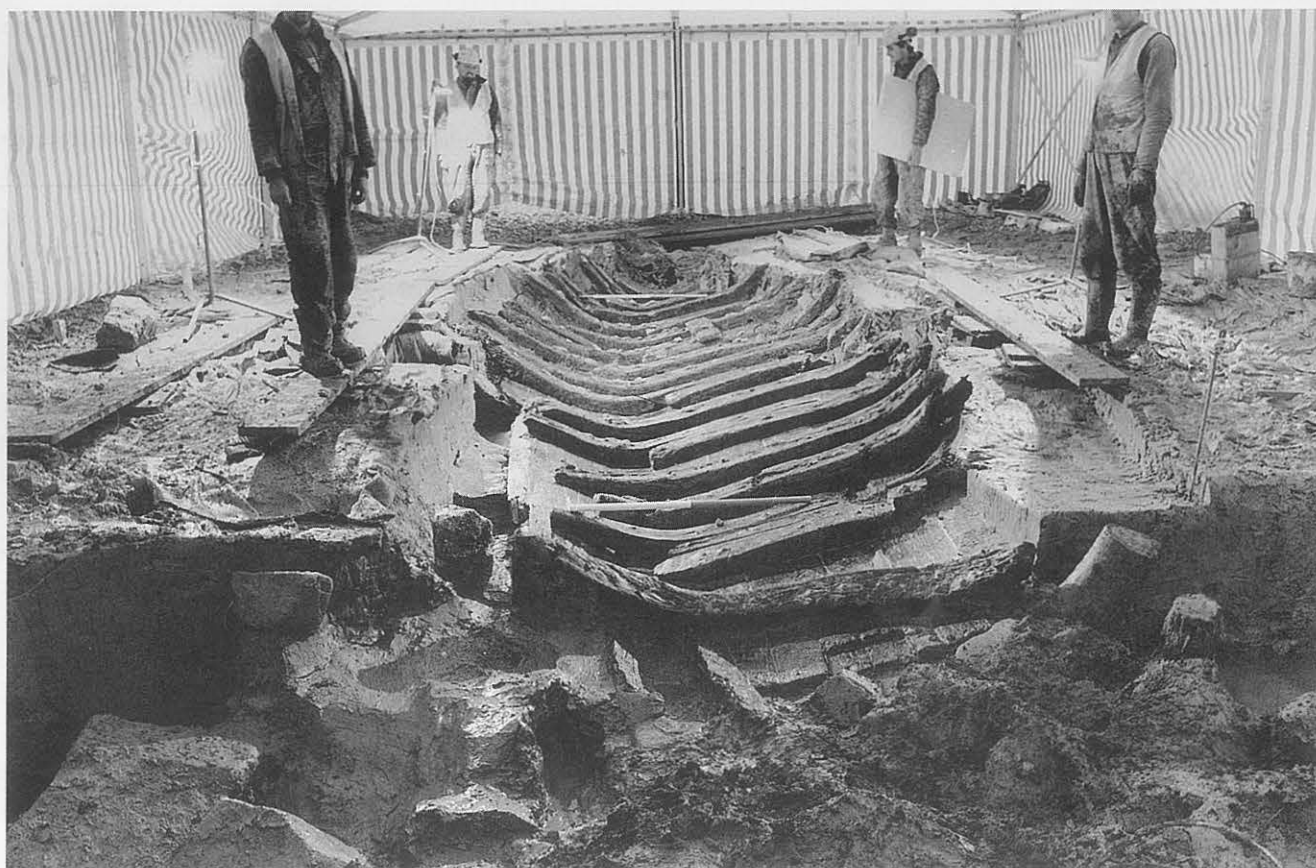
Figure 2.10 Photograph of boat *in situ* looking south (bow).

2378; Fig 2.9) deposited prior to the accumulation of fine silty clays that sealed both the boat and the structure. It lay on its hull bottom with a list of 12–15% to port (assuming the southern end is the bow – see below), such that a maximum of five side strakes survived on the port side and only three on the starboard side. The bow was highly fragmented, either

due to recent disturbance or damage from maintenance of the nearby reen. Modern machining had reduced the ground level to approximately 4m OD resulting in some damage to the uppermost surviving elements along the starboard side, but fortunately little disturbance to the more complete port side.

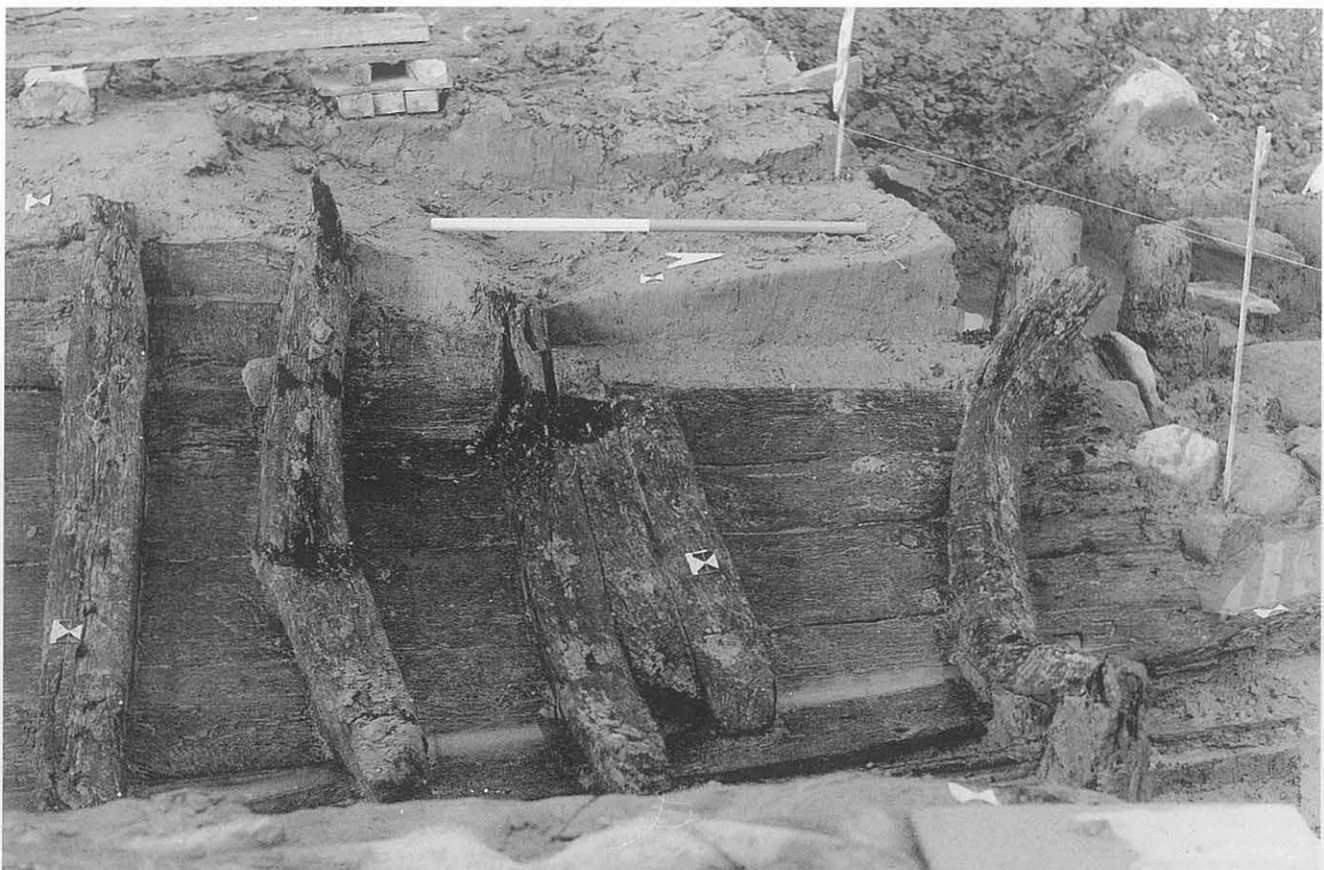
Figure 2.18 Photograph of planking on starboard quarter from F13 (left) to F16. Scale: 1m.

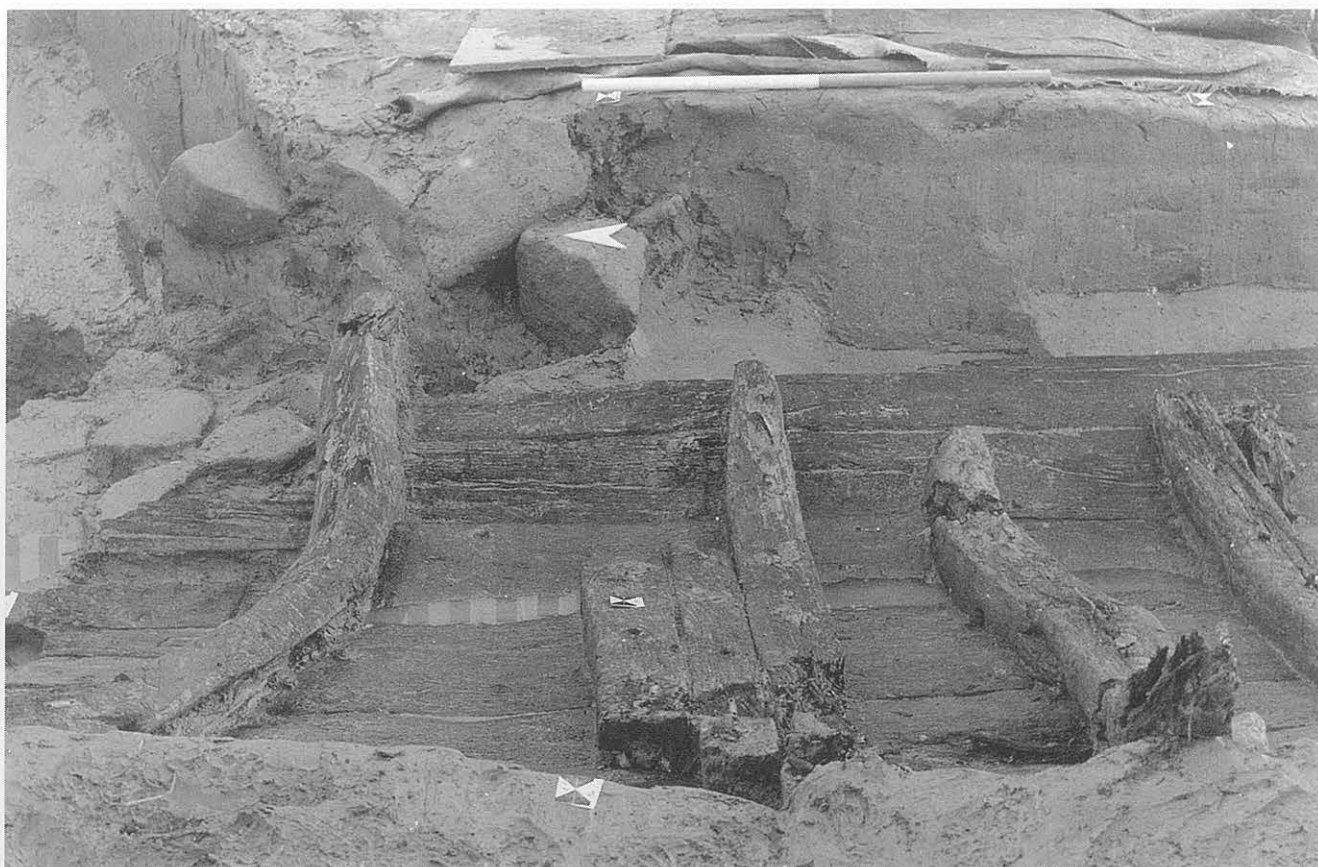
Figure 2.19 Photograph of port planking and framing from F16 (left) to F13. Scale: 1m.

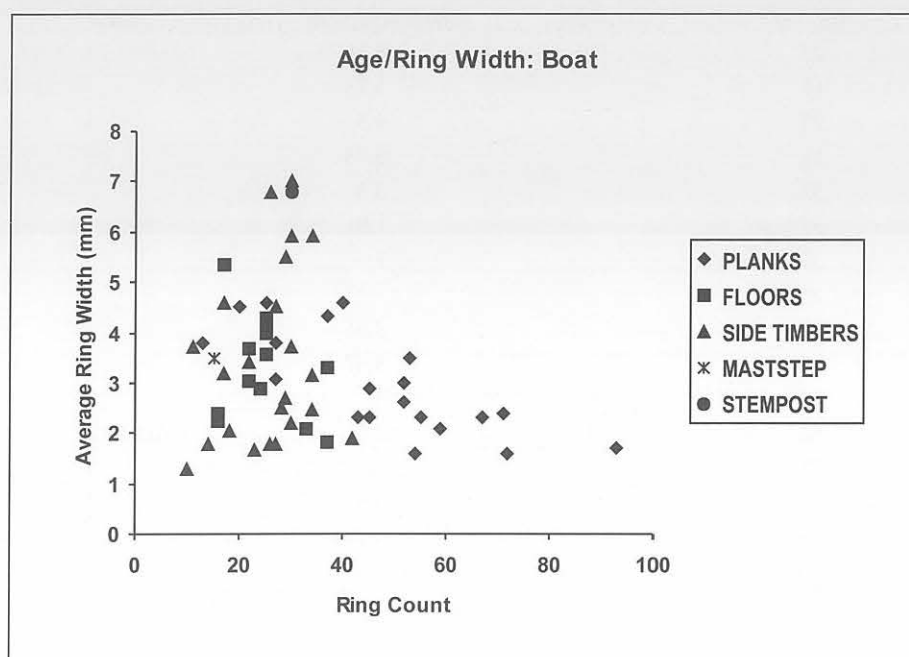
Figure 3.6.2
Average ring widths plotted
against ring count for samples
from selected boat timbers.

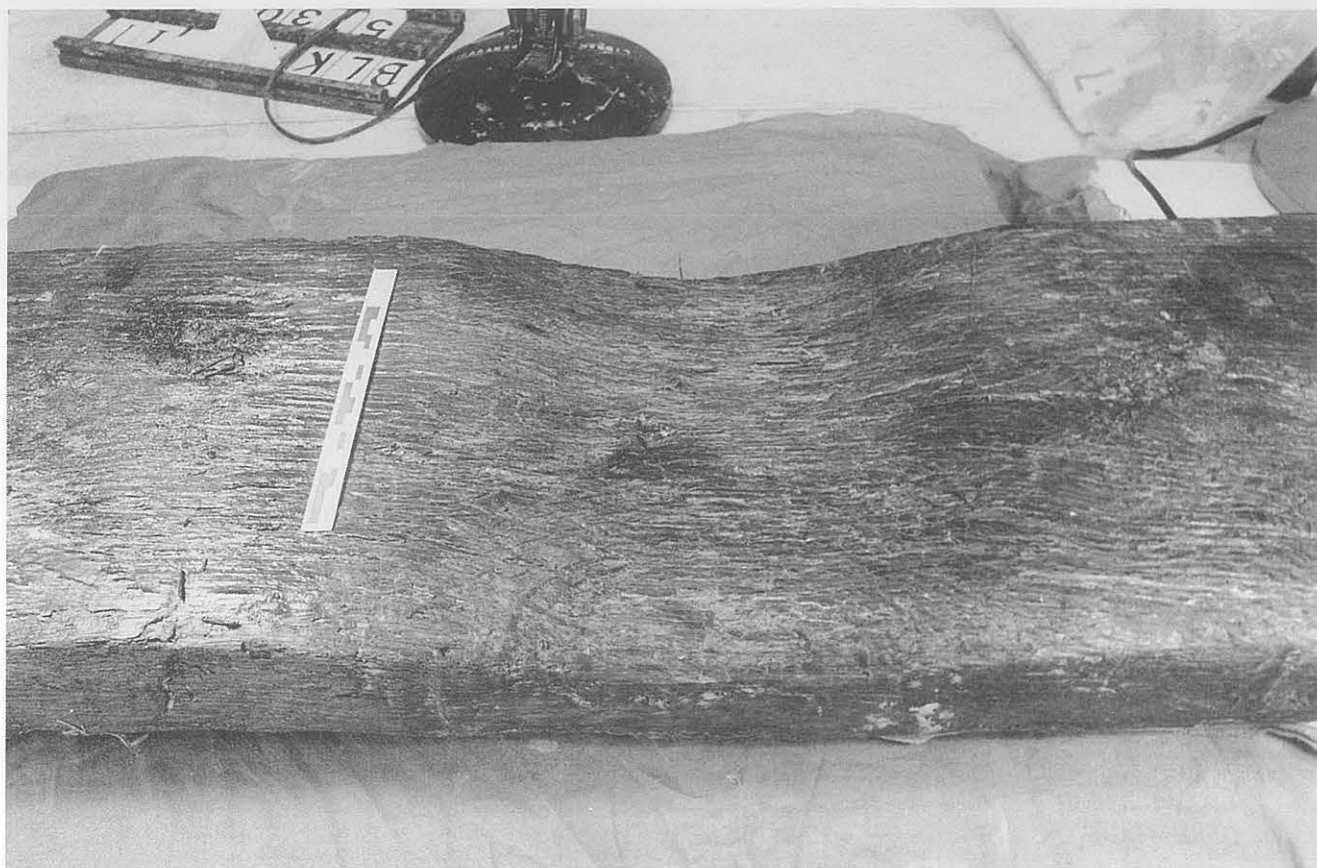
Figure 6.9A Worn area on plank-keel P1 between half-frame F5St and floor F6.

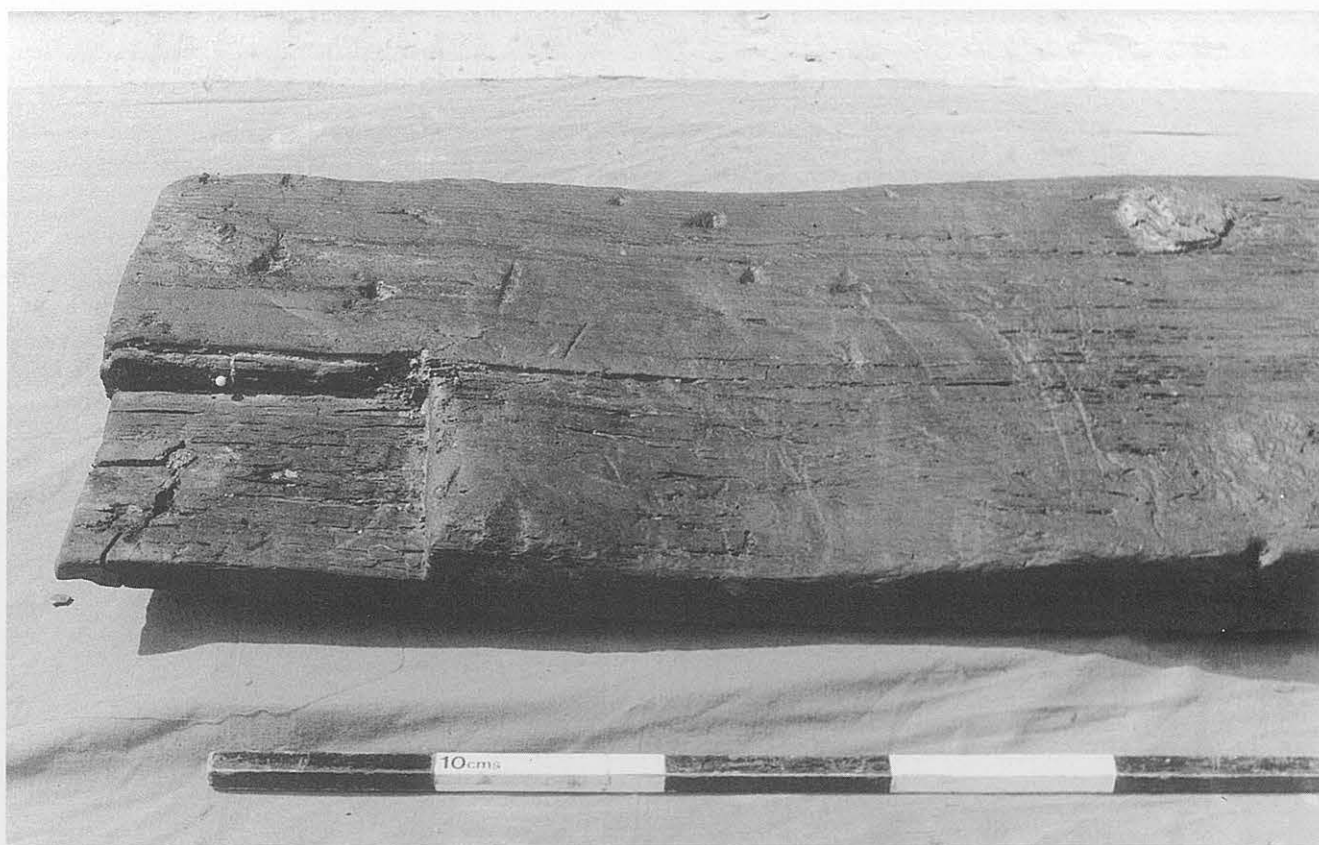
Figure 6.9B Worn area on plank-keel P1 between F16 and F17. The port half of the housing for the stern post is to the left. The missing floor F17 would formerly have been at this station in a double notch joint with the post (see Fig 6.10).

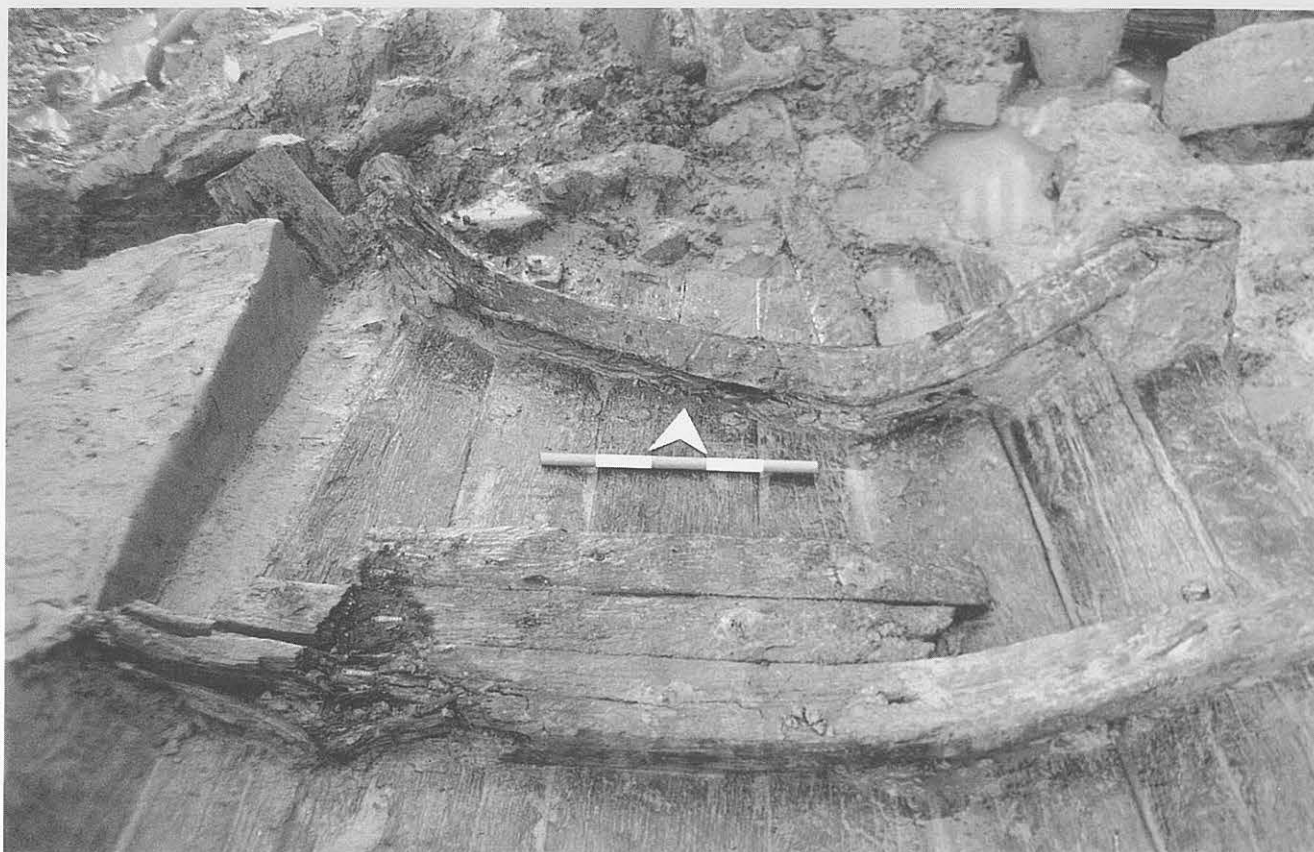
Figure 6.17 Looking aft towards the stone structure. From the bottom of this photograph the timbers are: floor F15; half-frame F15Pt; half-frame F15St; and floor F16.

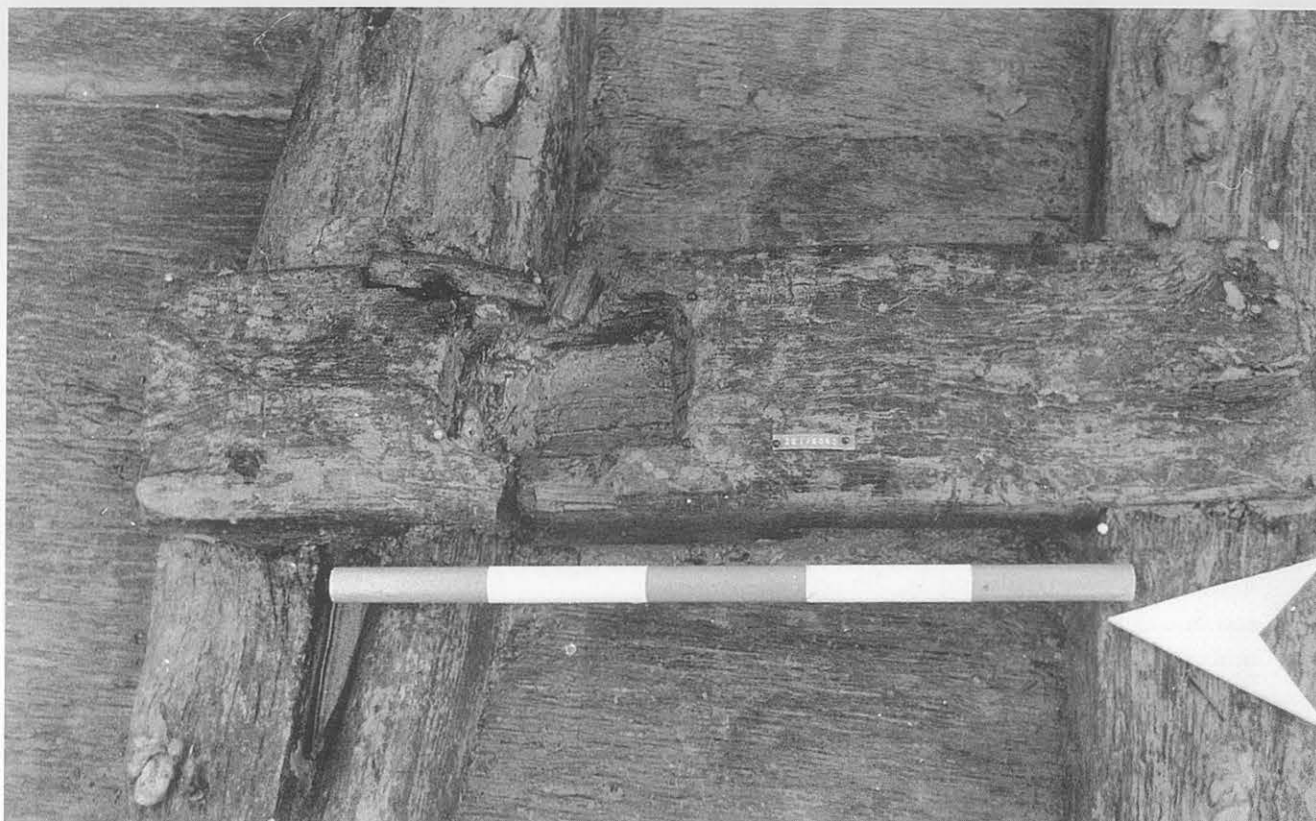
Figure 6.21 The mast-step timber straddling F6 (to the right) and F7Pt and St. The stern is to the left.

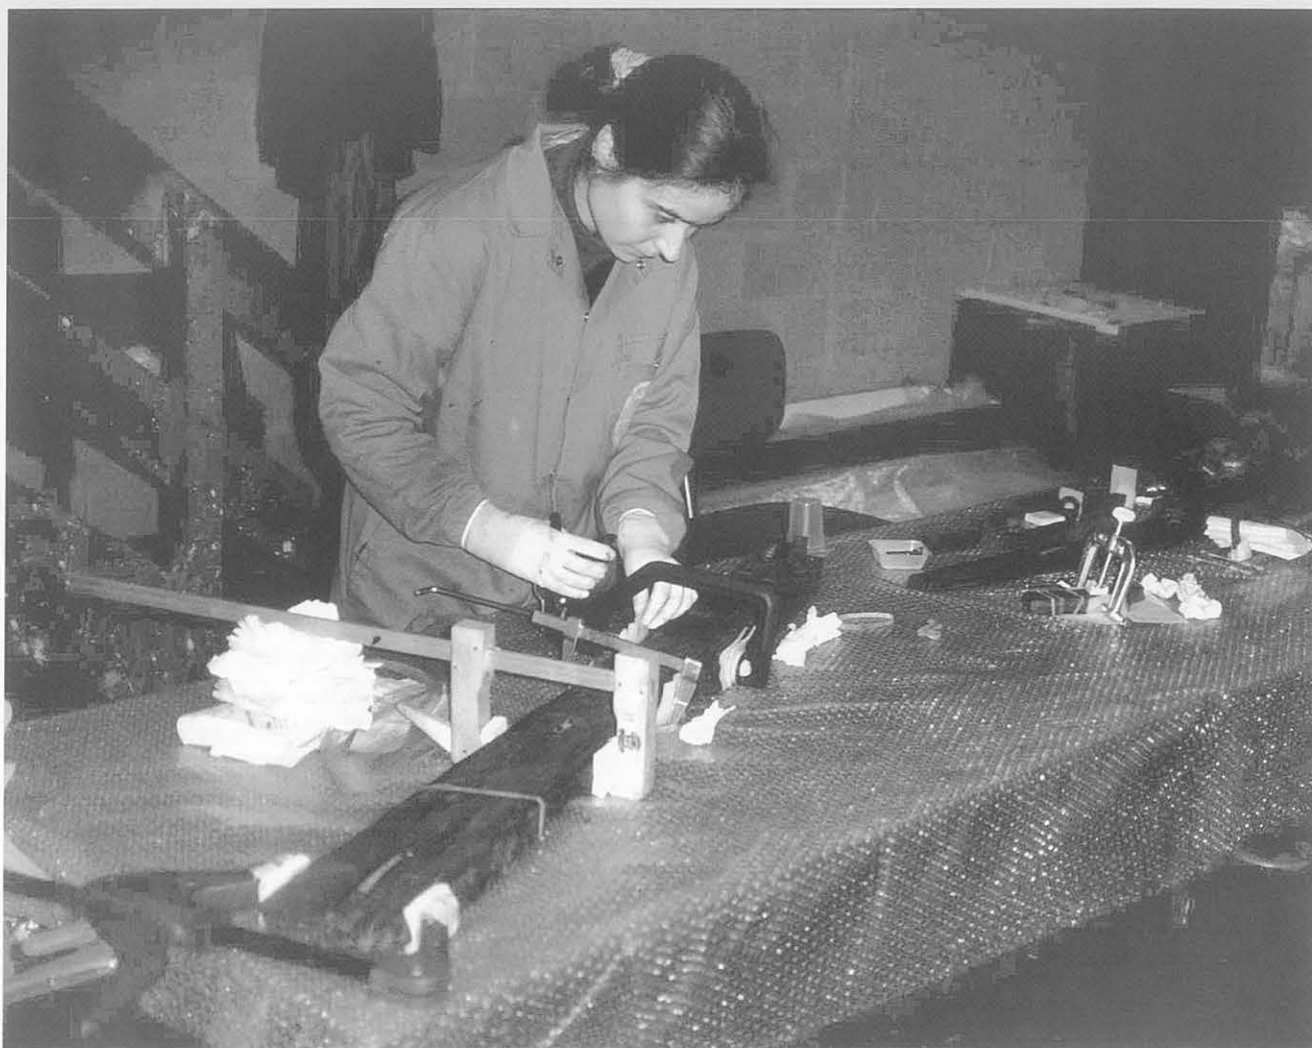
Figure 6.23 Fragmented planking being reassembled after conservation using an epoxy adhesive and a variety of braces and clamps. (Photograph by York Archaeological Trust)

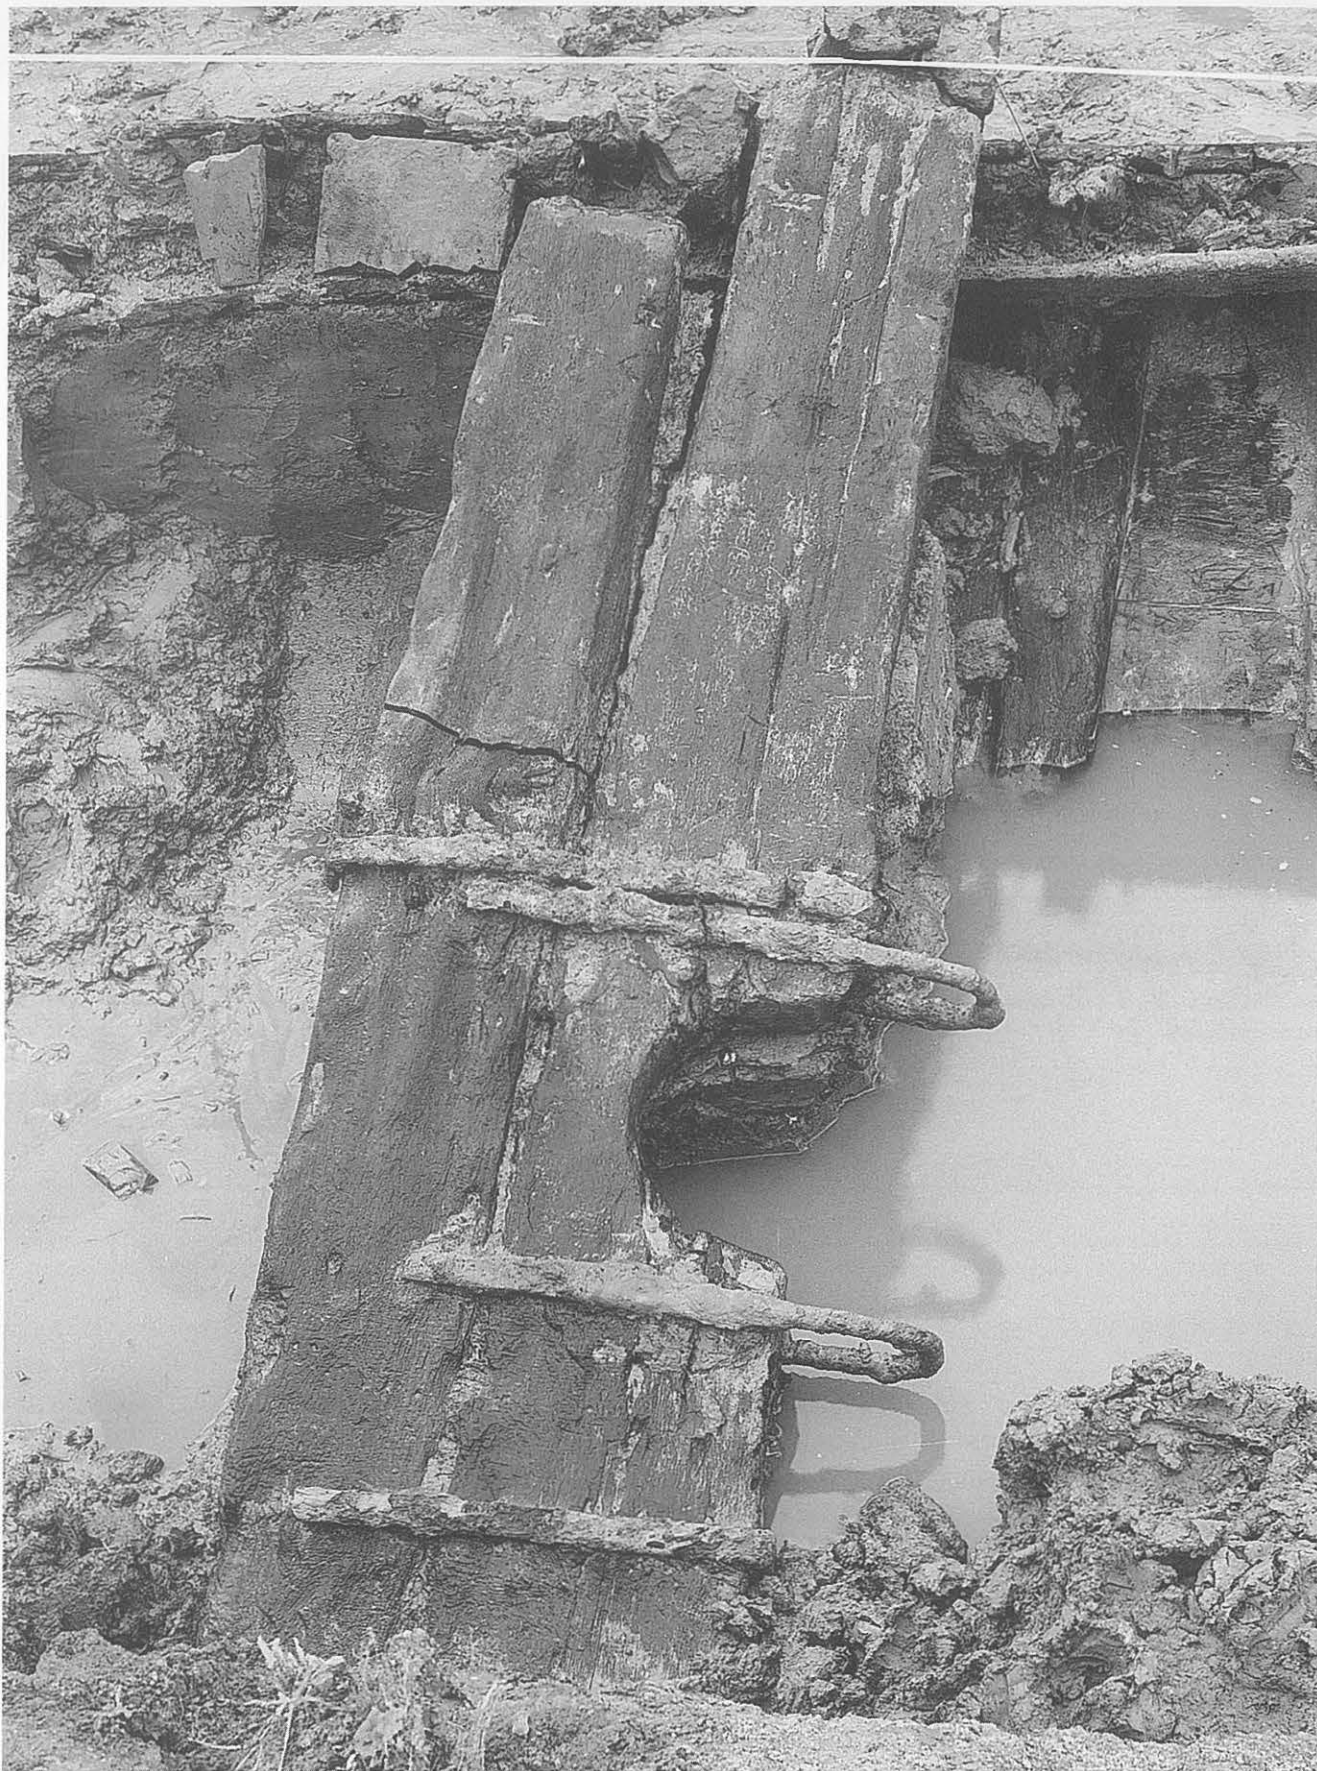
Figure 8.7 The mast beam of Zwammerdam 4. (Photograph by Seán McGrail)

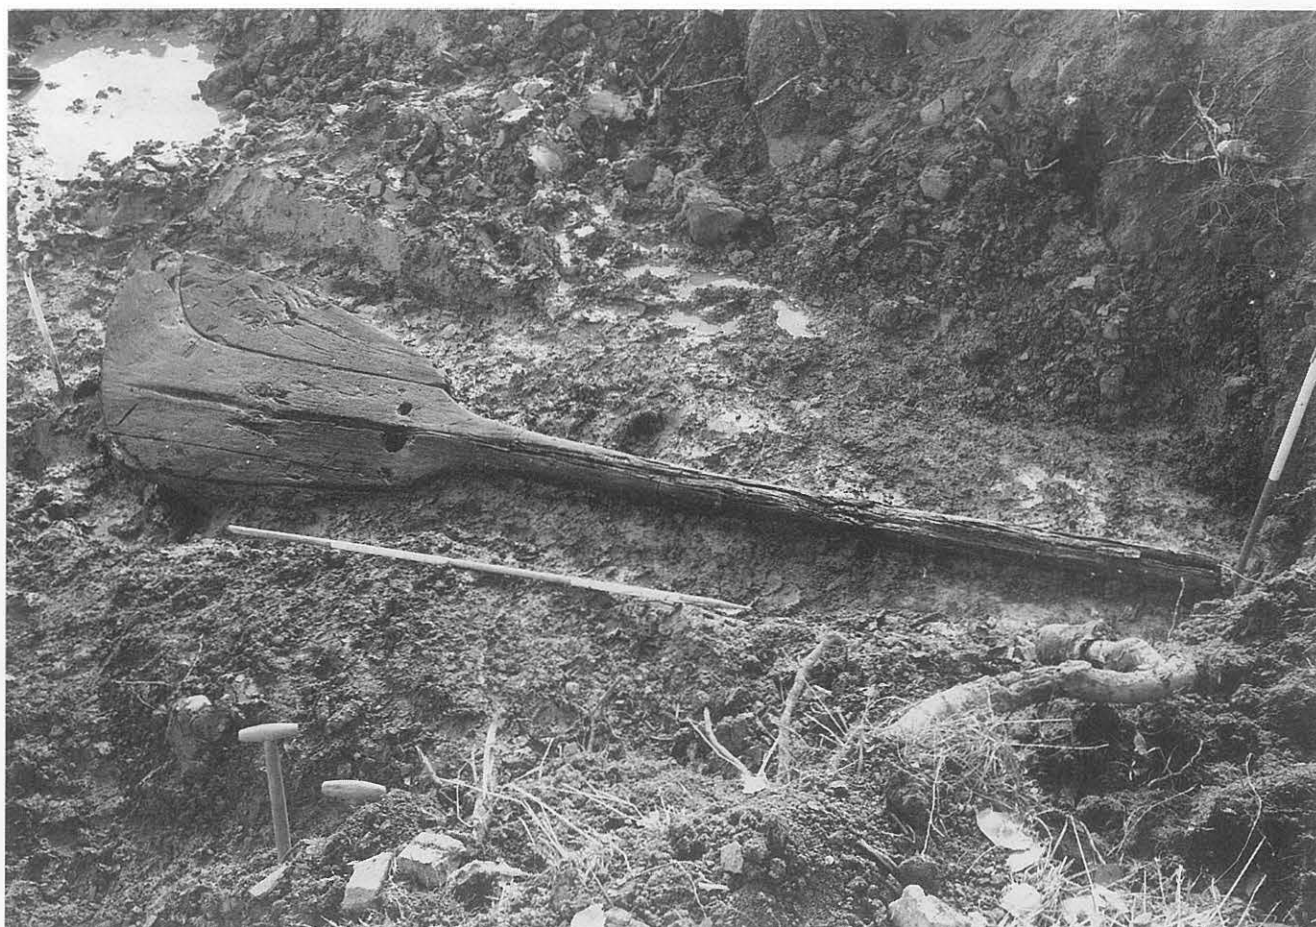
Figure 8.10 The 5.15m-long composite steering oar from Zwammerdam. (Photograph by Seán McGrail)
