# ARCHITECTURE IN ROMAN BRITAIN

Edited by **PETER JOHNSON** with Ian Haynes

**CBA Research Report 94**

**Council for British Archaeology**

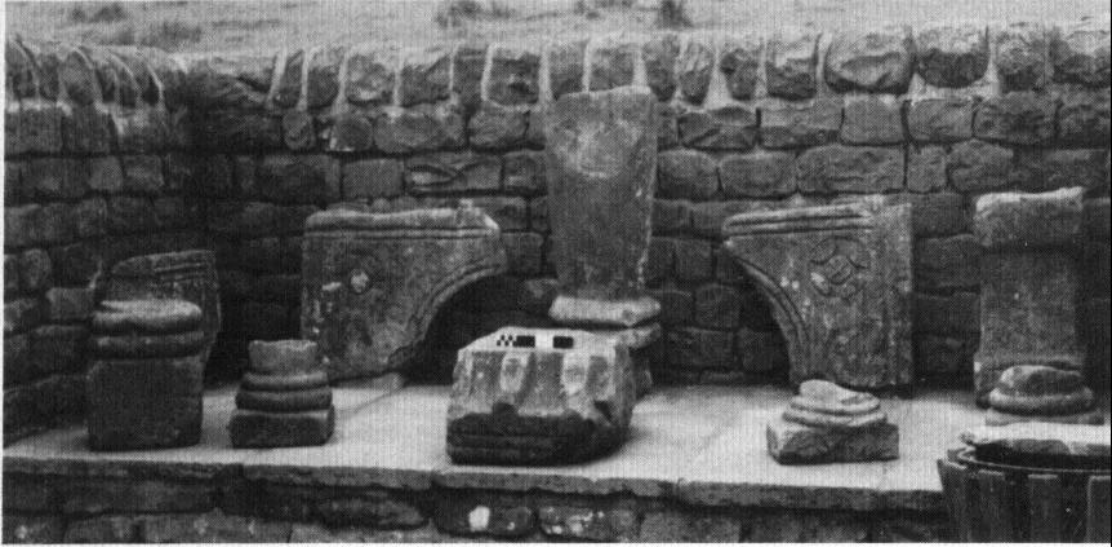
*Fig 2.2 Window heads, cornice and column fragments, Housesteads*

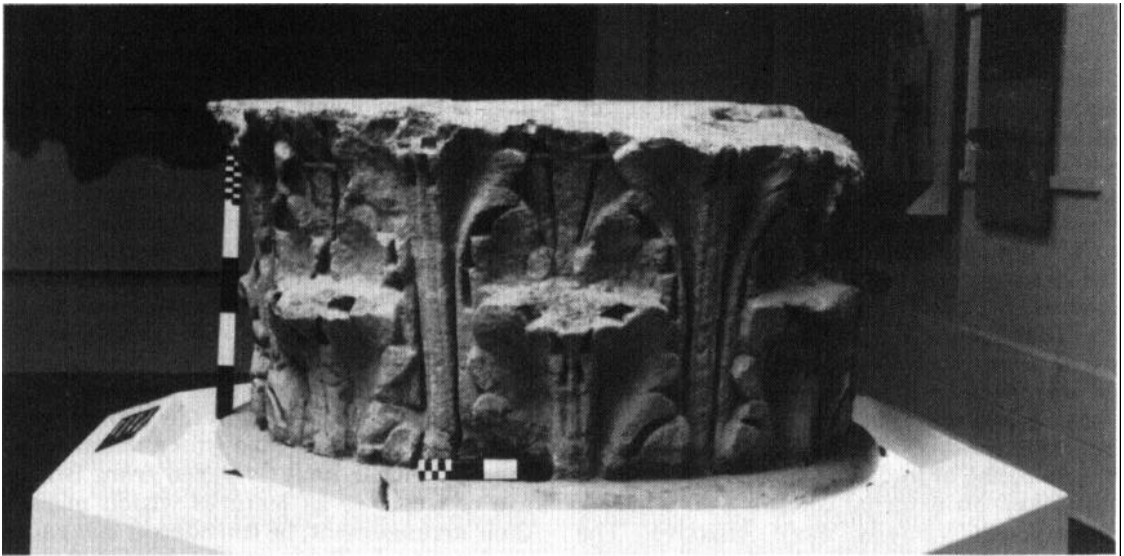
*Fig 2.3 Lower half of Corinthian capital from Cirencester*

Sculptured decoration might appear on two other parts of a building, apart from the columns and pediments already discussed. These are the entablature above the columns, and the wall surfaces. In Britain the Corinthian order is the most common of those which usually carry a decorated entablature (Fig 2.3; Blagg 1977). The nearest that any building in Britain comes to a complete Order is the Temple of Sulis Minerva at Bath, where, in addition to the fluted Corinthian columns and

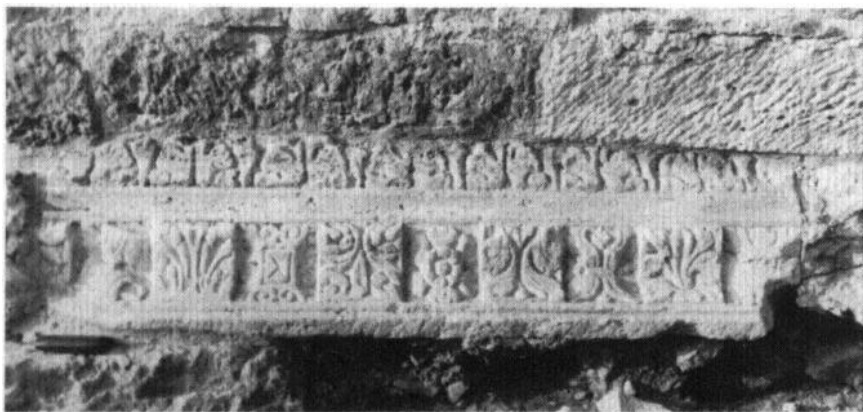
*Fig 2.4 Decorated cornice, Lincoln*

The normal Romano-British type of decorated cornice has projecting brackets alternating with square panels, as on that from *Verulamium*, which probably decorated the stage building of the theatre (Kenyon 1934, 221-2; Blagg 1977, 69), and that from the classical temple at Wroxeter, found with part of the frieze and a Corinthian capital (Blagg 1980b, 32-3). A temple or a funeral monument is the most likely original source for small decorated cornices from Lincoln (Fig 2.4), re-used in the Lower West Gate (Colyer 1975, pl xxxviii, a), and Brixworth, re-used in the Saxon church (Blagg 1978). Figured friezes, such as that of the Dioscuri from Corbridge (Fig 2.5; Phillips 1977, no 52) are uncommon, and fasciated architraves are equally rare. Plain mouldings may have served as cornices above courses of plain dressed masonry or even wooden architrave beams in many cases.

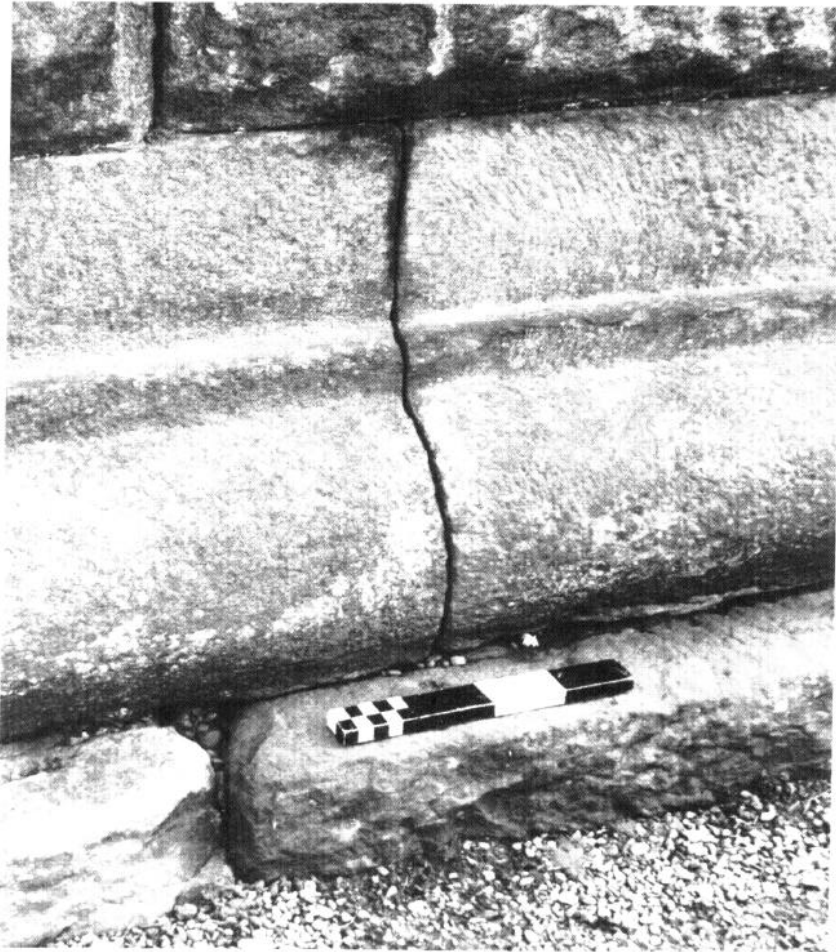
Fig 2.6 Rusticated masonry and base moulding, Building II, Corbridge

Visual contrast was also achieved through stone-carving techniques. Rusticated masonry, ie where the edges of a rectangular block are drafted smooth but the rest of the face is left in its roughed out state, uses what is actually an incomplete state of carving to give an effect of rugged strength, enhanced by the contrast of light and shadow on the uneven surface. On Building 11 at Corbridge, where it contrasts with the chiselled surface of the moulding at the base of the wall (Fig 2.6), the execution is sufficiently careful to show that the effect is intentional. To consider the work to be unfinished (de la Bédoyère 1991, 211, is also to disregard the fact that the masons' chippings of the construction layer were sealed by compacted courtyard gravel metalling (Bishop & Dore 1989, 105).

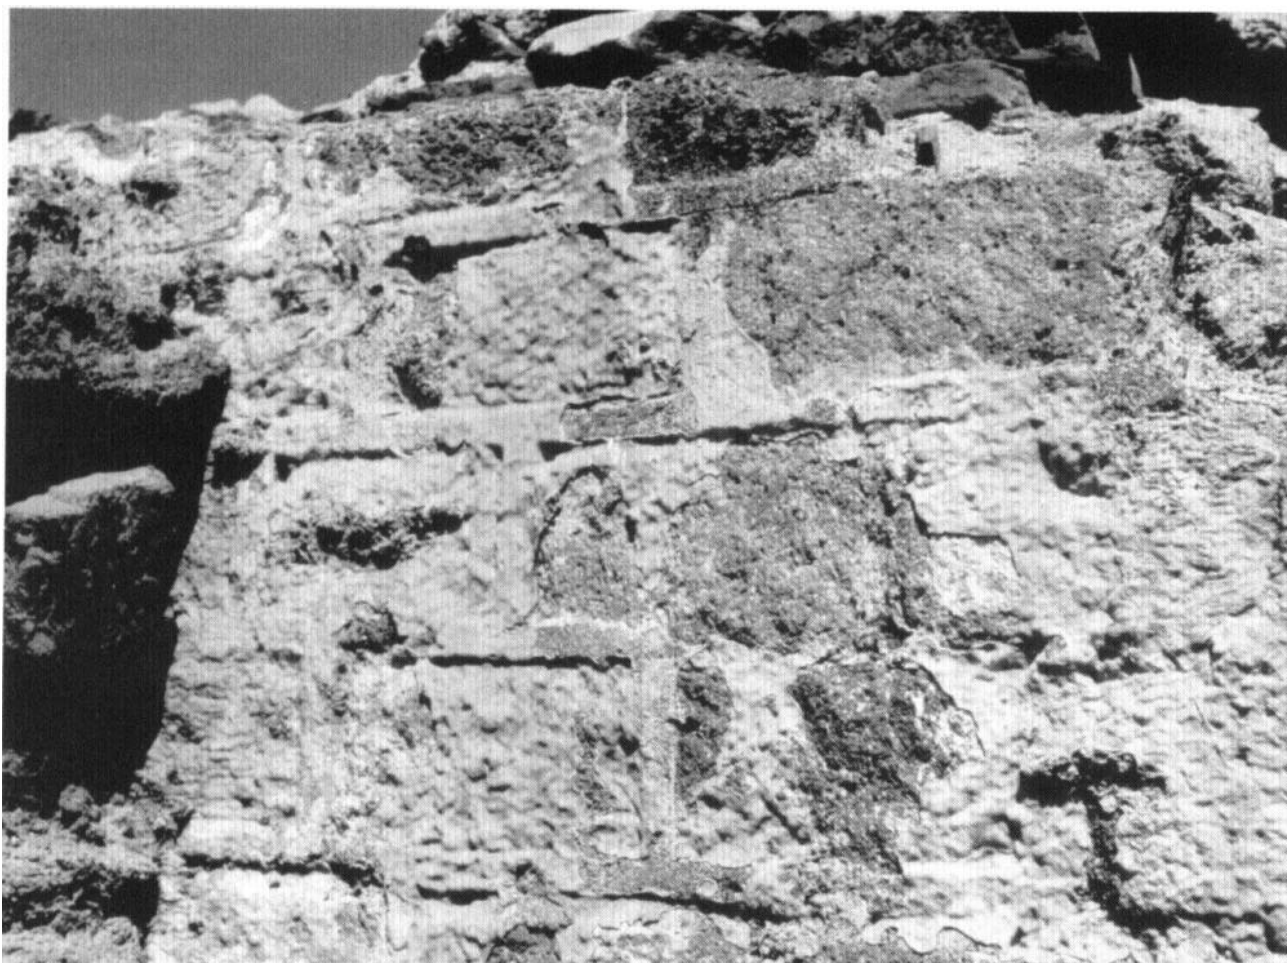
*Fig 3.5 Ribbon pointing preserved under a coating of lime scale in the reservoir of the Baths of Caracalla at Ankara. The facing stones are about 150mm in height*

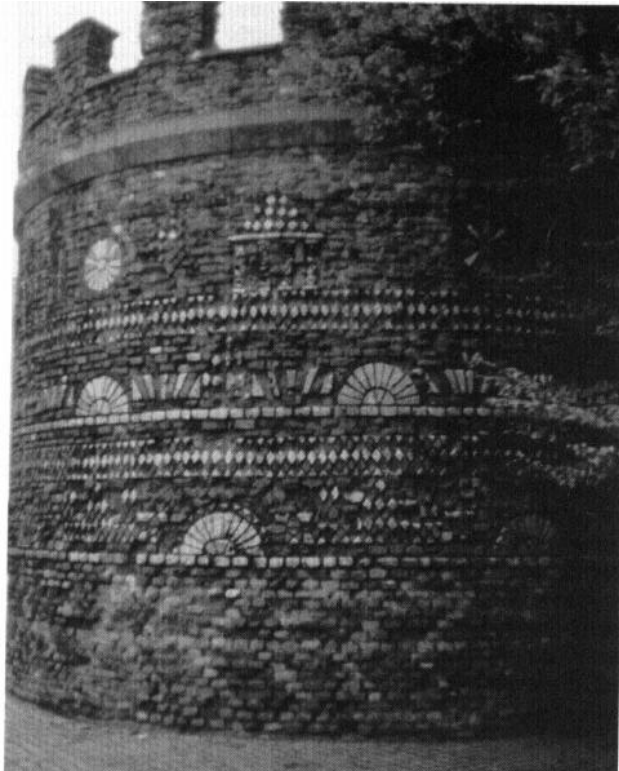
Fig 3.7. The Römerturm, a tower on the Augustan city wall at Cologne

the Roman world. The best known and most elaborate example is the *Römerturm* at Cologne, a circular tower forming part of the late Augustan defences of the *colonia* (Fig 3.7; Hellenkemper 1975, 789). Roundels, lunettes (Fig 3.8, 7), triangles formed by a pattern of lozenges (Fig 3.8, 2), bands of diapering, chevrons, and columns supporting pediments (Fig 3.8, 4) are picked out on the exterior surface of the tower in white, grey, red and buff facing stones.

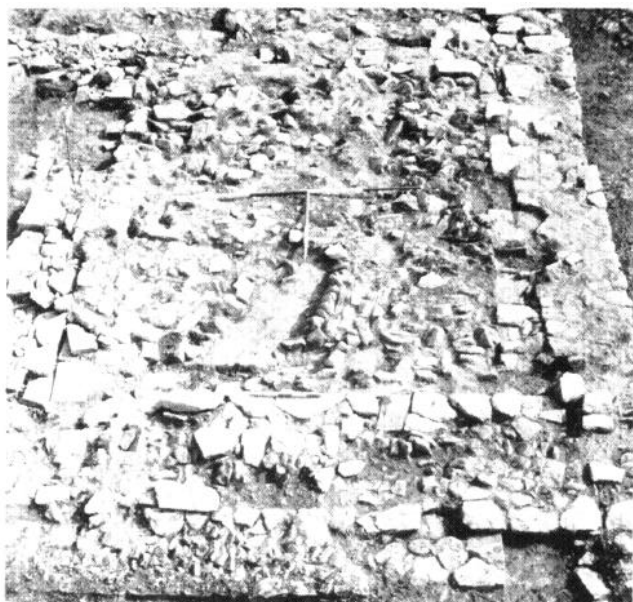
Fig 5.6 Redlands Farm, Northants: view of the hypocaust room showing collapsed masonry filling the cellar. Note the intact courses just below the centre of the photograph

century onwards. Most of the rooms in the building were covered with rubble characteristic of the gradual decay of masonry over a long period of time. In the hypocausted room, for instance, the rubble filled most of the cellar and had destroyed most of the *pilae*. There was one crucial exception: an intact panel at the south-east corner of the room collapsed inwards (Fig 5.6), with its painted wall plaster still *in situ* (see Fig 5.5). This panel seems to represent the full height of the room, although there are interpretational problems concerning roof configuration and fenestration if this is so (see below).

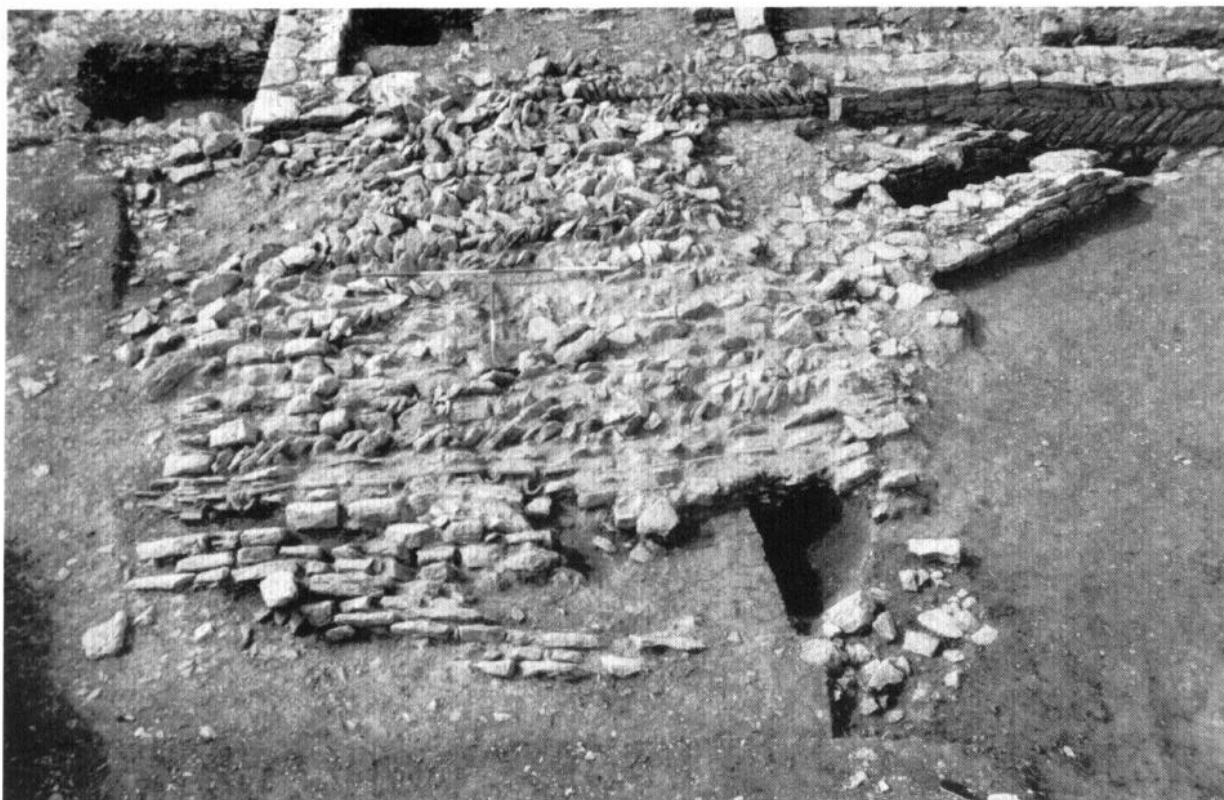
*Fig 5.7 Redlands Farm, Northants: detail of the collapsed gable wall of the villa's east wing*

Finally, the roof pitch of c 22.5° is again derived from the direct evidence of the gable wall. The progressive narrowing of the courses in the gable corresponds exactly to this pitch. The completeness of the masonry makes it unlikely that much, if any, of the roof line is missing. The roofs were tiled, with *tegulae* and *imbrices*. These were held in place by a combination of gravity and their interlocking construction, while some of the *tegulae* had nail holes bored through after firing. A pitch of 40° has been suggested by Brodribb (1987, 10) as a technical possibility, and a Roman building at Carsington,

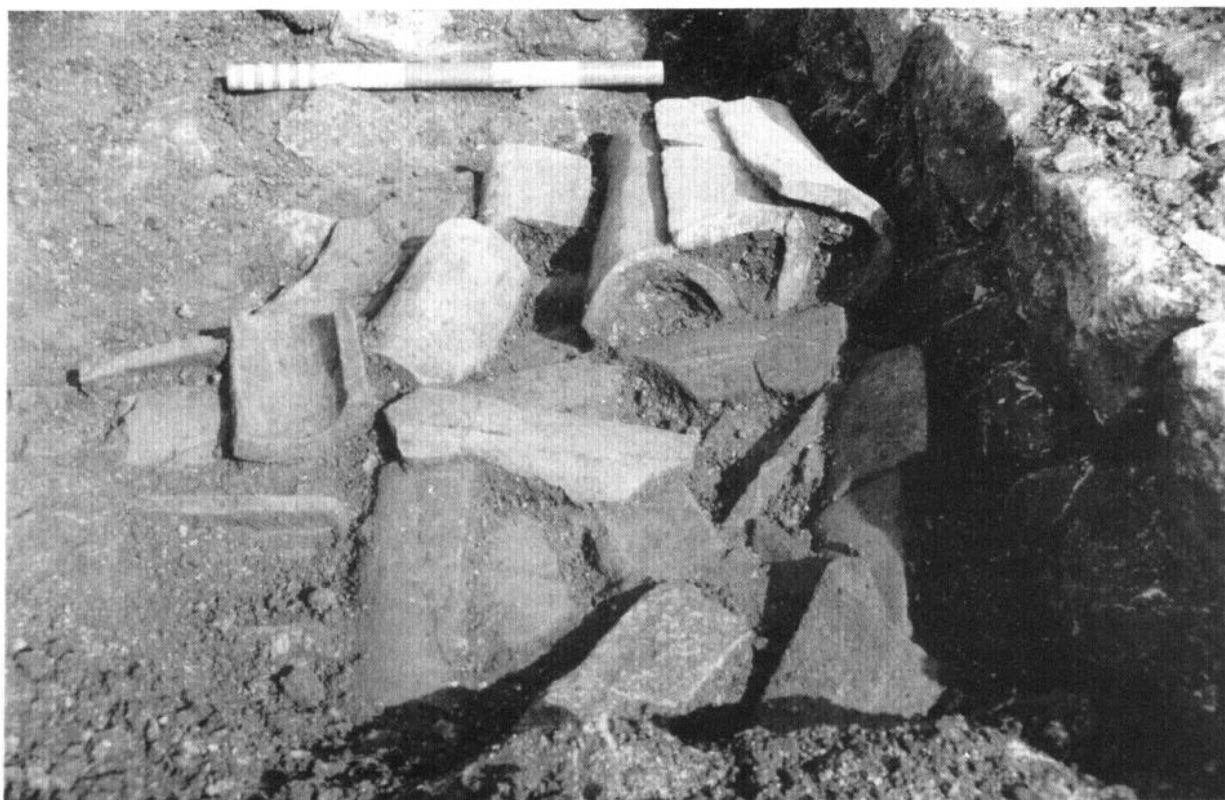
*Fig 5.8 Redlands Farm, Northants: imbrices stacked in the rear corridor of the villa*

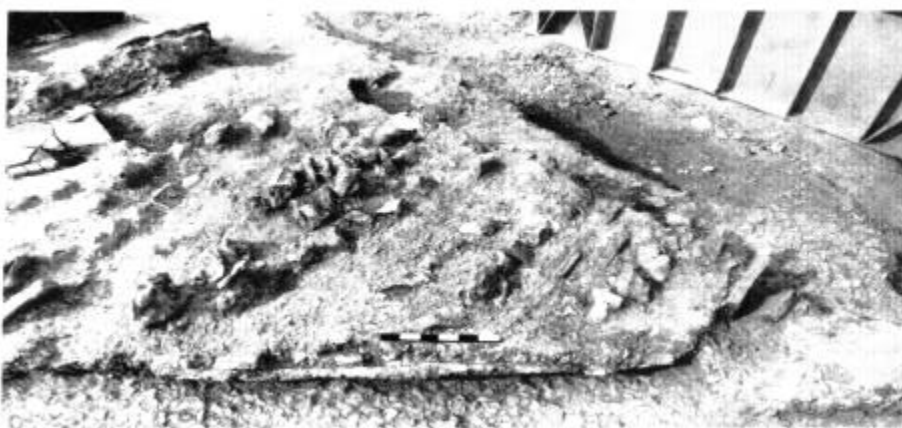
Fig 6.7 Meonstoke: the gable line of the roof of the nave, viewed from the south

projecting tile cornice running the width of the wall (Fig 6.7). It projected *c* 0.20m from the wall, and was constructed at an angle of *c* 30°. A single course of *tegulae* and *imbrices* formed the uppermost layer of the cornice (King & Potter 1990, Fig 71, arranged so that the backs of the tiles were mortared into the wall and their fronts projected down to clear rain-water from the windows and walling immediately below. The tiles were supported by projecting horizontal stone tiles, also mortared into position.

One of the best-preserved features in the mortar lines of the upper part of the gable was the roof line itself. This was represented by a layer of mortar c 40mm thick with a smooth outer surface, which presumably must originally have been the mortar rendering that sealed the top of the wall (Fig 6.7). Its outer surface would have carried the tiles that overhung the gable, but these had not survived *in situ* and may have fallen off some time before the collapse of the wall. The main importance of the survival of the roof line is the evidence it yields for a steep roof pitch; 47/48° from horizontal, thus giving an apex angle of just under 90°. The significance of this will be discussed below.

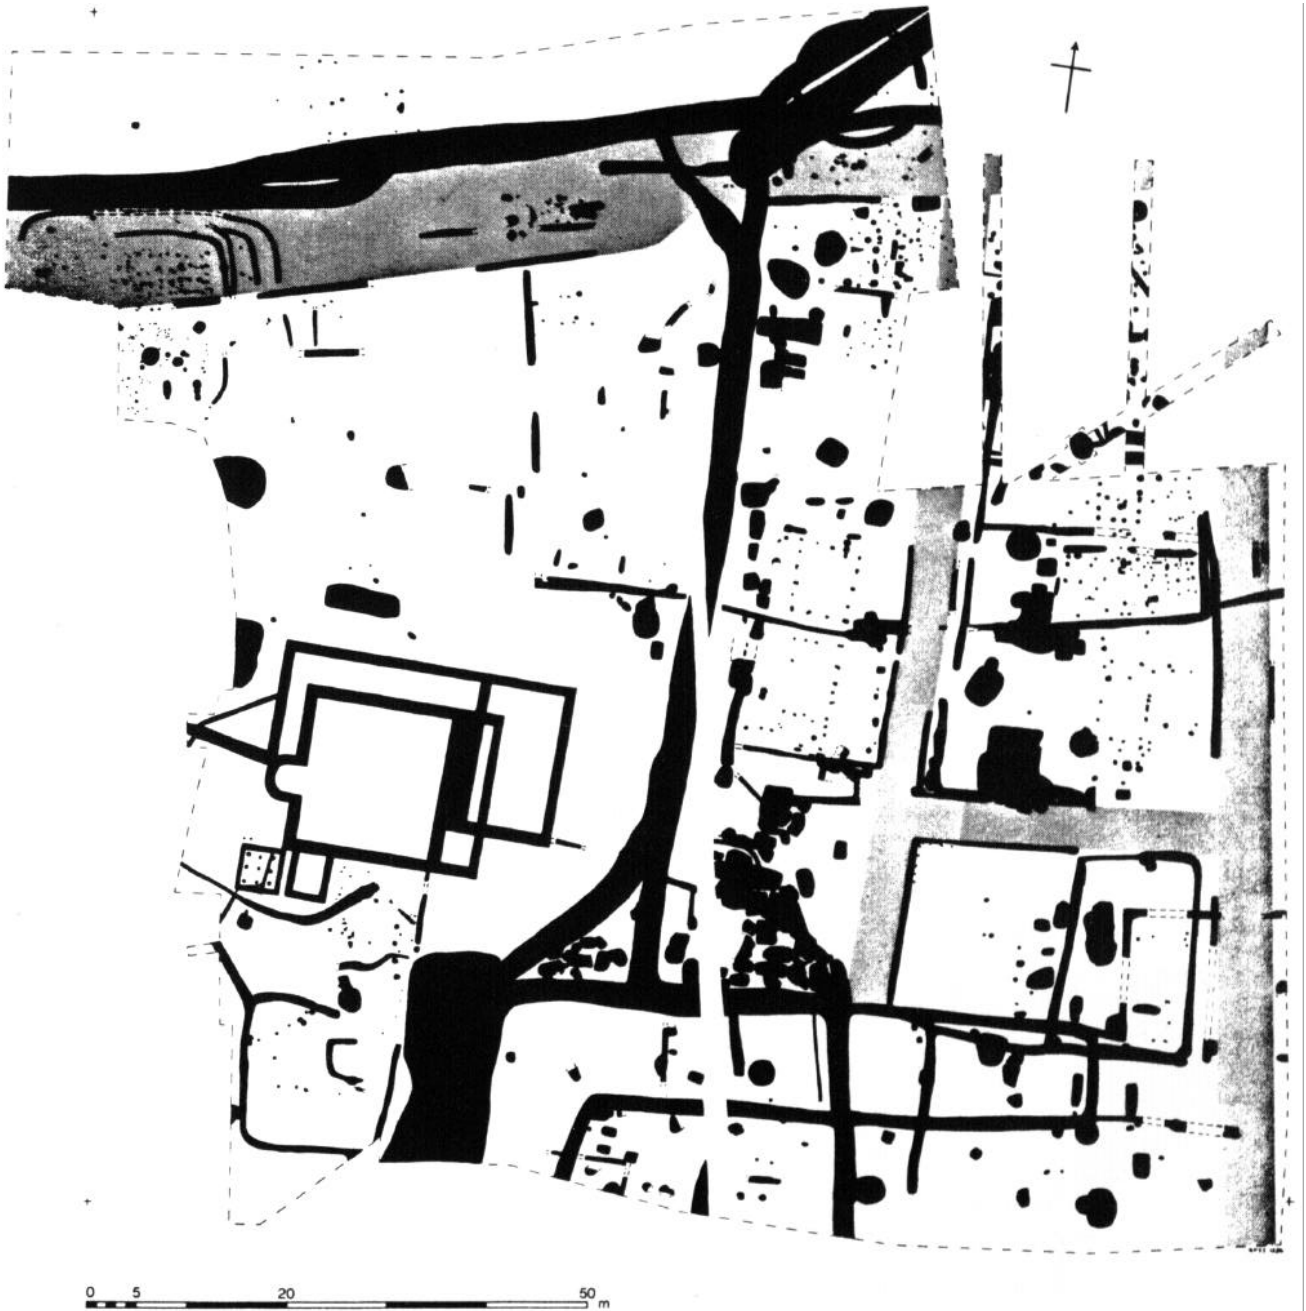
Fig 7.1 General plan of the main area excavations, showing features of all phases (S Crummy)

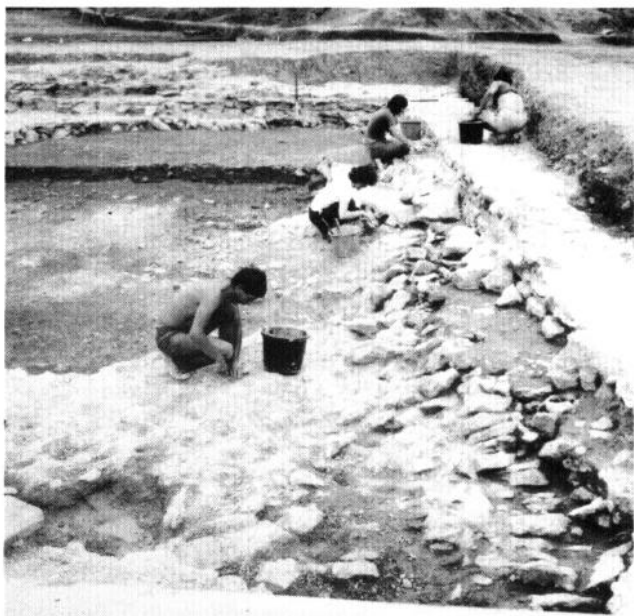
Fig 7.3 Excavation in progress upon the east side of the stone building

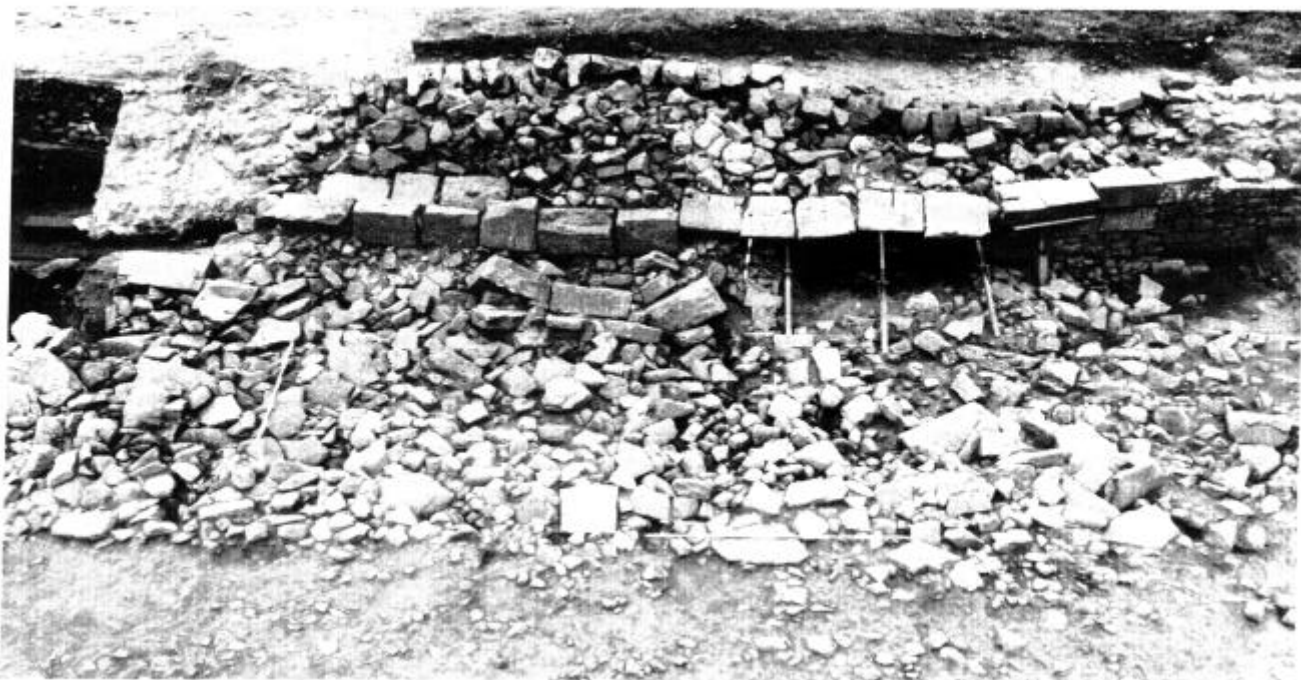
*Fig 9.3 Intact panel of the collapsed east wall of the fort*

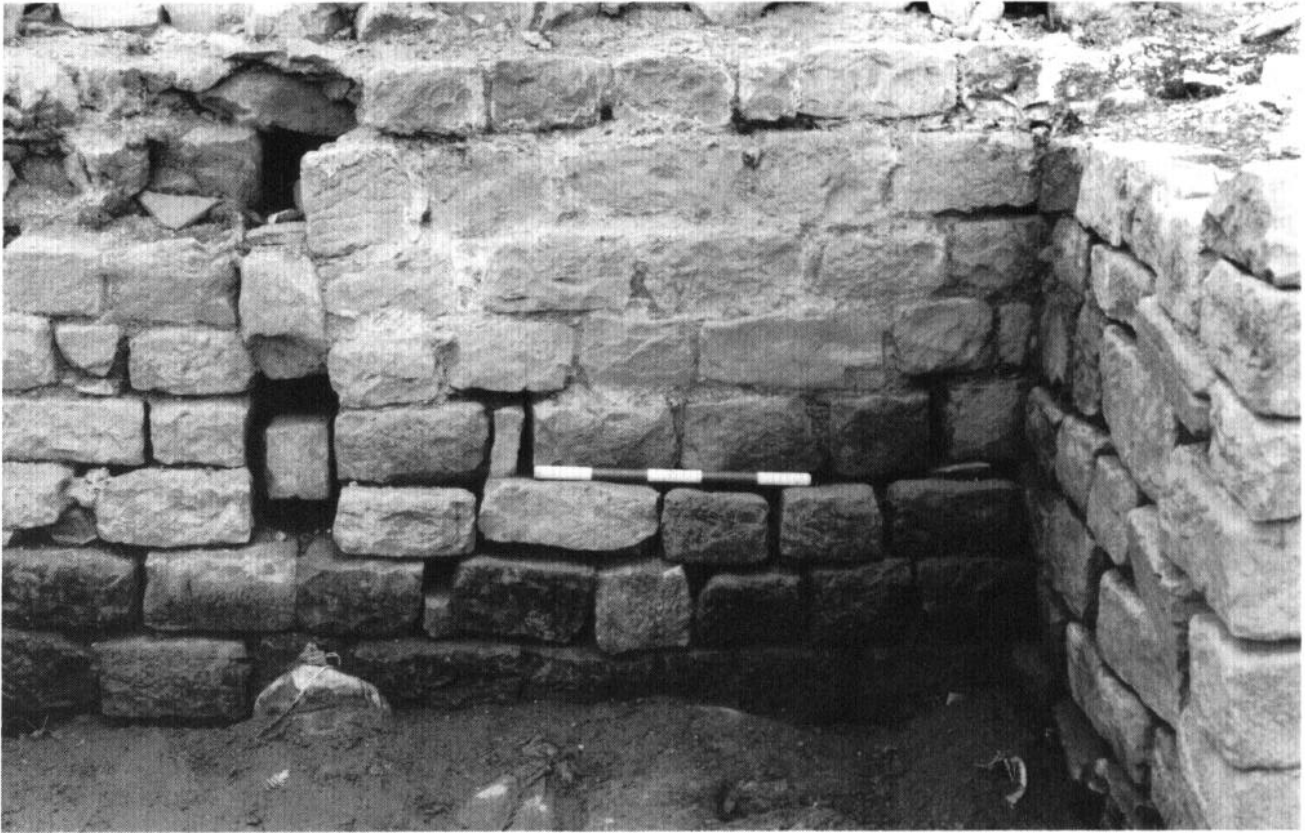
Fig 9.8 Roman pointing on the south wall of the south horreum

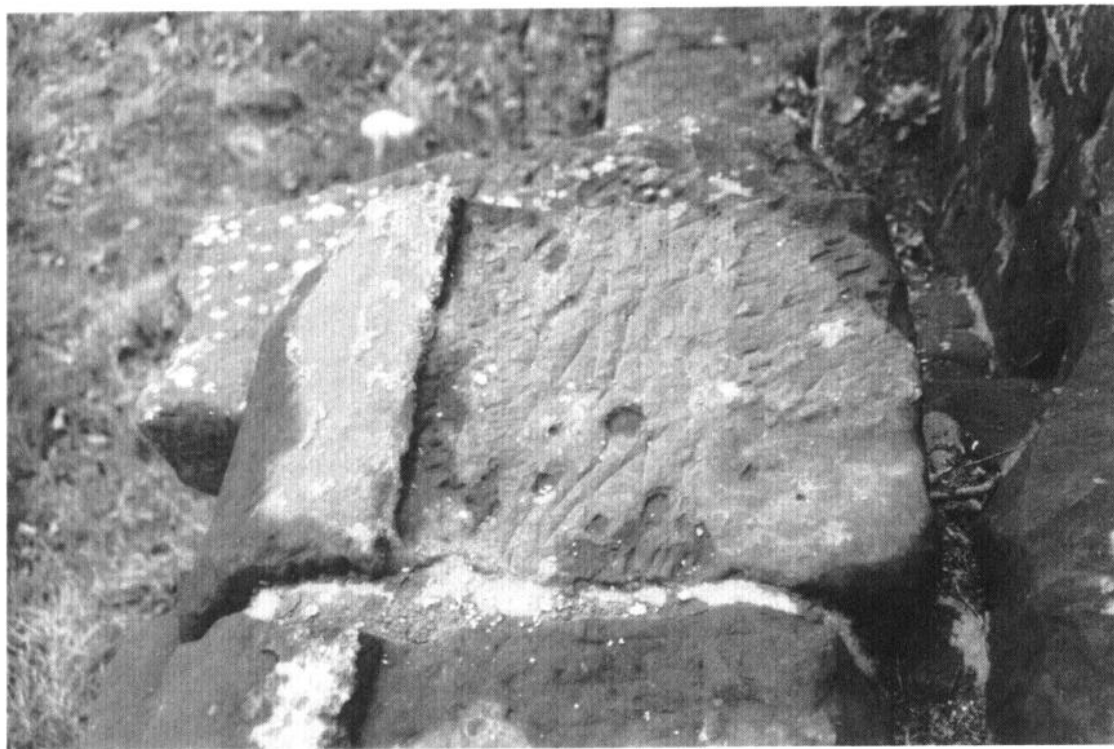
*Fig 10.12 Detail of the cornice and parapet rebate-structure restored west of the North Gate, Chester. Note the rebate-block with tooling to suggest the former existence of a traverse at that point*

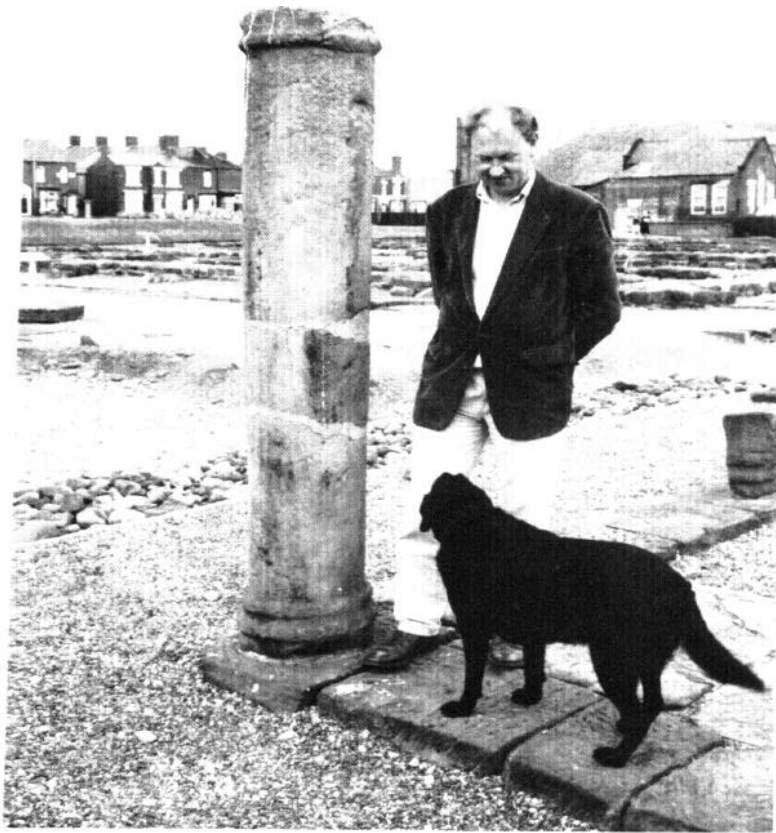
Fig 10.18 Restored 'Chester barrack-type' column in the principia at South Shields

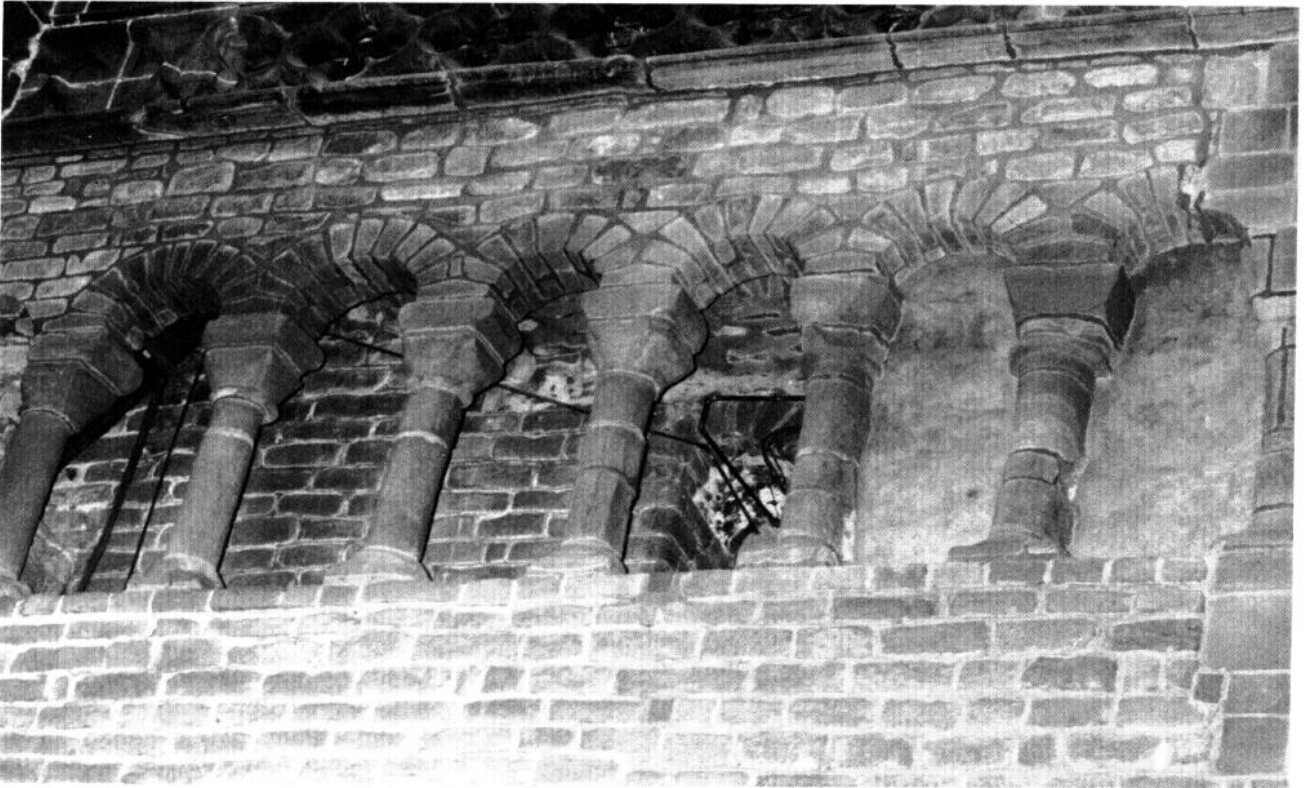
Fig 10.19 Part of the Norman fabric of Chester cathedral showing re-used legionary barrack veranda colonnade capitals (first and second from the right) and probably also re-used column drums and petit appareil

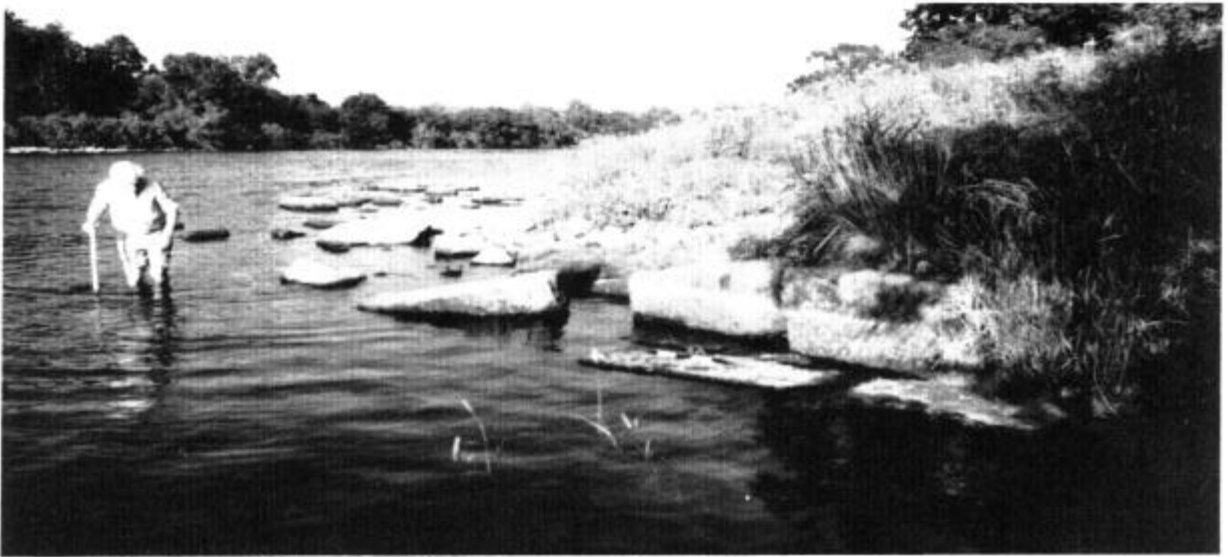
*Fig 11.4 Stones of the southern abutment at Corbridge (N Hodgson)*

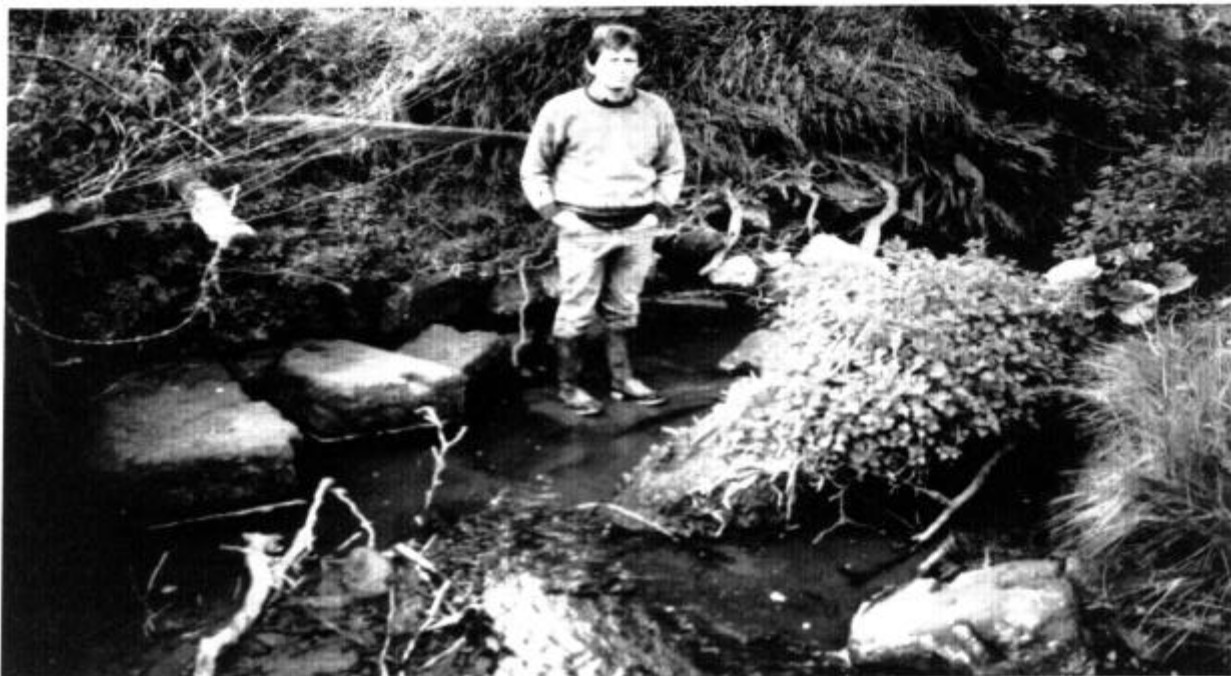
Fig 11.5 Blocks with dovetail-clamp sockets from the bridge at Risingham (N Hodgson)

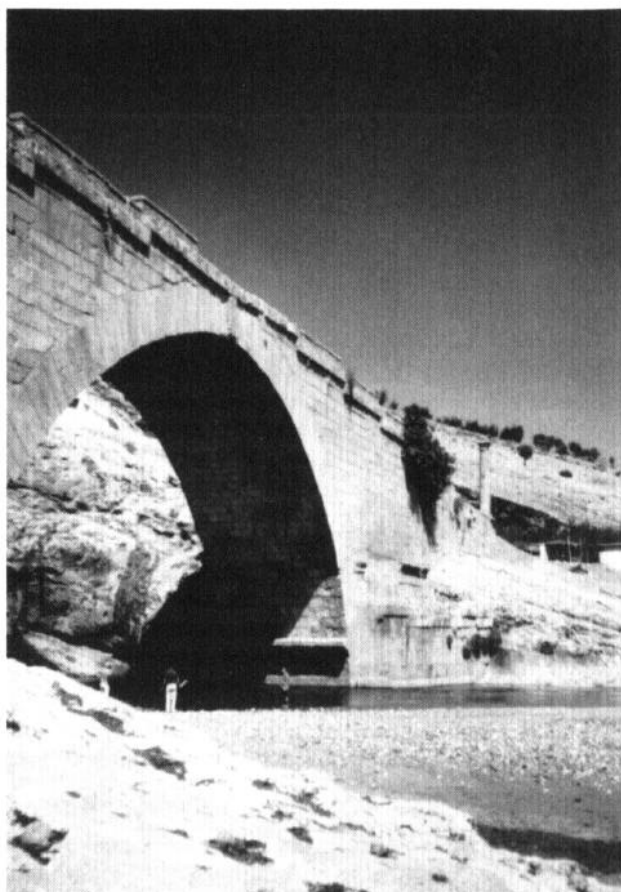
Fig 11.8 The Roman bridge at Cendere (Turkey). Note the column and parapet (N Hodgson)

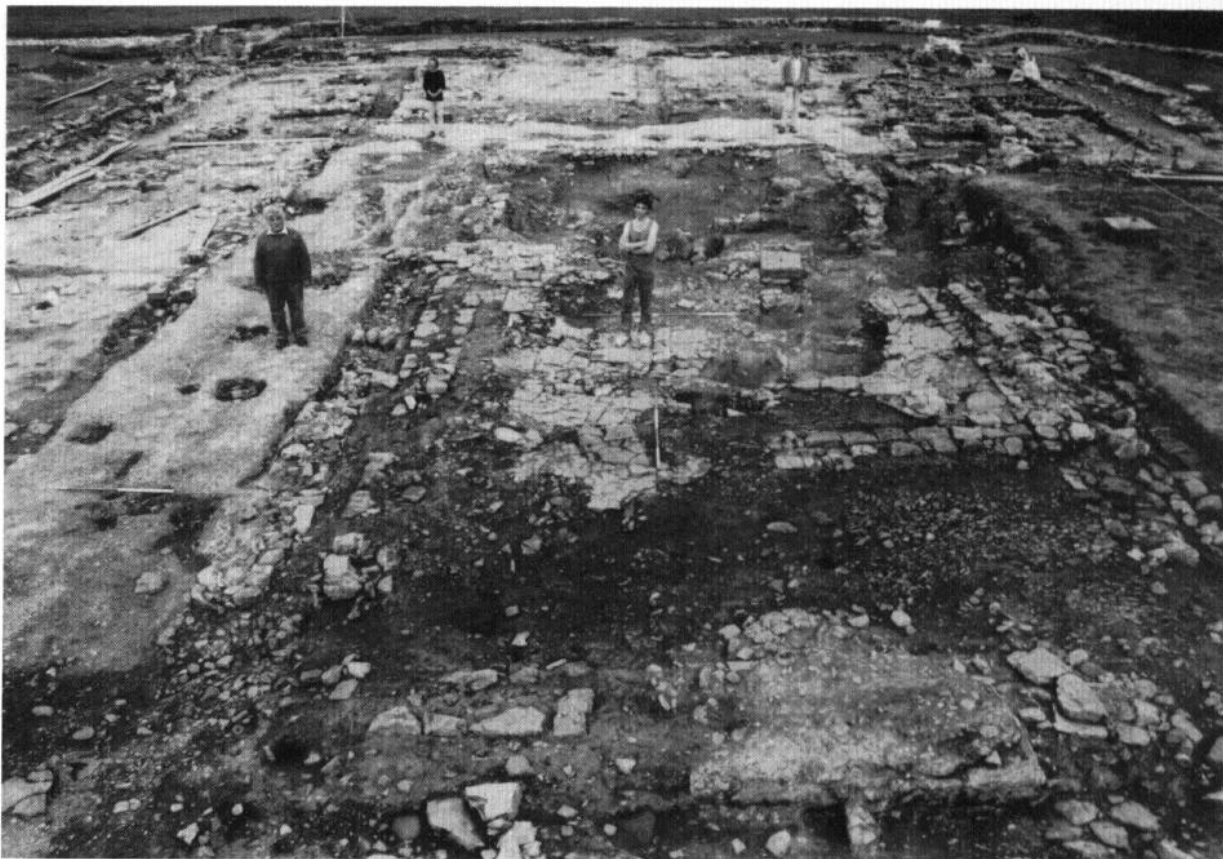
*Fig 12.4 View north-east along central courtyard, with mortar floor of portico on north-west and north-east sides. Scales with 0.50m divisions*

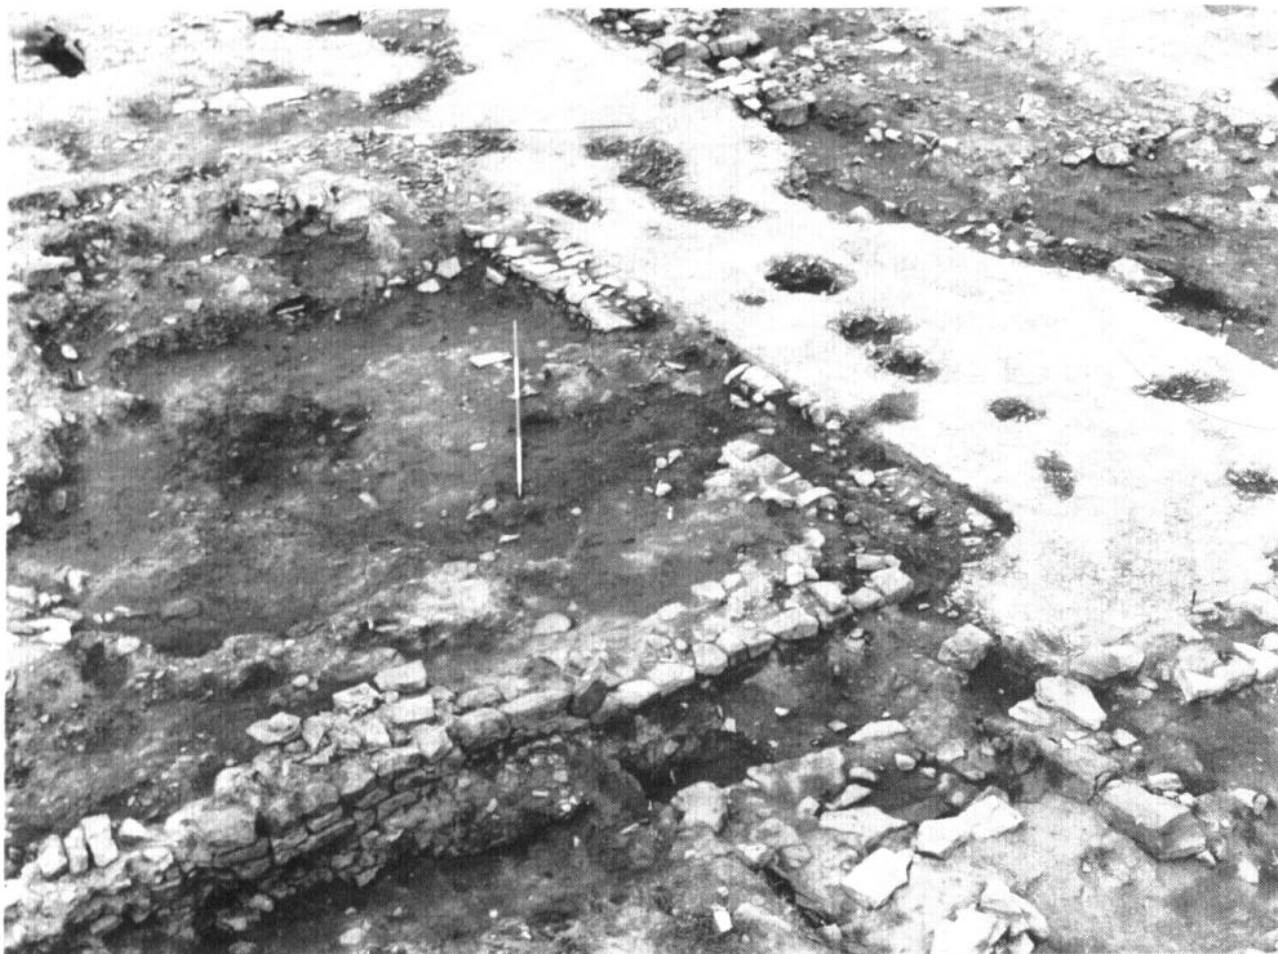
Fig 12.5 Mortar floor of north-east portico. Scales with 0.50m divisions

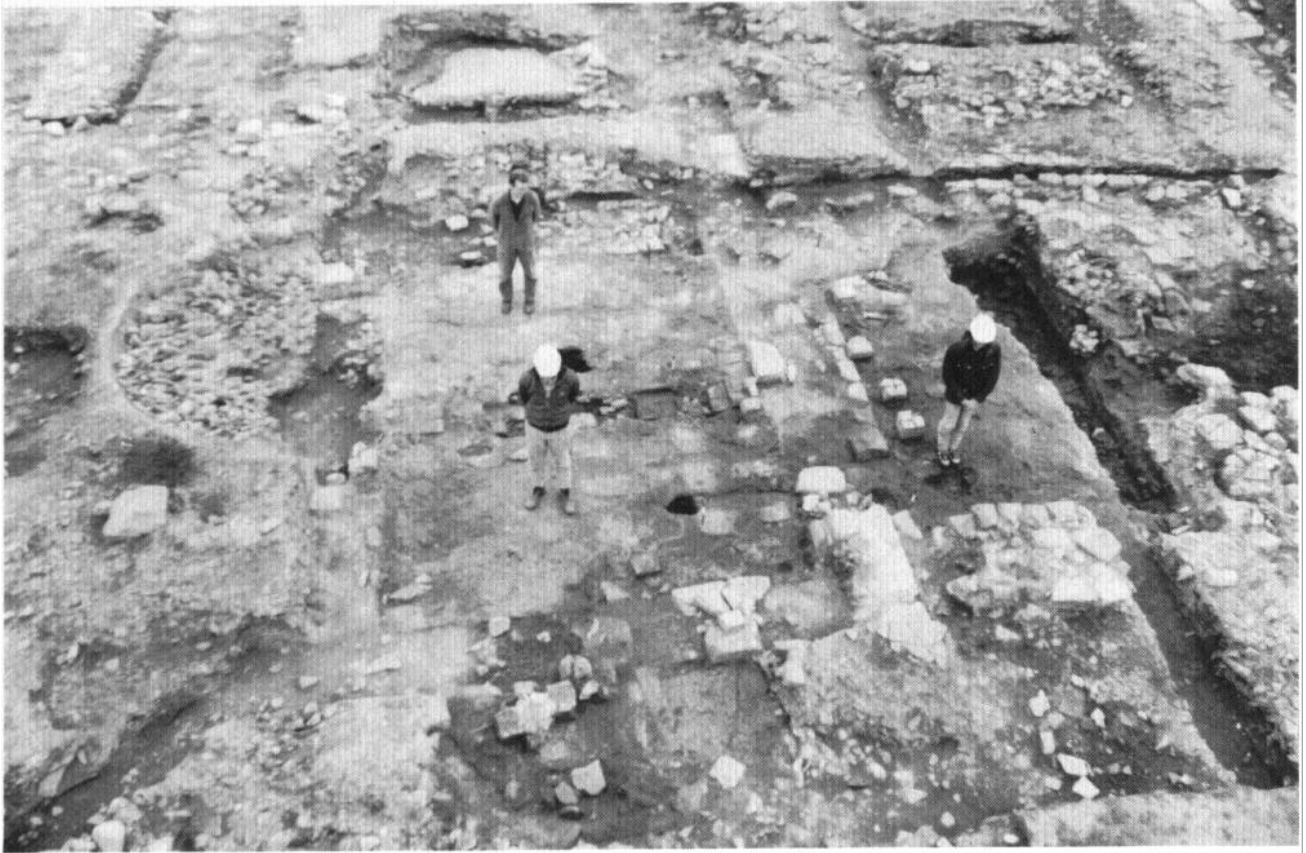
Fig 12.7 The baths after excavation, looking north-east
